Facility Condition Assessment Report

DeKalb County School System1701 Mountain Industrial Blvd
Stone Mountain, GA 30083

Avondale Stadium Facility Executive Summary ReportReport Date: 24 Jun 2011

COMET4 Survey Report Avondale Stadium Detailed Facility Needs Assessment Report

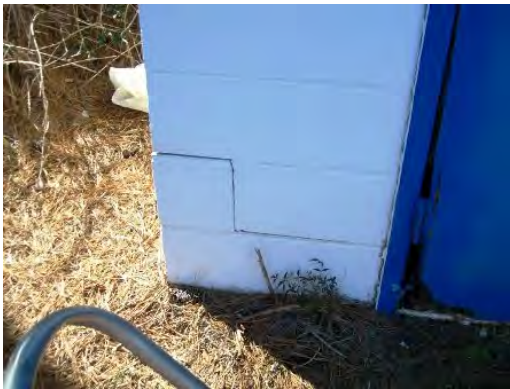
Assembly: **B2010**
System: **Exterior Walls**
Material: **Engineering Study for Exterior Walls**
Distress: **Needs Remediation**
Category: **Safety**
Correction: **Study analyze and develop solution**
Note: **The exterior walls have observable cracks that should be studied by a professional engineer. Pricing does not include remediation measures.**

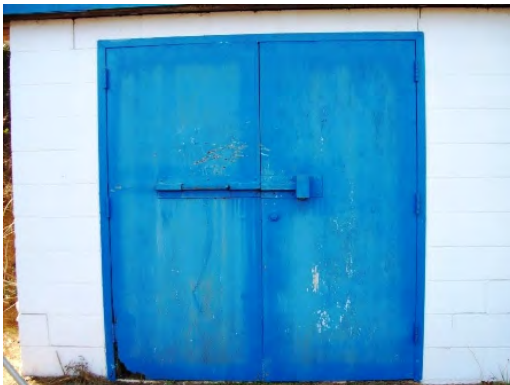
Assembly: **B2030**
System: **Exterior Doors**
Material: **System**
Distress: **Beyond Service Life**
Category: **Deferred Maintenance**
Correction: **Renew System**
Note: **The original metal exterior doors are aged, rusted, and damaged, and should be replaced.**

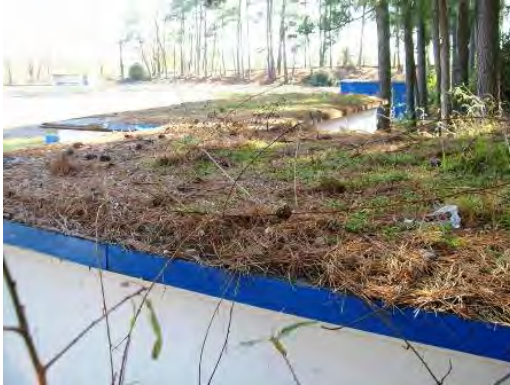
Assembly: **B3010**
System: **Roof Coverings**
Material: **System**
Distress: **Beyond Service Life**
Category: **Deferred Maintenance**
Correction: **Renew System**
Note: **The built-up roofing is aged, worn, and has heavy vegetation on it, and should be replaced.**

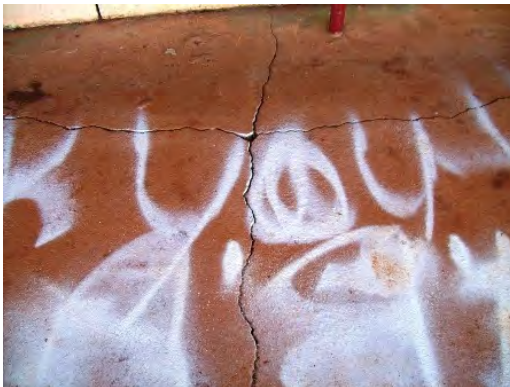
Assembly: **A1030**
System: **Slab on Grade**
Material: **Engineering Study for Foundations**
Distress: **Needs Remediation**
Category: **Safety**
Correction: **Study analyze and develop solution**
Note: **Differential settlement was observed throughout the dugout and an engineering study is recommended to determine the cause. Pricing does not include remediation measures.**

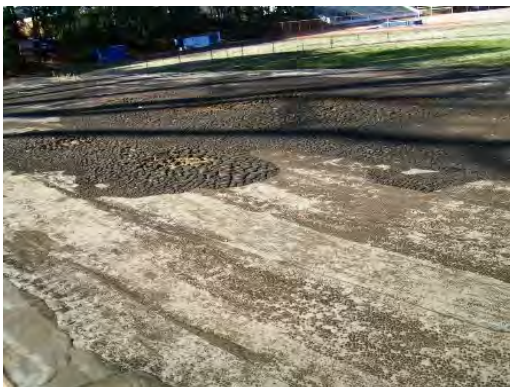
Assembly: **B3010**
System: **Roof Coverings**
Material: **System**
Distress: **Beyond Service Life**
Category: **Deferred Maintenance**
Correction: **Renew System**
Note: **The built-up roofing is aged and worn and should be replaced.**

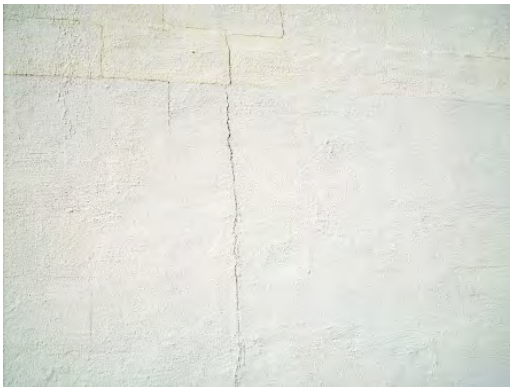
Assembly: **B2010**
System: **Exterior Walls**
Material: **Engineering Study for Exterior Walls**
Distress: **Needs Remediation**
Category: **Safety**
Correction: **Study analyze and develop solution**
Note: **The exterior walls have observable cracks that should be studied by a professional engineer. Pricing does not include remediation measures.**

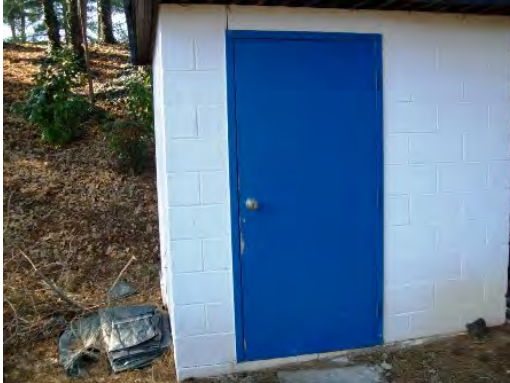
Assembly: **B2030**
System: **Exterior Doors**
Material: **System**
Distress: **Beyond Service Life**
Category: **Deferred Maintenance**
Correction: **Renew System**
Note: **The original metal exterior door is aged and should be replaced.**

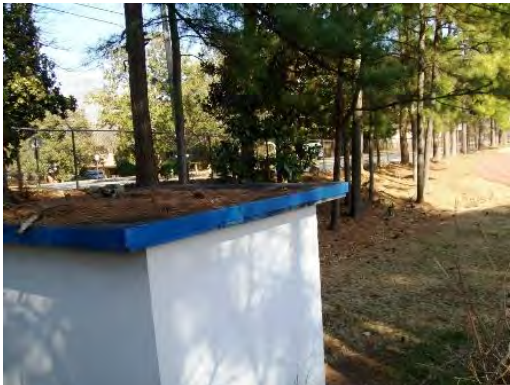
Assembly: **B3010**
System: **Roof Coverings**
Material: **System**
Distress: **Beyond Service Life**
Category: **Deferred Maintenance**
Correction: **Renew System**
Note: **The built-up roofing is aged and worn and should be replaced.**

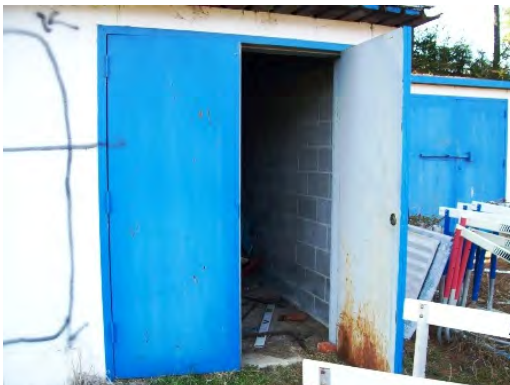
Assembly: **B2030**
System: **Exterior Doors**
Material: **System**
Distress: **Beyond Service Life**
Category: **Deferred Maintenance**
Correction: **Renew System**
Note: **The original metal exterior doors are aged and rusted and should be replaced.**

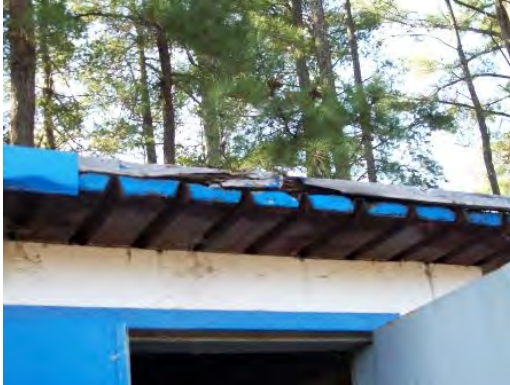
Assembly: **B3010**
System: **Roof Coverings**
Material: **System**
Distress: **Beyond Service Life**
Category: **Deferred Maintenance**
Correction: **Renew System**
Note: **The built-up roofing is aged and worn and should be replaced.**

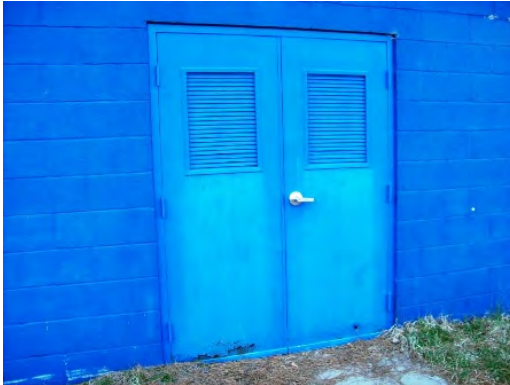
Assembly: **B2030**
System: **Exterior Doors**
Material: **System**
Distress: **Beyond Service Life**
Category: **Deferred Maintenance**
Correction: **Renew System**
Note: **The original metal exterior doors are aged and should be replaced.**

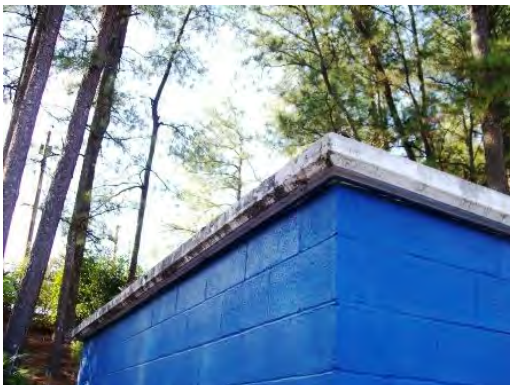
Assembly: **B3010**
System: **Roof Coverings**
Material: **System**
Distress: **Beyond Service Life**
Category: **Deferred Maintenance**
Correction: **Renew System**
Note: **The built-up roofing is aged and worn and should be replaced.**

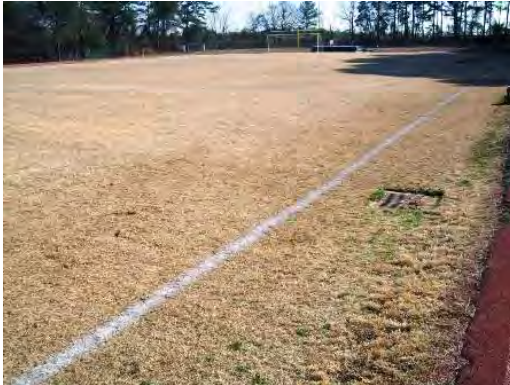
Assembly: **F1040**
System: **Special Facilities - Footbal Field - Natural Turf System**
Material: **Beyond Service Life**
Distress: **Beyond Service Life**
Category: **Deferred Maintenance**
Correction: **Renew System**
Note: **The grass is damaged and should be reseeded.**

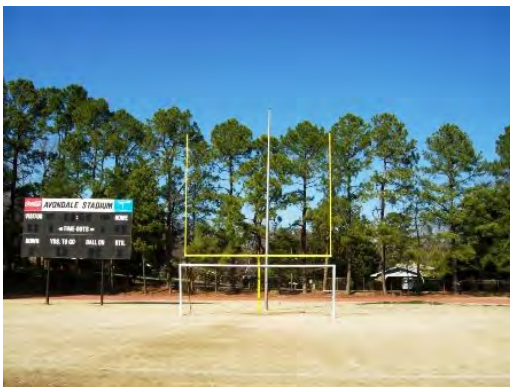
Assembly: **G2040**
System: **Site Development - Fencing; Goal Post; Scoreboard**
Material: **System**
Distress: **Beyond Service Life**
Category: **Deferred Maintenance**
Correction: **Renew System**
Note: **The goal posts, scoreboard, and fencing are beyond thier service life and should be replaced.**

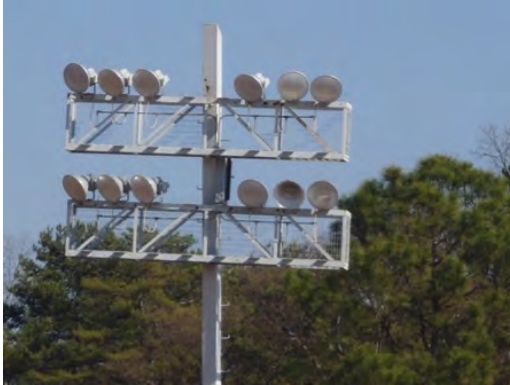
Assembly: **G4020**
System: **Site Lighting**
Material: **System**
Distress: **Beyond Service Life**
Category: **Deferred Maintenance**
Correction: **Renew System**
Note: **Stadium lighting is aged and should be replaced.**

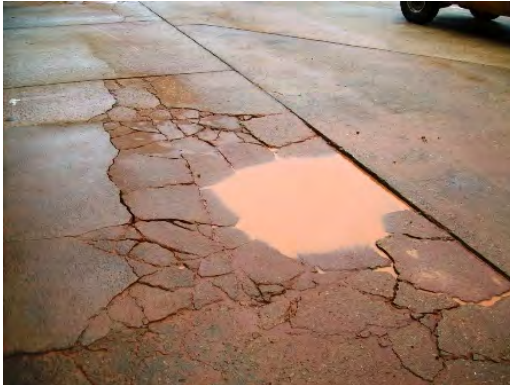
Assembly: **G2030**
System: **Pedestrian Paving**
Material: **System**
Distress: **Beyond Service Life**
Category: **Deferred Maintenance**
Correction: **Renew System**
Note: **The pedestrian paving and walkways are aged and damaged and should be replaced.**

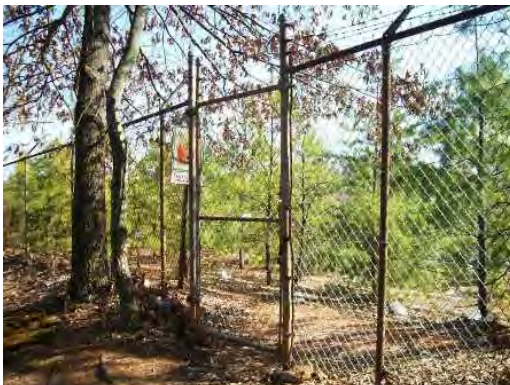
Assembly: **G2040105**
System: **Fence & Guardrails**
Material: **System**
Distress: **Beyond Service Life**
Category: **Deferred Maintenance**
Correction: **Renew System**
Note: **The fencing is aged and rusted and should be replaced.**
