DeKalb County School District/Stadiums

Adams Stadium

School Assessment Report

May 20, 2016

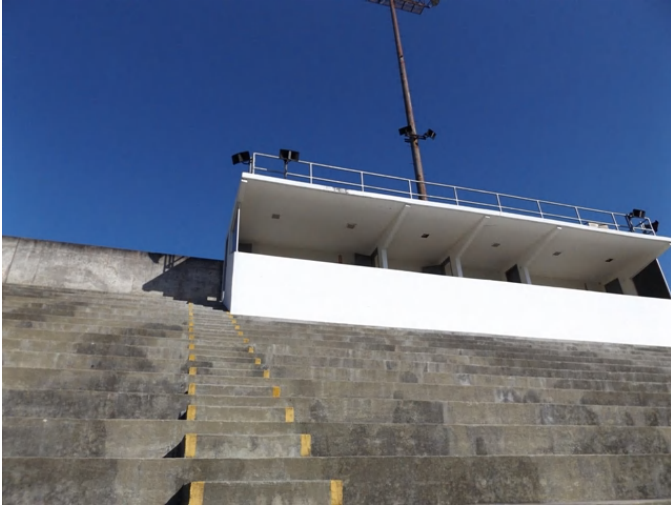
System: C2010 - Stair Construction

Location: Throughout Stadium

Distress: Inadequate

Notes: The stadium steps, access ramps, and stairs are unsafe, do not have adequate railing, are damaged, and do not provide ADA accessibility to all areas.

Correction: Replace stadium stairs (\$2.08/sf)

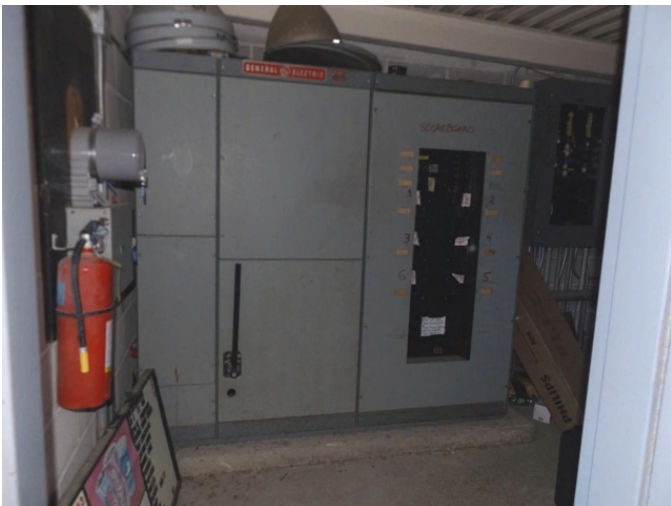
System: D5010 - Electrical Service/Distribution

Location: Throughout Stadium

Distress: Beyond Service Life

Notes: The electrical service and distribution system is beyond its expected service life, installed in a cramped space and does not have adequate space for safe maintenance, and should be replaced in a more adequate space.

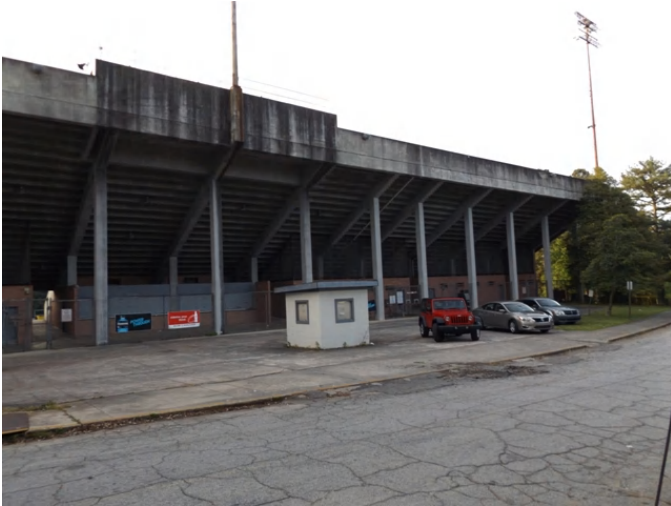
System: B2010 - Exterior Walls

Location: Exterior Surfaces

Distress: Needs Remediation

Notes: The exterior surfaces are stained and need to be pressure washed and repainted.

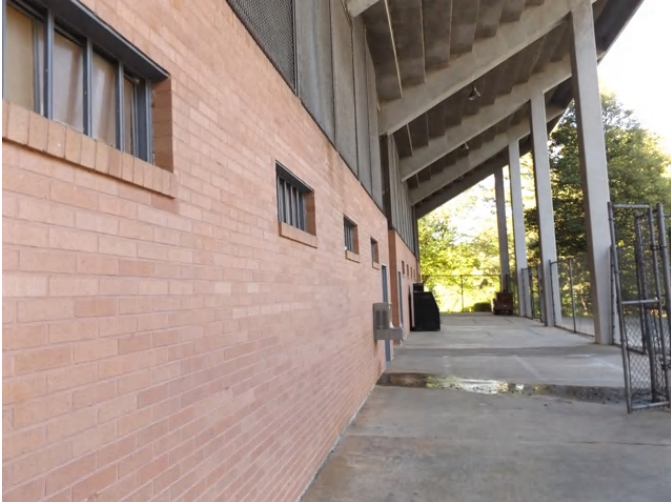
System: B2020 - Exterior Windows

Location: Exterior Walls

Distress: Beyond Service Life

Notes: The original exterior windows are beyond their expected service life and should be scheduled for replacement. Window caulking was identified as ACM by others.

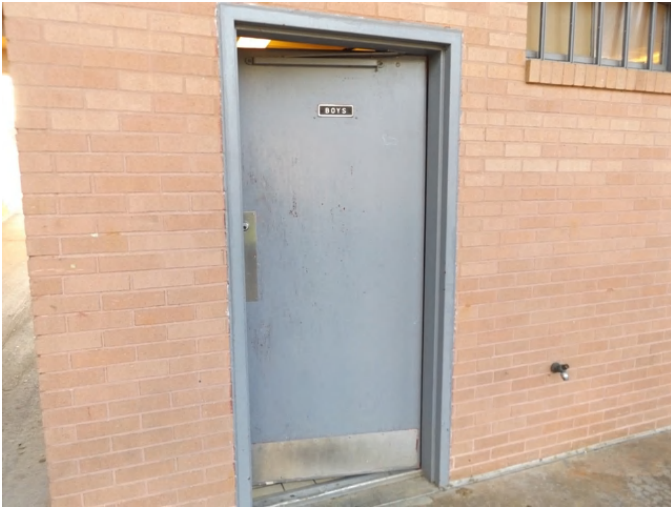
System: B2030 - Exterior Doors

Location: Exterior Walls

Distress: Beyond Service Life

Notes: The exterior doors are beyond their expected service life, not ADA compliant, and should be scheduled for replacement.

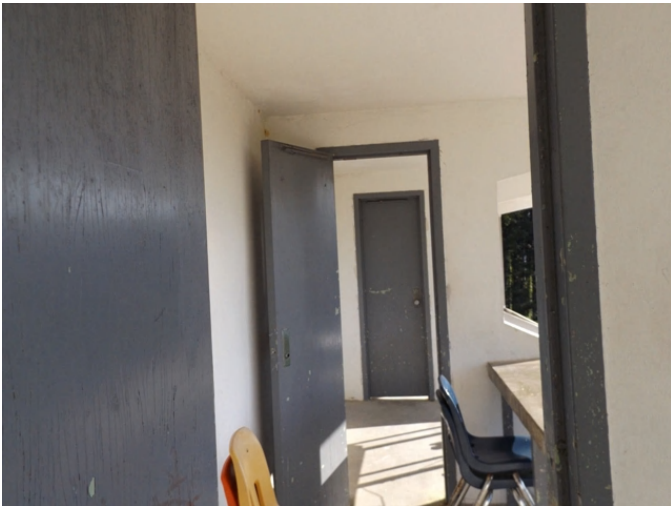
System: C1020 - Interior Doors

Location: Throughout Building

Distress: Beyond Service Life

Notes: The interior doors are weathered and beyond their expected service life and should be replaced to improve ADA accessibility.

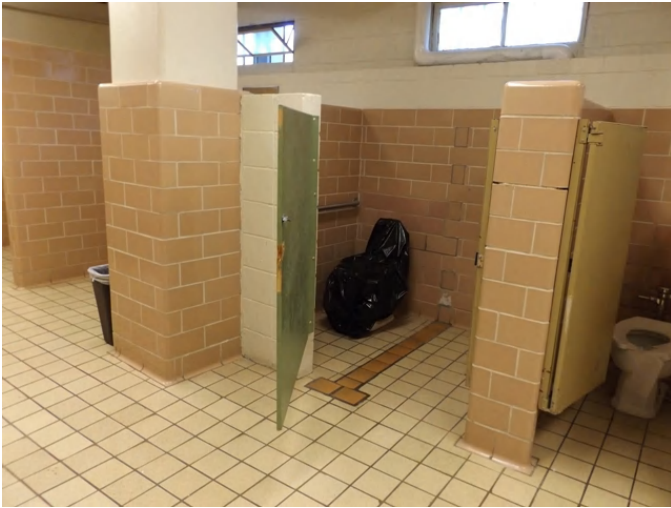
System: C1030 - Fittings

Location: Throughout Stadium

Distress: Beyond Service Life

Notes: Fittings, such as toilet partitions, lockers, signage, and handrails, are beyond their expected service life, and should be scheduled for replacement to improve ADA accessibility.

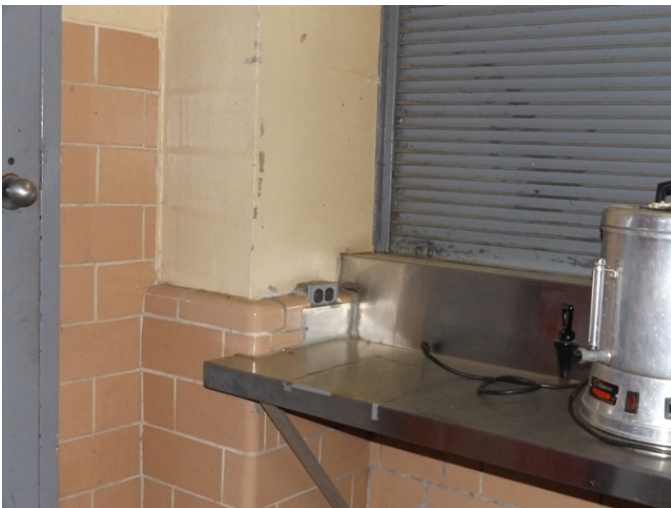
System: C3010 - Wall Finishes - Paint

Location: Throughout Stadium

Distress: Beyond Service Life

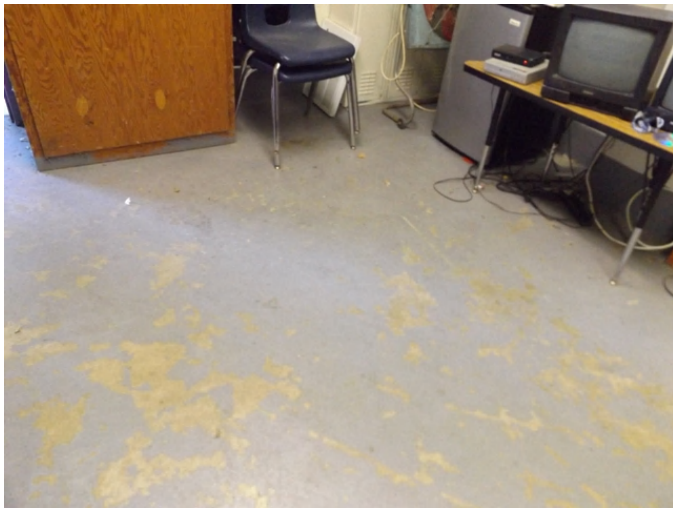
System: C3020 - Floor Finishes - Epoxy

Location: Offices

Distress: Beyond Service Life

Notes: The epoxy finish is aged, worn, and should be replaced.

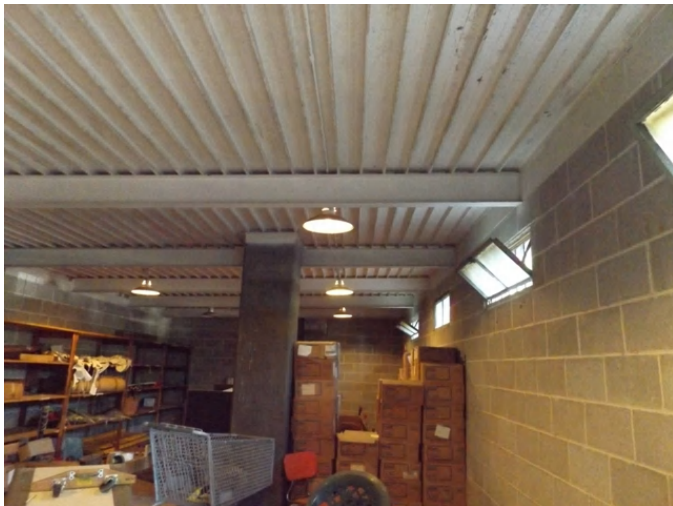
System: C3030 - Ceiling Finishes

Location: Throughout Stadium

Distress: Beyond Service Life

Notes: The ceiling finishes are beyond their expected service life and should be replaced.

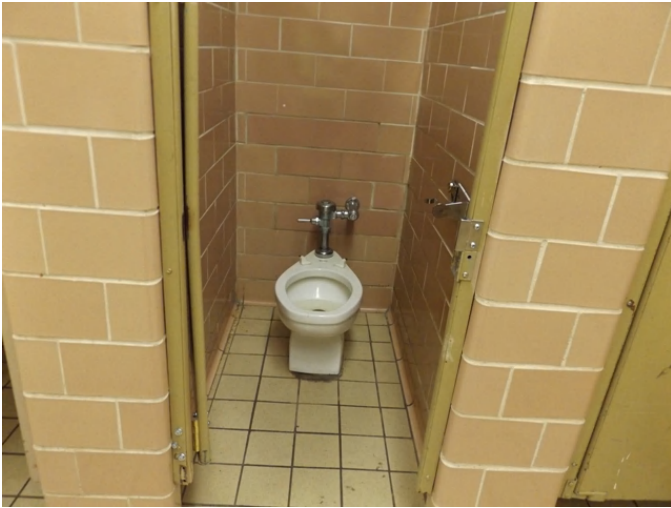
System: D2010 - Plumbing Fixtures

Location: Throughout Stadium

Distress: Beyond Service Life

Notes: The plumbing fixtures are beyond their expected service life, and should be scheduled for replacement to improve ADA accessibility.

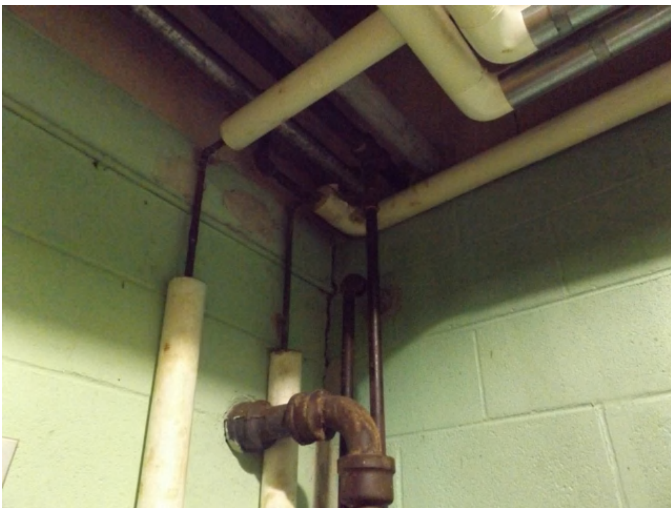
System: D2020 - Domestic Water Distribution

Location: Throughout Stadium

Distress: Beyond Service Life

Notes: The original domestic water distribution system is beyond its expected service life and should be scheduled for replacement. There is suspected materials on boiler and so it should be handled professionally.

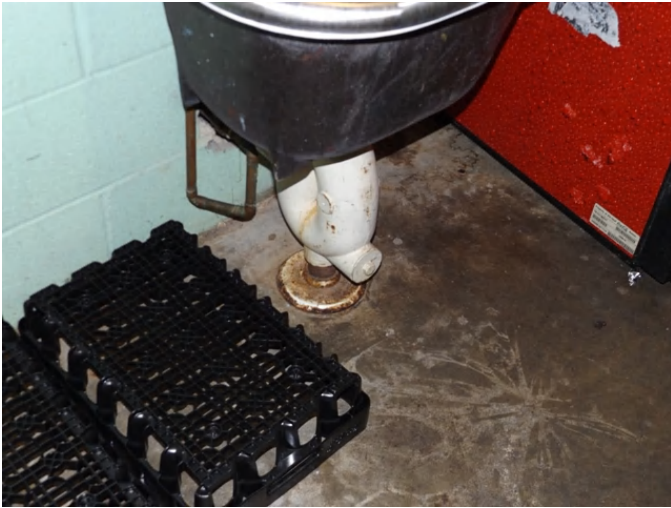
System: D2030 - Sanitary Waste

Location: Throughout Stadium

Distress: Beyond Service Life

Notes: The sanitary sewer system is beyond its expected service life and should be scheduled for replacement.

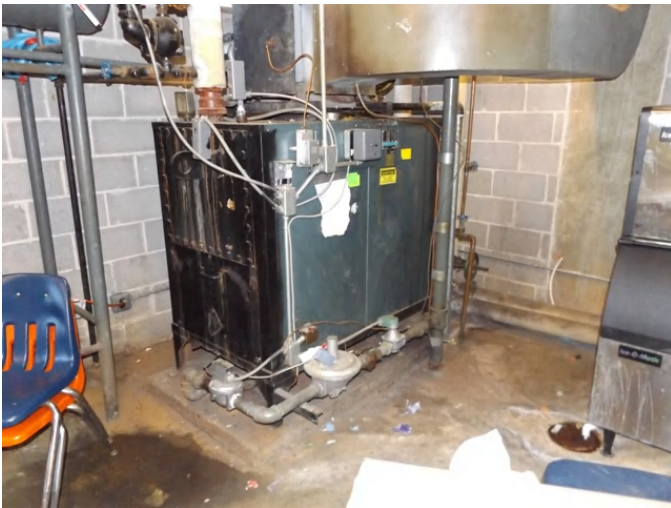
System: D2090 - Other Plumbing Systems - Nat Gas

Location: Throughout Stadium

Distress: Beyond Service Life

Notes: The galvanized steel natural gas piping is beyond its expected service life and should be replaced.

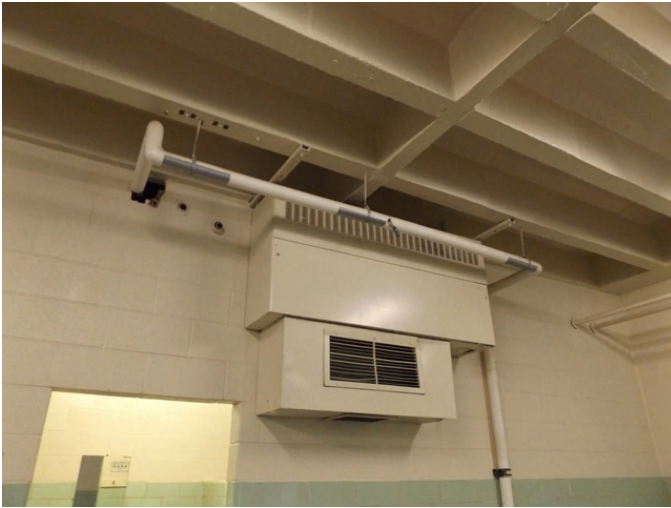
System: D3040 - Distribution Systems

Location: Throughout Stadium
Distress: Beyond Service Life
Category: Deferred Maintenance
Priority: 3 Priority
Correction: Renew System
Qty: 8,032.00
Unit of Measure: S.F.
Estimate: \$41,967.00
Assessor Name: Sam Mandola
Date Created: 04/11/2015

Notes: The original HVAC distribution system is beyond its expected service life and should be scheduled for replacement.

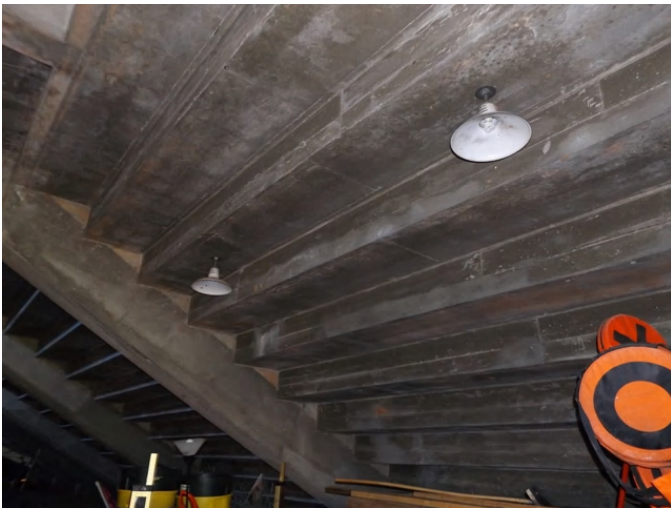
System: D5020 - Lighting and Branch Wiring

Location: Throughout Stadium
Distress: Beyond Service Life
Category: Deferred Maintenance
Priority: 3 Priority
Correction: Renew System
Qty: 25,800.00
Unit of Measure: S.F.
Estimate: \$519,638.00
Assessor Name: Sam Mandola
Date Created: 04/11/2015

Notes: The lighting system is beyond its service life and should be scheduled for replacement. SPLOST IV project 200-422 to replace stadium lighting is expected to be complete by August 2016.

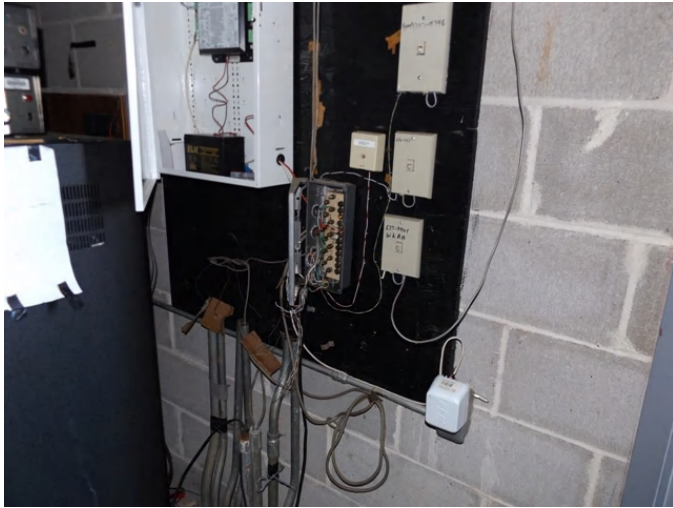
System: D5030 - Communications and Security

Location: Throughout Stadium

Distress: Beyond Service Life

Notes: The communications and security system, including telephone and data and PA and clock system, should be scheduled for replacement. A fire alarm system is missing and should be installed.

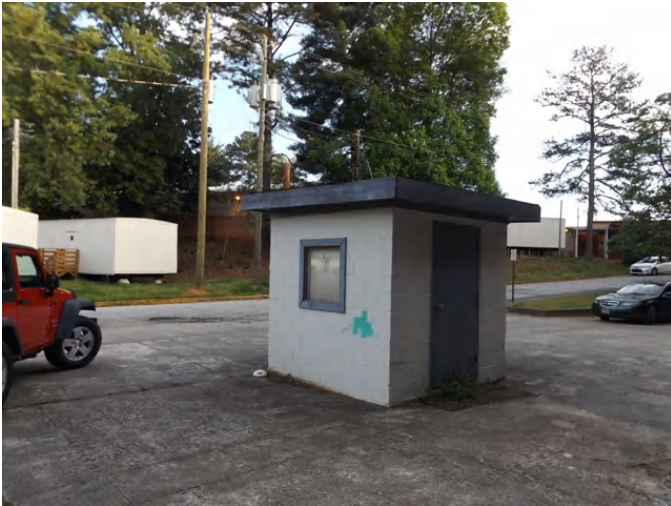
System: B2010 - Exterior Walls

Location: Exterior Walls

Distress: Beyond Service Life

Notes: The painted exterior wall finish is damaged and should be replaced.

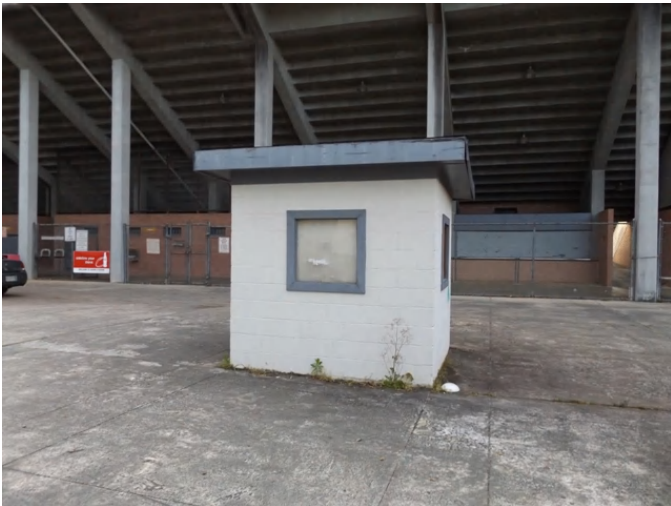
System: B2020 - Exterior Windows

Location: Exterior Walls

Distress: Beyond Service Life

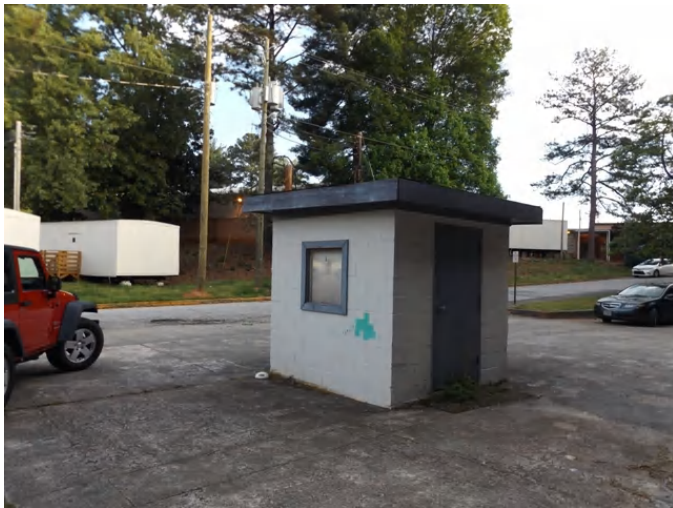
System: B2030 - Exterior Doors

Location: Exterior Wall
Distress: Beyond Service Life
Category: Deferred Maintenance
Priority: 3 Priority
Correction: Renew System
Qty: 64.00
Unit of Measure: S.F.
Estimate: \$56.00
Assessor Name: Somnath Das
Date Created: 05/06/2015

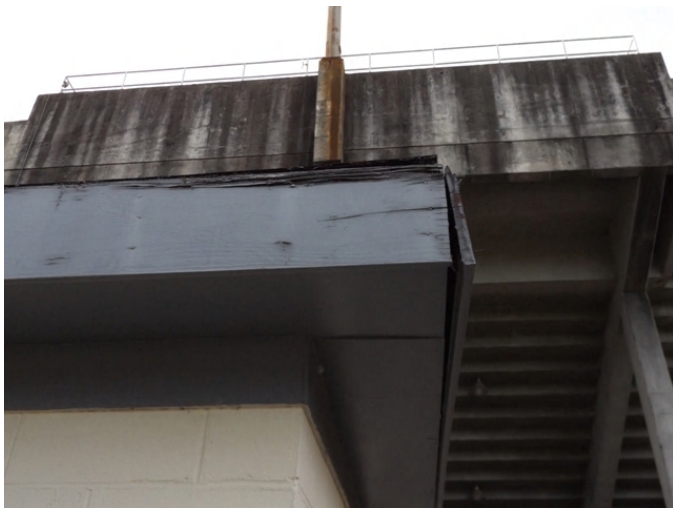
System: B3010 - Roof Coverings

Location: Roof
Distress: Beyond Service Life
Category: Deferred Maintenance
Priority: 3 Priority
Correction: Renew System
Qty: 64.00
Unit of Measure: S.F.
Estimate: \$1,182.00
Assessor Name: Somnath Das
Date Created: 05/06/2015

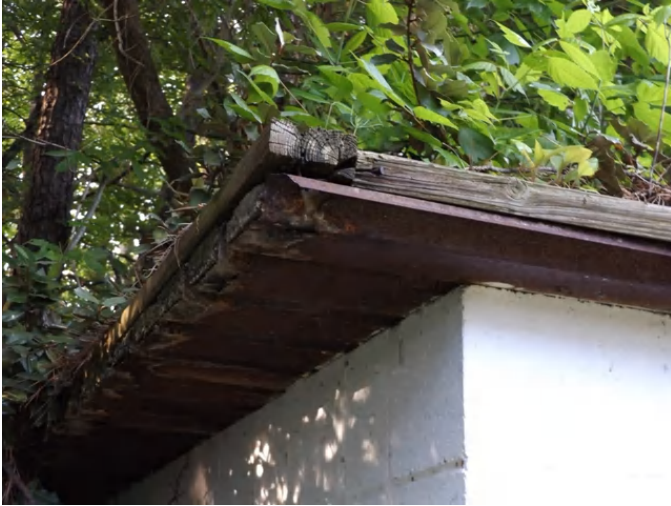
System: B1020 - Roof Construction

Location: Roof

Distress: Damaged

Notes: The roof construction is damaged, rusted through, and should be replaced.

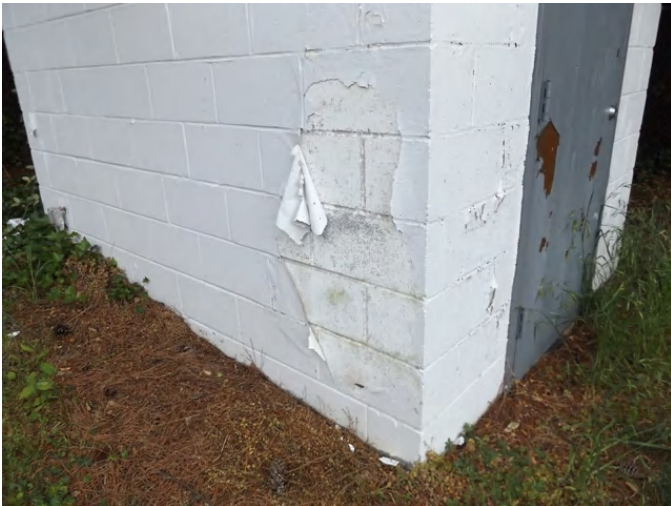
System: B2010 - Exterior Walls

Location: Exterior Walls

Distress: Beyond Service Life

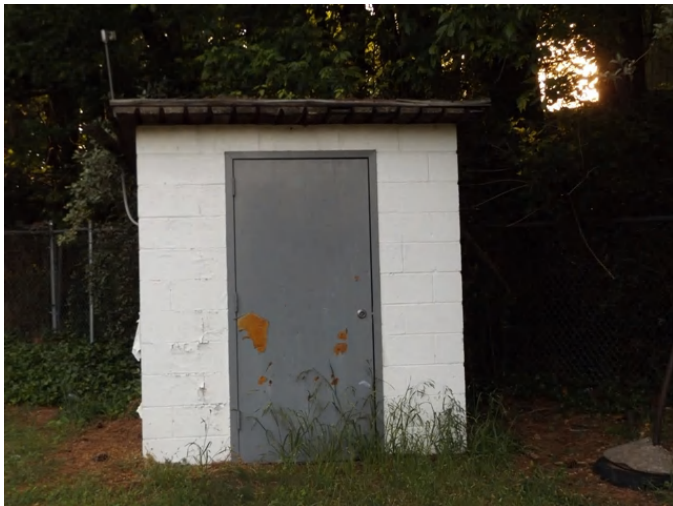
System: B2030 - Exterior Doors

Location: Exterior Wall
Distress: Beyond Service Life
Category: Deferred Maintenance
Priority: 3 Priority
Correction: Renew System
Qty: 100.00
Unit of Measure: S.F.
Estimate: \$572.00
Assessor Name: Charles Gulley
Date Created: 04/11/2015

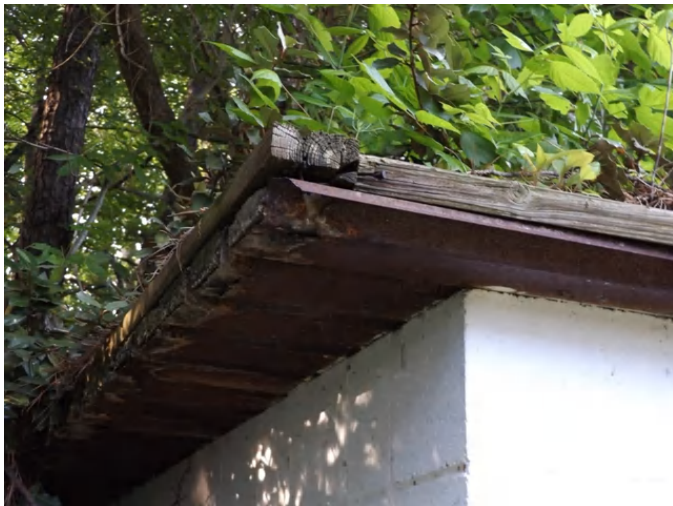
System: B3010 - Roof Coverings

Location: Roof
Distress: Beyond Service Life
Category: Deferred Maintenance
Priority: 3 Priority
Correction: Renew System
Qty: 100.00
Unit of Measure: S.F.
Estimate: \$1,847.00
Assessor Name: Charles Gulley
Date Created: 04/11/2015

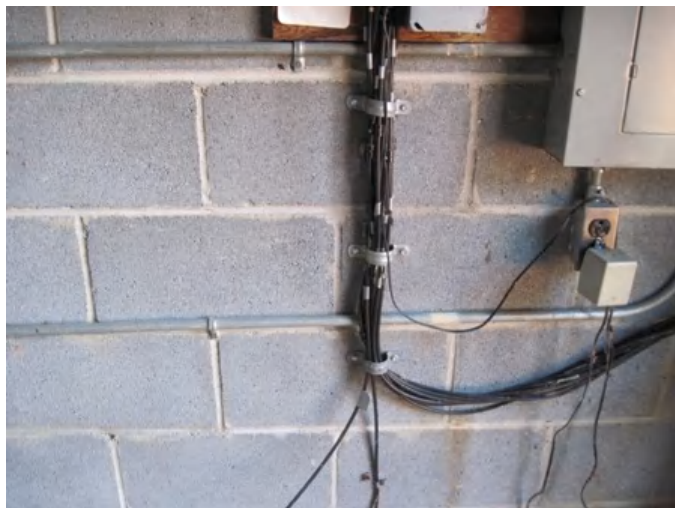
System: D5020 - Lighting and Branch Wiring

Location: Throughout Building

Distress: Beyond Service Life

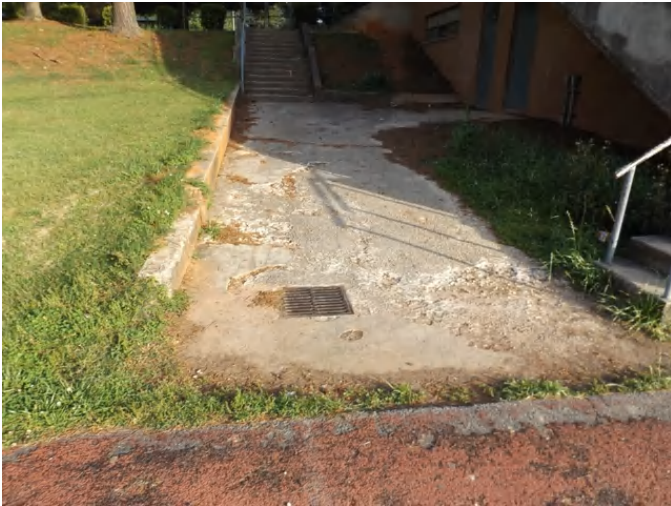
System: G2030 - Pedestrian Paving

Location: Site

Distress: Damaged

Notes: The original pedestrian paving is damaged, has trip hazards, is not fully ADA compliant, and should be replaced.

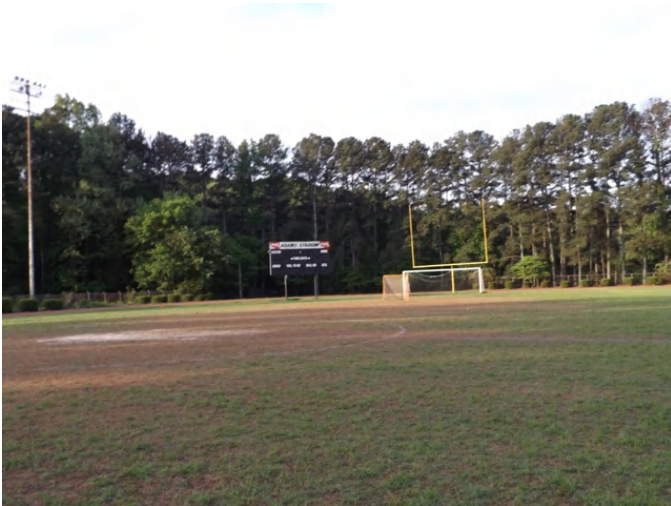
System: G2040 - Football Field

Location: Site

Distress: Damaged

Notes: The football field is damaged, worn, well beyond its expected service life, and should be scheduled for replacement. SPLOST IV project 202-422 to replace the turf is currently defunded.

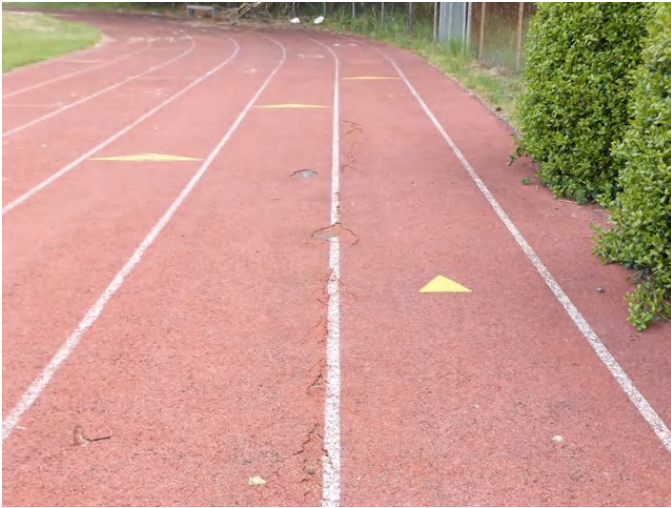
System: G2040 - Track

Location: Site

Distress: Damaged

Notes: The track is damaged, severely worn, has trip hazards, and should be replaced. SPLOST IV project 202-422 to replace the track is currently defunded.

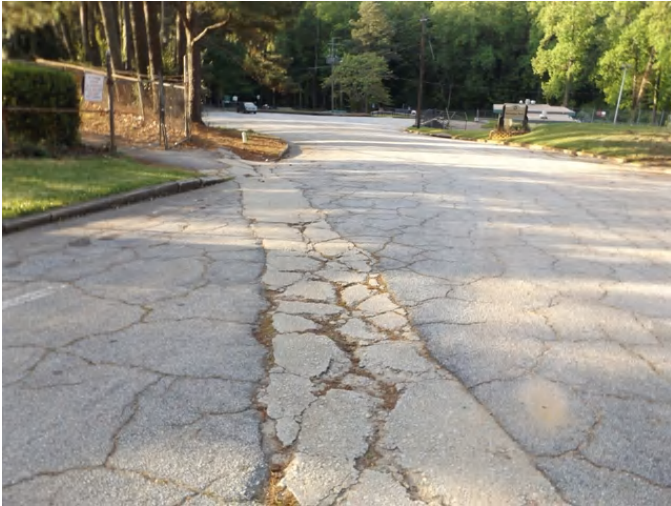
System: G2010 - Roadways

Location: Site

Distress: Damaged

Notes: The Kittredge Park roadway fronting the stadium is damaged and should be replaced.

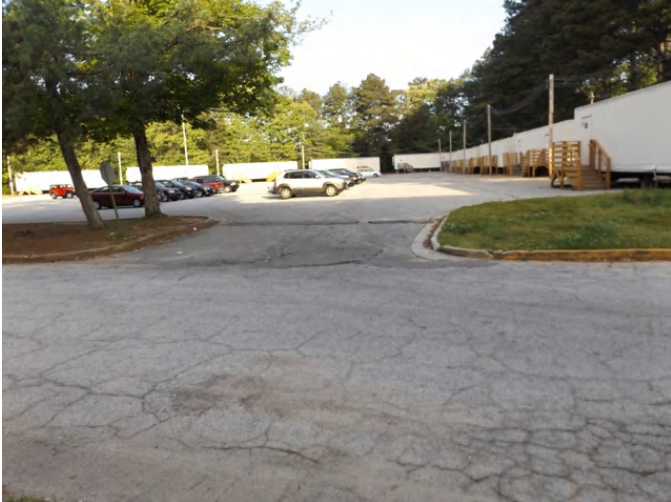
System: G2020 - Parking Lots

Location: Site

Distress: Beyond Service Life

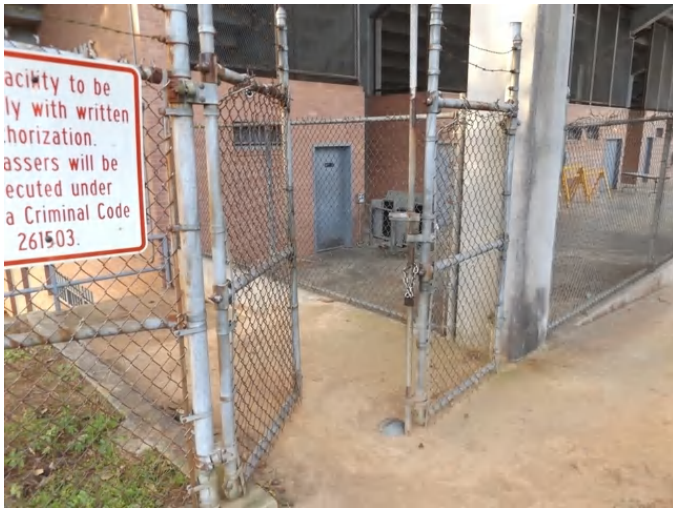
System: G2040 - Fencing & Guardrails

Location: Site

Distress: Beyond Service Life

Notes: The original fencing is beyond its service life and should be scheduled for replacement. SPLOST IV project 202-422 to replace the fencing is currently defunded.

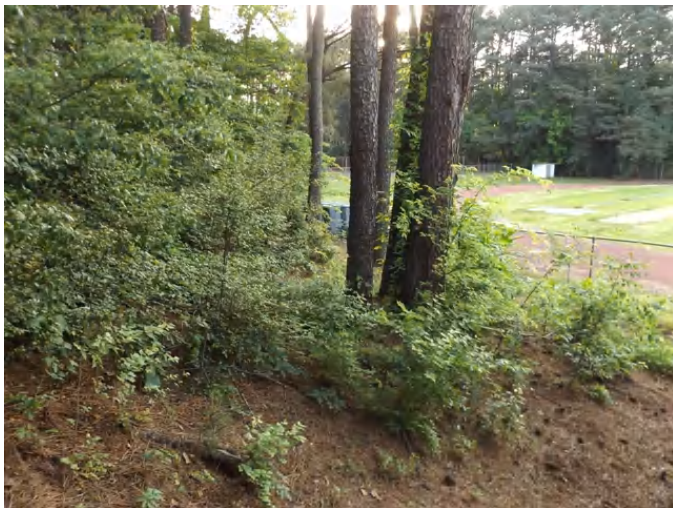
System: G2050 - Landscaping

Location: Site

Distress: Beyond Service Life

Notes: The landscaping is overgrown, has bare spots, and should be replaced.

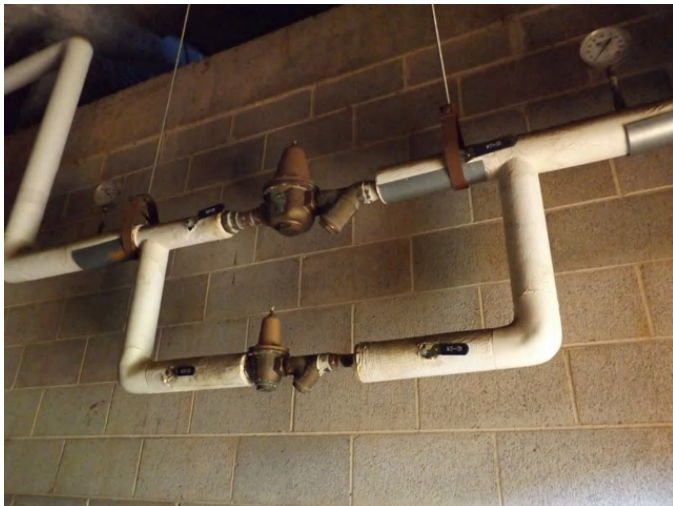
System: G3010 - Water Supply

Location: Site

Distress: Beyond Service Life

Notes: The original water supply system is beyond its expected service life and should be scheduled for replacement.

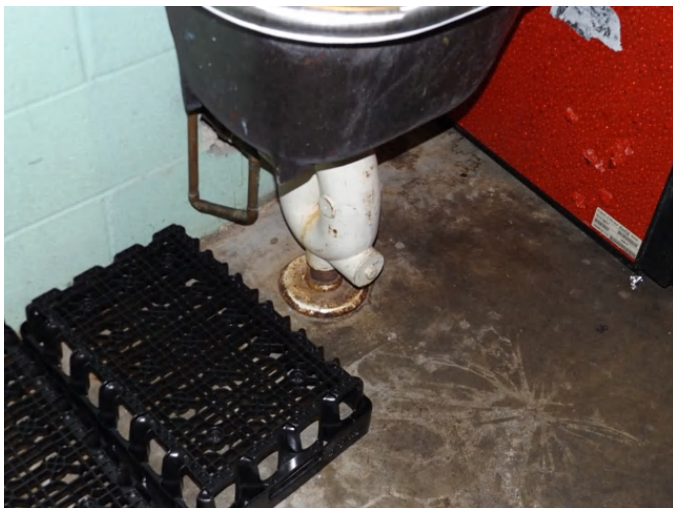
System: G3020 - Sanitary Sewer

Location: Site

Distress: Beyond Service Life

Notes: The original sanitary sewer service is beyond its expected service life and should be scheduled for replacement.

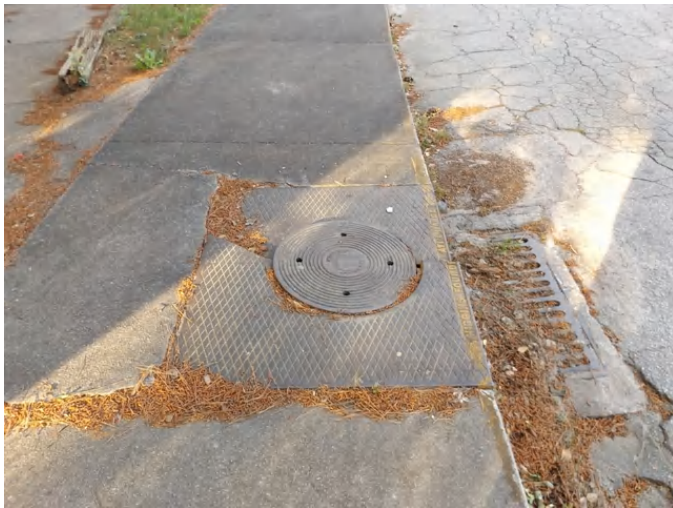
System: G3030 - Storm Sewer

Location: Site

Distress: Needs Remediation

Notes: The original storm water drainage system is in poor condition and needs remediation.

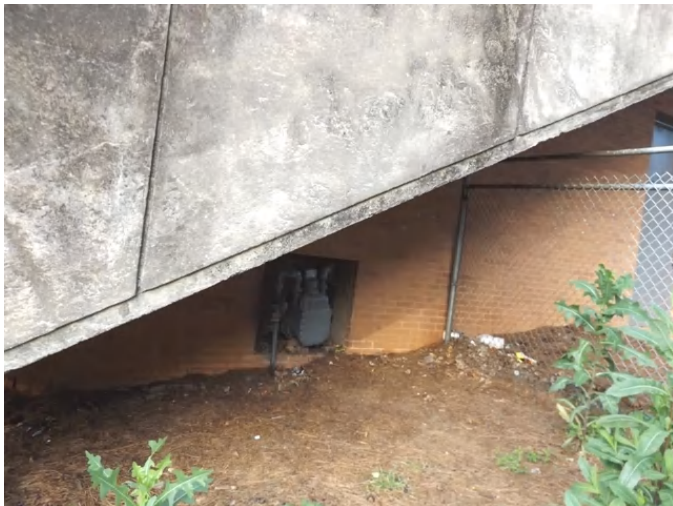
System: G3060 - Fuel Distribution

Location: Site

Distress: Beyond Service Life

Notes: The natural gas distribution is beyond its expected service life and should be scheduled for replacement.

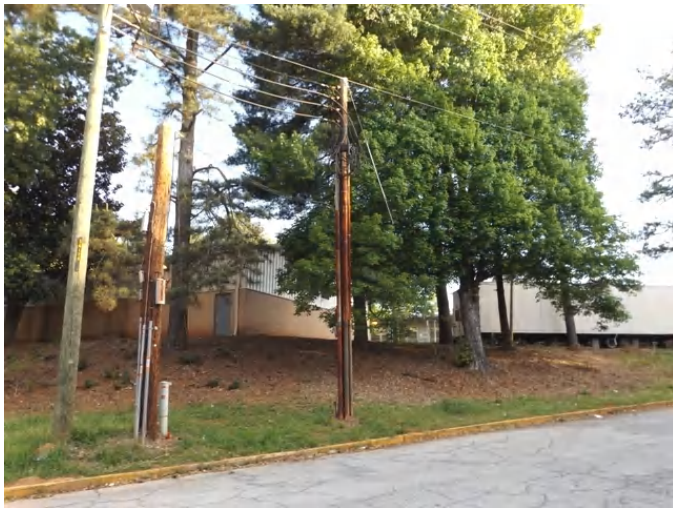
System: G4010 - Electrical Distribution

Location: Site

Distress: Beyond Service Life

Notes: The pole mounted transformer electrical service is beyond its expected service life and should be replaced with a pad mounted, oil filled transformer.

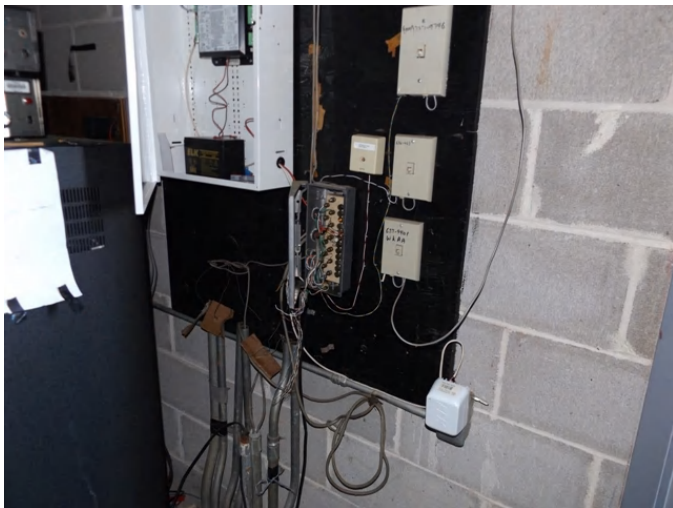
System: G4030 - Site Communications & Security

Location: Site

Distress: Beyond Service Life
