DeKalb County School District/High Schools

Arabia Mountain High

School Assessment Report

May 19, 2016

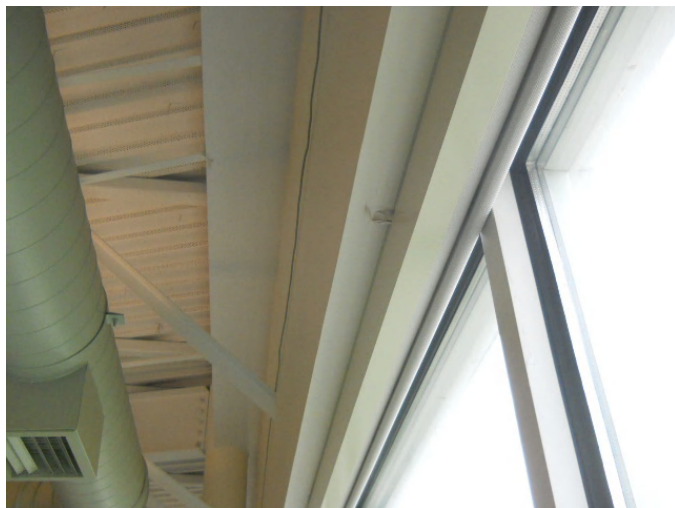
System: B2020 - Exterior Windows

Location: Rooms C133, C216, D216 and E216

Distress: Damaged

Notes: Exterior windows leak in rooms C133, C216, D216 and E216. Repair, re-seal exterior windows to prevent rain water leaks.

Correction: Repair 2'-0" x 3'-0" aluminum window - 2nd floor

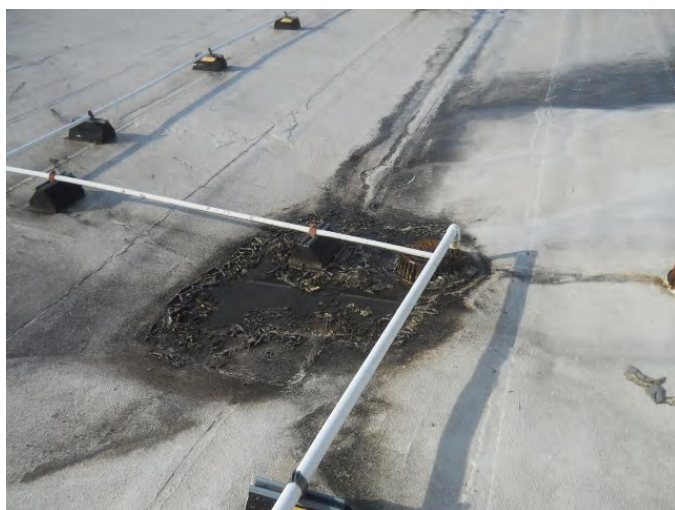
System: B3010 - Roof Coverings - BUR

Location: Roof Over A-Pod

Distress: Damaged

Notes: Roof is not properly sloped at drains, and standing water is causing roof covering deterioration. Two locations on the "A" pod roof.

Correction: Minor BUR membrane repairs, 2% of roof area

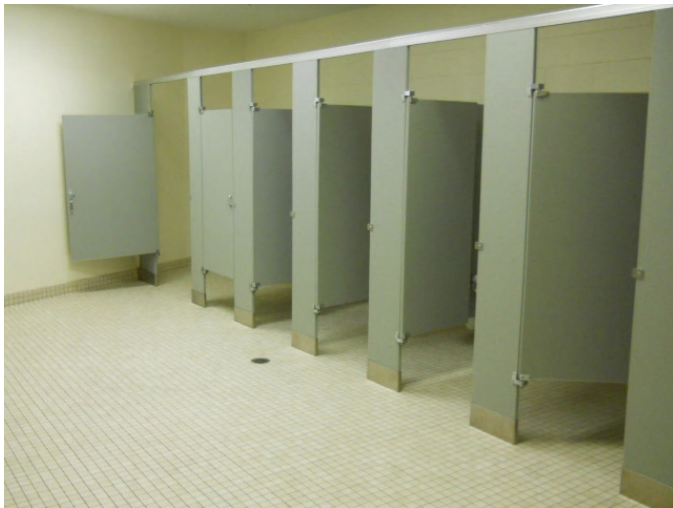
System: D2010 - Plumbing Fixtures

Location: First Floor

Distress: Missing

Notes: There is no ADA compliant restroom on the first floor. Construct two ADA compliant restrooms for boys and girls.

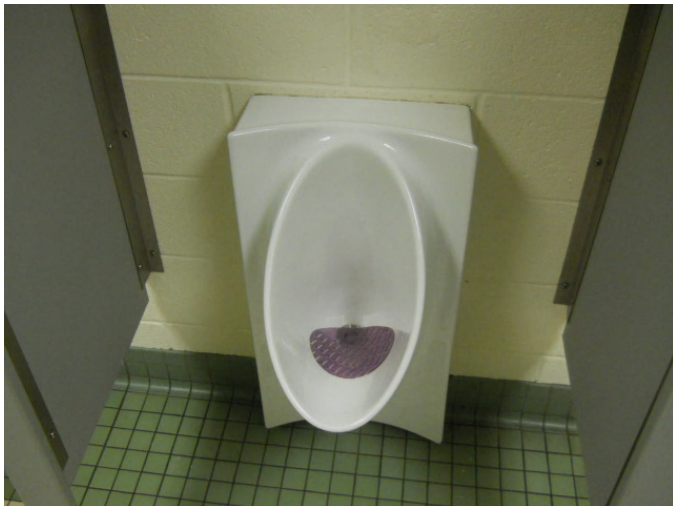
System: D2010 - Plumbing Fixtures

Location: All Boys Restrooms

Distress: Inadequate

Notes: The urinals in all boys restrooms are water-less units that are inadequately sized to handle the usage requirements of this building. Replace all 33 units with new, higher capacity water-less units to maintain LEED Silver certification.

Correction: Replace wall-hung urinal

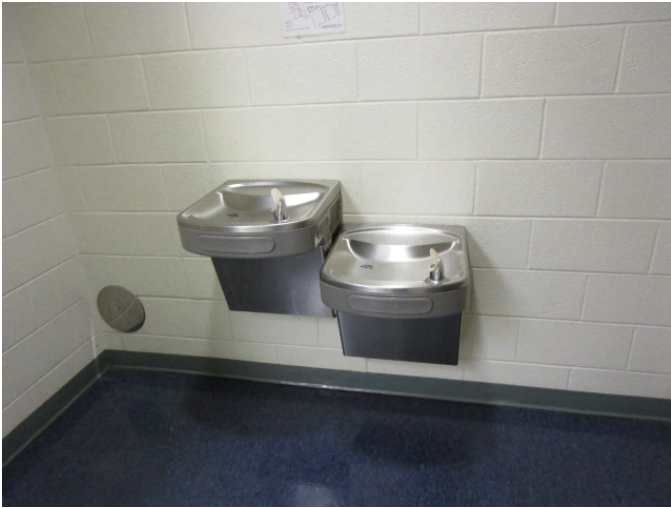
System: D2010 - Plumbing Fixtures

Location: South Classroom Wing

Distress: Needs Remediation

Notes: Water fountains protrude into the hallway more than four inches in the south classroom wing. Protrusion is not ADA compliant if more than four inches.

Correction: Remove/replace drinking fountain w/recessed ADA compliant drinking fountain

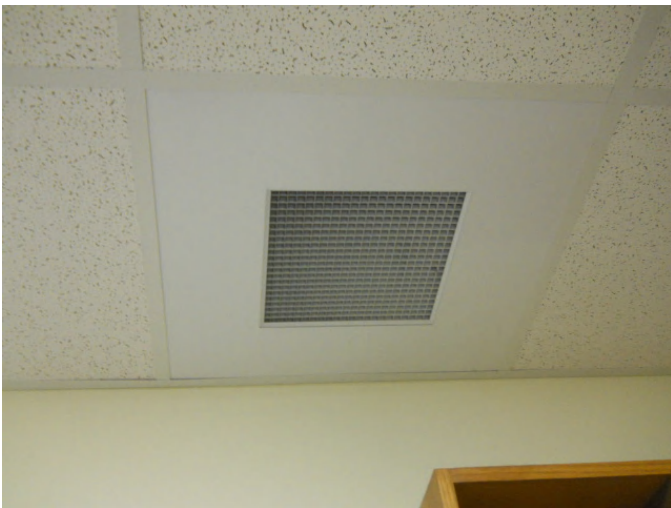
System: D3070 - System Test & Balance

Location: Throughout Building

Distress: Inadequate

Notes: Hot/cold complaints throughout the building. Recommend a test and balance of the HVAC system in all office areas and other areas where ducted returns are present.

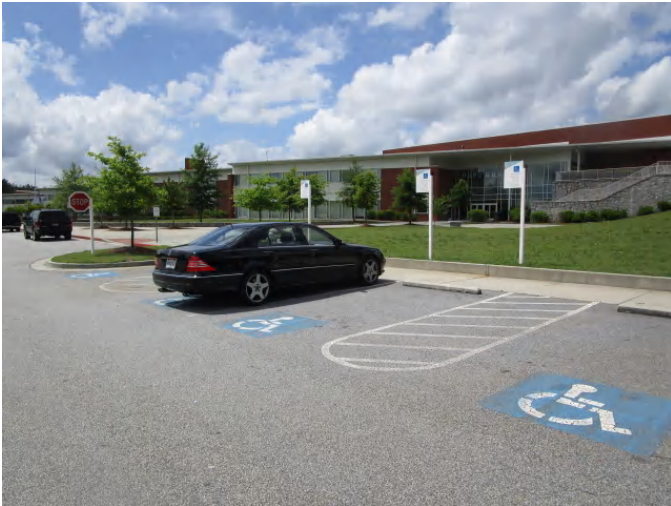
System: G2020 - Parking Lots

Location: Site

Distress: Needs Remediation

Notes: Parking spaces are not properly marked on the pavement or with signage for van accessible parking per ADA standards.

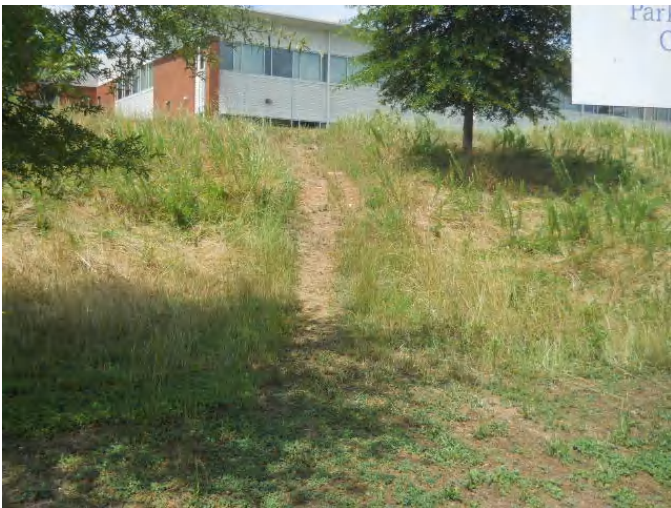
System: G2030 - Pedestrian Paving

Location: Site

Distress: Missing

Notes: Students have worn a path through the LEED Silver-certified landscaping, between the student parking lot and the main building. Add approved pedestrian pavement from student parking lot to the building.

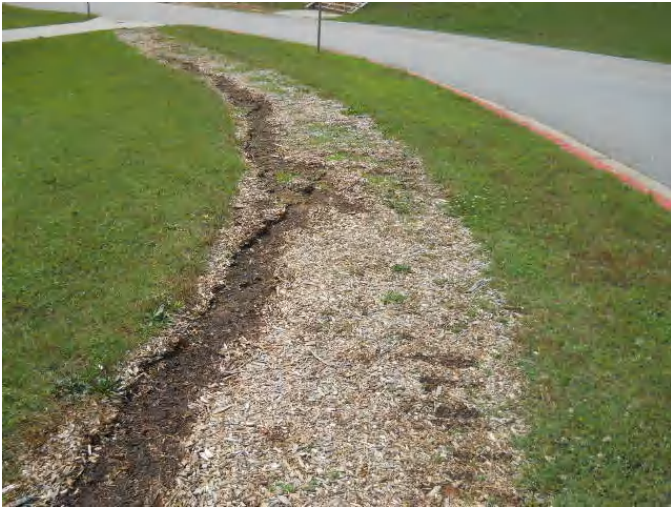
System: G2040 - Cross Country Trail

Location: Site
Distress: Beyond Service Life
Category: Deferred Maintenance
Priority: 3 Priority
Correction: Renew System
Qty: 25,000.00
Unit of Measure: S.F.
Estimate: \$338,250.00
Assessor Name: Eduardo Lopez
Date Created: 05/28/2015

Notes: The cross country training trail is washed out, missing mulch surface, and should be replaced.

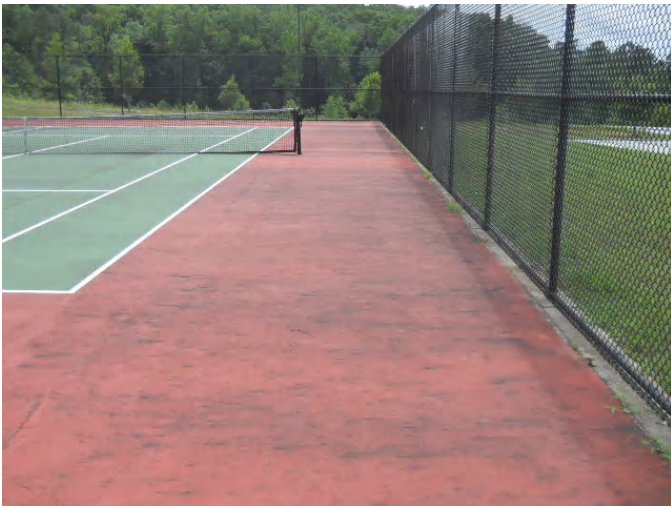
System: G2040 - Tennis Courts

Location: Site
Distress: Damaged
Category: Deferred Maintenance
Priority: 3 Priority
Correction: Renew System
Qty: 14,269.00
Unit of Measure: S.F.
Estimate: \$289,903.27
Assessor Name: Eduardo Lopez
Date Created: 12/16/2015

Notes: Tennis courts are deteriorating with cracks and should be repaired or replaced.

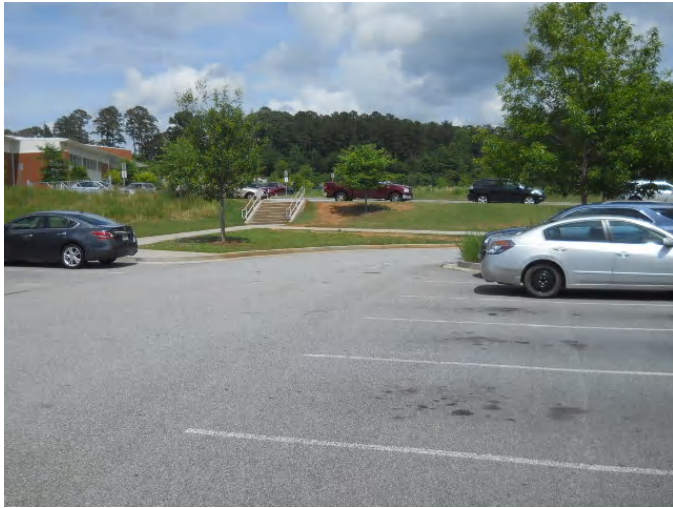
System: G2050 - Landscaping

Location: Site

Distress: Needs Remediation
