DeKalb County School District/Elementary Schools

Ashford Park Elementary

School Assessment Report

May 19, 2016

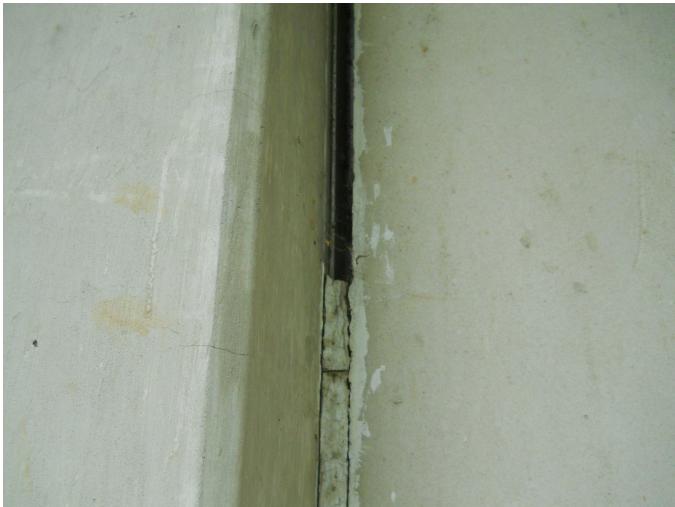
System: B2010 - Exterior Walls

Location: Throughout Building

Distress: Damaged

Notes: Expansion joints need to be repaired/replaced.

Correction: Repair / Replace expansion joint caulk material

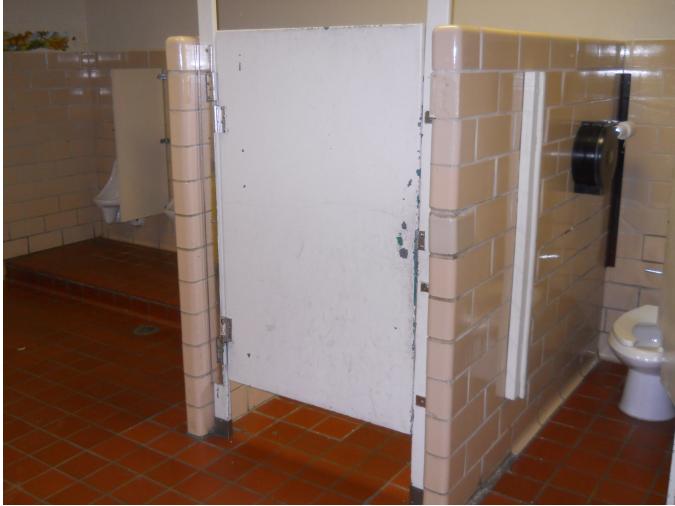
System: D2010 - Plumbing Fixtures

Location: Throughout Building

Distress: Needs Remediation

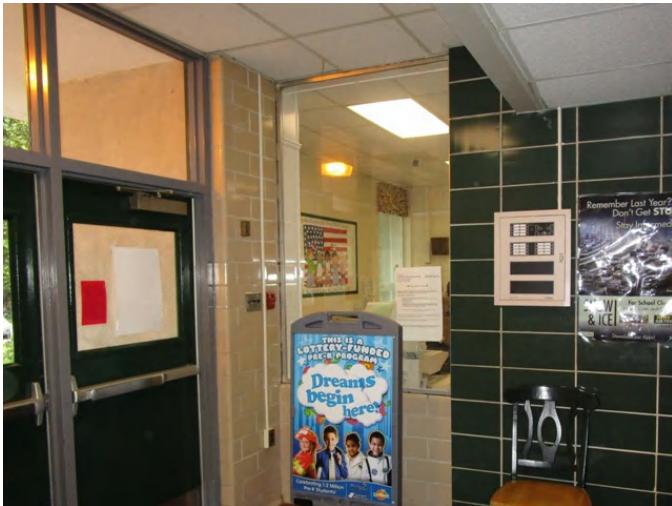
System: D5030 - Communications and Security - Fire Alarm

Location: Throughout Building

Distress: Beyond Service Life

Notes: The fire alarm system is beyond its expected service life and should be scheduled for replacement.

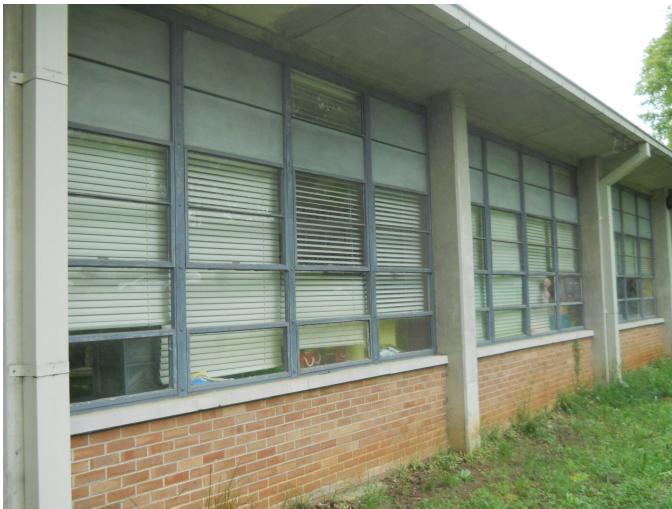
System: B2020 - Exterior Windows

Location: Throughout Building

Distress: Beyond Service Life

Notes: The aluminum frame, operable, single pane windows are aged, not energy efficient, and should be replaced. The windows leak and do not lock properly.

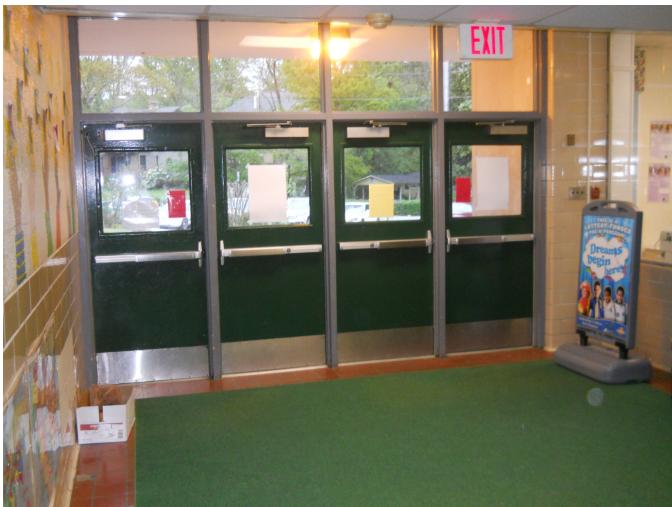
System: B2030 - Exterior Doors

Location: Throughout Building

Distress: Beyond Service Life

Notes: The original exterior doors are aged, rusted, and should be replaced.

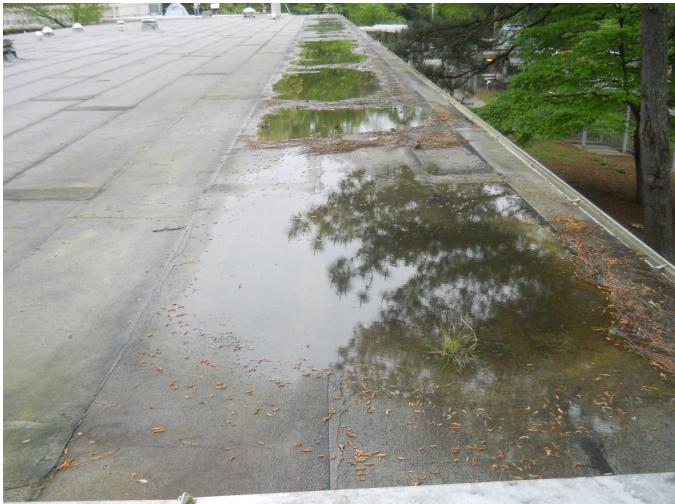
System: B3010 - Roof Coverings - BUR

Location: Roof

Distress: Damaged

Notes: The roof covering has delaminating, worn and ponding rain water, and should be replaced.

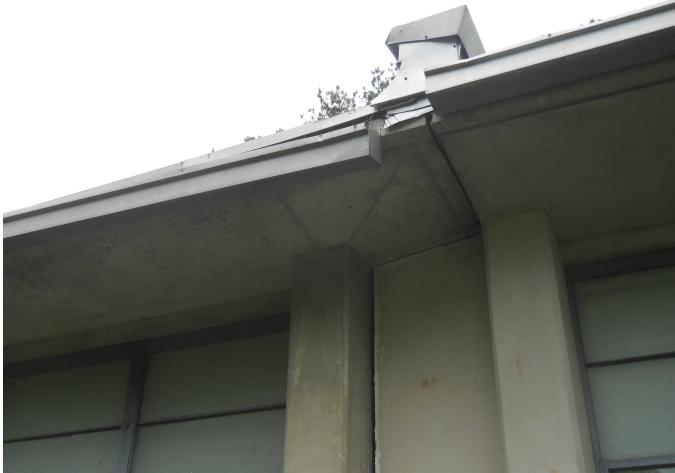
System: B3010 - Roof Coverings - BUR

Location: Roof

Distress: Damaged

Notes: Roof gutter and several downspouts are damaged on the south classroom wing.

Correction: Replace galvanized steel gutter, 6" box type, 26 ga.

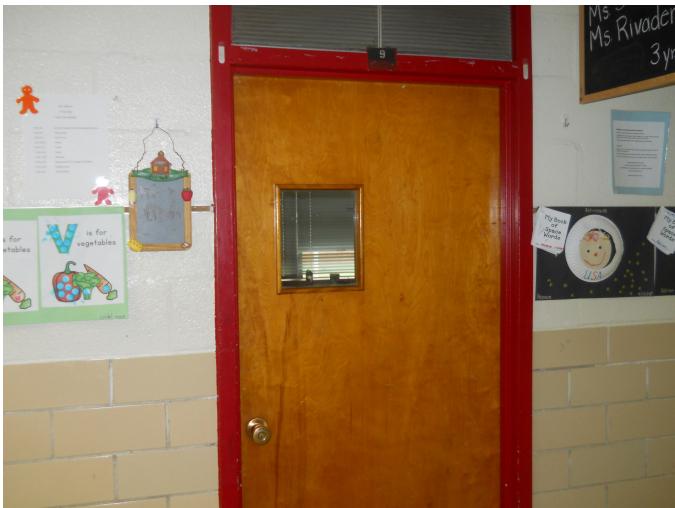
System: C1020 - Interior Doors

Location: Throughout Building

Distress: Beyond Service Life

Notes: Interior doors are beyond their expected service life, not ADA or building code compliant, and should be replaced.

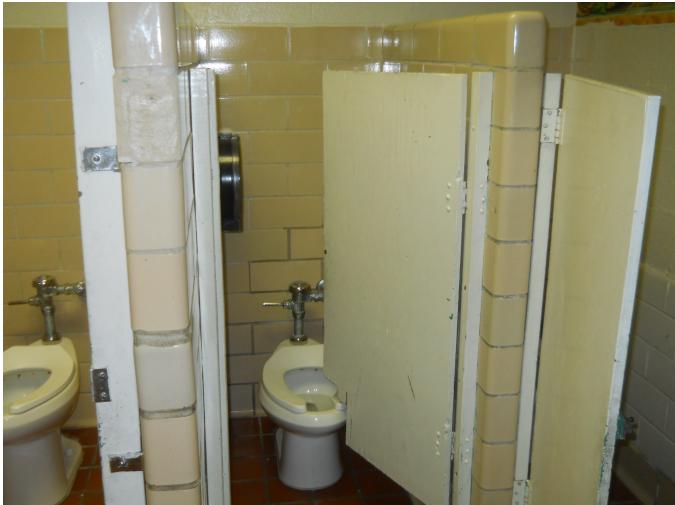
System: C1030 - Fittings

Location: Throughout Building

Distress: Beyond Service Life

Notes: Fittings, such as toilet partitions, handrails and signage, are beyond their expected service life, not ADA compliant, and should be replaced.

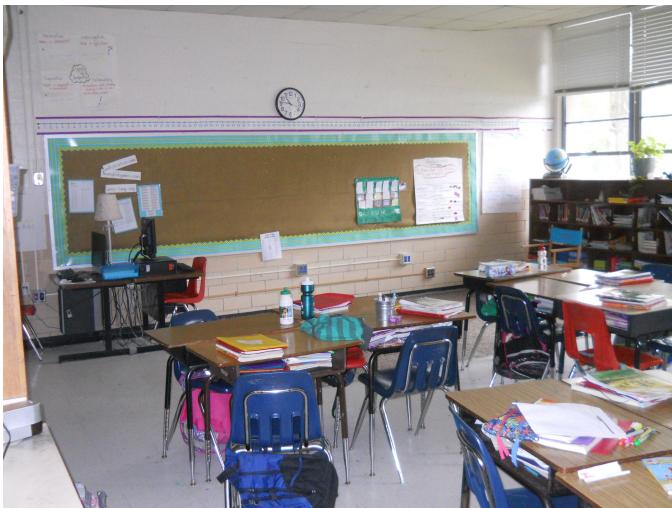
System: C3010 - Wall Finishes - Paint

Location: Throughout Building

Distress: Beyond Service Life

Notes: The painted wall finishes are beyond their expected service life, scuffed and stained, and should be replaced.

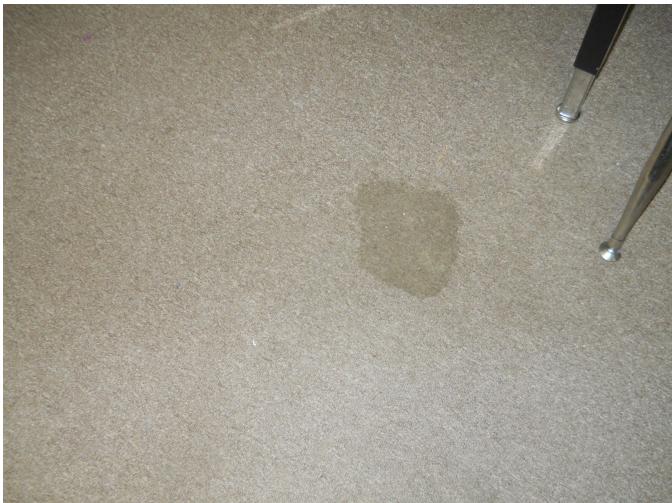
System: C3020 - Floor Finishes - Carpet

Location: Throughout Building

Distress: Beyond Service Life

Notes: The carpet in the offices and classrooms is aged, stained and frayed, and should be replaced.

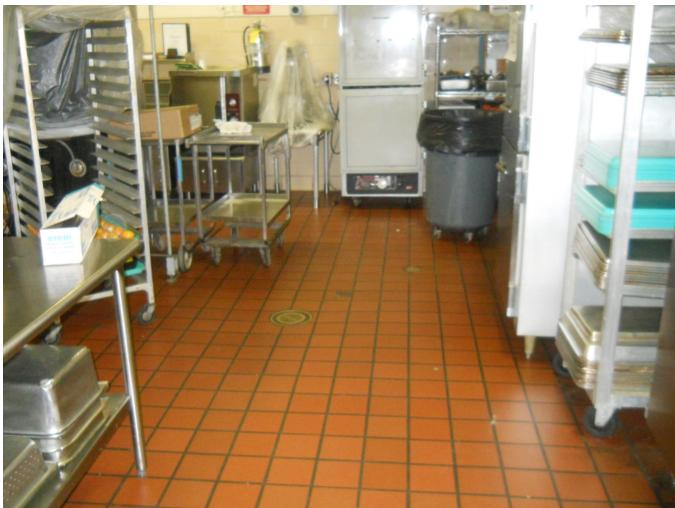
System: C3020 - Floor Finishes - Ceramic & Quarry Tile

Location: Kitchen and Restrooms

Distress: Beyond Service Life

Notes: The tile floor covering is beyond its expected service life, cracked, patched and worn, and should be replaced.

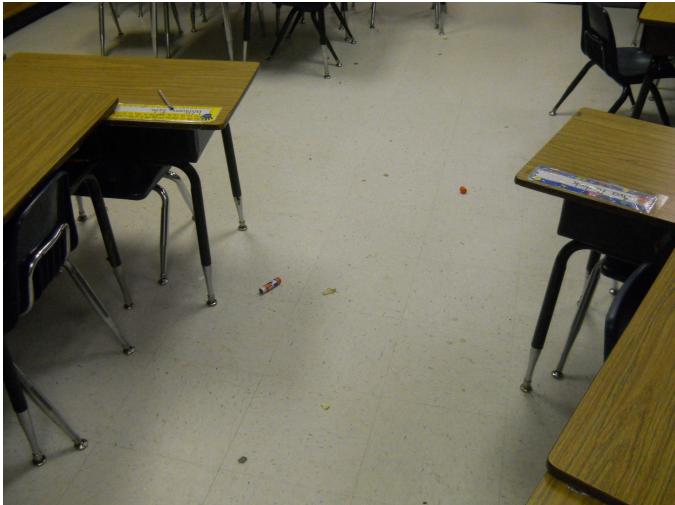
System: C3020 - Floor Finishes - VCT

Location: Throughout Building

Distress: Beyond Service Life

Notes: The VCT flooring is aged, cracked and worn, and should be replaced.

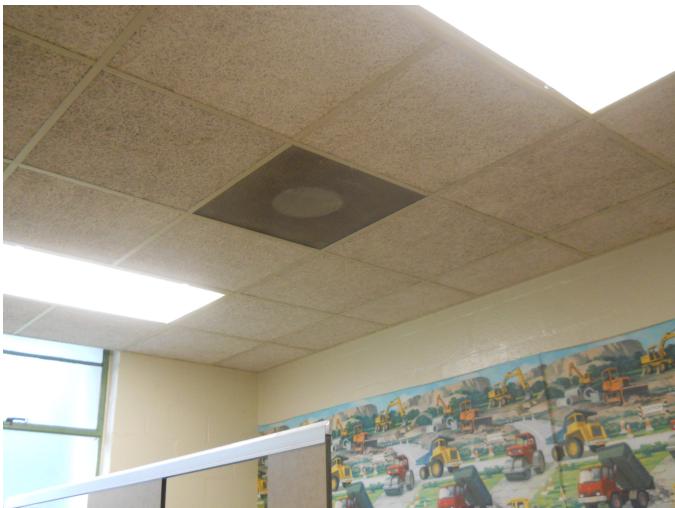
System: C3030 - Ceiling Finishes

Location: Throughout Building

Distress: Beyond Service Life

Notes: The original ceiling finishes are aged, failing, and should be replaced.

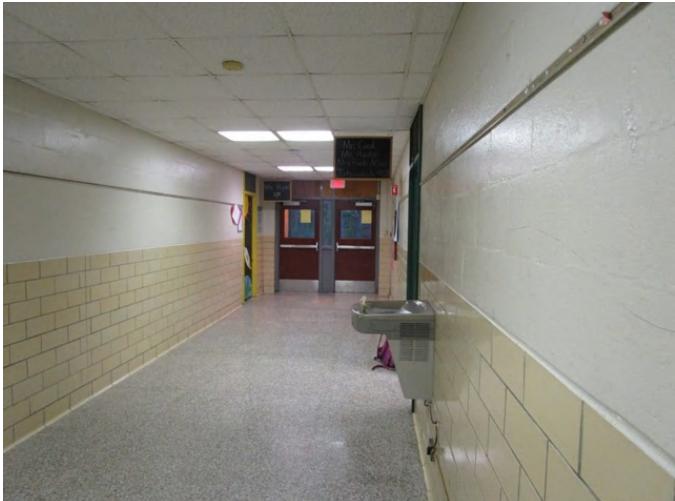
System: D2010 - Plumbing Fixtures

Location: South Classroom Hallway

Distress: Needs Remediation

Correction: Remove/replace drinking fountain w/recessed ADA compliant drinking fountain

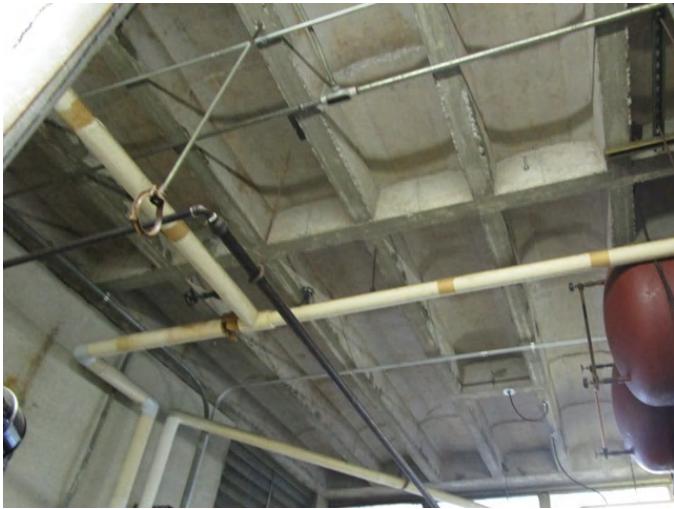
System: D2020 - Domestic Water Distribution

Location: Throughout Building

Distress: Beyond Service Life

Notes: The domestic water distribution system is beyond its expected service life, has water quality issues, and should be scheduled for replacement. SPLOST project 400-422 to replace backflow preventer.

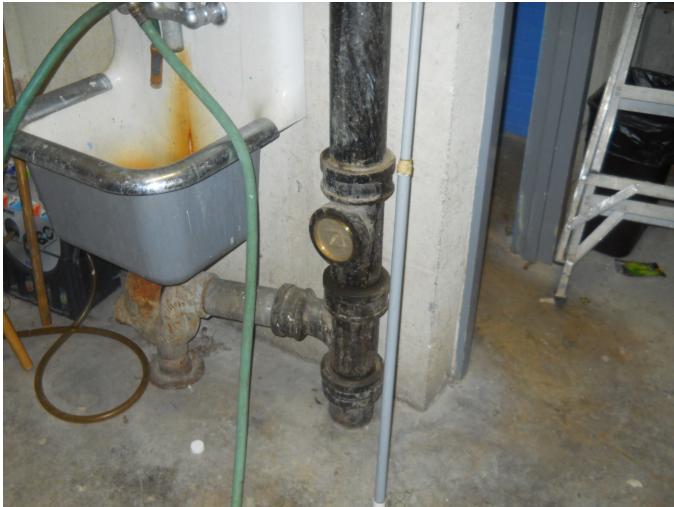
System: D2030 - Sanitary Waste

Location: Throughout Building

Distress: Beyond Service Life

Notes: The sanitary waste system is aged, has reported periodic failures and foul odors and should be replaced.

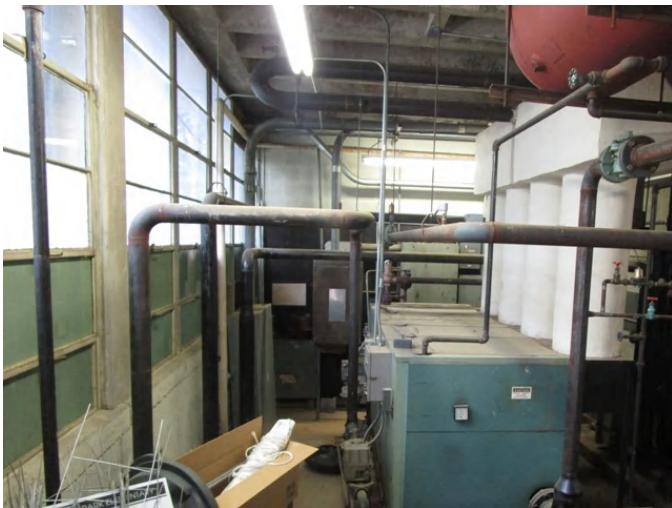
System: D3020 - Heat Generating Systems

Location: Mechanical Room

Distress: Beyond Service Life

Notes: The gas-fired boilers are operational and in fair condition, but are aging, inefficient, becoming logistically unsupportable, and should be scheduled for replacement.

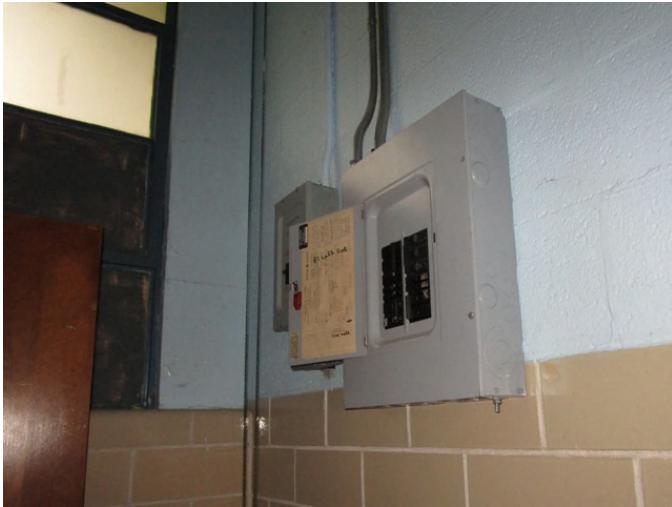
System: D5020 - Branch Wiring

Location: Throughout Building

Distress: Beyond Service Life

Notes: Branch wiring is nearing the end of its expected service life, inadequate, and should be replaced. The building does not have enough electrical outlets to serve current computer needs.

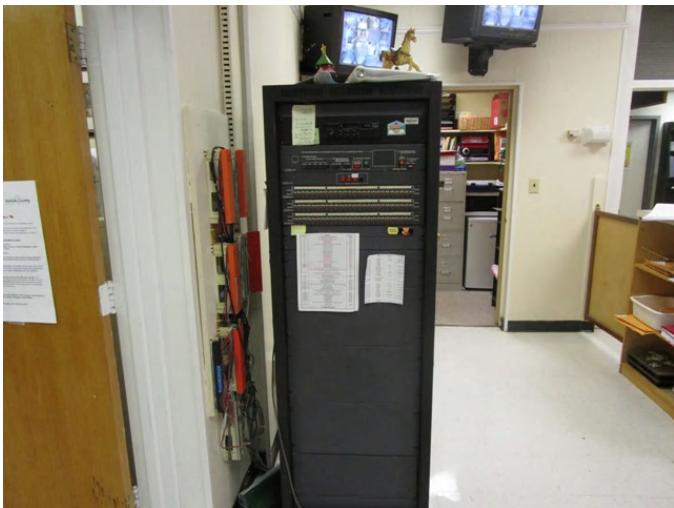
System: D5030 - Communications and Security - Clock & PA Systems

Location: Throughout Building

Distress: Beyond Service Life

Notes: Clock and PA systems are beyond their expected service life, inadequate, and should be scheduled for replacement.

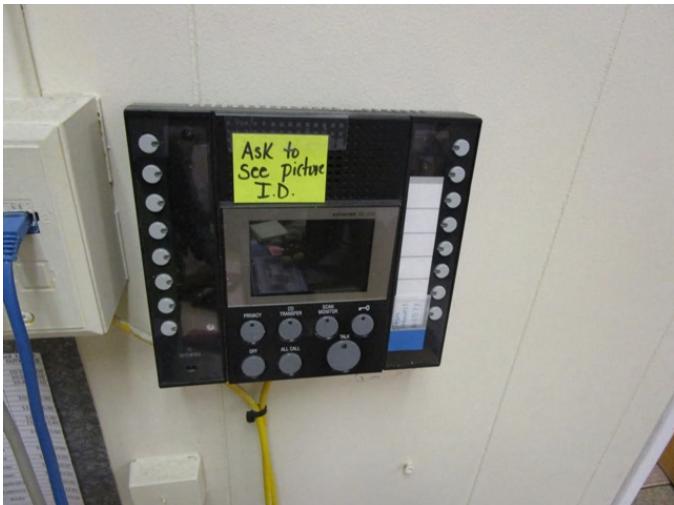
System: D5030 - Communications and Security - Security & CCTV

Location: Throughout Building

Distress: Beyond Service Life

Notes: The security and CCTV systems are beyond their expected service life and should be scheduled for replacement.

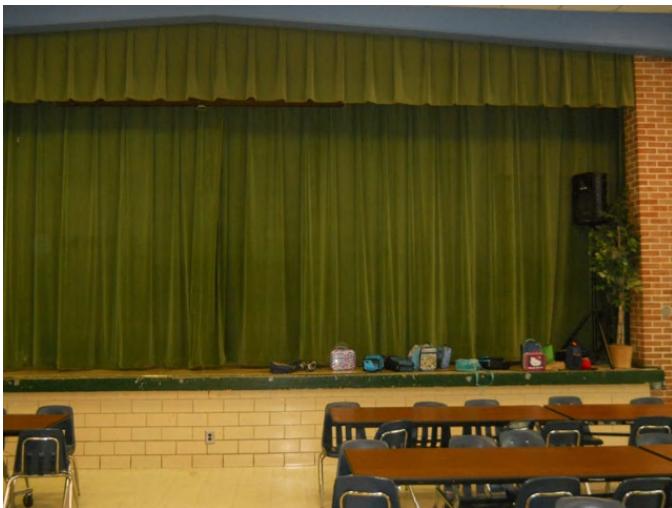
System: E1020 - Institutional Equipment

Location: Throughout Building

Distress: Beyond Service Life

Notes: Institutional equipment, such as theater and stage equipment, library equipment and audio-visual equipment, is beyond its expected service life and should be scheduled for replacement.

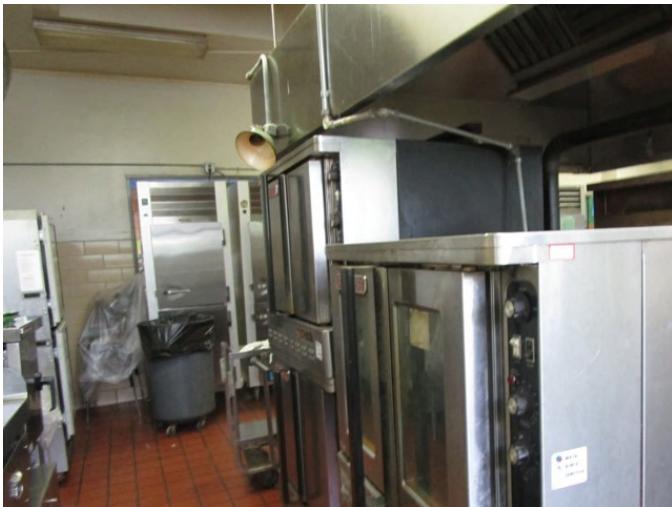
System: E1090 - Other Equipment (Kitchen Equipment)

Location: Kitchen

Distress: Beyond Service Life

Notes: The original kitchen equipment exhaust system is beyond its expected service life, becoming logistically unsupportable, and should be replaced. SPLOST project 400-422 to replace the kitchen equipment.

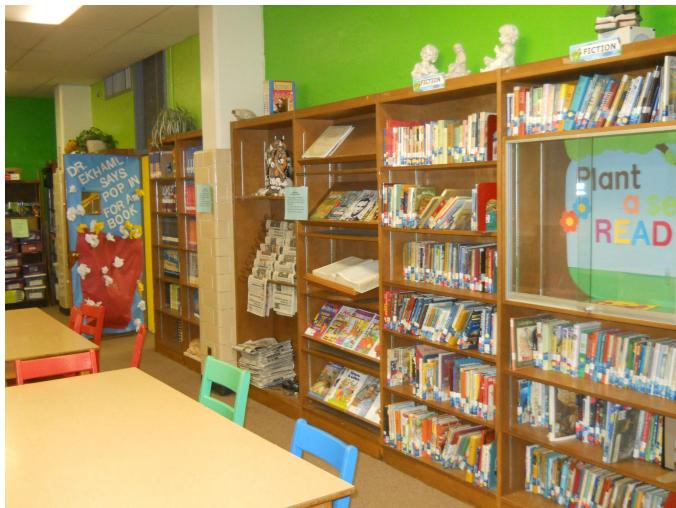
System: E2010 - Fixed Furnishings

Location: Throughout Building

Distress: Beyond Service Life

Notes: Fixed furnishings, such as built-in cabinets, are beyond their expected service life, damaged and worn, and should be replaced.

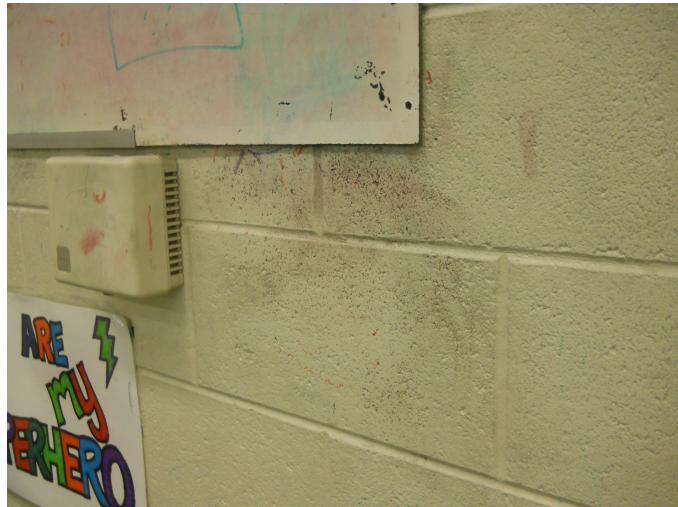
System: C3010 - Wall Finishes - Paint

Location: Throughout Building

Distress: Beyond Service Life

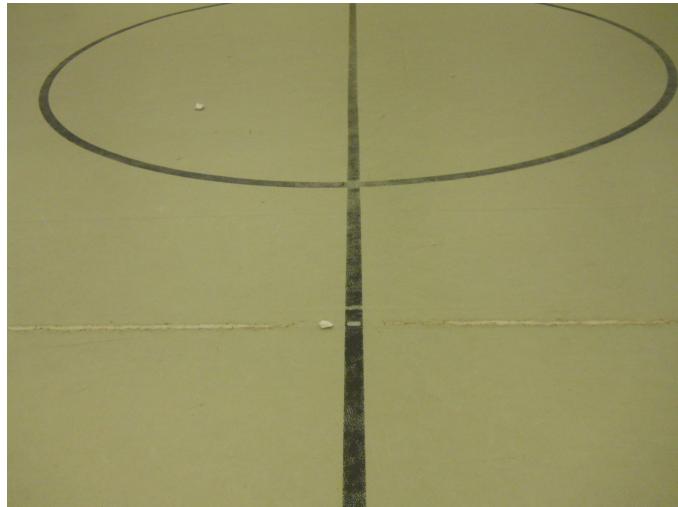
System: C3020 - Floor Finishes - Neoprene

Location: Basketball Court

Distress: Beyond Service Life

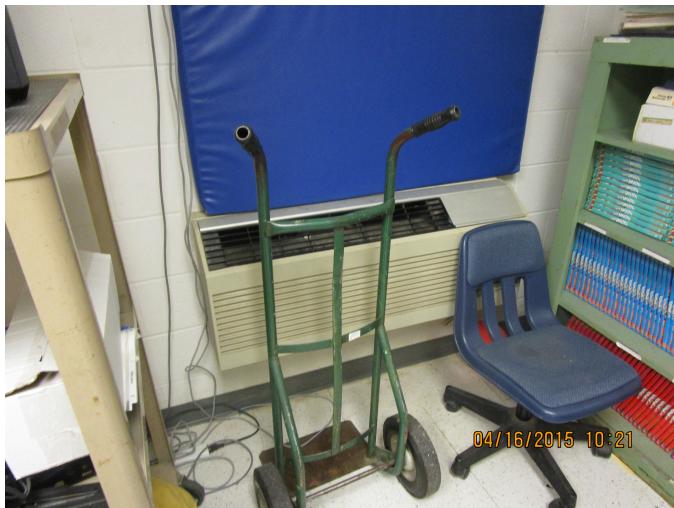
System: D3050 - Terminal & Package Units

Location: Throughout Building

Distress: Inadequate

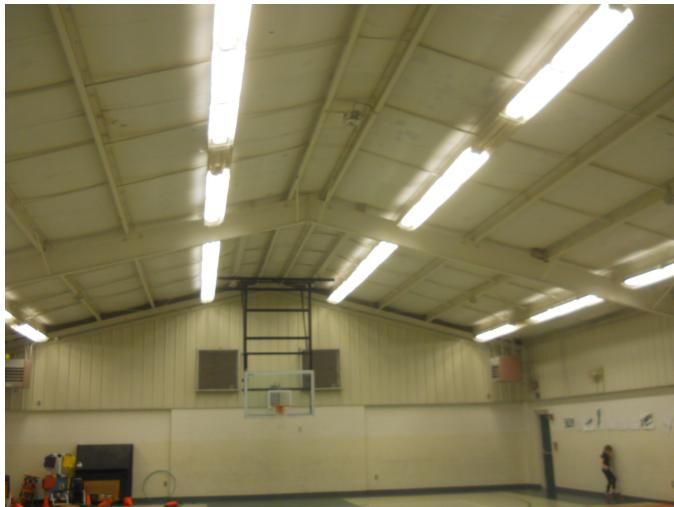
System: D5020 - Lighting

Location: Throughout Building

Distress: Inadequate

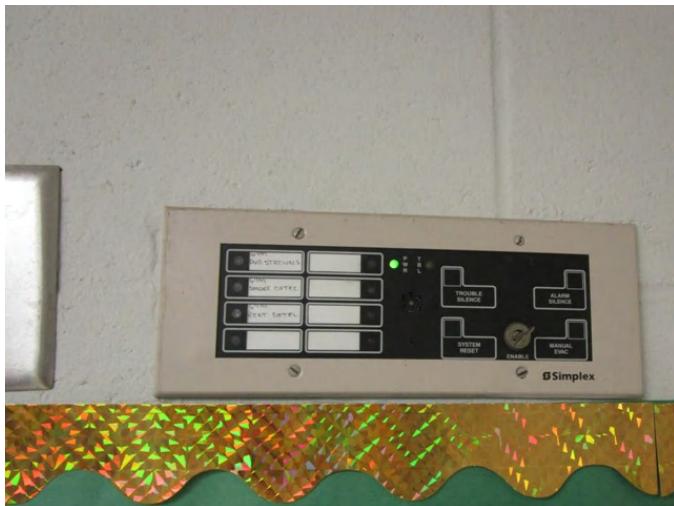
System: D5030 - Communications and Security - Fire Alarm

Location: Throughout Building

Distress: Beyond Service Life

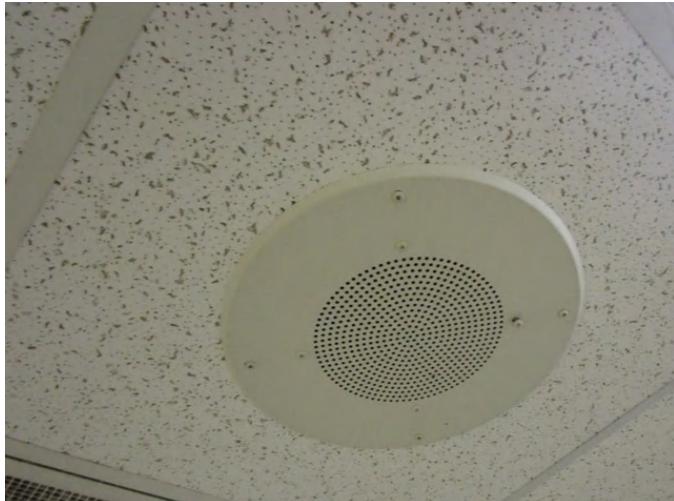
System: D5030 - Communications and Security - Public Address & Clock System

Location: Throughout Building

Distress: Beyond Service Life

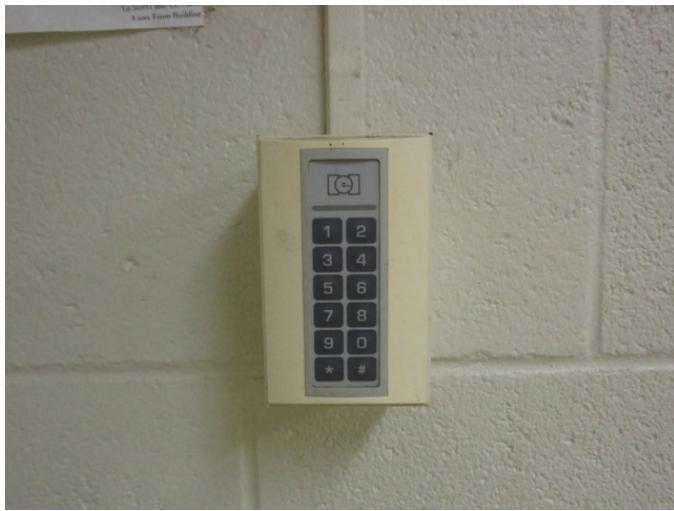
System: D5030 - Communications and Security - Security & CCTV

Location: Throughout Building

Distress: Beyond Service Life

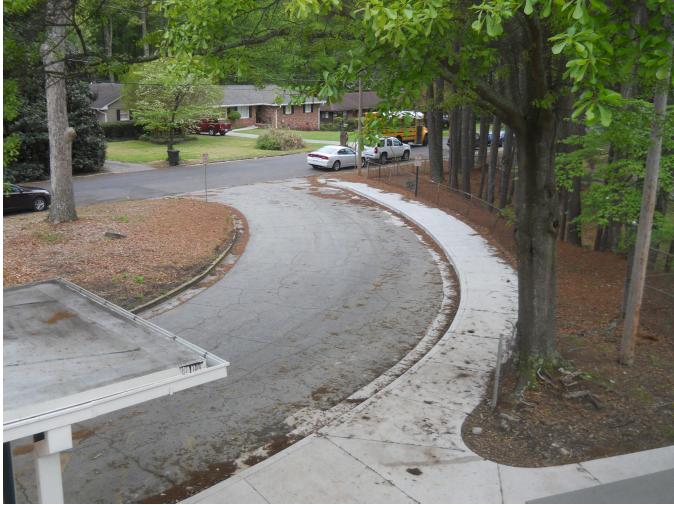
System: G2010 - Roadways

Location: Site

Distress: Beyond Service Life

Notes: Roadways are beyond their expected service life and should be scheduled for replacement.

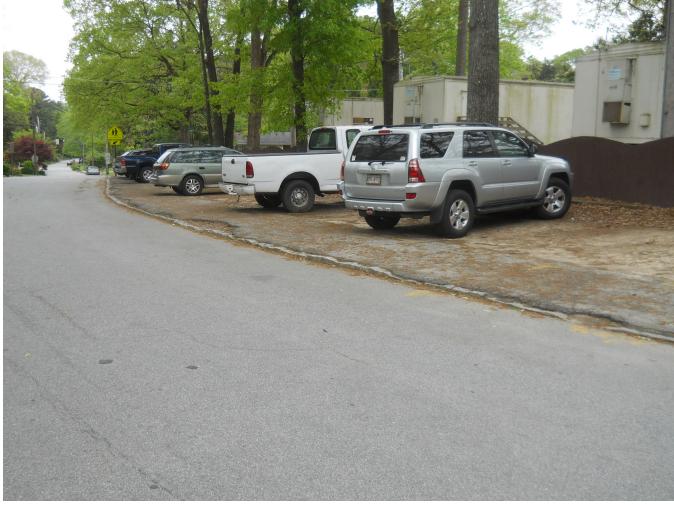
System: G2020 - Parking Lots

Location: Site

Distress: Beyond Service Life

Notes: The parking lots are beyond their expected service life, inadequate for school staff, not ADA compliant, and should be replaced. Parking spaces are not paved or properly marked on the pavement or with signage.

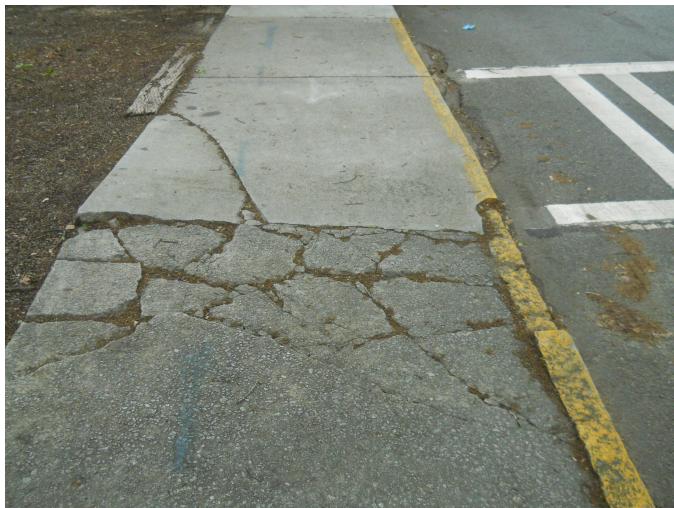
System: G2030 - Pedestrian Paving

Location: Site

Distress: Beyond Service Life

Notes: Pedestrian paving is beyond its expected service life, badly damaged with trip hazards, not ADA compliant, and should be scheduled for replacement.

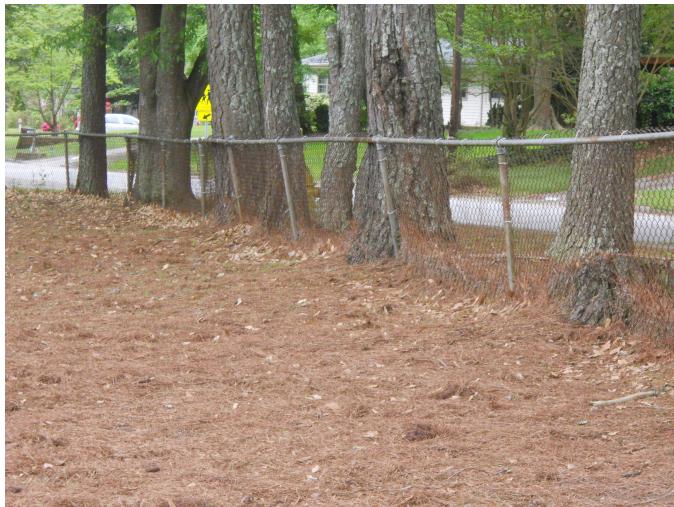
System: G2040 - Fencing & Guardrails

Location: Site

Distress: Beyond Service Life

Notes: Fencing is beyond its expected service life and should be scheduled for replacement.

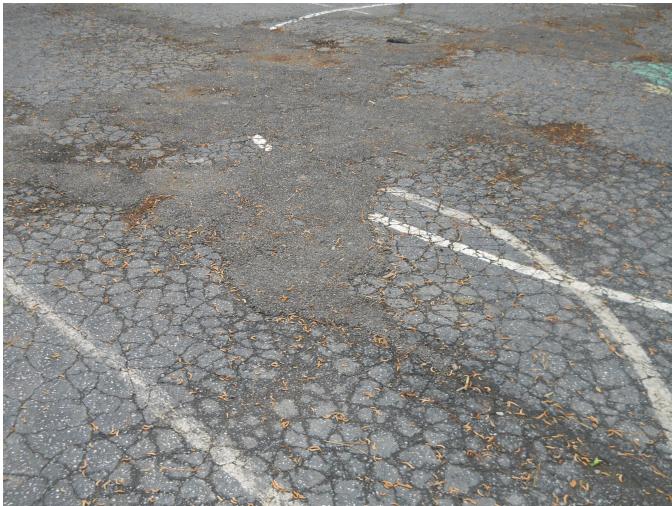
System: G2040 - Hard Surface Play Area

Location: Site

Distress: Beyond Service Life

Notes: The hard surface play area is beyond its expected service life, damaged with cracks and loss of surface, and should be replaced.

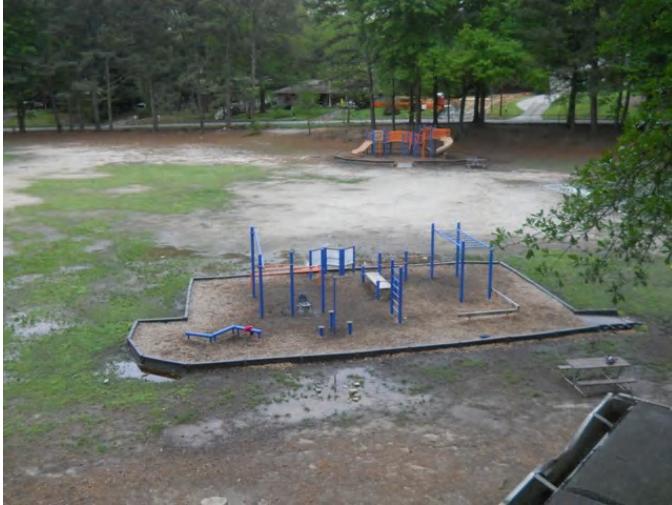
System: G2040 - Playing Field

Location: Site

Distress: Beyond Service Life

Notes: The playing field is beyond its expected service life, worn and bare, and should be replaced to prevent erosion.

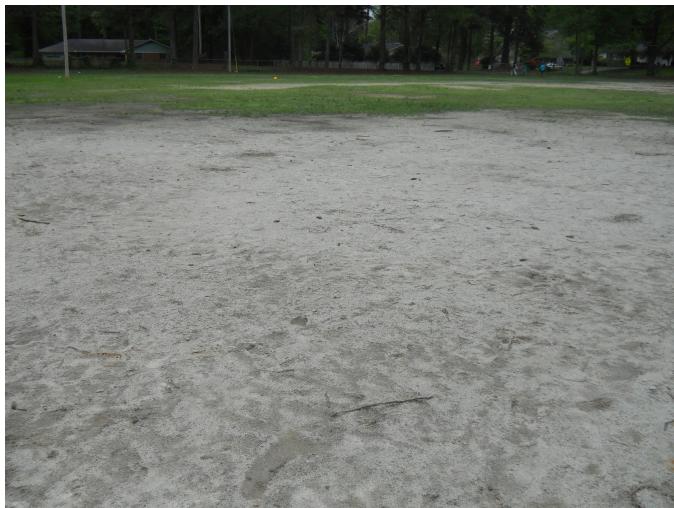
System: G2050 - Landscaping

Location: Site

Distress: Beyond Service Life

Notes: Landscaping is beyond its expected service life and should be scheduled for replacement.

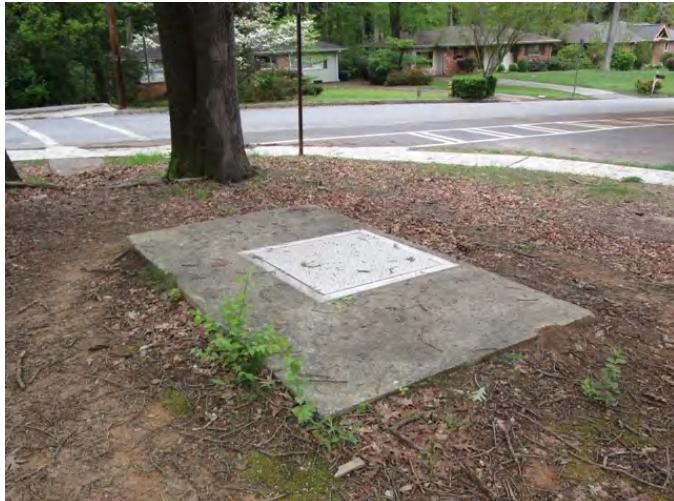
System: G3010 - Water Supply

Location: Site

Distress: Beyond Service Life

Notes: The site water supply system is beyond its expected service life and should be scheduled for replacement.

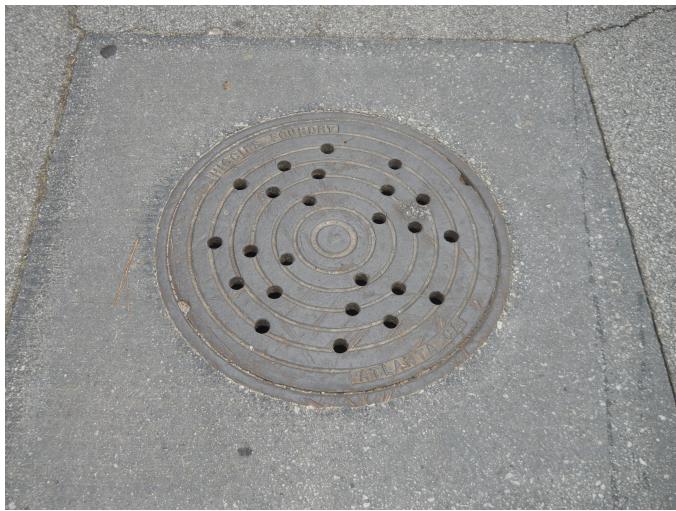
System: G3020 - Sanitary Sewer

Location: Site

Distress: Beyond Service Life

Notes: The site sanitary sewer system is beyond its expected service life and should be scheduled for replacement.

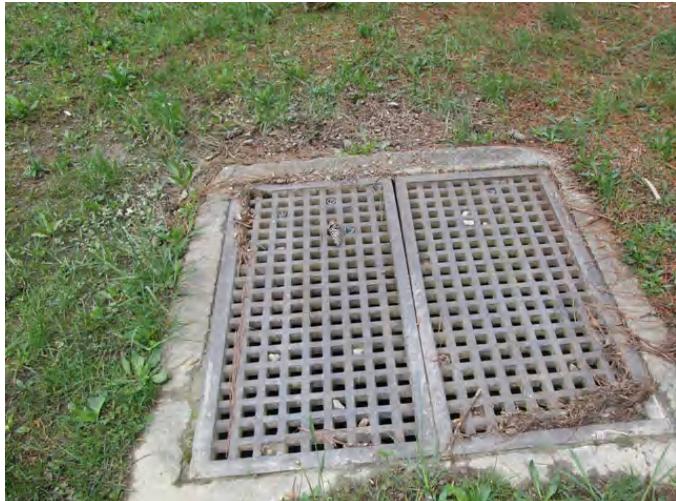
System: G3030 - Storm Sewer

Location: Site

Distress: Beyond Service Life

Notes: The storm sewer system is beyond its expected service life and should be scheduled for replacement.

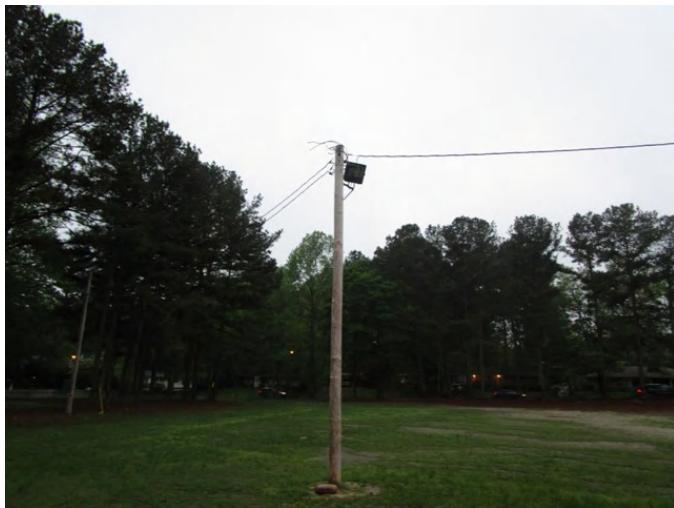
System: G4020 - Site Lighting

Location: Site

Distress: Beyond Service Life

Notes: Site lighting is beyond its expected service life, inadequate, and should be scheduled for replacement.

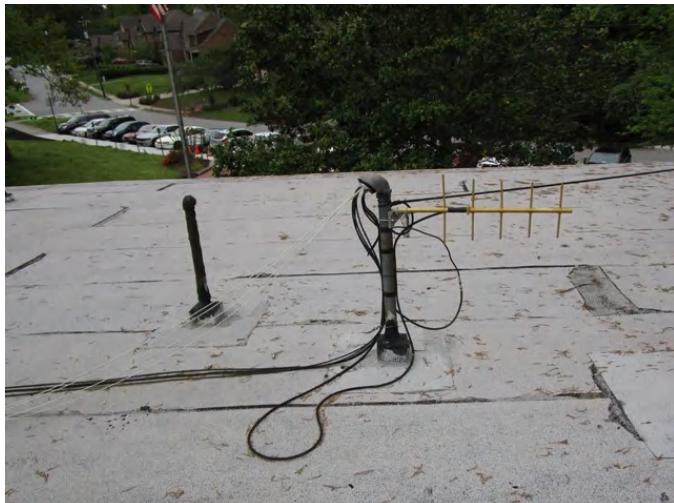
System: G4030 - Site Communications & Security

Location: Site

Distress: Beyond Service Life

Notes: The site communications and security systems are beyond their expected service life and should be scheduled for replacement.
