DeKalb County School District/Elementary Schools

Browns Mill Elementary

School Assessment Report

May 19, 2016

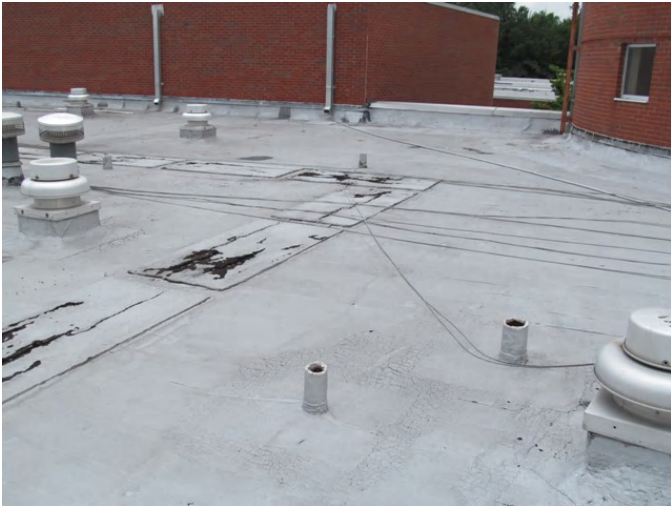
System: B3010 - Roof Coverings - BUR

Location: Roof

Distress: Damaged

Notes: The original roofing is damaged, has reported leaks, and should be replaced. SPLOST project 303-422 to replace the roof on the 1990 building.

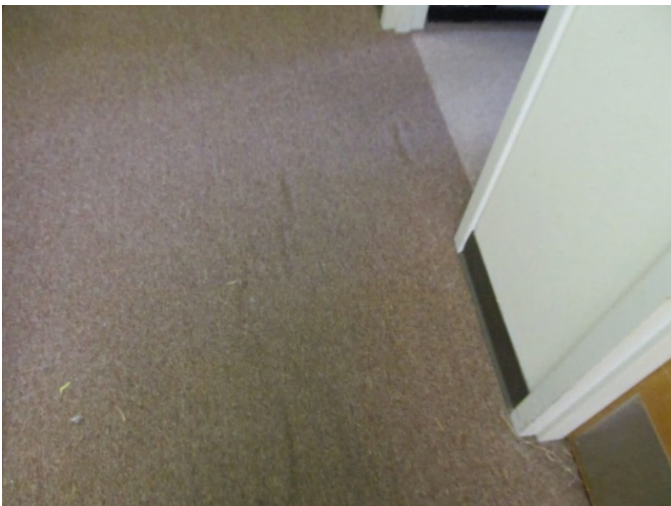
System: C3020 - Floor Finishes - Carpet

Location: Throughout Building

Distress: Beyond Service Life

Notes: The carpet is damaged, has multiple tripping hazards, and should be replaced.

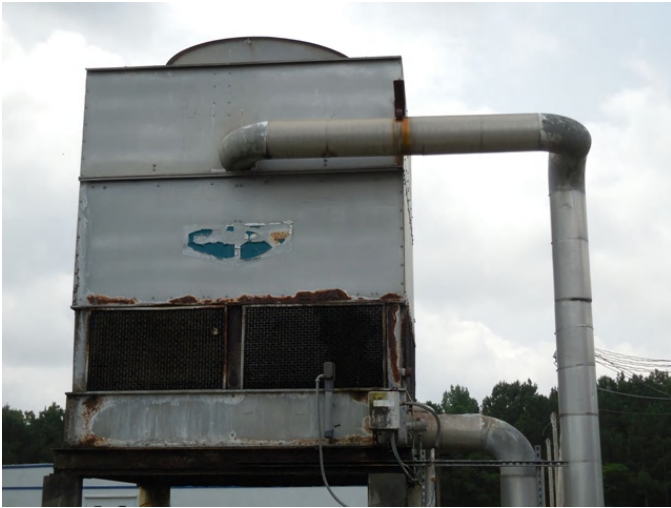
System: D3030 - Cooling Generating Systems

Location: South East Side of Building

Distress: Beyond Service Life

Notes: Cooling tower is rusted and coils are showing heavy sign of wear. The cooling generating system is beyond its expected service life and should be scheduled for replacement.

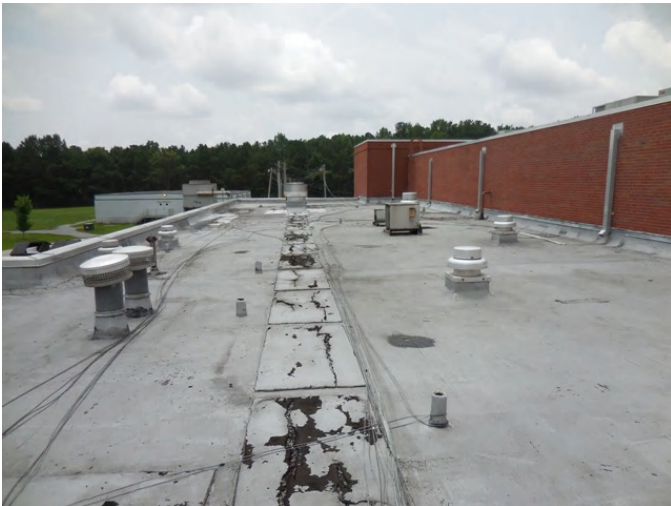
System: D3040 - Distribution & Exhaust Systems

Location: Throughout Building

Distress: Beyond Service Life

Notes: Fan coils and roof exhaust system are beyond their expected service life, constantly breaking down, and should be scheduled for replacement.

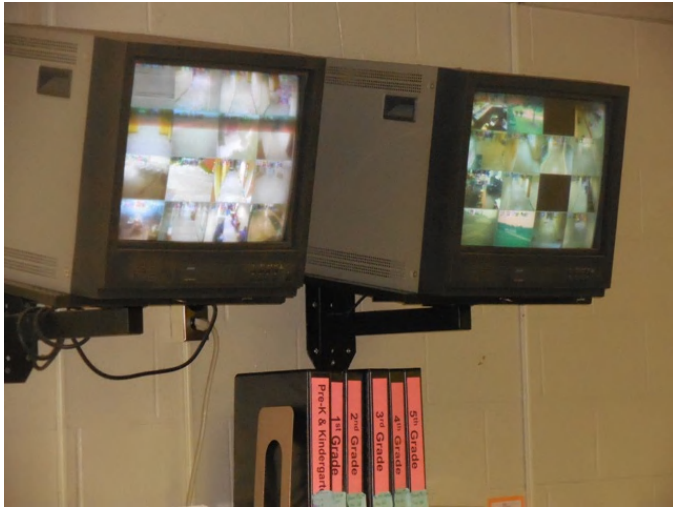
System: D5030 - Communications and Security - Security & CCTV

Location: Throughout Building

Distress: Inadequate

Notes: The entire system is beyond its expected service life and should be scheduled for replacement/upgraded to provide full coverage.

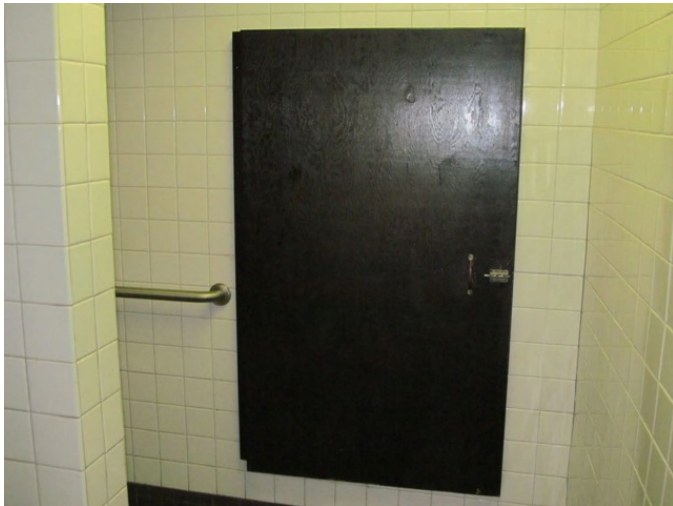
System: C1030 - Fittings

Location: Throughout Building

Distress: Beyond Service Life

Notes: Fittings, such as toilet partitions, handrails, signage and lockers, are beyond their expected service life, inadequate, not ADA compliant, and should be replaced.

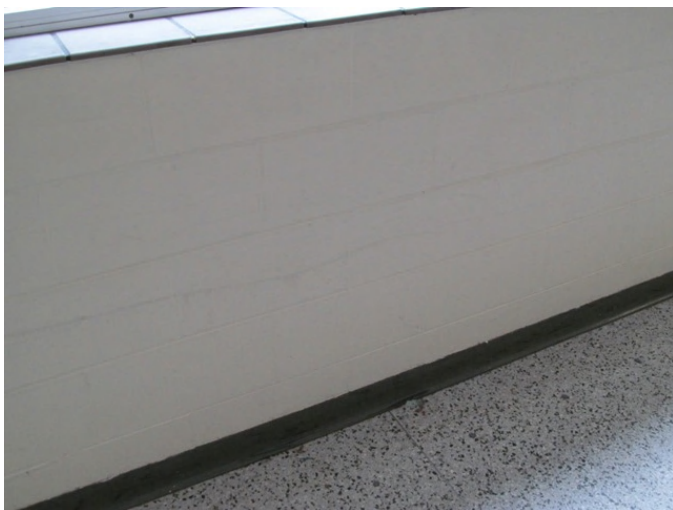
System: C3010 - Wall Finishes - Paint

Location: Throughout Building

Distress: Beyond Service Life

Notes: The painted wall finishes are beyond their expected service life and should be replaced.

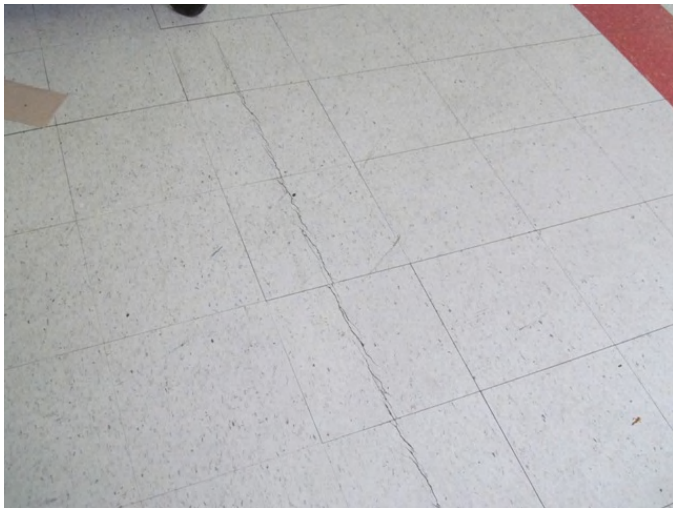
System: C3020 - Floor Finishes - VCT

Location: Throughout Building

Distress: Beyond Service Life

Notes: The original VCT floor covering is beyond its expected service life, showing signs of excessive wear due to uneven sub flooring, and should be replaced.

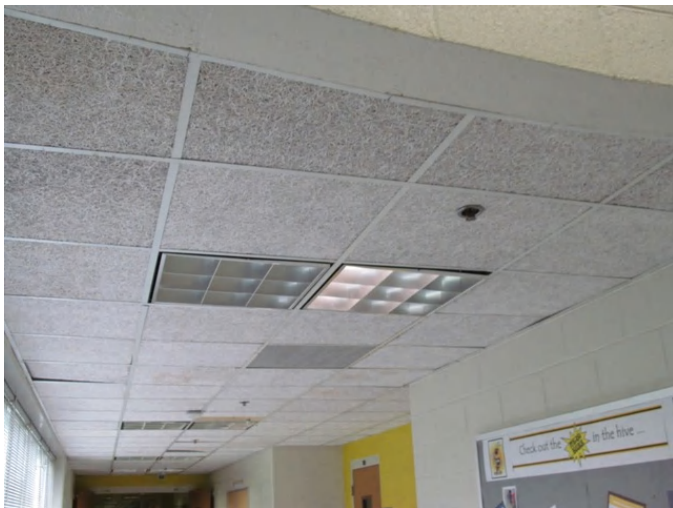
System: C3030 - Ceiling Finishes

Location: Throughout Building

Distress: Beyond Service Life

Notes: The acoustical ceiling system is original, beyond its expected service life, and should be replaced.

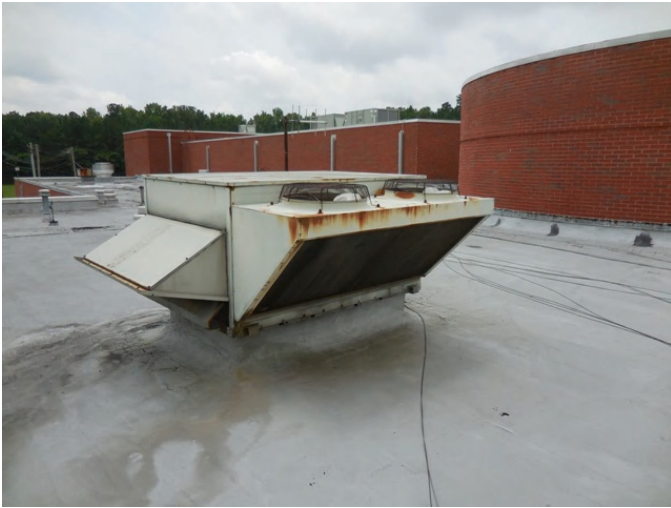
System: D3050 - Terminal & Package Units

Location: Roof

Distress: Damaged

Notes: Three RTUs were replaced in 2014. Two additional RTUs are original, rusted/corroded, and constantly break down. Estimated 20-ton units. SPLOST project 303-422 to replace the roof top units.

Correction: Replace multi-zone rooftop unit, 25 ton

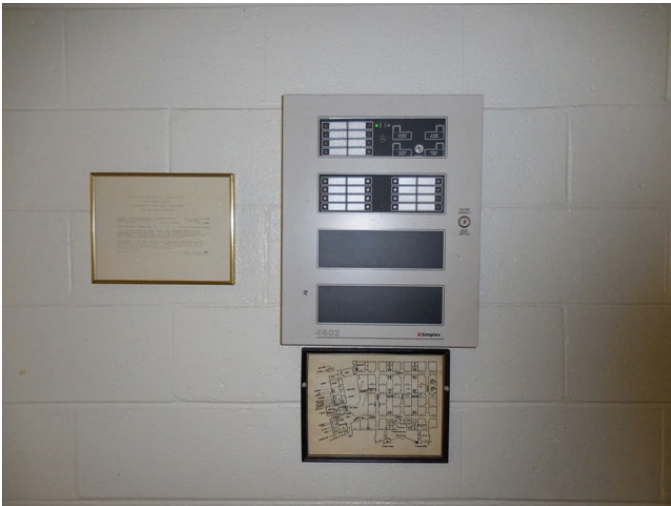
System: D5030 - Communications and Security - Fire Alarm

Location: Throughout Building

Distress: Beyond Service Life

Notes: The fire alarm system is beyond its expected service life and should be scheduled for replacement.

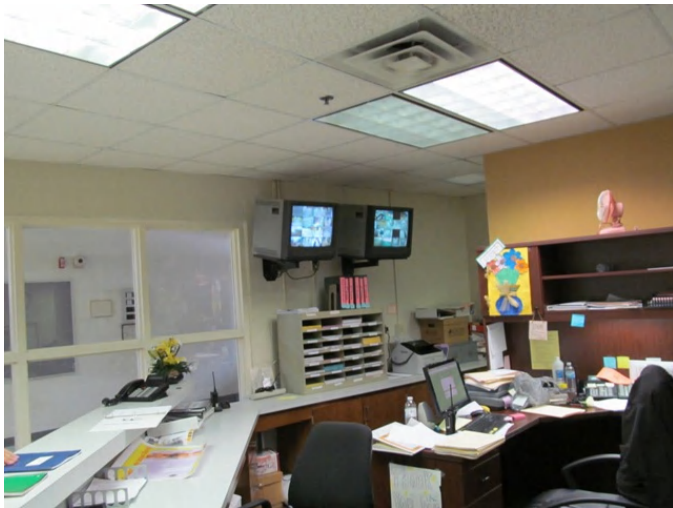
System: E2010 - Fixed Furnishings

Location: Throughout Building
Distress: Beyond Service Life
Category: Deferred Maintenance
Priority: 3 Priority
Correction: Renew System
Qty: 70,500.00
Unit of Measure: S.F.
Estimate: \$416,444.00
Assessor Name: Ben Nixon
Date Created: 04/11/2015

Notes: Fixed furnishings, including window shades, are beyond their expected service life and should be scheduled for replacement.

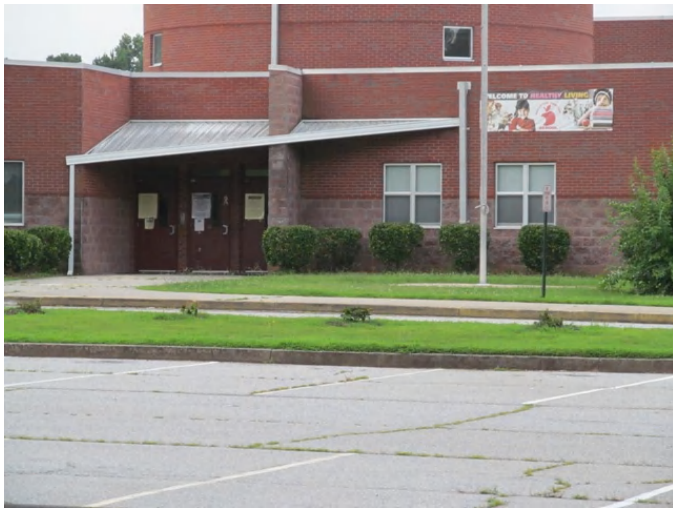
System: F1010 - Special Structures - Canopies

Location: Exterior of Building
Distress: Beyond Service Life
Category: Deferred Maintenance
Priority: 3 Priority
Correction: Renew System
Qty: 70,500.00
Unit of Measure: S.F.
Estimate: \$113,505.00
Assessor Name: Ben Nixon
Date Created: 10/07/2015

Notes: The canopies attached to the building are rusted and damaged and should be repaired/replaced.

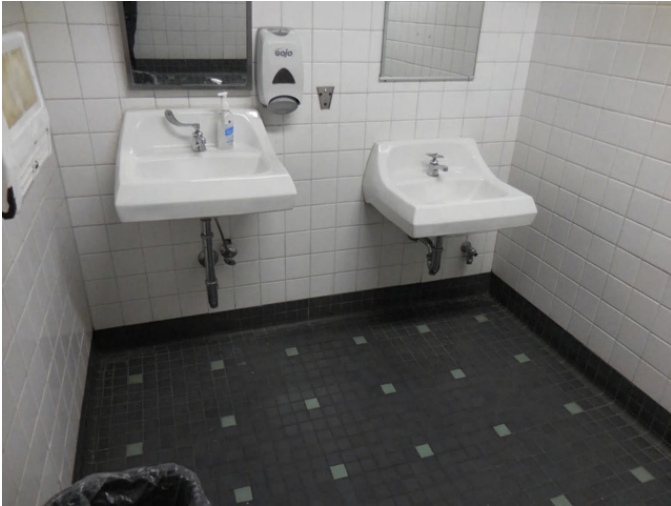
System: D2010 - Plumbing Fixtures

Location: Throughout Building

Distress: Beyond Service Life

Notes: The plumbing fixtures are beyond their expected service life, and should be scheduled for replacement and upgrading to improve ADA accessibility. Water fountains protrude into the hallway more than four inches. Protrusion is not ADA compliant if more than four inches.

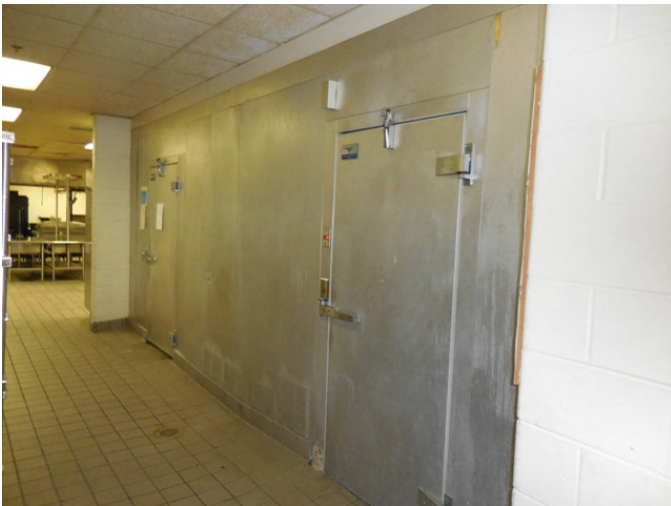
System: E1090 - Other Equipment - Kitchen Equipment

Location: Kitchen
Distress: Beyond Service Life
Category: Deferred Maintenance
Priority: 4 Priority
Correction: Renew System
Qty: 70,500.00
Unit of Measure: S.F.
Estimate: \$497,871.00
Assessor Name: Ben Nixon
Date Created: 04/11/2015

Notes: Kitchen equipment is beyond its expected service life and should be scheduled for replacement. Oven, stoves and walk-In coolers are original and showing signs of wear.

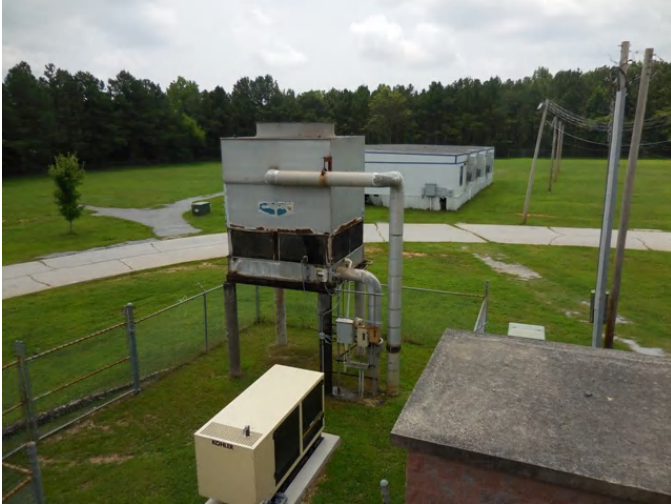
System: B3010 - Roof Coverings

Location: Roof

Distress: Beyond Service Life

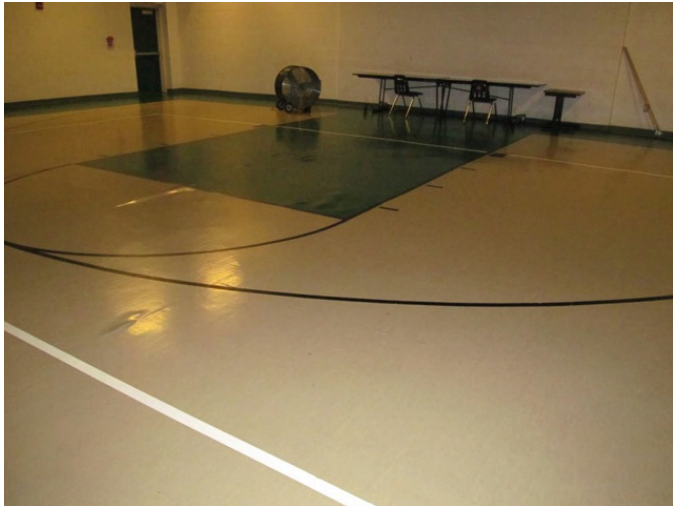
System: C3020 - Floor Finishes - Neoprene

Location: Basketball Court

Distress: Beyond Service Life

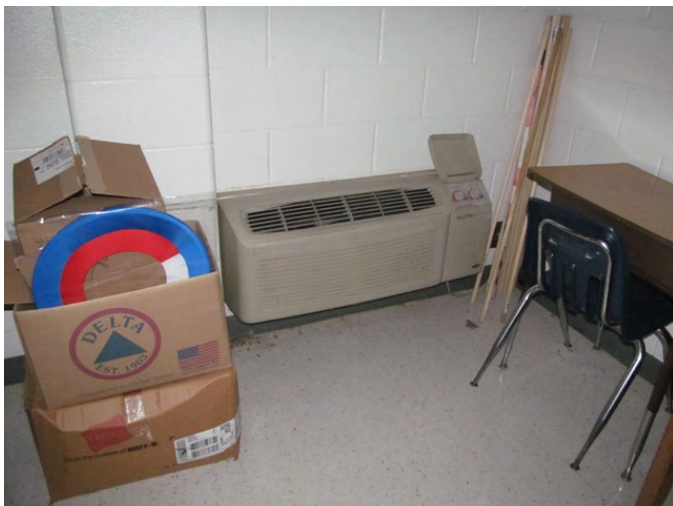
System: D3050 - Terminal & Package Units

Location: Throughout Building

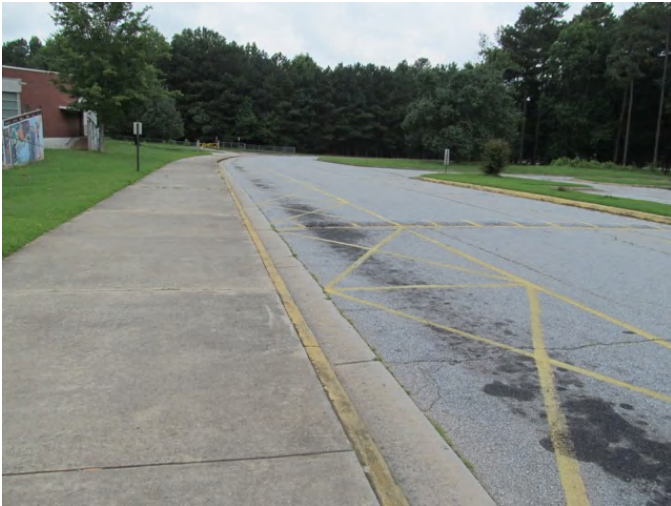
System: G2010 - Roadways

Location: Site

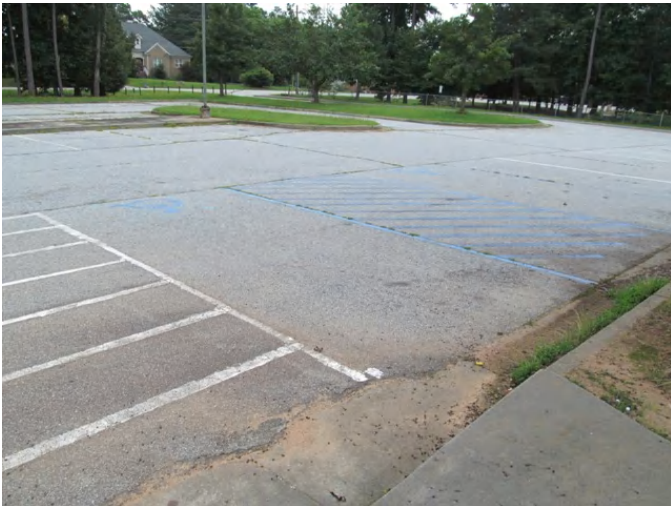
System: G2020 - Parking Lots

Location: Site

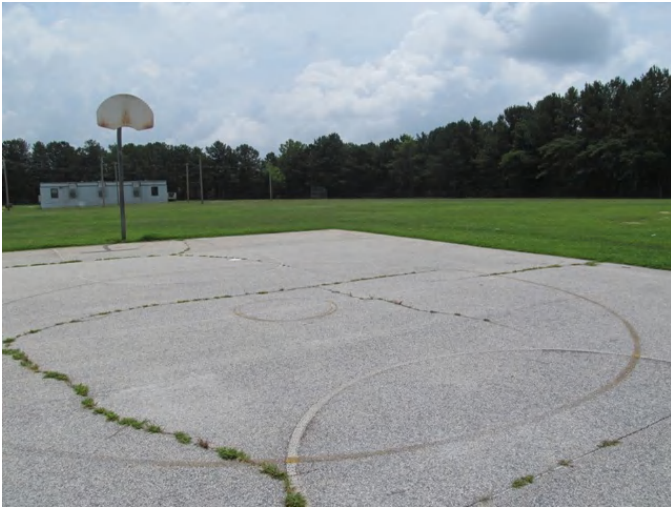
System: G2040 - Hard Surface Play Area

Location: Site

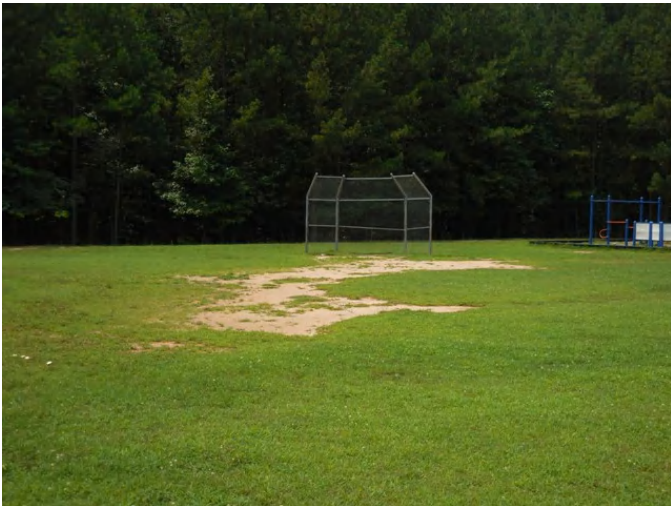
System: G2040 - Playing Field

Location: Site
