DeKalb County School District/Middle Schools

Cedar Grove Middle

School Assessment Report

May 20, 2016

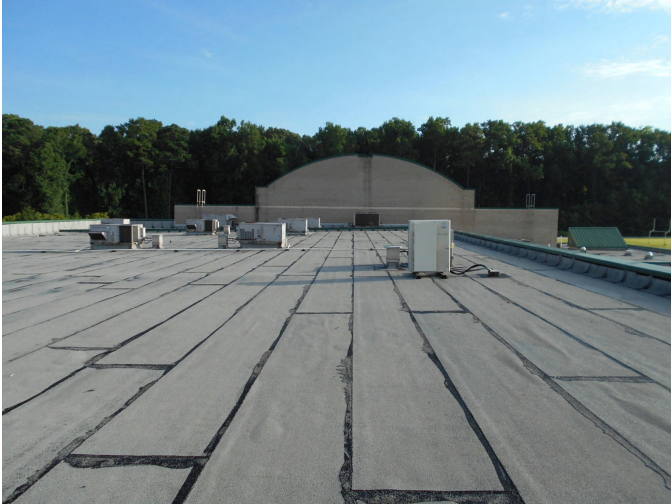
System: B3010 - Roof Coverings - BUR

Location: Roof

Distress: Damaged

Notes: The roof is nearing the end of its expected service life, is worn and delaminating, has several reported and observed leaks, and should be replaced.

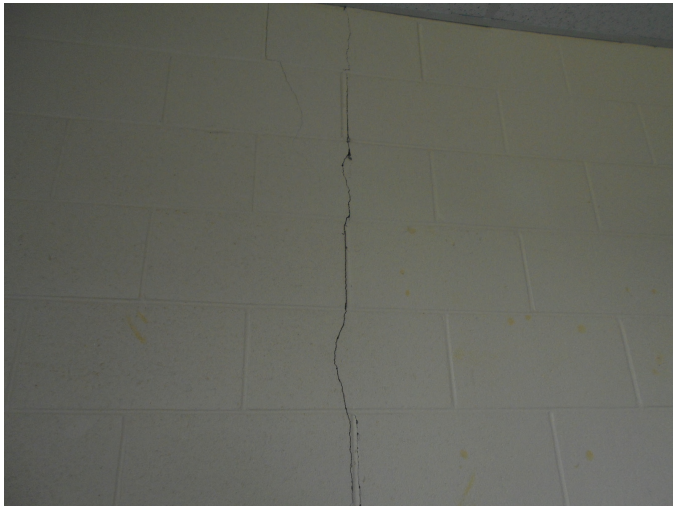
System: B2010 - Exterior Walls

Location: 907 CCR Lab

Distress: Damaged

Notes: Exterior wall with observed fissure. An engineering study is recommended to determine the cause. Pricing does not include remediation measures.

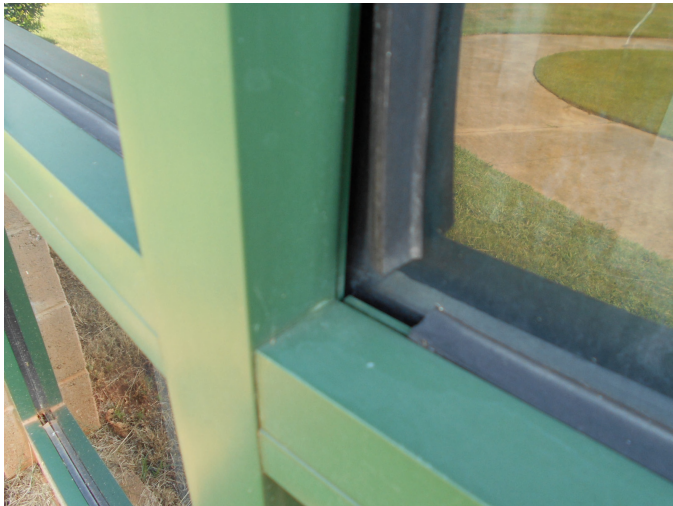
System: B2020 - Exterior Windows

Location: Cafeteria

Distress: Inadequate

Notes: The exterior window seals are inadequate, too short to effectively seal the window to the frame, causing leaks.

Correction: Repair 3' x 4' aluminum window - 1st floor

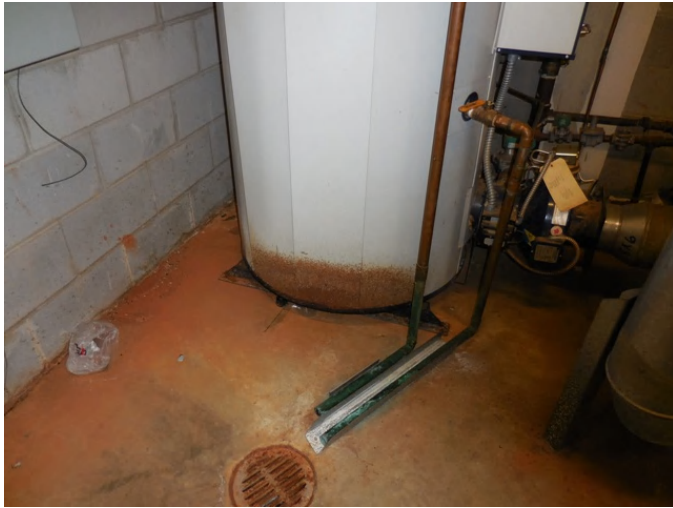
System: D2020 - Domestic Water Distribution

Location: Mechanical Room

Distress: Damaged

Notes: The 120 gallon gas hot water heater tank has started to rust and should be replaced.

Correction: Replace water heater, gas / oil, 70 gallon

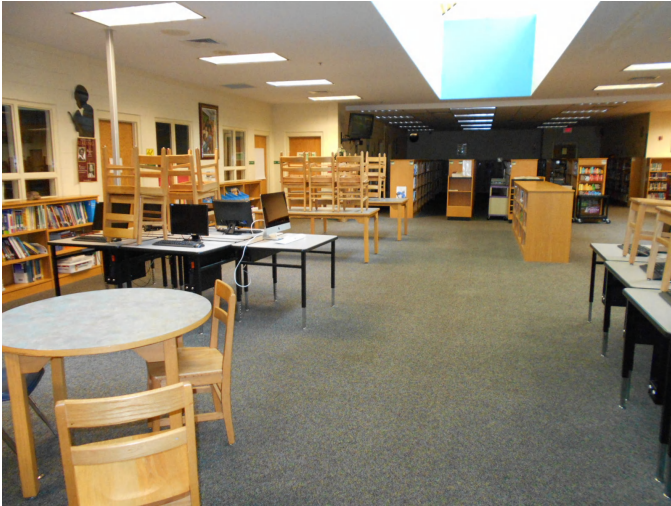
System: C3020 - Floor Finishes - Carpet

Location: Music Rooms, Media Center, Offices

Distress: Beyond Service Life

Notes: The carpet is beyond its expected service life, worn, and should be replaced.

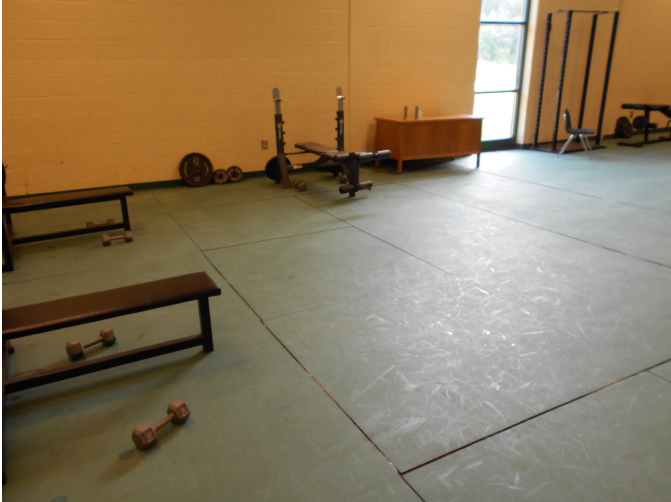
System: C3020 - Floor Finishes - Neoprene

Location: Wrestling Room

Distress: Beyond Service Life

Notes: The original neoprene flooring is beyond its expected service life, worn, and should be replaced.

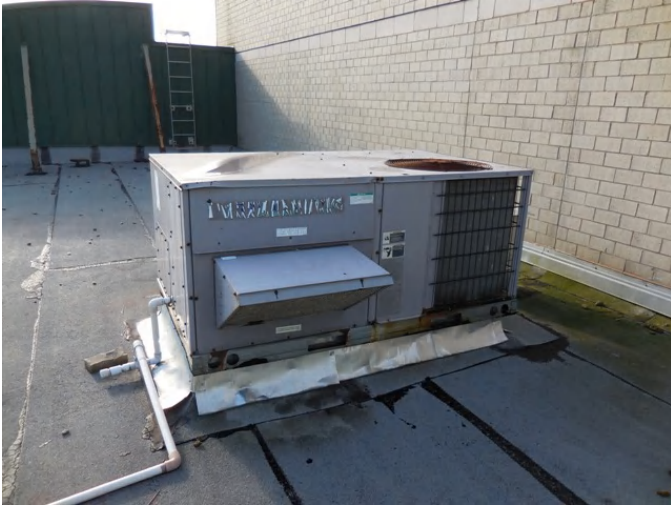
System: D3050 - Terminal & Package Units

Location: Roof

Distress: Beyond Service Life

Notes: RTUs on the roof and the water source heat pumps in the mezzanine areas of each hallway are at the end of their service life. The systems continuously break down and leave several areas without AC. The unit over the gym (RTU-12) caught fire and is no longer functional. Ensure a test and balance of the system.

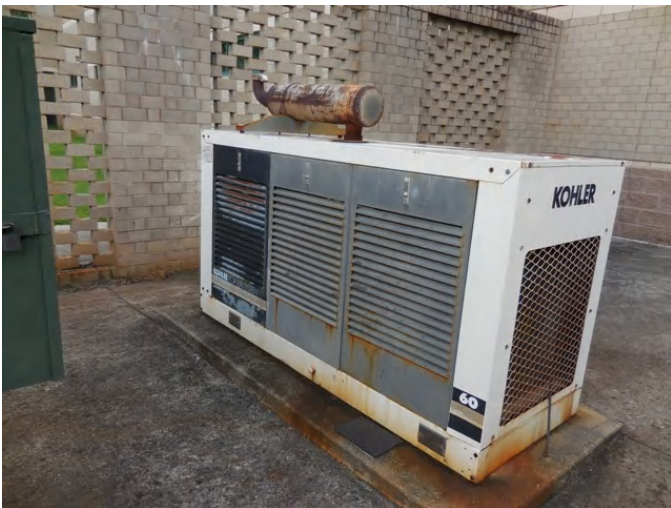
System: D5090 - Other Electrical Systems - Emergency Generator

Location: Outside Mechical Room

Distress: Damaged

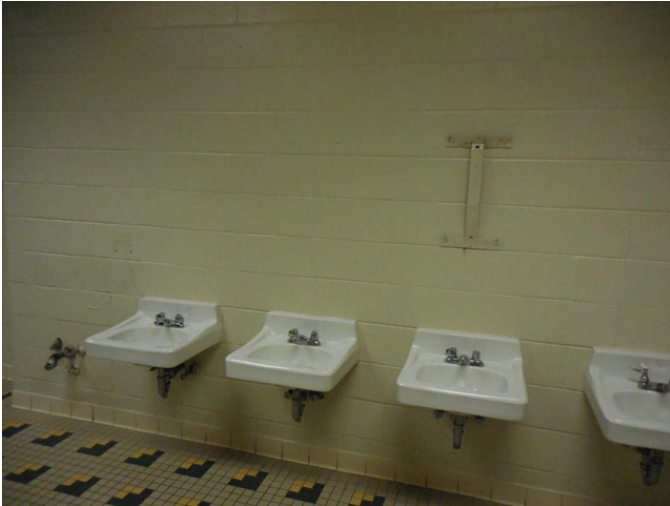
System: D2010 - Plumbing Fixtures

Location: Throughout Building

Distress: Damaged

Notes: Plumbing fixtures, are missing, damaged or loose, and should be replaced. Faucets and p-traps need repair or replacement. Sink handles and exposed piping are not ADA compliant.

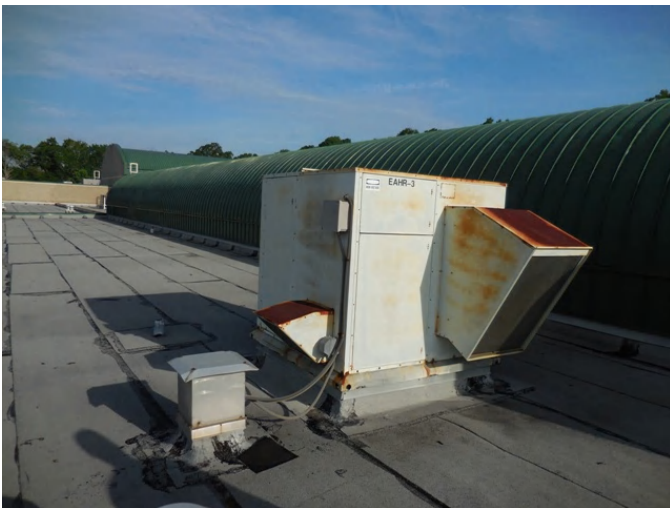
System: D3040 - Distribution Systems & Exhaust Systems

Location: Roof

Distress: Damaged

Notes: Roof top exhaust system to include two exhaust air heat recovery systems are rusted. Exhaust systems need to be repaired or replaced. The kiln exhaust system in room 403C does not function and should be repaired/replaced. SPLOST project 304-422 to replace exhaust fan systems throughout the building as needed by November 2016.

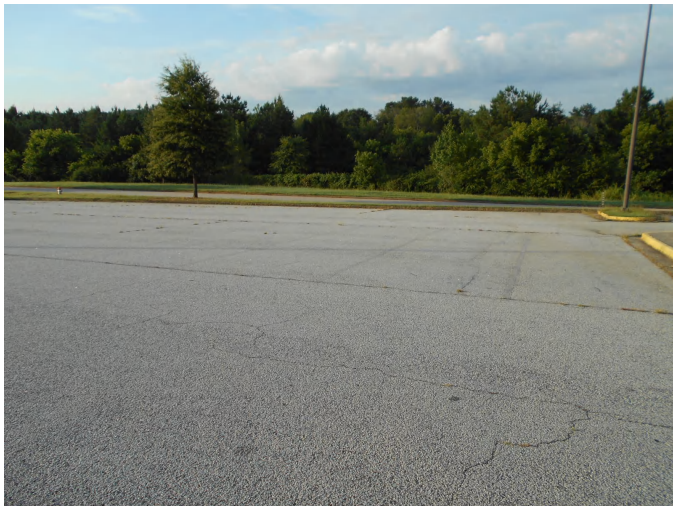
System: G2020 - Parking Lots

Location: Site

Distress: Damaged

Notes: The asphalt parking lot and roadways are in fair condition. Need to make minor repairs, sealcoat, and re-stripe.

Correction: Parking lot repair and sealcoating

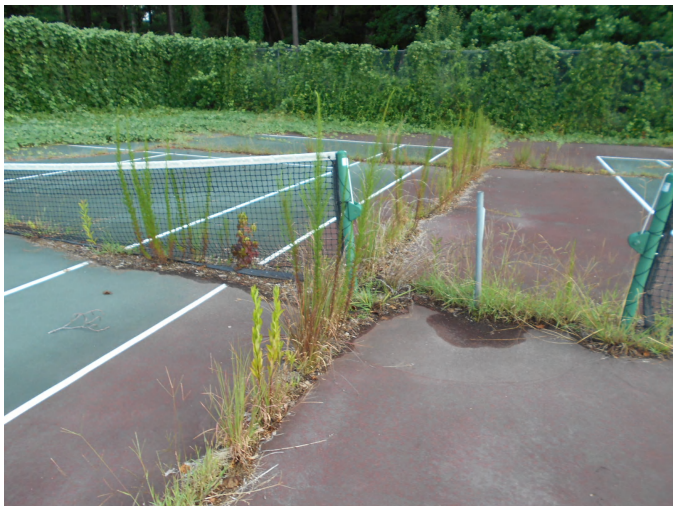
System: G2040 - Tennis Courts

Location: Site

Distress: Damaged

Notes: The tennis courts are in poor condition, not useable, and should be replaced.

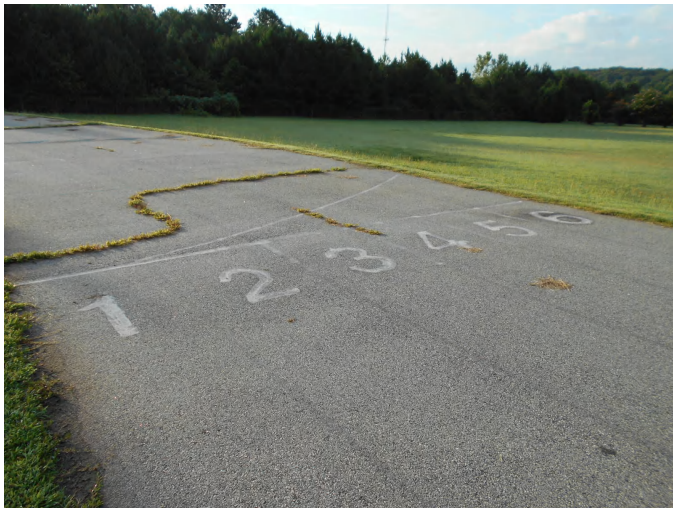
System: G2040 - Track

Location: Site

Distress: Beyond Service Life

Notes: The asphalt track is beyond its expected service life, failing, and should be replaced.

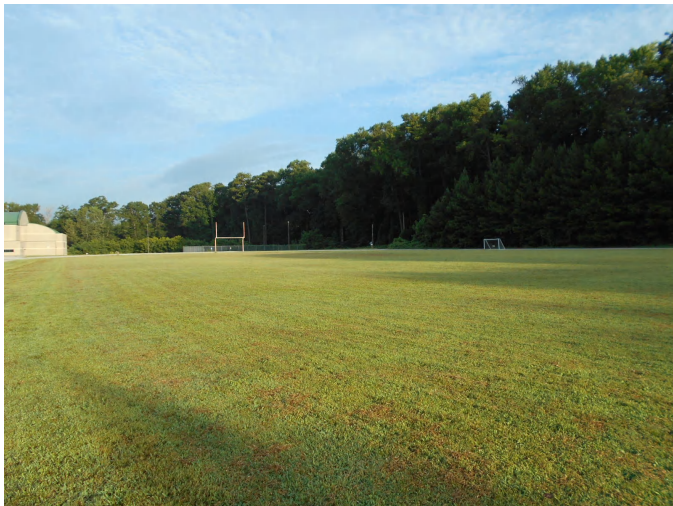
System: G2050 - Landscaping

Location: Site

Distress: Needs Remediation

Notes: The football field irrigation system has reportedly never worked and should be repaired.

Correction: Irrigation system, repair /replace controls and test system

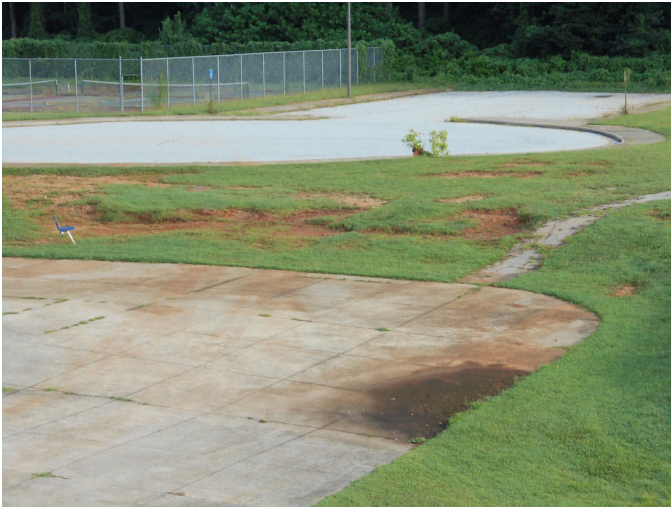
System: G2050 - Landscaping

Location: Site

Distress: Needs Remediation

Notes: Ground erosion between the rear parking lot and building. Recommend repairing the landscape system to prevent further erosion and correct the damage. One man week of labor to fill erosion, install erosion control mats, and keep the area watered until the grass has matured.

Correction: Irrigation system, repair /replace controls and test system

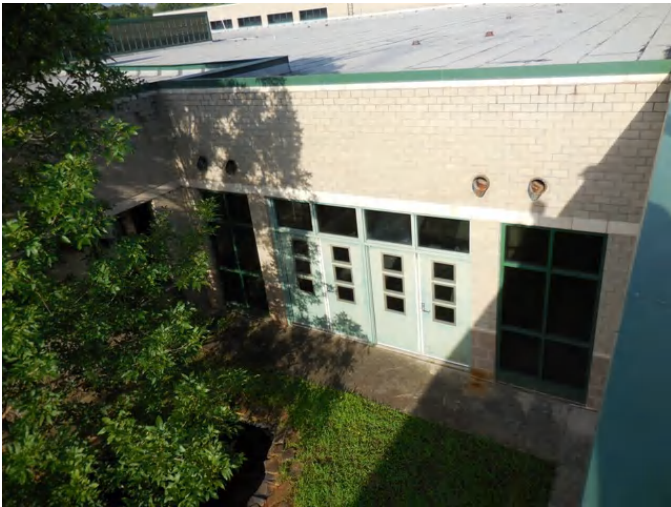
System: G3030 - Storm Sewer

Location: Courtyards

Distress: Needs Remediation

Notes: Storm drains continuously clog and flood the courtyard areas, specifically the courtyards between 700-800 and 600-700 hallways. Water comes from the roof and drains into the courtyard. The landscaping allows debris to collect on top of and in the drain system. Recommend clearing and leaning the drain system. SPLOST project 304-422 to repair storm drains between the 700 and 800 halls and the 600 and 700 halls to eliminate flooding on site by January 2017. Estimate for this deficiency is to clear and grub, and to remove debris from drainage area and the drain system.
