**DeKalb County School District/Middle Schools**

# **Chamblee Middle**

## **School Assessment Report**

**May 20, 2016**

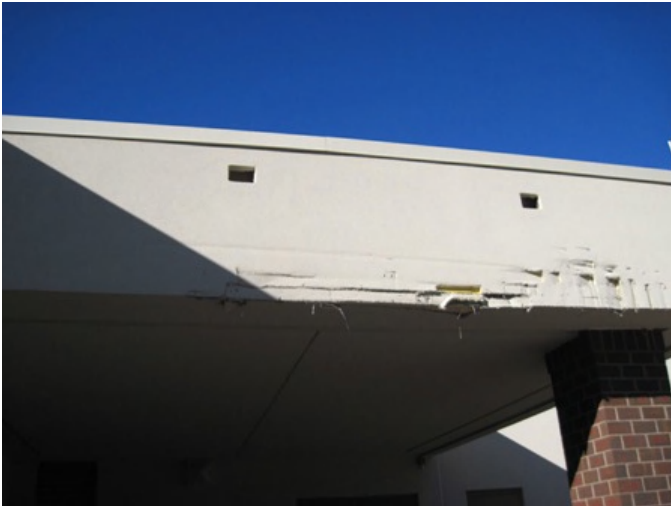
#### System: B2010 - Exterior Walls

**Location:** Kitchen Loading Area

**Distress:** Damaged

**Notes:** The bottom edge of the canopy is damaged and should be repaired.

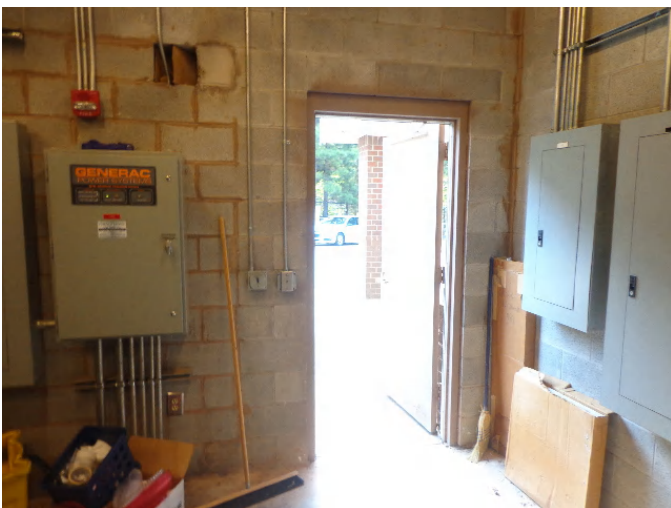
#### System: B2030 - Exterior Doors

**Location:** Electrical Room

**Distress:** Missing

**Notes:** Emergency exit door is missing a panic hardware device per different code standards and should be provided.

**Correction:** Replace door panic device

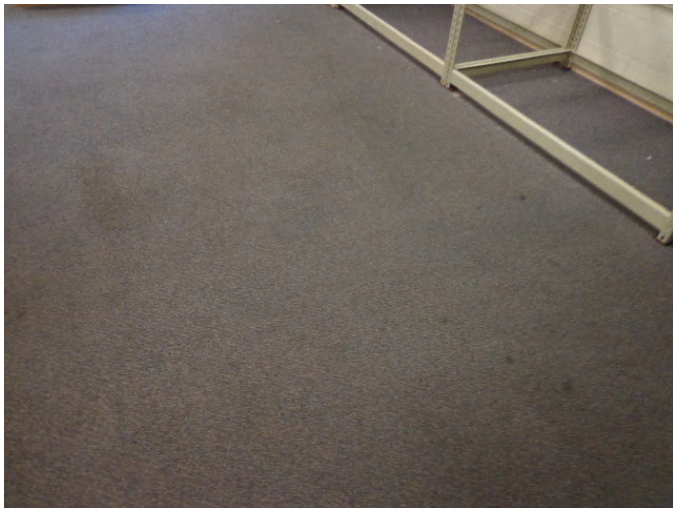
**System: C3020 - Floor Finishes - Carpet**

**Location:** Throughout Building  
**Distress:** Beyond Service Life  
**Category:** Deferred Maintenance  
**Priority:** 3 Priority  
**Correction:** Renew System  
**Qty:** 11,148.00  
**Unit of Measure:** S.F.  
**Estimate:** \$104,234.00  
**Assessor Name:** Eduardo Lopez  
**Date Created:** 04/11/2015

**Notes:** The carpet is aged and stained, and should be replaced.

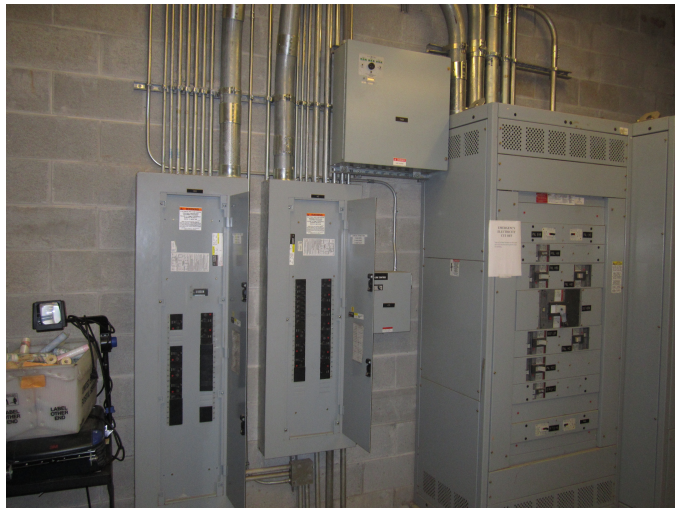
**System: D5010 - Electrical Service/Distribution**

**Location:** Main Electrical Room

**Distress:** Inadequate

**Notes:** Staff reports electrical outages due to tripped breakers and other issues resulting from most lightning storms. TVSS unit at main electrical service switchgear appears adequate, but is installed improperly. Re-install the TVSS with minimum length conductor connection to switchgear bus and without any bends in conductors. Best practice is to bolt directly to the bus with absolute minimum conductor length.
