DeKalb County School District/Leased/Charter

Clarkston Community Center

School Assessment Report

May 19, 2016

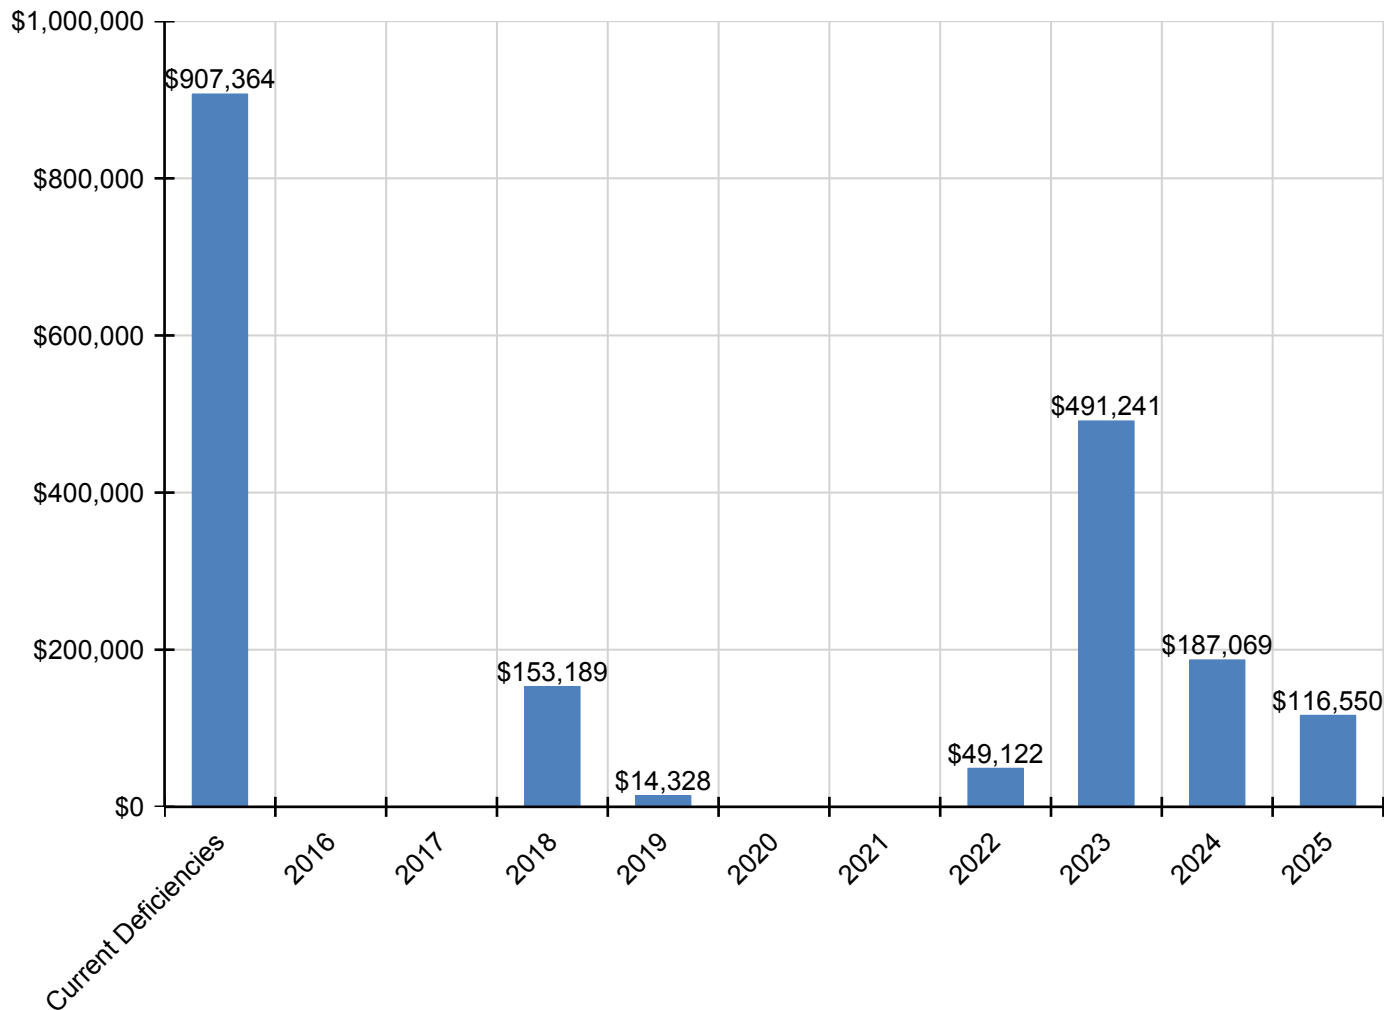
Forecasted Capital Renewal Requirement

The following chart shows the current building deficiencies and the forecasted capital renewal (system replacement) requirements over the next ten years.

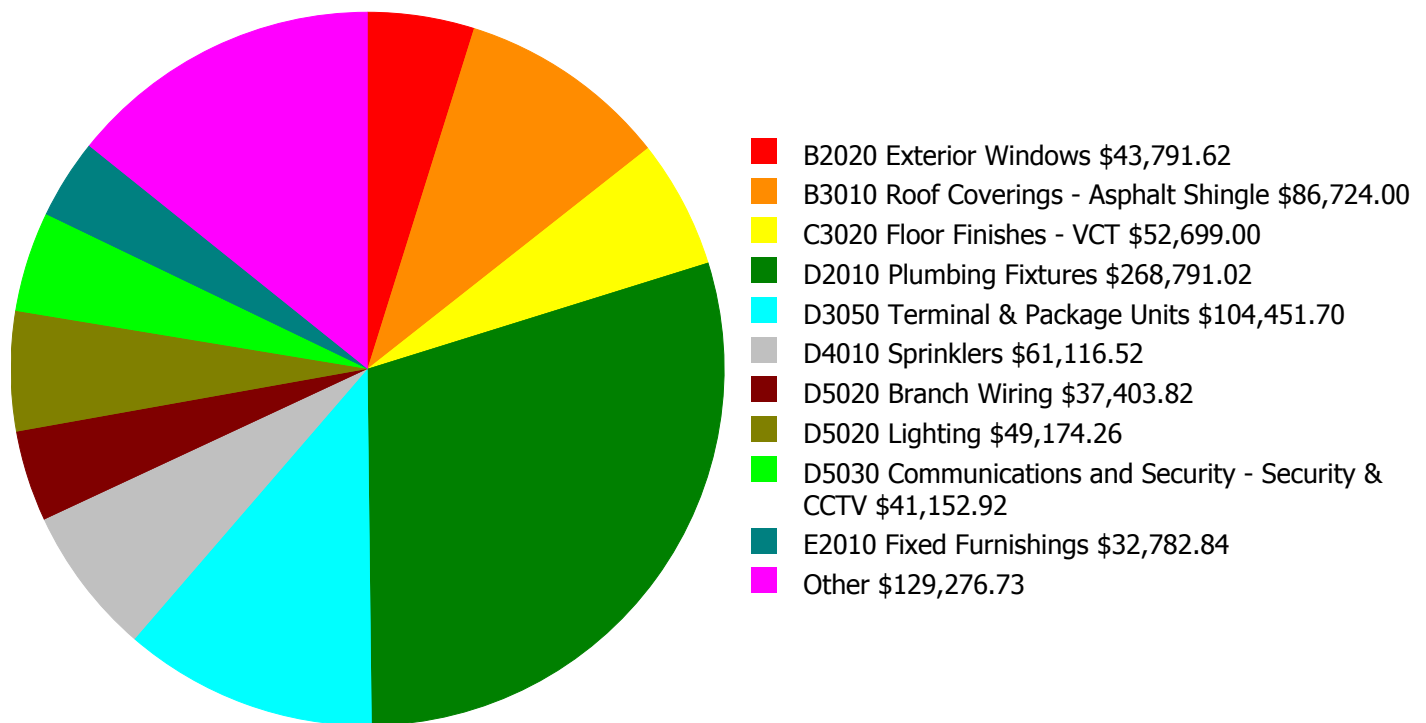
Deficiency Summary by System

Current deficiencies include assemblies that have reached or exceed their design life or components of the assemblies that are in need of repair. Assemblies that have reached their design life are identified as current deficiencies and assigned the distress 'Beyond Service Life'. The following chart lists all current deficiencies associated with this facility broken down by UNIFORMAT system.

Budget Estimate Total: \$907,364.43

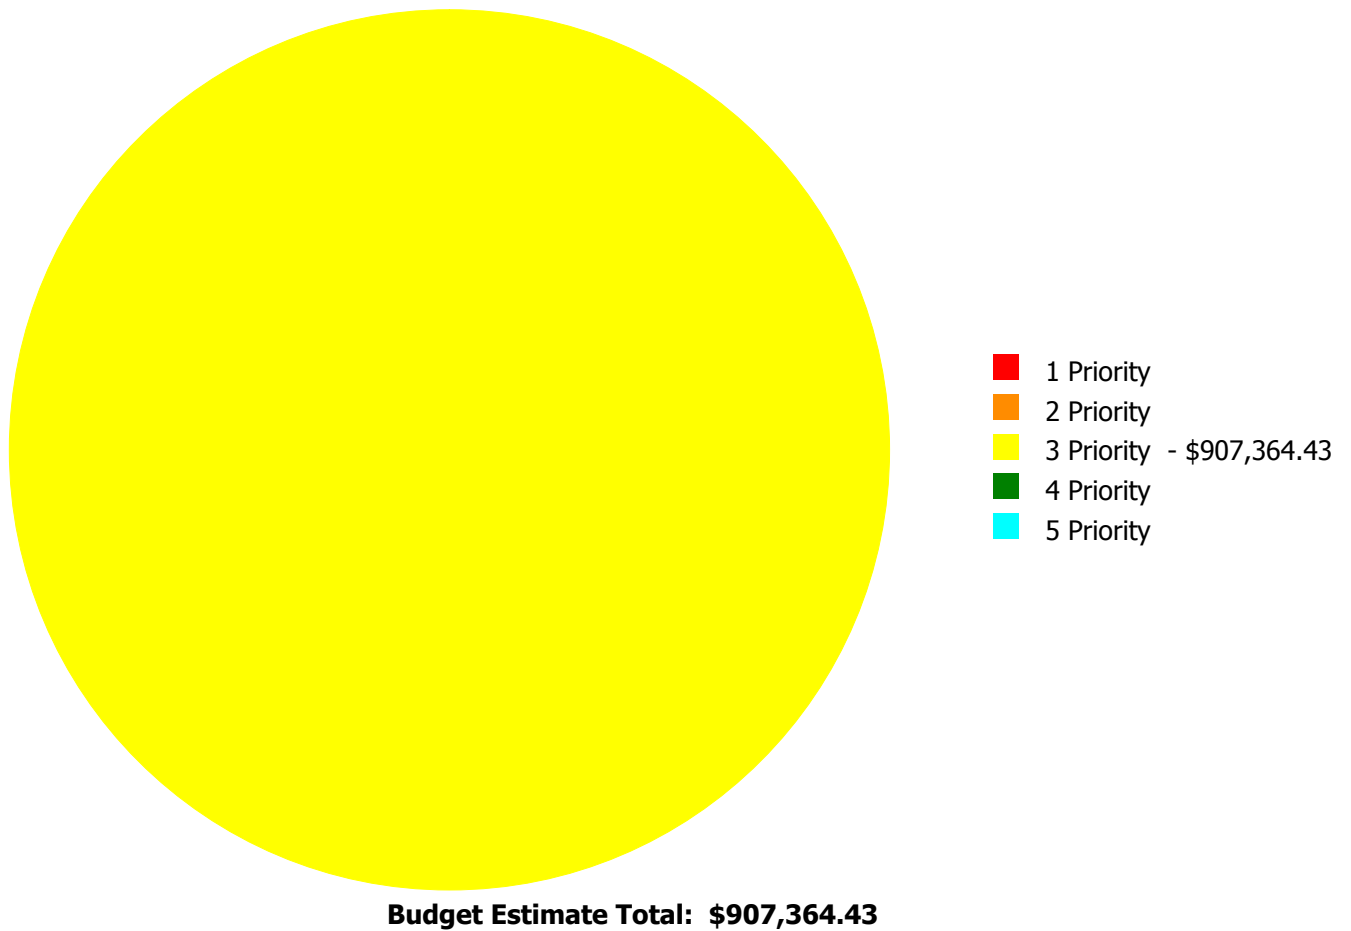
Deficiency Summary by Priority

The following chart shows the total repair costs broken down by priority. Assessors assigned deficiencies within eCOMET to one of the following priority categories:

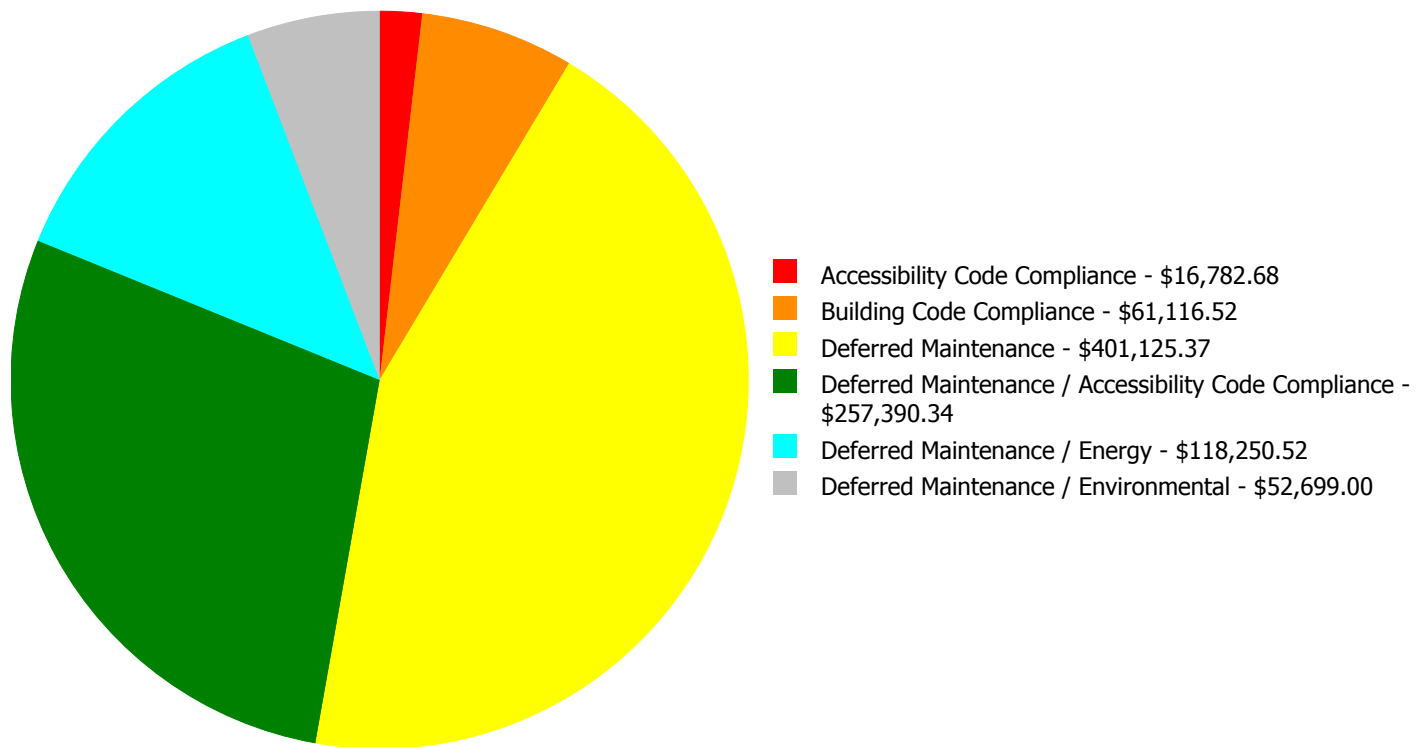
Deficiency Summary by Category

The following chart shows the total repair costs broken down by deficiency categories. Assessors assigned deficiencies to one of the following categories:

Budget Estimate Total: \$907,364.43

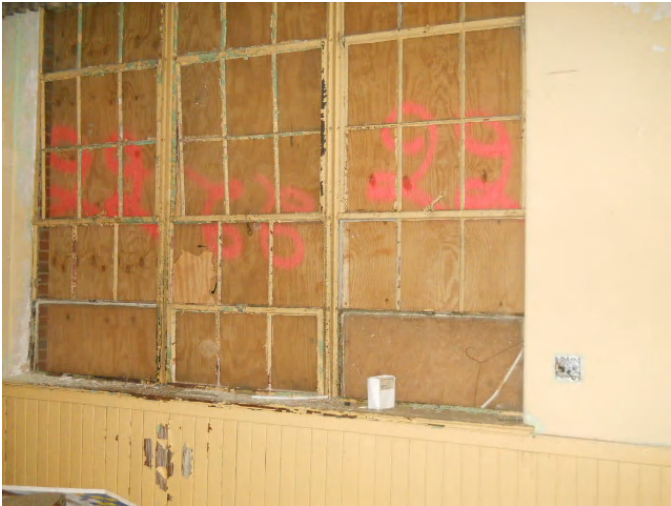
System: B2020 - Exterior Windows

Location: Non-renovated Portion of Building

Distress: Beyond Service Life

Notes: The exterior window system in the non-renovated portion of the building are beyond expected service life and should be replaced/renovated.

Correction: Replace 3'-0" x 4'-0" vinyl clad window - 1st floor.

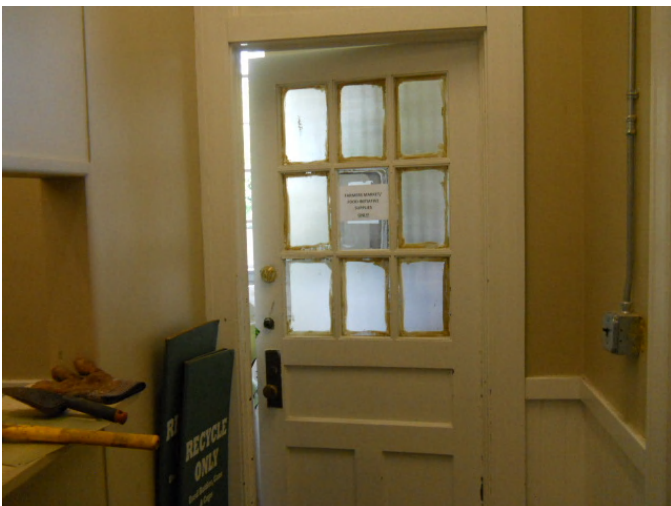
System: B2030 - Exterior Doors

Location: Non-renovated Portion of Building

Distress: Beyond Service Life

Notes: The exterior doors in the non-renovated portion of the building are beyond expected service life and should be replaced.

Correction: Replace 3'-0" x 7'-0" solid core, painted, door

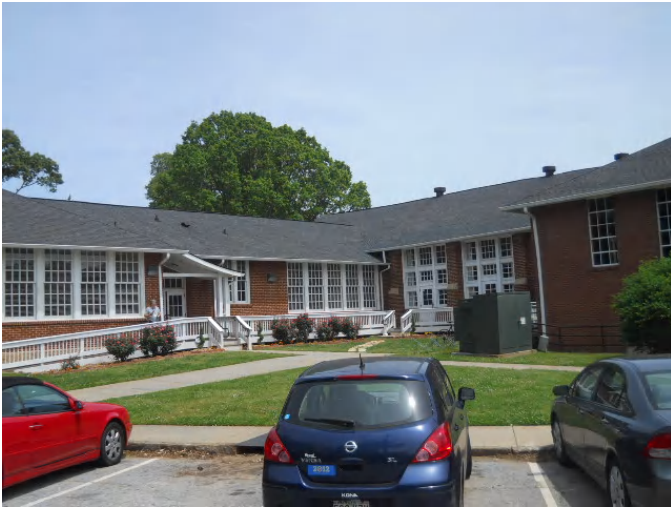
System: B3010 - Roof Coverings - Asphalt Shingle

Location: Roof

Distress: Needs Remediation

Notes: Asphalt shingle roof installed in 1998. There was a partial new overlay in 2008 according to the community center director. The roof still leaks in several locations and should be replaced. In addition, the gutters are too small and there are not enough downspouts.

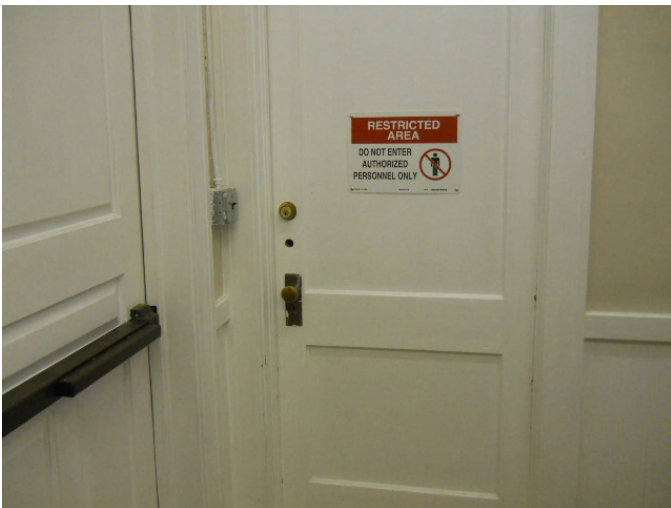
System: C1020 - Interior Doors

Location: Non-renovated Portion of Building

Distress: Beyond Service Life

Notes: The interior doors in the non-renovated portion of the building are beyond expected service life and should be replaced.

Correction: Replace 3'-0" x 7'-0" solid core wood door, interior

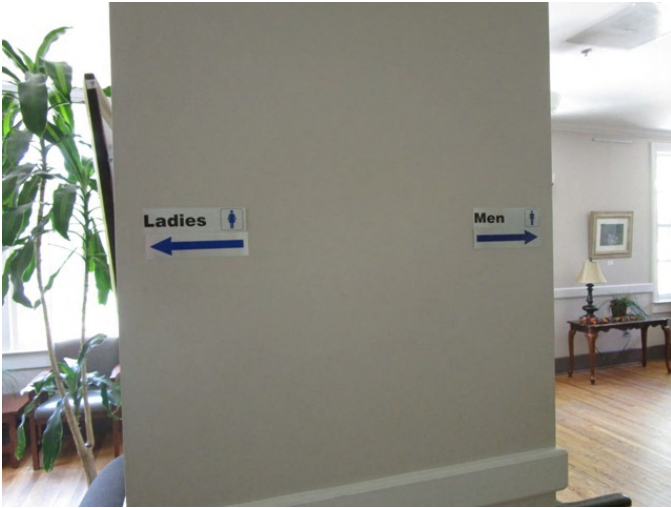
System: C1030 - Fittings

Location: Throughout Building

Distress: Inadequate

Notes: The signage is not ADA compliant.

Correction: Remove and replace the signage w/ADA compliant signage.

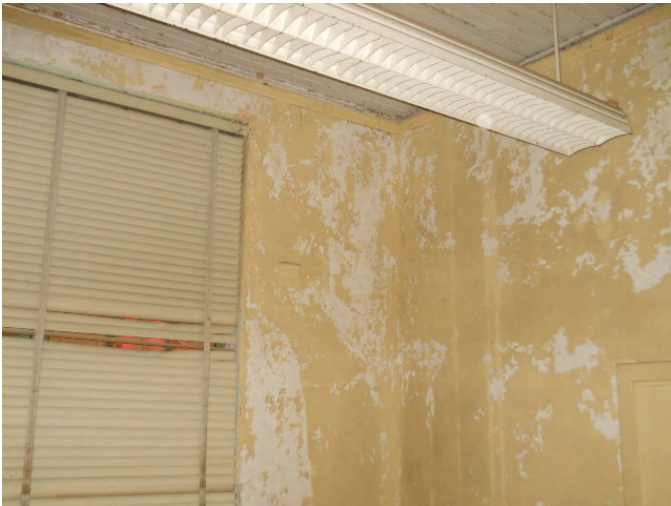
System: C3010 - Wall Finishes - Paint

Location: Non-renovated Portion of Building

Distress: Beyond Service Life

Notes: The interior wall surfaces in the un-renovated portion of the building are beyond expected service life and need to be repaired.

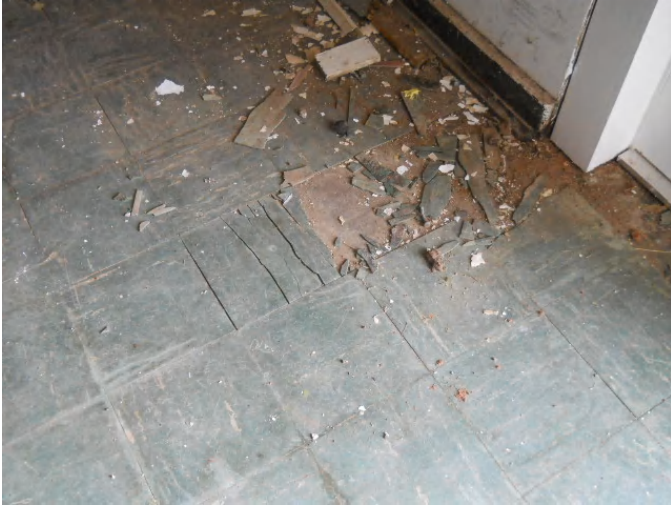
System: C3020 - Floor Finishes - VCT

Location: Non-renovated Portion of Building

Distress: Beyond Service Life

Notes: The floor covering in the non-renovated portion of the building is beyond service life, damaged, potentially hazardous, and should be replaced.

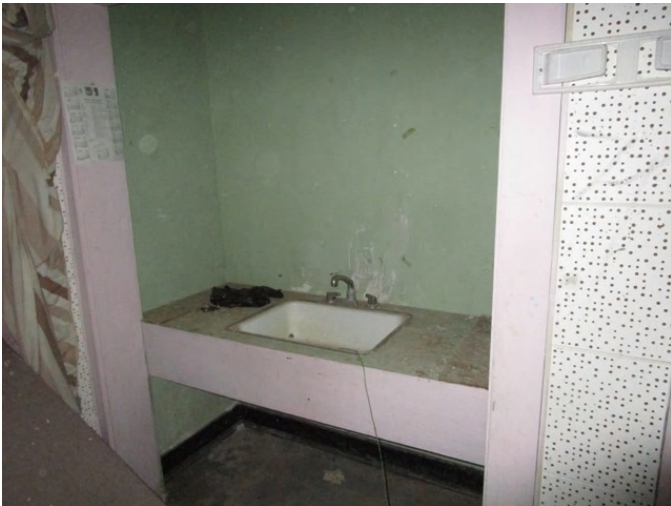
System: D2010 - Plumbing Fixtures

Location: Throughout Building

Distress: Beyond Service Life

Notes: The restrooms in the renovated portion of the building are not ADA compliant. The plumbing fixtures in the un-renovated portion of the building are beyond expected service life and should be replaced.

Correction: Replace lab sink and fittings, polyethylene sink, plastic

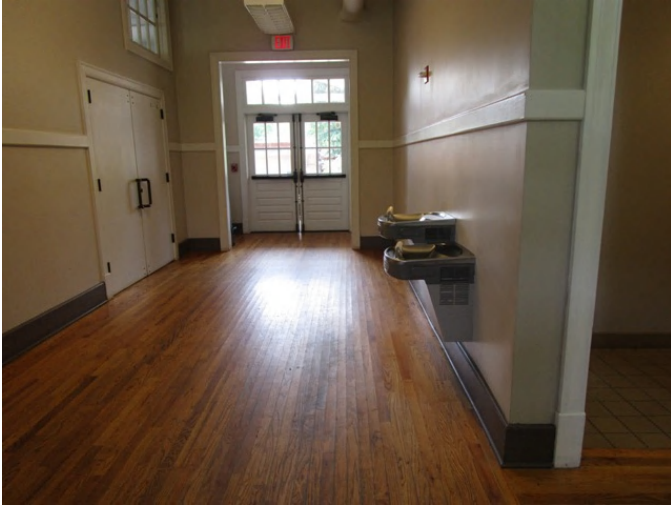
System: D2010 - Plumbing Fixtures

Location: South Classroom Wing

Distress: Needs Remediation

Notes: Water fountains protrude into the hallway more than four inches in the south classroom wing. Protrusion is not ADA compliant if more than four inches.

Correction: Remove/replace drinking fountain w/recessed ADA compliant drinking fountain

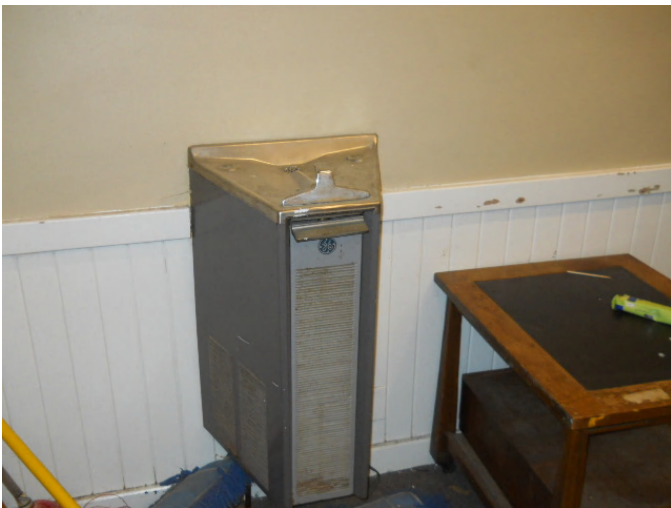
System: D2020 - Domestic Water Distribution

Location: Non-renovated Portion of Building

Distress: Beyond Service Life

Notes: The domestic water system in the non-renovated portion of the building is beyond expected service life and should be replaced.

Correction: Inspect for leaks steam converter, domestic hot water

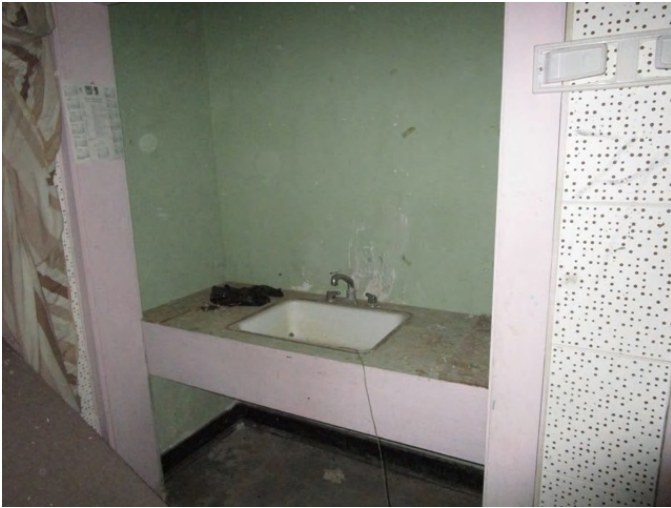
System: D2030 - Sanitary Waste

Location: Non-renovated Portion of Building

Distress: Beyond Service Life

Notes: The sanitary sewer system in the non-renovated portion of the building is beyond expected service life and should be replaced.

Correction: Replace floor drain w/o bucket

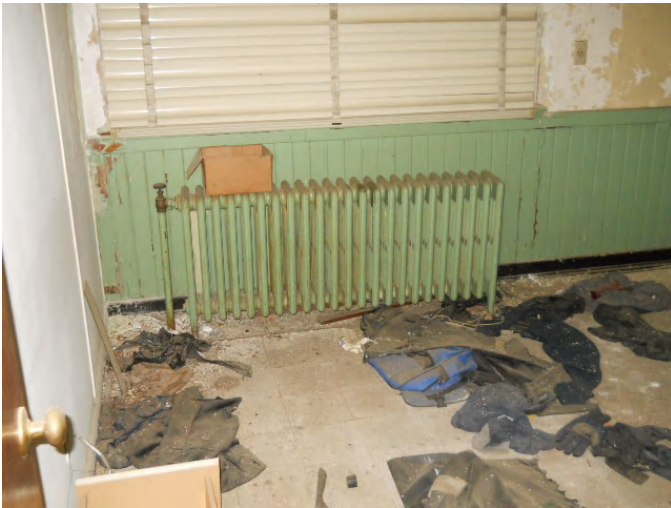
System: D3040 - Distribution & Exhaust Systems

Location: Non-renovated Portion of Building

Distress: Beyond Service Life

Notes: The HVAC distribution systems in the non-renovated portion of the building are beyond expected service life and should be replaced.

Correction: Repair fan coil unit, 30 ton

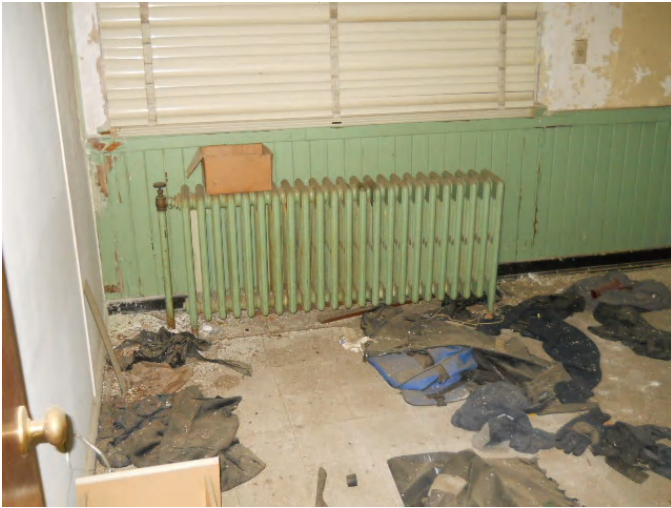
System: D3050 - Terminal & Package Units

Location: Non-renovated Portion of Building

Distress: Beyond Service Life

Notes: The HVAC terminal and package units in the non-renovated portion of the building are beyond expected service life, or are missing, and should be replaced.

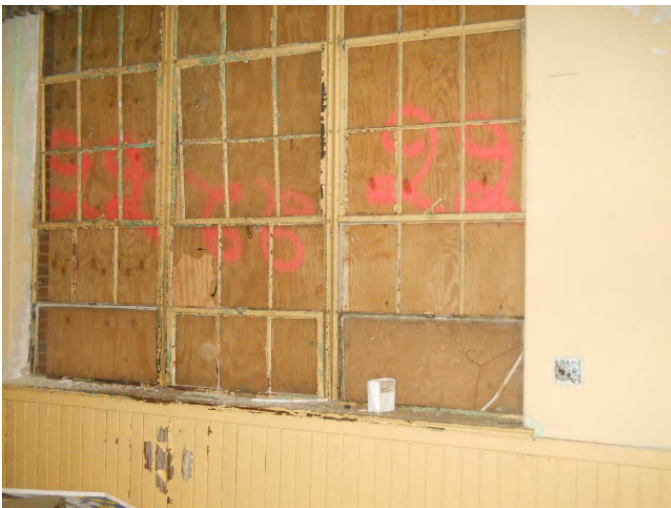
System: D3060 - Controls & Instrumentation

Location: Non-renovated Portion of Building

Distress: Beyond Service Life

Notes: The HVAC system controls in the non-renovated portion of the building are beyond expected service life, or are missing, and should be replaced.

Correction: Remove/replace HVAC controls

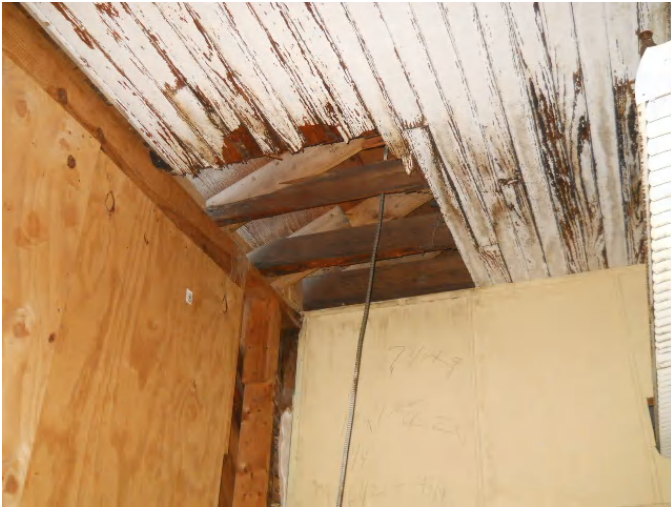
System: D4010 - Sprinklers

Location: Non-renovated Portion of Building

Distress: Missing

Notes: The portion of the building that was not renovated does not have a sprinkler system. Recommend adding a sprinkler system.

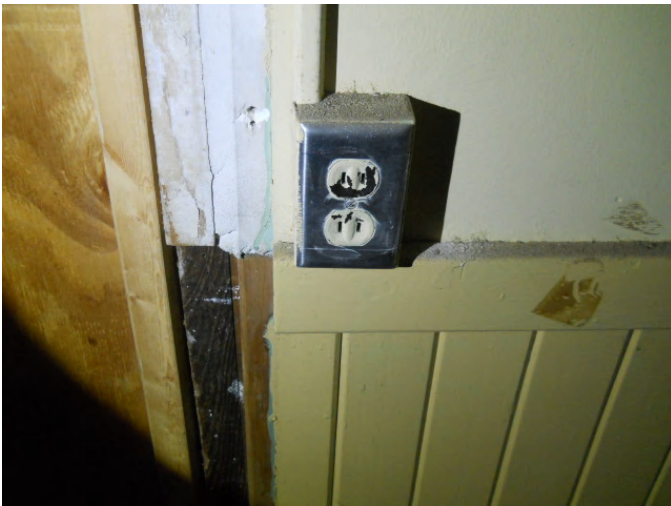
System: D5020 - Branch Wiring

Location: Non-renovated Portion of Building

Distress: Beyond Service Life

Notes: The branch wiring in the non-renovated portion of the building is beyond expected service life and should be replaced.

Correction: Add/replace exit lighting

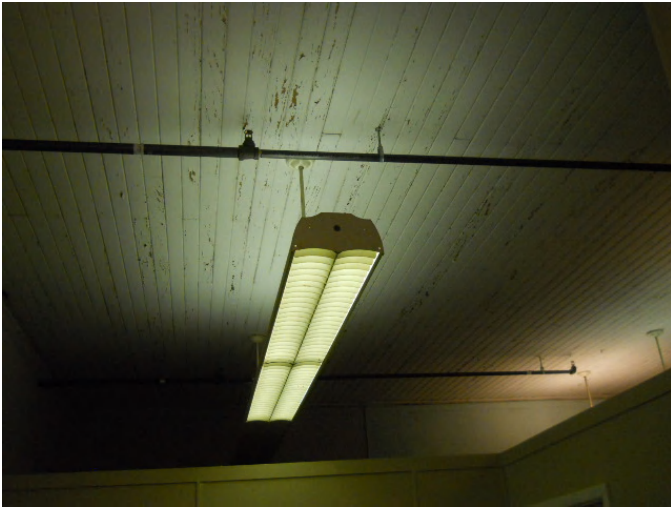
System: D5020 - Lighting

Location: Non-renovated Portion of Building

Distress: Beyond Service Life

Notes: The lighting system in the non-renovated portion of the building is beyond expected service life and should be replaced.

Correction: Add/replace exit lighting

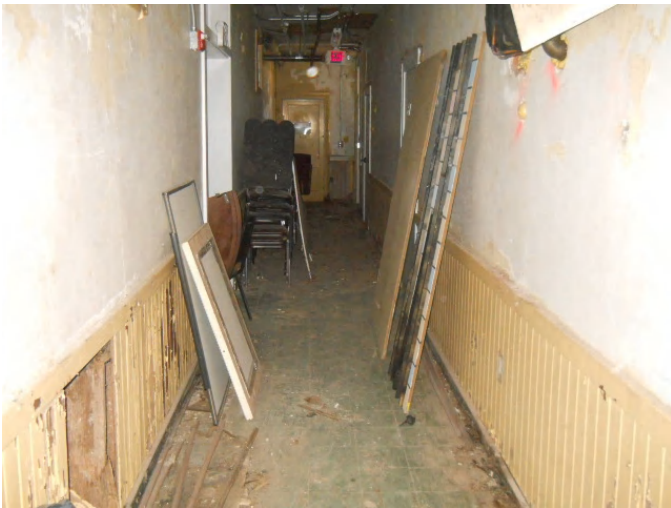
System: D5030 - Communications and Security - Security & CCTV

Location: Non-renovated Portion of Building

Distress: Beyond Service Life

Notes: The fire alarm, security, CCTV, paging, phone, and access systems in the non-renovated portion of the building are beyond expected service life, or missing, and should be replaced.

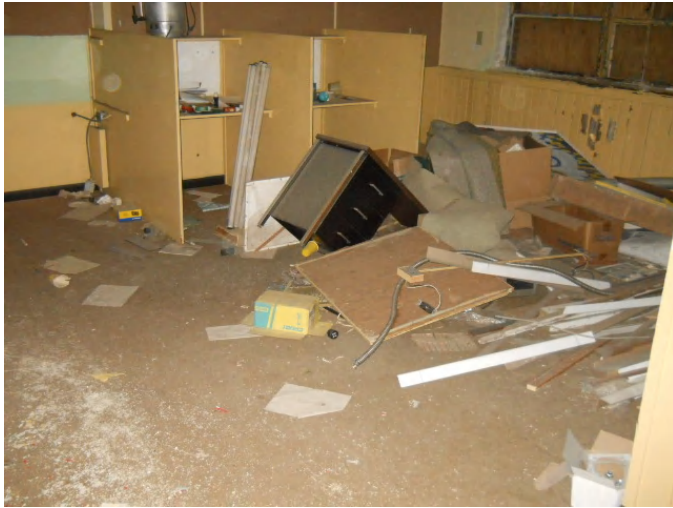
System: E2010 - Fixed Furnishings

Location: Non-renovated Portion of Building

Distress: Beyond Service Life

Notes: Fixed furnishings in the non-renovated portion of the building are beyond expected service life, damaged, and should be replaced.

Correction: Remove/replace fixed furnishings

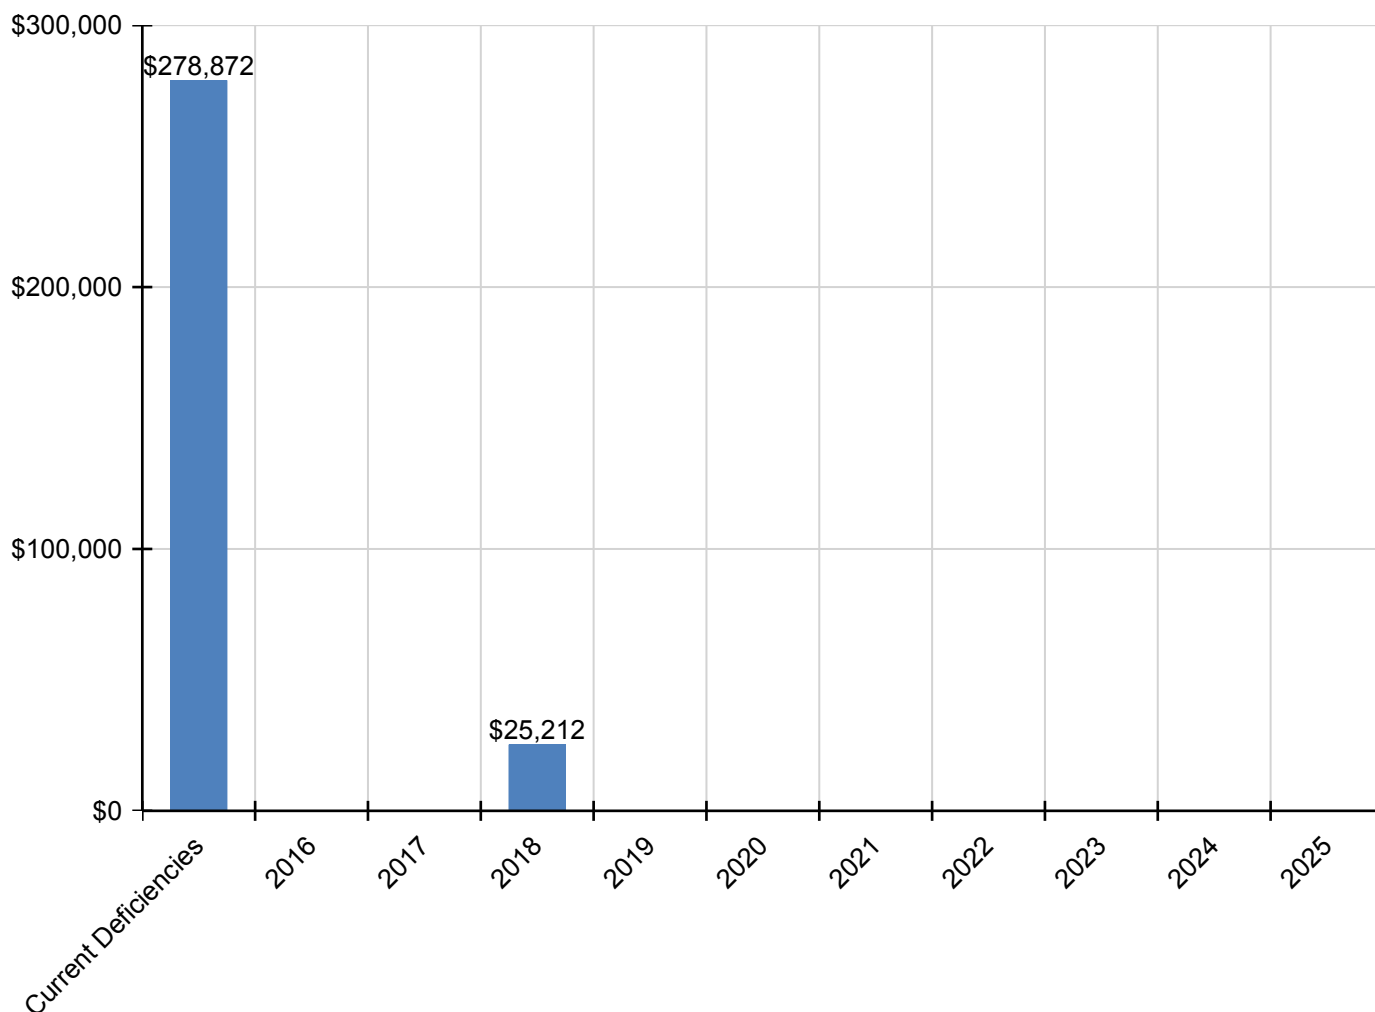
Forecasted Capital Renewal Requirement

The following chart shows the current building deficiencies and the forecasted capital renewal (system replacement) requirements over the next ten years.

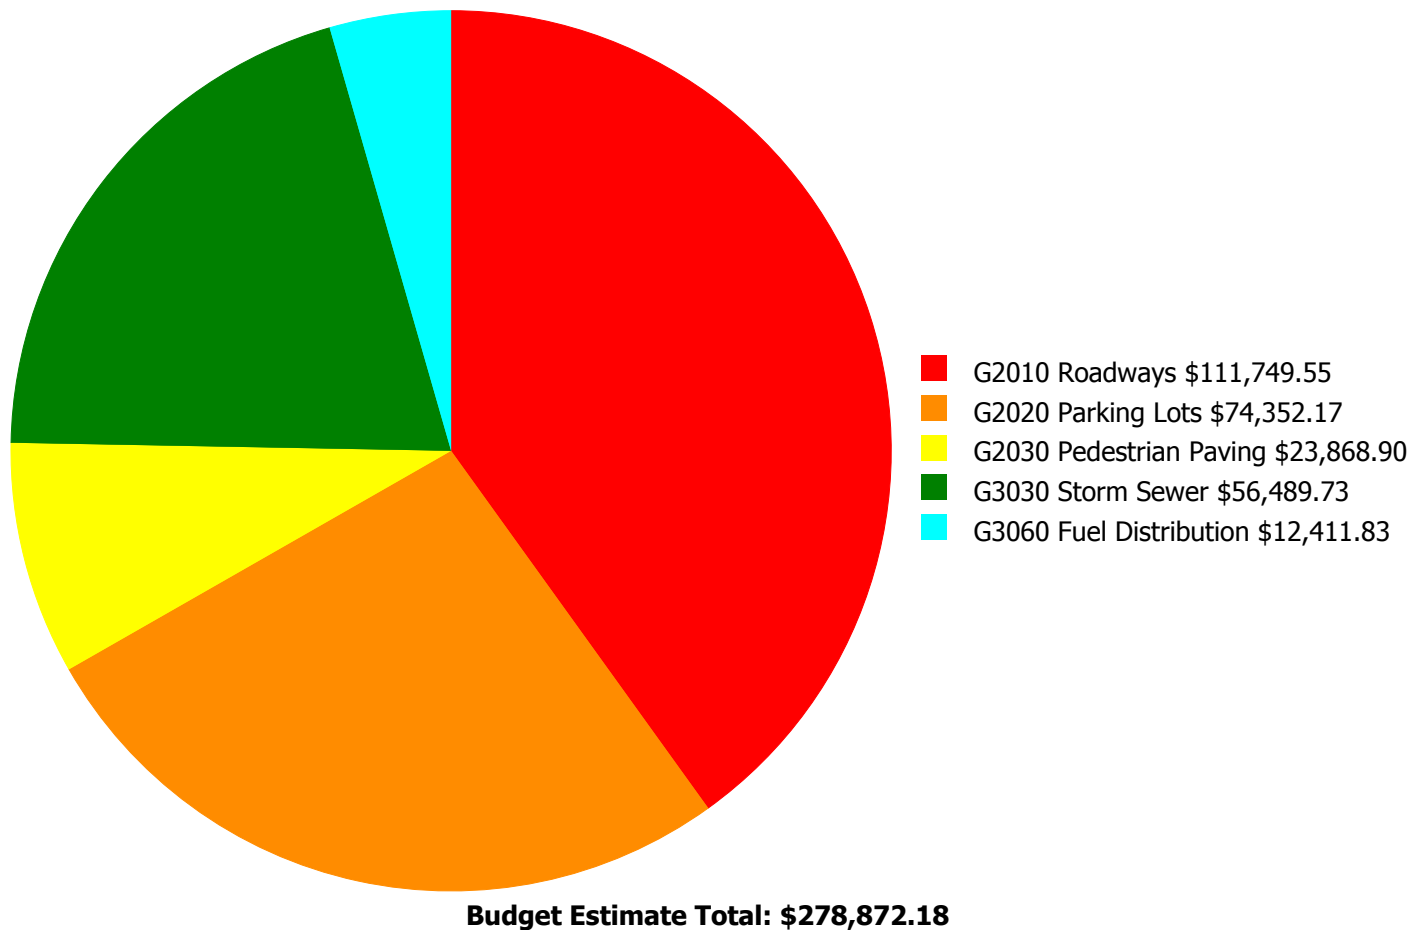
Deficiency Summary by System

Current deficiencies include assemblies that have reached or exceed their design life or components of the assemblies that are in need of repair. Assemblies that have reached their design life are identified as current deficiencies and assigned the distress 'Beyond Service Life'. The following chart lists all current deficiencies associated with this facility broken down by UNIFORMAT system.

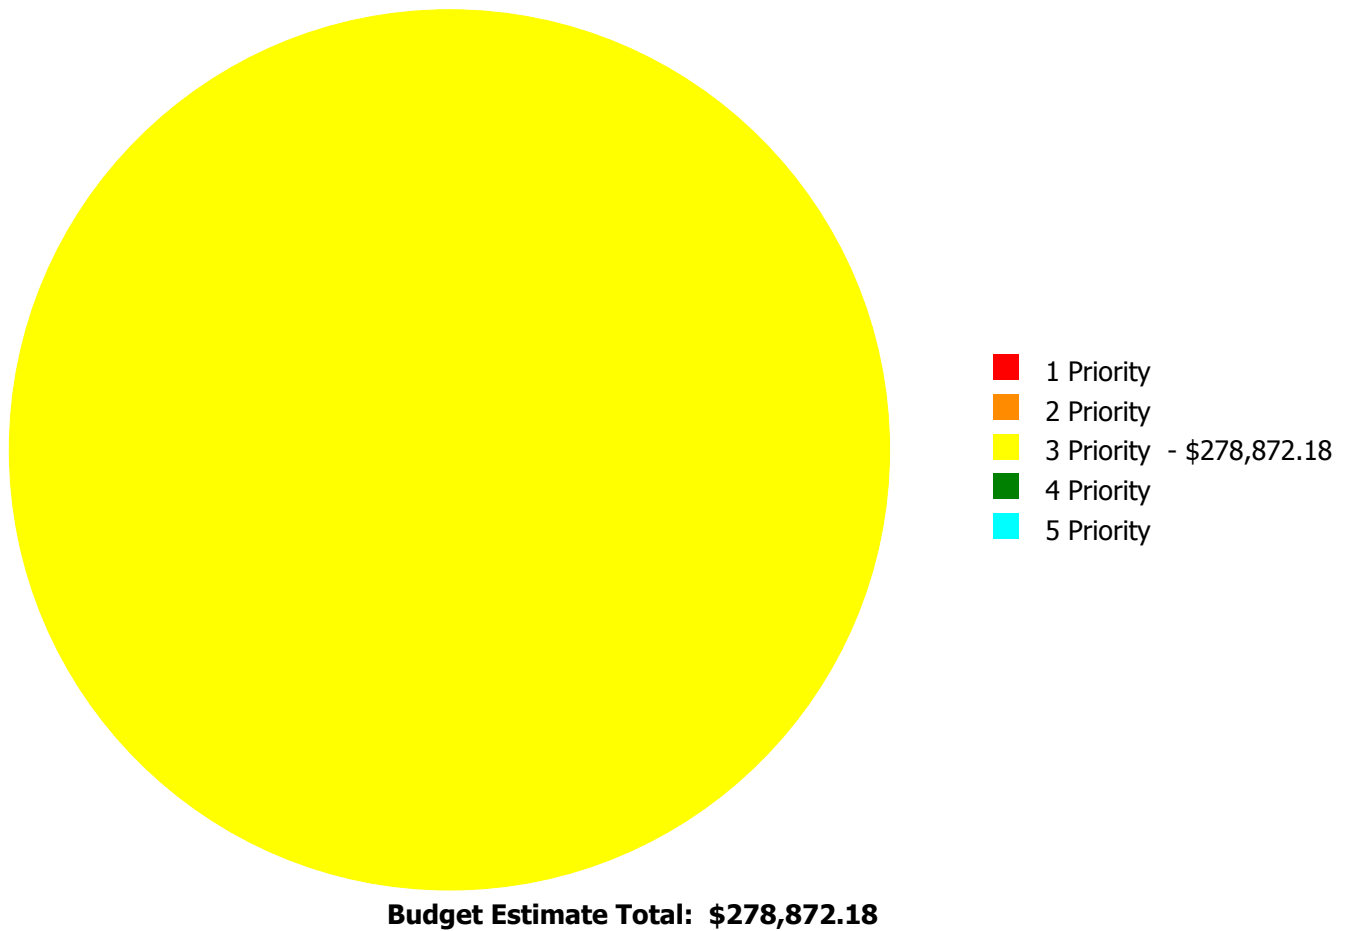
Deficiency Summary by Priority

The following chart shows the total repair costs broken down by priority. Assessors assigned deficiencies within eCOMET to one of the following priority categories:

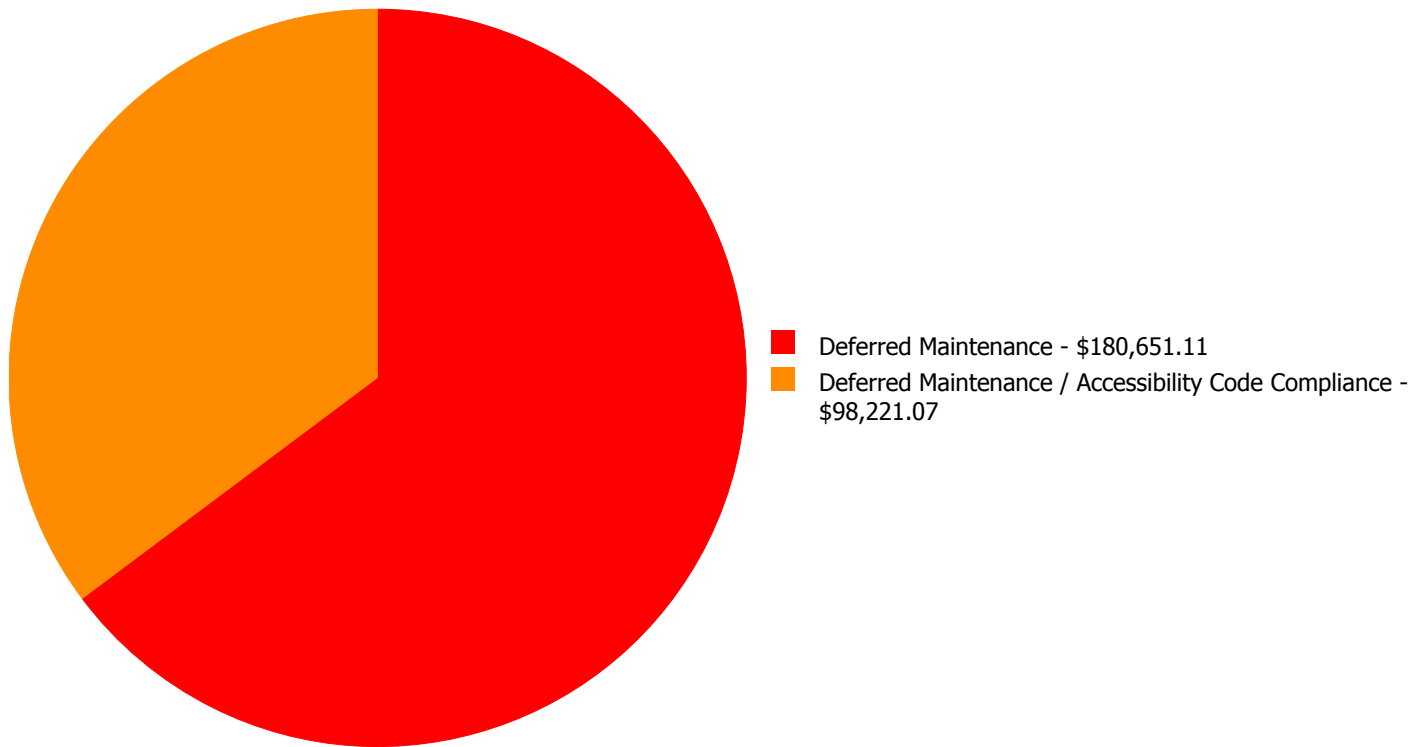
Deficiency Summary by Category

The following chart shows the total repair costs broken down by deficiency categories. Assessors assigned deficiencies to one of the following categories:

Budget Estimate Total: \$278,872.18

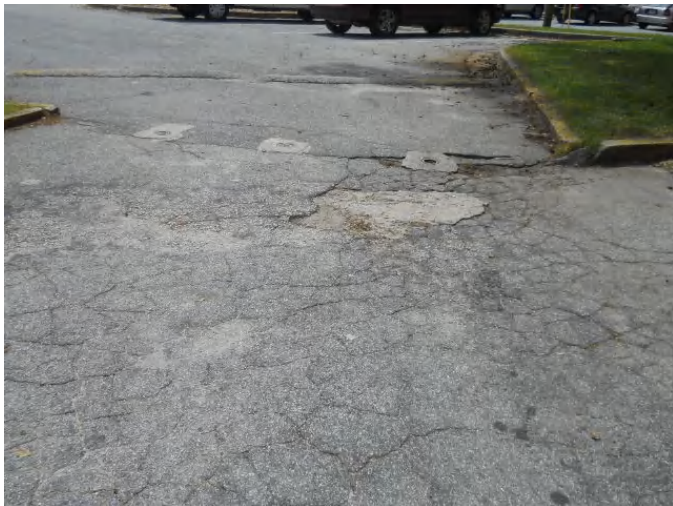
System: G2010 - Roadways

Location: Site

Distress: Beyond Service Life

Notes: Roadways are beyond expected service life, damaged, and worn, and should be replaced.

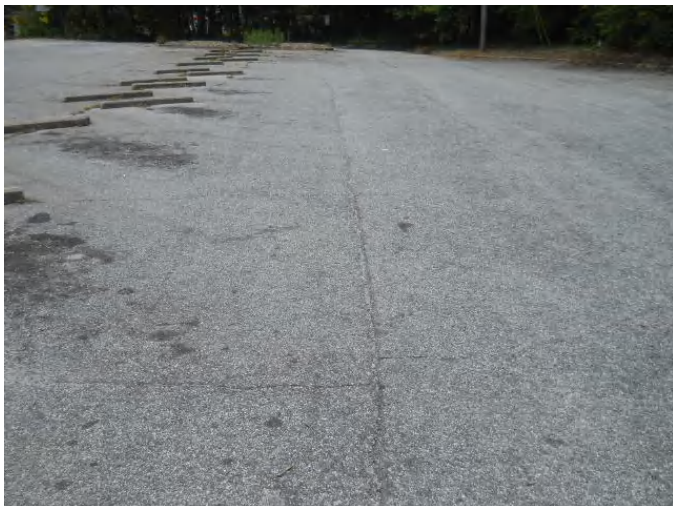
System: G2020 - Parking Lots

Location: Site

Distress: Beyond Service Life

Notes: The parking lots are beyond expected service life, deteriorated, not fully ADA compliant, and should be scheduled for replacement.

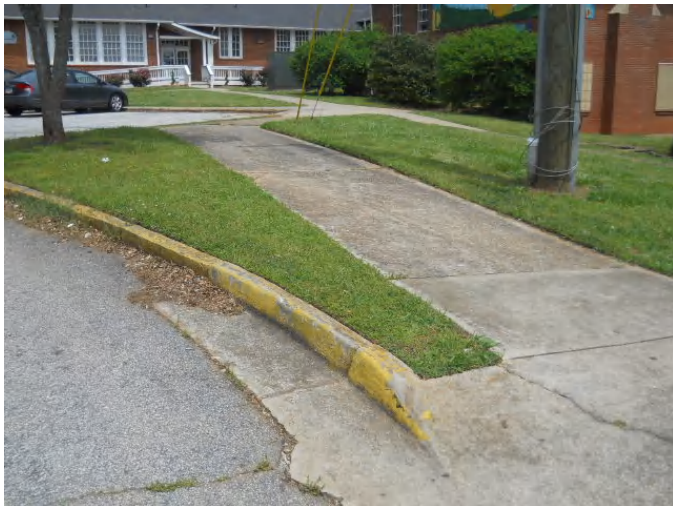
System: G2030 - Pedestrian Paving

Location: Site

Distress: Beyond Service Life

Notes: Pedestrian paving is beyond expected service life, cracking, not ADA compliant, and should be scheduled for replacement.

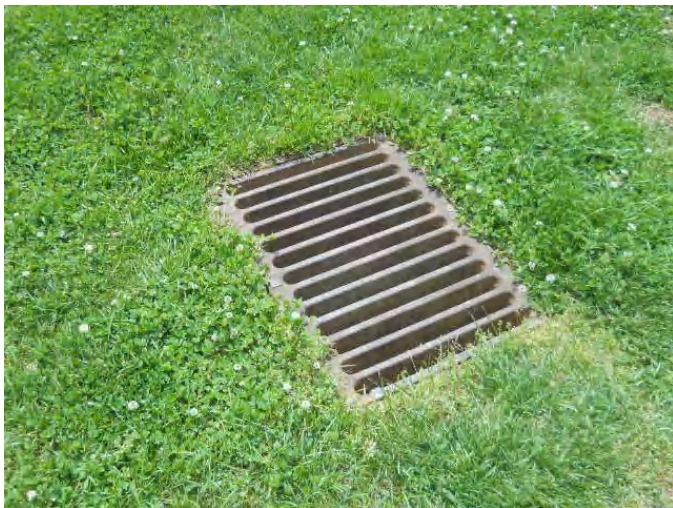
System: G3030 - Storm Sewer

Location: Site

Distress: Beyond Service Life

Notes: The storm water drainage system is beyond expected service life and should be replaced.

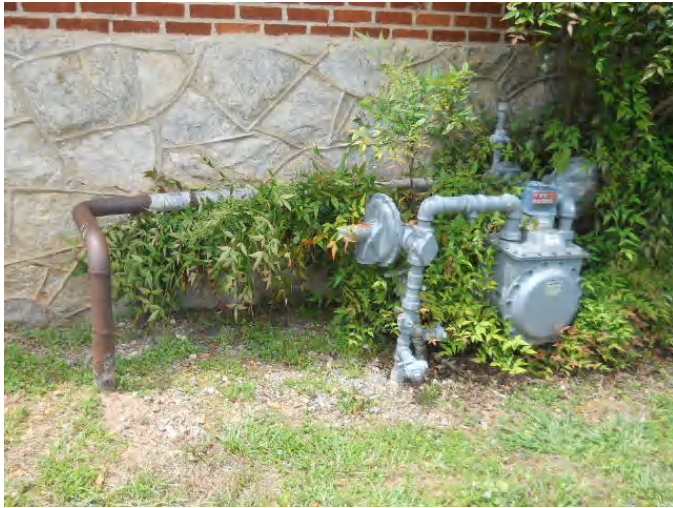
System: G3060 - Fuel Distribution

Location: Site

Distress: Beyond Service Life

Notes: The natural gas distribution line is beyond expected service life and should be replaced.
