DeKalb County School District/Leased/Charter

Clarkston Community Soccer Facility

Final
School Assessment Report

May 19, 2016

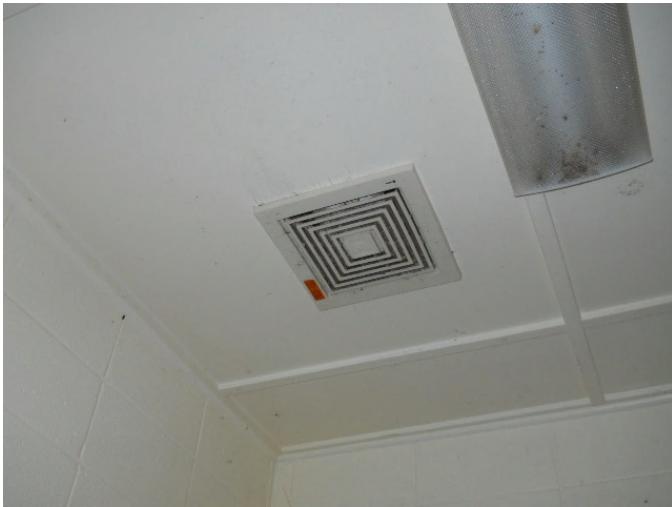
System: D3040 - Exhaust Systems

Location: Throughout Building

Distress: Needs Remediation

Notes: The exhaust system does not work and should be replaced.

Correction: Renew System

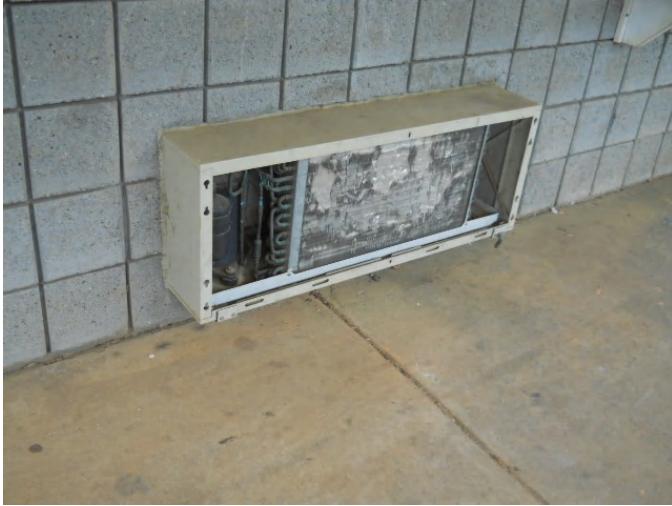
System: D3050 - Terminal & Package Units

Location: Exterior Wall

Distress: Damaged

Notes: The split system HVAC unit is not functional and should be replaced.

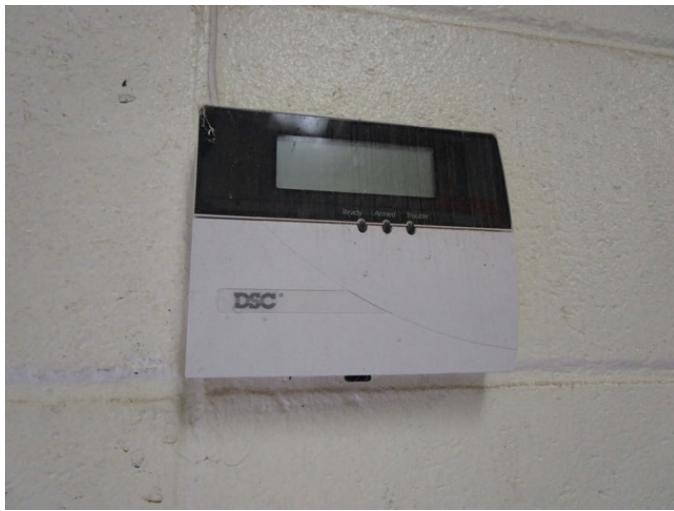
System: D5030 - Communications and Security

Location: Throughout Building

Distress: Beyond Service Life

Notes: Communications and security system is beyond its expected service life and should be scheduled for replacement.

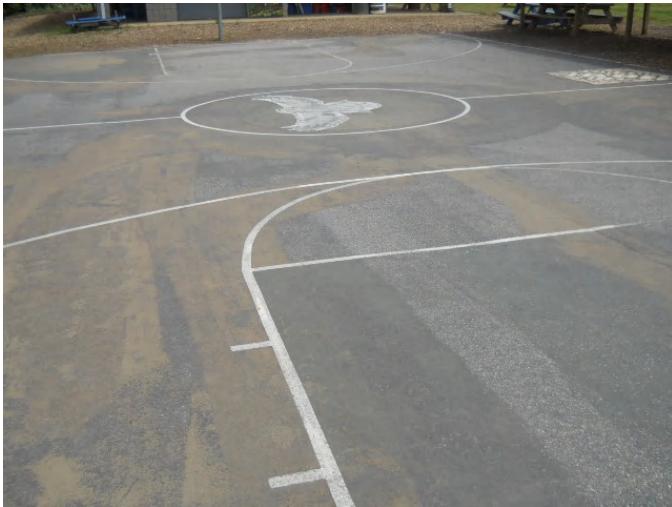
System: G2040 - Hard Surface Play Area

Location: Site

Distress: Damaged

Notes: The hard surface play area is cracking and should be repaired.

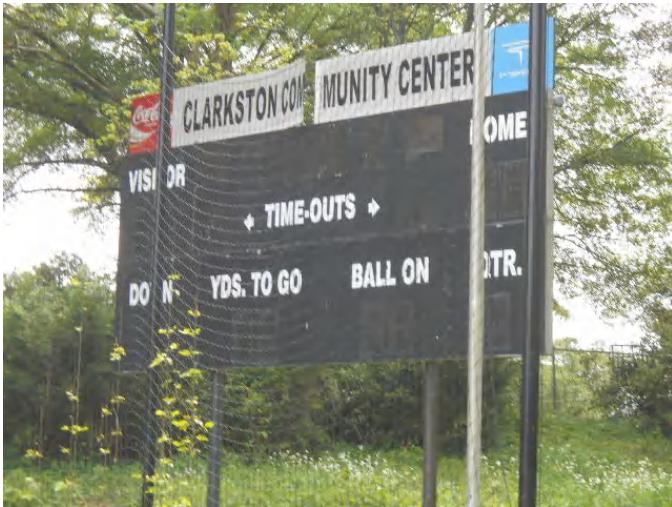
System: G2040 - Soccer/Lacross Field

Location: Soccer Field

Distress: Beyond Service Life

Notes: The grass on the soccer field is in poor condition and it should be re-sodded, the score board and the surrounding wooden structures also need to be scheduled for replacement.
