DeKalb County School District/Education Other

# East Campus I/DeKalb Alternative

## School Assessment Report

May 19, 2016

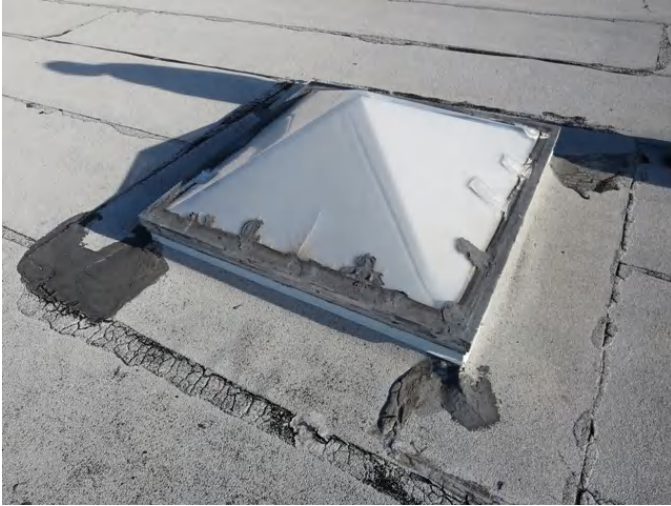
#### **System: B3020 - Roof Openings**

**Location:** Roof

**Distress:** Beyond Service Life

**Notes:** The roof hatch does not meet current code, and should be replaced. Also, the skylights are broken and should be replaced. All roof openings are beyond their expected service life and should be replaced in conjunction with the roof covering.

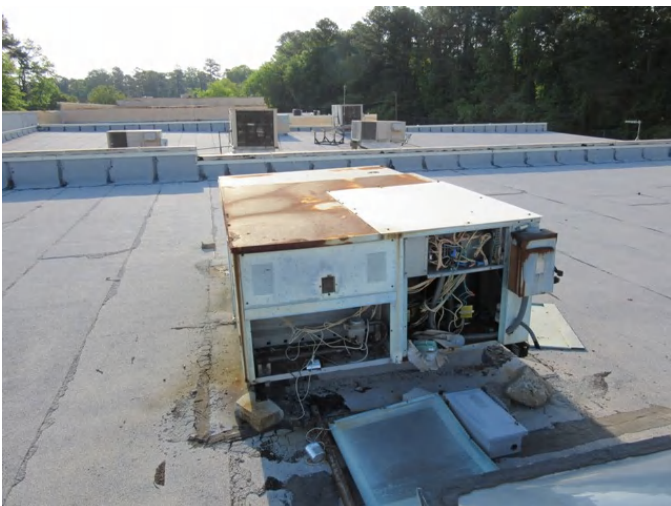
#### **System: D3050 - Terminal & Package Units**

**Location:** Roof

**Distress:** Beyond Service Life

**Notes:** The current HVAC system is antiquated and ineffective. Multiple units are in disrepair or operating at a reduced capacity. The existing zone distribution is inadequate due to a significant reduction in cooling and heating capacity.

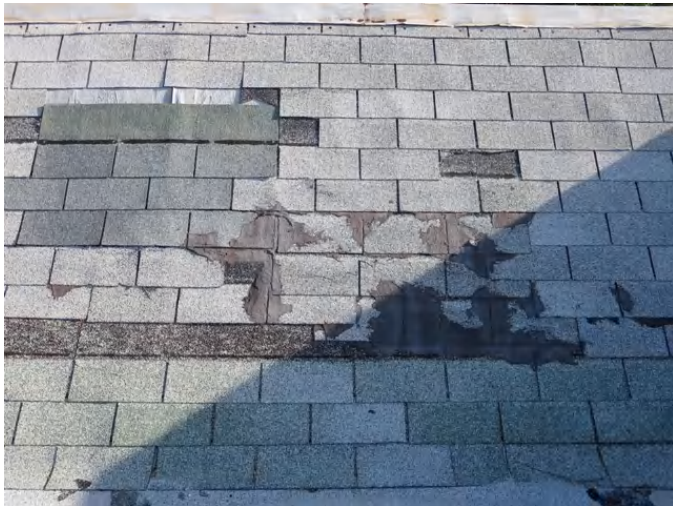
**System: B3010 - Roof Coverings - Asphalt Shingles**

**Location:** Roof

**Distress:** Damaged

**Notes:** The asphalt shingle roofing is damaged, aged, and should be replaced.

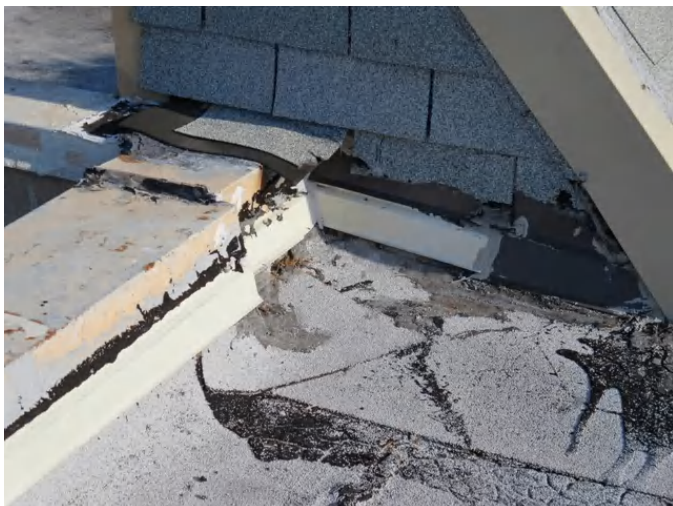
**System: B3010 - Roof Coverings - BUR**

**Location:** Roof

**Distress:** Damaged

**Notes:** The built up roofing is aged and damaged, and has reported leaks, and should be replaced. Roof drainage is inadequate, causing flooding along the entrance to the school and at various other places.

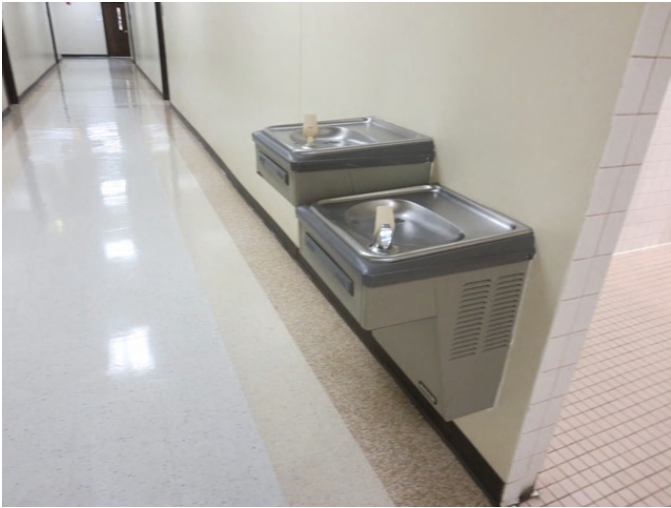
**System: D2010 - Plumbing Fixtures**

**Location:** Throughout Building

**Distress:** Needs Remediation

**Correction:** Remove/replace drinking fountain w/recessed ADA compliant drinking fountain

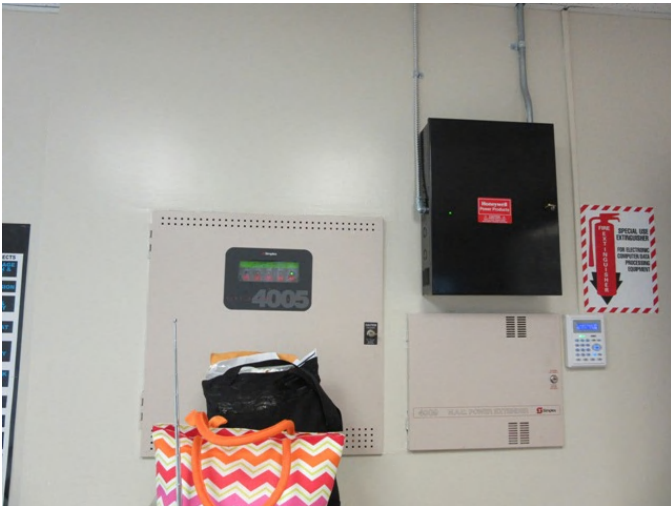
**System: D5030 - Communications and Security - Fire Alarm**

**Location:** Throughout Building

**Distress:** Beyond Service Life

**Notes:** The fire alarm system is beyond its expected service life and should be scheduled for replacement.

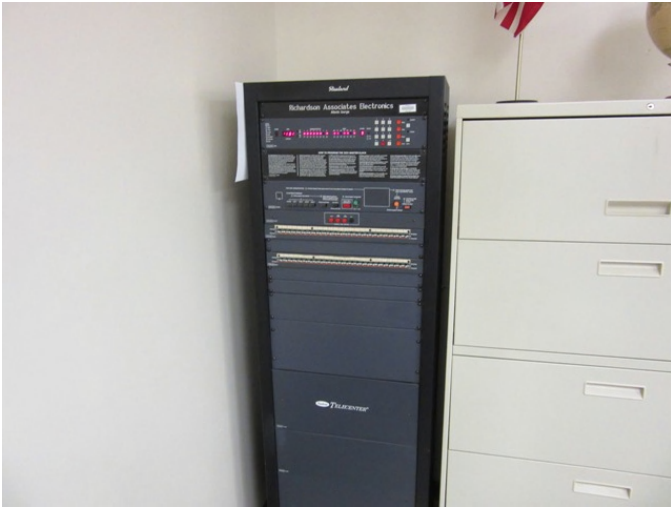
**System: D5030 - Communications and Security - PA & Clock Systems**

**Location:** Throughout Building

**Distress:** Beyond Service Life

**Notes:** PA and clock systems are beyond their expected service life and should be scheduled for replacement.

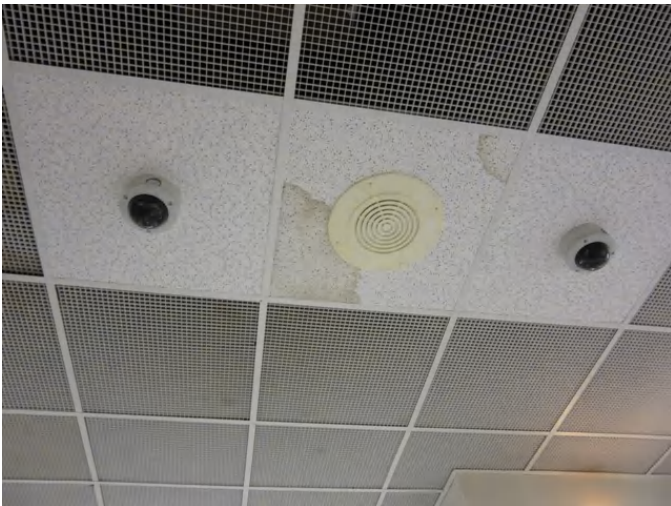
**System: D5030 - Communications and Security - Security & CCTV**

**Location:** Throughout Building

**Distress:** Beyond Service Life

**Notes:** The existing security and CCTV system is beyond its expected service life and should be scheduled for replacement.

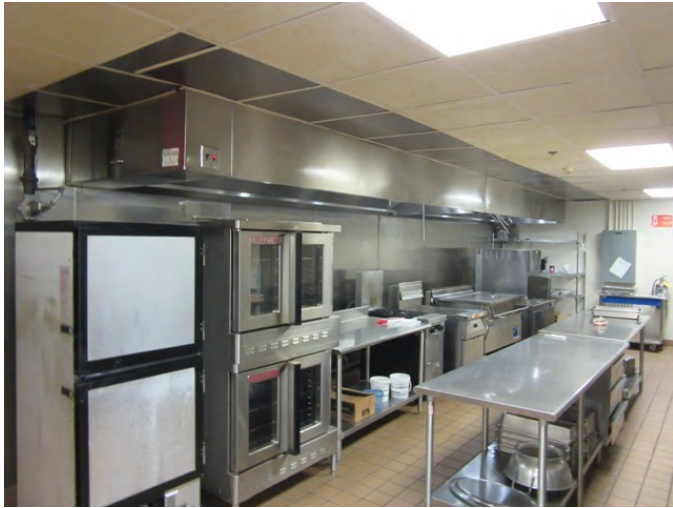
**System: E1090 - Other Equipment (Kitchen Equipment)**

**Location:** Kitchen

**Distress:** Beyond Service Life

**Notes:** The kitchen equipment is beyond its expected service life and should be scheduled for replacement.

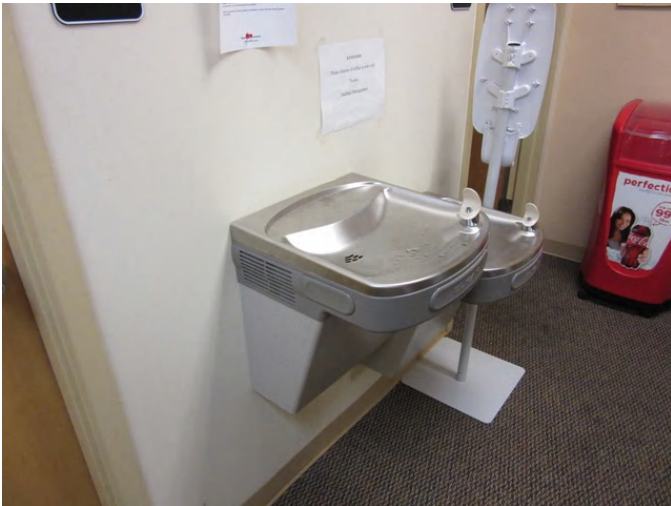
#### System: D2010 - Plumbing Fixtures

**Location:** Throughout Building

**Distress:** Needs Remediation

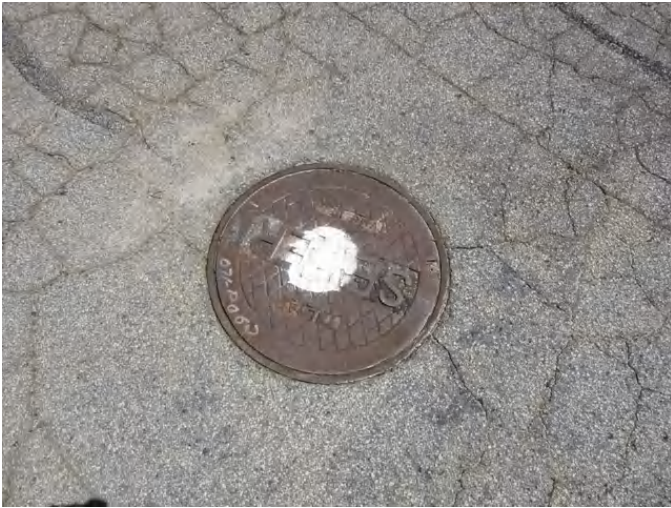
**System: D2030 - Sanitary Waste**

**Location:** Throughout Building

**Distress:** Beyond Service Life

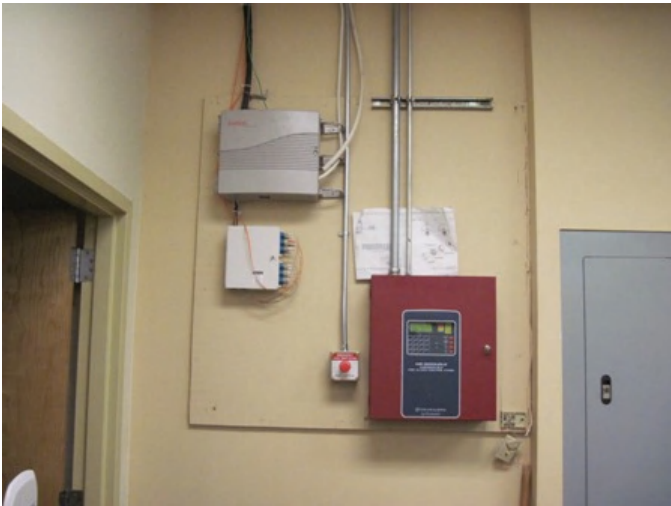
**System: D5030 - Communications and Security - Fire Alarm**

**Location:** Throughout Building

**Distress:** Beyond Service Life

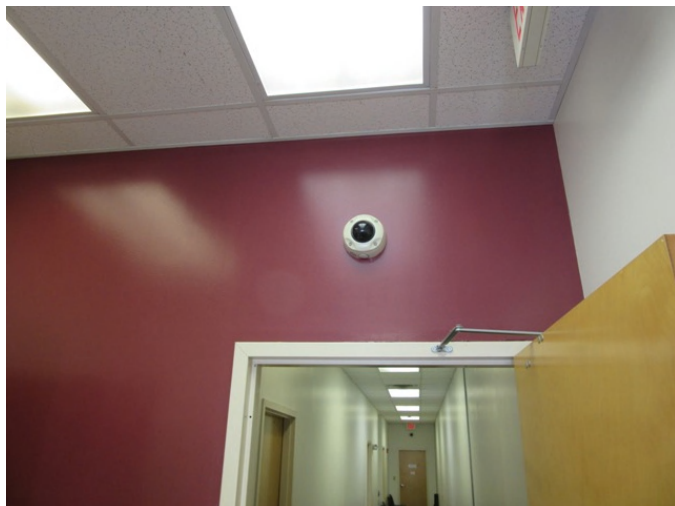
**System: D5030 - Communications and Security - Security & CCTV**

**Location:** Throughout Building

**Distress:** Beyond Service Life

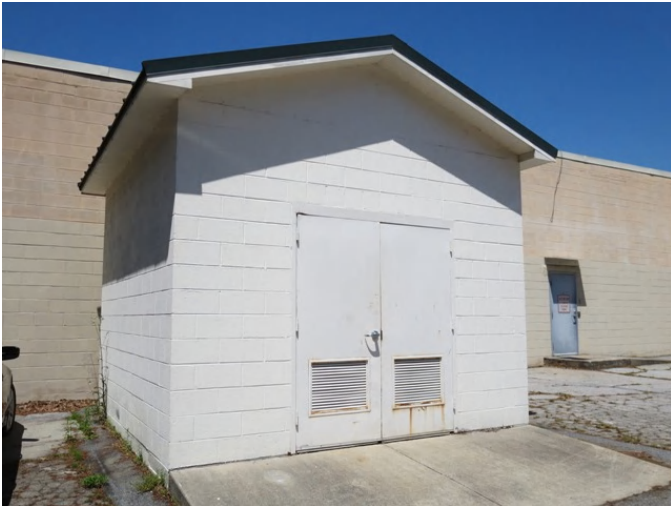
#### System: B2030 - Exterior Doors

**Location:** Exterior Wall

**Distress:** Beyond Service Life

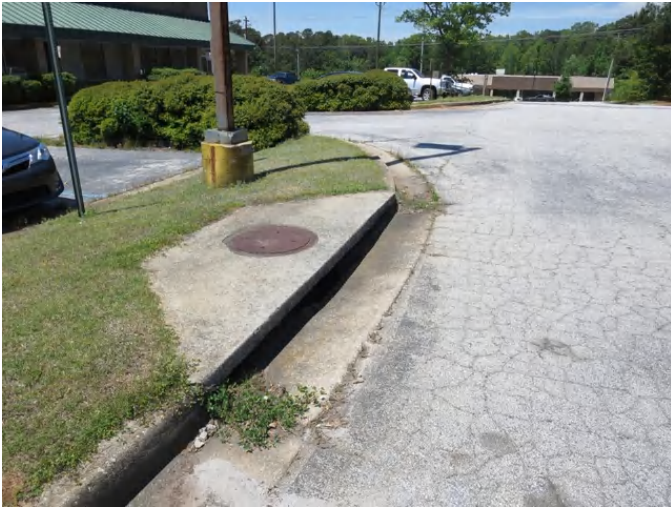
#### System: G2010 - Roadways

**Location:** Site

**Distress:** Beyond Service Life

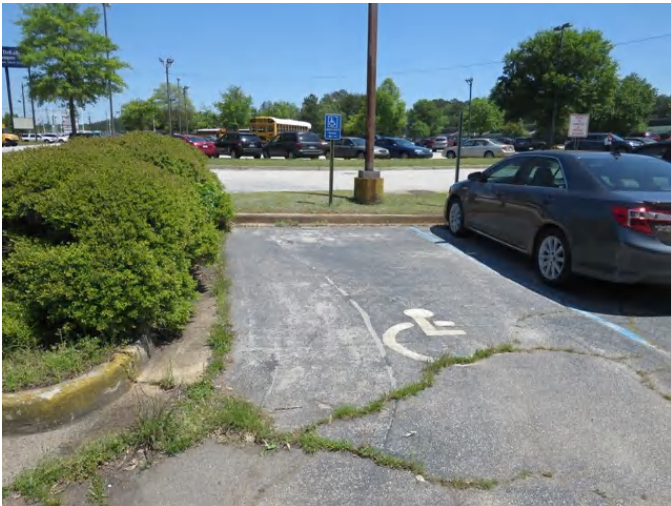
#### System: G2020 - Parking Lots

**Location:** Site

**Distress:** Damaged

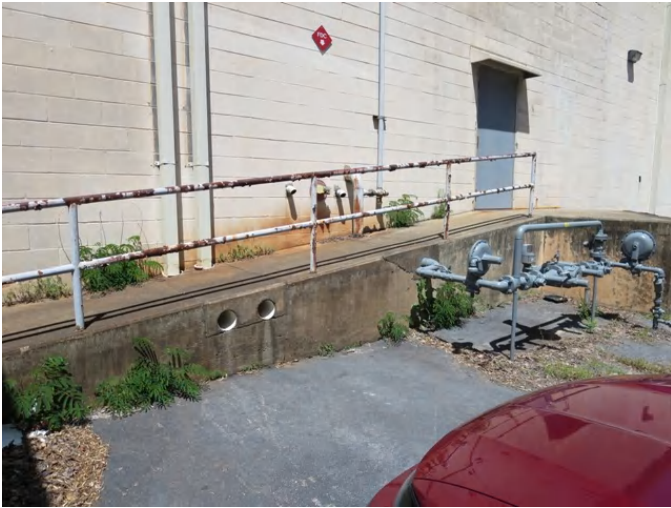
**System: G2030 - Pedestrian Paving**

**Location:** Site

**Distress:** Beyond Service Life

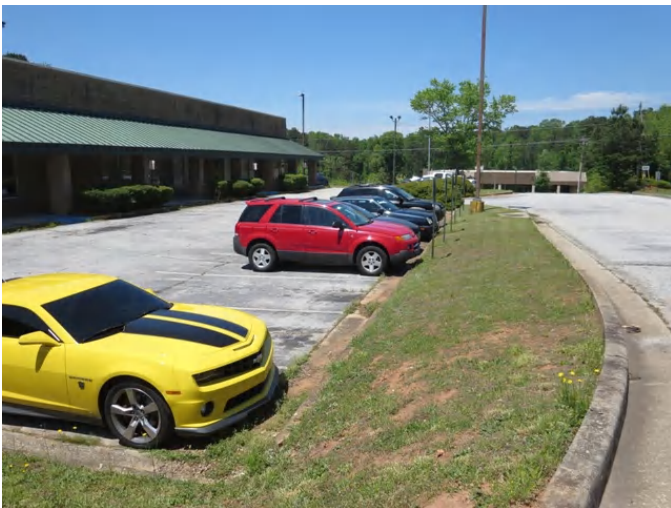
**System: G2050 - Landscaping**

**Location:** Site

**Distress:** Beyond Service Life

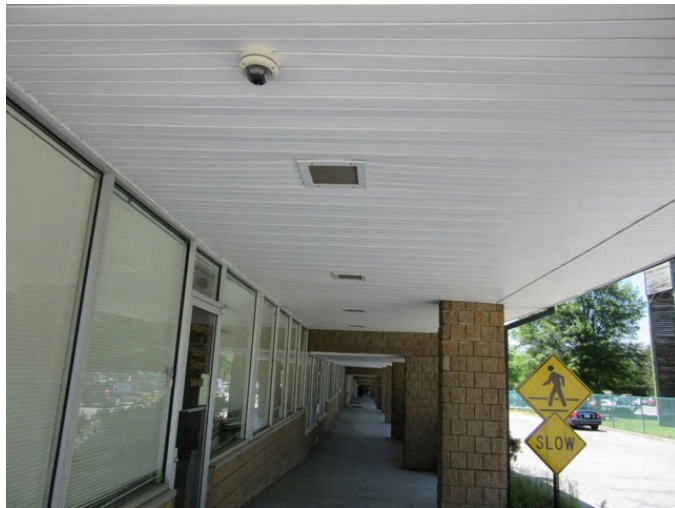
**System: G4030 - Site Communications & Security**

**Location:** Throughout Building

**Distress:** Beyond Service Life
