**DeKalb County School District/Admin/Support**

# **Doraville Administration**

## **School Assessment Report**

**May 19, 2016**

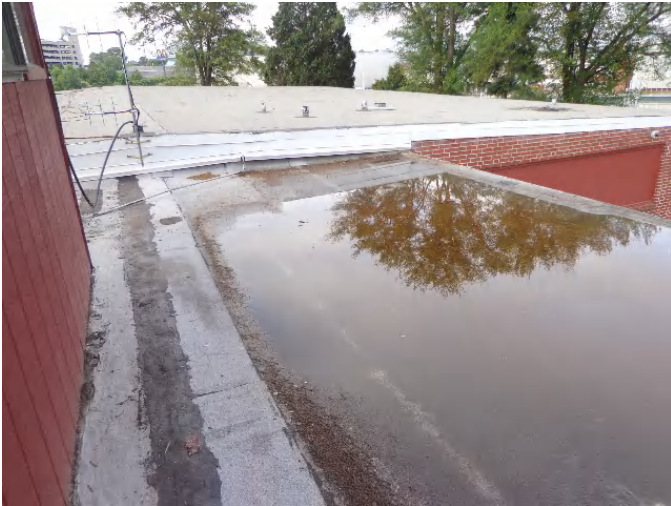
#### **System: B3010 - Roof Coverings - BUR**

**Location:** Roof

**Distress:** Beyond Service Life

**Notes:** The built-up roof covering is aged, showing signs of failure, has ponding water, and is scheduled for replacement under a SPLOST project 311-422.

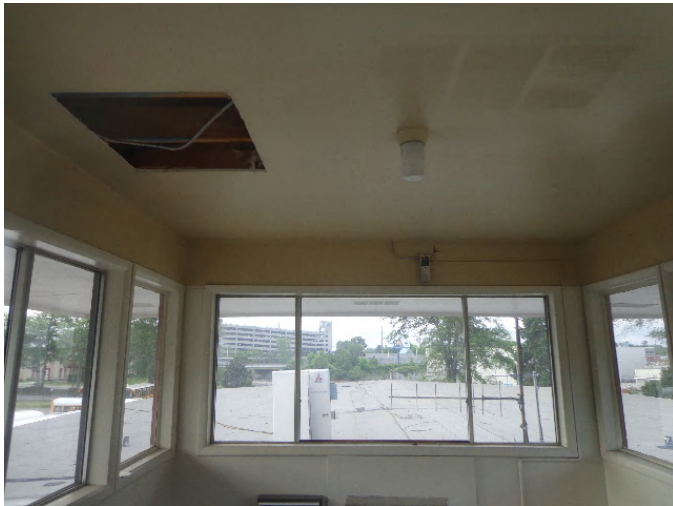
**System: B2020 - Exterior Windows**

**Location:** Observation Room

**Distress:** Beyond Service Life

**Notes:** Exterior windows are beyond their expected service life and should be scheduled for replacement.

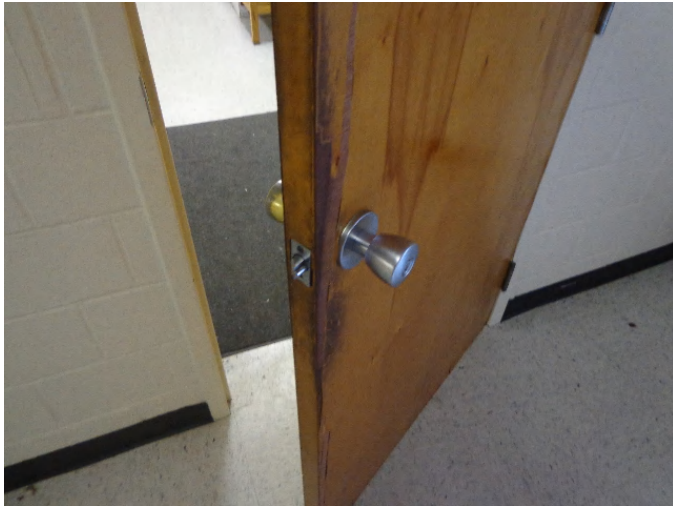
**System: C1020 - Interior Doors**

**Location:** Throughout Building

**Distress:** Beyond Service Life

**Notes:** The interior doors are aged, failing, not ADA compliant, and should be scheduled for replacement.

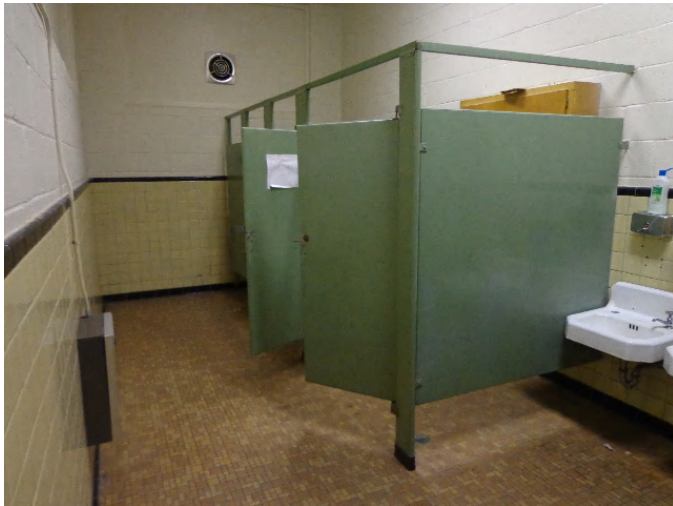
**System: C1030 - Fittings**

**Location:** Throughout Building

**Distress:** Beyond Service Life

**Notes:** Fittings, such as toilet partitions, handrails and room signage, throughout the building are aged, in marginal condition, not ADA compliant, and should be scheduled for replacement.

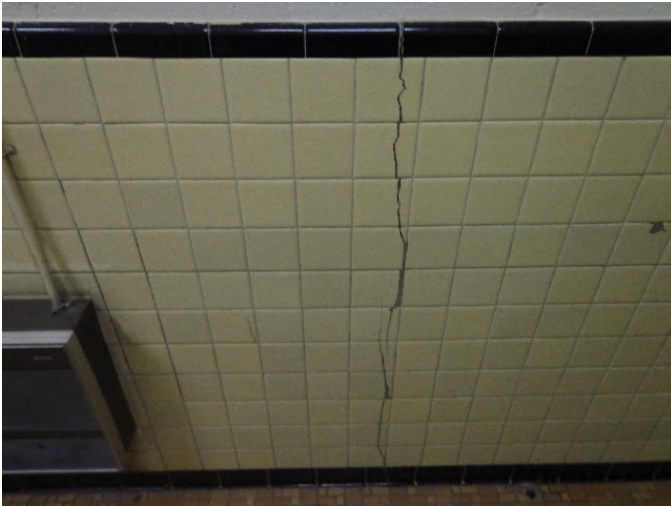
**System: C3010 - Wall Finishes - Ceramic Tile**

**Location:** Restrooms  
**Distress:** Beyond Service Life  
**Category:** Deferred Maintenance  
**Priority:** 3 Priority  
**Correction:** Renew System  
**Qty:** 455.00  
**Unit of Measure:** S.F.  
**Estimate:** \$5,140.00  
**Assessor Name:** Ben Nixon  
**Date Created:** 04/11/2015

**Notes:** The ceramic tile in the restrooms is aged, chipped, and cracked, and should be replaced.

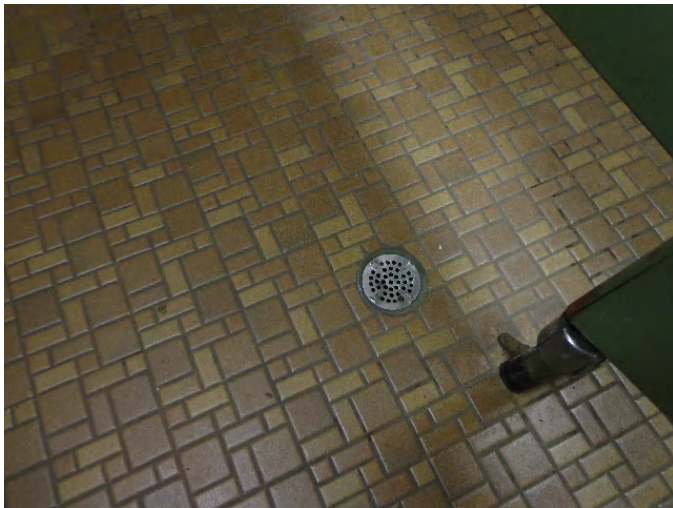
**System: C3020 - Floor Finishes - Ceramic Tile**

**Location:** Restrooms

**Distress:** Beyond Service Life

**Notes:** The ceramic tile in the restrooms are aged, worn and should be replaced.

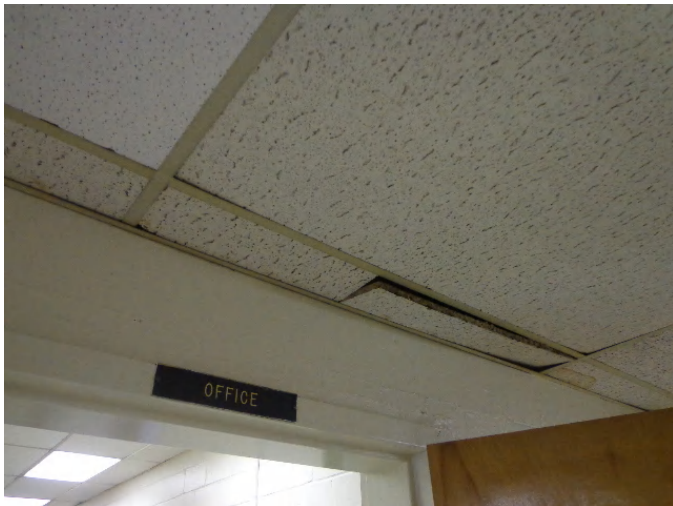
**System: C3030 - Ceiling Finishes**

**Location:** Throughout Building

**Distress:** Beyond Service Life

**Notes:** The ceiling tiles have been replaced as needed. However the grid shows signs of aging and most tiles are sagging or damaged and should be replaced.

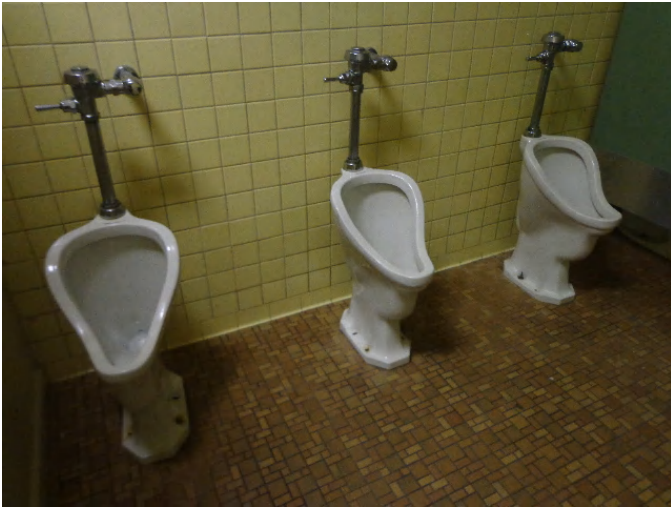
**System: D2010 - Plumbing Fixtures**

**Location:** Throughout Building

**Distress:** Beyond Service Life

**Notes:** Plumbing fixtures are beyond expected service life, failing, and should be replaced to improve ADA accessibility.

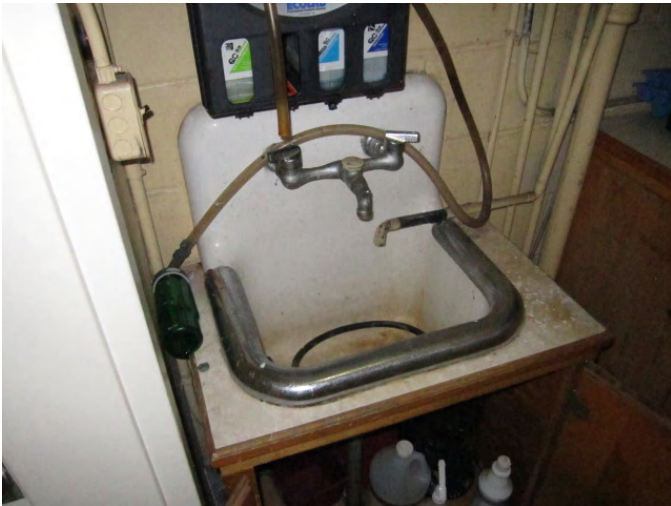
**System: D2020 - Domestic Water Distribution**

**Location:** Throughout Building

**Distress:** Beyond Service Life

**Notes:** The domestic water distribution system is aged, has water quality issues, and should be replaced. The water heater was removed and not reinstalled.

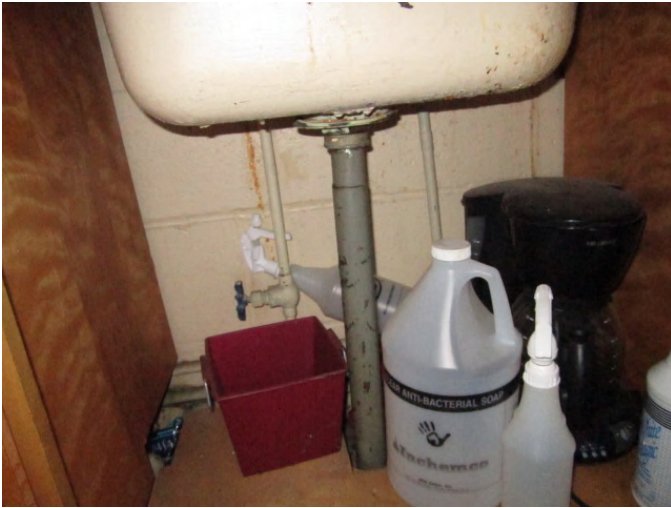
**System: D2030 - Sanitary Waste**

**Location:** Throughout Building

**Distress:** Beyond Service Life

**Notes:** The sanitary waste system is aged, has reported periodic failures, and should be replaced.

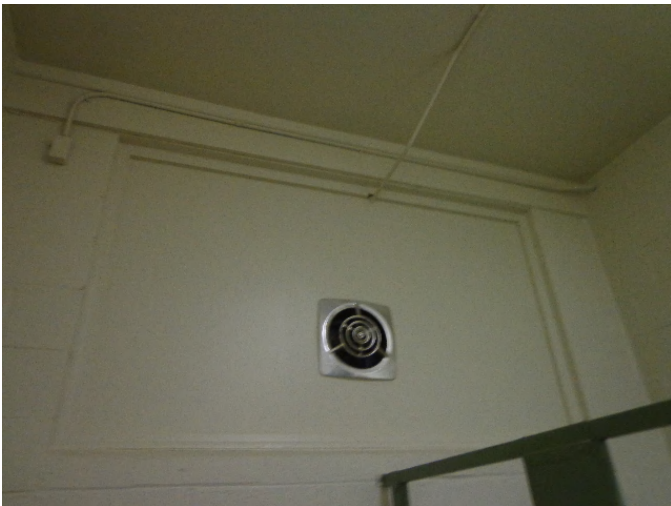
**System: D3040 - Distribution Systems & Exhaust Systems**

**Location:** Throughout Building

**Distress:** Beyond Service Life

**Notes:** The exhaust system is original to the building age, beyond its expected service life, and non operational, and should be replaced.

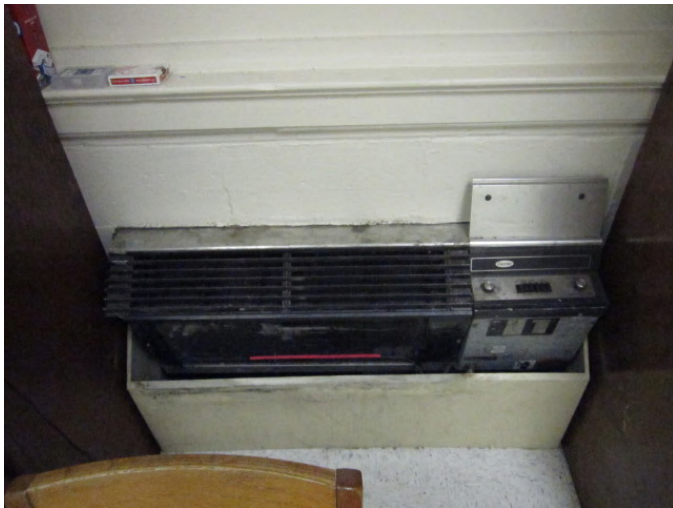
**System: D3050 - Terminal & Package Units**

**Location:** Throughout Building

**Distress:** Beyond Service Life

**Notes:** The system is beyond its expected service life, failing, and should be scheduled for replacement.

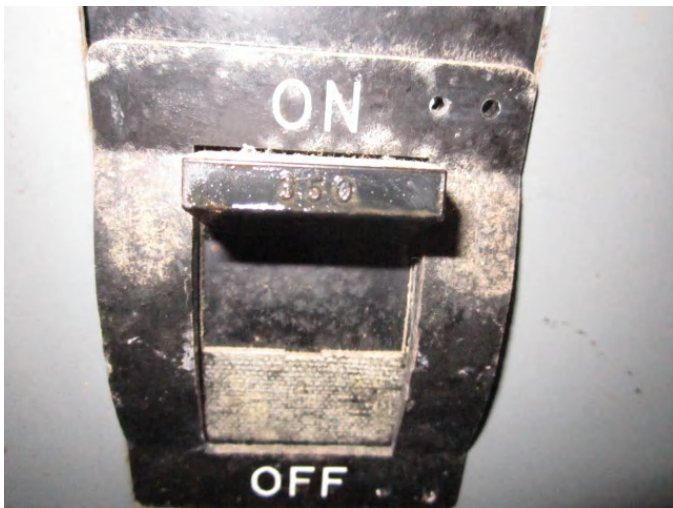
**System: D5010 - Electrical Service/Distribution**

**Location:** Throughout Building

**Distress:** Beyond Service Life

**Notes:** Electrical service is beyond its expected service life and should be scheduled for replacement.

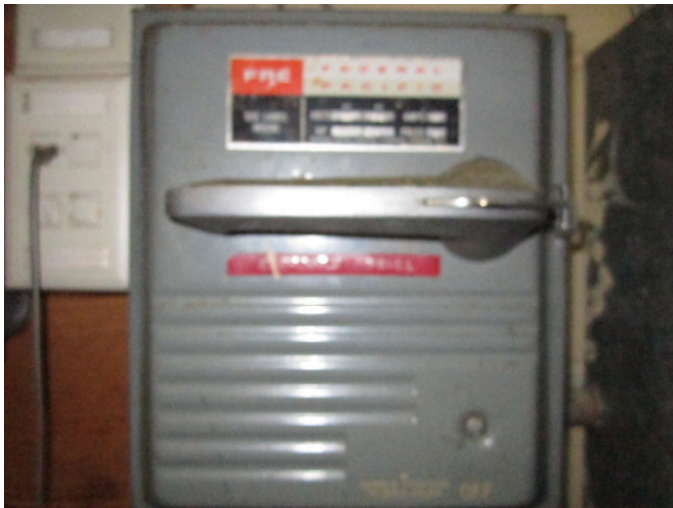
**System: D5020 - Branch Wiring**

**Location:** Throughout Building  
**Distress:** Beyond Service Life  
**Category:** Deferred Maintenance  
**Priority:** 3 Priority  
**Correction:** Renew System  
**Qty:** 5,545.00  
**Unit of Measure:** S.F.  
**Estimate:** \$41,050.00  
**Assessor Name:** Ben Nixon  
**Date Created:** 04/11/2015

**Notes:** Wiring is aged, failing, and should be replaced.

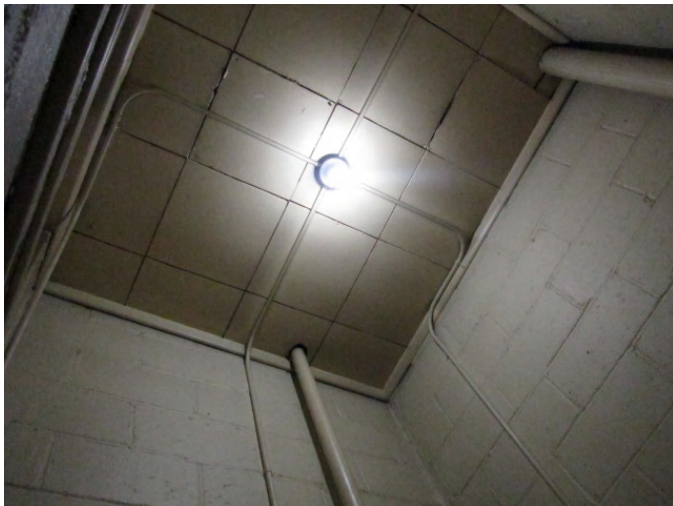
**System: D5020 - Lighting**

**Location:** Throughout Building  
**Distress:** Beyond Service Life  
**Category:** Deferred Maintenance  
**Priority:** 3 Priority  
**Correction:** Renew System  
**Qty:** 5,545.00  
**Unit of Measure:** S.F.  
**Estimate:** \$61,300.00  
**Assessor Name:** Ben Nixon  
**Date Created:** 04/11/2015

**Notes:** Lighting is aged, failing, and should be replaced. Staff reported that exterior building lighting is inadequate and there isn't any lighting at the main entrance or rear side of the building.

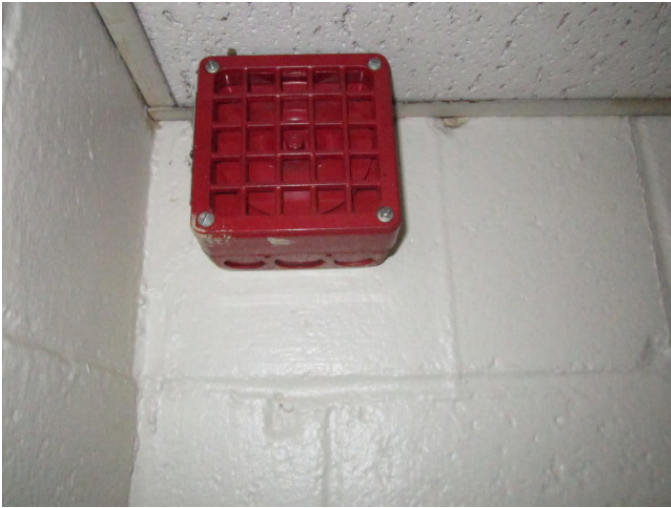
**System: D5030 - Communications and Security - Fire Alarm**

**Location:** Throughout Building

**Distress:** Beyond Service Life

**Notes:** The fire alarm is beyond its expected service life, failing, not code compliant, and should be scheduled for replacement.

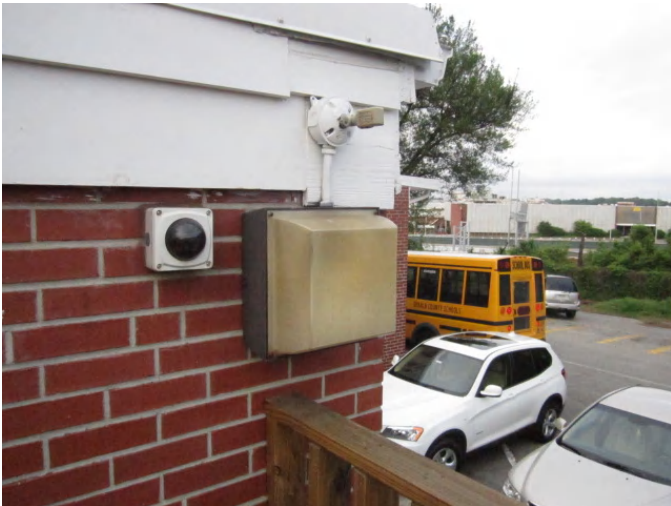
**System: D5030 - Communications and Security - Security & CCTV**

**Location:** Throughout Building

**Distress:** Damaged

**Notes:** Both the security and CCTV systems are beyond their expected service life, damaged, and should be scheduled for replacement.

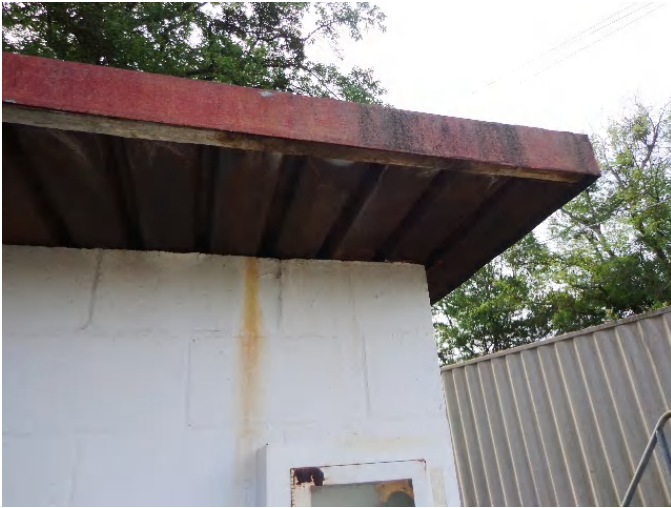
#### System: B1020 - Roof Construction

**Location:** Roof

**Distress:** Beyond Service Life

**Correction:** Replace entire roof (\$14.20/sf)

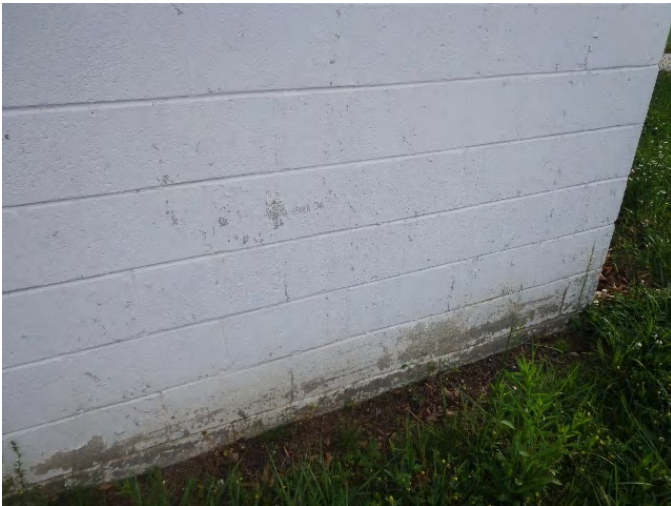
#### System: B2010 - Exterior Walls

**Location:** Exterior Walls

**Distress:** Beyond Service Life

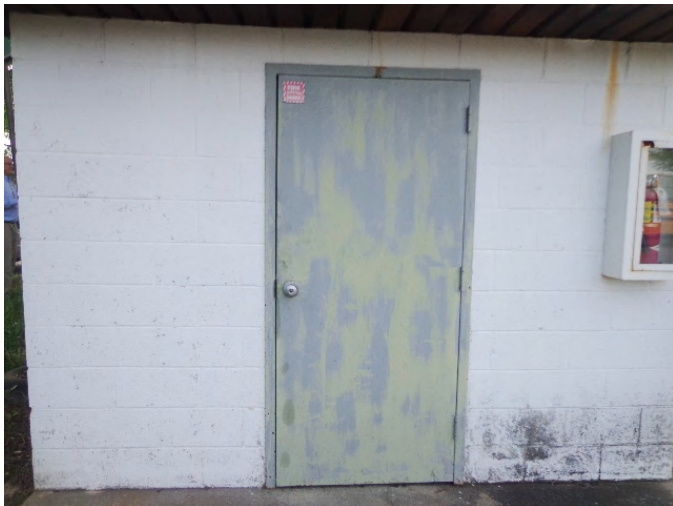
### **System: B2030 - Exterior Doors**

**Location:** Exterior Wall

**Distress:** Beyond Service Life

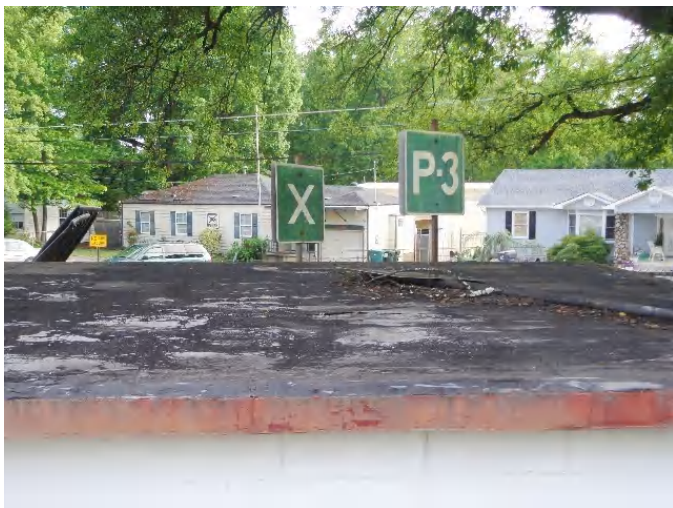
### **System: B3010 - Roof Coverings - BUR**

**Location:** Roof

**Distress:** Beyond Service Life

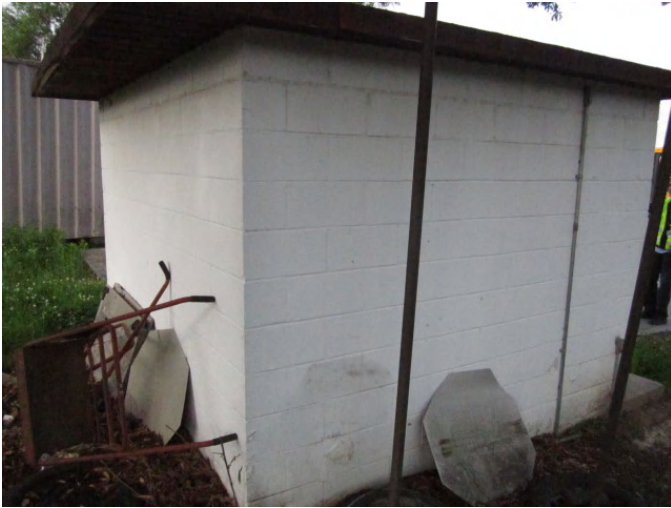
**System: D5020 - Lighting and Branch Wiring**

**Location:** Throughout Building

**Distress:** Beyond Service Life

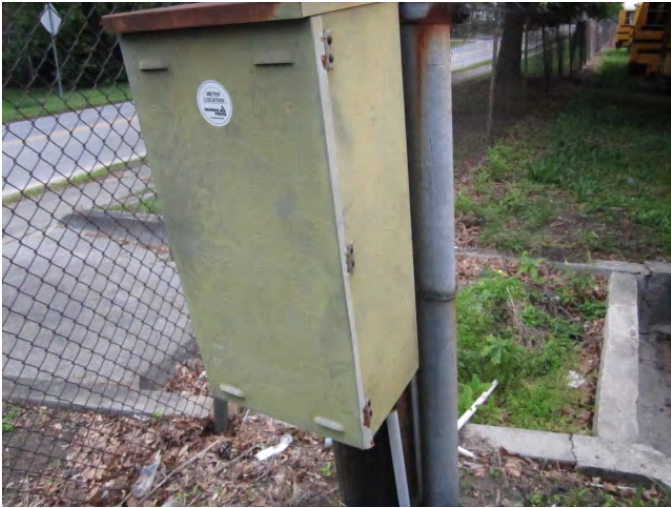
**System: G4010 - Electrical Distribution**

**Location:** Site  
**Distress:** Beyond Service Life  
**Category:** Deferred Maintenance  
**Priority:** 3 Priority  
**Correction:** Renew System  
**Qty:** 5,645.00  
**Unit of Measure:** S.F.  
**Estimate:** \$11,549.67  
**Assessor Name:** Eduardo Lopez  
**Date Created:** 04/27/2015

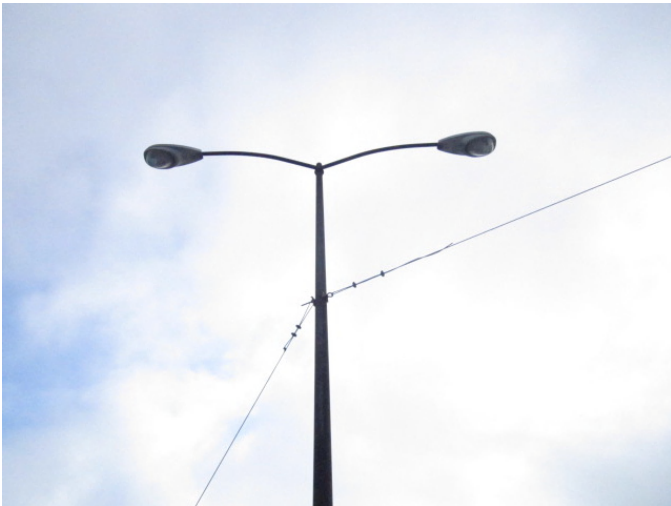
**System: G4020 - Site Lighting**

**Location:** Site  
**Distress:** Beyond Service Life  
**Category:** Deferred Maintenance / Safety  
**Priority:** 3 Priority  
**Correction:** Renew System  
**Qty:** 5,645.00  
**Unit of Measure:** S.F.  
**Estimate:** \$7,140.93  
**Assessor Name:** Sam Mandola  
**Date Created:** 04/27/2015
