DeKalb County School District/Elementary Schools

Dresden Elementary

School Assessment Report

May 19, 2016

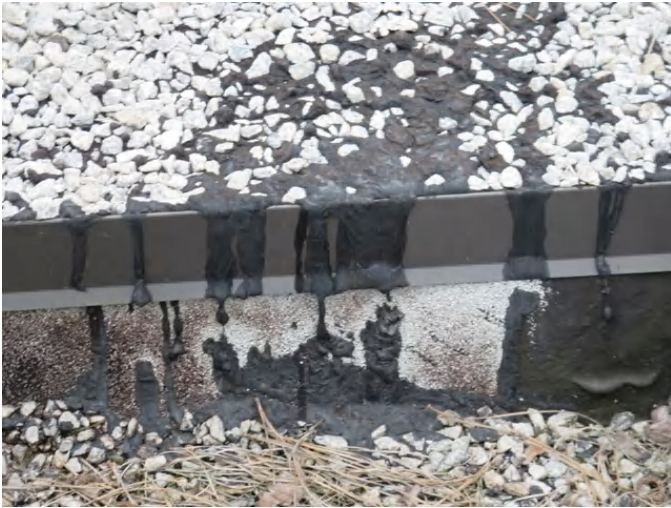
System: B3010 - Roof Coverings - BUR

Location: Roof

Distress: Beyond Service Life

Notes: The built-up roof covering is aged, showing signs of failure, has reported leaks, and should be replaced. SPLOST project 106-422 to replace the roof on the 63, 65, and 67 buildings.

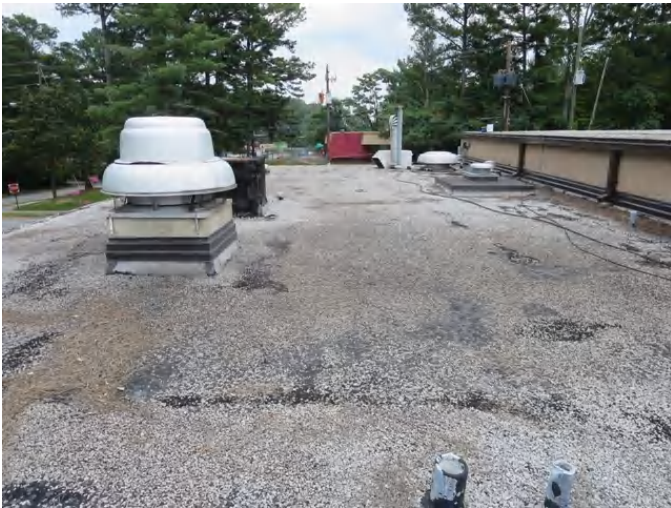
System: B3020 - Roof Openings

Location: Roof

Distress: Beyond Service Life

Notes: The roof openings are aging, showing signs of failure, and should be replaced in conjunction with the roof. SPLOST project 106-422 to replace the roof openings on the 63, 65, and 67 buildings.

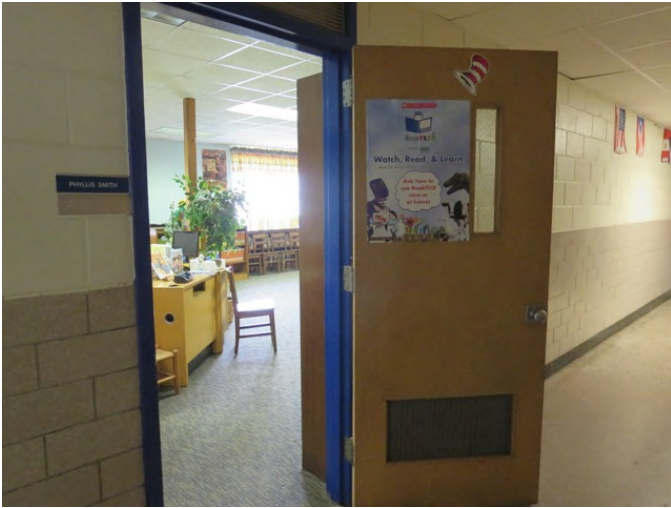
System: C1020 - Interior Doors

Location: Throughout Building

Distress: Beyond Service Life

Notes: The interior doors are aged, failing, and should be renovated or to comply with building code and improve ADA accessibility.

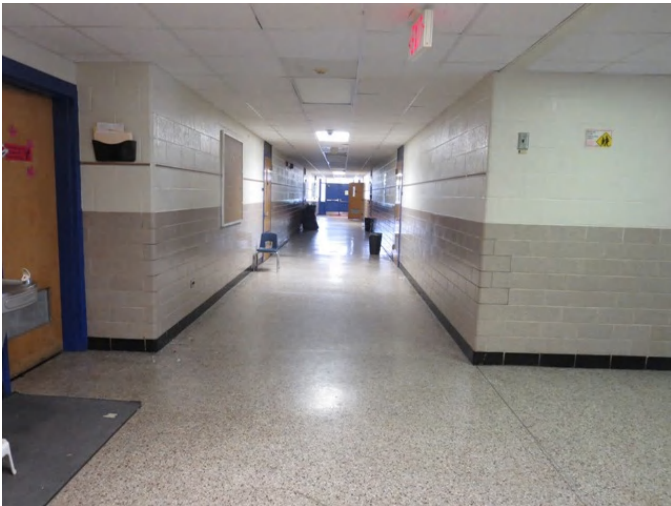
System: C3010 - Wall Finishes - Ceramic & Glazed

Location: Throughout Building

Distress: Beyond Service Life

Notes: The wall finishes are aged, scuffed and stained, and should be replaced.

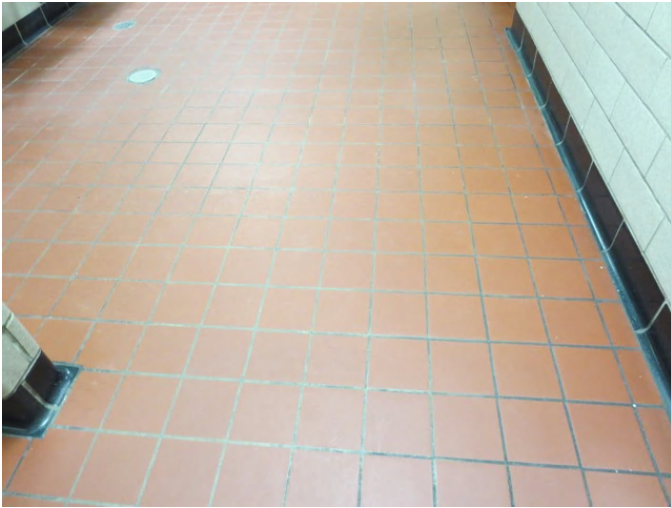
System: C3020 - Floor Finishes - Ceramic & Quarry Tile

Location: Kitchen and Restrooms

Distress: Beyond Service Life

Notes: The tile floor covering is beyond its expected service life and should be replaced.

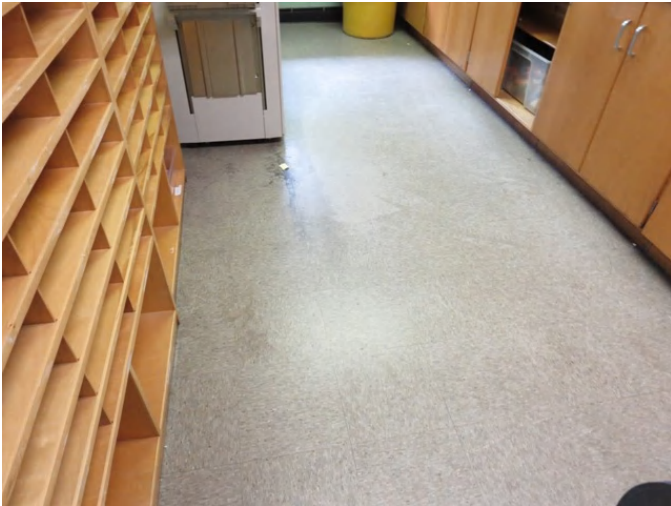
System: C3020 - Floor Finishes - VCT

Location: Classrooms and Cafeteria

Distress: Beyond Service Life

Notes: The VCT flooring has some deterioration due to age and wear, and should be replaced.

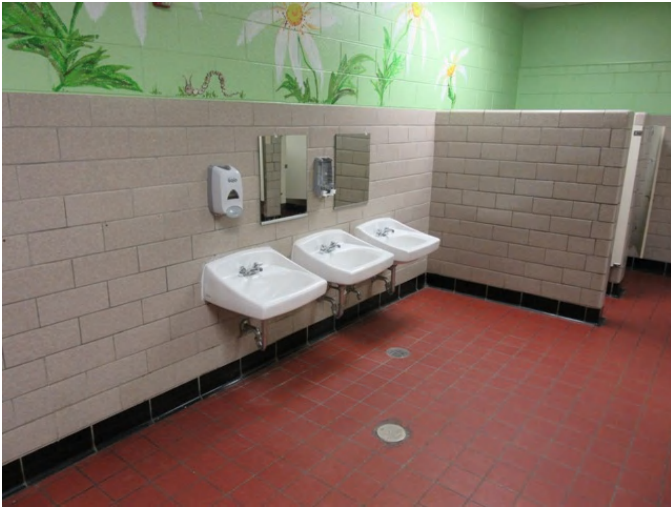
System: D2010 - Plumbing Fixtures

Location: Throughout Building

Distress: Damaged

Notes: Plumbing fixtures throughout the facility are failing early and need extensive maintenance, and should be scheduled for replacement. SPLOST project 106-422 to provide hall restroom renovations.

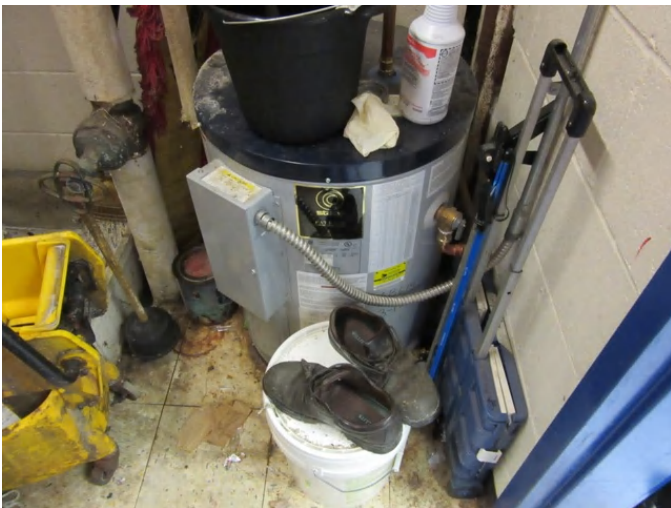
System: D2020 - Domestic Water Distribution

Location: Throughout Building

Distress: Beyond Service Life

Notes: The domestic water distribution system is beyond its expected service life and should be scheduled for replacement.

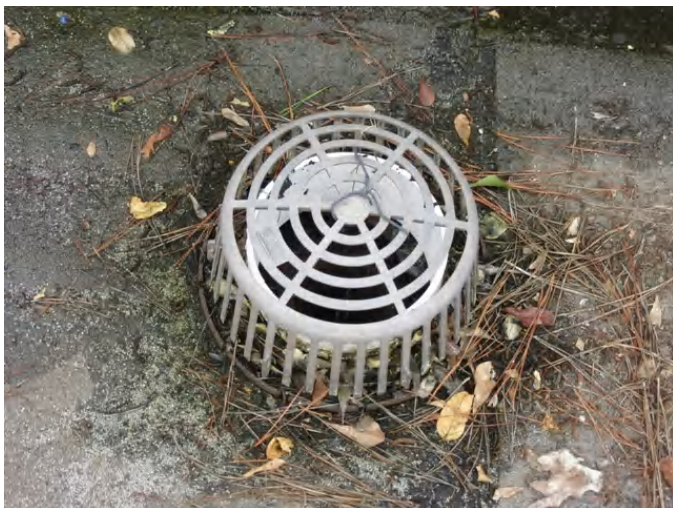
System: D2040 - Rain Water Drainage

Location: Throughout Building

Distress: Beyond Service Life

Notes: The rain water drainage system is in poor condition, beyond service life and should be scheduled for replacement.

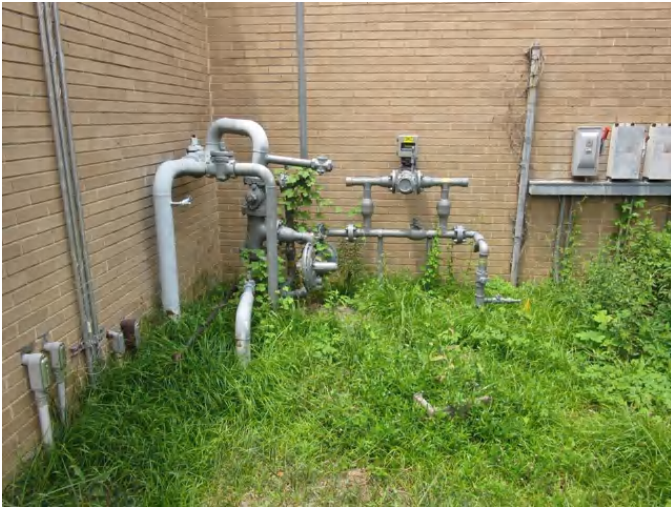
System: D2090 - Other Plumbing Systems - Natural Gas

Location: Northeast Side of Building

Distress: Beyond Service Life

Notes: The natural gas system is beyond its expected service life and should be scheduled for replacement.

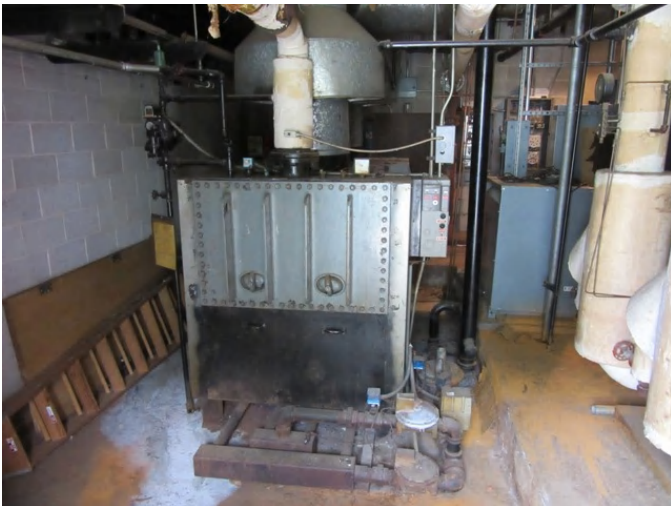
System: D3020 - Heat Generating Systems

Location: Mechanical Room

Distress: Beyond Service Life

Notes: The boiler is beyond its expected service life and should be scheduled for replacement.

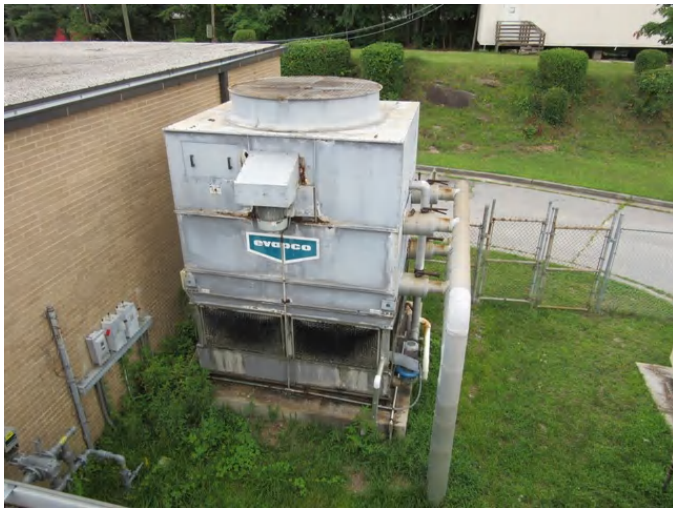
System: D3030 - Cooling Generating Systems

Location: Northeast Side of Building

Distress: Beyond Service Life

Notes: The cooling generating system is beyond its expected service life and should be scheduled for replacement.

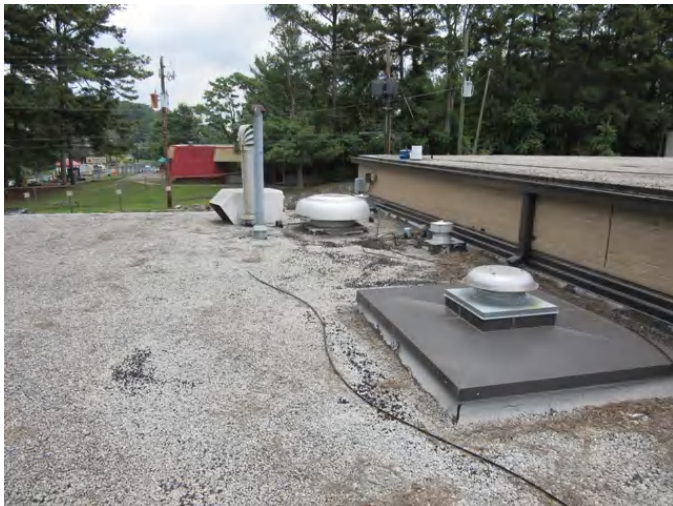
System: D3040 - Distribution & Exhaust Systems

Location: Restrooms

Distress: Beyond Service Life

Notes: The distribution and exhaust systems are beyond their expected service life and should be scheduled for replacement.

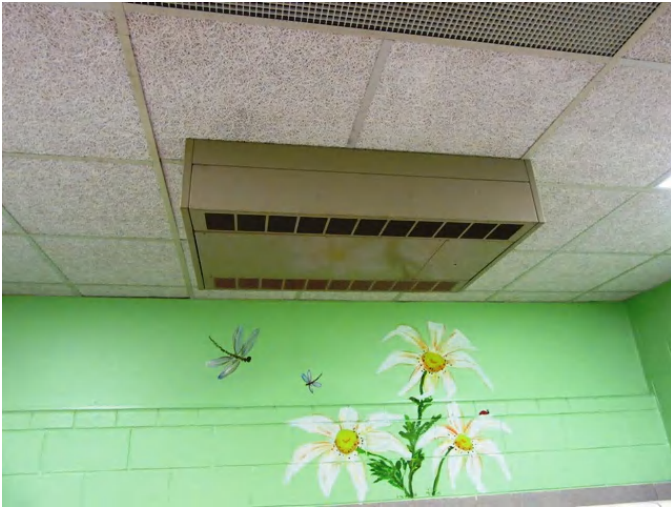
System: D3050 - Terminal & Package Units

Location: Throughout Building

Distress: Beyond Service Life

Notes: The terminal and package units are beyond their expected service life, require extensive maintenance, and should be scheduled for replacement.

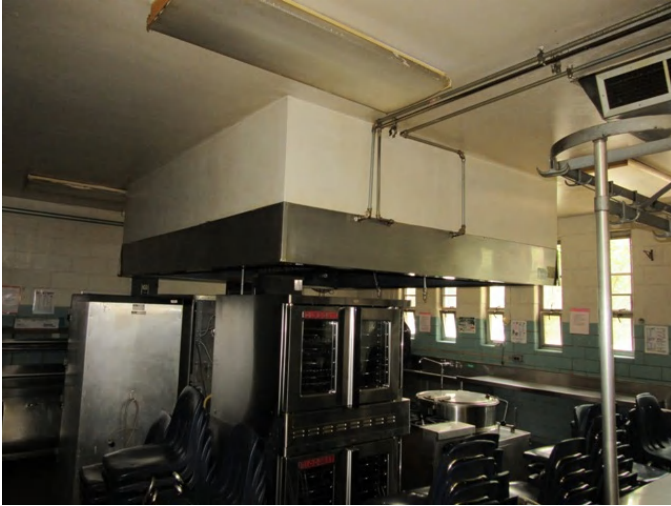
System: D3090 - Other HVAC Systems/Equip - Kitchen Hood

Location: Kitchen

Distress: Beyond Service Life

Notes: The kitchen hood is beyond service life and should be scheduled for replacement. Replacement of the kitchen hood is an add alternate under SPLOST IV.

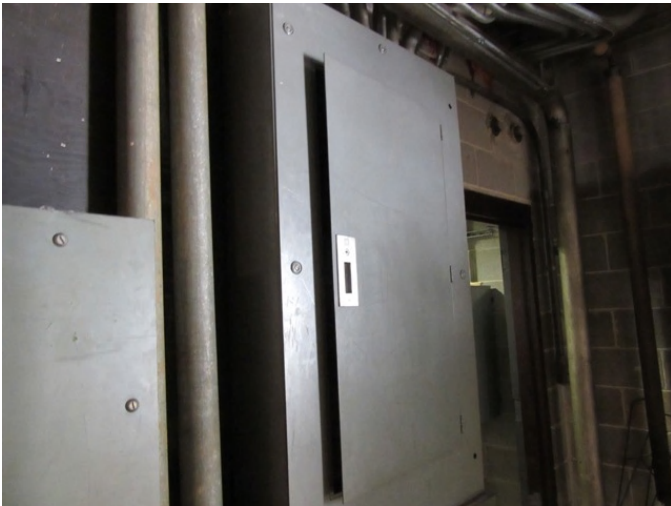
System: D5010 - Electrical Service/Distribution

Location: Main Switch Room/Throughout Building

Distress: Beyond Service Life

Notes: The electrical service/distribution system is beyond its expected service life and no longer supports modern load requirements. The primary service and branch wiring should be scheduled for replacement.

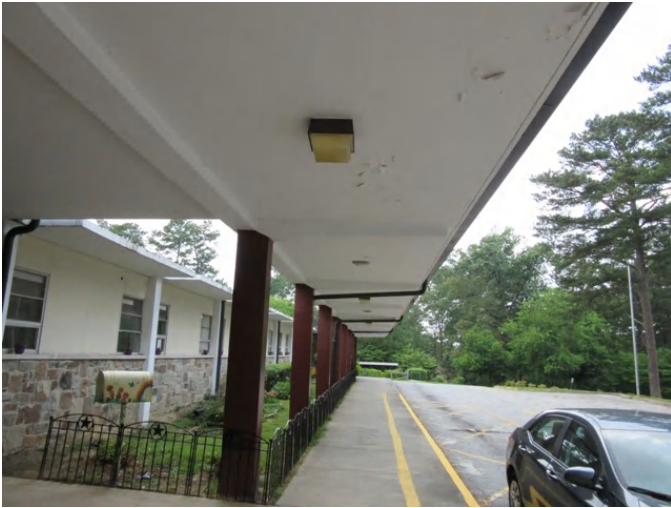
System: D5020 - Branch Wiring

Location: Throughout Building

Distress: Beyond Service Life

Notes: The branch wiring system is beyond its expected service life, unable to meet current usage needs, and should be replaced. Electrical outlets in the kitchen are not GFI.

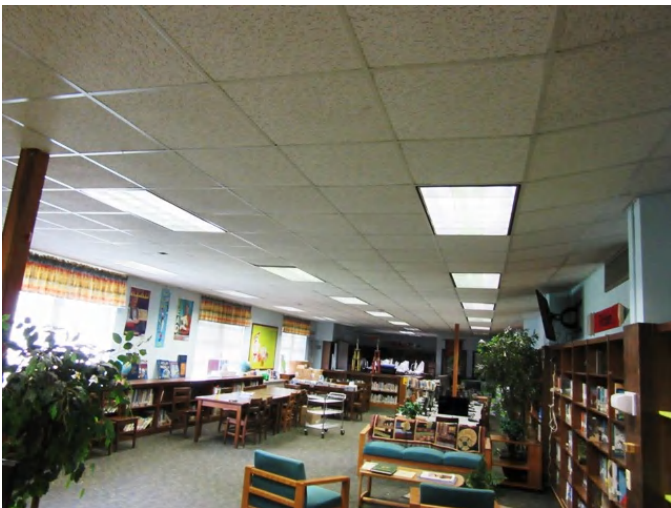
System: D5020 - Lighting

Location: Throughout Building

Distress: Beyond Service Life

Notes: The lighting system is beyond its expected service life and should be scheduled for replacement. SPLOST project 106-422 to replace the lighting system throughout the buildings.

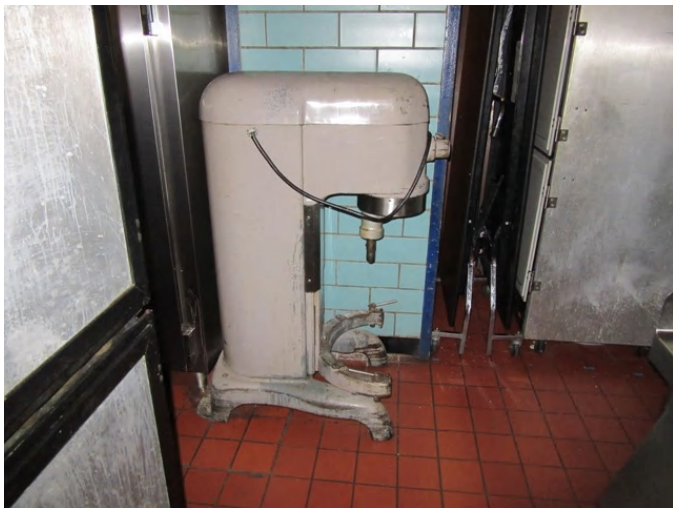
System: E1090 - Other Equipment (Kitchen Equipment)

Location: Kitchen

Distress: Beyond Service Life

Notes: Kitchen equipment is beyond its expected service life and should be scheduled for replacement. SPLOST project 106-422 to replace the kitchen equipment.

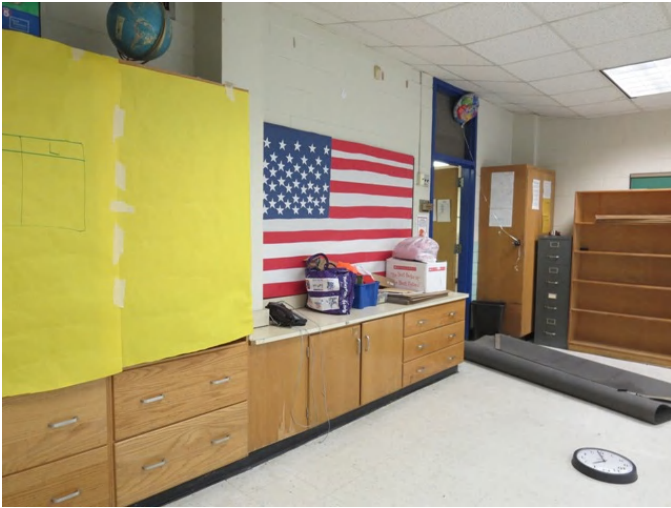
System: E2010 - Fixed Furnishings

Location: Throughout Building

Distress: Beyond Service Life

Notes: Fixed furnishings, such as built-in cabinets, are beyond their expected service life, damaged and worn, and should be replaced.

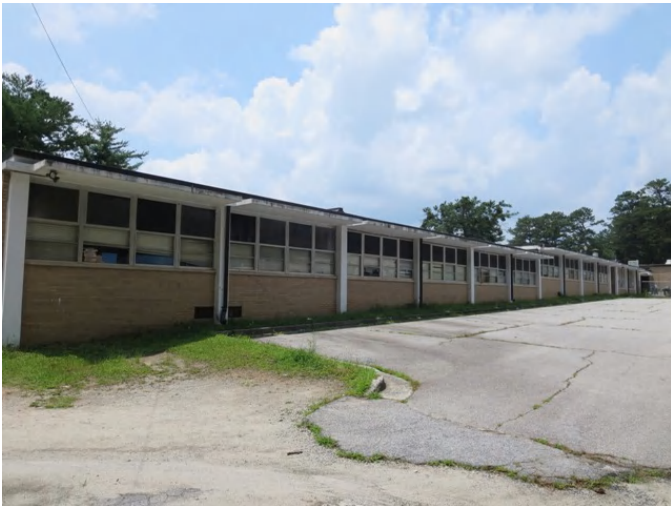
System: F1010 - Special Structures - Canopies

Location: Exterior Walls

Distress: Beyond Service Life

Notes: Canopies on the exterior walls of the building are beyond their expected service life, deteriorated, and should be repaired repaired/replaced.

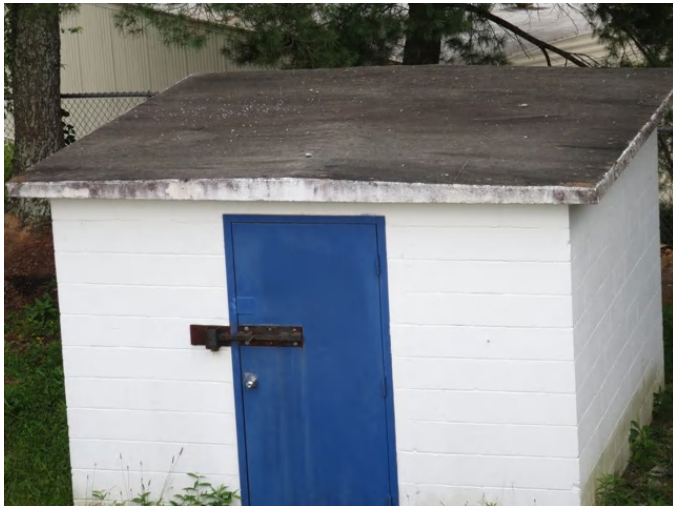
System: B3010 - Roof Coverings

Location: Roof

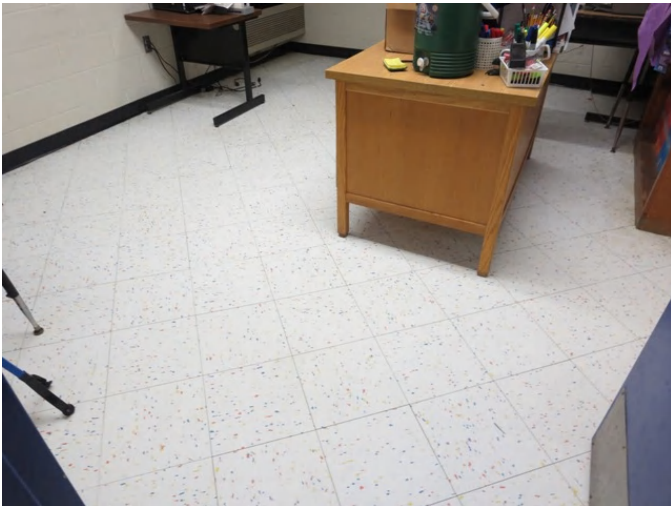
System: C3020 - Floor Finishes - VCT

Location: Entrance Area and Offices

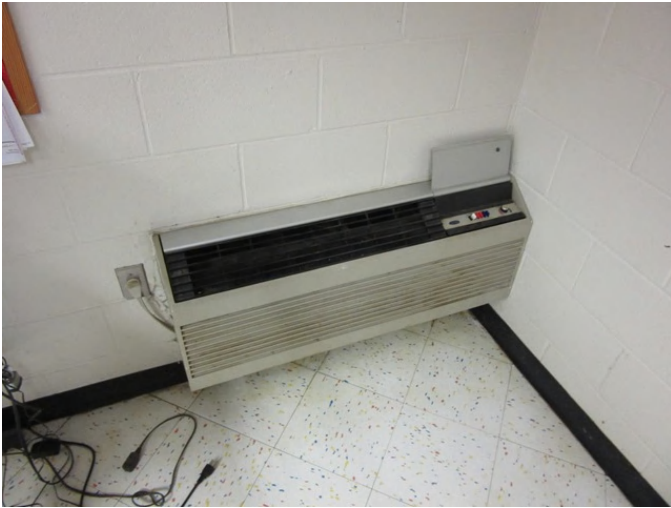
System: D3050 - Terminal & Package Units

Location: Throughout Building

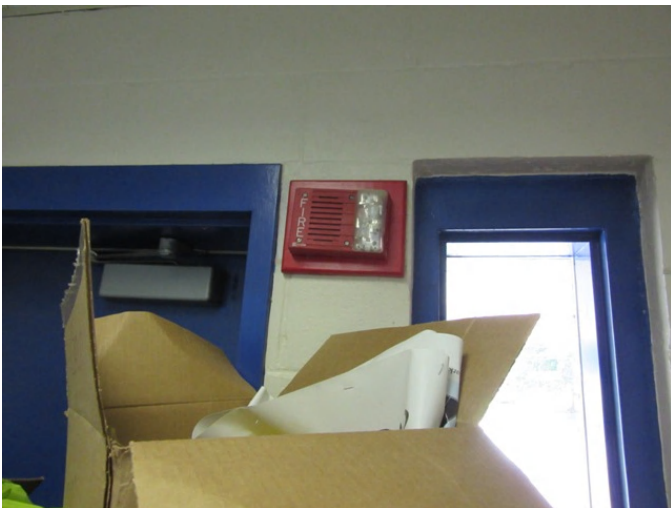
System: D5030 - Communications and Security - Fire Alarm

Location: Throughout Building

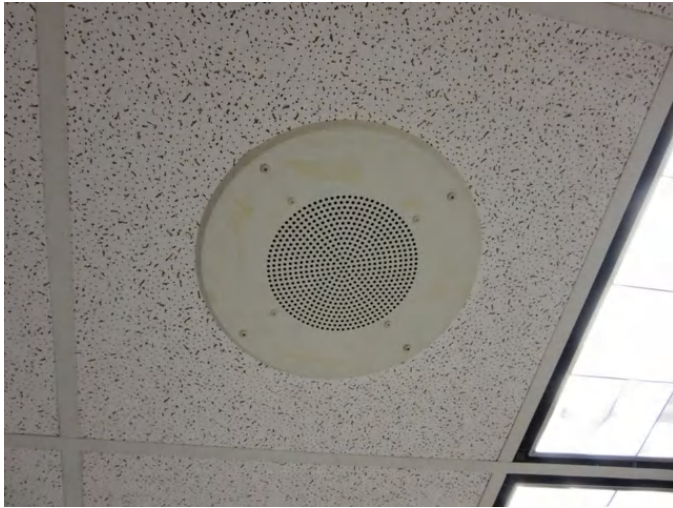
System: D5030 - Communications and Security - Public Address & Clock System

Location: Throughout Building

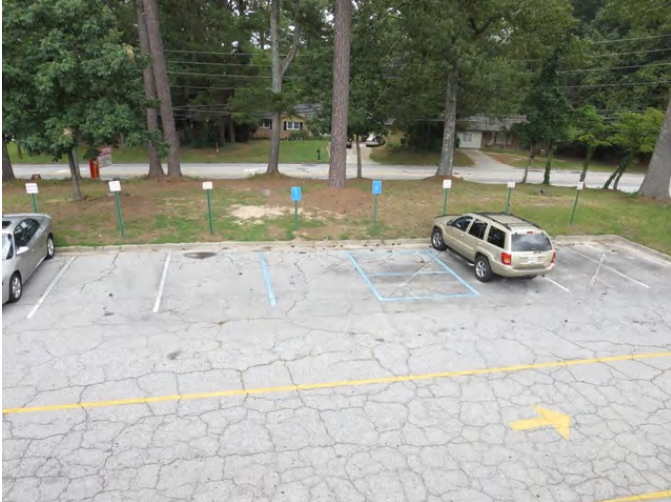
System: G2020 - Parking Lots

Location: North Side of Site

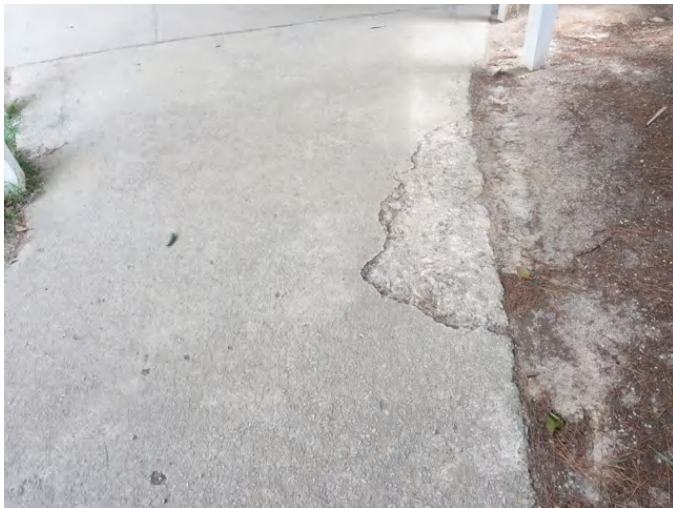
System: G2030 - Pedestrian Paving

Location: Site

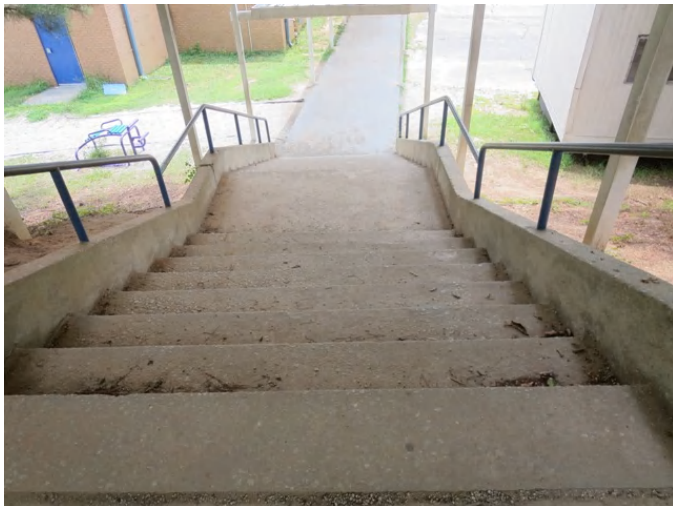
System: G2040 - Fencing & Guardrails

Location: Site

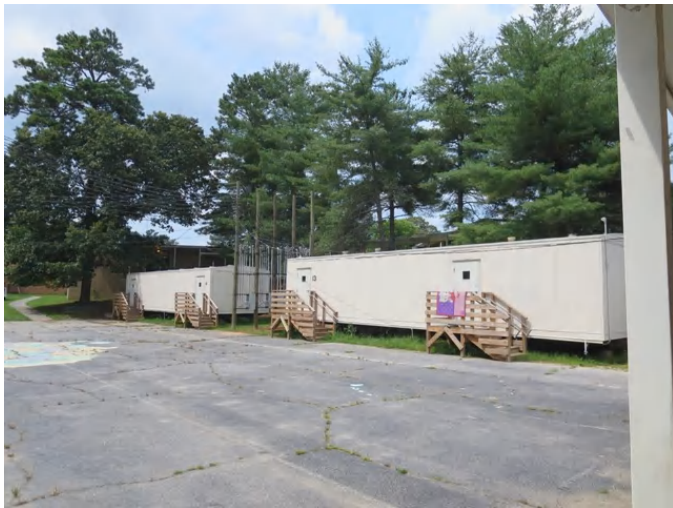
System: G2040 - Hard Surface Play Area

Location: Site
Distress: Beyond Service Life
Category: Deferred Maintenance
Priority: 3 Priority
Correction: Renew System
Qty: 8,515.00
Unit of Measure: S.F.
Estimate: \$58,634.00
Assessor Name: Sam Mandola
Date Created: 07/17/2015

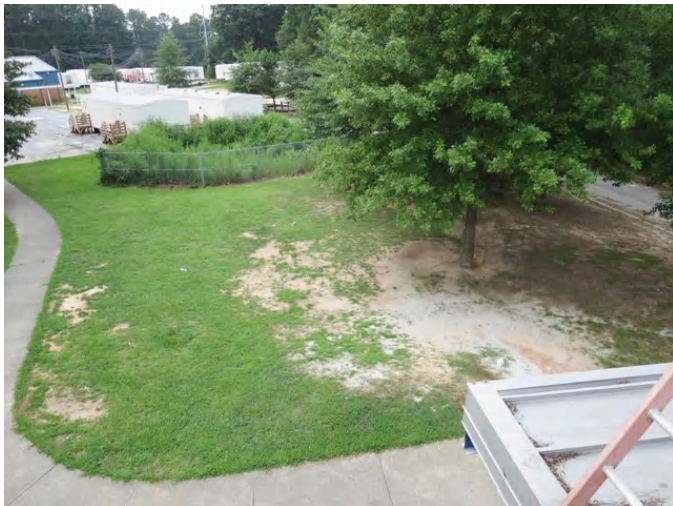
System: G2050 - Landscaping

Location: Site
Distress: Beyond Service Life
Category: Deferred Maintenance
Priority: 3 Priority
Correction: Renew System
Qty: 69,880.00
Unit of Measure: S.F.
Estimate: \$111,459.00
Assessor Name: Sam Mandola
Date Created: 07/17/2015

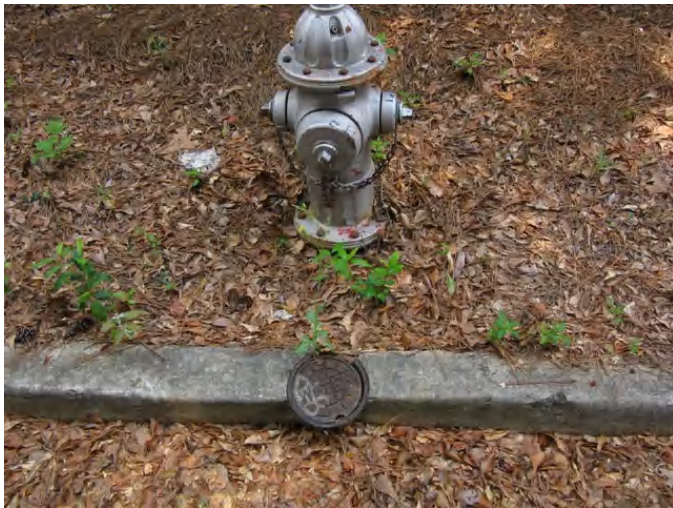
System: G3010 - Water Supply

Location: Site
Distress: Beyond Service Life
Category: Deferred Maintenance
Priority: 3 Priority
Correction: Renew System
Qty: 69,880.00
Unit of Measure: S.F.
Estimate: \$140,668.00
Assessor Name: Sam Mandola
Date Created: 07/15/2015

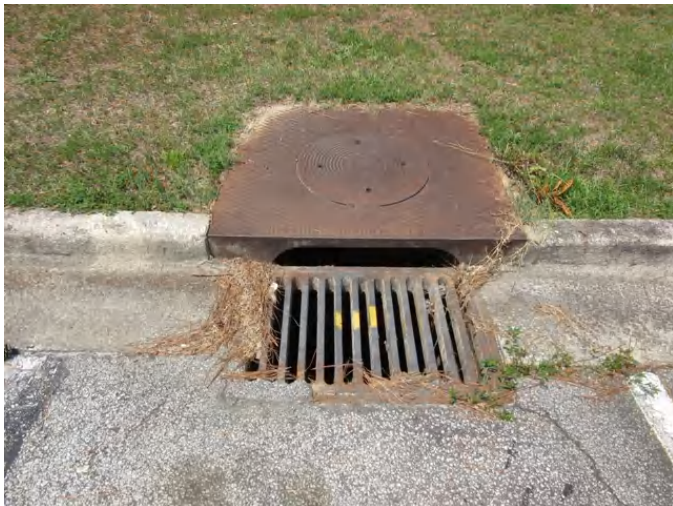
System: G3020 - Sanitary Sewer

Location: Site
Distress: Beyond Service Life
Category: Deferred Maintenance
Priority: 3 Priority
Correction: Renew System
Qty: 69,880.00
Unit of Measure: S.F.
Estimate: \$88,398.00
Assessor Name: Sam Mandola
Date Created: 07/15/2015

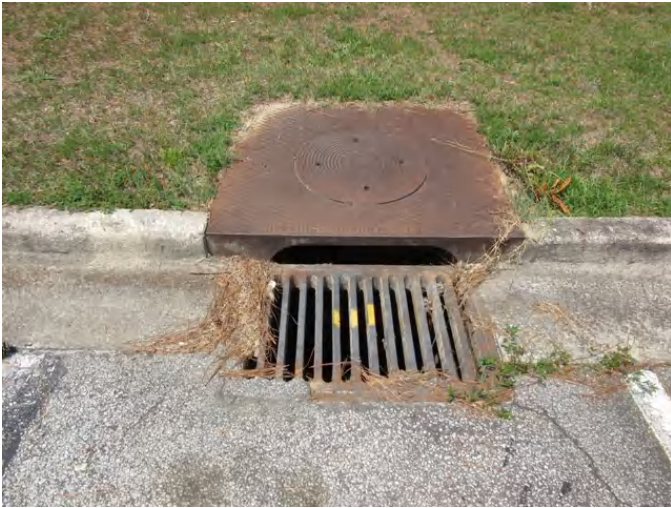
System: G3030 - Storm Sewer

Location: Site

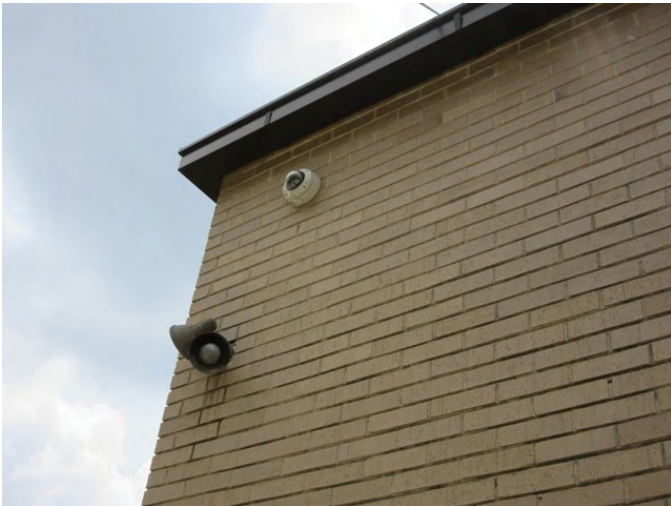
System: G4030 - Site Communications & Security

Location: Site
