DeKalb County School District/Elementary Schools

E.L. Bouie Elementary

School Assessment Report

May 19, 2016

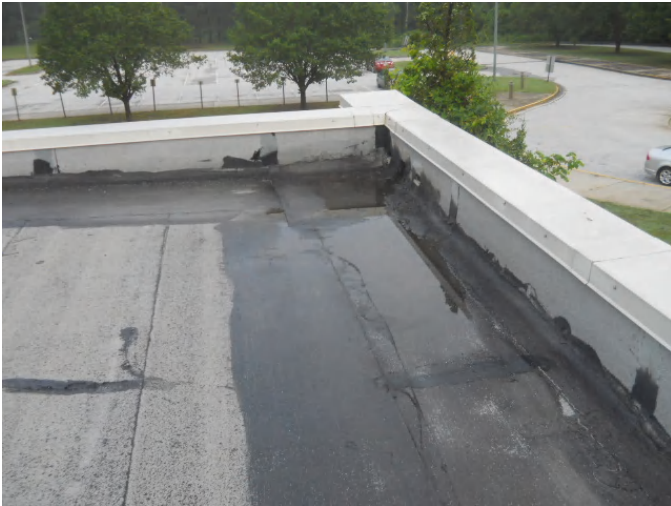
System: B3010 - Roof Coverings - BUR

Location: Roof

Distress: Beyond Service Life

Notes: The roof is beyond its expected service life, inadequately sloped to drain water to scuppers in several locations, holding water, leaking, and should be replaced. Roof replacement is part of SPLOST project 302-422.

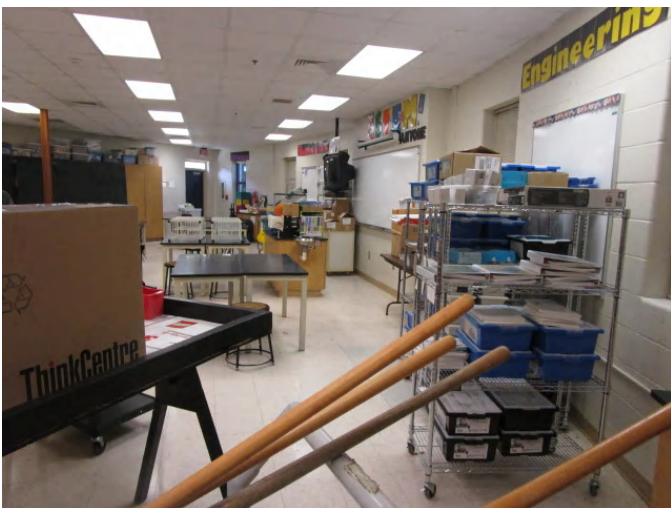
System: D2090 - Other Plumbing Systems - Natural Gas

Location: Throughout Building

Distress: Missing

Notes: SPLOST project 302-422 to install an emergency gas shutoff by the science lab.

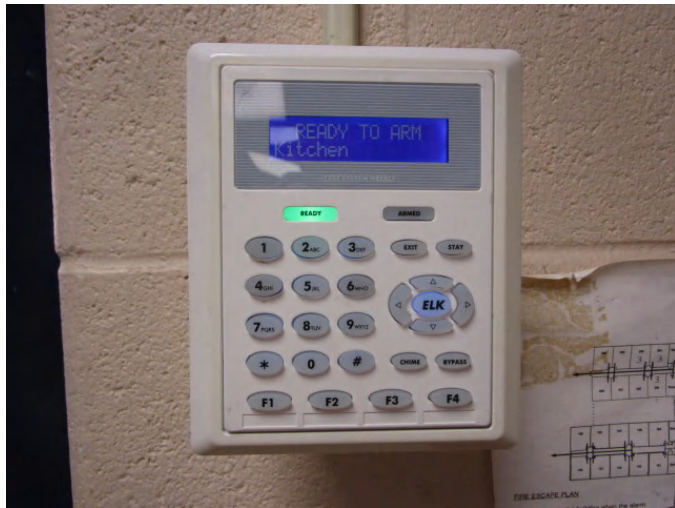
System: D5030 - Communications and Security - Security & CCTV

Location: Throughout Building

Distress: Beyond Service Life

Notes: The security and CCTV systems are beyond their expected service life and should be scheduled for replacement.

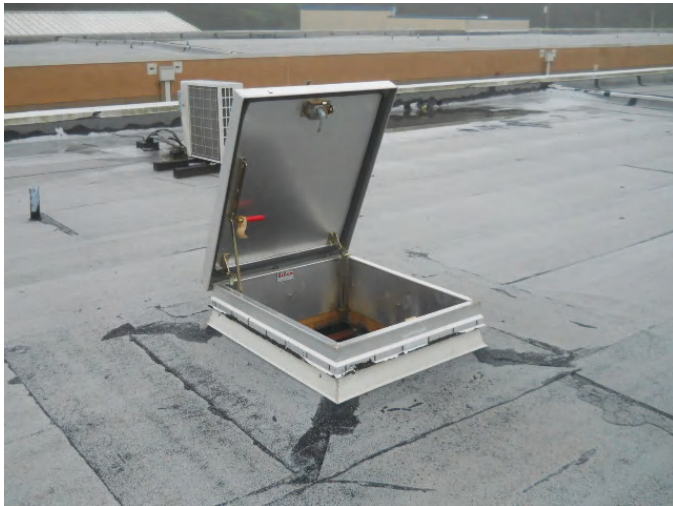
System: B3020 - Roof Openings

Location: Roof

Distress: Inadequate

Correction: Replace roof hatch and structure single unit

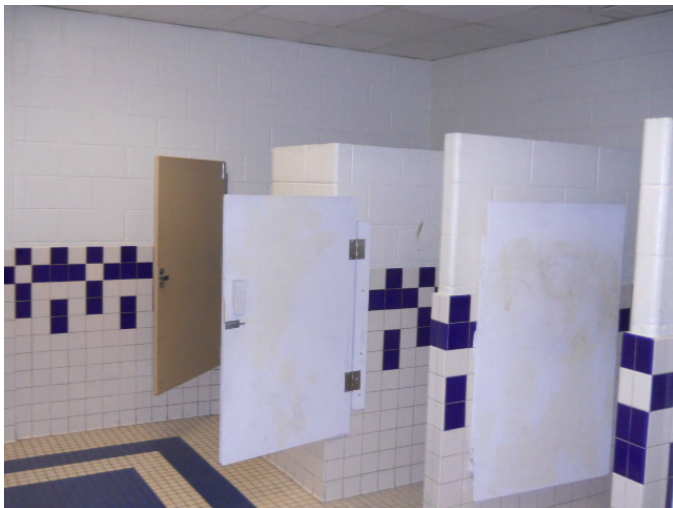
System: C1030 - Fittings

Location: Restrooms

Distress: Damaged

Notes: The restroom toilet partition doors are damaged, missing, and should be replaced.

Correction: Replace toilet partitions, laminate clad-overhead braced, per stall

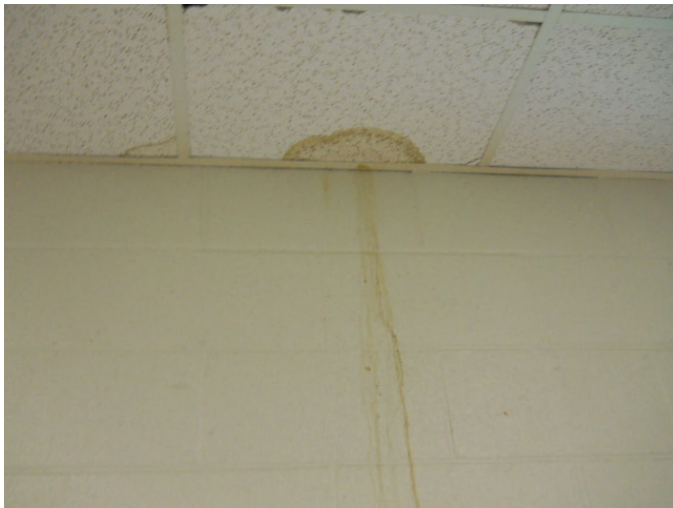
System: C3010 - Wall Finishes - Paint

Location: Throughout Building

Distress: Beyond Service Life

Notes: The painted wall finishes are beyond their expected service life and should be replaced.

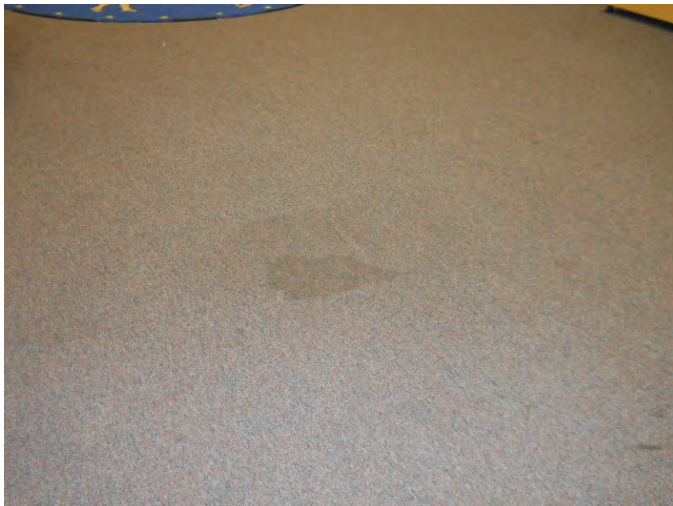
System: C3020 - Floor Finishes - Carpet

Location: Throughout Building

Distress: Beyond Service Life

Notes: The carpet is beyond its expected service life and should be replaced.

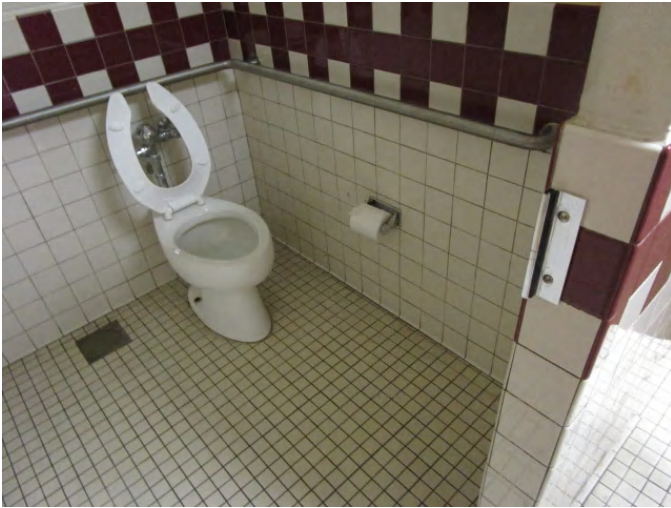
System: D2010 - Plumbing Fixtures

Location: Throughout Building

Distress: Beyond Service Life

Notes: The plumbing fixtures are nearing the end of their expected service life, not ADA compliant, and should be scheduled for replacement. Most drinking fountains do not work.

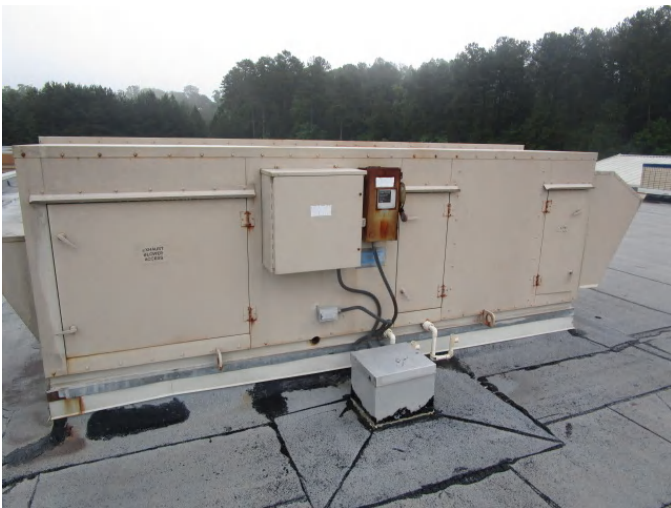
System: D3040 - Distribution & Exhaust Systems

Location: Throughout Building

Distress: Beyond Service Life

Notes: The distribution and exhaust systems are beyond their expected service life and should be scheduled for replacement. There is little or no exhaust in restrooms and the restroom vents are too close to the outside air intake on some air handlers.

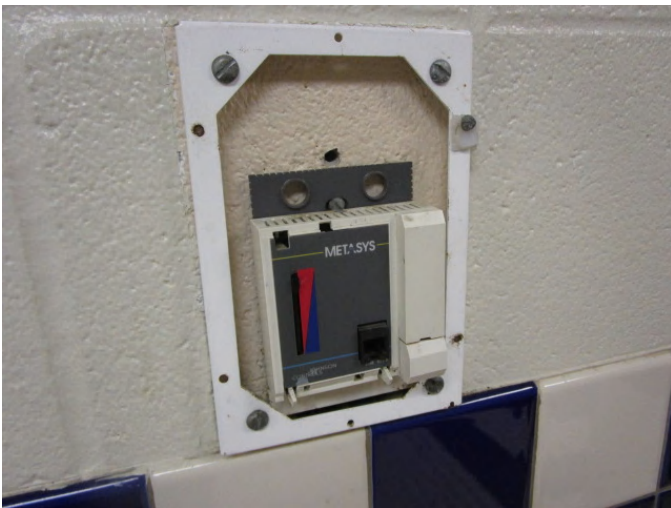
System: D3060 - Controls & Instrumentation

Location: Throughout Building

Distress: Beyond Service Life

Notes: The controls and instrumentation system is beyond its expected service life, does not function properly, and should be scheduled for replacement.

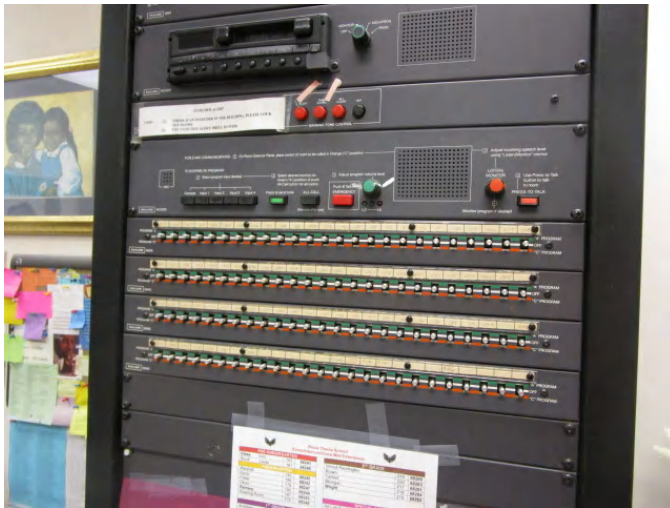
System: D5030 - Communications and Security - Clock & PA Systems

Location: Throughout Building

Distress: Beyond Service Life

Notes: Clock and PA systems are beyond their expected service life and should be scheduled for replacement.

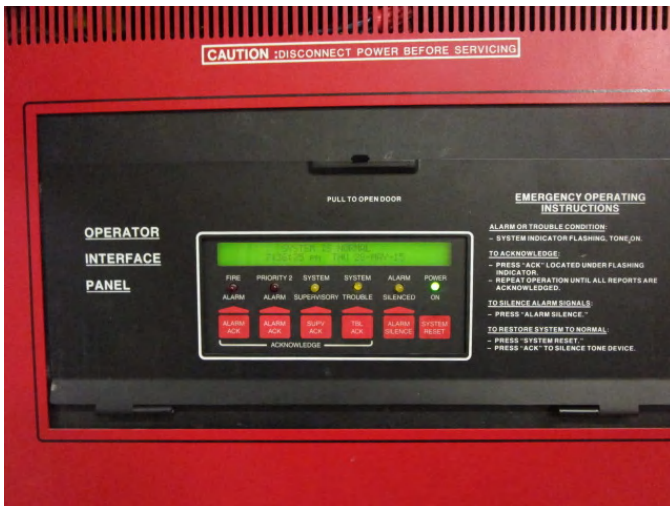
System: D5030 - Communications and Security - Fire Alarm

Location: Throughout Building

Distress: Beyond Service Life

Notes: The fire alarm system is beyond its expected service life and should be scheduled for replacement.

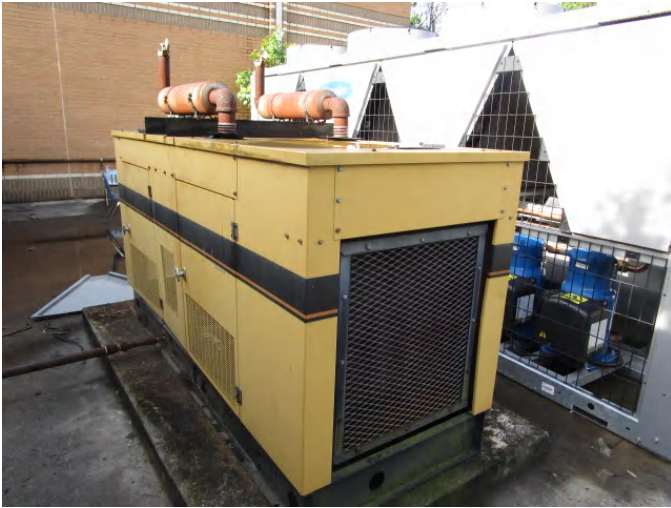
System: D5090 - Other Electrical Systems - Emergency Generator

Location: Exterior of Building

Distress: Beyond Service Life

Notes: The emergency generator is beyond its expected service life, reportedly does not work, and should be scheduled for replacement.

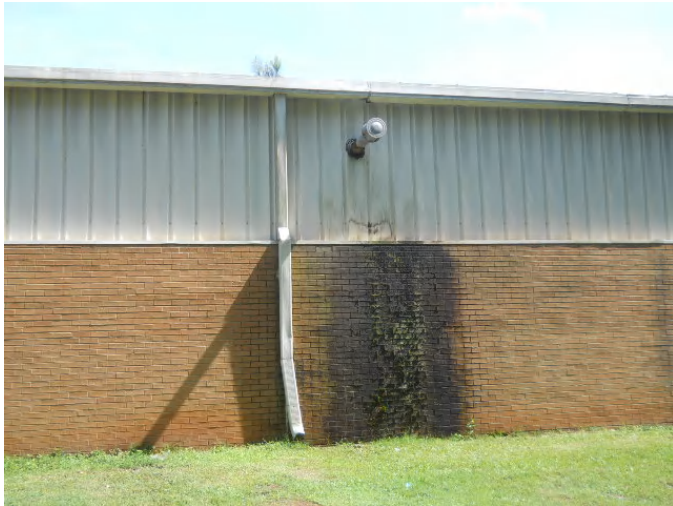
System: B3010 - Roof Coverings - Standing Seam Metal

Location: Roof

Distress: Damaged

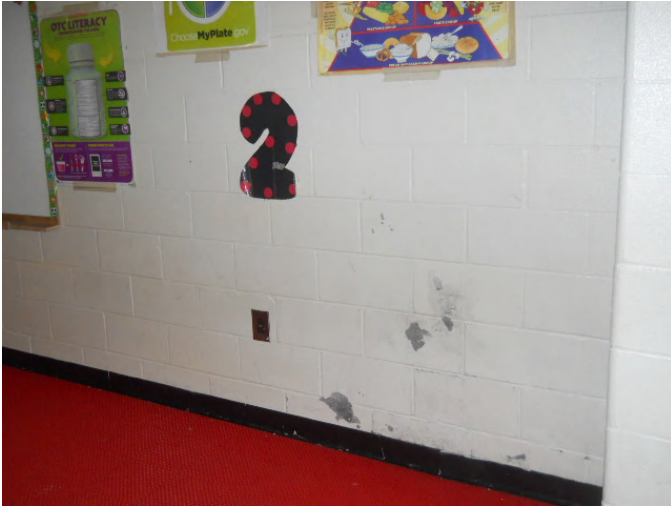
System: C3010 - Wall Finishes - Paint

Location: Throughout Building

Distress: Beyond Service Life

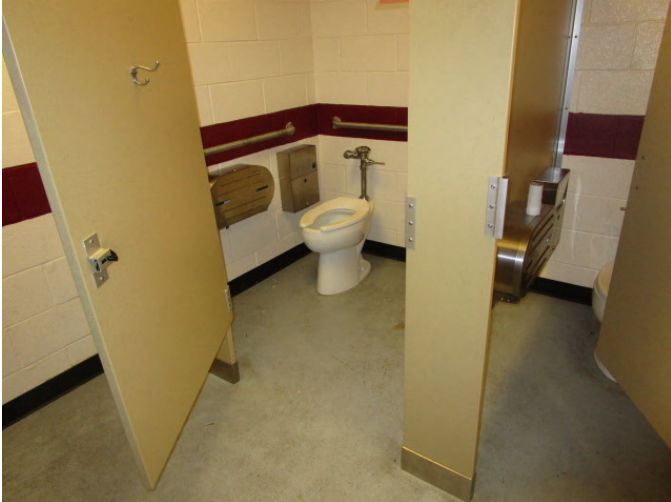
System: D2010 - Plumbing Fixtures

Location: Throughout Building

Distress: Needs Remediation

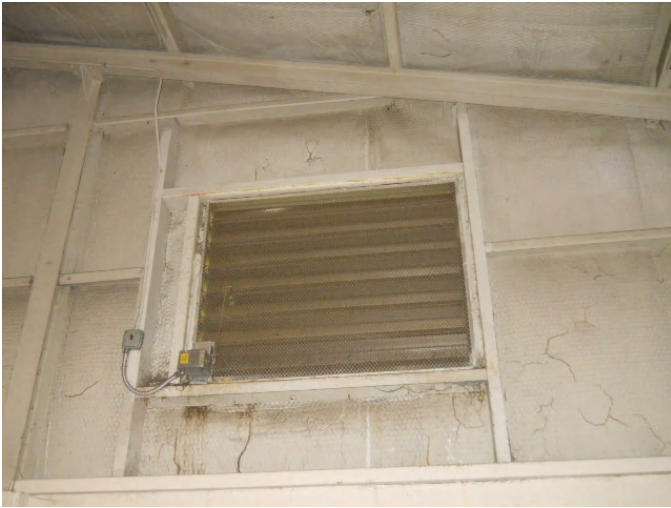
System: D3050 - Terminal & Package Units

Location: Throughout Building

Distress: Inadequate

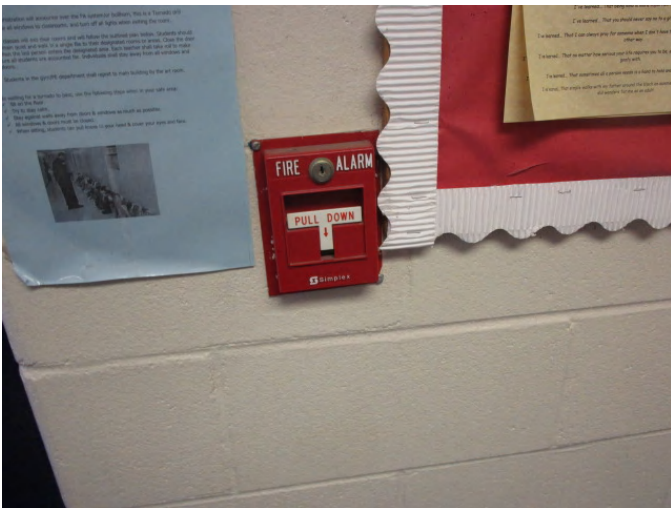
System: D5030 - Communications and Security - Fire Alarm

Location: Throughout Building

Distress: Beyond Service Life

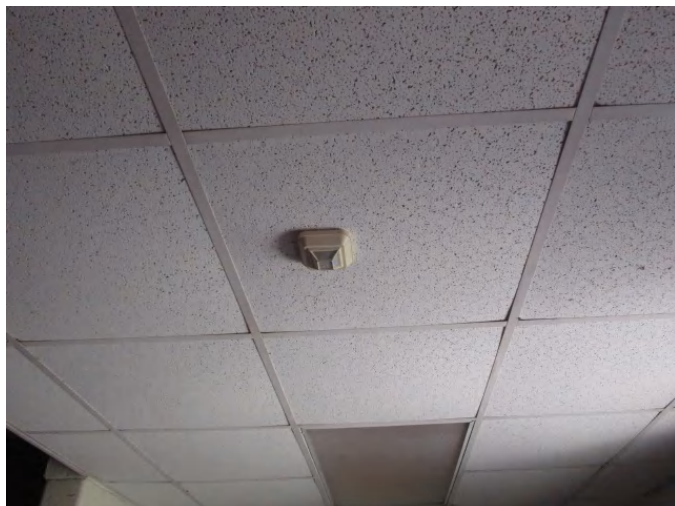
System: D5030 - Communications and Security - Security & CCTV

Location: Throughout Building

Distress: Beyond Service Life

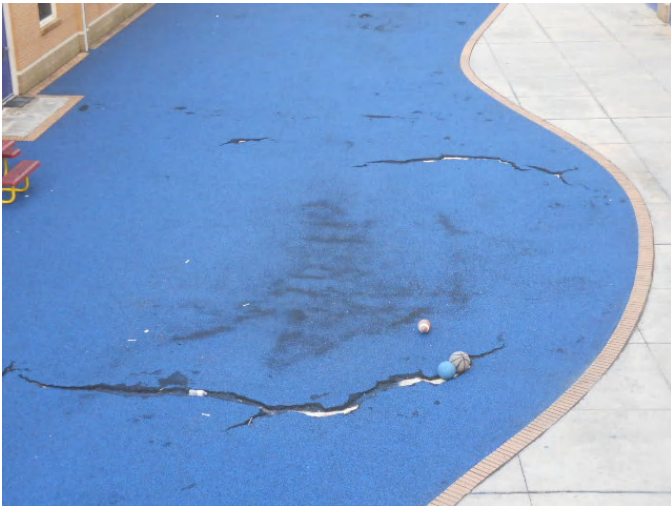
System: G2040 - Hard Surface Play Area

Location: Site

Distress: Damaged

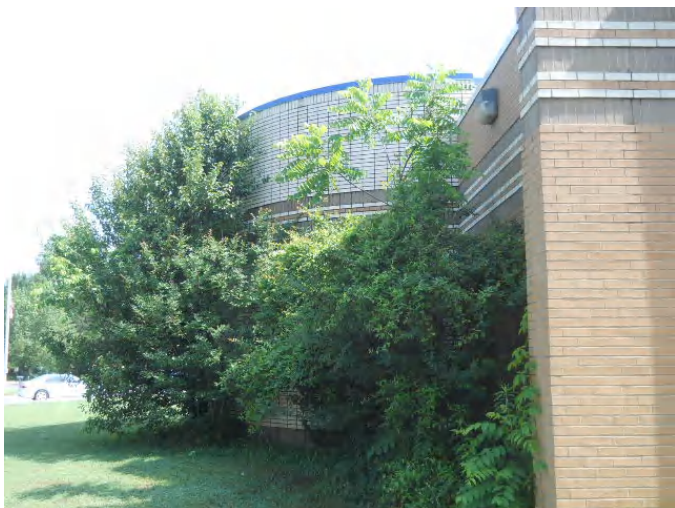
System: G2050 - Landscaping

Location: Site

Distress: Beyond Service Life
