DeKalb County School District/Admin/Support

East Campus II - Transportation

School Assessment Report

May 19, 2016

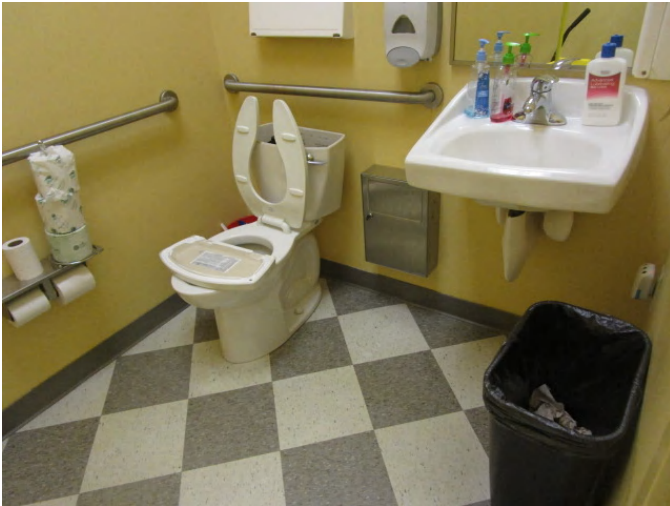
System: D2010 - Plumbing Fixtures

Location: Throughout Building

Distress: Inadequate

Notes: Plumbing fixtures/restrooms are not ADA compliant, do not have 60" turn radius in the ADA stall. Construct one ADA compliant unisex restroom.

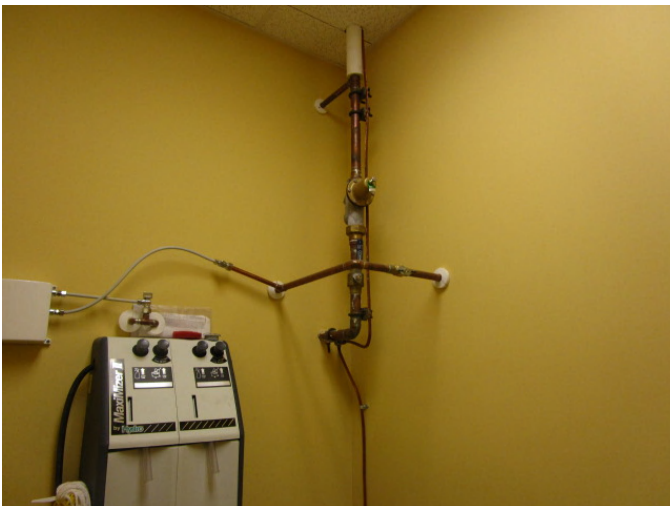
System: D2020 - Domestic Water Distribution

Location: Site

Distress: Beyond Service Life

Notes: The domestic water distribution system is beyond its expected service life and should be scheduled for replacement.

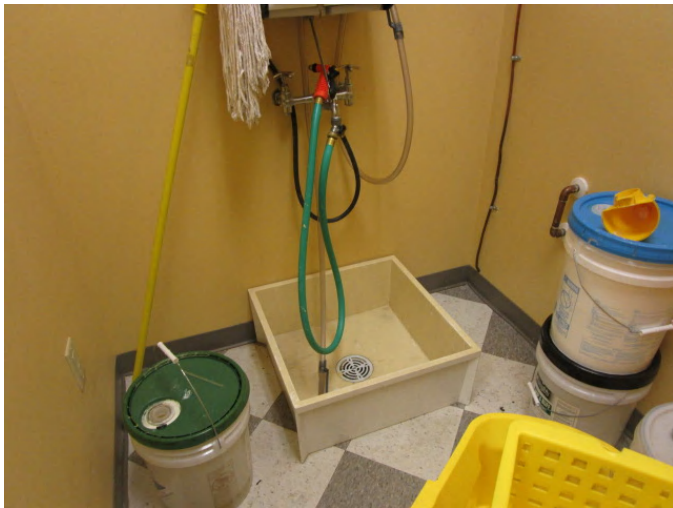
System: D2030 - Sanitary Waste

Location: Throughout Building

Distress: Beyond Service Life

Notes: The sanitary waste system is beyond its expected service life and should be scheduled for replacement.

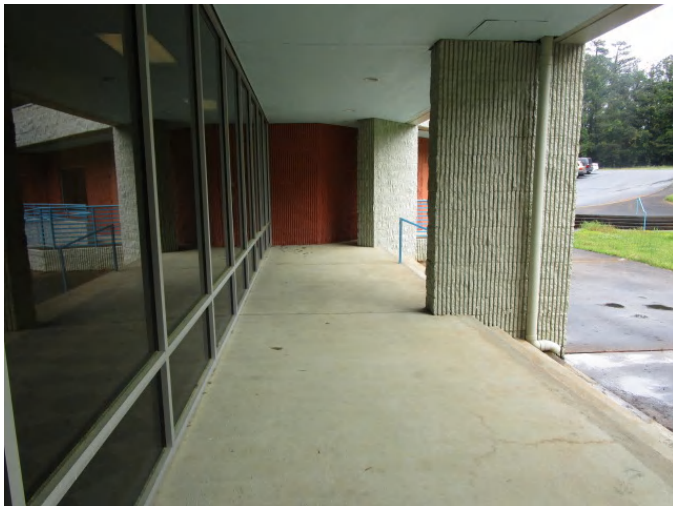
System: D2040 - Rain Water Drainage

Location: Site

Distress: Beyond Service Life

Notes: The rain water drainage system is beyond its expected service life and should be scheduled for replacement.

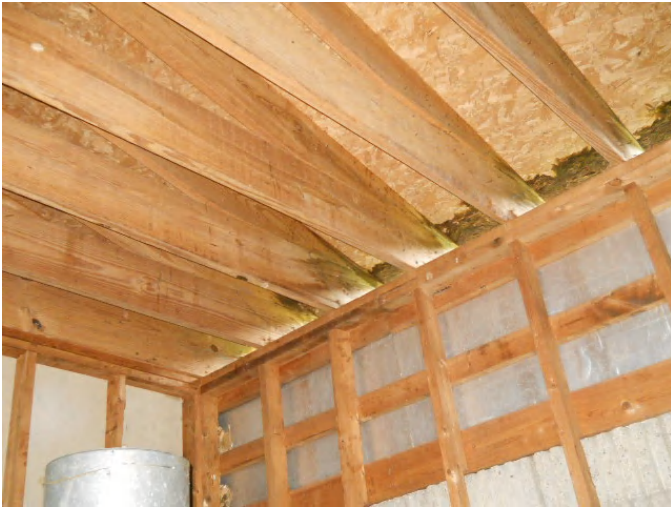
System: B1020 - Roof Construction

Location: Roof

Distress: Beyond Service Life

Notes: The building is abandoned. The roof structure and covering are beyond their expected service life.

Correction: Replace entire roof (\$13.54/sf)

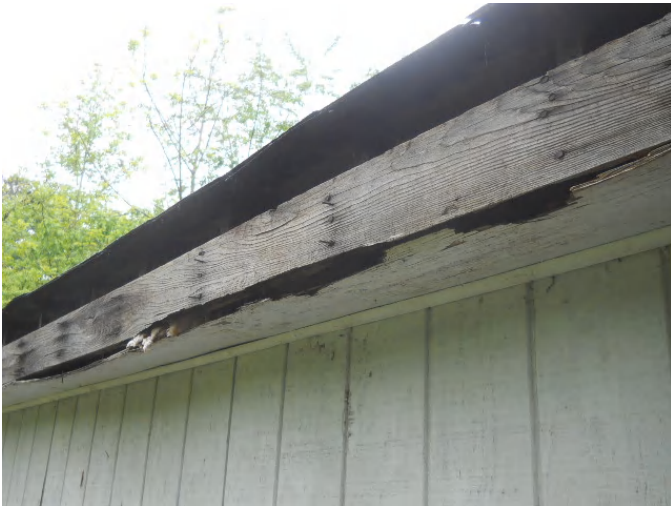
System: B2010 - Exterior Walls

Location: Exterior Walls

Distress: Beyond Service Life

Notes: The building is abandoned. The exterior walls are beyond their expected service life.

Correction: Replace exterior walls (\$34.08/sf)

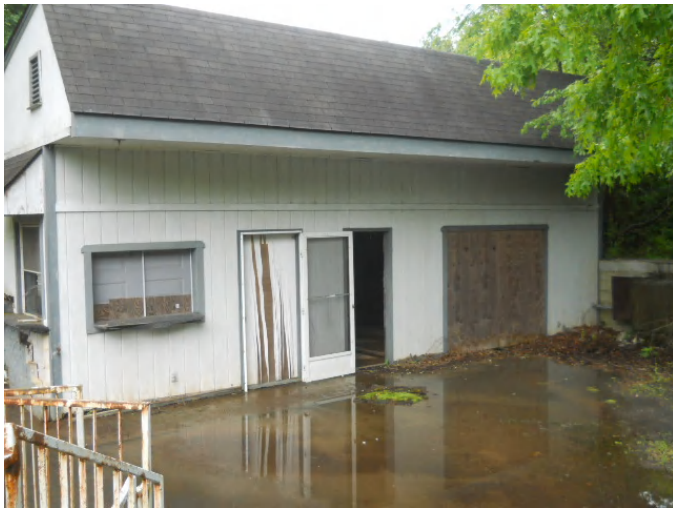
System: B2020 - Exterior Windows

Location: Exterior Walls

Distress: Beyond Service Life

Notes: The building is abandoned. The exterior windows are beyond their expected service life.

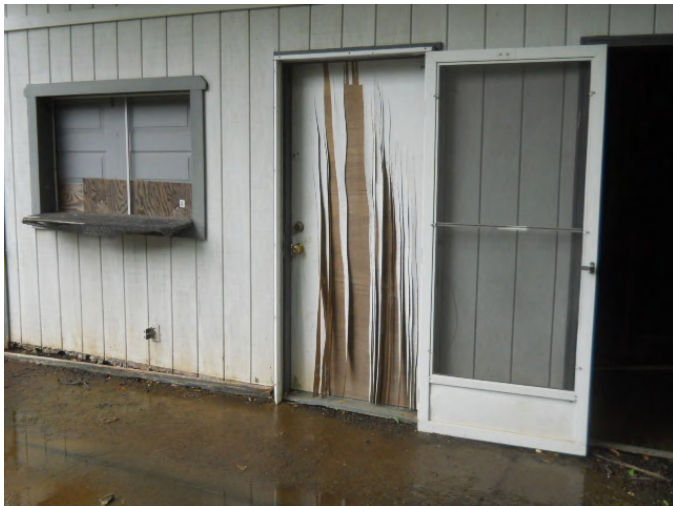
System: B2030 - Exterior Doors

Location: Exterior Walls

Distress: Beyond Service Life

Notes: The building is abandoned. The exterior wood doors are beyond their expected service life.

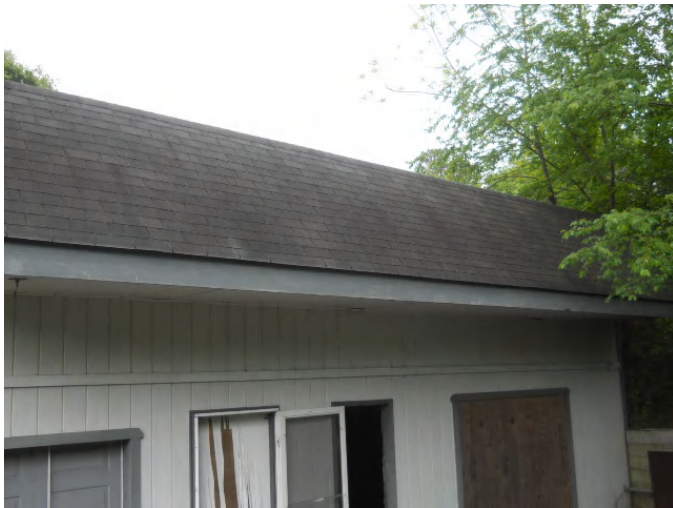
System: B3010 - Roof Coverings

Location: Roof
Distress: Beyond Service Life
Category: Deferred Maintenance
Priority: 3 Priority
Correction: Renew System
Qty: 800.00
Unit of Measure: S.F.
Estimate: \$14,775.00
Assessor Name: Sam Mandola
Date Created: 04/11/2015

Notes: The building is abandoned. The roof covering system is beyond its expected service life.

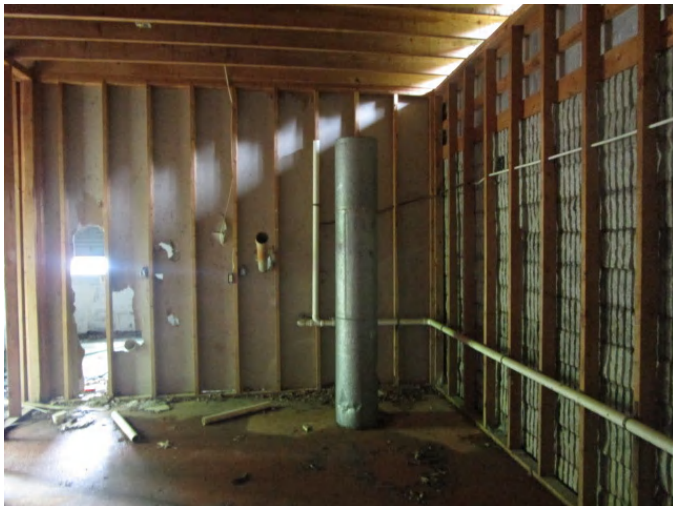
System: C1010 - Partitions

Location: Throughout Building
Distress: Beyond Service Life
Category: Deferred Maintenance
Priority: 3 Priority
Correction: Renew System
Qty: 800.00
Unit of Measure: S.F.
Estimate: \$11,475.00
Assessor Name: Sam Mandola
Date Created: 04/30/2015

Notes: The original interior wall partitions are aged, damaged, and in very poor condition.

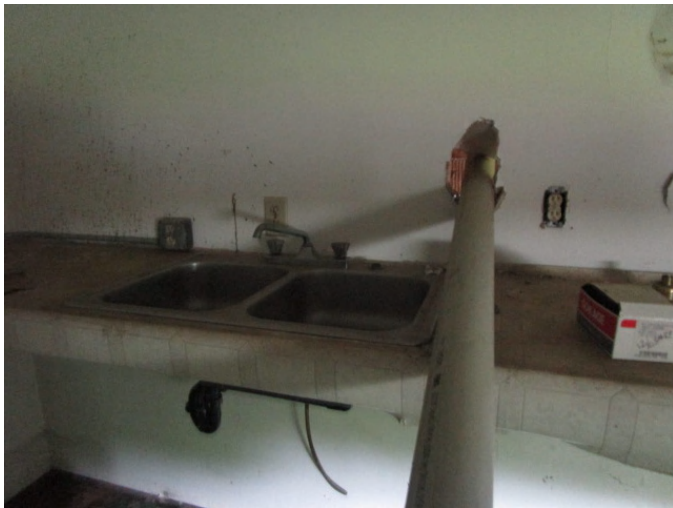
System: D2010 - Plumbing Fixtures

Location: Throughout Building

Distress: Beyond Service Life

Notes: The plumbing fixture system is beyond service life and should be scheduled for replacement.

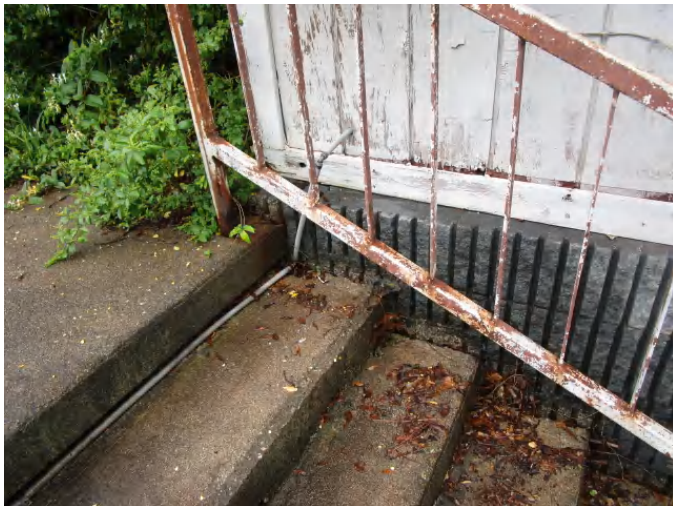
System: D2020 - Domestic Water Distribution

Location: Throughout Building

Distress: Beyond Service Life

Notes: The domestic water distribution system is beyond its expected service life and should be scheduled for replacement.

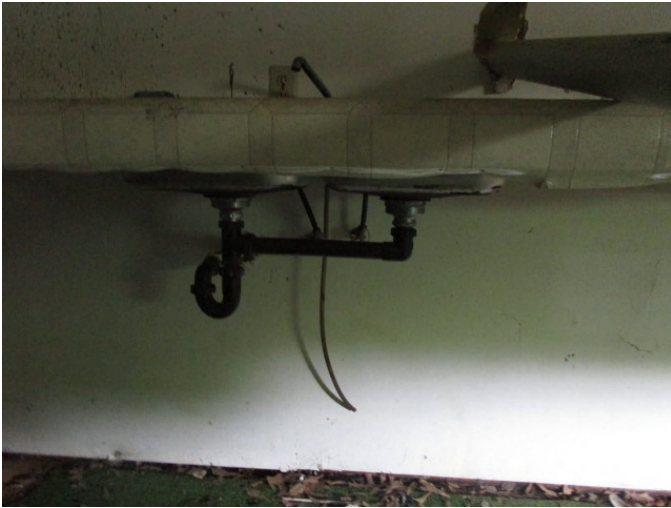
System: D2030 - Sanitary Waste

Location: Throughout Building

Distress: Beyond Service Life

Notes: The sanitary waste system is beyond its expected service life and should be scheduled for replacement.

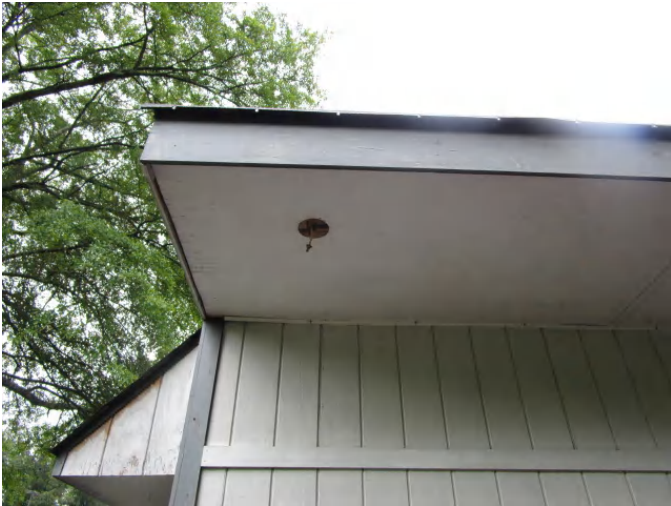
System: D5020 - Lighting and Branch Wiring

Location: Throughout Building

Distress: Beyond Service Life

Notes: The lighting and branch wiring system is beyond its expected service life and should be scheduled for replacement.

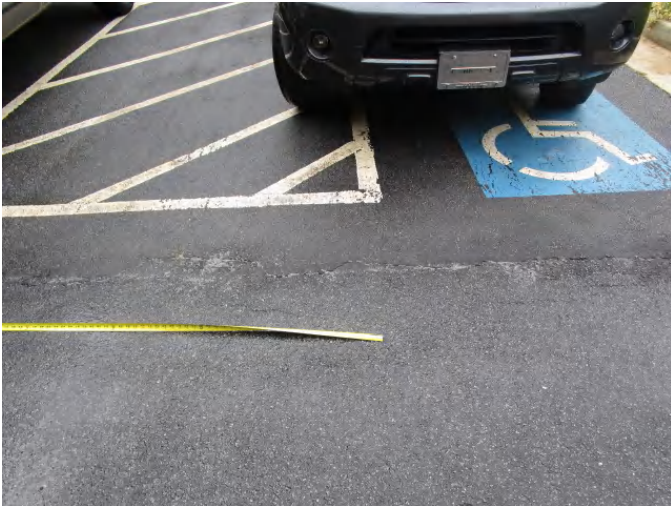
System: G2020 - Parking Lots

Location: Site

Distress: Inadequate

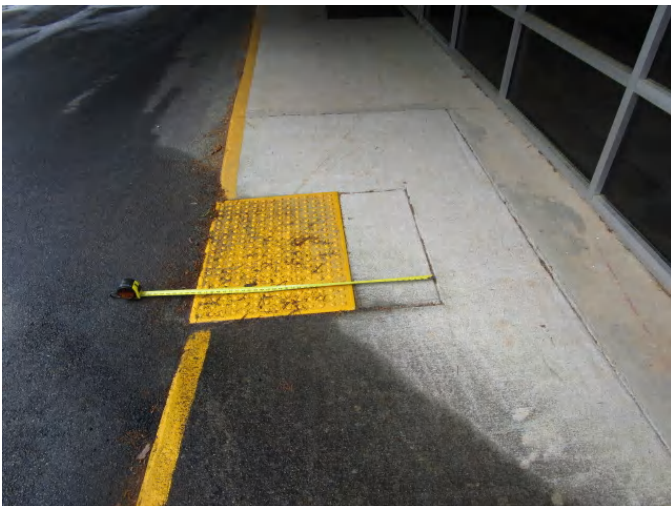
System: G2030 - Pedestrian Paving

Location: Site

Distress: Inadequate

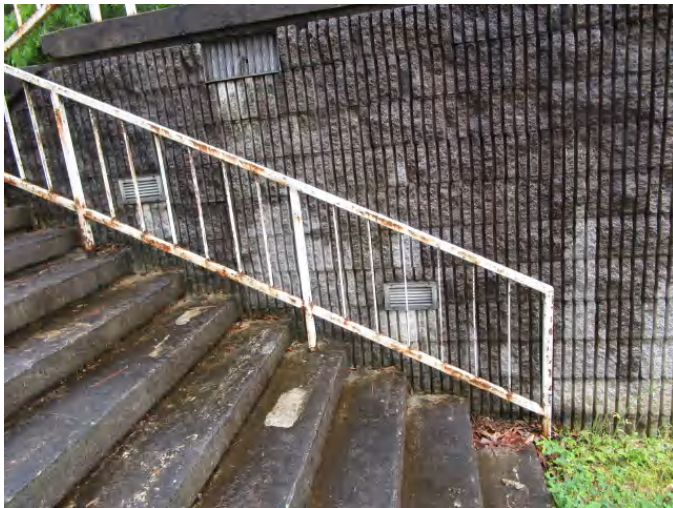
System: G2040 - Fencing & Guardrails

Location: Site

Distress: Damaged

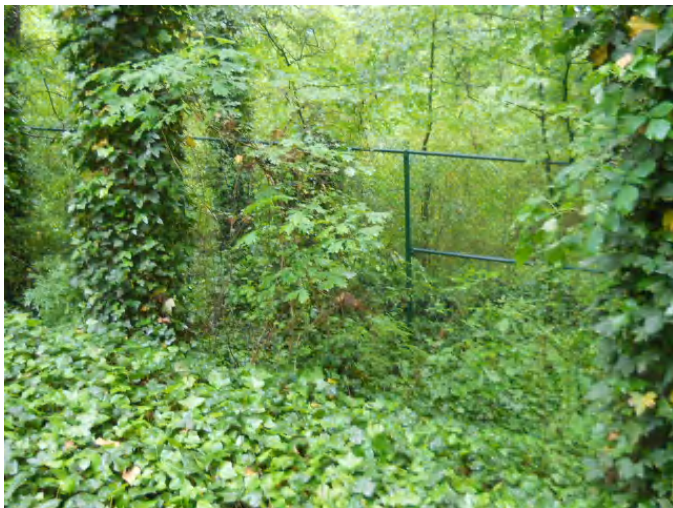
System: G2050 - Landscaping

Location: Site

Distress: Beyond Service Life

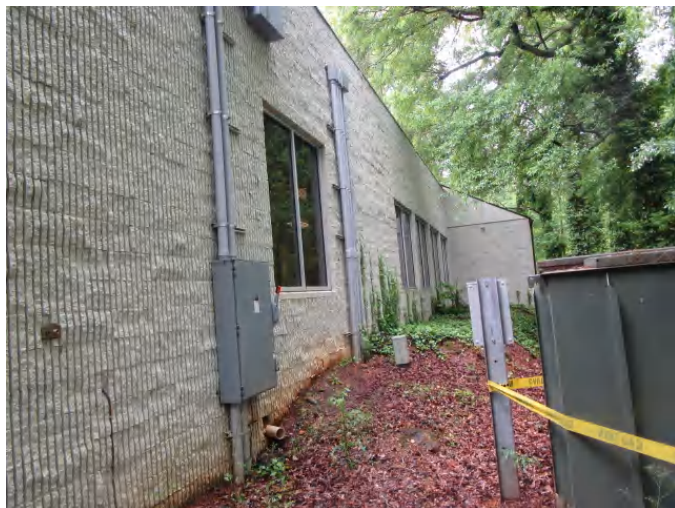
System: G4010 - Electrical Distribution

Location: Site

Distress: Beyond Service Life
