DeKalb County School District/Vacant

Environmental Studies Center

School Assessment Report

May 20, 2016

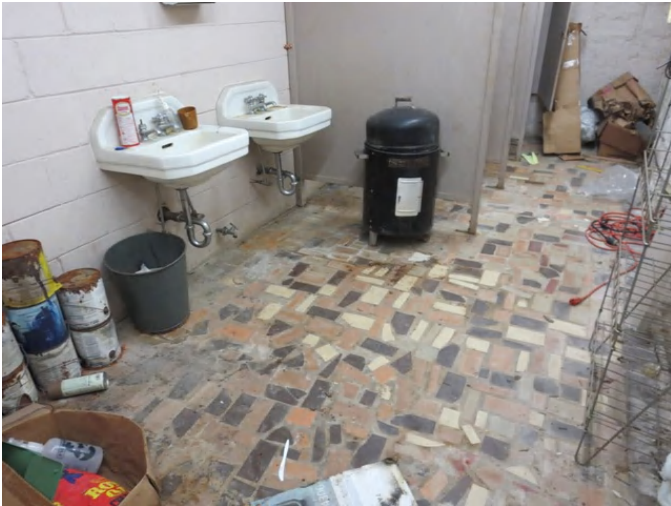
System: C3020405 - Stone

Location: Restrooms

Distress: Beyond Service Life

Notes: The quarry tile in the restrooms is aged, chipped and worn, and should be scheduled for replacement.

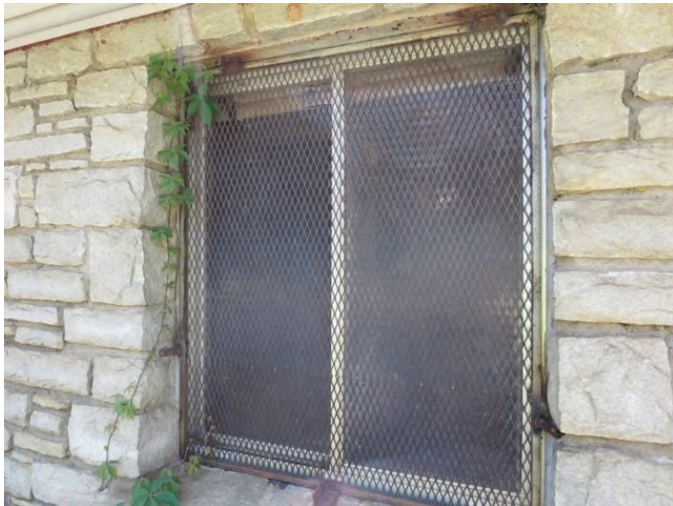
System: B2020 - Exterior Windows

Location: Throughout Building

Distress: Beyond Service Life

Notes: The aluminum frame, operable, single pane windows are aged, not energy efficient, and should be scheduled for replacement.

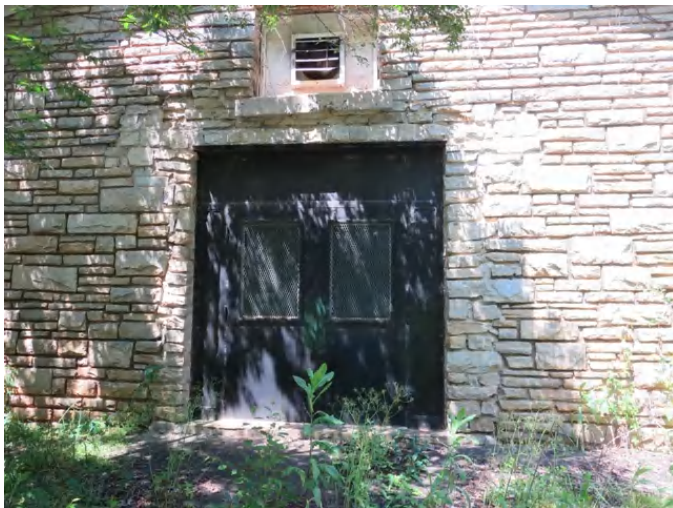
System: B2030 - Exterior Doors

Location: Throughout Building

Distress: Beyond Service Life

Notes: The original exterior doors are aged, rusted and inefficient, and should be scheduled for replacement.

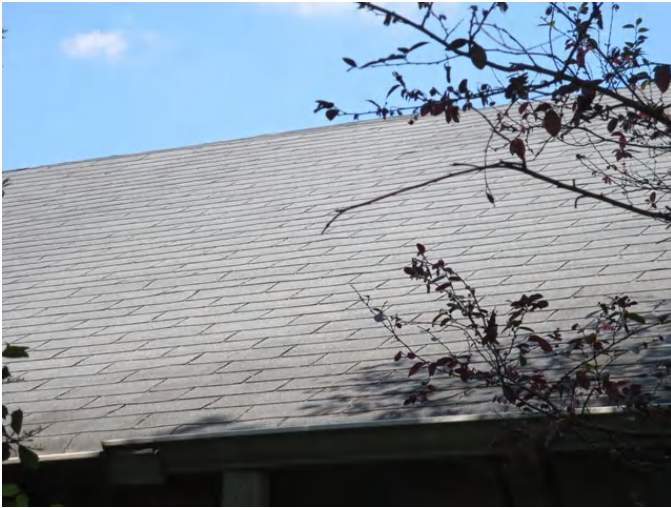
System: B3010 - Roof Coverings - Asphal Shingles

Location: Roof
Distress: Beyond Service Life
Category: Deferred Maintenance / Energy
Priority: 3 Priority
Correction: Renew System
Qty: 6,500.00
Unit of Measure: S.F.
Estimate: \$26,455.00
Assessor Name: Ben Nixon
Date Created: 05/14/2015

Notes: The asphalt shingle roofing is aged, damaged and inefficient, and should be scheduled for replacement.

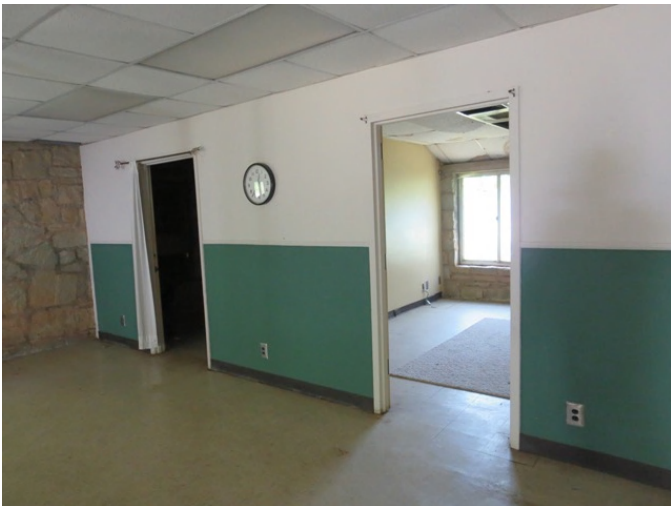
System: C1010 - Partitions

Location: Throughout Building
Distress: Beyond Service Life
Category: Deferred Maintenance
Priority: 3 Priority
Correction: Renew System
Qty: 14,200.00
Unit of Measure: S.F.
Estimate: \$95,438.00
Assessor Name: Ben Nixon
Date Created: 06/16/2015

Notes: The original partitions are aged, damaged, and in very poor condition.

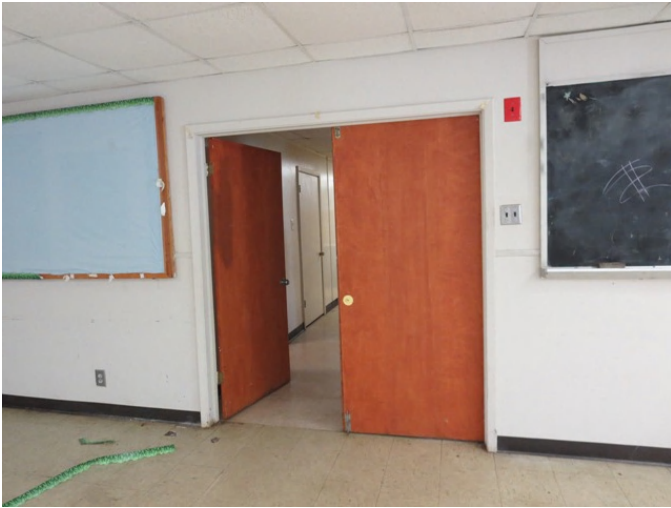
System: C1020 - Interior Doors

Location: Throughout Building

Distress: Beyond Service Life

Notes: The interior doors are aged, failing, hardware is not ADA compliant, and should be scheduled for replacement.

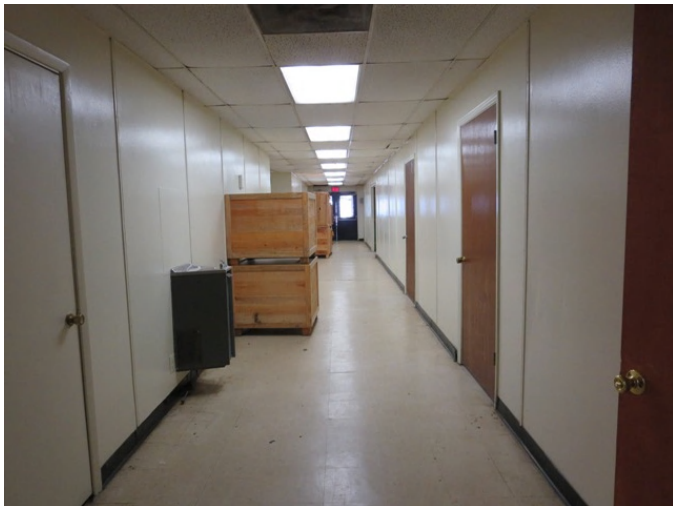
System: C3010230 - Paint & Covering

Location: Throughout Building

Distress: Beyond Service Life

Notes: Painted wall finishes are damaged, faded and stained, and should be renewed.

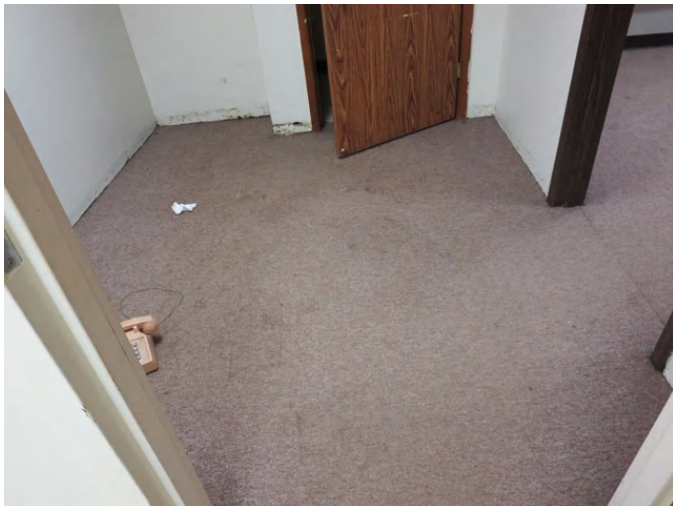
System: C3020901 - Carpet with Pad

Location: Offices

Distress: Beyond Service Life

Notes: The carpet is stained, showing signs of early failure, and should be scheduled for replacement.

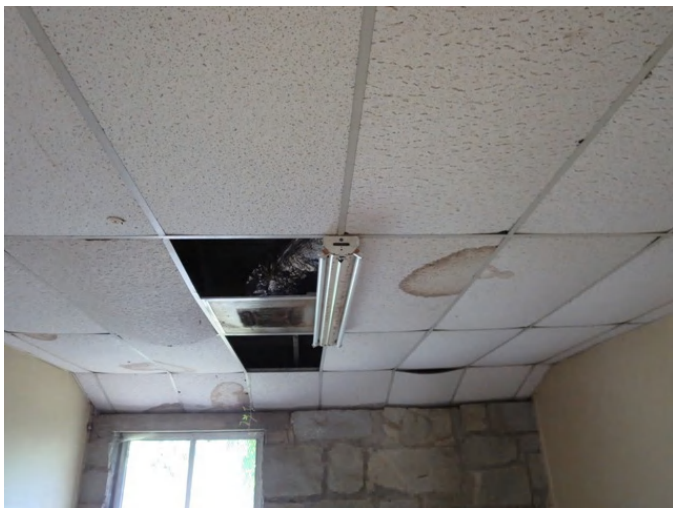
System: C3030210 - Acoustical Ceilings

Location: Throughout Building

Distress: Beyond Service Life

Notes: The acoustical ceiling system is aged, damaged, and should be scheduled for replacement.

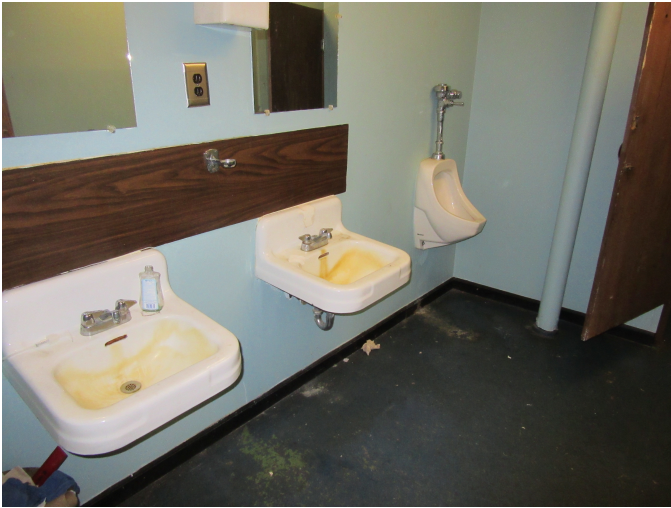
System: D2010 - Plumbing Fixtures

Location: Restrooms

Distress: Beyond Service Life

Notes: The plumbing fixtures are aged, inefficient, not ADA complaint, and should be scheduled for replacement.

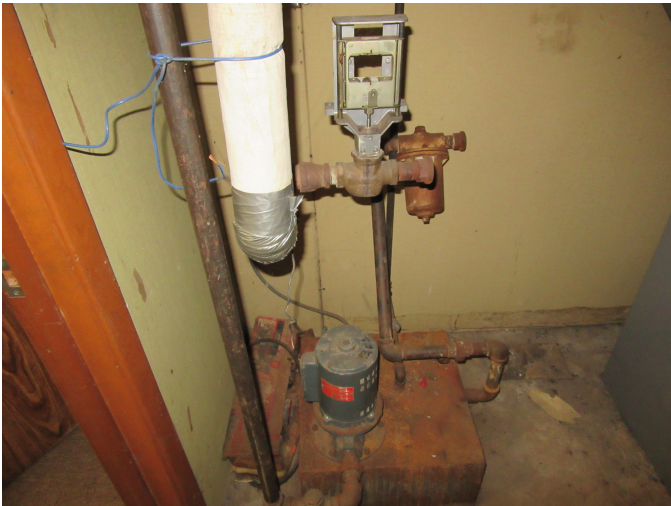
System: D2020 - Domestic Water Distribution

Location: Throughout Building

Distress: Beyond Service Life

Notes: The domestic water distribution is aged, abandoned, not code compliant, and should be scheduled for replacement.

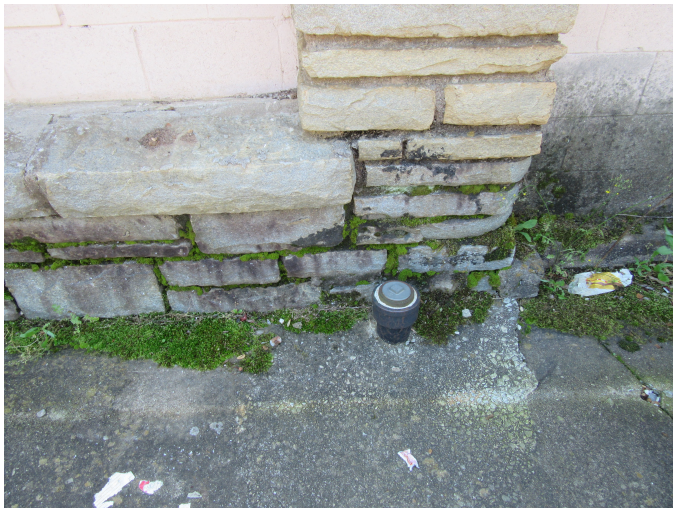
System: D2030 - Sanitary Waste

Location: Throughout Building
Distress: Beyond Service Life
Category: Deferred Maintenance
Priority: 3 Priority
Correction: Renew System
Qty: 14,200.00
Unit of Measure: S.F.
Estimate: \$47,485.00
Assessor Name: Ben Nixon
Date Created: 05/14/2015

Notes: The sanitary waste system is aged and should be scheduled for replacement.

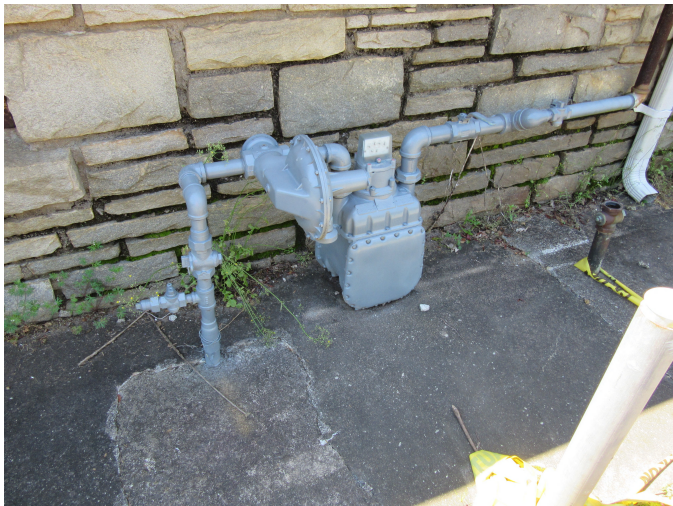
System: D2090 - Other Plumbing Systems - Natural Gas

Location: Throughout Building
Distress: Beyond Service Life
Category: Deferred Maintenance / Building Code Compliance
Priority: 3 Priority
Correction: Renew System
Qty: 14,200.00
Unit of Measure: S.F.
Estimate: \$5,779.00
Assessor Name: Ben Nixon
Date Created: 05/14/2015

Notes: The natural gas system is aged, not code compliant, and should be scheduled for replacement.

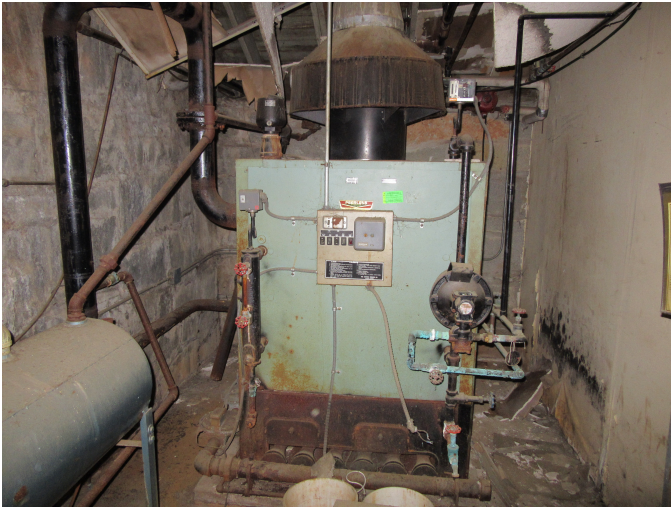
System: D3020 - Heat Generating Systems

Location: Mechanical Room

Distress: Beyond Service Life

Notes: The boiler is aged, inefficient, not code compliant, and should be scheduled for replacement. It is either abandoned or no longer functions.

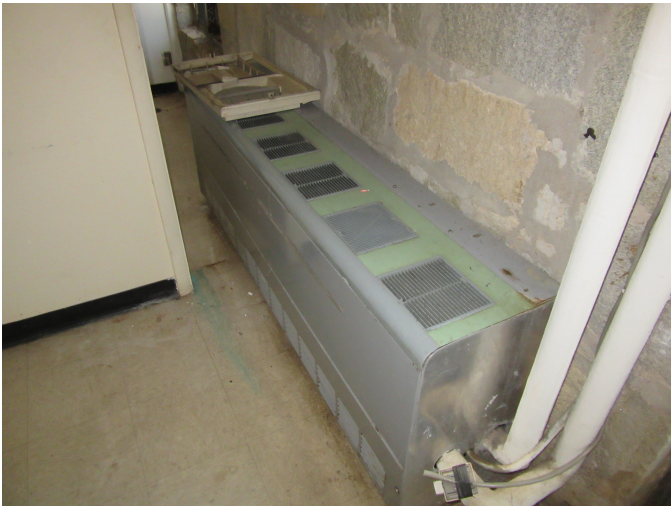
System: D3040 - Distribution & Exhaust Systems

Location: Throughout Building

Distress: Beyond Service Life

Notes: The distribution and exhaust system is aged, inefficient, and should be scheduled for replacement.

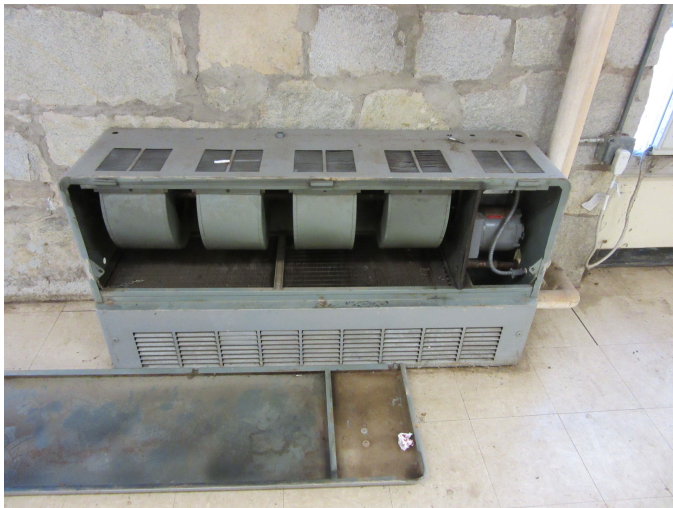
System: D3050 - Terminal & Package Units

Location: Throughout Building

Distress: Beyond Service Life

Notes: The terminal and package units are aged, inefficient, and should be scheduled for replacement.

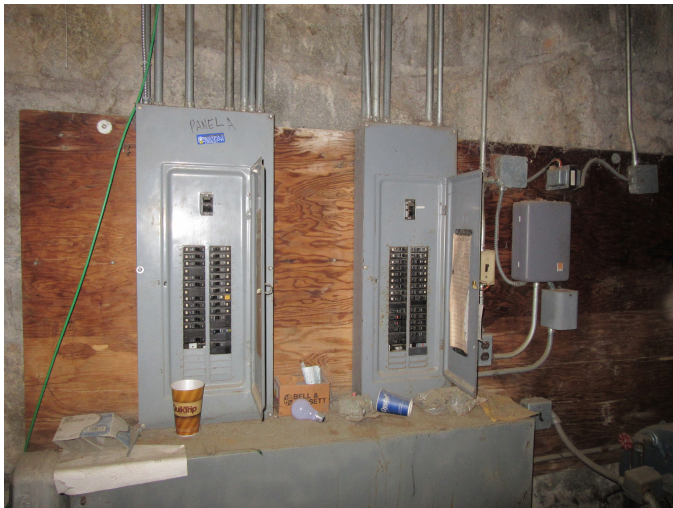
System: D5010 - Electrical Service/Distribution

Location: Throughout Building

Distress: Beyond Service Life

Notes: The electrical service and distribution system is aged, inefficient, and should be replaced.

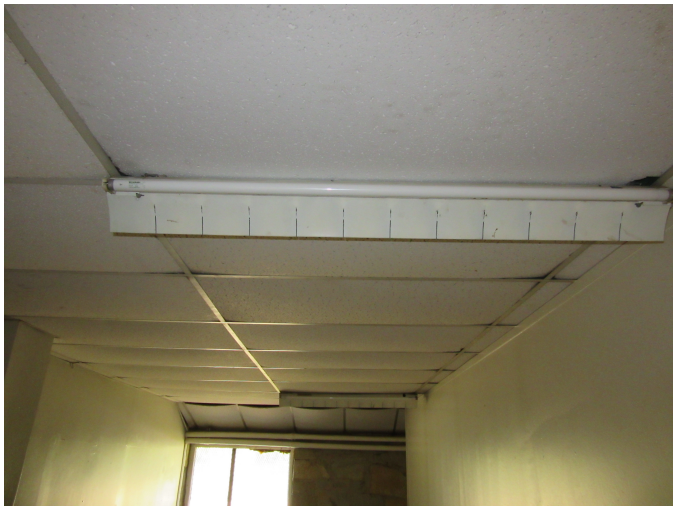
System: D5020 - Branch Wiring

Location: Throughout Building

Distress: Beyond Service Life

Notes: The branch wiring is aged, not code compliant, and should be scheduled for replacement.

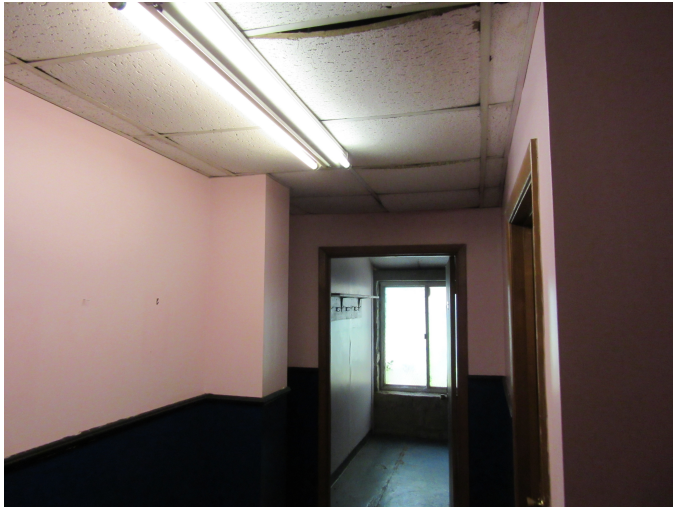
System: D5020 - Lighting

Location: Throughout Building

Distress: Beyond Service Life

Notes: The lighting system is aged, inefficient and not code compliant, and should be scheduled for replacement.

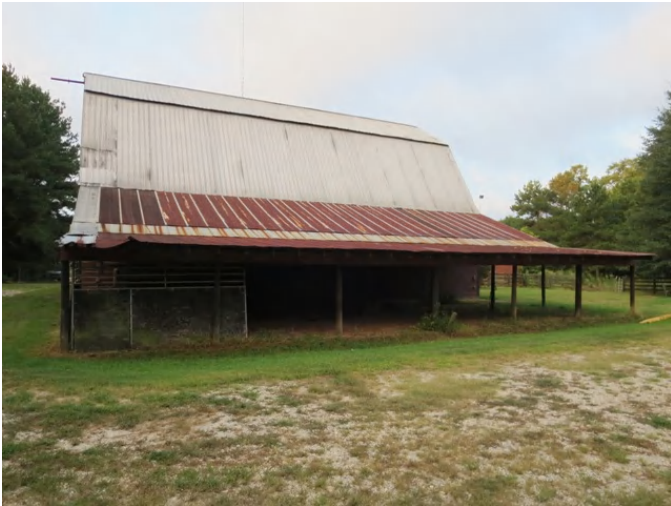
System: B3010 - Roof Coverings - Metal

Location: Roof

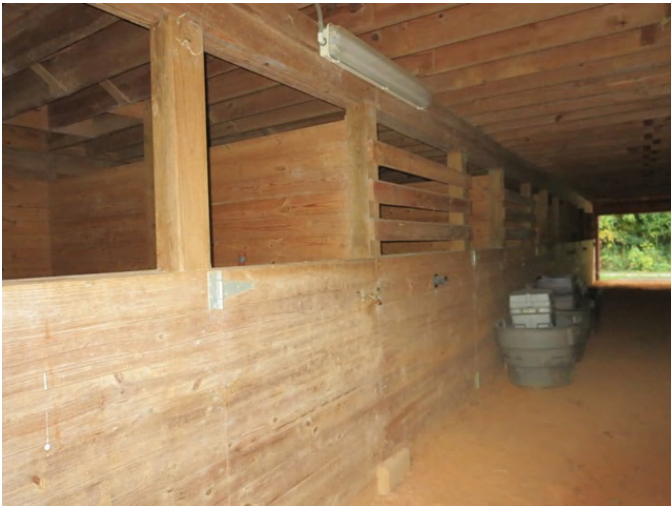
System: C1010 - Partitions

Location: Throughout Building

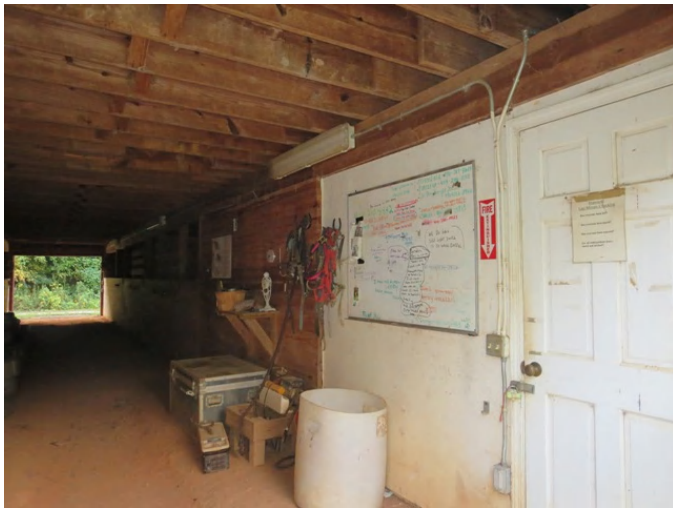
System: C1020 - Interior Doors

Location: Corridor

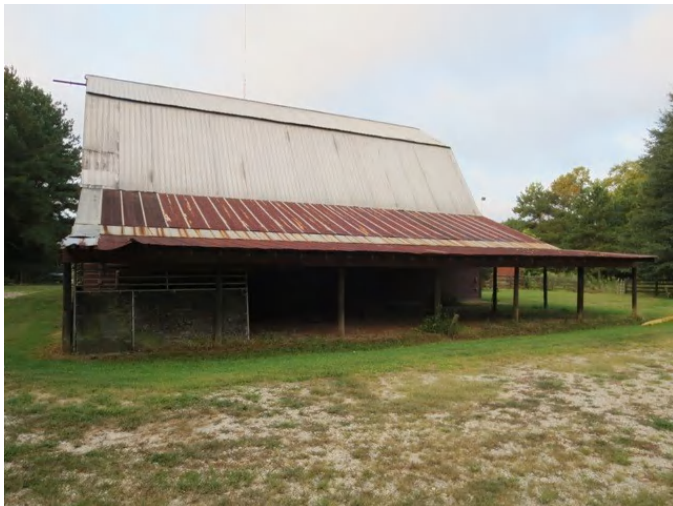
System: F1010340 - Special Structures - Overhang

Location: Roof Overhang

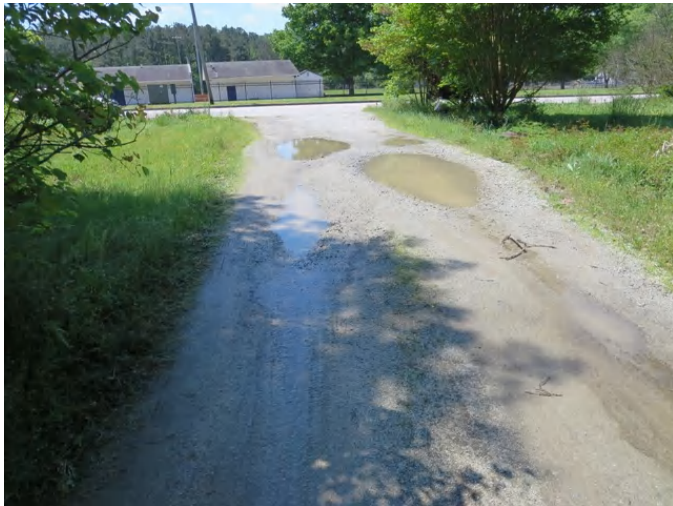
System: G2010 - Roadways

Location: Site

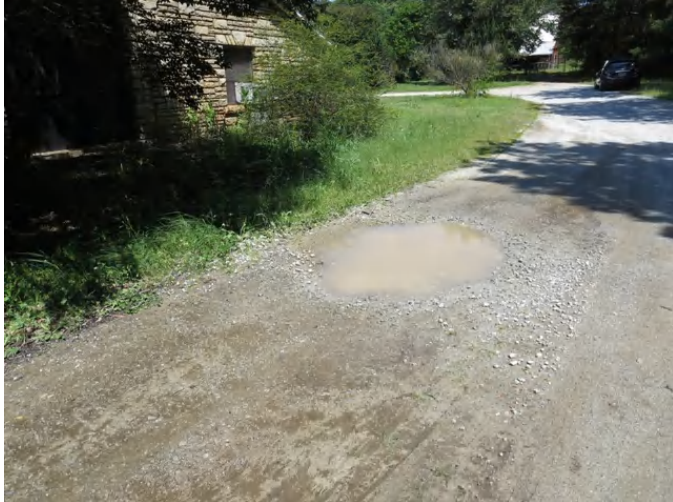
System: G2020 - Parking Lots

Location: Site

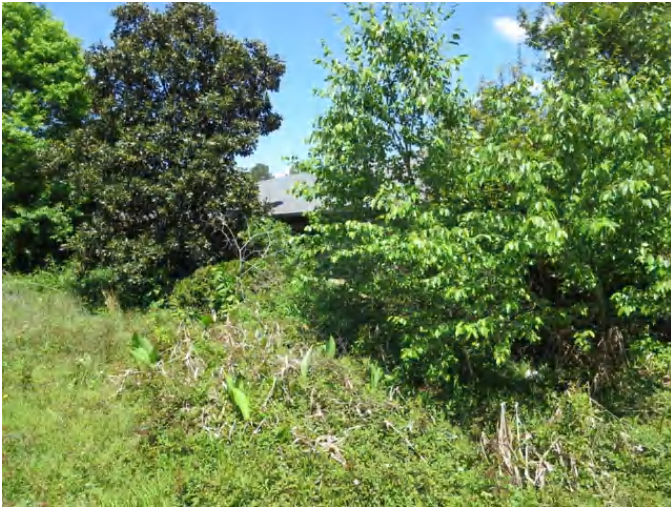
System: G2050 - Landscaping

Location: Site

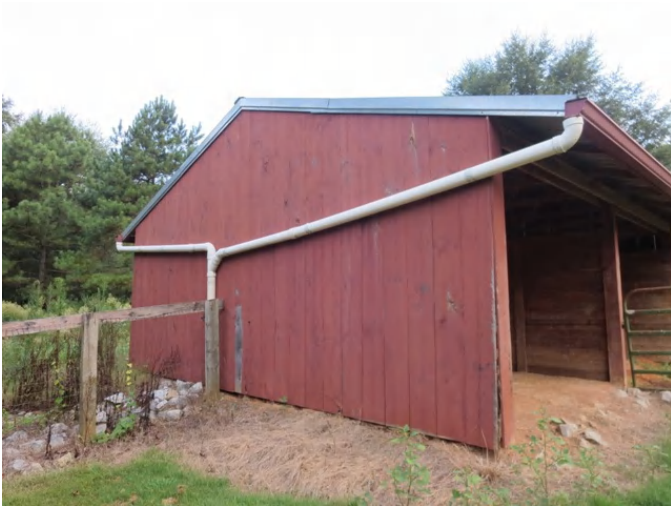
System: B2010 - Exterior Walls

Location: Exterior Walls

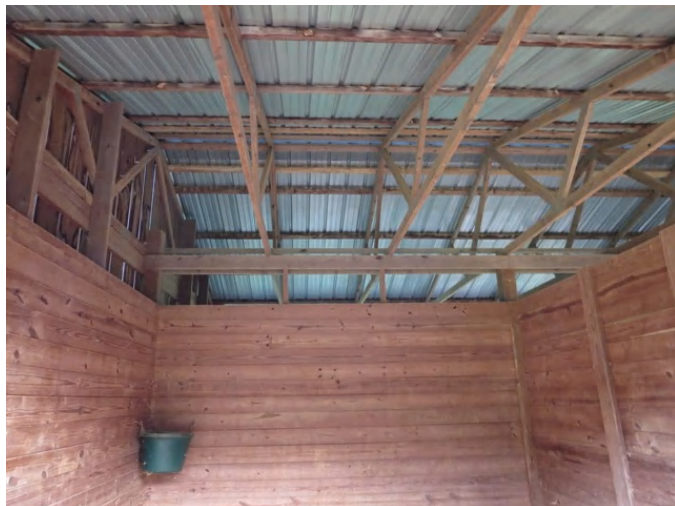
System: C1010 - Partitions

Location: Throughout Building

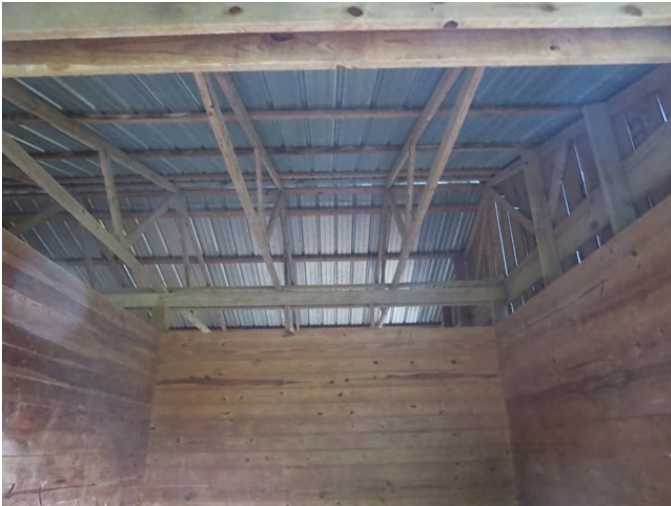
System: C1010 - Partitions

Location: Throughout Building
