DeKalb County School District/Elementary Schools

Evansdale Elementary

School Assessment Report

May 19, 2016

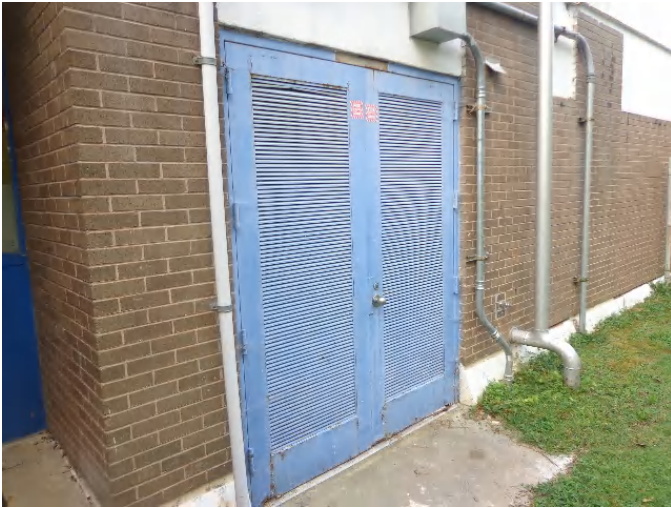
System: B2030 - Exterior Doors

Location: Throughout Building

Distress: Beyond Service Life

Notes: The original exterior doors are aged, rusted, and some do not lock/seal properly, becoming a safety hazard.

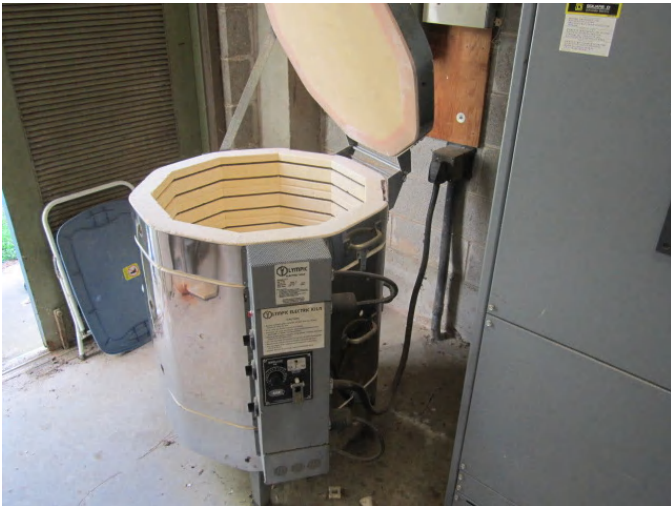
System: D3040 - Distribution & Exhaust Systems

Location: Mechanical Room

Distress: Needs Remediation

Notes: The kiln is located in the mechanical room and is without proper ventilation. The kiln should be relocated to code-compliant location. Recommend an architectural/engineering study to identify whether an acceptable space is available within the school for modifications to allow proper operation of the kiln.

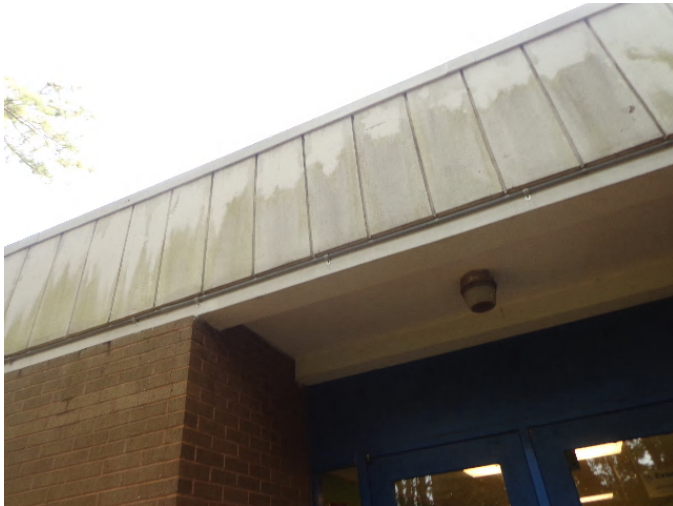
System: B2010 - Exterior Walls

Location: Exterior Walls

Distress: Beyond Service Life

Notes: Exterior accent trim is faded and stained and should be refinished.

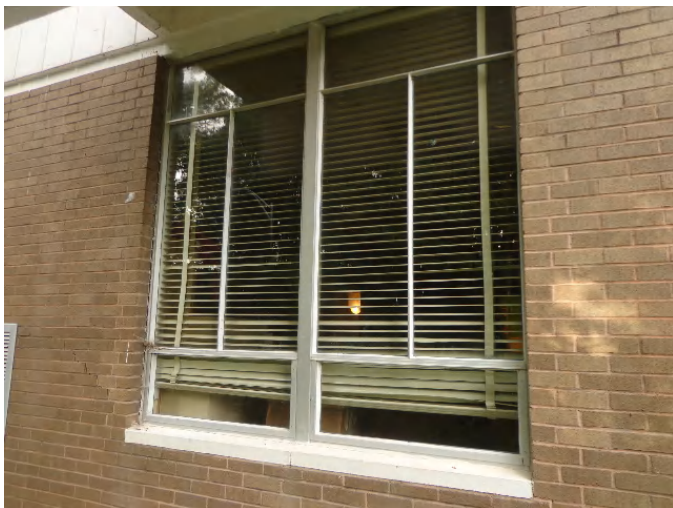
System: B2020 - Exterior Windows

Location: Throughout Building

Distress: Beyond Service Life

Notes: The aluminum frame, operable, single pane windows are aged, not energy efficient, and should be replaced.

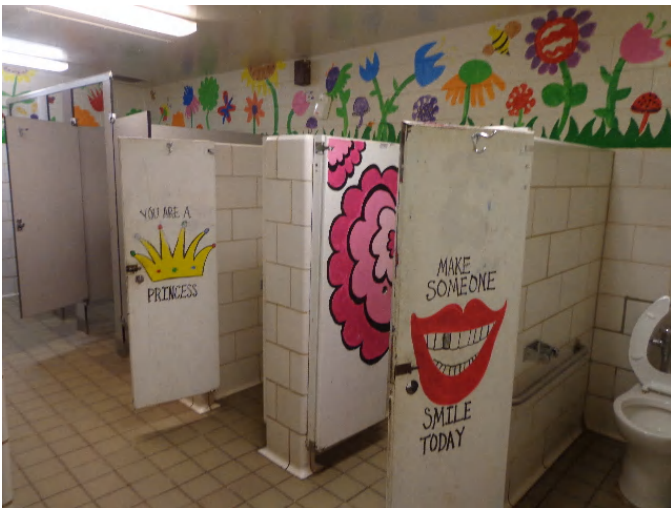
System: C1030 - Fittings

Location: Throughout Building

Distress: Beyond Service Life

Notes: ADA-compliant signage has been provided in some restrooms. However, the fittings throughout the building are in marginal condition, toilet partitions are aged, handrails and room signage are not ADA compliant, and the entire system should be replaced.

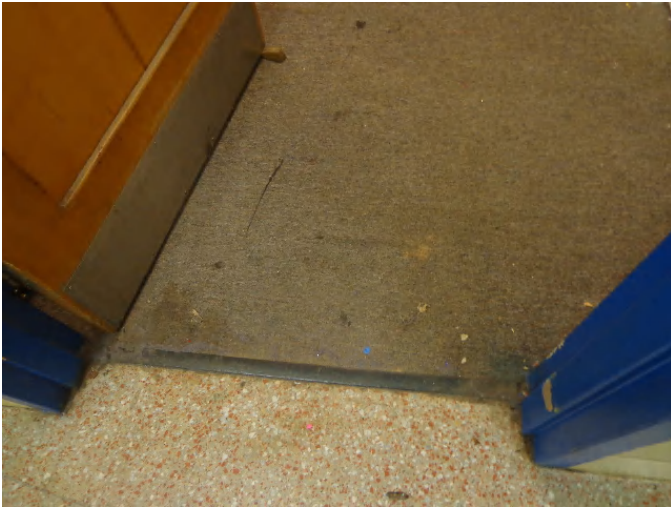
System: C3020 - Floor Finishes - Carpet

Location: Throughout Building
Distress: Beyond Service Life
Category: Deferred Maintenance
Priority: 3 Priority
Correction: Renew System
Qty: 3,892.00
Unit of Measure: S.F.
Estimate: \$36,390.00
Assessor Name: Ben Nixon
Date Created: 04/11/2015

Notes: The carpet in the offices and classrooms is aged, stained, frayed and torn, and should be replaced.

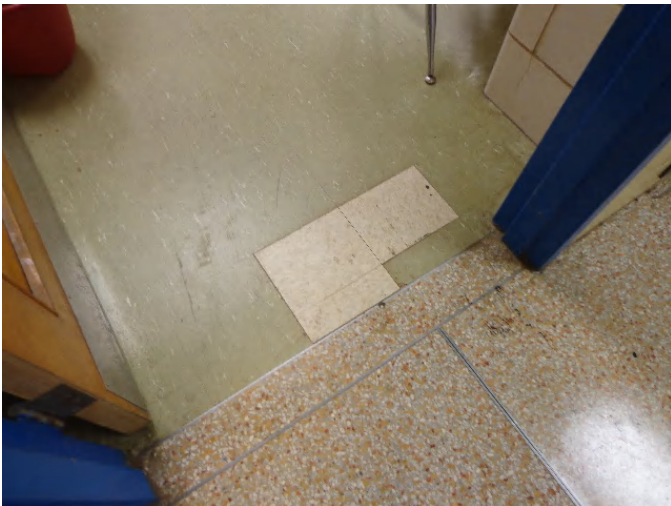
System: C3020 - Floor Finishes - VCT

Location: Throughout Building
Distress: Beyond Service Life
Category: Deferred Maintenance / Environmental
Priority: 3 Priority
Correction: Renew System
Qty: 28,208.00
Unit of Measure: S.F.
Estimate: \$296,015.00
Assessor Name: Ben Nixon
Date Created: 04/11/2015

Notes: The VCT flooring has been replaced in some areas. However, in most classrooms, the VCT flooring is original, cracked, patched and worn, and should be replaced.

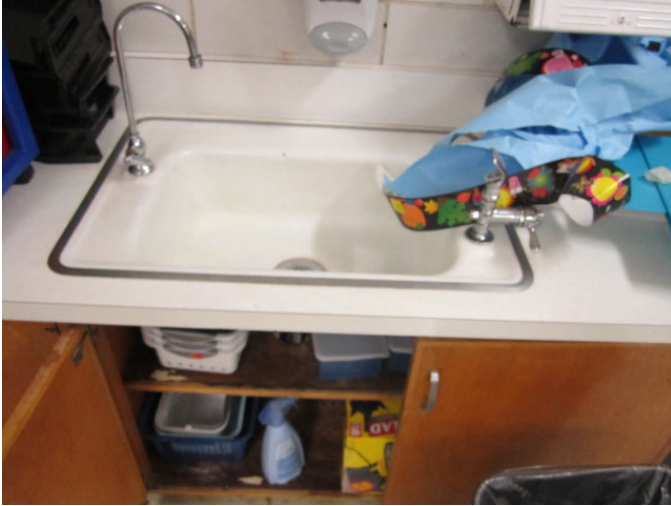
System: D2020 - Domestic Water Distribution

Location: Throughout Building

Distress: Beyond Service Life

Notes: The domestic water distribution system is beyond its expected service life, aged, and should be scheduled for replacement. Domestic water heaters or converters not equipped with adequate expansion compensation. School staff reports water is not clear after a long weekend or holiday.

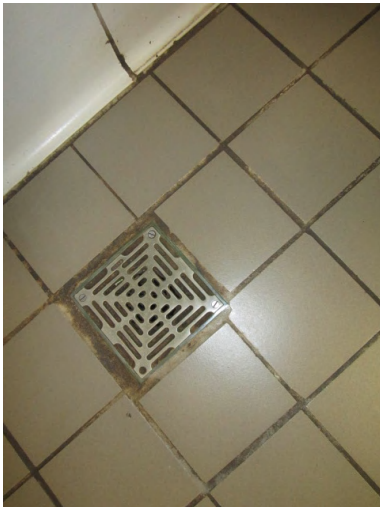
System: D2030 - Sanitary Waste

Location: Throughout Building

Distress: Beyond Service Life

Notes: The sanitary waste system is beyond its expected service life and should be scheduled for replacement. SPLOST project 412-422 to replace grease trap.

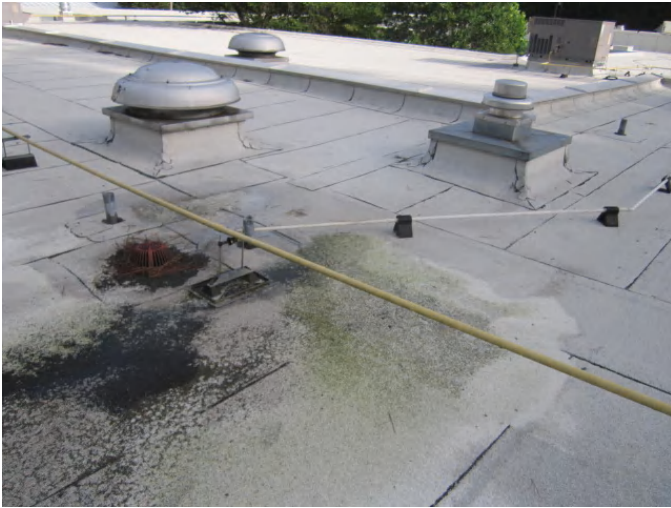
System: D3040 - Distribution & Exhaust Systems

Location: Throughout Building

Distress: Beyond Service Life

Notes: The distribution and exhaust systems are beyond their expected service life and should be scheduled for replacement. Black mastic on fiberglass duct wrap is identified as ACM by others. SPLOST project 412-422 to replace the exhaust systems as needed.

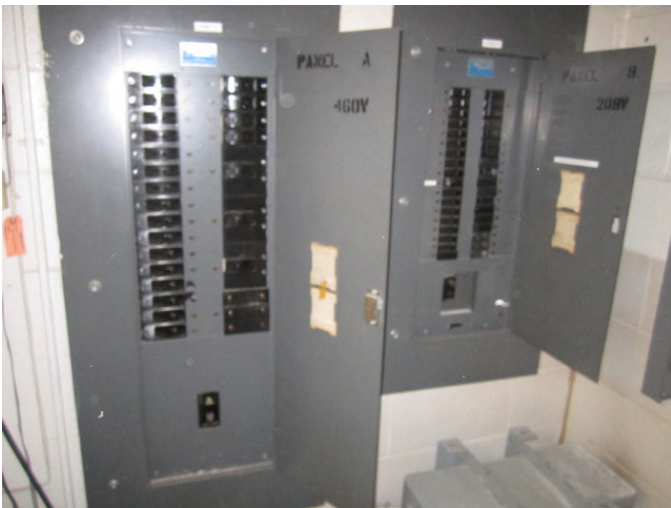
System: D5020 - Branch Wiring

Location: Throughout Building

Distress: Beyond Service Life

Notes: The branch wiring system is beyond its expected service life, aged, and should be scheduled for replacement.

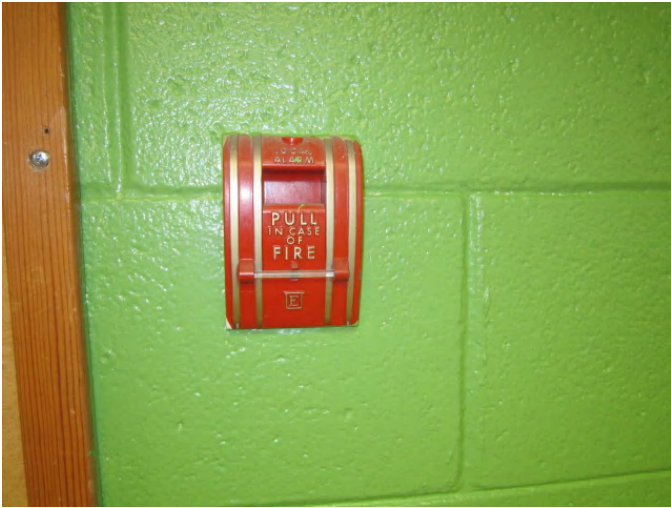
System: D5030 - Communications and Security - Fire Alarm

Location: Throughout Building

Distress: Beyond Service Life

Notes: The fire alarm system is beyond its expected service life, not building code compliant, and should be scheduled for replacement. Visible alarms (strobes) are missing in multiple occupancy, common use areas, such as restrooms.

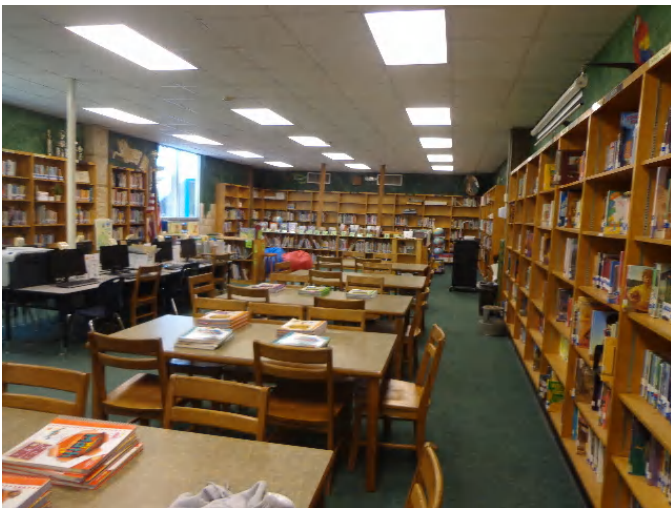
System: E1020 - Institutional Equipment

Location: Throughout Building

Distress: Beyond Service Life

Notes: Institutional equipment, such as theater and stage equipment and library equipment, is beyond its expected service life and should be scheduled for replacement.

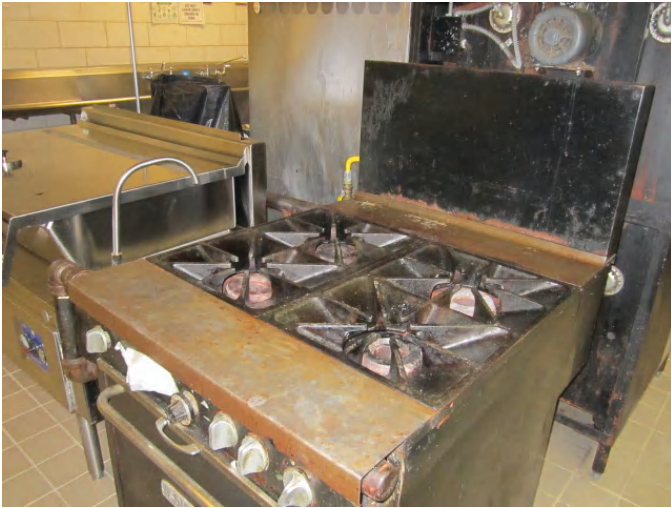
System: E1090 - Other Equipment - Kitchen Equipment

Location: Kitchen

Distress: Beyond Service Life

Notes: Kitchen equipment is beyond its expected service life and should be scheduled for replacement.

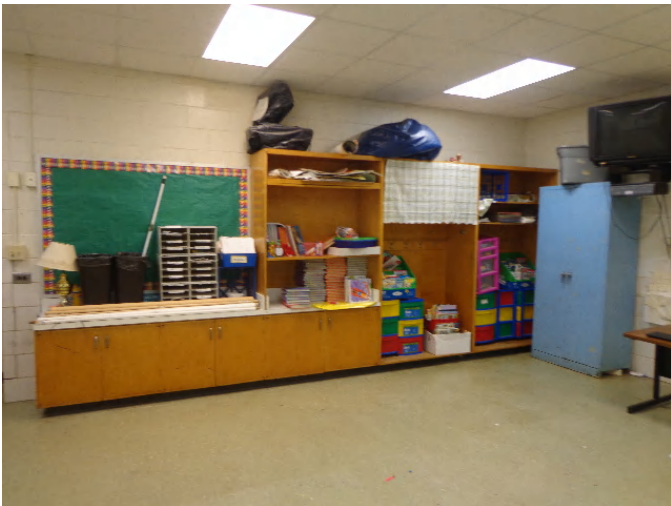
System: E2010 - Fixed Furnishings

Location: Throughout Building

Distress: Beyond Service Life

Notes: Fixed furnishings, such as built-in cabinets, are beyond their expected service life, damaged and worn, and should be replaced.

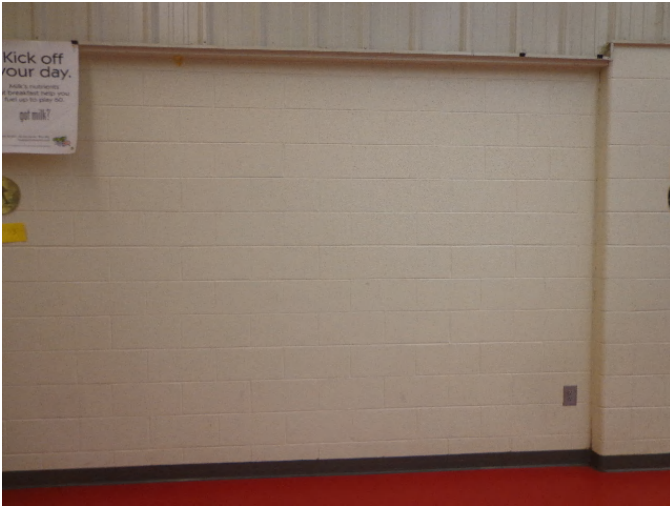
System: C3010 - Wall Finishes - Paint

Location: Throughout Building

Distress: Beyond Service Life

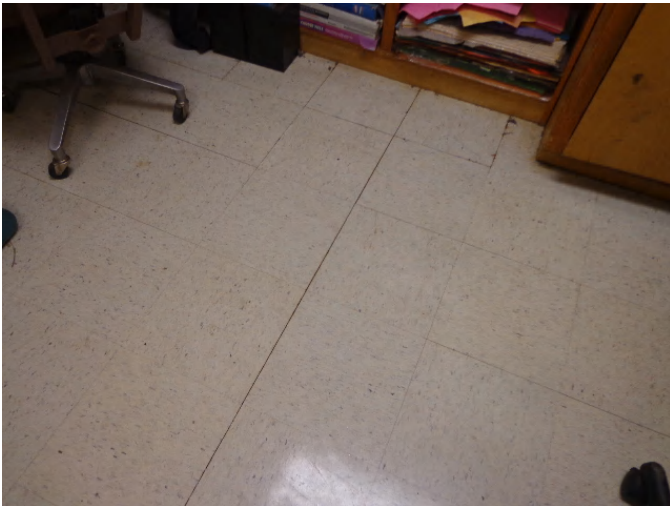
System: C3020 - Floor Finishes - VCT

Location: Entrance Area and Offices

Distress: Beyond Service Life

Notes: The VCT flooring is aged, stained and worn, and should be replaced.

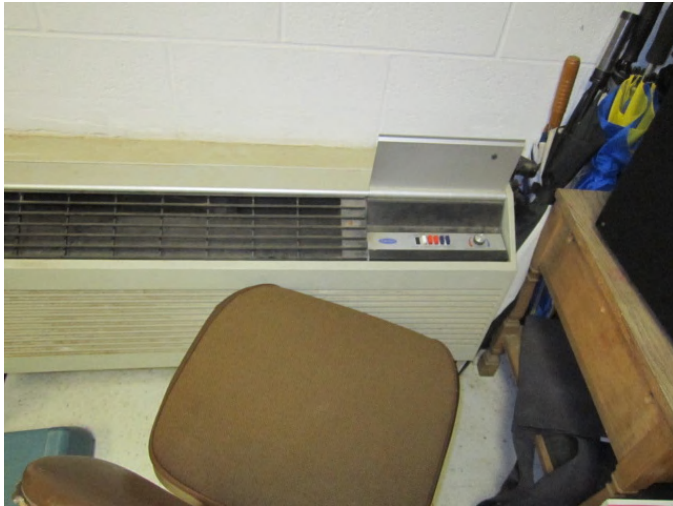
System: D3050 - Terminal & Package Units

Location: Throughout Building

Distress: Inadequate

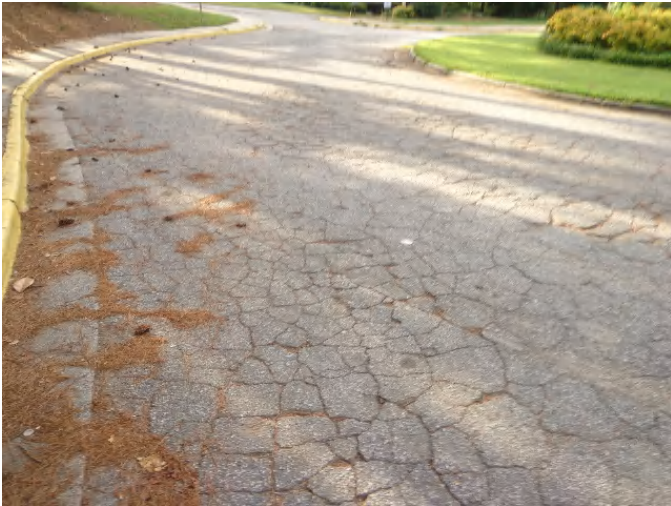
System: G2010 - Roadways

Location: Site

Distress: Beyond Service Life

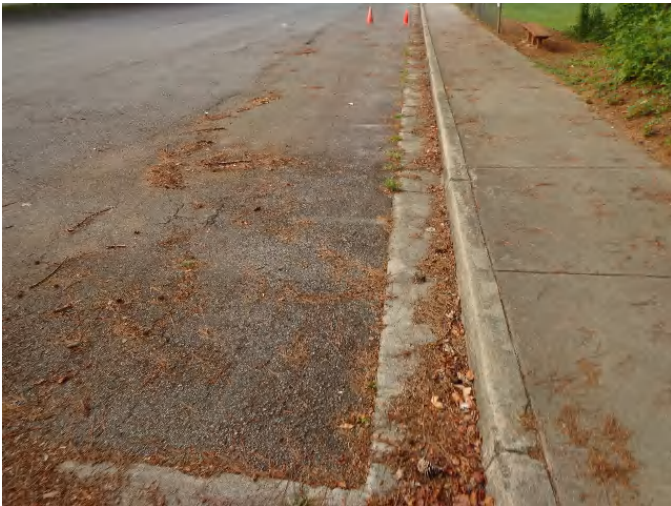
System: G2020 - Parking Lots

Location: Site

Distress: Beyond Service Life

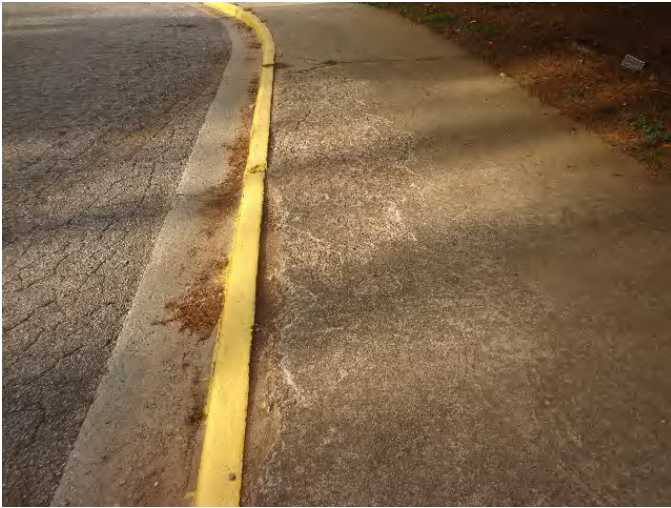
System: G2030 - Pedestrian Paving

Location: Site

Distress: Beyond Service Life

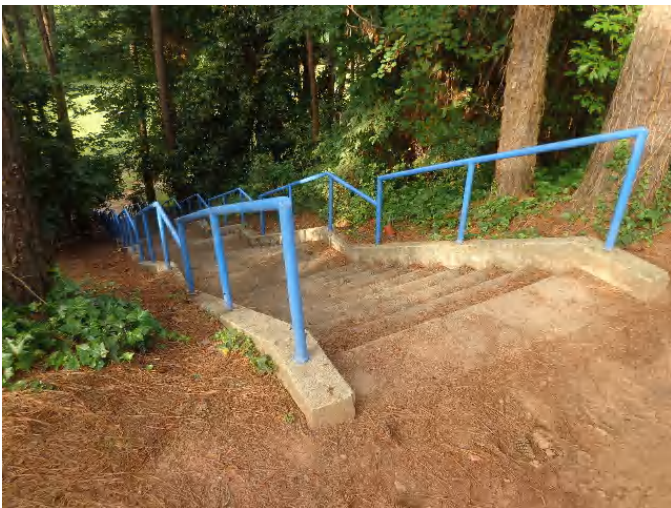
System: G2040 - Fencing & Guardrails

Location: Site

Distress: Beyond Service Life

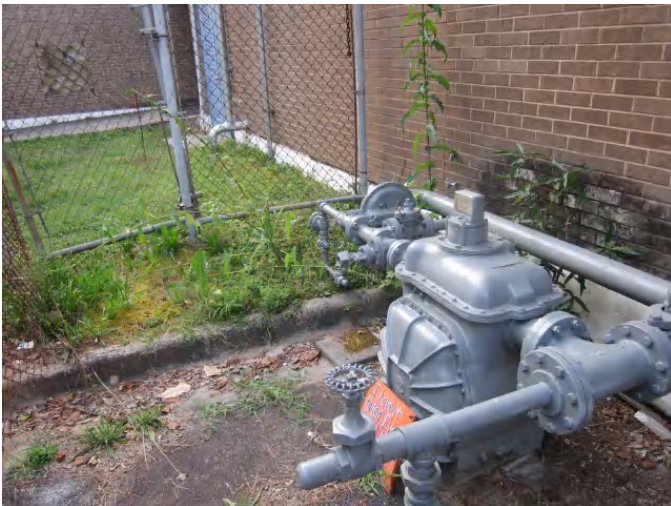
System: G3060 - Fuel Distribution

Location: Site

Distress: Beyond Service Life

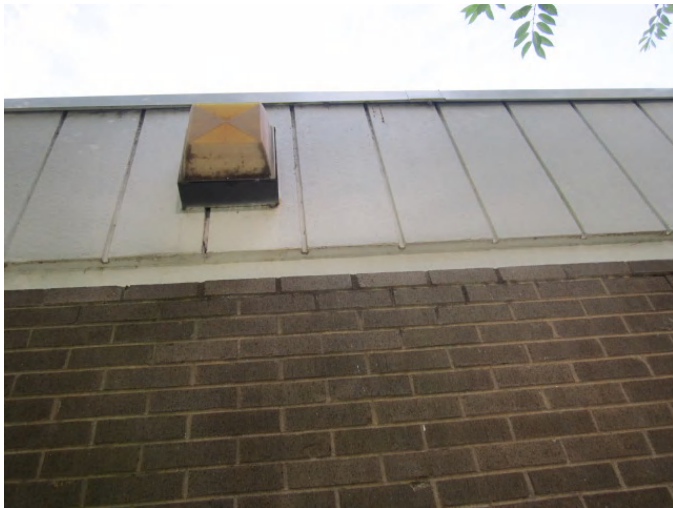
System: G4020 - Site Lighting

Location: Site
Distress: Beyond Service Life
Category: Deferred Maintenance
Priority: 3 Priority
Correction: Renew System
Qty: 53,988.00
Unit of Measure: S.F.
Estimate: \$68,295.00
Assessor Name: Sam Mandola
Date Created: 07/07/2015

Notes: Site lighting is beyond its expected service life, inadequate, and should be scheduled for replacement.

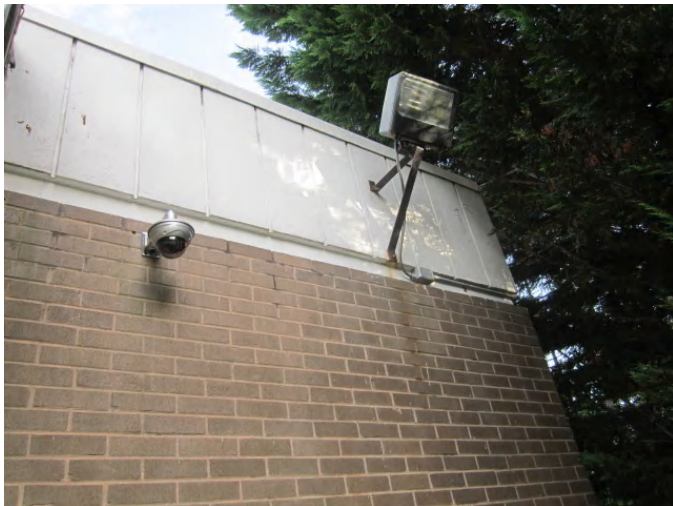
System: G4030 - Site Communications & Security

Location: Site
Distress: Beyond Service Life
Category: Deferred Maintenance
Priority: 3 Priority
Correction: Renew System
Qty: 53,988.00
Unit of Measure: S.F.
Estimate: \$39,789.00
Assessor Name: Sam Mandola
Date Created: 07/07/2015

Notes: The site communications and security systems are beyond their expected service life and should be scheduled for replacement.
