DeKalb County School District/Education Other

Former Avondale Middle School

School Assessment Report

May 19, 2016

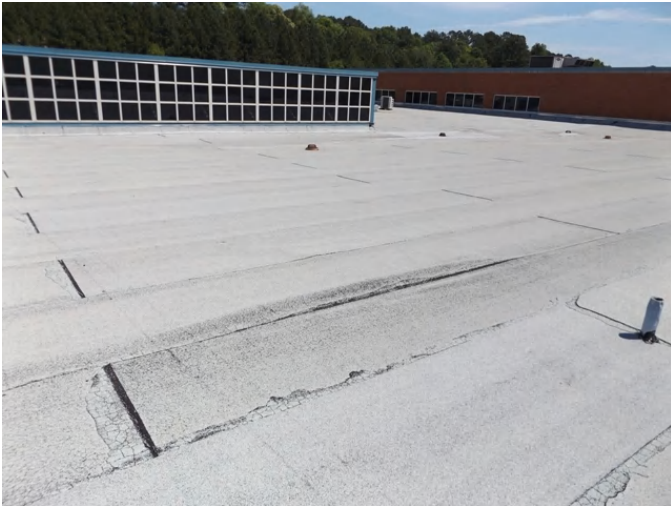
System: B3010 - Roof Coverings - BUR

Location: Roof

Distress: Beyond Service Life

Notes: Numerous roof leaks were reported throughout the building. The built-up roof covering is near the end of its expected service life and should be replaced.

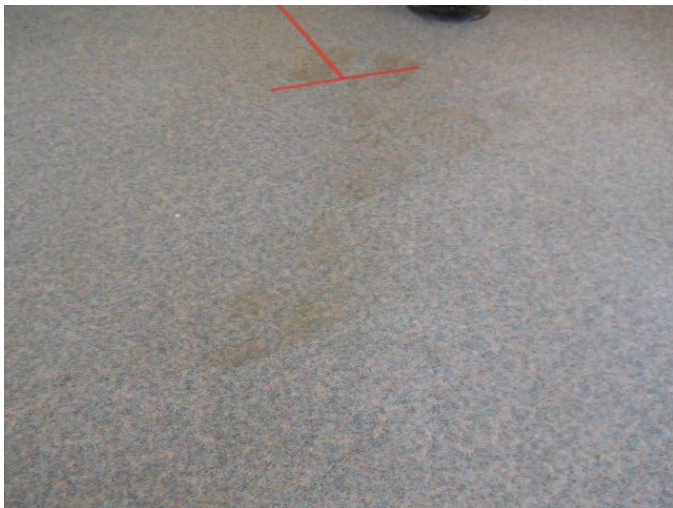
System: C3020 - Floor Finishes - Carpet

Location: Media Center and Chorus Room

Distress: Beyond Service Life

Notes: The carpet in the media center and the chorus room is beyond its service life, worn, and should be replaced.

Correction: Replace carpet

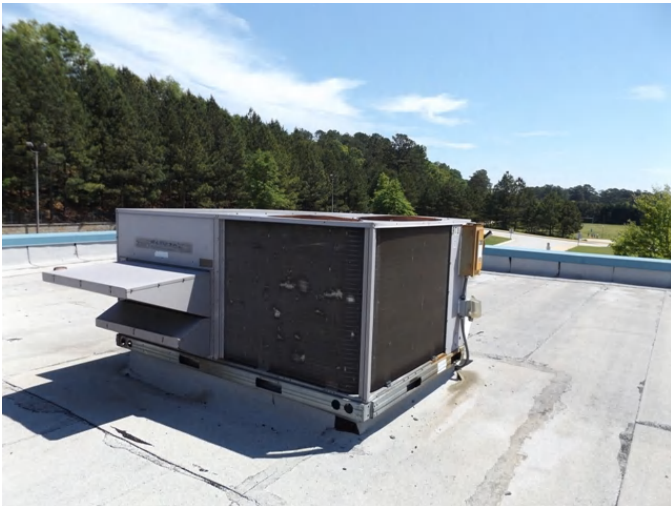
System: D3050 - Terminal & Package Units

Location: Roof

Distress: Beyond Service Life

Notes: The terminal and package units are aged, rusted, reported as inadequate for the administrative office space, and should be replaced.

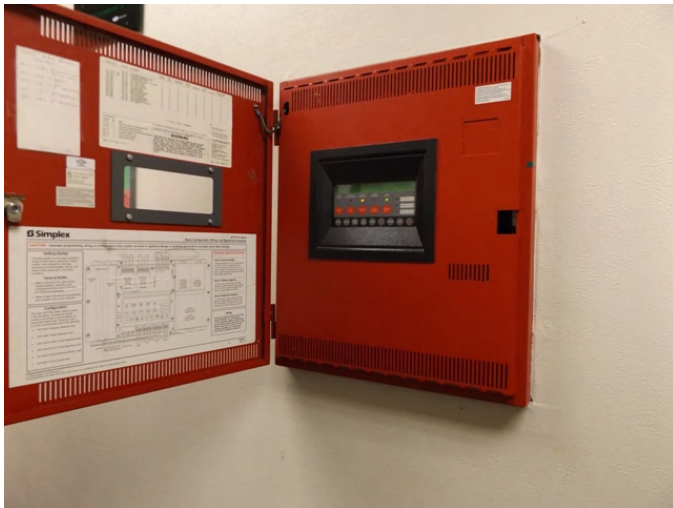
System: D5030 - Communications and Security - Fire Alarm

Location: Throughout Building

Distress: Beyond Service Life

Notes: The fire alarm system is beyond its expected service life and should be scheduled for replacement.

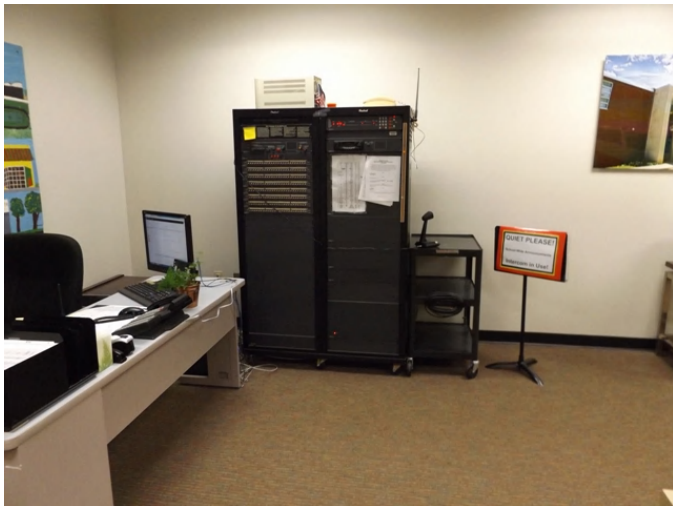
System: D5030 - Communications and Security - PA & Clock Systems

Location: Throughout Building

Distress: Beyond Service Life

Notes: The original PA and clock system is aged, reported to be intermittent, and should be replaced.

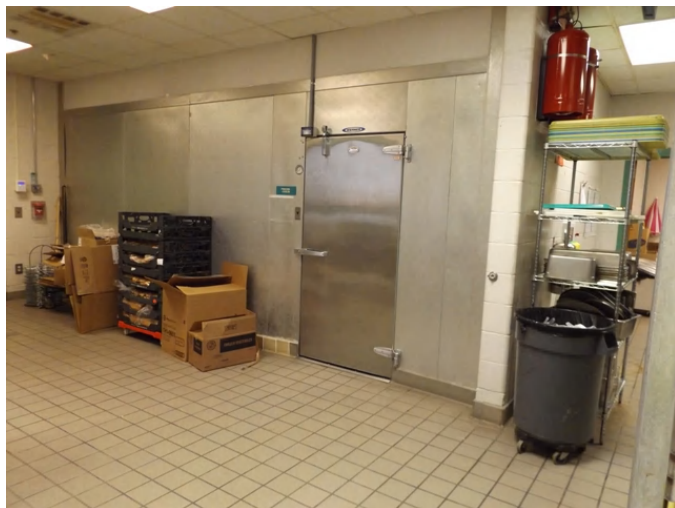
System: E1090 - Other Equipment - Kitchen Equipment

Location: Kitchen

Distress: Beyond Service Life

Notes: The kitchen equipment is beyond its expected service life and should be scheduled for replacement.

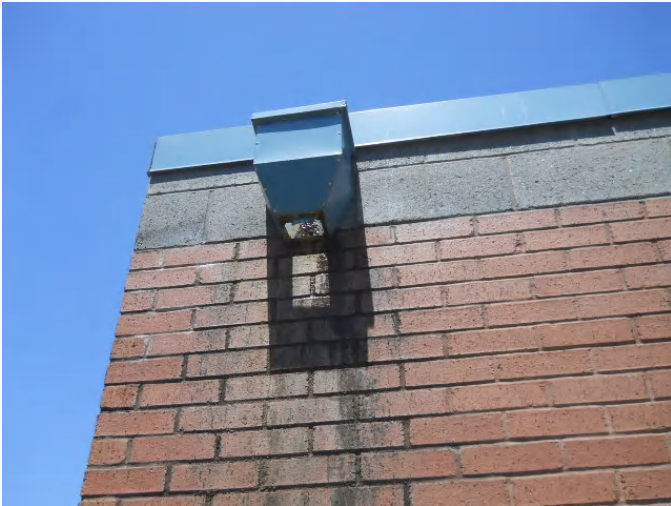
System: B3010 - Roof Coverings

Location: Roof

Distress: Damaged

Notes: The roof drainage gutter is damaged and detached. Clean out all roof gutters before installing new downspout.

Correction: Replace aluminum downspout, 3" x 4", .024" thick

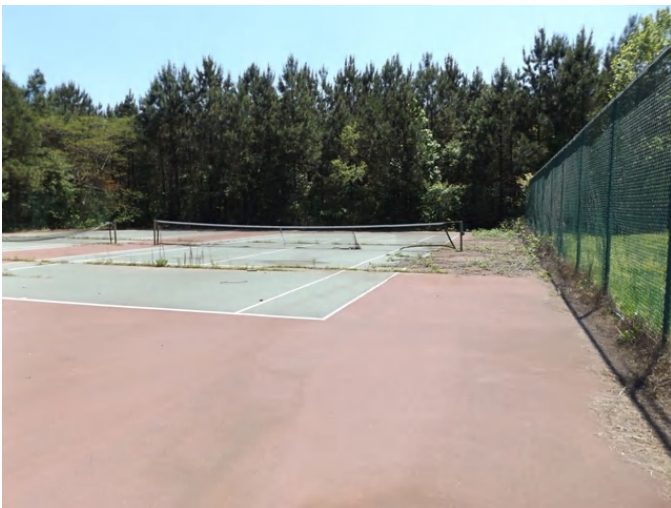
System: G2040 - Tennis Courts

Location: Site

Distress: Damaged

Notes: The tennis courts are deteriorated, damaged, and should be replaced

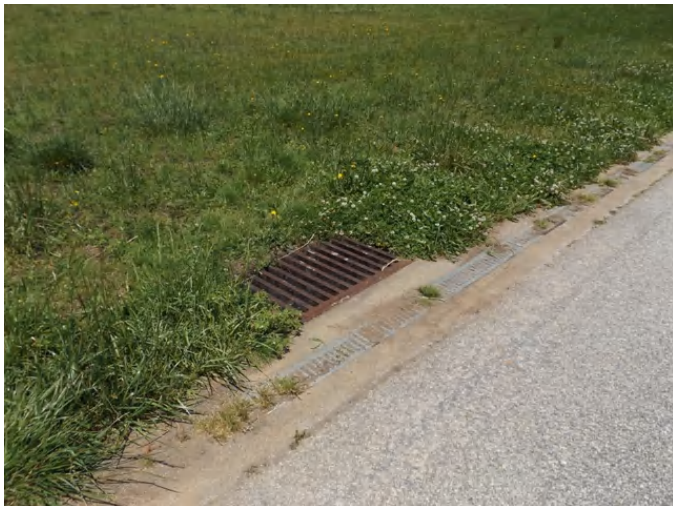
System: G3030 - Storm Sewer

Location: Field and Track
Distress: Inadequate
Category: Deferred Maintenance
Priority: 3 Priority
Correction: Stormwater trench drain, internal cleaning and inspection.
Qty: 1.00
Unit of Measure: Job
Estimate: \$12,781.69
Assessor Name: Eduardo Lopez
Date Created: 09/11/2015

Notes: Severe flooding is reported on field after heavy rain. Clean and inspect trench drain around track and field.

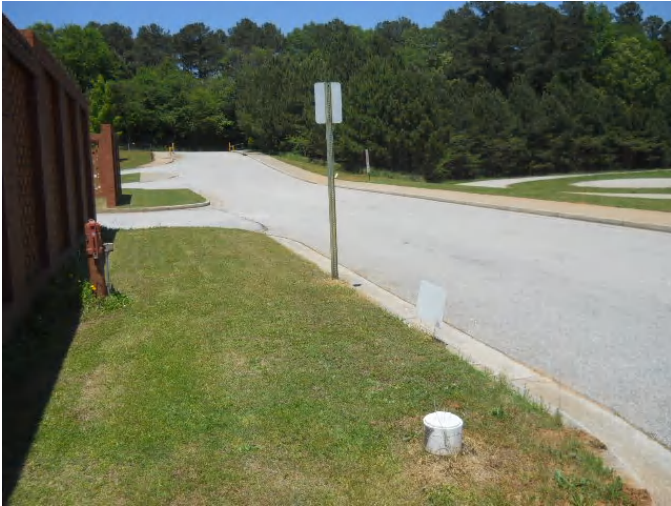
System: G4020 - Site Lighting

Location: Street Entrance

Distress: Inadequate
