DeKalb County School District/Leased/Charter

Former Shallowford Elementary

School Assessment Report

May 19, 2016

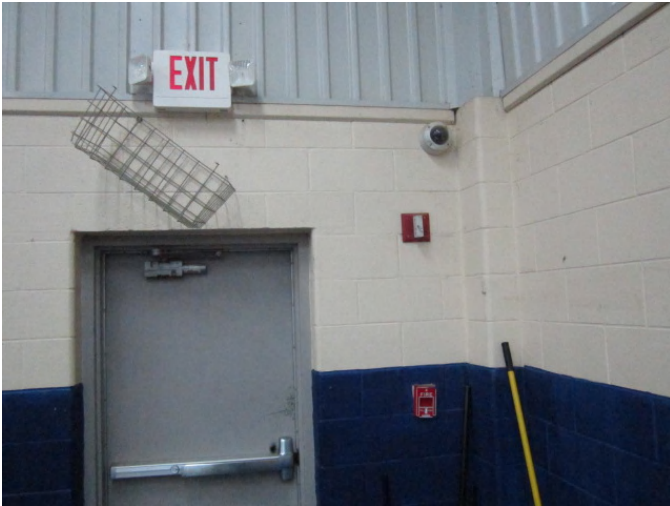
System: D5020 - Lighting

Location: Throughout Building

Distress: Needs Remediation

Notes: Exit lights are not functioning.

Correction: Add/replace illuminated exit signage

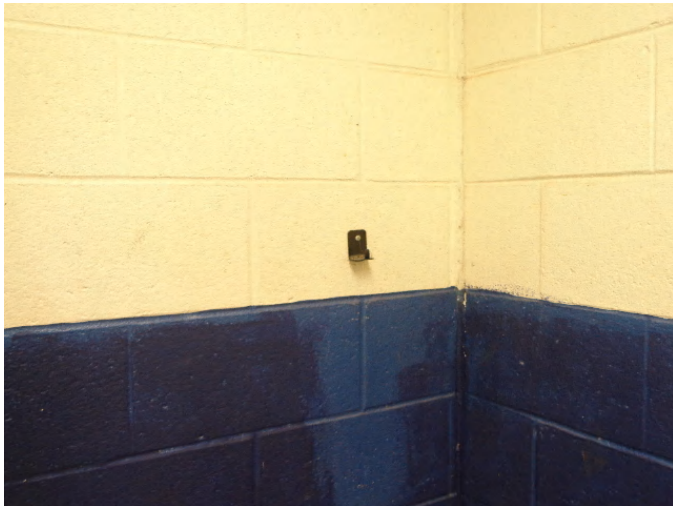
System: D4090 - Other Fire Protection Systems

Location: Throughout Building

Distress: Missing

Notes: The gym is currently being occupied and fire extinguishers are missing and should be provided.

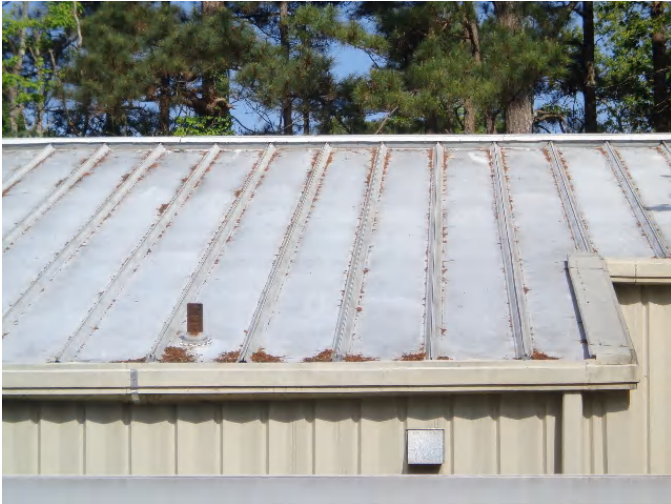
System: B3010 - Roof Coverings - Standing Seam Metal

Location: Roof

Distress: Inadequate

Notes: Metal roof has debris on it, including the gutters and downspouts, and should be cleaned to prevent damage.

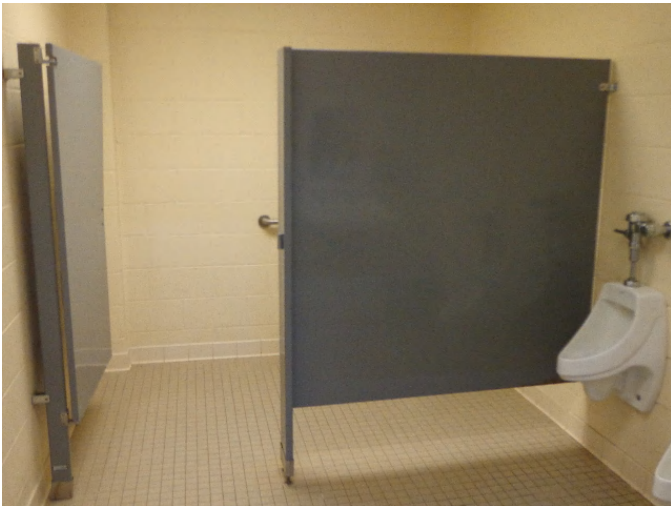
System: C1030 - Fittings

Location: Throughout Building

Distress: Inadequate

Notes: Fittings, such as toilet partitions and signage, are in marginal condition, missing in some instances, and not ADA compliant, and should be replaced.

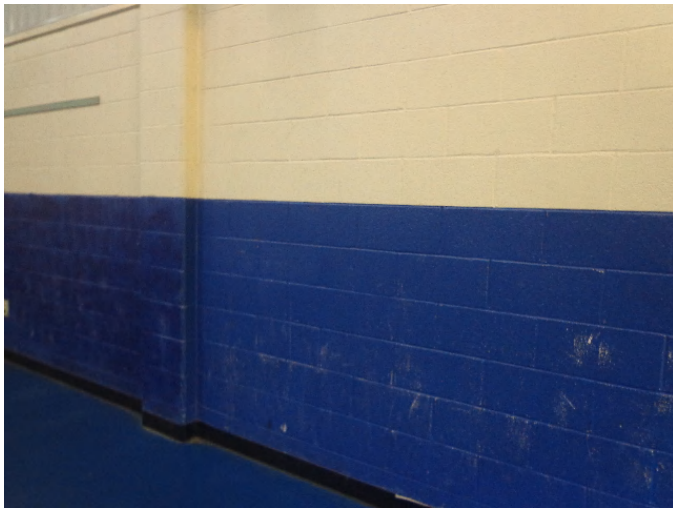
System: C3010 - Wall Finishes - Paint

Location: Throughout Building

Distress: Beyond Service Life

Notes: The wall finishes are aged, scuffed, stained, and fading and should be repainted.

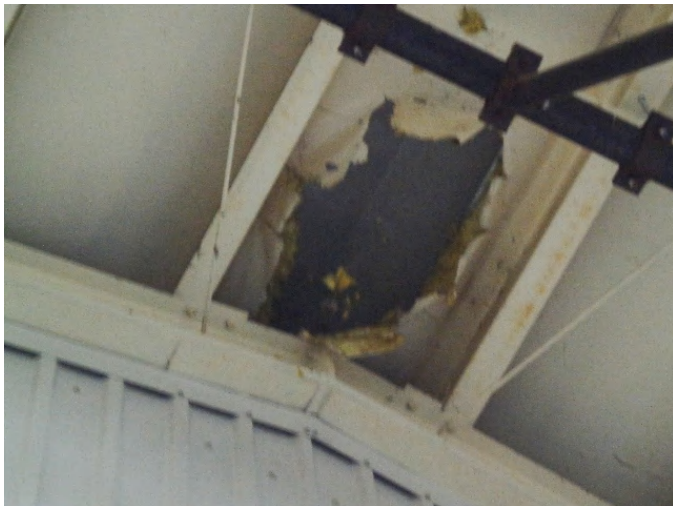
System: C3030 - Ceiling Finishes

Location: Ceiling

Distress: Damaged

Notes: The ceiling insulation blanket is damaged in different locations and should be repaired.

Correction: Replace Vinyl Backed Fiberglass Insulation Blankets

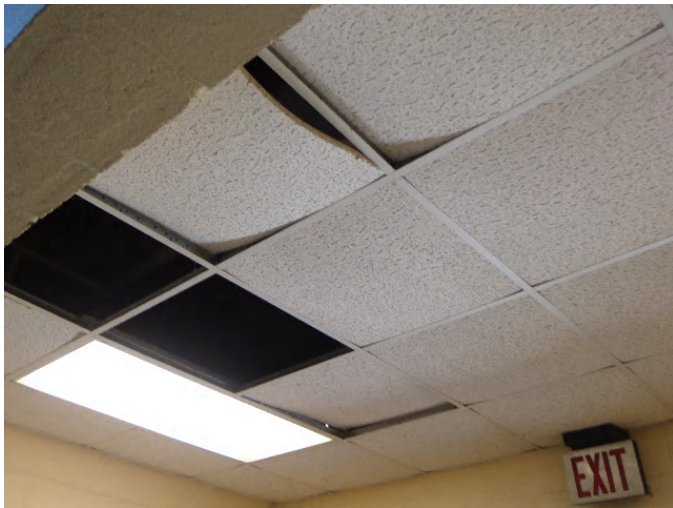
System: C3030 - Ceiling Finishes

Location: Office

Distress: Inadequate

Notes: Acoustic ceiling tiles are in deteriorating condition, missing or sagging, and should be replaced.

Correction: Replace acoustic tile ceiling, non fire-rated

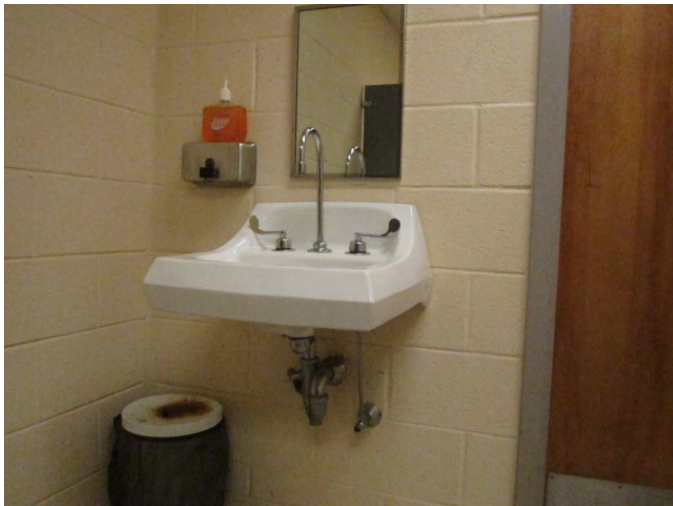
System: D2010 - Plumbing Fixtures

Location: Restrooms

Distress: Missing

Notes: Exposed pipes under sinks are not sufficiently insulated against contact. Add insulation.

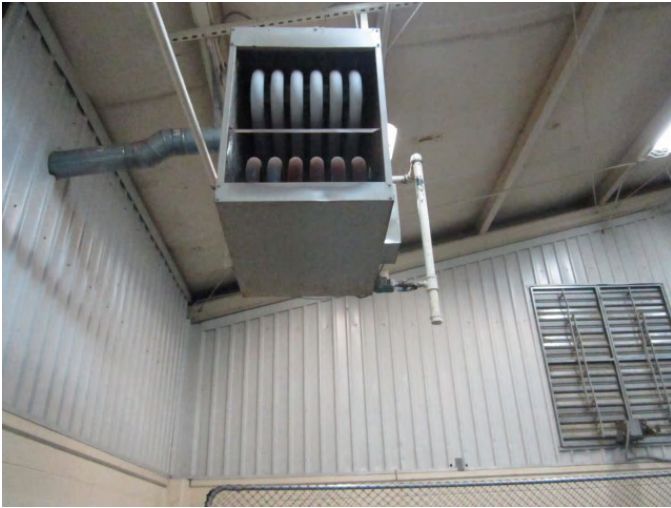
System: D3050 - Terminal & Package Units

Location: Throughout Building

Distress: Beyond Service Life

Notes: The system is beyond its expected service life and should be scheduled for replacement. In addition to replacing existing system, add an air conditioning system for the main open area of the gym.

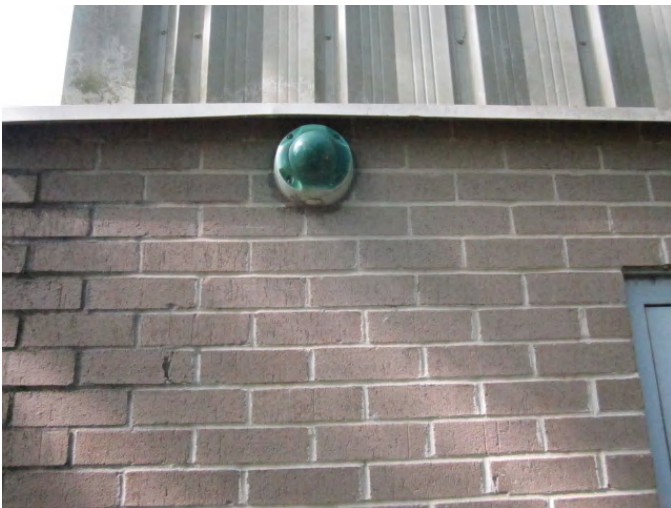
System: D5030 - Communications and Security - Security & CCTV

Location: Throughout Building

Distress: Beyond Service Life

Notes: The system is beyond its expected service life, damaged due to vandalism, and should be scheduled for replacement. One exterior-mounted CCTV camera was painted over. It is not clear to what extent the site security system is functioning.

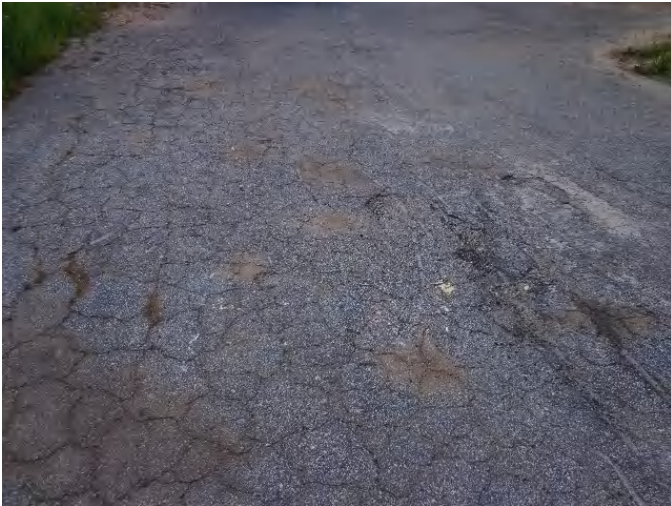
System: G2010 - Roadways

Location: Site

Distress: Beyond Service Life

Notes: The roadways are beyond service life, damaged, and should be replaced.

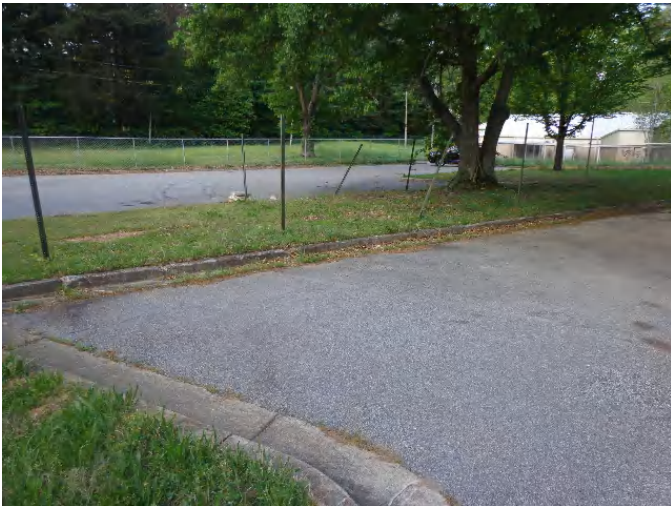
System: G2020 - Parking Lots

Location: Site

Distress: Beyond Service Life

Notes: The parking lot is beyond its expected service life, damaged with many cracks, not ADA compliant, and should be re-surfaced and restriped.

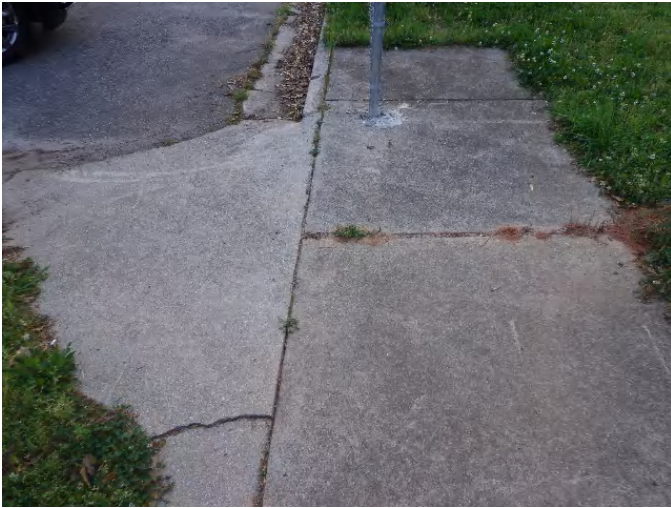
System: G2030 - Pedestrian Paving

Location: Site

Distress: Beyond Service Life

Notes: Pedestrian paving is beyond its expected service life, damaged, and not ADA compliant, and should be replaced.

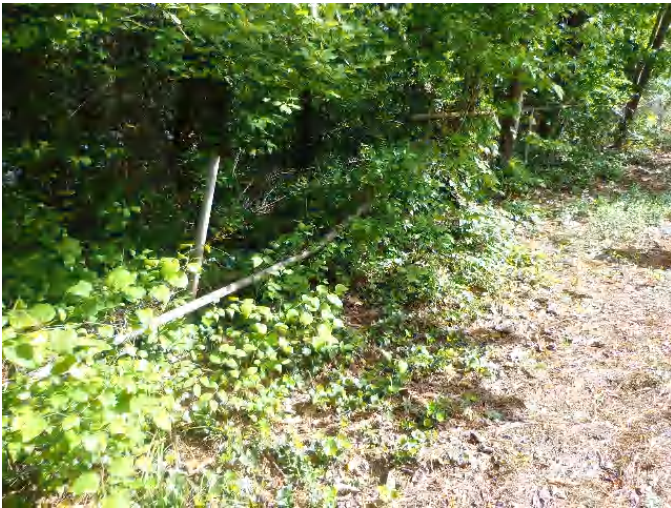
System: G2040 - Fencing & Guardrails

Location: Behind Building

Distress: Damaged

Notes: The fence is damaged and should be repaired.

Correction: Remove/replace chain link fencing

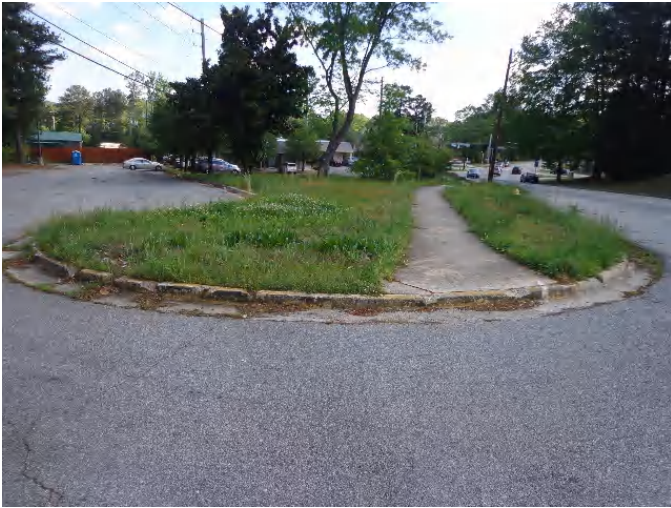
System: G2050 - Landscaping

Location: Site
Distress: Beyond Service Life
Category: Deferred Maintenance
Priority: 3 Priority
Correction: Renew System
Qty: 5,488.00
Unit of Measure: S.F.
Estimate: \$8,753.36
Assessor Name: Eduardo Lopez
Date Created: 04/27/2015

Notes: Landscaping is severely overgrown in different areas, has significant areas of soil erosion, and should be improved/maintained.

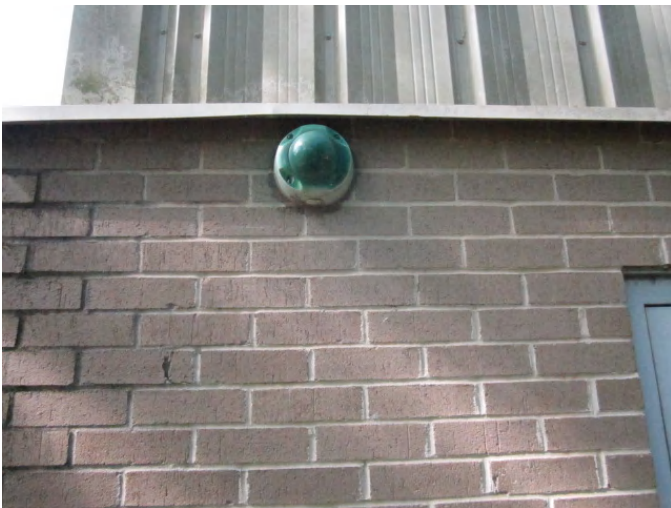
System: G4030 - Site Communications & Security

Location: Site
Distress: Beyond Service Life
Category: Deferred Maintenance
Priority: 3 Priority
Correction: Renew System
Qty: 5,488.00
Unit of Measure: S.F.
Estimate: \$3,676.96
Assessor Name: Eduardo Lopez
Date Created: 08/13/2015

Notes: Site communications and security systems are beyond their expected service life, vandalized, and should be scheduled for replacement.
