DeKalb County School District/Middle Schools

Freedom Middle

School Assessment Report

May 20, 2016

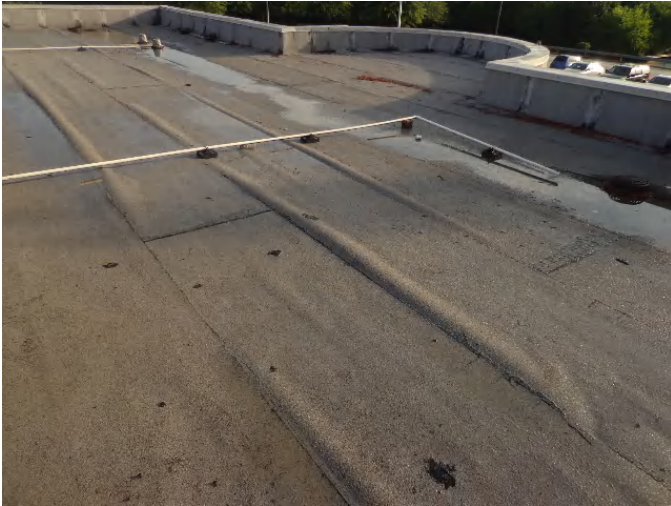
System: B3010 - Roof Coverings - BUR

Location: Roof

Distress: Damaged

Notes: The built-up roof covering is in poor condition, with severe bubbling, deteriorated flashing, inadequate slope towards the roof drains, ponding water, and reported leaks in different areas. SPLOST project 312-422 to perform detailed roof study by April 2017.

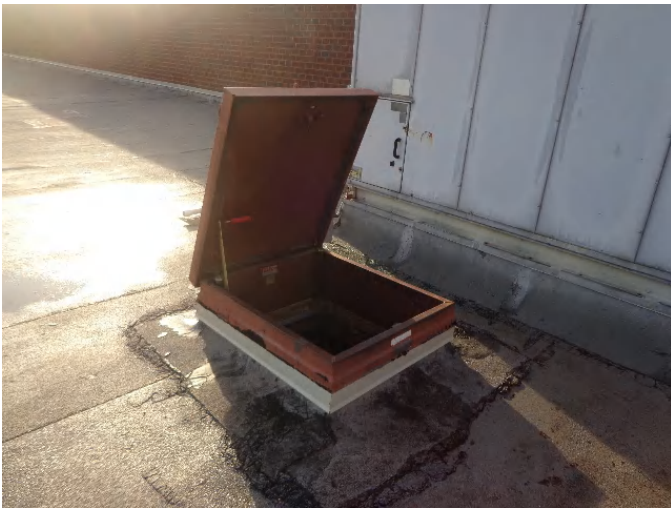
System: B3020 - Roof Openings

Location: Roof

Distress: Inadequate

Notes: The roof hatches do not comply with OSHA standards; roof opening protection and proper extension of fixed ladder to platform is not provided.

Correction: Replace roof hatch and structure single unit

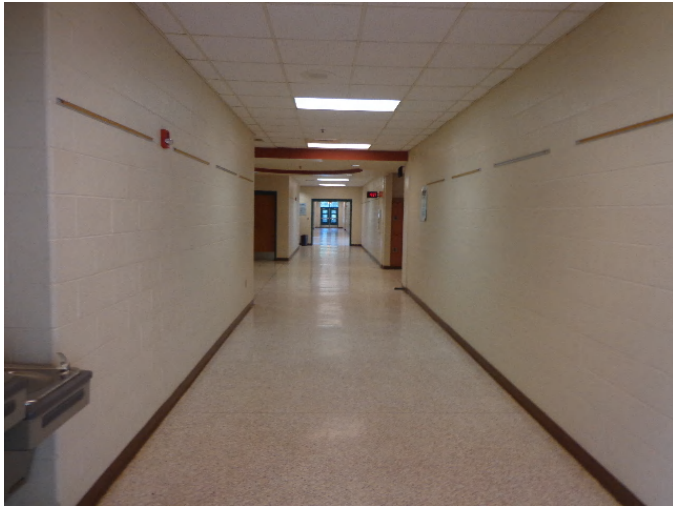
System: C3010 - Wall Finishes - Paint

Location: Throughout Building

Distress: Beyond Service Life

Notes: The painted wall finishes are beyond their expected service life, scuffed and stained, and should be renewed.

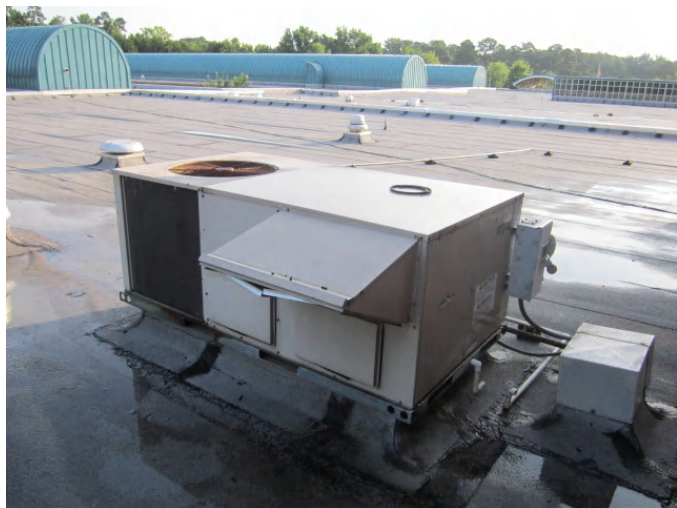
System: D3050 - Terminal & Package Units

Location: Throughout Building

Distress: Beyond Service Life

Notes: Terminal and package units are nearing the end of their expected service life, in poor condition, and should be scheduled for replacement.

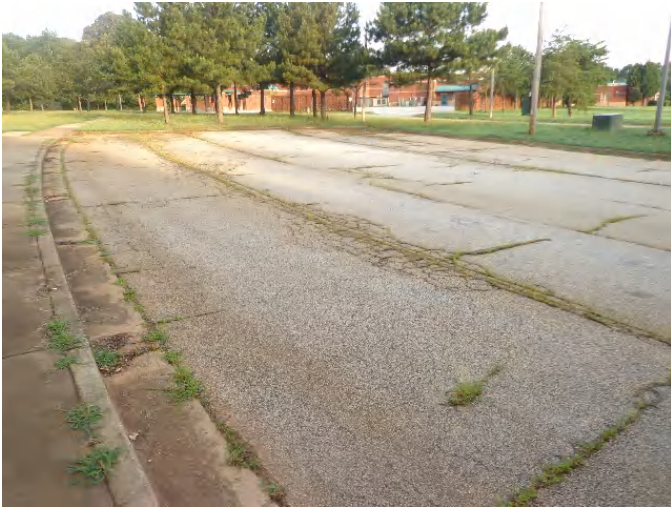
System: G2010 - Roadways

Location: Site

Distress: Damaged

Notes: The roadways are damaged, with many cracks and potholes, and are scheduled for patch/repair/replacement under SPLOST project 312-422 by November 2016.

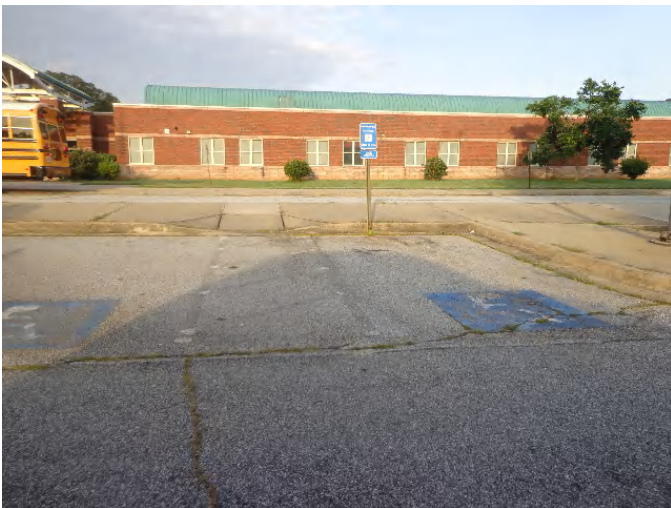
System: G2020 - Parking Lots

Location: Site

Distress: Damaged

Notes: The parking lot is damaged, with many cracks and should be repaved and re-striped. The parking area has sufficient ADA parking spaces; however, signage is not visible and/or missing and should be provided per ADA standards.

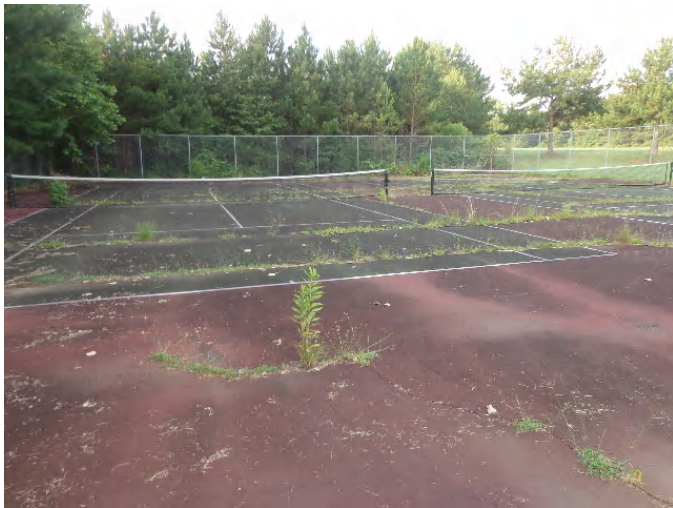
System: G2040 - Tennis Courts

Location: Site
Distress: Beyond Service Life
Category: Deferred Maintenance
Priority: 3 Priority
Correction: Renew System
Qty: 13,505.00
Unit of Measure: S.F.
Estimate: \$274,381.09
Assessor Name: Eduardo Lopez
Date Created: 06/26/2015

Notes: The tennis courts are in poor condition, with many cracks, and should be replaced.

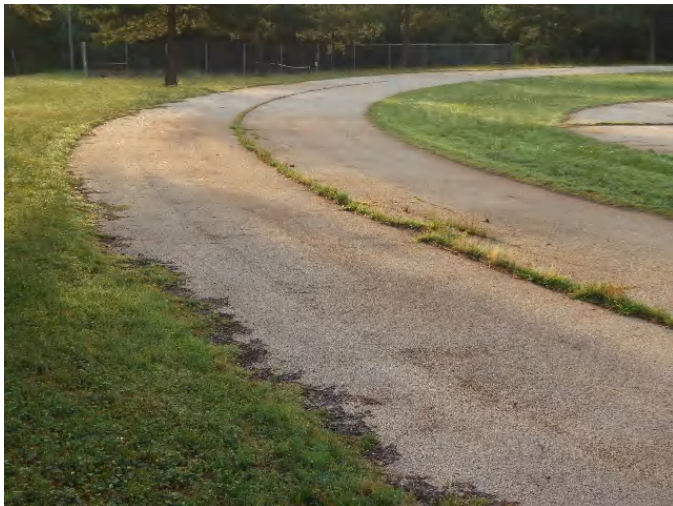
System: G2040 - Track

Location: Site
Distress: Beyond Service Life
Category: Deferred Maintenance
Priority: 3 Priority
Correction: Renew System
Qty: 36,917.00
Unit of Measure: S.F.
Estimate: \$285,885.25
Assessor Name: Eduardo Lopez
Date Created: 06/26/2015

Notes: The track is beyond its expected service life, in poor condition, and should be replaced.

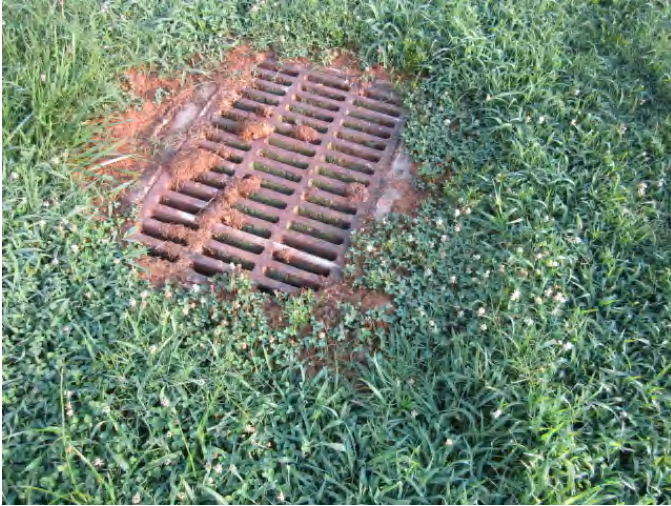
System: G3030 - Storm Sewer

Location: Site Courtyard
Distress: Beyond Service Life
Category: Deferred Maintenance
Priority: 3 Priority
Correction: Renew System
Qty: 161,263.00
Unit of Measure: S.F.
Estimate: \$629,732.02
Assessor Name: Eduardo Lopez
Date Created: 06/28/2015

Notes: There are severe problems with ponding water and flooding which originates from the courtyard area. An engineering study and corrective action is required.
