DeKalb County School District/Elementary Schools

Hawthorne Elementary

School Assessment Report

May 19, 2016

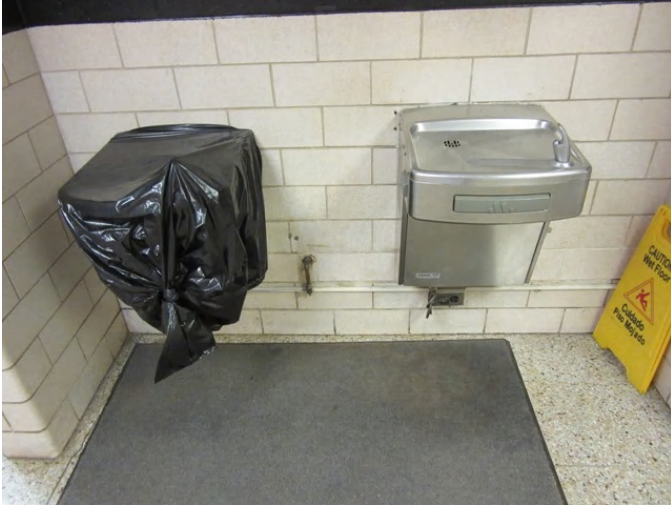
System: D2010 - Plumbing Fixtures

Location: Throughout Building

Distress: Beyond Service Life

Notes: The plumbing fixtures are beyond their expected service life, worn, inadequate, and should be scheduled for replacement, including upgrades to improve ADA accessibility. Water fountains protrude into the hallway more than allowable under ADA.

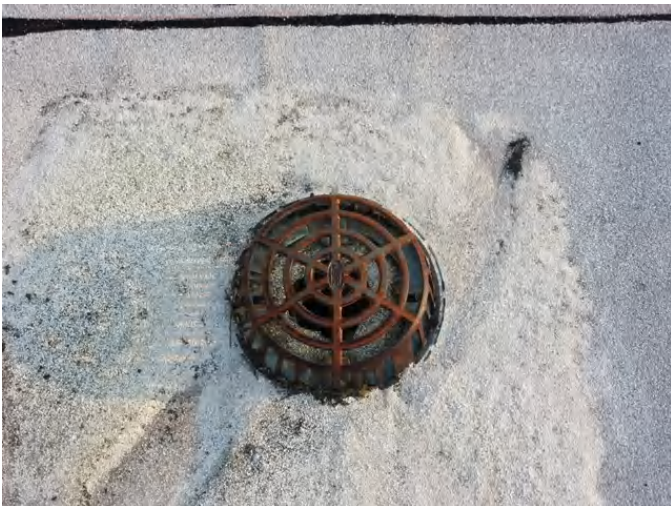
System: D2040 - Rain Water Drainage

Location: Throughout Building

Distress: Beyond Service Life

Notes: The rain water drainage system is beyond its expected service life, in poor condition, and should be scheduled for replacement. SPLOST project 414-422 to replace/repair rain water roof drainage.

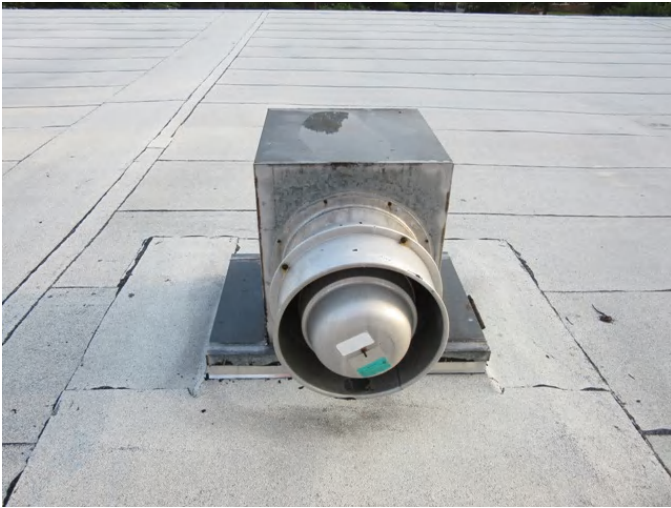
System: D3040 - Distribution & Exhaust Systems

Location: Throughout Building

Distress: Beyond Service Life

Notes: The distribution and exhaust systems are beyond their expected serve life, inadequate, and should be scheduled for replacement. There is no exhaust in the restrooms. SPLOST project 414-422 to replace the exhaust systems throughout the building.

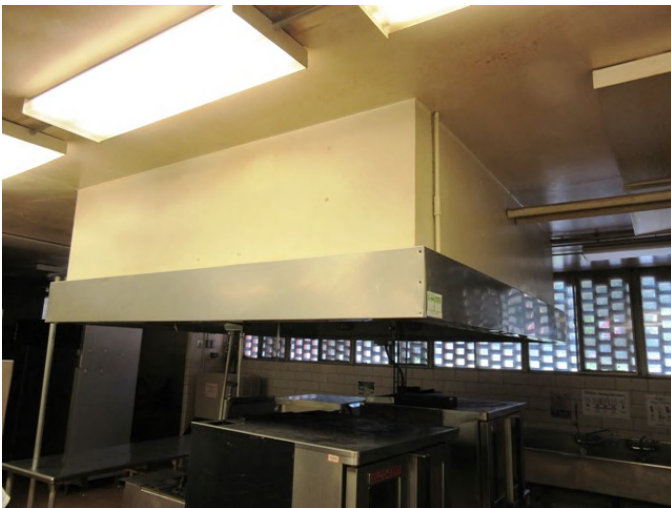
System: D3090 - Other HVAC Systems/Equip - Kitchen Hood

Location: Kitchen

Distress: Beyond Service Life

Notes: The kitchen hood system is beyond its expected service life and should be scheduled for replacement. SPLOST project 414-422 to replace kitchen hood.

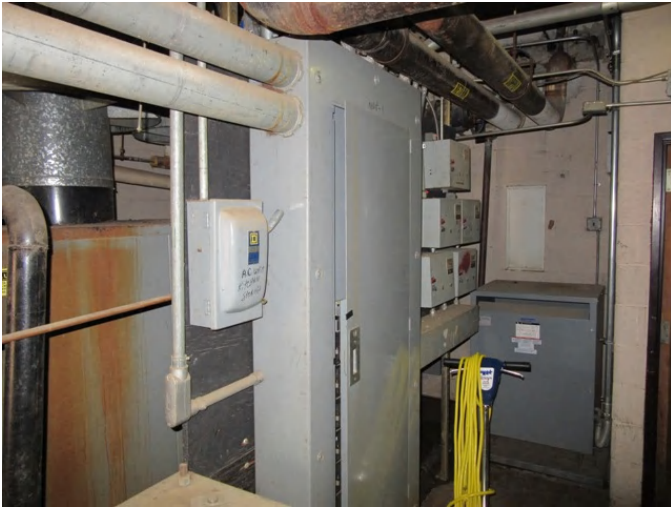
System: D5010 - Electrical Service/Distribution

Location: Main Switch Room/Throughout Building

Distress: Beyond Service Life

Notes: The electrical service/distribution system is beyond its expected service life and should be scheduled for replacement. SPLOST project 414-422 to replace electrical service and distribution system to eliminate outages and breaker tripping.

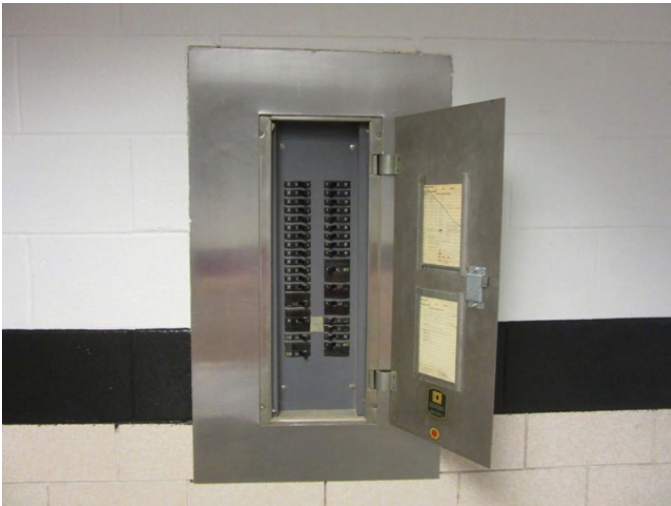
System: D5020 - Branch Wiring

Location: Throughout Building

Distress: Beyond Service Life

Notes: The branch wiring system is beyond its expected service life, inadequate, not building code compliant, and should be scheduled for replacement. Electrical outlets in wet areas are not GFI. SPLOST project 414-422 to evaluate the need to replace the branch wiring system to support the current building loads.

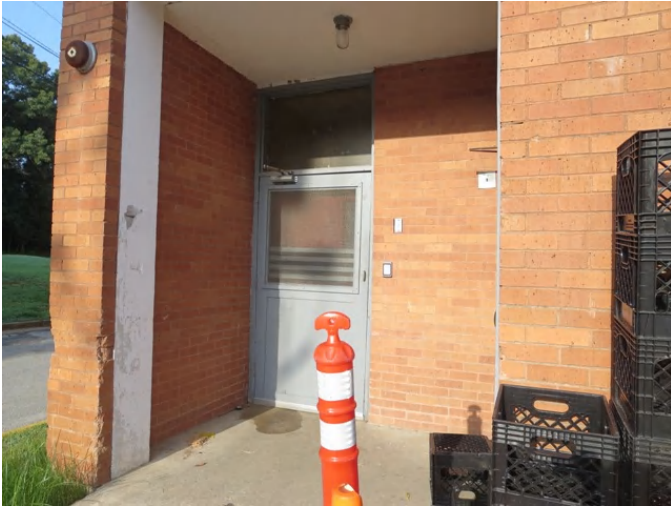
System: B2030 - Exterior Doors

Location: Throughout Building

Distress: Beyond Service Life

Notes: The original exterior doors are aged, rusted, and should be replaced. SPLOST project 414-422 to replace exterior doors.

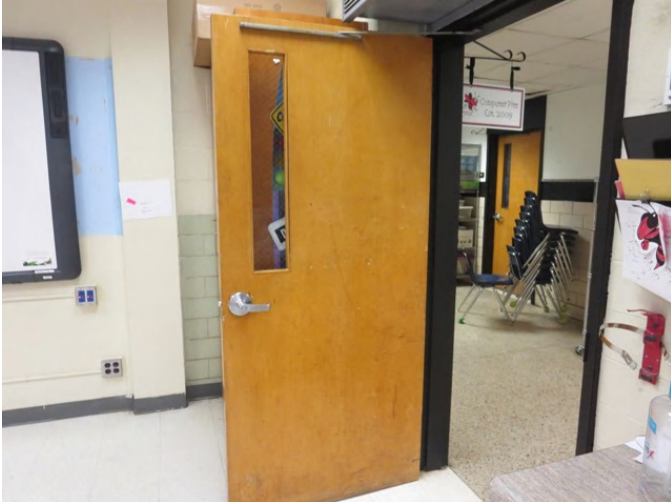
System: C1020 - Interior Doors

Location: Throughout Building

Distress: Beyond Service Life

Notes: The interior doors are aged, failing, not ADA compliant, and should be repaired or replaced.

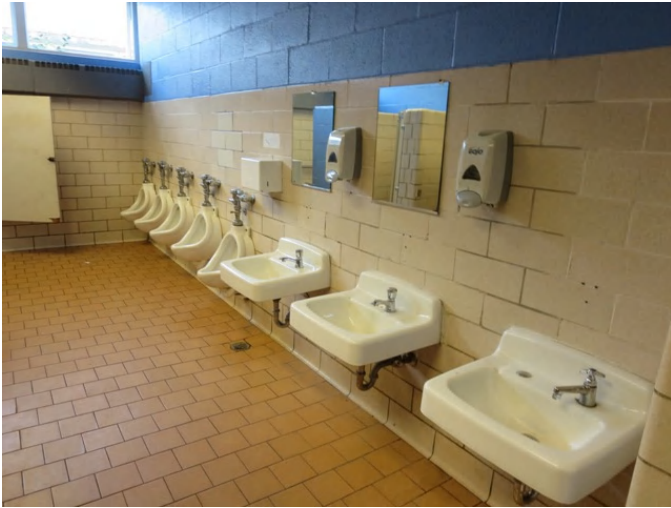
System: C3010 - Wall Finishes - Ceramic & Glazed

Location: Throughout Building

Distress: Beyond Service Life

Notes: The ceramic wall finishes are aged, scuffed, faded and stained, and should be replaced.

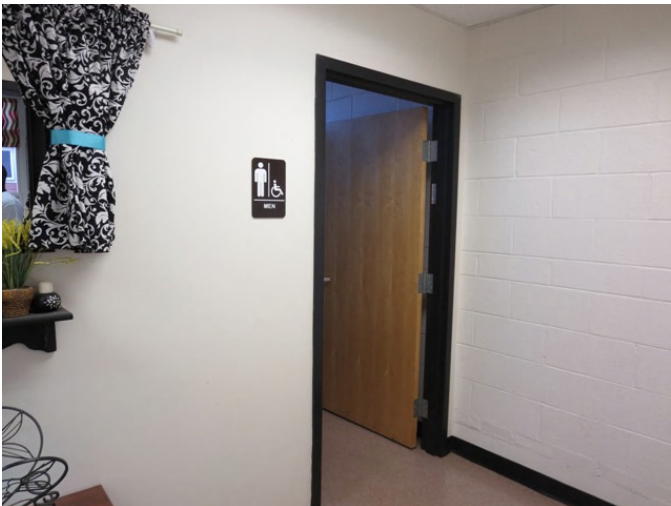
System: C3010 - Wall Finishes - Paint

Location: Throughout Building

Distress: Beyond Service Life

Notes: The painted wall finish has some deterioration due to age and use, and should be replaced.

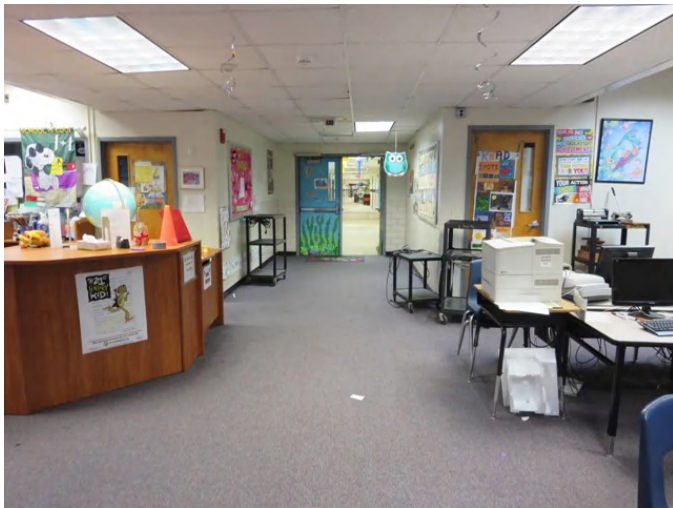
System: C3020 - Floor Finishes - Carpet

Location: Media Center

Distress: Beyond Service Life

Notes: The carpet is beyond its expected service life, stained, and should be replaced.

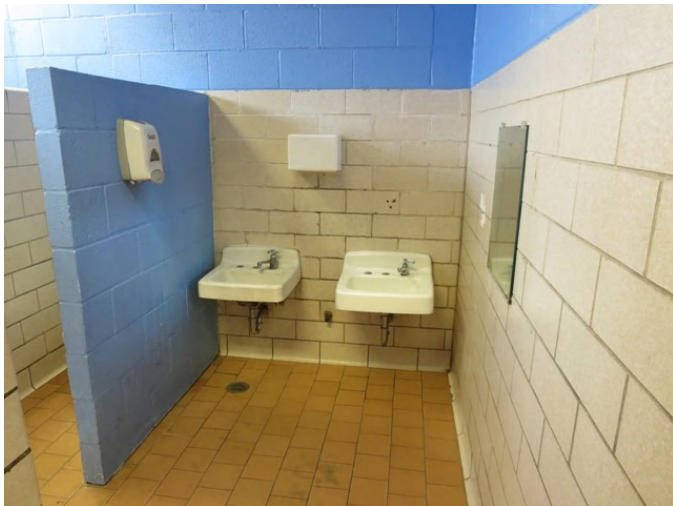
System: C3020 - Floor Finishes - Ceramic & Quarry Tile

Location: Kitchen and Restrooms

Distress: Beyond Service Life

Notes: The tile floor covering is beyond its expected service life, cracked, patched and worn, and should be replaced.

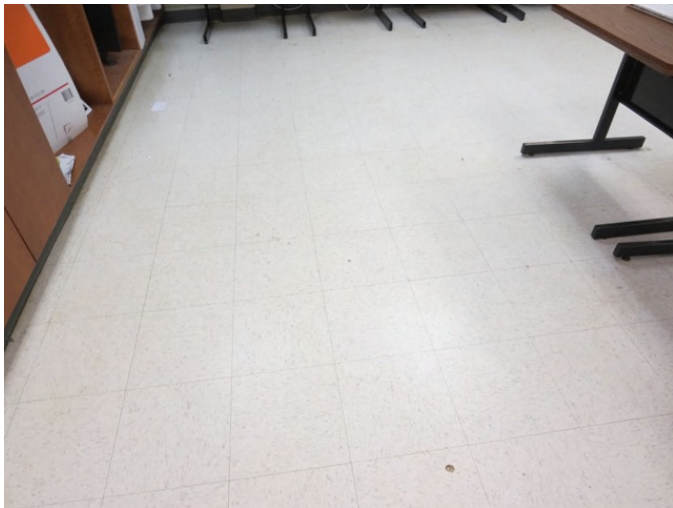
System: C3020 - Floor Finishes - VCT

Location: Cafeteria and Some Classrooms

Distress: Beyond Service Life

Notes: The VCT flooring is aged, cracked and worn, and should be replaced.

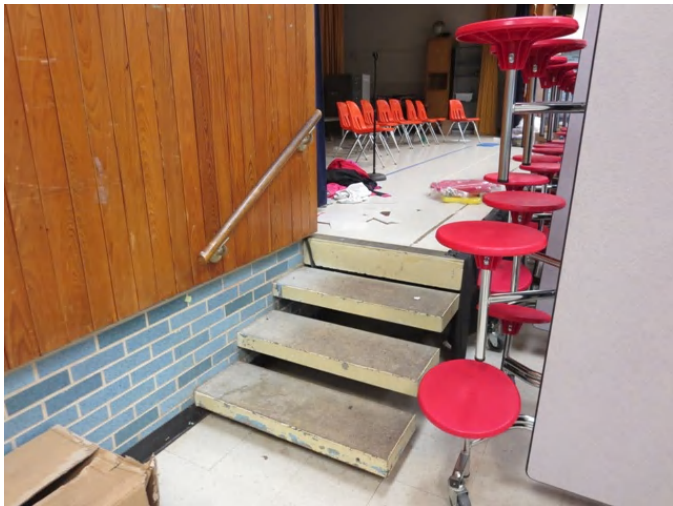
System: D1010 - Elevators and Lifts

Location: Cafeteria/Stage

Distress: Missing

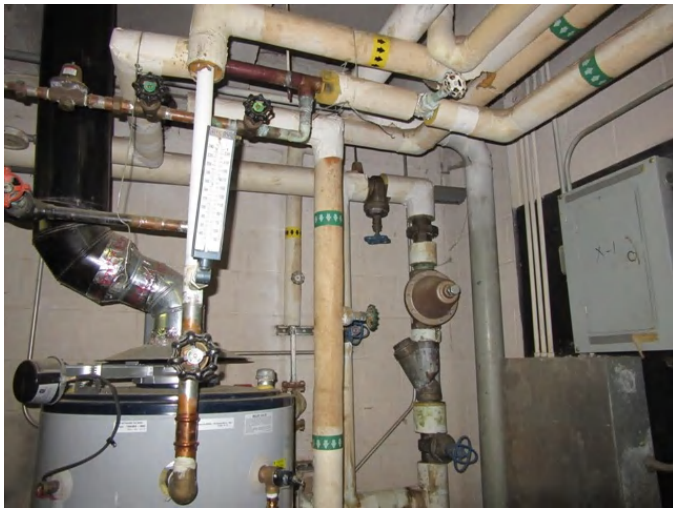
System: D2020 - Domestic Water Distribution

Location: Throughout Building
Distress: Beyond Service Life
Category: Deferred Maintenance
Priority: 3 Priority
Correction: Renew System
Qty: 47,940.00
Unit of Measure: S.F.
Estimate: \$210,409.00
Assessor Name: Ben Nixon
Date Created: 04/11/2015

Notes: The domestic water distribution system is beyond its expected service life, inadequate, and should be scheduled for replacement. There is no hot water in some of the restrooms.

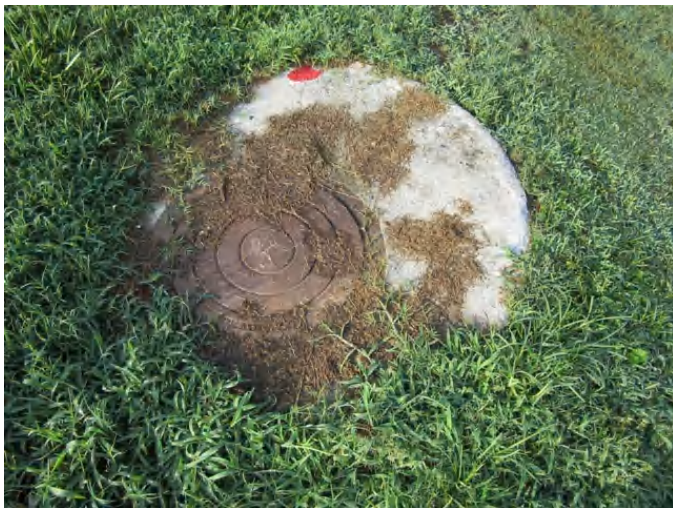
System: D2030 - Sanitary Waste

Location: Throughout Building
Distress: Beyond Service Life
Category: Deferred Maintenance
Priority: 3 Priority
Correction: Renew System
Qty: 47,940.00
Unit of Measure: S.F.
Estimate: \$179,823.00
Assessor Name: Sam Mandola
Date Created: 04/11/2015

Notes: The sanitary waste system is beyond its expected service life and should be scheduled for replacement.

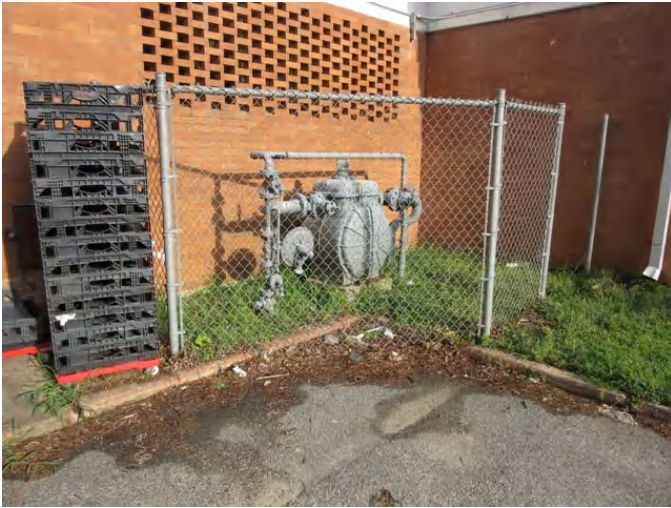
System: D2090 - Other Plumbing Systems - Natural Gas

Location: South Side of Building

Notes: The natural gas system is beyond its expected service life and should be scheduled for replacement. SPLOST project 414-422 to replace/repair natural gas system and replace grease trap.

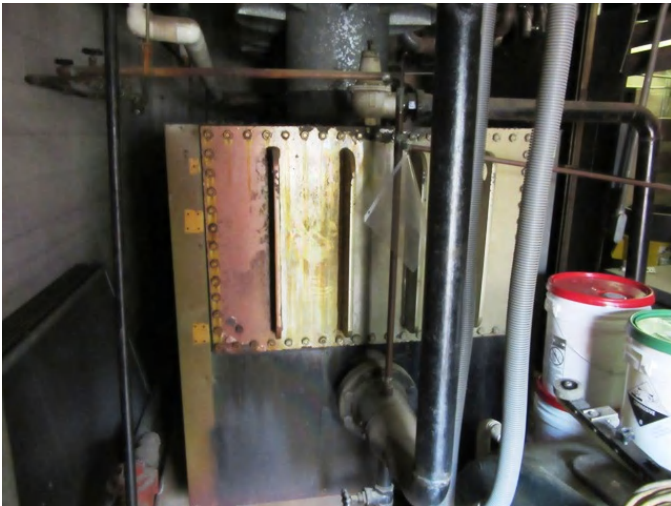
System: D3020 - Heat Generating Systems

Location: Mechanical Room

Notes: The heat generating system is beyond its expected service life and should be scheduled for replacement.

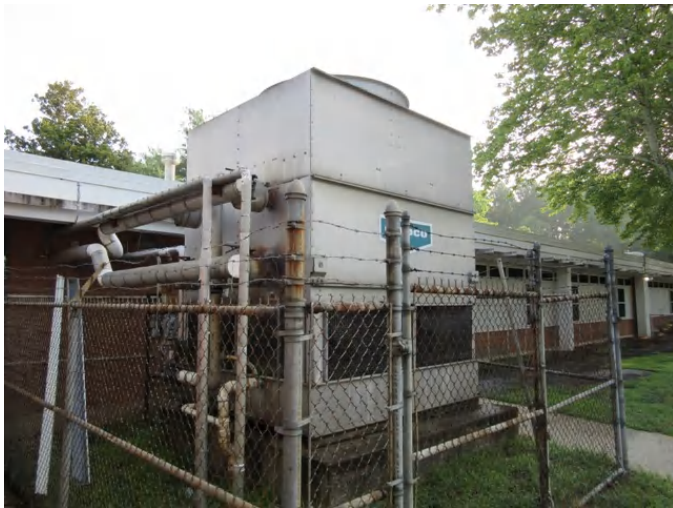
System: D3030 - Cooling Generating Systems

Location: South Side of Building

Notes: The cooling generating system is beyond its expected service life and should be scheduled for replacement.

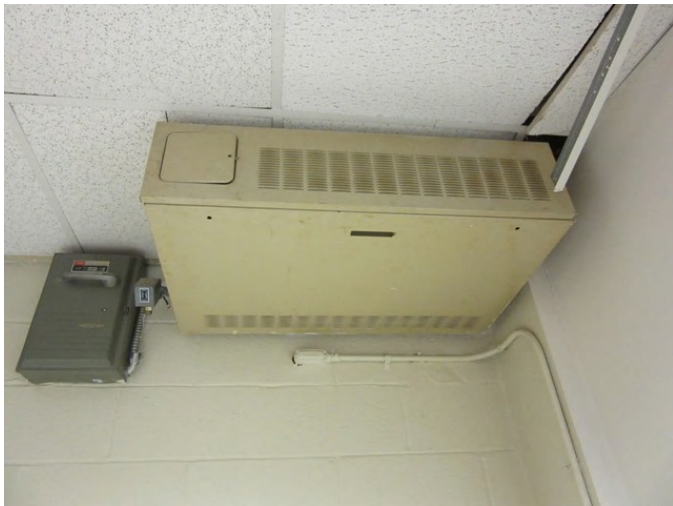
System: D3050 - Terminal & Package Units

Location: Throughout Building

Notes: The terminal and package units are beyond their expected service life and should be scheduled for replacement. HVAC fans, including those within AHUs, do not have permanent belt guards as required by OSHA.

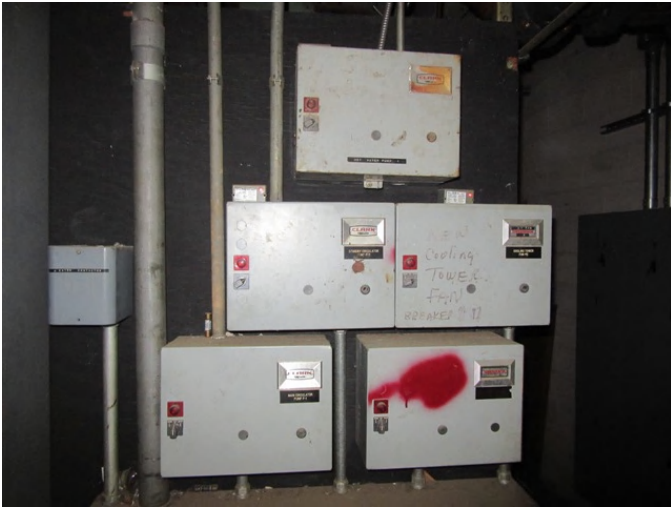
System: D3060 - Controls & Instrumentation

Location: Throughout Building

Notes: The controls and instrumentation system is beyond its expected service life and should be scheduled for replacement.

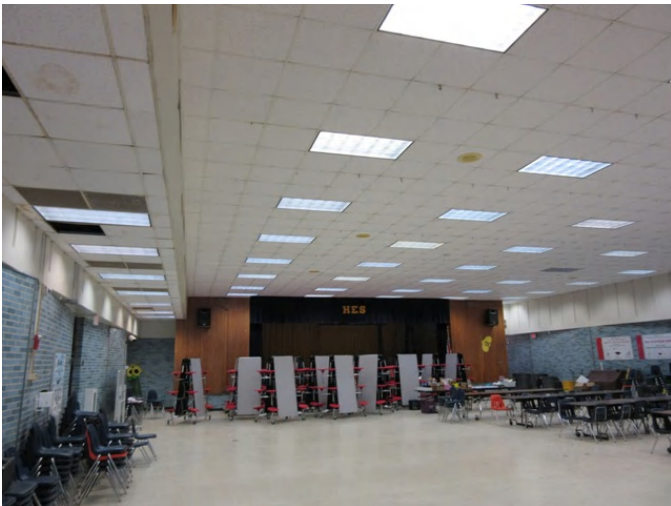
System: D5020 - Lighting

Location: Throughout Building

Distress: Inadequate

Notes: SPLOST project 414-422 to replace current lighting fixtures with 277 volt throughout the building. Emergency lighting is missing in hallways.

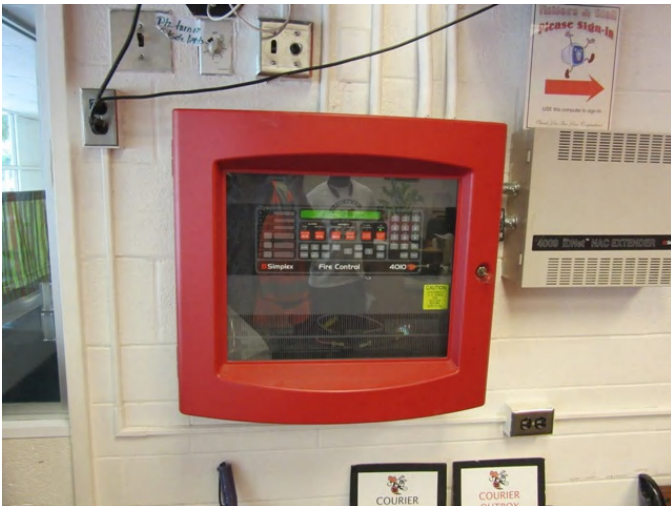
System: D5030 - Communications and Security - Fire Alarm

Location: Throughout Building
Distress: Beyond Service Life
Category: Deferred Maintenance
Priority: 3 Priority
Correction: Renew System
Qty: 47,940.00
Unit of Measure: S.F.
Estimate: \$64,863.00
Assessor Name: Ben Nixon
Date Created: 04/11/2015

Notes: The fire alarm system, including primary and secondary panels, are beyond their service life and should be scheduled for replacement.

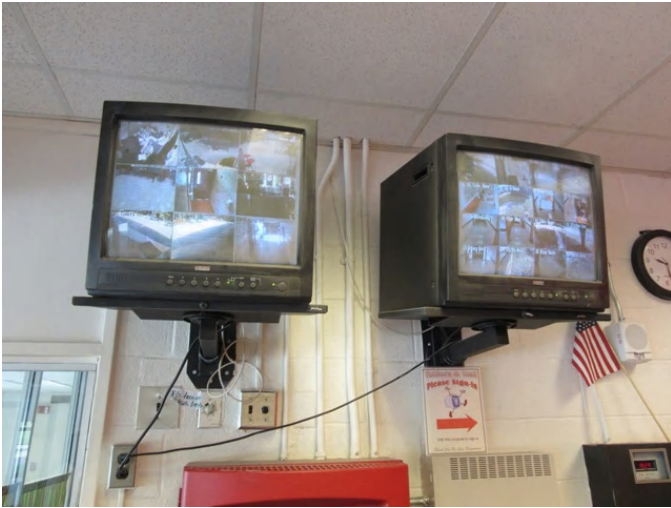
System: D5030 - Communications and Security - Security & CCTV

Location: Throughout Building

Notes: The security and CCTV systems are beyond their expected service life, inadequate, and should be scheduled for replacement.

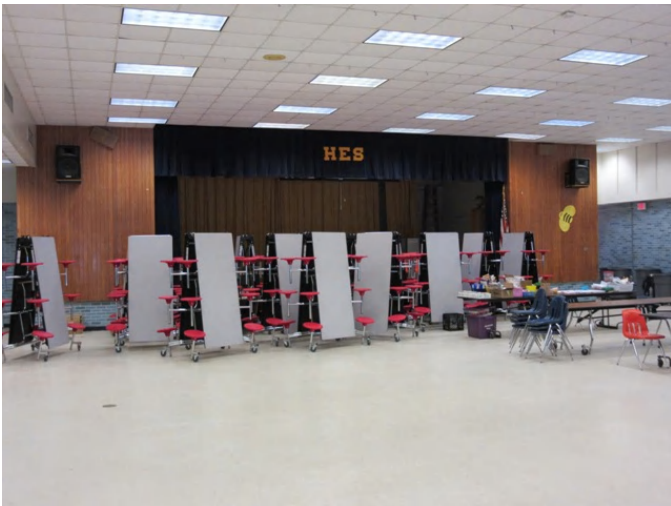
System: E1020 - Institutional Equipment

Location: Throughout Building

Notes: Institutional equipment, such as theater and stage equipment, is beyond its expected service life and should be scheduled for replacement.

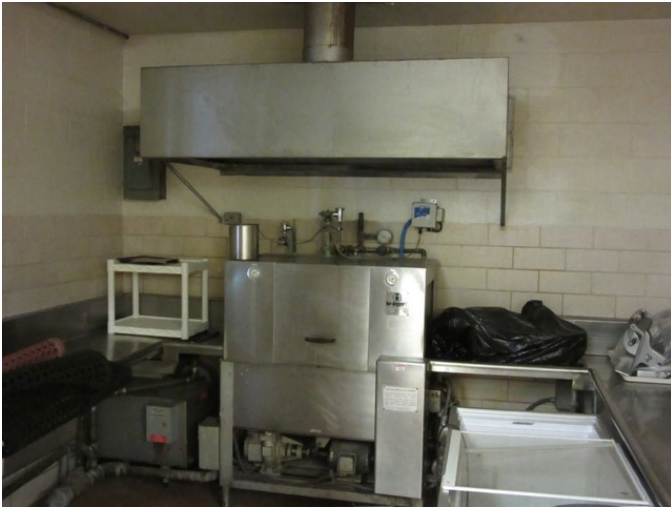
System: E1090 - Other Equipment - Kitchen Equipment

Location: Kitchen

Notes: Kitchen equipment is beyond its expected service life and should be scheduled for replacement. The grease trap no longer functions as intended and is scheduled to be replaced under SPLOST.

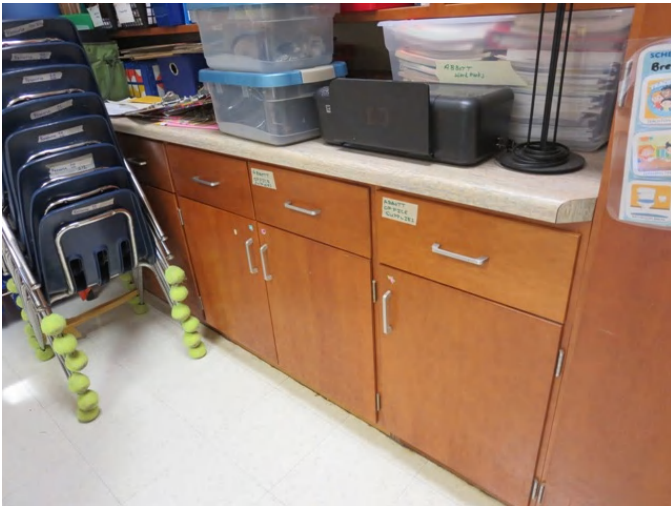
System: E2010 - Fixed Furnishings

Location: Throughout Building

Distress: Beyond Service Life

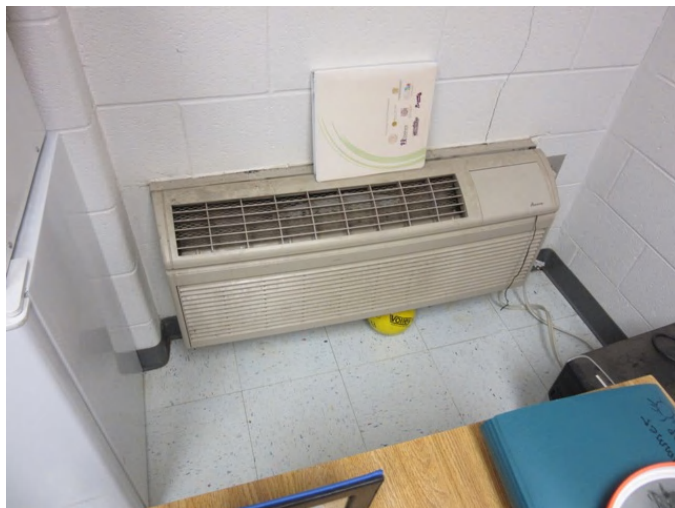
System: D3050 - Terminal & Package Units

Location: Throughout Building

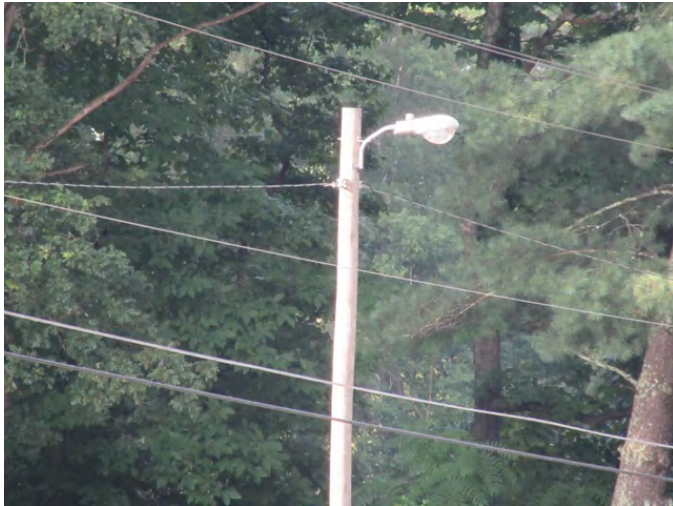
System: G4020 - Site Lighting

Location: Site

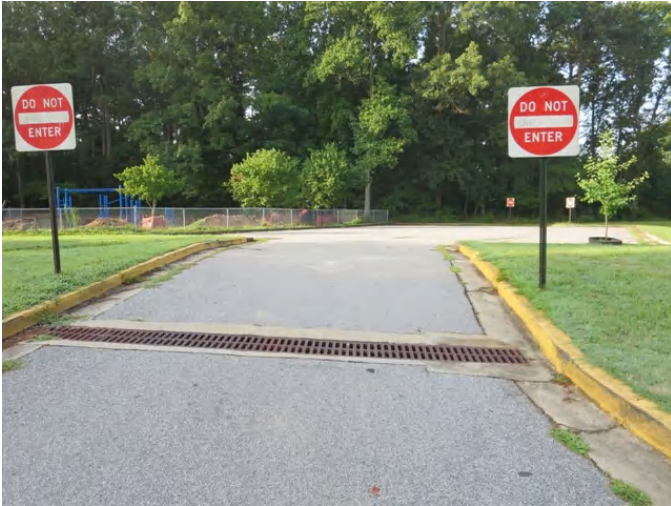
System: G2010 - Roadways

Location: West Side of Site

Distress: Beyond Service Life

Notes: Roadways are beyond their expected service life, have some deterioration, and should be scheduled for replacement.

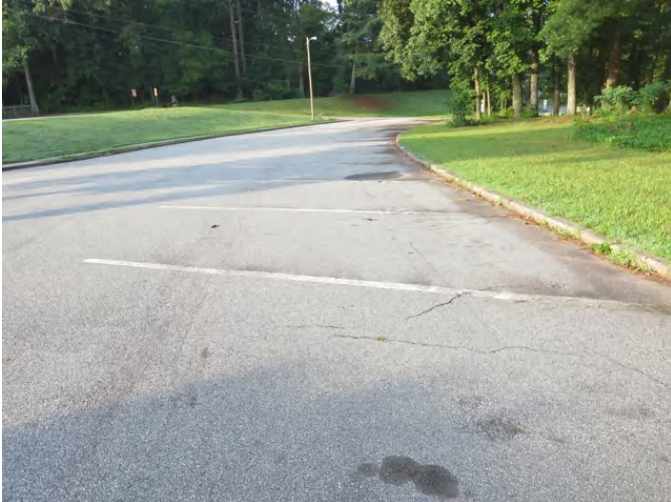
System: G2020 - Parking Lots

Location: South Side of Site

Distress: Beyond Service Life

Notes: The parking lots are beyond their expected service life, deteriorating, not fully ADA compliant, and should be replaced.

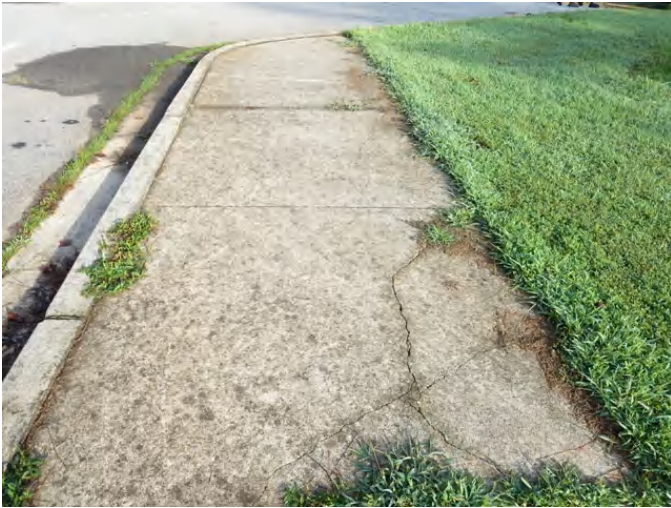
System: G2030 - Pedestrian Paving

Location: Site

Distress: Beyond Service Life

Notes: Pedestrian paving is beyond its expected service life, damaged, and should be replaced. SPLOST project 414-422 to replace/repair pedestrian paving throughout site.

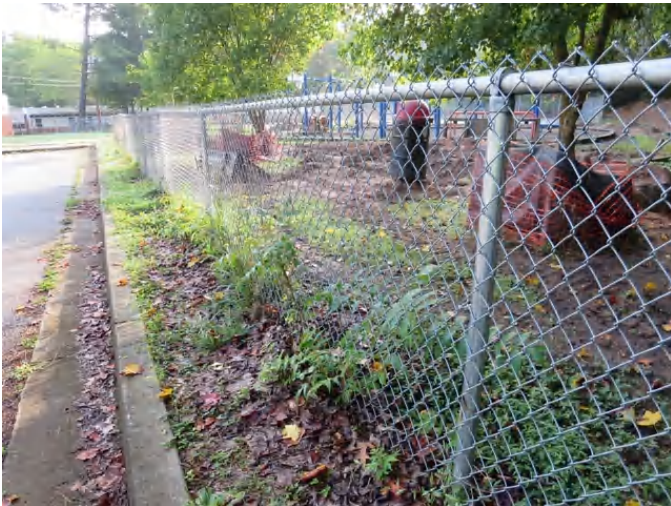
System: G2040 - Fencing & Guardrails

Location: Site

Distress: Beyond Service Life

Notes: Fencing is beyond its expected service life and should be scheduled for replacement.

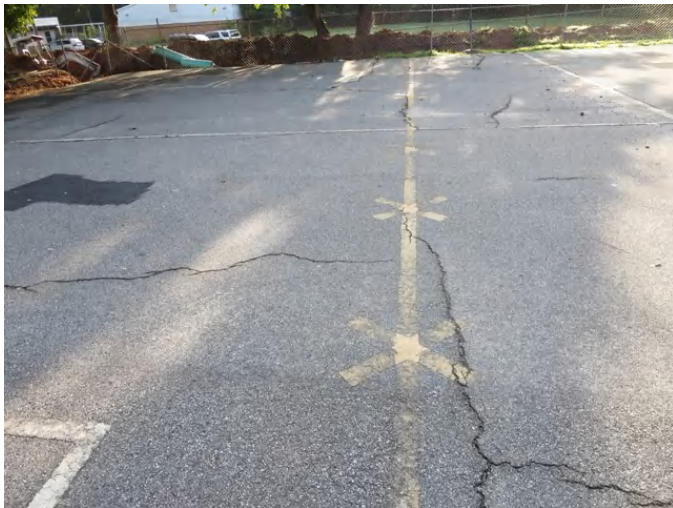
System: G2040 - Hard Surface Play Area

Location: South Site of Site

Distress: Beyond Service Life

Notes: The hard surface play area is beyond its expected service life, damaged with cracks, and should be replaced. Basketball goals are also damaged and should be replaced.

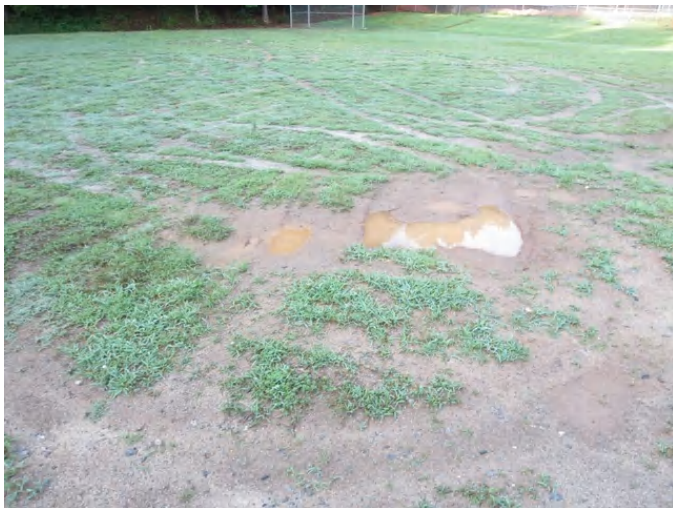
System: G2040 - Playing Field

Location: Site

Distress: Beyond Service Life

Notes: The playing field is beyond its expected service life, worn and bare, and should be replaced and barricaded to prevent erosion and damage from cars driving on it.

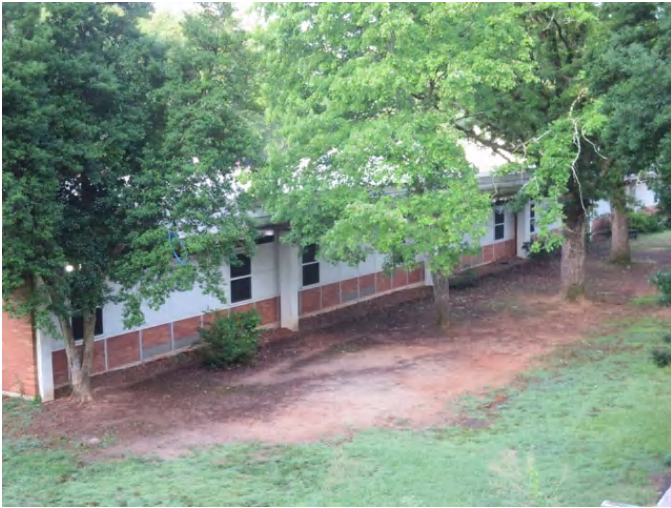
System: G2050 - Landscaping

Location: Site

Distress: Beyond Service Life

Notes: Landscaping is beyond its expected service life, damaged, and should be replaced. In addition, the site does not drain properly in all areas; SPLOST project 414-422 to review and make repairs.

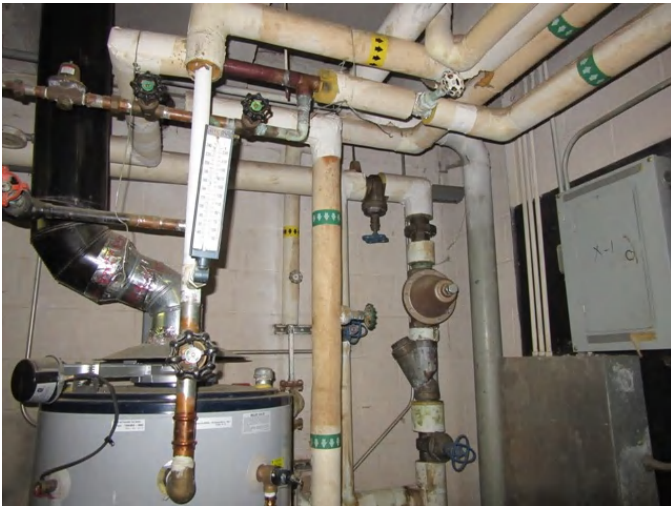
System: G3010 - Water Supply

Location: Site

Distress: Beyond Service Life

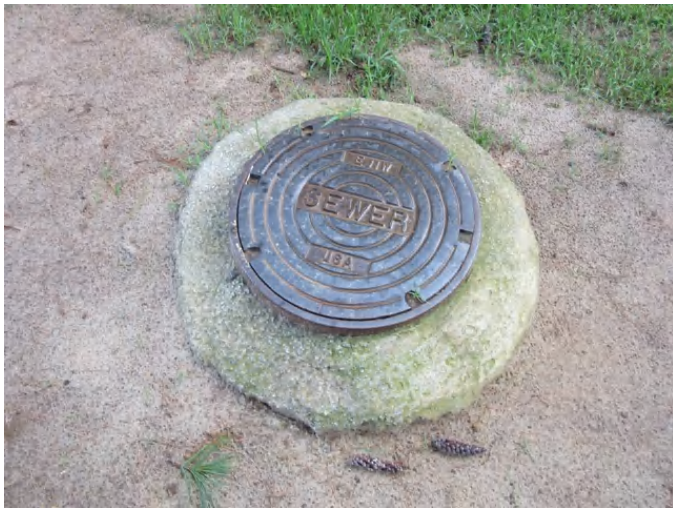
System: G3020 - Sanitary Sewer

Location: Site
Distress: Beyond Service Life
Category: Deferred Maintenance
Priority: 3 Priority
Correction: Renew System
Qty: 53,528.00
Unit of Measure: S.F.
Estimate: \$67,712.92
Assessor Name: Eduardo Lopez
Date Created: 07/16/2015

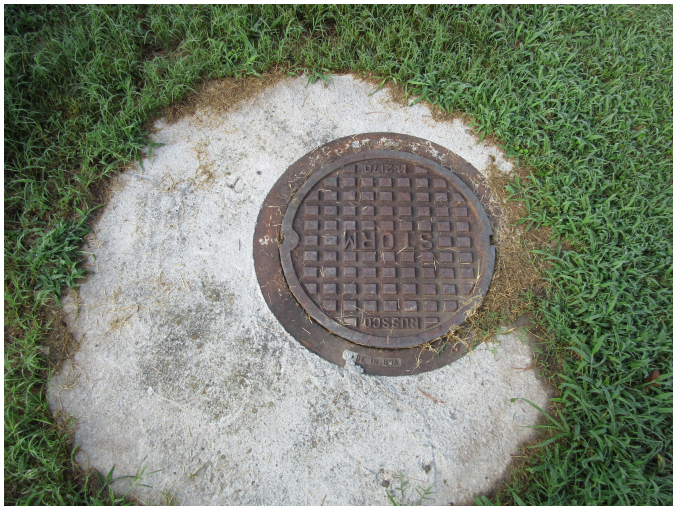
System: G3030 - Storm Sewer

Location: Site
Distress: Beyond Service Life
Category: Deferred Maintenance
Priority: 3 Priority
Correction: Renew System
Qty: 53,528.00
Unit of Measure: S.F.
Estimate: \$209,026.84
Assessor Name: Sam Mandola
Date Created: 07/16/2015

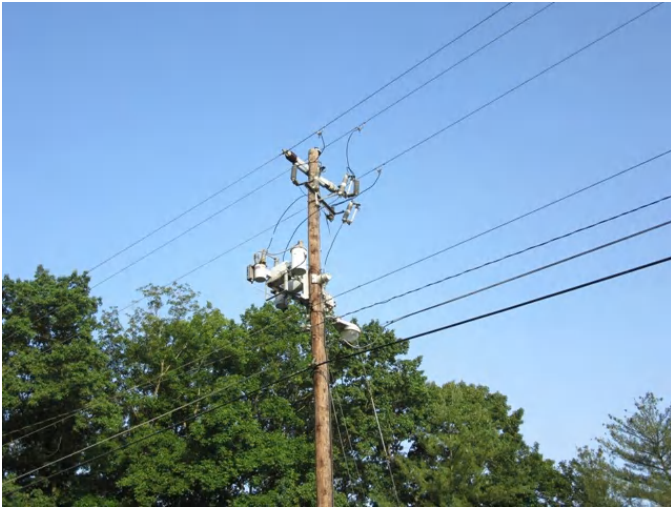
System: G4010 - Electrical Distribution

Location: Site
Distress: Beyond Service Life
Category: Deferred Maintenance
Priority: 3 Priority
Correction: Renew System
Qty: 53,528.00
Unit of Measure: S.F.
Estimate: \$109,518.29
Assessor Name: Eduardo Lopez
Date Created: 07/16/2015

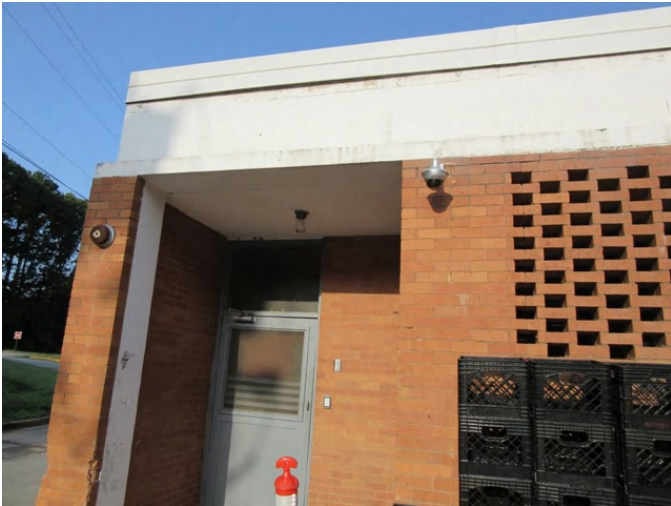
System: G4030 - Site Communications & Security

Location: Site
Distress: Beyond Service Life
Category: Deferred Maintenance
Priority: 3 Priority
Correction: Renew System
Qty: 53,528.00
Unit of Measure: S.F.
Estimate: \$39,450.14
Assessor Name: Sam Mandola
Date Created: 07/16/2015

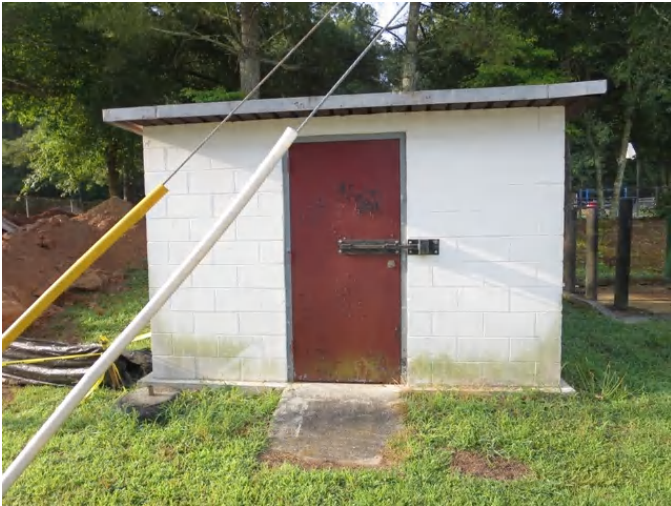
System: B2030 - Exterior Doors

Location: South Elevation

Distress: Beyond Service Life

Notes: The original exterior door is aged, rusted, and should be replaced.

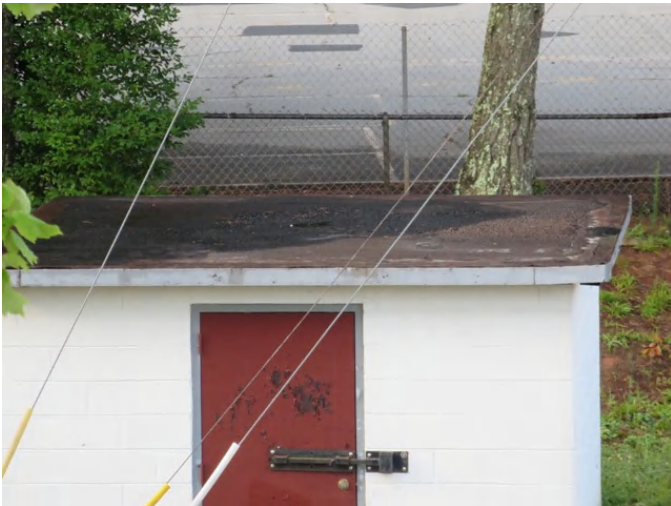
System: B3010 - Roof Coverings

Location: Roof

Distress: Beyond Service Life
