DeKalb County School District/Middle Schools

Henderson Middle

School Assessment Report

May 20, 2016

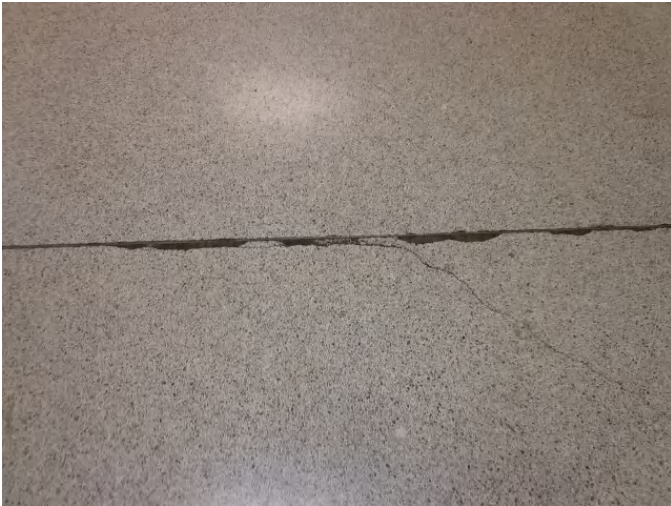
System: A1010 - Standard Foundations

Location: Throughout Building

Distress: Damaged

Notes: Floors are cracked throughout the building. An engineering study is recommended to determine the cause. Pricing does not include remediation measures.

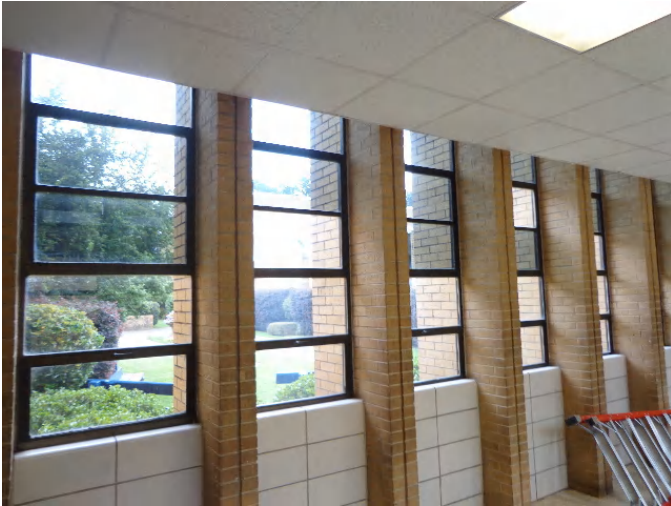
System: B2020 - Exterior Windows

Location: Throughout Building

Distress: Beyond Service Life

Notes: The aluminum frame, operable, single pane windows are aged, rusted, not energy efficient, and should be replaced. The windows do not seal properly and reportedly shake when the wind blows.

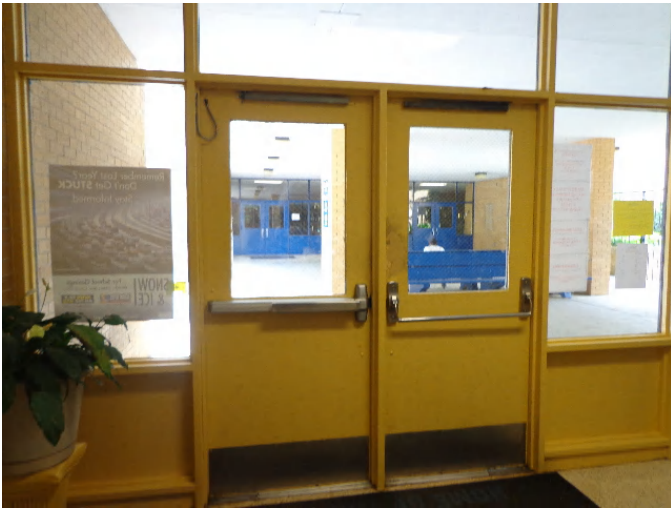
System: B2030 - Exterior Doors

Location: Throughout Building

Distress: Beyond Service Life

Notes: The original exterior doors are aged, do not seal properly and not energy efficient, and should be replaced.

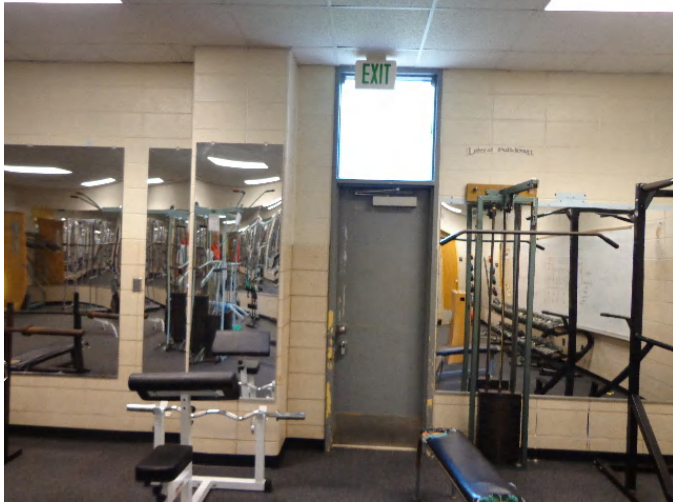
System: B2030 - Exterior Doors

Location: 702 Weight Room, 603 Orchestra Classroom, and Mechanical Room

Distress: Missing

Correction: Replace door panic device

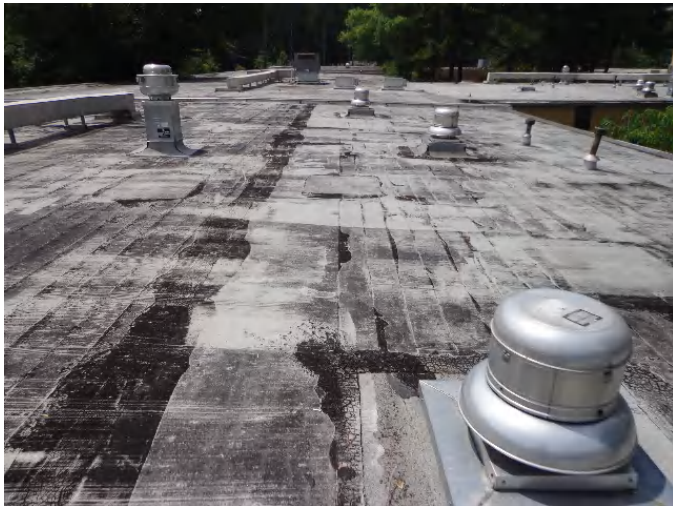
System: B3010 - Roof Coverings - BUR

Location: Roof

Distress: Beyond Service Life

Notes: The built-up roof covering is in deteriorating condition, with cracking, bubbling, loss of surface, patches, ponding water, and reported water leaks, and should be replaced.

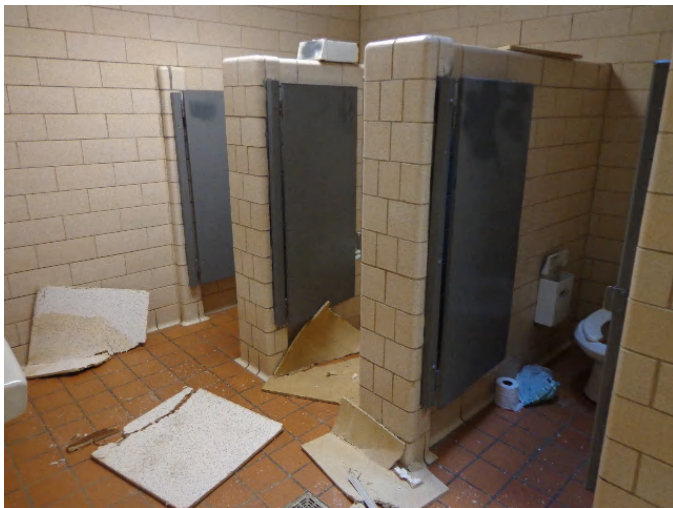
System: C1030 - Fittings

Location: Restrooms Next to 604 Tech Lab and Locker Rooms

Distress: Beyond Service Life

Notes: Most toilet and urinal partitions were replaced, except for the ones in restrooms next to 604 tech lab and locker rooms.

Correction: Replace toilet partitions, phenolic-overhead braced, per stall

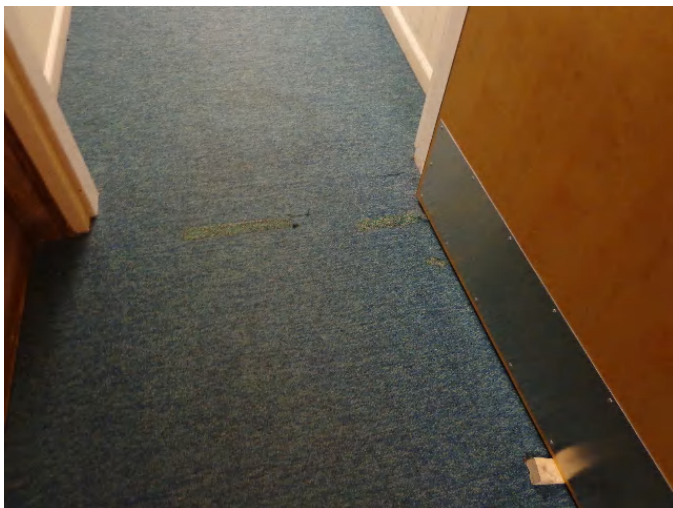
System: C3020 - Floor Finishes - Carpet

Location: Offices and Weight Room

Distress: Beyond Service Life

Notes: The media center has a newer carpet; however, in most areas the carpet is aged, stained, and torn, and should be replaced.

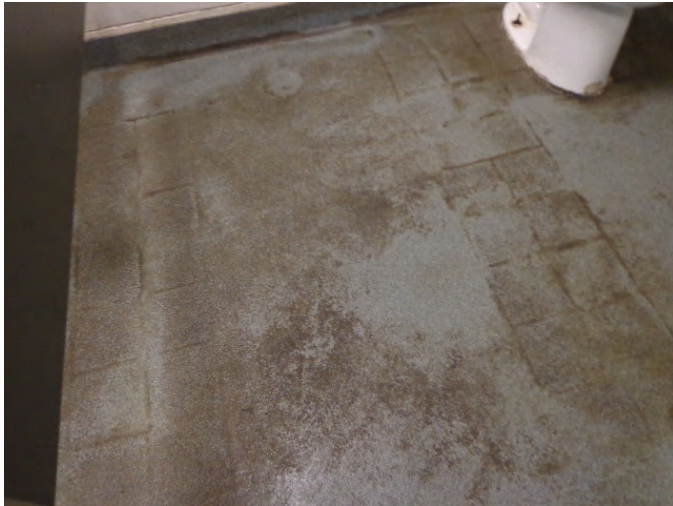
System: C3020 - Floor Finishes - Ceramic & Quarry Tile

Location: Restrooms

Distress: Inadequate

Notes: The original quarry tile in the restrooms was painted over with an epoxy coat finish, which is an unsuitable material. The epoxy finish is wearing off rapidly and it is not possible to wash or clean this surface. The epoxy finish should be removed and replaced with a more suitable coating material for wet areas.

Correction: Replace epoxy flooring

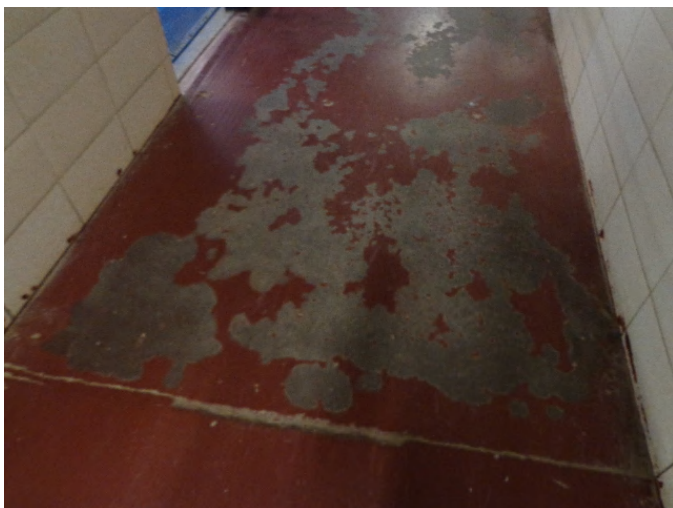
System: C3020 - Floor Finishes - Epoxy

Location: Locker Rooms

Distress: Beyond Service Life

Notes: The epoxy floor finish is in poor condition, with different areas worn and stained, and should be replaced.

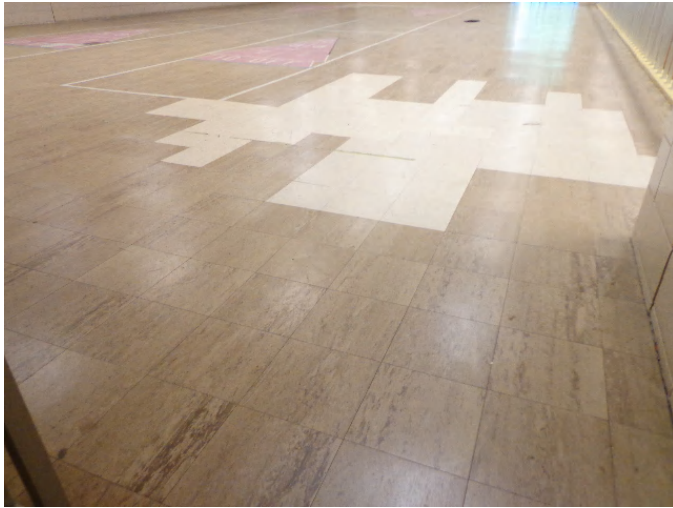
System: C3020 - Floor Finishes - VCT

Location: Throughout Building

Distress: Beyond Service Life

Notes: The VCT flooring is aged, cracked, worn and patched, and should be replaced.

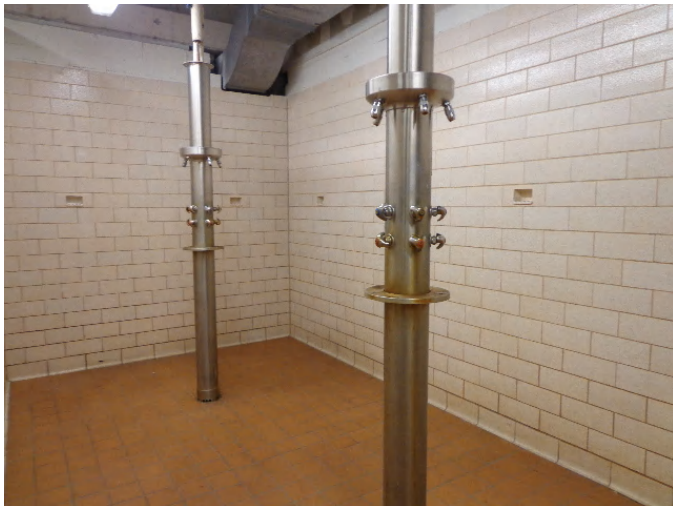
System: D2010 - Plumbing Fixtures

Location: Locker Rooms

Distress: Missing

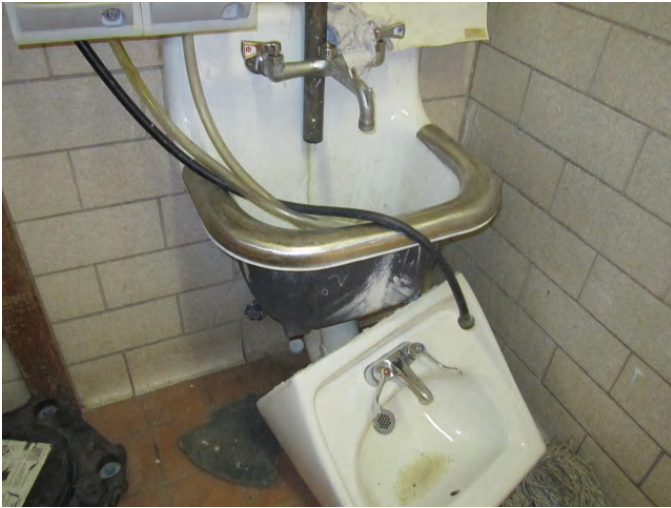
System: D2020 - Domestic Water Distribution

Location: Throughout Building

Distress: Beyond Service Life

Notes: The domestic water distribution system is beyond its expected service life and should be scheduled for replacement. School staff reports that water is not clear after long weekends or holidays. SPLOST IV project 512-422, including 416-422, may include plumbing upgrades.

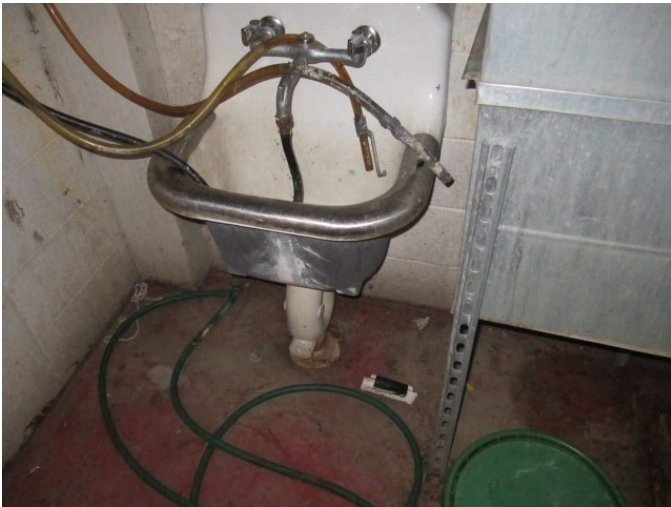
System: D2030 - Sanitary Waste

Location: Throughout Building

Distress: Beyond Service Life

Notes: The sanitary waste system is beyond its expected service life and should be scheduled for replacement. SPLOST IV project 512-422, including 416-422, may include replacement of the grease trap.

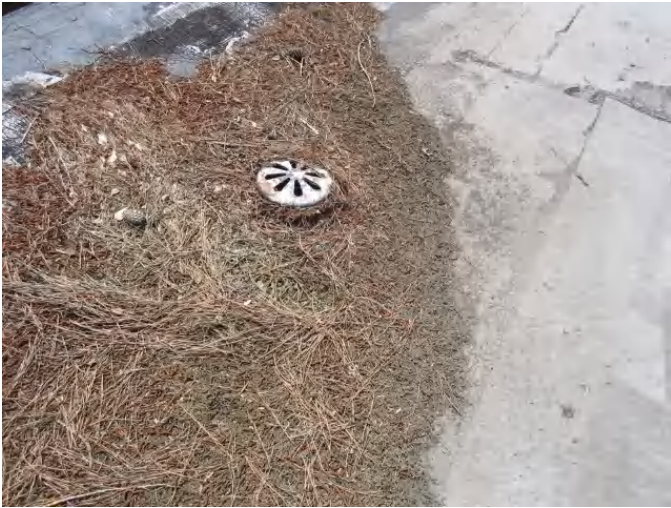
System: D2040 - Rain Water Drainage

Location: Roof

Distress: Beyond Service Life

Notes: The roof drainage system is beyond its expected service life, reportedly stopped up, and should be replaced in conjunction with the roof. SPLOST IV project 512-422, including 416-422, may include plumbing upgrades.

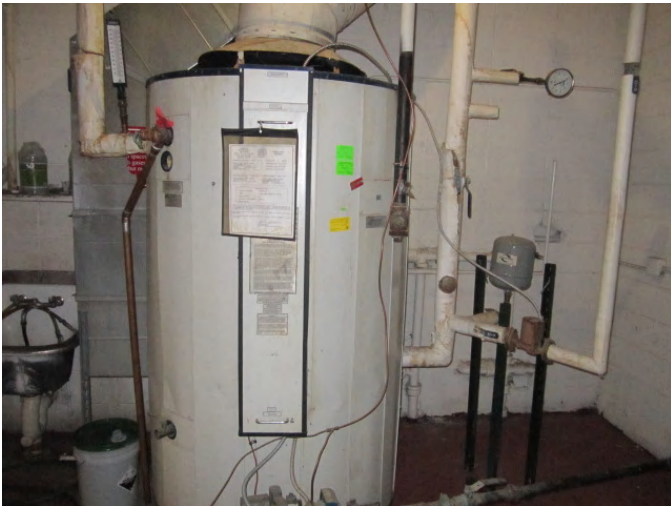
System: D2090 - Other Plumbing Systems - Natural Gas

Location: Throughout Building

Distress: Beyond Service Life

Notes: The natural gas distribution system is beyond its expected service life and should be scheduled for replacement. SPLOST IV project 512-422, including 416-422, may include plumbing upgrades.

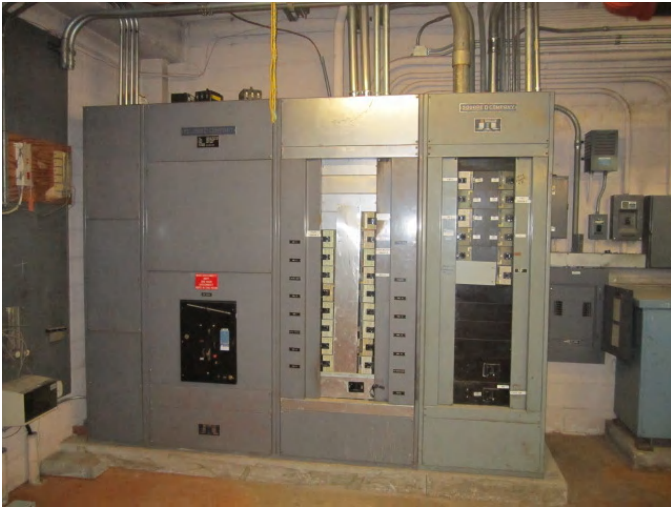
System: D5010 - Electrical Service/Distribution

Location: Throughout Building
Distress: Beyond Service Life
Category: Deferred Maintenance
Priority: 3 Priority
Correction: Renew System
Qty: 158,140.00
Unit of Measure: S.F.
Estimate: \$295,722.00
Assessor Name: Ben Nixon
Date Created: 06/11/2015

Notes: The electrical service/distribution system is beyond its expected service life and should be scheduled for replacement. SPLOST IV project 512-422, including 416-422, may include electrical upgrades.

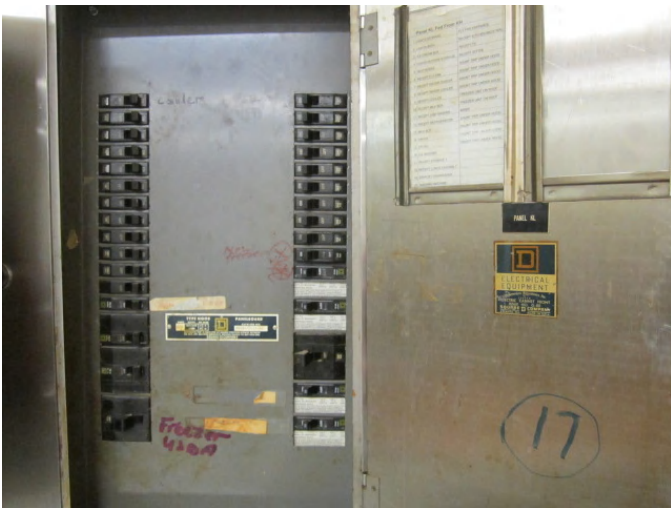
System: D5020 - Branch Wiring

Location: Throughout Building
Distress: Beyond Service Life
Category: Deferred Maintenance
Priority: 3 Priority
Correction: Renew System
Qty: 158,140.00
Unit of Measure: S.F.
Estimate: \$946,310.00
Assessor Name: Ben Nixon
Date Created: 04/11/2015

Notes: The branch wiring system is beyond its expected service life and should be scheduled for replacement. SPLOST IV project 512-422, including 416-422, may include electrical upgrades.

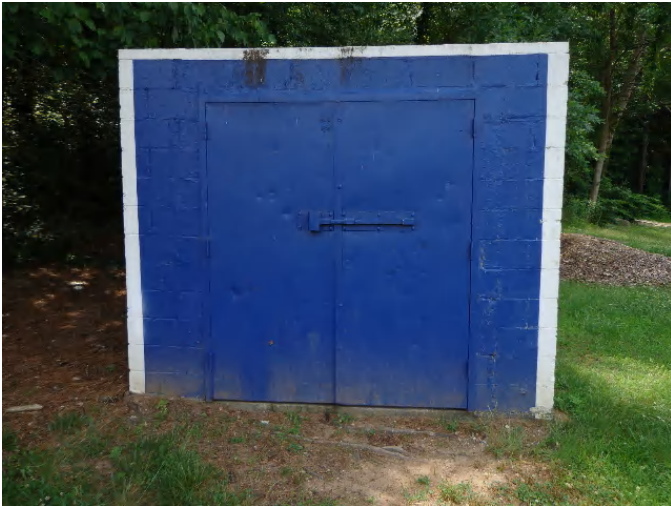
System: B2030 - Exterior Doors

Location: Exterior Wall

Distress: Beyond Service Life

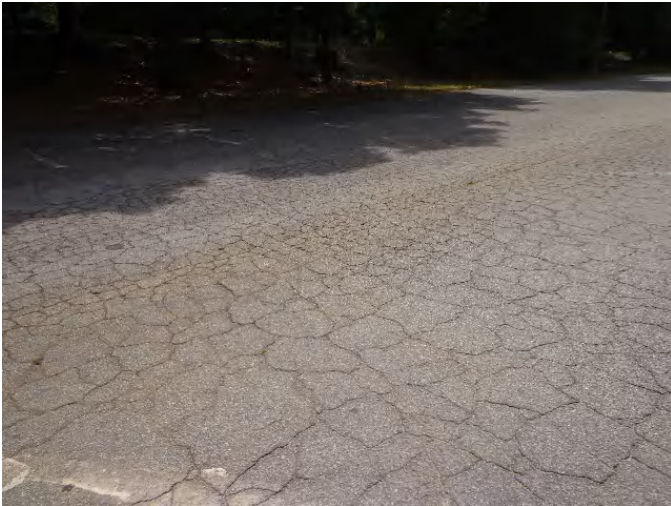
System: G2010 - Roadways

Location: Site

Distress: Beyond Service Life

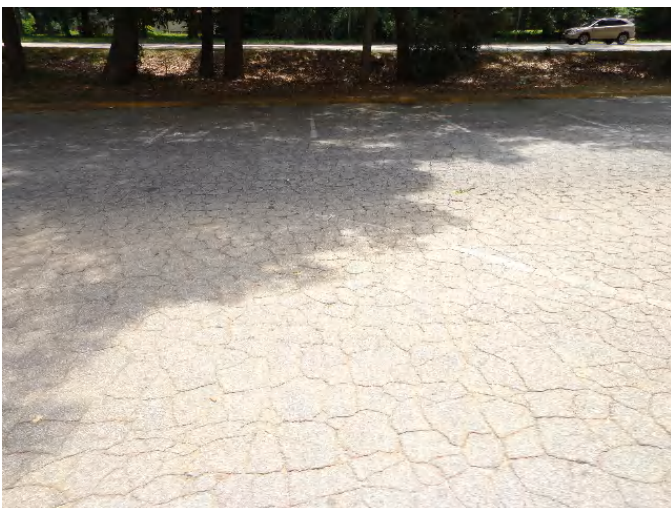
System: G2020 - Parking Lots

Location: Site

Distress: Beyond Service Life

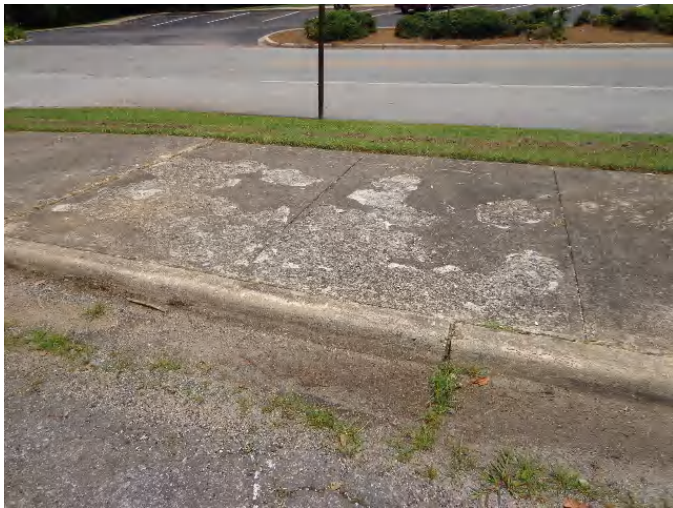
System: G2030 - Pedestrian Paving

Location: Site

Distress: Beyond Service Life

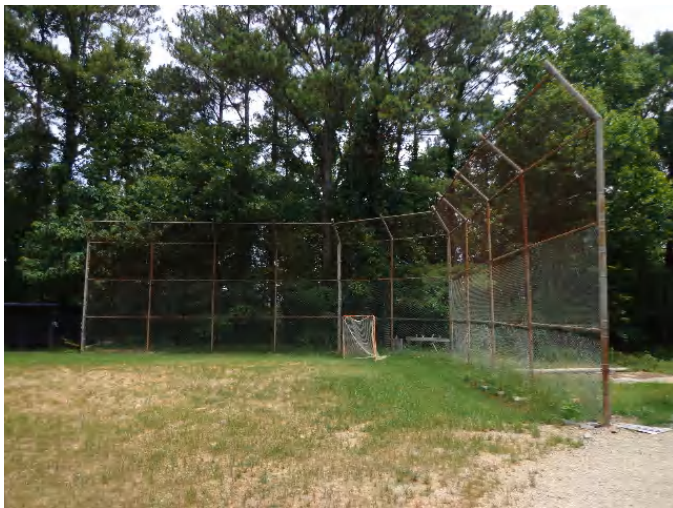
System: G2040 - Baseball Field

Location: Site

Distress: Beyond Service Life

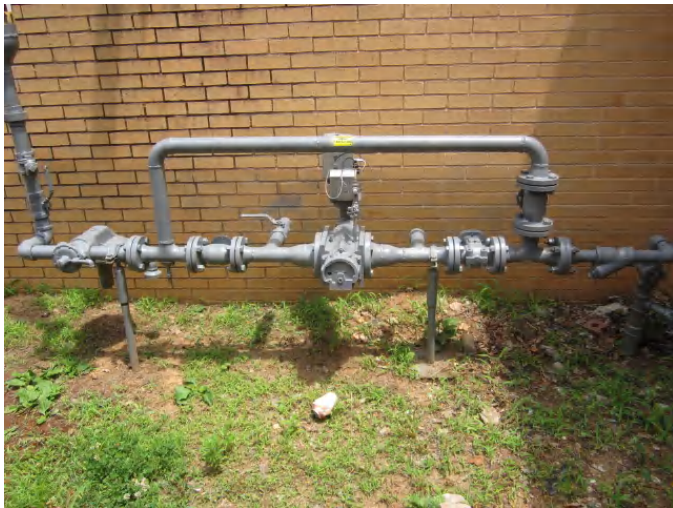
System: G3060 - Fuel Distribution

Location: Site
Distress: Beyond Service Life
Category: Deferred Maintenance
Priority: 3 Priority
Correction: Renew System
Qty: 158,260.00
Unit of Measure: S.F.
Estimate: \$135,787.08
Assessor Name: Eduardo Lopez
Date Created: 06/15/2015

Notes: Natural gas service is beyond its expected service life and should be scheduled for replacement.

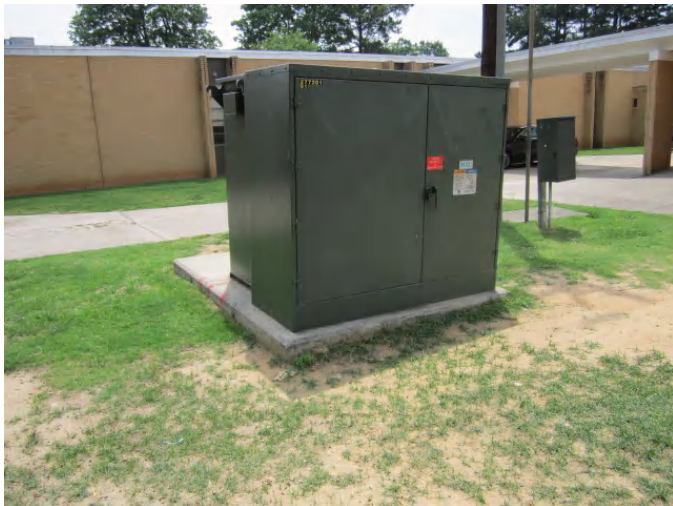
System: G4010 - Electrical Distribution

Location: Site
Distress: Beyond Service Life
Category: Deferred Maintenance
Priority: 3 Priority
Correction: Renew System
Qty: 158,260.00
Unit of Measure: S.F.
Estimate: \$323,799.96
Assessor Name: Eduardo Lopez
Date Created: 06/10/2015

Notes: The electrical distribution system is beyond its expected service life and should be scheduled for replacement. SPLOST IV project 512-422, including 416-422, may include electrical upgrades.

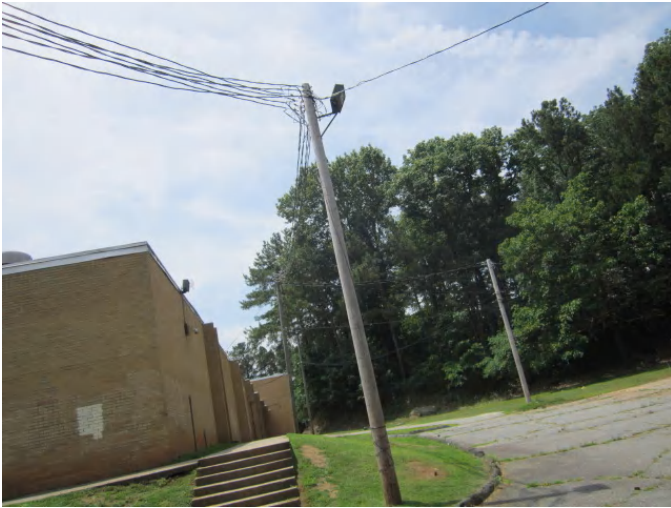
System: G4020 - Site Lighting

Location: Site

Distress: Beyond Service Life

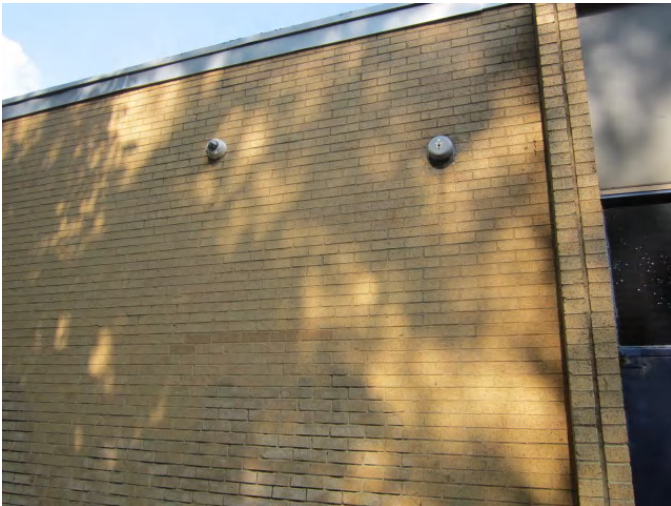
System: G4030 - Site Communications & Security

Location: Site

Distress: Beyond Service Life
