DeKalb County School District/Elementary Schools

Huntley Hills Elementary

School Assessment Report

May 19, 2016

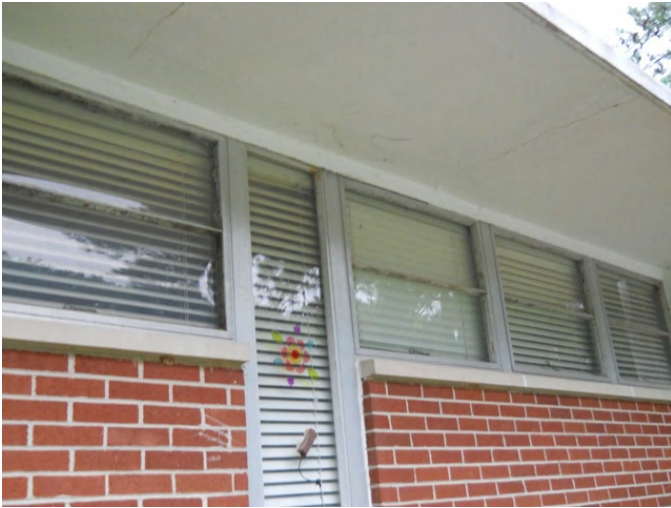
System: B2020 - Exterior Windows

Location: Throughout Building

Distress: Beyond Service Life

Notes: The exterior window system is original construction, beyond service life, leaks, and should be replaced.

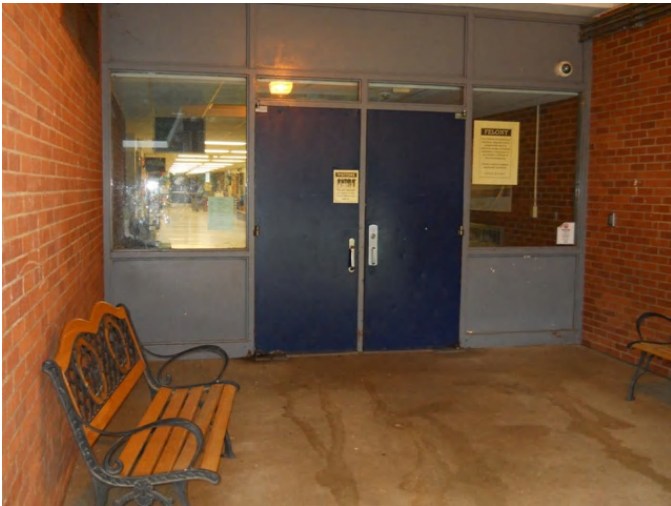
System: B2030 - Exterior Doors

Location: Throughout Building

Distress: Beyond Service Life

Notes: The exterior door system is beyond its expected service life and should be replaced.

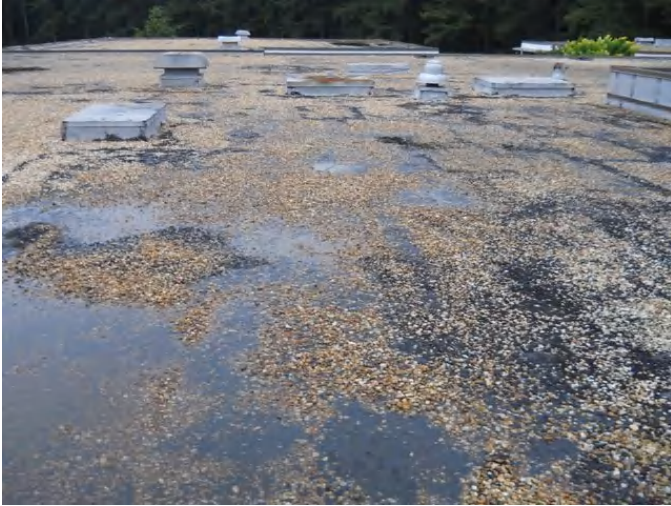
System: B3010 - Roof Coverings - BUR

Location: Roof

Distress: Beyond Service Life

Notes: The roof is leaking, gutters are plugged with debris, and should be replaced. SPLOST project 112-422 to replace the roofs on the 64, 66 and 68 buildings.

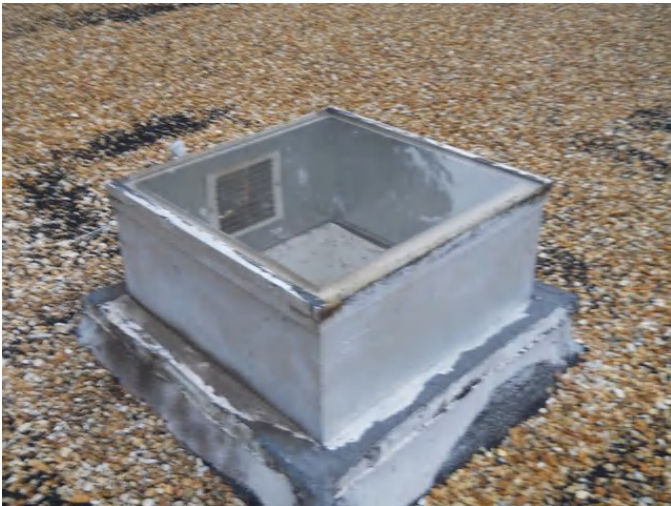
System: B3020 - Roof Openings

Location: Roof

Notes: The building does not have a safe roof hatch/ladder for maintenance personnel. Roof skylights are leaking. Recommend replacement of skylights and installation of an OSHA-compliant roof hatch/ladder system. SPLOST project 112-442 to install roof hatch and ladder as appropriate.

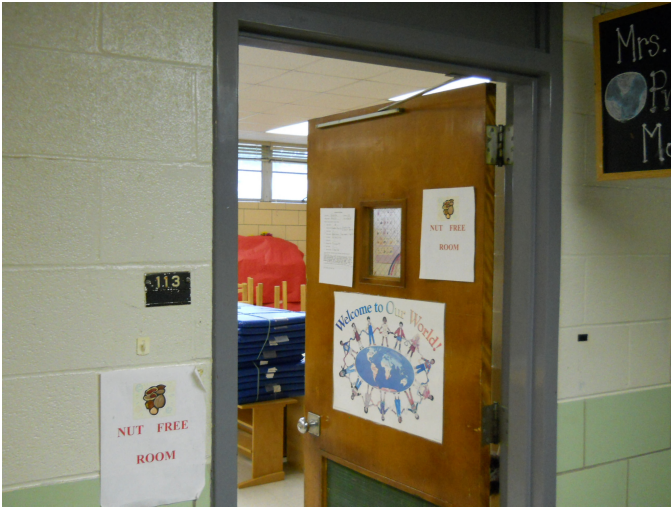
System: C1020 - Interior Doors

Location: Throughout Building

Notes: The interior doors are original and should be replaced to improve ADA accessibility.

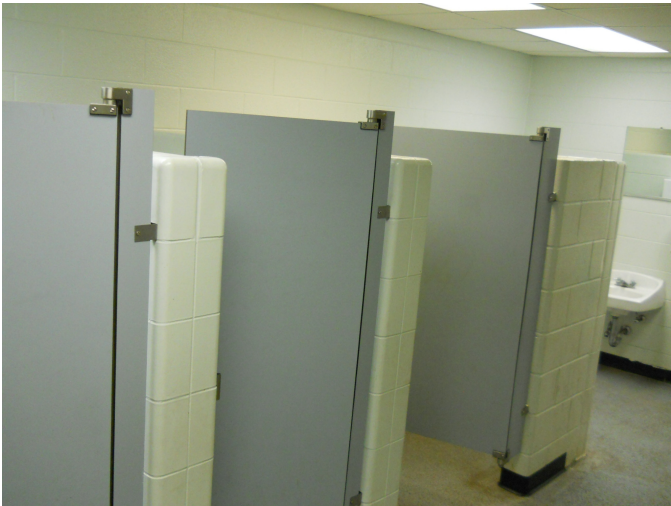
System: C1030 - Fittings

Location: Throughout Building

Notes: Fittings, such as toilet partitions, handrails and signage, are beyond their expected service life, not ADA compliant, and should be replaced. SPLOST project 112-422 to provide hall bathroom renovations.

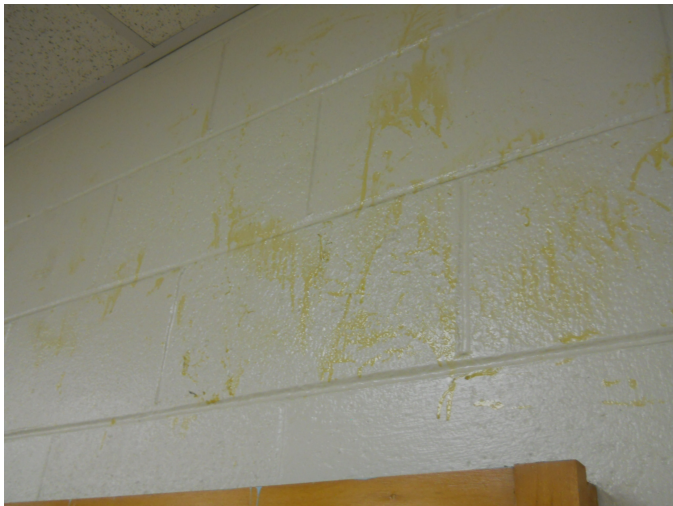
System: C3010 - Wall Finishes - Paint

Location: Throughout Building

Notes: The painted wall finishes are beyond their expected service life, dirty and worn, and should be replaced.

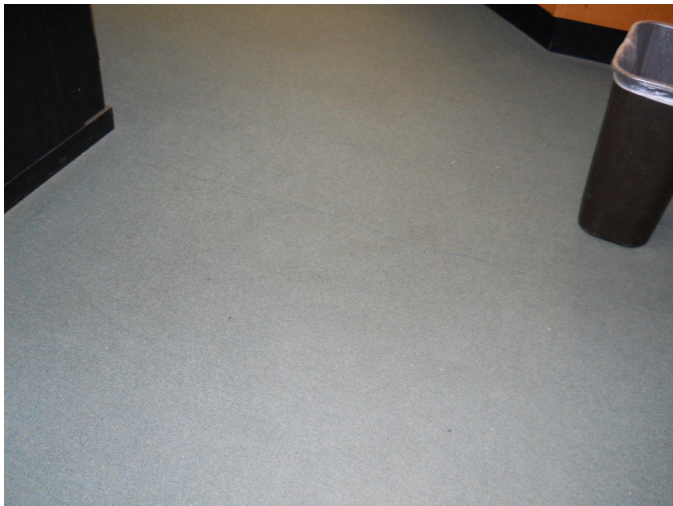
System: C3020 - Floor Finishes - Carpet

Location: Media Center, Offices

Notes: The carpet is beyond its expected service life, worn, and should be replaced.

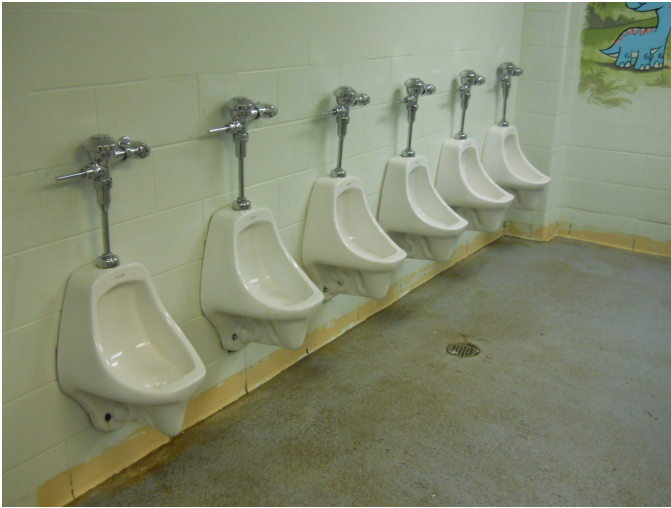
System: C3020 - Floor Finishes - Epoxy Paint

Location: Restrooms
Distress: Inadequate
Category: Deferred Maintenance
Priority: 3 Priority
Correction: Renew System
Qty: 4,853.00
Unit of Measure: S.F.
Estimate: \$6,032.00
Assessor Name: Ben Nixon
Date Created: 07/16/2015

Notes: The epoxy floor covering is inadequate, cannot maintain sanitary conditions, and should be replaced.

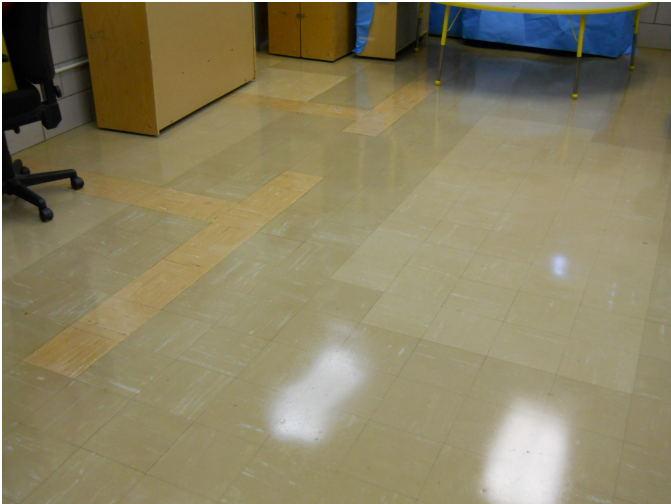
System: C3020 - Floor Finishes - VCT

Location: Classrooms
Distress: Beyond Service Life
Category: Deferred Maintenance / Environmental
Priority: 3 Priority
Correction: Replace VCT flooring
Qty: 21,500.00
Unit of Measure: S.F.
Estimate: \$178,020.00
Assessor Name: Ben Nixon
Date Created: 07/06/2015

Notes: Most classrooms still have VAT flooring. The VAT floor covering is beyond its expected service life and should be replaced.

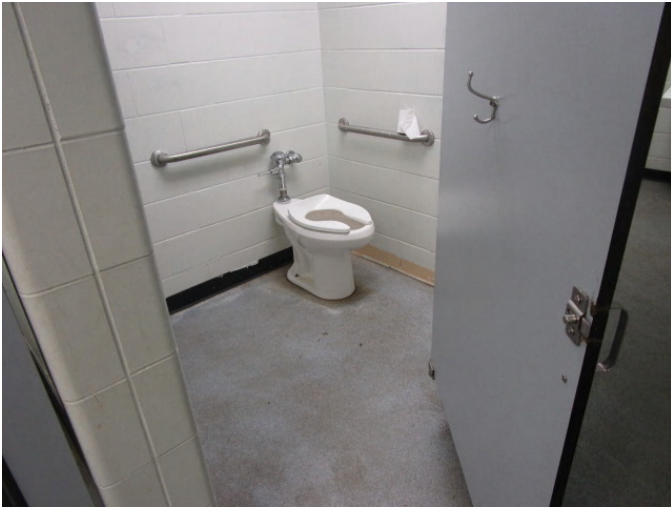
System: D2010 - Plumbing Fixtures

Location: Throughout Building

Notes: Plumbing fixtures are beyond their expected service life, not ADA compliant, including protrusions into the hallway more than four inches, and should be scheduled for replacement.

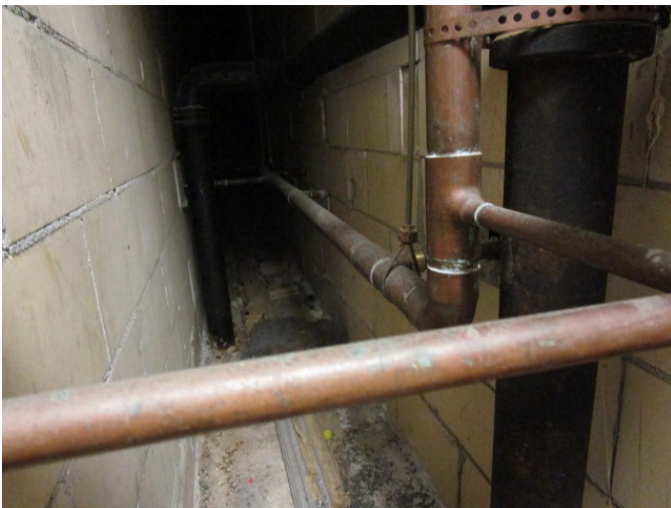
System: D2020 - Domestic Water Distribution

Location: Throughout Building

Notes: The domestic water distribution system is beyond its expected service life and should be scheduled for replacement.

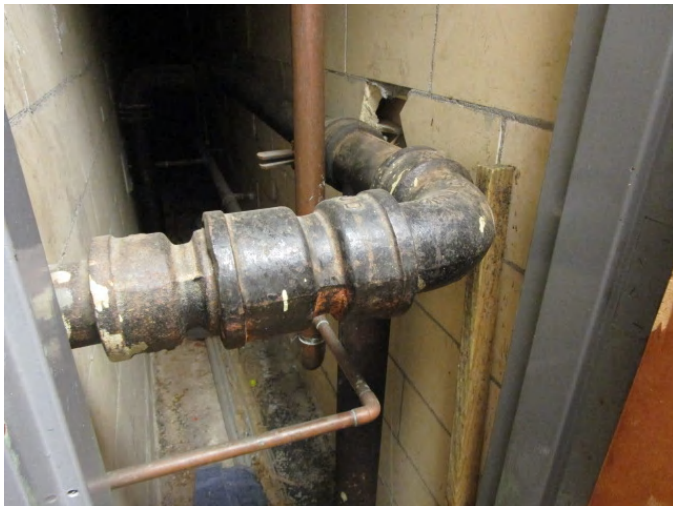
System: D2030 - Sanitary Waste

Location: Throughout Building
Distress: Beyond Service Life
Category: Deferred Maintenance
Priority: 3 Priority
Correction: Renew System
Qty: 48,534.00
Unit of Measure: S.F.
Estimate: \$182,051.00
Assessor Name: Sam Mandola
Date Created: 04/11/2015

Notes: The sanitary waste system is beyond its expected service life and should be scheduled for replacement.

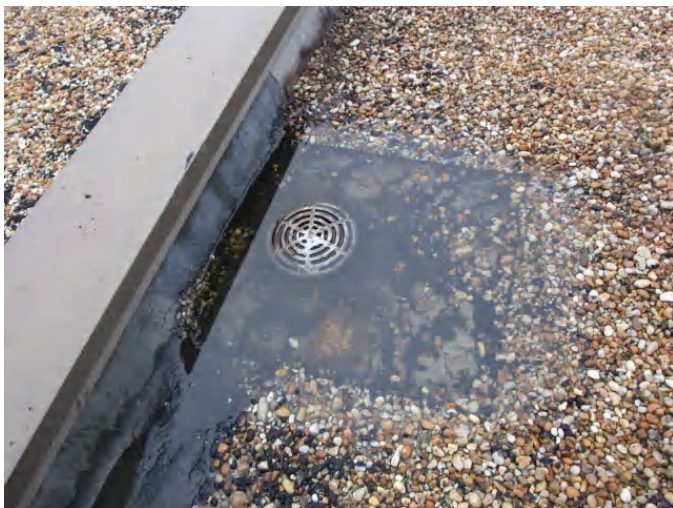
System: D2040 - Rain Water Drainage

Location: Throughout Building
Distress: Beyond Service Life
Category: Deferred Maintenance
Priority: 3 Priority
Correction: Renew System
Qty: 48,534.00
Unit of Measure: S.F.
Estimate: \$52,320.00
Assessor Name: Ben Nixon
Date Created: 04/11/2015

Notes: The rainwater drainage system is beyond its expected service life and should be scheduled for replacement.

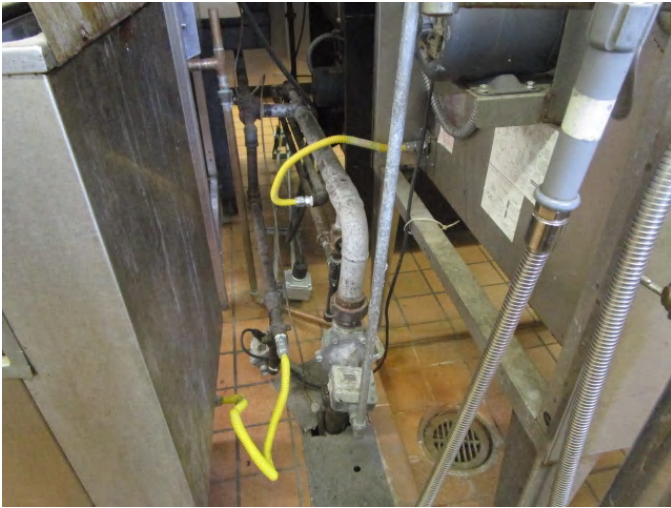
System: D2090 - Other Plumbing Systems - Natural Gas

Location: Throughout Building
Distress: Beyond Service Life
Category: Deferred Maintenance
Priority: 3 Priority
Correction: Renew System
Qty: 48,534.00
Unit of Measure: S.F.
Estimate: \$21,889.00
Assessor Name: Sam Mandola
Date Created: 04/11/2015

Notes: The natural gas system is beyond its expected service life and should be scheduled for replacement. SPLOST project 112-422 to replace grease trap and backflow preventer.

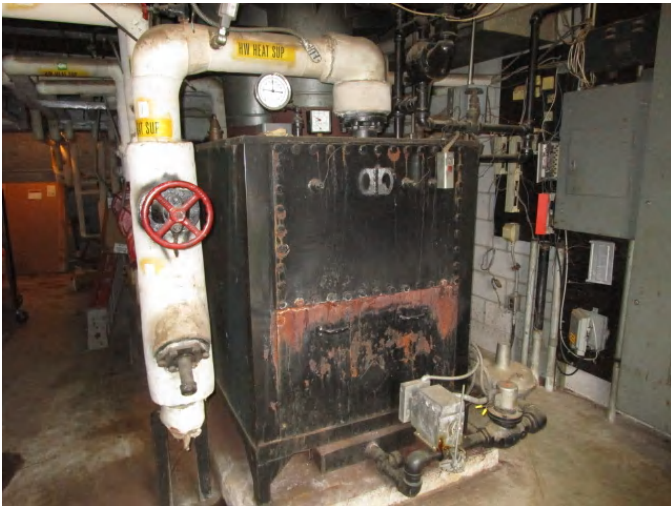
System: D3020 - Heat Generating Systems

Location: Mechanical Room
Distress: Beyond Service Life
Category: Deferred Maintenance / Energy
Priority: 3 Priority
Correction: Renew System
Qty: 48,534.00
Unit of Measure: S.F.
Estimate: \$242,913.00
Assessor Name: Ben Nixon
Date Created: 04/11/2015

Notes: The heat generating system is beyond its expected service life and should be scheduled for replacement.

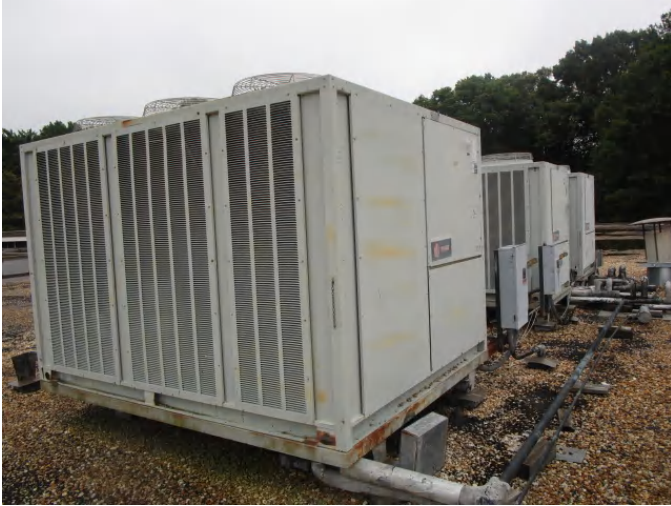
System: D3030 - Cooling Generating Systems

Location: Roof/Throughout Building

Notes: The cooling generating system is beyond its expected service life and should be scheduled for replacement. SPLOST project 112-422 to replace the air cooled chiller, air distribution and exhaust systems.

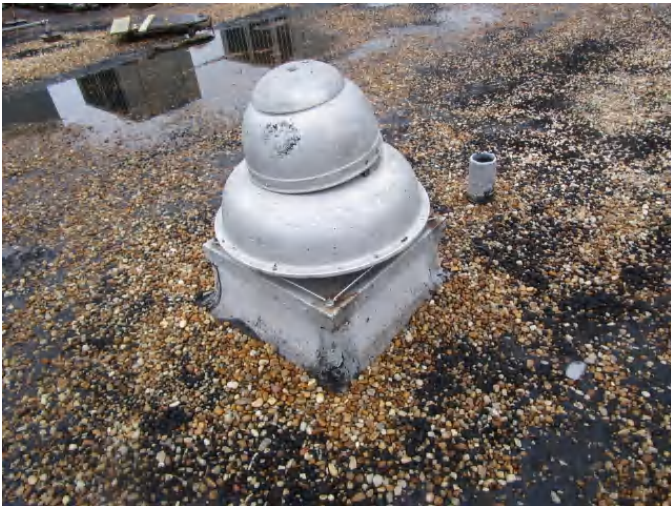
System: D3040 - Distribution & Exhaust Systems

Location: Throughout Building

Notes: The distribution systems and exhaust systems are beyond their expected service life and should be scheduled for replacement. SPLOST project 112-422 to replace the air cooled chiller, air distribution and exhaust systems.

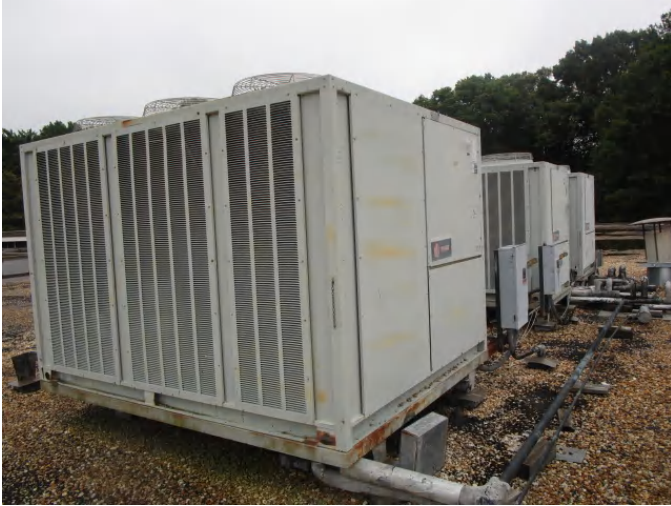
System: D3050 - Terminal & Package Units

Location: Throughout Building

Notes: The terminal and package units are beyond their expected service life and should be scheduled for replacement.

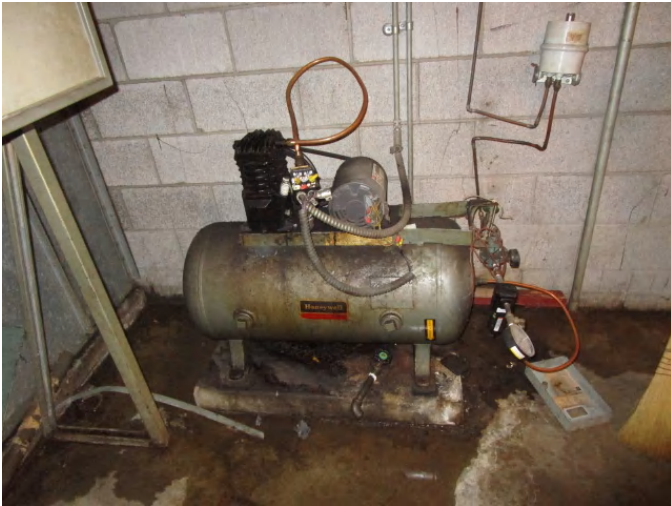
System: D3060 - Controls & Instrumentation

Location: Throughout Building

Notes: The controls and instrumentation system is beyond its expected service life and should be scheduled for replacement.

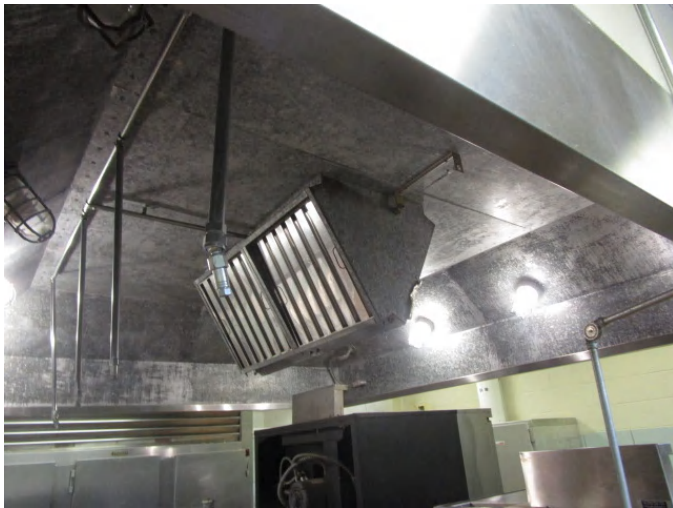
System: D3090 - Other HVAC Systems/Equip - Kitchen Hood

Location: Kitchen

Notes: The kitchen hood system is beyond its expected service life and should be scheduled for replacement.

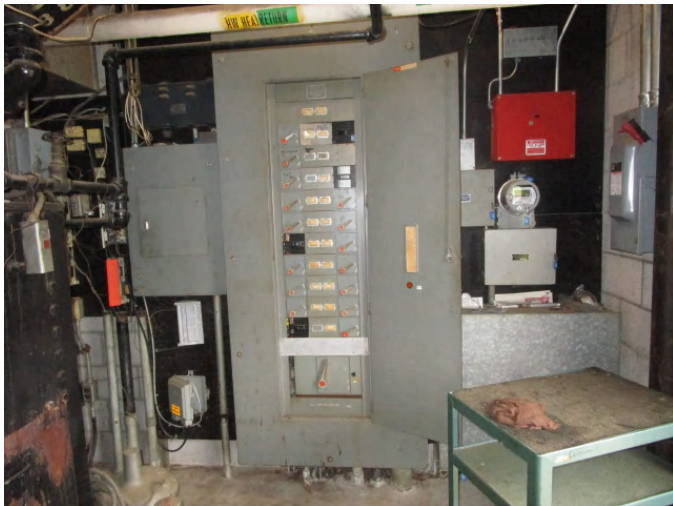
System: D5010 - Electrical Service/Distribution

Location: Main Switch Room/Throughout Building

Notes: The electrical service/distribution system is beyond its expected service life and should be scheduled for replacement.

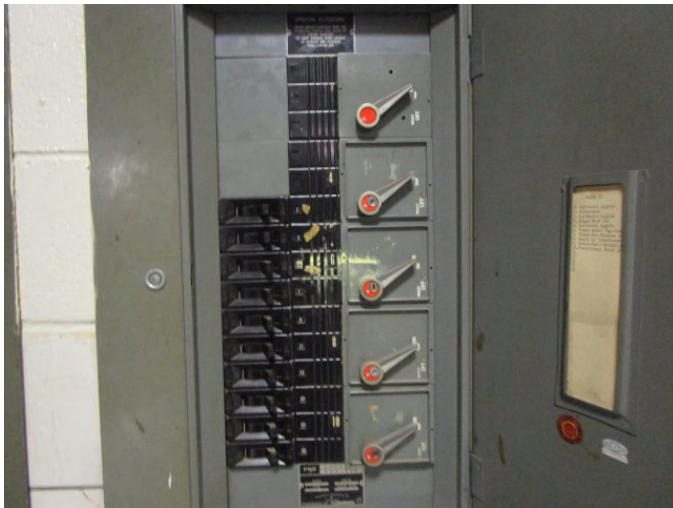
System: D5020 - Branch Wiring

Location: Throughout Building
Distress: Beyond Service Life
Category: Deferred Maintenance
Priority: 3 Priority
Correction: Renew System
Qty: 48,534.00
Unit of Measure: S.F.
Estimate: \$361,967.00
Assessor Name: Ben Nixon
Date Created: 04/11/2015

Notes: The branch wiring system is beyond its expected service life and should be scheduled for replacement.

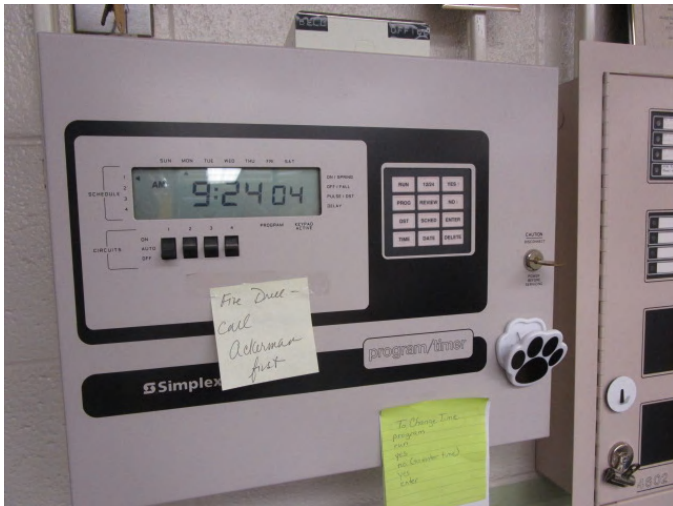
System: D5030 - Communications and Security - Clock & PA Systems

Location: Throughout Building
Distress: Beyond Service Life
Category: Deferred Maintenance
Priority: 3 Priority
Correction: Renew System
Qty: 48,534.00
Unit of Measure: S.F.
Estimate: \$298,969.00
Assessor Name: Ben Nixon
Date Created: 04/11/2015

Notes: Clock and PA systems are beyond their expected service life and should be scheduled for replacement.

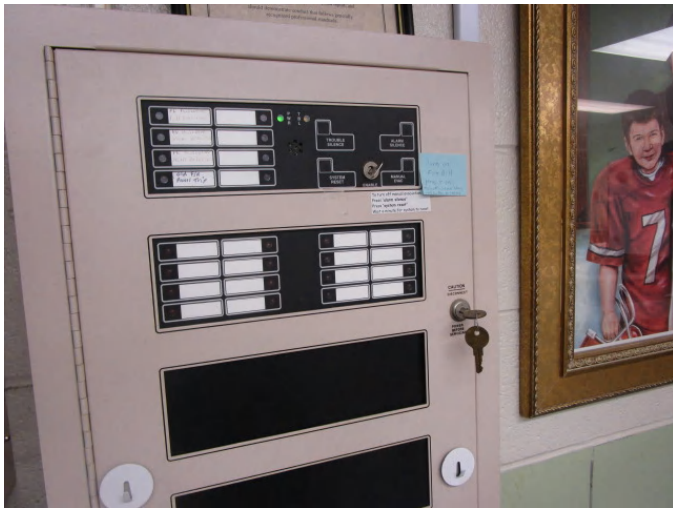
System: D5030 - Communications and Security - Fire Alarm

Location: Throughout Building

Notes: The fire alarm system is beyond its expected service life and should be scheduled for replacement.

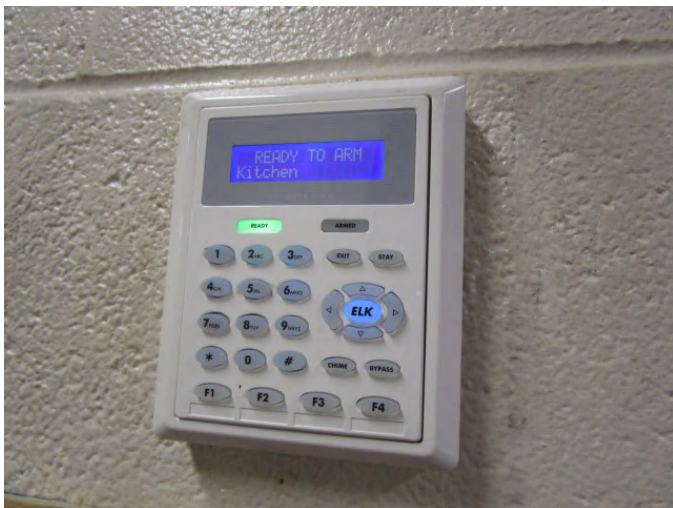
System: D5030 - Communications and Security - Security & CCTV

Location: Throughout Building

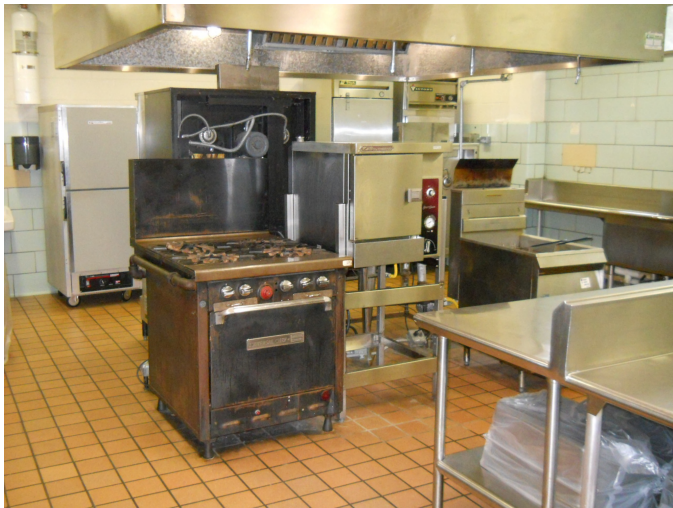
System: E1090 - Other Equipment - Kitchen Equip

Location: Kitchen

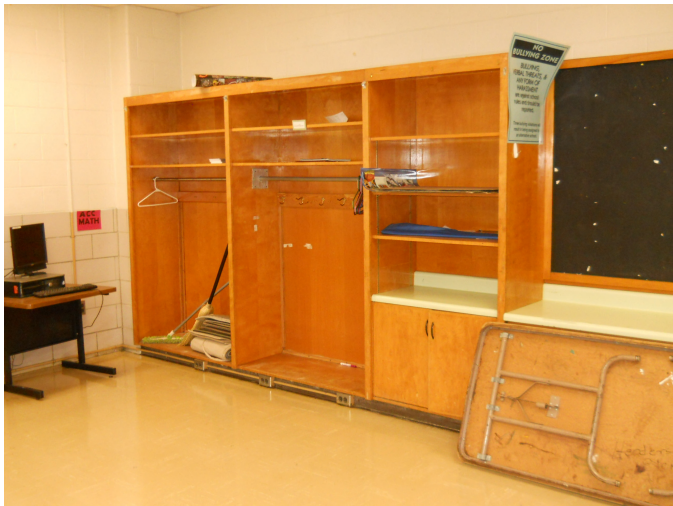
System: E2010 - Fixed Furnishings

Location: Throughout Building

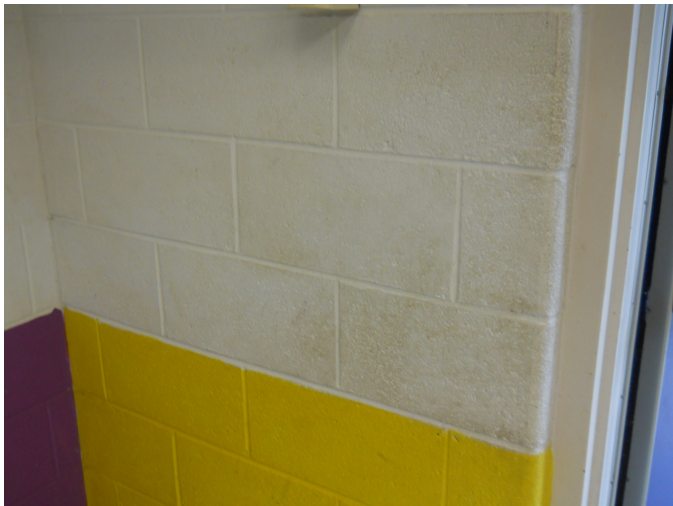
System: C3010 - Wall Finishes - Paint

Location: Throughout Building

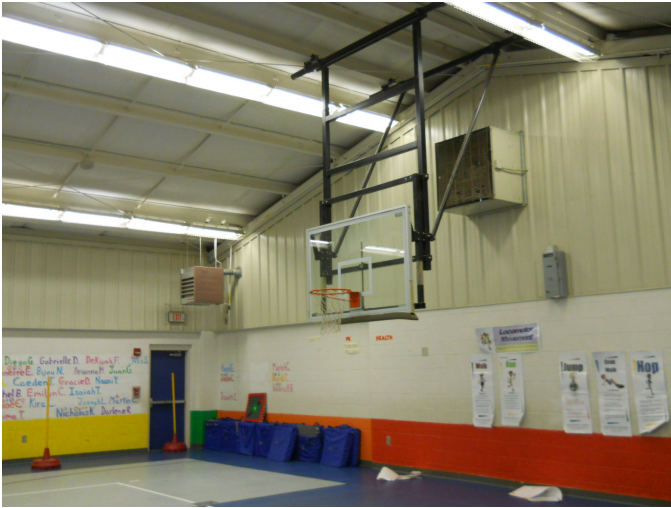
System: D3050 - Terminal & Package Units

Location: Throughout Building

Distress: Inadequate

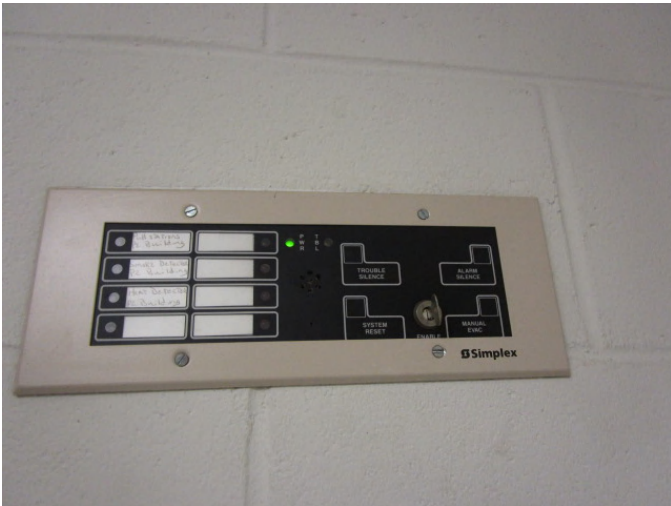
System: D5030 - Communications and Security - Fire Alarm

Location: Throughout Building

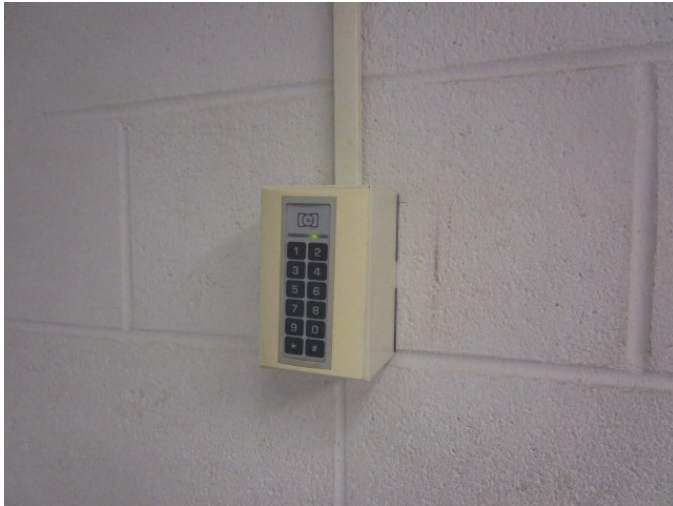
System: D5030 - Communications and Security - Security & CCTV

Location: Throughout Building

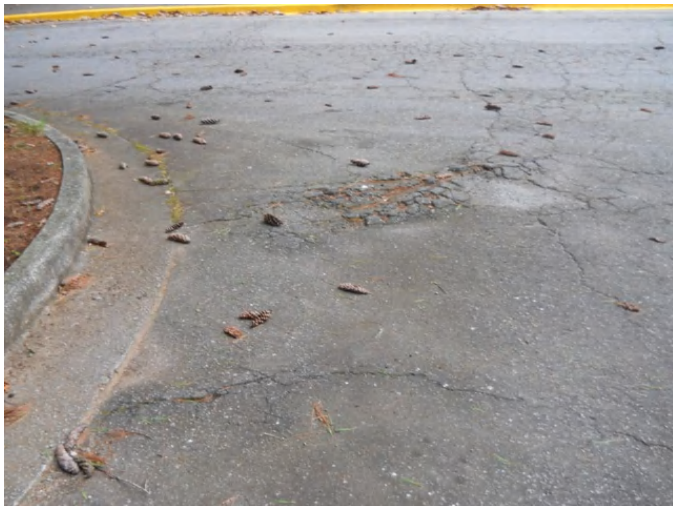
System: G2010 - Roadways

Location: Site

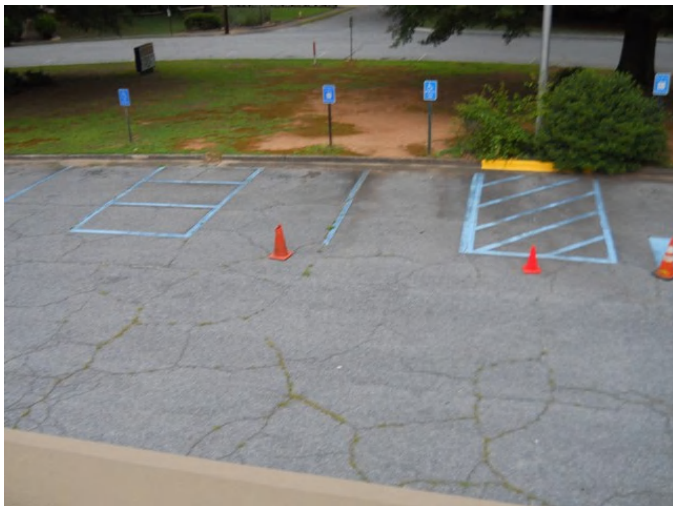
System: G2020 - Parking Lots

Location: Site

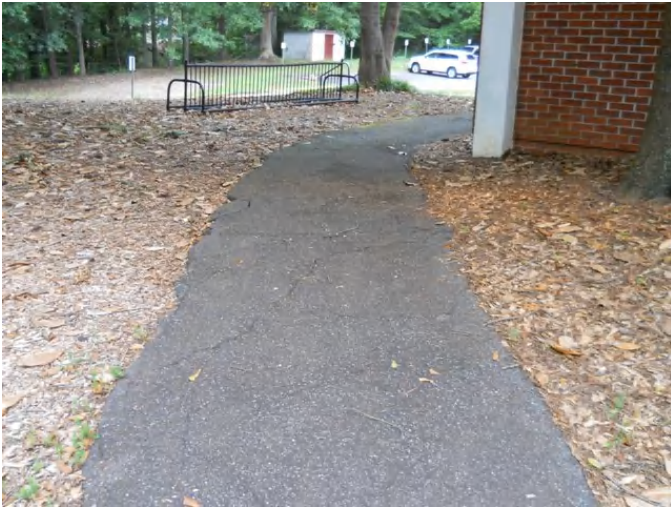
System: G2030 - Pedestrian Paving

Location: Site
Distress: Beyond Service Life
Category: Deferred Maintenance
Priority: 3 Priority
Correction: Renew System
Qty: 54,162.00
Unit of Measure: S.F.
Estimate: \$89,367.30
Assessor Name: Eduardo Lopez
Date Created: 07/06/2015

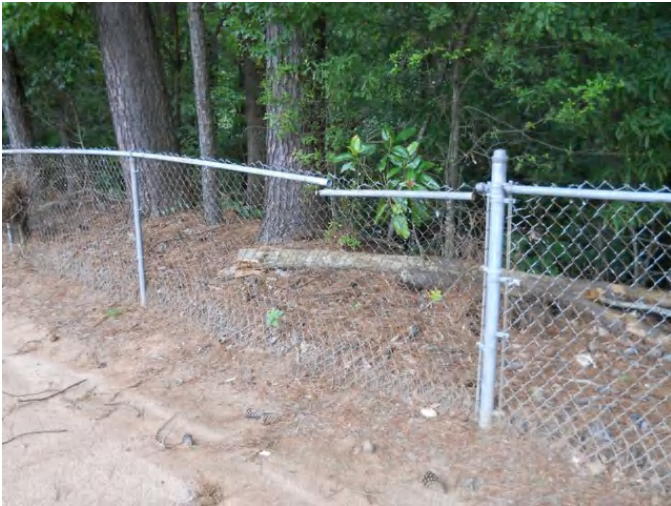
System: G2040 - Fencing & Guardrails

Location: Site
Distress: Beyond Service Life
Category: Deferred Maintenance
Priority: 3 Priority
Correction: Renew System
Qty: 54,162.00
Unit of Measure: S.F.
Estimate: \$54,216.16
Assessor Name: Eduardo Lopez
Date Created: 07/06/2015

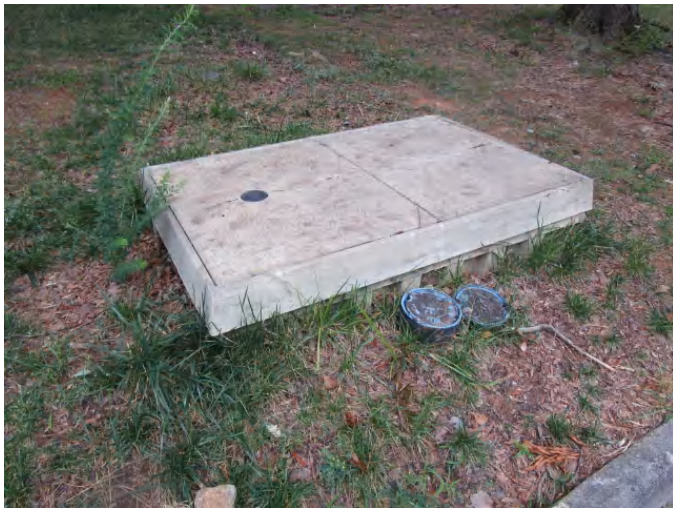
System: G3010 - Water Supply

Location: Site

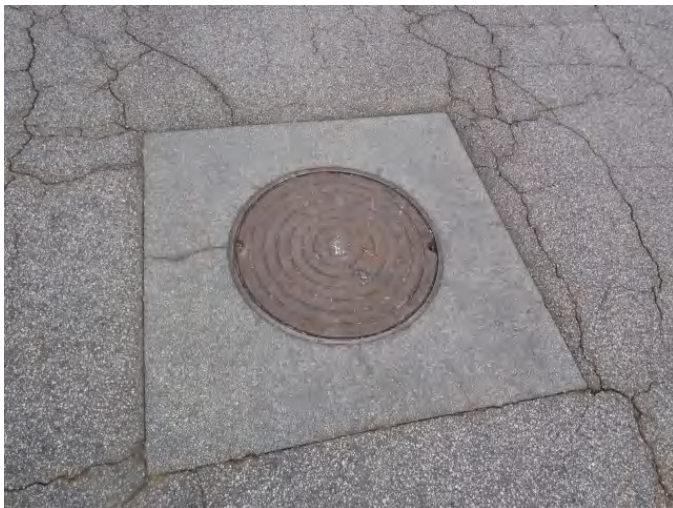
System: G3020 - Sanitary Sewer

Location: Site

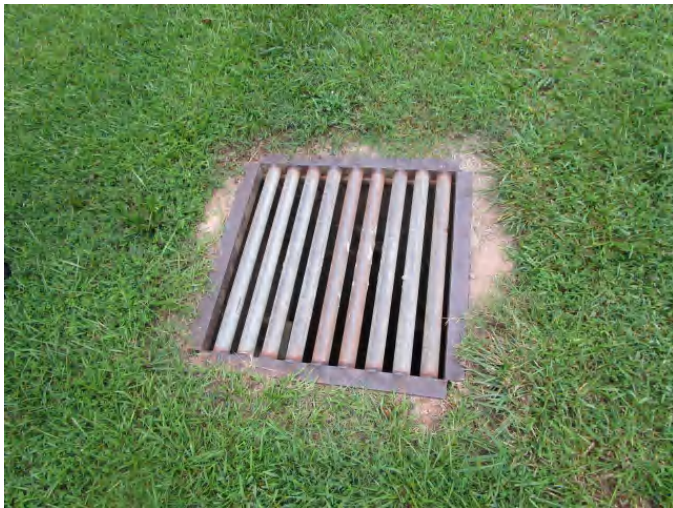
System: G3030 - Storm Sewer

Location: Site
Distress: Beyond Service Life
Category: Deferred Maintenance
Priority: 3 Priority
Correction: Renew System
Qty: 54,162.00
Unit of Measure: S.F.
Estimate: \$211,502.61
Assessor Name: Eduardo Lopez
Date Created: 07/06/2015

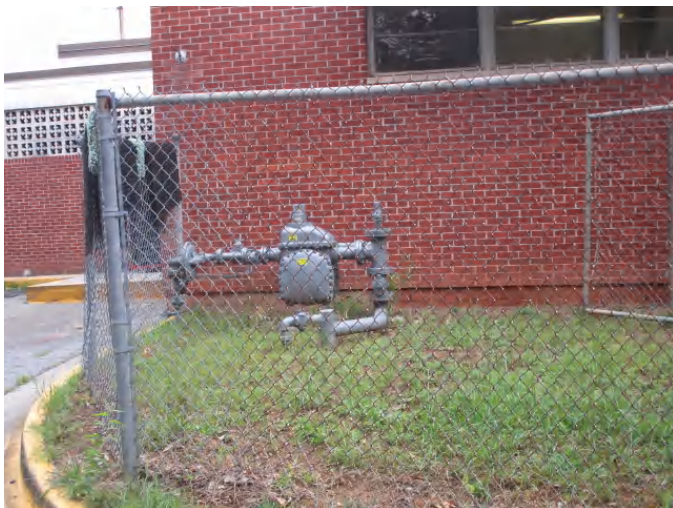
System: G3060 - Fuel Distribution

Location: Site
Distress: Beyond Service Life
Category: Deferred Maintenance
Priority: 3 Priority
Correction: Renew System
Qty: 54,162.00
Unit of Measure: S.F.
Estimate: \$46,471.00
Assessor Name: Eduardo Lopez
Date Created: 07/06/2015

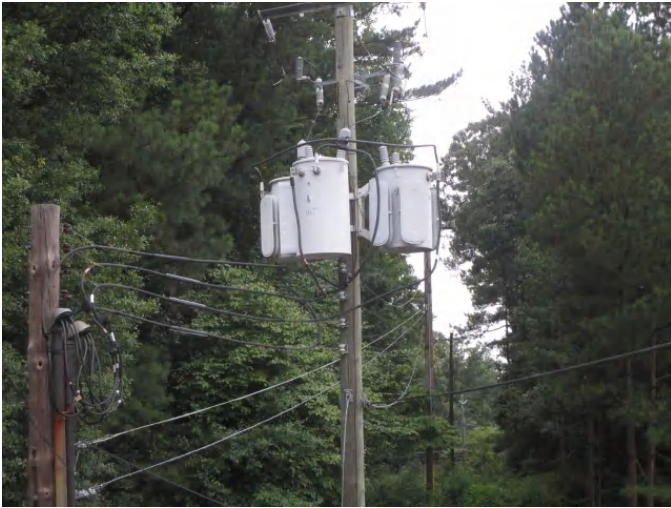
System: G4010 - Electrical Distribution

Location: Site
Distress: Beyond Service Life
Category: Deferred Maintenance
Priority: 3 Priority
Correction: Renew System
Qty: 54,162.00
Unit of Measure: S.F.
Estimate: \$110,815.45
Assessor Name: Eduardo Lopez
Date Created: 07/06/2015

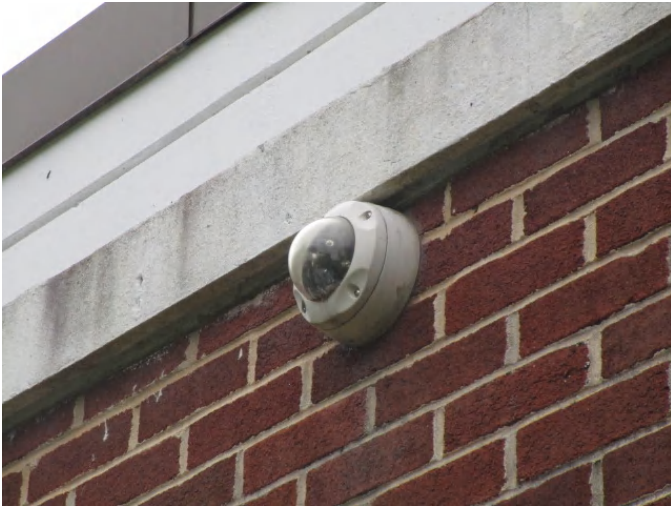
System: G4030 - Site Communications & Security

Location: Site
Distress: Beyond Service Life
Category: Deferred Maintenance
Priority: 3 Priority
Correction: Renew System
Qty: 54,162.00
Unit of Measure: S.F.
Estimate: \$39,917.39
Assessor Name: Eduardo Lopez
Date Created: 07/17/2015
