DeKalb County School District/Elementary Schools

# Idlewood Elementary

## School Assessment Report

May 19, 2016

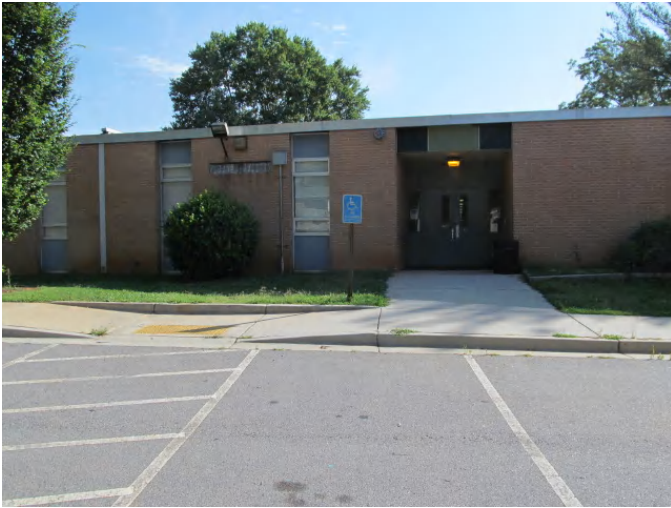
#### System: B2020 - Exterior Windows

**Location:** Throughout Building

**Distress:** Beyond Service Life

**Notes:** The windows are original, not energy efficient, and should be scheduled for replacement.

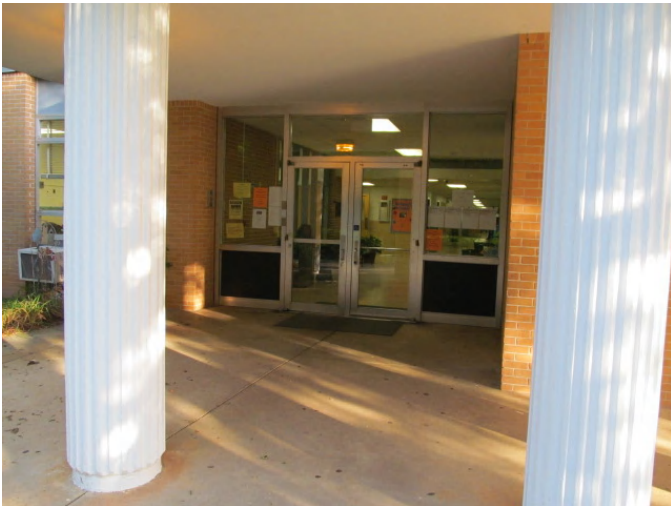
#### System: B2030 - Exterior Doors

**Location:** Throughout Building

**Distress:** Beyond Service Life

**Notes:** The exterior doors are original, beyond their expected service life, not ADA compliant, and should be replaced.

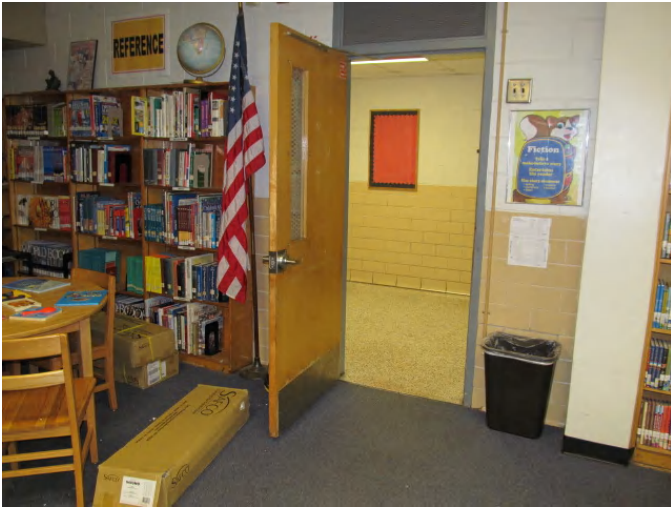
**System: C1020 - Interior Doors**

**Location:** Throughout Building

**Distress:** Beyond Service Life

**Notes:** The interior doors are original, worn, not ADA or building code compliant, and should be scheduled for replacement.

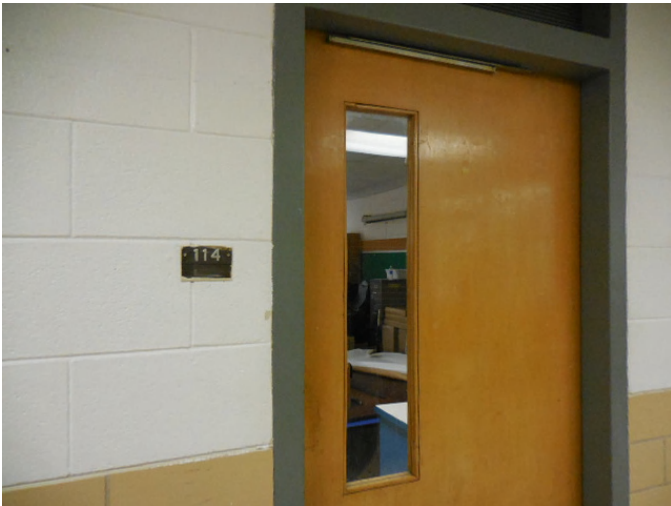
**System: C1030 - Fittings**

**Location:** Throughout Building

**Distress:** Inadequate

**Notes:** Room signage is not ADA compliant, beyond its expected service life, and should be replaced.

**Correction:** Remove and replace the signage w/ADA compliant signage.

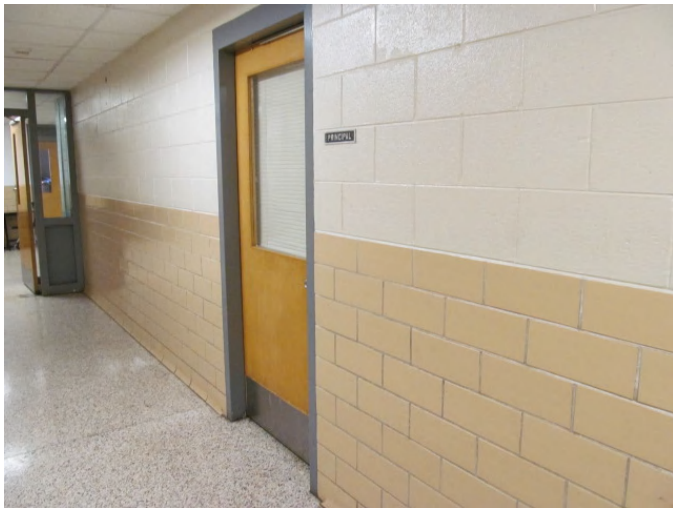
**System: C3010 - Wall Finishes - Paint**

**Location:** Throughout Building

**Distress:** Beyond Service Life

**Notes:** The painted wall finishes are beyond their expected service life and should be replaced.

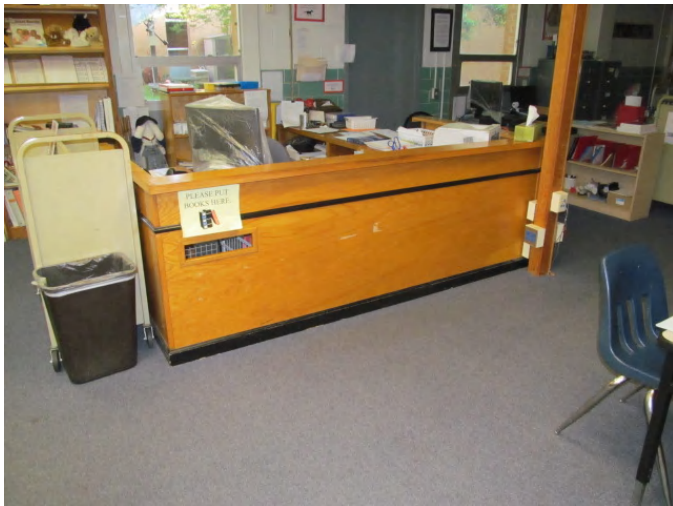
**System: C3020 - Floor Finishes - Carpet**

**Location:** Library

**Distress:** Beyond Service Life

**Notes:** The carpet is beyond its expected service life and should be replaced.

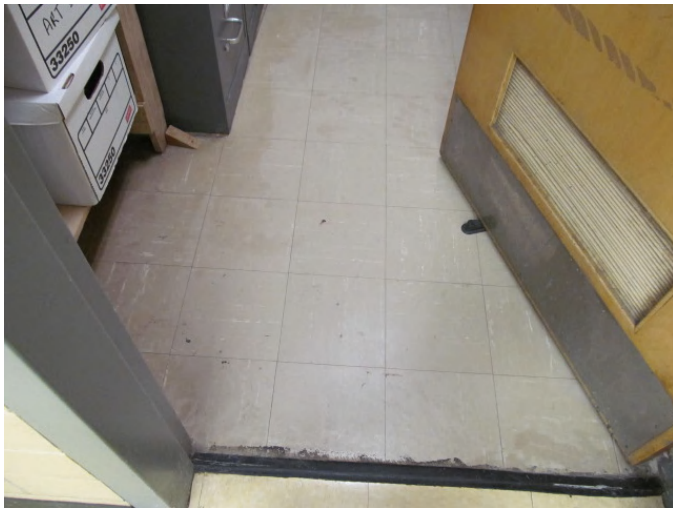
**System: C3020 - Floor Finishes - VCT**

**Location:** Throughout Building

**Distress:** Beyond Service Life

**Notes:** The VCT and VAT flooring is beyond its expected service life, damaged and missing in areas, and should be replaced.

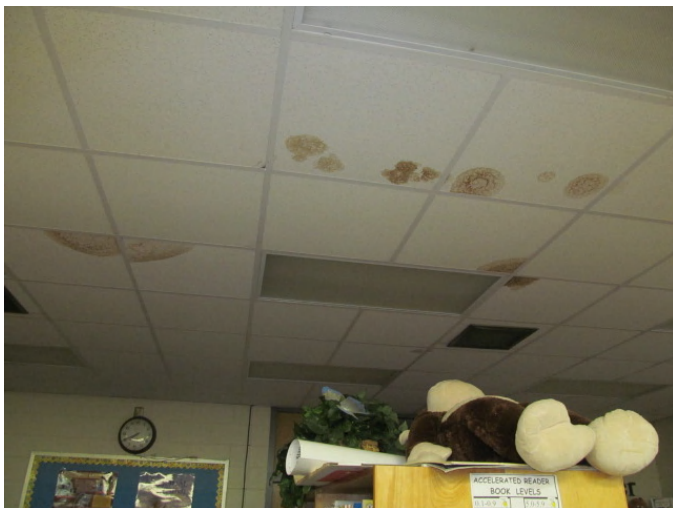
**System: C3030 - Ceiling Finishes**

**Location:** Throughout Building

**Distress:** Beyond Service Life

**Notes:** The acoustical ceiling system is beyond its expected service life, damaged, and should be replaced.

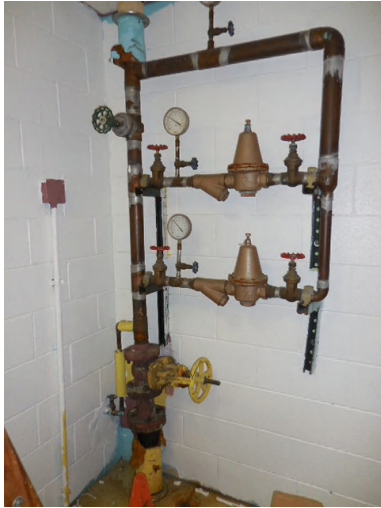
**System: D2020 - Domestic Water Distribution**

**Location:** Throughout Building

**Distress:** Beyond Service Life

**Notes:** The domestic water distribution system is beyond its expected service life, not code compliant, and should be scheduled for replacement. Domestic water heaters and converters are not equipped with temperature/pressure relief valves and adequate expansion compensation.

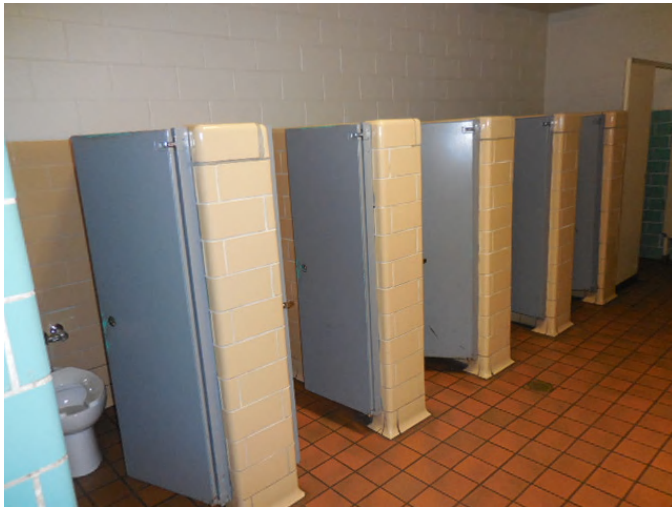
**System: D2030 - Sanitary Waste**

**Location:** Throughout Building

**Distress:** Beyond Service Life

**Notes:** The sanitary waste system is beyond its expected service life and should be scheduled for replacement.

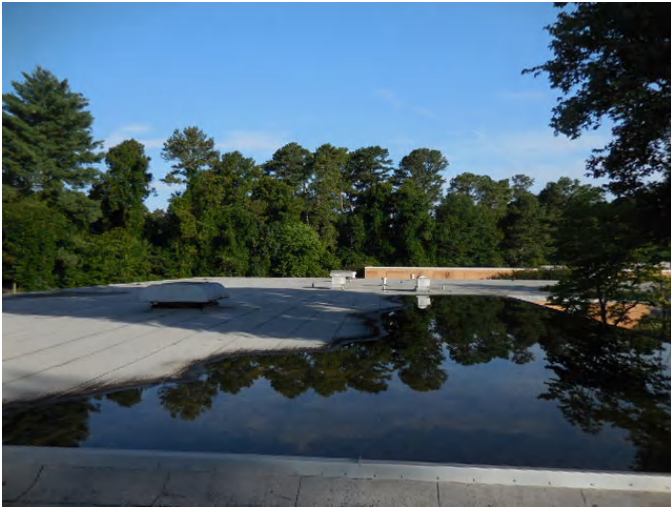
**System: D2040 - Rain Water Drainage**

**Location:** Throughout Building

**Distress:** Beyond Service Life

**Notes:** Rainwater drainage system is beyond its expected service life, causing ponding on the roof, and should be scheduled for replacement.

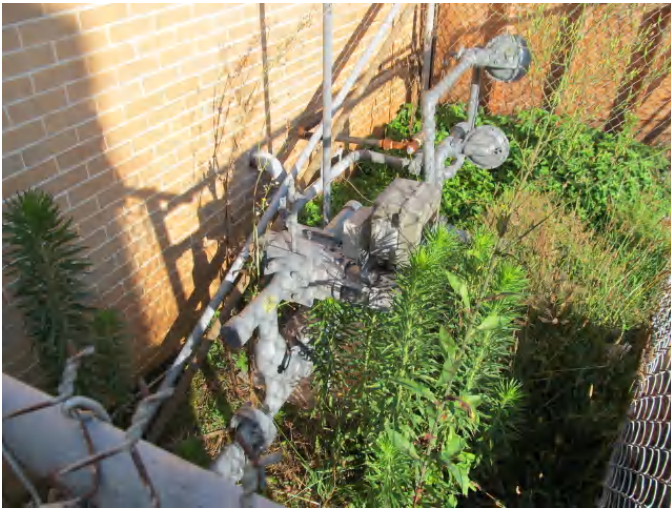
**System: D2090 - Other Plumbing Systems - Natural Gas**

**Location:** Mechanical Room

**Distress:** Beyond Service Life

**Notes:** The natural gas system is beyond its expected service life and should be scheduled for replacement. SPLOST project 113-422 to replace grease trap.

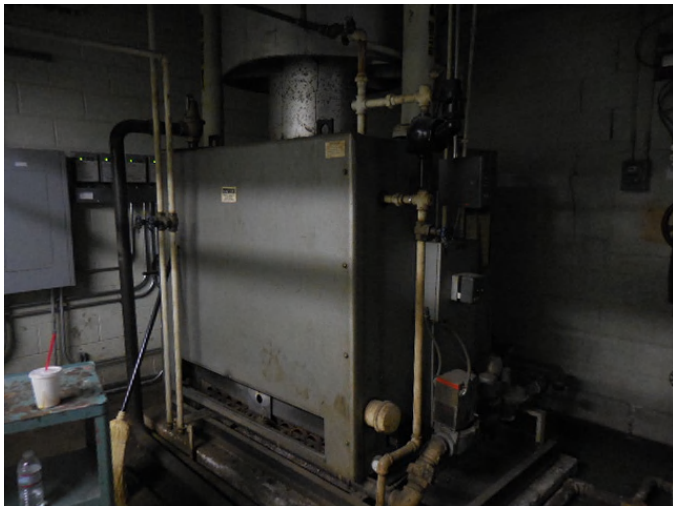
**System: D3020 - Heat Generating Systems**

**Location:** Mechanical Room

**Distress:** Beyond Service Life

**Notes:** The heat generating system is beyond its expected service life and should be scheduled for replacement.

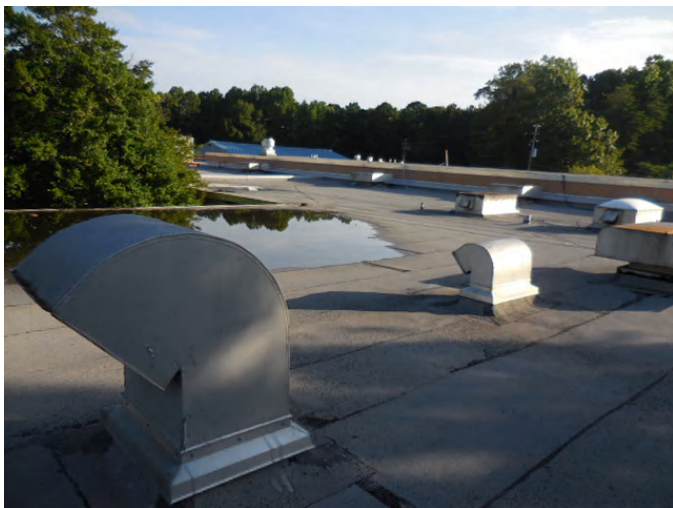
**System: D3040 - Distribution & Exhaust Systems**

**Location:** Throughout Building

**Distress:** Beyond Service Life

**Notes:** The distribution and exhaust systems are beyond their expected service life and should be scheduled for replacement.

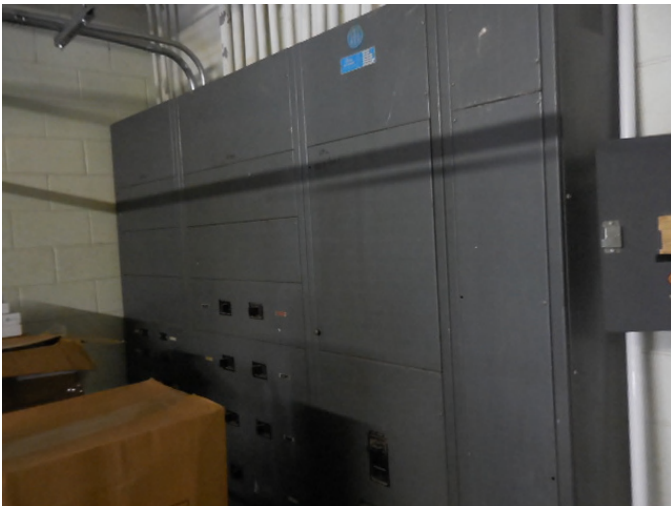
**System: D5010 - Electrical Service/Distribution**

**Location:** Main Switch Room/Throughout Building

**Distress:** Beyond Service Life

**Notes:** The electrical service/distribution system is original, beyond its expected service life and should be scheduled for replacement. SPLOST project 113-422 to replace the electrical service entrance.

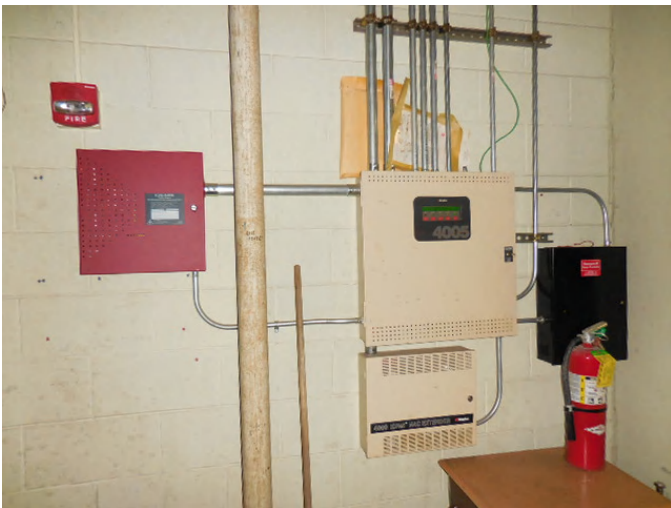
**System: D5030 - Communications and Security - Fire Alarm**

**Location:** Throughout Building

**Distress:** Beyond Service Life

**Notes:** The fire alarm system is beyond its expected service life, inadequate, and should be scheduled for replacement.

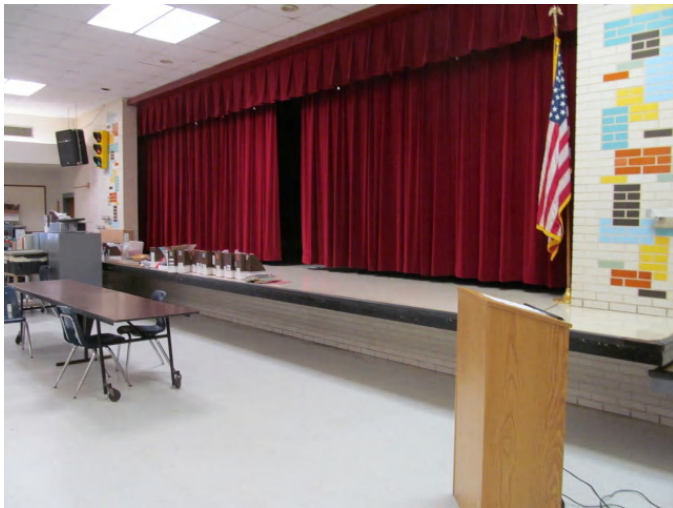
**System: E1020 - Institutional Equipment**

**Location:** Throughout Building

**Distress:** Beyond Service Life

**Notes:** Institutional equipment, such as theater and stage equipment, library equipment and audio-visual equipment, is beyond its expected service life and should be scheduled for replacement.

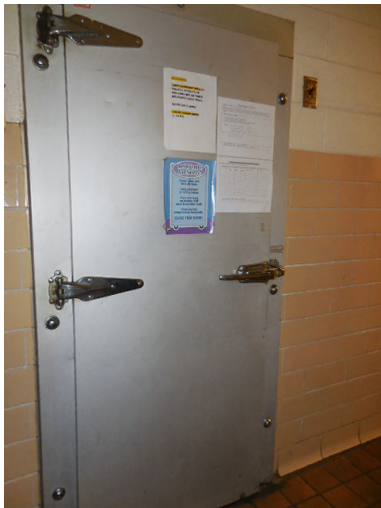
**System: E1090 - Other Equipment (Kitchen Equipment) - Walk In Cooler**

**Location:** Kitchen

**Distress:** Beyond Service Life

**Notes:** Kitchen equipment, including the walk-in coolers, is beyond its expected service life and should be scheduled for replacement.

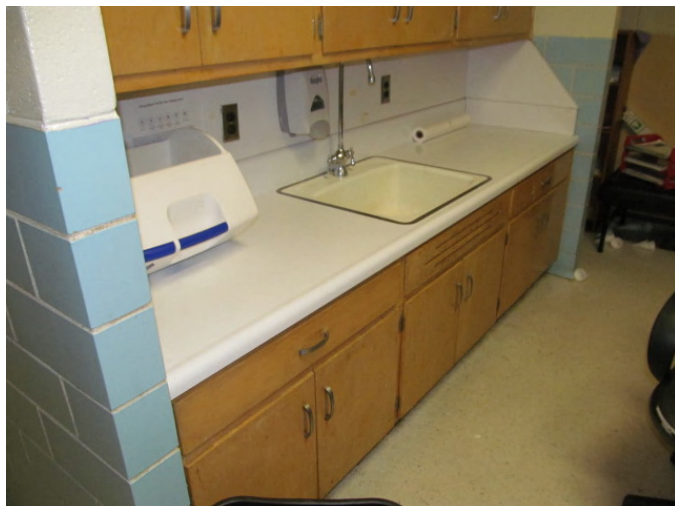
**System: E2010 - Fixed Furnishings**

**Location:** Throughout Building

**Distress:** Beyond Service Life

**Notes:** Fixed furnishings, such as built-in cabinets, are beyond their expected service life and worn, and should be replaced.

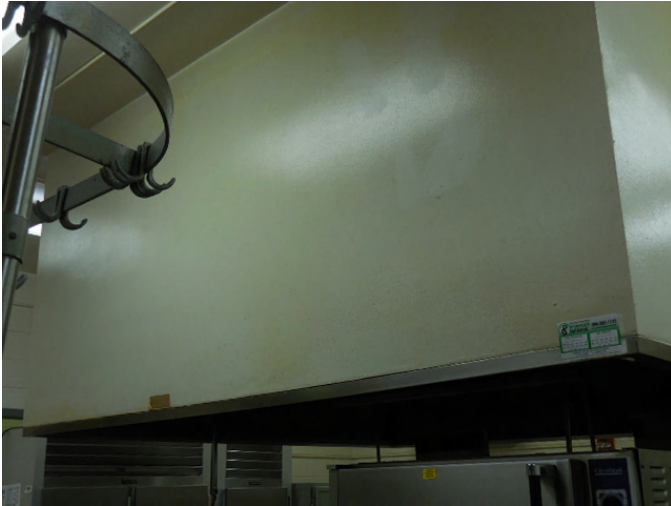
**System: D3090 - Other HVAC Systems/Equip - Kitchen Hood**

**Location:** Kitchen

**Distress:** Beyond Service Life

**Notes:** The kitchen hood system is beyond its expected service life and should be scheduled for replacement.

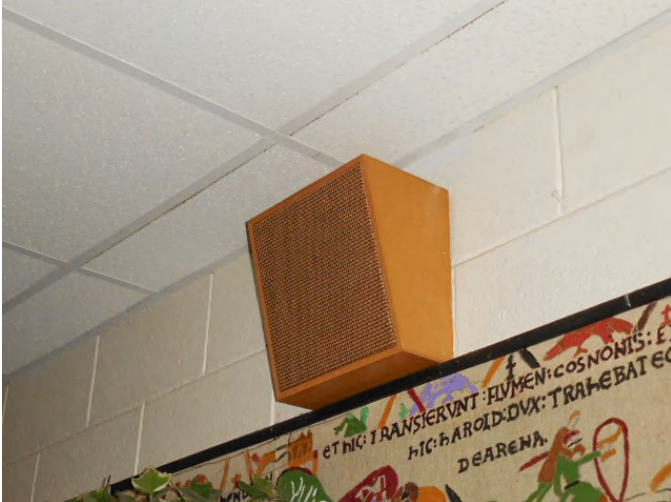
**System: D5030 - Communications and Security - Clock & PA Systems**

**Location:** Throughout Building

**Distress:** Beyond Service Life

**Notes:** Clock and PA systems are beyond their expected service life, requires frequent maintenance, and should be scheduled for replacement.

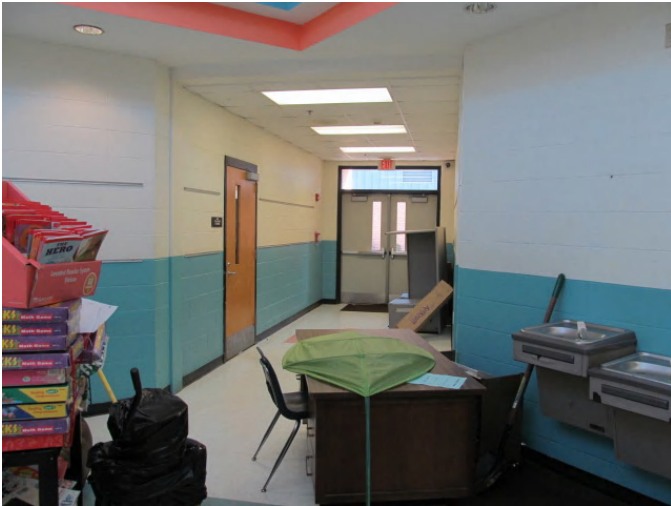
#### **System: C3010 - Wall Finishes - Paint**

**Location:** Throughout Building

**Distress:** Beyond Service Life

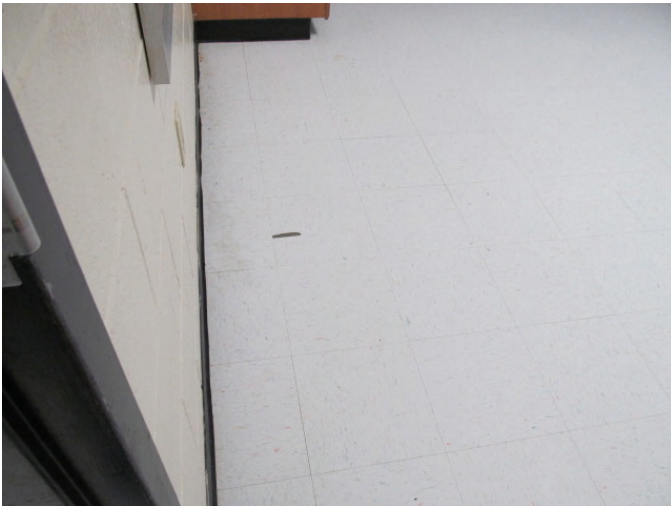
#### **System: C3020 - Floor Finishes - VCT**

**Location:** Throughout Building

**Distress:** Beyond Service Life

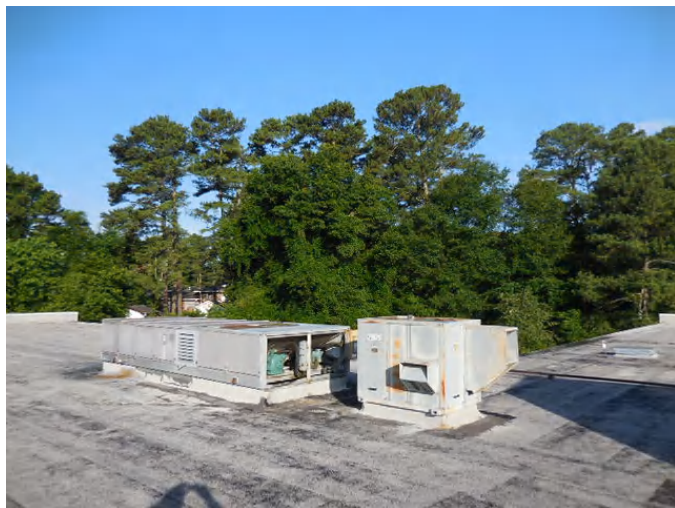
**System: D3050 - Terminal & Package Units**

**Location:** Roof

**Distress:** Beyond Service Life

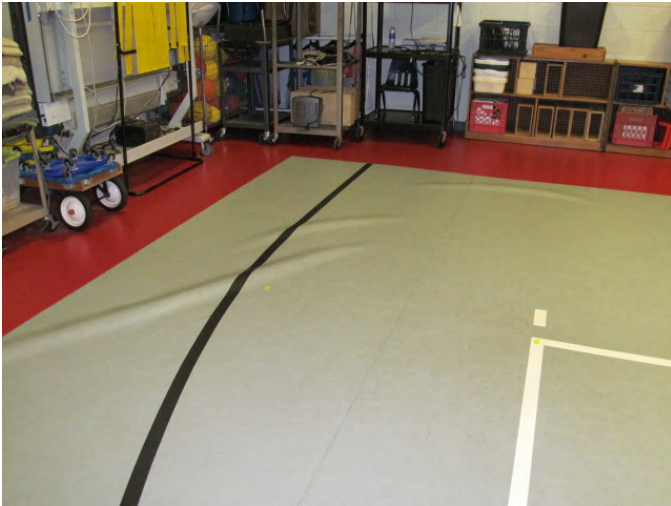
#### **System: C3020 - Floor Finishes - Neoprene**

**Location:** Basketball Court

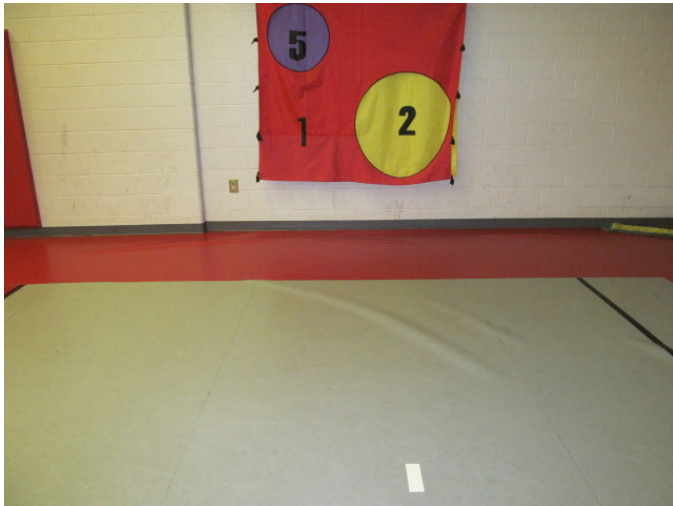
**System: C3010 - Wall Finishes - Paint**

**Location:** Throughout Building

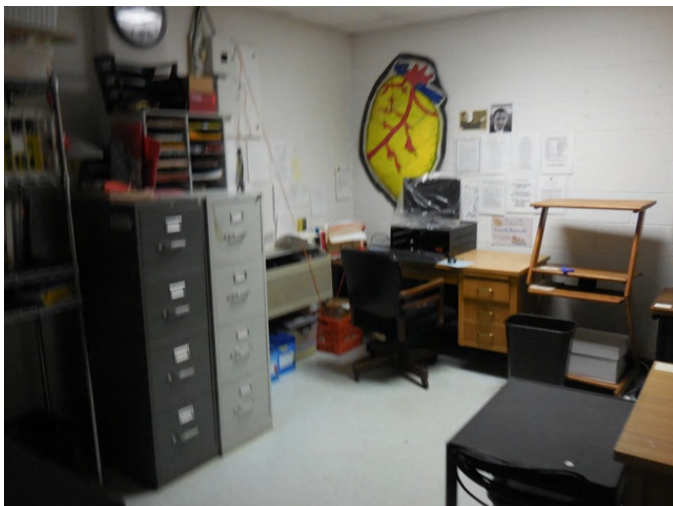
**System: C3020 - Floor Finishes - VCT**

**Location:** Entrance Area and Offices

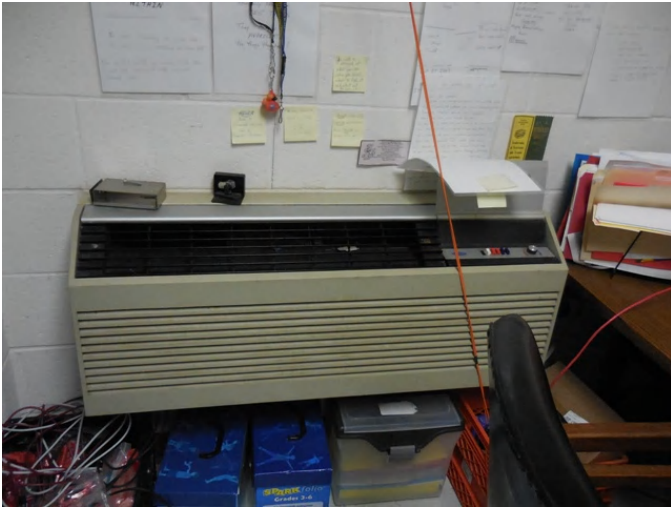
**System: D3050 - Terminal & Package Units**

**Location:** Throughout Building

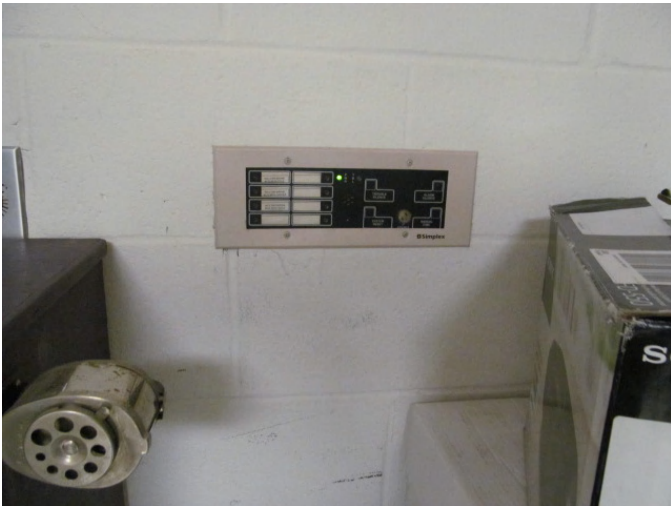
**System: D5030 - Communications and Security - Fire Alarm**

**Location:** Throughout Building

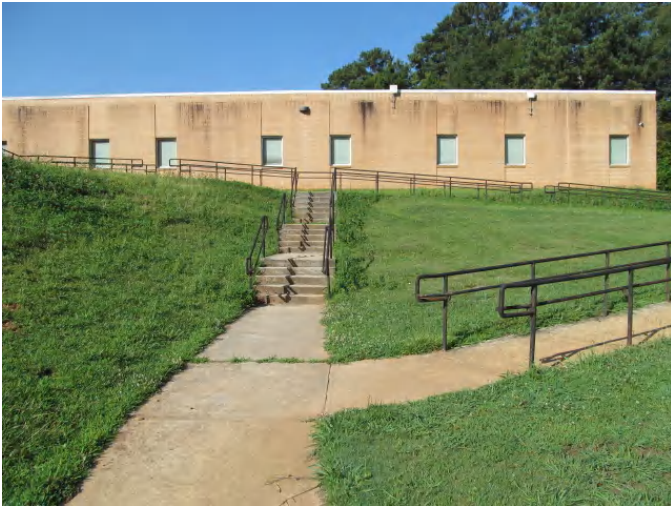
#### **System: G2030 - Pedestrian Paving**

**Location:** Site

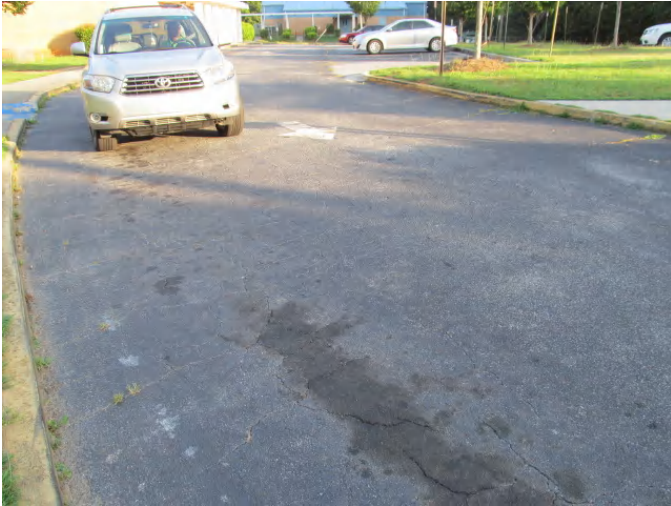
**System: G2010 - Roadways**

**Location:** Site

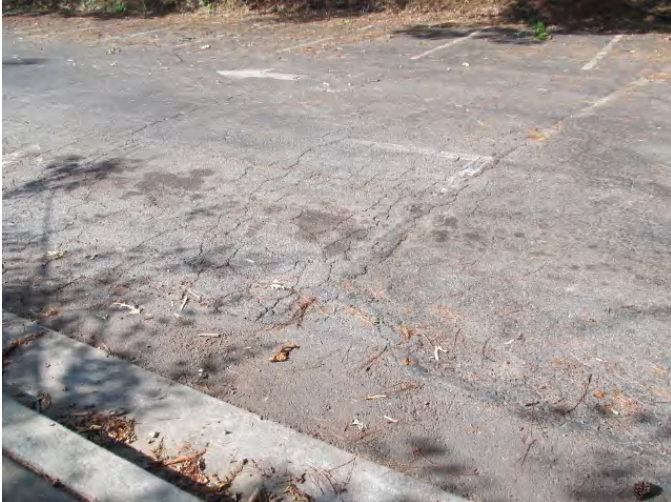
**System: G2020 - Parking Lots**

**Location:** Site

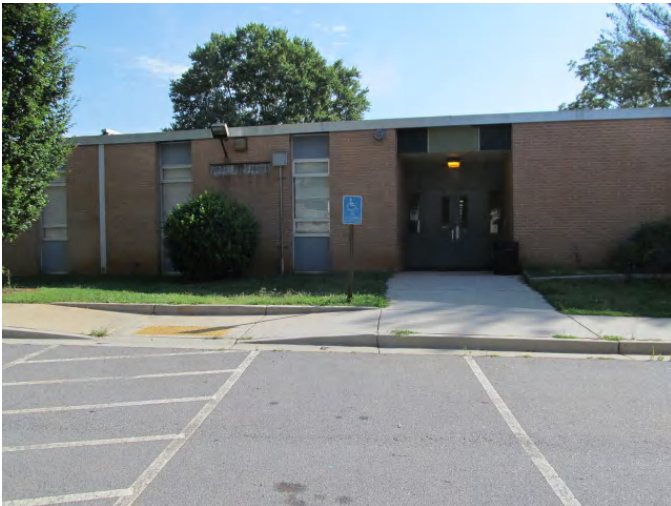
### **System: G4020 - Site Lighting**

**Location:** Site
