DeKalb County School District/Elementary Schools

Jolly Elementary

School Assessment Report

May 19, 2016

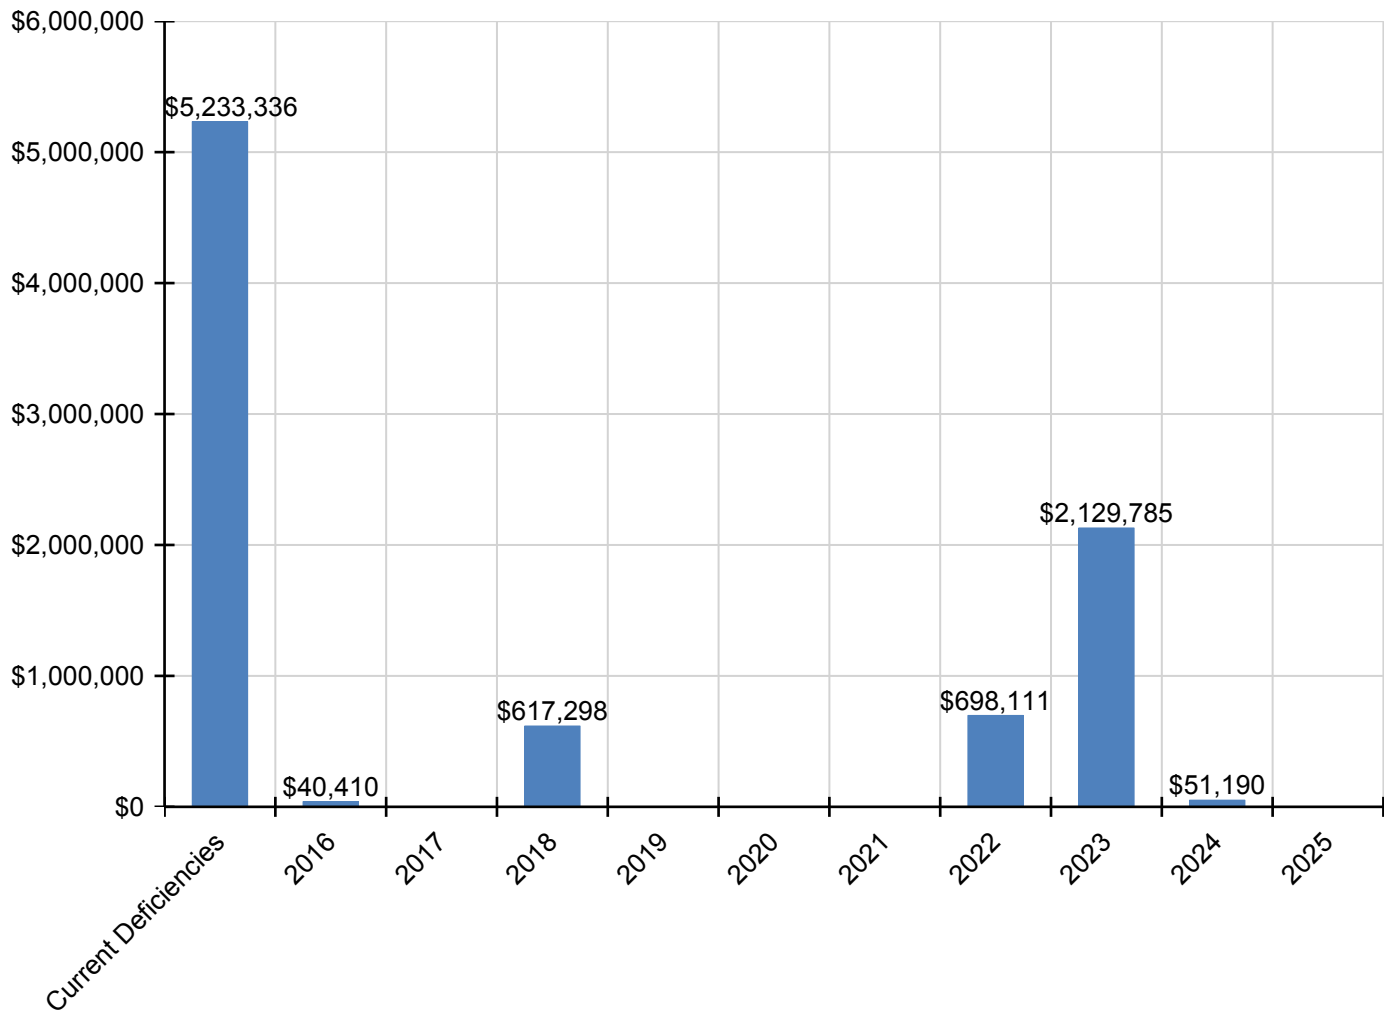
The following chart shows the current building deficiencies and the forecasted capital renewal (system replacement) requirements over the next ten years.

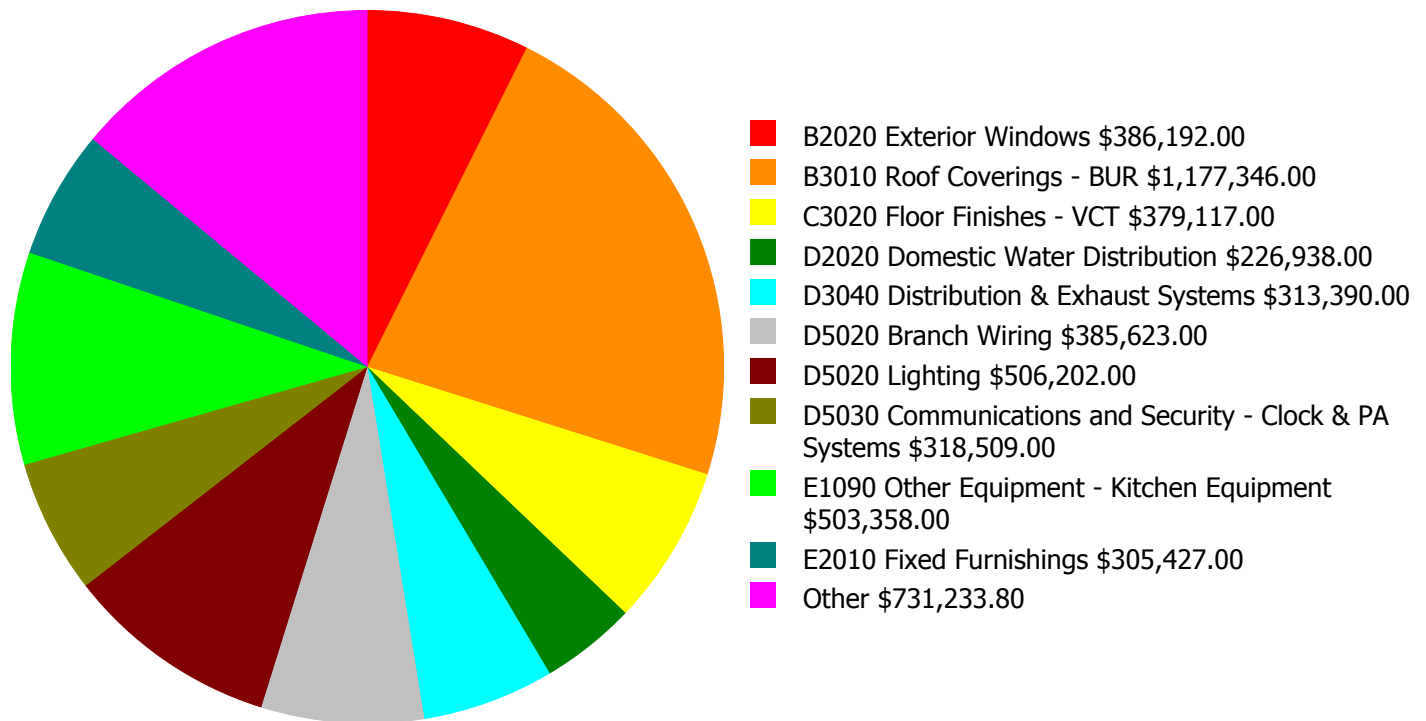
Current deficiencies include assemblies that have reached or exceed their design life or components of the assemblies that are in need of repair. Assemblies that have reached their design life are identified as current deficiencies and assigned the distress 'Beyond Service Life'. The following chart lists all current deficiencies associated with this facility broken down by UNIFORMAT system.

Budget Estimate Total: \$5,233,335.80

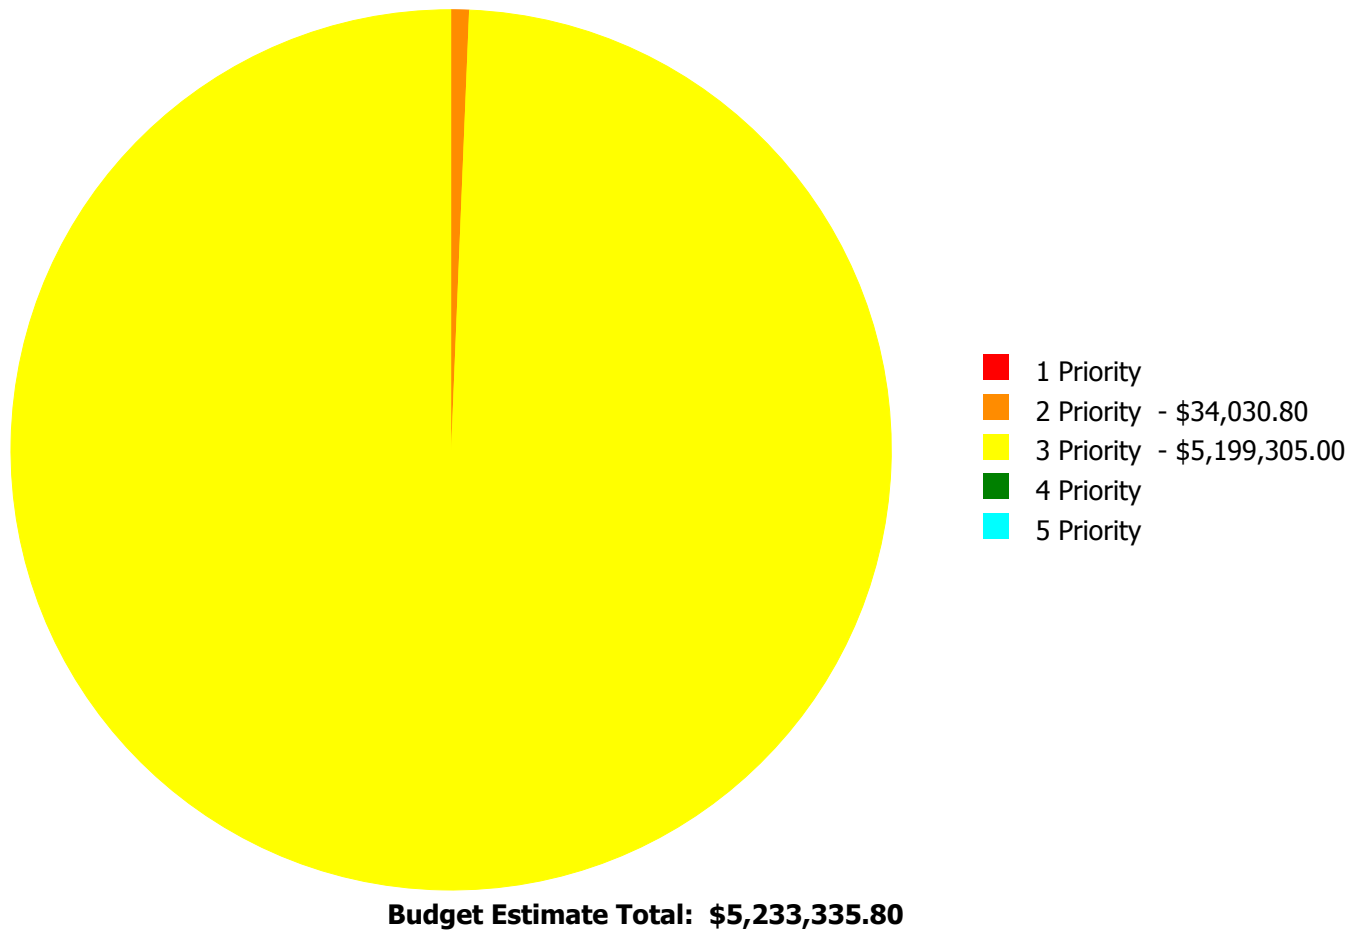
The following chart shows the total repair costs broken down by priority. Assessors assigned deficiencies within eCOMET to one of the following priority categories:

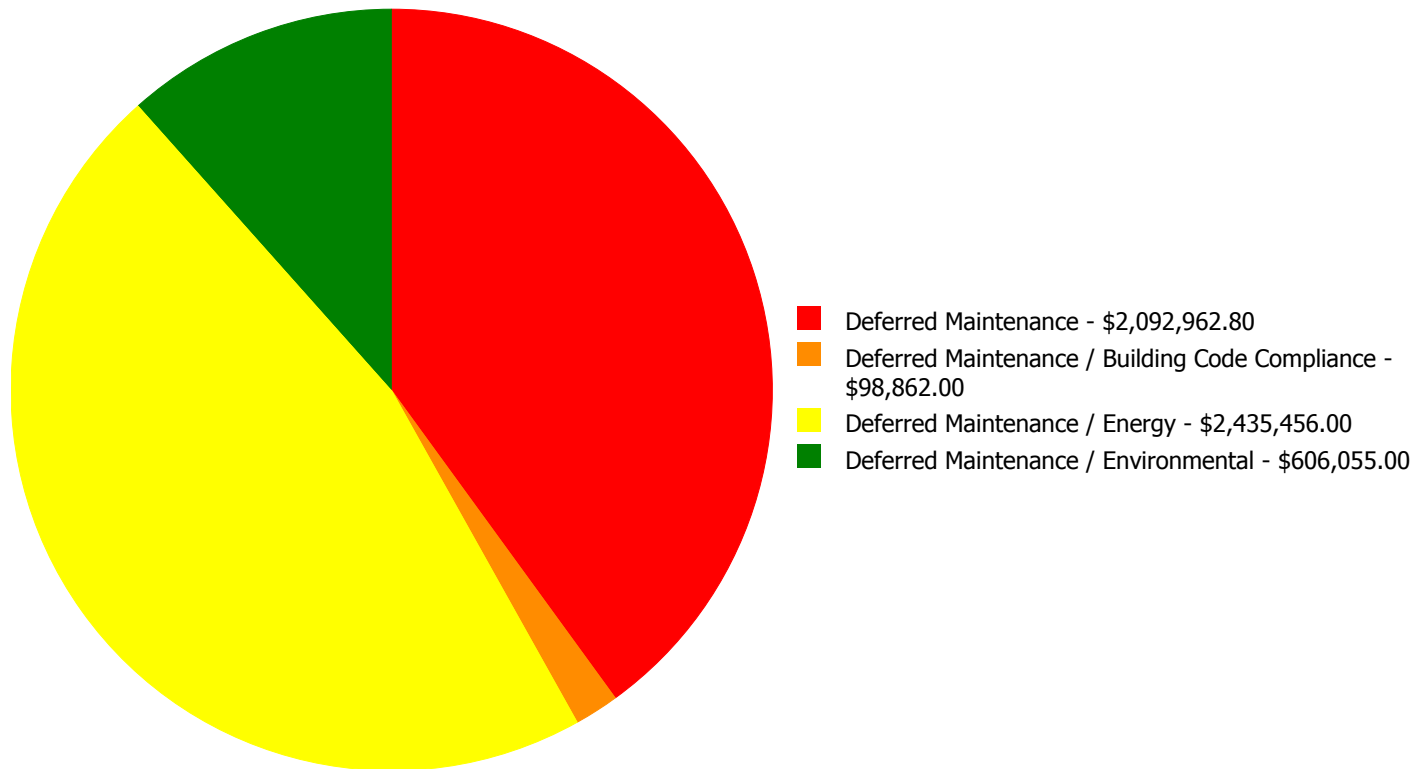
The following chart shows the total repair costs broken down by deficiency categories. Assessors assigned deficiencies to one of the following categories:

Budget Estimate Total: \$5,233,335.80

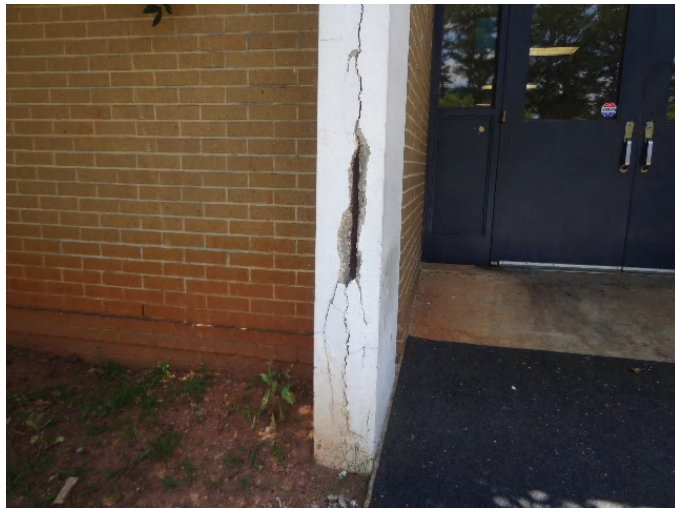
System: B2010 - Exterior Walls

Location: Exterior Wall Shades

Distress: Damaged

Notes: The exterior wall shades are cracking and exposing the rebars.

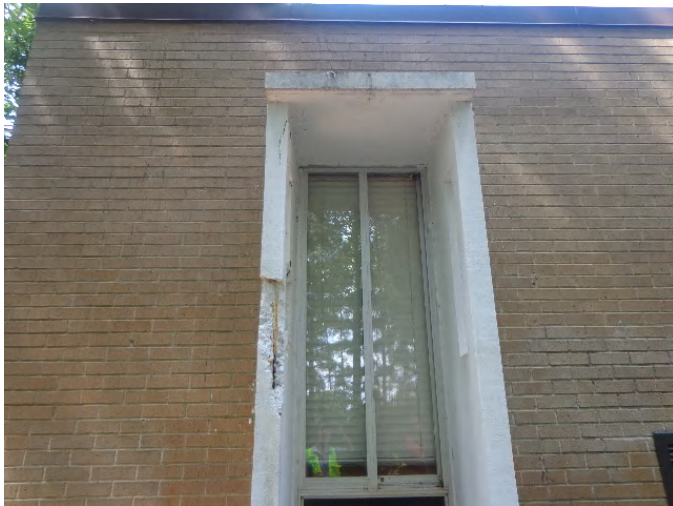
System: B2020 - Exterior Windows

Location: Throughout Building

Distress: Beyond Service Life

Notes: The aluminum frame, single pane, operable windows are aged, not energy efficient, and should be replaced.

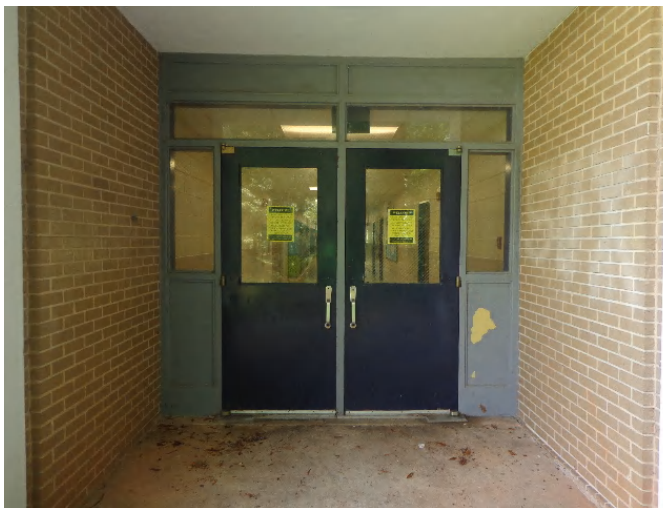
System: B2030 - Exterior Doors

Location: Throughout Building

Distress: Beyond Service Life

Notes: The original exterior doors are aged, rusted, and should be replaced. Exit doors at cafeteria are missing panic hardware.

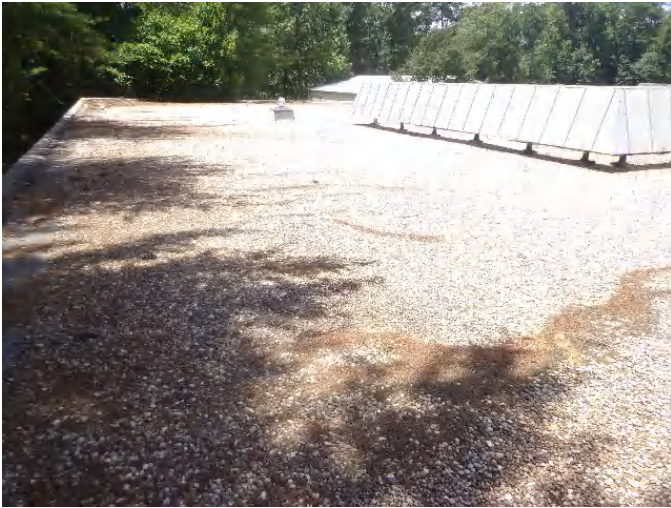
System: B3010 - Roof Coverings - BUR

Location: Roof

Distress: Beyond Service Life

Notes: Built-up roof covering is in deteriorating condition, with loss of top surface and should be replaced.

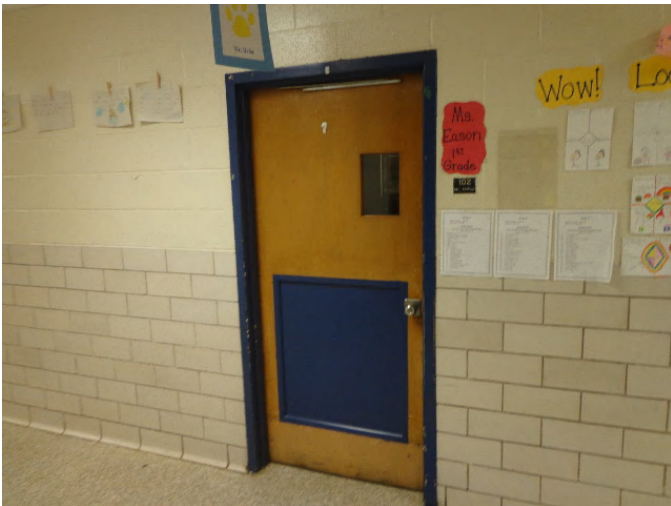
System: C1020 - Interior Doors

Location: Throughout Building

Distress: Beyond Service Life

Notes: The interior doors are aged, failing, not ADA or building code compliant, and should be replaced.

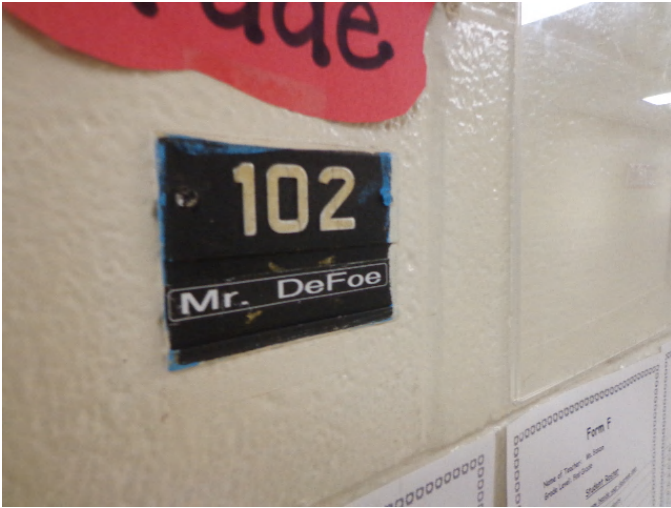
System: C1030 - Fittings

Location: Throughout Building

Distress: Beyond Service Life

Notes: Fittings, such as toilet partitions, handrails and signage, are beyond their expected service life and should be replaced. SPLOST project 115-422 to provide hall restroom renovations.

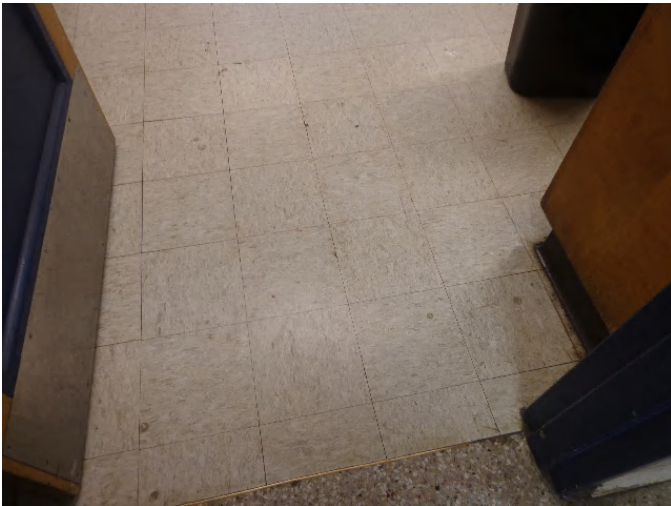
System: C3020 - Floor Finishes - VCT

Location: Throughout Building

Distress: Beyond Service Life

Notes: The VCT flooring is aged, cracked and worn, and should be replaced.

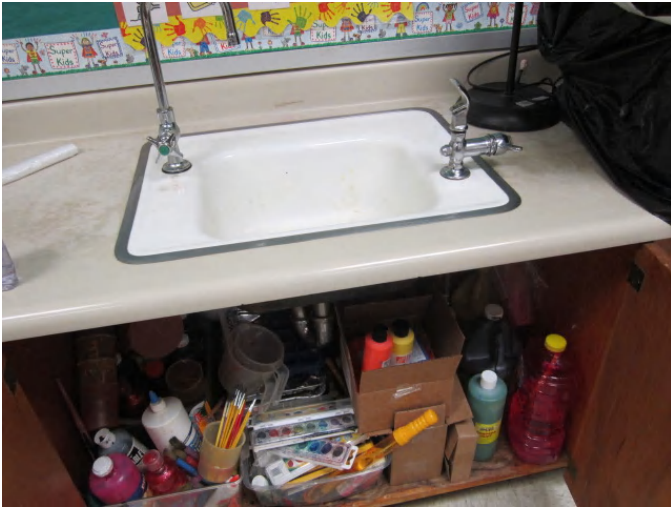
System: D2020 - Domestic Water Distribution

Location: Throughout Building

Distress: Beyond Service Life

Notes: The domestic water distribution system is beyond its expected service life, has water quality issues, and should be scheduled for replacement. SPLOST 115-422 to replace the interior building domestic water piping in the 68 and 69 buildings.

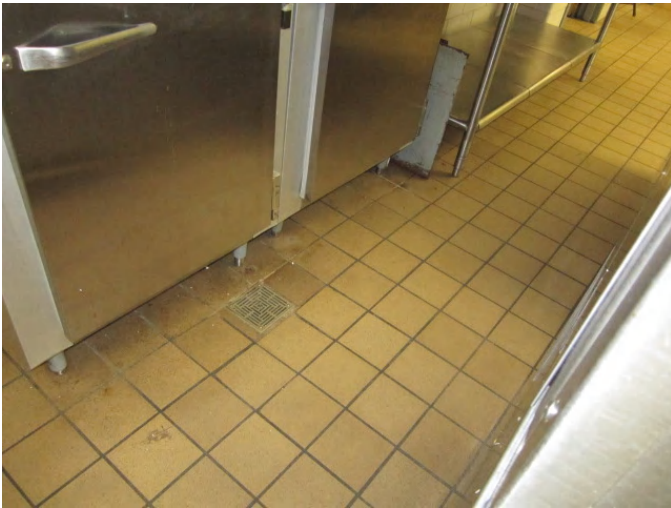
System: D2030 - Sanitary Waste

Location: Throughout Building

Distress: Beyond Service Life

Notes: The sanitary waste system is beyond its expected service life and should be scheduled for replacement.

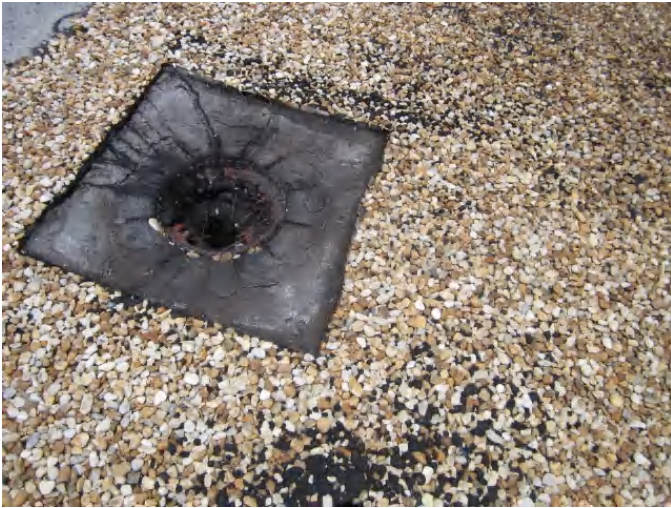
System: D2040 - Rain Water Drainage

Location: Throughout Building

Distress: Beyond Service Life

Notes: The rainwater drainage system is beyond its expected service life, overflows, and should be replaced in conjunction with the roof.

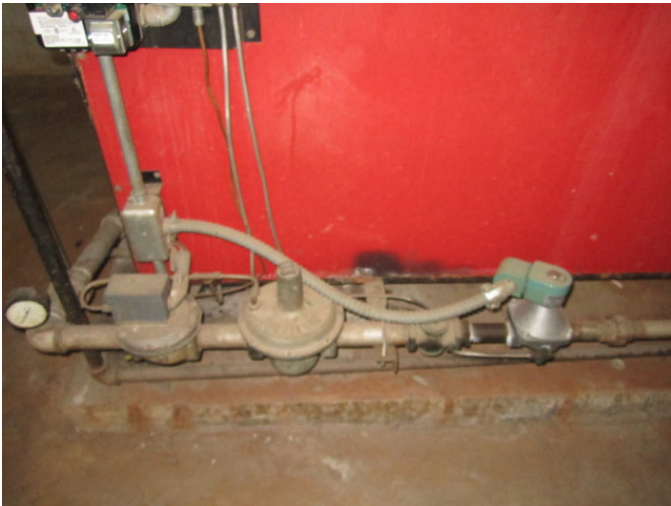
System: D2090 - Other Plumbing Systems - Natural Gas

Location: Throughout Building

Distress: Beyond Service Life

Notes: The natural gas system is beyond its expected service life and should be scheduled for replacement. SPLOST project 115-422 to replace the grease trap.

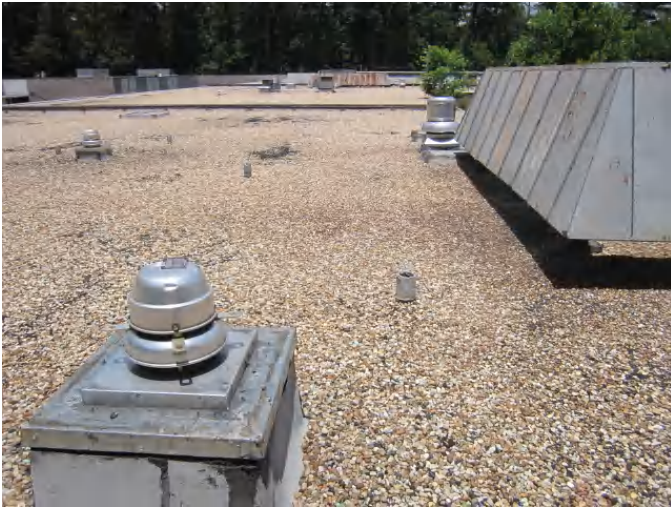
System: D3040 - Distribution & Exhaust Systems

Location: Throughout Building

Distress: Beyond Service Life

Notes: The distribution and exhaust systems are beyond their expected service life, non-functional in areas, and should be scheduled for replacement. SPLOST project 115-422 to replace exhaust fans.

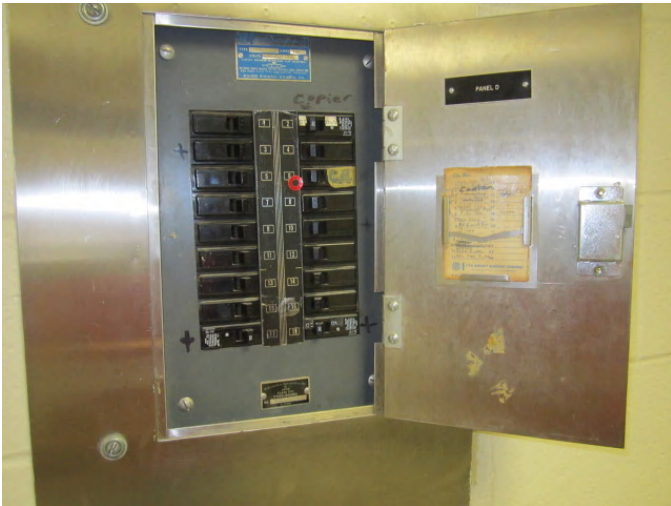
System: D5020 - Branch Wiring

Location: Throughout Building

Distress: Beyond Service Life

Notes: The branch wiring system is beyond its expected service life, aged, and should be scheduled for replacement.

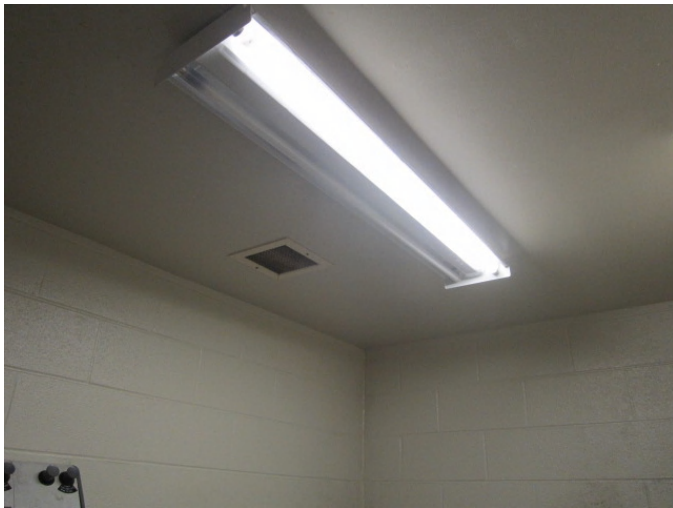
System: D5020 - Lighting

Location: Throughout Building

Distress: Beyond Service Life

Notes: The lighting system is beyond its expected service life, aged, and should be scheduled for replacement. SPLOST project 115-422 to replace the electrical lighting systems throughout the buildings.

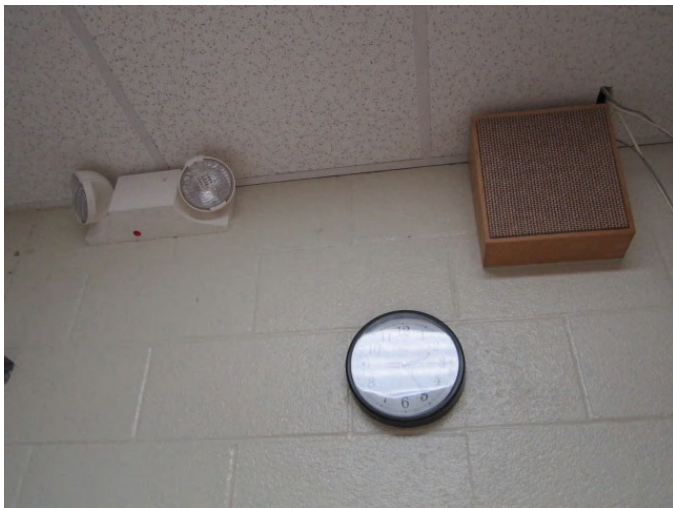
System: D5030 - Communications and Security - Clock & PA Systems

Location: Throughout Building

Distress: Beyond Service Life

Notes: Clock and PA systems are beyond their expected service life, aged, and should be scheduled for replacement.

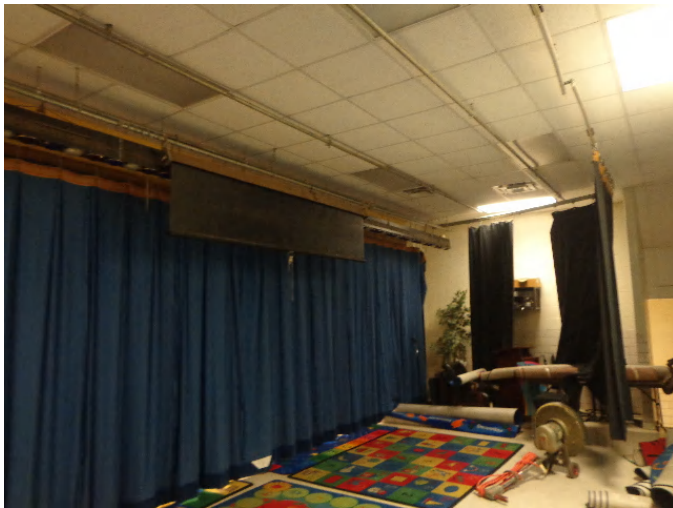
System: E1020 - Institutional Equipment

Location: Throughout Building

Distress: Beyond Service Life

Notes: Institutional equipment, such as theater and stage equipment, library equipment and audio-visual equipment, is beyond its expected service life and should be scheduled for replacement.

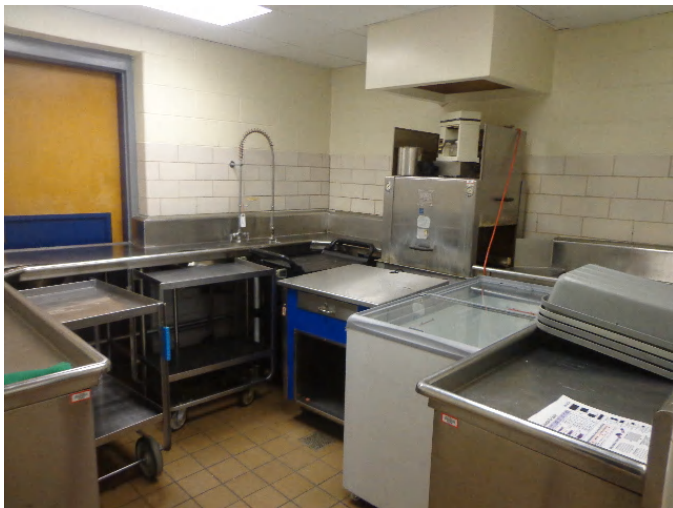
System: E1090 - Other Equipment - Kitchen Equipment

Location: Kitchen

Distress: Beyond Service Life

Notes: Kitchen equipment is beyond its expected service life and should be scheduled for replacement.

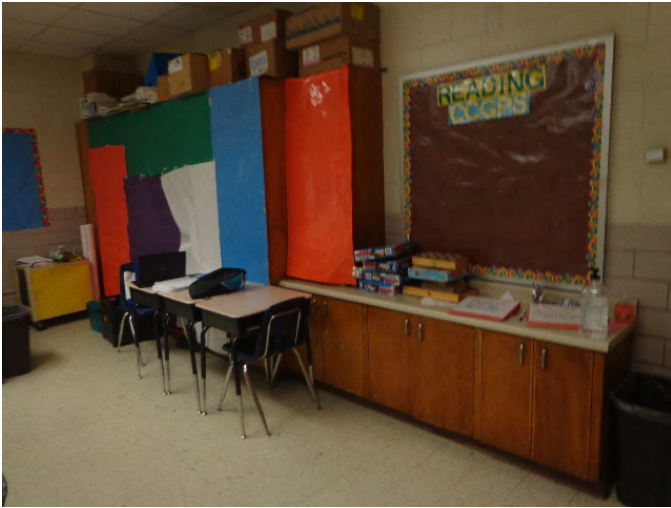
System: E2010 - Fixed Furnishings

Location: Throughout Building

Distress: Beyond Service Life

Notes: Fixed furnishings, such as built-in cabinets, are beyond their expected service life and worn, and should be replaced.

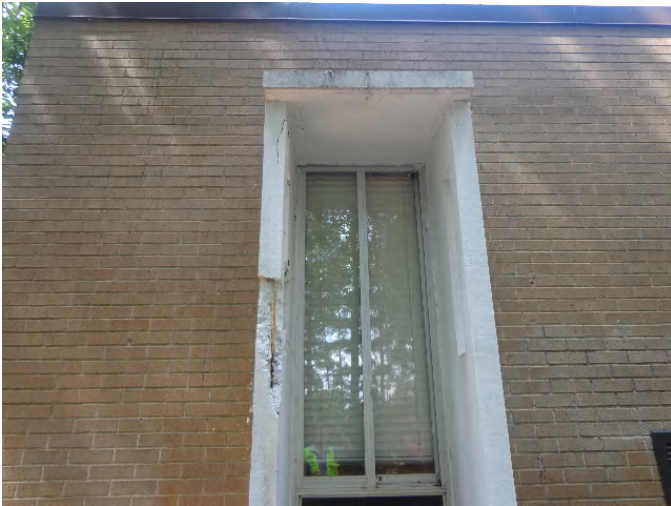
System: F1010 - Special Structures - Canopies

Location: Exterior of Building

Distress: Beyond Service Life

Notes: Canopies are beyond their expected service life, damaged, and should be renovated or replaced.

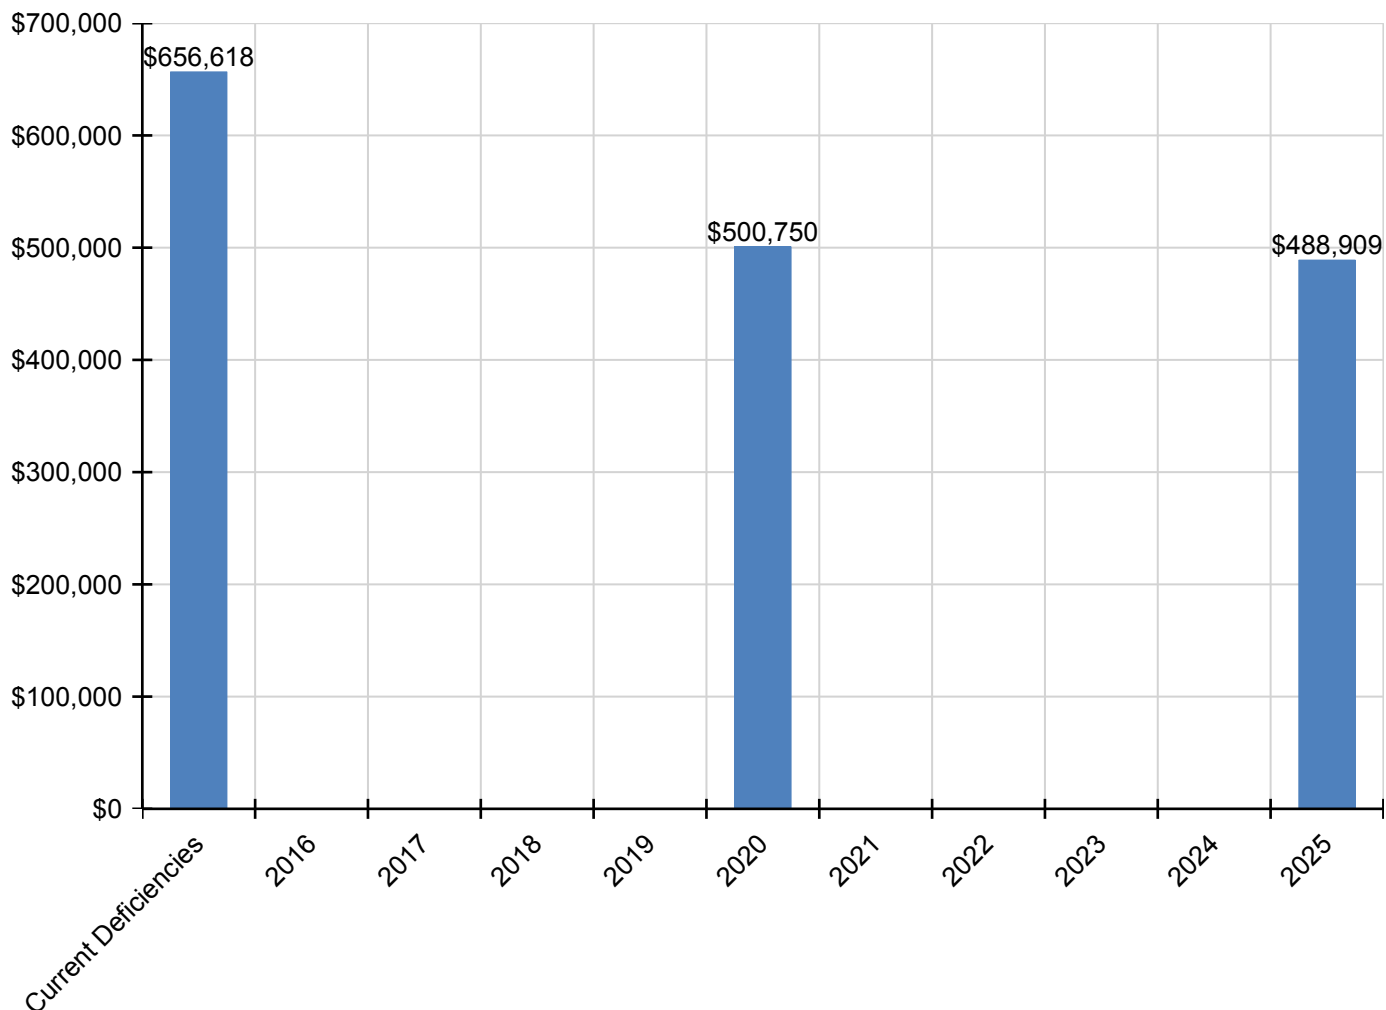
The following chart shows the current building deficiencies and the forecasted capital renewal (system replacement) requirements over the next ten years.

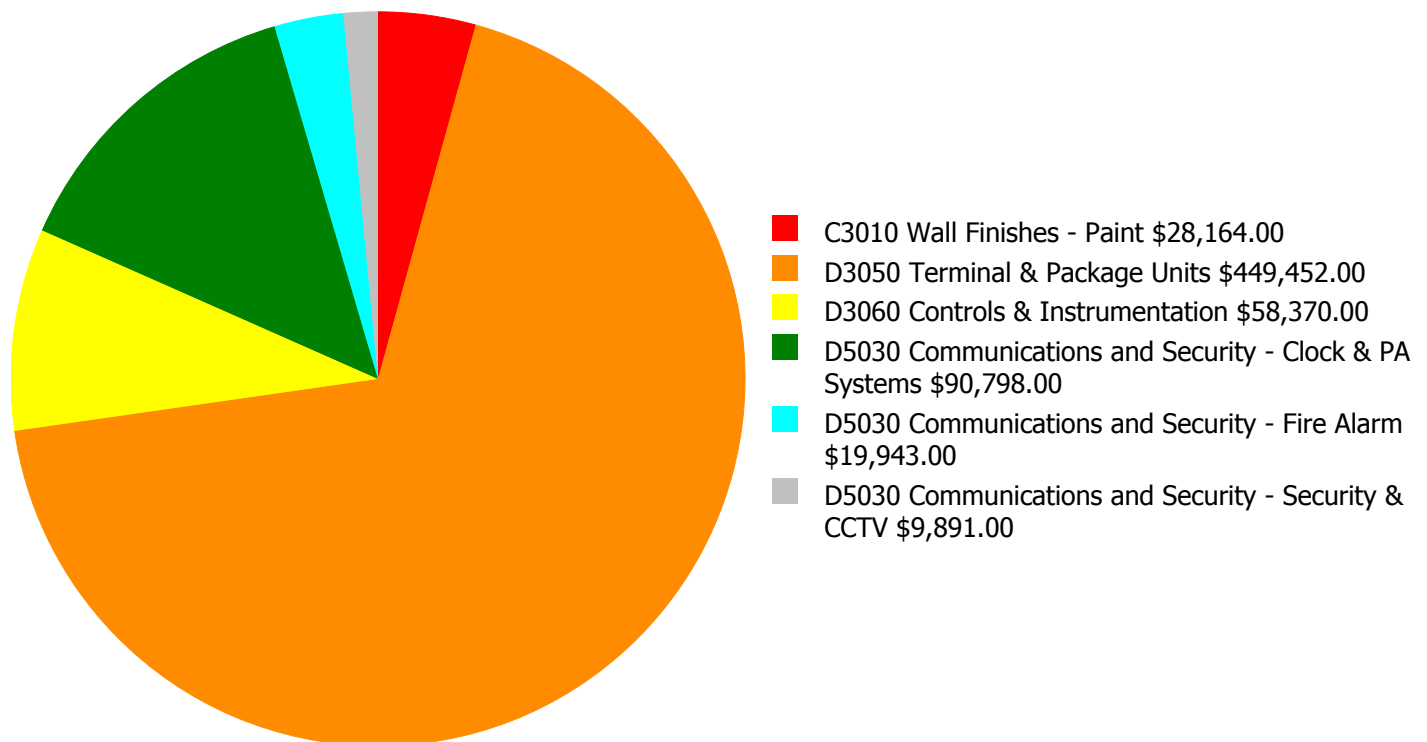
Current deficiencies include assemblies that have reached or exceed their design life or components of the assemblies that are in need of repair. Assemblies that have reached their design life are identified as current deficiencies and assigned the distress 'Beyond Service Life'. The following chart lists all current deficiencies associated with this facility broken down by UNIFORMAT system.

Budget Estimate Total: \$656,618.00

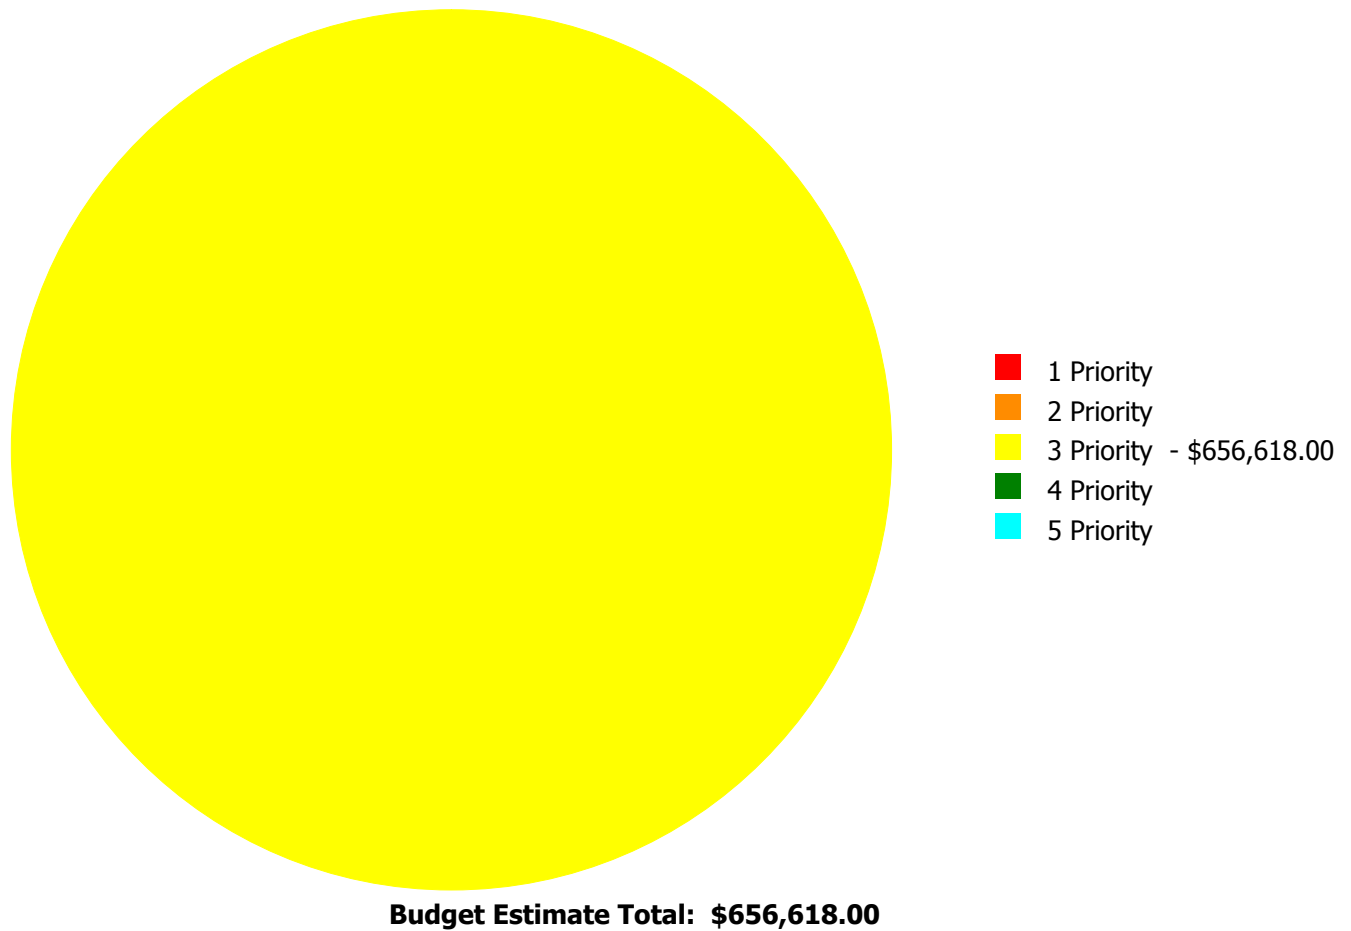
The following chart shows the total repair costs broken down by priority. Assessors assigned deficiencies within eCOMET to one of the following priority categories:

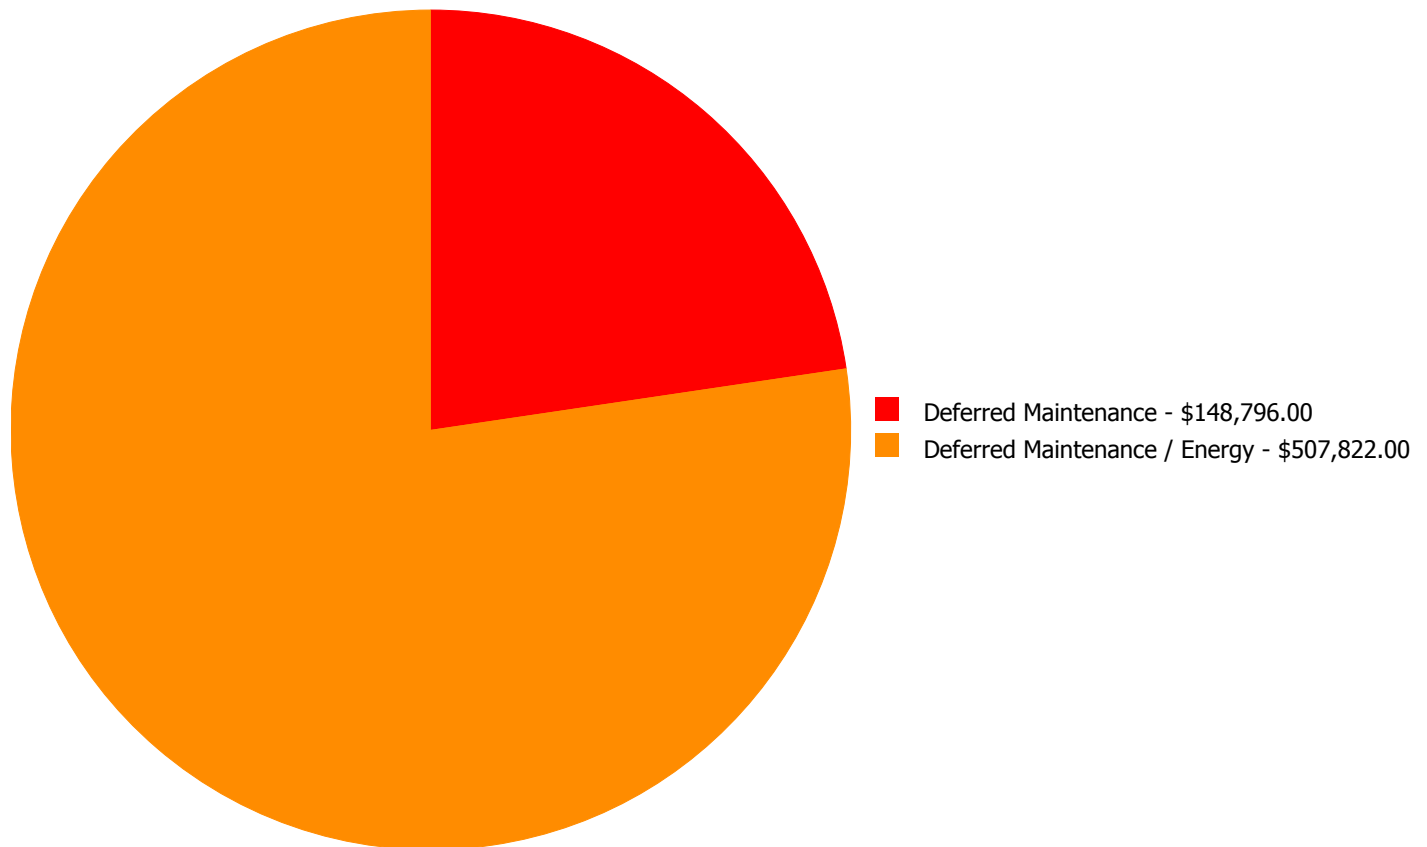
The following chart shows the total repair costs broken down by deficiency categories. Assessors assigned deficiencies to one of the following categories:

Budget Estimate Total: \$656,618.00

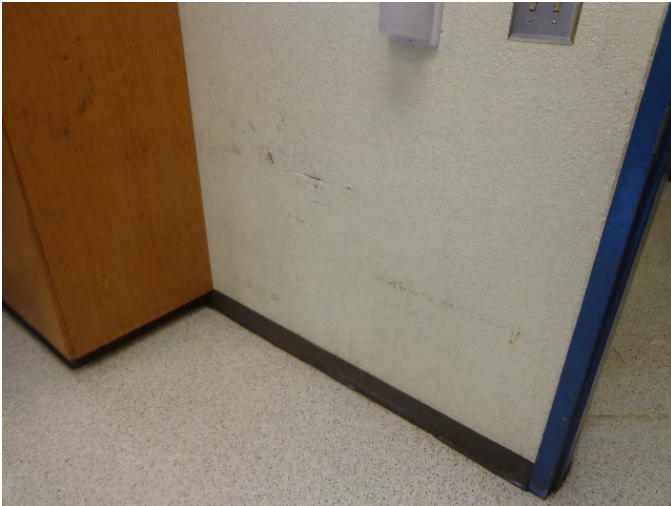
System: C3010 - Wall Finishes - Paint

Location: Throughout Building

Distress: Beyond Service Life

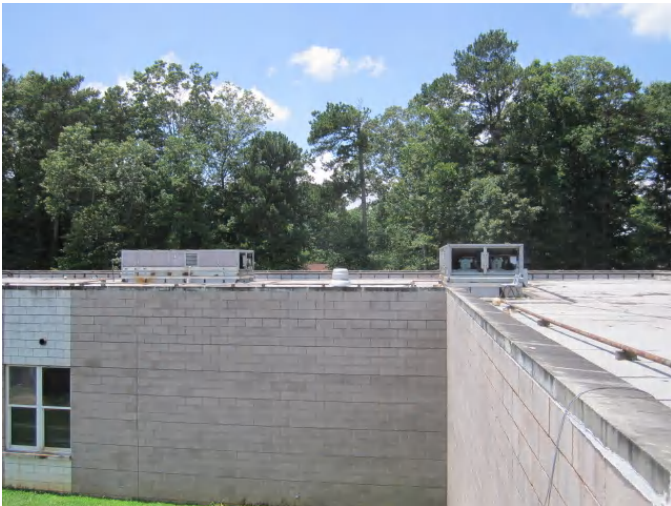
System: D3050 - Terminal & Package Units

Location: Throughout Building

Distress: Beyond Service Life

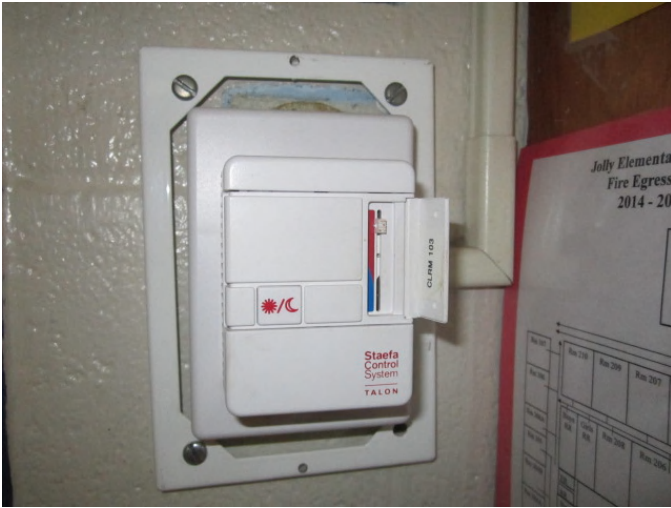
System: D3060 - Controls & Instrumentation

Location: Throughout Building

Distress: Inadequate

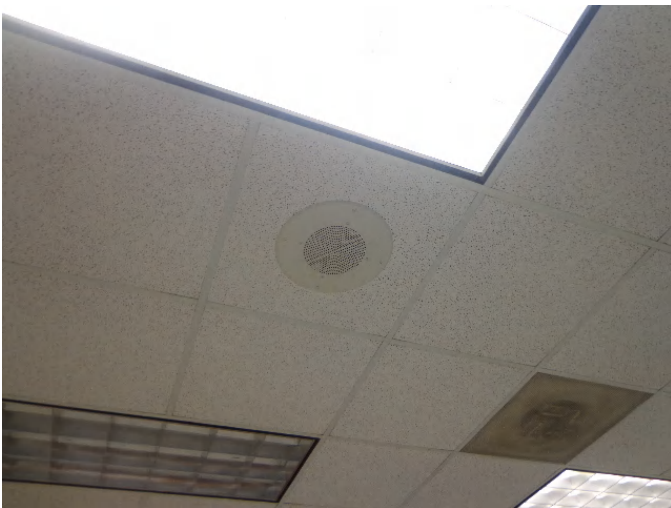
System: D5030 - Communications and Security - Clock & PA Systems

Location: Throughout Building

Distress: Beyond Service Life

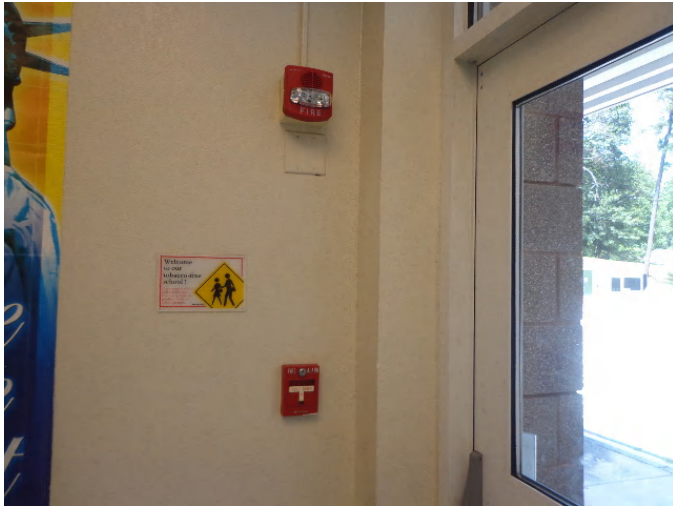
System: D5030 - Communications and Security - Fire Alarm

Location: Throughout Building

Distress: Beyond Service Life

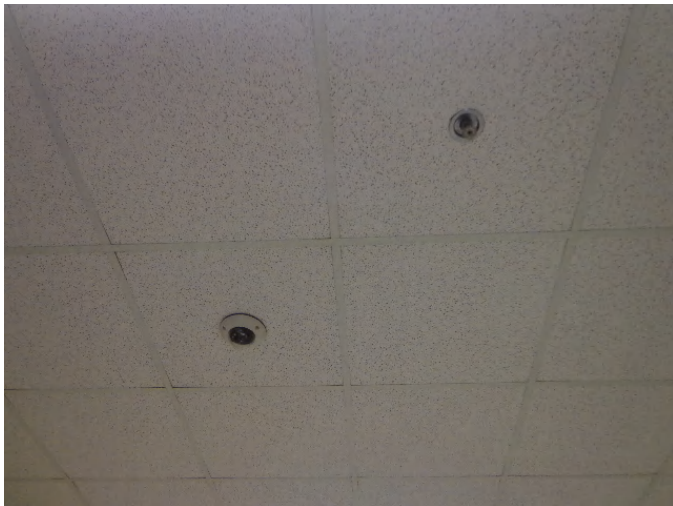
System: D5030 - Communications and Security - Security & CCTV

Location: Throughout Building

Distress: Beyond Service Life

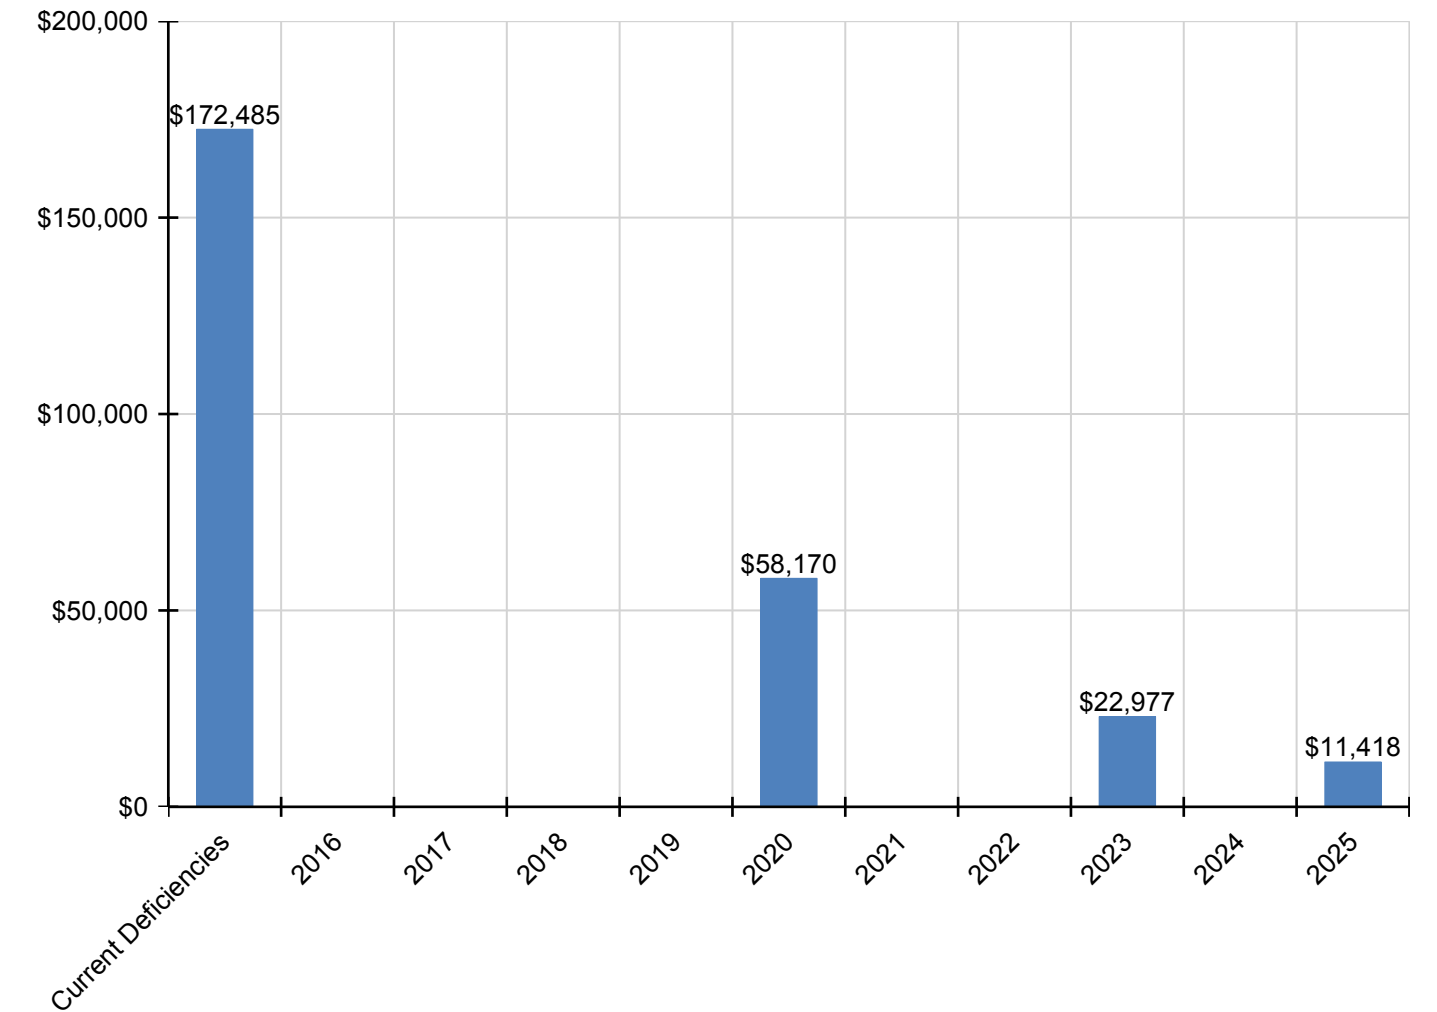
The following chart shows the current building deficiencies and the forecasted capital renewal (system replacement) requirements over the next ten years.

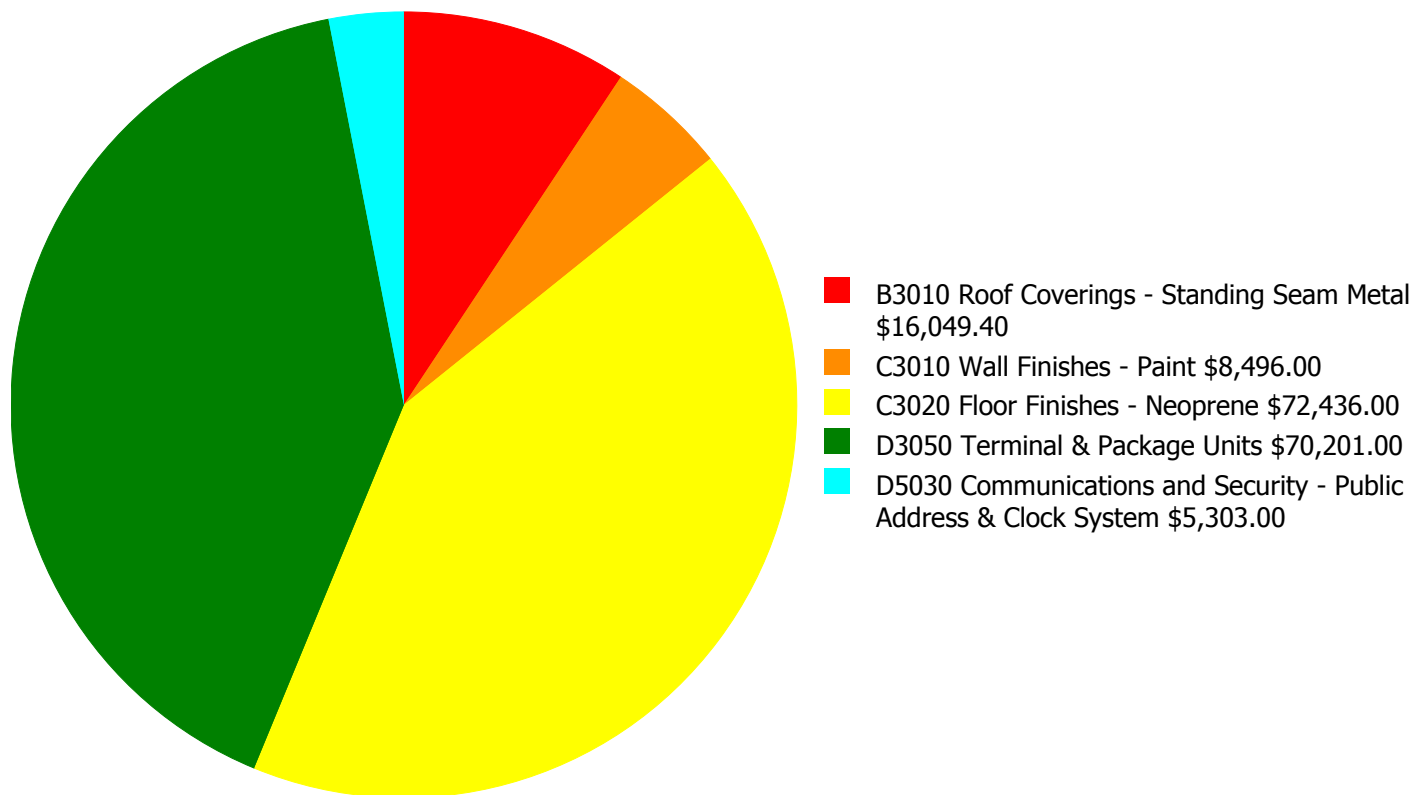
Current deficiencies include assemblies that have reached or exceed their design life or components of the assemblies that are in need of repair. Assemblies that have reached their design life are identified as current deficiencies and assigned the distress 'Beyond Service Life'. The following chart lists all current deficiencies associated with this facility broken down by UNIFORMAT system.

Budget Estimate Total: \$172,485.40
