DeKalb County School District/Elementary Schools

Jolly Elementary

School Assessment Report

May 19, 2016

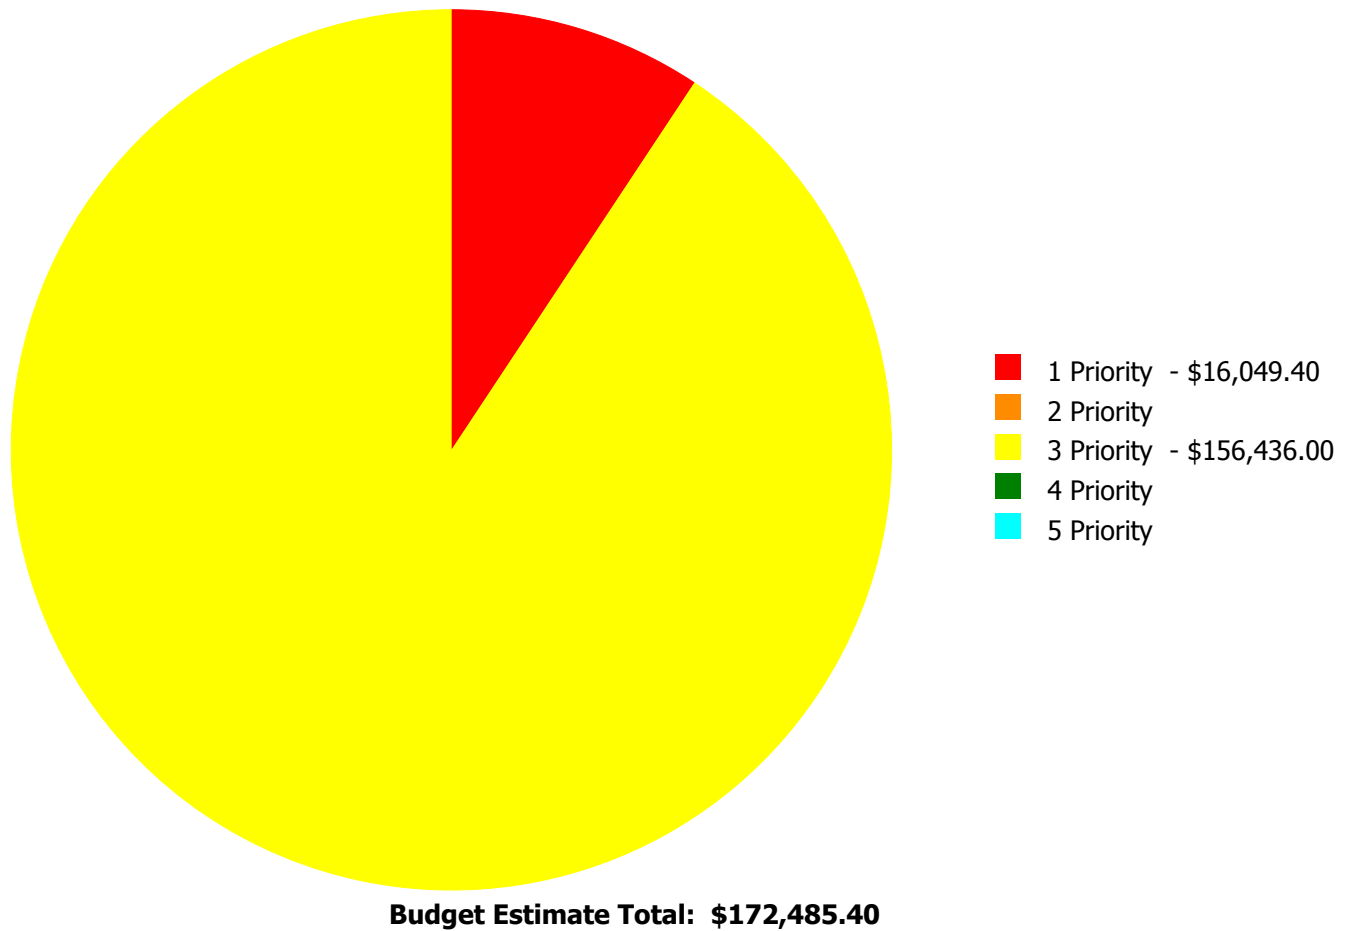
The following chart shows the total repair costs broken down by priority. Assessors assigned deficiencies within eCOMET to one of the following priority categories:

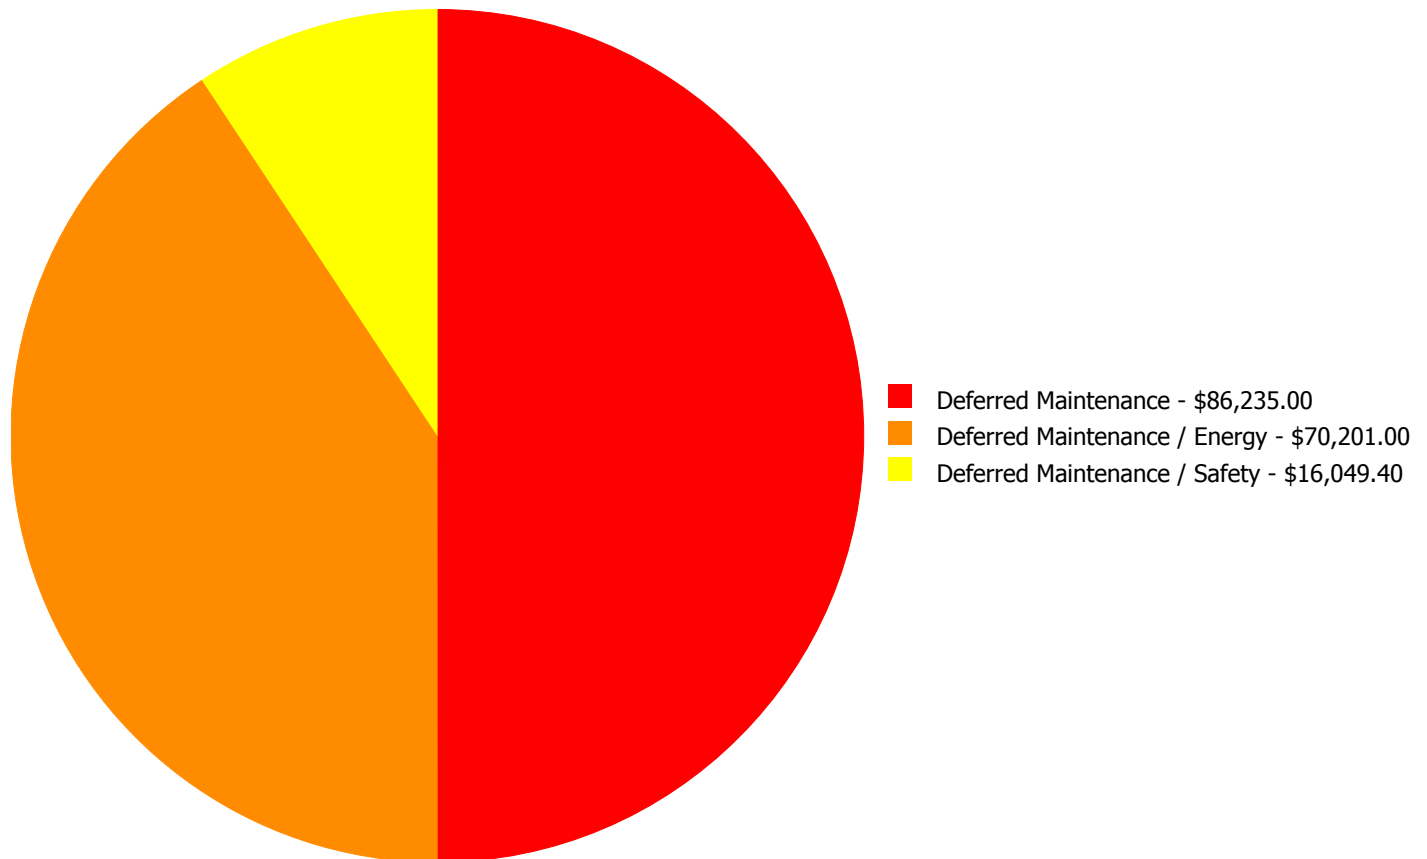
The following chart shows the total repair costs broken down by deficiency categories. Assessors assigned deficiencies to one of the following categories:

Budget Estimate Total: \$172,485.40

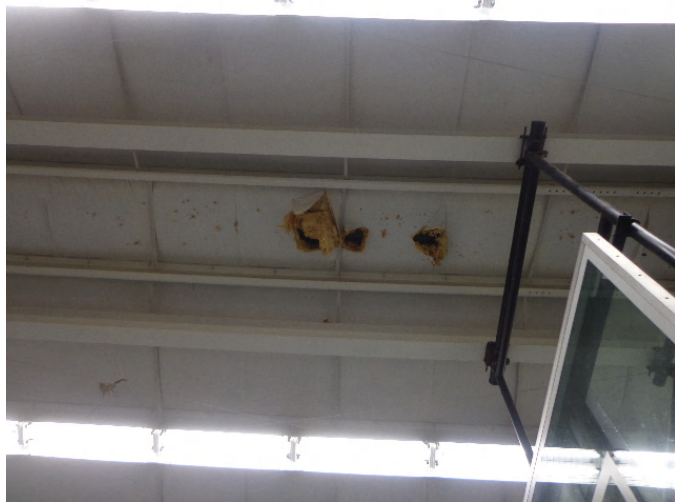
System: B3010 - Roof Coverings - Standing Seam Metal

Location: Roof

Distress: Damaged

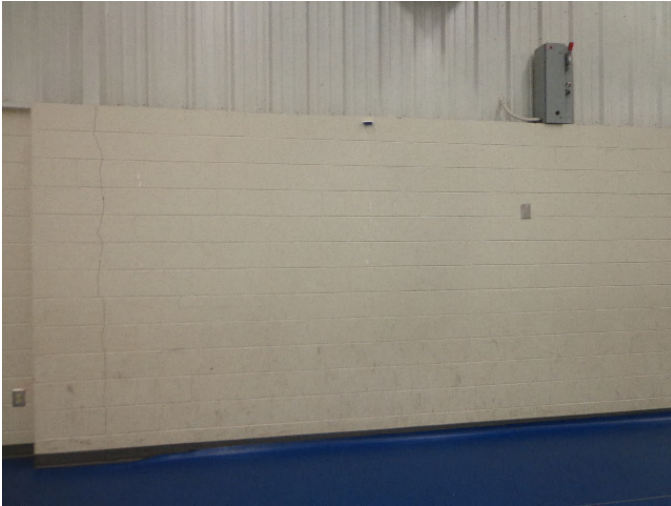
System: C3010 - Wall Finishes - Paint

Location: Throughout Building

Distress: Beyond Service Life

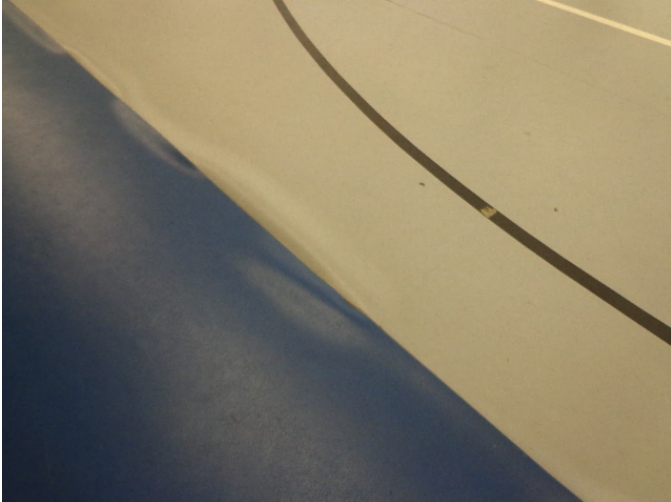
System: C3020 - Floor Finishes - Neoprene

Location: Basketball Court

Distress: Beyond Service Life

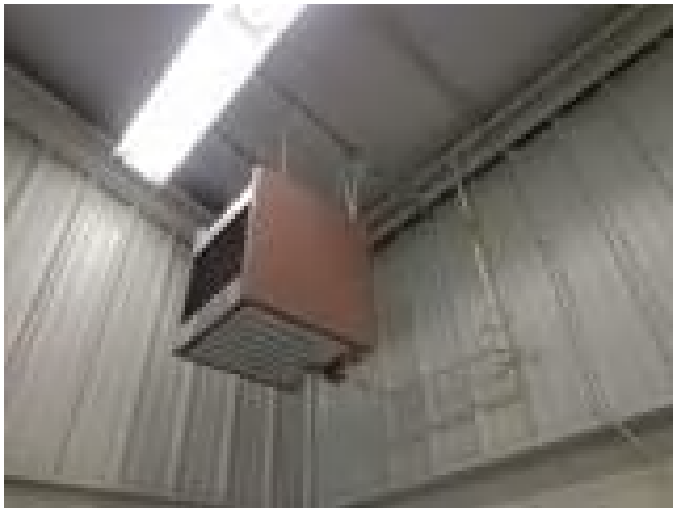
System: D3050 - Terminal & Package Units

Location: Throughout Building

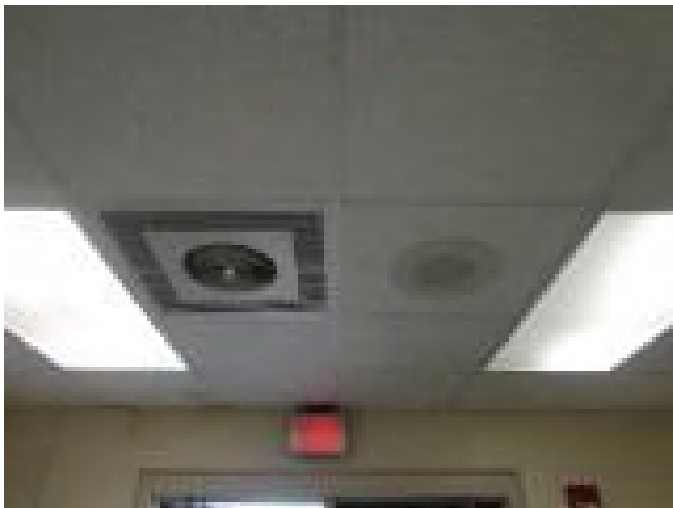
System: D5030 - Communications and Security - Public Address & Clock System

Location: Throughout Building

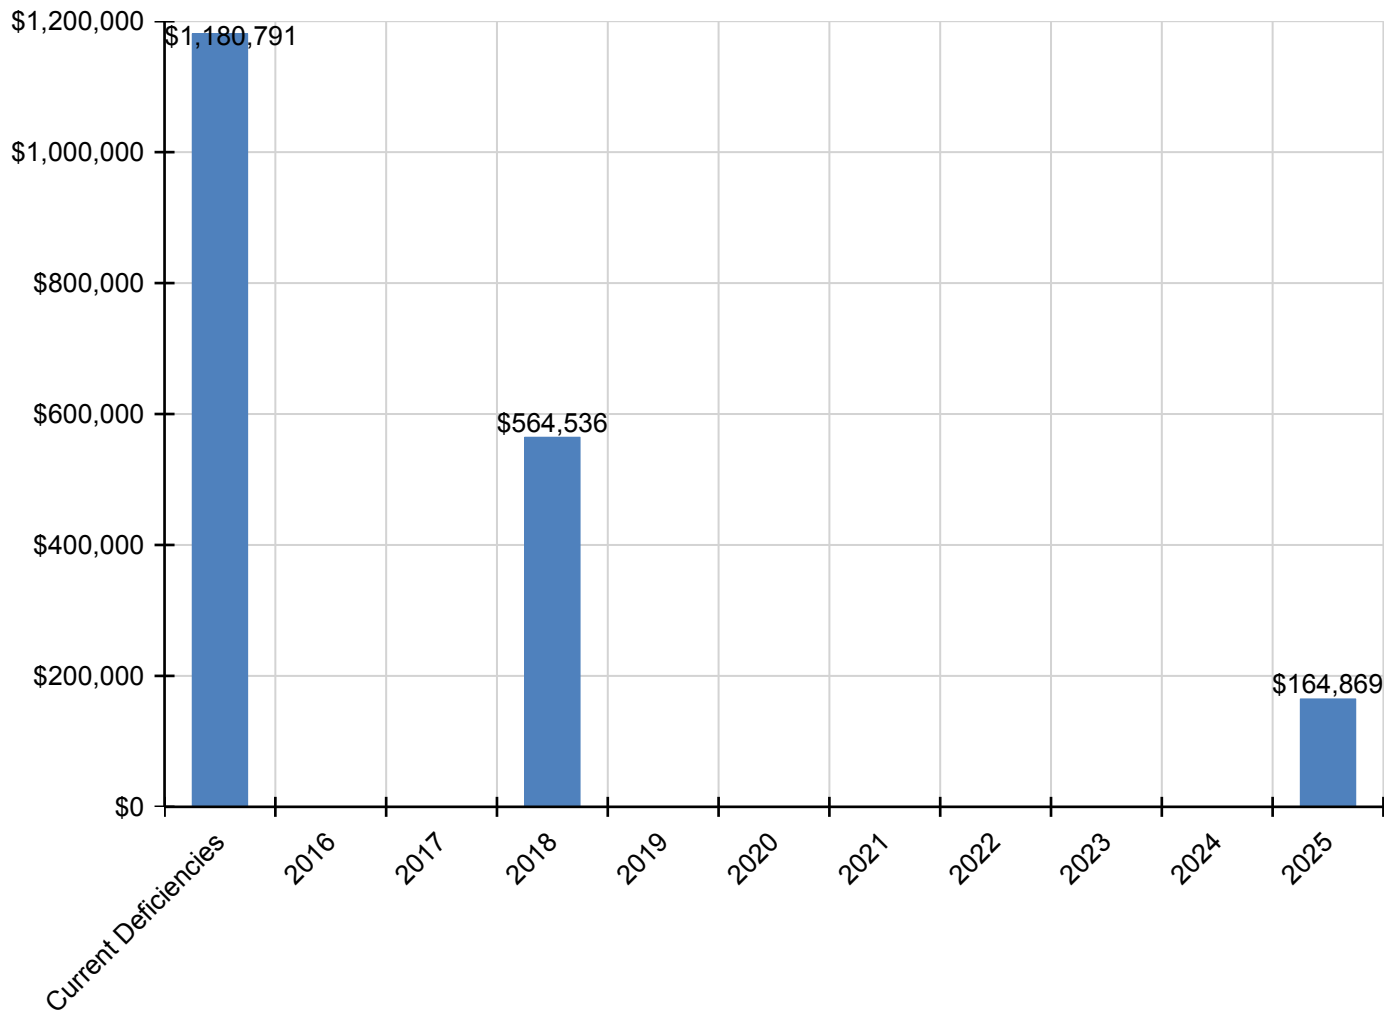
The following chart shows the current building deficiencies and the forecasted capital renewal (system replacement) requirements over the next ten years.

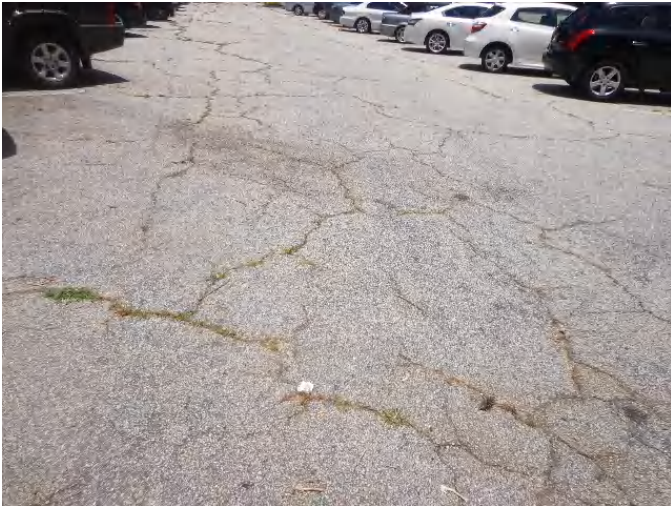
System: G2010 - Roadways

Location: Site

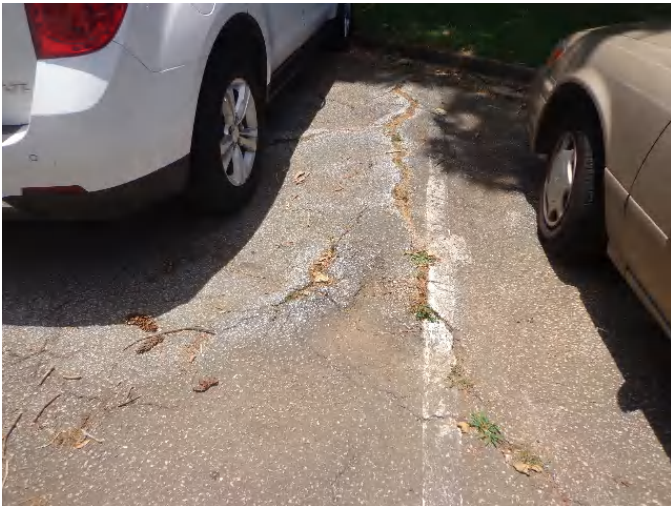
System: G2020 - Parking Lots

Location: Site

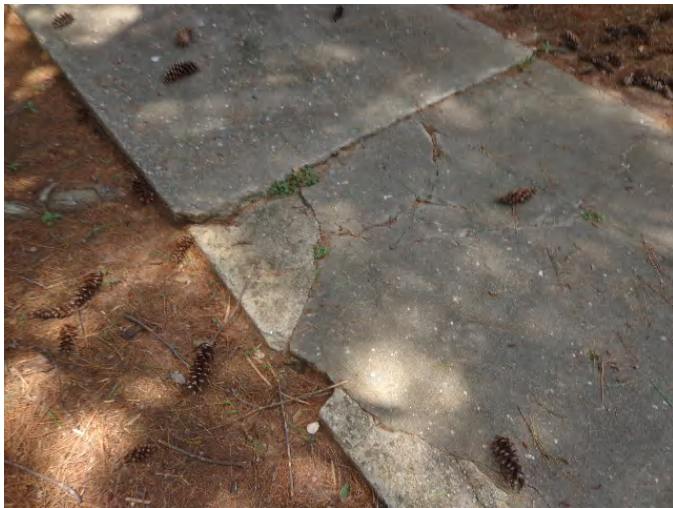
System: G2030 - Pedestrian Paving

Location: Site

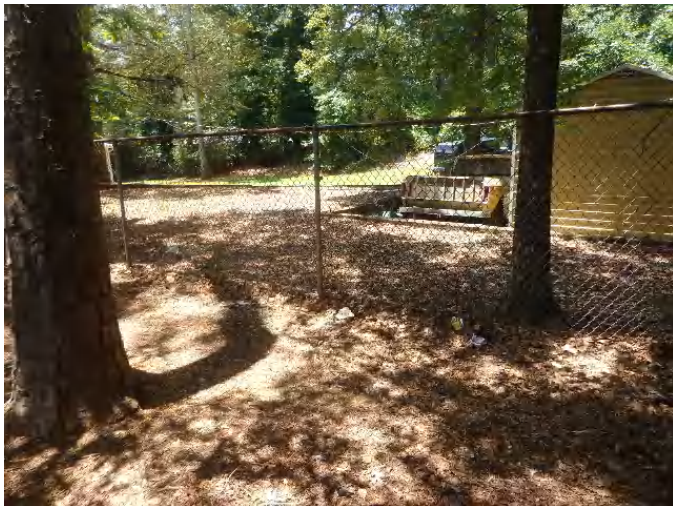
System: G2040 - Fencing & Guardrails

Location: Site

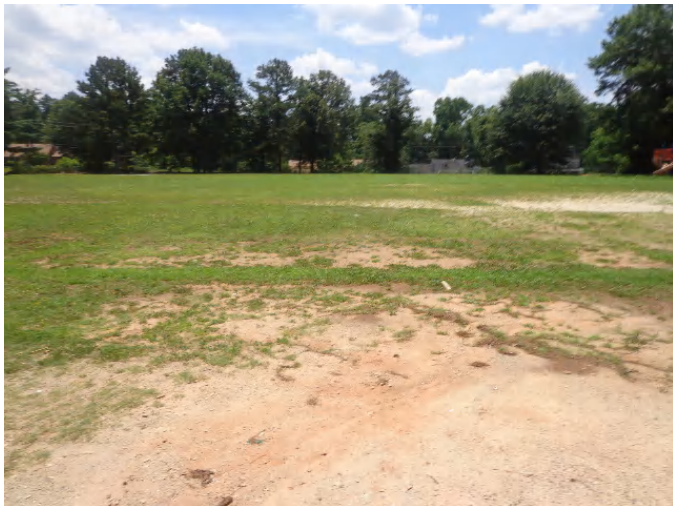
System: G2040 - Playing Field

Location: Site
Distress: Beyond Service Life
Category: Deferred Maintenance
Priority: 3 Priority
Correction: Renew System
Qty: 91,507.00
Unit of Measure: S.F.
Estimate: \$394,578.00
Assessor Name: Eduardo Lopez
Date Created: 06/30/2015

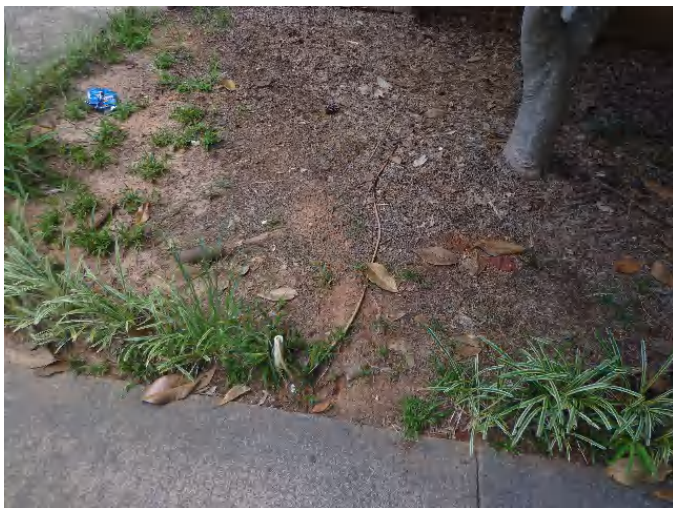
System: G2050 - Landscaping

Location: Site
Distress: Beyond Service Life
Category: Deferred Maintenance
Priority: 3 Priority
Correction: Renew System
Qty: 71,924.00
Unit of Measure: S.F.
Estimate: \$114,719.00
Assessor Name: Sam Mandola
Date Created: 06/22/2015

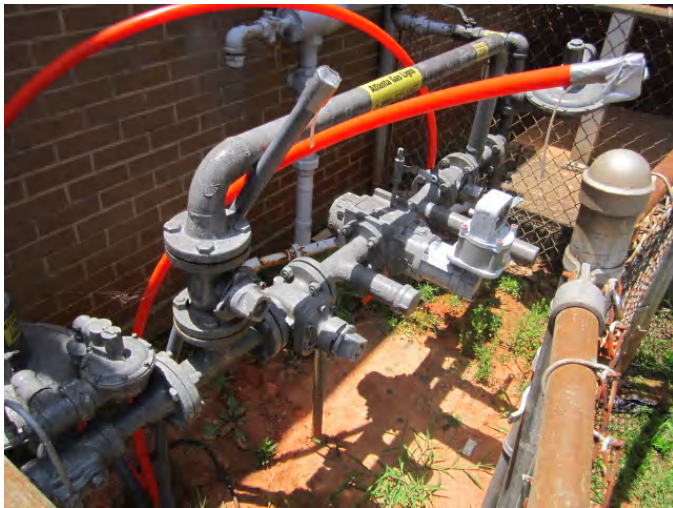
System: G3060 - Fuel Distribution

Location: Site

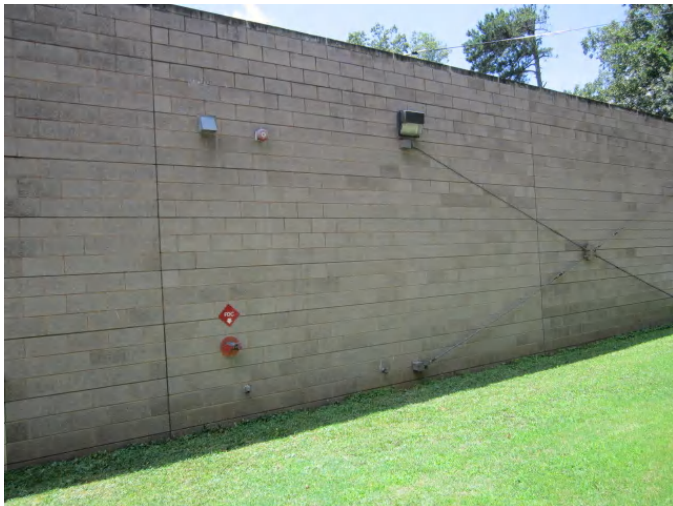
System: G4020 - Site Lighting

Location: Site

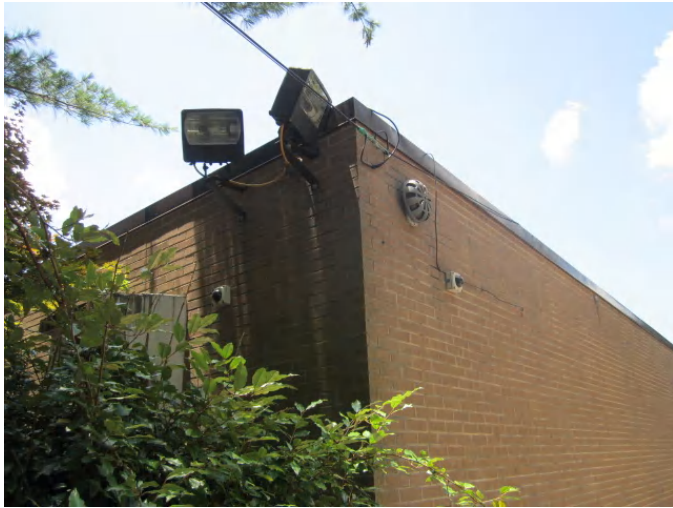
System: G4030 - Site Communications & Security

Location: Site
