Kelley Lake Elementary

School Assessment Report

May 19, 2016

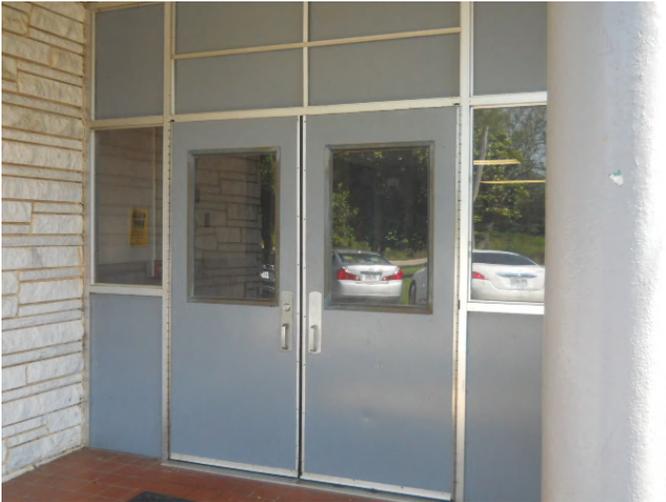
System: B2030 - Exterior Doors

Location: Throughout Building

Notes: The exterior doors are beyond their expected service life, do not lock/seal properly, and should be replaced.

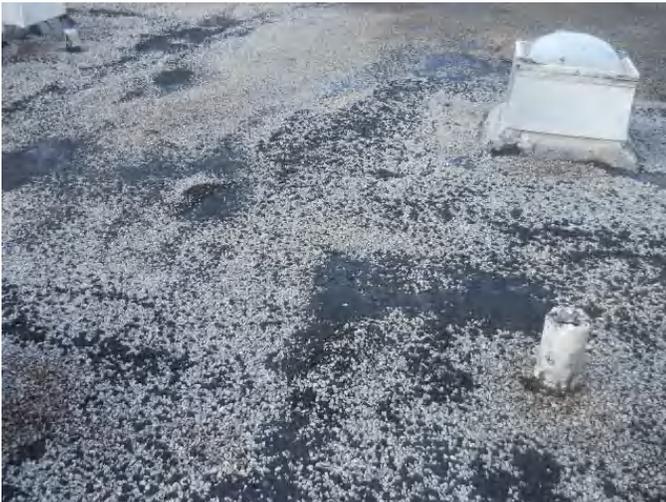
System: B3010 - Roof Coverings - BUR

Location: Roof

Notes: The roof covering is beyond its expected service life, has numerous reported leaks, and should be replaced. SPLOST add-alternative project 116-422 to replace the roof on the 1963, 1965 and 1969 buildings.

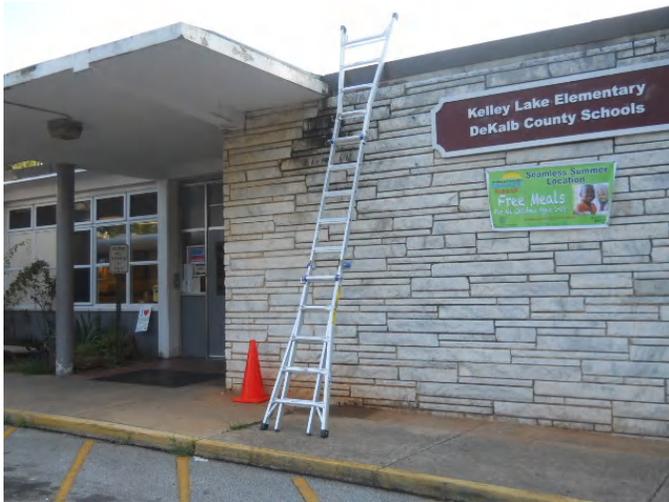
System: B3020 - Roof Openings

Location: Roof
Distress: Missing
Category: Safety
Priority: 3 Priority
Correction: Renew System
Qty: 51,186.00
Unit of Measure: S.F.
Estimate: \$33,220.00
Assessor Name: Sam Mandola
Date Created: 04/11/2015

Notes: The building does not have a roof hatch. Recommend installation of a safe roof ladder and hatch system for maintenance staff. SPLOST add-alternative project 116-422 to add roof hatches and ladders to the 1963, 1965 and 1969 buildings.

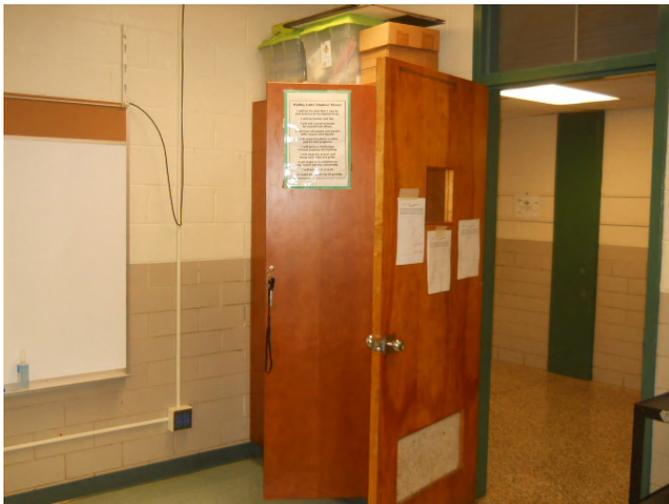
System: C1020 - Interior Doors

Location: Throughout Building
Distress: Beyond Service Life
Category: Deferred Maintenance / Accessibility Code Compliance
Priority: 3 Priority
Correction: Renew System
Qty: 51,186.00
Unit of Measure: S.F.
Estimate: \$97,868.00
Assessor Name: Sam Mandola
Date Created: 04/11/2015

Notes: The interior doors are original and should be replaced to improve ADA accessibility.

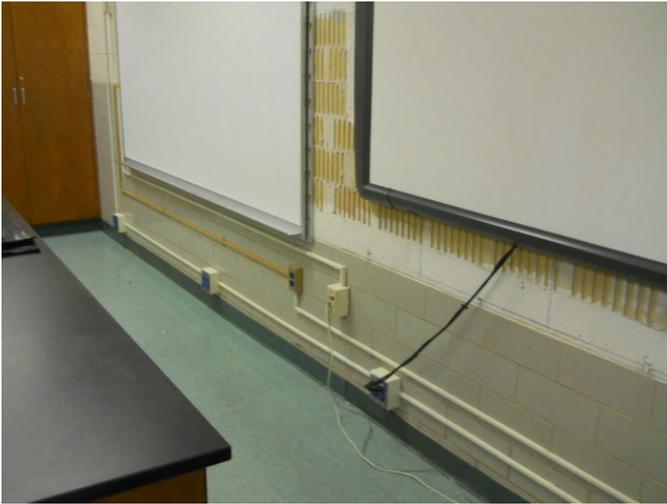
System: C3010 - Wall Finishes - Paint

Location: Throughout Building
Distress: Beyond Service Life
Category: Deferred Maintenance
Priority: 3 Priority
Correction: Renew System
Qty: 30,712.00
Unit of Measure: S.F.
Estimate: \$65,202.00
Assessor Name: Ben Nixon
Date Created: 04/11/2015

Notes: The painted wall finishes are beyond their expected service life and should be replaced.

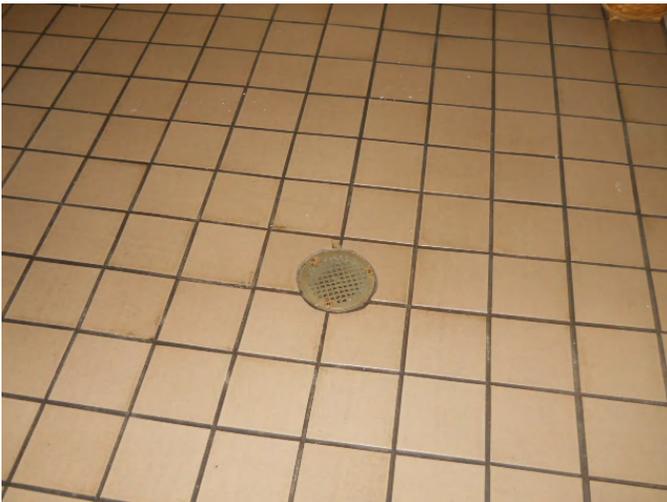
System: C3020 - Floor Finishes - Ceramic & Quarry Tile

Location: Kitchen and Restrooms
Distress: Beyond Service Life
Category: Deferred Maintenance
Priority: 3 Priority
Correction: Renew System
Qty: 4,606.00
Unit of Measure: S.F.
Estimate: \$73,415.00
Assessor Name: Ben Nixon
Date Created: 04/11/2015

Notes: The tile floor covering is beyond its expected service life and should be replaced.

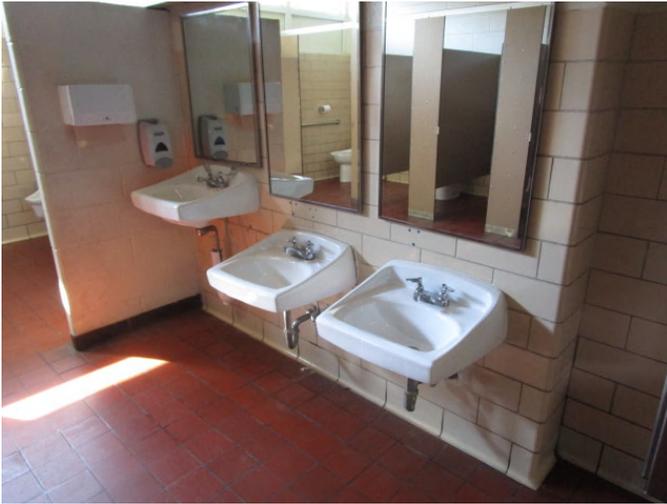
System: D2010 - Plumbing Fixtures

Location: Throughout Building
Distress: Beyond Service Life
Category: Deferred Maintenance / Accessibility Code Compliance
Priority: 3 Priority
Correction: Renew System
Qty: 51,186.00
Unit of Measure: S.F.
Estimate: \$994,339.00
Assessor Name: Sam Mandola
Date Created: 04/11/2015

Notes: Plumbing fixtures are beyond their expected service life and should be scheduled for replacement to improve ADA accessibility. SPLOST IV project 116-422 to renovate hall restrooms.

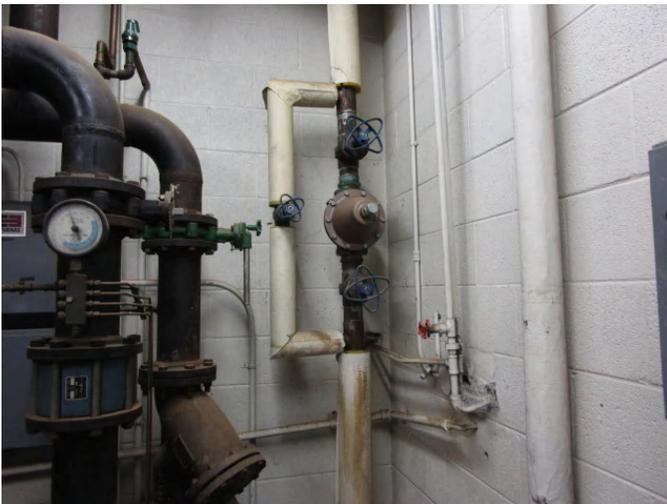
System: D2020 - Domestic Water Distribution

Location: Throughout Building
Distress: Beyond Service Life
Category: Deferred Maintenance / Environmental
Priority: 3 Priority
Correction: Renew System
Qty: 51,186.00
Unit of Measure: S.F.
Estimate: \$224,655.00
Assessor Name: Ben Nixon
Date Created: 06/13/2015

Notes: The domestic water distribution system is beyond its expected service life, has water quality issues, and should be scheduled for replacement.

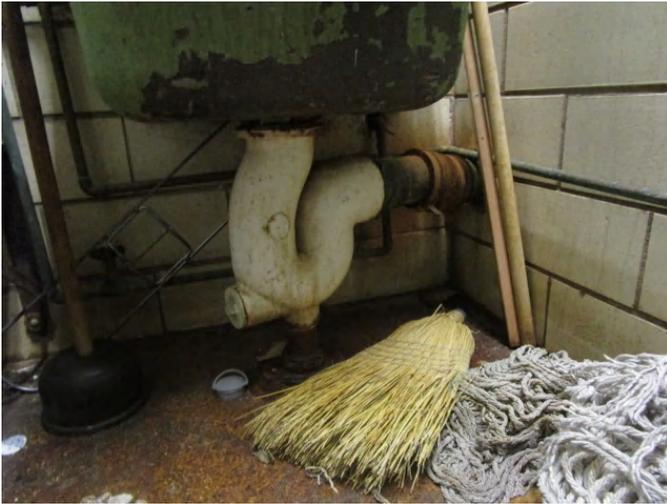
System: D2030 - Sanitary Waste

Location: Throughout Building
Distress: Beyond Service Life
Category: Deferred Maintenance
Priority: 3 Priority
Correction: Renew System
Qty: 51,186.00
Unit of Measure: S.F.
Estimate: \$191,999.00
Assessor Name: Sam Mandola
Date Created: 06/15/2015

Notes: The sanitary waste system is beyond its expected service life and should be scheduled for replacement.

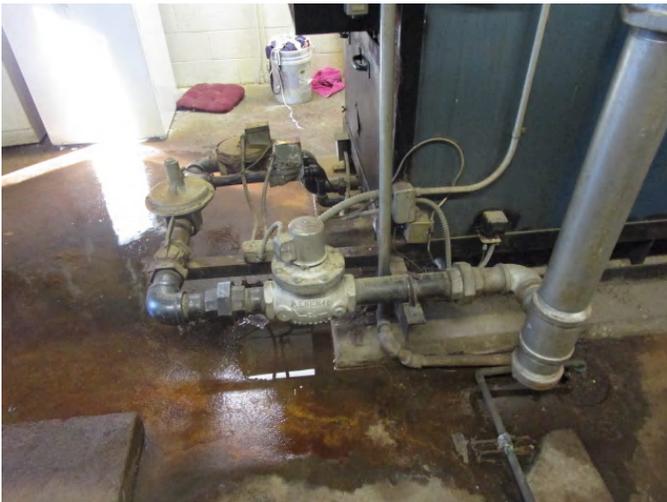
System: D2090 - Other Plumbing Systems - Natural Gas

Location: Throughout Building
Distress: Beyond Service Life
Category: Deferred Maintenance
Priority: 3 Priority
Correction: Renew System
Qty: 51,186.00
Unit of Measure: S.F.
Estimate: \$23,085.00
Assessor Name: Sam Mandola
Date Created: 04/11/2015

Notes: The natural gas system is beyond its expected service life and should be scheduled for replacement. SPLOST project 116-422 to replace grease trap and backflow preventer.

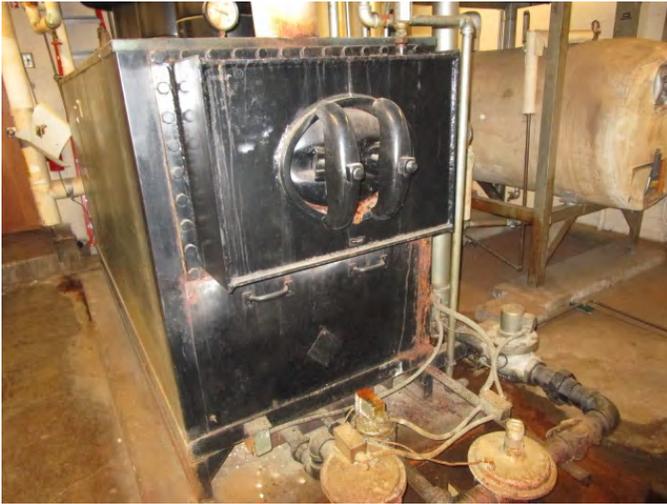
System: D3020 - Heat Generating Systems

Location: Mechanical Room
Distress: Beyond Service Life
Category: Deferred Maintenance / Energy
Priority: 3 Priority
Correction: Renew System
Qty: 51,186.00
Unit of Measure: S.F.
Estimate: \$256,186.00
Assessor Name: Ben Nixon
Date Created: 04/11/2015

Notes: The heat generating system is beyond its expected service life, inadequate, and should be scheduled for replacement.

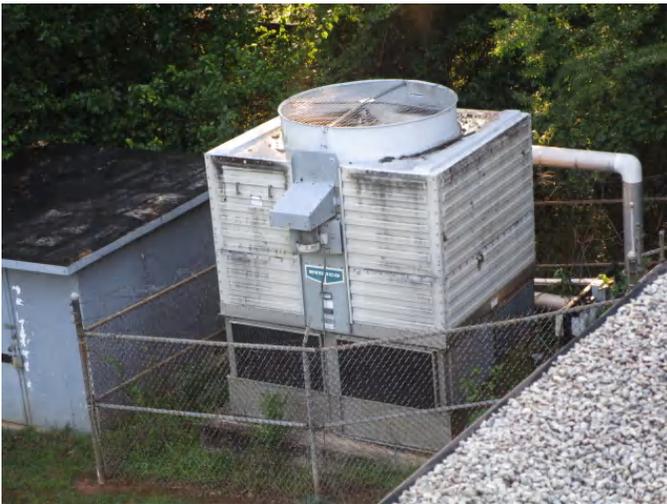
System: D3030 - Cooling Generating Systems

Location: Exterior of Building
Distress: Beyond Service Life
Category: Deferred Maintenance / Energy
Priority: 3 Priority
Correction: Renew System
Qty: 51,186.00
Unit of Measure: S.F.
Estimate: \$266,321.00
Assessor Name: Sam Mandola
Date Created: 04/11/2015

Notes: The cooling generating system is beyond its expected service life and should be scheduled for replacement. SPLOST project 116-422 to replace the cooling tower.

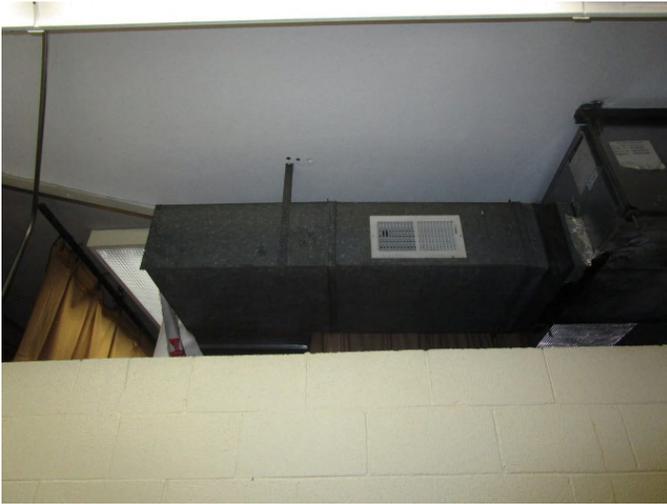
System: D3040 - Distribution & Exhaust Systems

Location: Throughout Building
Distress: Beyond Service Life
Category: Deferred Maintenance / Environmental
Priority: 3 Priority
Correction: Renew System
Qty: 51,186.00
Unit of Measure: S.F.
Estimate: \$310,238.00
Assessor Name: Sam Mandola
Date Created: 04/11/2015

Notes: The distribution and exhaust systems are beyond their expected service life and should be scheduled for replacement. SPLOST project 116-422 to replace the air distribution and exhaust systems throughout the buildings.

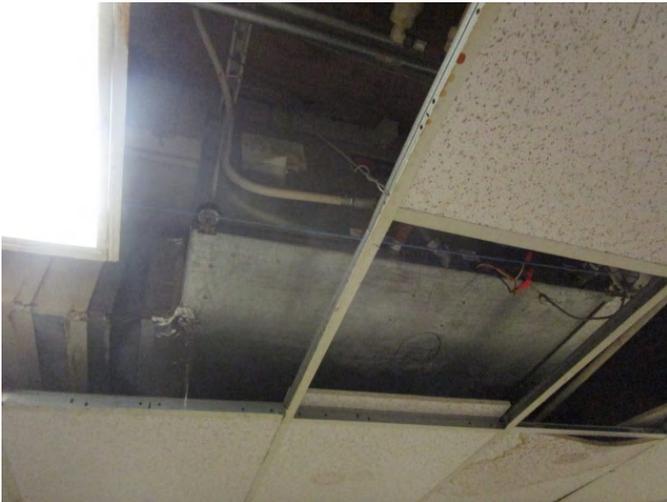
System: D3050 - Terminal & Package Units

Location: Throughout Building
Distress: Beyond Service Life
Category: Deferred Maintenance / Energy
Priority: 3 Priority
Correction: Renew System
Qty: 51,186.00
Unit of Measure: S.F.
Estimate: \$1,042,761.00
Assessor Name: Sam Mandola
Date Created: 04/11/2015

Notes: The terminal and package units are beyond their expected service life, inadequate, and should be scheduled for replacement. SPLOST project 116-422 to replace the water source heat pumps.

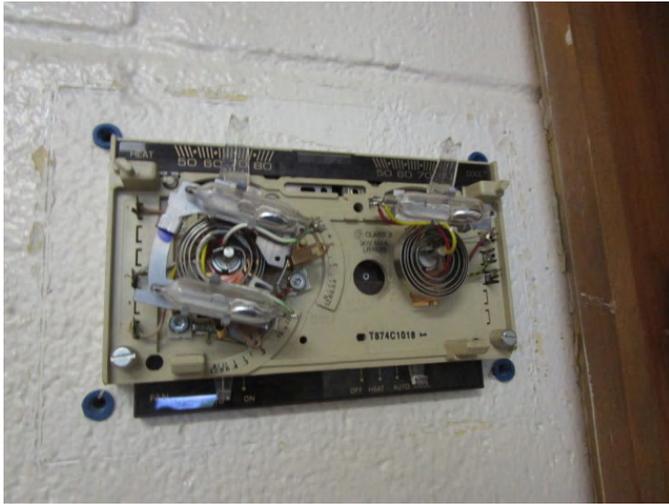
System: D3060 - Controls & Instrumentation

Location: Throughout Building
Distress: Beyond Service Life
Category: Deferred Maintenance / Energy
Priority: 3 Priority
Correction: Renew System
Qty: 51,186.00
Unit of Measure: S.F.
Estimate: \$202,697.00
Assessor Name: Ben Nixon
Date Created: 04/11/2015

Notes: The controls and instrumentation system is beyond its expected service life, does not function properly, and should be scheduled for replacement.

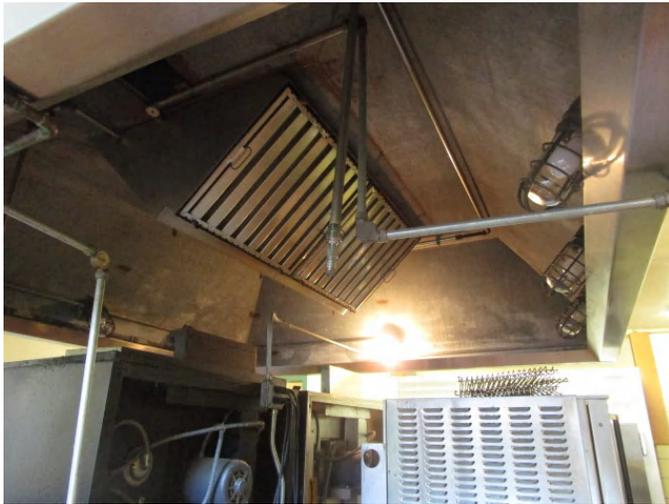
System: D3090 - Other HVAC Systems/Equip - Kitchen Hood

Location: Kitchen
Distress: Beyond Service Life
Category: Deferred Maintenance
Priority: 3 Priority
Correction: Renew System
Qty: 51,186.00
Unit of Measure: S.F.
Estimate: \$69,255.00
Assessor Name: Sam Mandola
Date Created: 04/11/2015

Notes: The kitchen hood system is beyond its expected service life and should be scheduled for replacement.

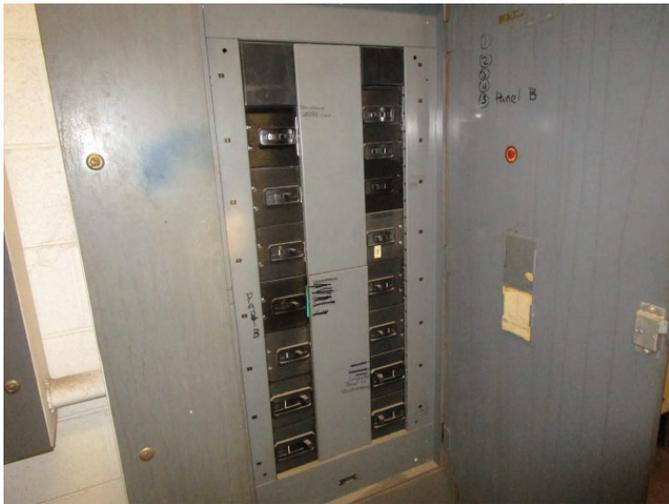
System: D5010 - Electrical Service/Distribution

Location: Main Switch Room/Throughout Building
Distress: Beyond Service Life
Category: Deferred Maintenance
Priority: 3 Priority
Correction: Renew System
Qty: 51,186.00
Unit of Measure: S.F.
Estimate: \$101,911.00
Assessor Name: Ben Nixon
Date Created: 04/11/2015

Notes: The electrical service/distribution system is beyond its expected service life and should be scheduled for replacement.

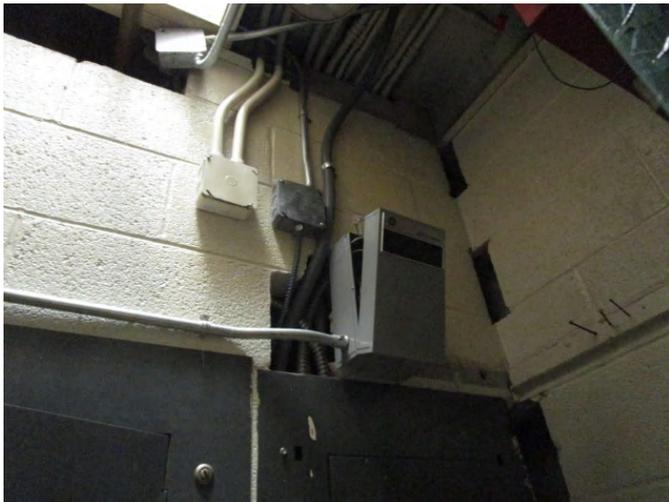
System: D5020 - Branch Wiring

Location: Throughout Building
Distress: Beyond Service Life
Category: Deferred Maintenance
Priority: 3 Priority
Correction: Renew System
Qty: 51,186.00
Unit of Measure: S.F.
Estimate: \$381,745.00
Assessor Name: Ben Nixon
Date Created: 04/11/2015

Notes: The branch wiring system is beyond its expected service life and should be scheduled for replacement.

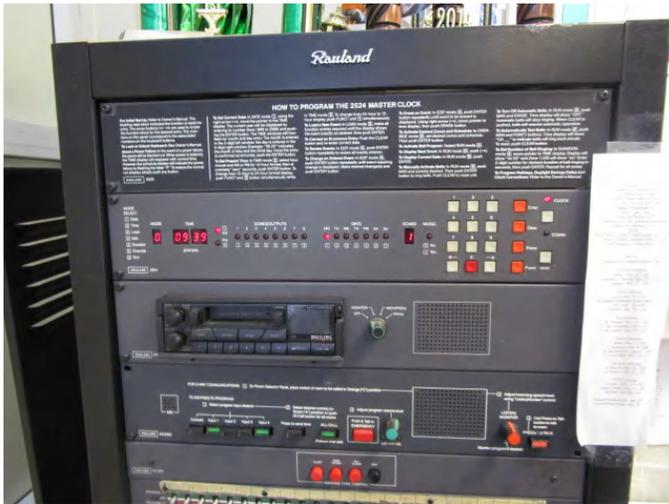
System: D5030 - Communications and Security - Clock & PA Systems

Location: Throughout Building
Distress: Beyond Service Life
Category: Deferred Maintenance
Priority: 3 Priority
Correction: Renew System
Qty: 51,186.00
Unit of Measure: S.F.
Estimate: \$315,306.00
Assessor Name: Ben Nixon
Date Created: 04/11/2015

Notes: Clock and PA systems are beyond their expected service life and should be scheduled for replacement.

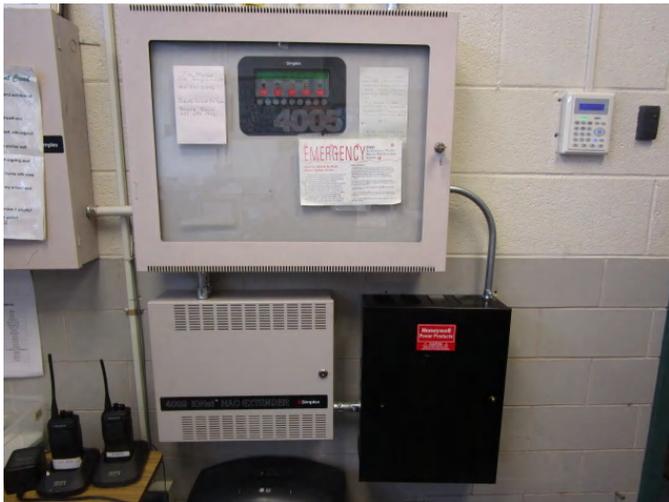
System: D5030 - Communications and Security - Fire Alarm

Location: Throughout Building
Distress: Beyond Service Life
Category: Deferred Maintenance
Priority: 3 Priority
Correction: Renew System
Qty: 51,186.00
Unit of Measure: S.F.
Estimate: \$69,255.00
Assessor Name: Ben Nixon
Date Created: 04/11/2015

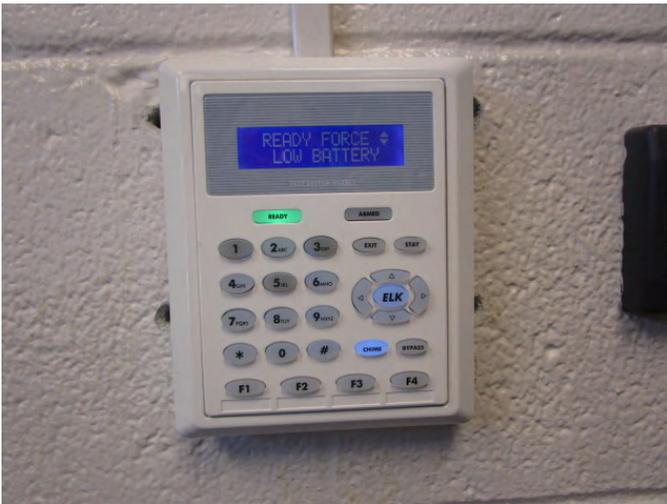
System: D5030 - Communications and Security - Security & CCTV

Location: Throughout Building
Distress: Beyond Service Life
Category: Deferred Maintenance
Priority: 3 Priority
Correction: Renew System
Qty: 51,186.00
Unit of Measure: S.F.
Estimate: \$34,346.00
Assessor Name: Ben Nixon
Date Created: 04/11/2015

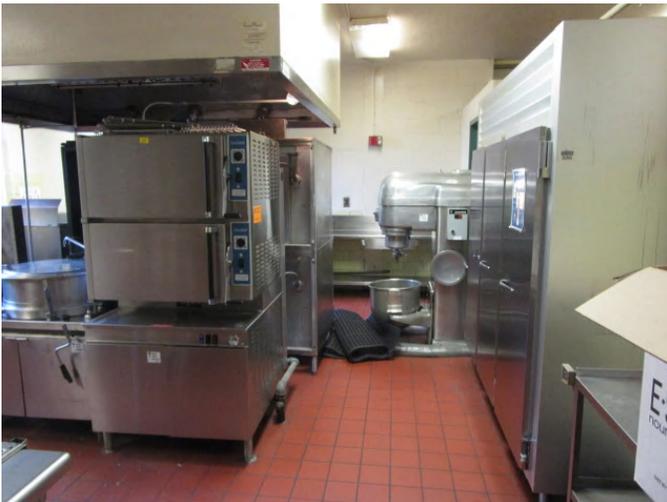
System: E1090 - Other Equipment (Kitchen Equipment)

Location: Kitchen
Distress: Beyond Service Life
Category: Deferred Maintenance
Priority: 3 Priority
Correction: Renew System
Qty: 51,186.00
Unit of Measure: S.F.
Estimate: \$552,348.00
Assessor Name: Sam Mandola
Date Created: 04/11/2015

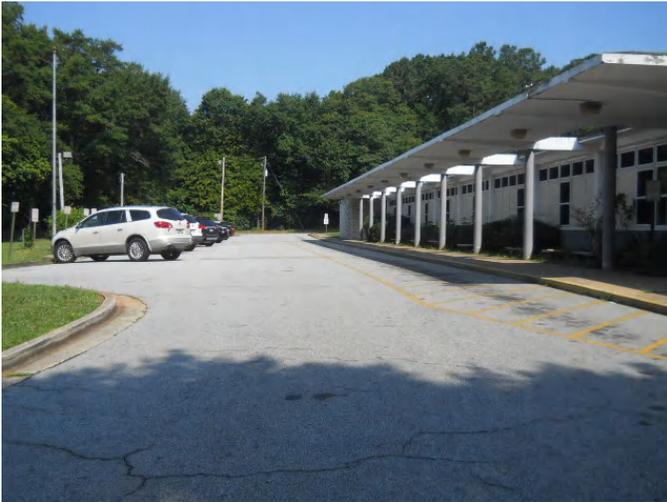
System: G2010 - Roadways

Location: Site
Distress: Beyond Service Life
Category: Deferred Maintenance
Priority: 3 Priority
Correction: Renew System
Qty: 36,383.00
Unit of Measure: S.F.
Estimate: \$206,910.12
Assessor Name: Eduardo Lopez
Date Created: 06/13/2015
