DeKalb County School District/Elementary Schools

Kingsley Elementary

School Assessment Report

May 19, 2016

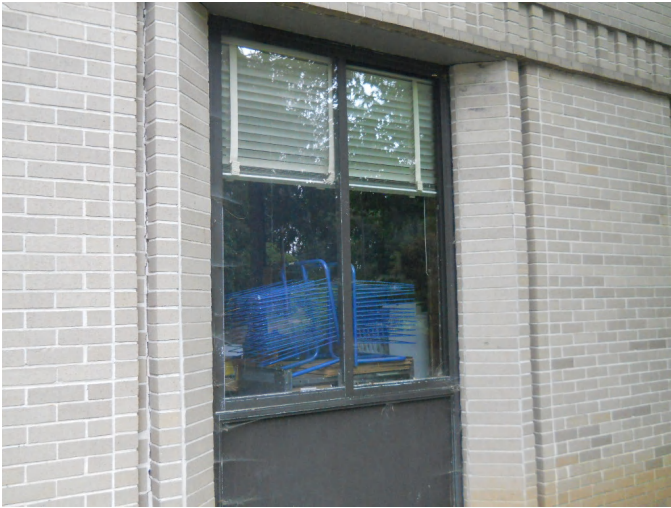
System: B2020 - Exterior Windows

Location: Throughout Building

Distress: Beyond Service Life

Notes: The exterior window system is original, beyond its expected service life, and should be replaced.

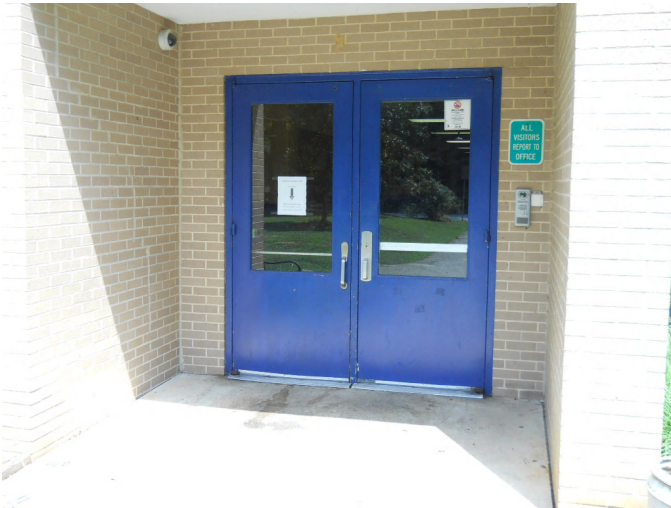
System: B2030 - Exterior Doors

Location: Throughout Building

Distress: Beyond Service Life

Notes: The exterior doors are original, worn, and should be replaced.

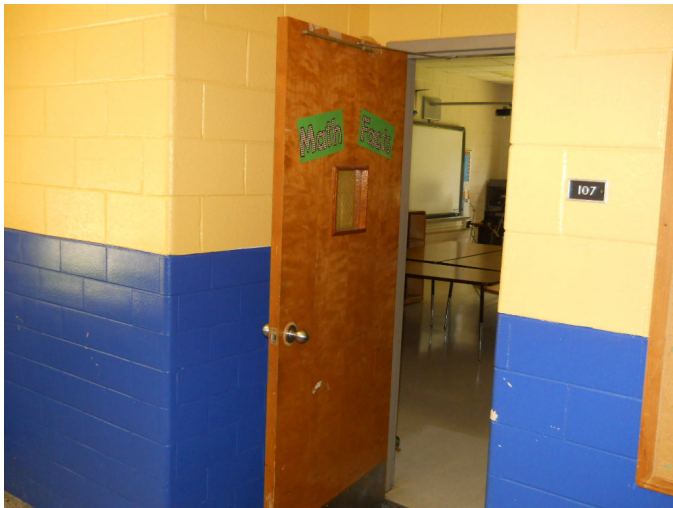
System: C1020 - Interior Doors

Location: Throughout Building

Distress: Beyond Service Life

Notes: The interior doors are original, beyond their expected service life, not ADA or building code compliant, and should be replaced.

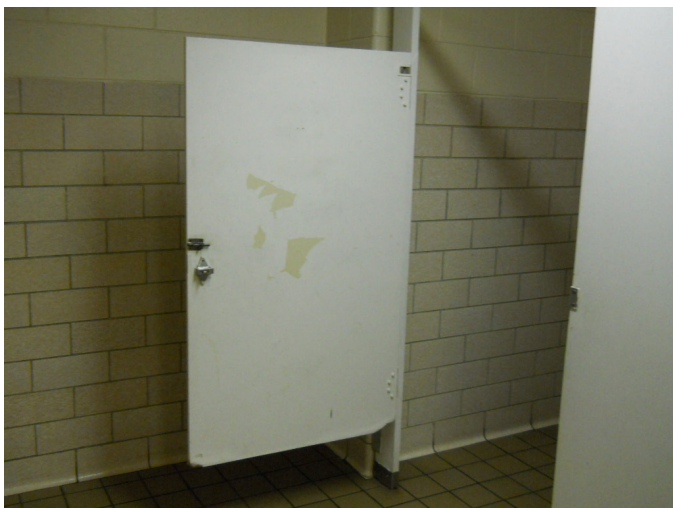
System: C1030 - Fittings

Location: Throughout Building

Distress: Beyond Service Life

Notes: Fittings, such as toilet partitions, handrails and signage, are beyond their expected service life and should be replaced. SPLOST project 117-422 to provide hall restroom renovations.

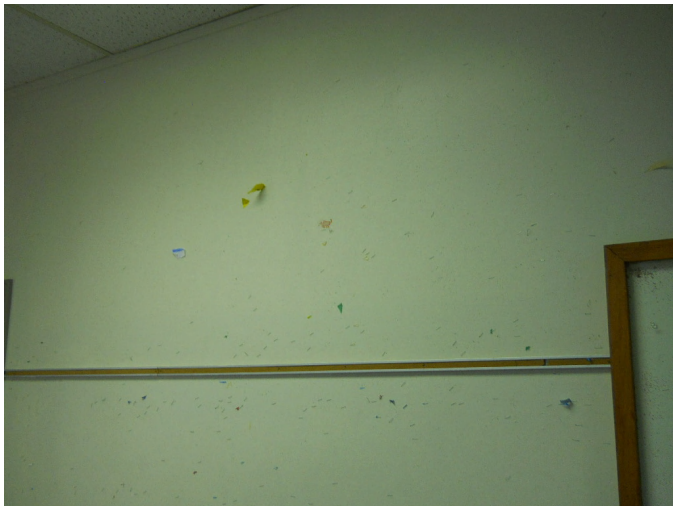
System: C3010 - Wall Finishes - Paint

Location: Throughout Building

Distress: Beyond Service Life

Notes: The painted wall finishes are beyond their expected service life, dirty and worn, and should be replaced.

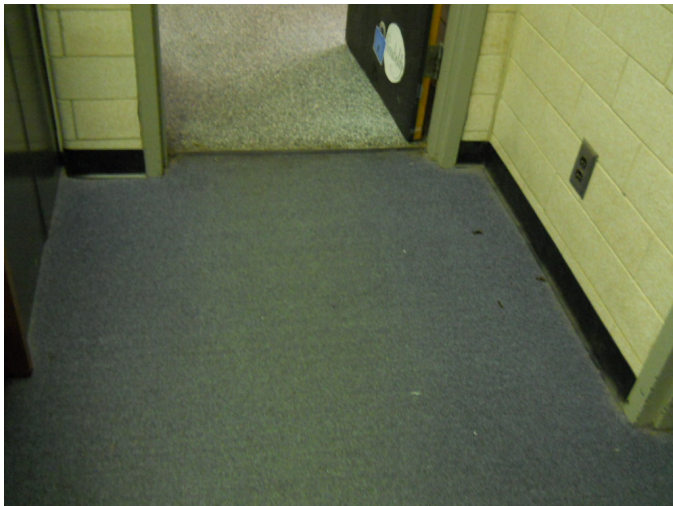
System: C3020 - Floor Finishes - Carpet

Location: Media Center

Distress: Beyond Service Life

Notes: The carpet in the media center is aged, worn and dirty, and should be replaced.

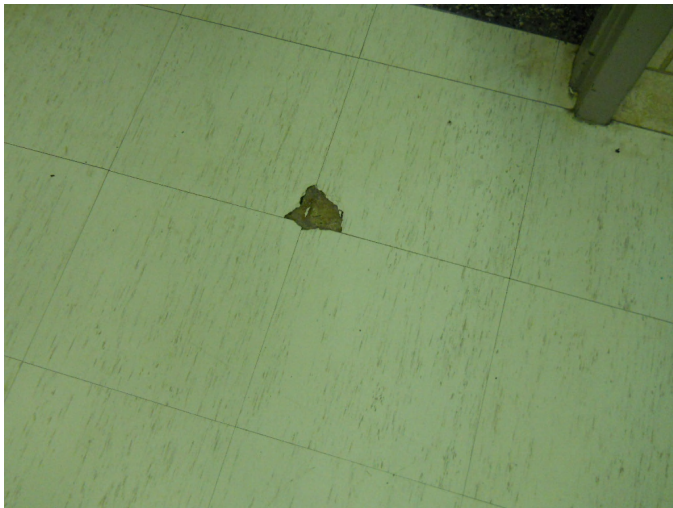
System: C3020 - Floor Finishes - VCT

Location: Throughout Building

Distress: Beyond Service Life

Notes: The VCT floor covering is beyond its expected service life and should be replaced.

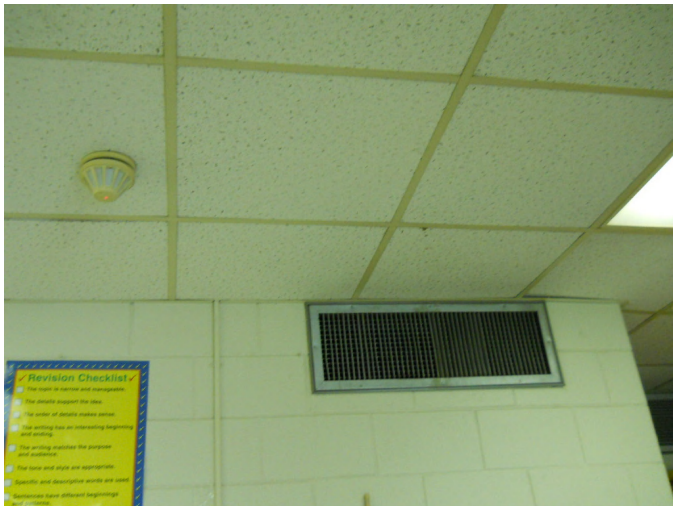
System: C3030 - Ceiling Finishes

Location: Throughout Building

Distress: Beyond Service Life

Notes: The acoustical ceiling system is beyond its expected service life and should be replaced.

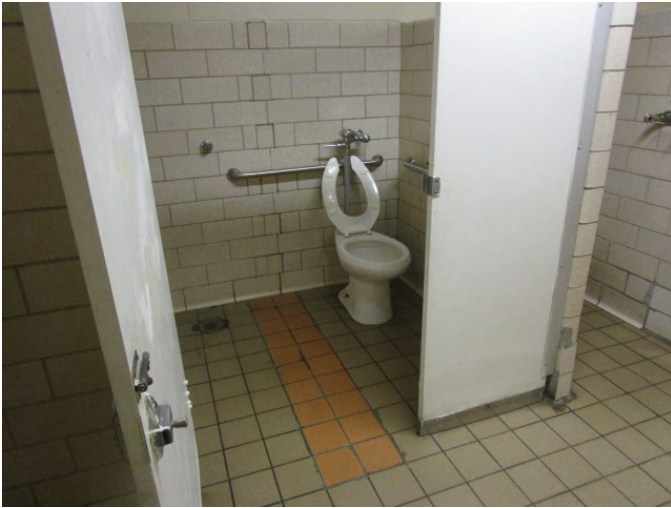
System: D2010 - Plumbing Fixtures

Location: Throughout Building

Distress: Beyond Service Life

Notes: The plumbing fixtures are beyond their expected service life, not ADA compliant, and should be scheduled for replacement. Some water fountains protrude into the hallway more than four inches in the south classroom wing. Protrusion is not ADA compliant if more than four inches. SPLOST project 117-422 to provide hall restroom renovations.

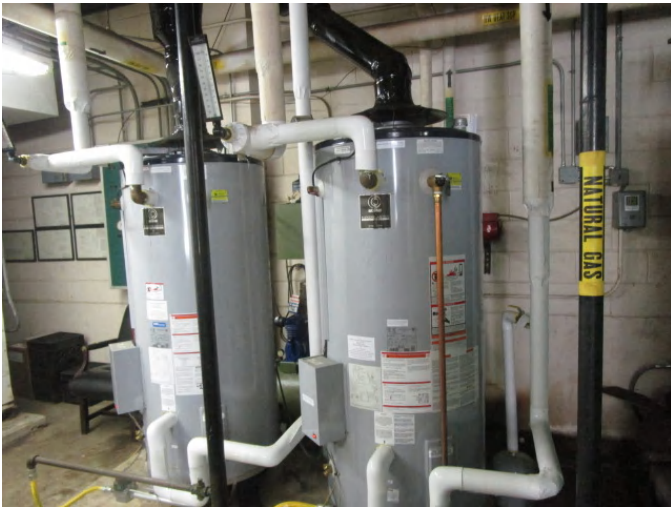
System: D2020 - Domestic Water Distribution

Location: Throughout Building

Distress: Beyond Service Life

Notes: The domestic water distribution system is beyond its expected service life and should be scheduled for replacement.

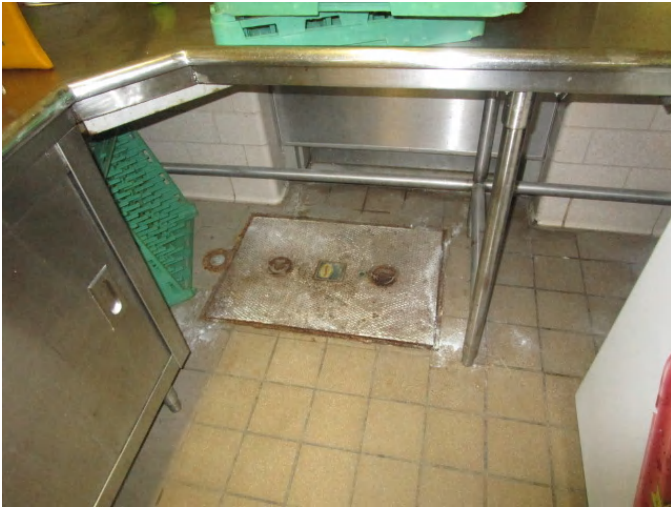
System: D2030 - Sanitary Waste

Location: Throughout Building

Distress: Beyond Service Life

Notes: The sanitary waste system is beyond its expected service life and should be scheduled for replacement.

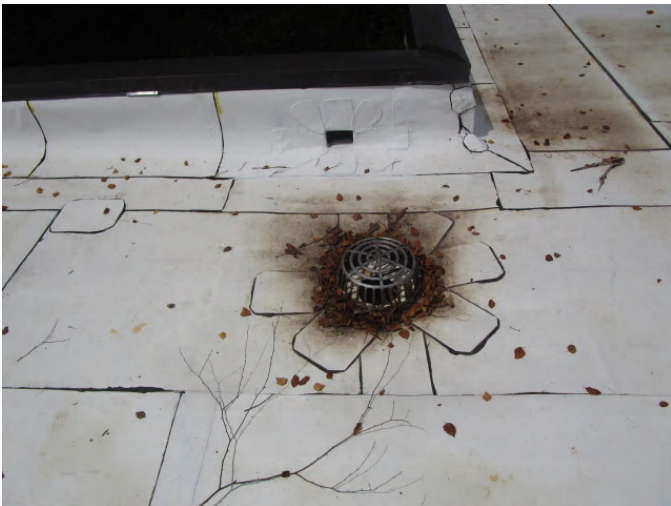
System: D2040 - Rain Water Drainage

Location: Throughout Building

Distress: Beyond Service Life

Notes: The rainwater drainage system is beyond its expected service life and should be scheduled for replacement.

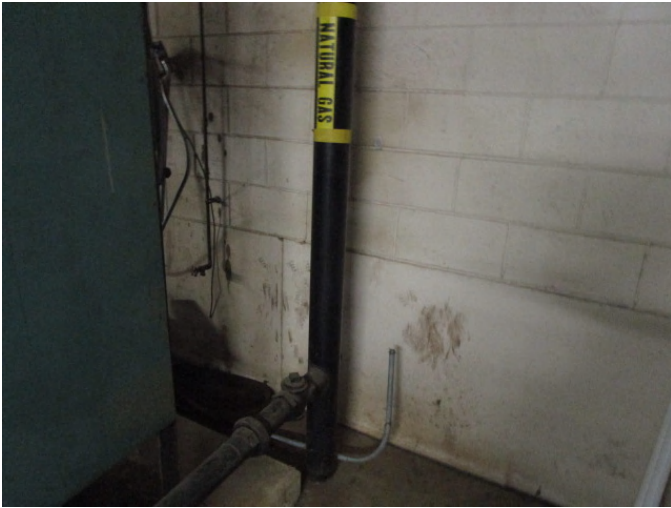
System: D2090 - Other Plumbing Systems - Natural Gas

Location: Throughout Building

Distress: Beyond Service Life

Notes: The natural gas system is beyond its expected service life and should be scheduled for replacement.

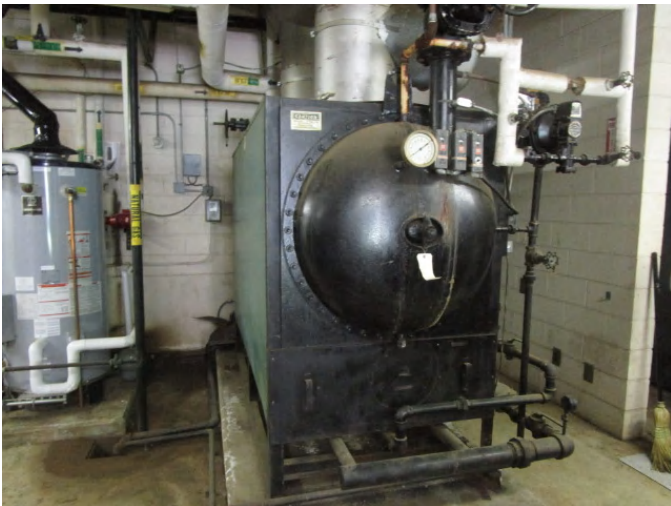
System: D3020 - Heat Generating Systems

Location: Mechanical Room

Distress: Beyond Service Life

Notes: The heat generating system is beyond its expected service life and should be scheduled for replacement. White mastic on fiberglass pipe insulation is identified as ACM by others.

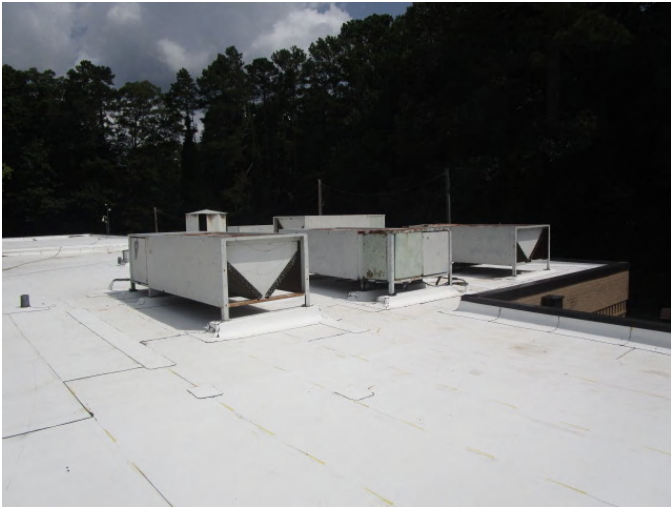
System: D3030 - Cooling Generating Systems

Location: Outside Mechanical Room

Distress: Beyond Service Life

Notes: The cooling generating system is beyond its expected service life and should be scheduled for replacement. White mastic on fiberglass pipe insulation is identified as ACM by others.

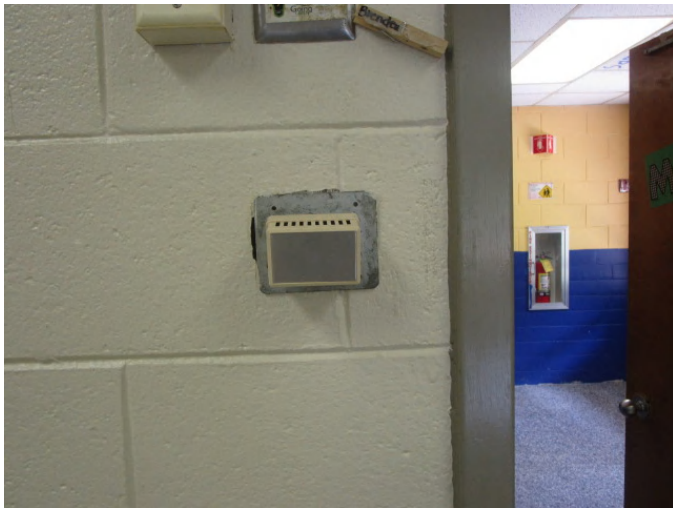
System: D3060 - Controls & Instrumentation

Location: Throughout Building
Distress: Beyond Service Life
Category: Deferred Maintenance / Energy
Priority: 3 Priority
Correction: Renew System
Qty: 55,000.00
Unit of Measure: S.F.
Estimate: \$217,800.00
Assessor Name: Ben Nixon
Date Created: 04/11/2015

Notes: The controls and instrumentation system is beyond its expected service life and should be scheduled for replacement.

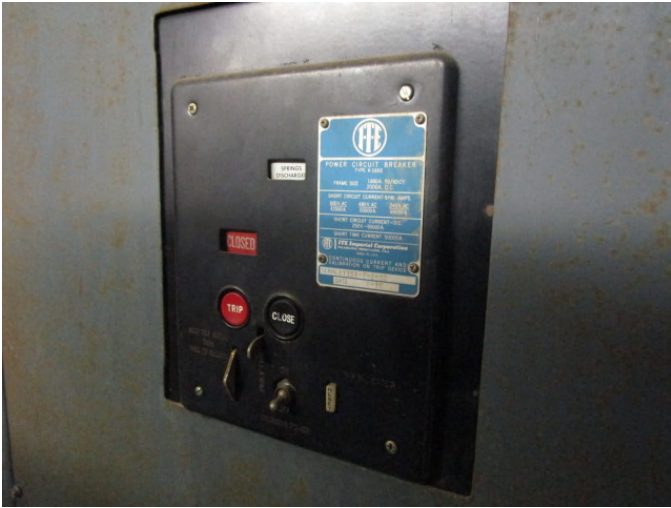
System: D5010 - Electrical Service/Distribution

Location: Main Switch Room/Throughout Building

Distress: Beyond Service Life

Notes: The electrical service/distribution system is beyond its expected service life and should be scheduled for replacement. SPLOST project 117-422 to replace the main electrical switchboard.

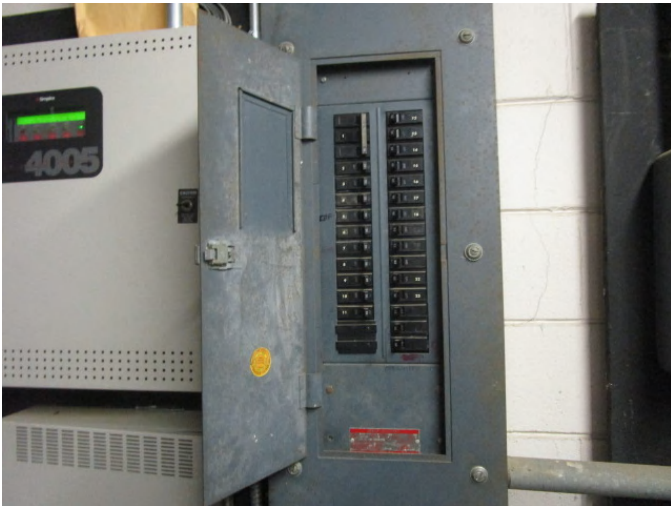
System: D5020 - Branch Wiring

Location: Throughout Building

Distress: Beyond Service Life

Notes: The branch wiring system is beyond its expected service life and should be scheduled for replacement. SPLOST project 117-422 to replace the original wiring system throughout the building.

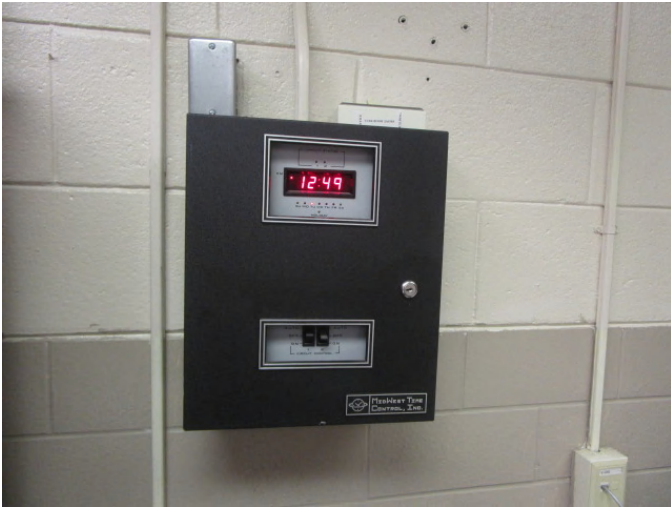
System: D5030 - Communications and Security - Clock & PA Systems

Location: Throughout Building
Distress: Beyond Service Life
Category: Deferred Maintenance
Priority: 3 Priority
Correction: Renew System
Qty: 55,000.00
Unit of Measure: S.F.
Estimate: \$338,800.00
Assessor Name: Ben Nixon
Date Created: 04/11/2015

Notes: Clock and PA systems are beyond their expected service life and should be scheduled for replacement.

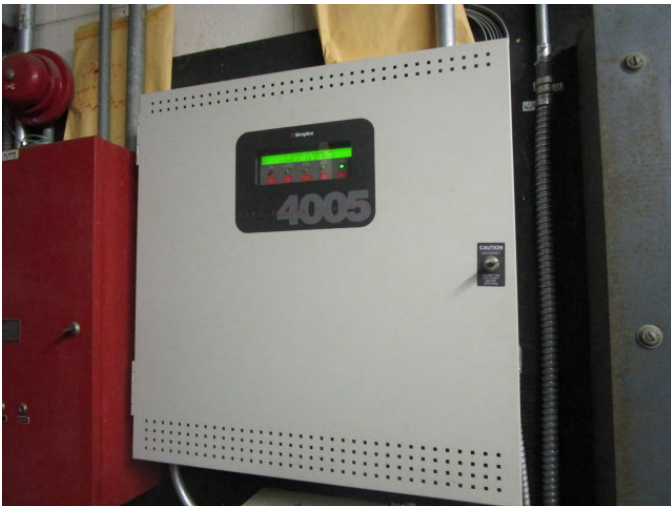
System: D5030 - Communications and Security - Fire Alarm

Location: Throughout Building
Distress: Beyond Service Life
Category: Deferred Maintenance
Priority: 3 Priority
Correction: Renew System
Qty: 55,000.00
Unit of Measure: S.F.
Estimate: \$74,415.00
Assessor Name: Ben Nixon
Date Created: 07/15/2015

Notes: The fire alarm system is beyond its expected service life and should be scheduled for replacement.

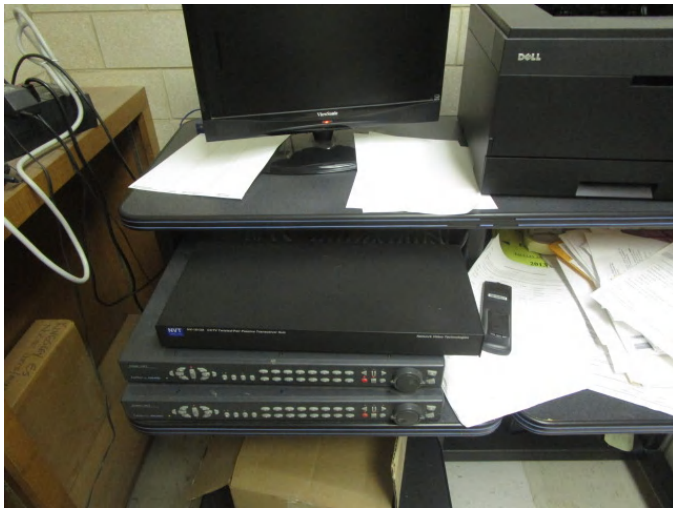
System: D5030 - Communications and Security - Security & CCTV

Location: Throughout Building

Distress: Beyond Service Life

Notes: The security and CCTV systems are beyond their expected service life and should be scheduled for replacement.

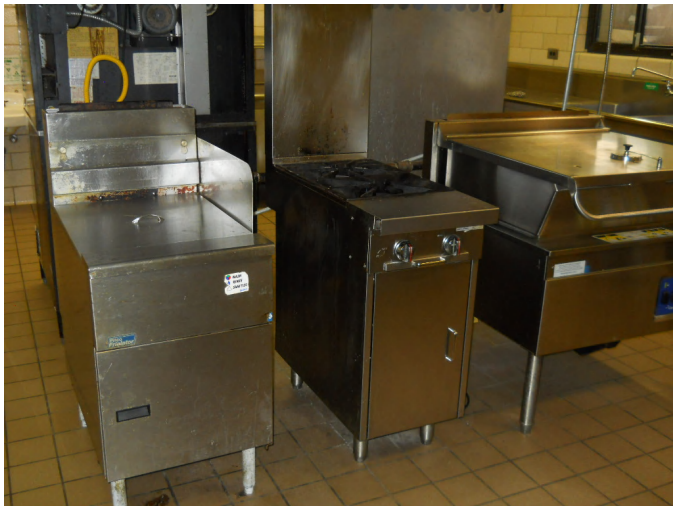
System: E1090 - Other Equipment - Kitchen Equipment

Location: Kitchen

Distress: Beyond Service Life

Notes: Kitchen equipment is beyond its expected service life and should be scheduled for replacement.

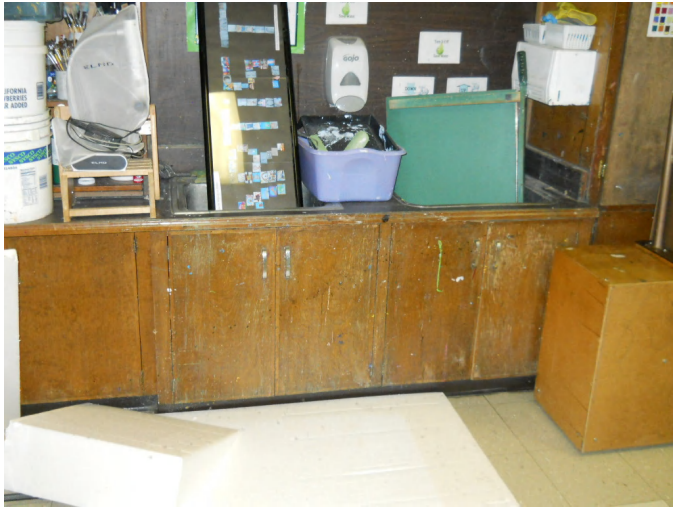
System: E2010 - Fixed Furnishings

Location: Throughout Building

Distress: Beyond Service Life

Notes: Fixed furnishings, such as built-in cabinets, are beyond their expected service life, damaged and worn, and should be replaced.

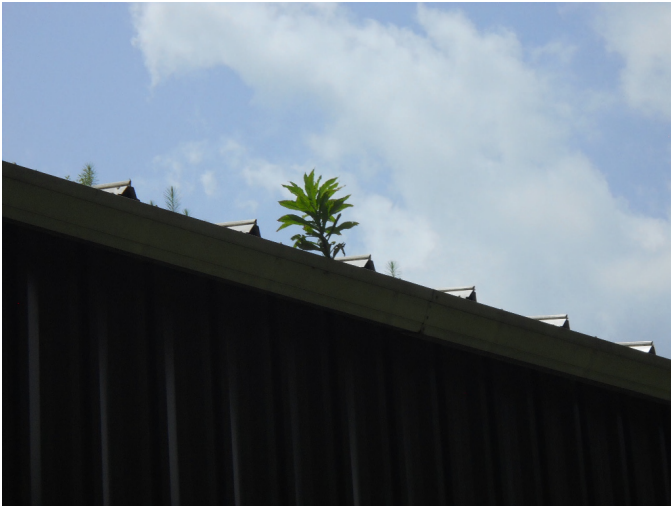
System: B3010 - Roof Coverings - Standing Seam Metal

Location: Gym, Exterior Gutters

Distress: Damaged

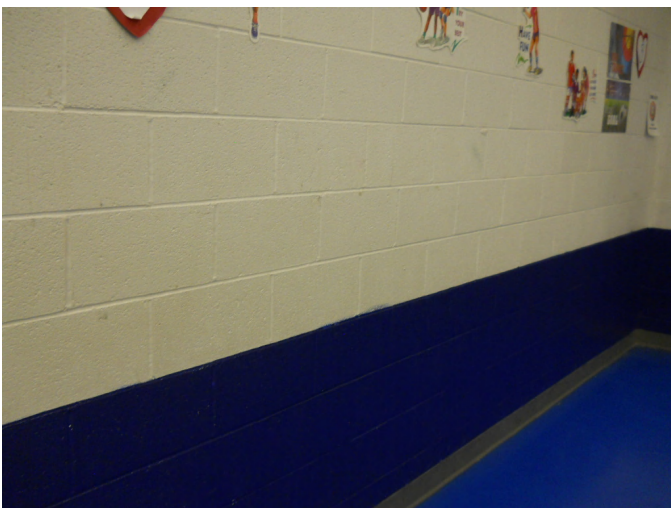
System: C3010 - Wall Finishes - Paint

Location: Throughout Building

Distress: Beyond Service Life

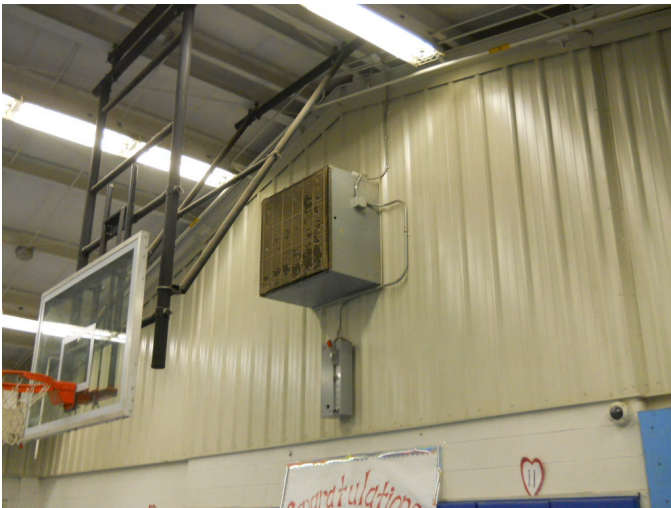
System: D3050 - Terminal & Package Units

Location: Throughout Building

Distress: Inadequate

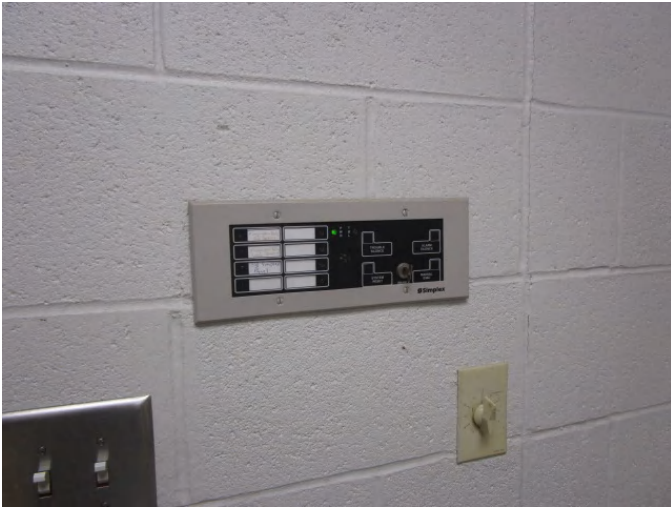
System: D5030 - Communications and Security - Fire Alarm

Location: Throughout Building

Distress: Beyond Service Life

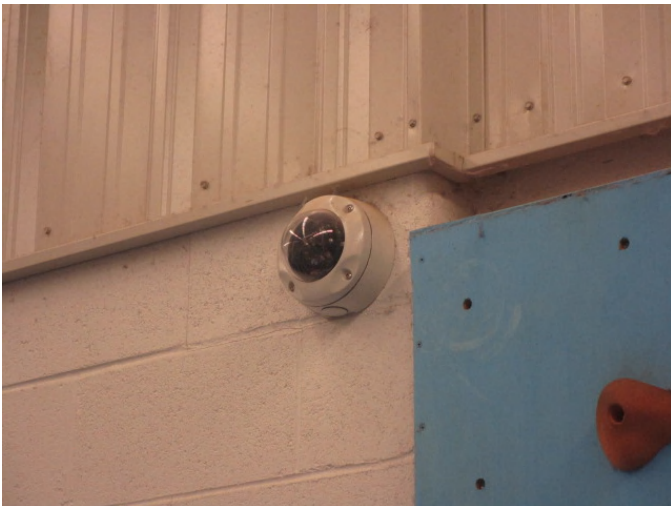
System: D5030 - Communications and Security - Security & CCTV

Location: Throughout Building

Distress: Beyond Service Life
