DeKalb County School District/Elementary Schools

Kittredge Magnet School at Nancy Creek

School Assessment Report

May 19, 2016

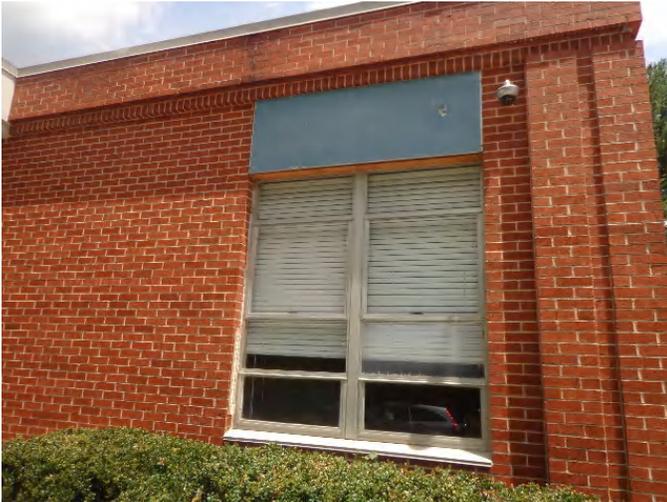
System: B2020 - Exterior Windows

Location: Throughout Building

Notes: The aluminum frame, operable, single pane windows are aged, damaged, not energy efficient, and should be replaced.

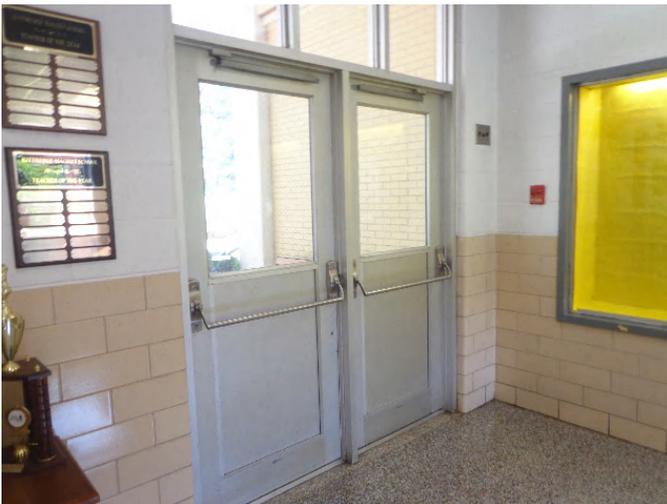
System: B2030 - Exterior Doors

Location: Throughout Building

Notes: The original exterior doors are aged, rusted, and should be replaced.

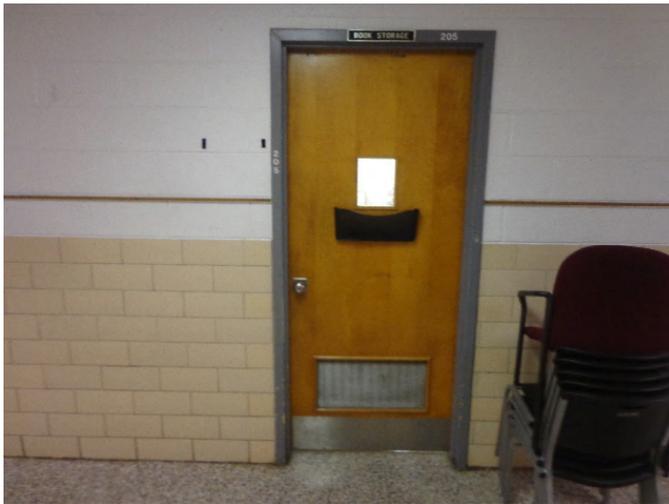
System: C1020 - Interior Doors

Location: Throughout Building
Distress: Beyond Service Life
Category: Deferred Maintenance / Accessibility Code Compliance
Priority: 3 Priority
Correction: Renew System
Qty: 51,685.00
Unit of Measure: S.F.
Estimate: \$98,822.00
Assessor Name: Sam Mandola
Date Created: 04/11/2015

Notes: The interior doors are aged, failing, not ADA or building code compliant, and should be replaced.

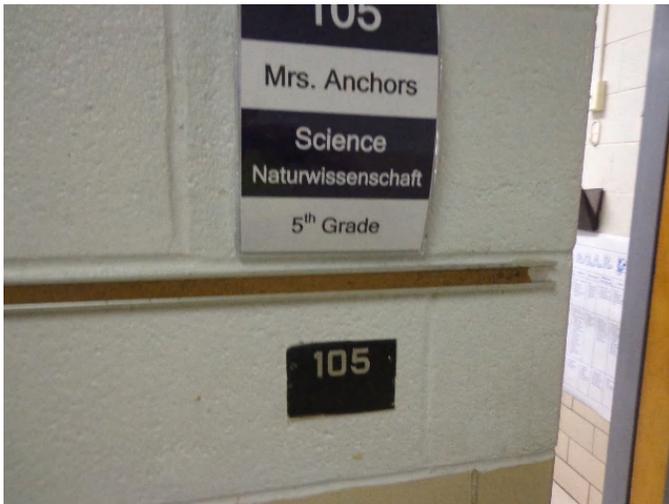
System: C1030 - Fittings

Location: Throughout Building
Distress: Beyond Service Life
Category: Deferred Maintenance / Accessibility Code Compliance
Priority: 3 Priority
Correction: Renew System
Qty: 51,685.00
Unit of Measure: S.F.
Estimate: \$158,621.00
Assessor Name: Sam Mandola
Date Created: 04/11/2015

Notes: Restrooms partitions were replaced recently. However, the remainder of the fittings are in marginal condition, with handrails and room signage that are not ADA compliant, and should be replaced.

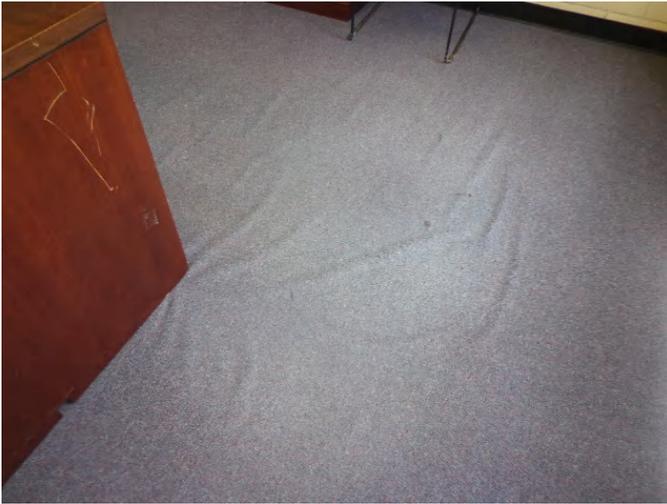
System: C3020 - Floor Finishes - Carpet

Location: Throughout Building
Distress: Beyond Service Life
Category: Deferred Maintenance
Priority: 3 Priority
Correction: Renew System
Qty: 6,202.00
Unit of Measure: S.F.
Estimate: \$57,989.00
Assessor Name: Sam Mandola
Date Created: 04/11/2015

Notes: The carpet is aged, stained, frayed and torn, and should be replaced.

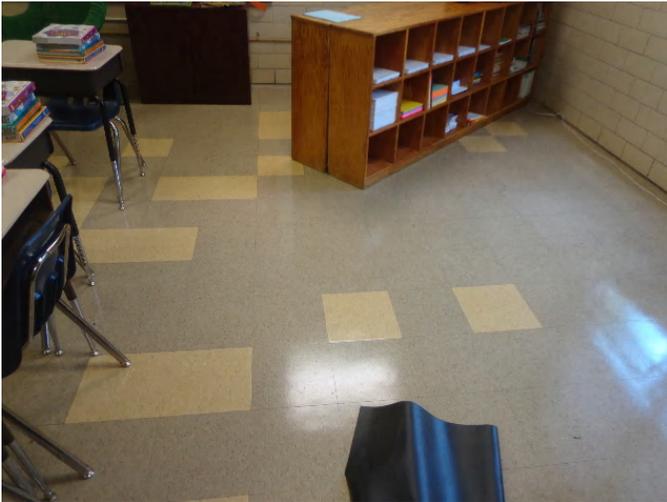
System: C3020 - Floor Finishes - VCT

Location: Throughout Building
Distress: Beyond Service Life
Category: Deferred Maintenance / Environmental
Priority: 3 Priority
Correction: Renew System
Qty: 31,339.00
Unit of Measure: S.F.
Estimate: \$328,871.00
Assessor Name: Sam Mandola
Date Created: 04/11/2015

Notes: The VCT flooring is aged, patched, worn and uneven, and should be replaced as it is a safety hazard.

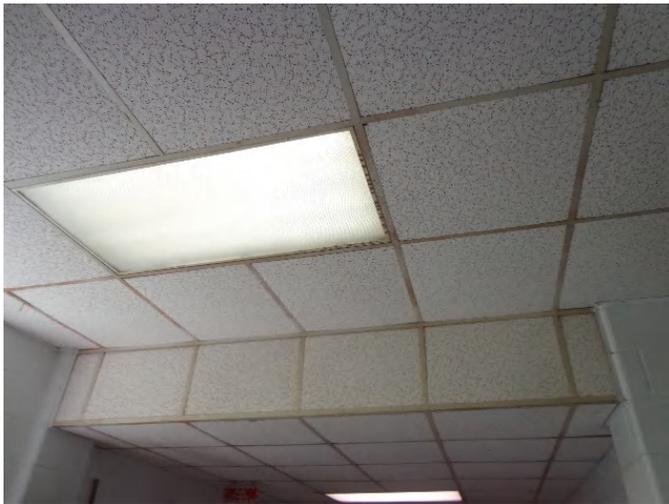
System: C3030 - Ceiling Finishes

Location: Throughout Building
Distress: Beyond Service Life
Category: Deferred Maintenance
Priority: 3 Priority
Correction: Renew System
Qty: 51,685.00
Unit of Measure: S.F.
Estimate: \$567,398.00
Assessor Name: Sam Mandola
Date Created: 04/11/2015

Notes: The acoustical ceiling tiles have been replaced as needed. However, the grid shows signs of aging and most tiles are sagging or damaged and should be replaced.

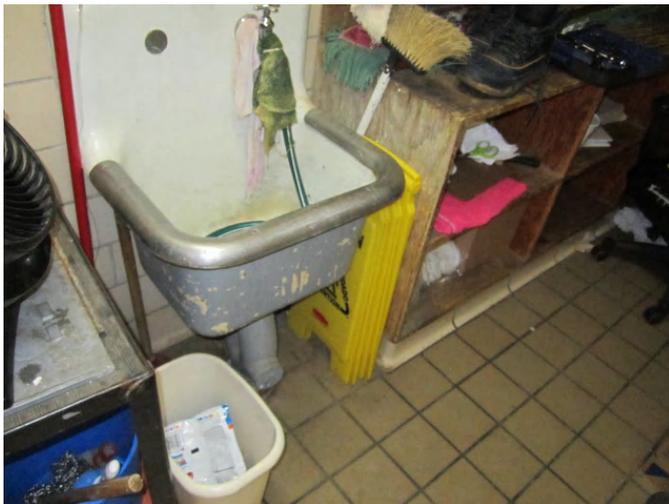
System: D2010 - Plumbing Fixtures

Location: Throughout Building
Distress: Beyond Service Life
Category: Deferred Maintenance / Accessibility Code Compliance
Priority: 3 Priority
Correction: Renew System
Qty: 51,685.00
Unit of Measure: S.F.
Estimate: \$1,004,033.00
Assessor Name: Sam Mandola
Date Created: 04/11/2015

Notes: The plumbing fixtures are beyond their expected service life, not ADA compliant, and should be scheduled for replacement.

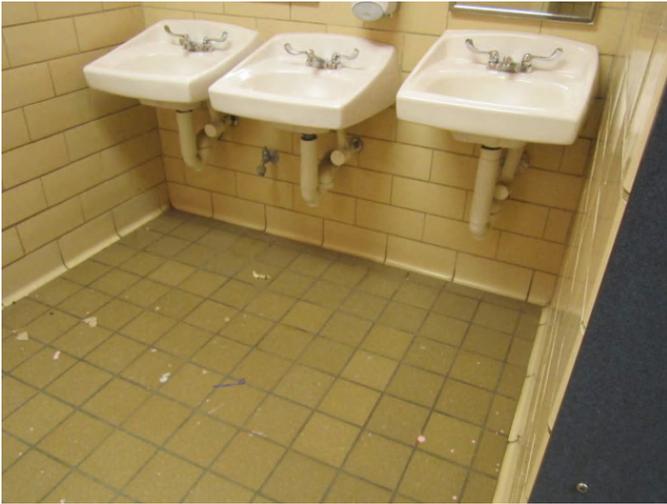
System: D2020 - Domestic Water Distribution

Location: Throughout Building

Notes: The domestic water distribution system is beyond its expected service life, not code compliant, and should be scheduled for replacement. Potable water supply is not protected by a reduced pressure backflow prevention device.

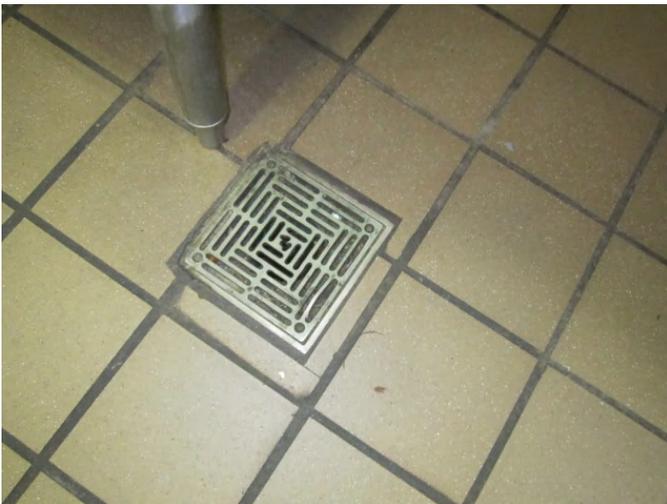
System: D2030 - Sanitary Waste

Location: Throughout Building

Notes: The sanitary waste system is beyond its expected service life and should be scheduled for replacement.

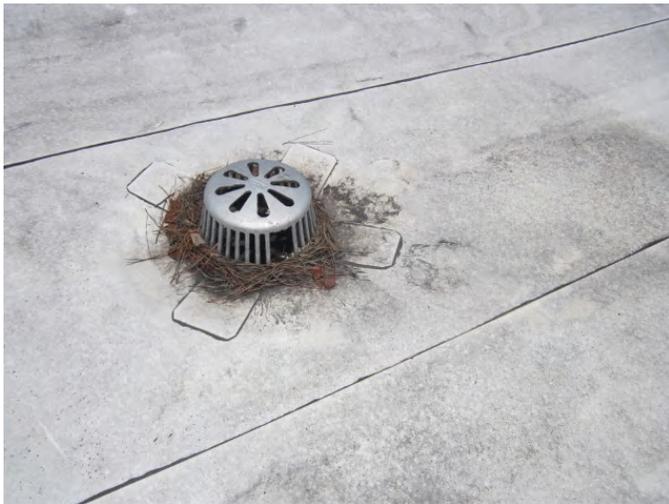
System: D2040 - Rain Water Drainage

Location: Throughout Building
Distress: Beyond Service Life
Category: Deferred Maintenance
Priority: 3 Priority
Correction: Renew System
Qty: 51,685.00
Unit of Measure: S.F.
Estimate: \$55,716.00
Assessor Name: Sam Mandola
Date Created: 08/03/2015

Notes: The rainwater drainage system is beyond its expected service life and should be scheduled for replacement.

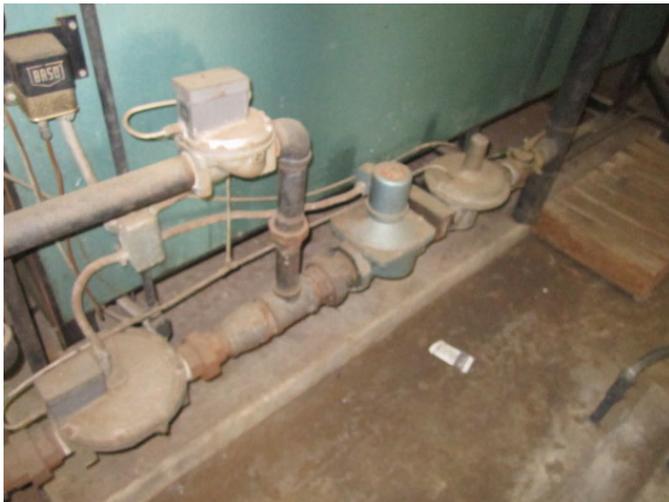
System: D2090 - Other Plumbing Systems - Natural Gas

Location: Throughout Building
Distress: Beyond Service Life
Category: Deferred Maintenance
Priority: 3 Priority
Correction: Renew System
Qty: 51,685.00
Unit of Measure: S.F.
Estimate: \$23,310.00
Assessor Name: Sam Mandola
Date Created: 08/03/2015

Notes: The natural gas system is beyond its expected service life and should be scheduled for replacement. SPLOST project 417-422 to replace grease trap and backflow preventer.

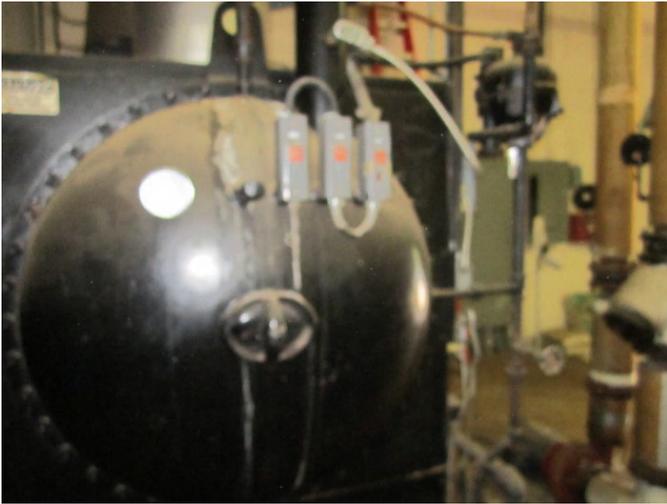
System: D3020 - Heat Generating Systems

Location: Mechanical Room
Distress: Beyond Service Life
Category: Deferred Maintenance / Environmental
Priority: 3 Priority
Correction: Renew System
Qty: 51,685.00
Unit of Measure: S.F.
Estimate: \$258,683.00
Assessor Name: Sam Mandola
Date Created: 04/11/2015

Notes: The heat generating system is beyond its expected service life, not building code compliant, and should be scheduled for replacement. Black and white tar like material on piping / fittings is identified as ACM by others.

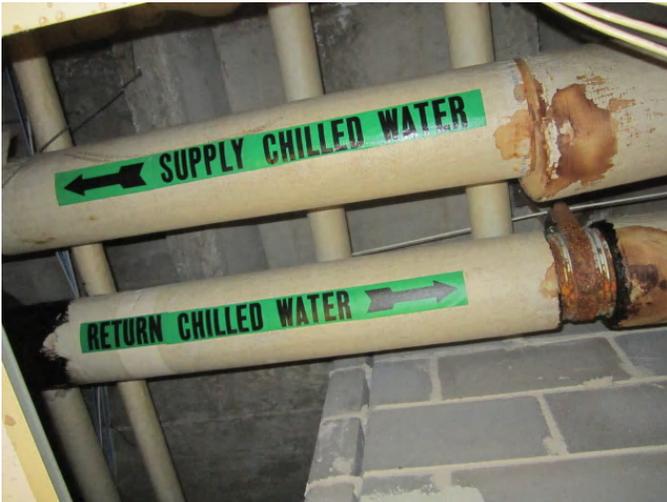
System: D3040 - Distribution & Exhaust Systems

Location: Throughout Building
Distress: Beyond Service Life
Category: Deferred Maintenance / Environmental
Priority: 3 Priority
Correction: Renew System
Qty: 51,685.00
Unit of Measure: S.F.
Estimate: \$313,263.00
Assessor Name: Sam Mandola
Date Created: 04/11/2015

Notes: The distribution and exhaust systems are beyond their expected service life and should be scheduled for replacement. Black and white tar like material on piping / fittings is identified as ACM by others.

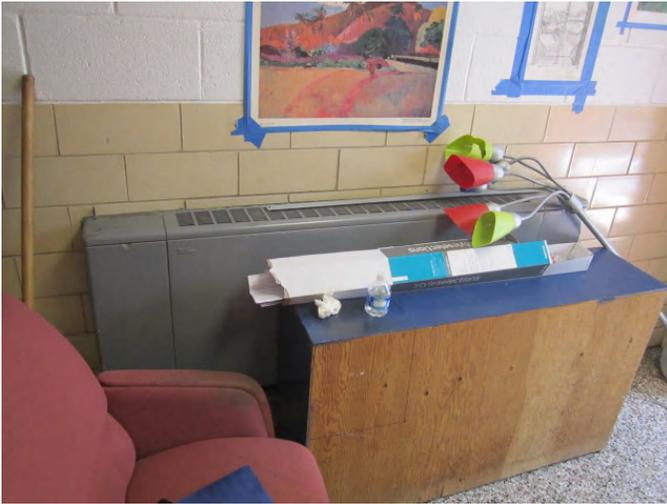
System: D3050 - Terminal & Package Units

Location: Throughout Building
Distress: Beyond Service Life
Category: Deferred Maintenance / Energy
Priority: 3 Priority
Correction: Renew System
Qty: 51,685.00
Unit of Measure: S.F.
Estimate: \$1,052,927.00
Assessor Name: Sam Mandola
Date Created: 04/11/2015

Notes: The terminal and package units are beyond their expected service life and should be scheduled for replacement.

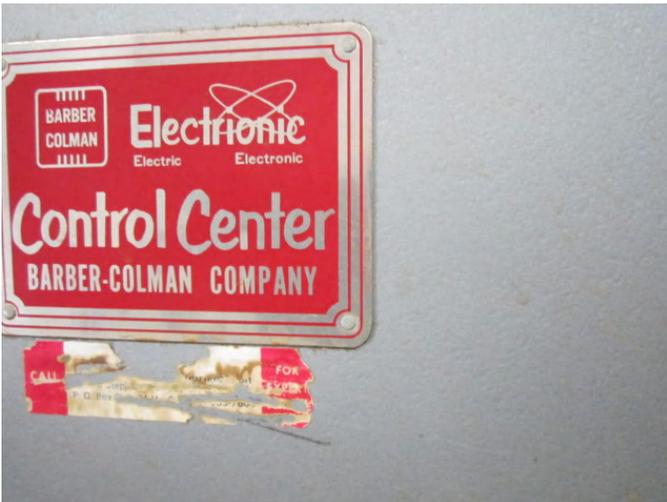
System: D3060 - Controls & Instrumentation

Location: Throughout Building
Distress: Beyond Service Life
Category: Deferred Maintenance / Energy
Priority: 3 Priority
Correction: Renew System
Qty: 51,685.00
Unit of Measure: S.F.
Estimate: \$204,673.00
Assessor Name: Sam Mandola
Date Created: 08/03/2015

Notes: The controls and instrumentation system is beyond its expected service life, aged, and should be scheduled for replacement.

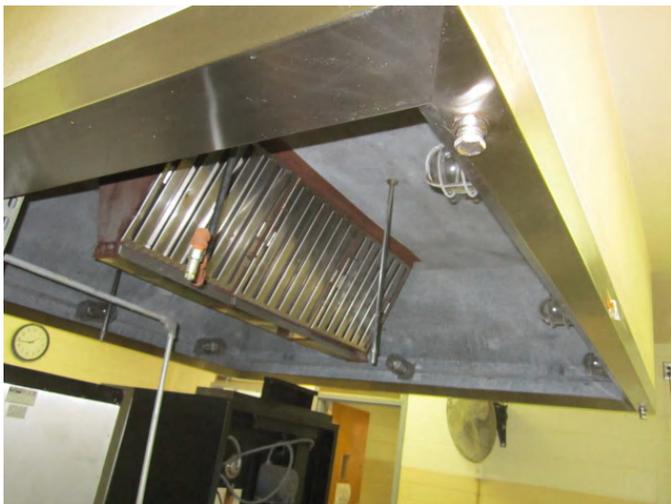
System: D3090 - Other HVAC Systems/Equip - Kitchen Hood

Location: Kitchen
Distress: Beyond Service Life
Category: Deferred Maintenance
Priority: 3 Priority
Correction: Renew System
Qty: 51,685.00
Unit of Measure: S.F.
Estimate: \$69,930.00
Assessor Name: Sam Mandola
Date Created: 04/11/2015

Notes: The kitchen hood system is beyond its expected service life, aged, and should be scheduled for replacement.

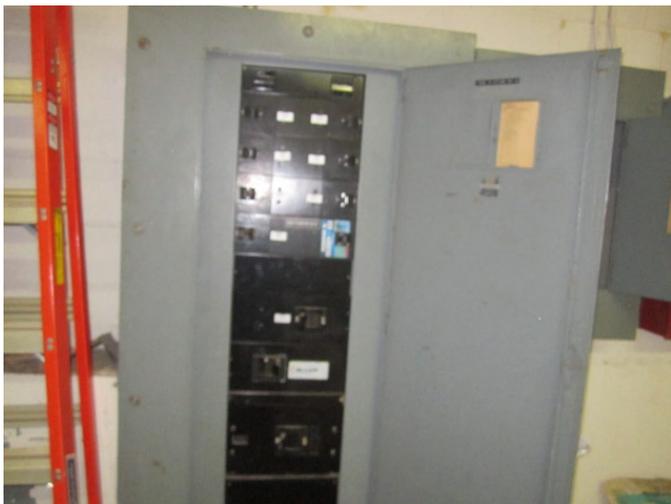
System: D5010 - Electrical Service/Distribution

Location: Main Switch Room/Throughout Building
Distress: Beyond Service Life
Category: Deferred Maintenance
Priority: 3 Priority
Correction: Renew System
Qty: 51,685.00
Unit of Measure: S.F.
Estimate: \$102,905.00
Assessor Name: Sam Mandola
Date Created: 04/11/2015

Notes: The electrical service/distribution system is beyond its expected service life, aged, and should be scheduled for replacement.

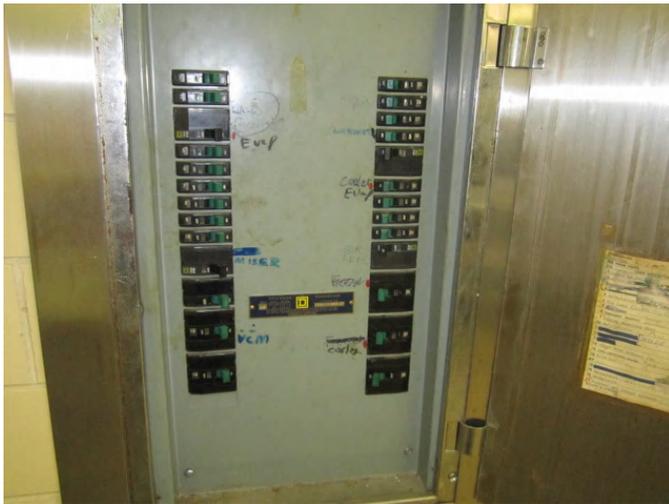
System: D5020 - Branch Wiring

Location: Throughout Building
Distress: Beyond Service Life
Category: Deferred Maintenance
Priority: 3 Priority
Correction: Renew System
Qty: 51,685.00
Unit of Measure: S.F.
Estimate: \$385,467.00
Assessor Name: Sam Mandola
Date Created: 04/11/2015

Notes: The branch wiring system is beyond its expected service life, aged, and should be scheduled for replacement.

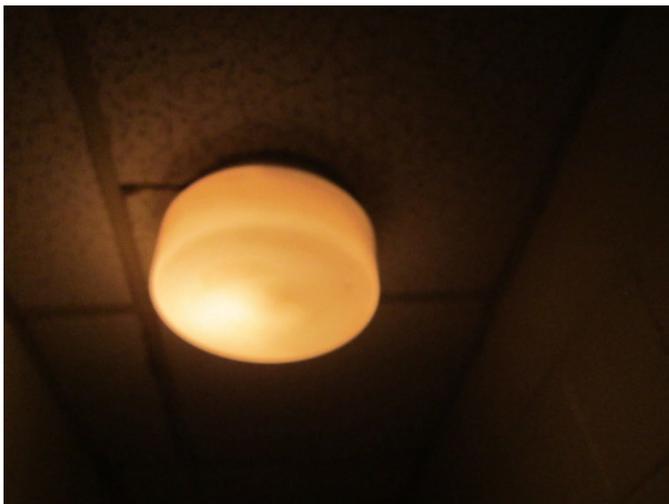
System: D5020 - Lighting

Location: Throughout Building
Distress: Beyond Service Life
Category: Deferred Maintenance / Energy
Priority: 3 Priority
Correction: Renew System
Qty: 51,685.00
Unit of Measure: S.F.
Estimate: \$505,996.00
Assessor Name: Sam Mandola
Date Created: 04/11/2015

Notes: The lighting system is beyond its expected service life, aged, and should be scheduled for replacement.

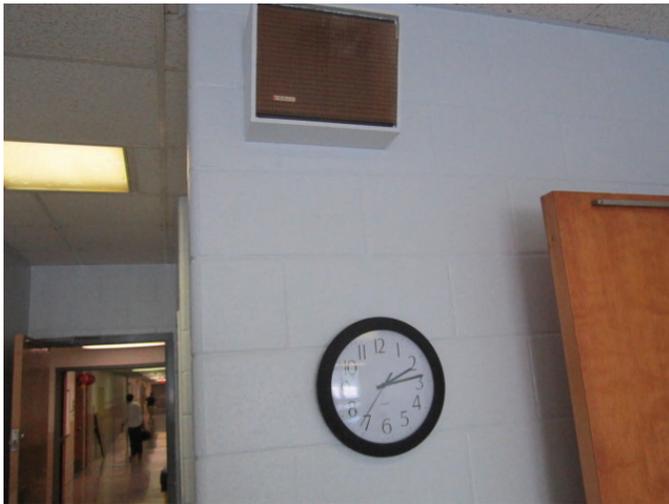
System: D5030 - Communications and Security - Clock & PA Systems

Location: Throughout Building
Distress: Beyond Service Life
Category: Deferred Maintenance
Priority: 3 Priority
Correction: Renew System
Qty: 51,685.00
Unit of Measure: S.F.
Estimate: \$318,380.00
Assessor Name: Sam Mandola
Date Created: 08/03/2015

Notes: Clock and PA systems are beyond their expected service life, aged, and should be scheduled for replacement.

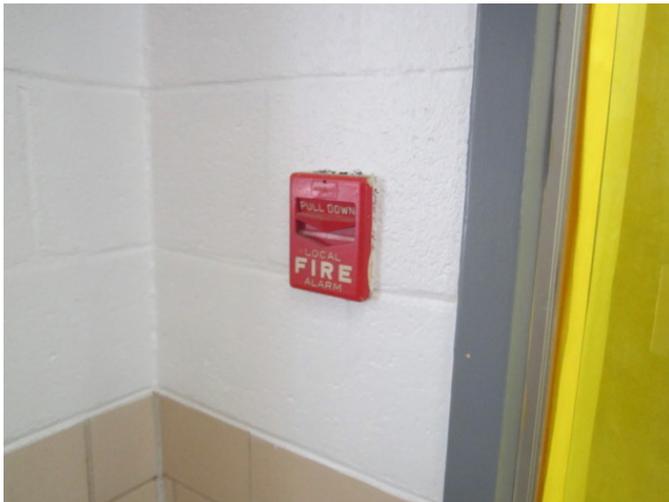
System: D5030 - Communications and Security - Fire Alarm

Location: Throughout Building
Distress: Beyond Service Life
Category: Deferred Maintenance / Building Code Compliance
Priority: 3 Priority
Correction: Renew System
Qty: 51,685.00
Unit of Measure: S.F.
Estimate: \$69,930.00
Assessor Name: Sam Mandola
Date Created: 08/03/2015

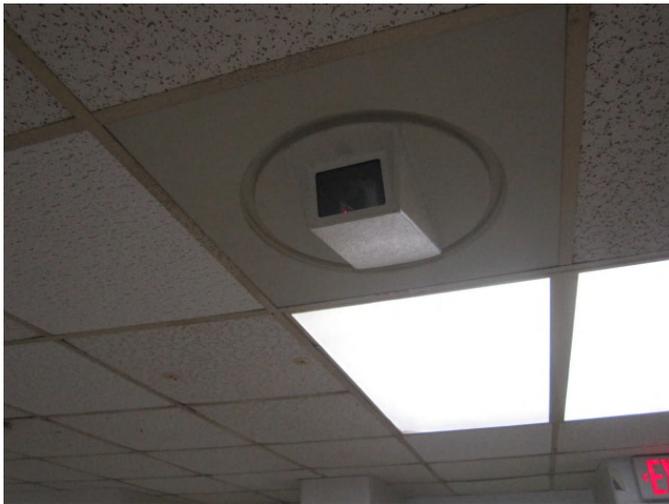
System: D5030 - Communications and Security - Security & CCTV

Location: Throughout Building
Distress: Beyond Service Life
Category: Deferred Maintenance
Priority: 3 Priority
Correction: Renew System
Qty: 51,685.00
Unit of Measure: S.F.
Estimate: \$34,681.00
Assessor Name: Sam Mandola
Date Created: 08/03/2015

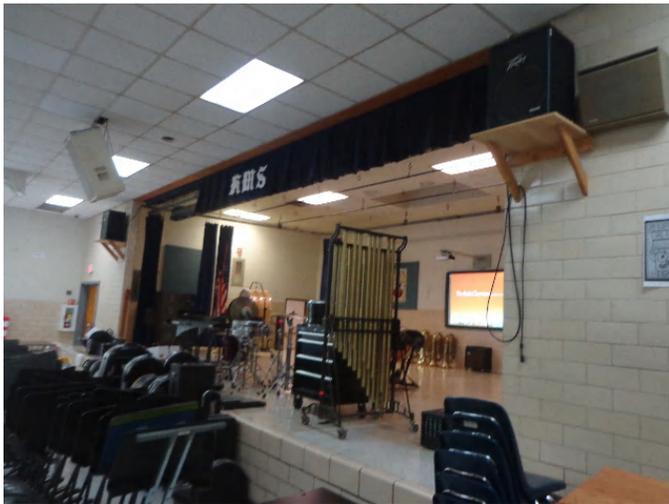
System: E1020 - Institutional Equipment

Location: Throughout Building
Distress: Beyond Service Life
Category: Deferred Maintenance
Priority: 3 Priority
Correction: Renew System
Qty: 51,685.00
Unit of Measure: S.F.
Estimate: \$22,741.00
Assessor Name: Sam Mandola
Date Created: 08/03/2015

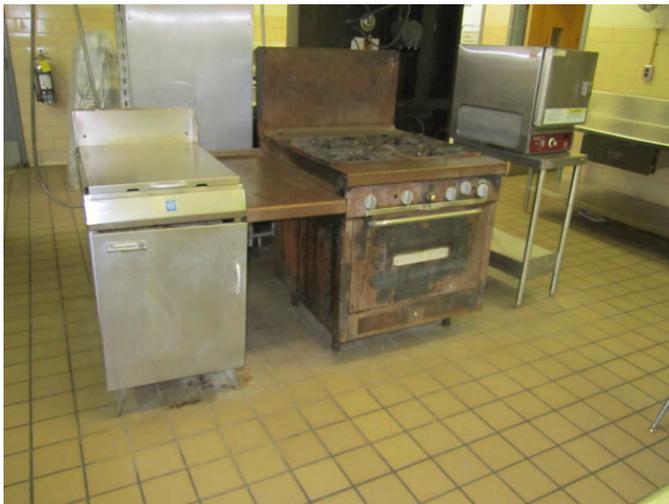
System: E1090 - Other Equipment - Kitchen Equipment

Location: Kitchen
Distress: Beyond Service Life
Category: Deferred Maintenance
Priority: 3 Priority
Correction: Renew System
Qty: 51,685.00
Unit of Measure: S.F.
Estimate: \$498,037.00
Assessor Name: Sam Mandola
Date Created: 04/11/2015

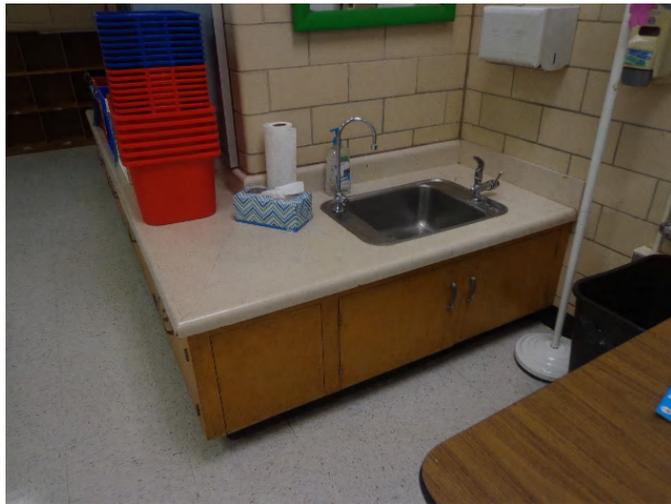
System: E2010 - Fixed Furnishings

Location: Throughout Building
Distress: Beyond Service Life
Category: Deferred Maintenance
Priority: 3 Priority
Correction: Renew System
Qty: 51,685.00
Unit of Measure: S.F.
Estimate: \$305,303.00
Assessor Name: Sam Mandola
Date Created: 04/11/2015

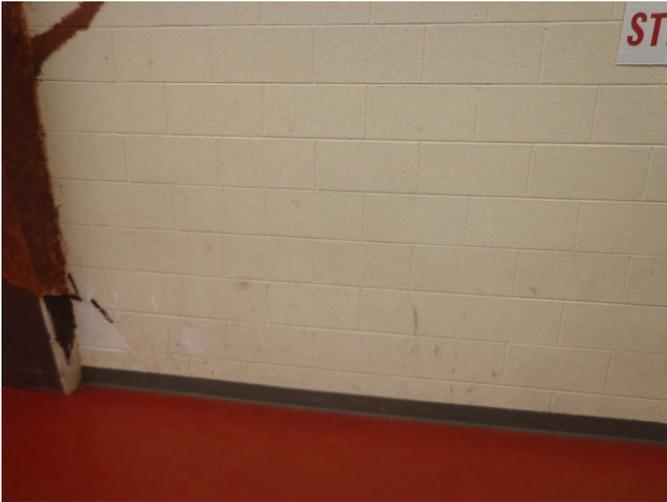
System: C3010 - Wall Finishes - Paint

Location: Throughout Building
