DeKalb County School District/Elementary Schools

Knollwood Elementary

School Assessment Report

May 19, 2016

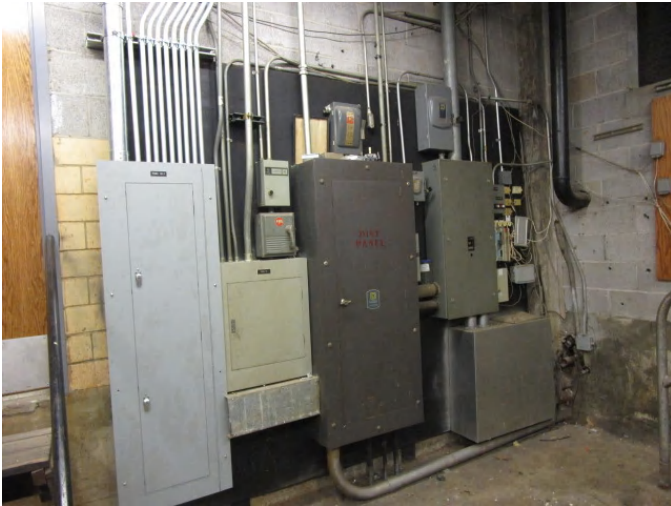
System: D5020 - Branch Wiring

Location: Throughout Building

Distress: Beyond Service Life

Notes: The branch wiring system is beyond its expected service life and should be scheduled for replacement. There are non-GFI receptacles near some classroom sinks.

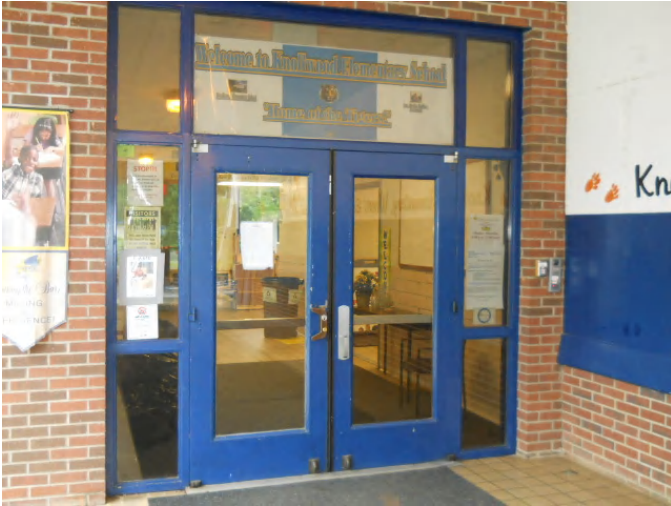
System: B2030 - Exterior Doors

Location: Throughout Building

Distress: Beyond Service Life

Notes: The exterior door system is beyond its expected service life, worn, and should be replaced.

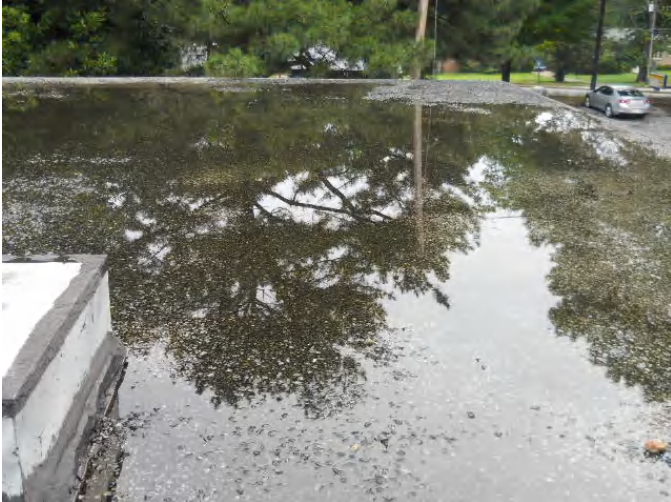
System: B3010 - Roof Coverings - BUR

Location: Roof

Distress: Beyond Service Life

Notes: The roof covering is beyond its expected service life, holding excessive water, and should be replaced.

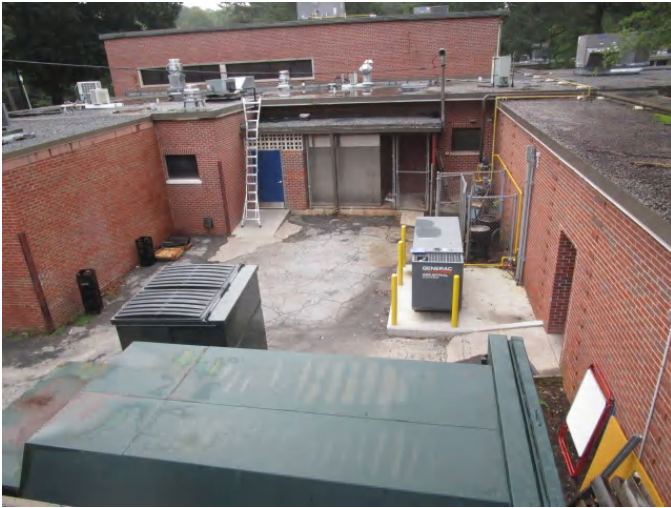
System: B3020 - Roof Openings

Location: Roof

Distress: Missing

Notes: There is no roof access hatch. Recommend installing OSHA-compliant hatch and ladder for safe access of maintenance personnel.

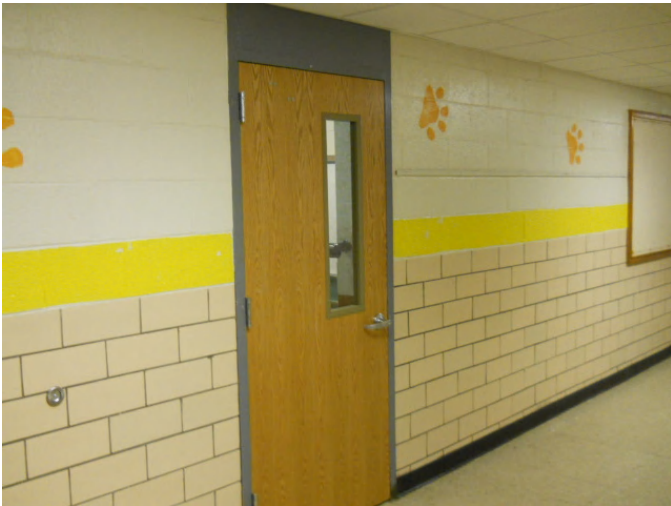
System: C1030 - Fittings

Location: Throughout Building

Distress: Inadequate

Notes: Signage is not ADA compliant, beyond its expected service life, and should be replaced.

Correction: Remove and replace the signage w/ADA compliant signage.

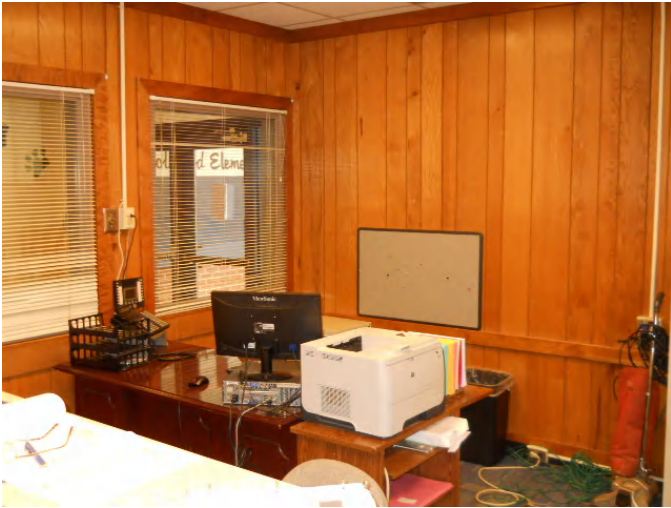
System: C3010 - Wall Finishes - Wood Paneling

Location: Main Office
Distress: Beyond Service Life
Category: Deferred Maintenance
Priority: 3 Priority
Correction: Renew System
Qty: 840.00
Unit of Measure: S.F.
Estimate: \$6,274.00
Assessor Name: Ben Nixon
Date Created: 03/03/2016

Notes: Wood paneling is beyond its expected service life and should be scheduled for replacement.

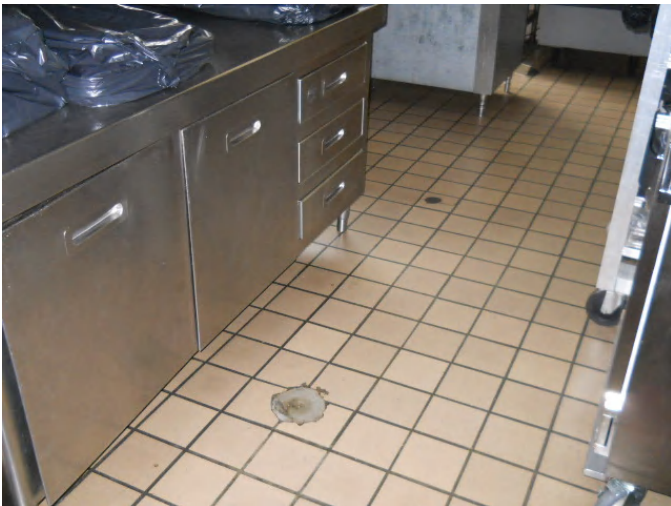
System: C3020 - Floor Finishes - Ceramic & Quarry Tile

Location: Throughout Building
Distress: Beyond Service Life
Category: Deferred Maintenance
Priority: 3 Priority
Correction: Renew System
Qty: 4,568.00
Unit of Measure: S.F.
Estimate: \$72,809.00
Assessor Name: Ben Nixon
Date Created: 06/16/2015

Notes: The tile floor covering is beyond its expected service life and should be replaced.

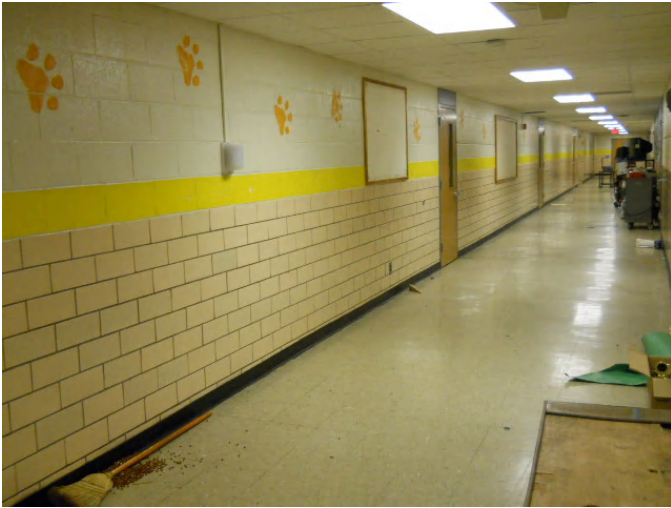
System: C3020 - Floor Finishes - VCT

Location: Throughout Building

Notes: The VCT floor covering is beyond its expected service life, worn and separating, and should be replaced.

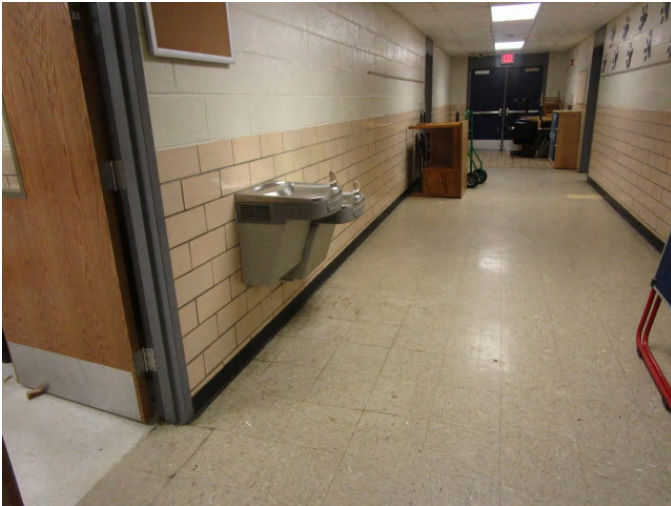
System: D2010 - Plumbing Fixtures

Location: Hallway and Cafeteria

Correction: Remove/replace drinking fountain w/recessed ADA compliant drinking fountain

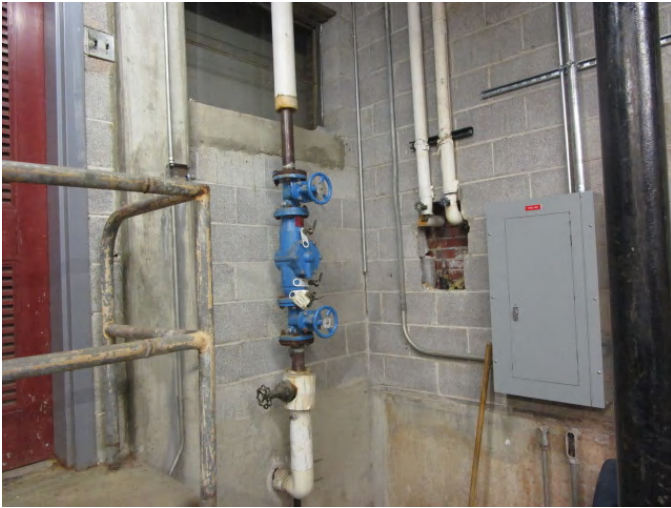
System: D2020 - Domestic Water Distribution

Location: Throughout Building

Notes: The domestic water distribution system is beyond its expected service life, has water quality issues, and should be scheduled for replacement.

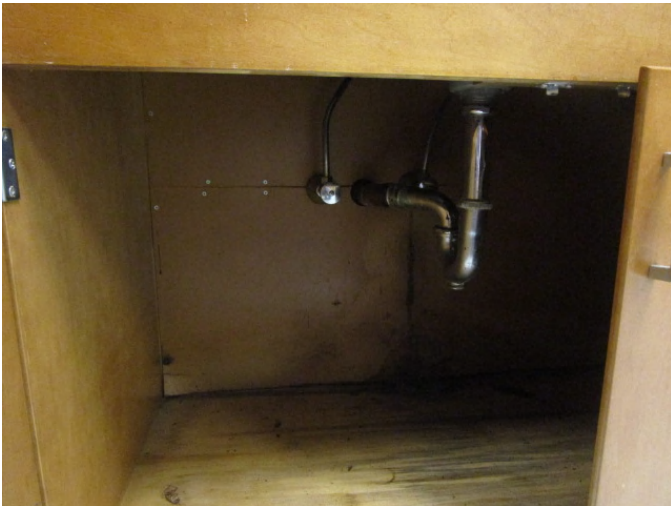
System: D2030 - Sanitary Waste

Location: Throughout Building

Notes: The sanitary waste system is beyond its expected service life and should be scheduled for replacement. School staff reports an occasional sewer gas smell in the building.

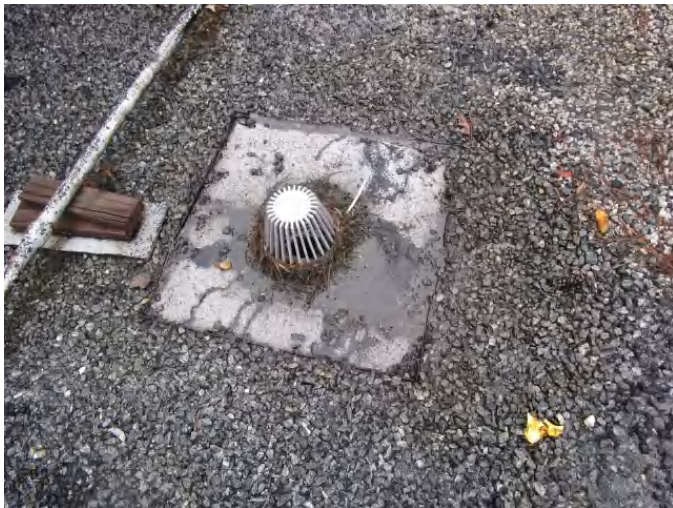
System: D2040 - Rain Water Drainage

Location: Throughout Building

Notes: The rainwater drainage system is beyond its expected service life, non-functional, and should be replaced in conjunction with the roof.

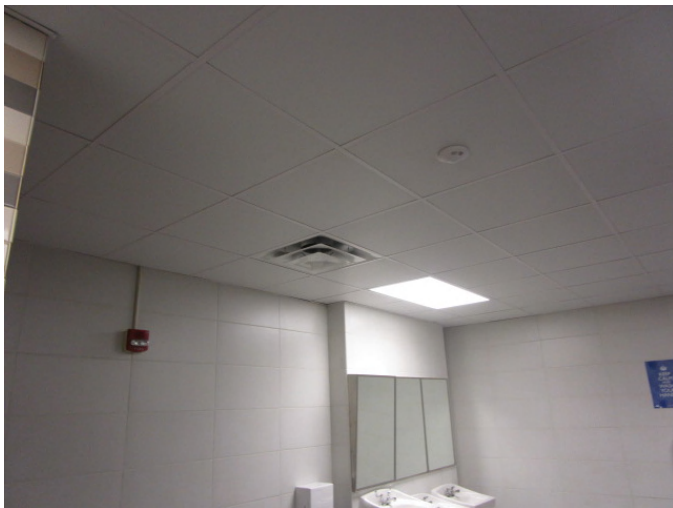
System: D3040 - Distribution & Exhaust Systems

Location: Restrooms

Distress: Inadequate

Notes: Restroom exhaust is inadequate. Recommend installation of new restroom exhaust system.

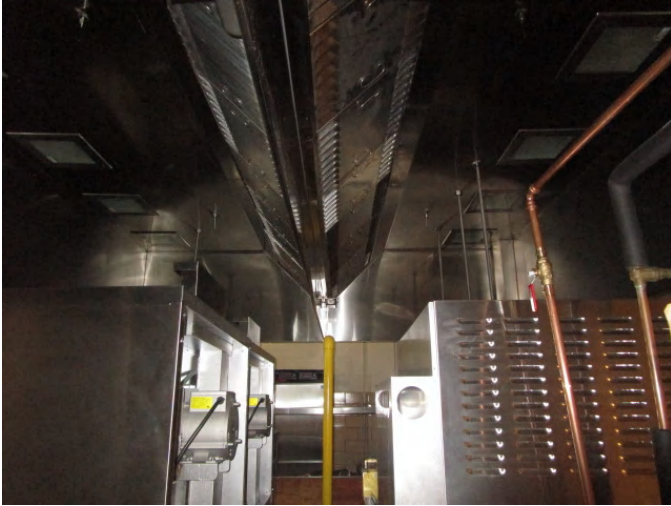
System: D3090 - Other HVAC Systems/Equip - Kitchen Hood

Location: Kitchen

Notes: The kitchen hood system is beyond its expected service life and should be scheduled for replacement.

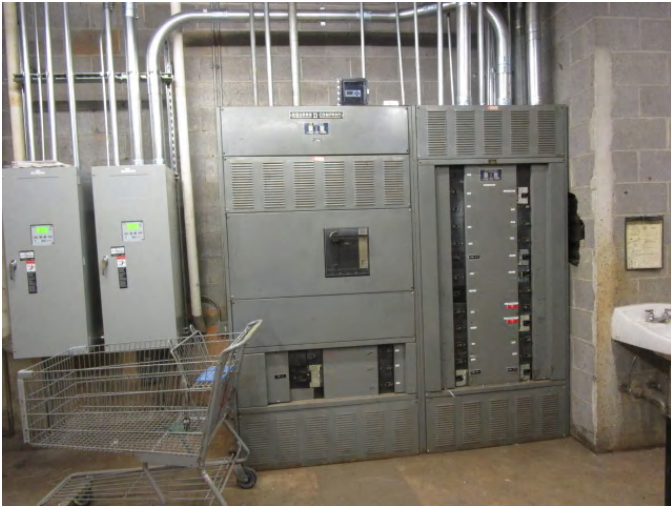
System: D5010 - Electrical Service/Distribution

Location: Main Switch Room/Throughout Building

Notes: The electrical service/distribution system is beyond its expected service life and should be scheduled for replacement.

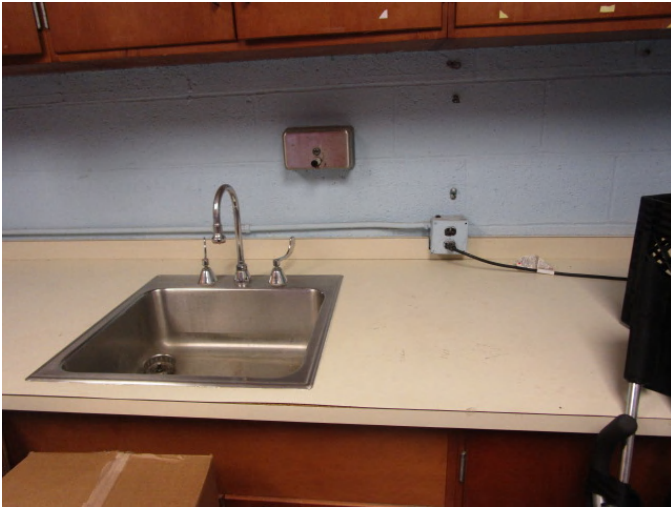
System: D5020 - Branch Wiring

Location: Throughout Building

Distress: Inadequate

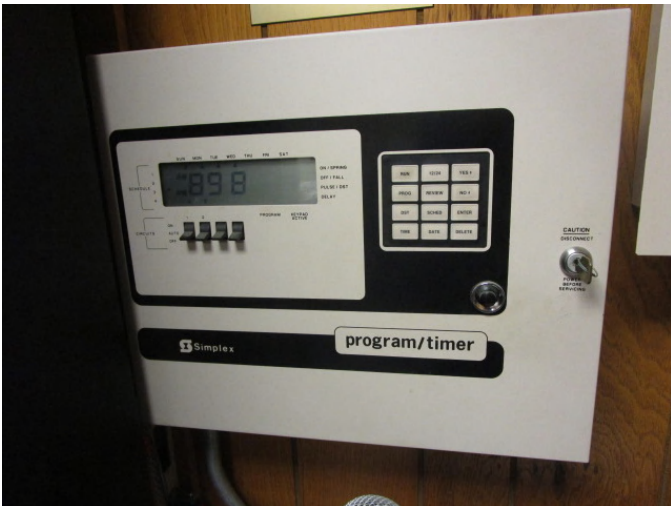
System: D5030 - Communications and Security - Clock & PA Systems

Location: Throughout Building

Distress: Beyond Service Life

Notes: Clock and PA systems are beyond their expected service life and should be scheduled for replacement.

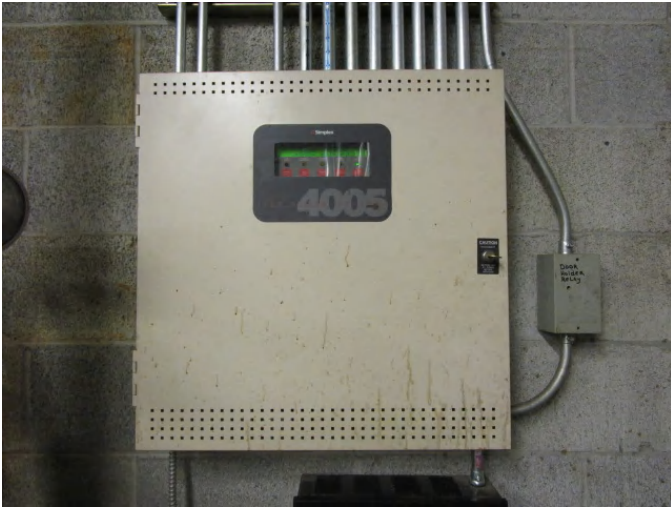
System: D5030 - Communications and Security - Fire Alarm

Location: Throughout Building

Notes: The fire alarm system is beyond its expected service life and should be scheduled for replacement.

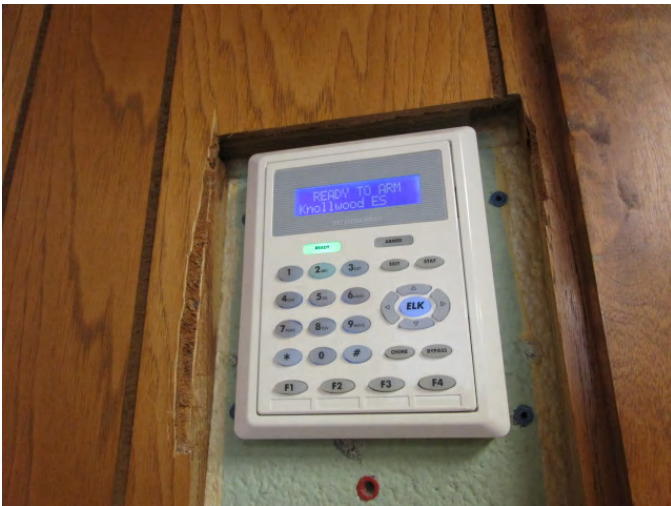
System: D5030 - Communications and Security - Security & CCTV

Location: Throughout Building

Notes: The security and CCTV systems are beyond their expected service life and should be scheduled for replacement.

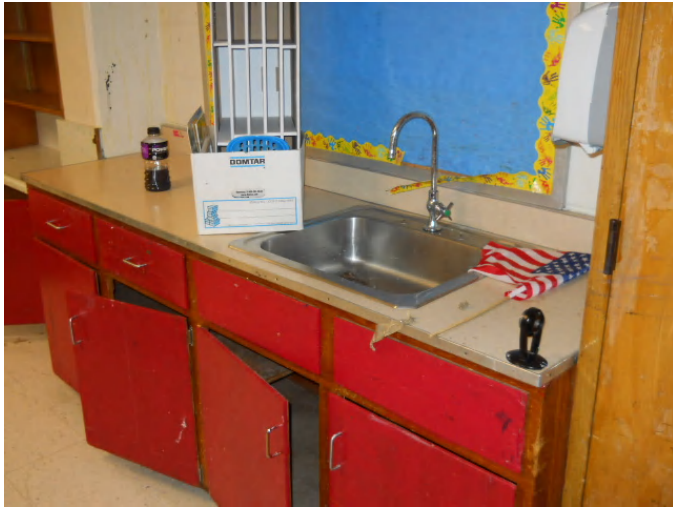
System: E2010 - Fixed Furnishings

Location: Throughout Building

Notes: Fixed furnishings, such as built-in cabinets, are beyond their expected service life and worn, and should be replaced.

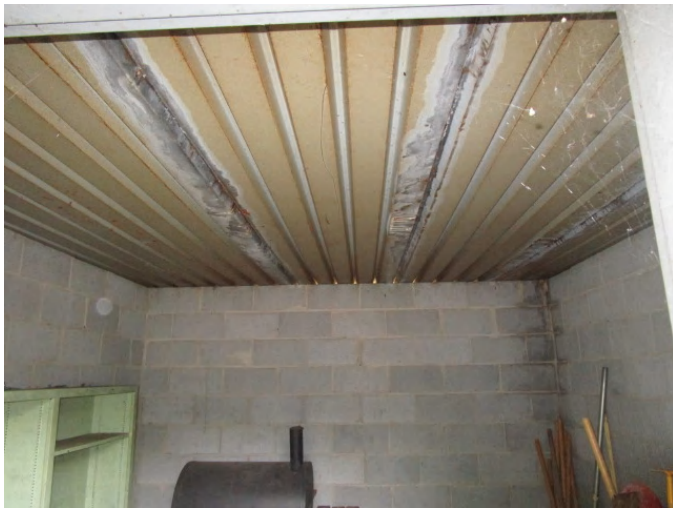
System: B1020 - Roof Construction

Location: Roof

Distress: Damaged

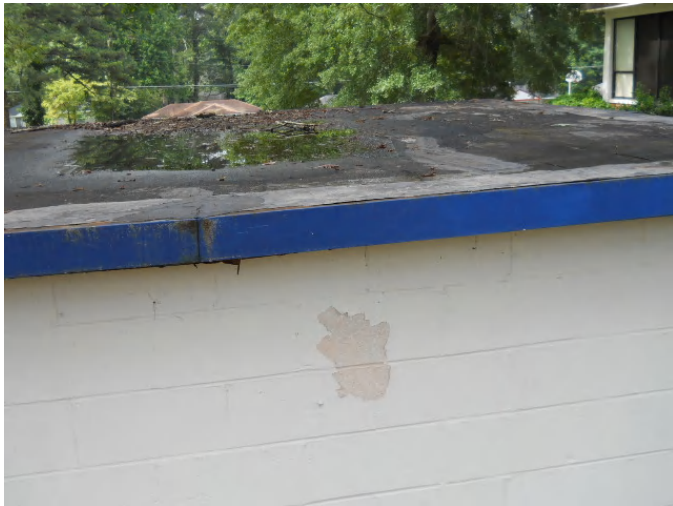
System: B3010 - Roof Coverings

Location: Roof

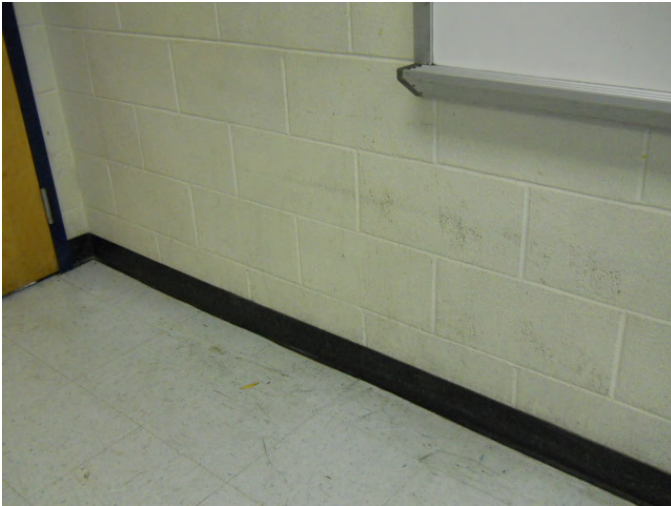
System: C3010 - Wall Finishes - Paint

Location: Throughout Building

Distress: Beyond Service Life

Notes: The painted wall finishes are beyond their expected service life, dirty, and should be replaced.

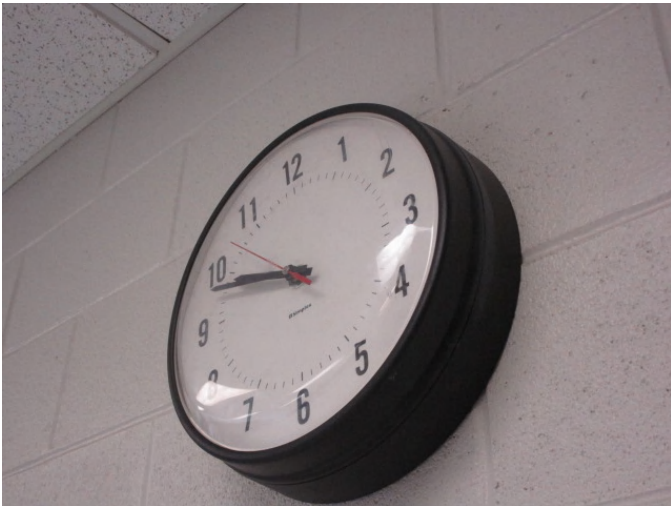
System: D5030 - Communications and Security - Clock & PA Systems

Location: Throughout Building

Distress: Beyond Service Life

Notes: Clock and PA systems are beyond their expected service life and should be scheduled for replacement.

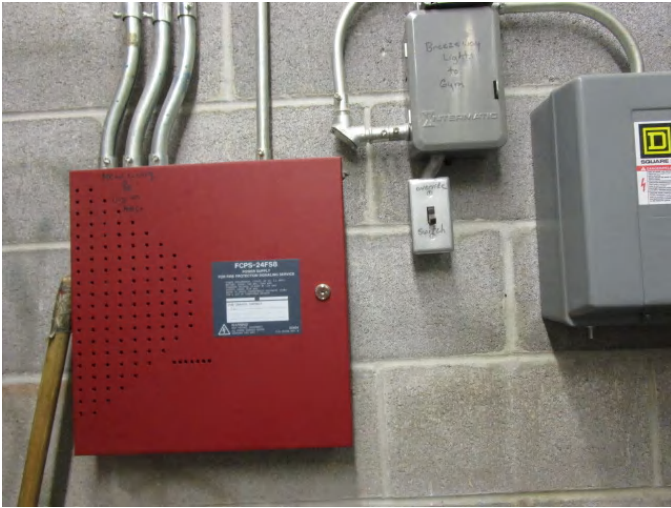
System: D5030 - Communications and Security - Fire Alarm

Location: Throughout Building

Distress: Beyond Service Life

Notes: The fire alarm system is beyond its expected service life and should be scheduled for replacement.

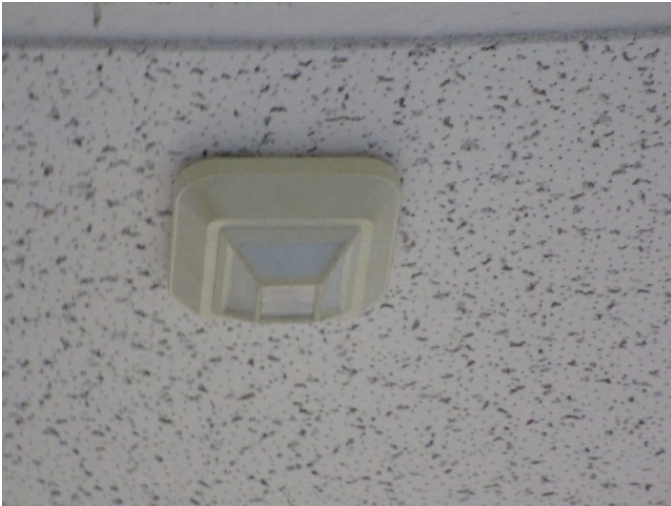
System: D5030 - Communications and Security - Security & CCTV

Location: Throughout Building

Distress: Beyond Service Life

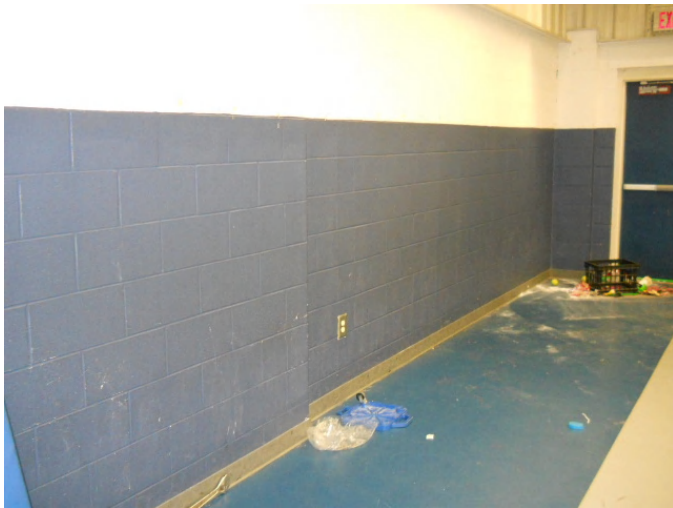
System: C3010 - Wall Finishes - Paint

Location: Throughout Building

Distress: Beyond Service Life

Notes: The painted wall finishes are beyond their expected service life and should be replaced.

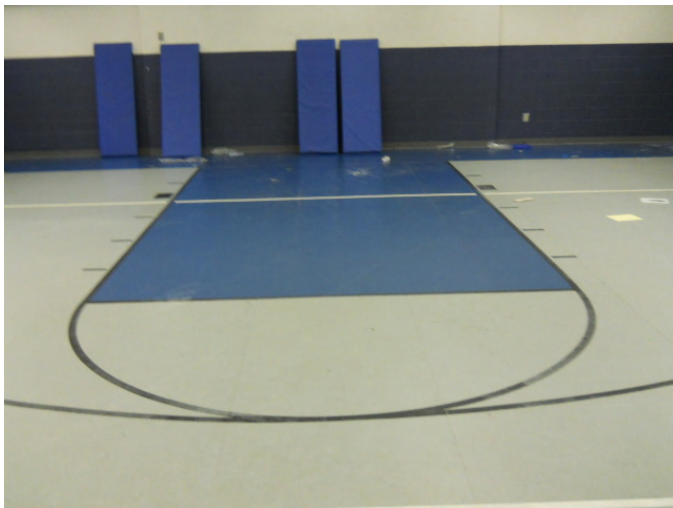
System: C3020 - Floor Finishes - Neoprene

Location: Basketball Court

Distress: Beyond Service Life

Notes: The athletic floor covering is beyond its expected service life, worn, and should be replaced.

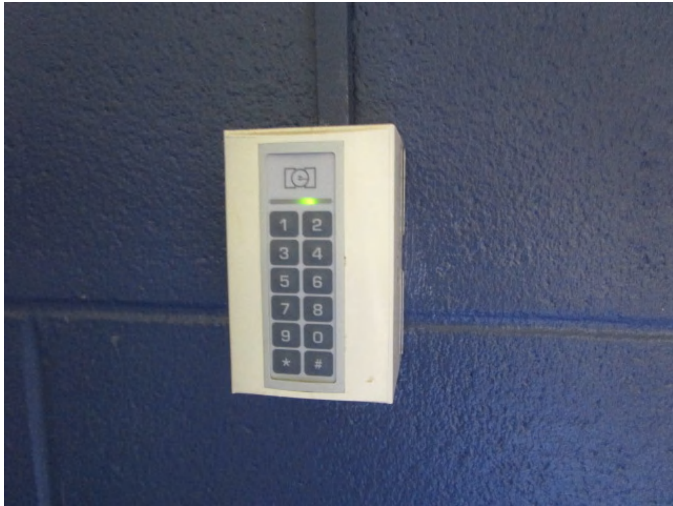
System: D5030 - Communications and Security - Security & CCTV

Location: Throughout Building

Distress: Beyond Service Life

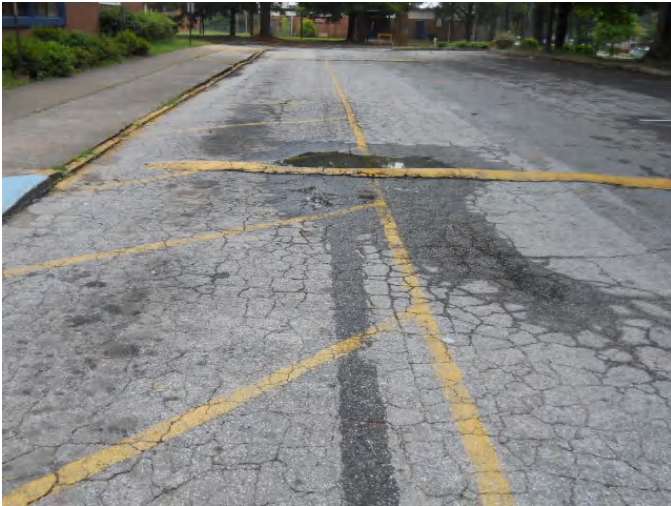
System: G2010 - Roadways

Location: Site

Distress: Beyond Service Life

Notes: Roadways are beyond their expected service life, damaged with cracks and potholes, and should be replaced.

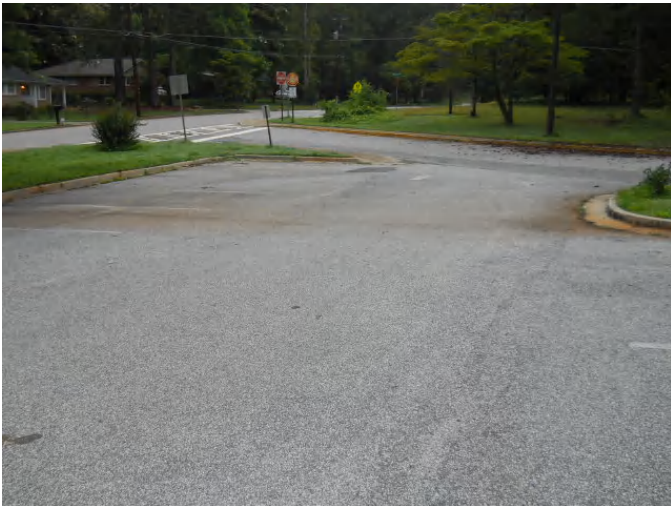
System: G2020 - Parking Lots

Location: Site

Distress: Beyond Service Life

Notes: The parking lots are beyond their expected service life, damaged, not ADA compliant, and should be replaced.

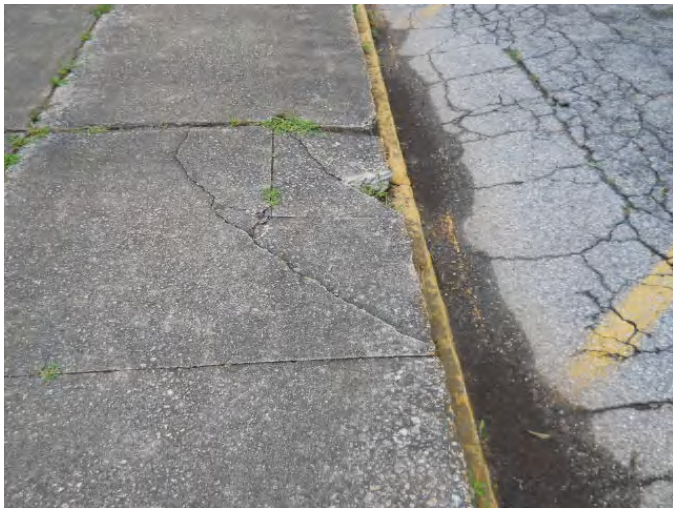
System: G2030 - Pedestrian Paving

Location: Site

Distress: Beyond Service Life

Notes: Pedestrian paving is beyond its expected service life, damaged, not ADA compliant, and should be replaced.

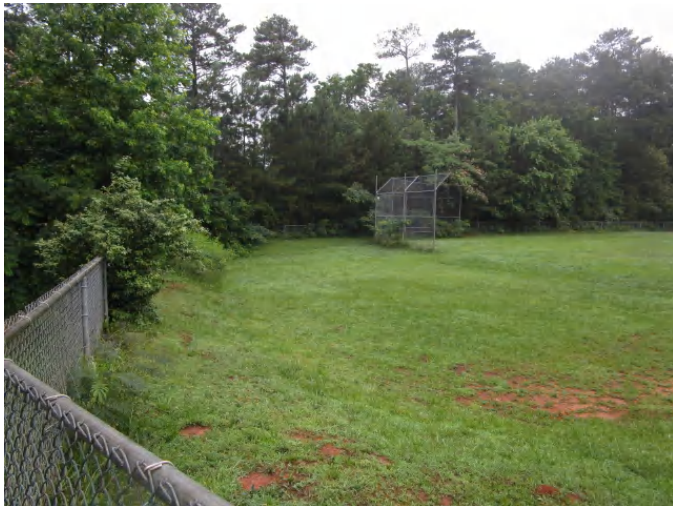
System: G2040 - Fencing & Guardrails

Location: Site

Distress: Beyond Service Life

Notes: Fencing is beyond its expected service life, damaged, and should be scheduled for replacement.

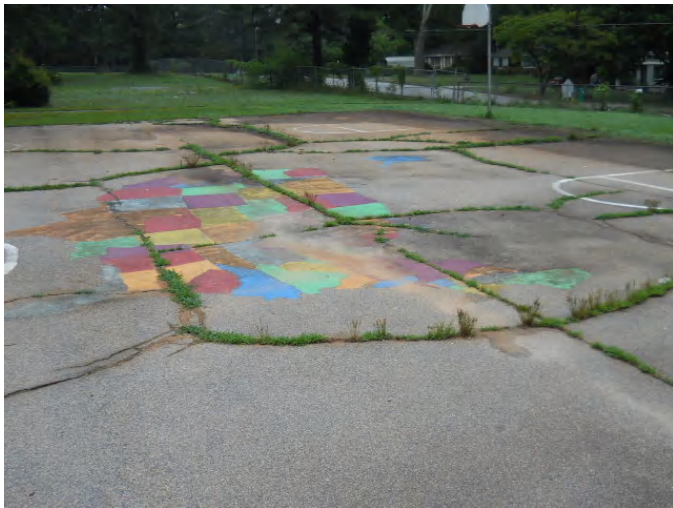
System: G2040 - Hard Surface Play Area

Location: Site

Distress: Beyond Service Life

Notes: The hard surface play area is beyond its expected service life, damaged with cracks, and should be replaced. Basketball goals are also damaged and should be replaced.

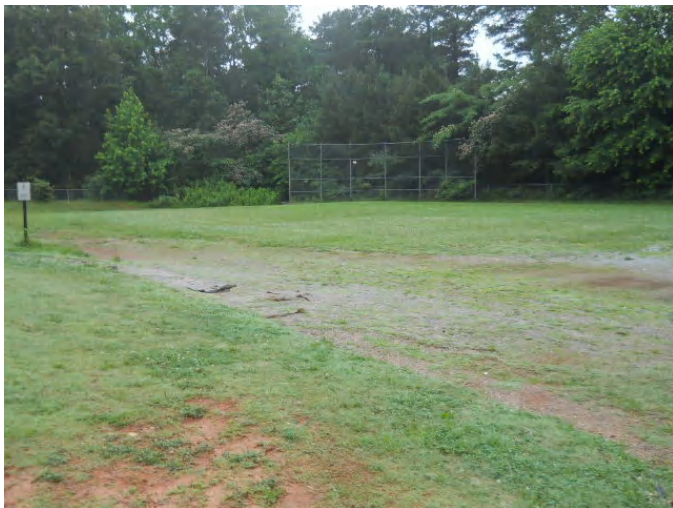
System: G2050 - Landscaping

Location: Site

Distress: Beyond Service Life

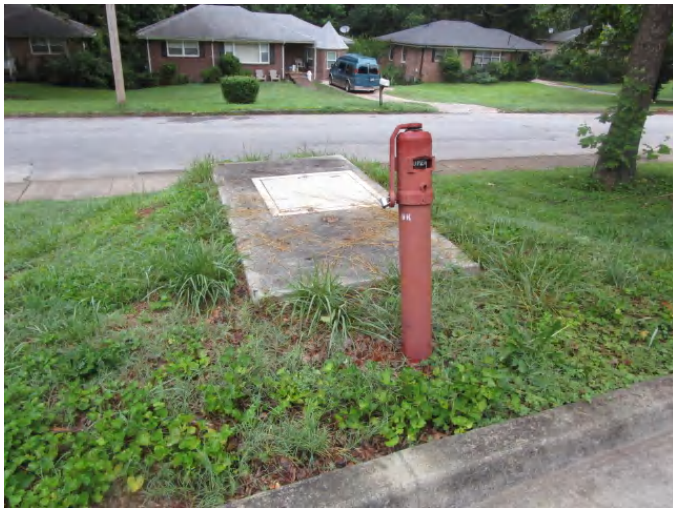
System: G3010 - Water Supply

Location: Site
Distress: Beyond Service Life
Category: Deferred Maintenance
Priority: 3 Priority
Correction: Renew System
Qty: 66,759.00
Unit of Measure: S.F.
Estimate: \$134,385.87
Assessor Name: Eduardo Lopez
Date Created: 06/10/2015

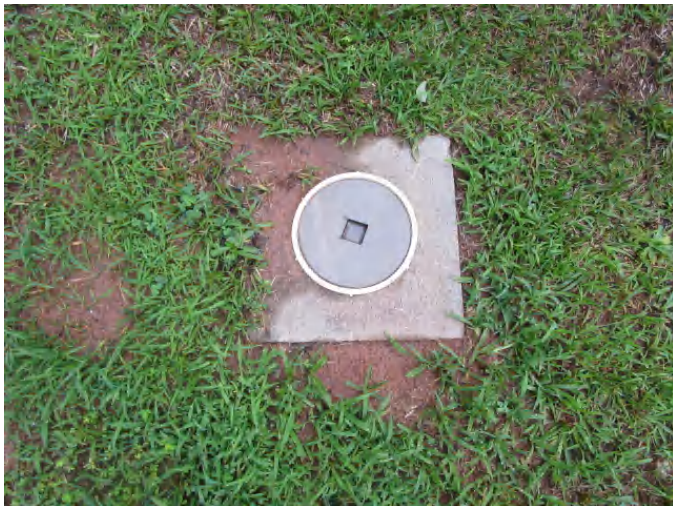
System: G3020 - Sanitary Sewer

Location: Site
Distress: Beyond Service Life
Category: Deferred Maintenance
Priority: 3 Priority
Correction: Renew System
Qty: 66,759.00
Unit of Measure: S.F.
Estimate: \$84,450.14
Assessor Name: Eduardo Lopez
Date Created: 06/10/2015

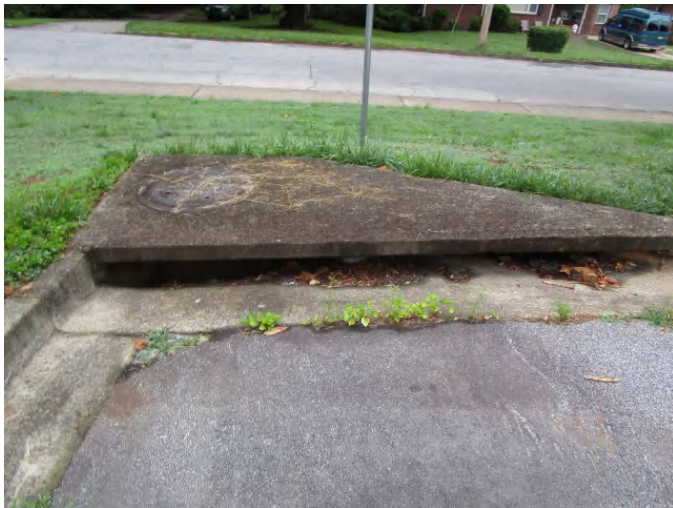
System: G3030 - Storm Sewer

Location: Site
Distress: Beyond Service Life
Category: Deferred Maintenance
Priority: 3 Priority
Correction: Renew System
Qty: 66,759.00
Unit of Measure: S.F.
Estimate: \$260,693.90
Assessor Name: Eduardo Lopez
Date Created: 06/10/2015

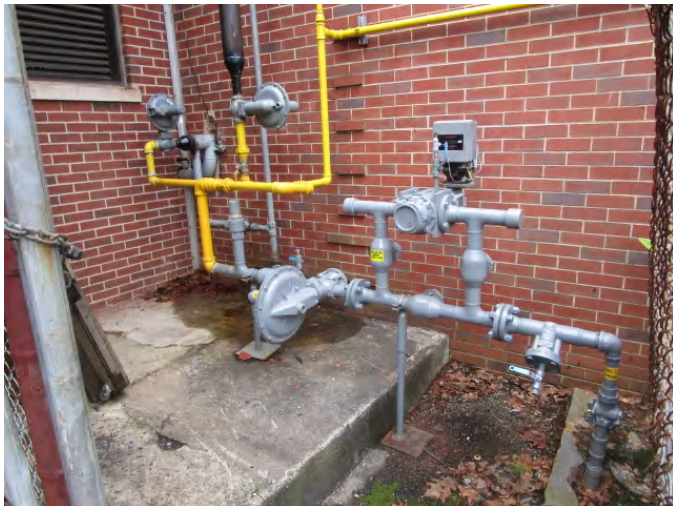
System: G3060 - Fuel Distribution

Location: Site
Distress: Beyond Service Life
Category: Deferred Maintenance
Priority: 3 Priority
Correction: Renew System
Qty: 66,759.00
Unit of Measure: S.F.
Estimate: \$57,279.22
Assessor Name: Eduardo Lopez
Date Created: 06/10/2015

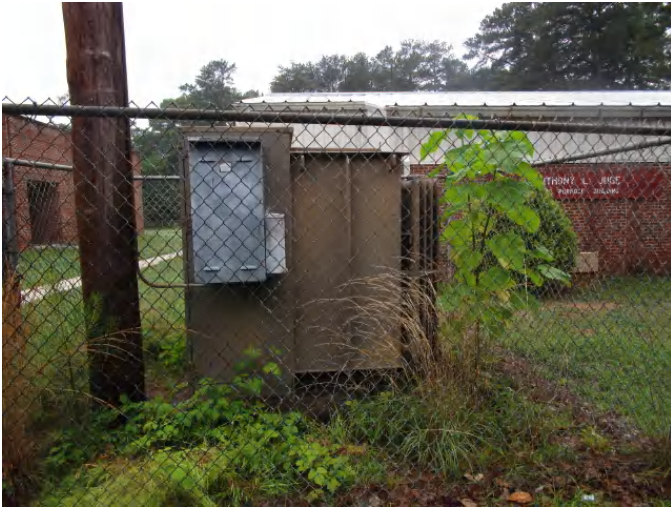
System: G4010 - Electrical Distribution

Location: Site
Distress: Beyond Service Life
Category: Deferred Maintenance
Priority: 3 Priority
Correction: Renew System
Qty: 66,759.00
Unit of Measure: S.F.
Estimate: \$136,588.91
Assessor Name: Eduardo Lopez
Date Created: 06/10/2015

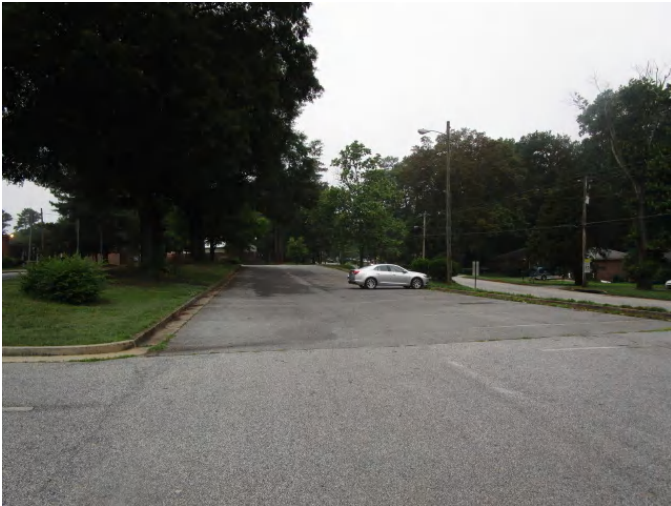
System: G4020 - Site Lighting

Location: Site
Distress: Beyond Service Life
Category: Deferred Maintenance
Priority: 3 Priority
Correction: Renew System
Qty: 66,759.00
Unit of Measure: S.F.
Estimate: \$84,450.14
Assessor Name: Eduardo Lopez
Date Created: 06/10/2015

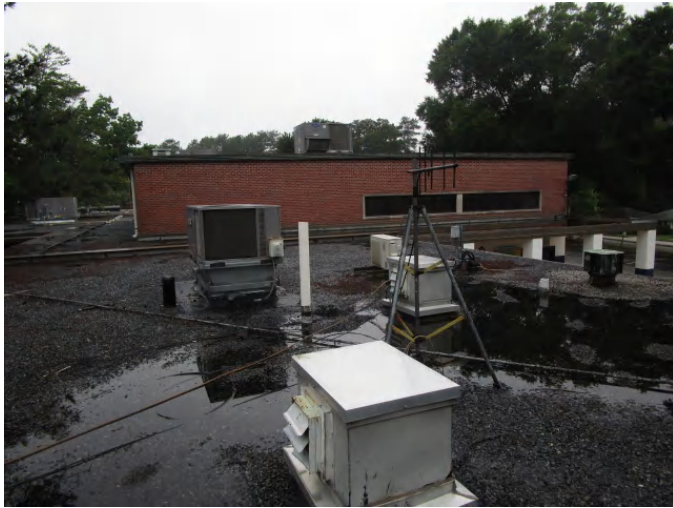
System: G4030 - Site Communications & Security

Location: Site

Distress: Beyond Service Life

Notes: The site communications and security systems are beyond their expected service life and should be scheduled for replacement.
