DeKalb County School District/High Schools

Lakeside High

School Assessment Report

January 12, 2017

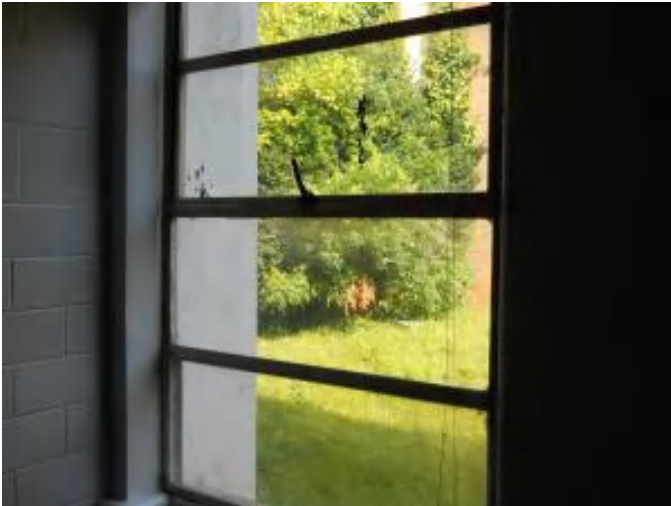
System: B2020 - Exterior Windows

Location: Throughout Building

Notes: The exterior windows were not replaced during the 2012 renovation. The system is beyond its expected service life and should be scheduled for replacement.

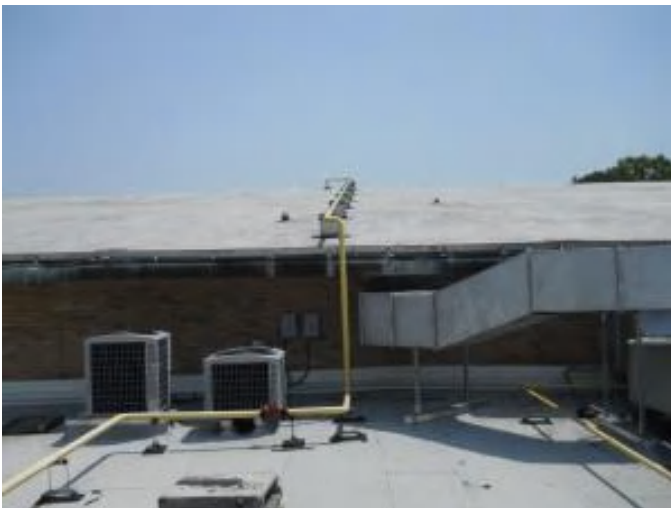
System: B3010 - Roof Coverings - BUR

Location: Roof

Notes: The roof over the gym and natatorium is leaking, beyond its expected service life, and should be replaced.

Correction: Total BUR roof replacement

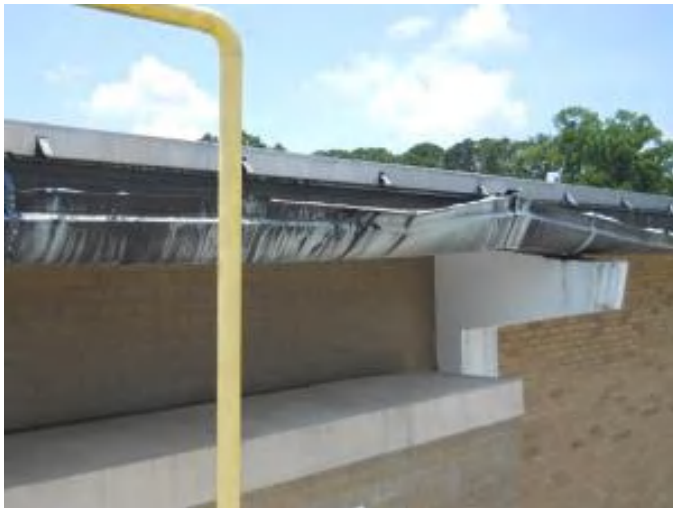
System: B3010 - Roof Coverings - BUR

Location: Roof

Notes: The gutter system on the gym is beyond its expected service life, detached from the building, and should be replaced.

Correction: Replace 5" copper box gutters, 16 oz.

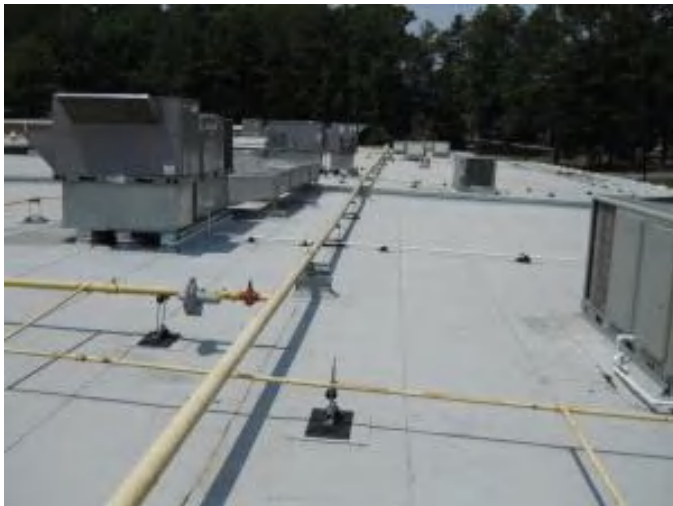
System: B3020 - Roof Openings

Location: Roof

Distress: Missing

Notes: There is no safe roof access for maintenance personnel. Recommend installation of an OSHA-compliant roof hatch/ladder system for safe access.

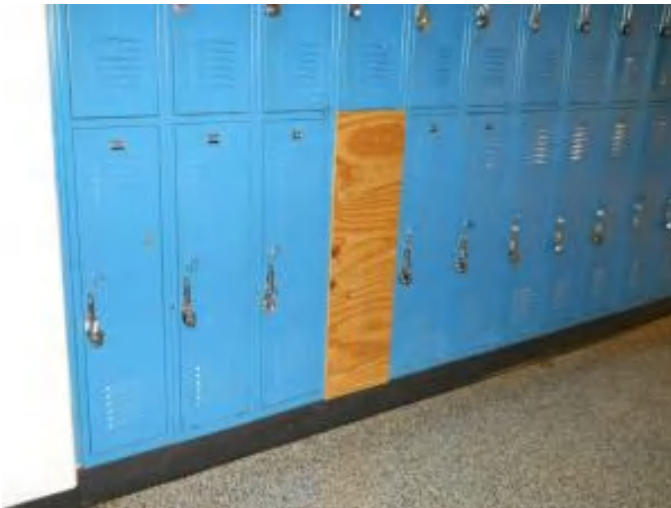
System: C1030 - Fittings

Location: Throughout Building
Distress: Beyond Service Life
Category: Deferred Maintenance
Priority: 3 Priority
Correction: Renew System
Qty: 164,666.00
Unit of Measure: S.F.
Estimate: \$1,123,022.00
Assessor Name: Eduardo Lopez
Date Created: 07/02/2015

Notes: The lockers are original, beyond their expected service life, and should be replaced.

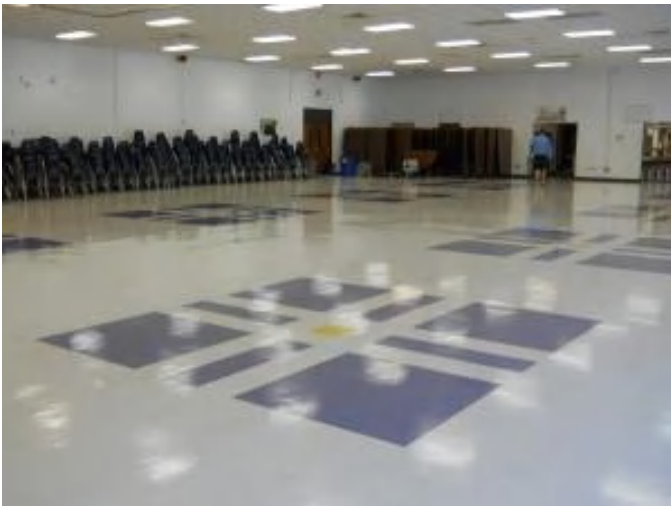
System: C3020 - Floor Finishes - VCT

Location: Cafeteria
Distress: Damaged
Category: Deferred Maintenance
Priority: 3 Priority
Correction: Replace VCT flooring
Qty: 8,600.00
Unit of Measure: S.F.
Estimate: \$71,208.00
Assessor Name: Eduardo Lopez
Date Created: 07/05/2015

Notes: The VCT flooring in the cafeteria is loose in many places. This was identified as a problem immediately after installation during the 2011 renovation. The VCT flooring should be replaced.

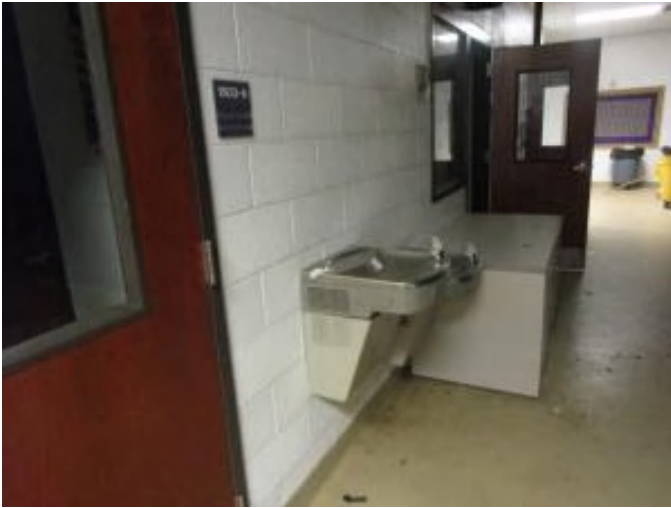
System: D2010 - Plumbing Fixtures

Location: Hallways

Correction: Remove/replace drinking fountain w/recessed ADA compliant drinking fountain

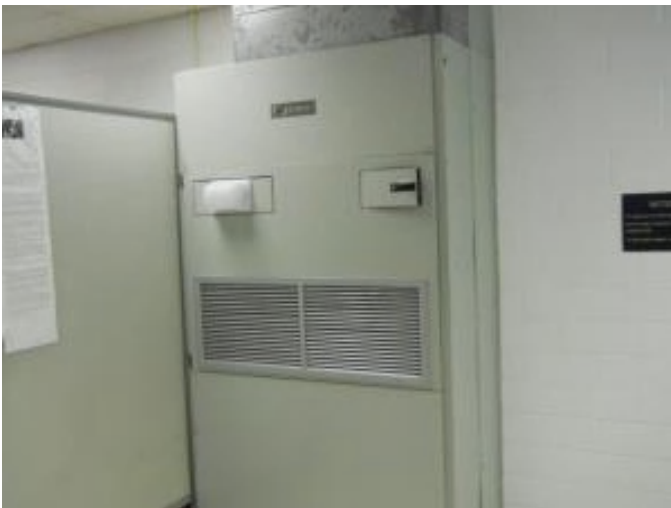
System: D3050 - Terminal & Package Units

Location: Throughout Building

Notes: During the 2011/2012 renovation, approximately 40 BARD units were not replaced in the classrooms. The units are beyond their expected service life, disruptive to class due to excessive noise, and should be replaced.

Correction: Replace air conditioner, thru-the-wall, 2 ton

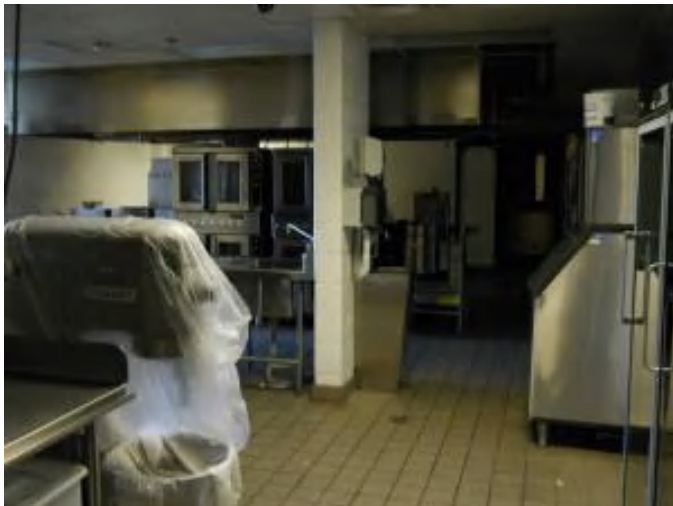
System: E1090 - Other Equipment - Kitchen Equipment

Location: Kitchen
Distress: Beyond Service Life
Category: Deferred Maintenance
Priority: 3 Priority
Correction: Renew System
Qty: 164,666.00
Unit of Measure: S.F.
Estimate: \$368,852.00
Assessor Name: Eduardo Lopez
Date Created: 07/05/2015

Notes: Kitchen equipment is beyond its expected service life and should be scheduled for replacement.

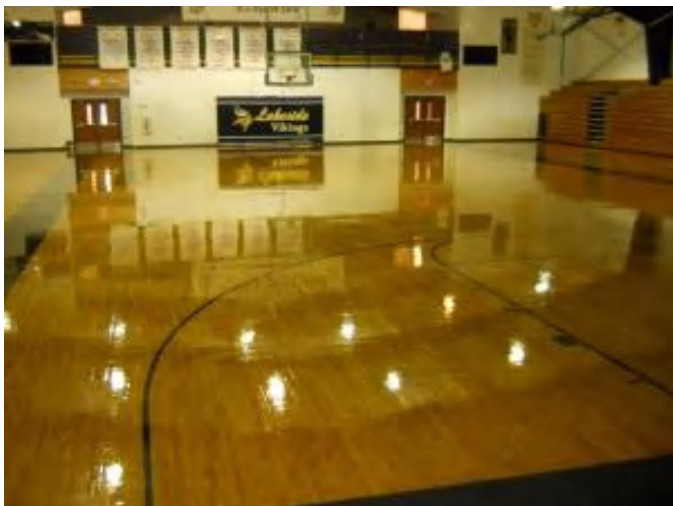
System: E1090 - Other Equipment - Sports Equipment

Location: Gym
Distress: Beyond Service Life
Category: Deferred Maintenance
Priority: 3 Priority
Correction: Renew System
Qty: 164,666.00
Unit of Measure: S.F.
Estimate: \$256,879.00
Assessor Name: Eduardo Lopez
Date Created: 12/11/2015

Notes: Sports equipment is beyond its expected service life and should be scheduled for replacement.

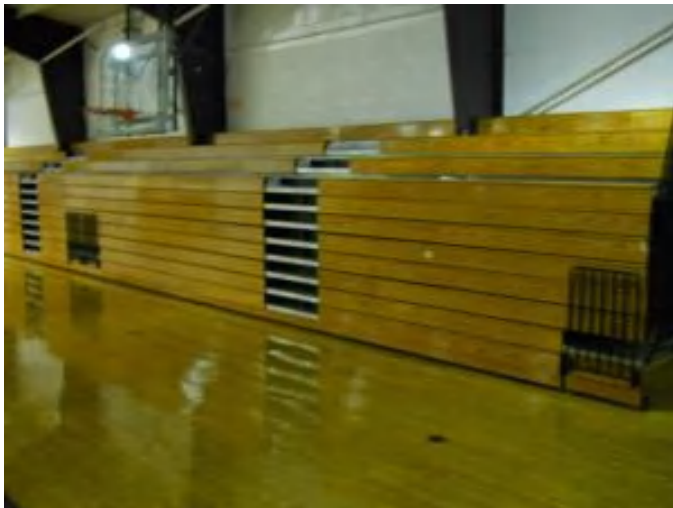
System: E2020 - Moveable Furnishings

Location: Gym

Notes: The expandable, movable bleachers are beyond their expected service life and should be replaced.

Correction: Replace Movable Gym Bleachers

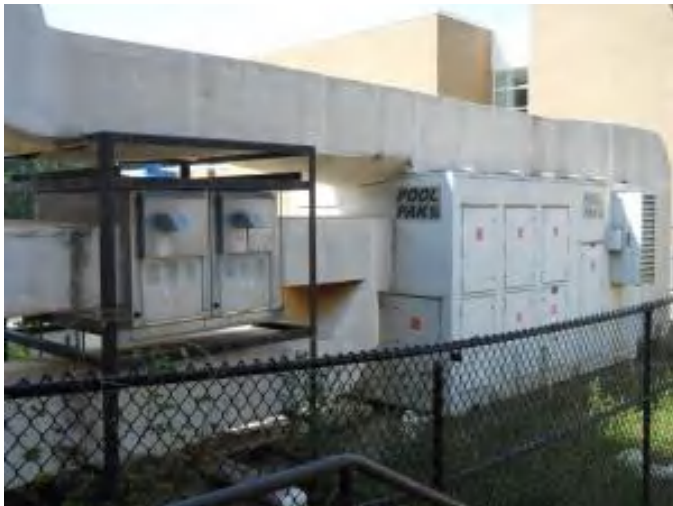
System: F1040 - Special Facilities - Natatorium

Location: Natatorium

Notes: The natatorium equipment is beyond its expected service life, has failed, and should be replaced. The HVAC system also does not work.

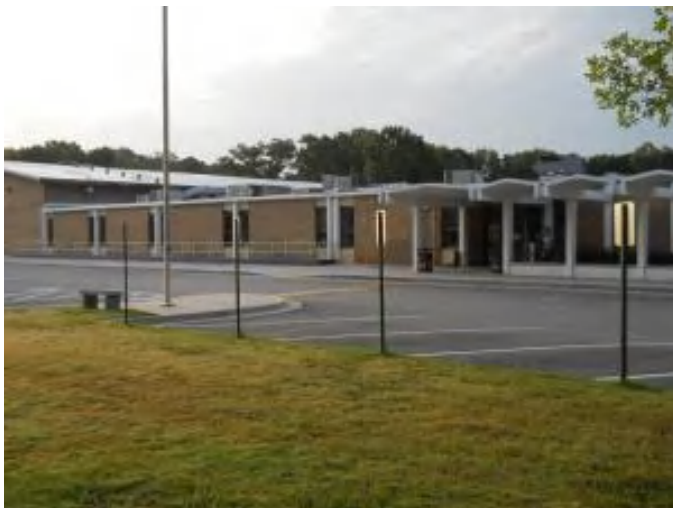
System: G2010 - Roadways

Location: Site

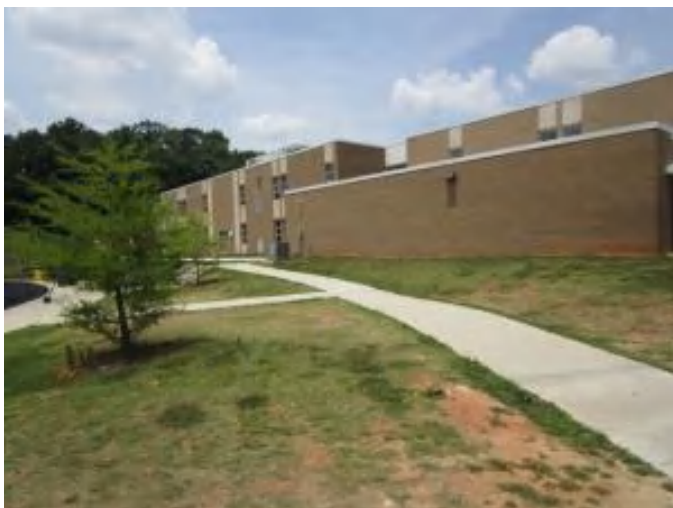
System: G4020 - Site Lighting

Location: Site

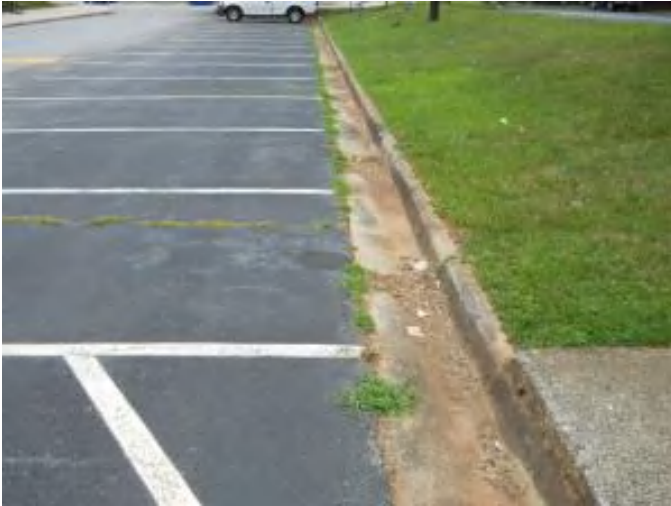
System: G2020 - Parking Lots

Location: Teachers' Parking Lot

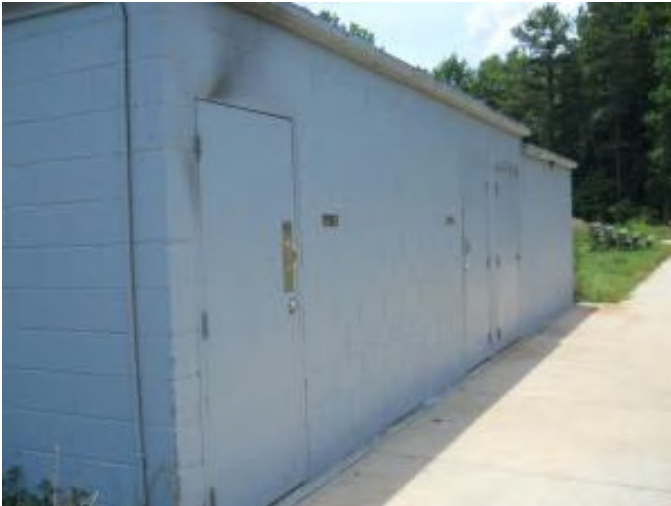
System: B2030 - Exterior Doors

Location: Exterior Wall

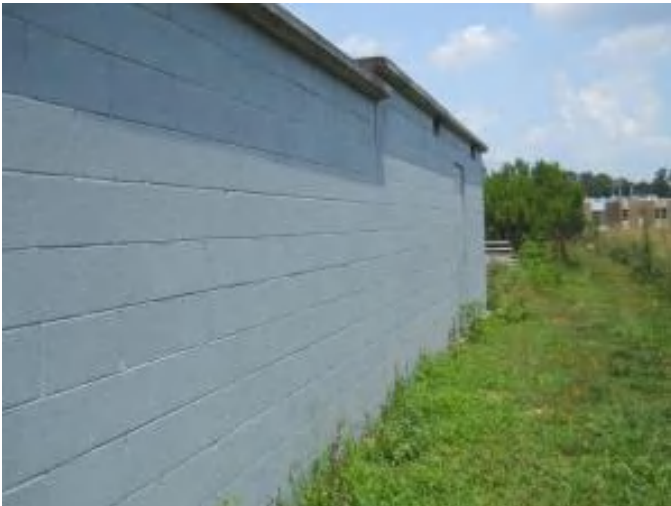
System: B3010 - Roof Coverings

Location: Roof
