DeKalb County School District/Elementary Schools

Laurel Ridge Elementary

School Assessment Report

May 19, 2016

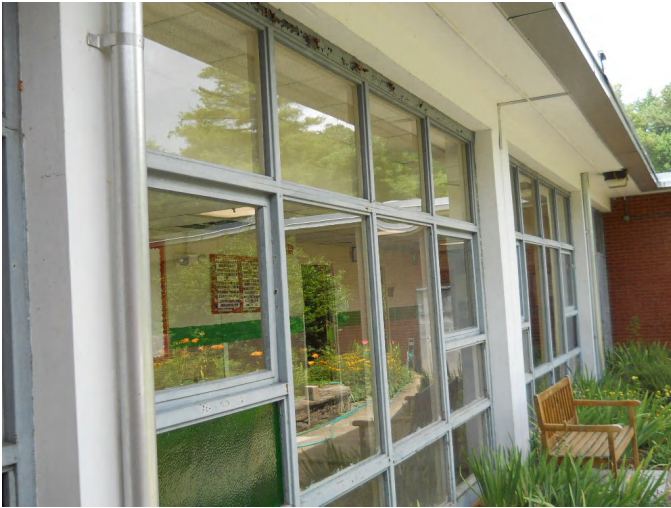
System: B2020 - Exterior Windows

Location: Throughout Building

Distress: Beyond Service Life

Notes: The exterior windows are original construction, beyond their expected service life, not energy efficient, and reportedly leak.

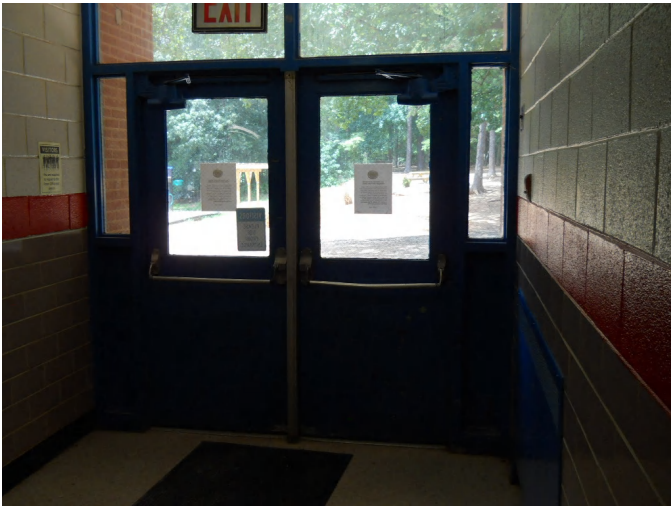
System: B2030 - Exterior Doors

Location: Throughout Building

Distress: Beyond Service Life

Notes: The exterior doors are beyond their expected service life, not energy efficient, do not lock/seal properly, and should be replaced.

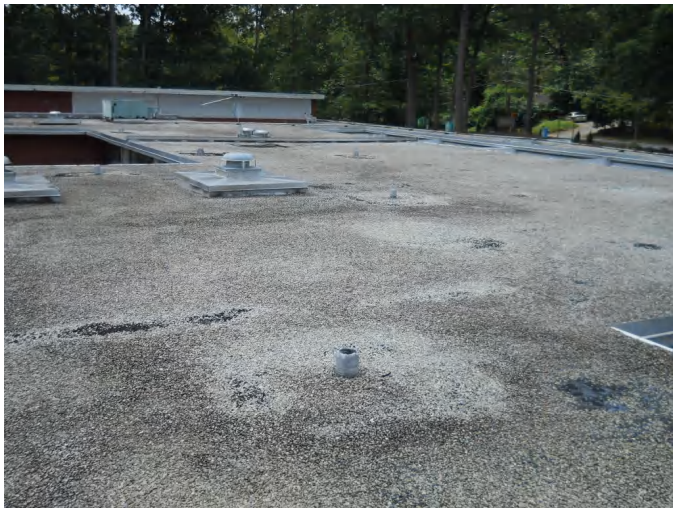
System: B3020 - Roof Openings

Location: Roof

Distress: Missing

Notes: There is no safe roof access for maintenance personnel. Recommend installation of an OSHA-compliant roof hatch/ladder system for safe access.

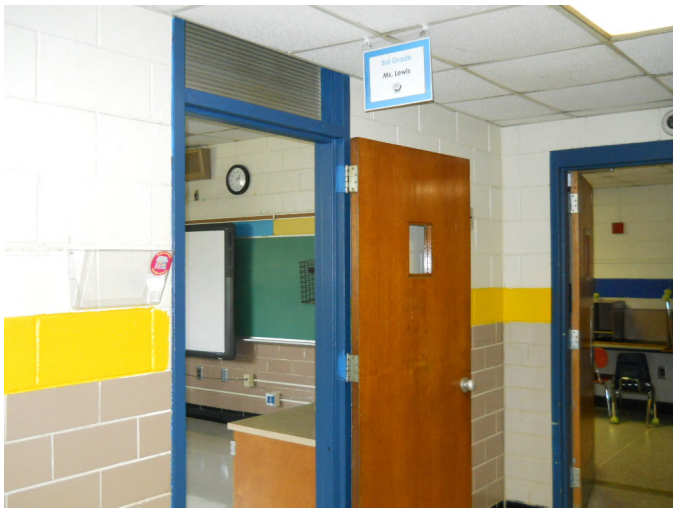
System: C1020 - Interior Doors

Location: Throughout Building

Distress: Beyond Service Life

Notes: Interior doors are beyond their expected service life, not ADA compliant, and should be replaced.

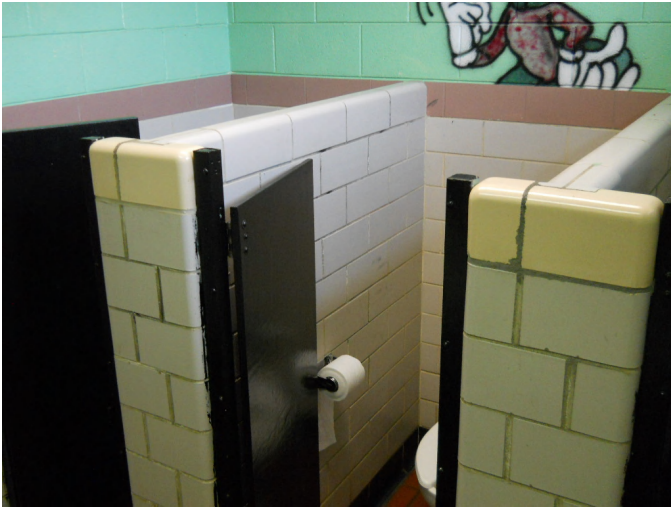
System: C1030 - Fittings

Location: Throughout Building

Distress: Beyond Service Life

Notes: Fittings, such as toilet partitions, chalk and tack boards and signage, are beyond service life, deteriorating, and should be replaced. SPLOST project 118-422 to provide hall restroom renovations.

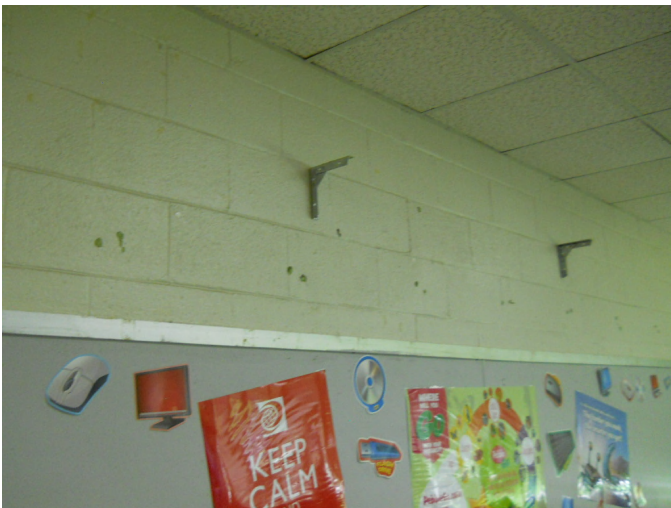
System: C3010 - Wall Finishes - Paint

Location: Throughout Building

Distress: Beyond Service Life

Notes: The painted wall finishes are beyond their expected service life, dirty, and should be replaced.

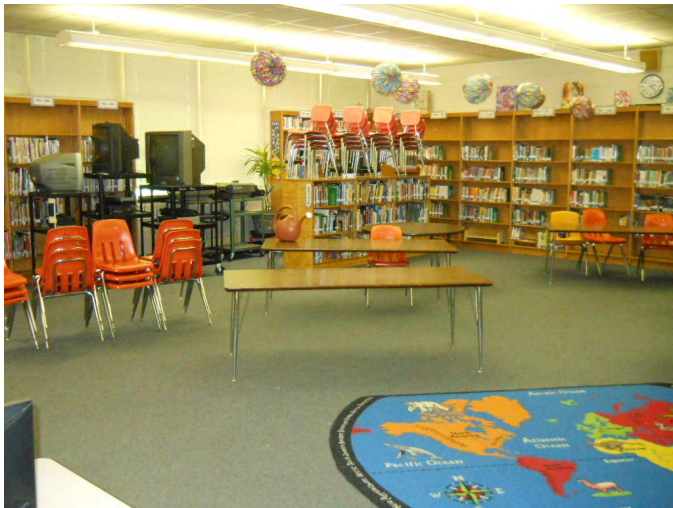
System: C3020 - Floor Finishes - Carpet

Location: Media Center, Offices

Distress: Beyond Service Life

Notes: The carpet is beyond its expected service life and worn, and should be replaced.

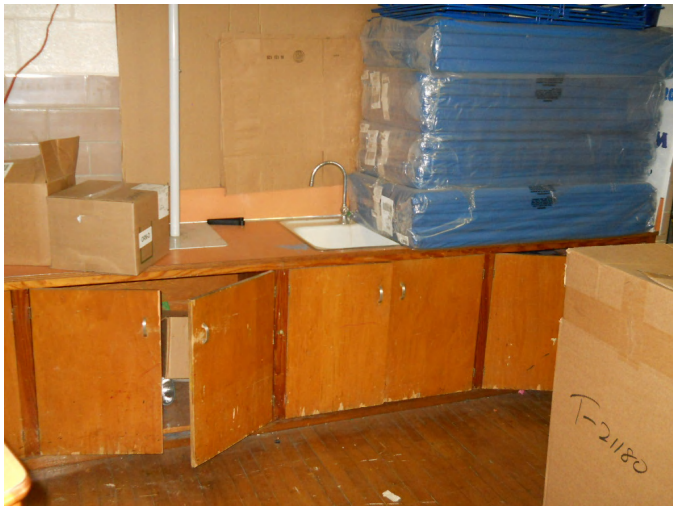
System: C3020 - Floor Finishes - Wood

Location: Stage

Distress: Beyond Service Life

Notes: The wood floor finish is beyond its expected service life, damaged, and should be replaced.

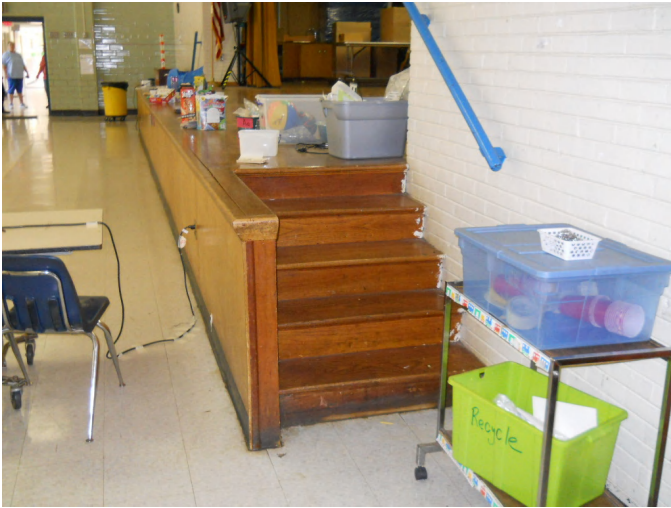
System: D1010 - Elevators and Lifts

Location: Stage

Distress: Missing

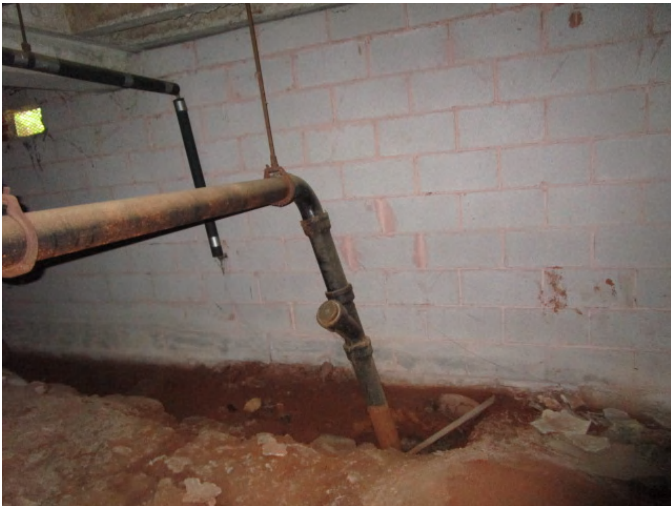
System: D2030 - Sanitary Waste

Location: Throughout Building

Distress: Beyond Service Life

Notes: The sanitary waste system is beyond its expected service life and should be scheduled for replacement.

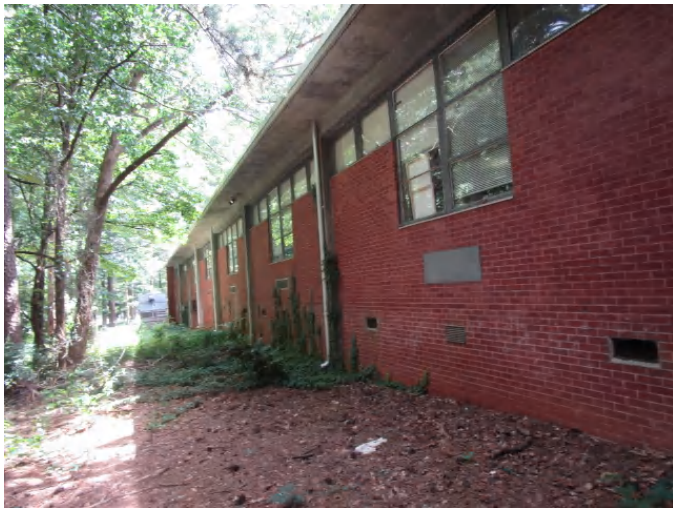
System: D2040 - Rain Water Drainage

Location: Throughout Building

Distress: Beyond Service Life

Notes: The rainwater drainage system is beyond its expected service life and should be scheduled for replacement.

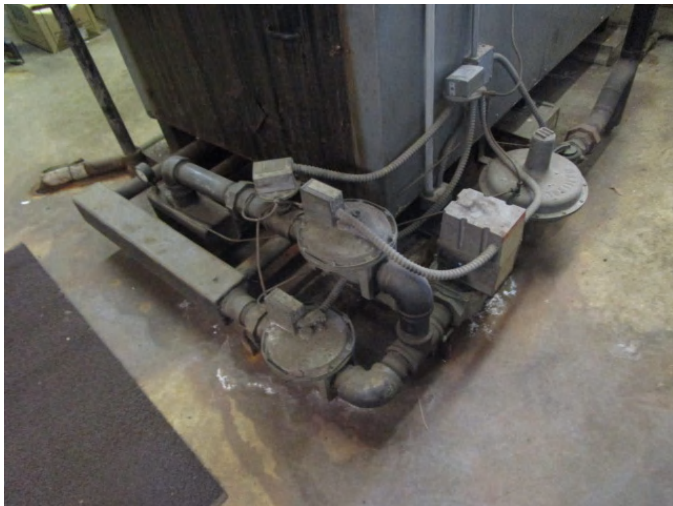
System: D2090 - Other Plumbing Systems - Natural Gas

Location: Throughout Building

Distress: Beyond Service Life

Notes: The natural gas system is beyond its expected service life and should be scheduled for replacement. SPLOST project 118-422 to replace grease trap.

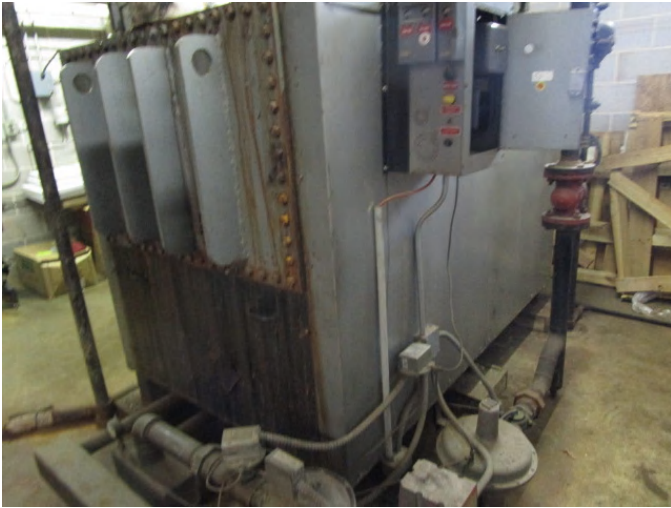
System: D3020 - Heat Generating Systems

Location: Mechanical Room

Distress: Beyond Service Life

Notes: The heat generating system is beyond its expected service life, inadequate, and should be scheduled for replacement.

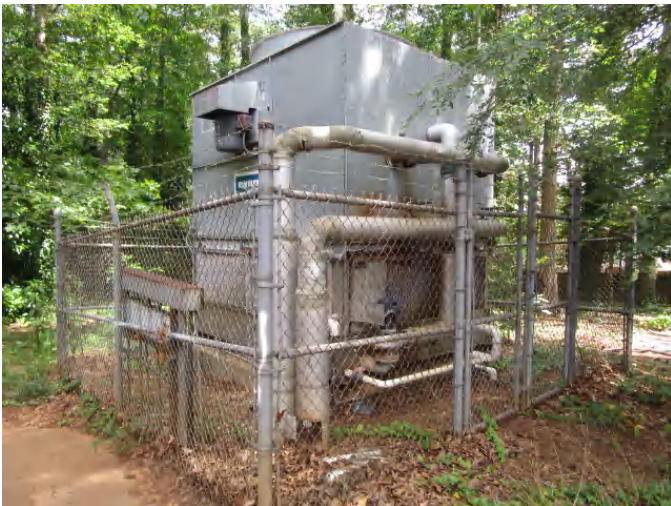
System: D3030 - Cooling Generating Systems

Location: Outside Mechanical Room

Distress: Beyond Service Life

Notes: The cooling generating system is beyond its expected service life and should be scheduled for replacement.

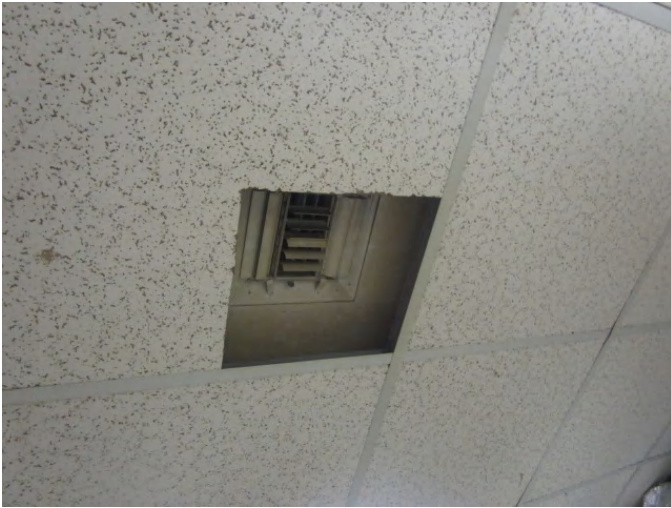
System: D3040 - Distribution & Exhaust Systems

Location: Throughout Building

Distress: Beyond Service Life

Notes: The distribution systems and exhaust systems are beyond their expected service life, inadequate, and should be scheduled for replacement. School staff reports odors in the building.

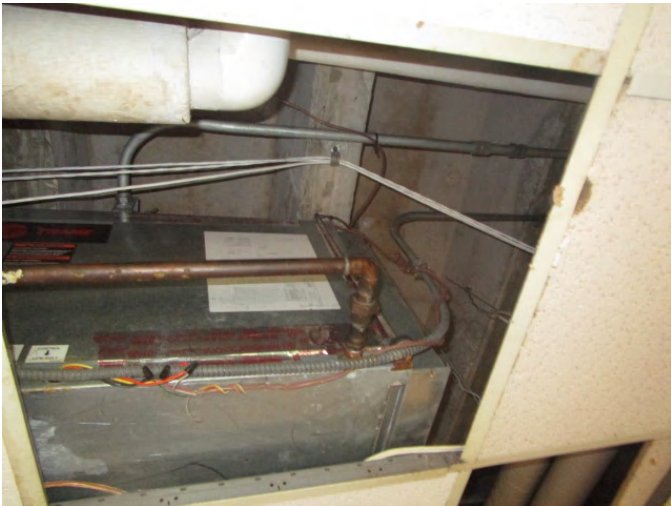
System: D3050 - Terminal & Package Units

Location: Throughout Building

Distress: Beyond Service Life

Notes: Terminal and package units are beyond their expected service life, inadequate, and should be scheduled for replacement.

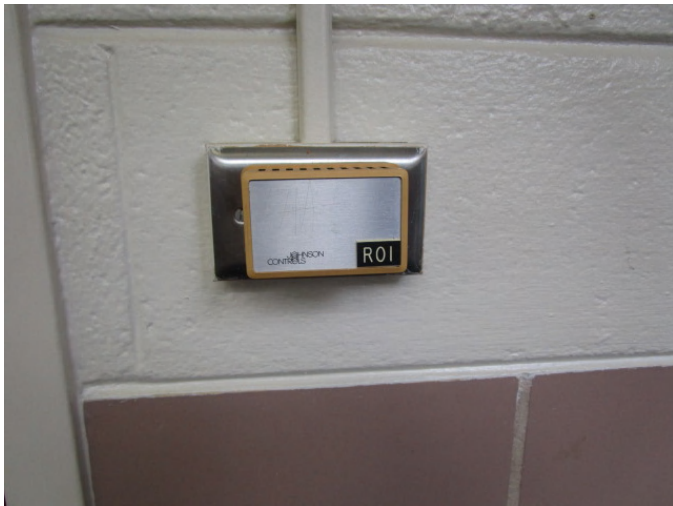
System: D3060 - Controls & Instrumentation

Location: Throughout Building

Distress: Beyond Service Life

Notes: The controls and instrumentation system is beyond its expected service life and should be scheduled for replacement.

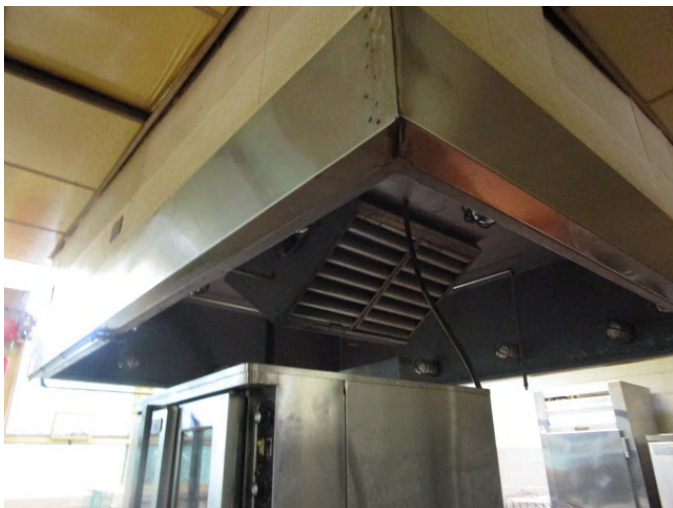
System: D3090 - Other HVAC Systems/Equip - Kitchen Hood

Location: Kitchen

Distress: Beyond Service Life

Notes: The kitchen hood system is beyond its expected service life and should be scheduled for replacement.

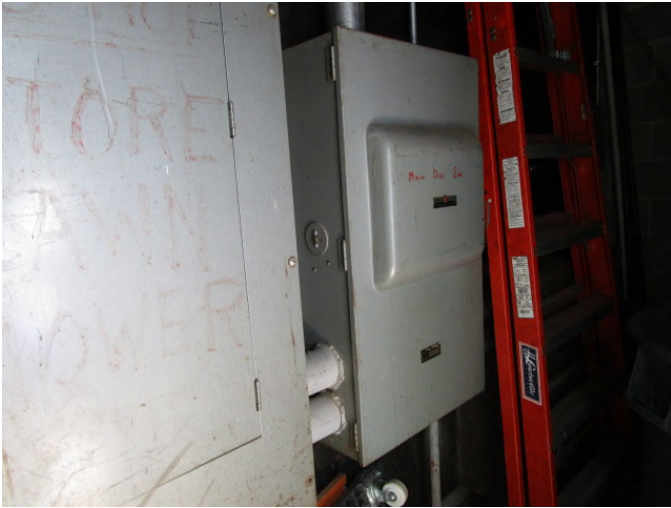
System: D5010 - Electrical Service/Distribution

Location: Main Switch Room/Throughout Building

Distress: Beyond Service Life

Notes: The electrical service/distribution system is beyond its expected service life and should be scheduled for replacement.

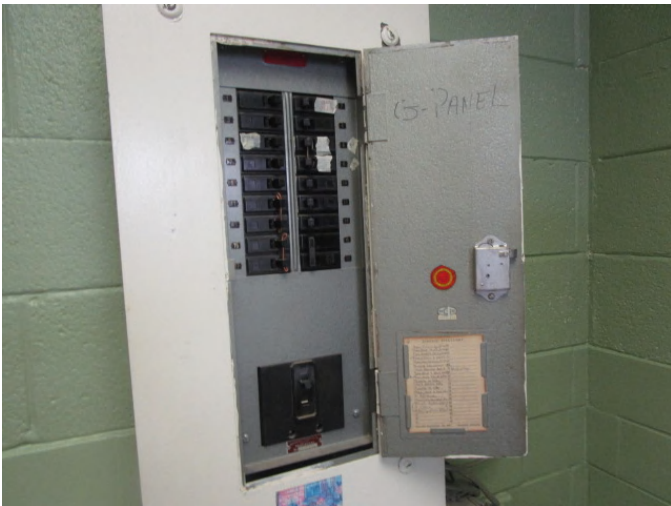
System: D5020 - Branch Wiring

Location: Throughout Building

Distress: Beyond Service Life

Notes: The branch wiring system is beyond its expected service life and should be scheduled for replacement. GFI outlets are missing near wet areas.

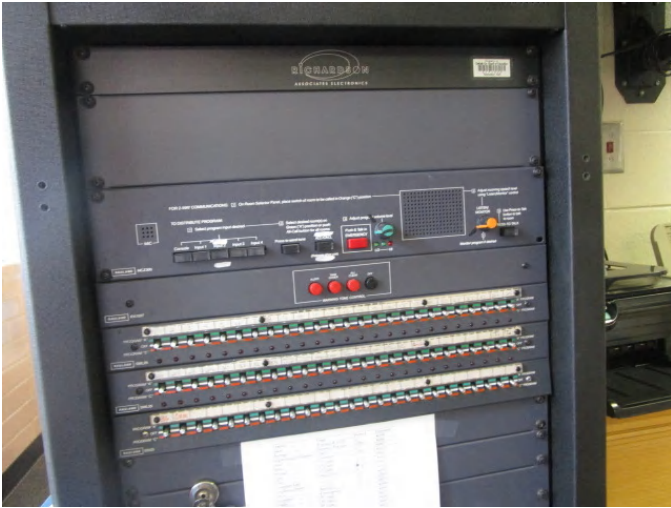
System: D5030 - Communications and Security - Clock & PA Systems

Location: Throughout Building

Distress: Beyond Service Life

Notes: Clock and PA systems are beyond their expected service life and should be scheduled for replacement.

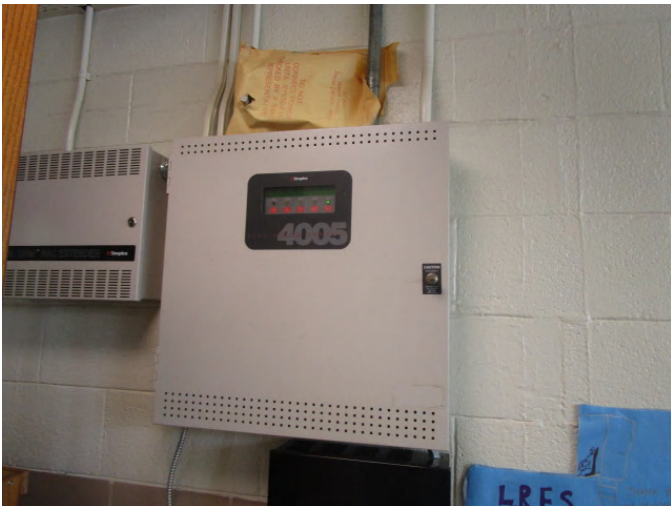
System: D5030 - Communications and Security - Fire Alarm

Location: Throughout Building

Distress: Beyond Service Life

Notes: The fire alarm system is beyond its expected service life, not code compliant, and should be scheduled for replacement.

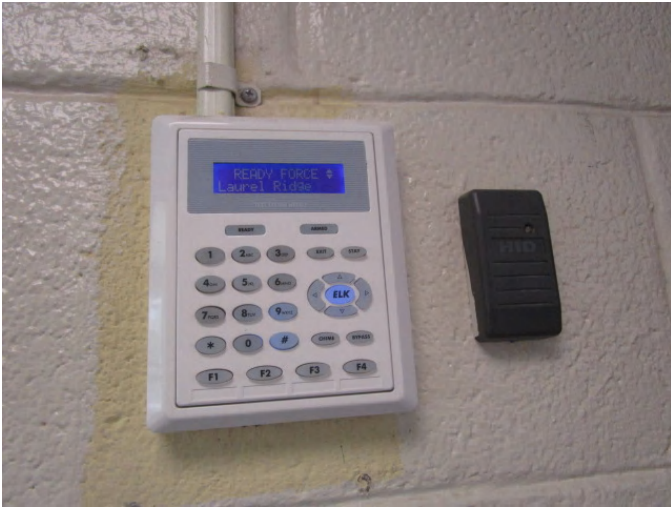
System: D5030 - Communications and Security - Security & CCTV

Location: Throughout Building

Distress: Beyond Service Life

Notes: The security and CCTV systems are beyond their expected service life and should be scheduled for replacement.

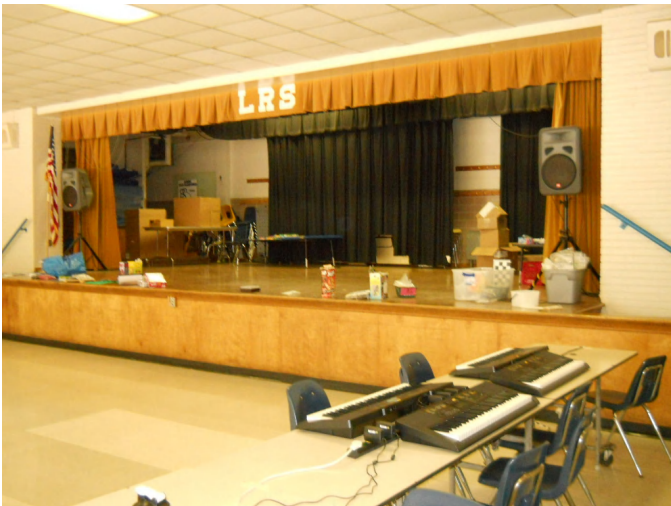
System: E1020 - Institutional Equipment

Location: Throughout Building

Distress: Beyond Service Life

Notes: Institutional equipment, such as theater and stage equipment and library equipment, is beyond its expected service life and should be scheduled for replacement.

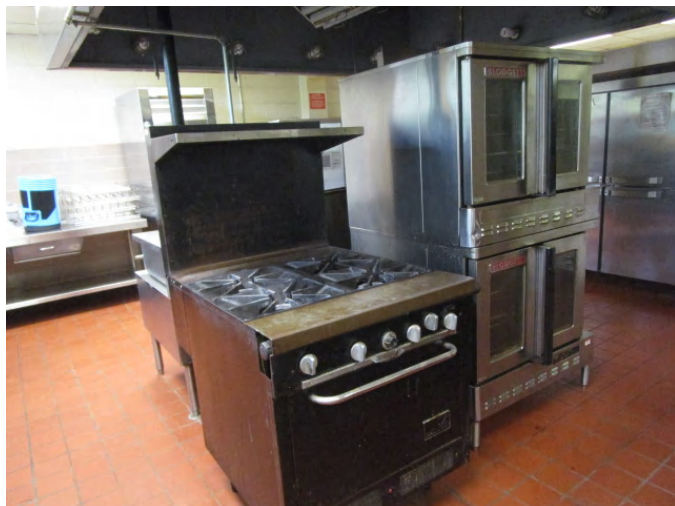
System: E1090 - Other Equipment (Kitchen Equipment)

Location: Kitchen

Distress: Beyond Service Life

Notes: Kitchen equipment is beyond its expected service life and should be scheduled for replacement.

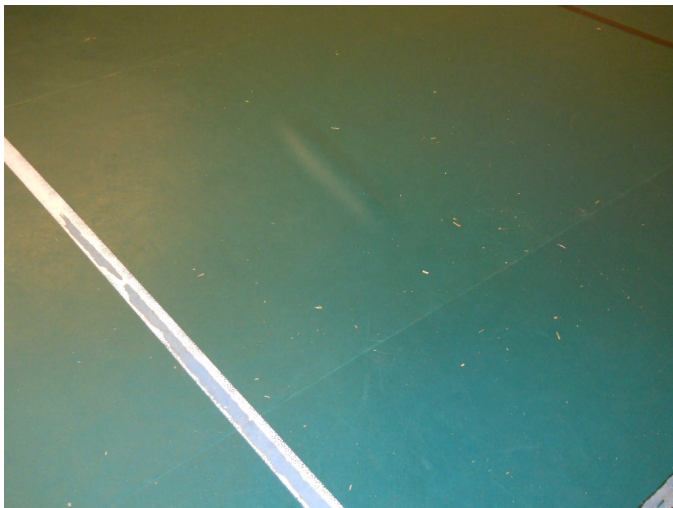
System: C3020 - Floor Finishes - Neoprene

Location: Basketball Court

Distress: Beyond Service Life

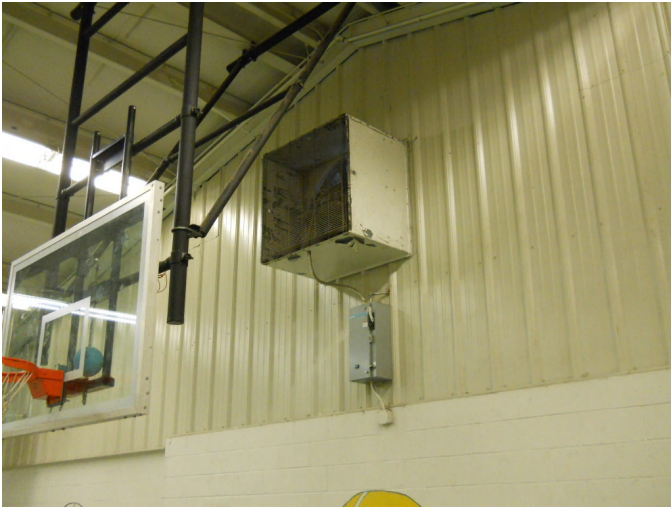
System: D3050 - Terminal & Package Units

Location: Throughout Building

Distress: Inadequate

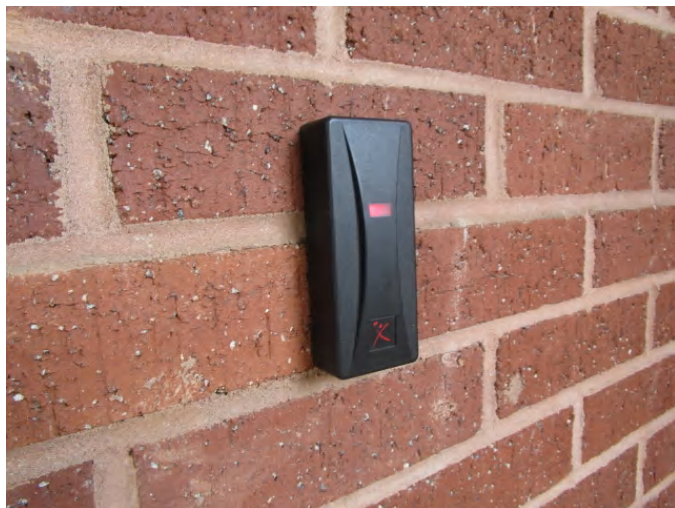
System: D5030 - Communications and Security - Security & CCTV

Location: Throughout Building

Distress: Beyond Service Life

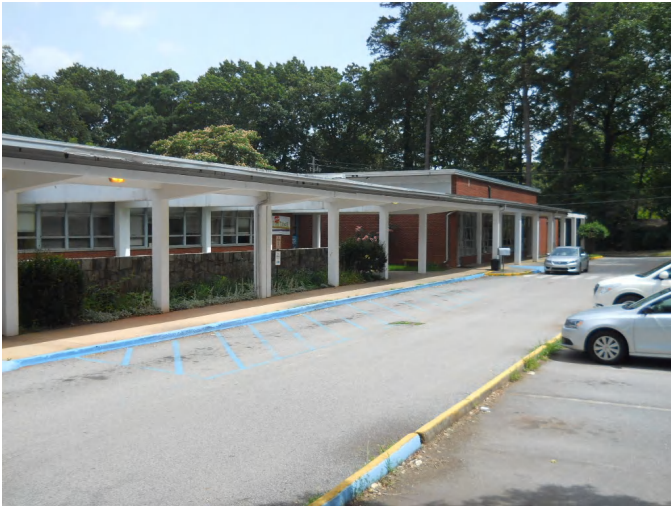
System: G2010 - Roadways

Location: Site

Distress: Beyond Service Life

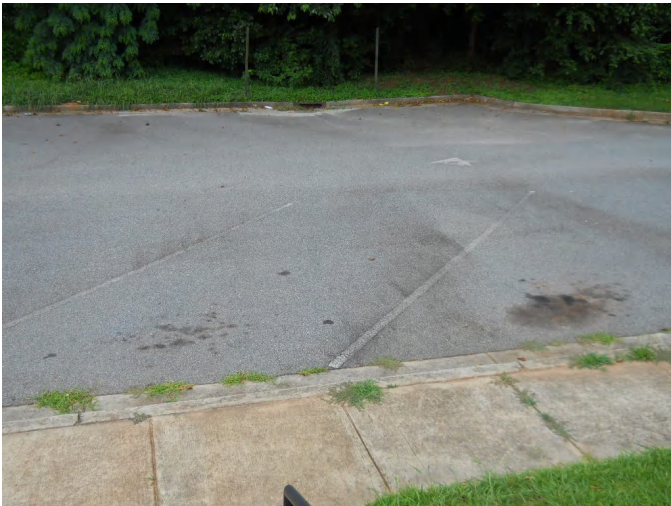
System: G2020 - Parking Lots

Location: Site

Distress: Beyond Service Life

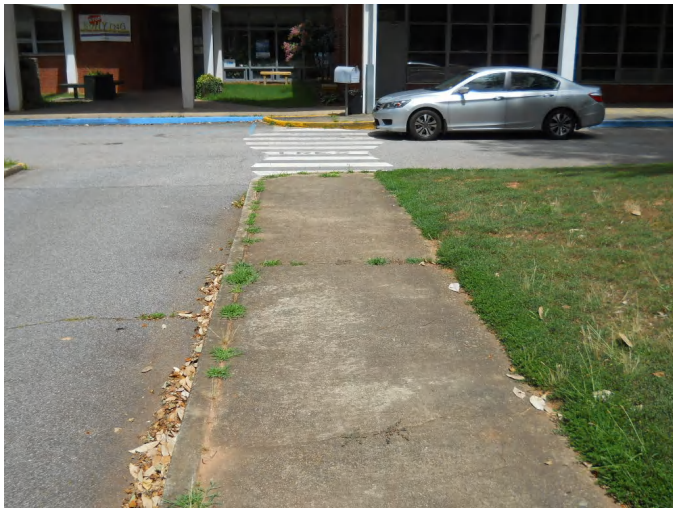
System: G2030 - Pedestrian Paving

Location: Site

Distress: Beyond Service Life

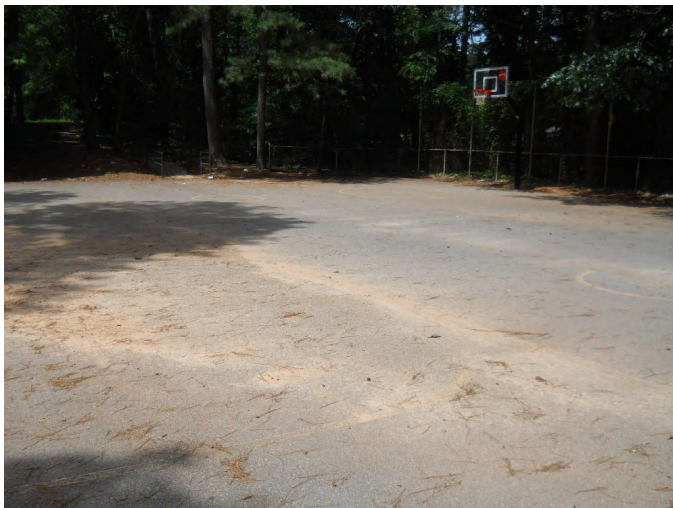
System: G2040 - Hard Surface Play Area

Location: Site

Distress: Beyond Service Life

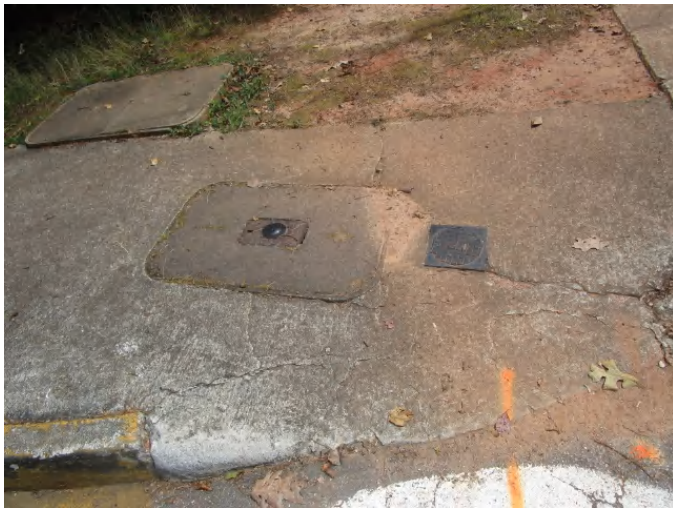
System: G3010 - Water Supply

Location: Site

Distress: Beyond Service Life

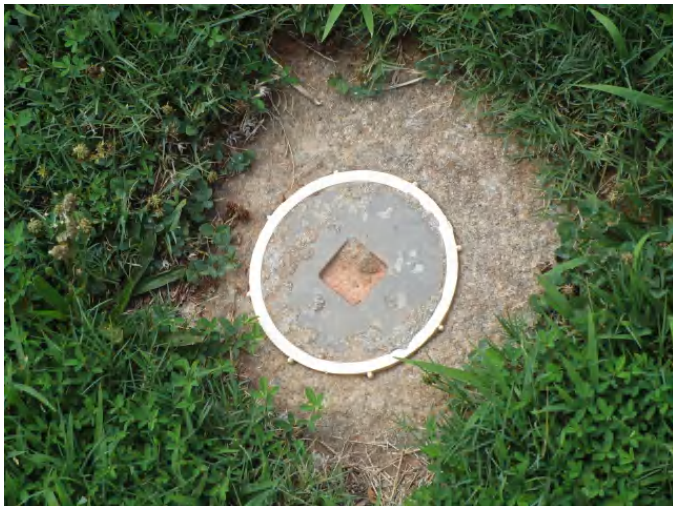
System: G3020 - Sanitary Sewer

Location: Site

Distress: Beyond Service Life

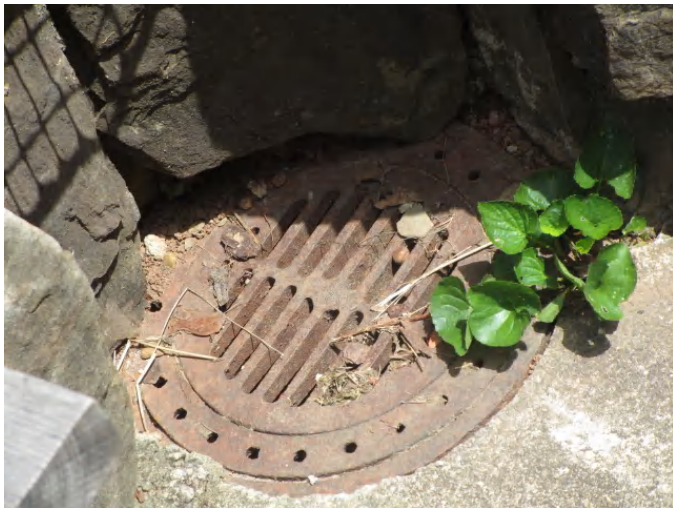
System: G3030 - Storm Sewer

Location: Site

Distress: Beyond Service Life

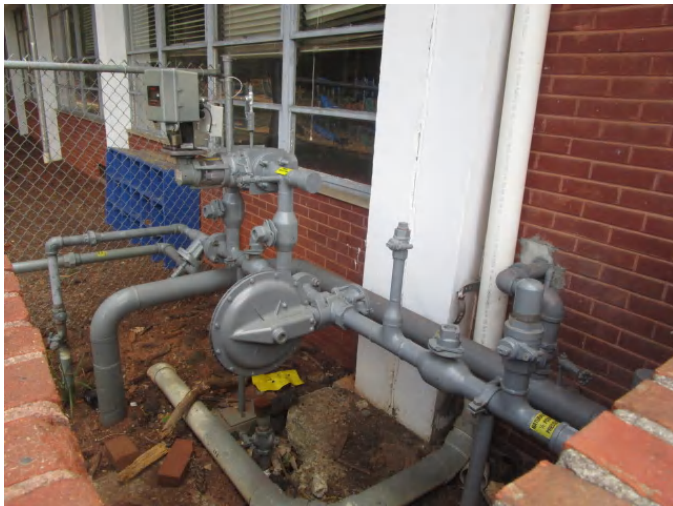
System: G3060 - Fuel Distribution

Location: Site

Distress: Beyond Service Life

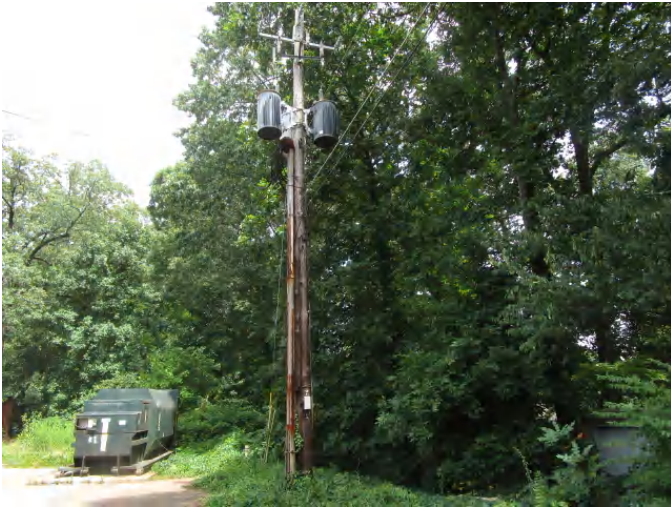
System: G4010 - Electrical Distribution

Location: Site
Distress: Beyond Service Life
Category: Deferred Maintenance
Priority: 3 Priority
Correction: Renew System
Qty: 58,384.00
Unit of Measure: S.F.
Estimate: \$119,453.66
Assessor Name: Eduardo Lopez
Date Created: 06/29/2015

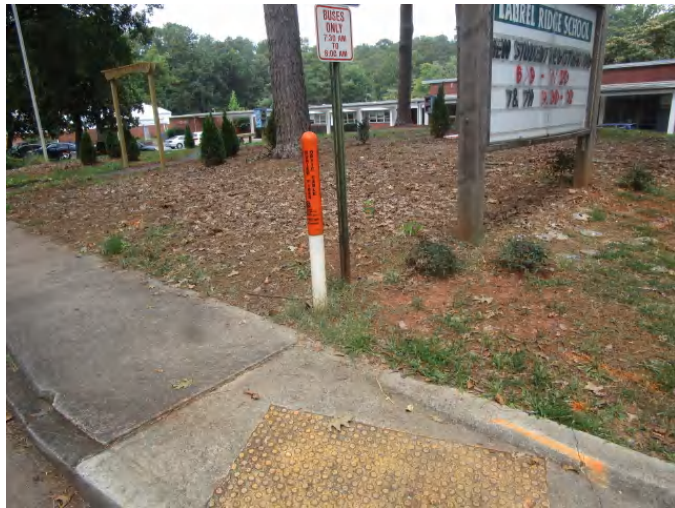
System: G4030 - Site Communications & Security

Location: Site
