DeKalb County School District/High Schools

# Lithonia High

## School Assessment Report

May 19, 2016

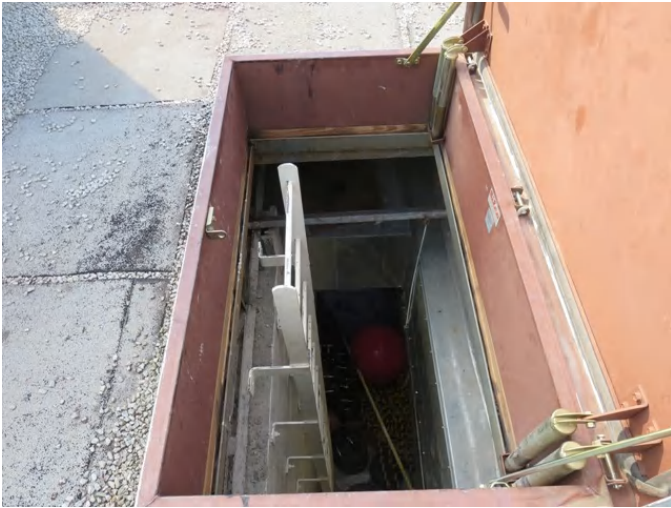
#### **System: B3020 - Roof Openings**

**Location:** Roof

**Distress:** Inadequate

**Notes:** Roof hatch opening is too narrow, does not comply with OSHA standards. Roof protection and proper extension of fixed ladder to platform should be provided.

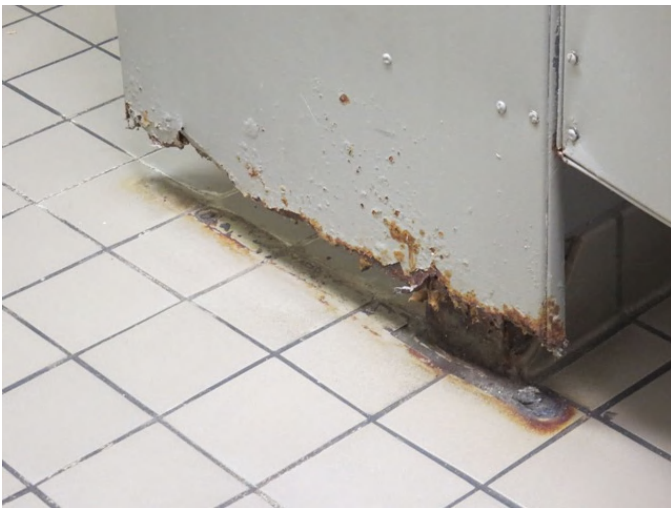
#### **System: C1030 - Fittings**

**Location:** Throughout Building

**Distress:** Damaged

**Notes:** The toilet partitions throughout the building are rusted at the base, in poor condition, and should be replaced.

**Correction:** Replace toilet partitions, stainless steel-overhead braced, per stall

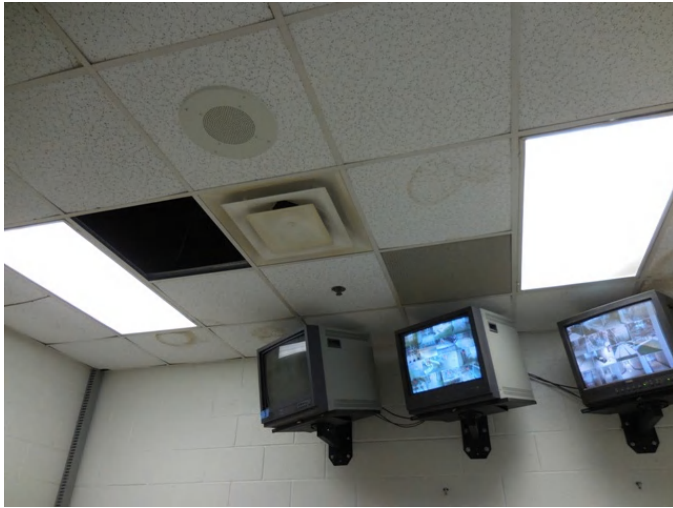
**System: D5030 - Communications and Security - Security & CCTV**

**Location:** Throughout Building

**Distress:** Inadequate

**Notes:** The security and CCTV systems are beyond their expected service life, inadequate, and should be scheduled for replacement, with upgrades to provide full coverage.

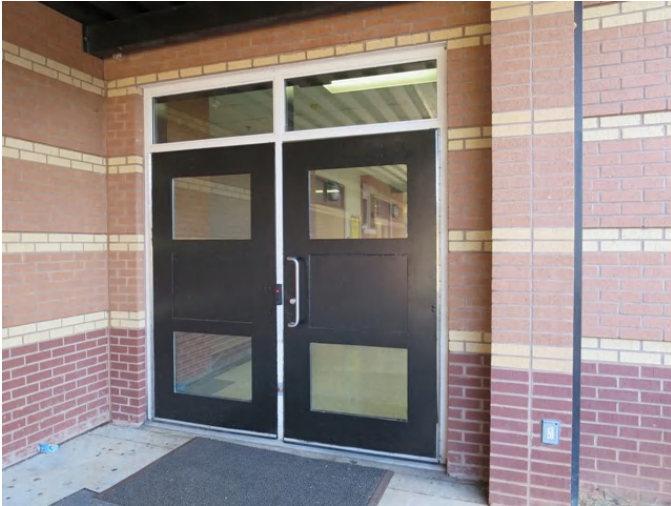
**System: B2030 - Exterior Doors**

**Location:** Throughout Building

**Distress:** Needs Remediation

**Notes:** The exterior doors have some deterioration due to weather and should be refinished.

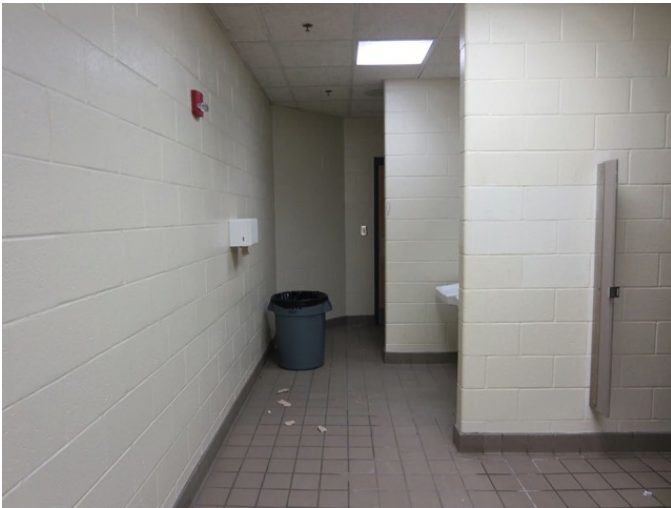
**System: C3010 - Wall Finishes - Paint**

**Location:** Throughout Building

**Distress:** Beyond Service Life

**Notes:** The painted wall finishes are beyond their expected service life, faded and stained, and should be replaced.

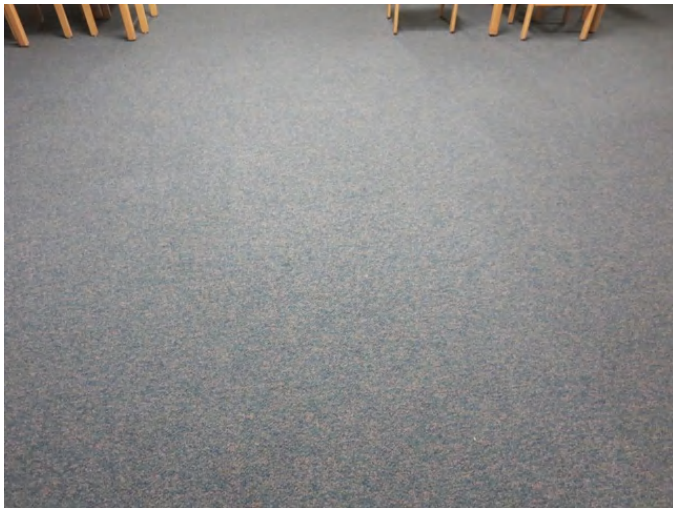
**System: C3020 - Floor Finishes - Carpet**

**Location:** Auditorium and Media Center

**Distress:** Beyond Service Life

**Notes:** The carpet in the media center, auditorium, and music classrooms is stained, showing signs of failure, and should be replaced.

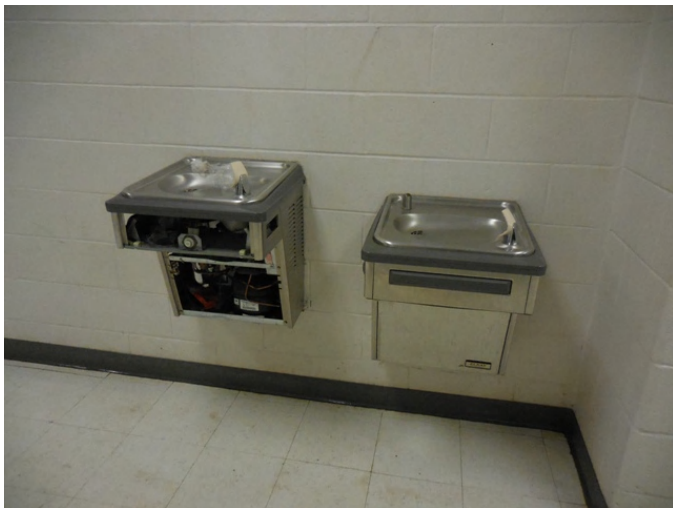
**System: D2010 - Plumbing Fixtures**

**Location:** Throughout Building

**Distress:** Damaged

**Notes:** Drinking fountains in the boys locker room, cafeteria area, 200 and 700 hallway restrooms are broken and need to be replaced.

**Correction:** Replace fountain drinking fountain

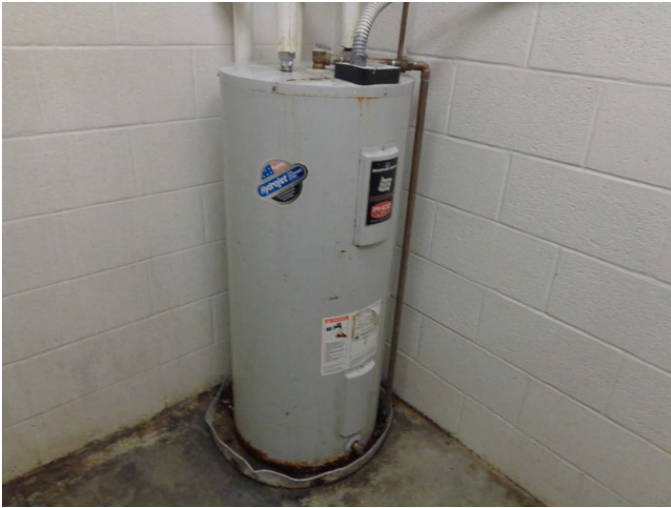
**System: D2020 - Domestic Water Distribution**

**Location:** Throughout Building

**Distress:** Damaged

**Notes:** Water heaters are rusted in the 700 hallway, 405 janitor closet, locker rooms and outdoor concession area, and should be scheduled for replacement before further damage.

**Correction:** Remove/replace domestic water heater, electric

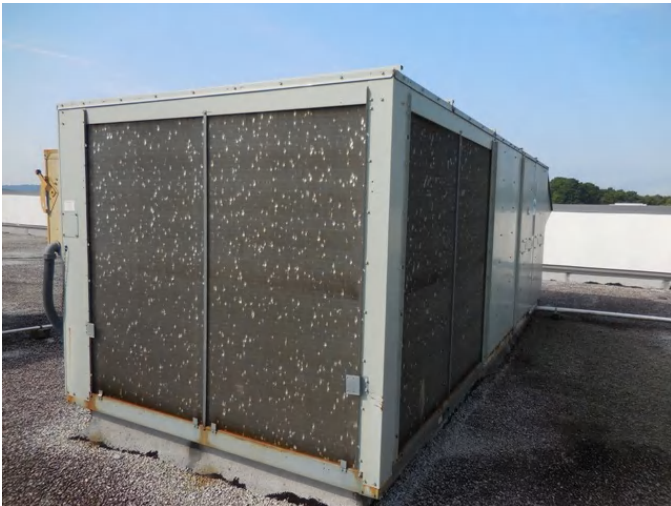
**System: D3050 - Terminal & Package Units**

**Location:** Roof

**Distress:** Damaged

**Notes:** School staff has reported numerous maintenance issues and breakdowns with roof top AC units. The RTUs are rusted and coils are damaged. Roof top, make up air, and energy recovery ventilators are nearing their end of service life and should be replaced.

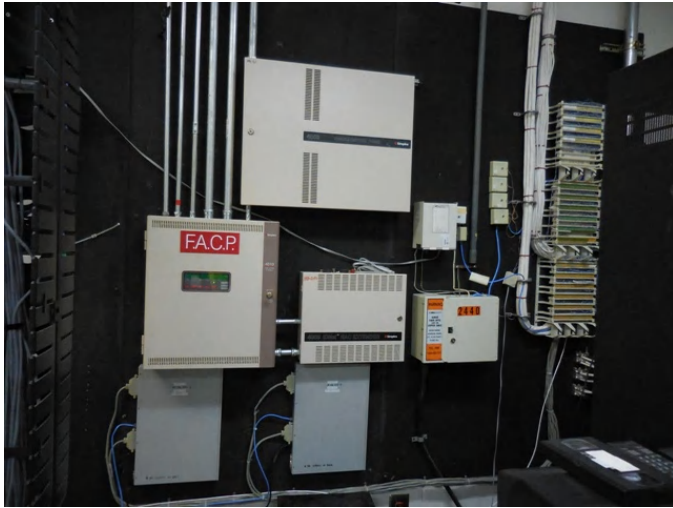
**System: D5030 - Communications and Security - Fire Alarm**

**Location:** Throughout Building

**Distress:** Needs Remediation

**Notes:** Staff reported several maintenance issues and outages associated with the fire alarm system. The system is nearing its end of its expected service life and should be scheduled for replacement.

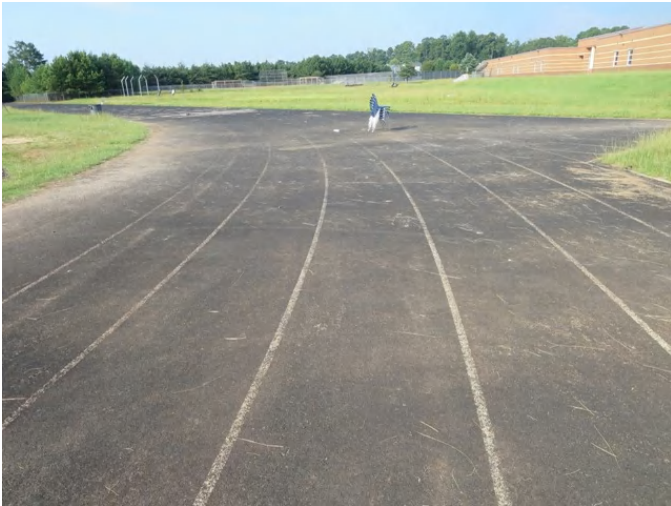
#### System: G2040 - Track

**Location:** Site

**Distress:** Beyond Service Life

**Notes:** The track is beyond its expected service life, deteriorating with loss of surface, and should be replaced.

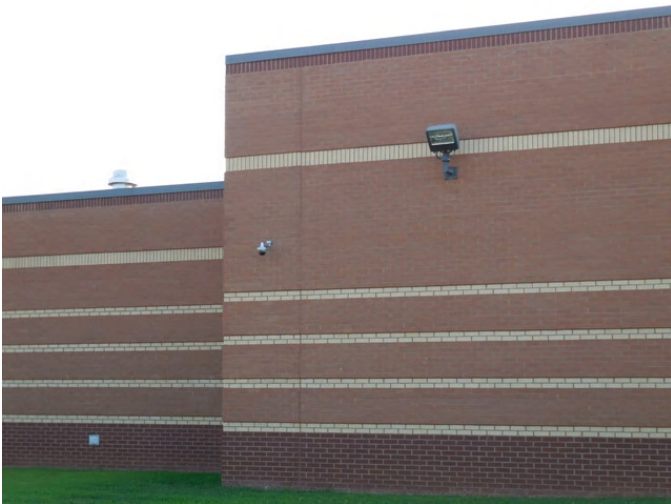
#### System: G4030 - Site Communications & Security

**Location:** Site

**Distress:** Inadequate

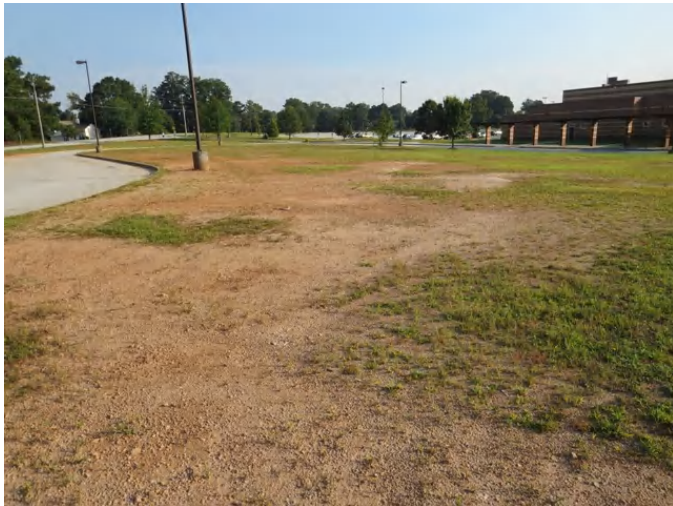
**System: G2050 - Landscaping**

**Location:** Site

**Distress:** Damaged
