Margaret Harris Comprehensive School

School Assessment Report

May 19, 2016

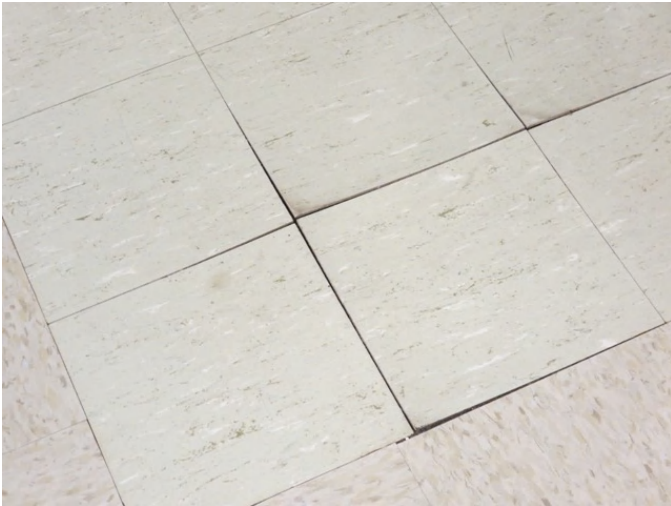
System: C3020 - Floor Finishes - VCT

Location: Computer Room

Distress: Damaged

Notes: The VCT flooring is separating from the substrate, causing a tripping hazard.

Correction: Replace VCT flooring

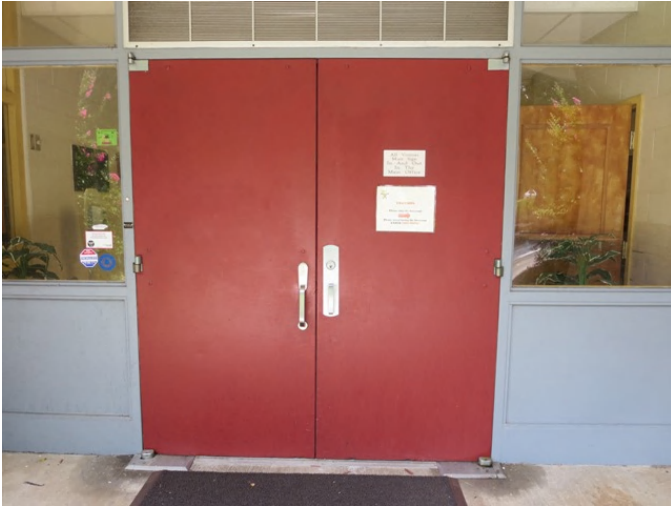
System: B2030 - Exterior Doors

Location: Throughout Building

Distress: Beyond Service Life

Notes: The original exterior doors are beyond their expected service life, not ADA compliant, not energy efficient, and should be scheduled for replacement. Building entrance should be provided with an automatic door opener and zero threshold for wheelchair access.

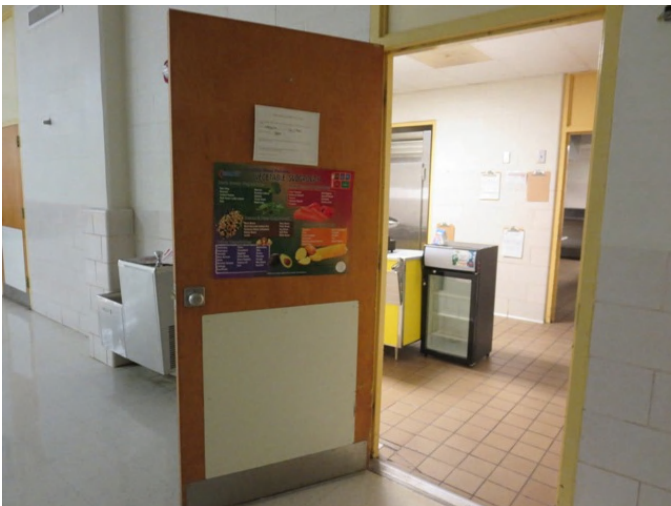
System: C1020 - Interior Doors

Location: Throughout Building

Distress: Inadequate

Notes: The interior doors are beyond their expected service life, (hardware is) not ADA compliant, and should be scheduled for replacement.

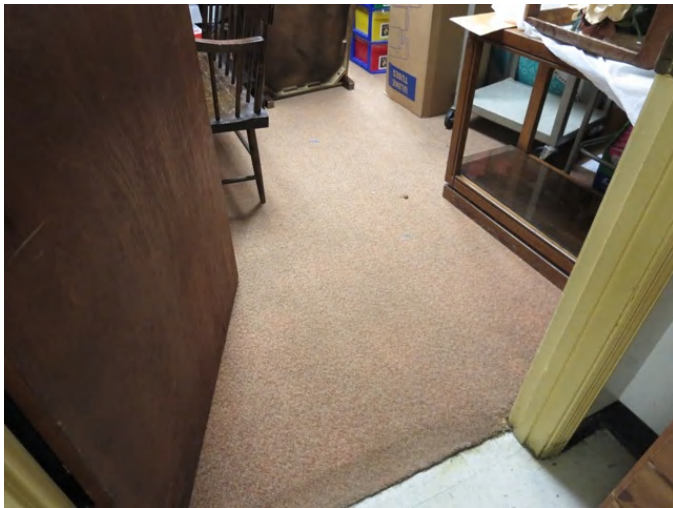
System: C3020 - Floor Finishes - Carpet

Location: Offices

Distress: Beyond Service Life

Notes: The carpet is beyond its expected service life, worn and dirty, and should be replaced.

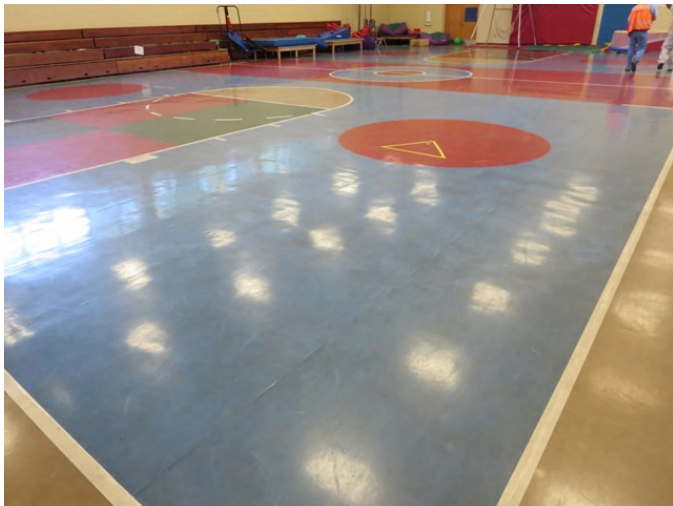
System: C3020 - Floor Finishes - Neoprene

Location: Gym

Distress: Beyond Service Life

Notes: The original flooring is in poor conditions, with different areas bubbling or separating from the substrate, and should be replaced.

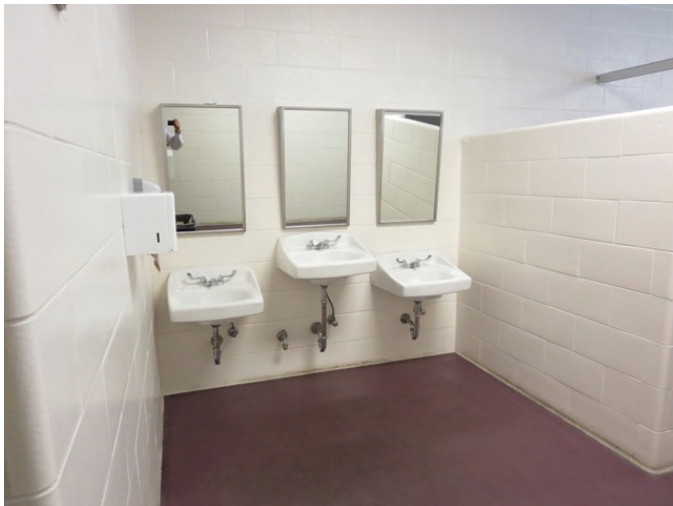
System: D2010 - Plumbing Fixtures

Location: Restrooms

Distress: Missing

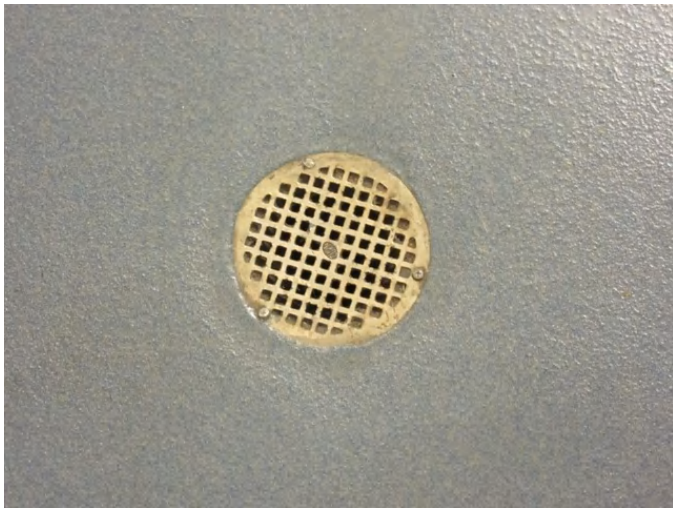
System: D2030 - Sanitary Waste

Location: Throughout Building

Distress: Beyond Service Life

Notes: The sanitary waste system is beyond its expected service life and should be scheduled for replacement.

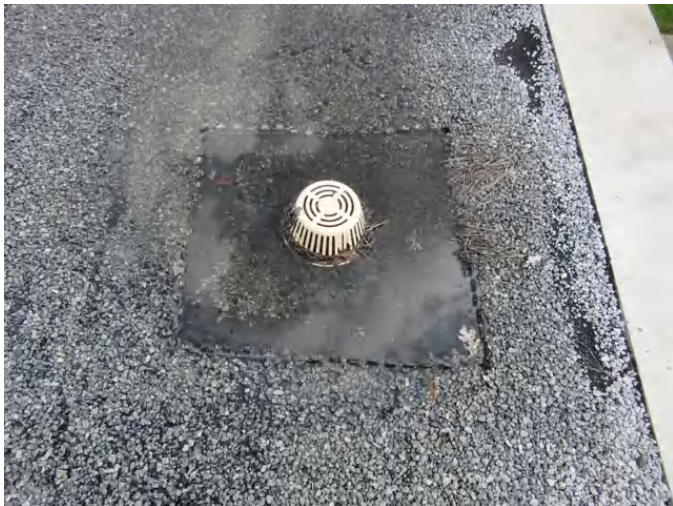
System: D2040 - Rain Water Drainage

Location: Roof

Distress: Beyond Service Life

Notes: The rain water drainage system is beyond its expected service life and should be scheduled for replacement.

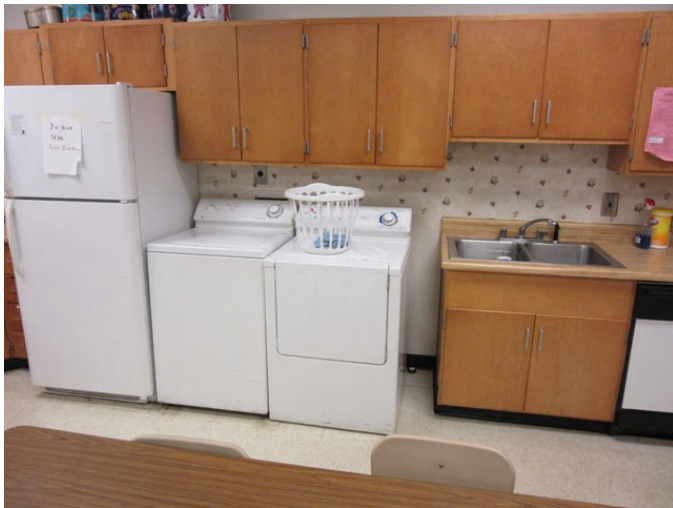
System: D5020 - Branch Wiring

Location: Home Economics and Special Ed.

Distress: Missing

Notes: GFCI outlets missing in wet areas.

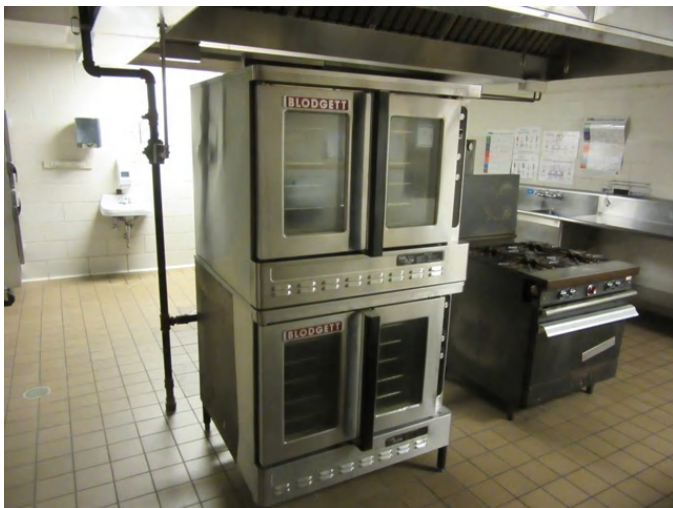
System: E1090 - Other Equipment - Kitchen Equipment

Location: Kitchen

Distress: Beyond Service Life

Notes: The kitchen equipment is beyond its expected service life and should be scheduled for replacement.

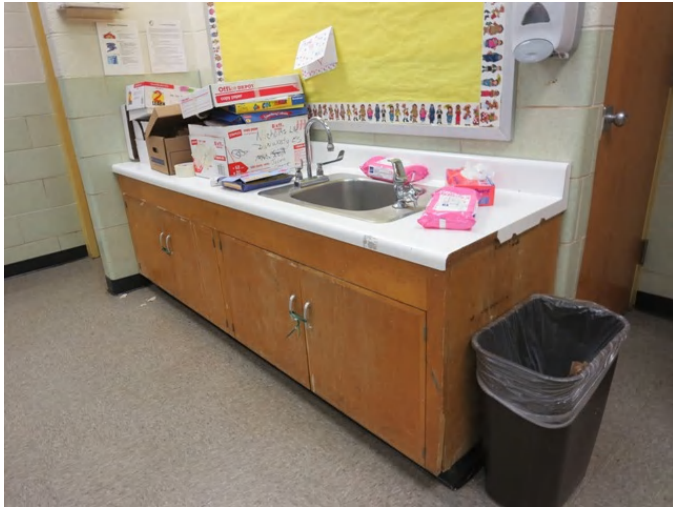
System: E2010 - Fixed Furnishings

Location: Throughout Building

Distress: Beyond Service Life

Notes: Fixed furnishings are beyond their expected service life, in marginal condition, and should be scheduled for replacement.

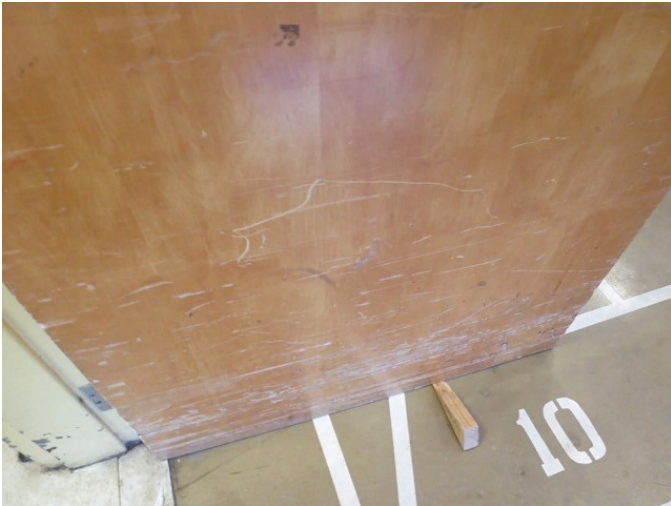
System: C1020 - Interior Doors

Location: Throughout Building

Distress: Beyond Service Life

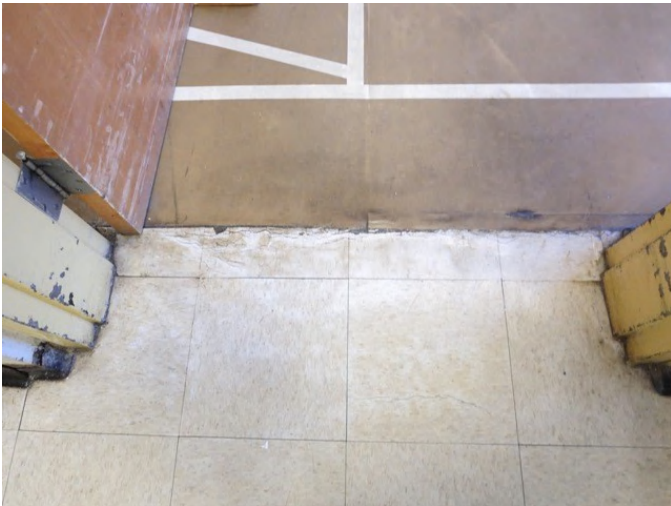
System: C3020 - Floor Finishes - VCT

Location: Throughout Building

Distress: Beyond Service Life

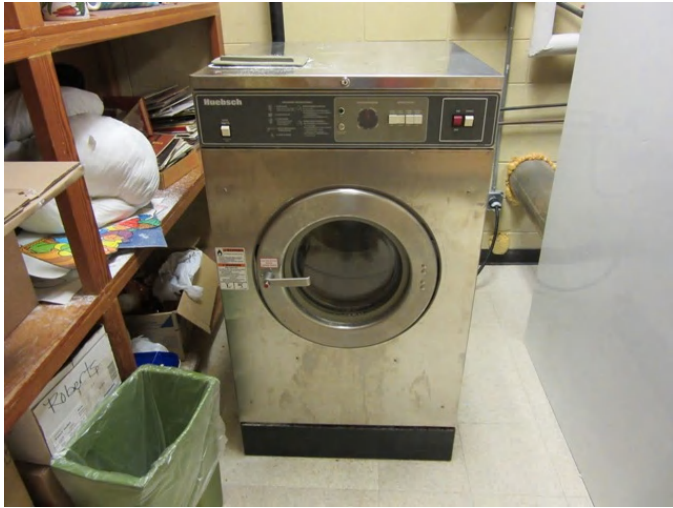
System: E1020 - Institutional Equipment (Laundry Equipment)

Location: Laundry Room

Notes: The washer and dryer are aged, in marginal condition, and should be replaced.

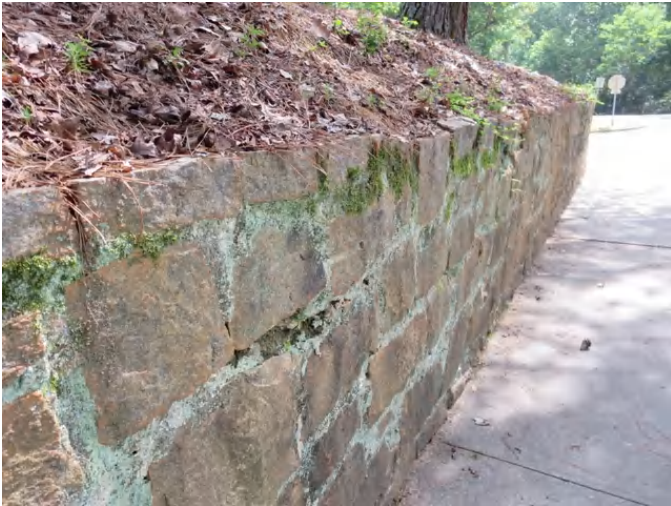
System: G2030 - Stone Retaining Wall

Location: Northeast Side of Site

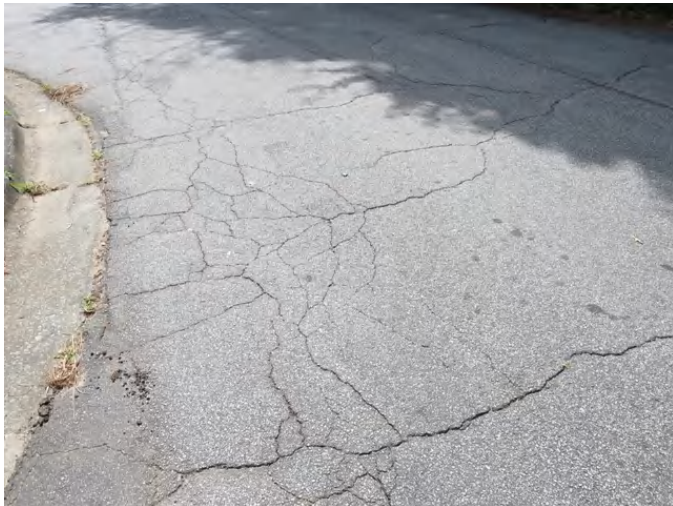
System: G2010 - Roadways

Location: Southeast Side of Site

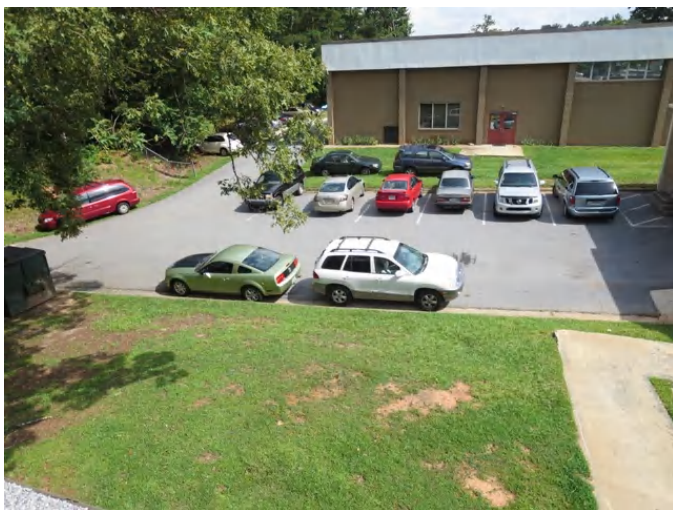
System: G2020 - Parking Lots

Location: Site

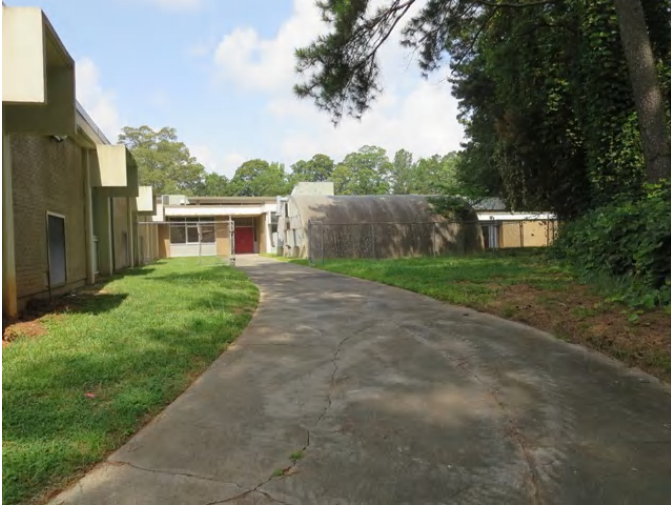
System: G2030 - Pedestrian Paving

Location: Site
Distress: Beyond Service Life
Category: Deferred Maintenance
Priority: 3 Priority
Correction: Renew System
Qty: 44,666.00
Unit of Measure: S.F.
Estimate: \$73,698.90
Assessor Name: Eduardo Lopez
Date Created: 07/16/2015

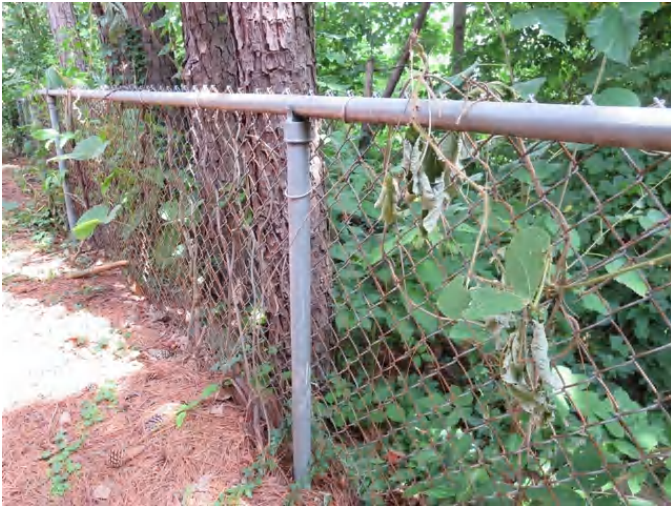
System: G2040 - Fencing & Guardrails

Location: Site
Distress: Beyond Service Life
Category: Deferred Maintenance
Priority: 3 Priority
Correction: Renew System
Qty: 44,666.00
Unit of Measure: S.F.
Estimate: \$44,710.67
Assessor Name: Eduardo Lopez
Date Created: 09/02/2015

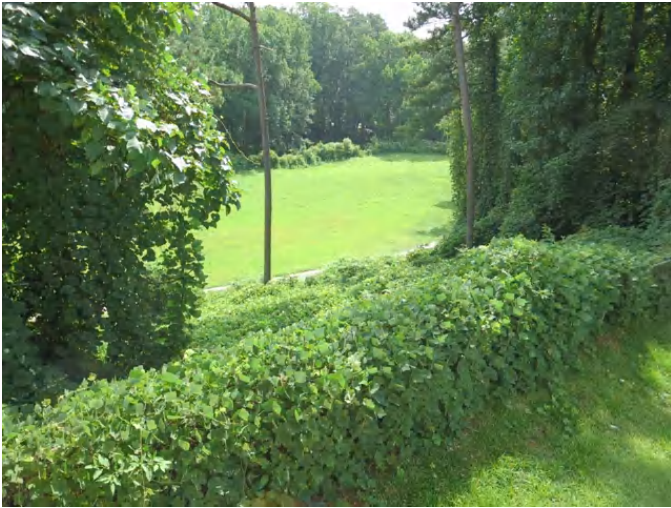
System: G2040 - Playing Field

Location: Site
Distress: Beyond Service Life
Category: Deferred Maintenance
Priority: 3 Priority
Correction: Renew System
Qty: 63,730.00
Unit of Measure: S.F.
Estimate: \$274,803.76
Assessor Name: Eduardo Lopez
Date Created: 09/08/2015

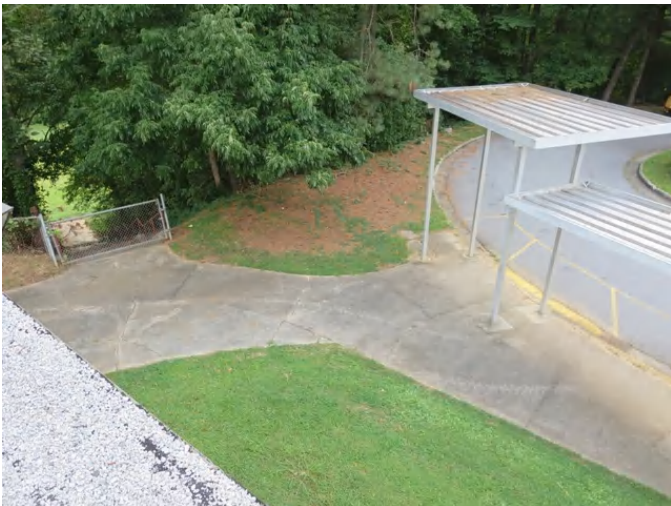
System: G2050 - Landscaping

Location: Site
Distress: Beyond Service Life
Category: Deferred Maintenance
Priority: 3 Priority
Correction: Renew System
Qty: 44,666.00
Unit of Measure: S.F.
Estimate: \$71,242.27
Assessor Name: Eduardo Lopez
Date Created: 07/16/2015

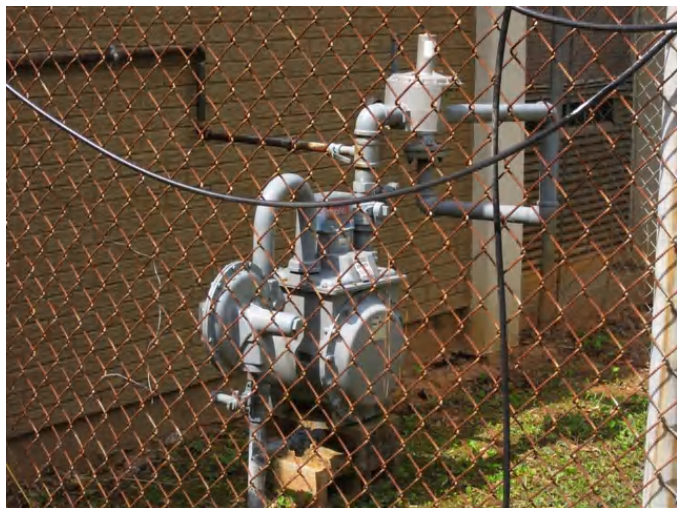
System: G3060 - Fuel Distribution

Location: Site

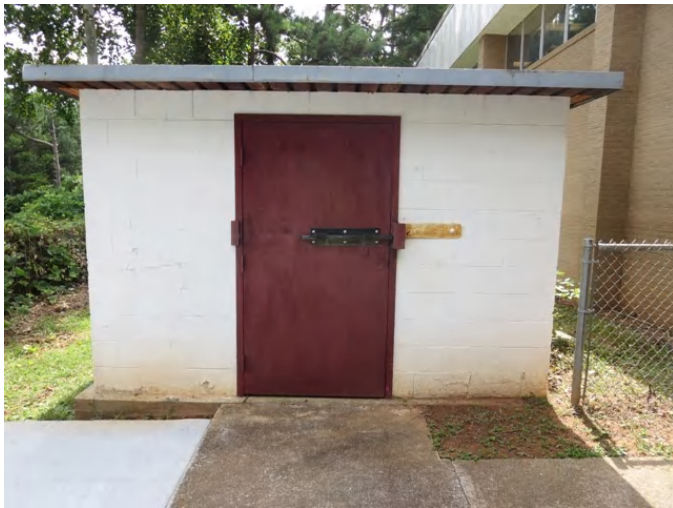
System: B2030 - Exterior Doors

Location: Exterior Wall

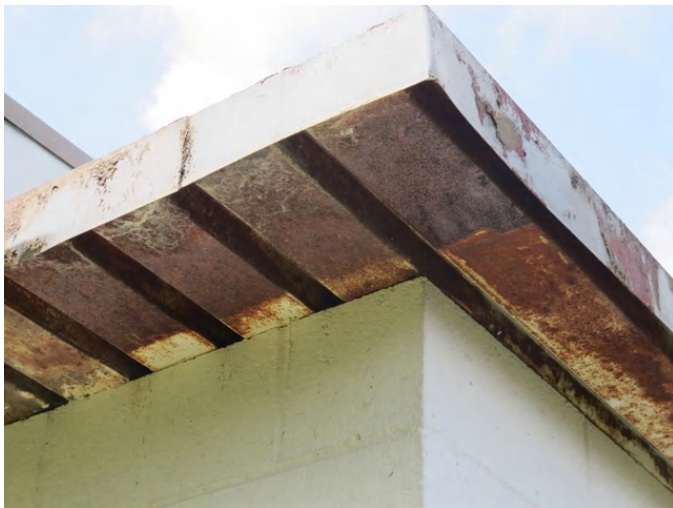
System: B3010 - Roof Coverings

Location: Roof

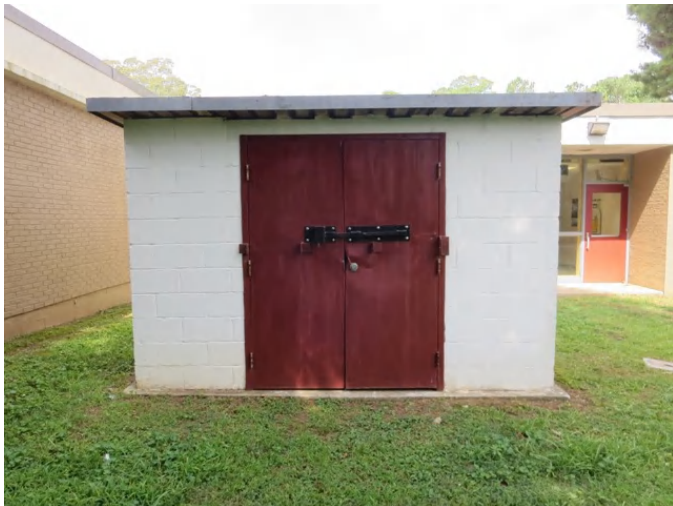
System: B2030 - Exterior Doors

Location: Exterior Wall

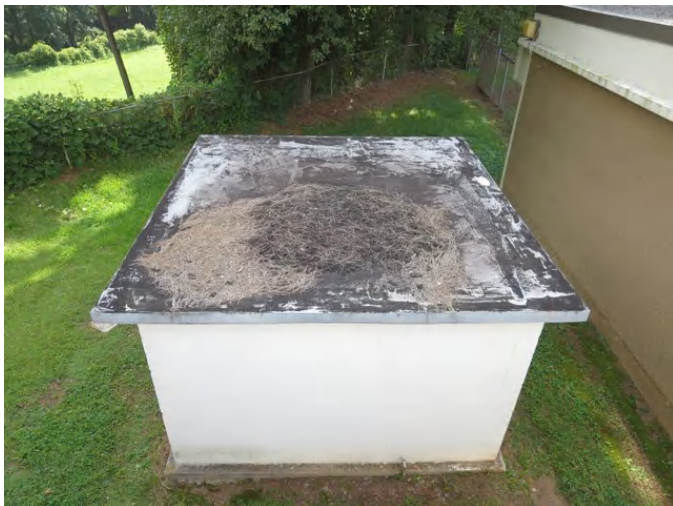
System: B3010 - Roof Coverings

Location: Roof
