DeKalb County School District/Middle Schools

Mary McLeod Bethune Middle

Final
School Assessment Report

May 20, 2016

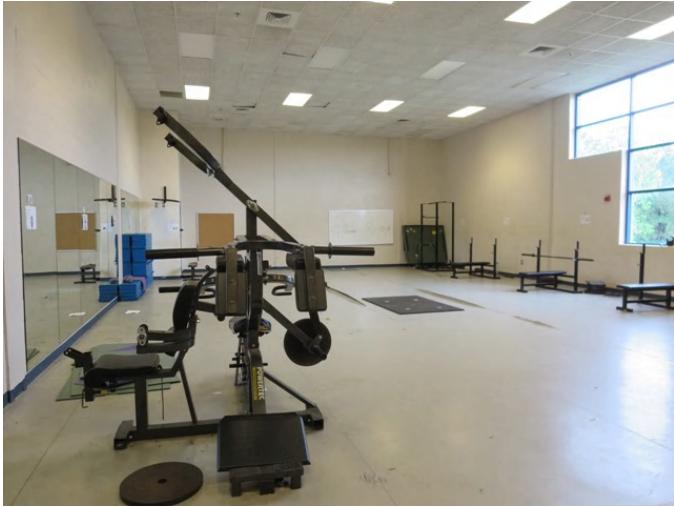
System: C3020 - Floor Finishes - VCT

Location: Weight Room

Distress: Damaged

Notes: The flooring cover in the weight room is in poor condition and a potential tripping hazard, and should be replaced.

Correction: Replace vinyl sheet flooring

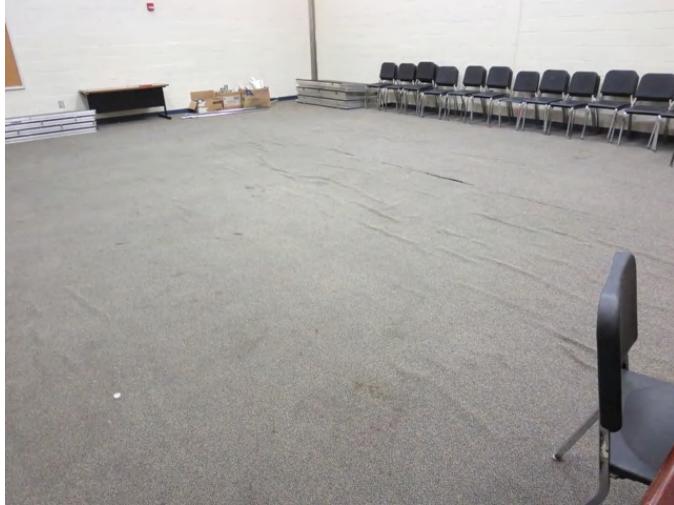
System: C3020 - Floor Finishes - Carpet

Location: Offices, Media Center, and Music

Distress: Damaged

Notes: The carpet is beyond its expected service life, stained, and a trip hazard, and should be replaced.

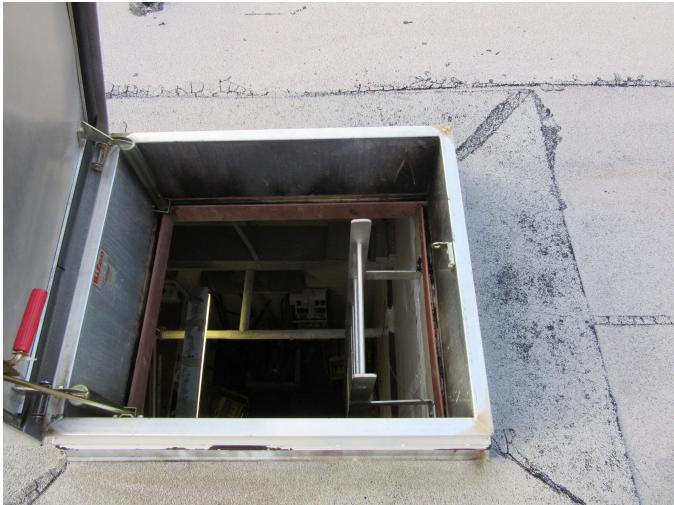
System: B3020 - Roof Openings

Location: Roof

Distress: Needs Remediation

Notes: The roof hatch/opening does not provide sufficient means of egress or entry and should be addressed to meet current building code.

Correction: Replace roof hatch and structure single unit

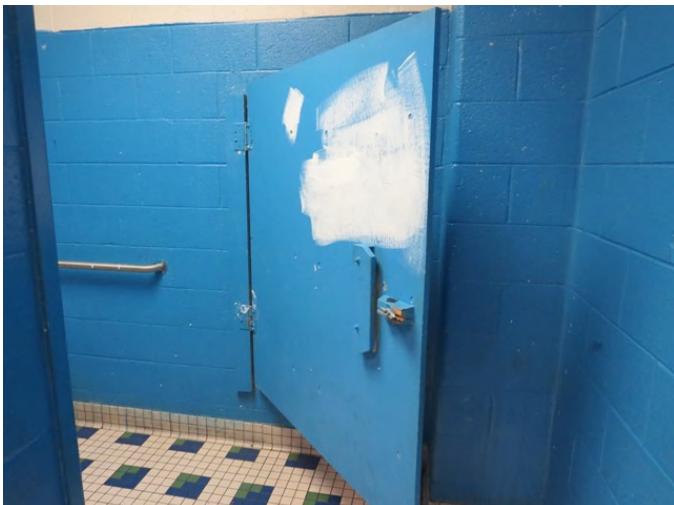
System: C1030 - Fittings

Location: Throughout Building

Distress: Beyond Service Life

Notes: Fittings, such as toilet partitions and accessories, handrails and signage, are damaged and failing, not ADA compliant, and should be replaced. Accessible showers are missing a fold out seat.

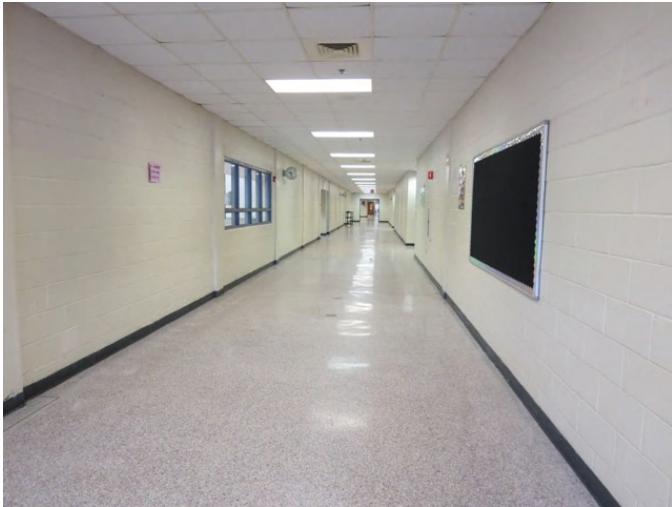
System: C3010 - Wall Finishes - Paint

Location: Throughout Building

Distress: Beyond Service Life

Notes: The painted wall finishes are beyond their expected service life and should be scheduled for replacement.

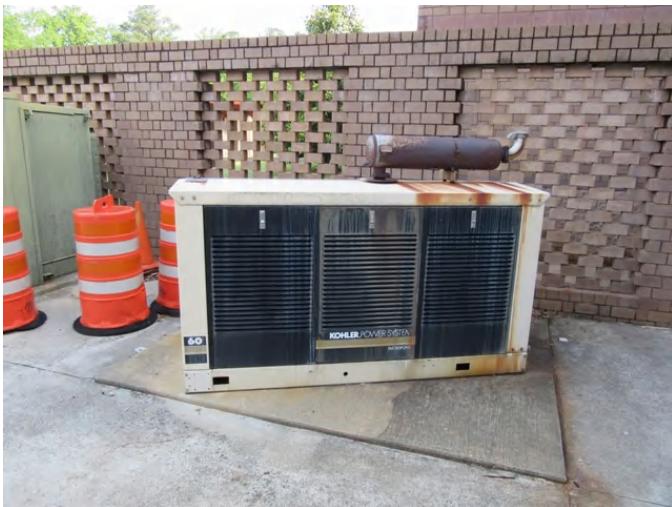
System: D5090 - Other Electrical Systems - Emergency Generator

Location: West Side of Site

Distress: Inadequate

Notes: The emergency generator is scheduled for replacement under SPLOST project 421-321-015F.

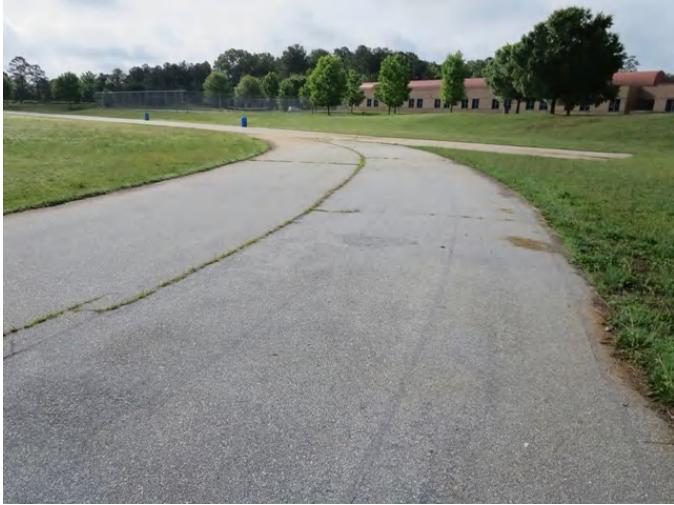
System: G2040 - Track

Location: Site

Distress: Beyond Service Life

Notes: The track is beyond its expected service life, is beginning to deteriorate, and should be scheduled for replacement.

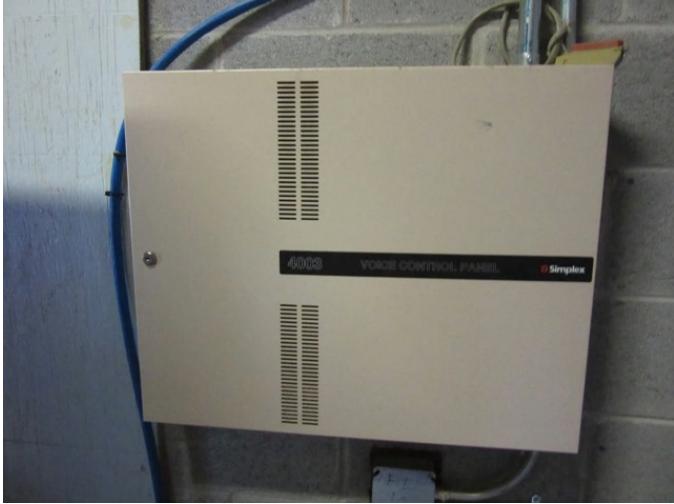
System: G4030 - Site Communications & Security

Location: Site

Distress: Beyond Service Life

Notes: The site communication and security system is beyond its expected service life and should be scheduled for replacement.
