McLendon Elementary

School Assessment Report

May 19, 2016

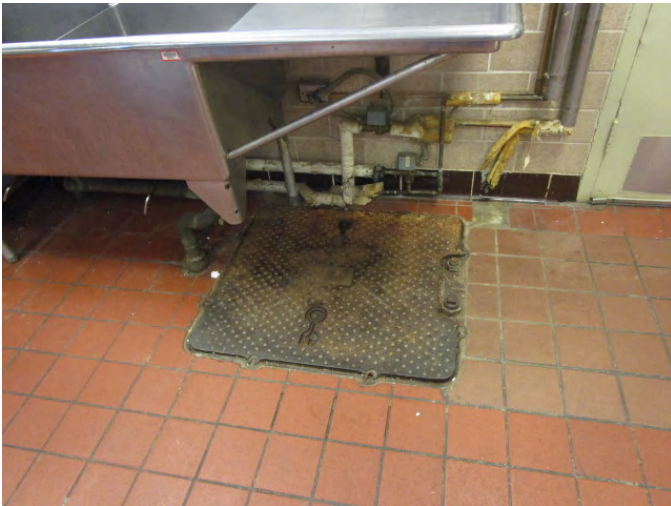
System: D2030 - Sanitary Waste

Location: Throughout Building

Distress: Beyond Service Life

Notes: The sanitary waste system is beyond its expected service life, possibly a source of odors in the building, and should be replaced. SPLOST project 420-422 to replace grease trap and backflow preventer.

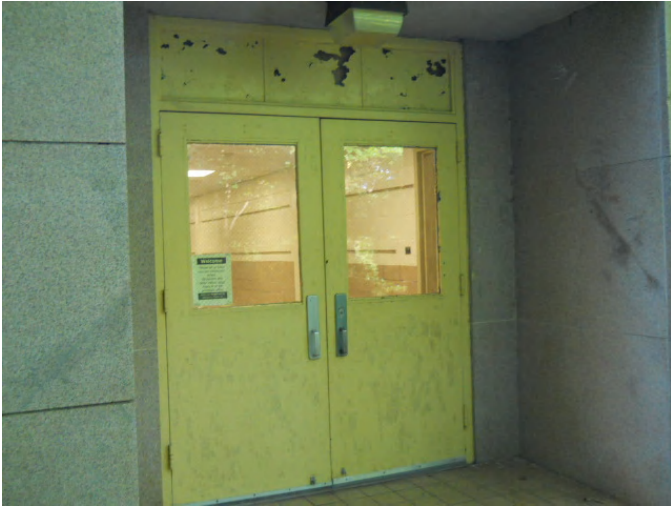
System: B2030 - Exterior Doors

Location: Throughout Building

Distress: Beyond Service Life

Notes: The original exterior doors are beyond their expected service life, rusted and damaged, not ADA compliant, and should be replaced.

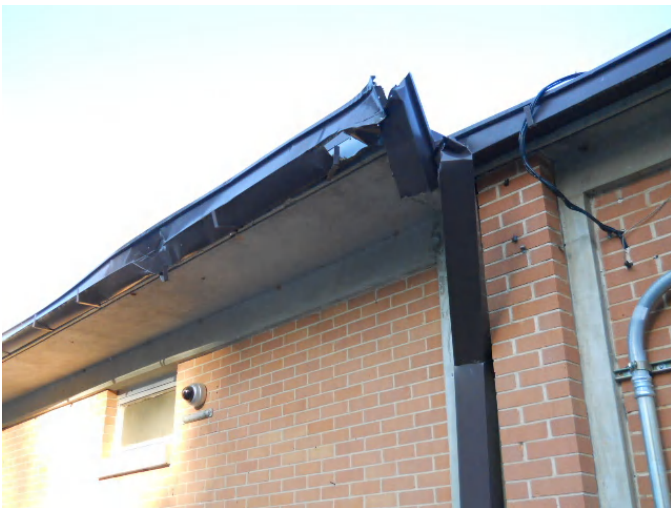
System: B3010 - Roof Coverings - BUR

Location: East Exterior Wall

Distress: Damaged

Notes: The gutter and downspout are damaged and not functional, and need to be repaired/replaced.

Correction: Replace Gutters and downspouts

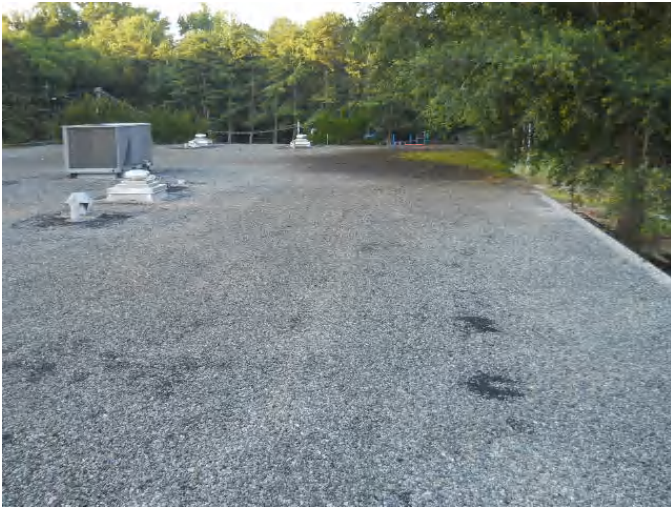
System: B3020 - Roof Openings

Location: Roof
Distress: Missing
Category: Safety
Priority: 3 Priority
Correction: Renew System
Qty: 53,365.00
Unit of Measure: S.F.
Estimate: \$30,525.00
Assessor Name: Ben Nixon
Date Created: 06/23/2015

Notes: There is no safe roof access for maintenance personnel. Recommend installation of an OSHA-compliant roof hatch/ladder system for safe access.

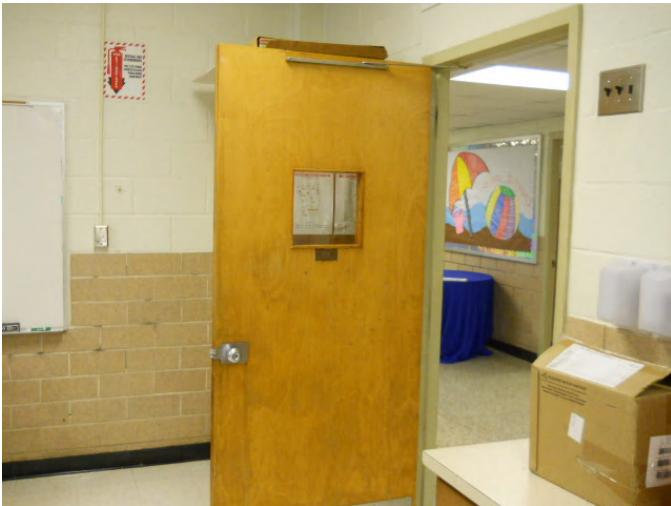
System: C1020 - Interior Doors

Location: Throughout Building
Distress: Beyond Service Life
Category: Deferred Maintenance / Accessibility Code Compliance
Priority: 3 Priority
Correction: Renew System
Qty: 53,365.00
Unit of Measure: S.F.
Estimate: \$102,034.00
Assessor Name: Ben Nixon
Date Created: 04/11/2015

Notes: Interior doors are beyond their expected service life, worn, not ADA compliant, and should be replaced.

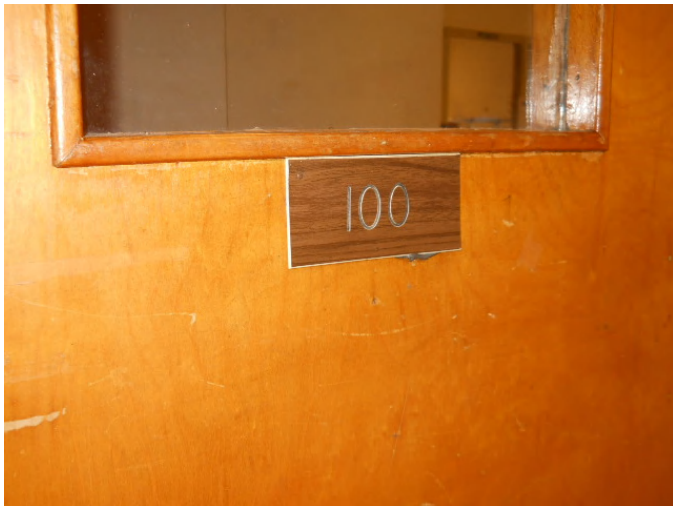
System: C1030 - Fittings

Location: Throughout Building

Distress: Inadequate

Notes: The signage throughout the building is inadequate, not ADA compliant, and should be replaced.

Correction: Remove and replace the signage w/ADA compliant signage.

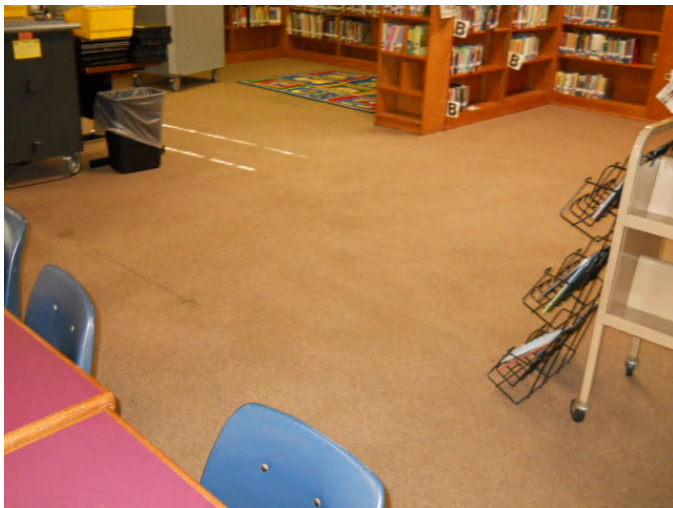
System: C3020 - Floor Finishes - Carpet

Location: Media Center, Offices

Distress: Beyond Service Life

Notes: The carpet is aged, stained and worn, and should be replaced.

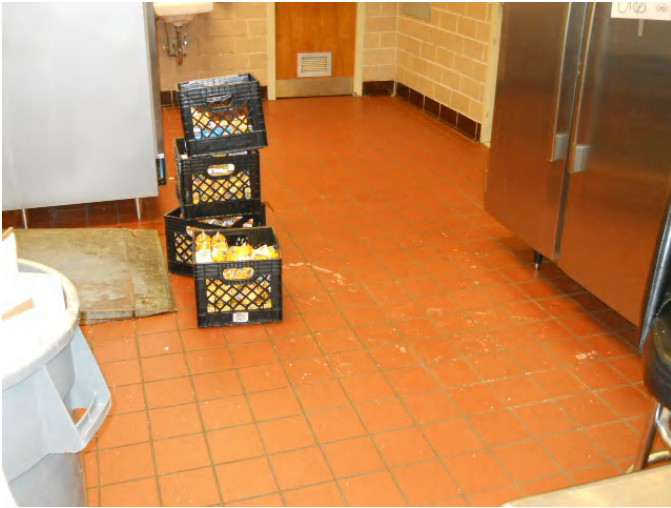
System: C3020 - Floor Finishes - Ceramic & Quarry Tile

Location: Kitchen and Restrooms

Distress: Beyond Service Life

Notes: The tile floor covering is beyond its expected service life and should be replaced.

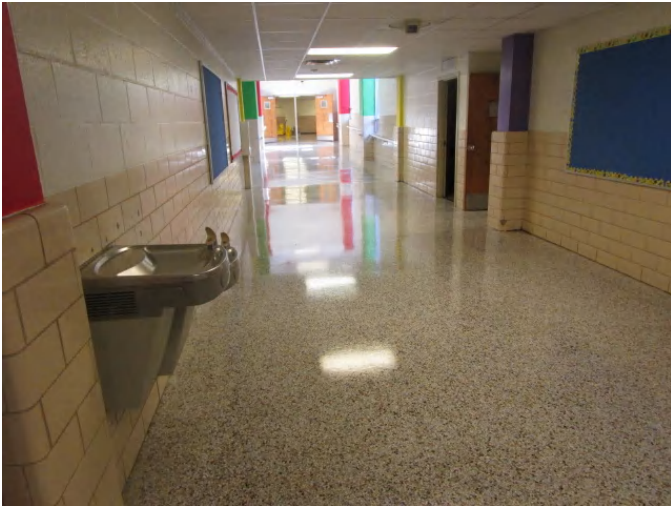
System: D2010 - Plumbing Fixtures

Location: Hallways

Distress: Needs Remediation

Correction: Remove/replace drinking fountain w/recessed ADA compliant drinking fountain

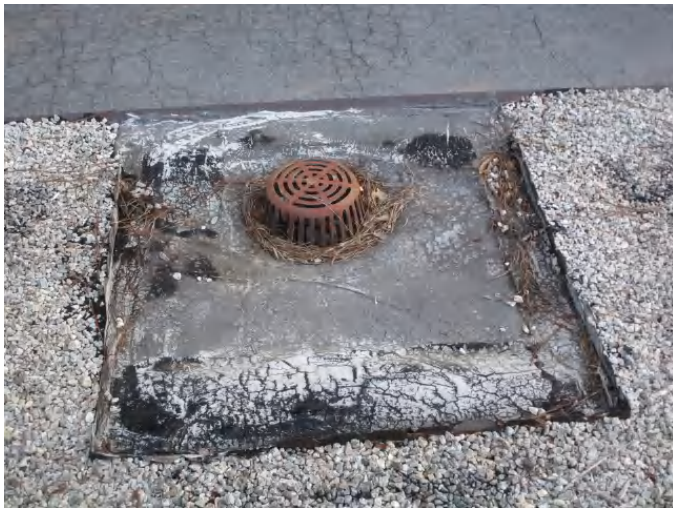
System: D2040 - Rain Water Drainage

Location: Throughout Building

Distress: Beyond Service Life

Notes: The rainwater drainage system is beyond its expected service life and should be scheduled for replacement. The drains have tar in them that cause water to backup on the roof.

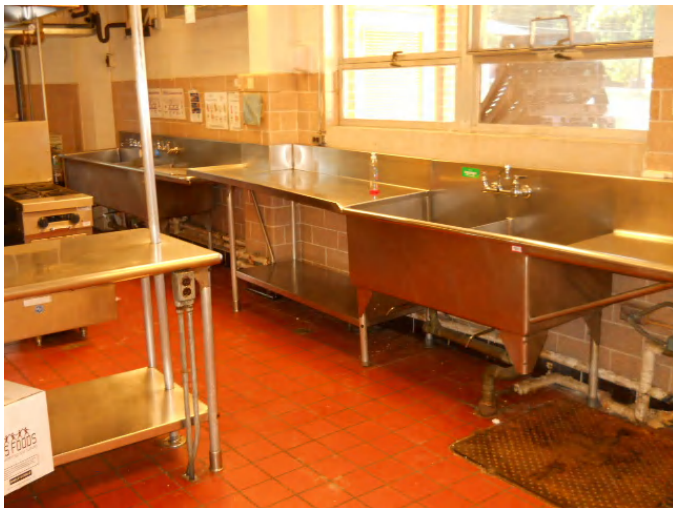
System: F1090 - Other Equipment (Kitchen Equipment)

Location: Kitchen

Distress: Beyond Service Life

Notes: Kitchen equipment is beyond its expected service life and should be scheduled for replacement.

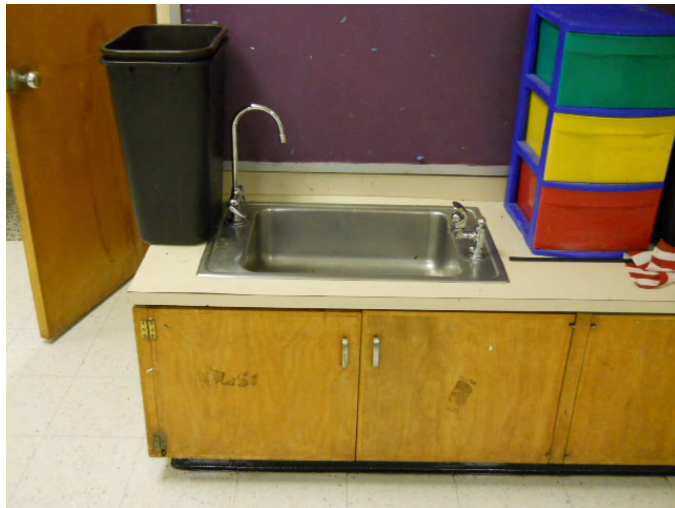
System: E2010 - Fixed Furnishings

Location: Throughout Building

Distress: Beyond Service Life

Notes: Fixed furnishings, such as built-in cabinets and window treatment, are beyond their expected service life, damaged and worn, and should be replaced.

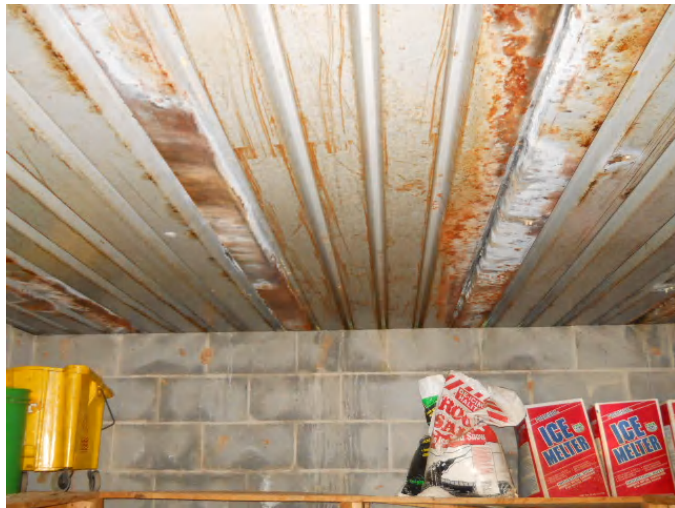
System: B1020 - Roof Construction

Location: Roof

Distress: Damaged

Correction: Replace steel decking

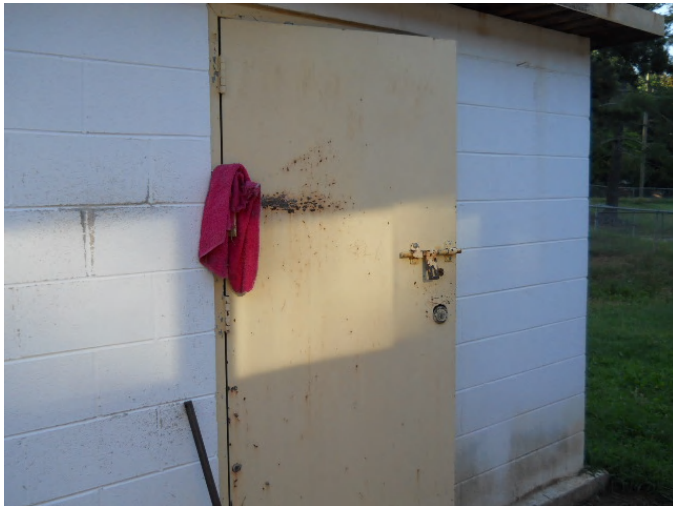
System: B2030 - Exterior Doors

Location: Exterior Wall
Distress: Beyond Service Life
Category: Deferred Maintenance
Priority: 3 Priority
Correction: Renew System
Qty: 120.00
Unit of Measure: S.F.
Estimate: \$681.00
Assessor Name: Dave Cunningham
Date Created: 04/11/2015

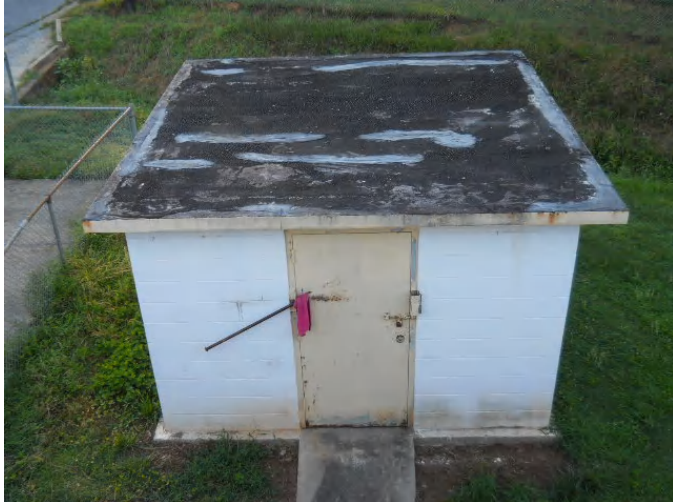
System: B3010 - Roof Coverings

Location: Roof
Distress: Beyond Service Life
Category: Deferred Maintenance
Priority: 3 Priority
Correction: Renew System
Qty: 120.00
Unit of Measure: S.F.
Estimate: \$2,216.00
Assessor Name: Dave Cunningham
Date Created: 04/11/2015

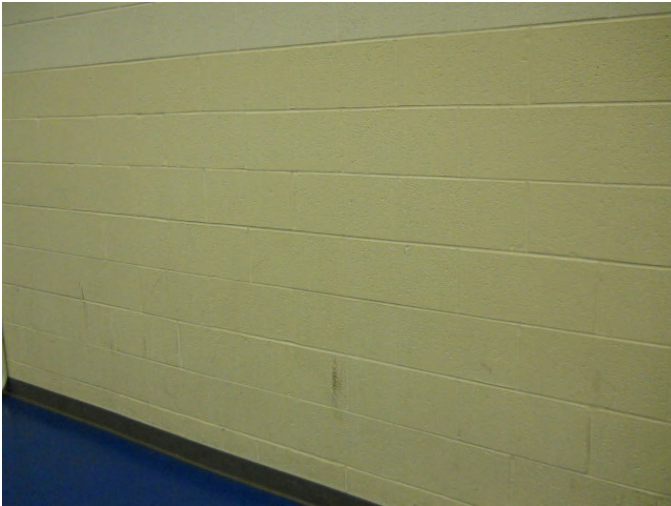
System: C3010 - Wall Finishes - Paint

Location: Throughout Building

Distress: Beyond Service Life

Notes: The painted wall finishes are beyond their expected service life and should be replaced.

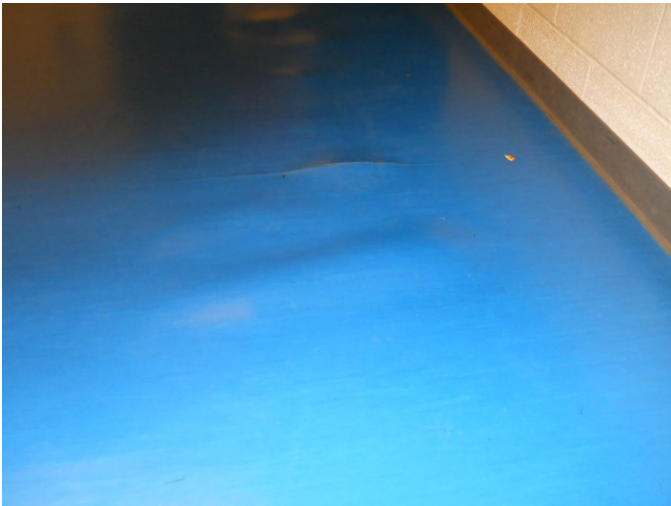
System: C3020 - Floor Finishes - Neoprene

Location: Basketball Court

Distress: Beyond Service Life

Notes: The gym floor covering is beyond expected service life, torn and has some delamination, and should be replaced.

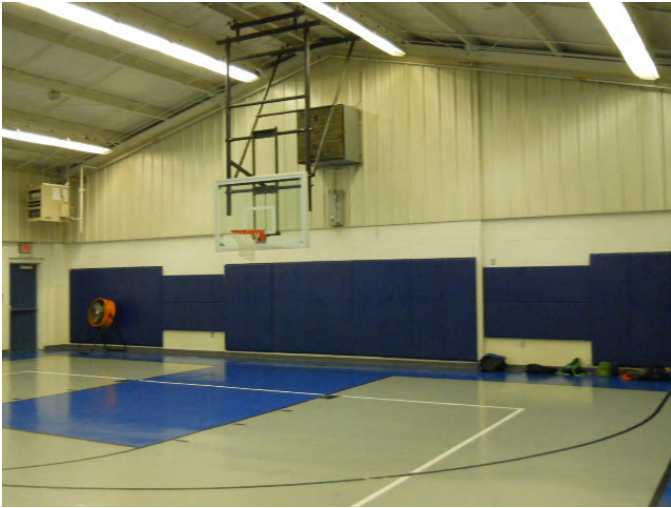
System: D3050 - Terminal & Package Units

Location: Throughout Building

Distress: Inadequate

Notes: The primary heating and cooling system consists of gas fire units heater, ventilation fans, and single PTAC unit in the office, which are inadequate and nearing the end of their expected life. These units should be replaced with a packaged system. SPLOST project 420-422 to install a 20 ton HVAC package in the gym.

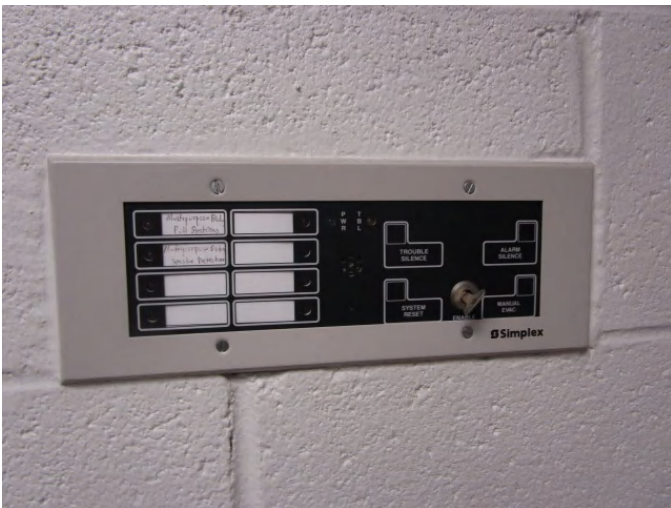
System: D5030 - Communications and Security - Fire Alarm

Location: Throughout Building

Distress: Beyond Service Life

Notes: The fire alarm system is beyond its expected service life and should be scheduled for replacement.

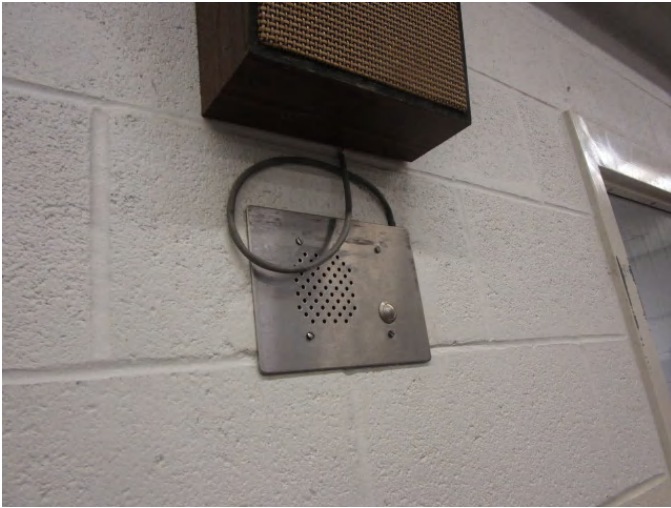
System: D5030 - Communications and Security - Public Address & Clock System

Location: Throughout Building

Distress: Beyond Service Life

Notes: The public address and clock system is beyond its expected service life and should be scheduled for replacement.

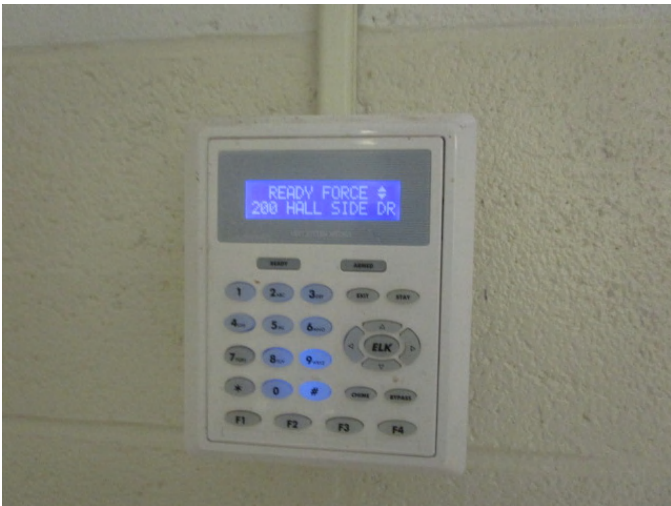
System: D5030 - Communications and Security - Security & CCTV

Location: Throughout Building

Distress: Beyond Service Life

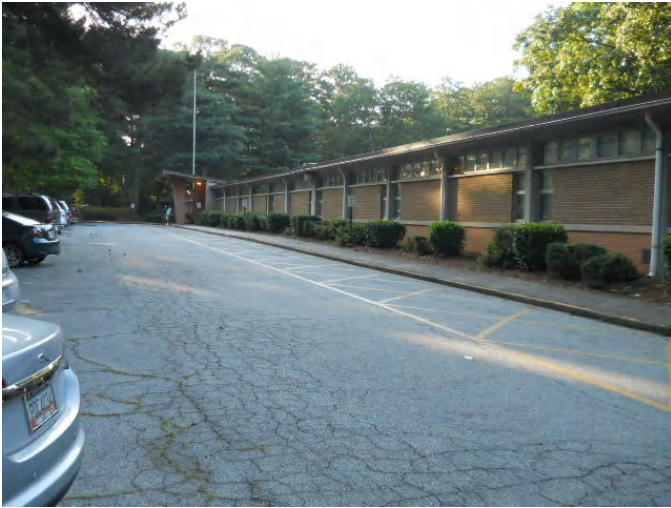
System: G2010 - Roadways

Distress: Beyond Service Life

Notes: Roadways are beyond their expected service life, damaged with cracks, worn, and should be replaced.

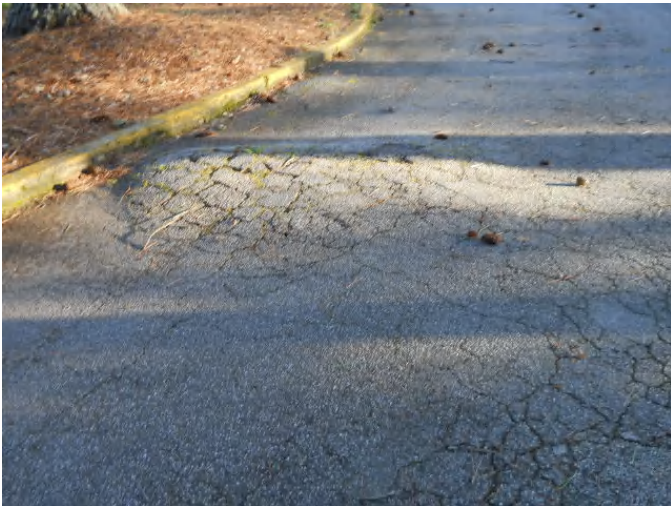
System: G2020 - Parking Lots

Distress: Beyond Service Life

Notes: The parking lots are beyond their expected service life, worn, inadequate, not ADA compliant, and should be replaced. An unpaved area is used for parking because the parking lot is not adequately sized. Directional signage from the accessible parking to the accessible building entrance is missing.

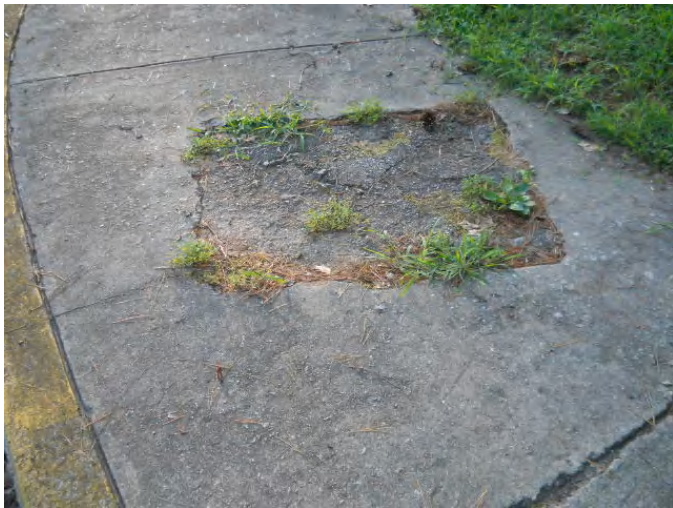
System: G2030 - Pedestrian Paving

Distress: Beyond Service Life

Notes: Pedestrian paving is beyond its expected service life, damaged, not ADA compliant, and should be replaced.

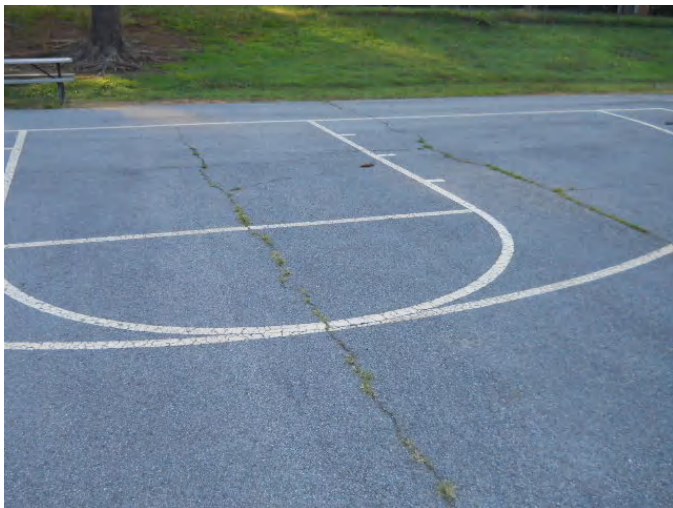
System: G2040 - Hard Surface Play Area

Distress: Beyond Service Life

Notes: The hard surface play area is beyond its expected service life, damaged with cracks, and should be replaced.

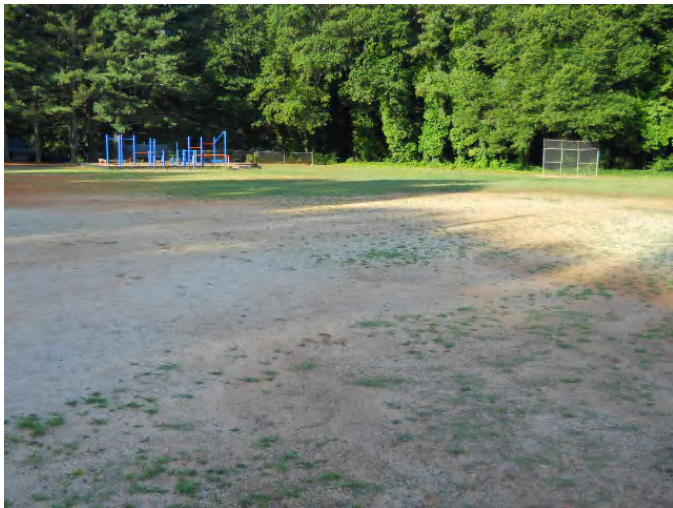
System: G2040 - Playing Field

Location: Site
Distress: Beyond Service Life
Category: Deferred Maintenance
Priority: 3 Priority
Correction: Renew System
Qty: 57,411.00
Unit of Measure: S.F.
Estimate: \$247,556.23
Assessor Name: Eduardo Lopez
Date Created: 07/31/2015

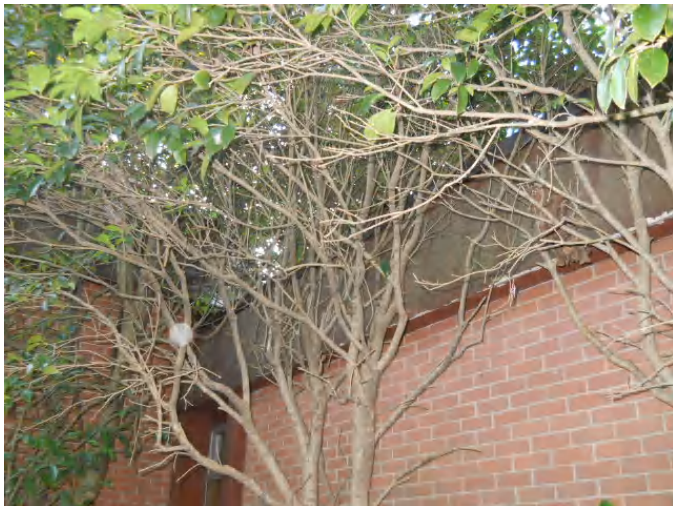
System: G2050 - Landscaping

Location: Site
Distress: Beyond Service Life
Category: Deferred Maintenance
Priority: 3 Priority
Correction: Renew System
Qty: 58,963.00
Unit of Measure: S.F.
Estimate: \$94,045.99
Assessor Name: Eduardo Lopez
Date Created: 06/23/2015

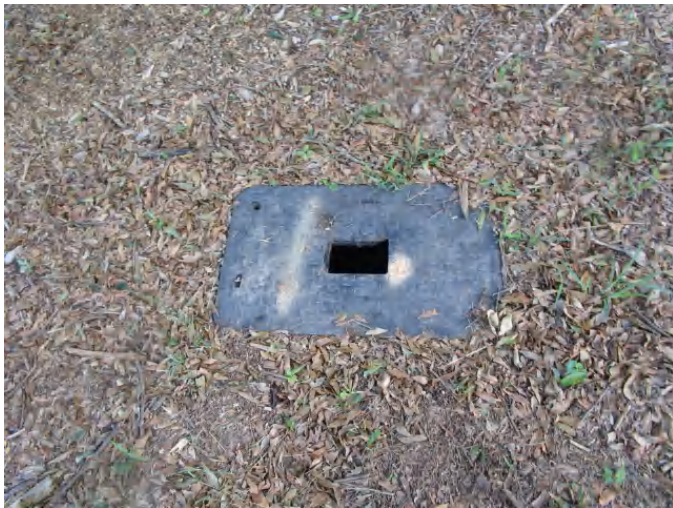
System: G3010 - Water Supply

Distress: Beyond Service Life

Notes: The site water supply system is beyond its expected service life and should be scheduled for replacement.

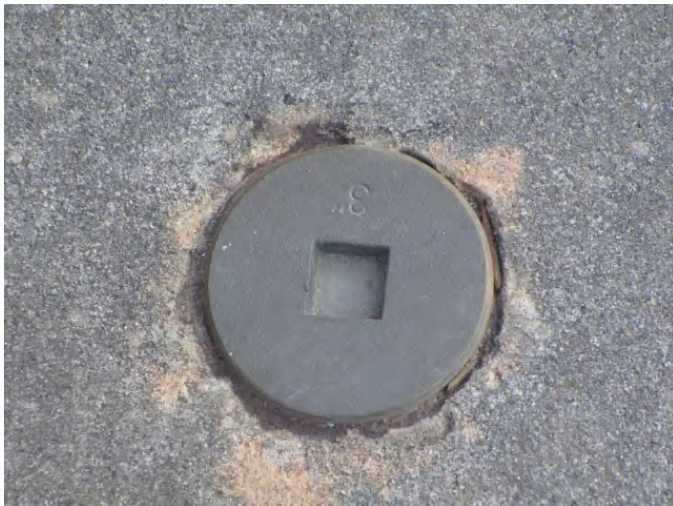
System: G3020 - Sanitary Sewer

Distress: Beyond Service Life

Notes: The site sanitary sewer system is beyond its expected service life and should be scheduled for replacement.

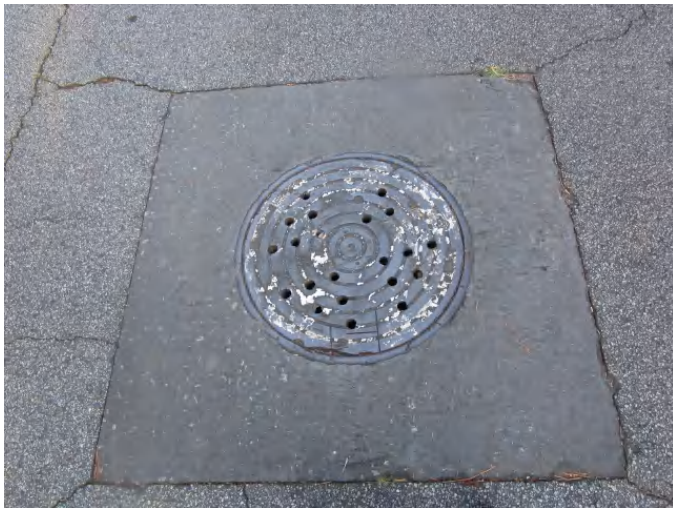
System: G3030 - Storm Sewer

Distress: Beyond Service Life

Notes: The site storm sewer system is beyond its expected service life and should be scheduled for replacement.

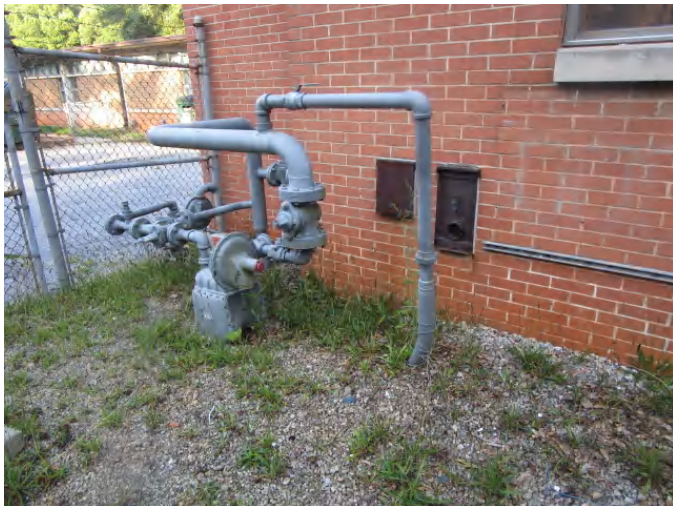
System: G3060 - Fuel Distribution

Distress: Beyond Service Life

Notes: The site fuel distribution system is beyond its expected service life and should be scheduled for replacement.

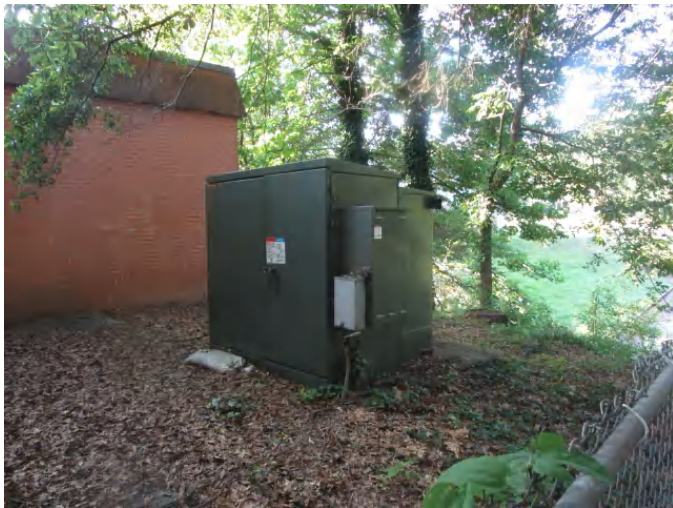
System: G4010 - Electrical Distribution

Location: Site
Distress: Beyond Service Life
Category: Deferred Maintenance
Priority: 3 Priority
Correction: Renew System
Qty: 58,963.00
Unit of Measure: S.F.
Estimate: \$120,638.30
Assessor Name: Eduardo Lopez
Date Created: 06/23/2015

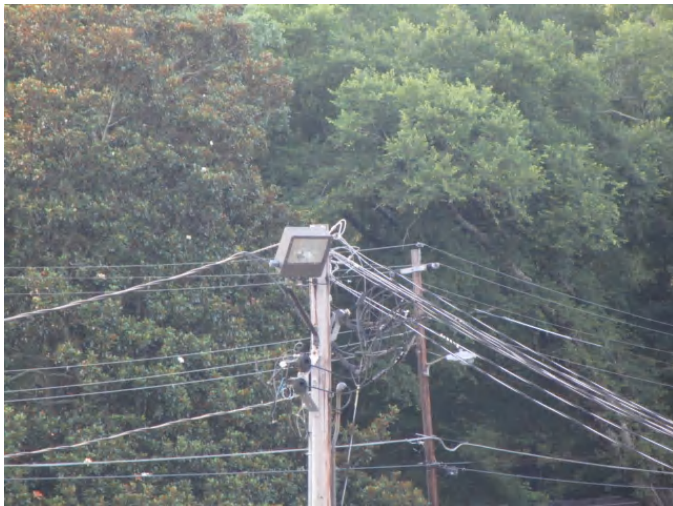
System: G4020 - Site Lighting

Location: Site
Distress: Beyond Service Life
Category: Deferred Maintenance
Priority: 3 Priority
Correction: Renew System
Qty: 58,963.00
Unit of Measure: S.F.
Estimate: \$74,588.20
Assessor Name: Eduardo Lopez
Date Created: 06/23/2015

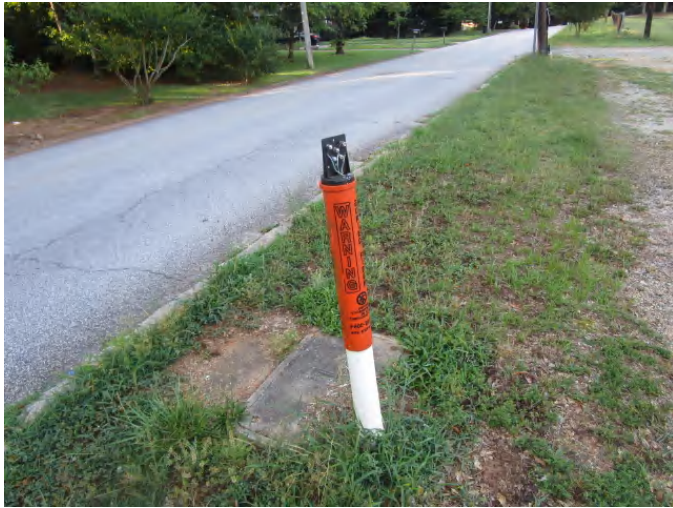
System: G4030 - Site Communications & Security

Distress: Beyond Service Life

Notes: The site communications and security systems are beyond their expected service life and should be scheduled for replacement.
