DeKalb County School District/Elementary Schools

Midway Elementary

School Assessment Report

May 19, 2016

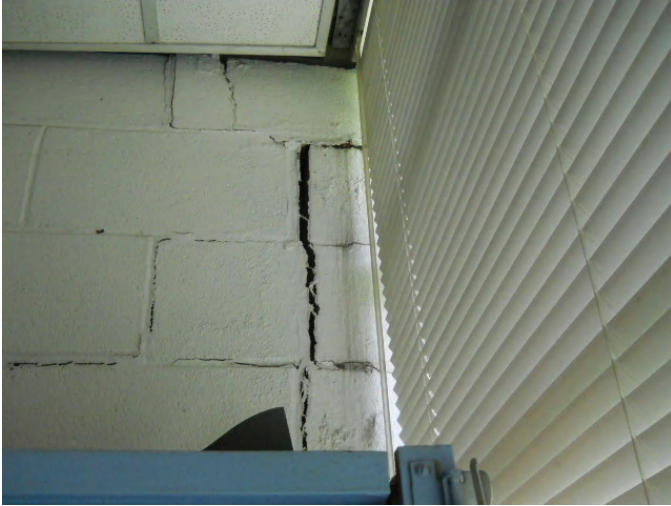
System: B2010 - Exterior Walls

Location: Media Center Exterior Wall

Distress: Damaged

Notes: There is a large settlement crack in the exterior wall, SW corner of the media center. Recommend engineering study to identify the cause. Pricing does not include remediation measures.

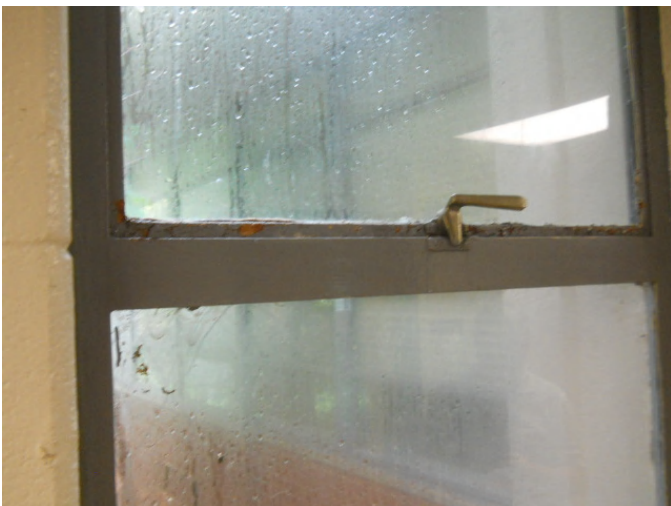
System: B2020 - Exterior Windows

Location: Throughout Building

Distress: Beyond Service Life

Notes: The exterior window systems are original construction, beyond service life, and should be replaced.

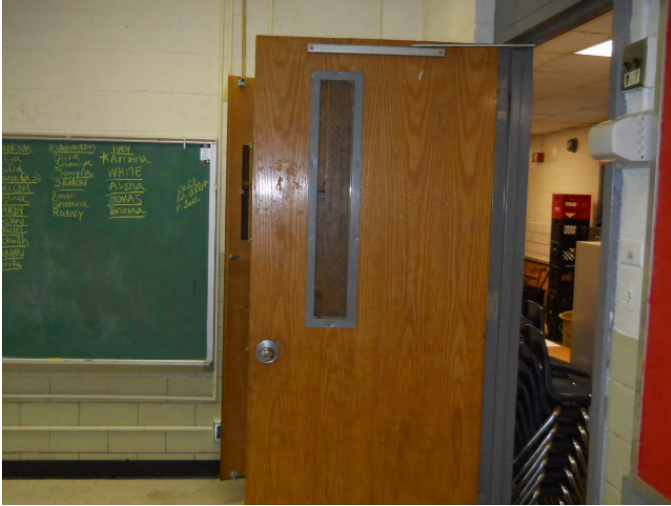
System: C1020 - Interior Doors

Location: Throughout Building

Distress: Beyond Service Life

Notes: Interior doors are beyond their expected service life, not ADA or building code compliant, and should be replaced.

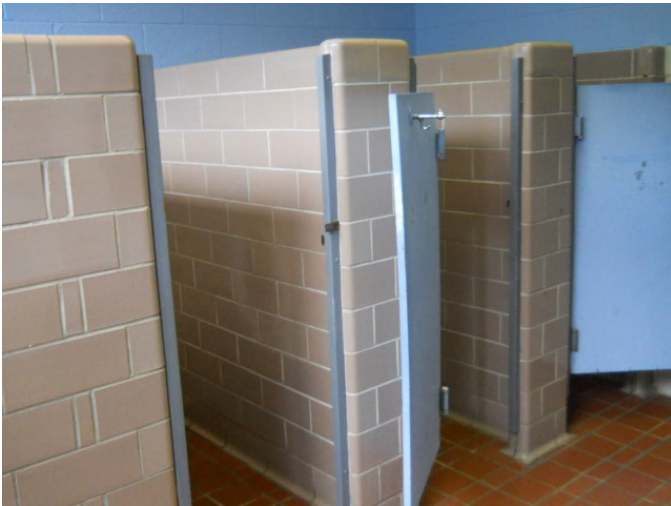
System: C1030 - Fittings

Location: Throughout Building

Distress: Beyond Service Life

Notes: Fittings, such as toilet partitions, handrails and signage, are beyond their expected service life, and should be replaced to improve ADA accessibility. Some, but not all of the toilet partitions were recently replaced in 2014.

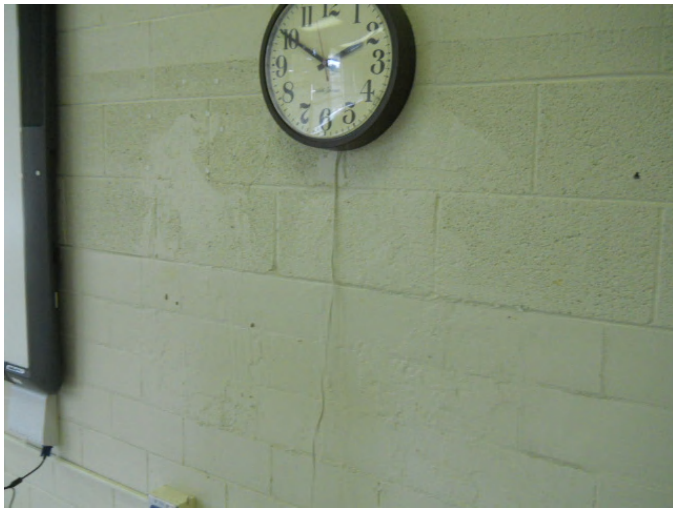
System: C3010 - Wall Finishes - Paint

Location: Throughout Building

Distress: Beyond Service Life

Notes: The painted wall finishes are beyond their expected service life and should be replaced.

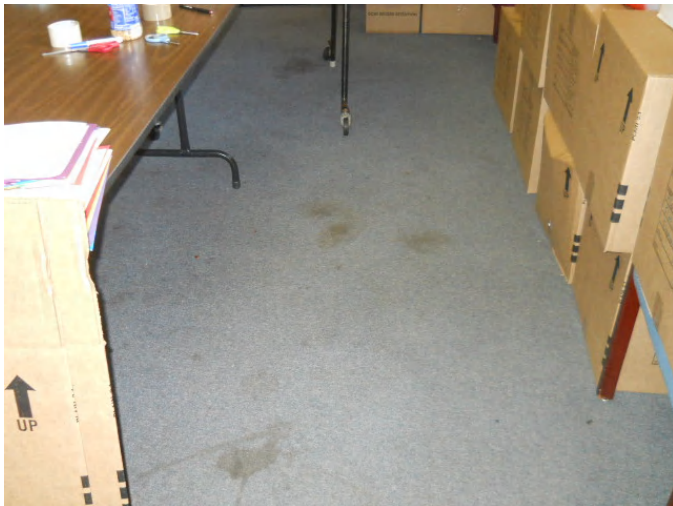
System: C3020 - Floor Finishes - Carpet

Location: Media Center, Offices

Distress: Beyond Service Life

Notes: The carpet is beyond its expected service life, stained, and should be replaced.

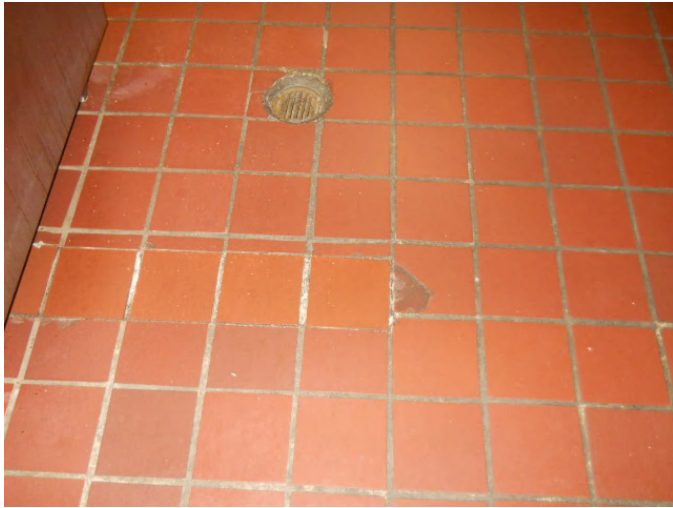
System: C3020 - Floor Finishes - Ceramic & Quarry Tile

Location: Kitchen and Restrooms

Distress: Beyond Service Life

Notes: The tile floor covering is beyond its expected service life and should be replaced.

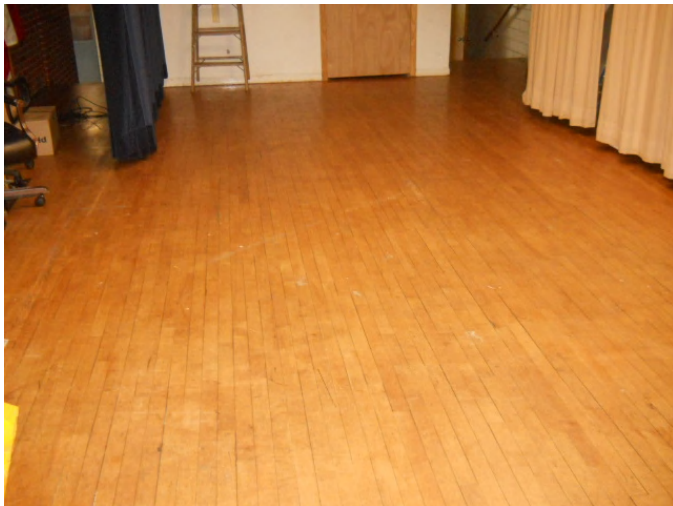
System: C3020 - Floor Finishes - Wood

Location: Stage

Distress: Beyond Service Life

Notes: The wood flooring is beyond its expected service life, stained and scratched, and should be replaced.

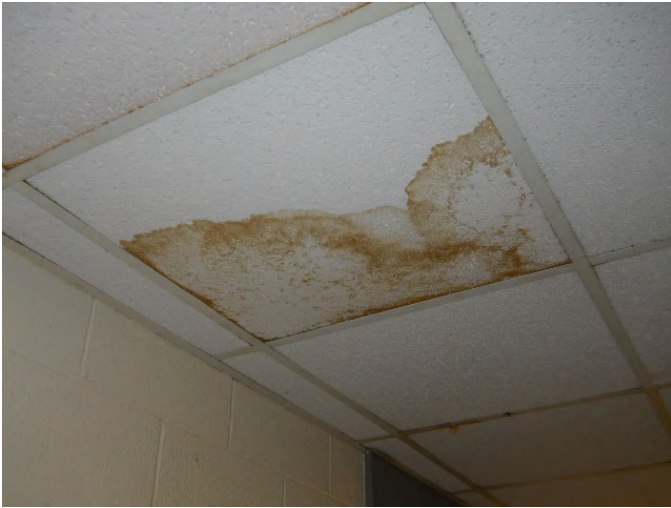
System: C3030 - Ceiling Finishes

Location: Throughout Building

Distress: Beyond Service Life

Notes: The acoustical ceiling system is beyond its expected service life, damaged and stained due to roof leaks, and should be replaced. Ceiling tiles (2'x2') in classrooms and media center are identified as ACM by others.

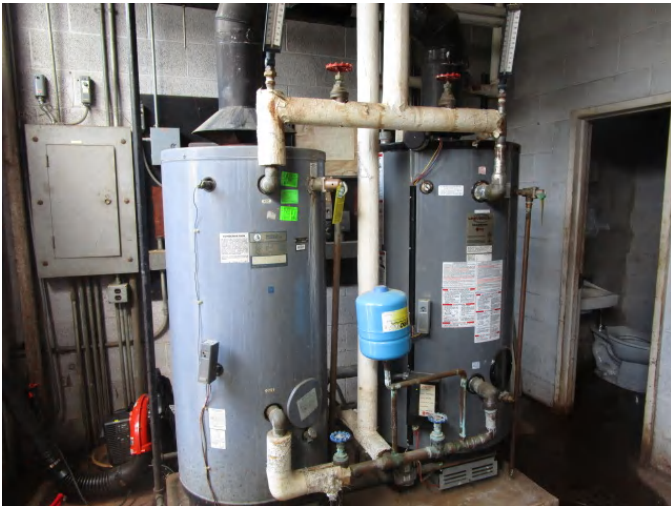
System: D2020 - Domestic Water Distribution

Location: Throughout Building

Distress: Beyond Service Life

Notes: The domestic water distribution system is beyond its expected service life, not building code compliant, and should be scheduled for replacement. Potable water supply is not protected by a reduced pressure backflow prevention device.

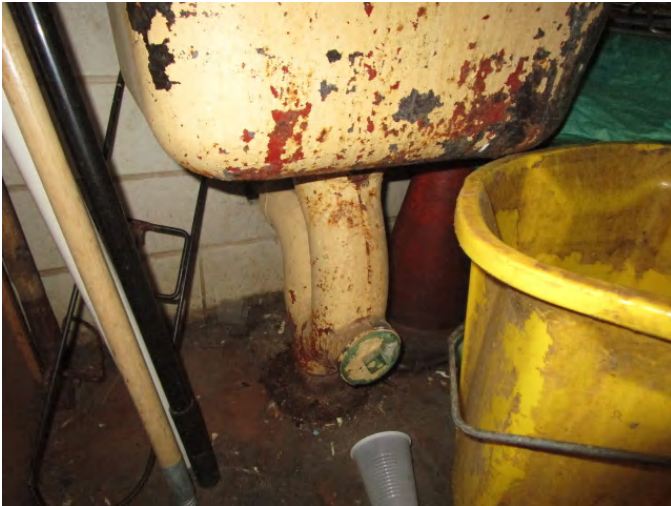
System: D2030 - Sanitary Waste

Location: Throughout Building
Distress: Beyond Service Life
Category: Deferred Maintenance
Priority: 3 Priority
Correction: Renew System
Qty: 43,980.00
Unit of Measure: S.F.
Estimate: \$164,969.00
Assessor Name: Ben Nixon
Date Created: 06/15/2015

Notes: The sanitary waste system is beyond its expected service life and should be scheduled for replacement.

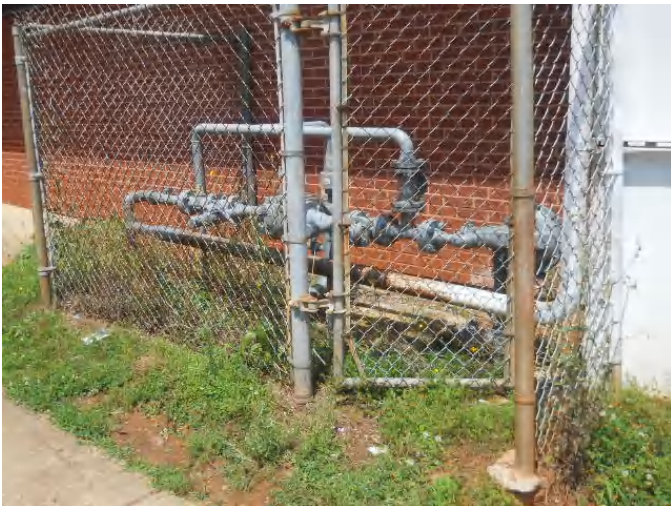
System: D2090 - Other Plumbing Systems - Natural Gas

Location: Throughout Building
Distress: Beyond Service Life
Category: Deferred Maintenance
Priority: 3 Priority
Correction: Renew System
Qty: 43,980.00
Unit of Measure: S.F.
Estimate: \$19,835.00
Assessor Name: Ben Nixon
Date Created: 01/13/2016

Notes: Natural gas system is beyond its expected service life and should be scheduled for replacement.

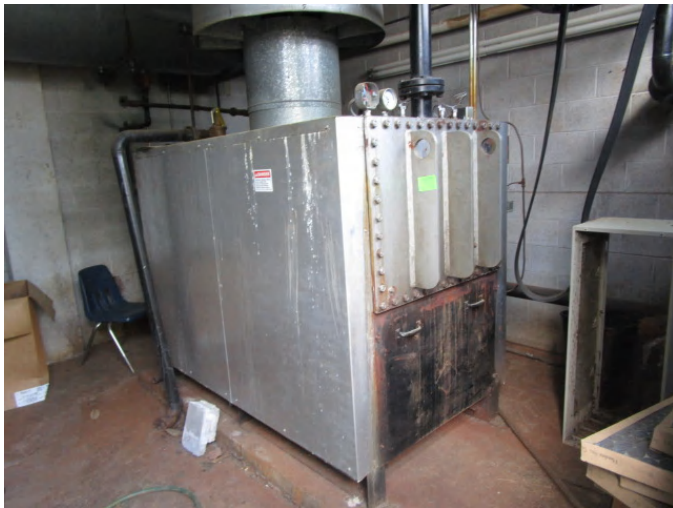
System: D3020 - Heat Generating Systems

Location: Mechanical Room

Distress: Beyond Service Life

Notes: The heat generating system is beyond its expected service life, inadequate, and should be scheduled for replacement.

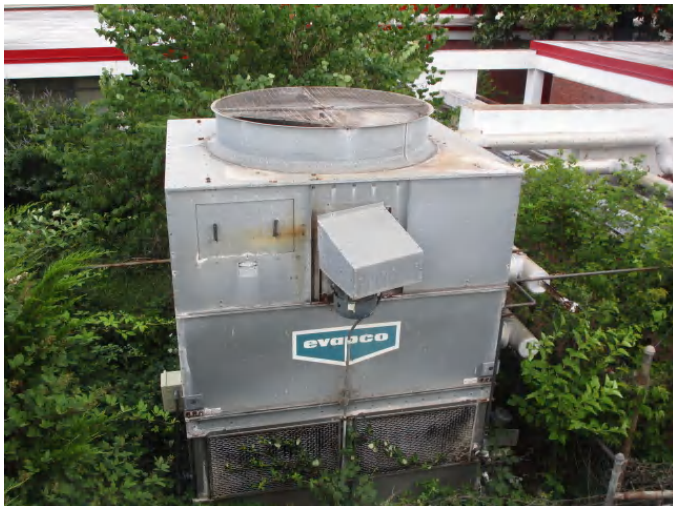
System: D3030 - Cooling Generating Systems

Location: Exterior of Building

Distress: Beyond Service Life

Notes: The cooling generating system is beyond its expected service life, inadequate, and should be scheduled for replacement.

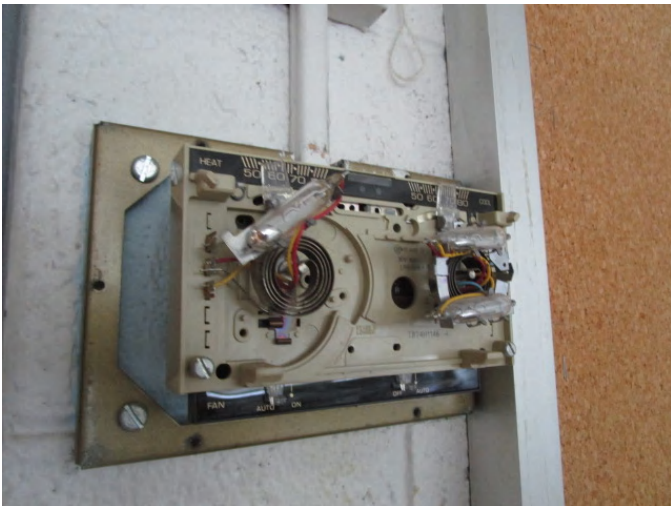
System: D3060 - Controls & Instrumentation

Location: Throughout Building

Distress: Beyond Service Life

Notes: The controls and instrumentation system is beyond its expected service life and should be scheduled for replacement.

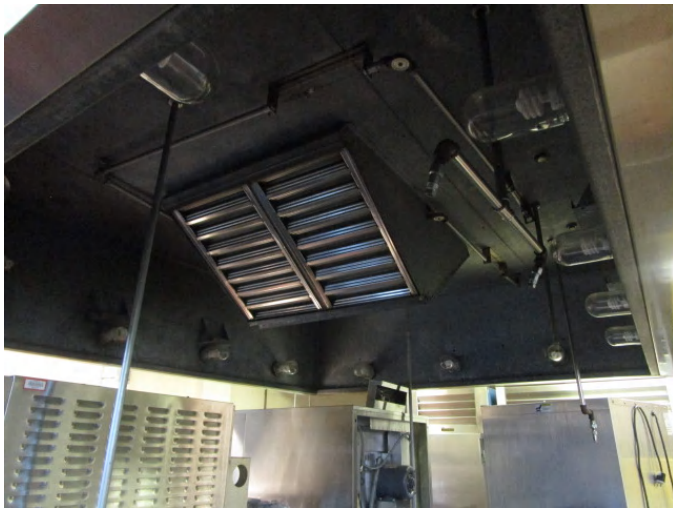
System: D3090 - Other HVAC Systems/Equip - Kitchen Hood

Location: Kitchen

Distress: Beyond Service Life

Notes: The kitchen hood system is beyond its expected service life and should be scheduled for replacement.

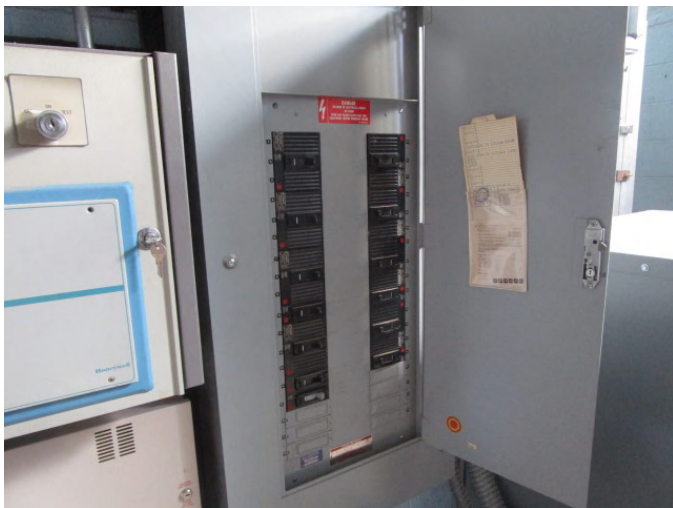
System: D5010 - Electrical Service/Distribution

Location: Main Switch Room/Throughout Building

Distress: Beyond Service Life

Notes: The electrical service/distribution system is beyond its expected service life and should be scheduled for replacement.

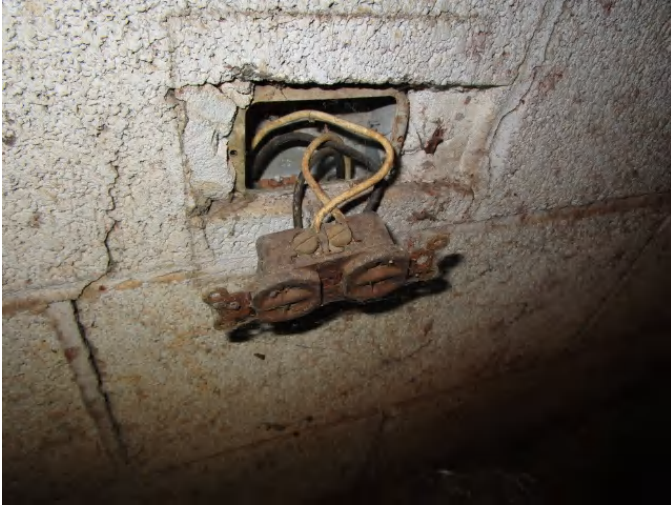
System: D5020 - Branch Wiring

Location: Throughout Building

Distress: Beyond Service Life

Notes: The branch wiring system is beyond its expected service life, inadequate, not building code compliant, and should be scheduled for replacement. The building does not have enough electrical outlets and a number of them do not work. Electrical outlets in wet areas of 1958 building are not GFI.

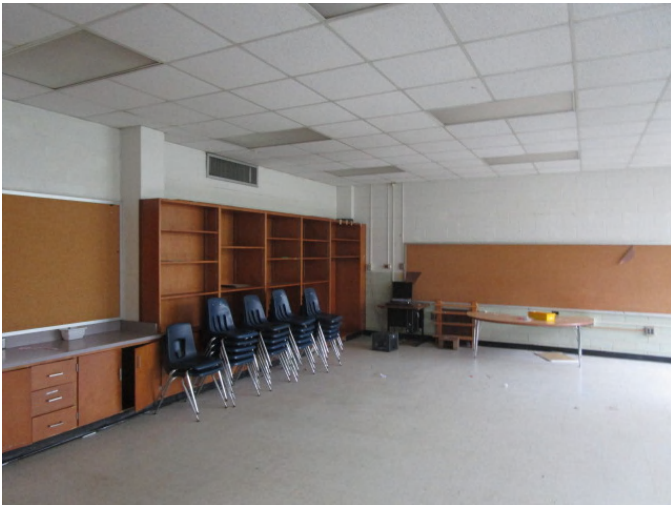
System: D5020 - Lighting

Location: Throughout Building

Distress: Beyond Service Life

Notes: The lighting system is beyond its expected service life and should be scheduled for replacement.

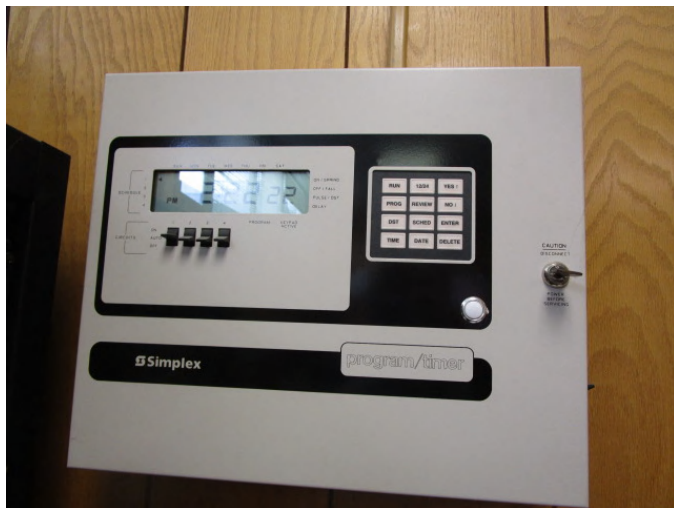
System: D5030 - Communications and Security - Clock & PA Systems

Location: Throughout Building

Distress: Beyond Service Life

Notes: Clock and PA systems are beyond their expected service life and should be scheduled for replacement.

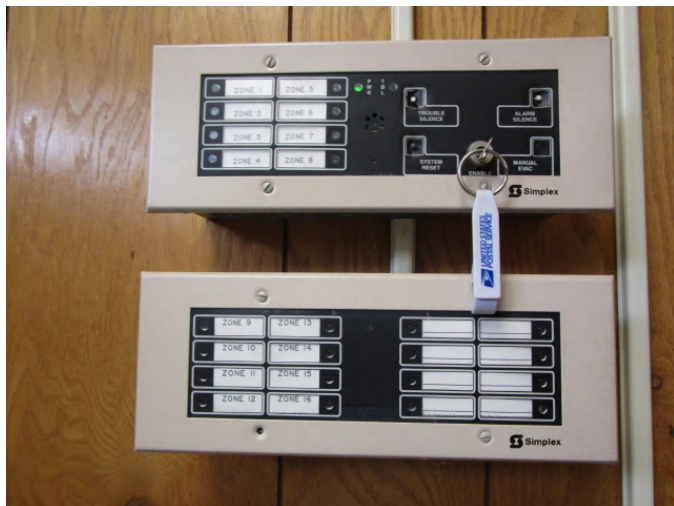
System: D5030 - Communications and Security - Fire Alarm

Location: Throughout Building

Distress: Beyond Service Life

Notes: The fire alarm system is beyond its expected service life and should be scheduled for replacement.

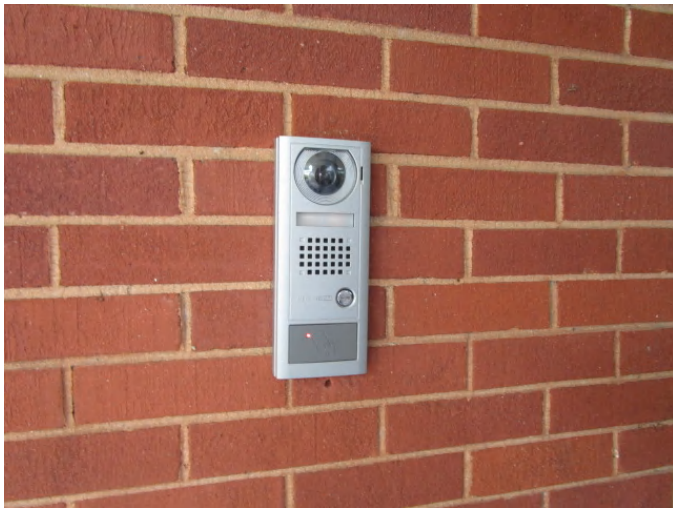
System: D5030 - Communications and Security - Security & CCTV

Location: Throughout Building

Distress: Beyond Service Life

Notes: The security and CCTV systems are beyond their expected service life and should be scheduled for replacement.

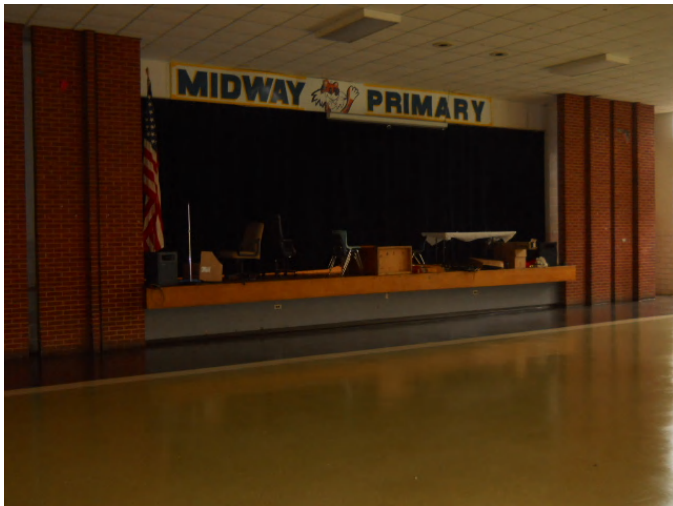
System: E1020 - Institutional Equipment

Location: Throughout Building

Distress: Beyond Service Life

Notes: Institutional equipment, such as theater and stage equipment, library equipment and audio-visual equipment, is beyond its expected service life and should be scheduled for replacement.

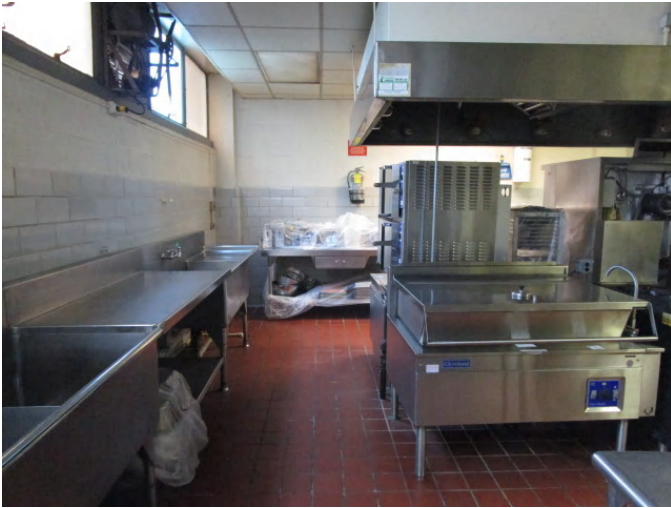
System: E1090 - Other Equipment (Kitchen Equipment)

Location: Kitchen

Distress: Beyond Service Life

Notes: Kitchen equipment is beyond its expected service life and should be scheduled for replacement.

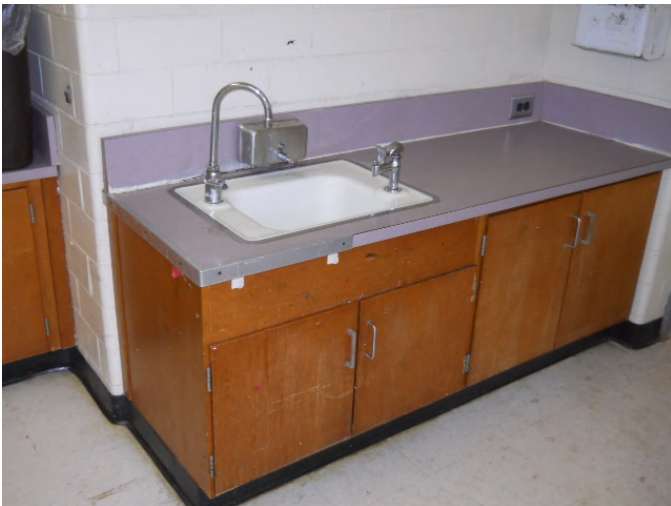
System: E2010 - Fixed Furnishings

Location: Throughout Building

Distress: Beyond Service Life

Notes: Fixed furnishings, such as built-in cabinets, are beyond their expected service life and worn, and should be replaced.

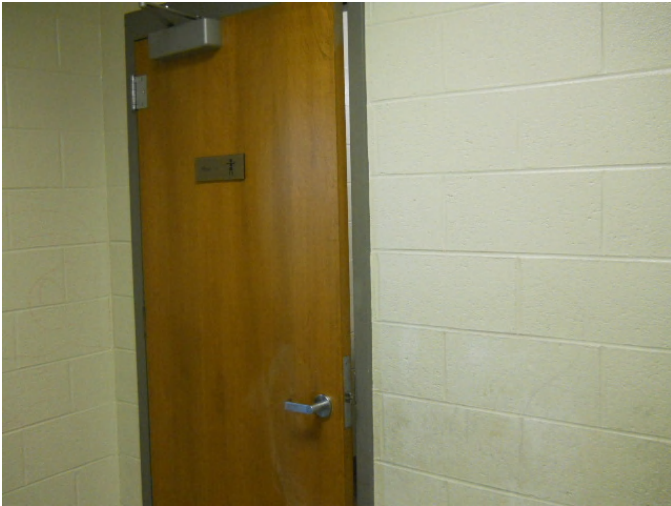
System: C3010 - Wall Finishes - Paint

Location: Throughout Building

Distress: Beyond Service Life

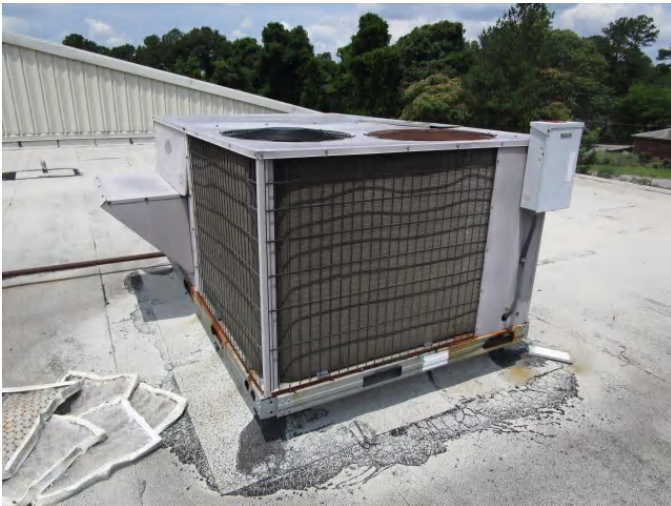
System: D3050 - Terminal & Package Units

Location: Roof

Distress: Beyond Service Life

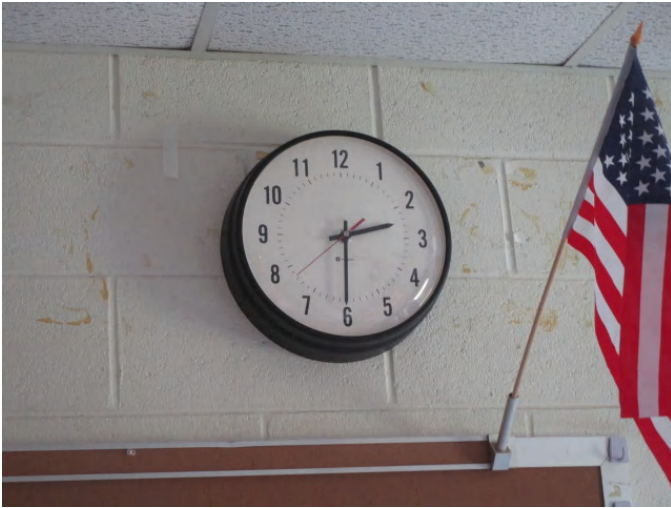
System: D5030 - Communications and Security - Clock & PA Systems

Location: Throughout Building
Distress: Beyond Service Life
Category: Deferred Maintenance
Priority: 3 Priority
Correction: Renew System
Qty: 27,320.00
Unit of Measure: S.F.
Estimate: \$168,291.00
Assessor Name: Ben Nixon
Date Created: 04/11/2015

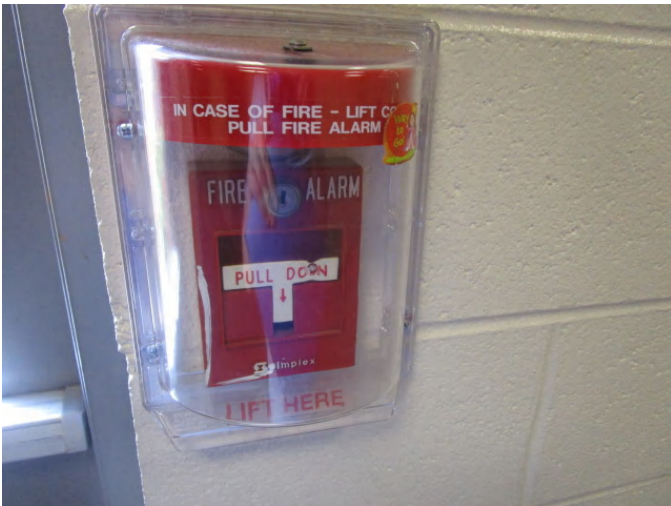
System: D5030 - Communications and Security - Fire Alarm

Location: Throughout Building
Distress: Beyond Service Life
Category: Deferred Maintenance
Priority: 3 Priority
Correction: Renew System
Qty: 27,320.00
Unit of Measure: S.F.
Estimate: \$36,964.00
Assessor Name: Ben Nixon
Date Created: 04/11/2015

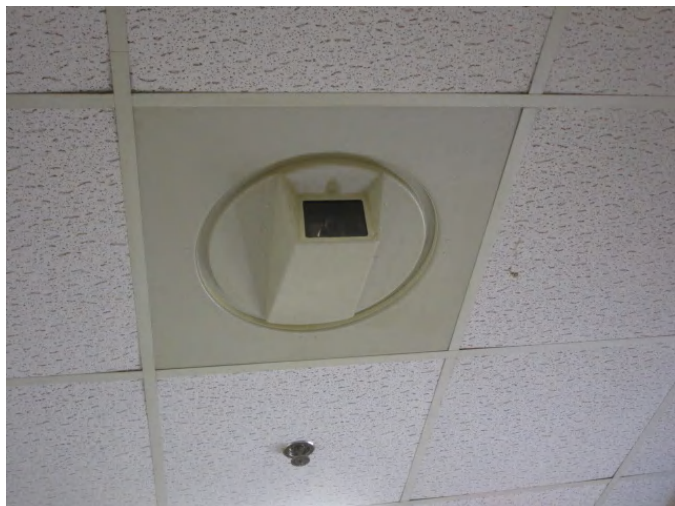
System: D5030 - Communications and Security - Security & CCTV

Location: Throughout Building

Distress: Beyond Service Life

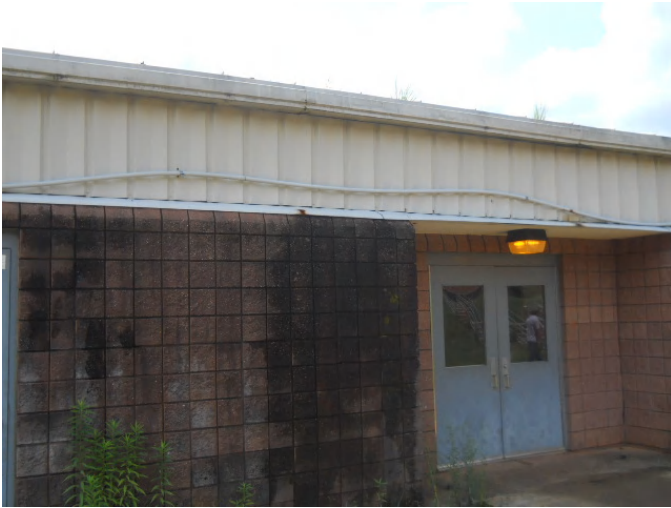
System: B3010 - Roof Coverings - Standing Seam Metal

Location: Roof and Exterior Walls

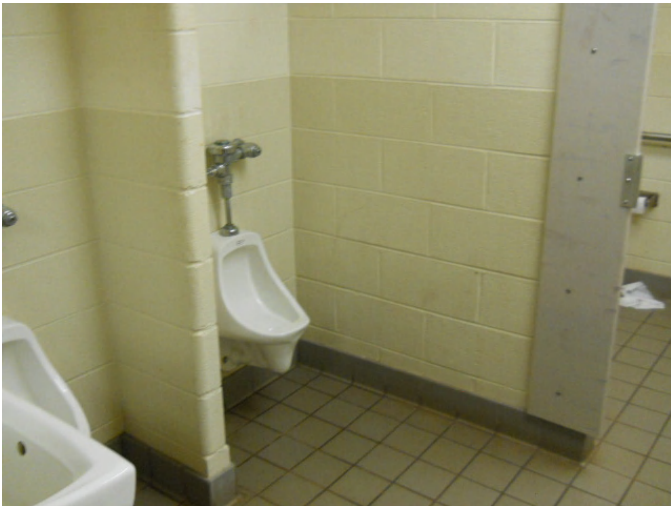
System: C3010 - Wall Finishes - Paint

Location: Throughout Building

Distress: Beyond Service Life

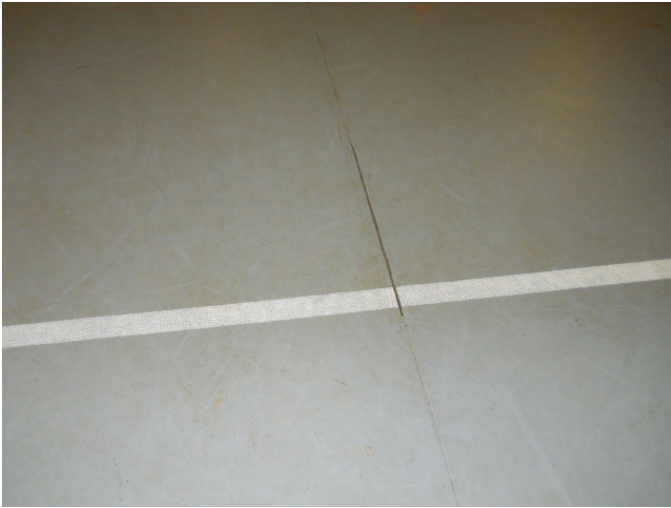
System: C3020 - Floor Finishes - Neoprene

Location: Basketball Court

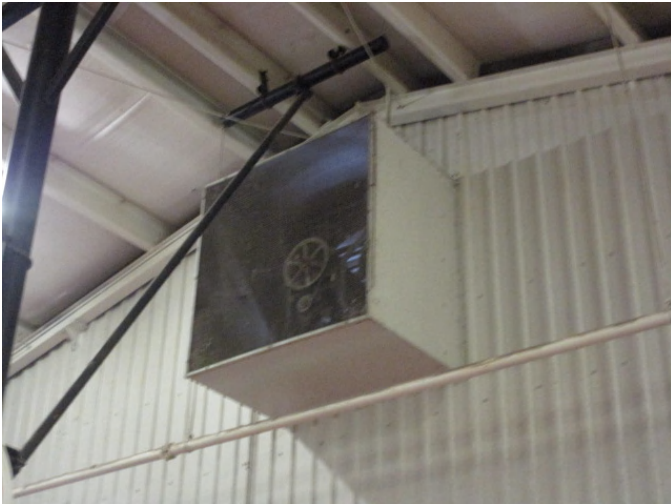
System: D3050 - Terminal & Package Units

Location: Throughout Building

Distress: Inadequate

Notes: One PTAC AC unit is located in the office area of the gym. It is beyond its expected service life. The main gym area does not have air conditioning and it should be provided. SPLOST IV project 320-422 to install a 20-ton HVAC unit in the gym.

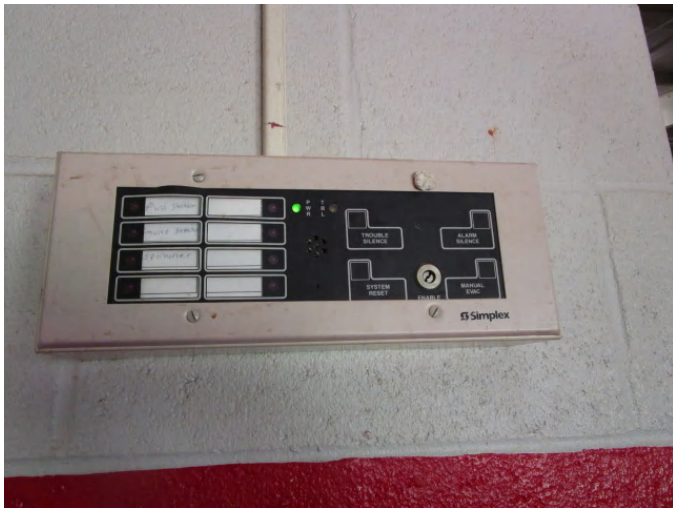
System: D5030 - Communications and Security - Fire Alarm

Location: Throughout Building

Distress: Beyond Service Life

Notes: The fire alarm system is beyond its expected service life and should be scheduled for replacement.

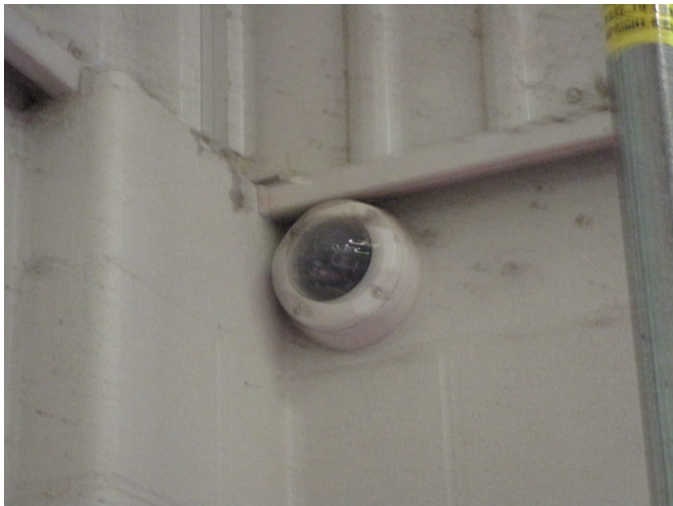
System: D5030 - Communications and Security - Security & CCTV

Location: Throughout Building

Distress: Beyond Service Life

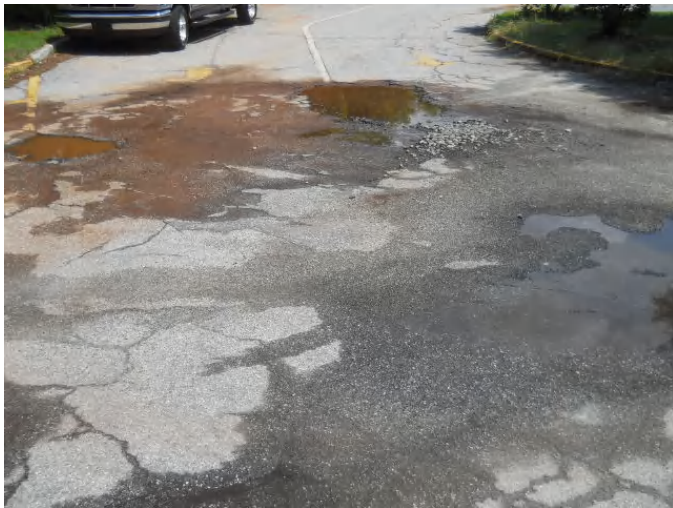
System: G2010 - Roadways

Location: Site

Distress: Beyond Service Life

Notes: Roadways are beyond their expected service life, damaged with cracks and potholes, and should be replaced.

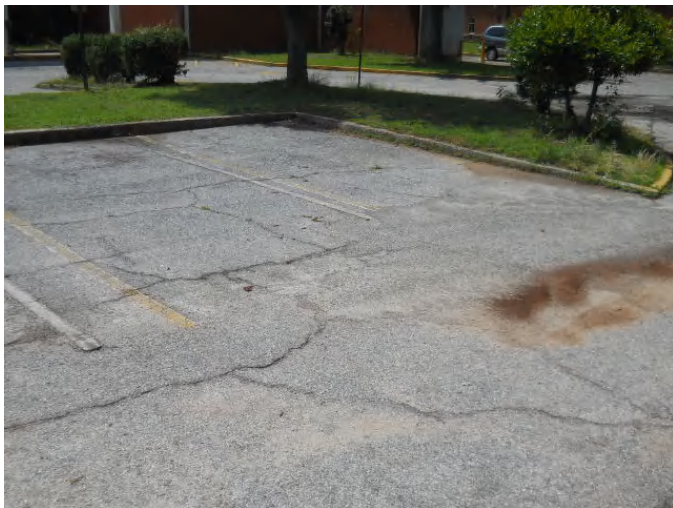
System: G2020 - Parking Lots

Location: Site

Distress: Beyond Service Life

Notes: The parking lot is beyond its expected service life, damaged, inadequate, not ADA compliant, and should be replaced.

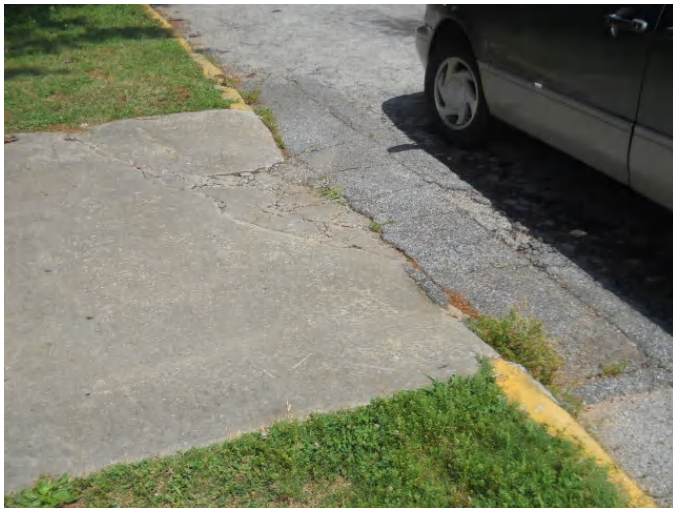
System: G2030 - Pedestrian Paving

Location: Site

Distress: Beyond Service Life

Notes: Pedestrian paving is beyond its expected service life, damaged, not ADA compliant, and should be replaced. School staff identified the need for handrails for safety reasons.

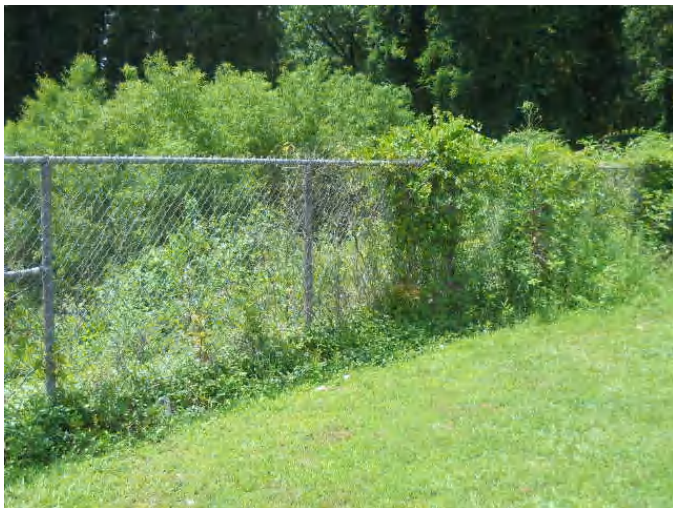
System: G2040 - Fencing & Guardrails

Location: Site

Distress: Beyond Service Life

Notes: Fencing is beyond its expected service life, damaged, and should be scheduled for replacement.

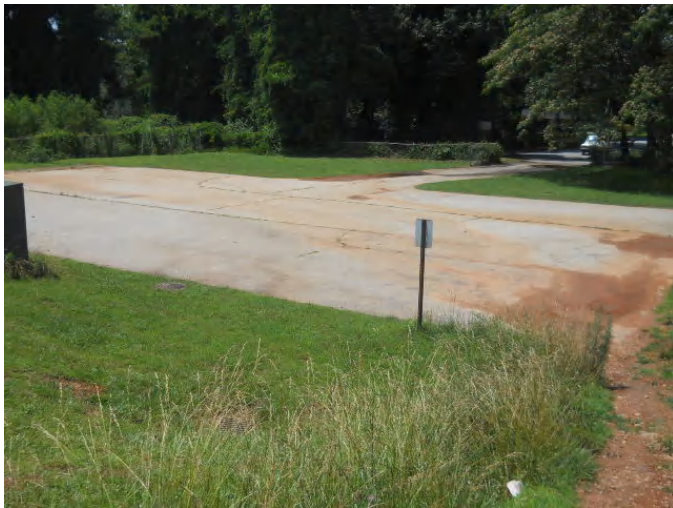
System: G2040 - Hard Surface Play Area

Location: Site

Distress: Beyond Service Life

Notes: The hard surface play area is beyond its expected service life, damaged with cracks, and should be replaced.

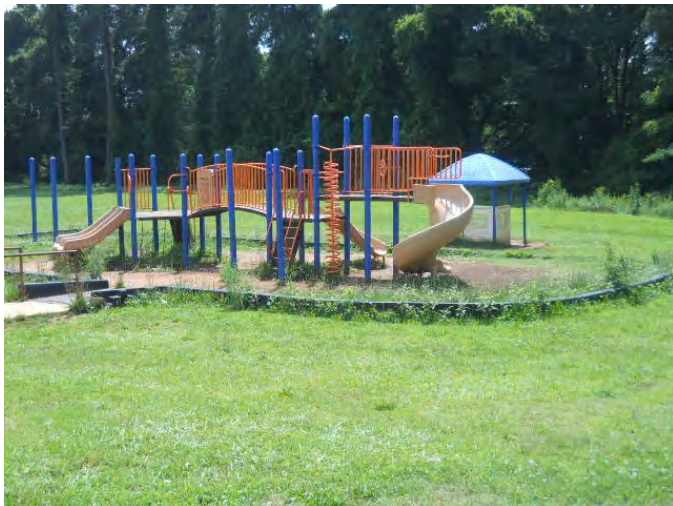
System: G2050 - Landscaping

Location: Site

Distress: Beyond Service Life

Notes: Landscaping is beyond its expected service life, inadequate, and should be scheduled for replacement.

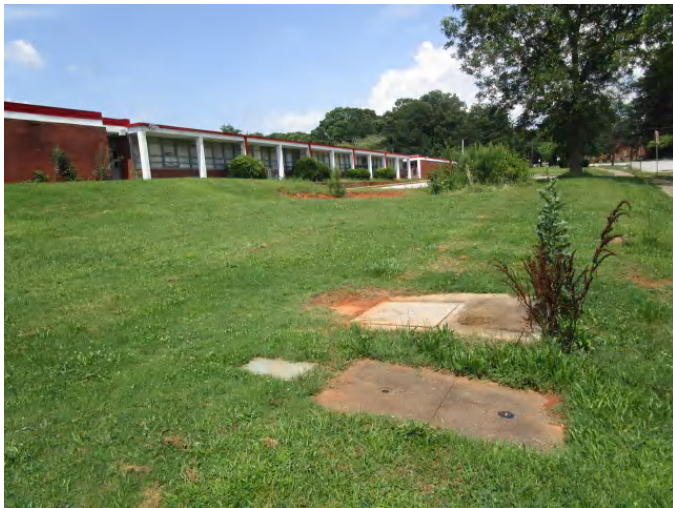
System: G3010 - Water Supply

Location: Site

Distress: Beyond Service Life

Notes: The site water supply system is beyond its expected service life and should be scheduled for replacement. SPLOST project 320-422 to replace the exterior domestic water supply piping.

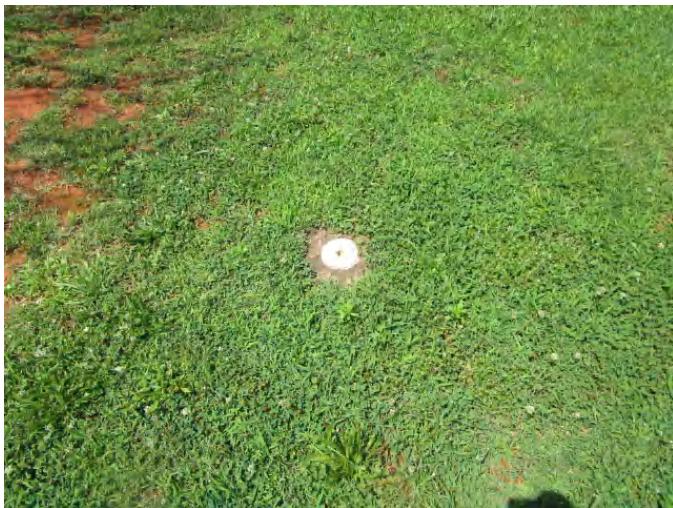
System: G3020 - Sanitary Sewer

Location: Site

Distress: Beyond Service Life

Notes: The site sanitary sewer system is beyond its expected service life and should be scheduled for replacement. SPLOST project 320-422 to replace the exterior sanitary sewer system.

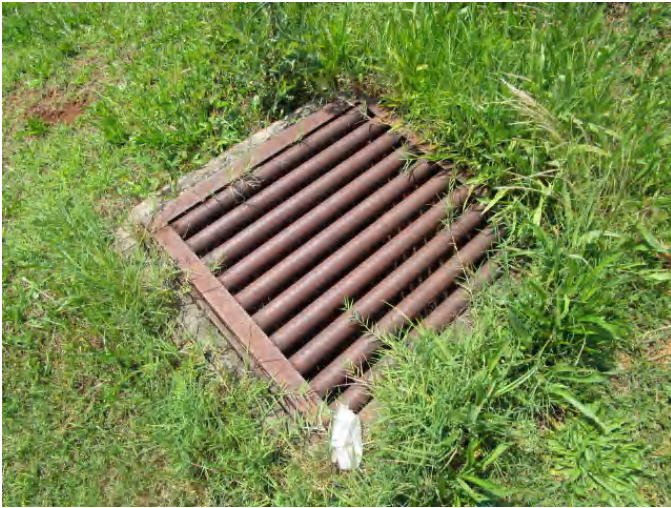
System: G3030 - Storm Sewer

Location: Site

Distress: Beyond Service Life

Notes: The storm sewer system is beyond its expected service life and should be scheduled for replacement.

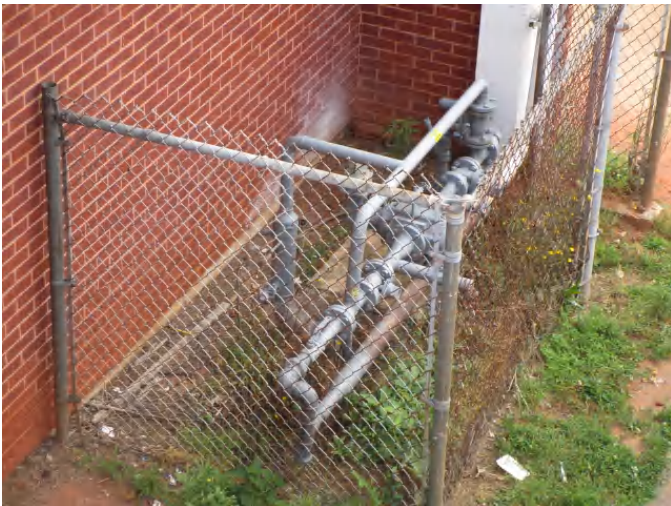
System: G3060 - Fuel Distribution

Location: Site

Distress: Beyond Service Life

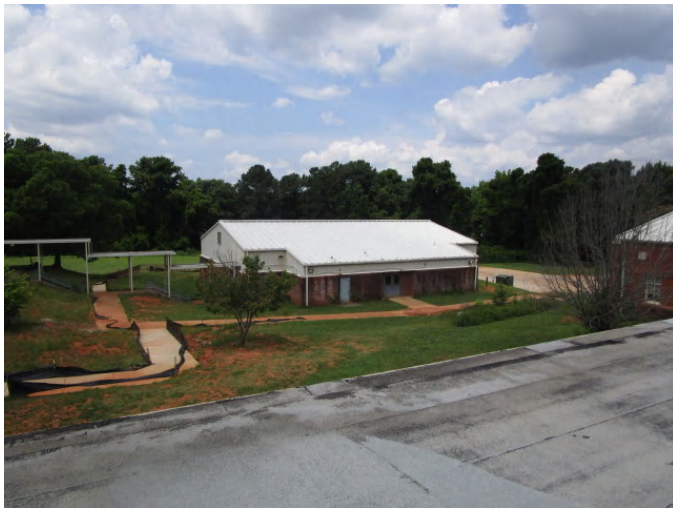
System: G4010 - Electrical Distribution

Location: Site

Distress: Beyond Service Life

Notes: The site electrical distribution system is beyond its expected service life and should be scheduled for replacement.

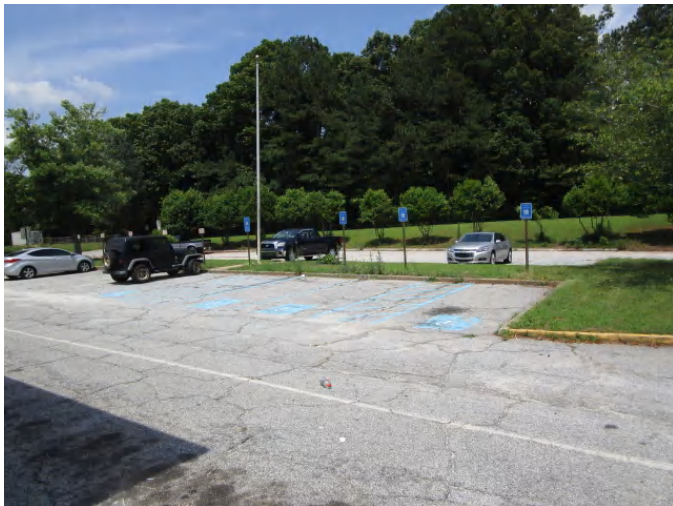
System: G4020 - Site Lighting

Location: Site

Distress: Beyond Service Life

Notes: Site lighting is beyond its expected service life, inadequate, and should be scheduled for replacement.

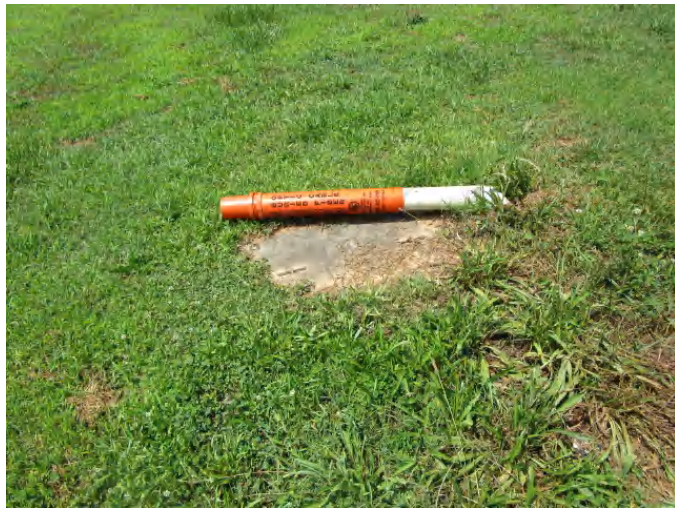
System: G4030 - Site Communications & Security

Location: Site

Distress: Beyond Service Life
