DeKalb County School District/High Schools

# Miller Grove High

## School Assessment Report

May 19, 2016

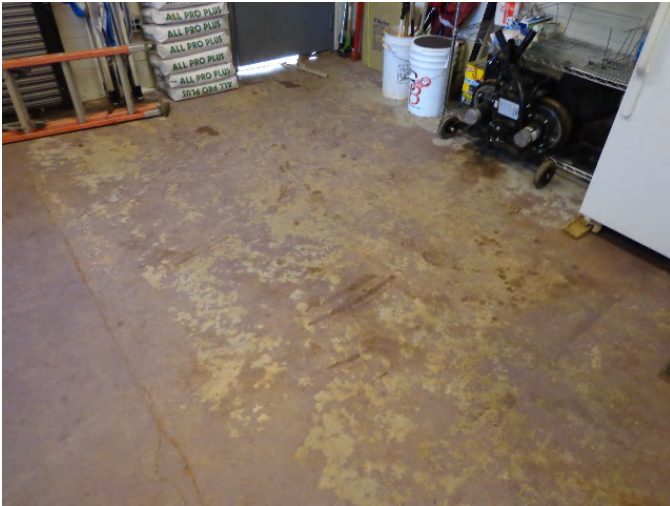
#### System: C3020 - Floor Finishes - Epoxy

**Location:** Throughout Building

**Distress:** Damaged

**Notes:** The epoxy floor finish is aged and worn, and should be replaced.

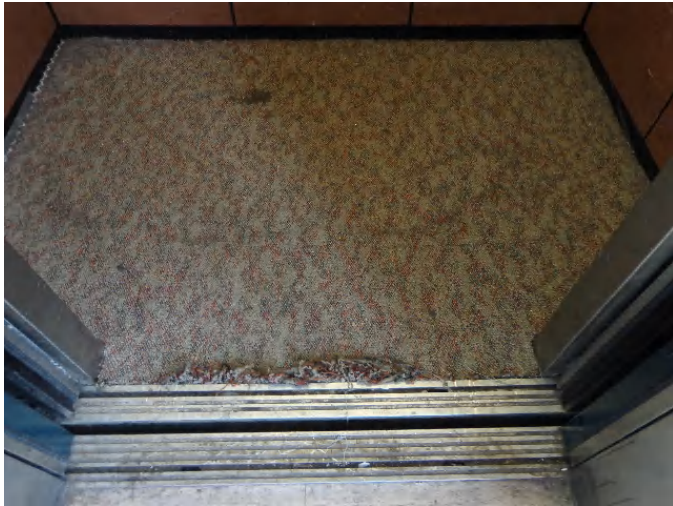
#### **System: C3020 - Floor Finishes - Carpet**

**Location:** Elevators

**Distress:** Damaged

**Notes:** The carpet floor finish in the elevators is damaged and a potential tripping hazard, and should be replaced.

**Correction:** Replace carpet

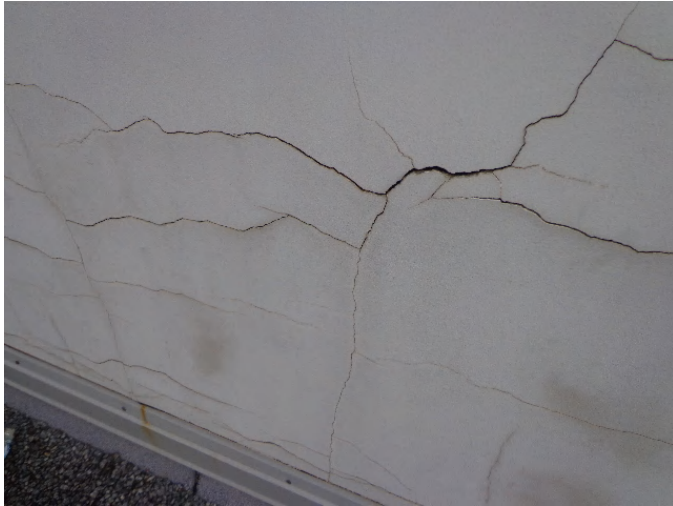
**System: B2010 - Exterior Walls**

**Location:** Exterior Walls

**Distress:** Damaged

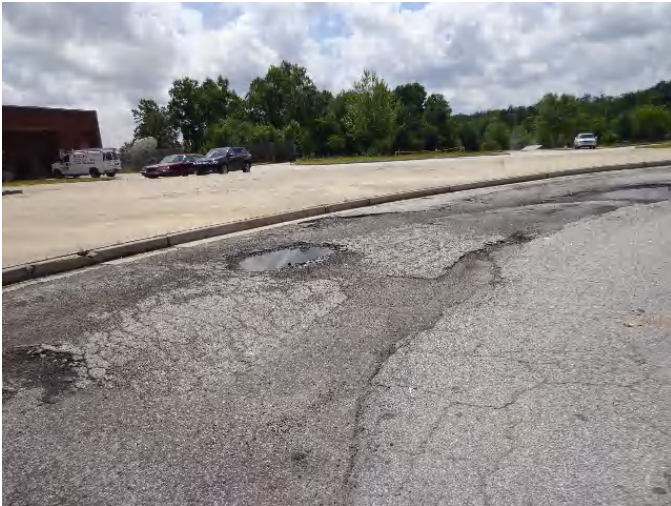
#### System: G2020 - Parking Lots

**Location:** School Bus Curb Parking Area

**Distress:** Damaged

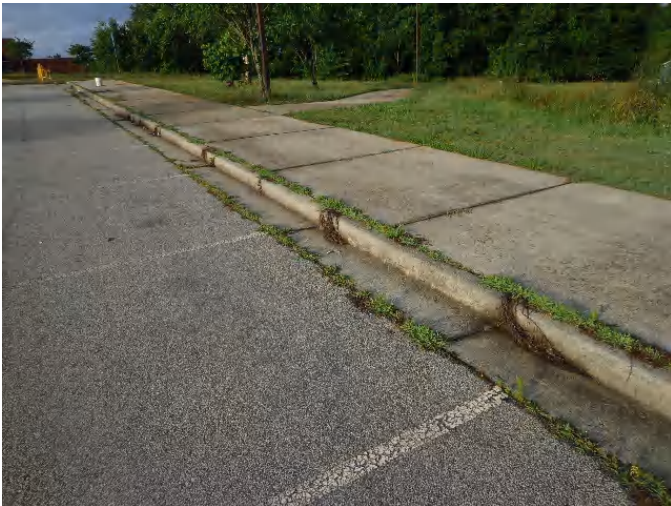
#### System: G2020 - Parking Lots

**Location:** Site

**Distress:** Inadequate

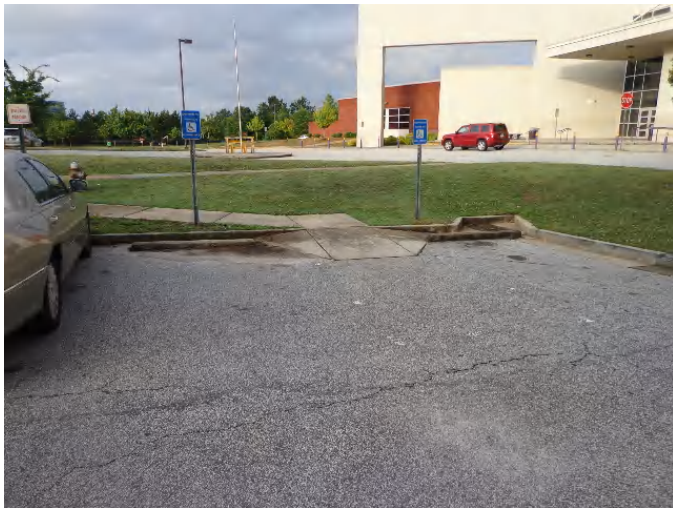
### **System: G2020 - Parking Lots**

**Location:** Site

**Distress:** Missing

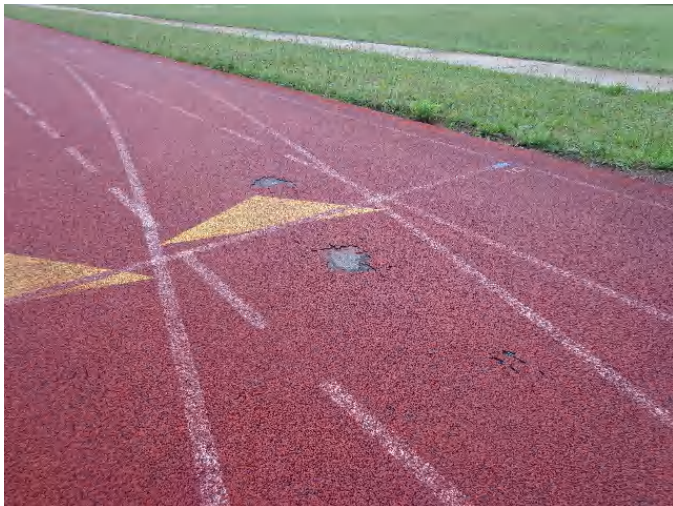
### **System: G2040 - Track**

**Location:** Site

**Distress:** Beyond Service Life

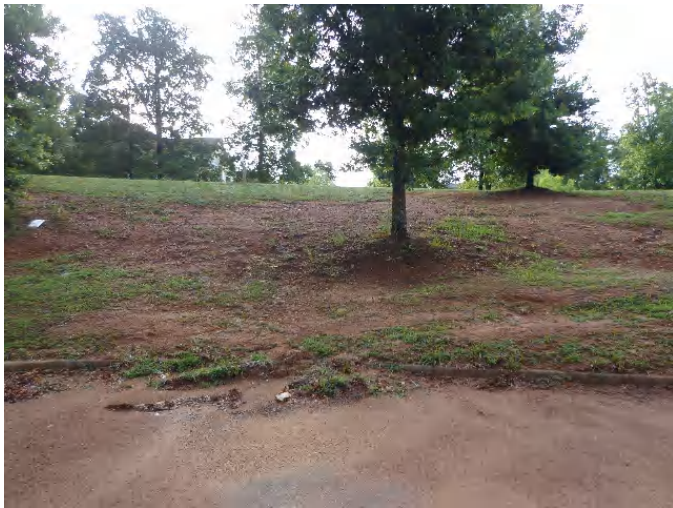
**System: G2050 - Landscaping**

**Location:** Site  
**Distress:** Damaged  
**Category:** Deferred Maintenance  
**Priority:** 3 Priority  
**Correction:** Renew System  
**Qty:** 254,181.00  
**Unit of Measure:** S.F.  
**Estimate:** \$405,418.70  
**Assessor Name:** Eduardo Lopez  
**Date Created:** 09/22/2015

**Notes:** Landscaping is worn and bare in areas, and should be provided to prevent erosion. Staff reports numerous broken irrigation pipes at the athletic fields that need to be replaced.
