DeKalb County School District/Elementary Schools

Montclair Elementary

School Assessment Report

May 19, 2016

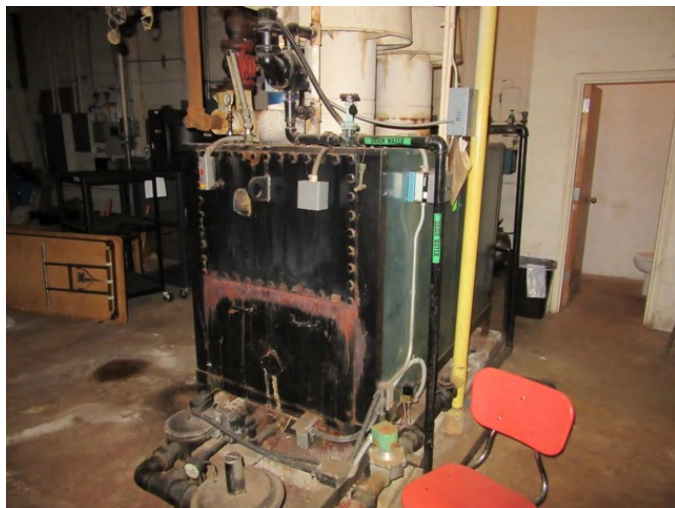
System: D3020 - Heat Generating Systems

Location: Mechanical Room

Distress: Beyond Service Life

Notes: The boiler is beyond its expected service life, contains hazardous materials, and should be scheduled for replacement.

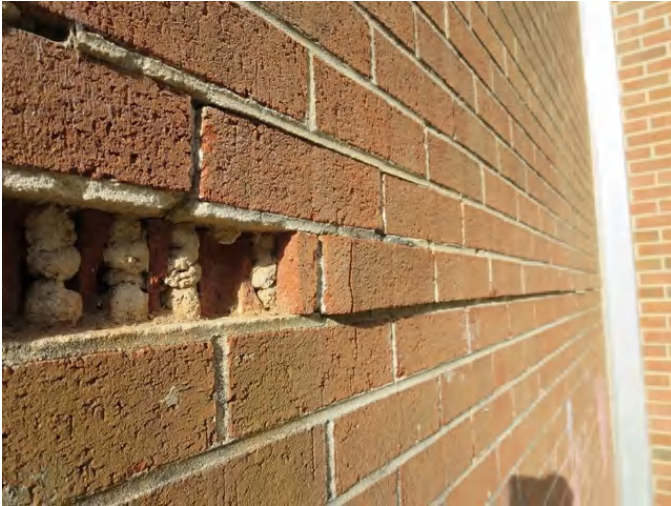
System: B2010 - Exterior Walls

Location: Exterior Wall

Distress: Damaged

Notes: Repair/repoint exterior brick wall where needed.

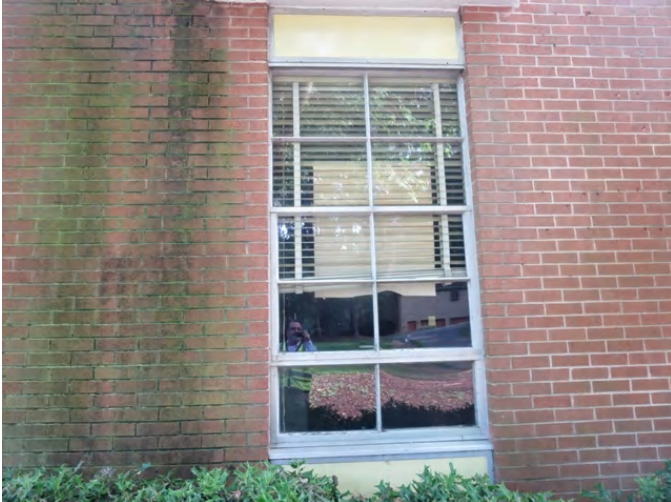
System: B2010 - Exterior Walls

Location: Exterior Walls

Distress: Needs Remediation

Notes: Exterior walls are stained and should be pressure washed to maintain appearance.

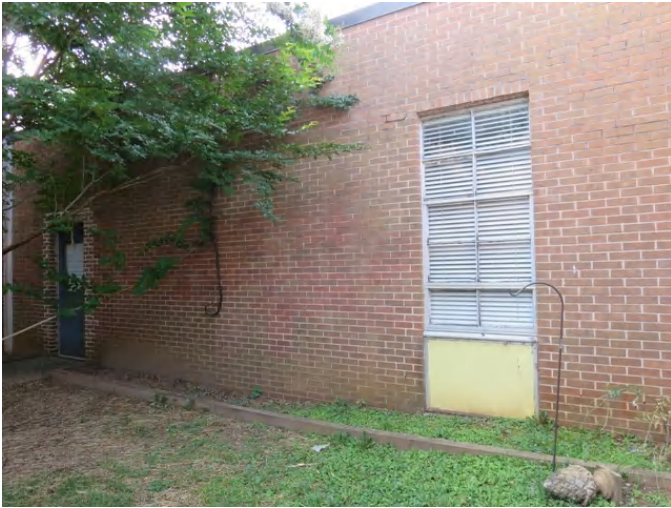
System: B2020 - Exterior Windows

Location: Throughout Building

Distress: Beyond Service Life

Notes: The aluminum frame, operable, single pane windows are aged, not energy efficient, and should be replaced. The windows leak in the kindergarten classrooms.

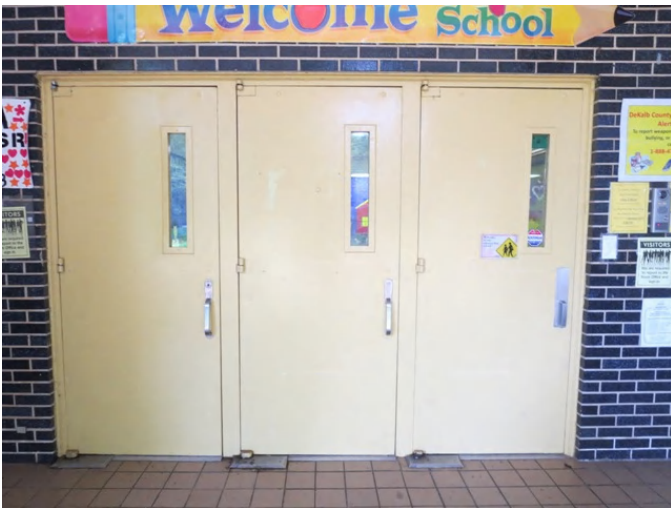
System: B2030 - Exterior Doors

Location: Throughout Building

Distress: Beyond Service Life

Notes: The original exterior doors are aged, rusted, do not lock/seal properly, not ADA compliant, and should be replaced.

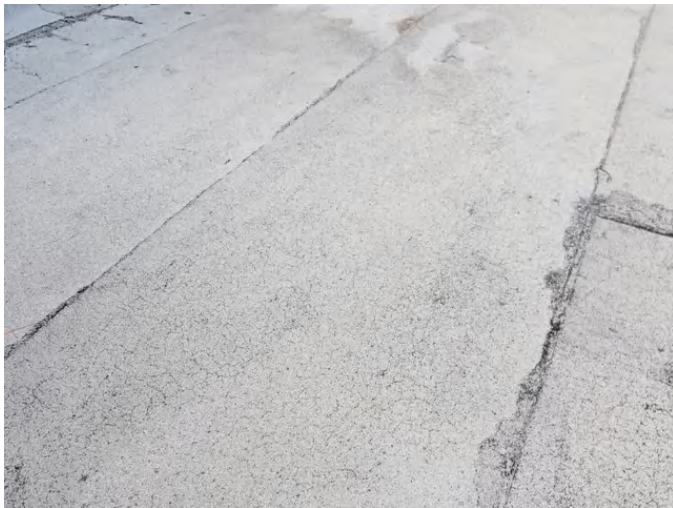
System: B3010 - Roof Coverings - BUR

Location: Roof
Distress: Beyond Service Life
Category: Deferred Maintenance / Energy
Priority: 3 Priority
Correction: Renew System
Qty: 42,533.00
Unit of Measure: S.F.
Estimate: \$968,476.00
Assessor Name: Ben Nixon
Date Created: 04/11/2015

Notes: The built-up roof covering is aged, showing signs of failure, and should be replaced.

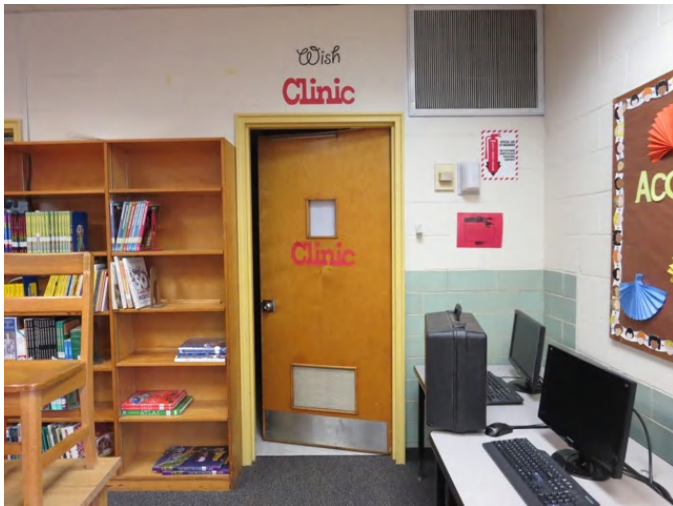
System: C1020 - Interior Doors

Location: Throughout Building
Distress: Beyond Service Life
Category: Deferred Maintenance / Building Code Compliance
Priority: 3 Priority
Correction: Renew System
Qty: 42,533.00
Unit of Measure: S.F.
Estimate: \$81,323.00
Assessor Name: Ben Nixon
Date Created: 04/11/2015

Notes: The interior doors are aged, failing, not ADA or building code compliant, and should be repaired or replaced.

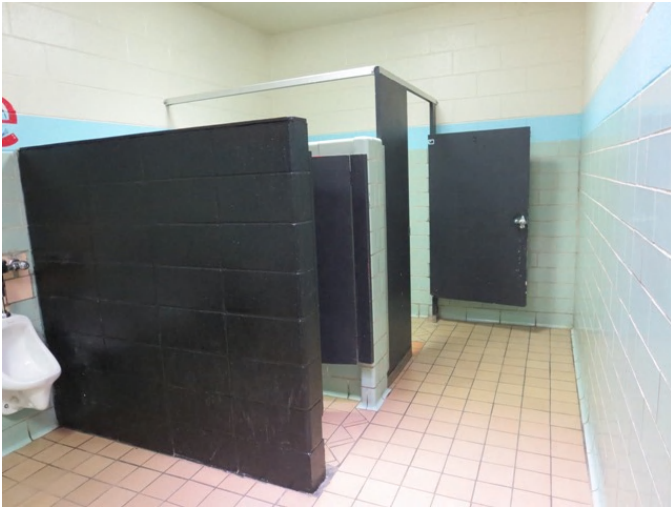
System: C1030 - Fittings

Location: Throughout Building

Distress: Beyond Service Life

Notes: Fittings, such as toilet partitions, handrails and signage, are beyond their expected service life, not ADA compliant, and should be replaced.

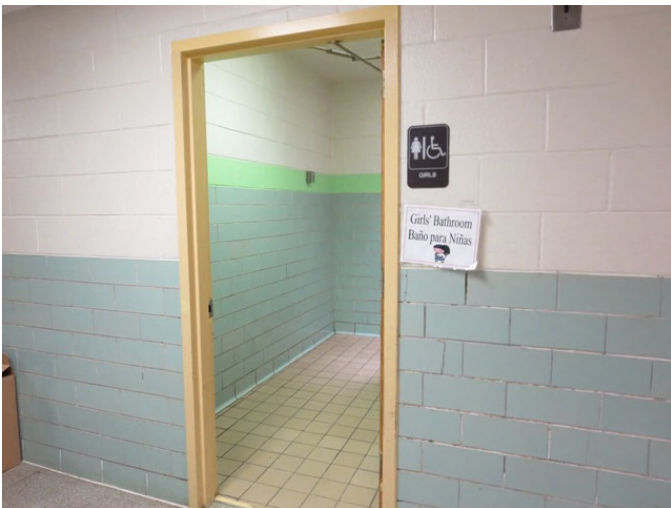
System: C3010 - Wall Finishes - Ceramic & Glazed

Location: Throughout Building

Distress: Beyond Service Life

Notes: The wall tiles are aged, broken, faded and stained, and should be replaced.

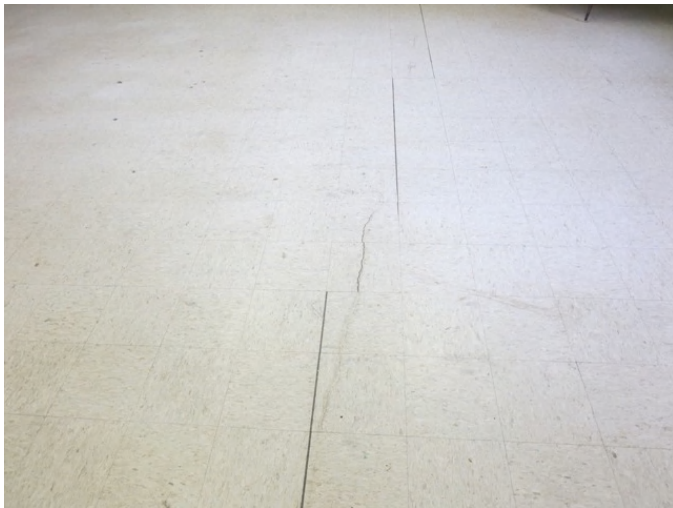
System: C3020 - Floor Finishes - VCT

Location: Classrooms

Distress: Beyond Service Life

Notes: The VCT and VAT flooring is aged, cracked and worn, and should be replaced.

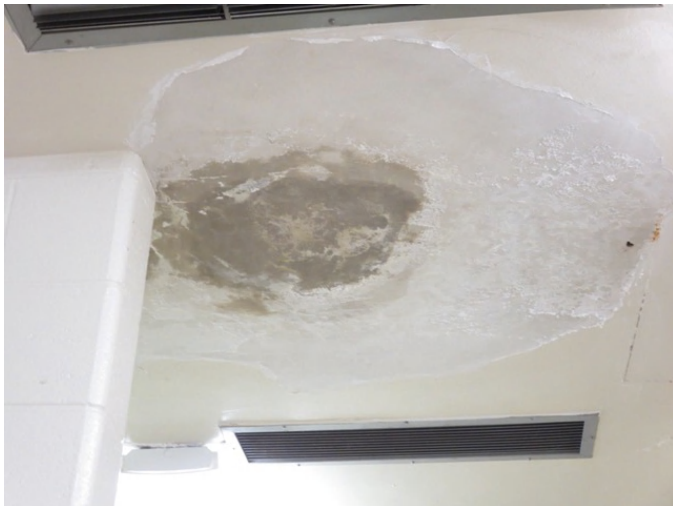
System: C3030 - Ceiling Finishes

Location: Restroom

Distress: Damaged

Notes: The original plaster ceiling is aged, damaged due to leaks, and should be renovated.

Correction: Repair plaster ceiling - (2% of ceilings)

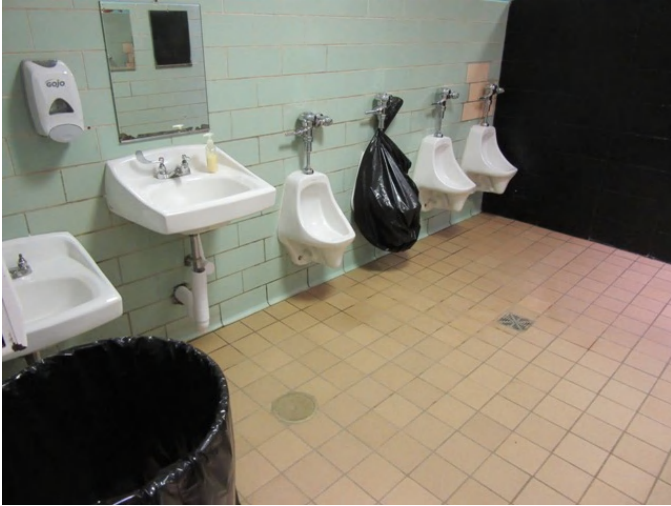
System: D2010 - Plumbing Fixtures

Location: Throughout Building

Distress: Beyond Service Life

Notes: The plumbing fixtures are beyond their expected service life, inadequate and broken, not ADA compliant, and should be scheduled for replacement. Water fountains protrude into the hallway more than four inches in the south classroom wing. Protrusion is not ADA compliant if more than four inches.

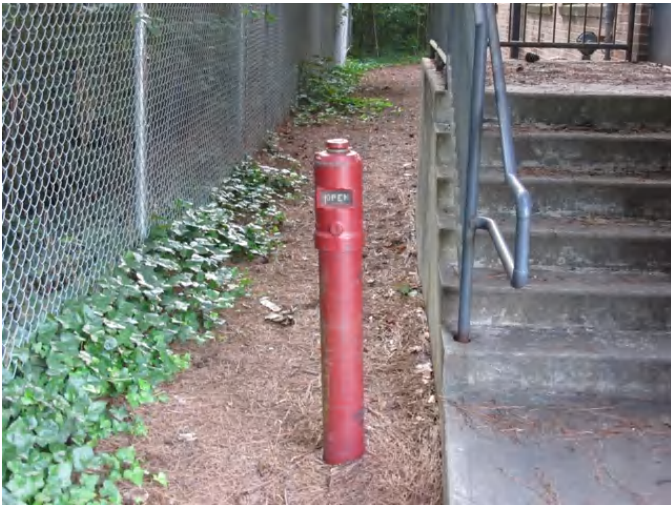
System: D2020 - Domestic Water Distribution

Location: Throughout Building

Distress: Beyond Service Life

Notes: The domestic water distribution system is beyond its expected service life and should be scheduled for replacement. SPLOST project 421-422 to replace the interior domestic water piping throughout the building.

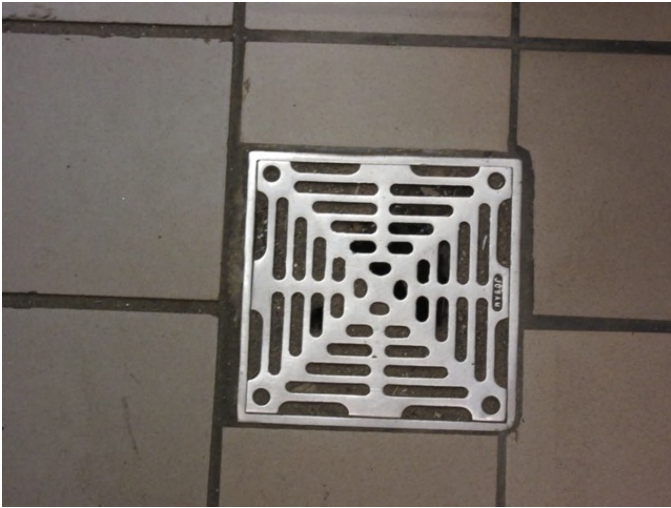
System: D2030 - Sanitary Waste

Location: Throughout Building

Distress: Beyond Service Life

Notes: The sanitary waste system is beyond its expected service life and should be scheduled for replacement. SPLOST project 421-422 to replace the grease trap and backflow preventer.

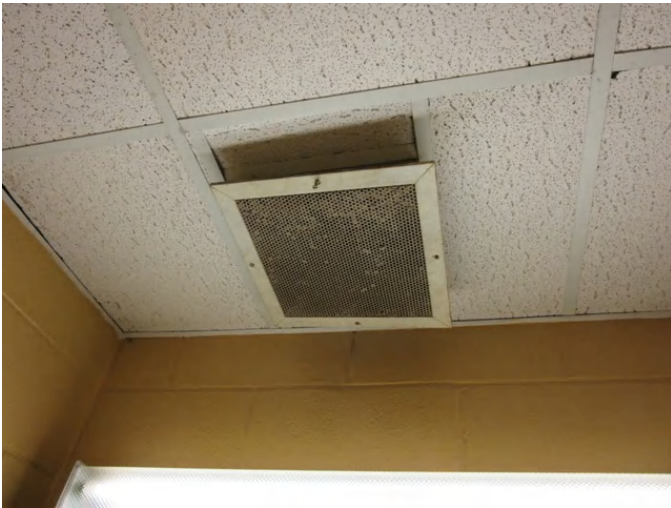
System: D3040 - Distribution & Exhaust Systems

Location: Throughout Building

Distress: Beyond Service Life

Notes: The distribution and exhaust systems are beyond their expected service life, missing, damaged and inadequate, and should be scheduled for replacement.

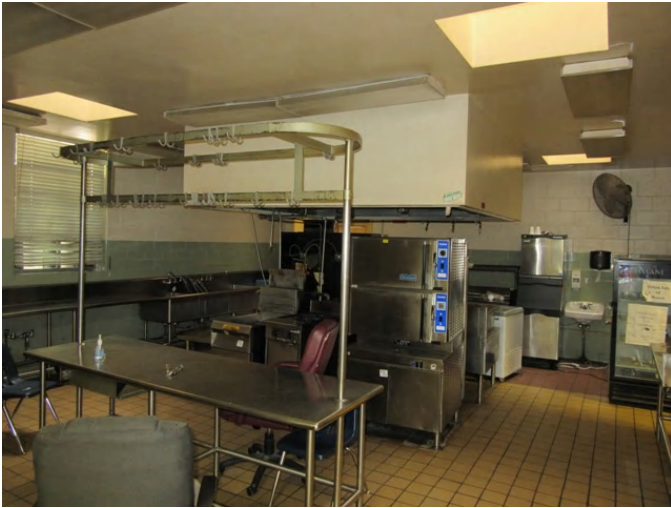
System: D3090 - Other HVAC Systems/Equip - Kitchen Hood

Location: Kitchen
Distress: Beyond Service Life
Category: Deferred Maintenance
Priority: 3 Priority
Correction: Renew System
Qty: 42,533.00
Unit of Measure: S.F.
Estimate: \$57,547.00
Assessor Name: Ben Nixon
Date Created: 04/11/2015

Notes: The kitchen hood system is beyond its expected service life and should be scheduled for replacement.

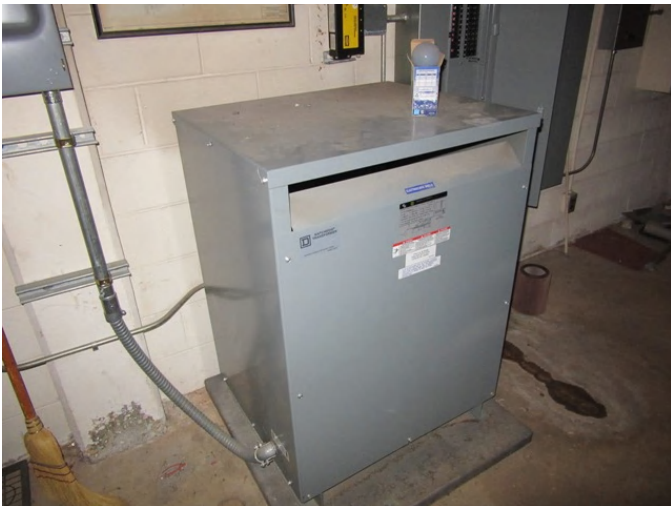
System: D5010 - Electrical Service/Distribution

Location: Main Switch Room/Throughout Building
Distress: Beyond Service Life
Category: Deferred Maintenance
Priority: 3 Priority
Correction: Renew System
Qty: 42,533.00
Unit of Measure: S.F.
Estimate: \$84,683.00
Assessor Name: Sam Mandola
Date Created: 04/11/2015

Notes: The electrical service/distribution system is beyond its expected service life and should be scheduled for replacement. SPLOST project 421-422 to replace the electrical service and distribution system.

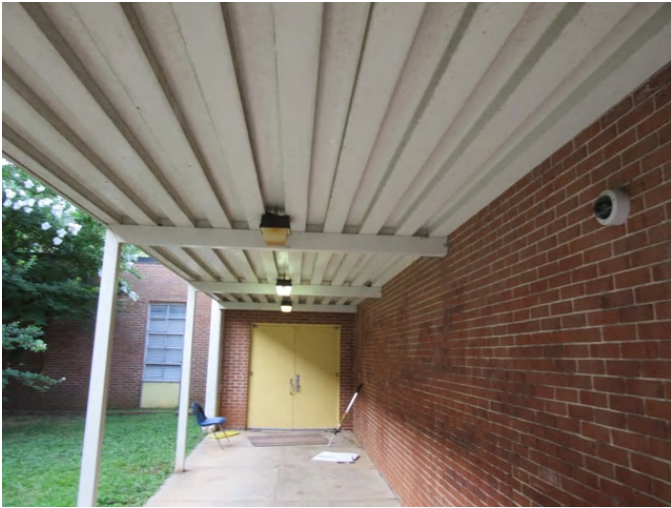
System: D5020 - Branch Wiring

Location: Throughout Building

Distress: Beyond Service Life

Notes: The branch wiring system is beyond its expected service life, no longer supports modern electronic systems, and should be scheduled for replacement.

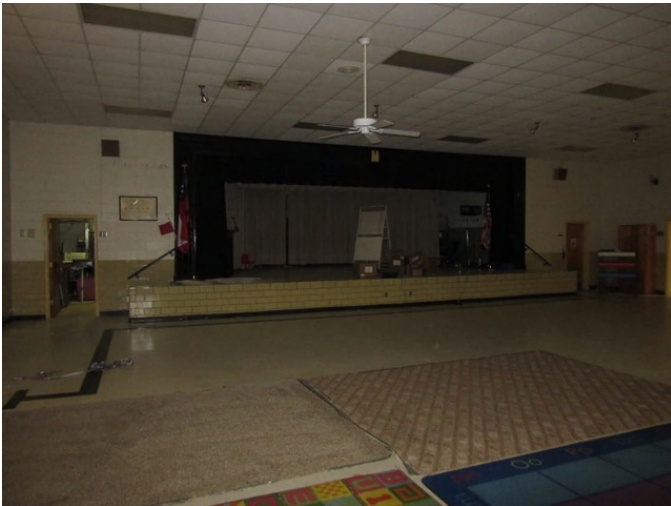
System: F1020 - Institutional Equipment

Location: Throughout Building

Distress: Beyond Service Life

Notes: Institutional equipment, such as theater and stage equipment, library equipment and audio-visual equipment, is beyond its expected service life and should be scheduled for replacement.

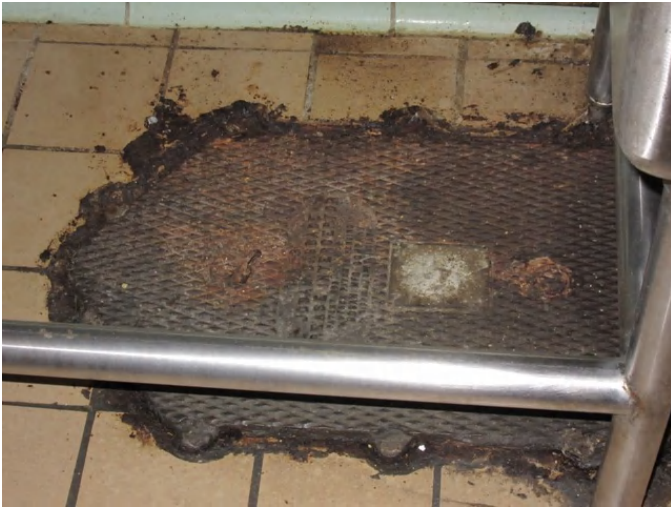
System: E1090 - Other Equipment - Kitchen Equipment

Location: Kitchen

Distress: Beyond Service Life

Notes: Kitchen equipment is beyond its expected service life and should be scheduled for replacement. The grease trap and backflow preventer are scheduled for replacement under the SPLOST IV program.

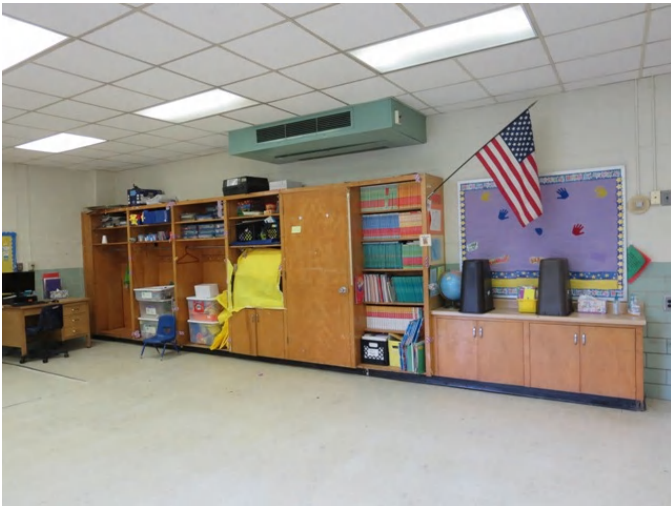
System: E2010 - Fixed Furnishings

Location: Throughout Building

Distress: Beyond Service Life

Notes: Fixed furnishings, such as built-in cabinets, are beyond their expected service life and worn, and should be replaced.

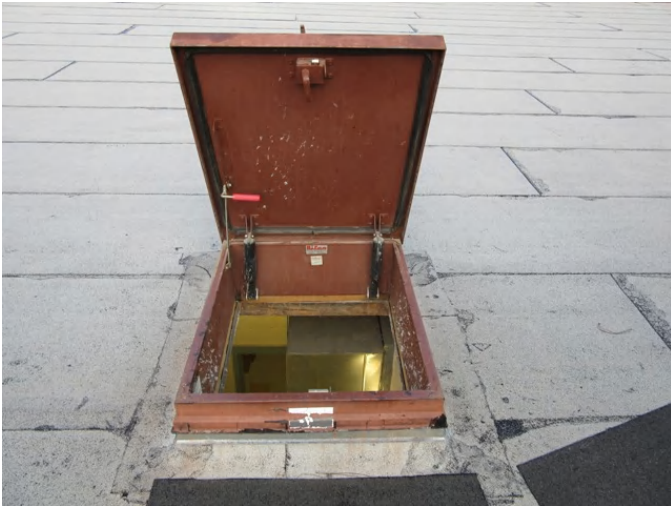
System: B3020 - Roof Openings

Location: Roof

Distress: Inadequate

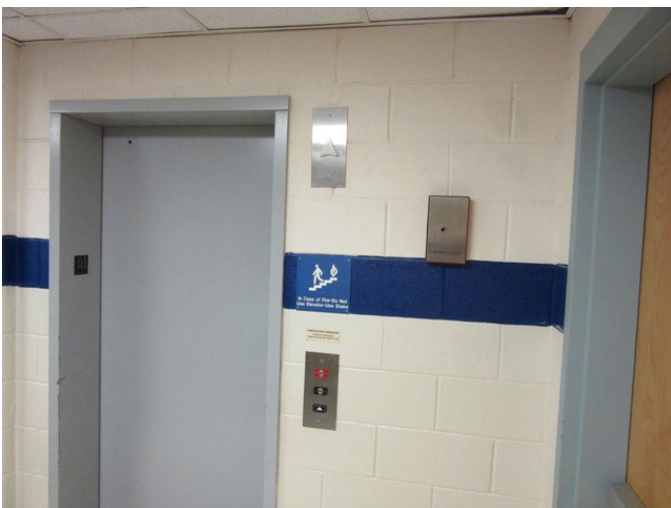
System: D1010 - Elevators and Lifts

Location: Southwest Corner

Distress: Damaged

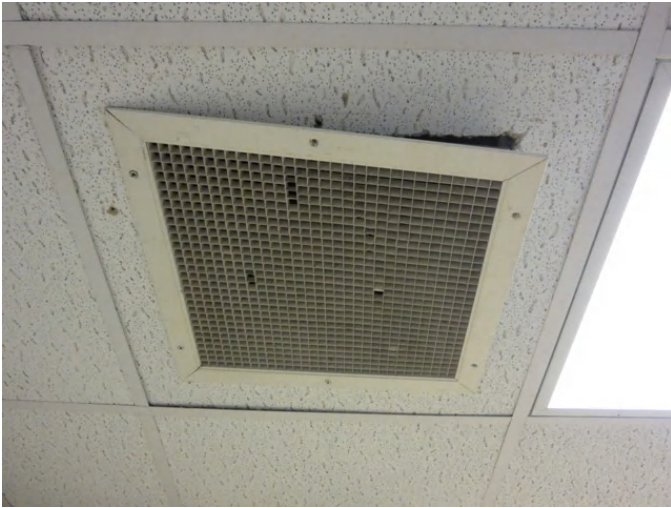
System: D3040 - Distribution & Exhaust Systems

Location: Restrooms

Distress: Damaged

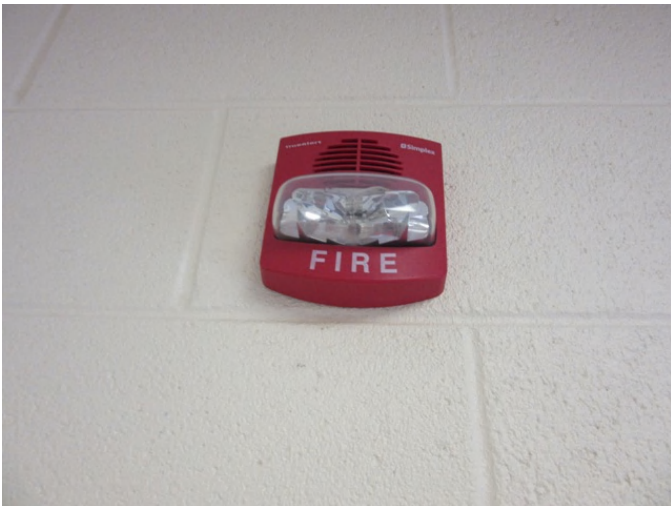
System: D5030 - Communications and Security - Fire Alarm

Location: Throughout Building

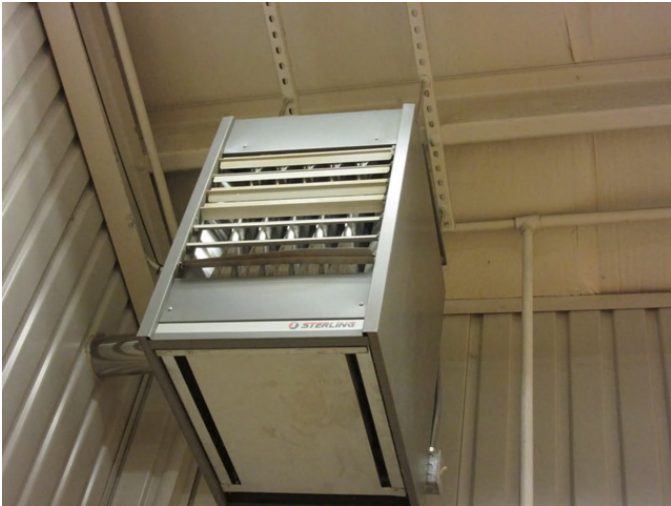
System: D3050 - Terminal & Package Units

Location: Throughout Building

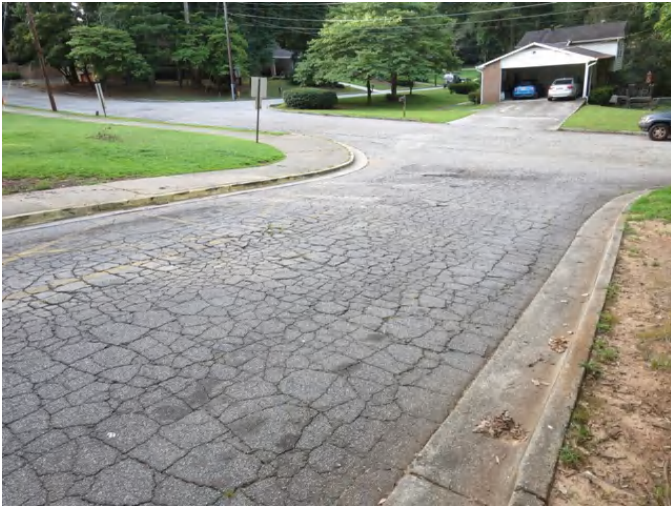
System: G2010 - Roadways

Location: Site

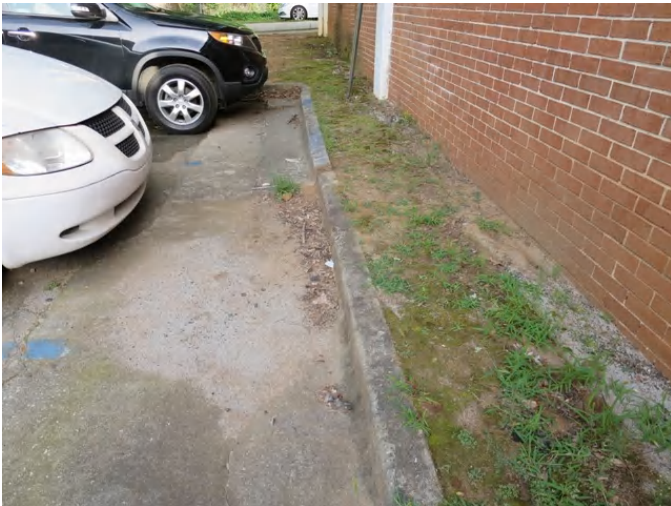
System: G2020 - Parking Lots

Location: East Side

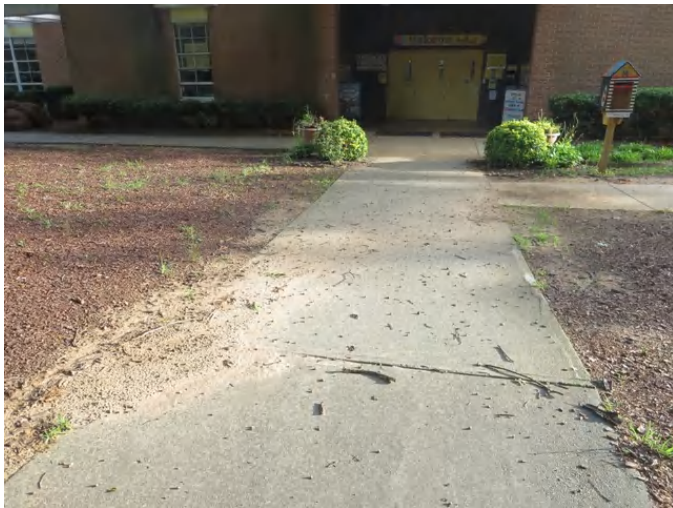
System: G2030 - Pedestrian Paving

Location: South and East Side of Site

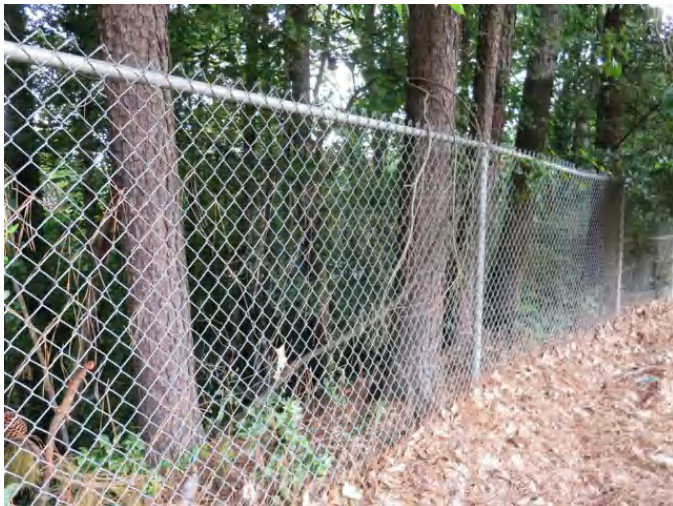
System: G2040 - Fencing & Guardrails

Location: Site

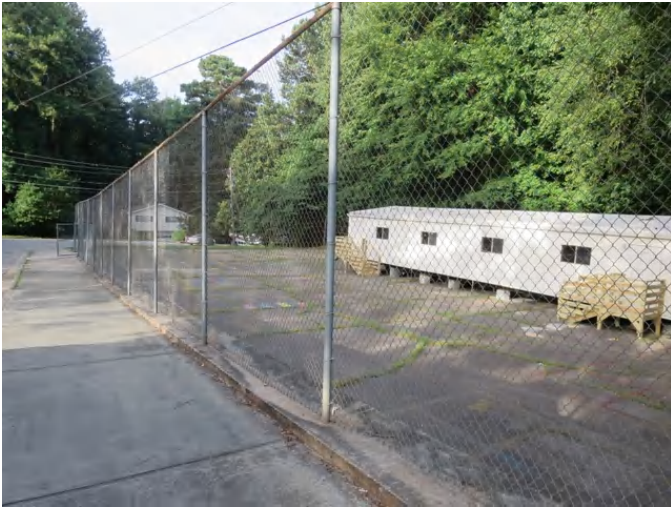
System: G2040 - Hard Surface Play Area

Location: West Side of Site

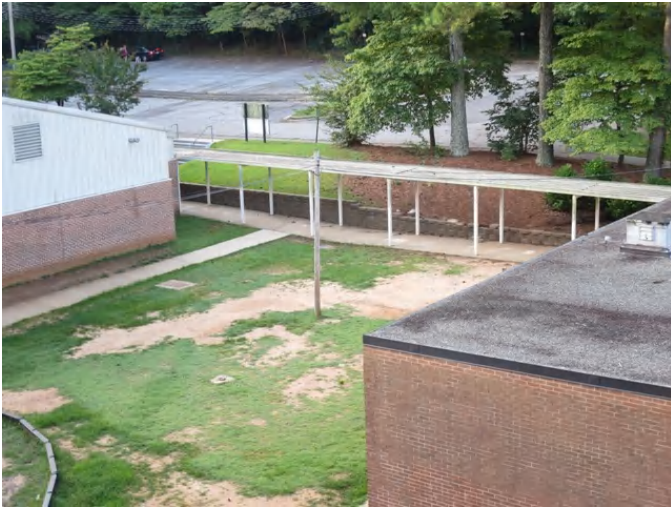
System: G2050 - Landscaping

Location: Site

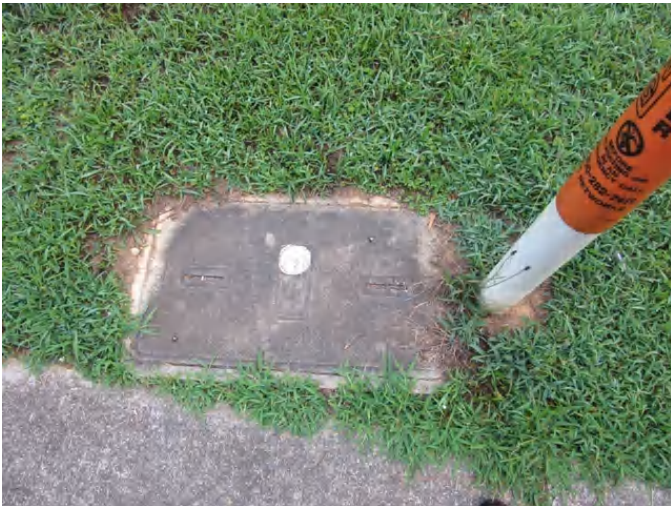
System: G4030 - Site Communications & Security

Location: Site
