DeKalb County School District/Elementary Schools

# Murphey Candler Elementary

## School Assessment Report

May 20, 2016

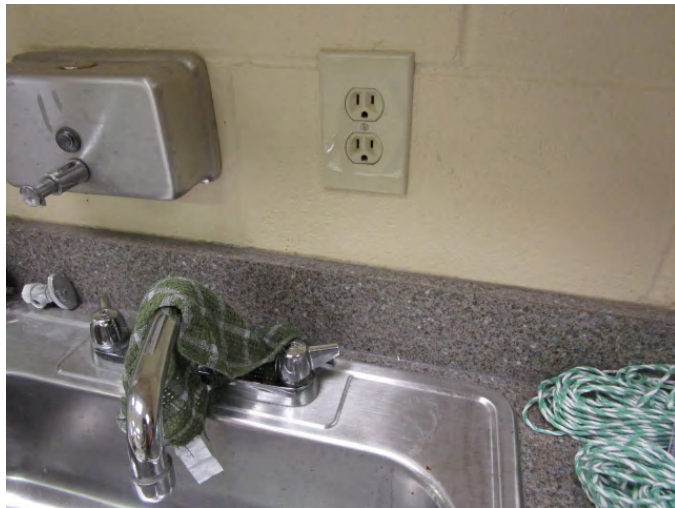
#### **System: D5020 - Branch Wiring**

**Location:** Throughout Building

**Distress:** Needs Remediation

**Notes:** Receptacles near sinks should be replaced with GFCI receptacles.

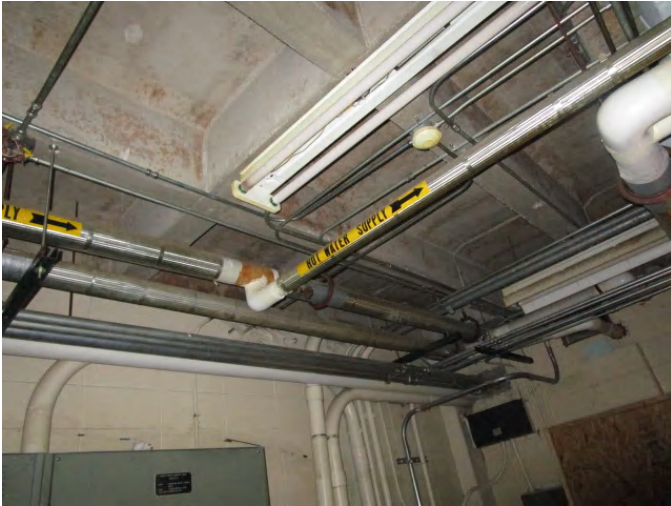
**System: D2020 - Domestic Water Distribution**

**Location:** Throughout Building

**Distress:** Beyond Service Life

**Notes:** The domestic water distribution system is beyond its expected service life, has water quality issues, and should be scheduled for replacement. SPLOST project 124-422 to replace the domestic water supply system.

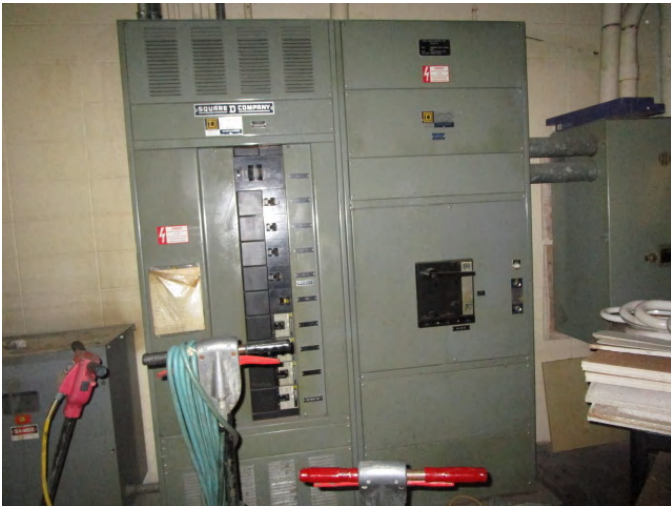
**System: D5010 - Electrical Service/Distribution**

**Location:** Main Switch Room/Throughout Building

**Distress:** Beyond Service Life

**Notes:** The electrical service/distribution system is beyond its expected service life and should be scheduled for replacement. There are a number of code issues, including water pipes directly above the main panel.

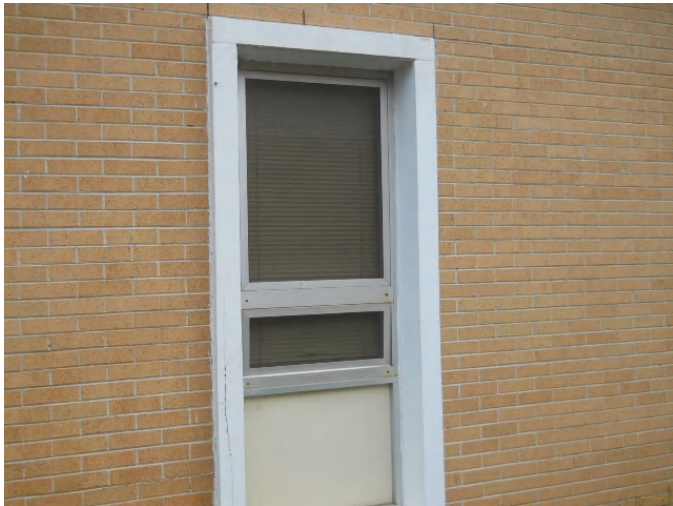
**System: B2020 - Exterior Windows**

**Location:** Throughout Building

**Distress:** Beyond Service Life

**Notes:** The exterior window systems are original to the building and addition construction dates. The systems are beyond expected life and should be replaced.

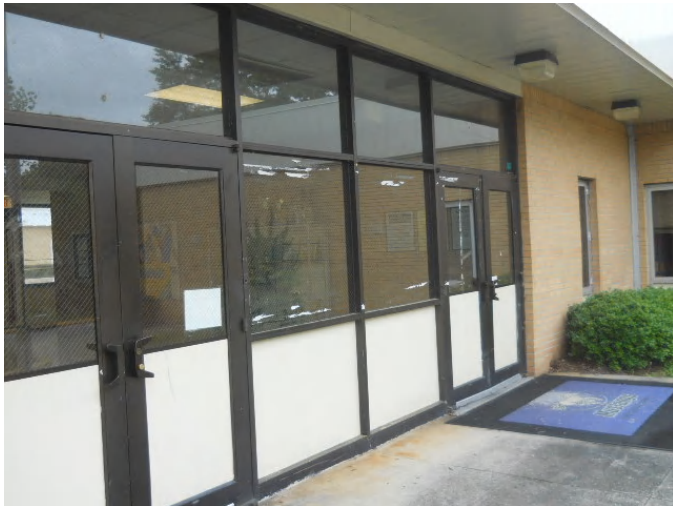
**System: B2030 - Exterior Doors**

**Location:** Throughout Building

**Distress:** Beyond Service Life

**Notes:** The exterior door system is original, beyond its expected service life, and should be replaced.

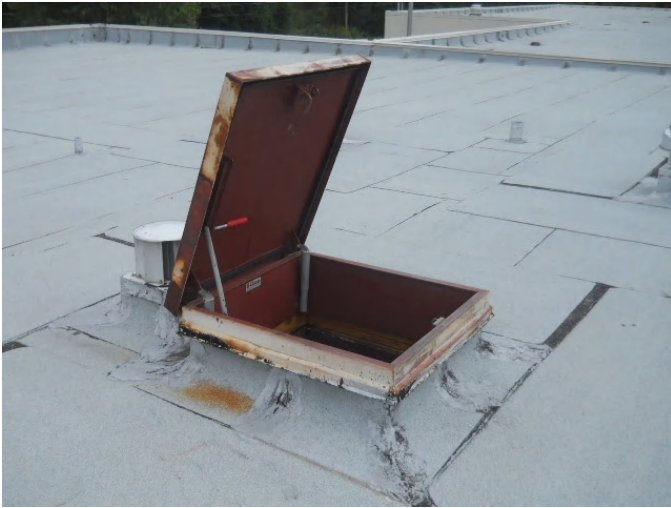
**System: B3020 - Roof Openings**

**Location:** Roof

**Distress:** Beyond Service Life

**Notes:** Roof openings are original to the 1975 building addition. The roof hatch should be replaced with a new hatch with the proper safety ladder.

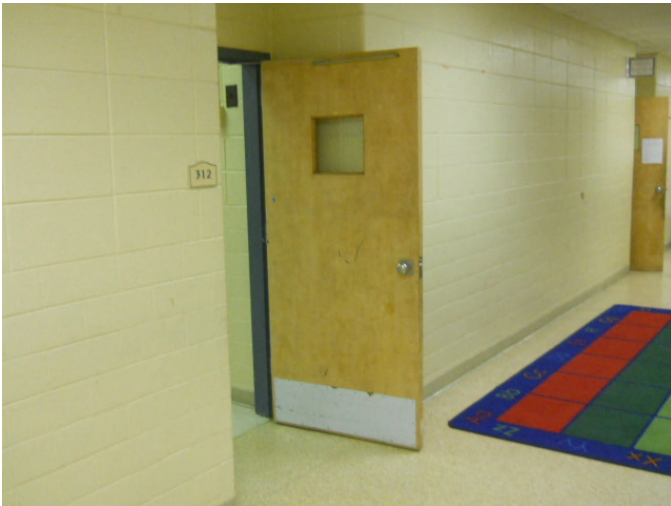
**System: C1020 - Interior Doors**

**Location:** Throughout Building

**Distress:** Beyond Service Life

**Notes:** Interior doors are beyond their expected service life, not ADA or building code compliant, and should be replaced.

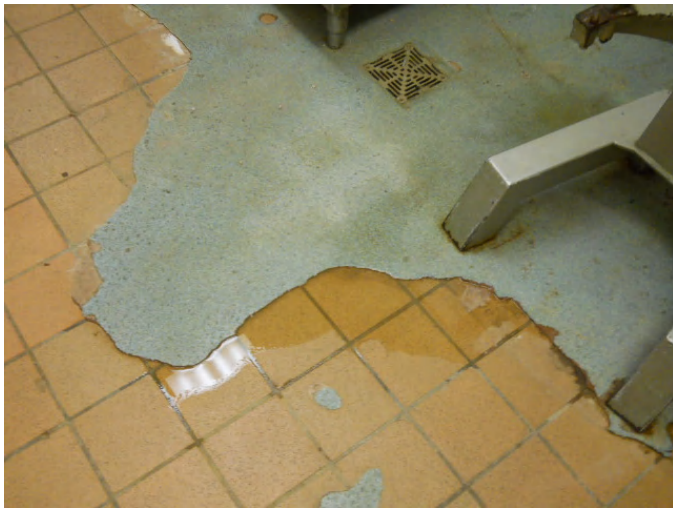
**System: C3020 - Floor Finishes - Ceramic & Quarry Tile**

**Location:** Kitchen and Restrooms

**Distress:** Damaged

**Notes:** The tile flooring has been covered with another floor surface that has failed. The floor is damaged and should be replaced.

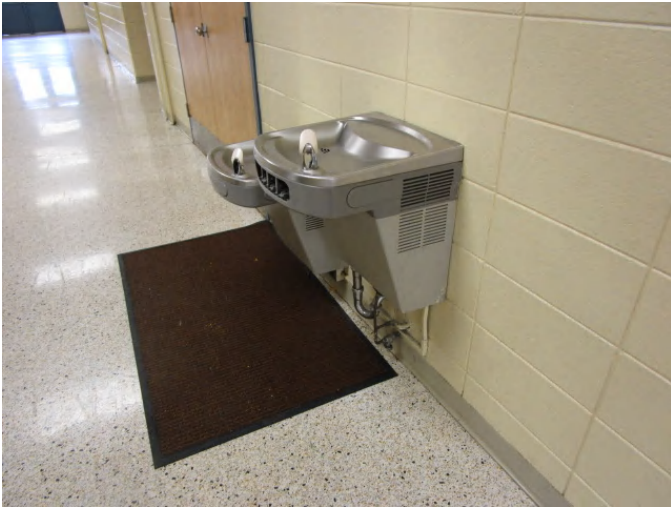
**System: D2010 - Plumbing Fixtures**

**Location:** Hallways

**Distress:** Needs Remediation

**Correction:** Remove/replace drinking fountain w/recessed ADA compliant drinking fountain

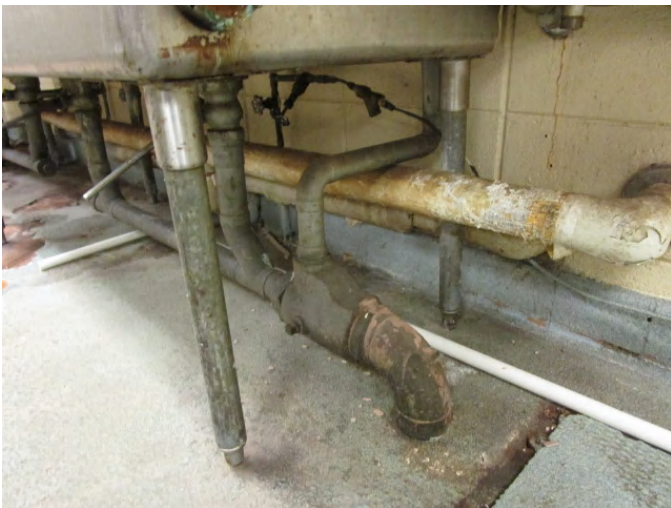
**System: D2030 - Sanitary Waste**

**Location:** Throughout Building

**Distress:** Beyond Service Life

**Notes:** The sanitary waste system is beyond its expected service life and should be scheduled for replacement.

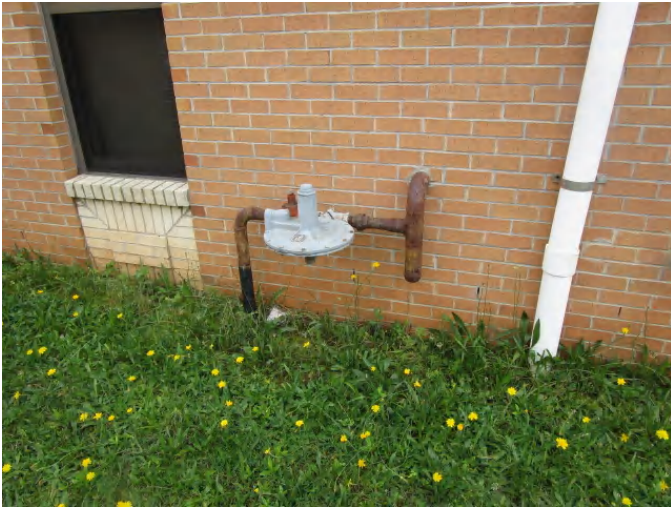
**System: D2090 - Other Plumbing Systems - Natural Gas**

**Location:** Throughout Building

**Distress:** Beyond Service Life

**Notes:** The natural gas system is beyond its expected service life and should be scheduled for replacement. SPLOST IV scope includes replacing the grease trap and backflow preventer.

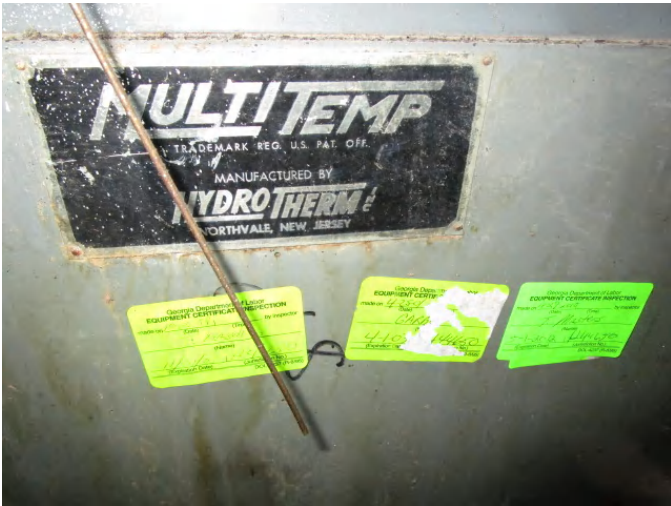
**System: D3020 - Heat Generating Systems**

**Location:** Mechanical Room

**Distress:** Beyond Service Life

**Notes:** The heat generating system is beyond its expected service life and should be scheduled for replacement.

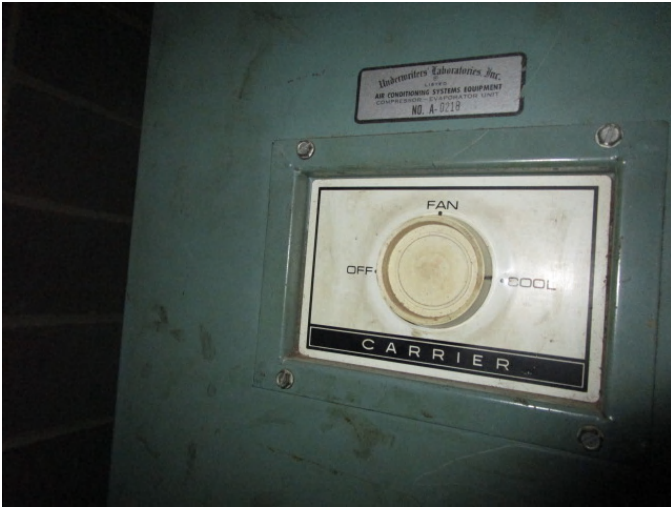
**System: D3040 - Distribution & Exhaust Systems**

**Location:** Throughout Building

**Distress:** Beyond Service Life

**Notes:** The distribution and exhaust systems are beyond their expected service life and should be scheduled for replacement. SPLOST project 124-422 to replace the air distribution and exhaust systems throughout the building.

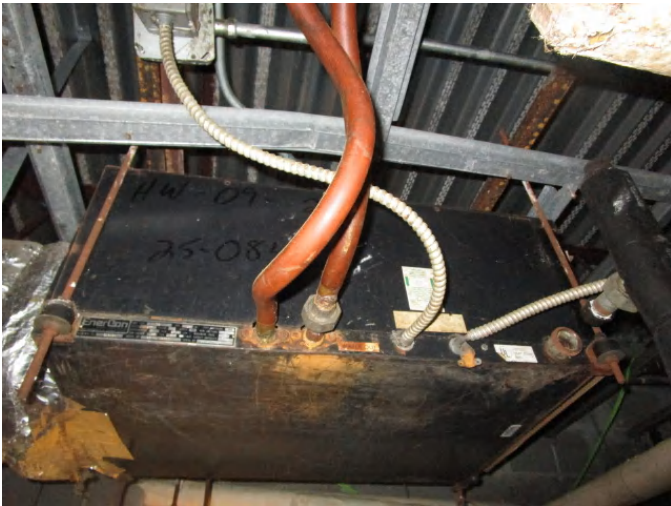
**System: D3050 - Terminal & Package Units**

**Location:** Throughout Building

**Distress:** Beyond Service Life

**Notes:** The water source terminal and package units are beyond their expected service life and should be scheduled for replacement. SPLOST IV scope includes replacing the package unit in the special education hall.

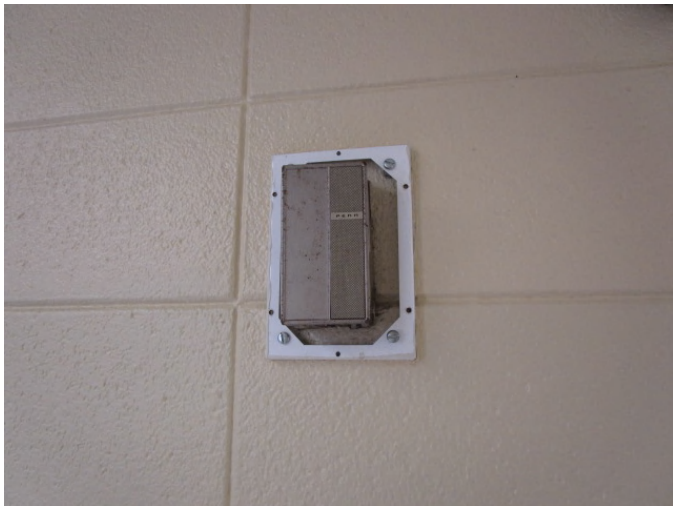
**System: D3060 - Controls & Instrumentation**

**Location:** Throughout Building

**Distress:** Beyond Service Life

**Notes:** The controls and instrumentation system is beyond its expected service life and should be scheduled for replacement.

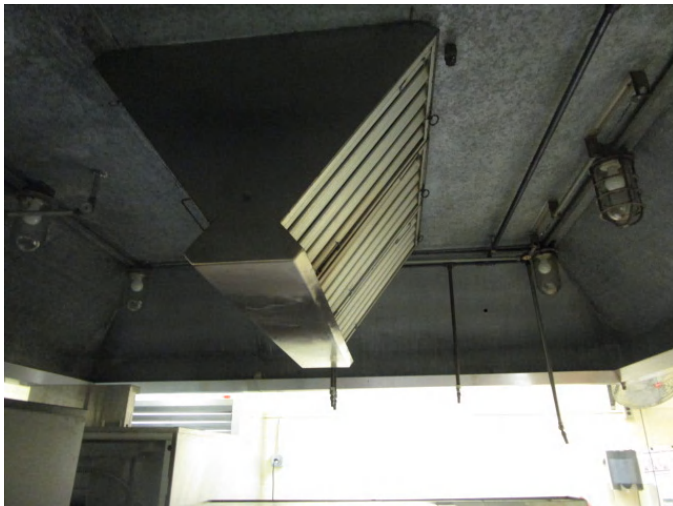
**System: D3090 - Other HVAC Systems/Equip - Kitchen Hood**

**Location:** Kitchen

**Distress:** Beyond Service Life

**Notes:** The kitchen hood system is beyond its expected service life and should be scheduled for replacement.

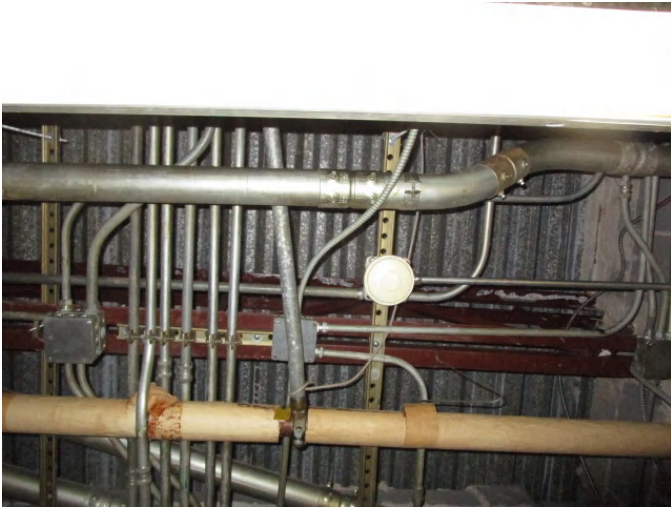
**System: D5020 - Branch Wiring**

**Location:** Throughout Building  
**Distress:** Beyond Service Life  
**Category:** Deferred Maintenance  
**Priority:** 3 Priority  
**Correction:** Renew System  
**Qty:** 49,390.00  
**Unit of Measure:** S.F.  
**Estimate:** \$368,351.00  
**Assessor Name:** Ben Nixon  
**Date Created:** 04/11/2015

**Notes:** The branch wiring system is beyond its expected service life, inadequate, and should be scheduled for replacement. More electrical outlets are required to server computers.

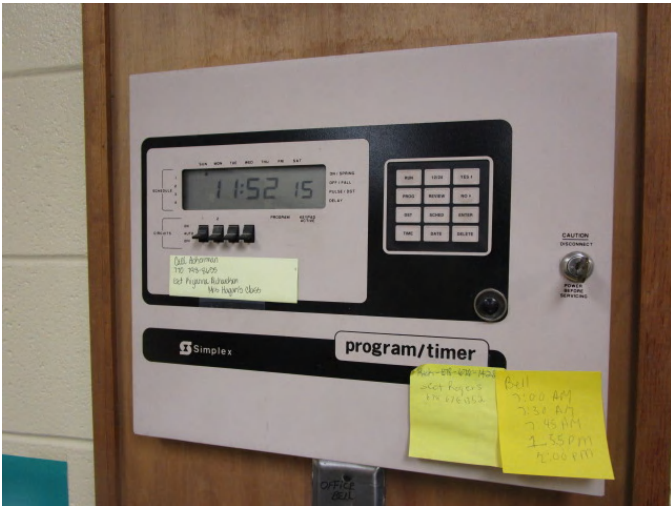
**System: D5030 - Communications and Security - Clock & PA Systems**

**Location:** Throughout Building  
**Distress:** Beyond Service Life  
**Category:** Deferred Maintenance  
**Priority:** 3 Priority  
**Correction:** Renew System  
**Qty:** 49,390.00  
**Unit of Measure:** S.F.  
**Estimate:** \$304,242.00  
**Assessor Name:** Ben Nixon  
**Date Created:** 05/28/2015

**Notes:** Clock and PA systems are beyond their expected service life and should be scheduled for replacement.

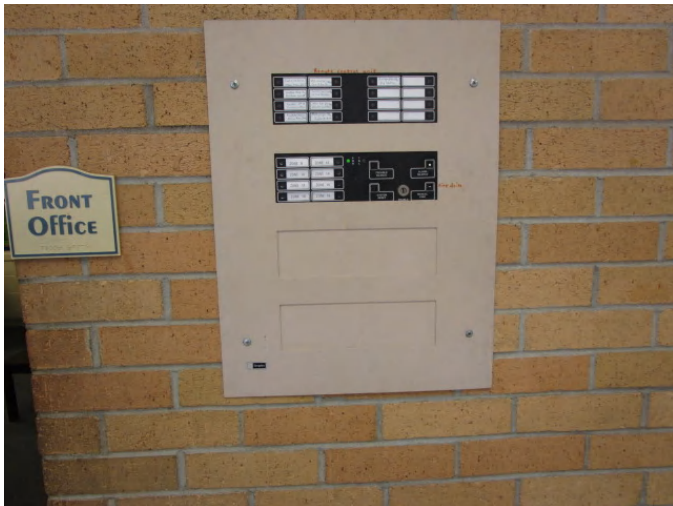
**System: D5030 - Communications and Security - Fire Alarm**

**Location:** Throughout Building

**Distress:** Beyond Service Life

**Notes:** The fire alarm system is beyond its expected service life and should be scheduled for replacement.

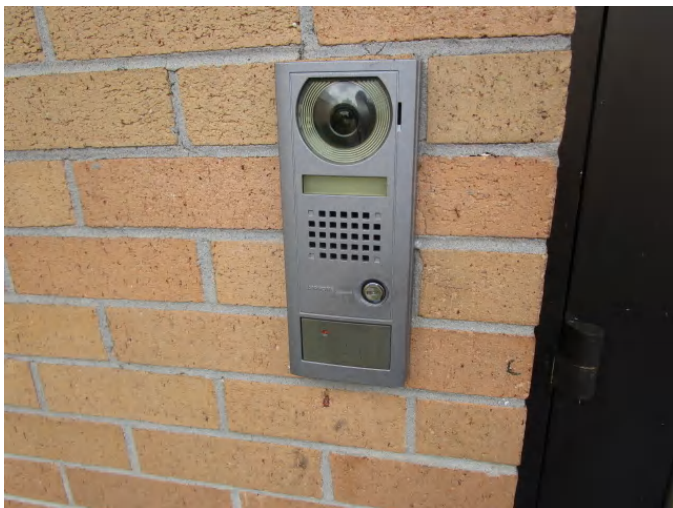
**System: D5030 - Communications and Security - Security & CCTV**

**Location:** Throughout Building

**Distress:** Beyond Service Life

**Notes:** The security and CCTV systems are beyond their expected service life and should be scheduled for replacement.

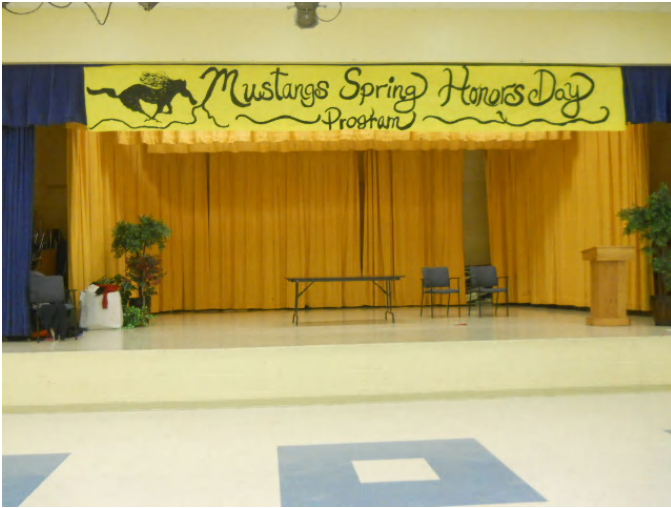
**System: E1020 - Institutional Equipment**

**Location:** Throughout Building

**Distress:** Beyond Service Life

**Notes:** Institutional equipment, such as theater and stage equipment, library equipment and audio-visual equipment, is beyond its expected service life and should be replaced.

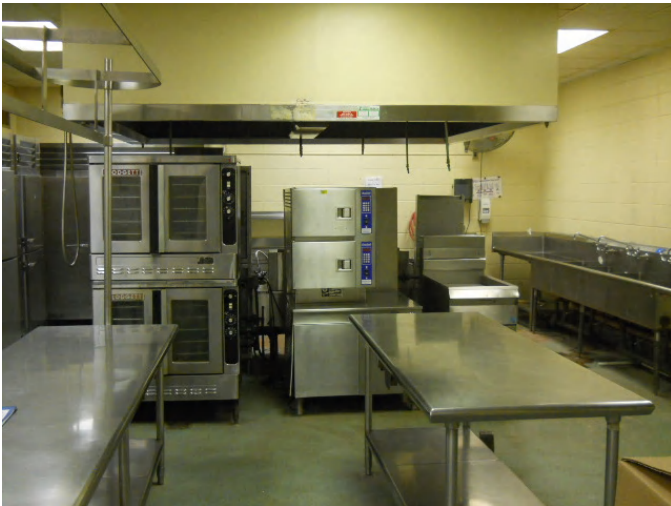
**System: E1090 - Other Equipment - Kitchen Equipment**

**Location:** Kitchen

**Distress:** Beyond Service Life

**Notes:** Kitchen equipment is beyond its expected service life and should be scheduled for replacement.

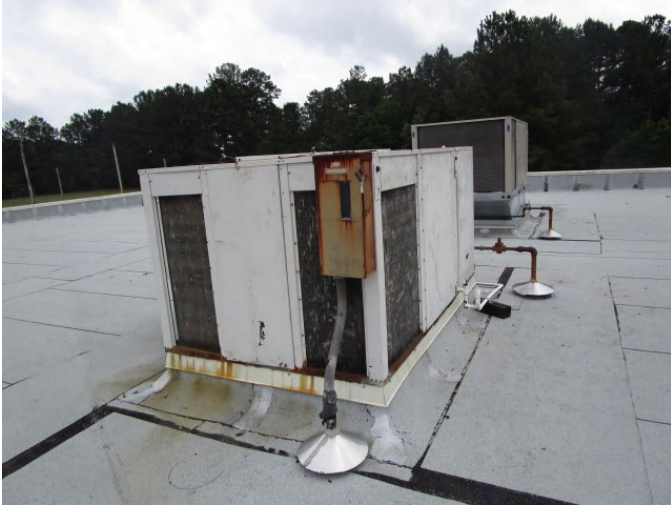
#### System: D3050 - Terminal & Package Units

**Location:** Roof

**Distress:** Beyond Service Life

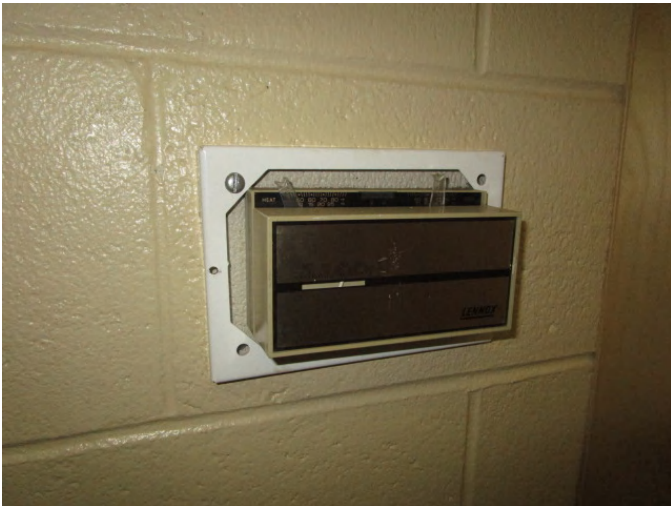
#### System: D3060 - Controls & Instrumentation

**Location:** Throughout Building

**Distress:** Beyond Service Life

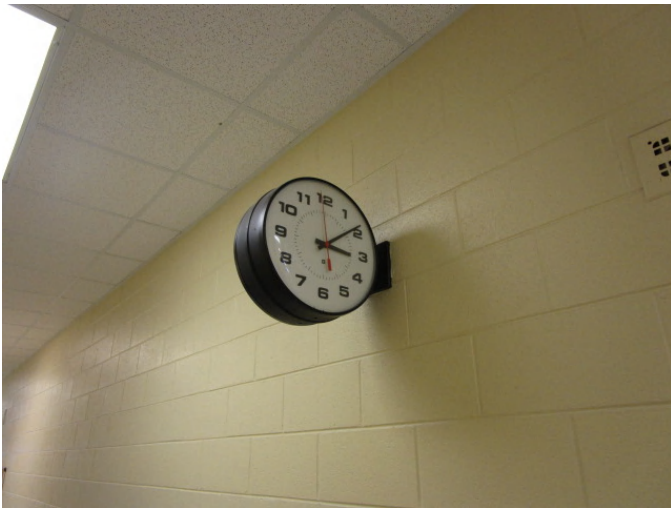
**System: D5030 - Communications and Security - Clock & PA Systems**

**Location:** Throughout Building

**Distress:** Beyond Service Life

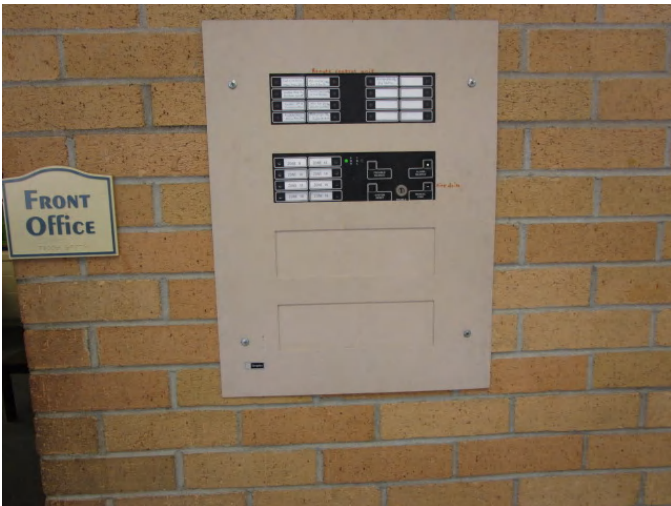
**System: D5030 - Communications and Security - Fire Alarm**

**Location:** Throughout Building

**Distress:** Beyond Service Life

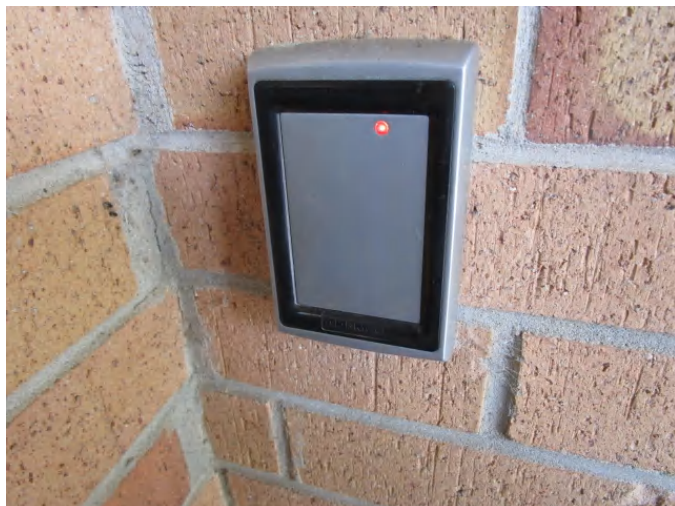
**System: D5030 - Communications and Security - Security & CCTV**

**Location:** Throughout Building

**Distress:** Beyond Service Life

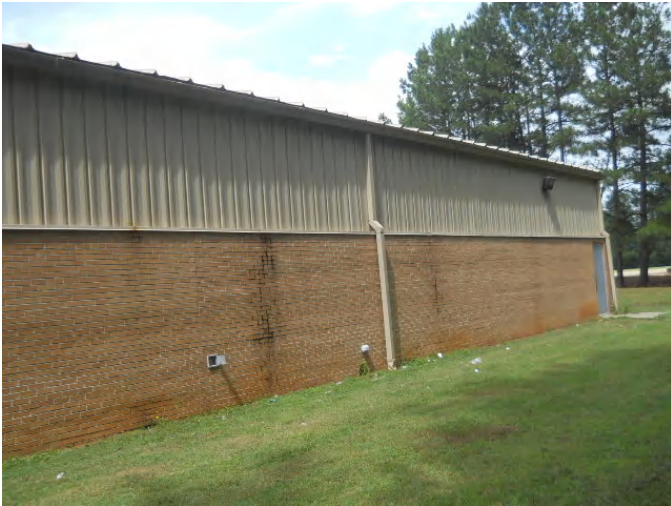
#### **System: B3010 - Roof Coverings - Standing Seam Metal**

**Location:** Roof

**Distress:** Damaged

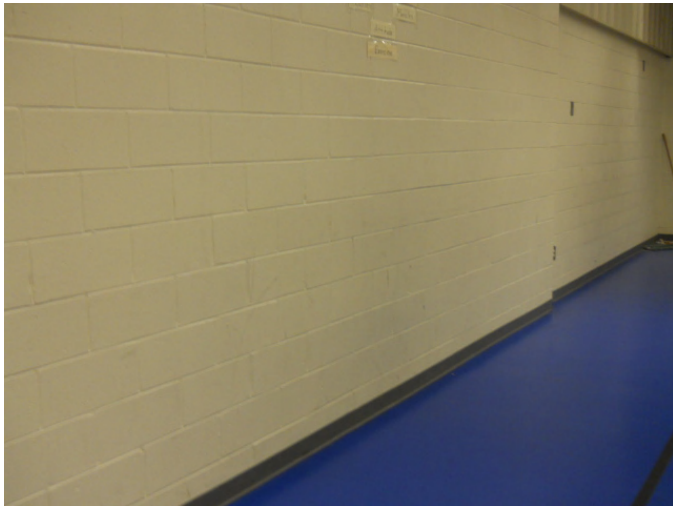
**System: C3010 - Wall Finishes - Paint**

**Location:** Throughout Building

**Distress:** Beyond Service Life

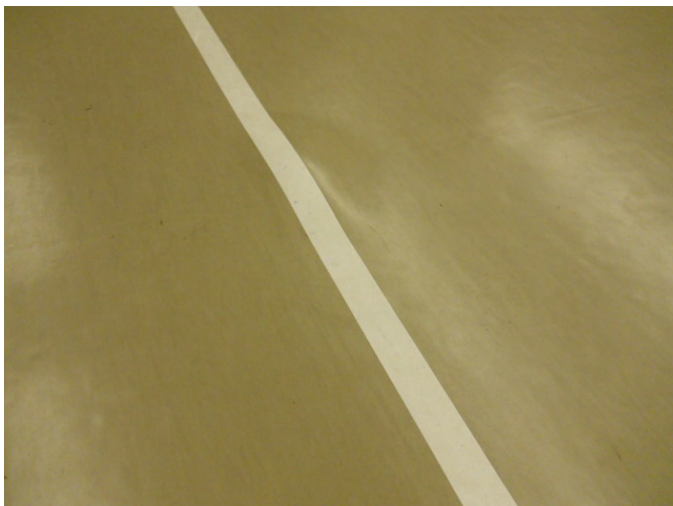
**System: C3020 - Floor Finishes - Neoprene**

**Location:** Basketball Court

**Distress:** Beyond Service Life

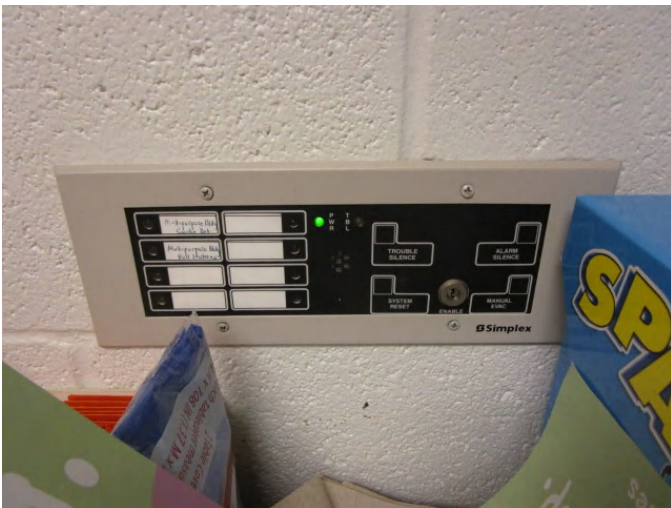
**System: D5030 - Communications and Security - Fire Alarm**

**Location:** Throughout Building

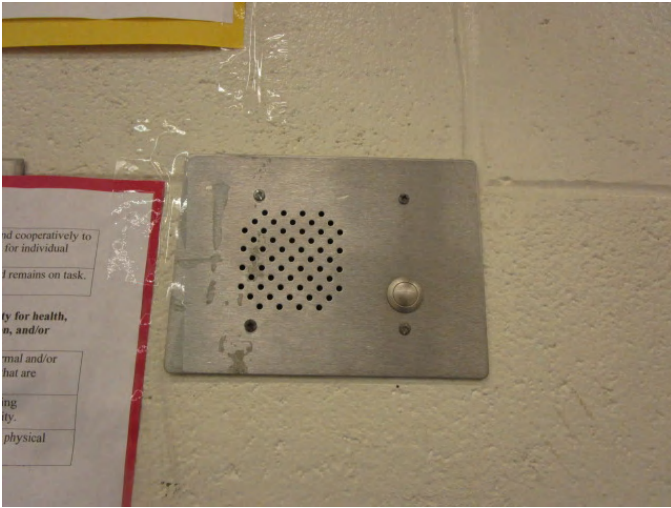
**System: D5030 - Communications and Security - Public Address & Clock System**

**Location:** Throughout Building

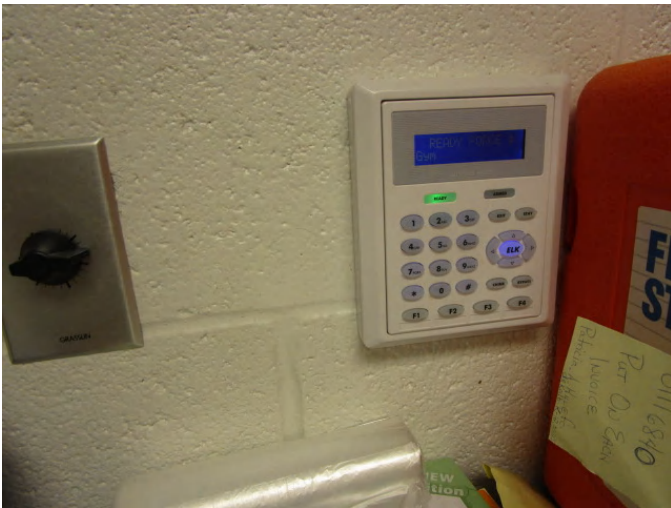
**System: D5030 - Communications and Security - Security & CCTV**

**Location:** Throughout Building

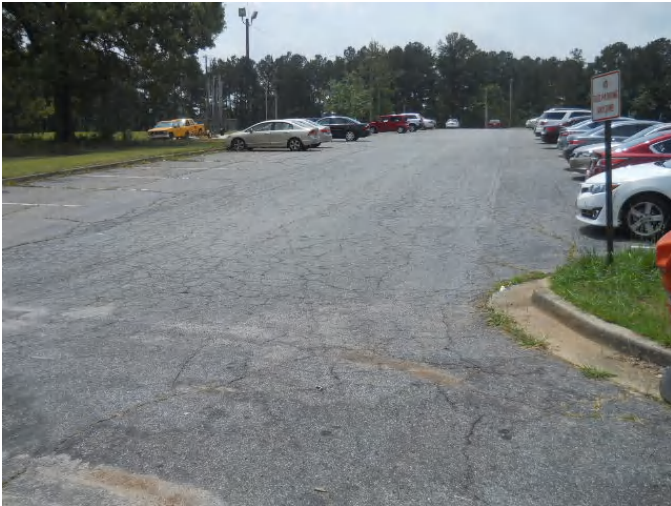
#### System: G2010 - Roadways

**Location:** Site

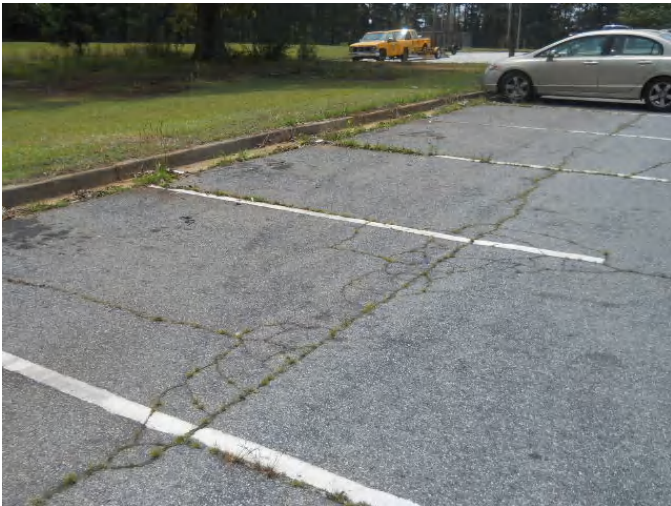
#### System: G2020 - Parking Lots

**Location:** Site

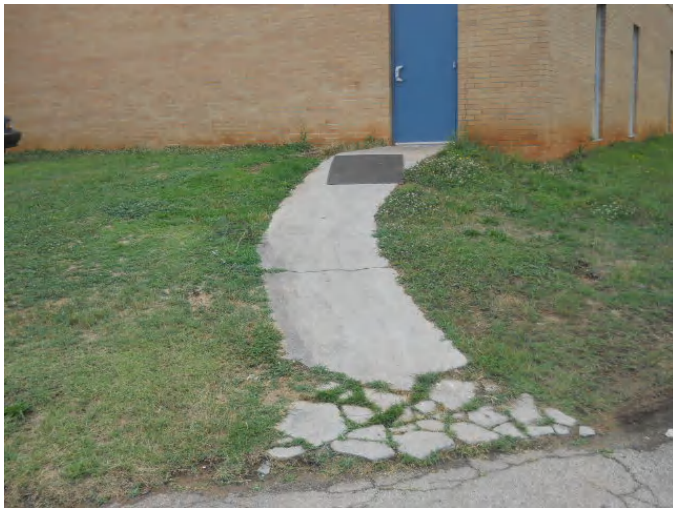
**System: G2030 - Pedestrian Paving**

**Location:** Site

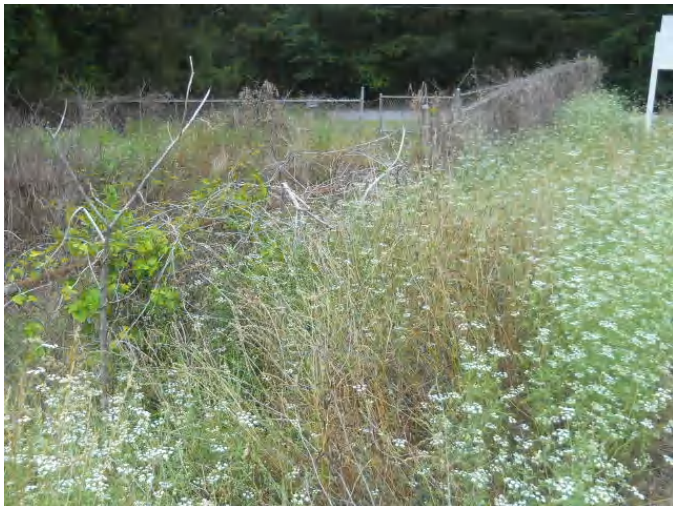
**System: G2040 - Fencing & Guardrails**

**Location:** Site

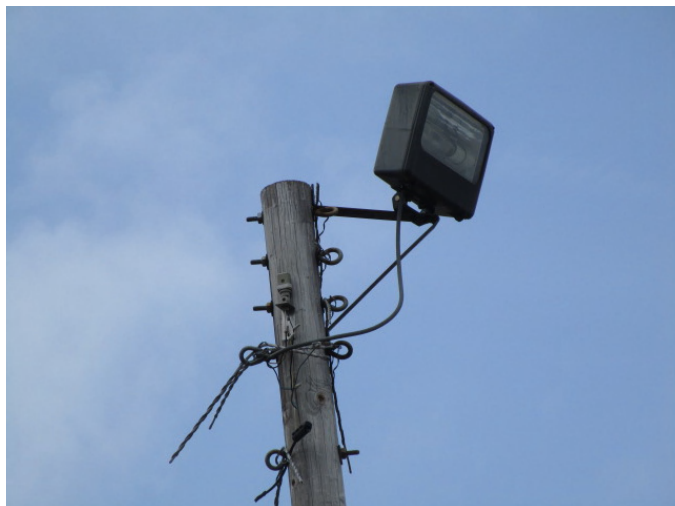
**System: G4020 - Site Lighting**

**Location:** Site
