DeKalb County School District/Elementary Schools

Narvie Harris Elementary

School Assessment Report

May 20, 2016

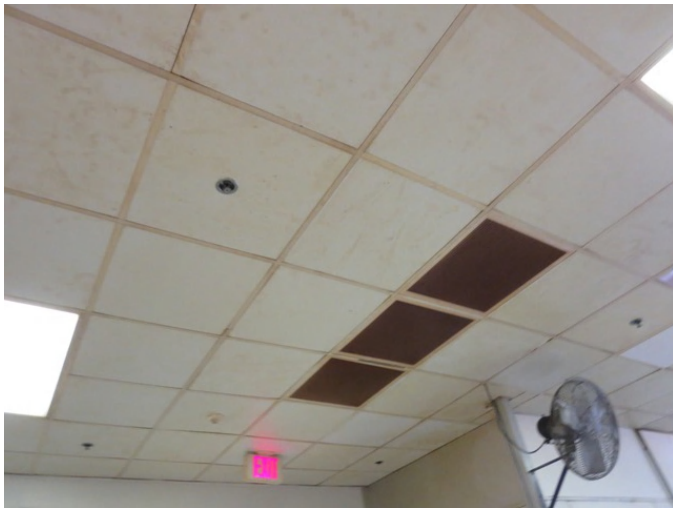
System: C3030 - Ceiling Finishes

Location: Kitchen

Distress: Damaged

Notes: The acoustical ceiling system is damaged due to the kitchen environment and should be replaced.

Correction: Replace acoustic tile ceiling, fire-rated

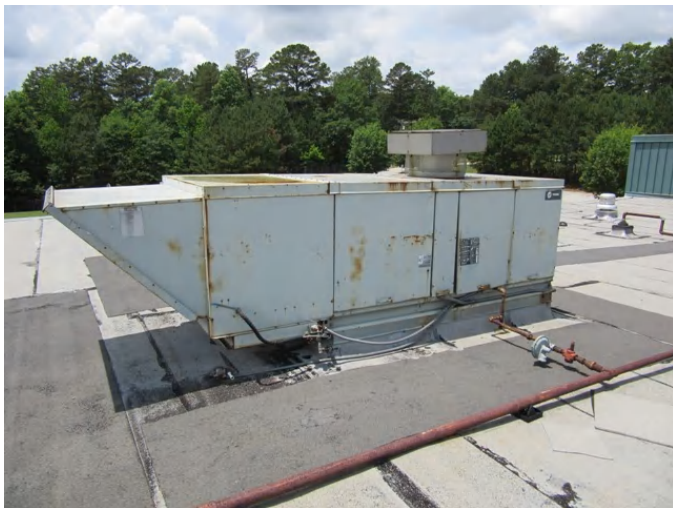
System: D3050 - Terminal & Package Units

Location: Roof

Distress: Beyond Service Life

Notes: The terminal and package units are beyond their expected service life, show significant wear to major and minor components, and should be scheduled for replacement.

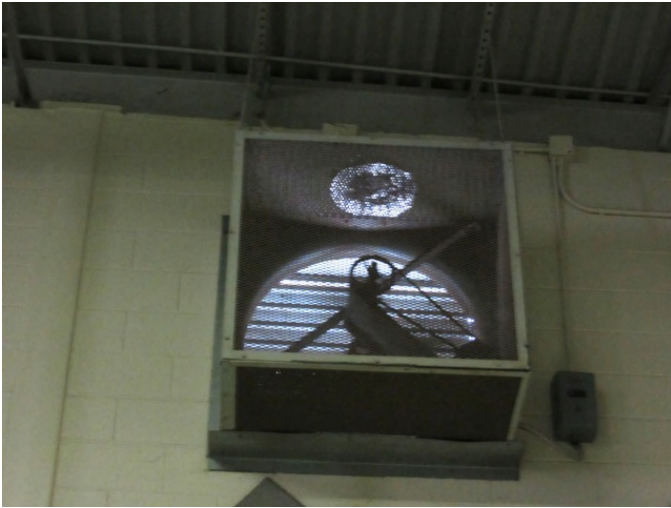
System: D3050 - Terminal & Package Units

Location: Throughout Building

Distress: Inadequate

Notes: The cooling system in the gym building consist of cross ventilation fans and should be upgraded to include a packaged DX unit.

Correction: Replace air conditioner, DX, 20 ton

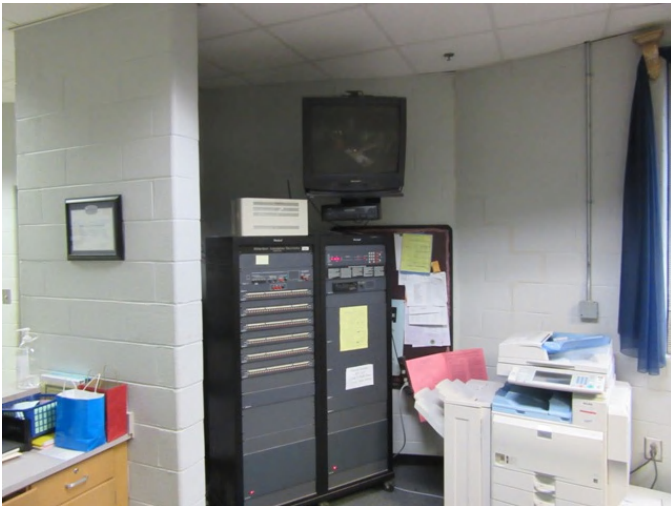
System: D5030 - Communications and Security - Clock & PA Systems

Location: Throughout Building

Distress: Beyond Service Life

Notes: Clock and PA systems are beyond their expected service life, inadequate, and should be scheduled for replacement.

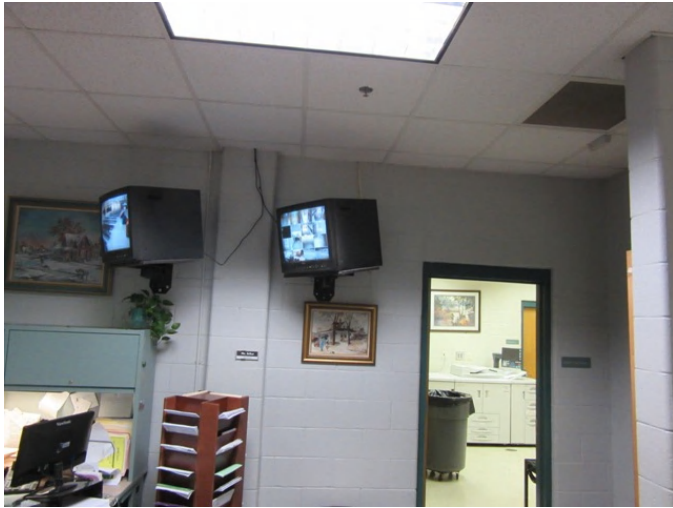
System: D5030 - Communications and Security - Security & CCTV

Location: Throughout Building

Distress: Beyond Service Life

Notes: The security and CCTV systems are beyond their expected service life, inadequate, and should be scheduled for replacement.

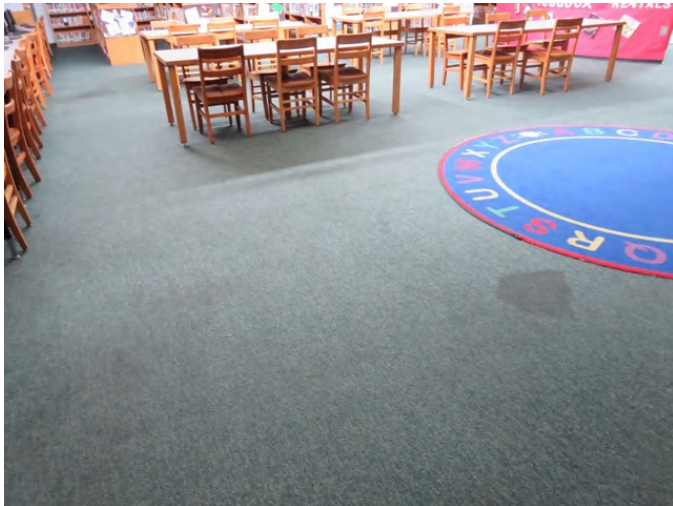
System: C3020 - Floor Finishes - Carpet

Location: Media Center, Music

Distress: Beyond Service Life

Notes: The carpet in the media center and music room is stained, showing signs of failure, and should be replaced.

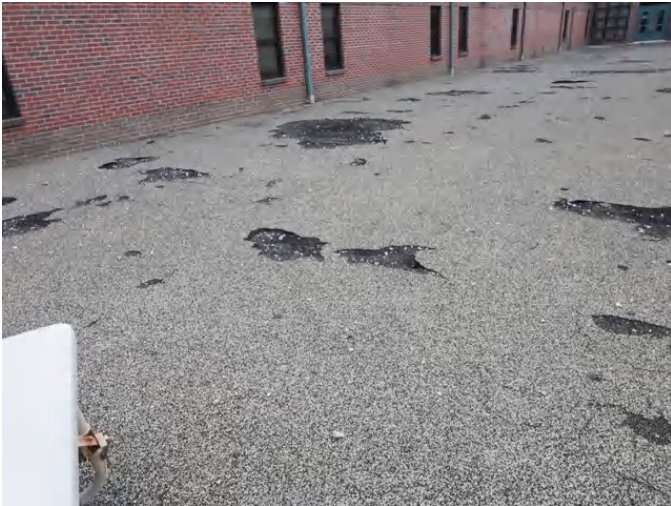
System: G2040 - Soft Surface Play Area

Location: North Side Courtyard

Distress: Beyond Service Life

Notes: The soft play surface is beyond its expected service life, has several holes and should be replaced, as it is a trip hazard.

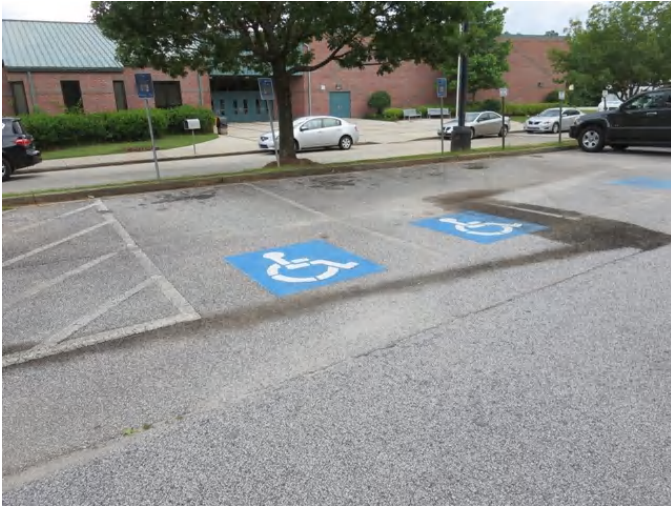
System: G2010 - Roadways

Location: Parking Lot

Distress: Missing

Notes: Provide ADA striping at handicap roadway crossing to comply with ADA standards.

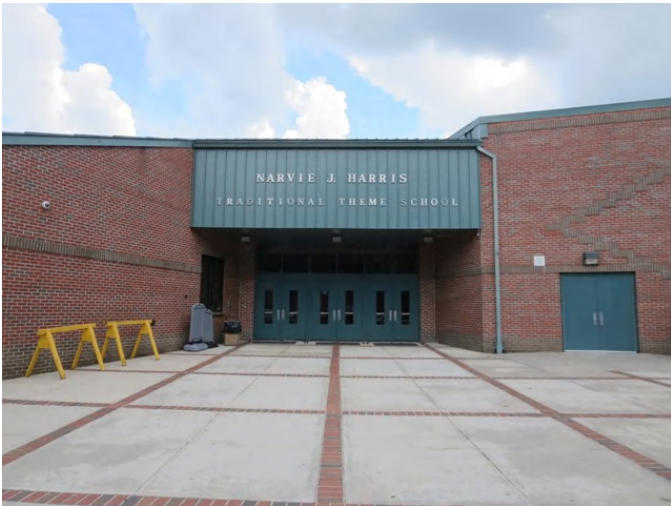
System: G4030 - Site Communications & Security

Location: Site

Distress: Beyond Service Life

Notes: The site communications and security systems are beyond their expected service life and should be scheduled for replacement.
