DeKalb County School District/Elementary Schools

Oak Grove Elementary

School Assessment Report

May 20, 2016

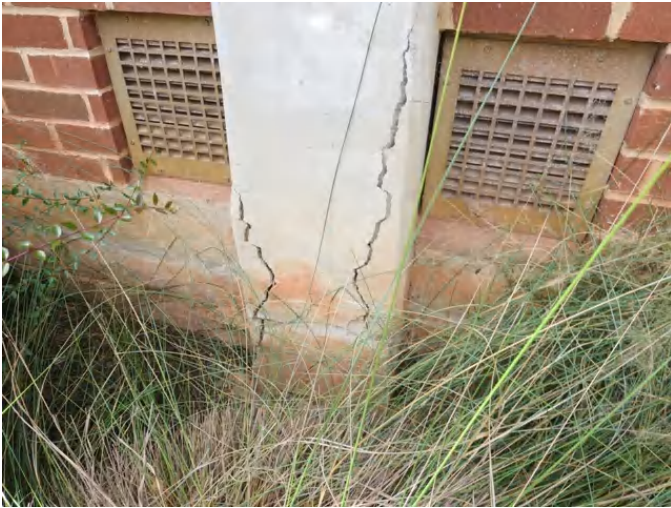
System: B2010 - Exterior Walls

Location: Throughout Building

Distress: Damaged

Notes: Exterior columns show signs of failure and an engineering study is recommended to determine the cause. Pricing does not include remediation measures.

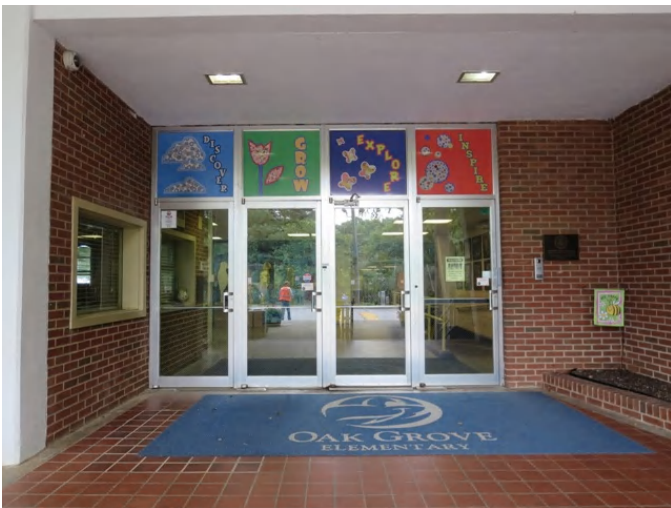
System: B2030 - Exterior Doors

Location: Throughout Building

Distress: Beyond Service Life

Notes: The original exterior doors are aged, rusted, do not operate properly, and should be replaced.

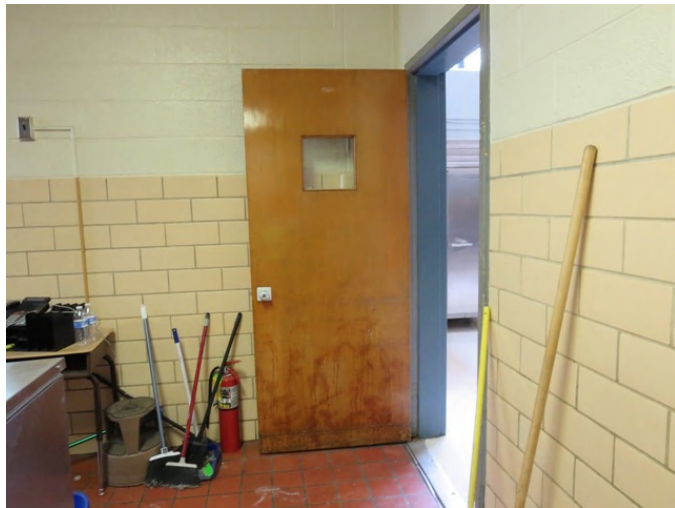
System: C1020 - Interior Doors

Location: Throughout Building

Notes: The interior doors are aged, failing, not ADA or building code compliant, and should be replaced.

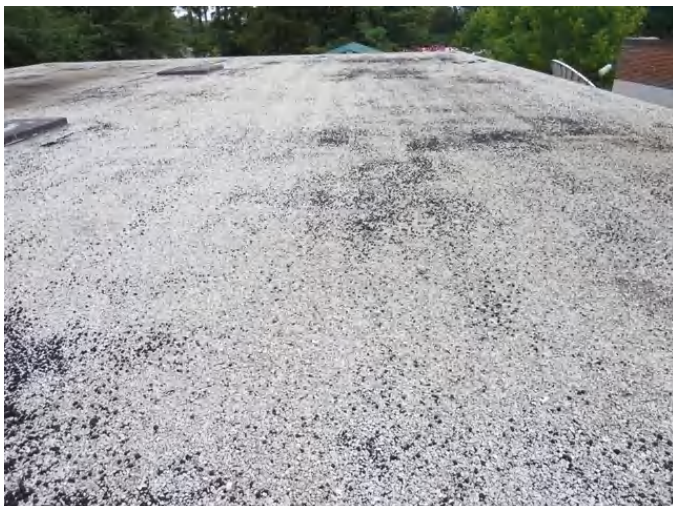
System: B3010 - Roof Coverings - BUR

Location: Roof

Notes: The built-up roof covering is aged, showing signs of failure, and should be replaced. SPLOST project 422-422 to replace the roofs on 1958 and 1963 buildings.

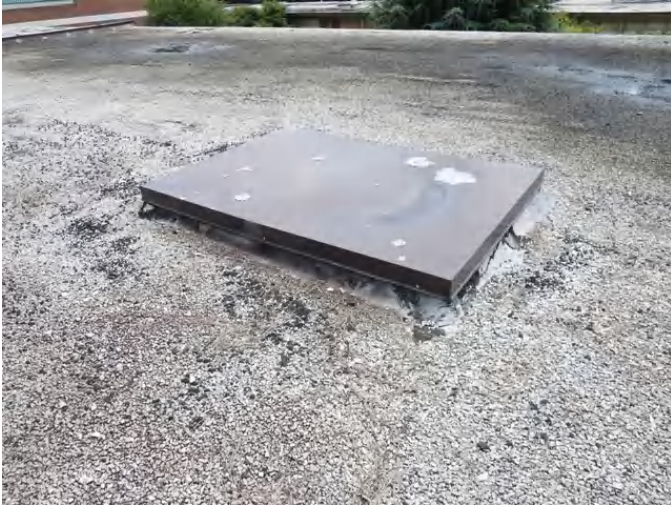
System: B3020 - Roof Openings

Location: Roof

Notes: The original metal roof openings are aged, rusted and damaged, and should be replaced. SPLOST project 422-422 to replace the roof openings.

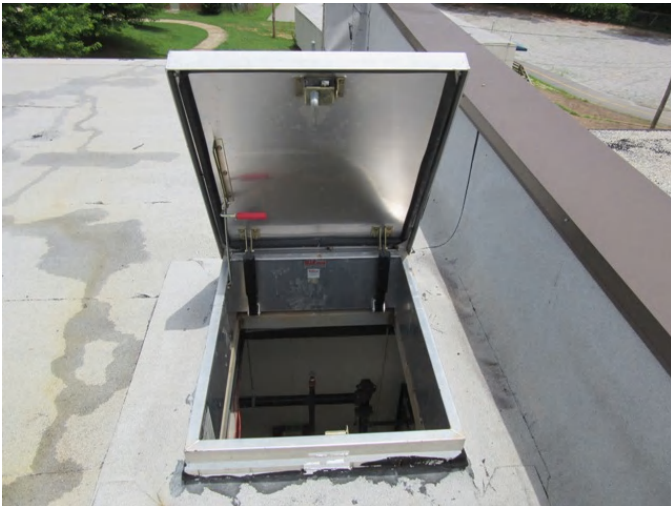
System: B3020 - Roof Openings

Location: Roof

Distress: Inadequate

Correction: Replace roof hatch and structure single unit

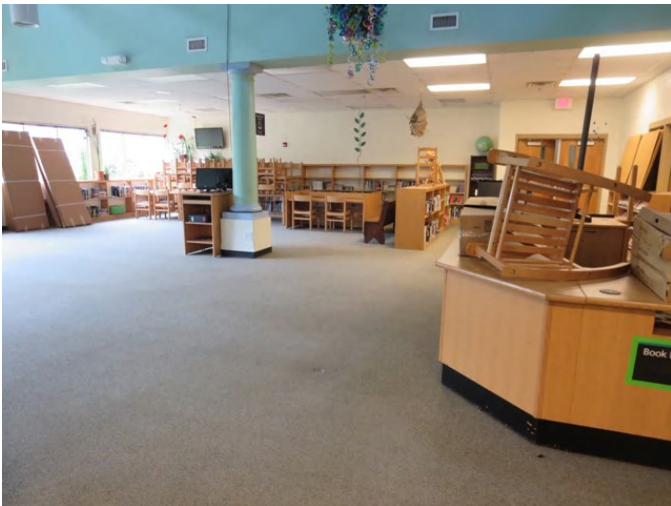
System: C3020 - Floor Finishes - Carpet

Location: Media Center

Notes: The carpet in the media center is stained and worn, and should be replaced.

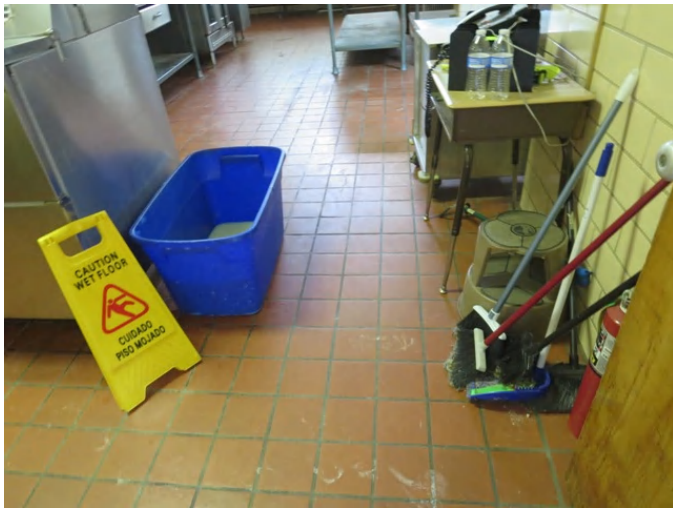
System: C3020 - Floor Finishes - Ceramic & Quarry Tile

Location: Kitchen and Restrooms

Notes: The tile floor covering is beyond its expected service life, stained and worn, and should be replaced.

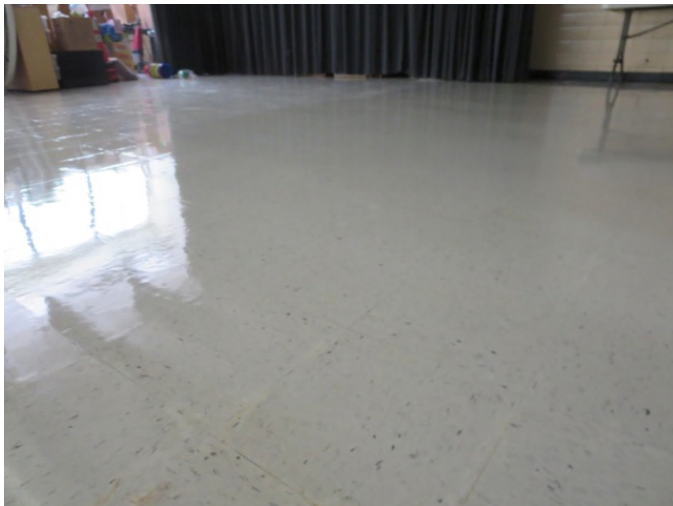
System: C3020 - Floor Finishes - VCT

Location: Throughout Building

Notes: The VCT floor covering is beyond its expected service life and worn, and should be replaced.

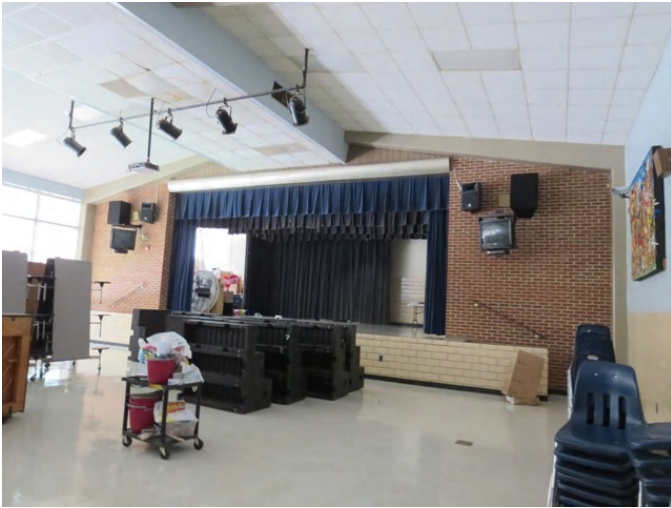
System: C3030 - Ceiling Finishes

Location: Throughout Building

Notes: The acoustical ceiling system is beyond its expected service life, damaged, and should be replaced.

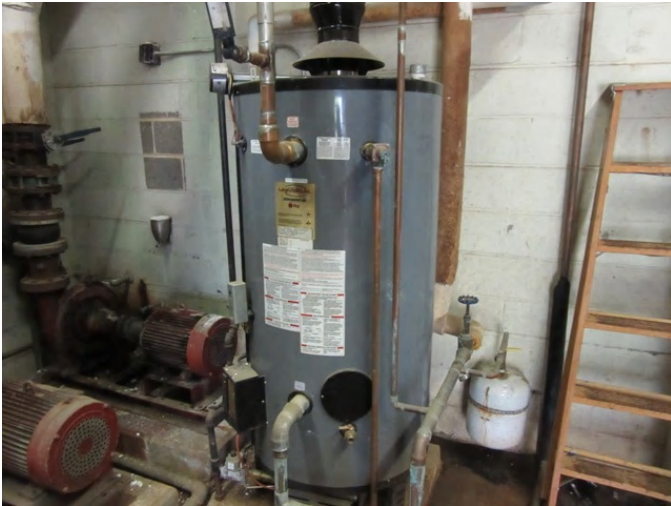
System: D2020 - Domestic Water Distribution

Location: Throughout Building

Notes: The domestic water distribution system is beyond its expected service life, has water quality issues, and should be scheduled for replacement. SPLOST project 422-422 to replace the interior domestic water piping throughout 1958 and 1963 buildings, if appropriate.

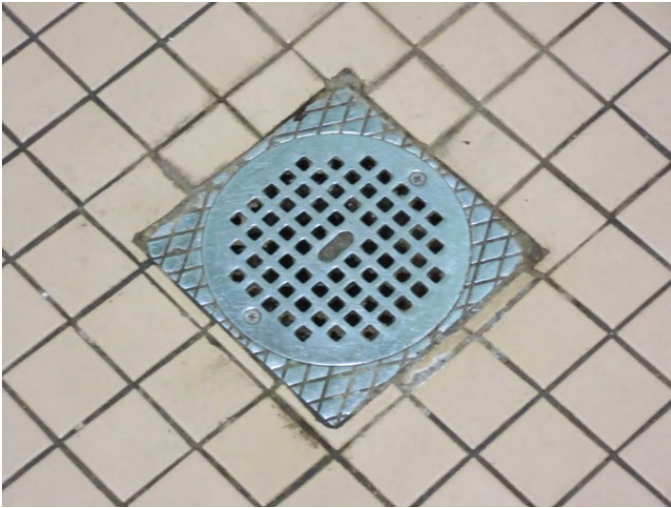
System: D2030 - Sanitary Waste

Location: Throughout Building

Notes: The sanitary waste system is beyond its expected service life and should be scheduled for replacement. School staff reports odors in the building.

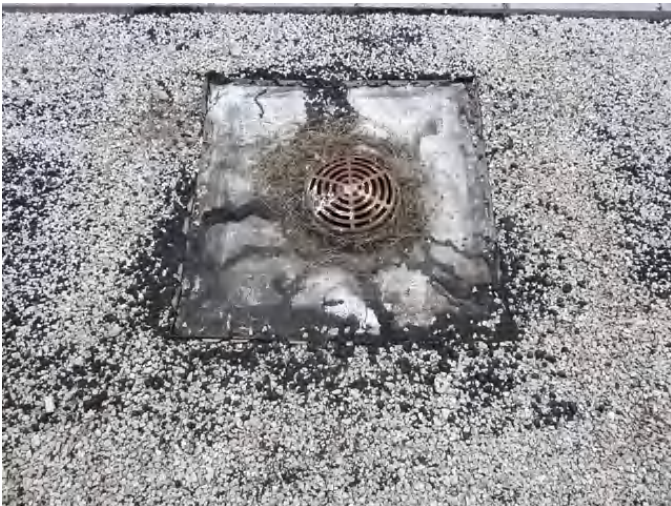
System: D2040 - Rain Water Drainage

Location: Throughout Building

Notes: The rain water drainage system is beyond service life and should be replaced in conjunction with the roof.

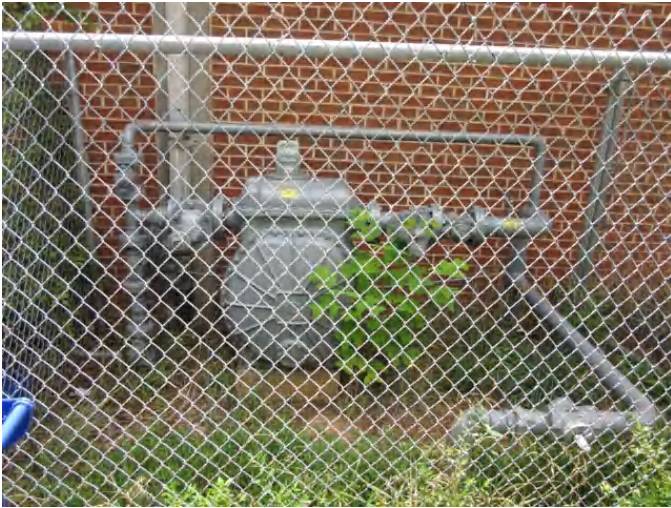
System: D2090 - Other Plumbing Systems - Natural Gas

Location: South Side of Building
Distress: Beyond Service Life
Category: Deferred Maintenance
Priority: 3 Priority
Correction: Renew System
Qty: 41,515.00
Unit of Measure: S.F.
Estimate: \$18,723.00
Assessor Name: Sam Mandola
Date Created: 07/17/2015

Notes: The natural gas system is beyond its expected service life and should be scheduled for replacement. SPLOST project 422-422 to replace the grease trap and the backflow preventer.

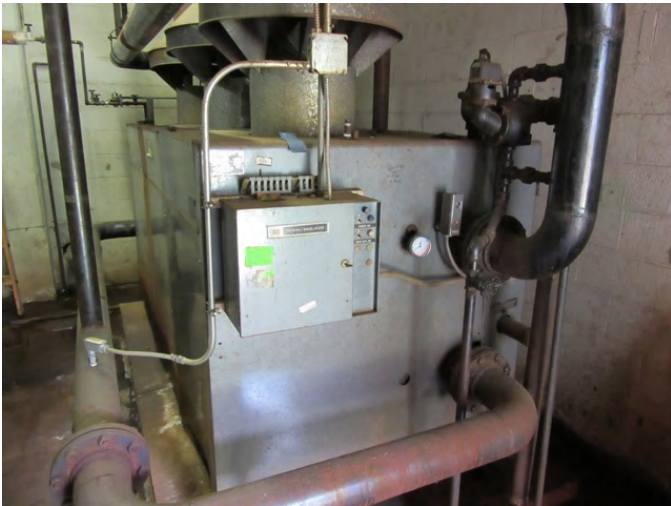
System: D3020 - Heat Generating Systems

Location: Mechanical Room
Distress: Beyond Service Life
Category: Deferred Maintenance / Environmental
Priority: 3 Priority
Correction: Renew System
Qty: 41,515.00
Unit of Measure: S.F.
Estimate: \$207,783.00
Assessor Name: Ben Nixon
Date Created: 04/11/2015

Notes: The original boiler is beyond its expected service life and inadequate, contains hazardous materials, and should be scheduled for replacement.

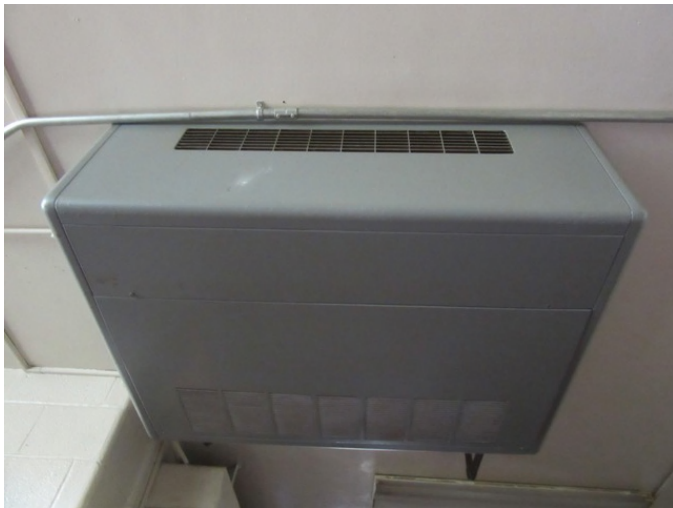
System: D3050 - Terminal & Package Units

Location: Throughout Building

Notes: The terminal and package units are beyond their expected service life and should be scheduled for replacement.

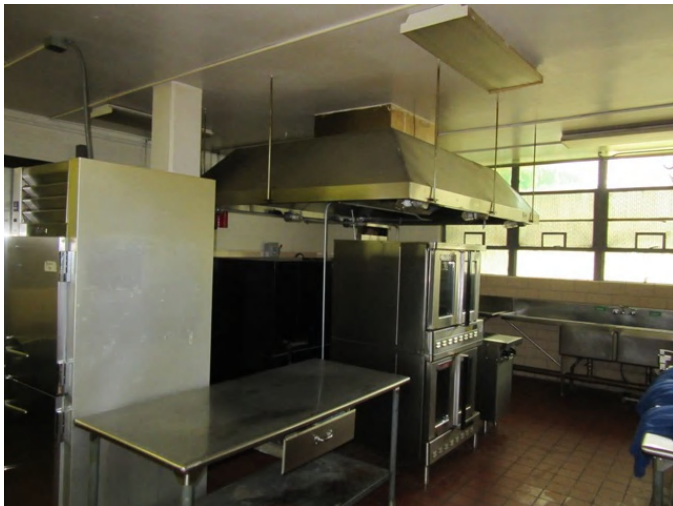
System: D3090 - Other HVAC Systems/Equip - Kitchen Hood

Location: Kitchen

Notes: The kitchen hood system is beyond its expected service life and should be scheduled for replacement. SPLOST project 422-422 to review and replace the kitchen equipment, if appropriate.

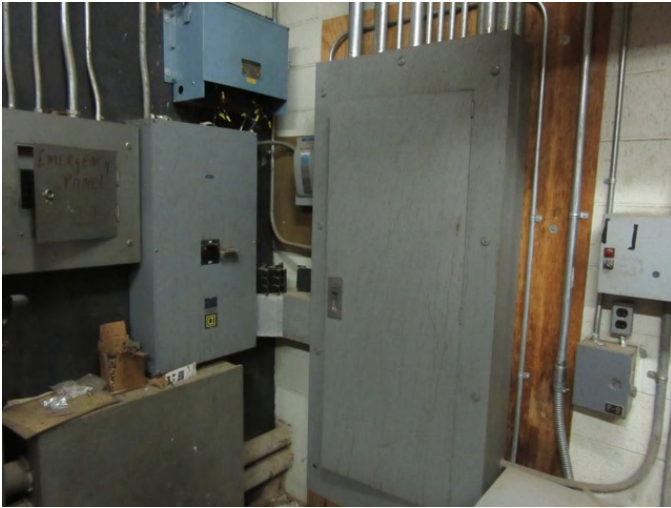
System: D5010 - Electrical Service/Distribution

Location: Main Switch Room/Throughout Building

Notes: The electrical service/distribution system is beyond its expected service life and should be scheduled for replacement. SPLOST project 422-422 to replace the electrical service and distribution system.

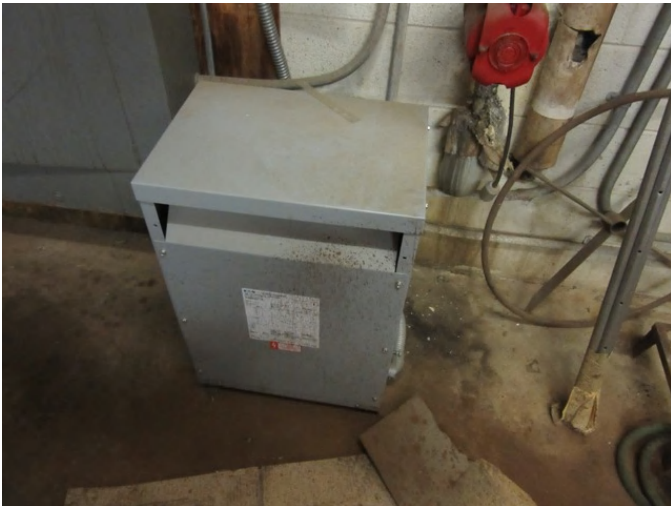
System: D5020 - Branch Wiring

Location: Throughout Building

Notes: The branch wiring system is beyond its expected service life, inadequate, and should be scheduled for replacement.

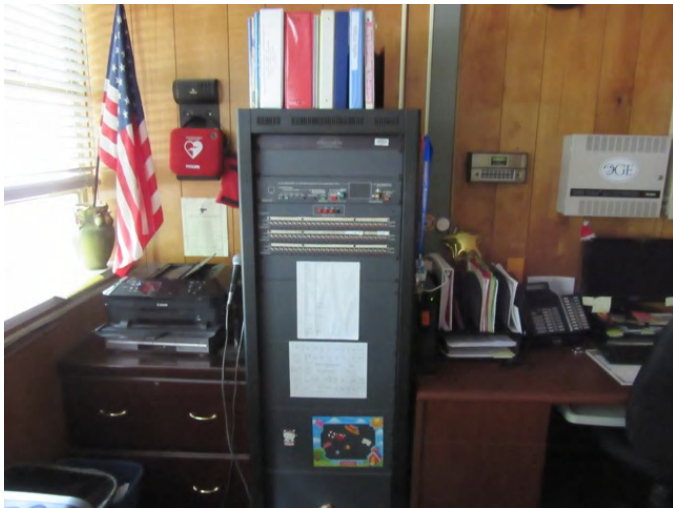
System: D5030 - Communications and Security - Clock & PA Systems

Location: Throughout Building
Distress: Beyond Service Life
Category: Deferred Maintenance
Priority: 3 Priority
Correction: Renew System
Qty: 41,515.00
Unit of Measure: S.F.
Estimate: \$255,732.00
Assessor Name: Ben Nixon
Date Created: 04/11/2015

Notes: Clock and PA systems are beyond their expected service life and should be scheduled for replacement.

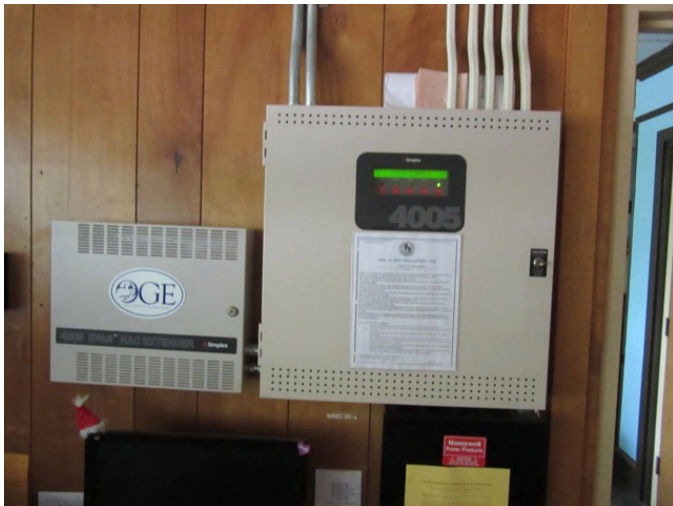
System: D5030 - Communications and Security - Fire Alarm

Location: Throughout Building
Distress: Beyond Service Life
Category: Deferred Maintenance
Priority: 3 Priority
Correction: Renew System
Qty: 41,515.00
Unit of Measure: S.F.
Estimate: \$56,170.00
Assessor Name: Ben Nixon
Date Created: 04/11/2015

Notes: The fire alarm system is beyond its expected service life and should be scheduled for replacement.

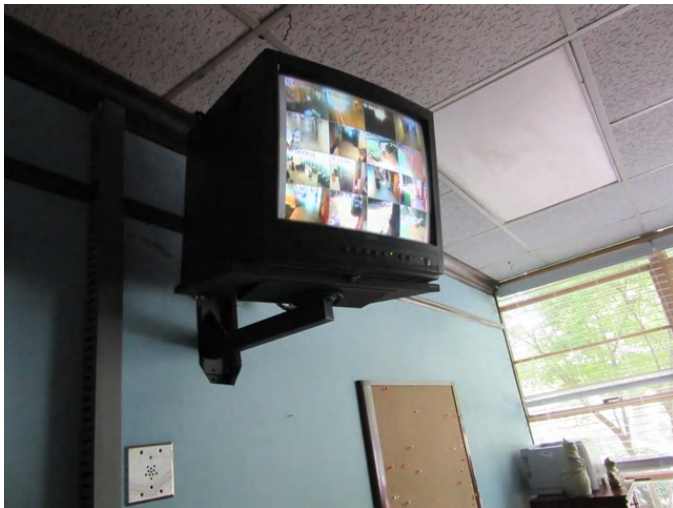
System: D5030 - Communications and Security - Security & CCTV

Location: Throughout Building

Notes: The security and CCTV systems are beyond their expected service life and should be scheduled for replacement.

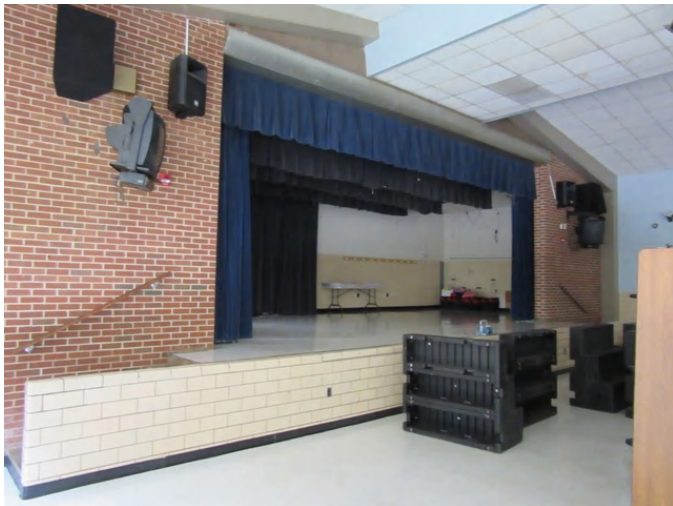
System: E1020 - Institutional Equipment

Location: Throughout Building

Notes: Institutional equipment, such as theater and stage equipment, is beyond its expected service life and should be scheduled for replacement.

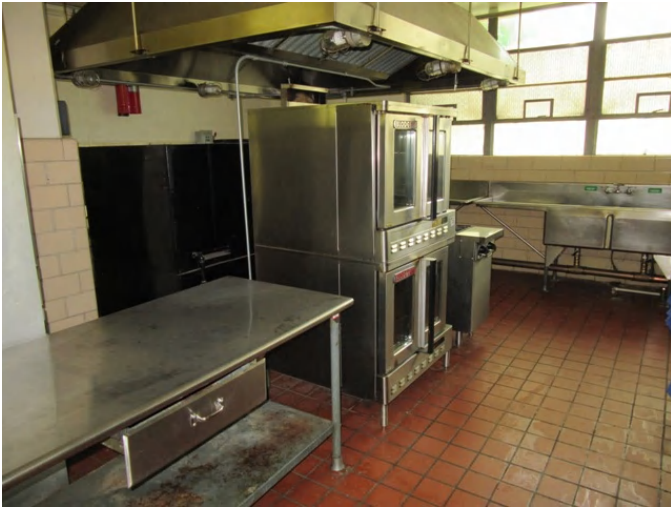
System: E1090 - Other Equipment - Kitchen Equipment

Location: Kitchen
Distress: Beyond Service Life
Category: Deferred Maintenance
Priority: 3 Priority
Correction: Renew System
Qty: 41,515.00
Unit of Measure: S.F.
Estimate: \$376,749.00
Assessor Name: Ben Nixon
Date Created: 07/17/2015

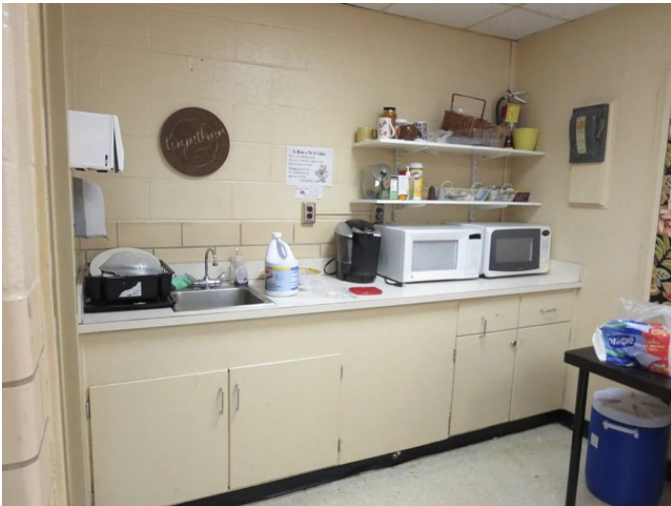
System: E2010 - Fixed Furnishings

Location: Throughout Building
Distress: Beyond Service Life
Category: Deferred Maintenance
Priority: 3 Priority
Correction: Renew System
Qty: 41,515.00
Unit of Measure: S.F.
Estimate: \$245,229.00
Assessor Name: Ben Nixon
Date Created: 04/11/2015

Notes: Fixed furnishings are beyond their expected service life and should be scheduled for replacement.

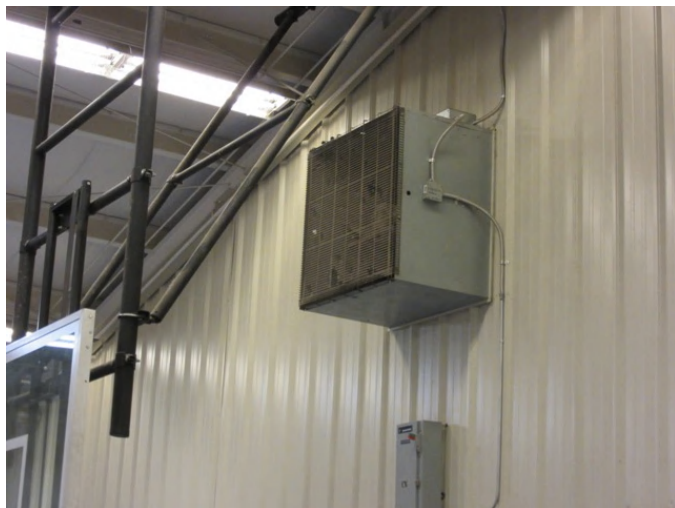
System: D3050 - Terminal & Package Units

Location: Throughout Building

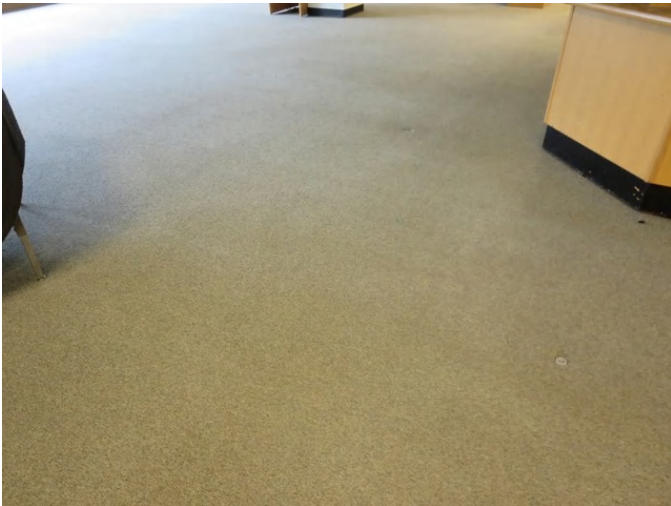
System: C3020 - Floor Finishes - Carpet

Location: Throughout Building

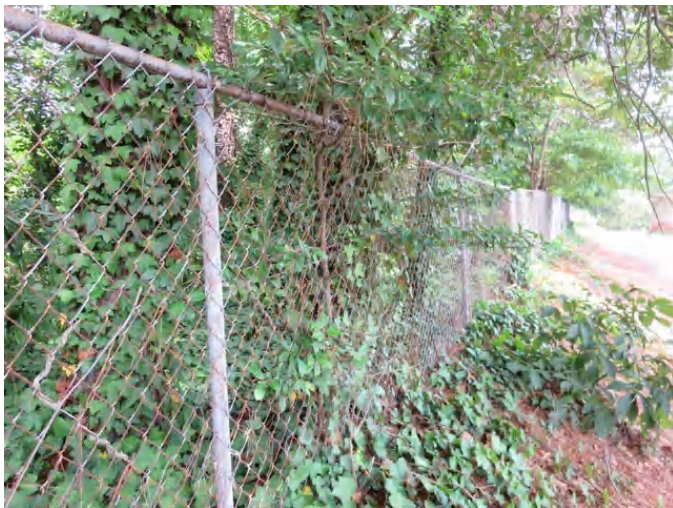
System: G2040 - Fencing & Guardrails

Location: Site

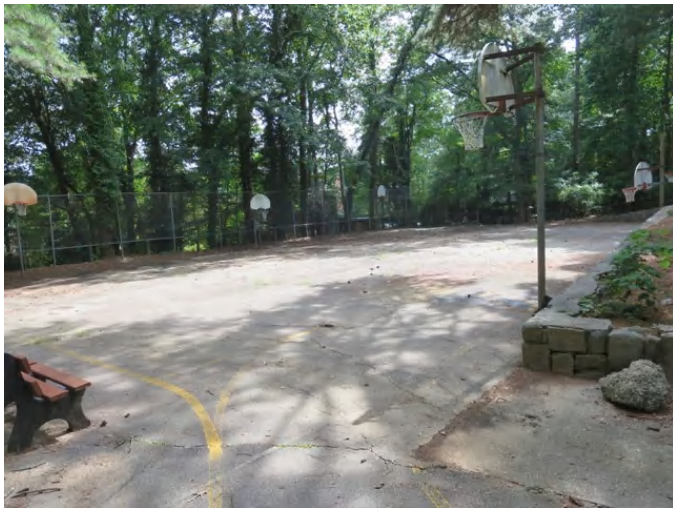
System: G2040 - Hard Surface Play Area

Location: South Side of Site

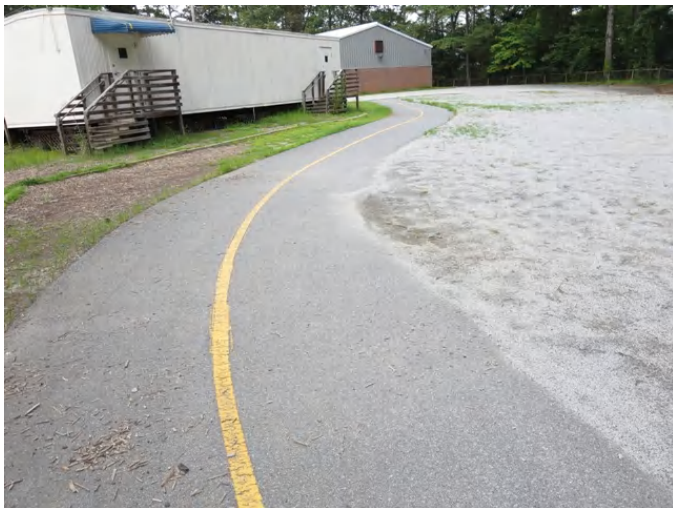
System: G2040 - Track

Location: Site

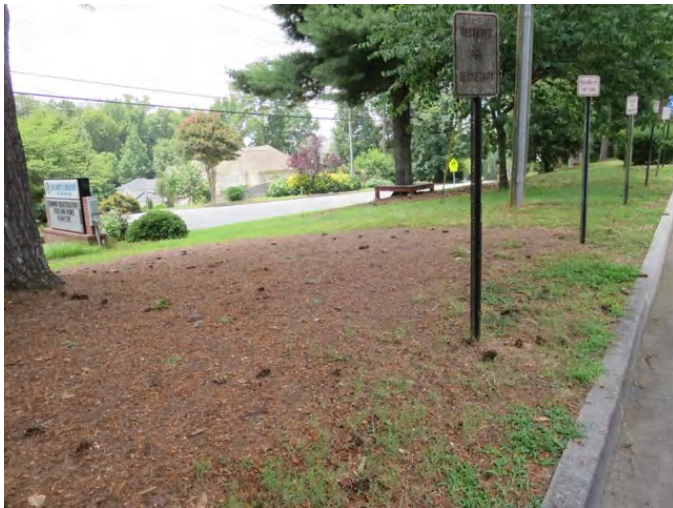
System: G2050 - Landscaping

Location: Site

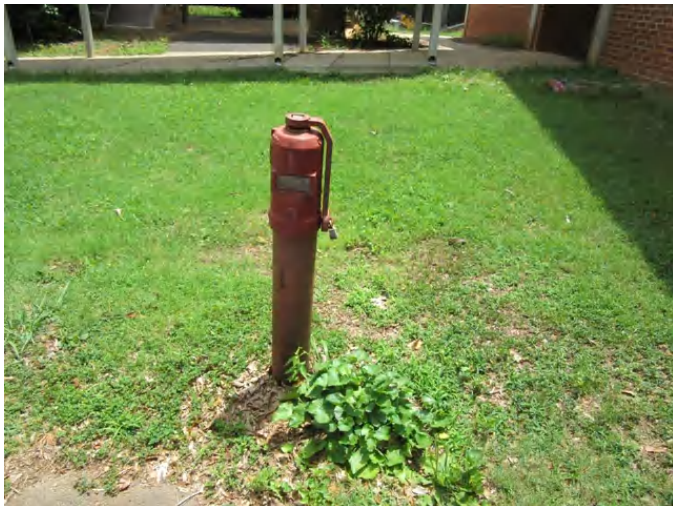
System: G3010 - Water Supply

Location: Site

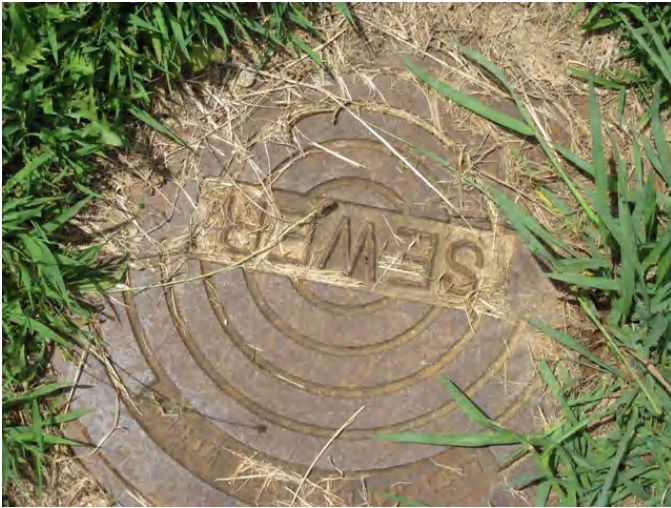
System: G3020 - Sanitary Sewer

Location: Site

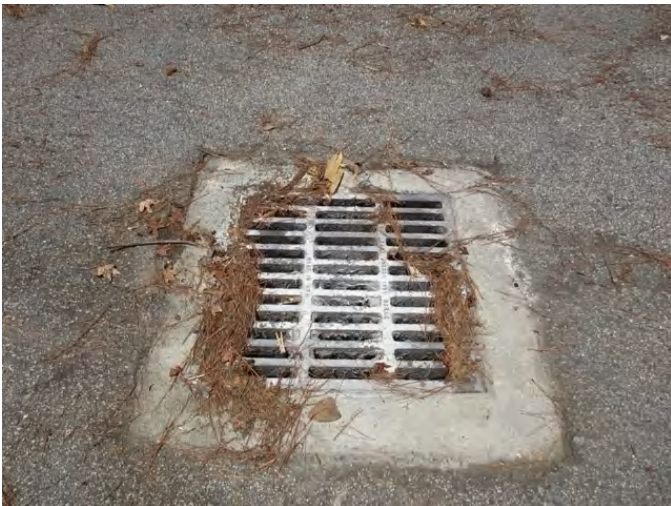
System: G3030 - Storm Sewer

Location: Site

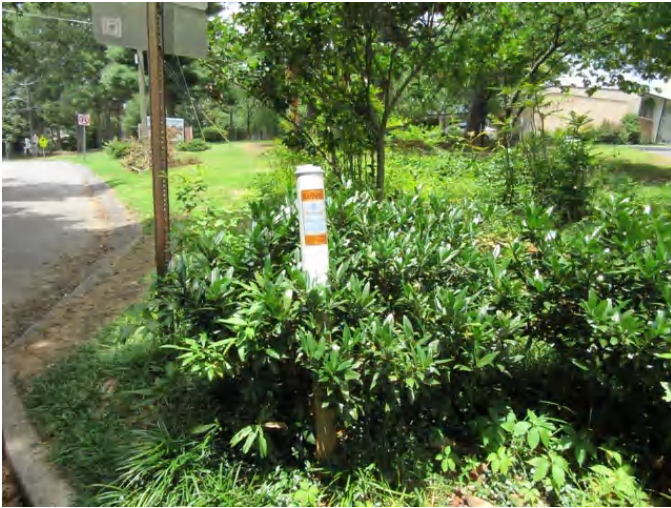
System: G4030 - Site Communications & Security

Location: Site

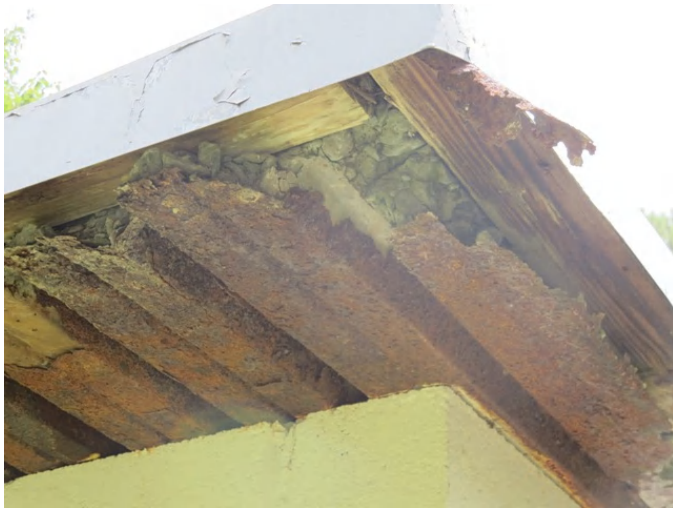
System: B1020 - Roof Construction

Location: Roof

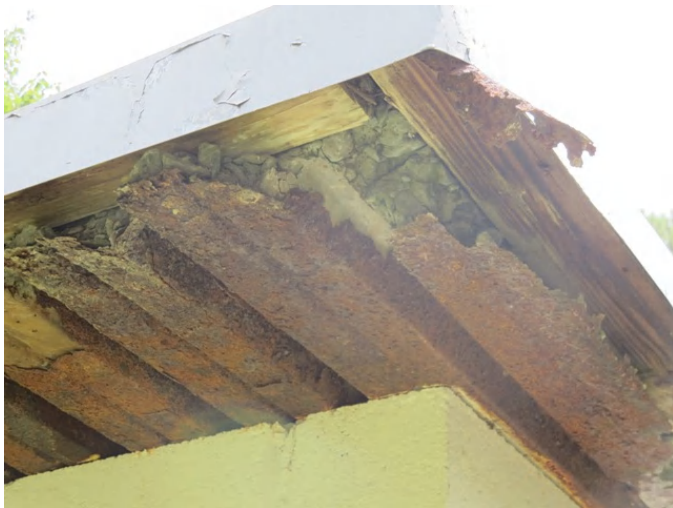
System: B3010 - Roof Coverings

Location: Roof
