DeKalb County School District/Leased/Charter

Old Rock Gym/Stone Mountain

School Assessment Report

May 20, 2016

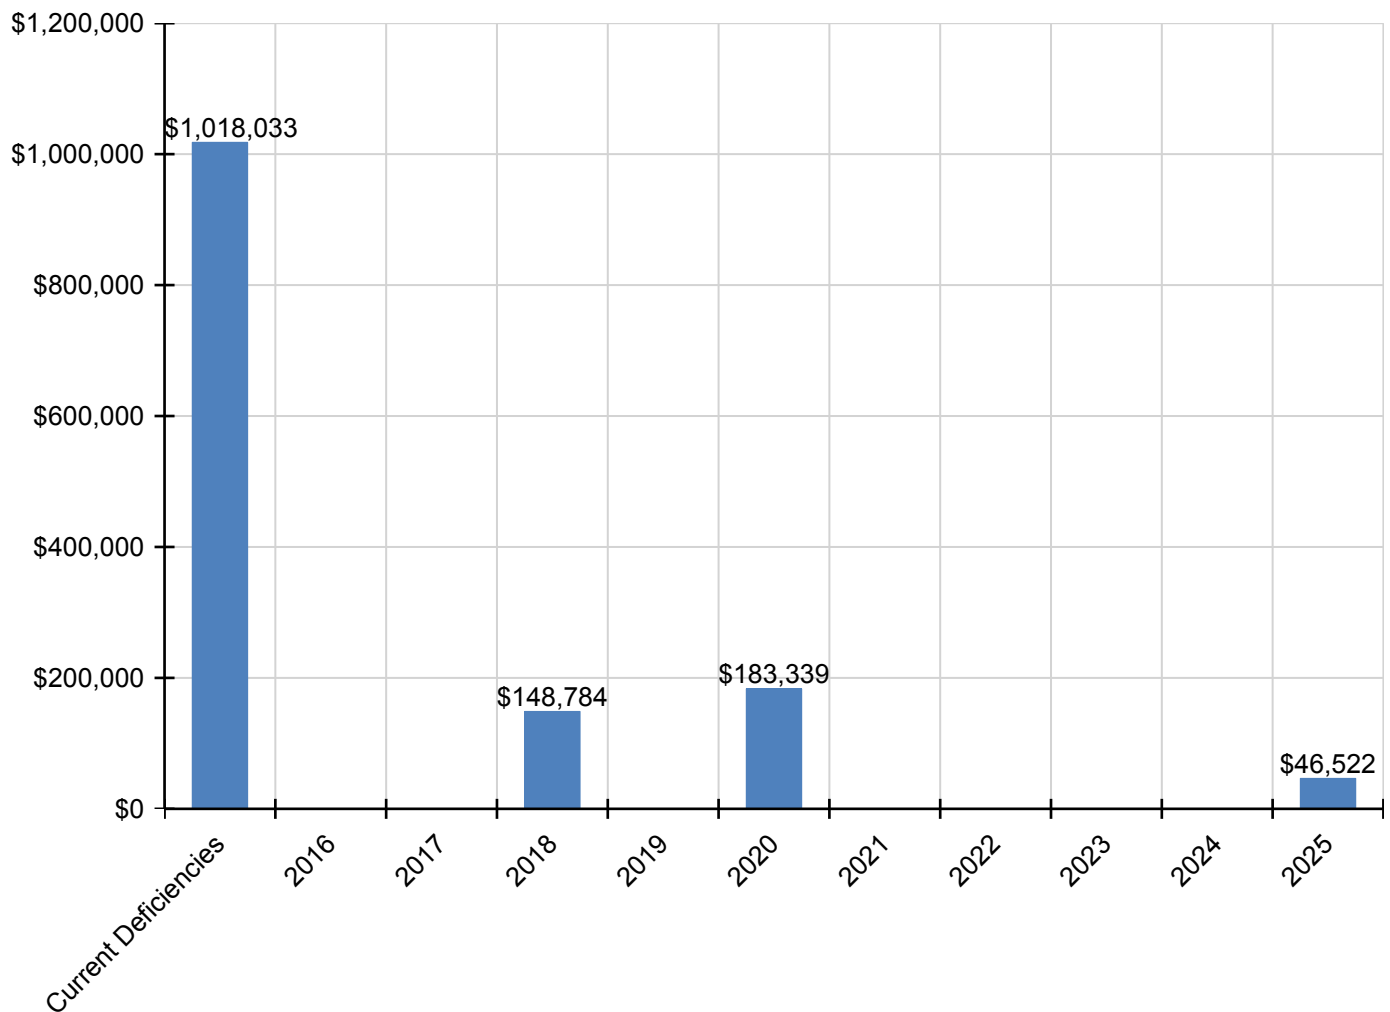
Forecasted Capital Renewal Requirement

The following chart shows the current building deficiencies and the forecasted capital renewal (system replacement) requirements over the next ten years.

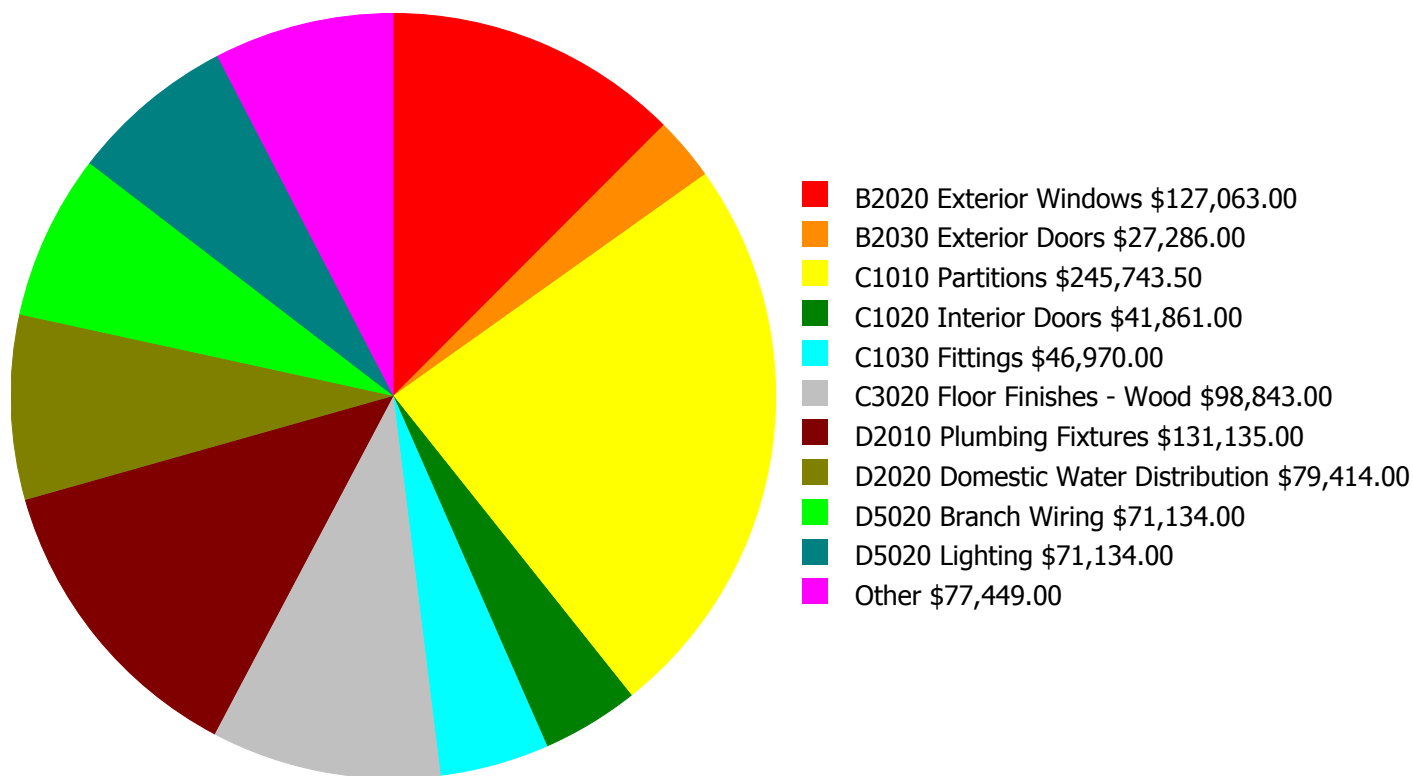
Deficiency Summary by System

Current deficiencies include assemblies that have reached or exceed their design life or components of the assemblies that are in need of repair. Assemblies that have reached their design life are identified as current deficiencies and assigned the distress 'Beyond Service Life'. The following chart lists all current deficiencies associated with this facility broken down by UNIFORMAT system.

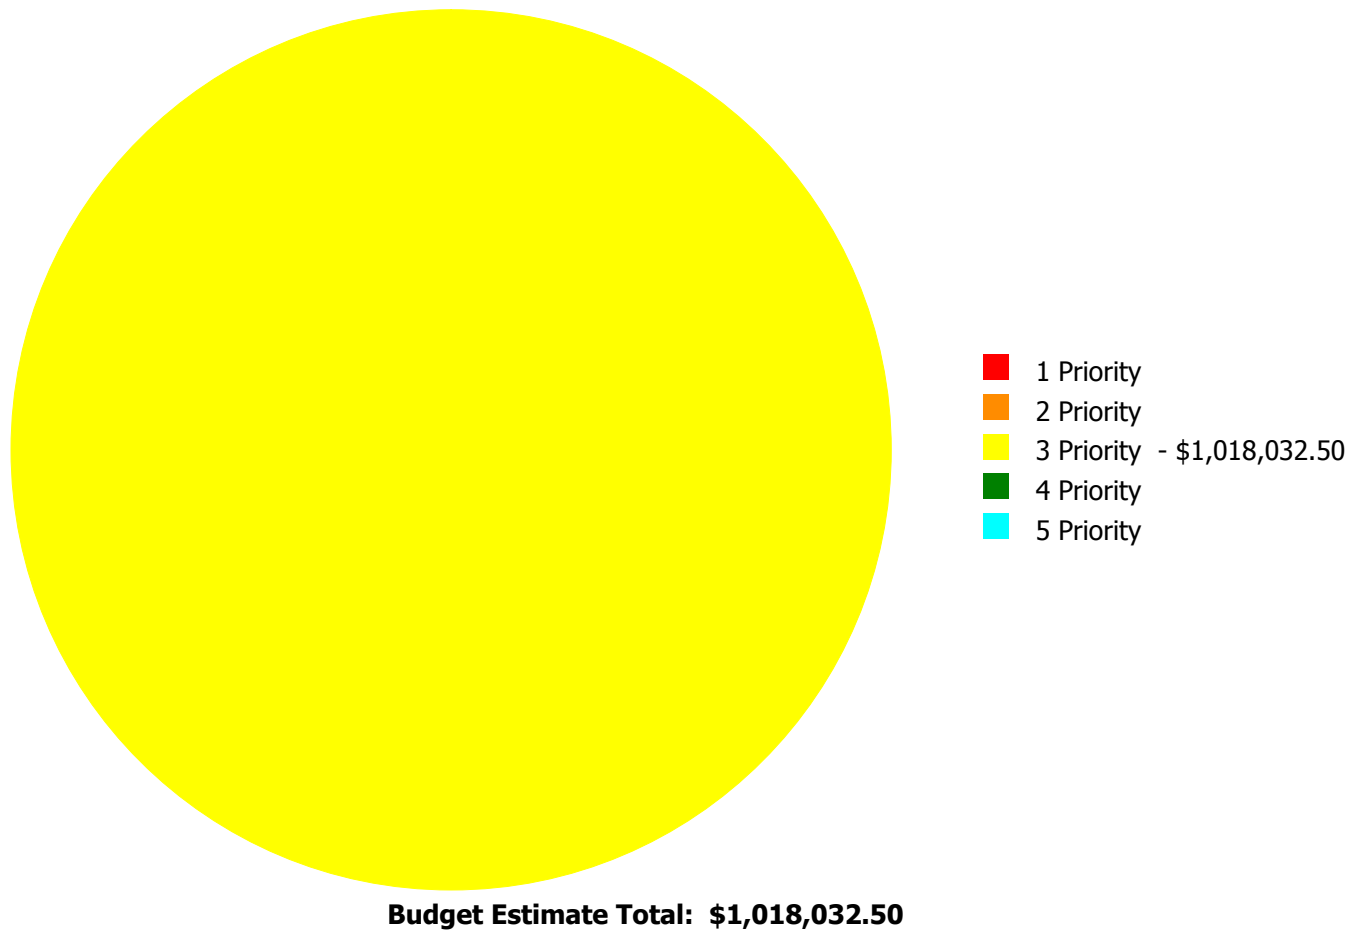
Deficiency Summary by Priority

The following chart shows the total repair costs broken down by priority. Assessors assigned deficiencies within eCOMET to one of the following priority categories:

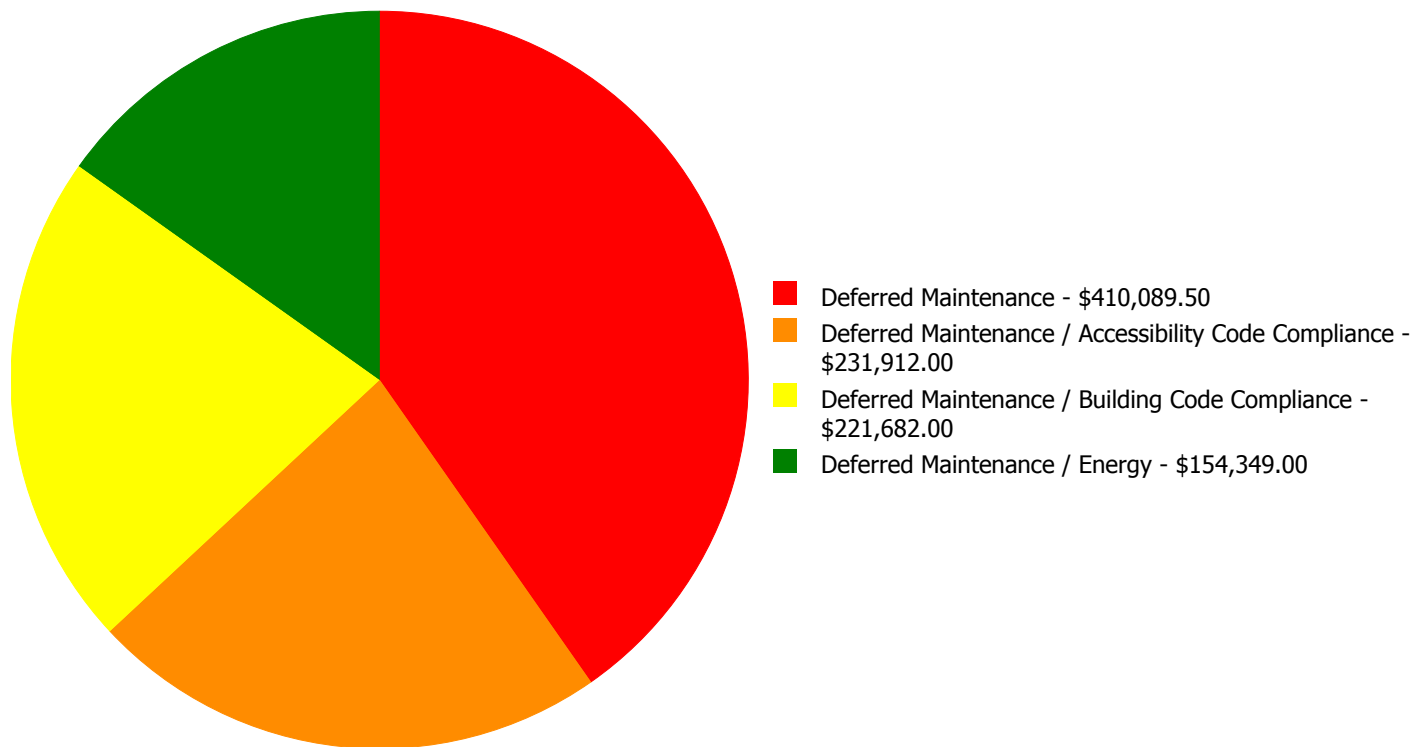
Deficiency Summary by Category

The following chart shows the total repair costs broken down by deficiency categories. Assessors assigned deficiencies to one of the following categories:

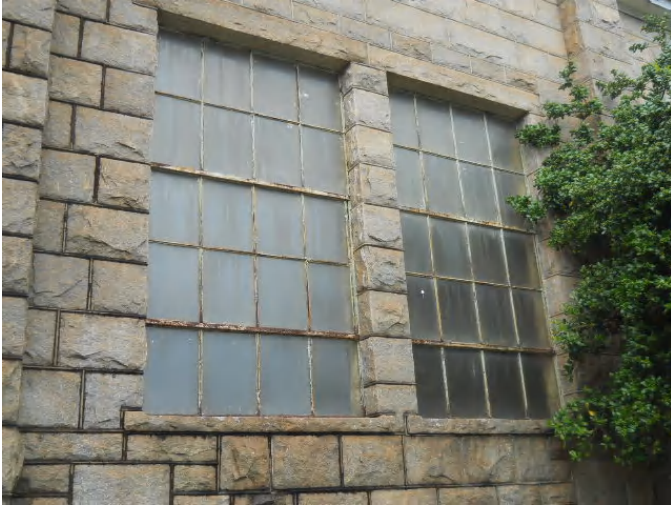
System: B2020 - Exterior Windows

Location: Exterior Walls

Distress: Beyond Service Life

Notes: The gym windows are original, beyond their expected service life, not energy efficient, and should be replaced.

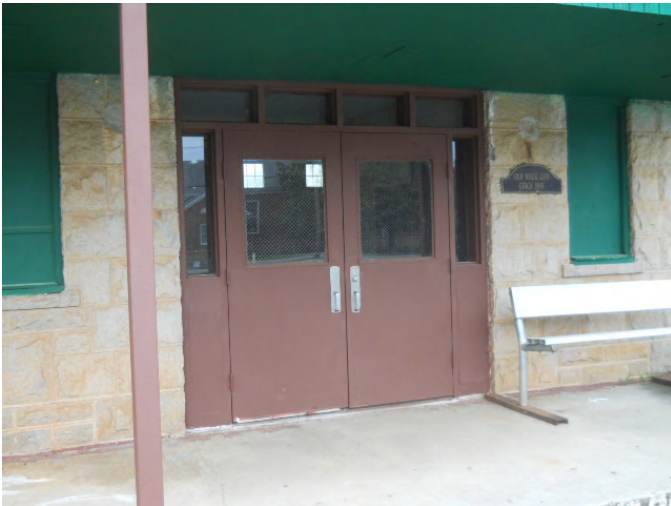
System: B2030 - Exterior Doors

Location: Throughout Building

Distress: Beyond Service Life

Notes: The original exterior doors are aged, rusted, beyond service life, and should be replaced.

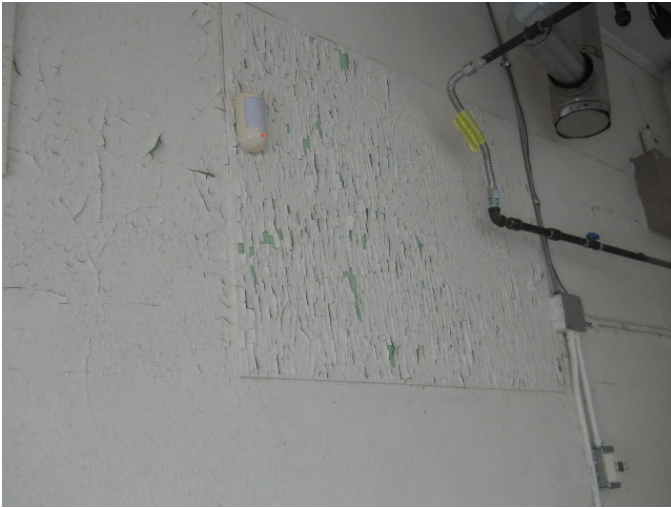
System: C1010 - Partitions

Location: Throughout Building

Distress: Damaged

Notes: The interior wall partitions are damaged and should be replaced.

Correction: Replace interior partitions (\$24.33/sf)

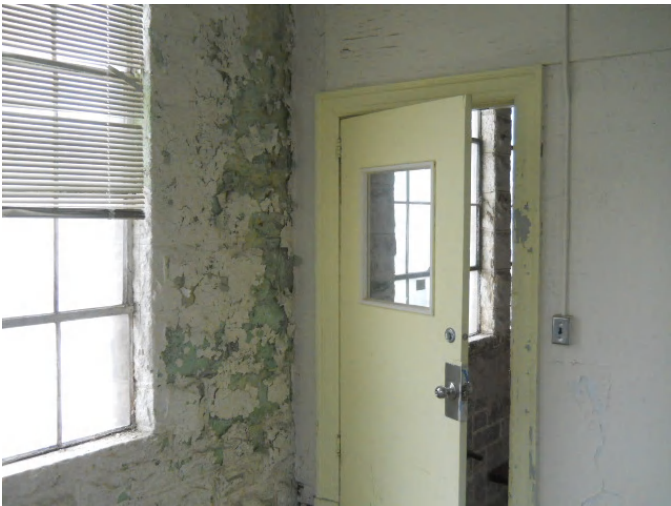
System: C1020 - Interior Doors

Location: Throughout Building

Distress: Beyond Service Life

Notes: The interior door systems are beyond their expected service life, not code or ADA compliant, and should be replaced.

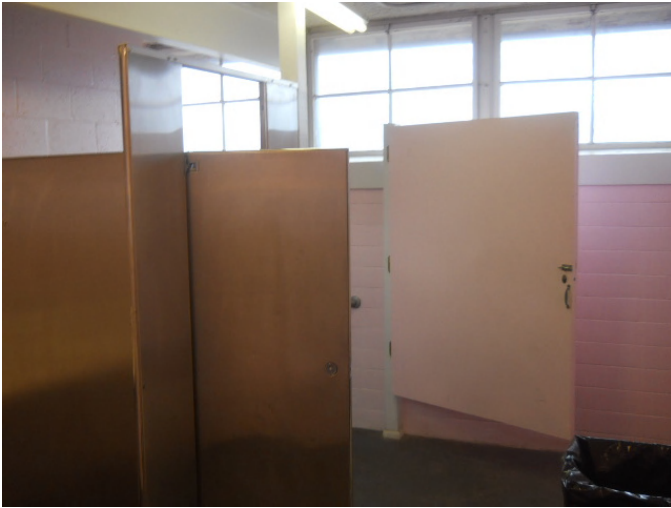
System: C1030 - Fittings

Location: Throughout Building

Distress: Beyond Service Life

Notes: Fittings, such as signage, handrails and toilet partitions, are beyond their expected service life, not code or ADA compliant, and should be replaced.

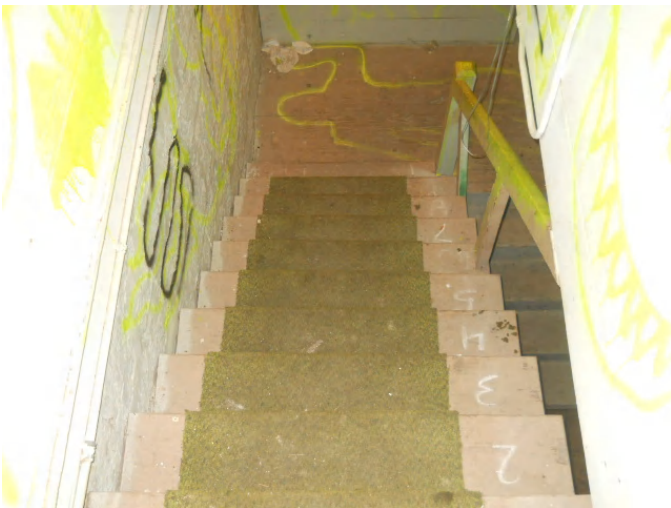
System: C20 - Stairs

Location: Basement Stairs

Distress: Beyond Service Life

Notes: The wood stairs are beyond their expected service life and should be replaced.

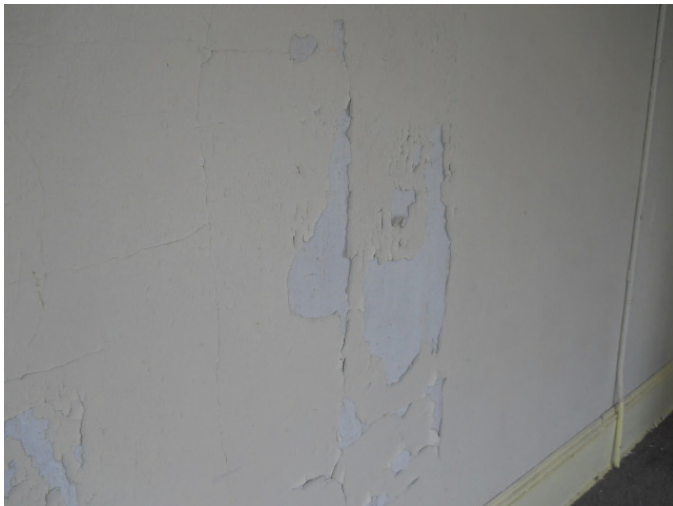
System: C3010 - Wall Finishes - Paint

Location: Throughout Building

Distress: Beyond Service Life

Notes: The wall finishes are aged, scuffed, fading, and stained, and should be replaced.

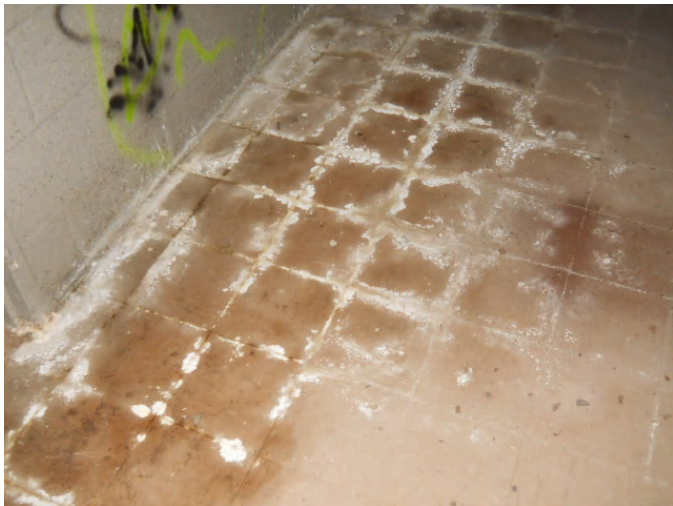
System: C3020 - Floor Finishes - VCT

Location: Throughout Building

Distress: Beyond Service Life

Notes: VCT floor finish is beyond its expected service life, damaged, and should be replaced.

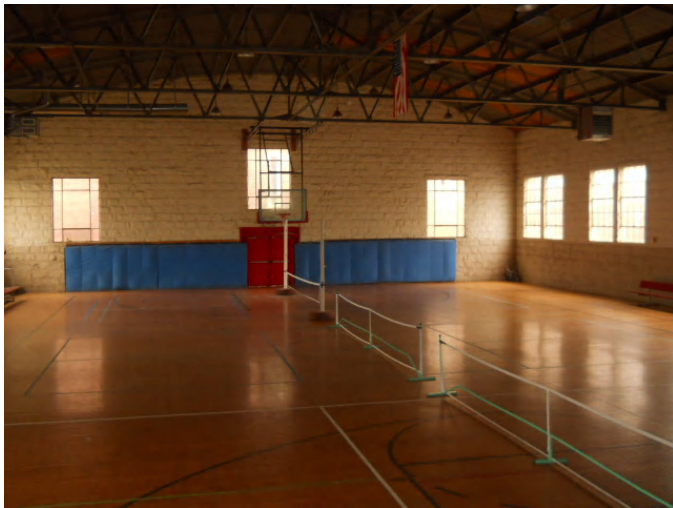
System: C3020 - Floor Finishes - Wood

Location: Gym

Distress: Beyond Service Life

Notes: The interior wood floors are beyond their expected service life and should be replaced.

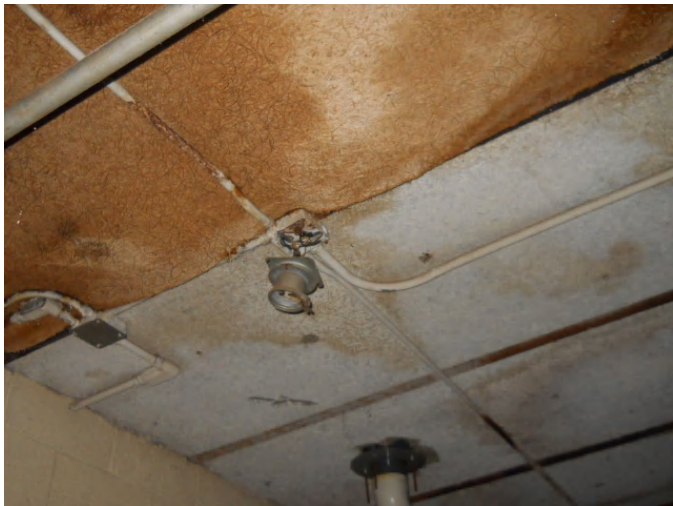
System: C3030 - Ceiling Finishes

Location: Throughout Building

Distress: Beyond Service Life

Notes: The ceiling finishes are beyond their expected service life, damaged, and should be replaced.

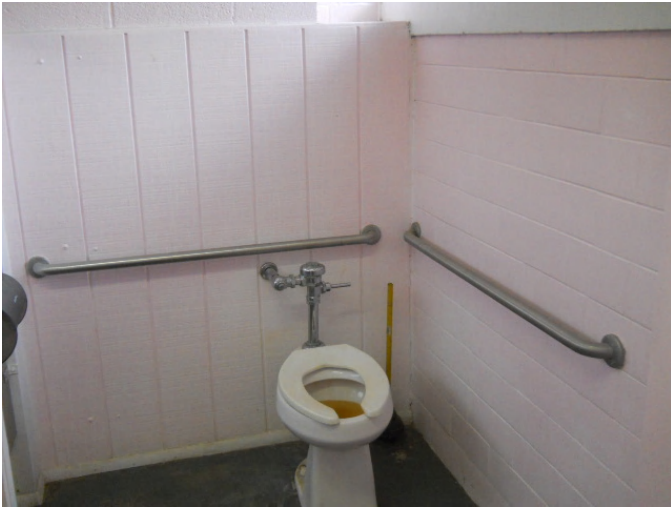
System: D2010 - Plumbing Fixtures

Location: Throughout Building

Distress: Beyond Service Life

Notes: The plumbing fixtures are original, beyond service life, and not ADA compliant, and should be replaced.

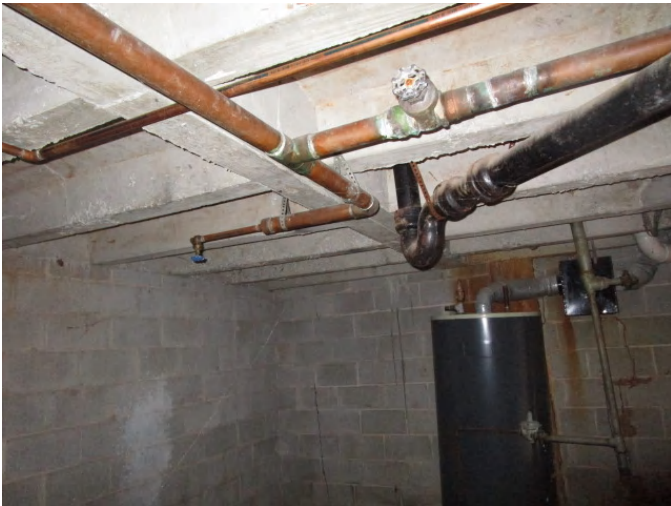
System: D2020 - Domestic Water Distribution

Location: Throughout Building

Distress: Beyond Service Life

Notes: The domestic water distribution system is beyond its expected service life and not code compliant, and should be scheduled for replacement.

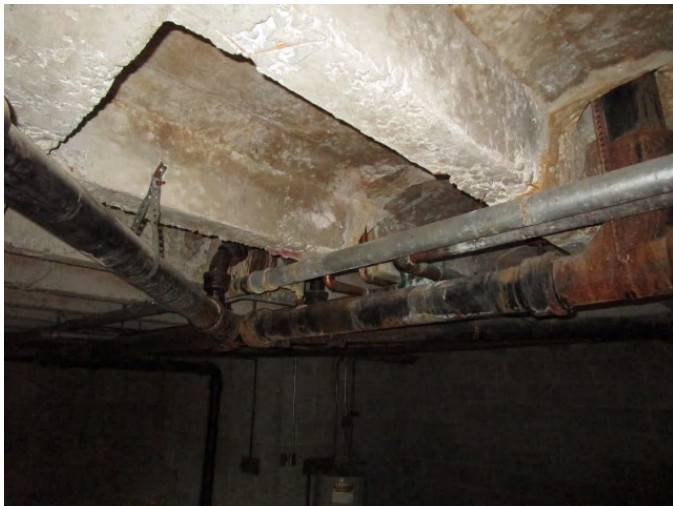
System: D2030 - Sanitary Waste

Location: Throughout Building

Distress: Beyond Service Life

Notes: The sanitary waste system is beyond its expected service life and should be scheduled for replacement.

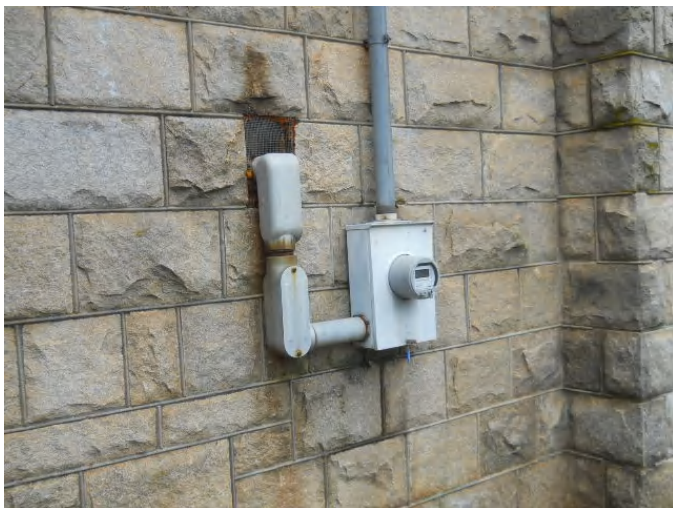
System: D5010 - Electrical Service/Distribution

Location: Throughout Building

Distress: Beyond Service Life

Notes: The electrical service/distribution system is beyond its expected service life and should be scheduled for replacement.

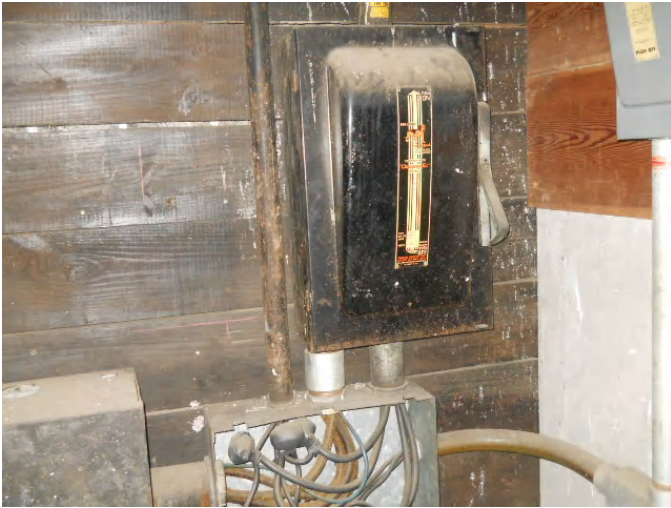
System: D5020 - Branch Wiring

Location: Throughout Building

Distress: Beyond Service Life

Notes: The branch wiring system is beyond its expected service life and not code compliant, and should be scheduled for replacement.

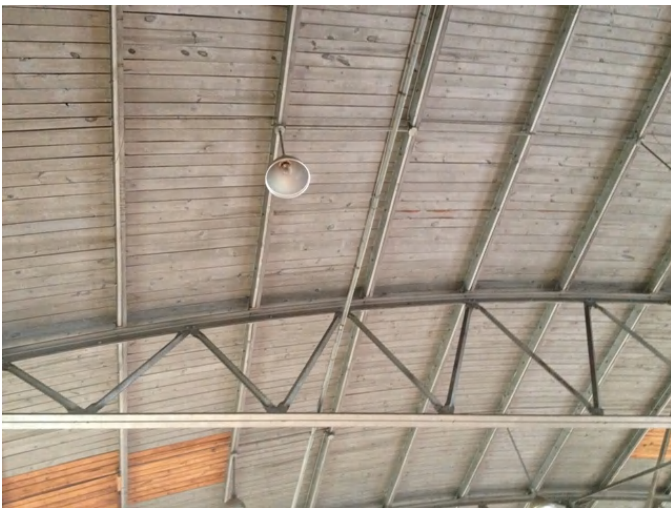
System: D5020 - Lighting

Location: Throughout Building

Distress: Beyond Service Life

Notes: The lighting system is beyond its expected service life and not code compliant, and should be scheduled for replacement.

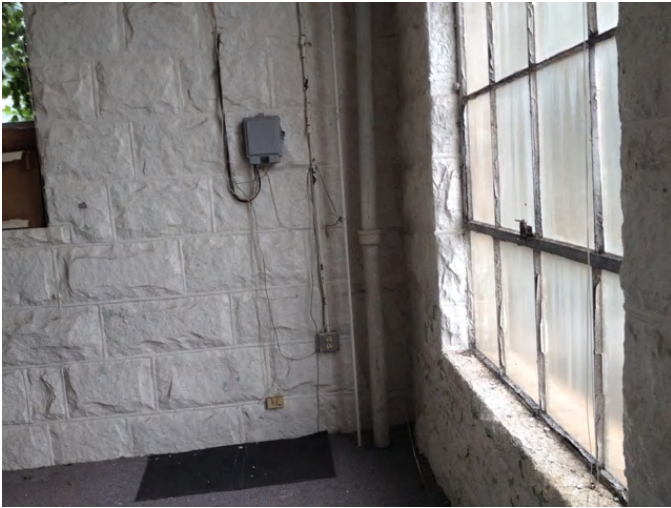
System: D5030 - Communications and Security - Security & CCTV

Location: Throughout Building

Distress: Beyond Service Life

Notes: The communications system is beyond its expected service life, not code or ADA compliant, and should be scheduled for replacement. There is no security system.

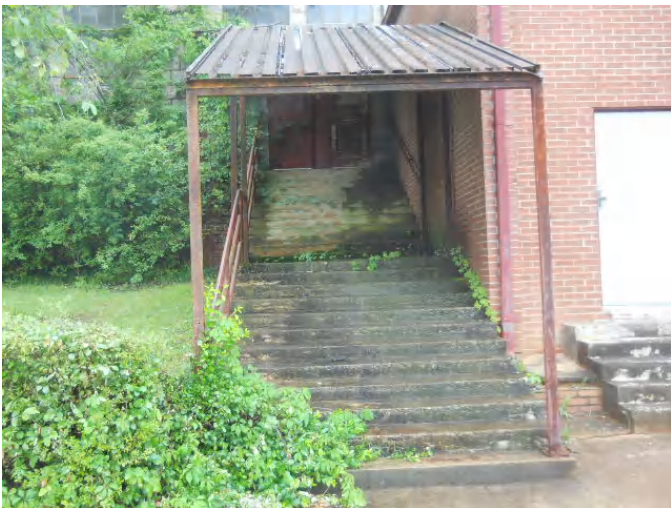
System: F1010 - Special Structures - Metal Canopies

Location: External Wall

Distress: Beyond Service Life

Notes: The metal canopy is in poor condition and should be replaced.

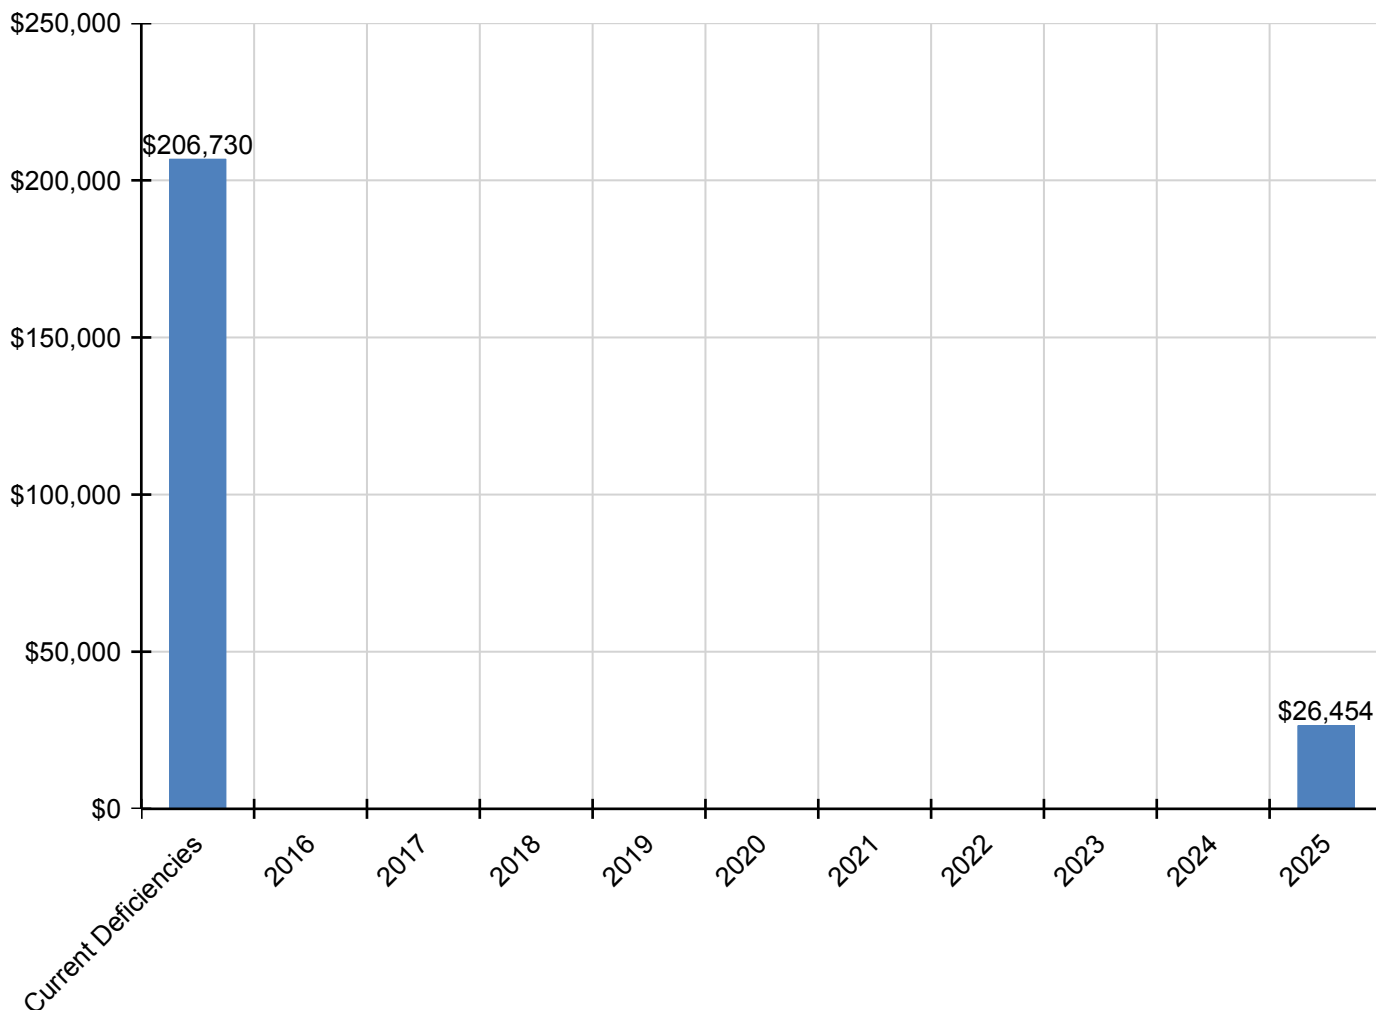
Forecasted Capital Renewal Requirement

The following chart shows the current building deficiencies and the forecasted capital renewal (system replacement) requirements over the next ten years.

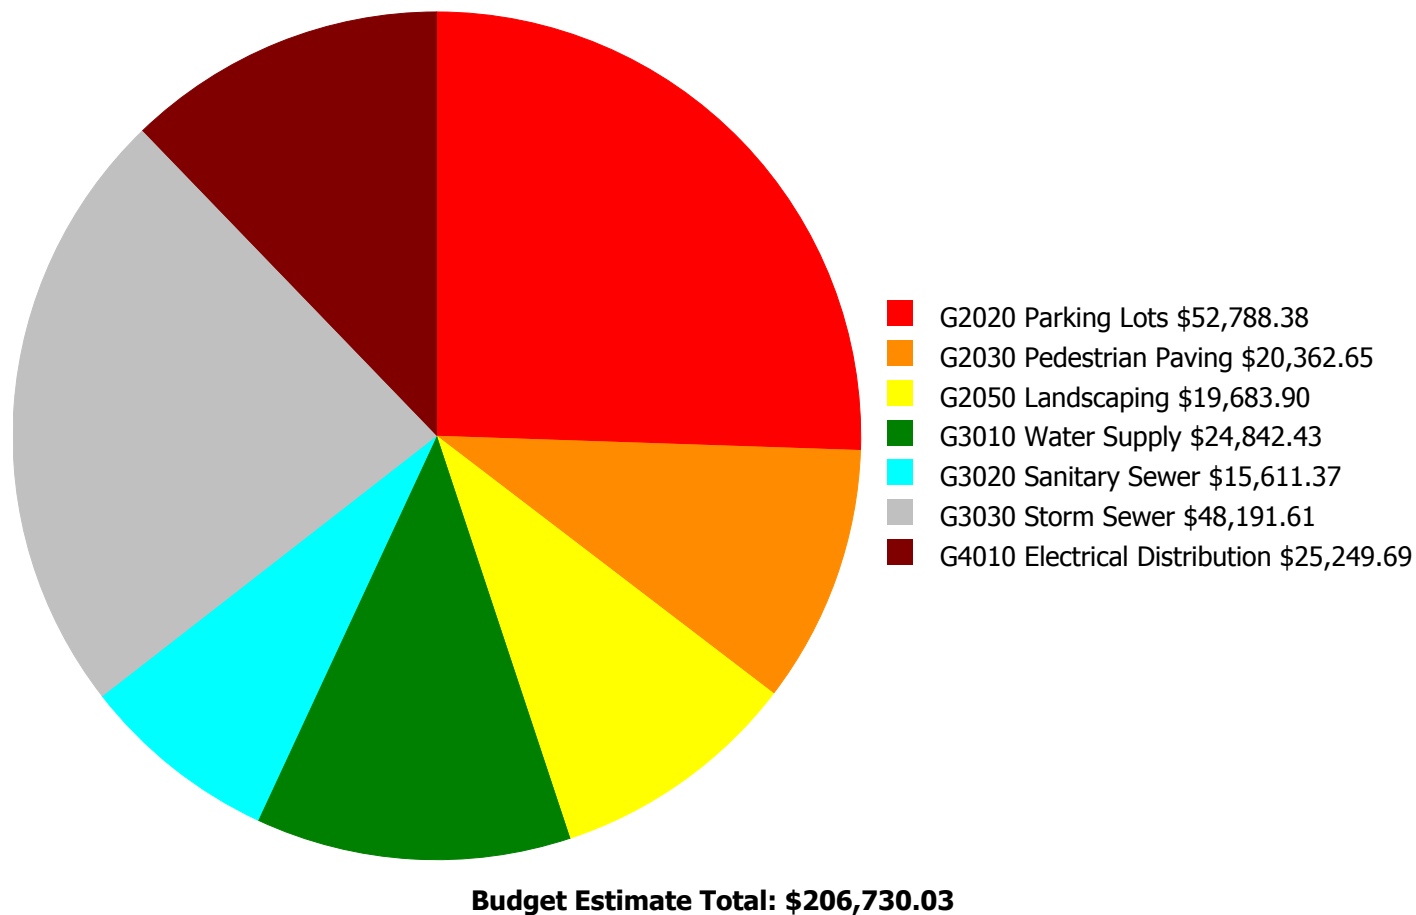
Deficiency Summary by System

Current deficiencies include assemblies that have reached or exceed their design life or components of the assemblies that are in need of repair. Assemblies that have reached their design life are identified as current deficiencies and assigned the distress 'Beyond Service Life'. The following chart lists all current deficiencies associated with this facility broken down by UNIFORMAT system.

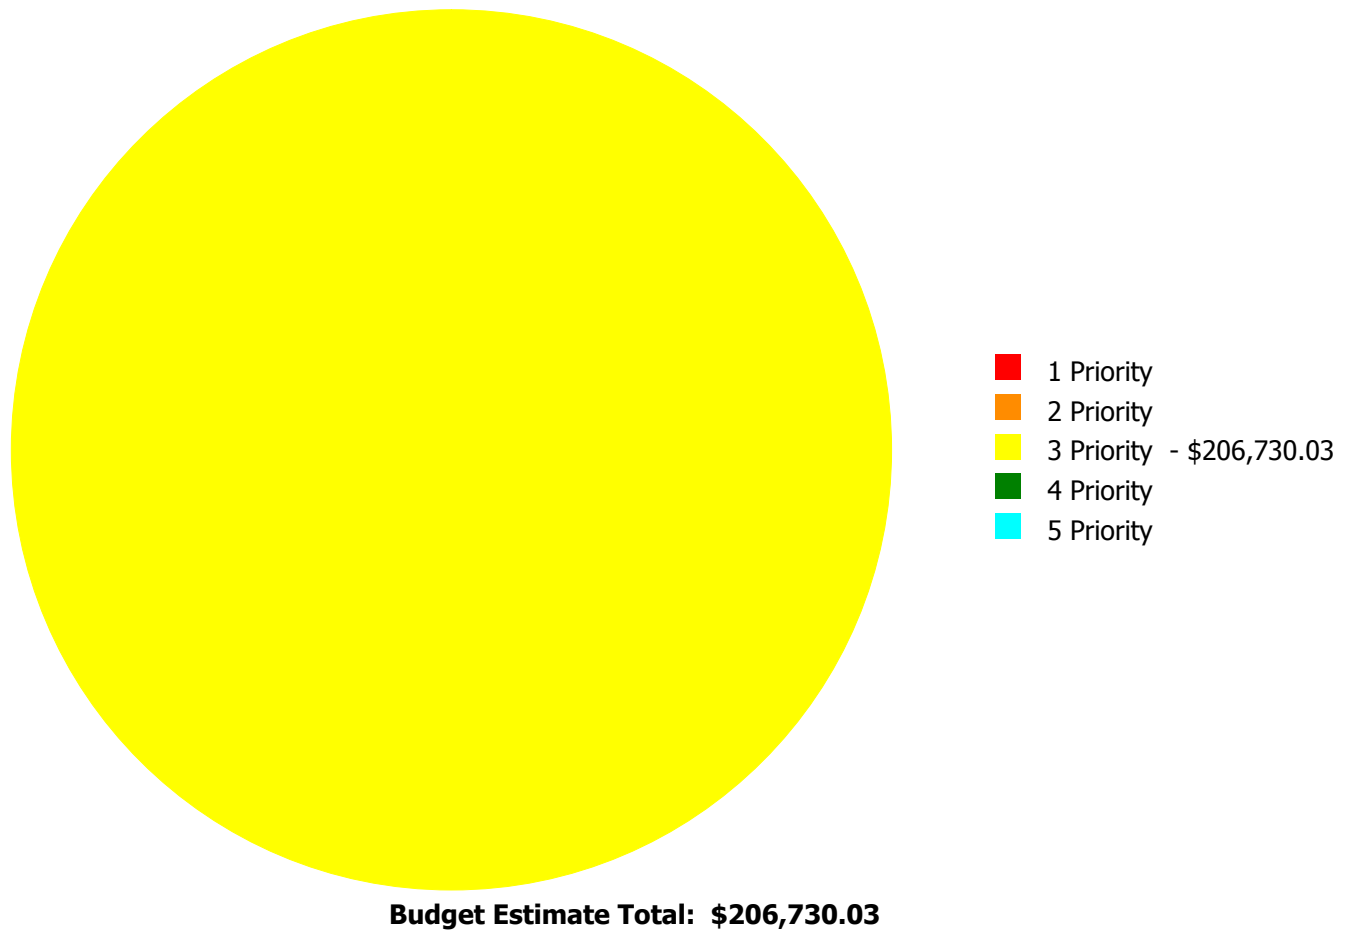
Deficiency Summary by Priority

The following chart shows the total repair costs broken down by priority. Assessors assigned deficiencies within eCOMET to one of the following priority categories:

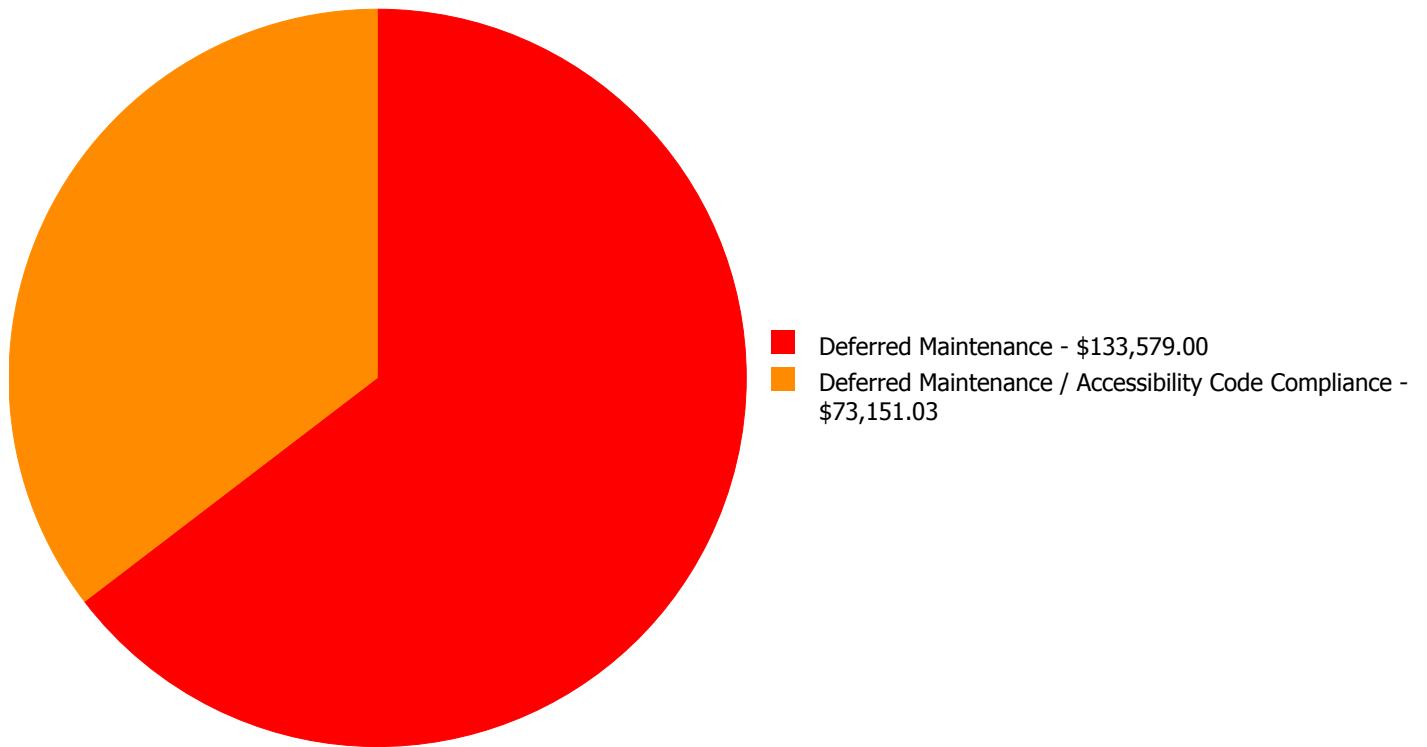
Deficiency Summary by Category

The following chart shows the total repair costs broken down by deficiency categories. Assessors assigned deficiencies to one of the following categories:

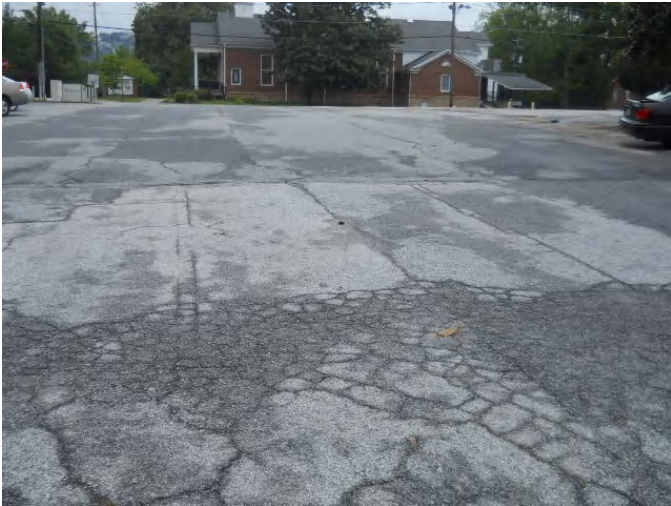
System: G2020 - Parking Lots

Location: Site

Distress: Beyond Service Life

Notes: The parking lot is deteriorated and should be replaced. The parking lot and signage are not fully ADA compliant.

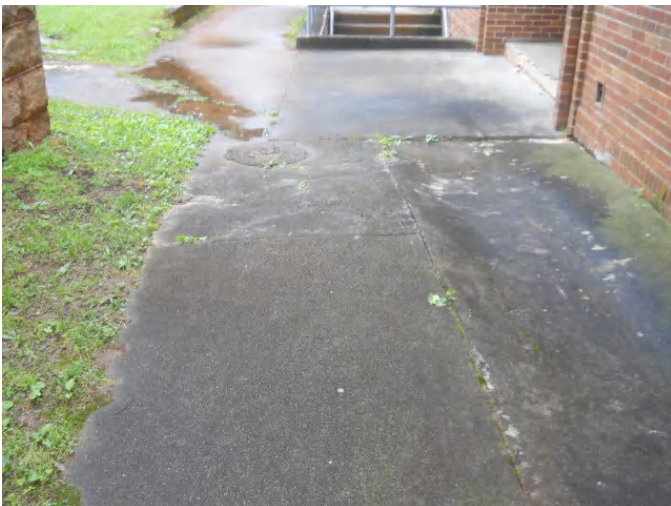
System: G2030 - Pedestrian Paving

Location: Site

Distress: Beyond Service Life

Notes: Pedestrian paving is beyond its expected service life, damaged, not fully ADA compliant, and should be replaced.

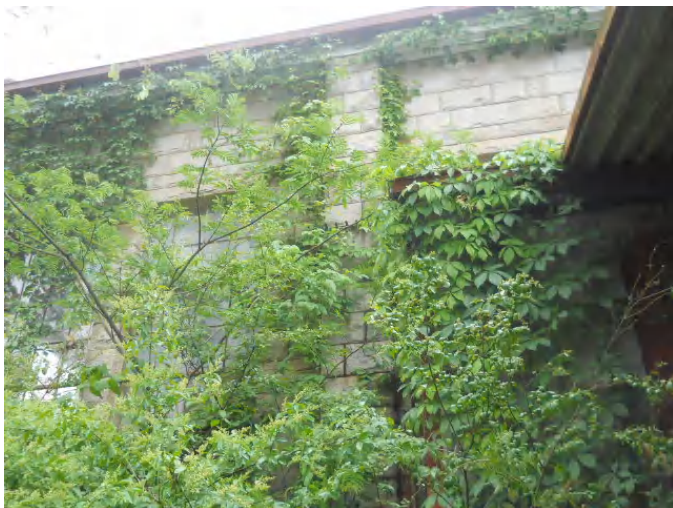
System: G2050 - Landscaping

Location: Site
Distress: Beyond Service Life
Category: Deferred Maintenance
Priority: 3 Priority
Correction: Renew System
Qty: 12,341.00
Unit of Measure: S.F.
Estimate: \$19,683.90
Assessor Name: Eduardo Lopez
Date Created: 05/18/2015

Notes: Lanscaping is beyond its expected service life, overgrown, and should be replaced.

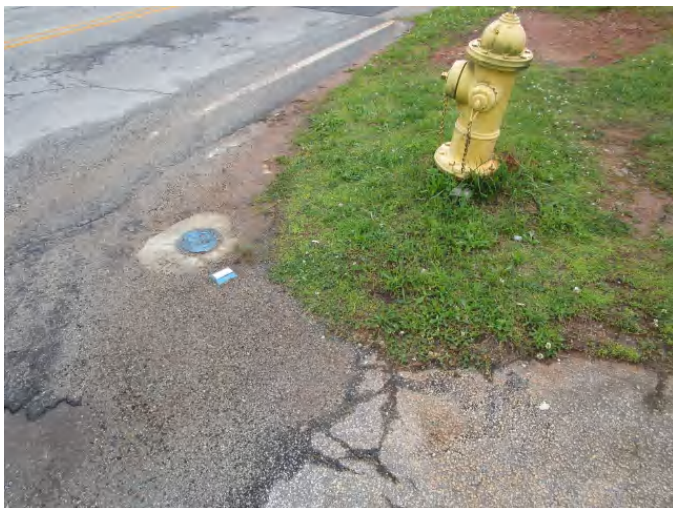
System: G3010 - Water Supply

Location: Site
Distress: Beyond Service Life
Category: Deferred Maintenance
Priority: 3 Priority
Correction: Renew System
Qty: 12,341.00
Unit of Measure: S.F.
Estimate: \$24,842.43
Assessor Name: Eduardo Lopez
Date Created: 04/30/2015

Notes: The site water supply system is beyond its expected service life and should be scheduled for replacement.

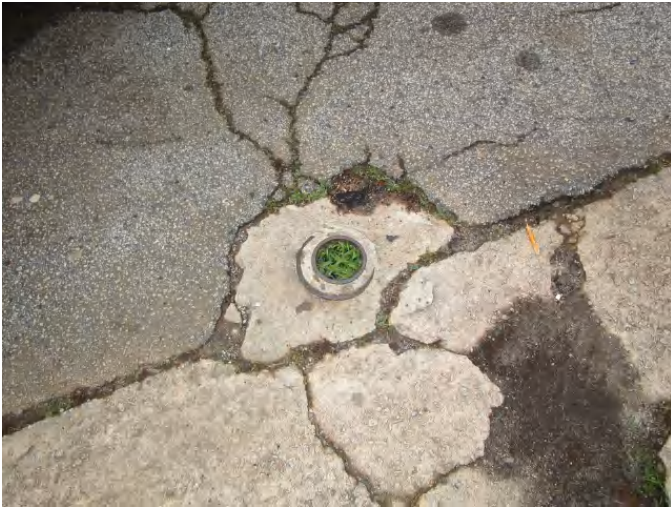
System: G3020 - Sanitary Sewer

Location: Site
Distress: Beyond Service Life
Category: Deferred Maintenance
Priority: 3 Priority
Correction: Renew System
Qty: 12,341.00
Unit of Measure: S.F.
Estimate: \$15,611.37
Assessor Name: Eduardo Lopez
Date Created: 04/30/2015

Notes: The site sanitary sewer system is beyond its expected service life and should be scheduled for replacement.

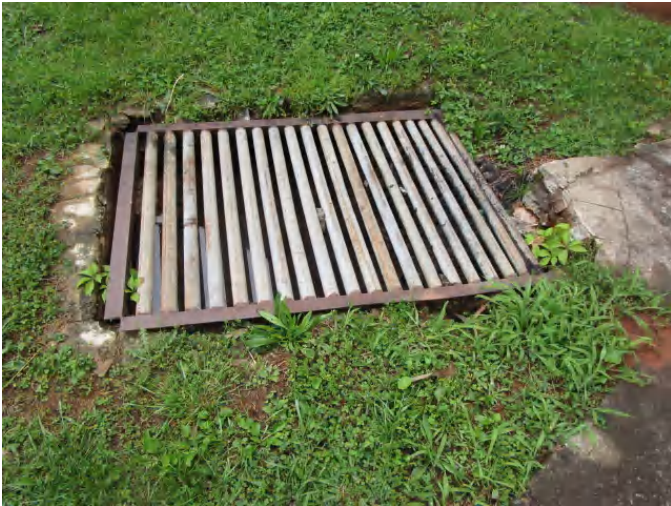
System: G3030 - Storm Sewer

Location: Site
Distress: Beyond Service Life
Category: Deferred Maintenance
Priority: 3 Priority
Correction: Renew System
Qty: 12,341.00
Unit of Measure: S.F.
Estimate: \$48,191.61
Assessor Name: Eduardo Lopez
Date Created: 04/30/2015

Notes: The site storm sewer system is beyond its expected service life and should be scheduled for replacement.

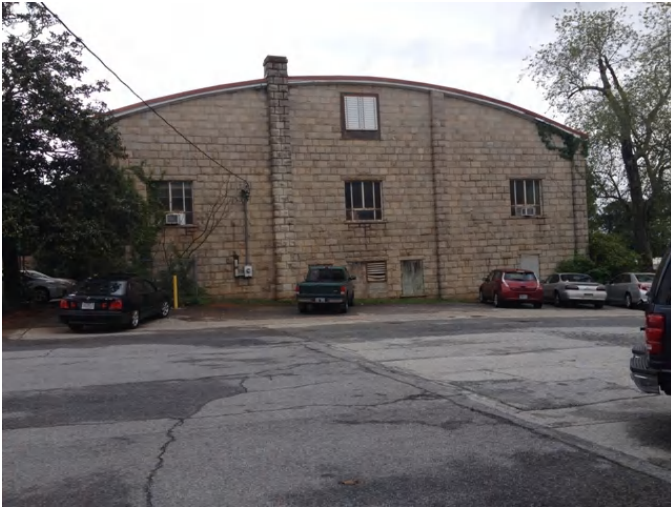
System: G4010 - Electrical Distribution

Location: Site

Distress: Beyond Service Life

Notes: The site electrical distribution system is beyond its expected service life and should be scheduled for replacement.
