DeKalb County School District/Elementary Schools

Panola Way Elementary

School Assessment Report

May 20, 2016

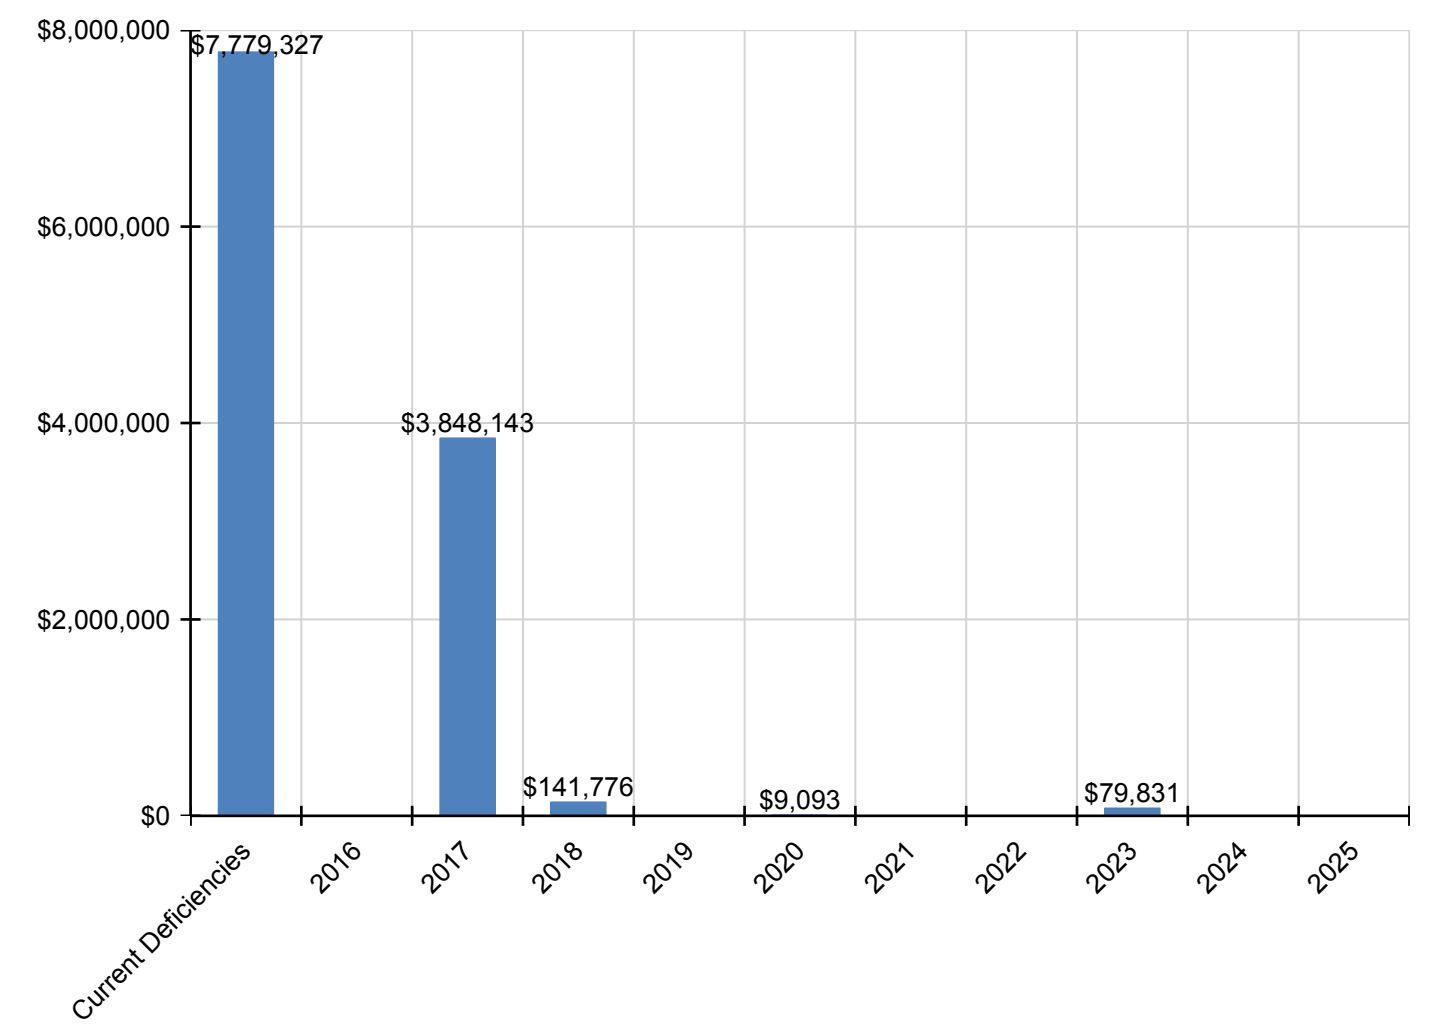
Forecasted Capital Renewal Requirement

The following chart shows the current building deficiencies and the forecasted capital renewal (system replacement) requirements over the next ten years.

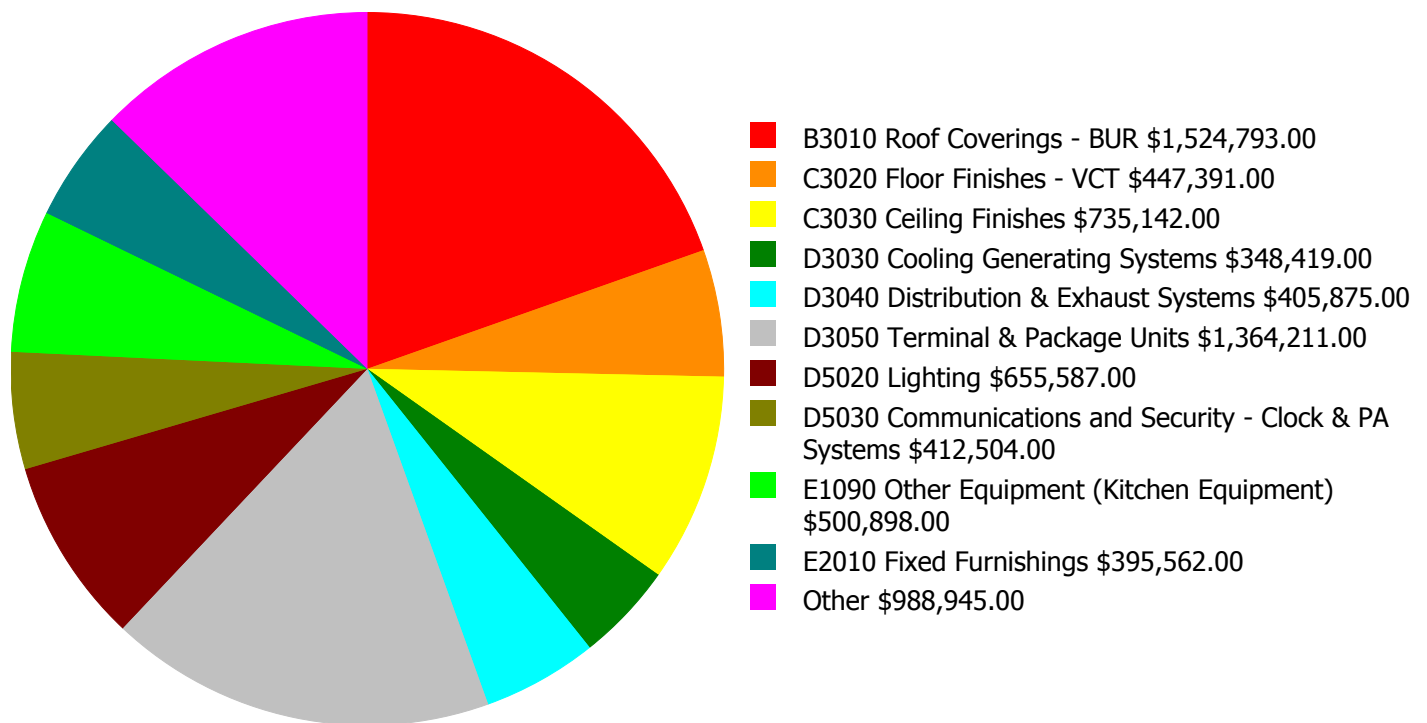
Deficiency Summary by System

Current deficiencies include assemblies that have reached or exceed their design life or components of the assemblies that are in need of repair. Assemblies that have reached their design life are identified as current deficiencies and assigned the distress 'Beyond Service Life'. The following chart lists all current deficiencies associated with this facility broken down by UNIFORMAT system.

Budget Estimate Total: \$7,779,327.00

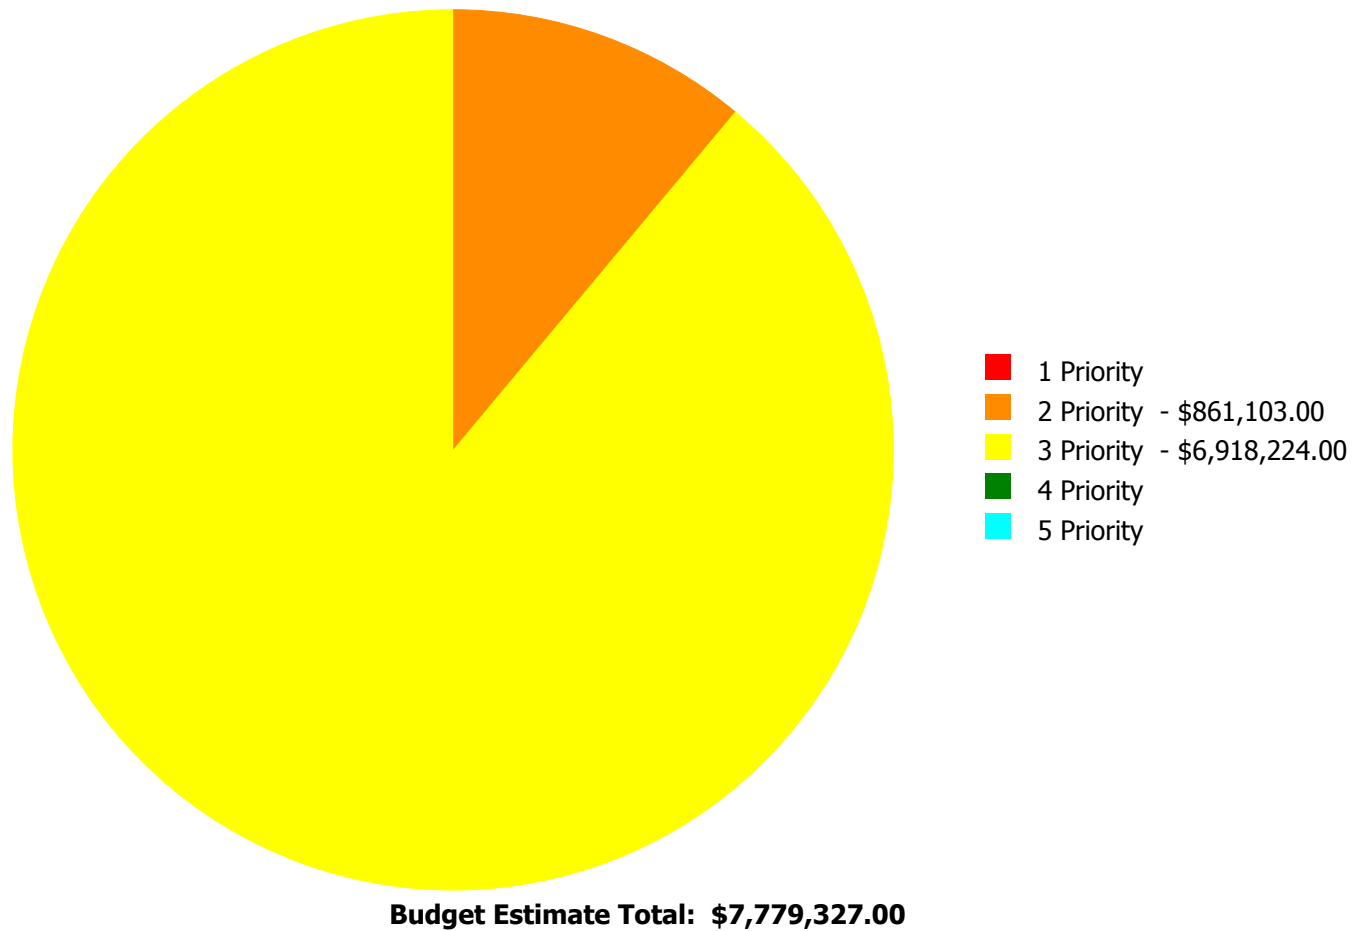
Deficiency Summary by Priority

The following chart shows the total repair costs broken down by priority. Assessors assigned deficiencies within eCOMET to one of the following priority categories:

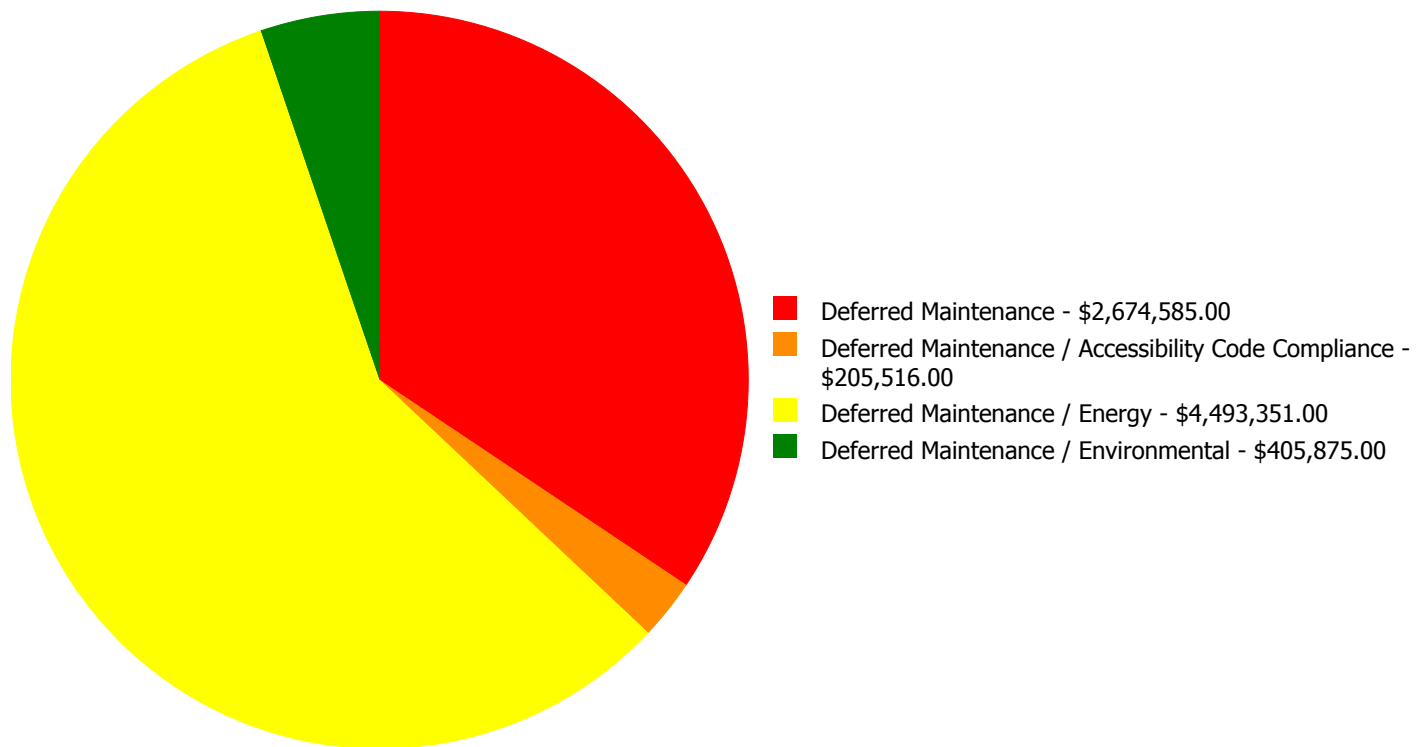
Deficiency Summary by Category

The following chart shows the total repair costs broken down by deficiency categories. Assessors assigned deficiencies to one of the following categories:

Budget Estimate Total: \$7,779,327.00

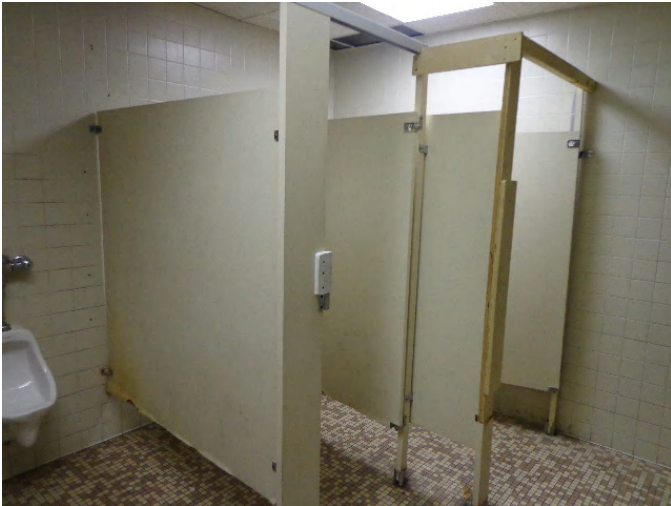
System: C1030 - Fittings

Location: Throughout Building

Distress: Beyond Service Life

Notes: Fittings are aged, in marginal condition with rough carpentry repairs, including many plywood doors, and missing grab bars. Room signage is not ADA compliant. A couple of restrooms are scheduled for replacement to comply with ADA standards under a current SPLOST project by 2016; however, this does not include all the restrooms (approximately 16). SPLOST project 125-422 to renovate hall restrooms.

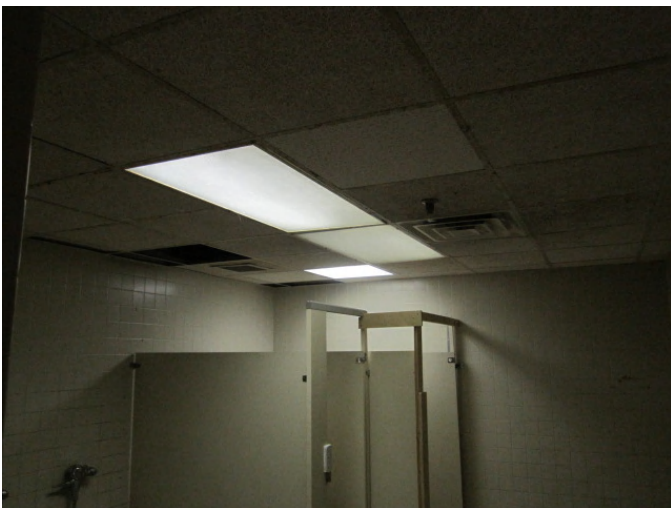
System: D5020 - Lighting

Location: Throughout Building

Distress: Beyond Service Life

Notes: The lighting system is beyond its expected service life, in poor condition, inefficient, and should be scheduled for replacement. SPLOST project 125-422 to replace the lighting system in the classrooms and restrooms by October 2016.

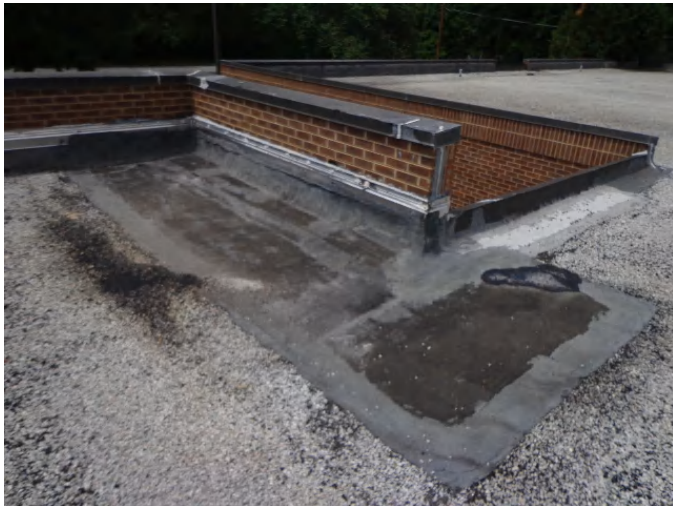
System: B3010 - Roof Coverings - BUR

Location: Roof

Distress: Beyond Service Life

Notes: Roof covering is beyond its expected service life and has reported leaks throughout the building. SPLOST project 125-422 to replace the roof.

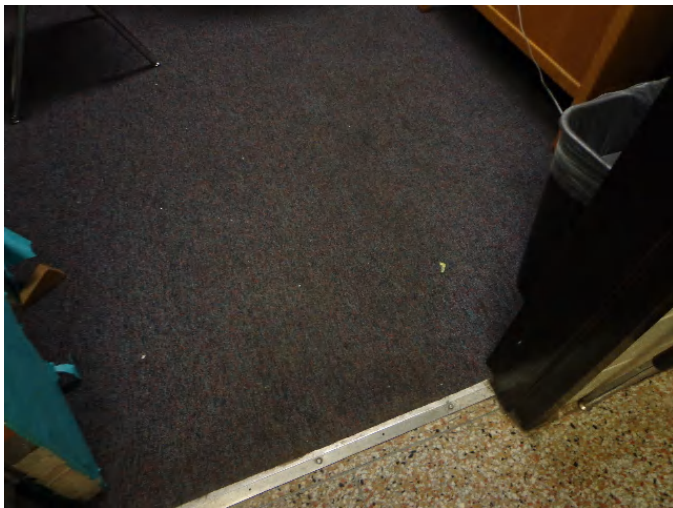
System: C3020 - Floor Finishes - Carpet

Location: Media Center and Offices

Distress: Beyond Service Life

Notes: The carpet is aged, stained and frayed, and should be replaced.

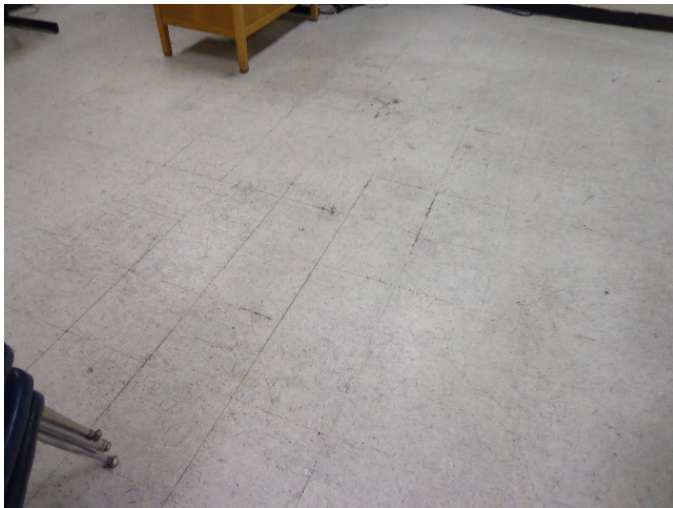
System: C3020 - Floor Finishes - VCT

Location: Throughout Building

Distress: Beyond Service Life

Notes: The VCT flooring is aged, cracked and worn, and should be replaced.

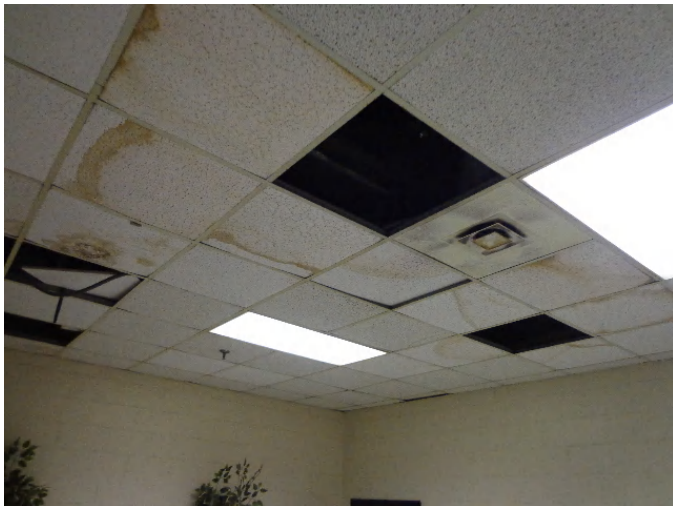
System: C3030 - Ceiling Finishes

Location: Throughout Building

Distress: Beyond Service Life

Notes: The ceiling finishes are beyond their expected service life, stained and damaged, and should be replaced.

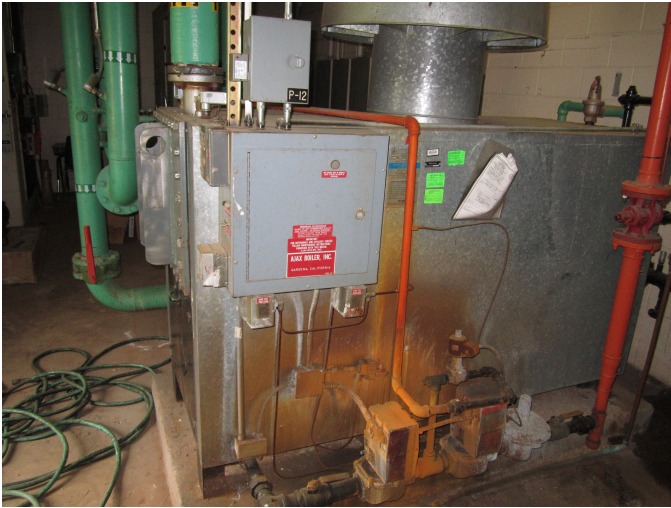
System: D3020 - Heat Generating Systems

Location: Mechanical Room

Distress: Beyond Service Life

Notes: The heating generating system (boiler) is beyond its expected service life and should be scheduled for replacement.

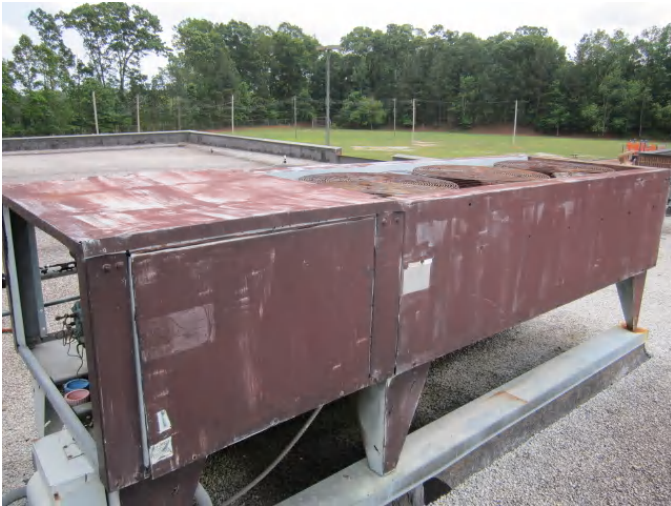
System: D3030 - Cooling Generating Systems

Location: Roof and Side of Building

Distress: Beyond Service Life

Notes: The cooling generating system, including rooftop chiller and on-grade cooling tower, is beyond its expected service life, inefficient, and should be scheduled for replacement. Cooling tower, pumps, piping and valves to be replaced under SPLOST project 125-422 by October 2016.

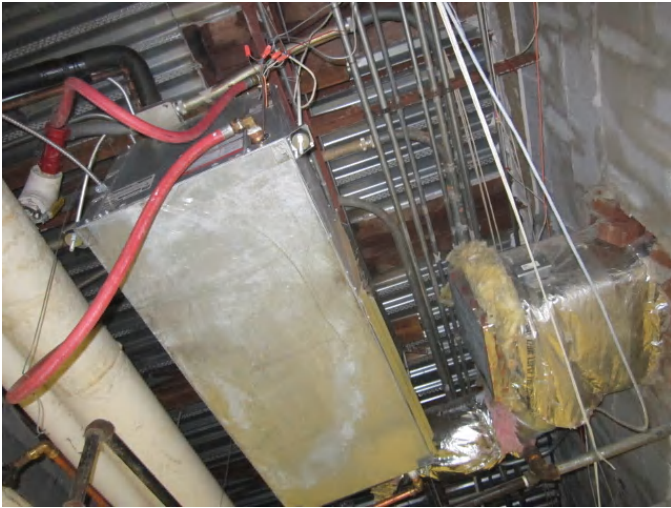
System: D3040 - Distribution & Exhaust Systems

Location: Throughout Building

Distress: Beyond Service Life

Notes: The distribution and exhaust systems are beyond their expected service life, inadequate, and should be scheduled for replacement. School staff reports indoor air-quality problems.

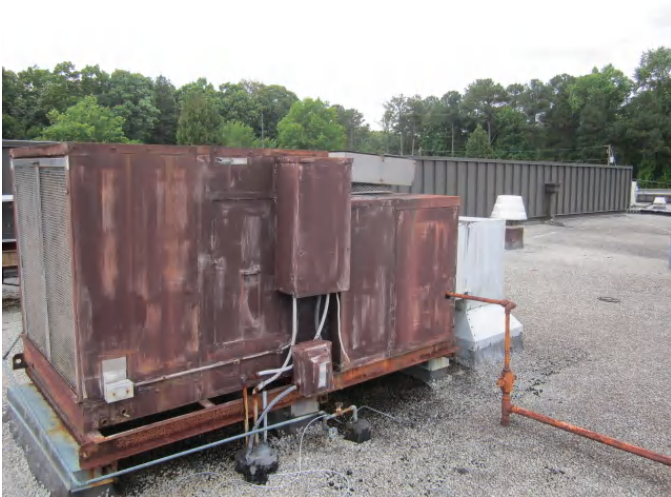
System: D3050 - Terminal & Package Units

Location: Roof

Distress: Beyond Service Life

Notes: The terminal and package units are beyond their expected service life, inefficient, and should be scheduled for replacement. SPLOST project 125-422 to replace the roof top units, fan coil units, and water source heat pumps by October 2016.

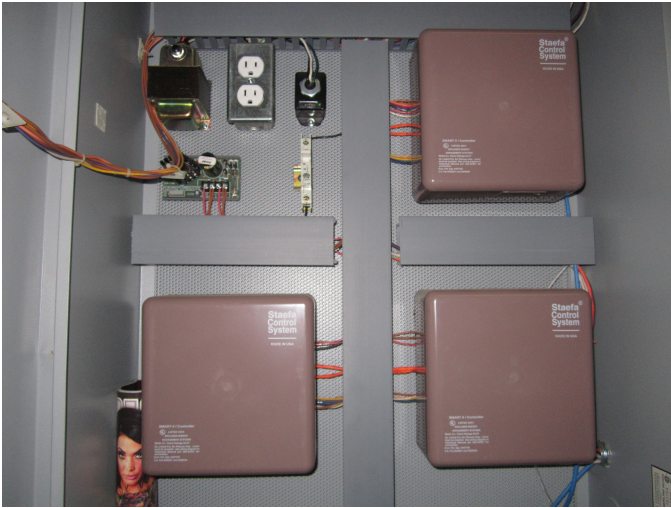
System: D3060 - Controls & Instrumentation

Location: Throughout Building

Distress: Beyond Service Life

Notes: Controls and instrumentation are beyond their expected service life, inadequate, and should be scheduled for replacement.

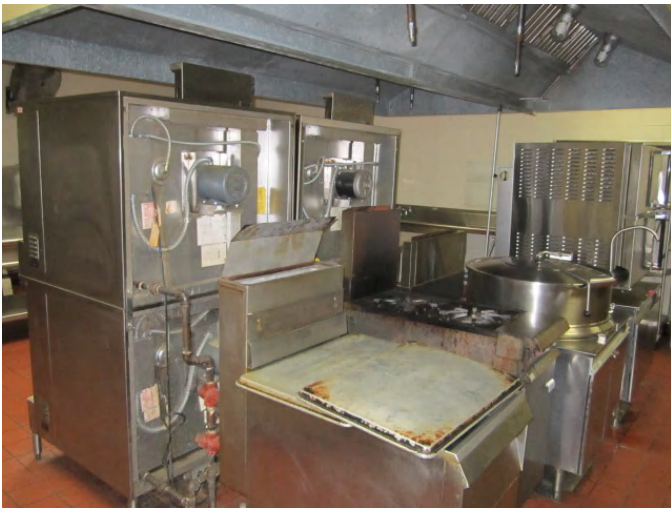
System: D3090 - Other HVAC Systems/Equip - Kitchen Hood

Location: Kitchen

Distress: Beyond Service Life

Notes: The kitchen hood system is beyond its expected service life and should be scheduled for replacement.

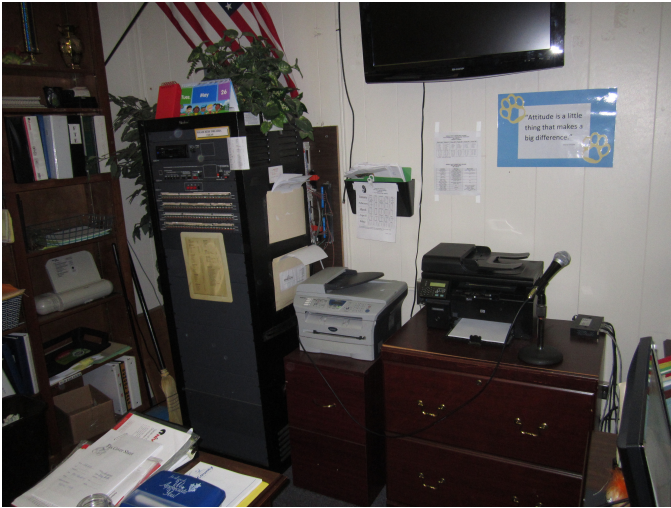
System: D5030 - Communications and Security - Clock & PA Systems

Location: Throughout Building

Distress: Beyond Service Life

Notes: The public address and clock systems are beyond their expected service life, have reported outages, and should be scheduled for replacement.

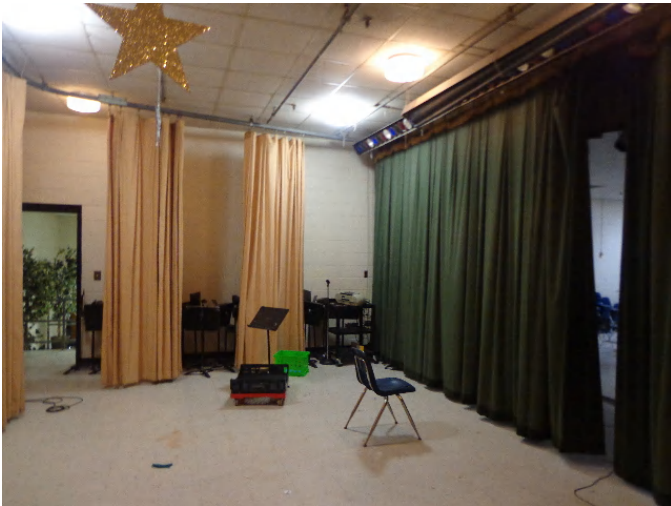
System: E1020 - Institutional Equipment

Location: Throughout Building

Distress: Beyond Service Life

Notes: Institutional equipment, such as theater and stage equipment and library equipment, is beyond its expected service life and should be scheduled for replacement.

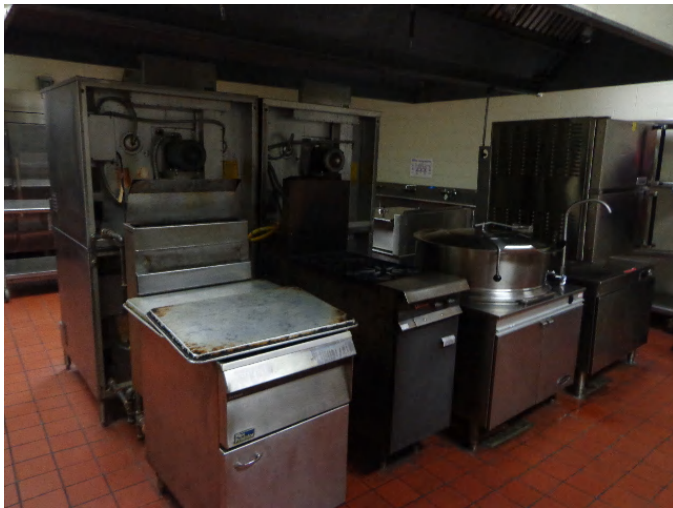
System: E1090 - Other Equipment (Kitchen Equipment)

Location: Kitchen

Distress: Beyond Service Life

Notes: Kitchen equipment is beyond its expected service life and should be scheduled for replacement.

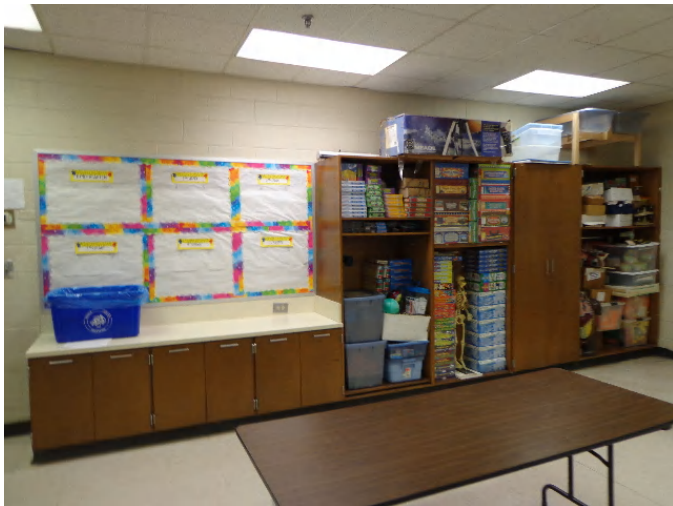
System: E2010 - Fixed Furnishings

Location: Throughout Building

Distress: Beyond Service Life

Notes: Fixed furnishings are beyond their expected service life and should be scheduled for replacement.

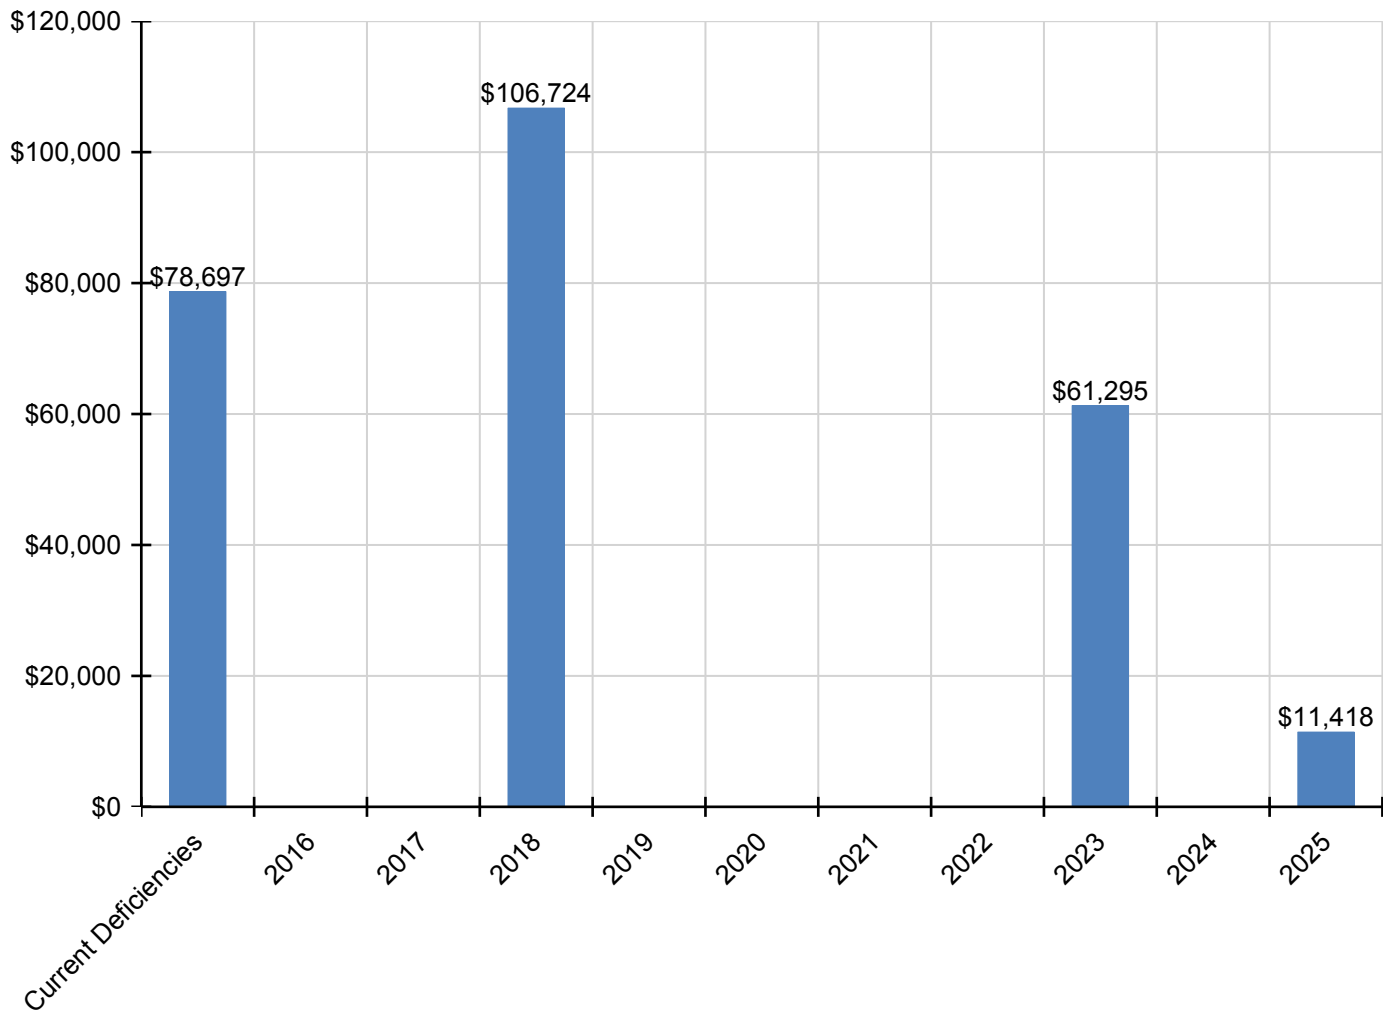
Forecasted Capital Renewal Requirement

The following chart shows the current building deficiencies and the forecasted capital renewal (system replacement) requirements over the next ten years.

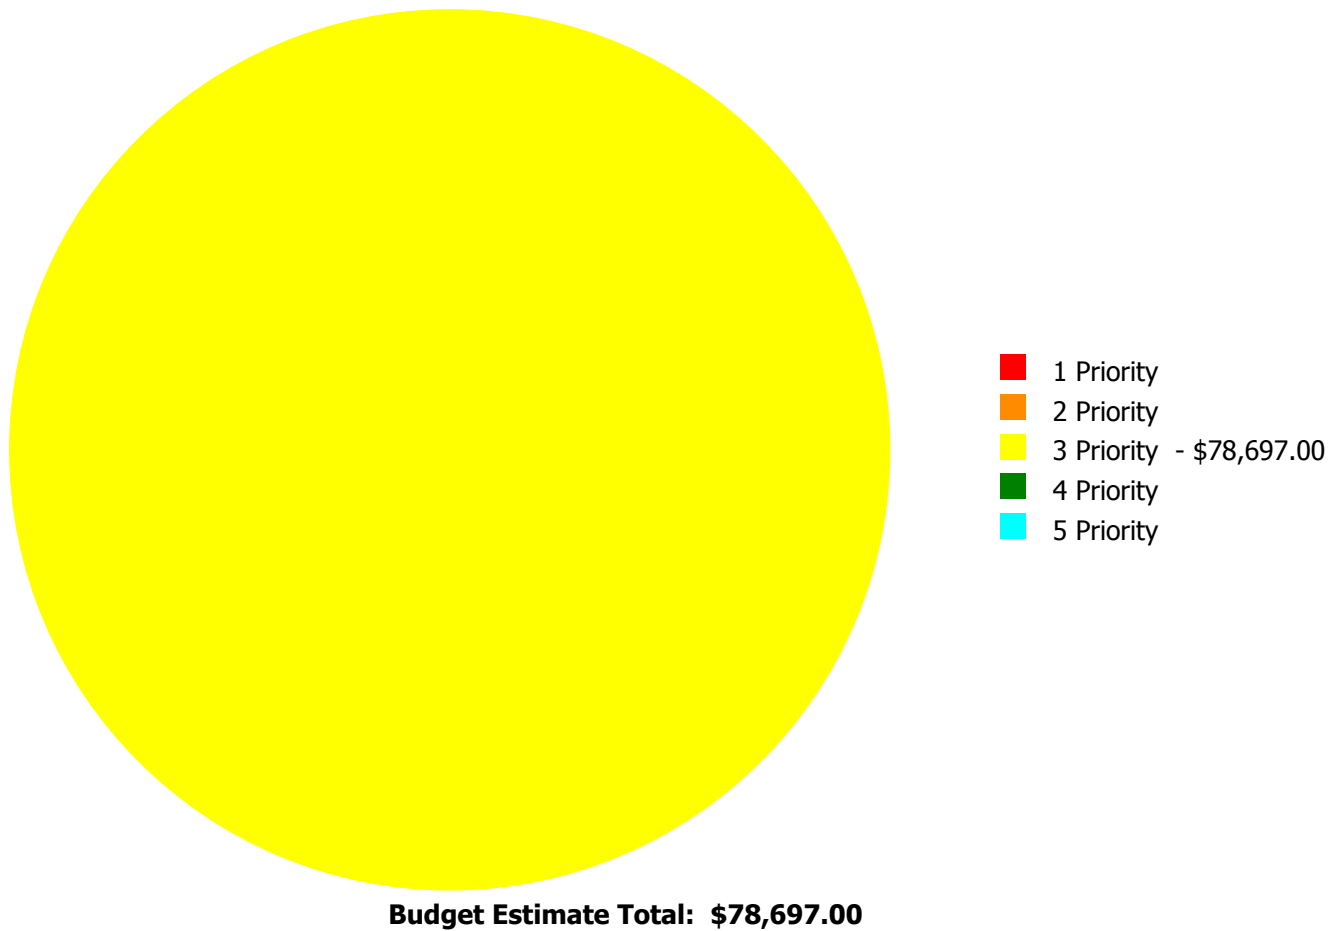
Deficiency Summary by Priority

The following chart shows the total repair costs broken down by priority. Assessors assigned deficiencies within eCOMET to one of the following priority categories:

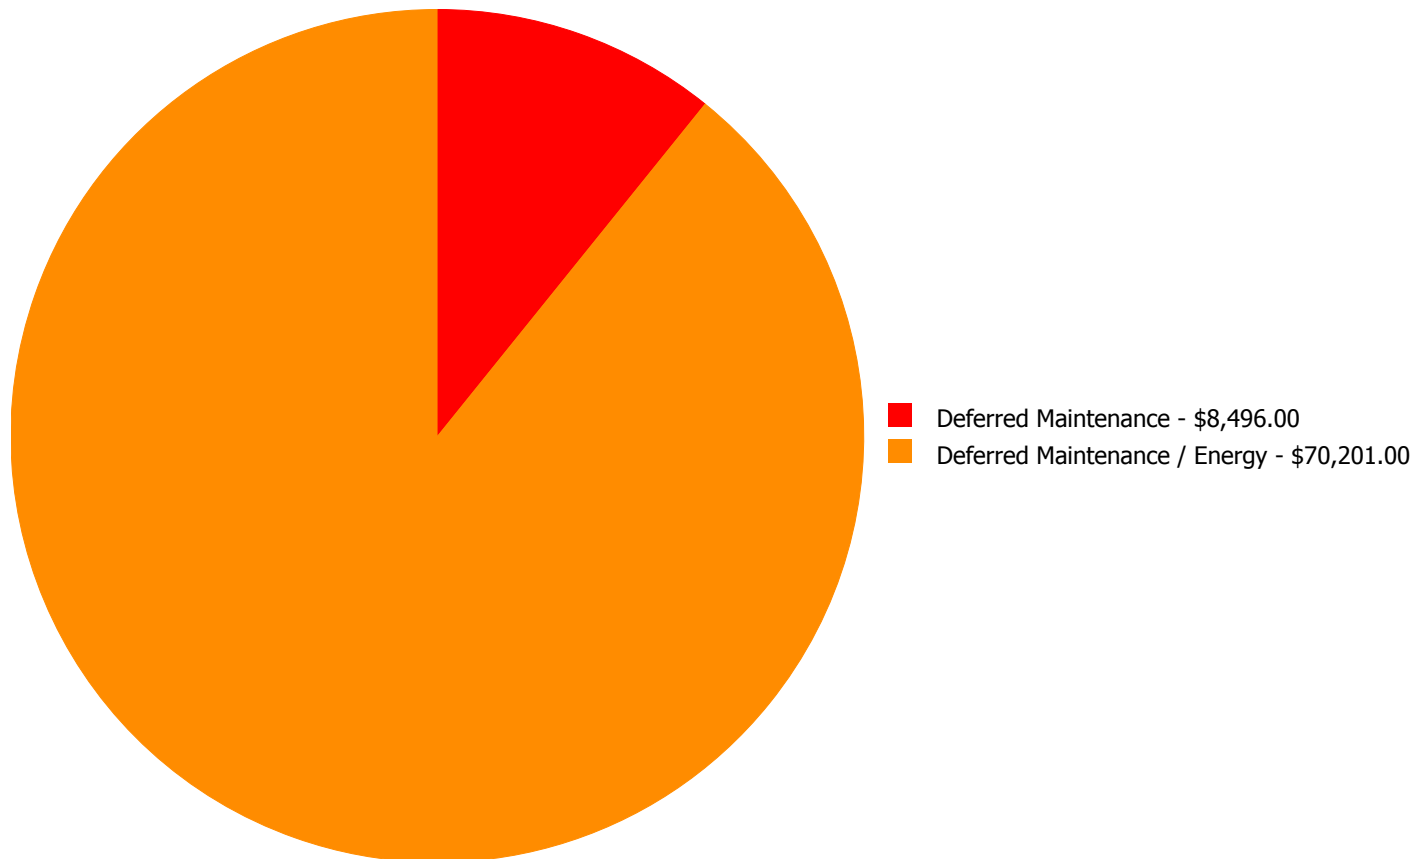
Deficiency Summary by Category

The following chart shows the total repair costs broken down by deficiency categories. Assessors assigned deficiencies to one of the following categories:

Budget Estimate Total: \$78,697.00

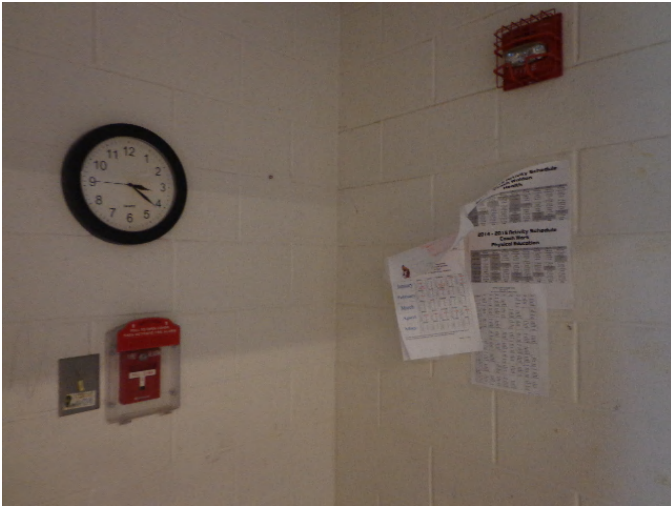
System: C3010 - Wall Finishes - Paint

Location: Throughout Building

Distress: Beyond Service Life

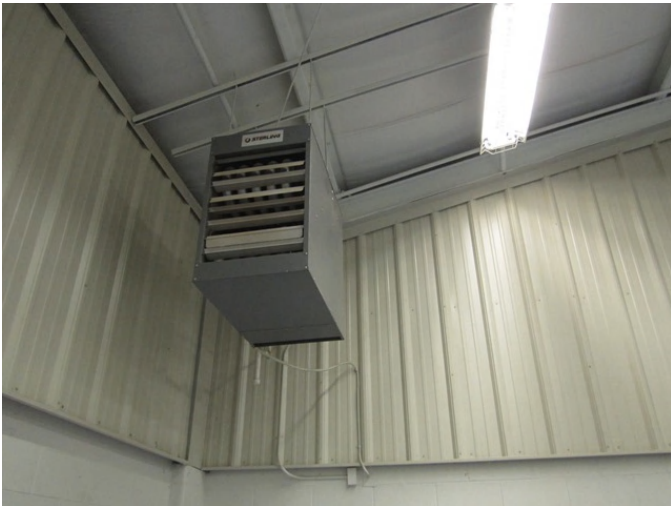
System: D3050 - Terminal & Package Units

Location: Throughout Building

Distress: Inadequate

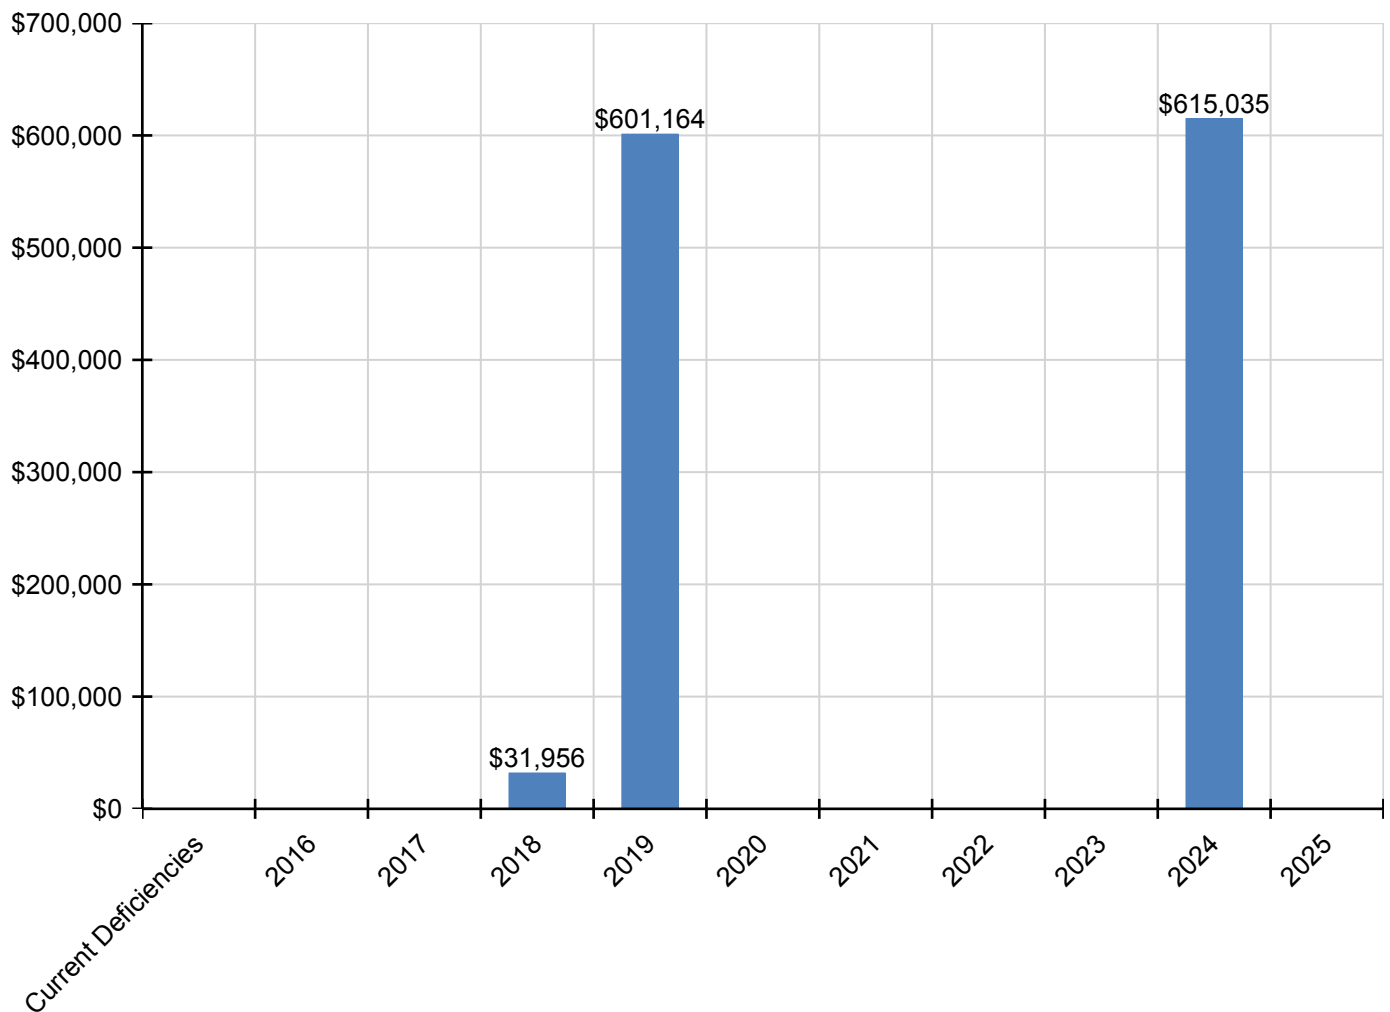
Forecasted Capital Renewal Requirement

The following chart shows the current building deficiencies and the forecasted capital renewal (system replacement) requirements over the next ten years.

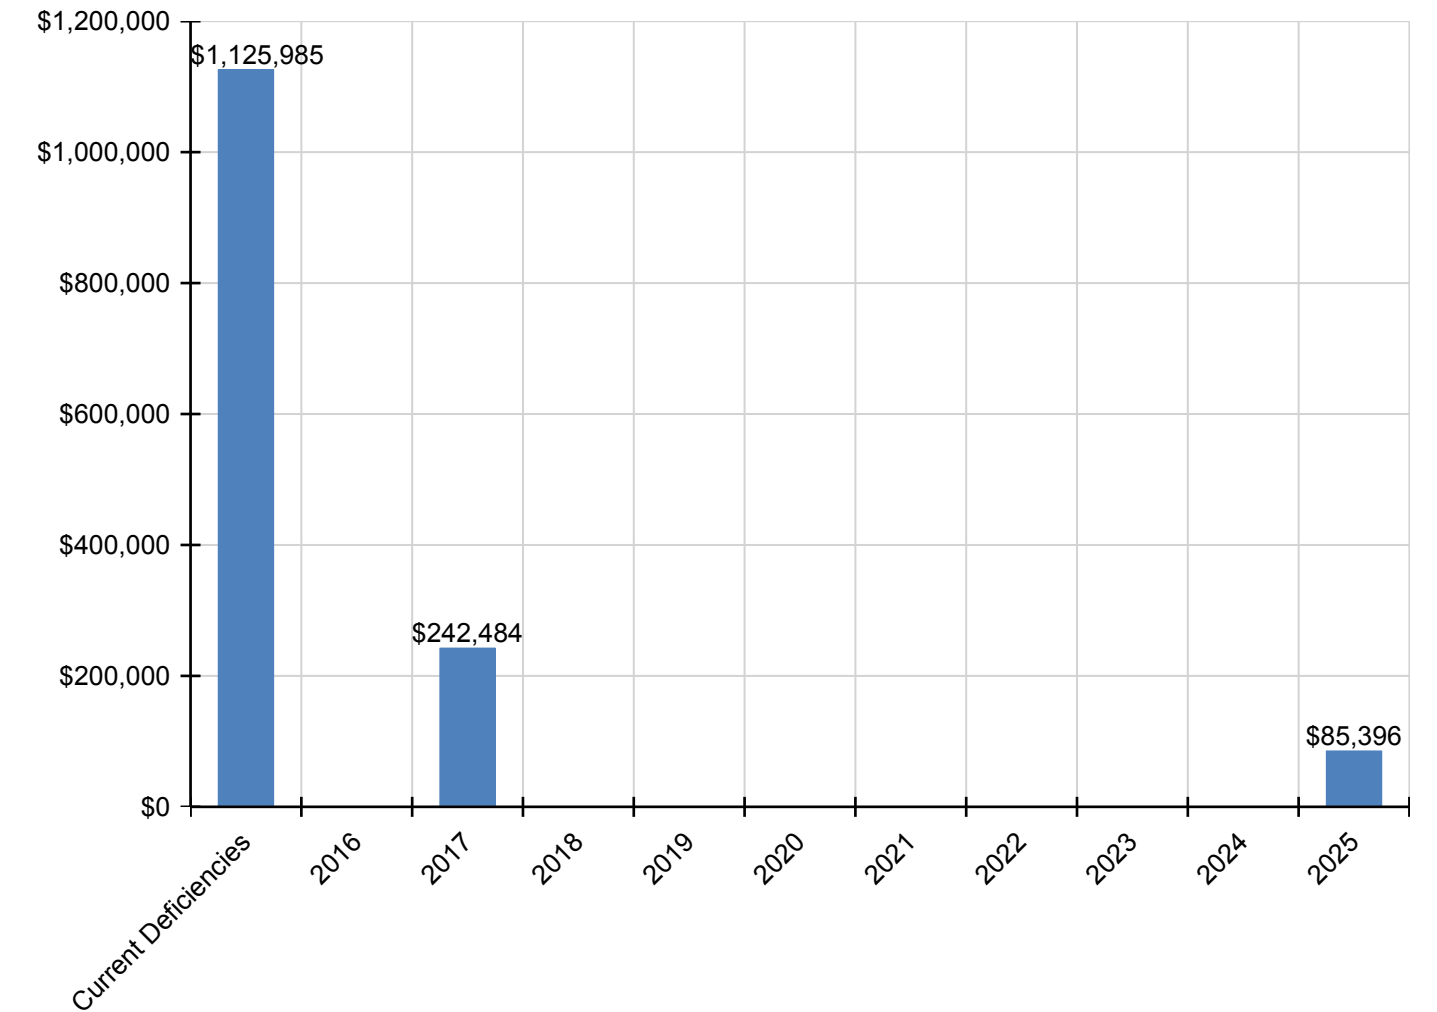
Forecasted Capital Renewal Requirement

The following chart shows the current building deficiencies and the forecasted capital renewal (system replacement) requirements over the next ten years.

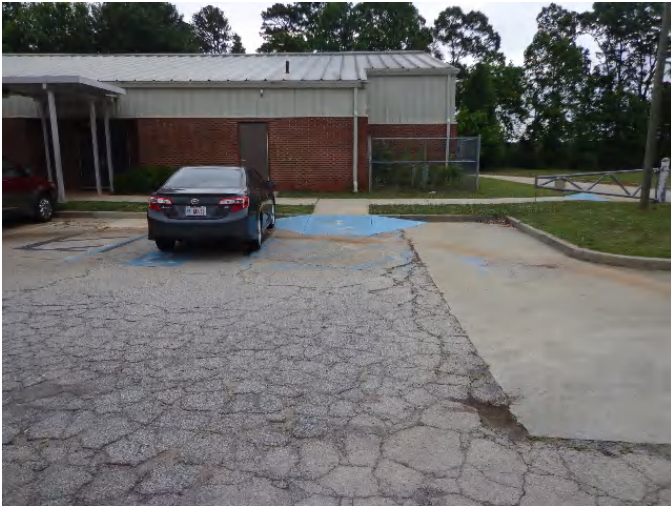
System: G2020 - Parking Lots

Location: Site

Distress: Missing

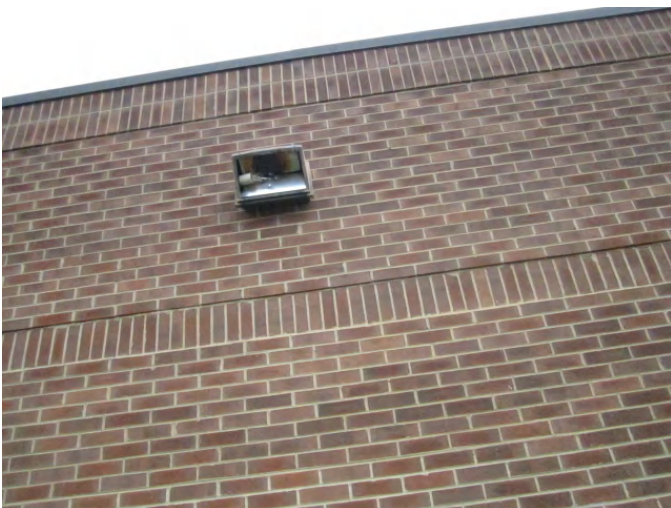
System: G4020 - Site Lighting

Location: Site

Distress: Needs Remediation

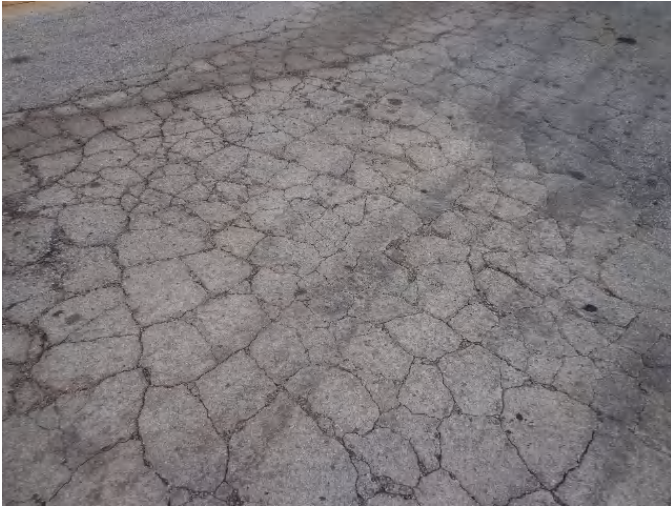
System: G2010 - Roadways

Location: Site

Distress: Beyond Service Life

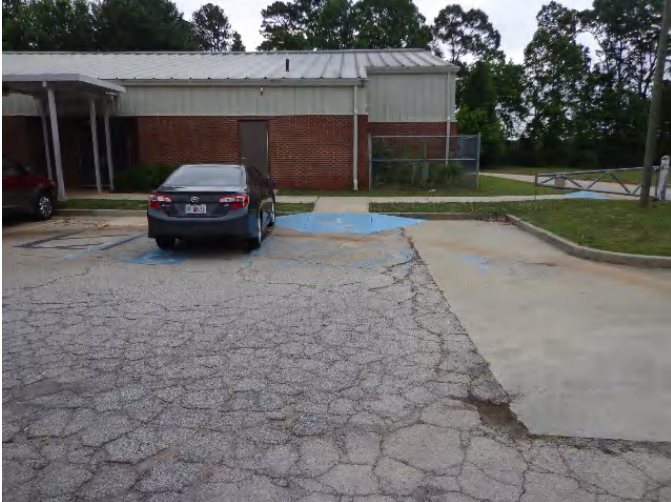
System: G2020 - Parking Lots

Location: Site

Distress: Beyond Service Life

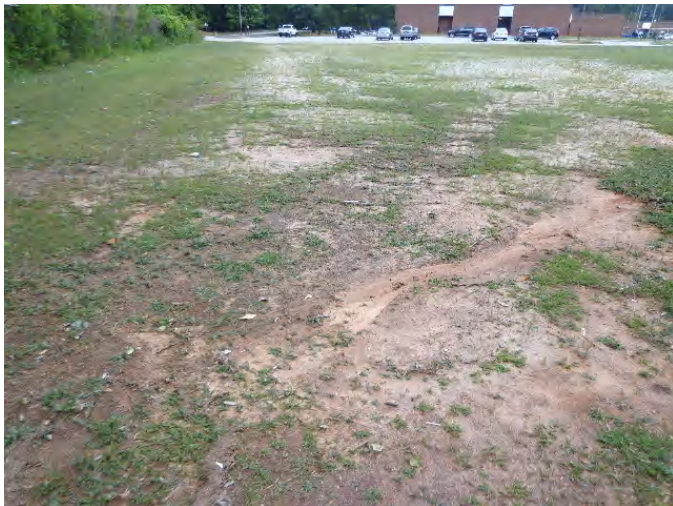
System: G2040 - Playing Field

Location: Site

Distress: Beyond Service Life

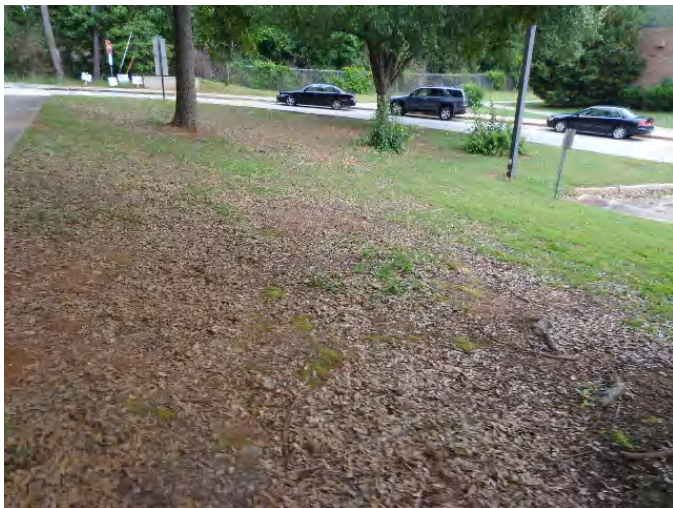
System: G2050 - Landscaping

Location: Site

Distress: Beyond Service Life

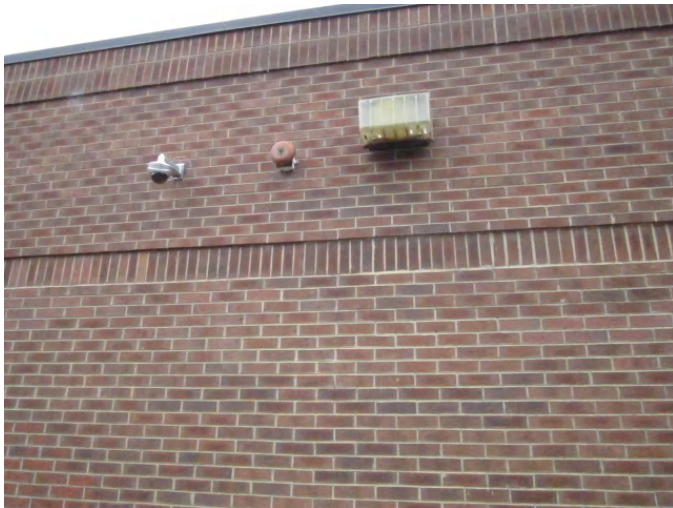
System: G4030 - Site Communications & Security

Location: Site

Distress: Beyond Service Life
