DeKalb County School District/Middle Schools

Peachtree Middle

School Assessment Report

May 20, 2016

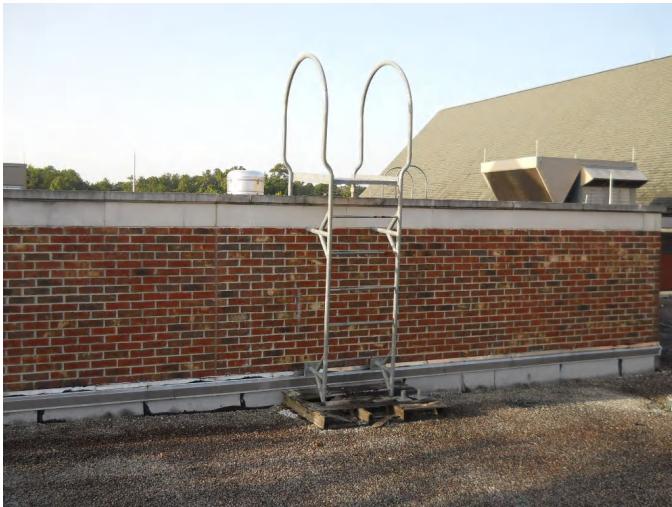
System: B2010 - Exterior Walls

Location: Roof

Distress: Needs Remediation

Notes: The roof ladder is incorrectly mounted, loose at the bottom, and not level.

Correction: Replace roof ladder with cage

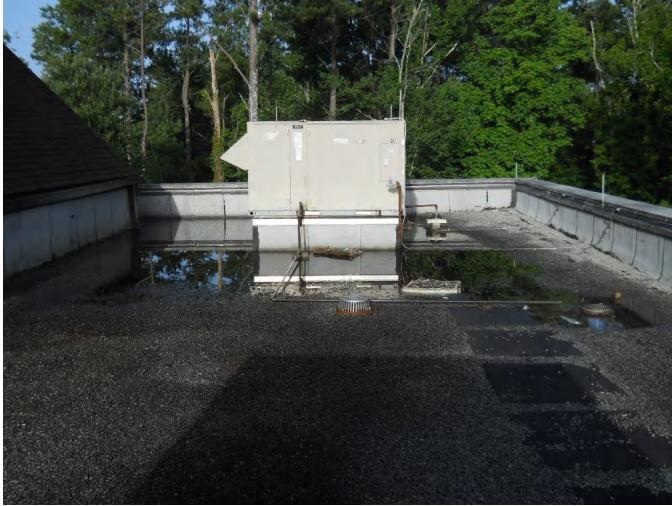
System: B3010 - Roof Coverings - BUR

Location: Roof

Distress: Needs Remediation

Notes: A section of the roof is incorrectly sloped, holding water, and will eventually cause roof leaks and roof failure. Recommend re-sloping the roof to allow rain water to flow to the drain system.

Correction: Minor roofing repairs, 2% of roof area, roll roofing

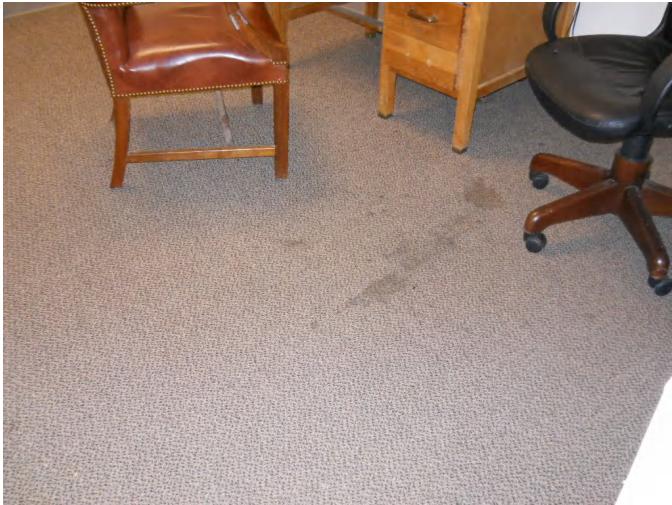
System: C3020 - Floor Finishes - Carpet

Location: Offices, Media, Classrooms, and Music

Distress: Beyond Service Life

Notes: The carpet is beyond its expected service life, worn and dirty, and should be replaced.

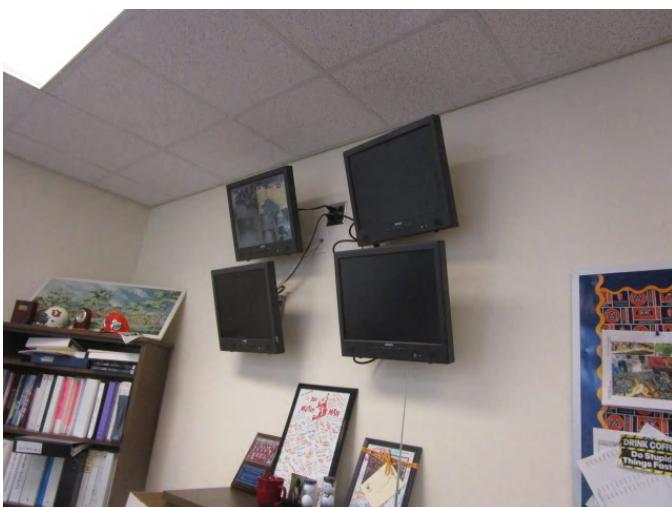
System: D5030 - Communications and Security - Security & CCTV

Location: Throughout Building

Distress: Beyond Service Life

Notes: The security and CCTV systems are beyond their expected service life and should be scheduled for replacement.

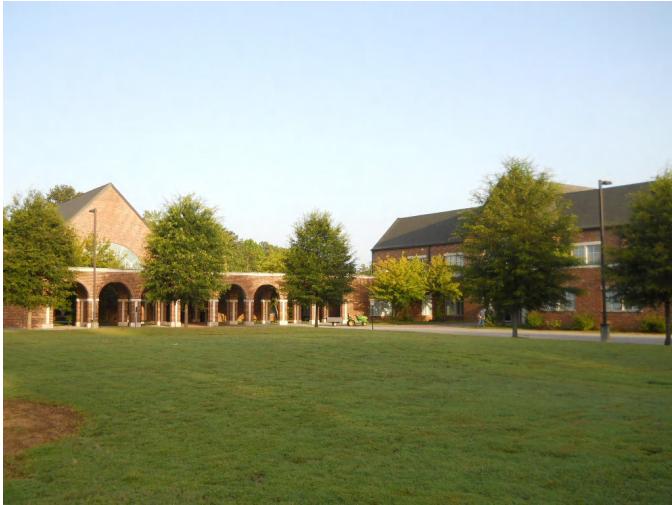
System: G2050 - Landscaping

Location: Site

Distress: Damaged

Notes: The irrigation system is nonfunctional and needs repair.

Correction: Irrigation system, repair /replace controls and test system
