DeKalb County School District/Elementary Schools

Pleasantdale Elementary

School Assessment Report

May 20, 2016

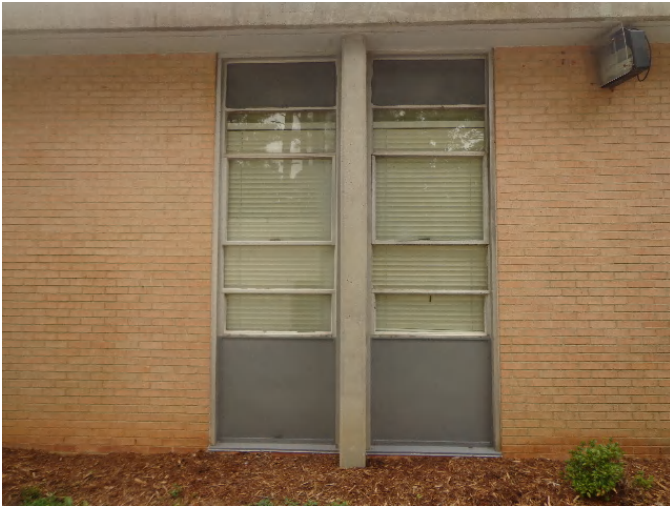
System: B2020 - Exterior Windows

Location: Throughout Building

Distress: Beyond Service Life

Notes: The aluminum frame, operable, single pane windows are aged, damaged, not energy efficient, and should be replaced. SPLOST project 507-422 to replace the school.

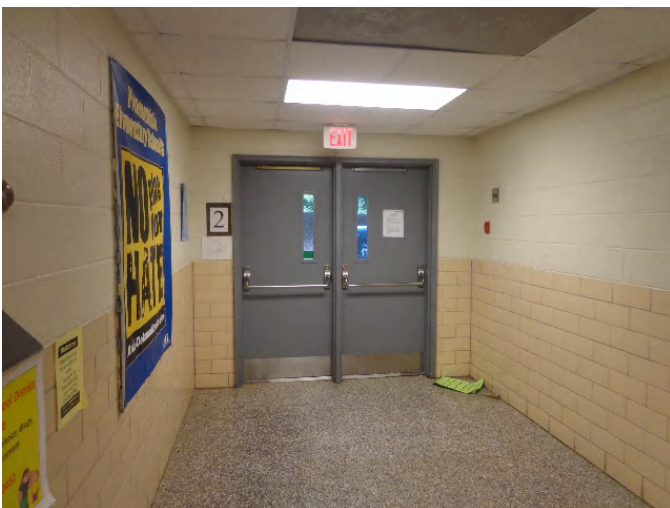
System: B2030 - Exterior Doors

Location: Throughout Building

Distress: Beyond Service Life

Notes: The original exterior doors are aged, rusted and should be replaced. SPLOST project 507-422 to replace the school.

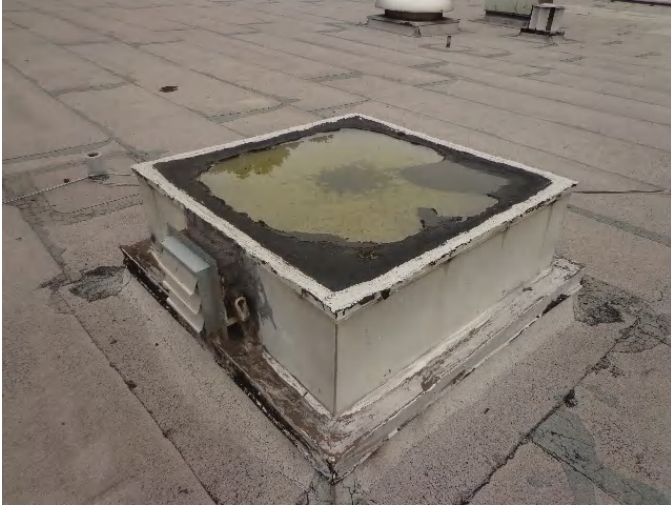
System: B3020 - Roof Openings

Location: Roof

Distress: Beyond Service Life

Notes: Skylights are in poor condition with temporary repairs to prevent water infiltration, and are recommended to be replaced. SPLOST project 507-422 to replace the school.

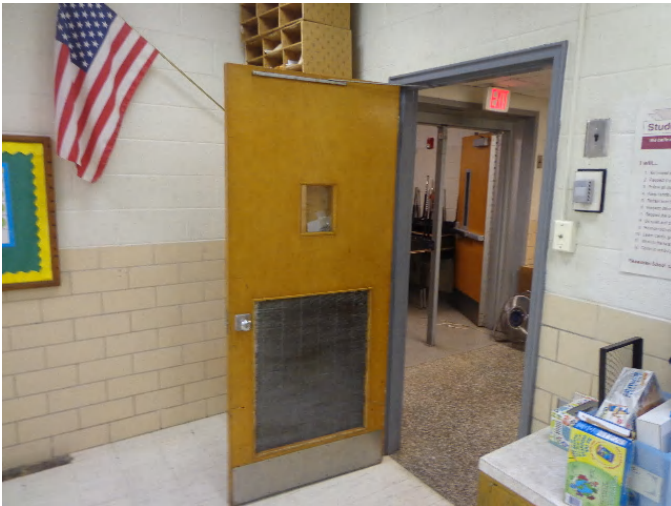
System: C1020 - Interior Doors

Location: Throughout Building

Distress: Beyond Service Life

Notes: The interior doors are aged, failing, not ADA or building code compliant, and should be replaced. SPLOST project 507-422 to replace the school.

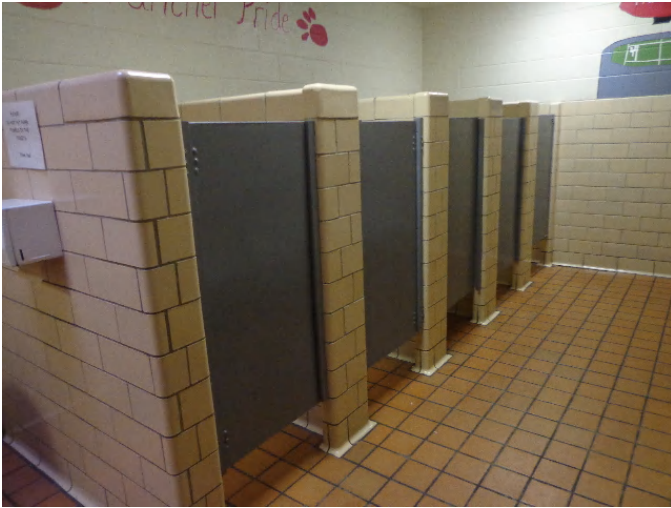
System: C1030 - Fittings

Location: Throughout Building

Distress: Beyond Service Life

Notes: Fittings, such as toilet partitions, handrails and signage, are beyond their expected service life, room signage is not ADA compliant, and the entire system should be replaced. SPLOST project 507-422 to replace the school.

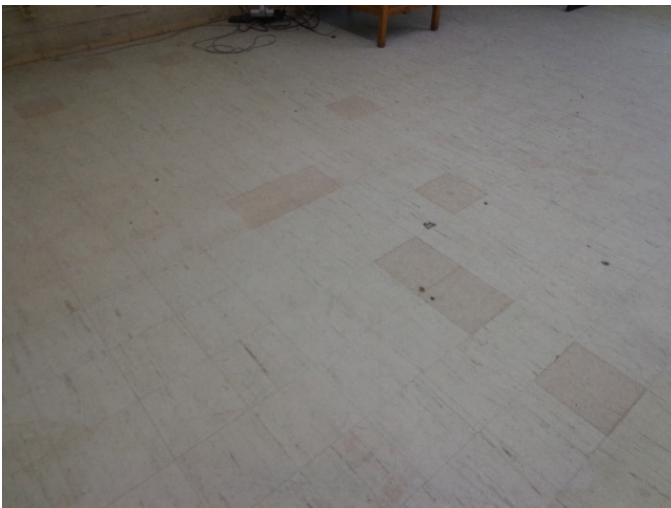
System: C3020 - Floor Finishes - VCT

Location: Throughout Building

Distress: Beyond Service Life

Notes: The VCT flooring is aged, cracked, worn and patched, and should be replaced. SPLOST project 507-422 to replace the school.

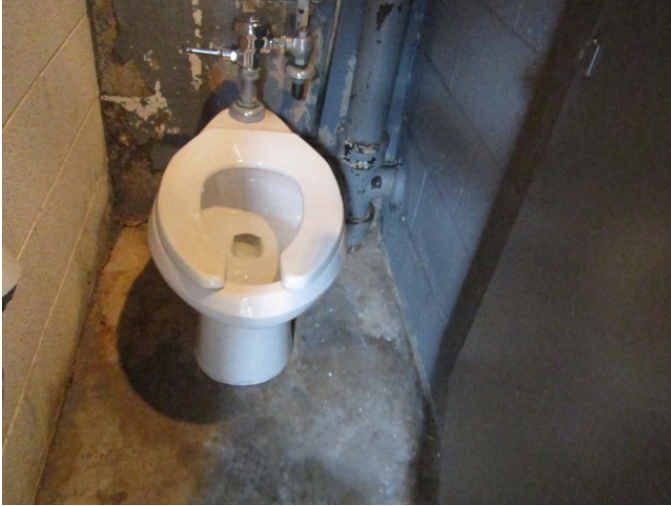
System: D2010 - Plumbing Fixtures

Location: Throughout Building

Distress: Beyond Service Life

Notes: The plumbing fixtures are beyond their expected service life, inadequate, and should be scheduled for replacement. SPLOST project 507-422 to replace school by 2018.

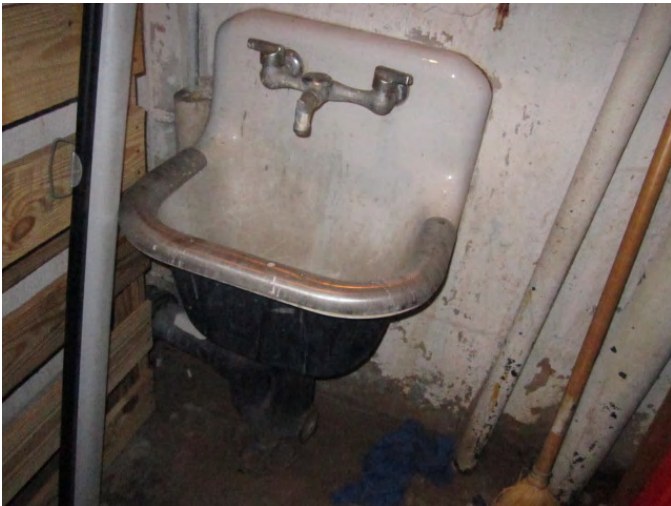
System: D2020 - Domestic Water Distribution

Location: Throughout Building

Distress: Beyond Service Life

Notes: The domestic water distribution system is beyond its expected service life, not building code compliant, and should be scheduled for replacement. SPLOST project 507-422 to replace the school.

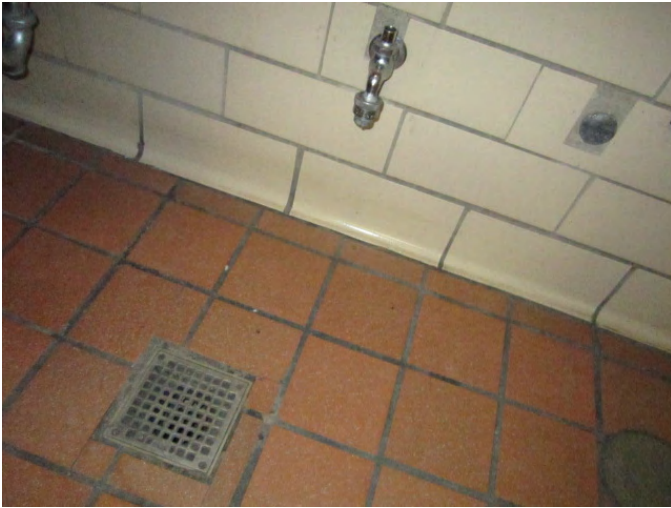
System: D2030 - Sanitary Waste

Location: Throughout Building
Distress: Beyond Service Life
Category: Deferred Maintenance
Priority: 3 Priority
Correction: Renew System
Qty: 45,816.00
Unit of Measure: S.F.
Estimate: \$171,856.00
Assessor Name: Ben Nixon
Date Created: 07/07/2015

Notes: The sanitary waste system is beyond its expected service life and should be scheduled for replacement. SPLOST project 507-422 to replace the school.

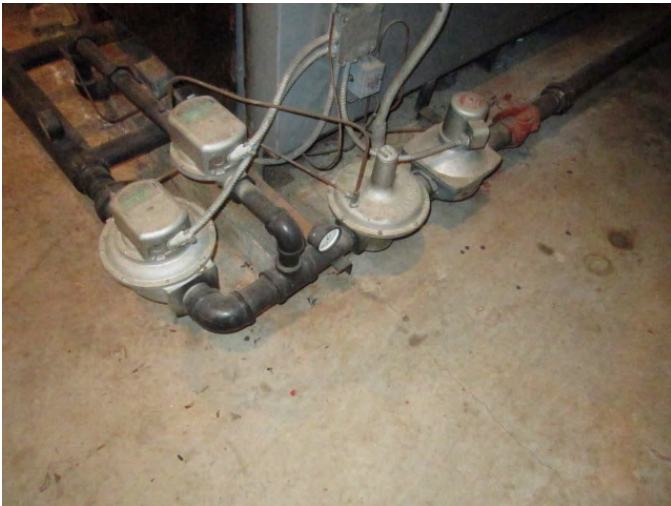
System: D2090 - Other Plumbing Systems - Natural Gas

Location: Throughout Building
Distress: Beyond Service Life
Category: Deferred Maintenance
Priority: 3 Priority
Correction: Renew System
Qty: 45,816.00
Unit of Measure: S.F.
Estimate: \$20,663.00
Assessor Name: Ben Nixon
Date Created: 07/07/2015

Notes: The natural gas system is beyond its expected service life and should be scheduled for replacement. SPLOST project 507-422 to replace the school.

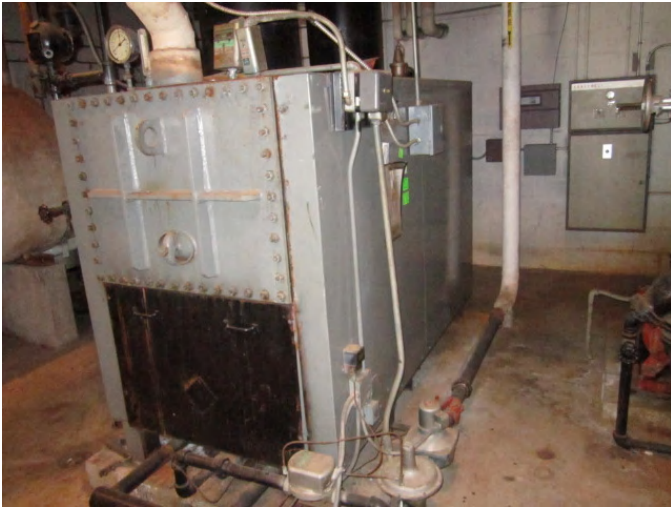
System: D3020 - Heat Generating Systems

Location: Mechanical Room

Distress: Beyond Service Life

Notes: The heat generating system is beyond its expected service life, inadequate, and should be scheduled for replacement. SPLOST project 507-422 to replace the school.

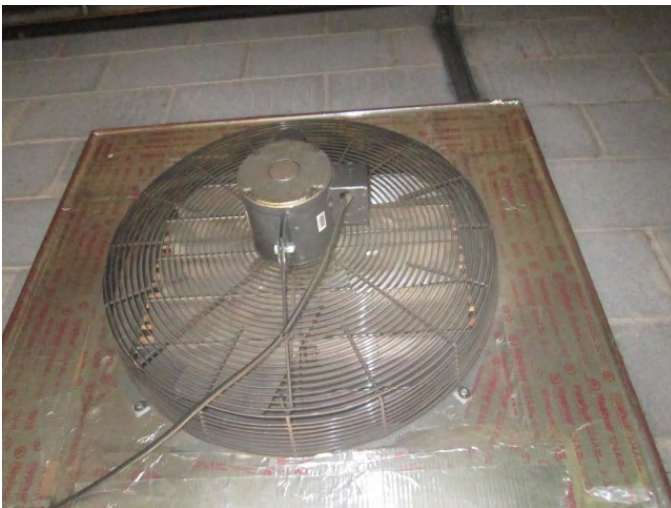
System: D3040 - Distribution & Exhaust Systems

Location: Throughout Building

Distress: Beyond Service Life

Notes: The distribution and exhaust systems are beyond their expected service life, inadequate, and should be scheduled for replacement. SPLOST project 507-422 to replace the school.

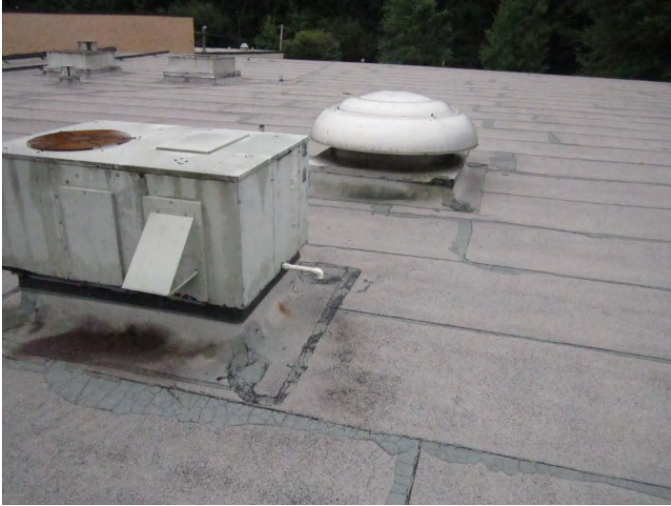
System: D3050 - Terminal & Package Units

Location: Throughout Building

Distress: Beyond Service Life

Notes: The terminal and package units are beyond their expected service life, inadequate, and should be scheduled for replacement. School staff reports that air conditioning is loud in certain rooms. SPLOST project 507-422 to replace the school.

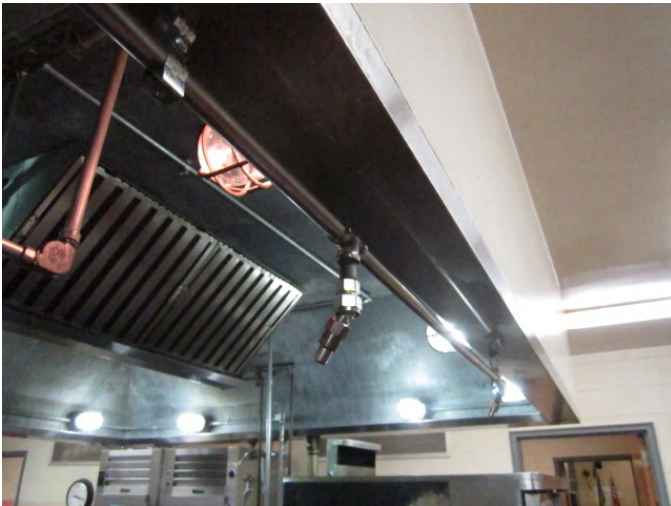
System: D3090 - Other HVAC Systems/Equip - Kitchen Hood

Location: Kitchen

Distress: Beyond Service Life

Notes: The kitchen hood system is beyond its expected service life, aged, and should be scheduled for replacement. SPLOST project 507-422 to replace the school.

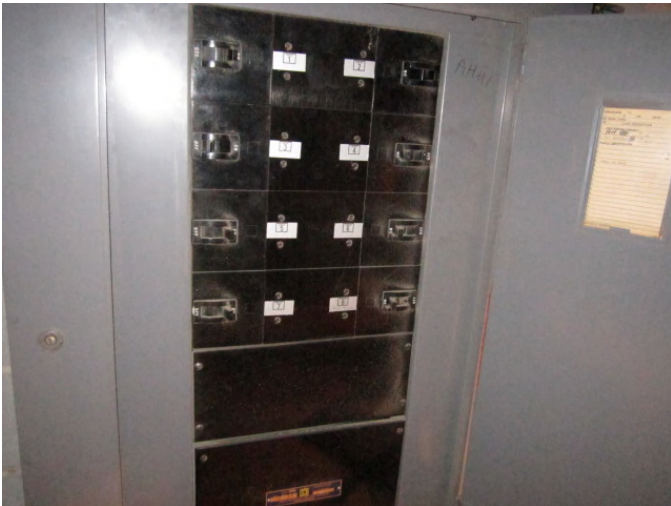
System: D5020 - Branch Wiring

Location: Throughout Building

Distress: Beyond Service Life

Notes: The branch wiring system is beyond its expected service life, aged, and should be scheduled for replacement. GFI outlets are missing in wet areas. SPLOST project 507-422 to replace the school.

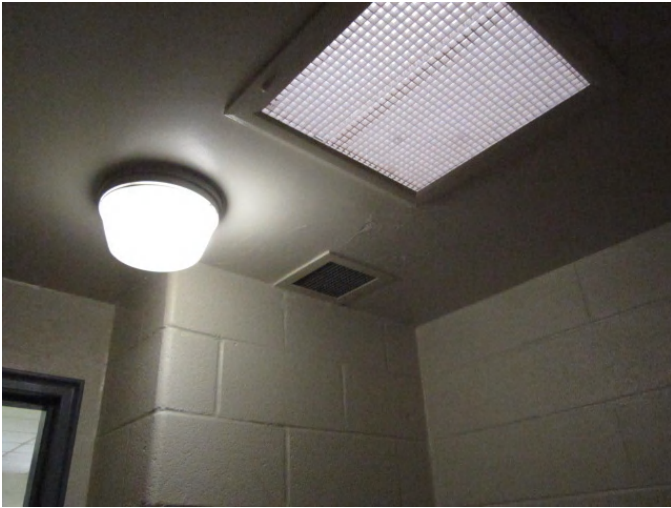
System: D5020 - Lighting

Location: Throughout Building

Distress: Beyond Service Life

Notes: The lighting system is beyond its expected service life, in poor condition, and should be scheduled for replacement. SPLOST project 507-422 to replace the school.

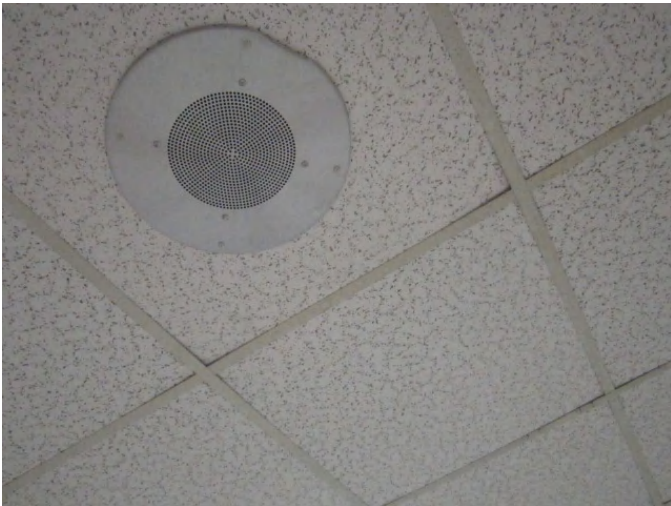
System: D5030 - Communications and Security - Clock & PA Systems

Location: Throughout Building

Distress: Beyond Service Life

Notes: Clock and PA systems are beyond their expected service life, aged, and should be scheduled for replacement. SPLOST project 507-422 to replace the school.

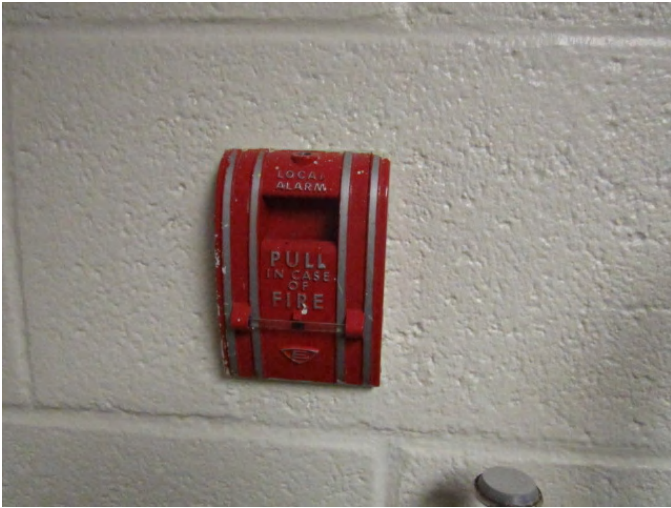
System: D5030 - Communications and Security - Fire Alarm

Location: Throughout Building

Distress: Beyond Service Life

Notes: The fire alarm system is beyond its expected service life and should be scheduled for replacement. Visible alarms (strobes) are not installed in multiple occupancy, common use areas. SPLOST project 507-422 to replace the school.

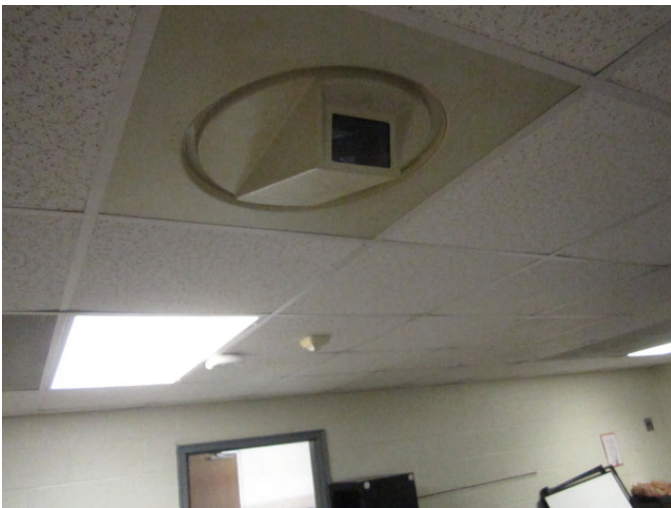
System: D5030 - Communications and Security - Security & CCTV

Location: Throughout Building

Distress: Beyond Service Life

Notes: The security and CCTV systems are beyond their expected service life, aged, and should be scheduled for replacement. SPLOST project 507-422 to replace the school.

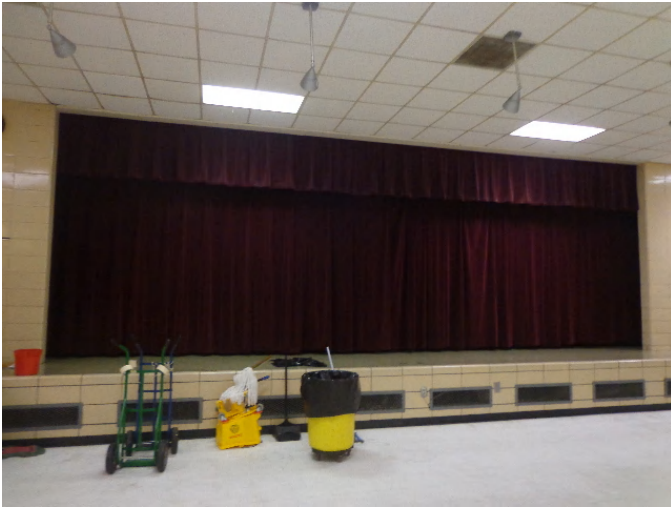
System: E1020 - Institutional Equipment

Location: Throughout Building

Distress: Beyond Service Life

Notes: Institutional equipment, such as theater and stage equipment and library equipment, is beyond its expected service life and should be scheduled for replacement. SPLOST project 507-422 to replace the school.

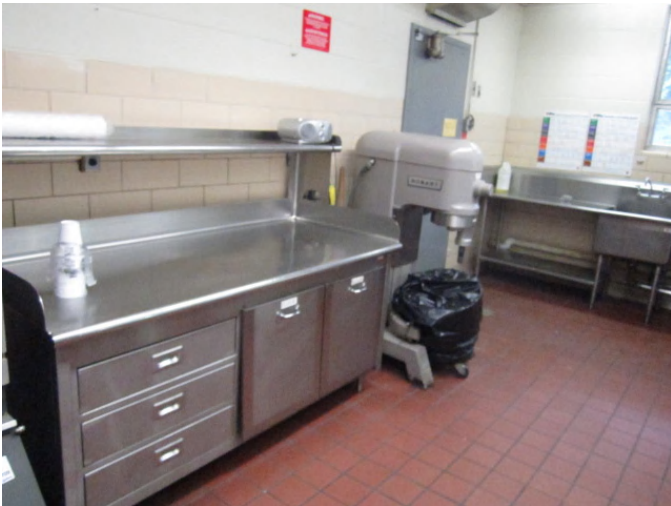
System: E1090 - Other Equipment - Kitchen Equipment

Location: Kitchen

Distress: Beyond Service Life

Notes: Kitchen equipment is beyond its expected service life and should be scheduled for replacement. SPLOST project 507-422 to replace the school.

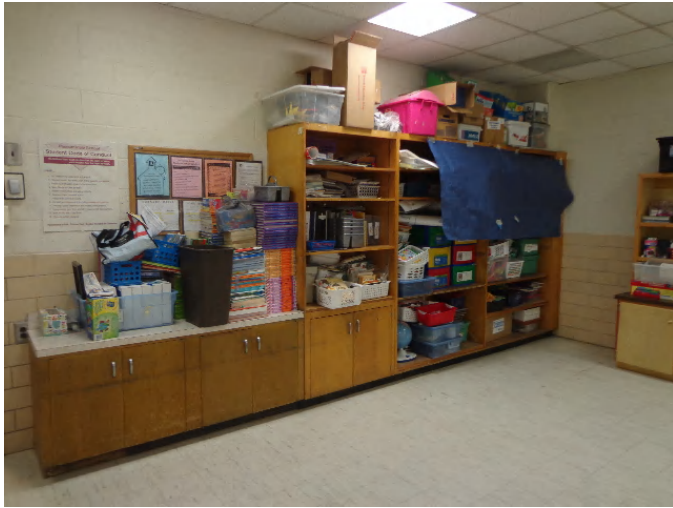
System: E2010 - Fixed Furnishings

Location: Throughout Building

Distress: Beyond Service Life

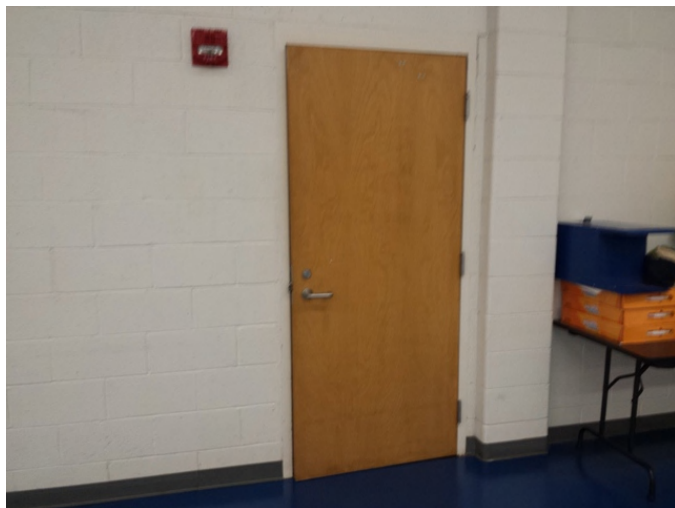
System: C1030 - Fittings

Location: Throughout Building

Distress: Missing

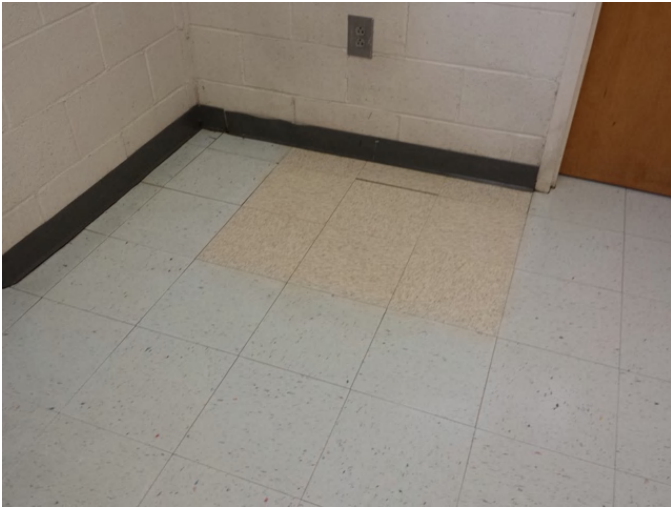
System: C3020 - Floor Finishes - VCT

Location: Entrance Area and Offices

Distress: Beyond Service Life

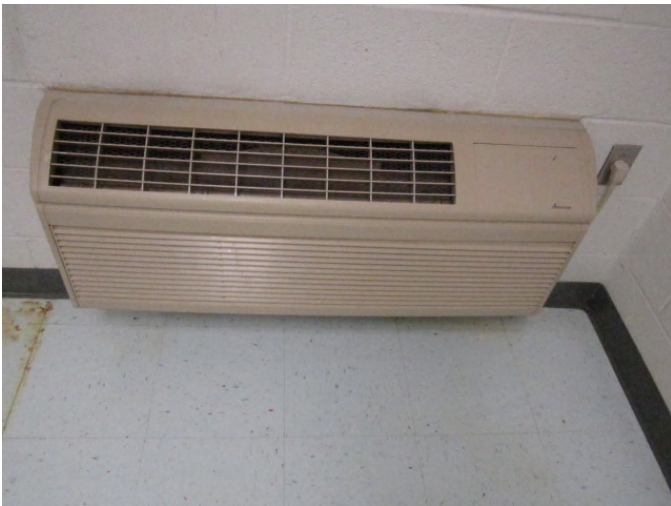
System: D3050 - Terminal & Package Units

Location: Throughout Building

Distress: Inadequate

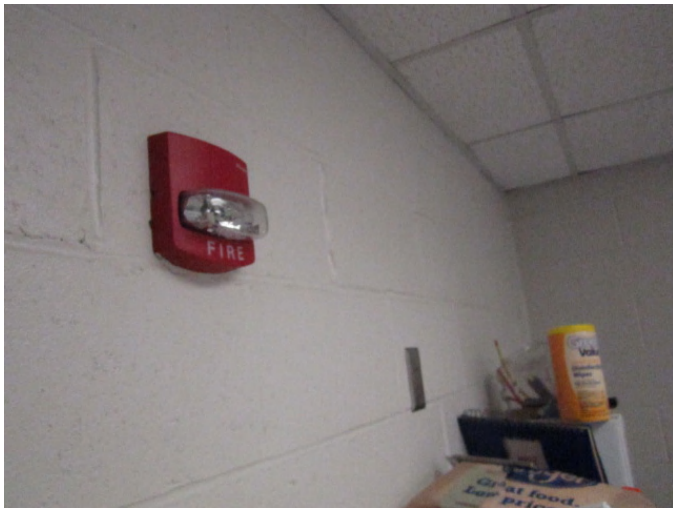
System: D5030 - Communications and Security - Fire Alarm

Location: Throughout Building

Distress: Beyond Service Life

Notes: The fire alarm system is beyond its expected service life and should be scheduled for replacement. SPLOST project 507-422 provides for replacing the school.

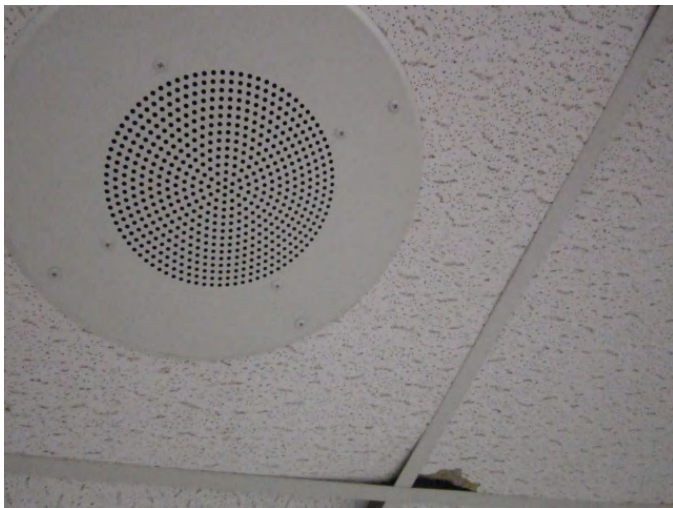
System: D5030 - Communications and Security - Public Address & Clock System

Location: Throughout Building

Distress: Beyond Service Life

Notes: The public address and clock system is beyond its expected service life, aged, and should be scheduled for replacement. SPLOST project 507-422 to replace the school.

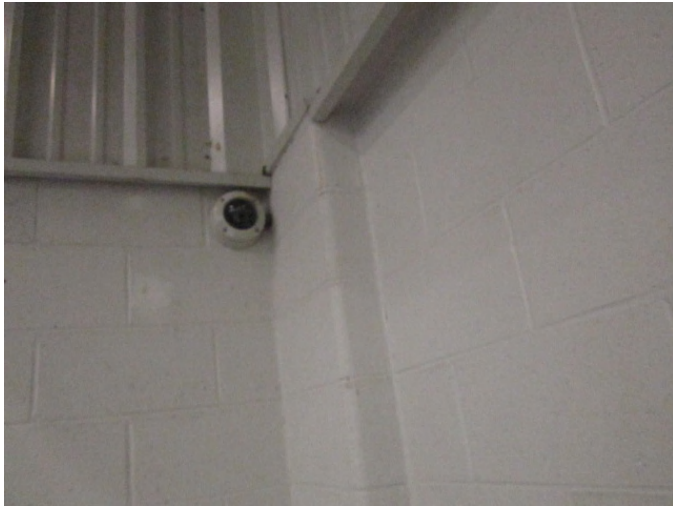
System: D5030 - Communications and Security - Security & CCTV

Location: Throughout Building

Distress: Beyond Service Life

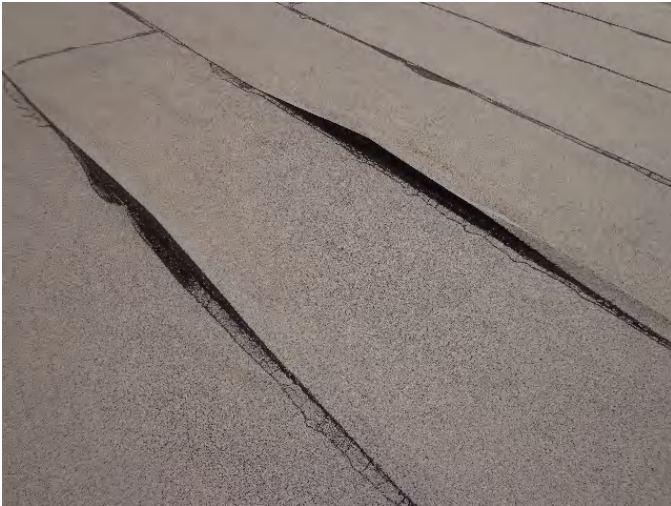
System: B3010 - Roof Coverings - BUR

Location: Roof

Distress: Beyond Service Life

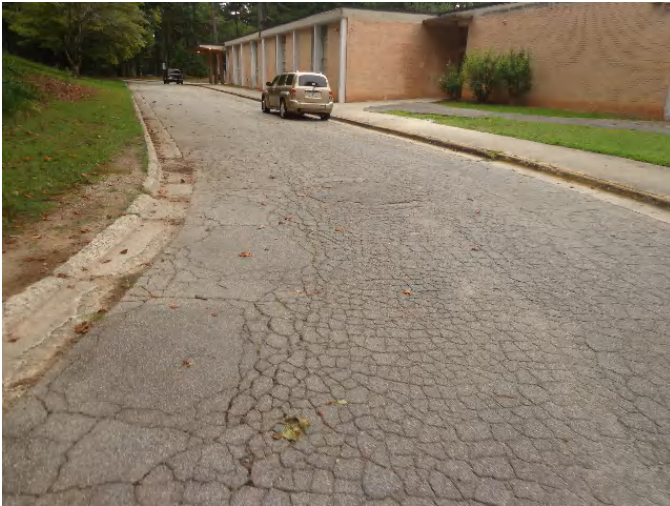
System: G2010 - Roadways

Location: Site

Distress: Beyond Service Life

Notes: Roadways are beyond their expected service life, damaged with many cracks and potholes, worn, and should be replaced. SPLOST project 507-422 to replace the school.

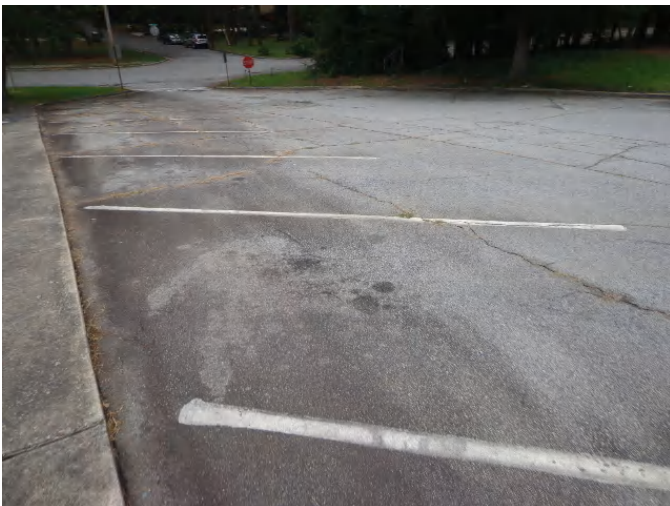
System: G2020 - Parking Lots

Location: Site

Distress: Beyond Service Life

Notes: The parking lot is beyond its expected service life, deteriorated with cracks, not ADA compliant, and should be replaced and re-striping. Accessible parking spaces are missing at the rear parking area and should be provided per ADA standards. SPLOST project 507-422 to replace the school.

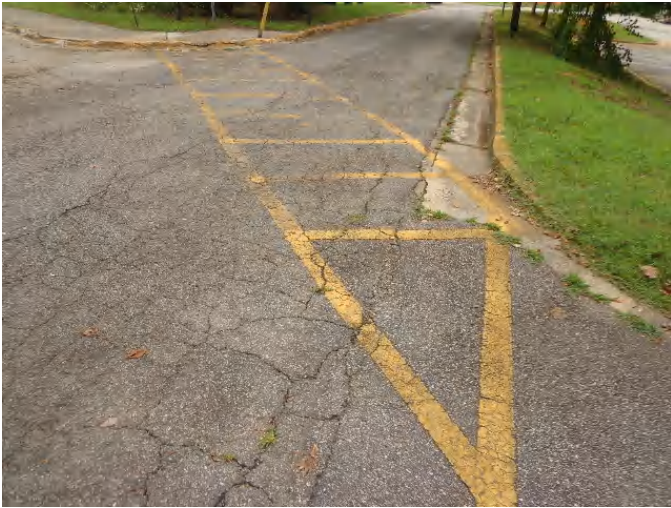
System: G2030 - Pedestrian Paving

Location: Site

Distress: Beyond Service Life

Notes: Pedestrian paving is beyond its expected service life, damaged with cracks, and should be replaced to include missing ramps per ADA standards. SPLOST project 507-422 to replace the school.

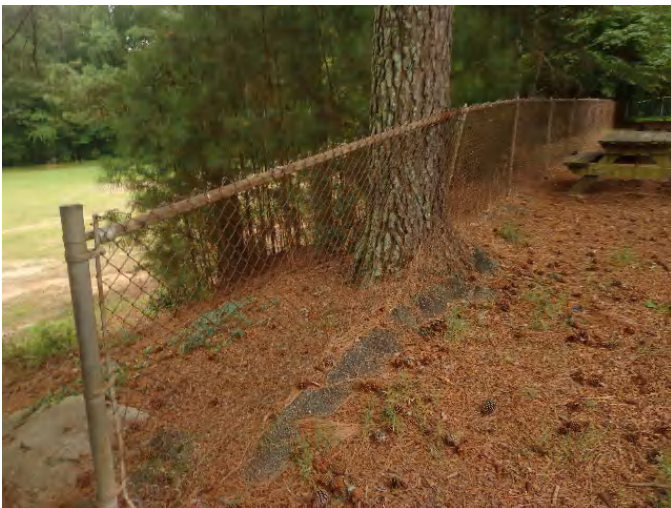
System: G2040 - Fencing & Guardrails

Location: Site

Distress: Beyond Service Life

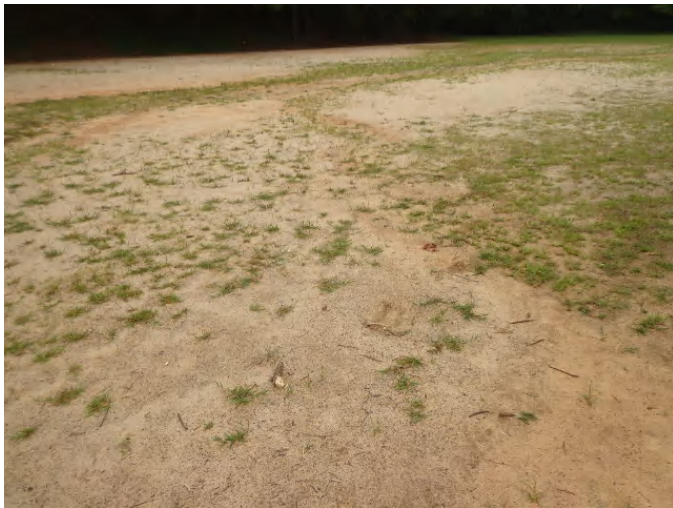
System: G2040 - Playing Field

Location: Site
Distress: Beyond Service Life
Category: Deferred Maintenance
Priority: 3 Priority
Correction: Renew System
Qty: 54,632.00
Unit of Measure: S.F.
Estimate: \$235,573.18
Assessor Name: Eduardo Lopez
Date Created: 07/05/2015

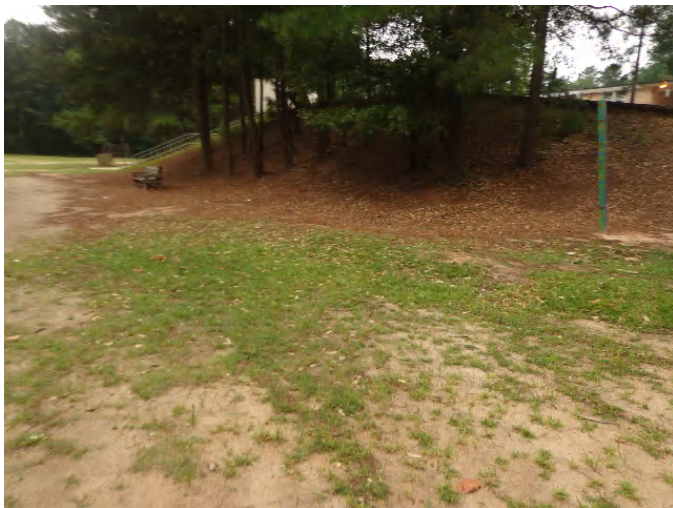
System: G2050 - Landscaping

Location: Site
Distress: Beyond Service Life
Category: Deferred Maintenance
Priority: 3 Priority
Correction: Renew System
Qty: 65,109.00
Unit of Measure: S.F.
Estimate: \$103,848.86
Assessor Name: Eduardo Lopez
Date Created: 07/05/2015

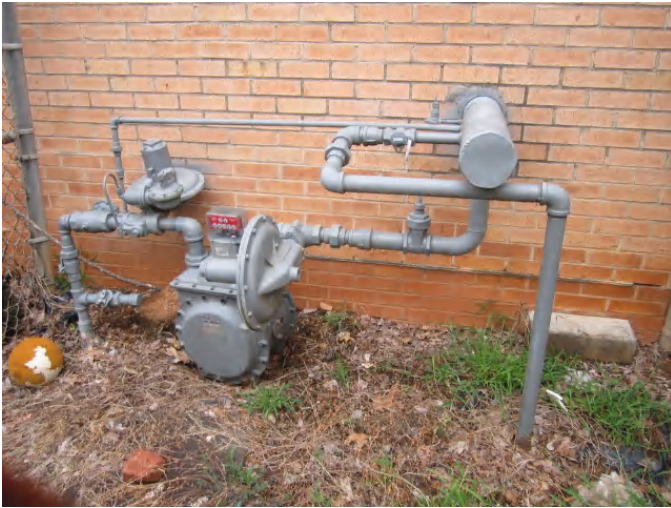
System: G3060 - Fuel Distribution

Location: Site

Distress: Beyond Service Life

Notes: The site fuel distribution system is beyond its expected service life and should be scheduled for replacement. SPLOST project 507-422 to replace the school. SPLOST project 507-422 to replace the school.

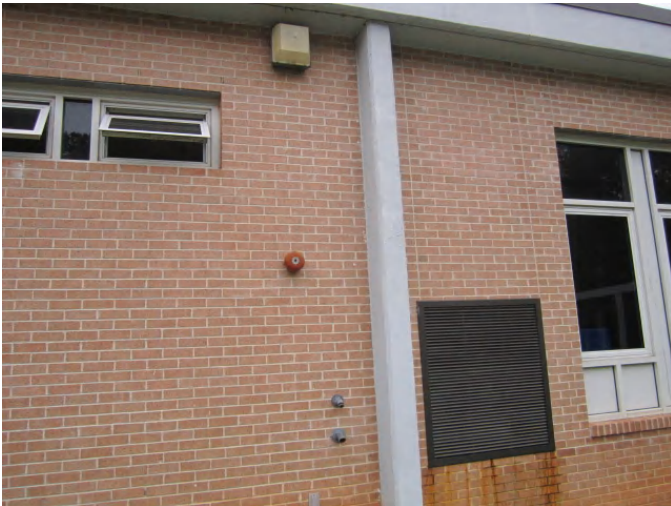
System: G4020 - Site Lighting

Location: Site

Distress: Beyond Service Life

Notes: Site lighting is beyond its expected service life, inadequate, and should be scheduled for replacement. SPLOST project 507-422 to replace the school.

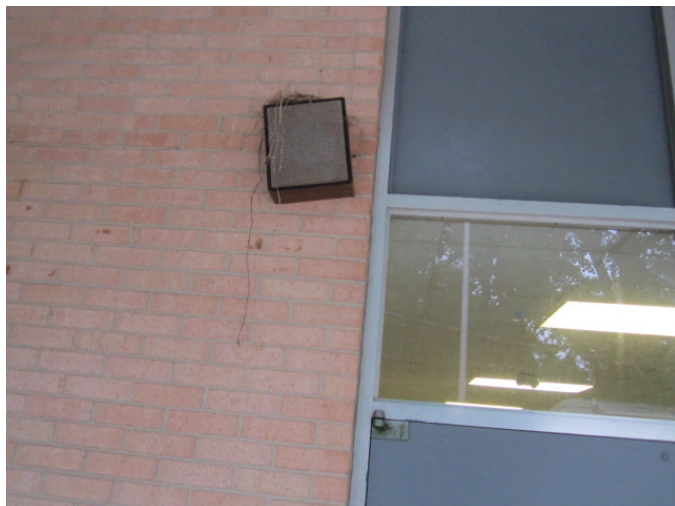
System: G4030 - Site Communications & Security

Location: Site

Distress: Beyond Service Life
