DeKalb County School District/Elementary Schools

Robert Shaw Theme Elementary

School Assessment Report

May 20, 2016

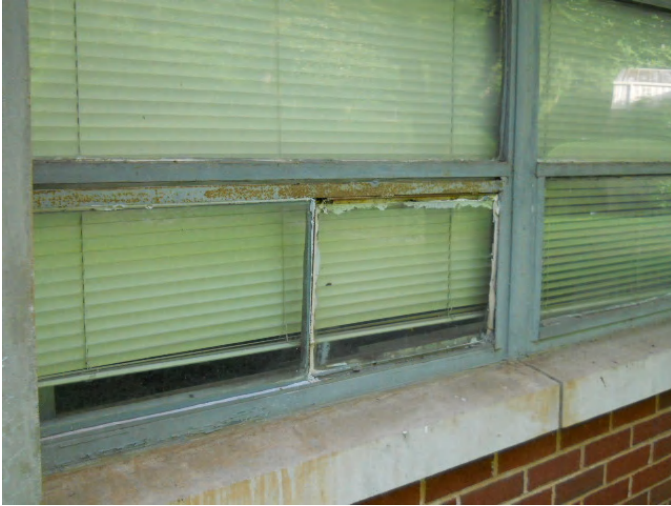
System: B2020 - Exterior Windows

Location: Throughout Building

Distress: Beyond Service Life

Notes: The exterior windows are original, beyond their expected service life, not energy efficient, and should be replaced.

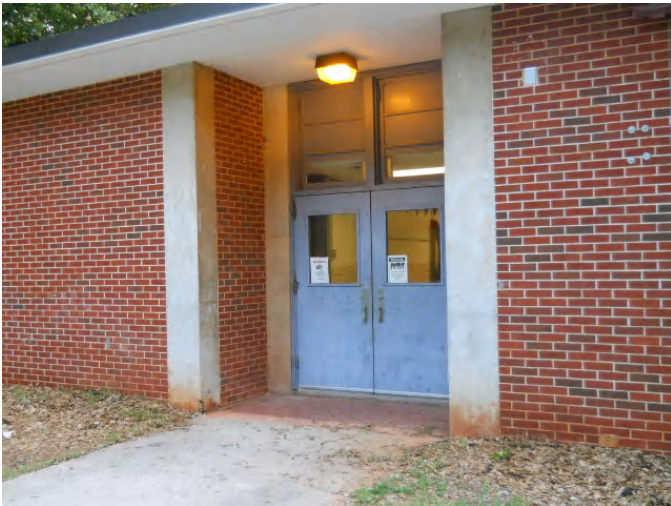
System: B2030 - Exterior Doors

Location: Throughout Building

Distress: Beyond Service Life

Notes: The exterior doors are original, beyond their expected service life, not energy efficient, and should be replaced.

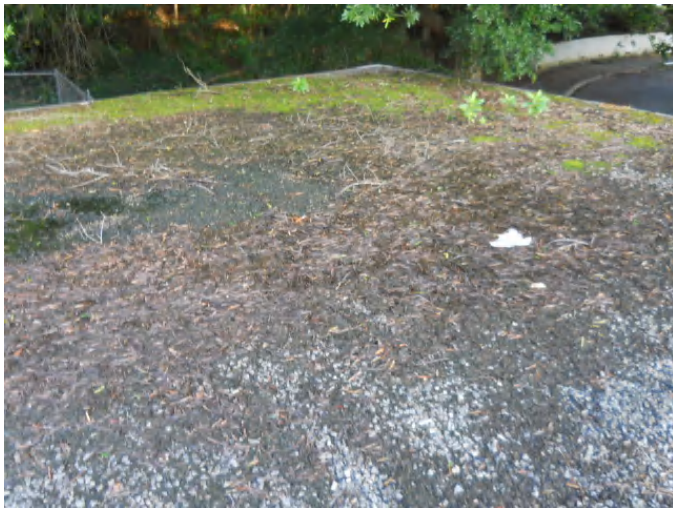
System: B3010 - Roof Coverings - BUR

Location: Roof

Distress: Beyond Service Life

Notes: The roof has reported leaks and is approaching the end of its service life. SPLOST project 322-422 to replace the roof on the 1955 and 1969 buildings.

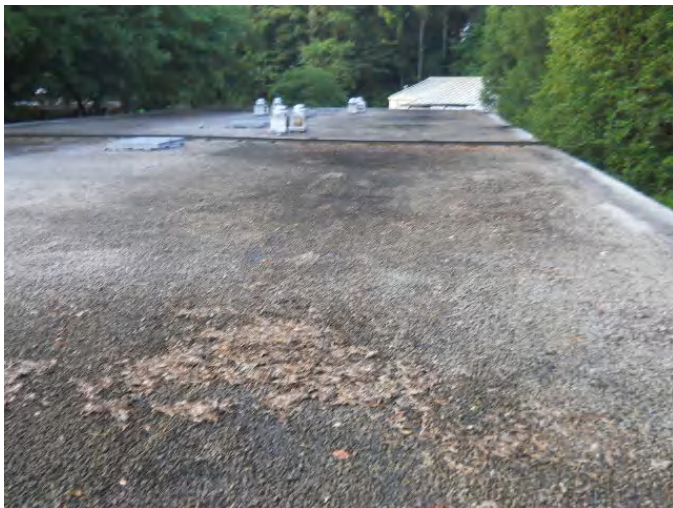
System: B3020 - Roof Openings

Location: Roof

Distress: Missing

Notes: There is no safe roof access for maintenance personnel. Recommend installation of an OSHA-compliant roof hatch/ladder system for safe access.

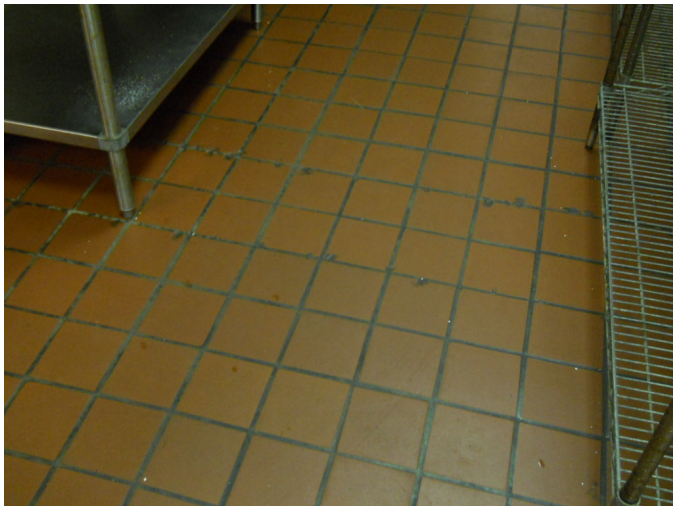
System: C3020 - Floor Finishes - Ceramic & Quarry Tile

Location: Kitchen and Restrooms
Distress: Beyond Service Life
Category: Deferred Maintenance
Priority: 3 Priority
Correction: Renew System
Qty: 5,640.00
Unit of Measure: S.F.
Estimate: \$89,896.00
Assessor Name: Ben Nixon
Date Created: 04/11/2015

Notes: The tile floor covering is beyond its expected service life and should be replaced.

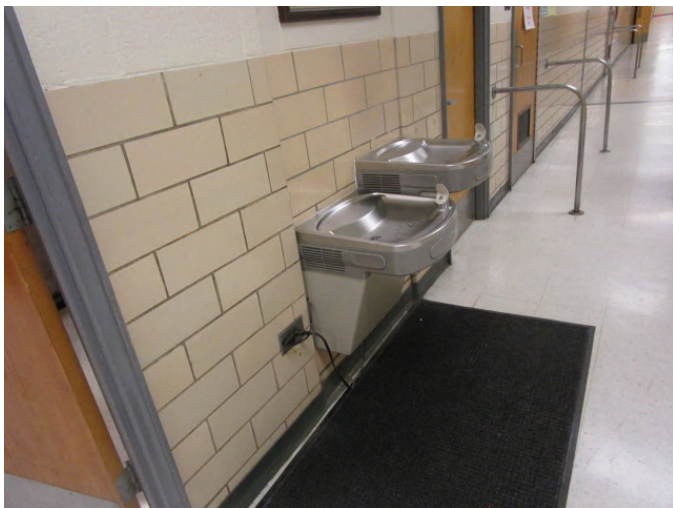
System: D2010 - Plumbing Fixtures

Location: Hallways
Distress: Needs Remediation
Category: Accessibility Code Compliance
Priority: 3 Priority
Correction: Remove/replace drinking fountain w/recessed ADA compliant drinking fountain
Qty: 2.00
Unit of Measure: Ea.
Estimate: \$11,400.68
Assessor Name: Ben Nixon
Date Created: 07/01/2015

Notes: Some water fountains protrude into the hallway more than four inches. Protrusion is not ADA compliant if more than four inches.

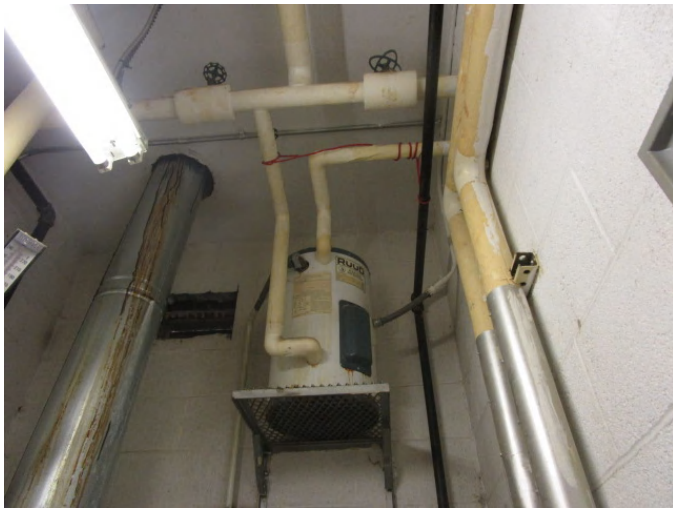
System: D2020 - Domestic Water Distribution

Location: Throughout Building

Distress: Beyond Service Life

Notes: The domestic water distribution system is beyond its expected service life and should be scheduled for replacement.

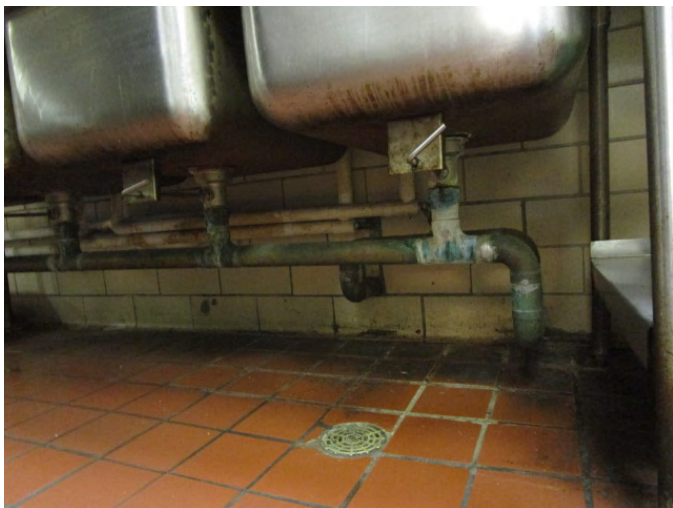
System: D2030 - Sanitary Waste

Location: Throughout Building

Distress: Beyond Service Life

Notes: The sanitary waste system is beyond its expected service life and should be scheduled for replacement.

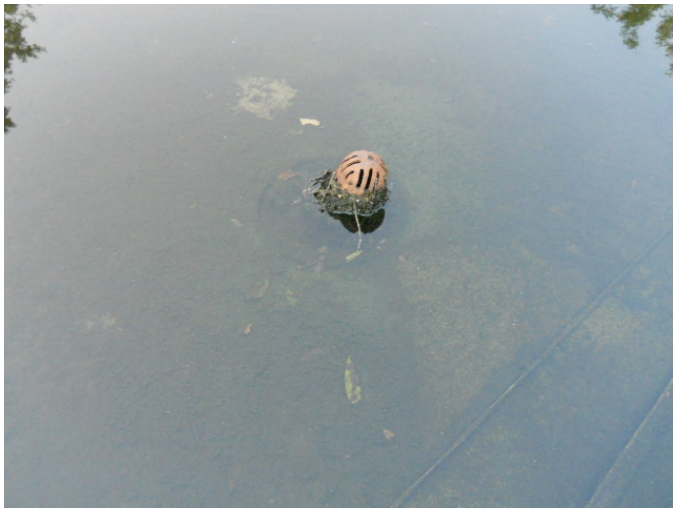
System: D2040 - Rain Water Drainage

Location: Throughout Building

Distress: Beyond Service Life

Notes: The rain water drainage system is not functional. Drains are plugged and not removing water from the roof. The system is beyond its expected service life and should be replaced.

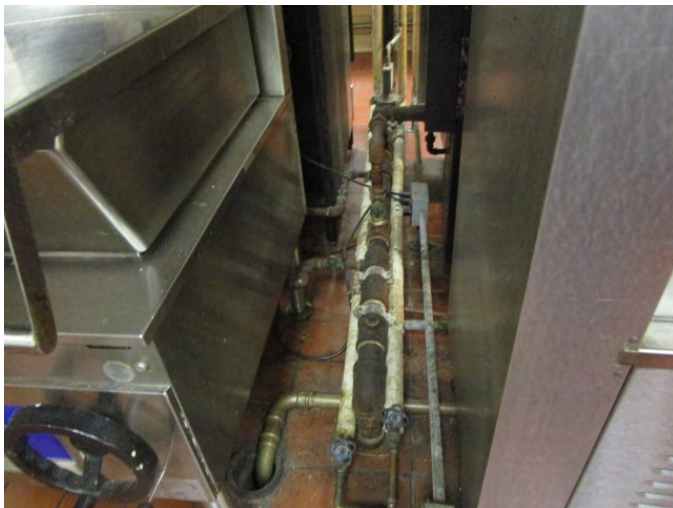
System: D2090 - Other Plumbing Systems - Natural Gas

Location: Throughout Building

Distress: Beyond Service Life

Notes: The natural gas system is beyond its expected service life and should be scheduled for replacement.

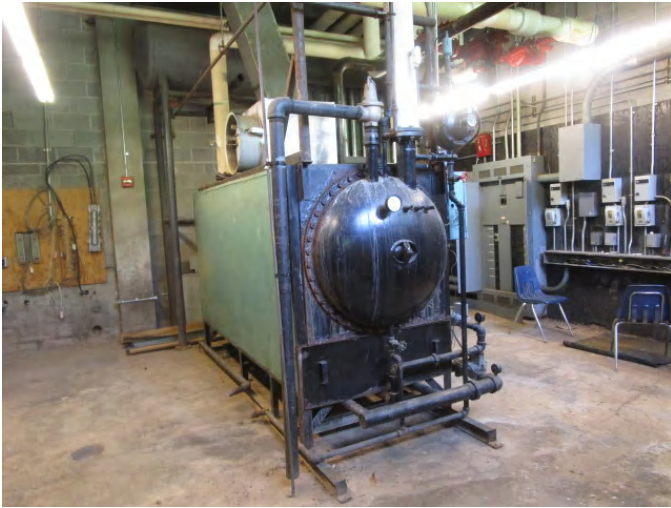
System: D3020 - Heat Generating Systems

Location: Mechanical Room

Distress: Beyond Service Life

Notes: The heat generating system is beyond its expected service life and should be scheduled for replacement. SPLOST project 322 -422 to evaluate HVAC system and make recommendation for replacement as needed.

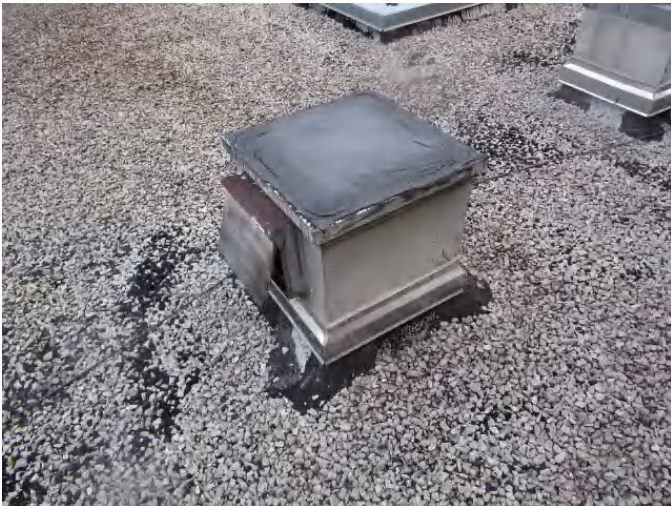
System: D3040 - Distribution & Exhaust Systems

Location: Throughout Building

Distress: Beyond Service Life

Notes: The distribution and exhaust systems are beyond their expected service life and should be scheduled for replacement.

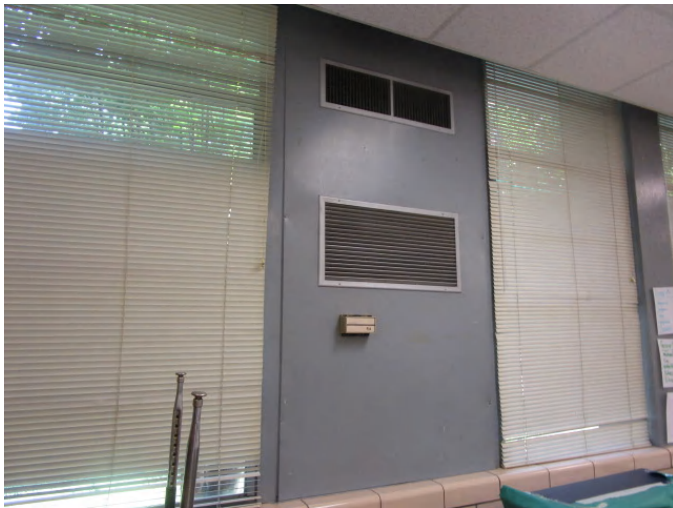
System: D3050 - Terminal & Package Units

Location: Throughout Building

Distress: Beyond Service Life

Notes: The terminal and package units are beyond their expected service life and should be scheduled for replacement. SPLOST project 322-422 to evaluate HVAC system and make recommendation for replacement as needed.

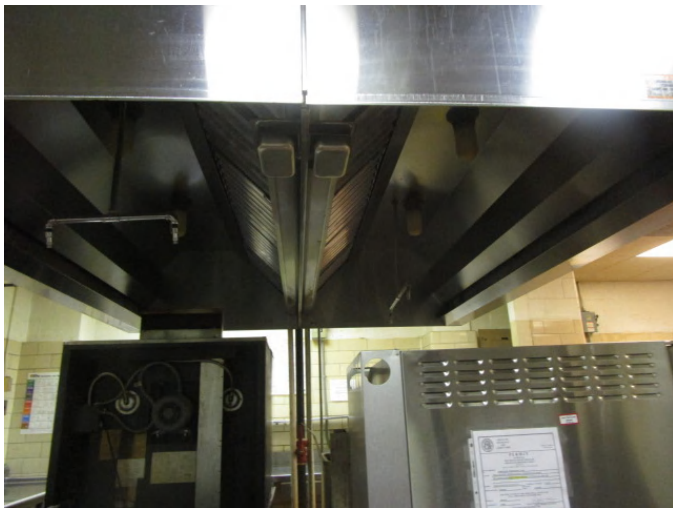
System: D3090 - Other HVAC Systems/Equip - Kitchen Hood

Location: Kitchen

Distress: Beyond Service Life

Notes: The kitchen hood system is beyond its expected service life and should be scheduled for replacement.

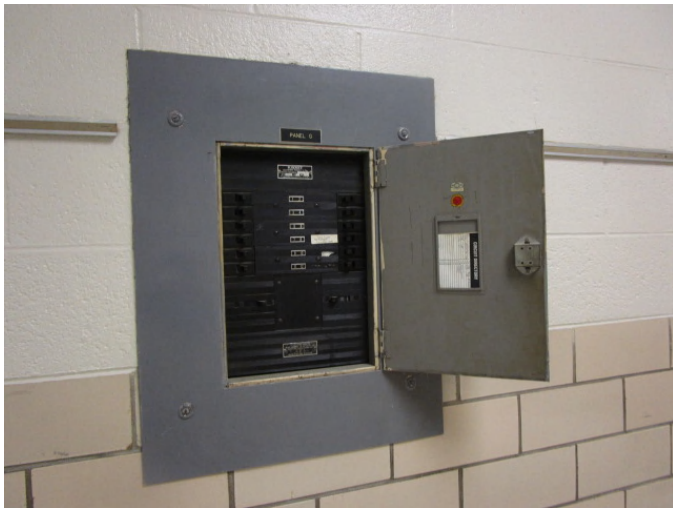
System: D5020 - Branch Wiring

Location: Throughout Building

Distress: Beyond Service Life

Notes: The branch wiring system is beyond its expected service life and should be scheduled for replacement. Electrical outlets are not GFI in wet areas.

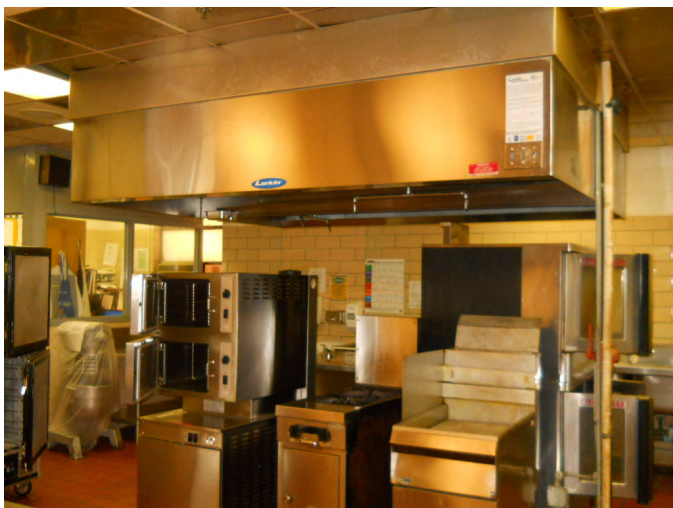
System: E1090 - Other Equipment (Kitchen Equipment)

Location: Kitchen

Distress: Beyond Service Life

Notes: Kitchen equipment is beyond its expected service life and should be scheduled for replacement.

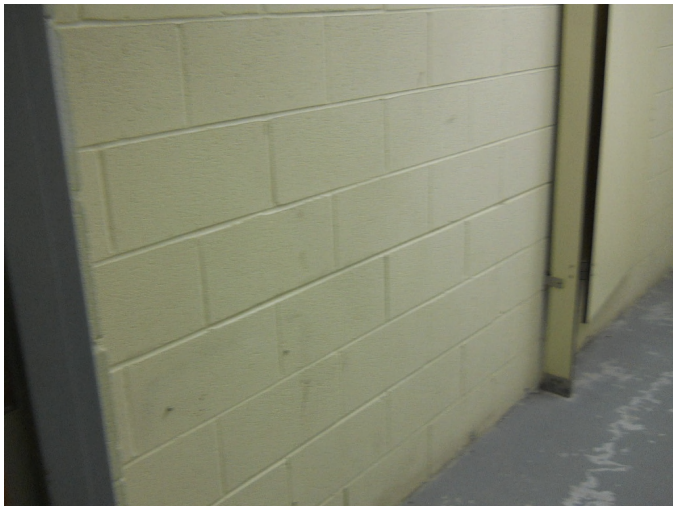
System: C3010 - Wall Finishes - Paint

Location: Throughout Building

Distress: Beyond Service Life

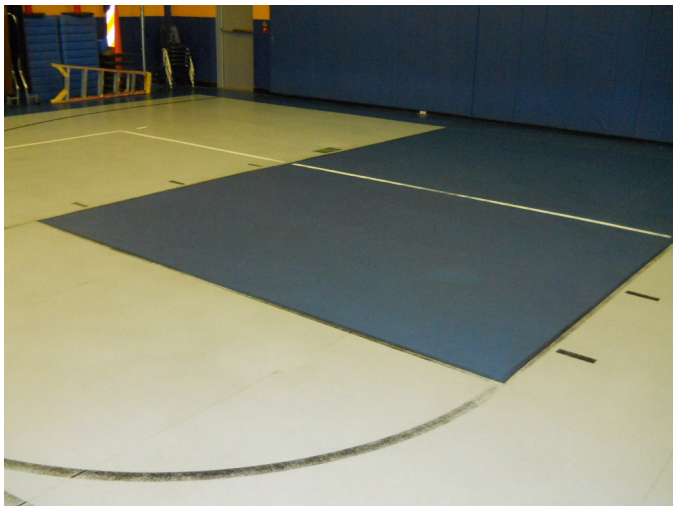
System: C3020 - Floor Finishes - Neoprene

Location: Basketball Court

Distress: Beyond Service Life

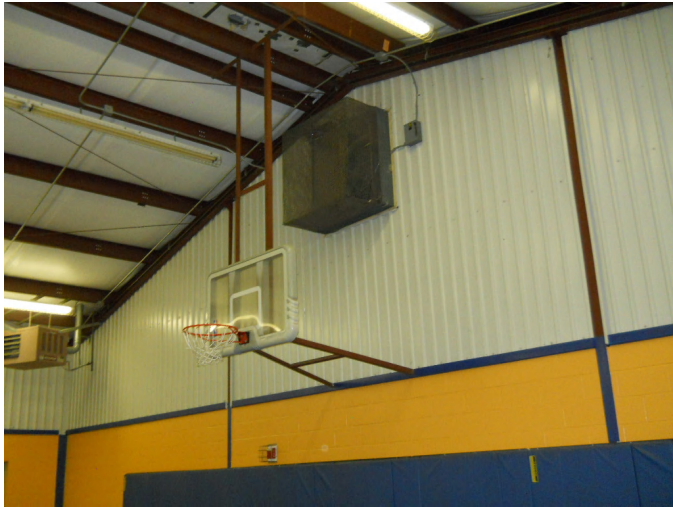
System: D3050 - Terminal & Package Units

Location: Throughout Building

Distress: Inadequate

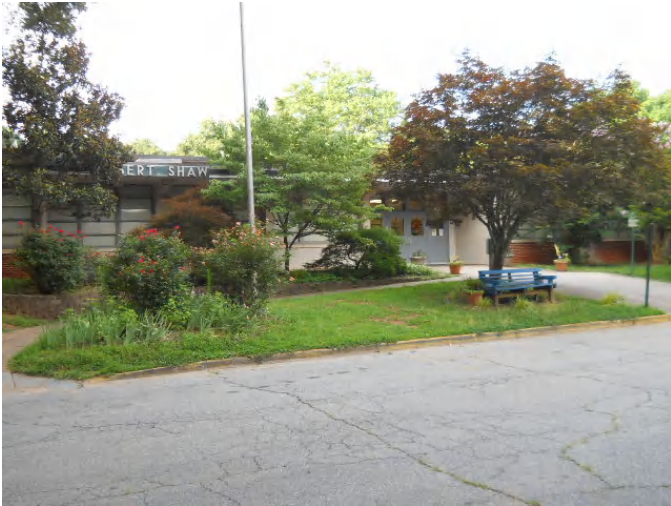
System: G2030 - Pedestrian Paving

Location: Front Entrance Ramp

Distress: Missing

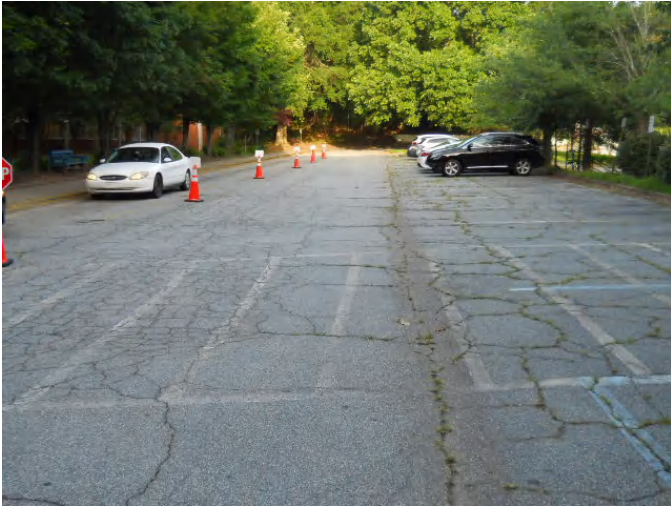
System: G2010 - Roadways

Location: Site

Distress: Beyond Service Life

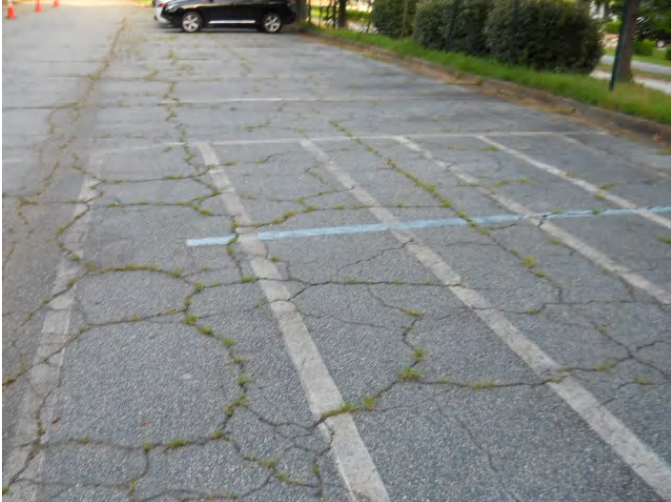
System: G2020 - Parking Lots

Location: Site

Distress: Beyond Service Life

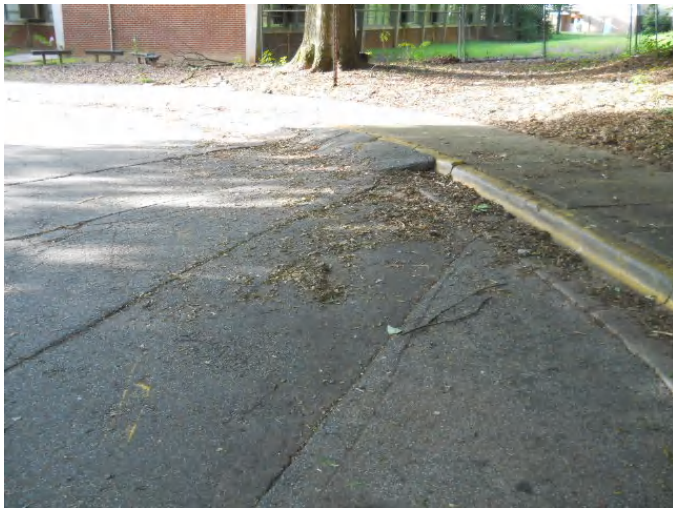
System: G2030 - Pedestrian Paving

Location: Site
Distress: Beyond Service Life
Category: Deferred Maintenance
Priority: 3 Priority
Correction: Renew System
Qty: 61,878.00
Unit of Measure: S.F.
Estimate: \$102,098.70
Assessor Name: Sam Mandola
Date Created: 06/28/2015

Notes: Pedestrian paving is beyond its expected service life, damaged, not fully ADA compliant, and should be replaced.

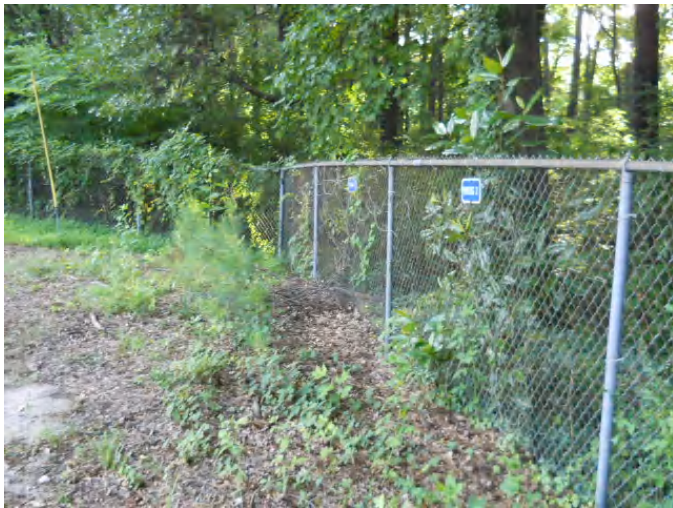
System: G2040 - Fencing & Guardrails

Location: Site
Distress: Beyond Service Life
Category: Deferred Maintenance
Priority: 3 Priority
Correction: Renew System
Qty: 61,878.00
Unit of Measure: S.F.
Estimate: \$61,939.88
Assessor Name: Eduardo Lopez
Date Created: 06/28/2015

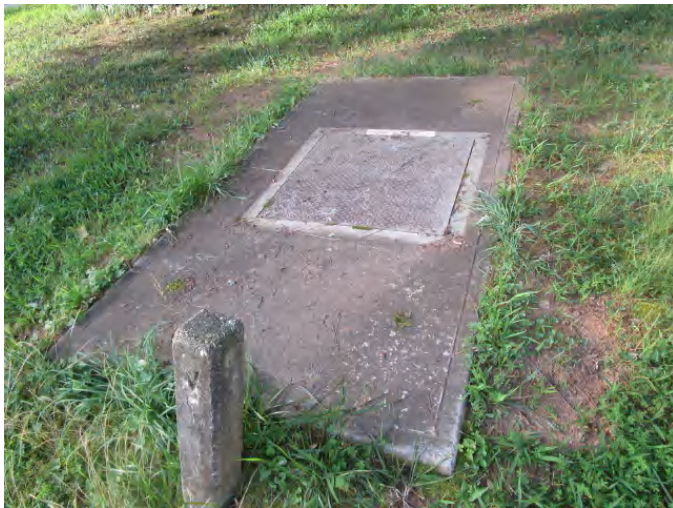
System: G3010 - Water Supply

Location: Site
Distress: Beyond Service Life
Category: Deferred Maintenance
Priority: 3 Priority
Correction: Renew System
Qty: 61,878.00
Unit of Measure: S.F.
Estimate: \$124,560.41
Assessor Name: Eduardo Lopez
Date Created: 06/28/2015

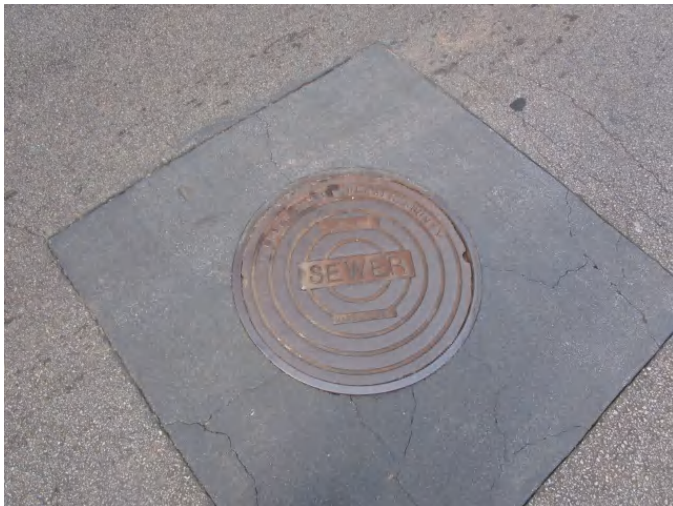
System: G3020 - Sanitary Sewer

Location: Site
Distress: Beyond Service Life
Category: Deferred Maintenance
Priority: 3 Priority
Correction: Renew System
Qty: 61,878.00
Unit of Measure: S.F.
Estimate: \$78,275.67
Assessor Name: Eduardo Lopez
Date Created: 06/28/2015

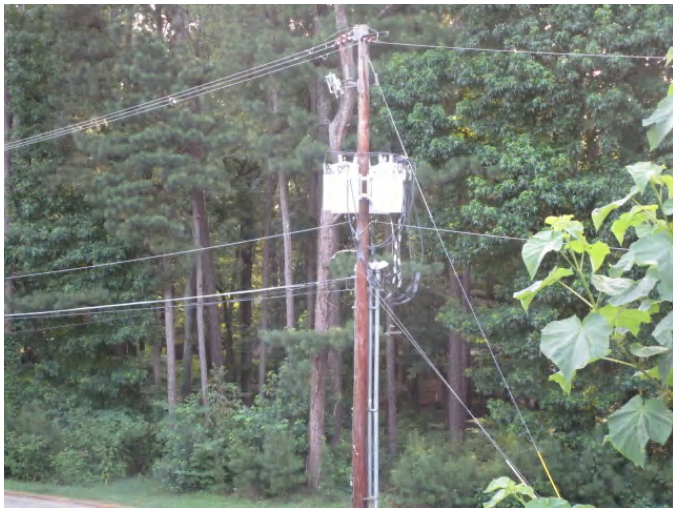
System: G4010 - Electrical Distribution

Location: Site
Distress: Beyond Service Life
Category: Deferred Maintenance
Priority: 3 Priority
Correction: Renew System
Qty: 61,878.00
Unit of Measure: S.F.
Estimate: \$126,602.39
Assessor Name: Sam Mandola
Date Created: 06/28/2015

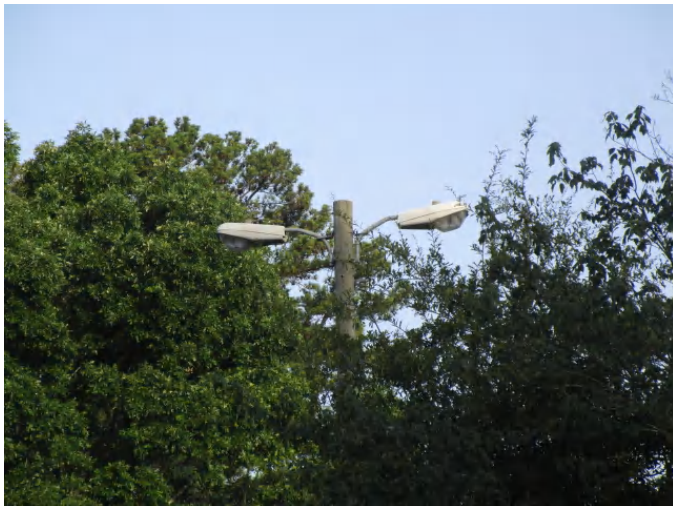
System: G4020 - Site Lighting

Location: Site
Distress: Beyond Service Life
Category: Deferred Maintenance
Priority: 3 Priority
Correction: Renew System
Qty: 61,878.00
Unit of Measure: S.F.
Estimate: \$78,275.67
Assessor Name: Eduardo Lopez
Date Created: 06/28/2015
