DeKalb County School District/Elementary Schools

Sagamore Hills Elementary

School Assessment Report

May 20, 2016

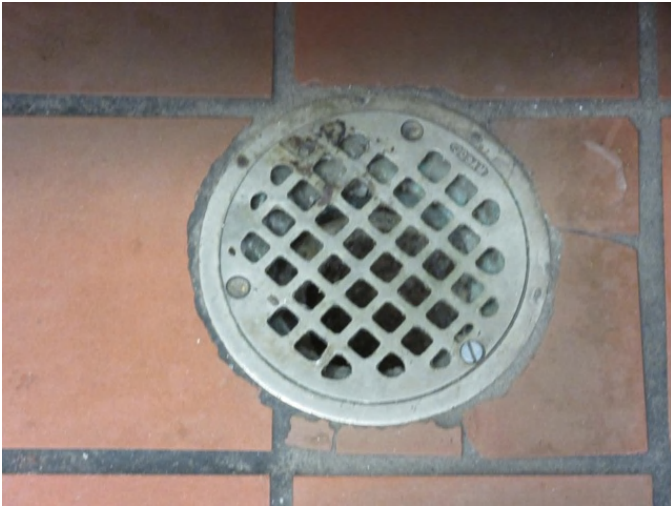
System: D2030 - Sanitary Waste

Location: Throughout Building

Distress: Beyond Service Life

Notes: The sanitary waste system is beyond its expected service life and should be scheduled for replacement.

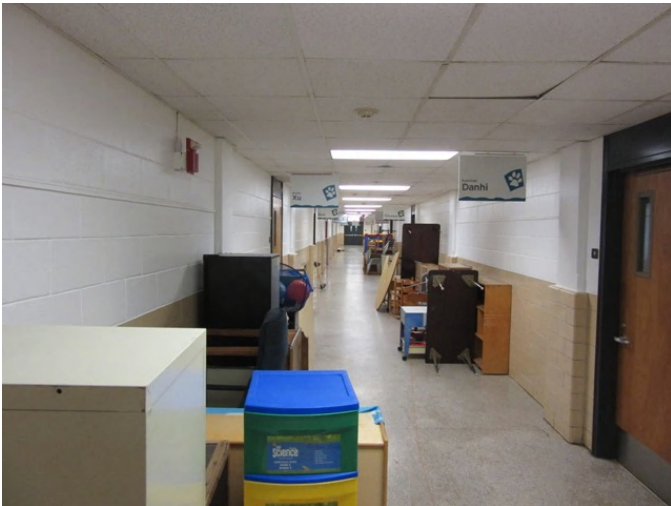
System: D5020 - Lighting

Location: Hallways

Distress: Missing

Correction: Replace fluorescent fixture, lay-in, recess mtd, 2' x 4', four 32 W

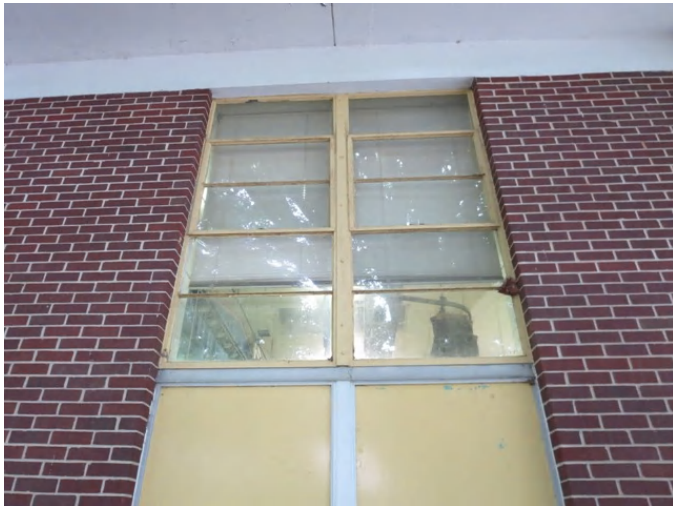
System: B2020 - Exterior Windows

Location: Throughout Building

Distress: Beyond Service Life

Notes: The aluminum frame, operable, single pane windows are aged, not energy efficient, and should be replaced.

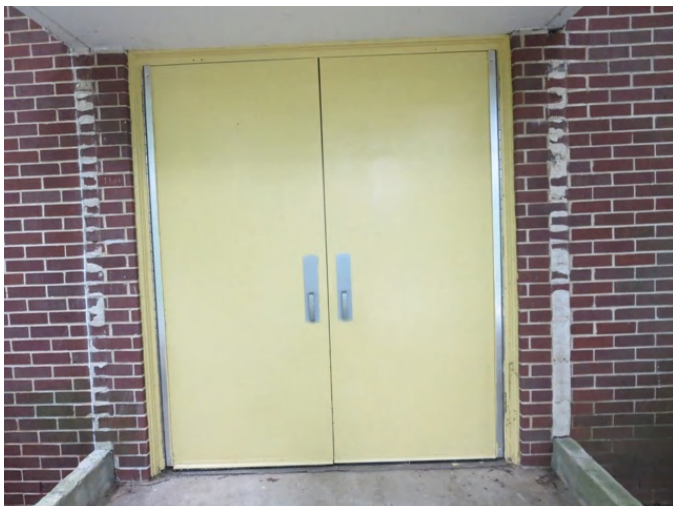
System: B2030 - Exterior Doors

Location: Throughout Building

Distress: Beyond Service Life

Notes: The original exterior doors are aged, rusted, and should be replaced.

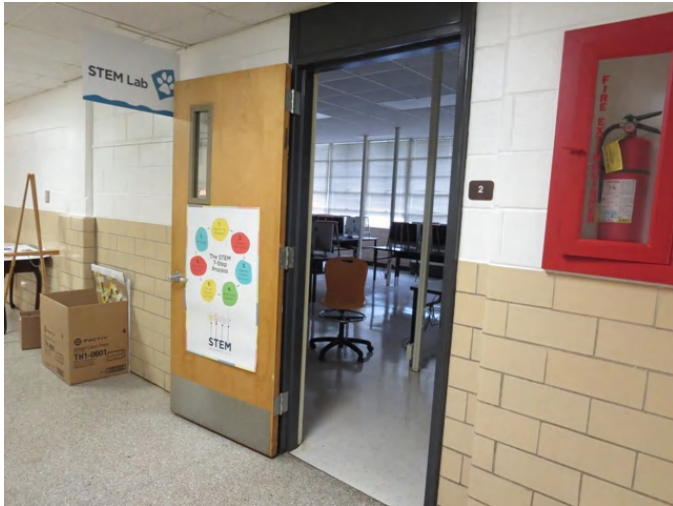
System: C1020 - Interior Doors

Location: Throughout Building

Distress: Beyond Service Life

Notes: The interior doors have some deterioration due to age, are not ADA compliant, and should be replaced.

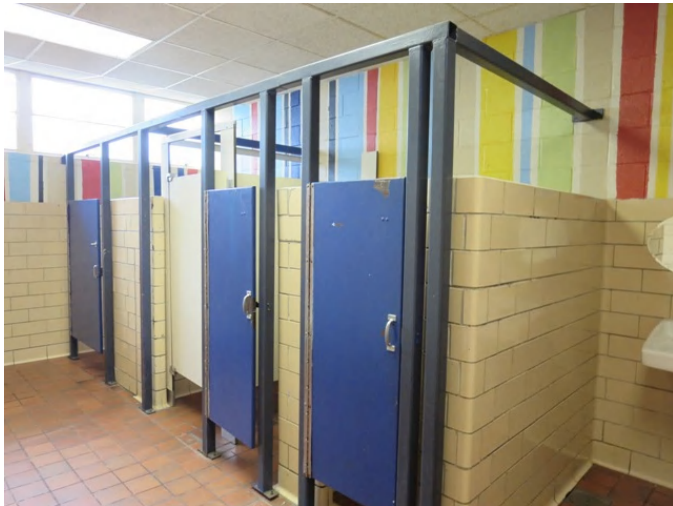
System: C1030 - Fittings

Location: Throughout Building

Distress: Beyond Service Life

Notes: Fittings, such as toilet partitions, handrails and signage, are beyond their expected service life, not ADA compliant, and should be replaced. SPLOST project 128-422 to provide hall restroom renovations.

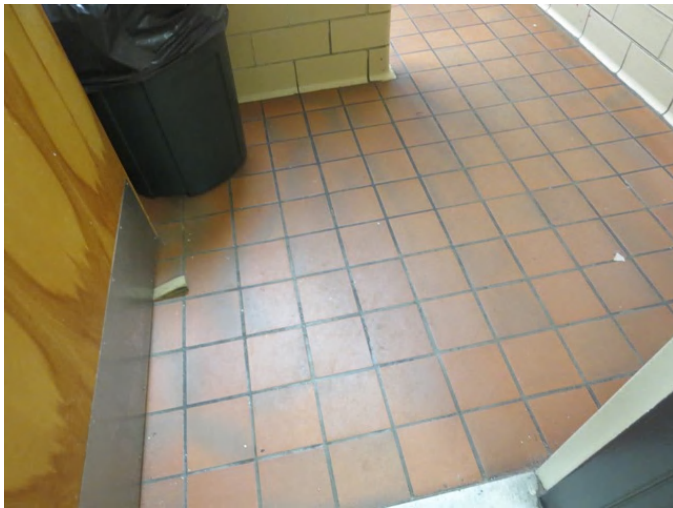
System: C3020 - Floor Finishes - Ceramic & Quarry Tile

Location: Kitchen and Restrooms

Distress: Beyond Service Life

Notes: The tile floor covering is beyond its expected service life, worn, and should be replaced.

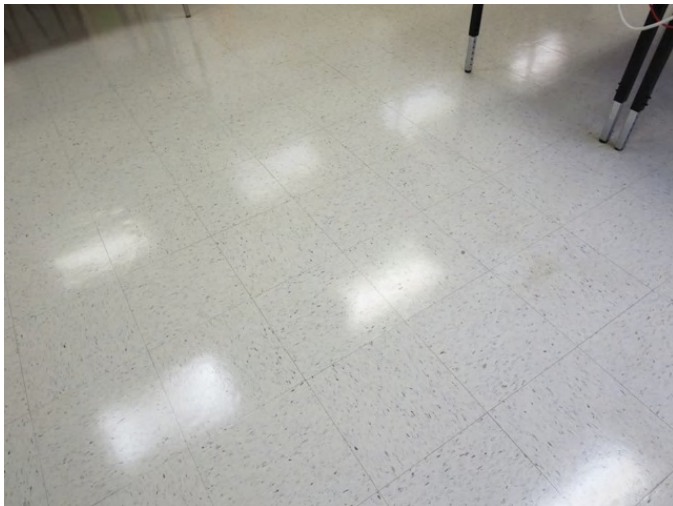
System: C3020 - Floor Finishes - VCT

Location: Throughout Building

Distress: Beyond Service Life

Notes: The VCT flooring is aged and worn, and should be replaced.

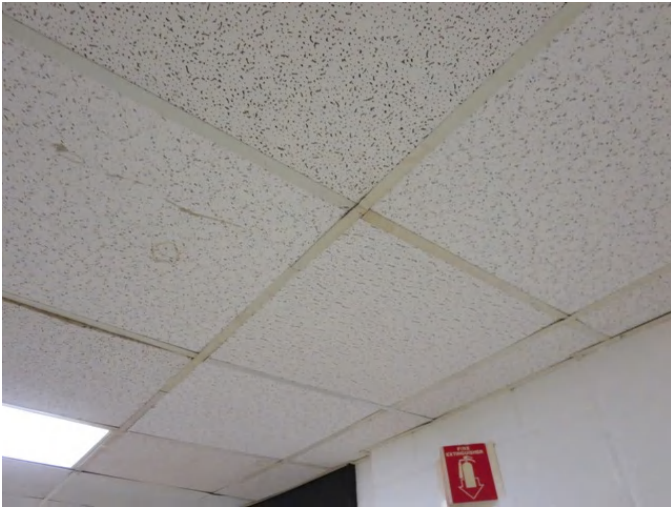
System: C3030 - Ceiling Finishes

Location: Throughout Building

Distress: Beyond Service Life

Notes: The acoustical ceiling tiles and grid system is damaged and should be renewed.

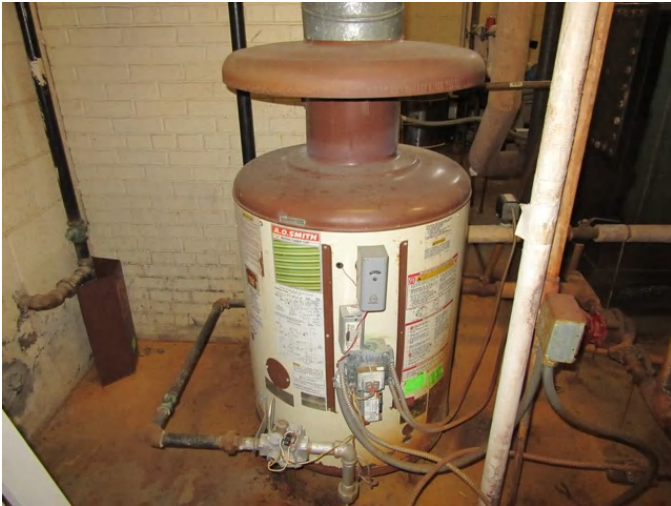
System: D2020 - Domestic Water Distribution

Location: Boiler Room

Distress: Beyond Service Life

Notes: The domestic water distribution system is beyond its expected service life, has water quality issues, and should be scheduled for replacement. SPLOST project 128-422 to replace the water source heat pumps and fan coil units in the 1961 and 1963 buildings.

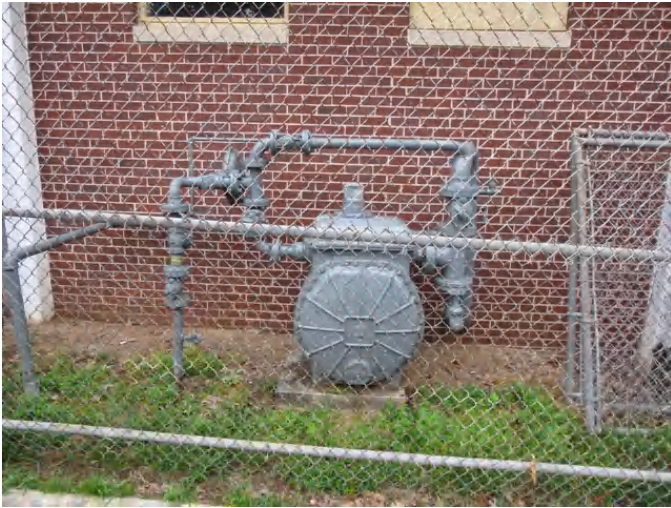
System: D2090 - Other Plumbing Systems - Natural Gas

Location: Northwest Side of Building

Distress: Beyond Service Life

Notes: The natural gas system is beyond its expected service life, not building code compliant, and should be scheduled for replacement. Natural gas piping is not sleeved or vented in boiler/mechanical room.

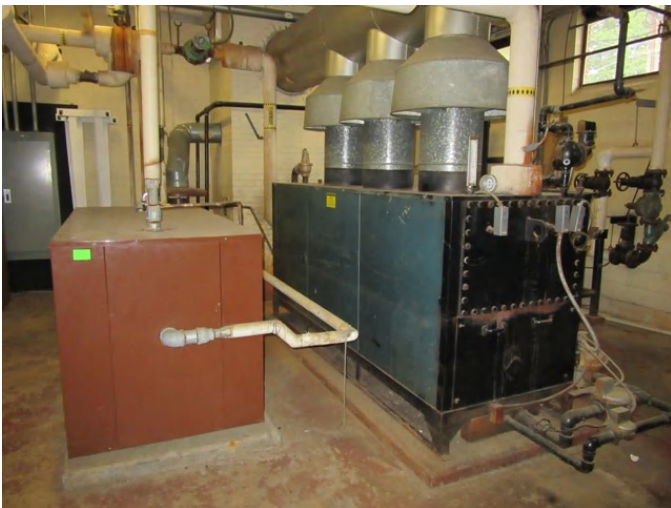
System: D3020 - Heat Generating Systems

Location: Mechanical Room

Distress: Beyond Service Life

Notes: The original boiler is beyond its expected service life and inadequate, contains hazardous materials, and should be scheduled for replacement.

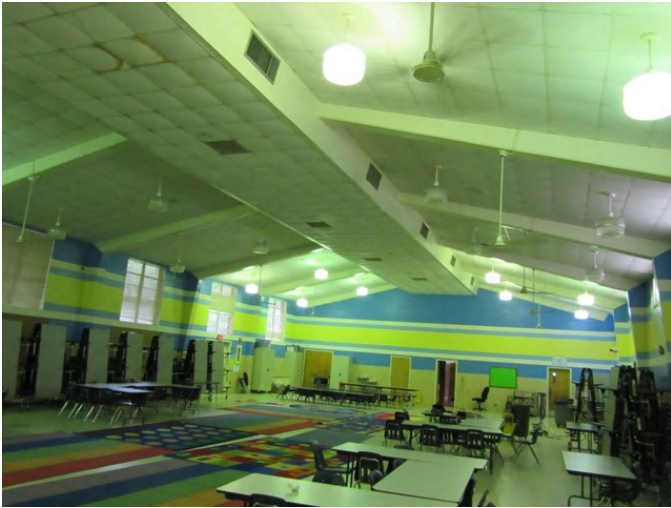
System: D3040 - Distribution & Exhaust Systems

Location: Throughout Building

Distress: Beyond Service Life

Notes: The distribution and exhaust systems are beyond their service life, inadequate, and should be scheduled for replacement. Restrooms lack working exhaust systems.

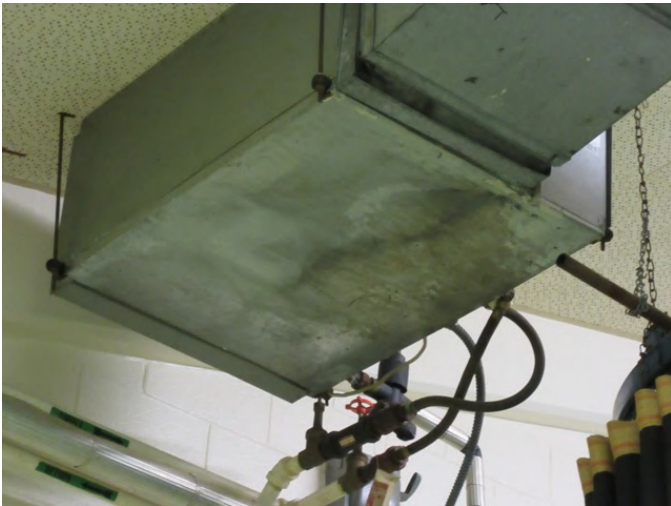
System: D3050 - Terminal & Package Units

Location: Throughout Building

Distress: Beyond Service Life

Notes: The water source heat pumps, fan coil units and integrated controls are beyond their expected service life and should be scheduled for replacement. SPLOST project 128-422 to replace the water source heat pumps and fan coil units in the 1961 and 1963 buildings.

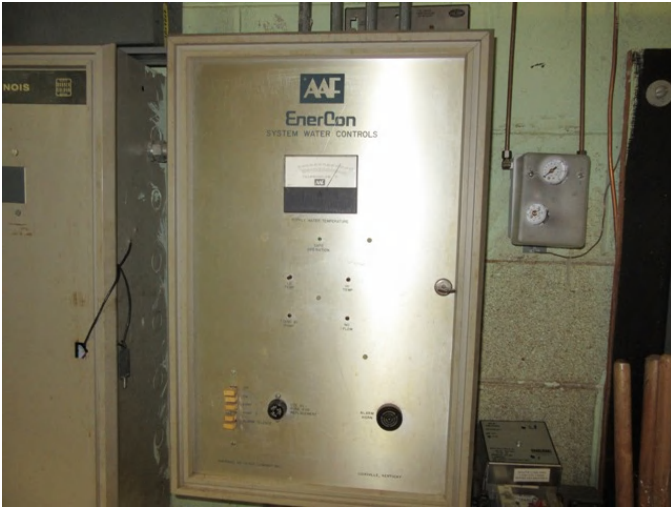
System: D3060 - Controls & Instrumentation

Location: Throughout Building

Distress: Beyond Service Life

Notes: The pneumatic controls and instrumentation system is beyond its expected service life, antiquated, and should be scheduled for replacement with a modern DDC electrical control system.

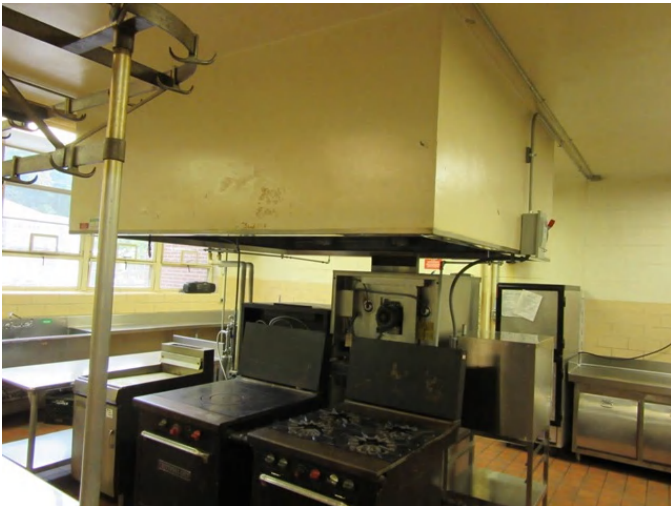
System: D3090 - Other HVAC Systems/Equip - Kitchen Hood

Location: Kitchen

Distress: Beyond Service Life

Notes: The kitchen hood system is beyond its expected service life and should be scheduled for replacement.

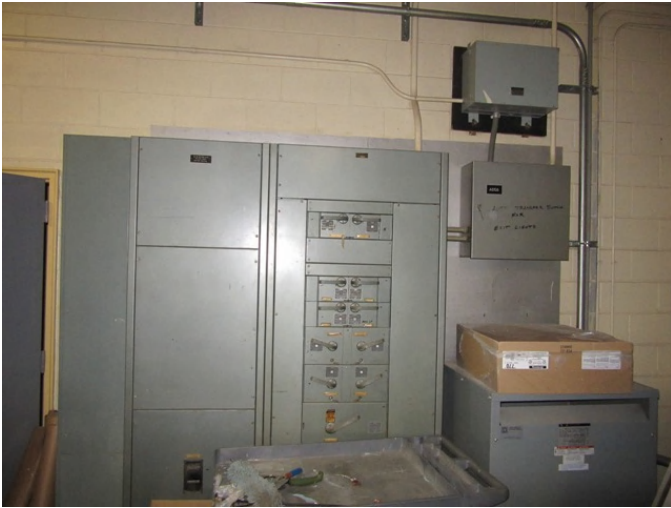
System: D5010 - Electrical Service/Distribution

Location: Main Switch Room/Throughout Building

Distress: Beyond Service Life

Notes: The primary service entrance and associated distribution panels are beyond their expected service life, not code compliant, and should be scheduled for replacement. There is insufficient clearance in front of electrical panels throughout the facility. Electrical outlets are not GFI in wet areas. SPLOST project 128-422 to upgrade the electrical service and distribution to meet current building loads in the 61 and 63 buildings.

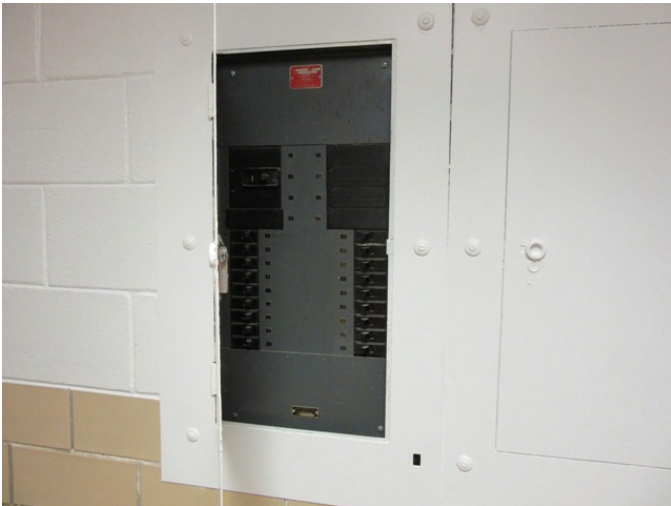
System: D5020 - Branch Wiring

Location: Throughout Building

Distress: Beyond Service Life

Notes: The branch wiring system is beyond its expected service life and should be scheduled for replacement.

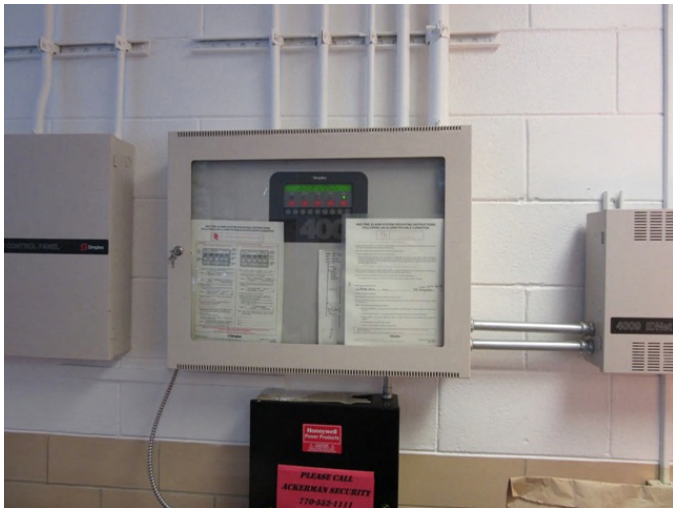
System: D5030 - Communications and Security - Fire Alarm

Location: Throughout Building

Distress: Beyond Service Life

Notes: The fire alarm system is beyond its expected service life, reported to have frequent false alarms, and should be scheduled for replacement.

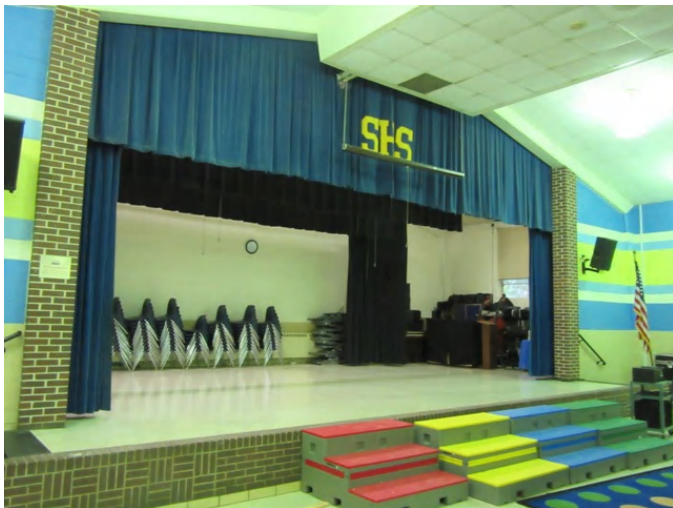
System: F1020 - Institutional Equipment

Location: Throughout Building

Distress: Beyond Service Life

Notes: Institutional equipment, such as theater and stage equipment, library equipment and audio-visual equipment, is beyond its expected service life and should be scheduled for replacement.

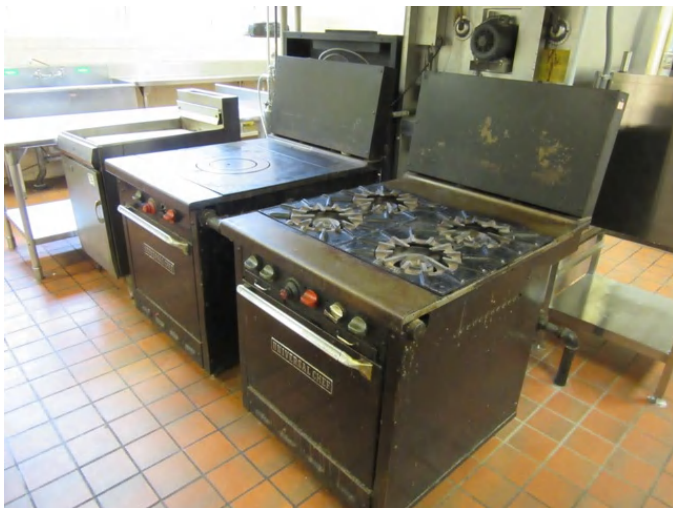
System: E1090 - Other Equipment - Kitchen Equipment

Location: Kitchen

Distress: Beyond Service Life

Notes: Kitchen equipment is beyond service life and should be scheduled for replacement. The grease trap is scheduled for replacement under SPLOST project 128-422.

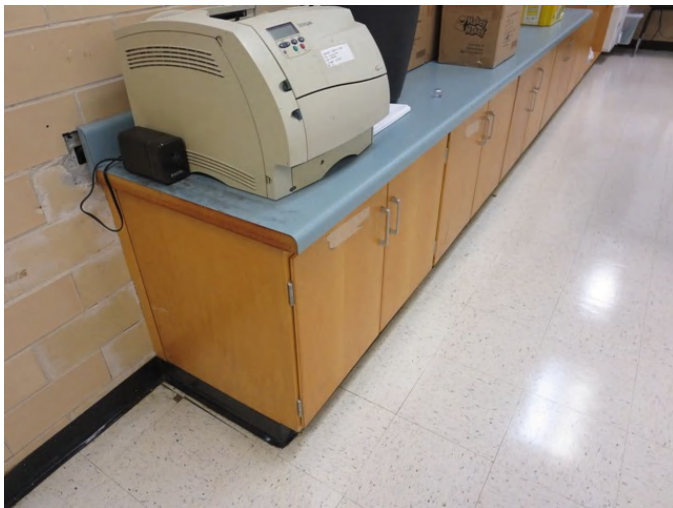
System: E2010 - Fixed Furnishings

Location: Throughout Building

Distress: Beyond Service Life

Notes: Fixed furnishings, such as built-in cabinets, are beyond their expected service life and worn, and should be replaced.

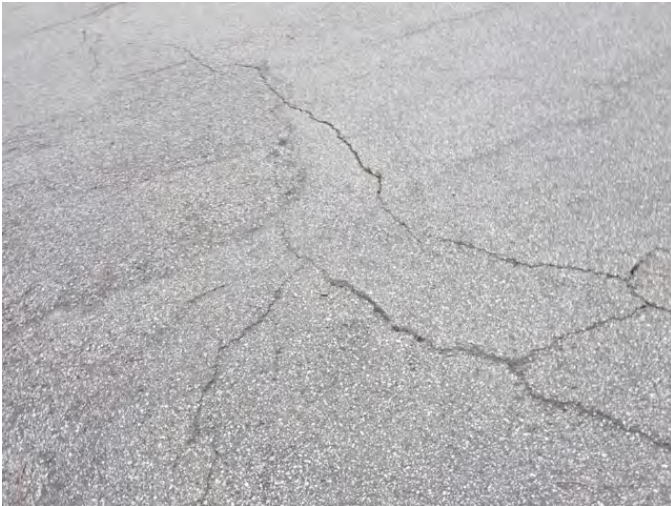
System: G2010 - Roadways

Location: Site

Distress: Beyond Service Life

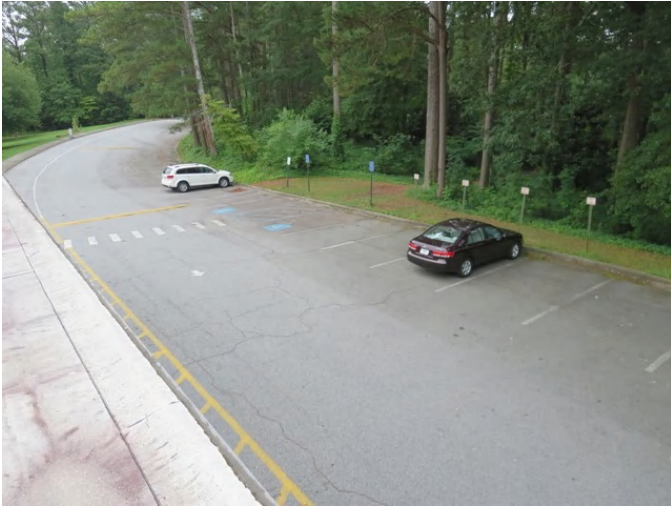
System: G2020 - Parking Lots

Location: North and South Side of Site

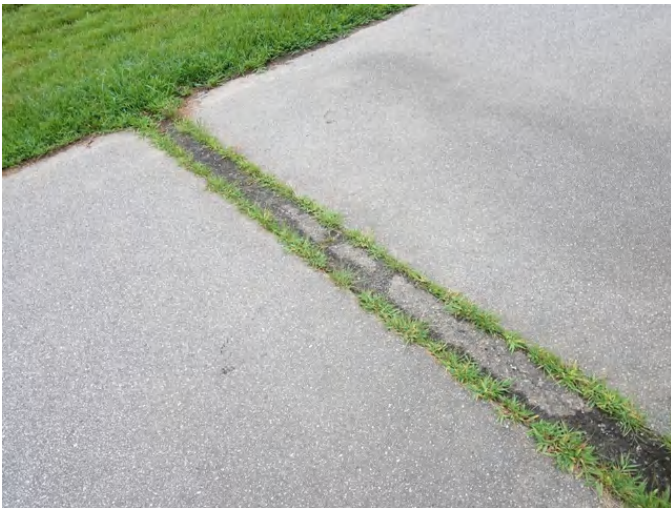
System: G2030 - Pedestrian Paving

Location: Site

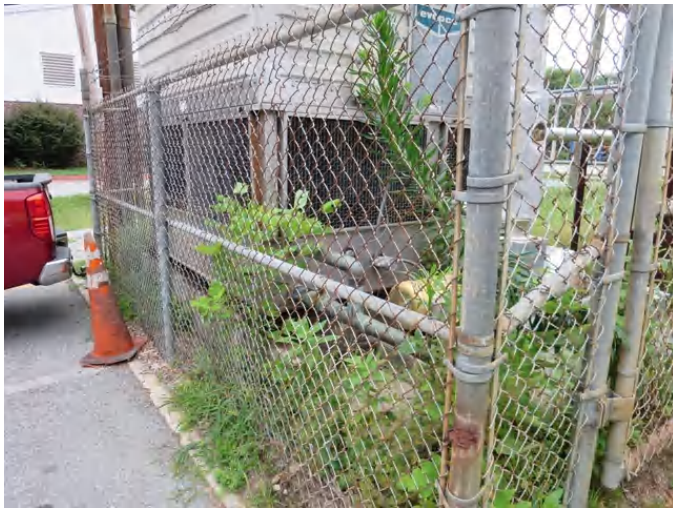
System: G2040 - Fencing & Guardrails

Location: Site

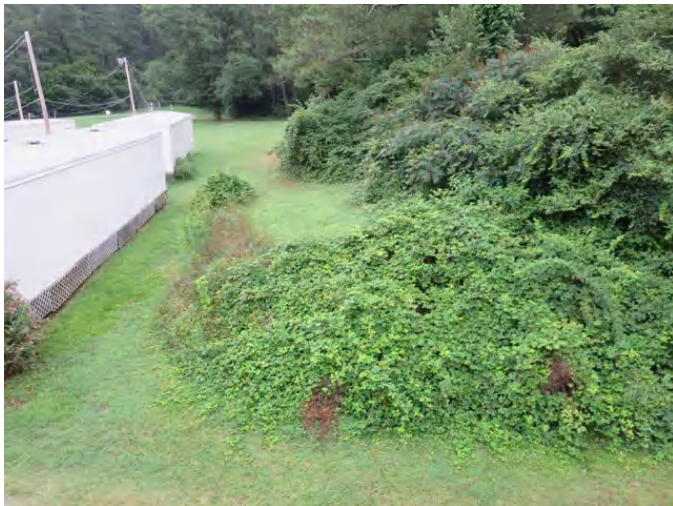
System: G2050 - Landscaping

Location: Site

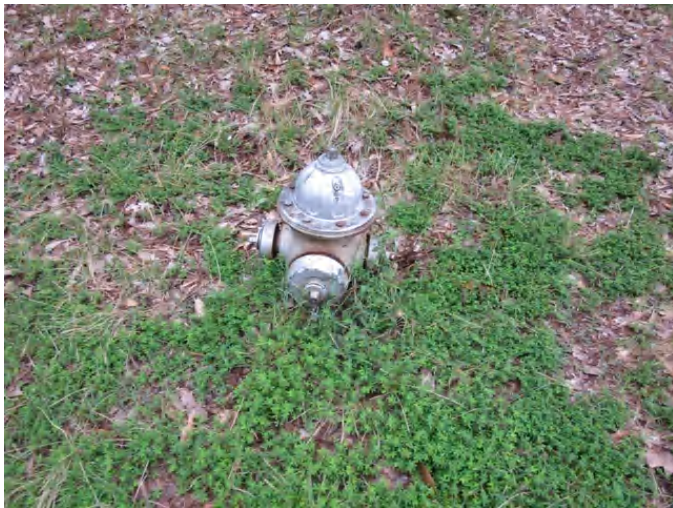
System: G3010 - Water Supply

Location: Site
Distress: Beyond Service Life
Category: Deferred Maintenance
Priority: 3 Priority
Correction: Renew System
Qty: 55,011.00
Unit of Measure: S.F.
Estimate: \$110,737.00
Assessor Name: Sam Mandola
Date Created: 07/13/2015

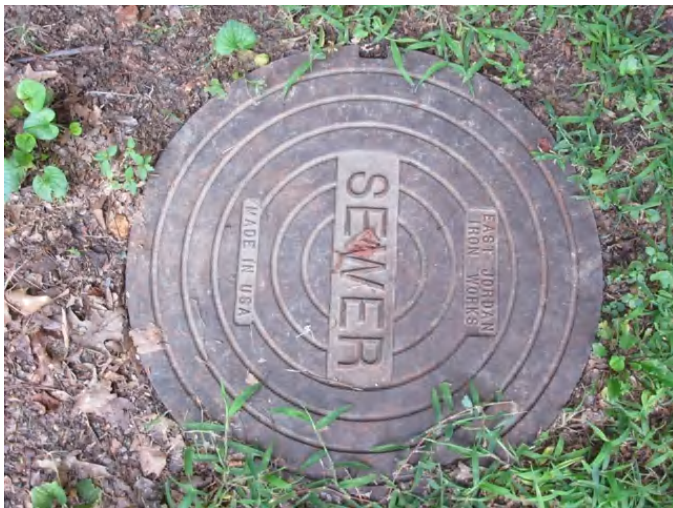
System: G3020 - Sanitary Sewer

Location: Site
Distress: Beyond Service Life
Category: Deferred Maintenance
Priority: 3 Priority
Correction: Renew System
Qty: 55,011.00
Unit of Measure: S.F.
Estimate: \$69,589.00
Assessor Name: Sam Mandola
Date Created: 07/13/2015

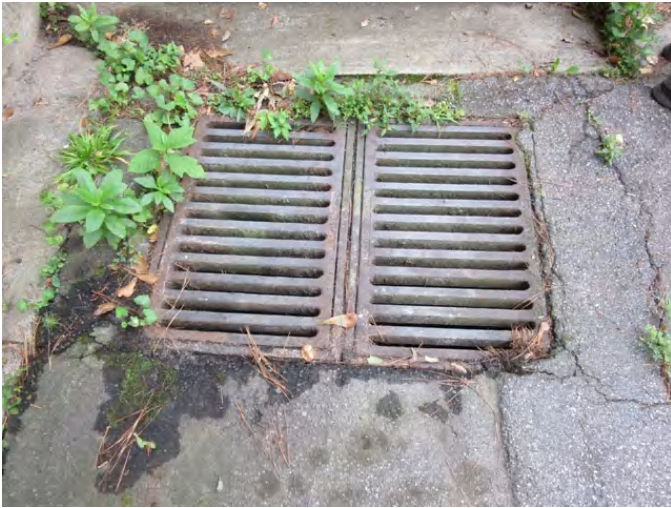
System: G3030 - Storm Sewer

Location: Site
Distress: Beyond Service Life
Category: Deferred Maintenance
Priority: 3 Priority
Correction: Renew System
Qty: 55,011.00
Unit of Measure: S.F.
Estimate: \$214,818.00
Assessor Name: Sam Mandola
Date Created: 07/13/2015

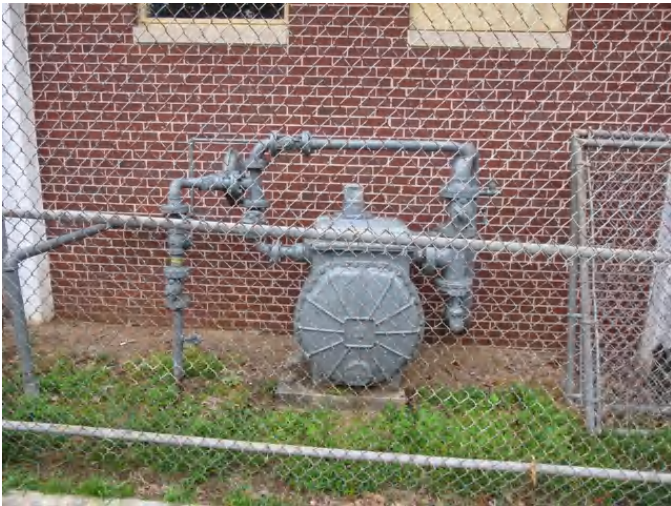
System: G3060 - Fuel Distribution

Location: Site
Distress: Beyond Service Life
Category: Deferred Maintenance
Priority: 3 Priority
Correction: Renew System
Qty: 55,011.00
Unit of Measure: S.F.
Estimate: \$47,199.00
Assessor Name: Sam Mandola
Date Created: 07/13/2015

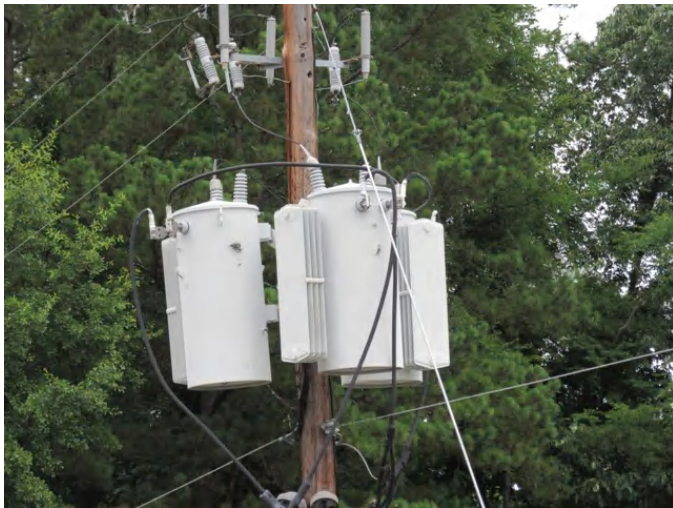
System: G4010 - Electrical Distribution

Location: Site
Distress: Beyond Service Life
Category: Deferred Maintenance
Priority: 3 Priority
Correction: Renew System
Qty: 55,011.00
Unit of Measure: S.F.
Estimate: \$112,553.00
Assessor Name: Sam Mandola
Date Created: 07/13/2015

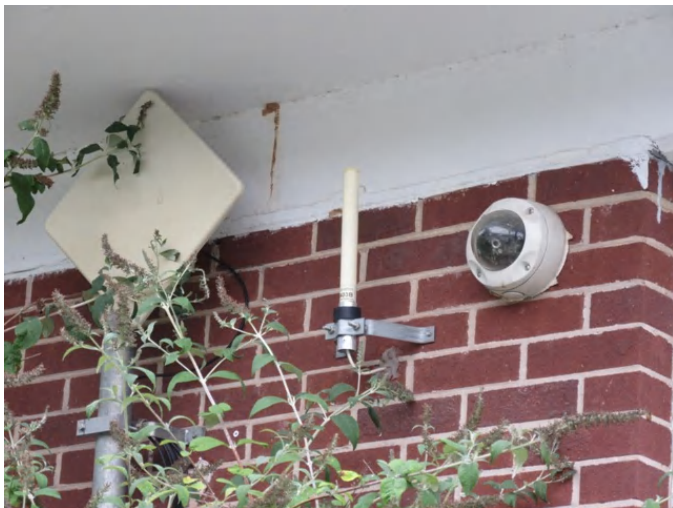
System: G4030 - Site Communications & Security

Location: Site
Distress: Beyond Service Life
Category: Deferred Maintenance
Priority: 3 Priority
Correction: Renew System
Qty: 55,011.00
Unit of Measure: S.F.
Estimate: \$40,543.00
Assessor Name: Sam Mandola
Date Created: 02/05/2016
