**DeKalb County School District/Middle Schools**

# **Salem Middle**

## **School Assessment Report**

**May 20, 2016**

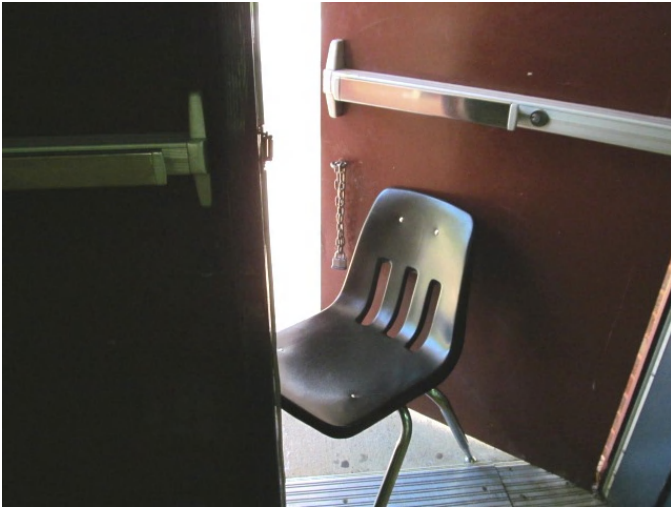
#### **System: B2030 - Exterior Doors**

**Location:** Throughout Building

**Distress:** Damaged

**Notes:** The exterior doors do not operate properly, are chained shut on the inside of the building and not ADA compliant, and should be replaced as soon as possible.

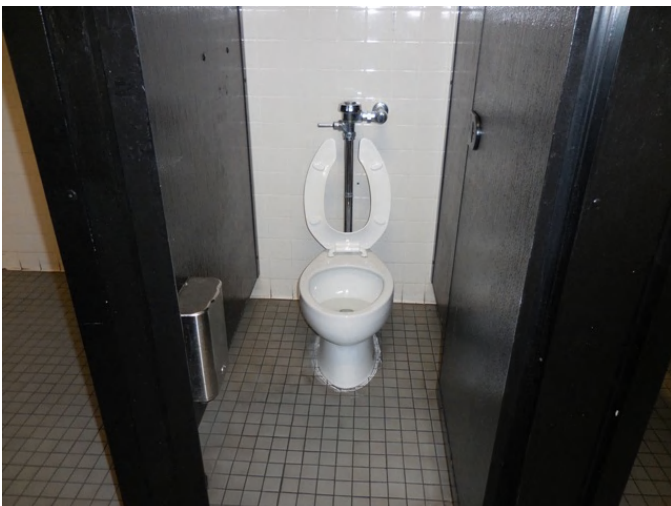
#### **System: D2010 - Plumbing Fixtures**

**Location:** Throughout Building

**Distress:** Damaged

**Notes:** Plumbing fixtures are nearing the end of their existing service life and many are loose, broken, or torn off walls. Recommend replacing fixtures to comply with ADA standards. Work done under SPLOST project 421-305 near the gym.

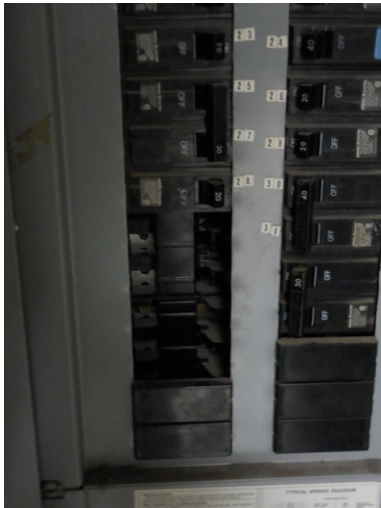
**System: D5010 - Electrical Service/Distribution**

**Location:** Panel Boards

**Distress:** Inadequate

**Correction:** Maintenance and repair - (5% of total fuses)  
switchgear, indoor, 600 V

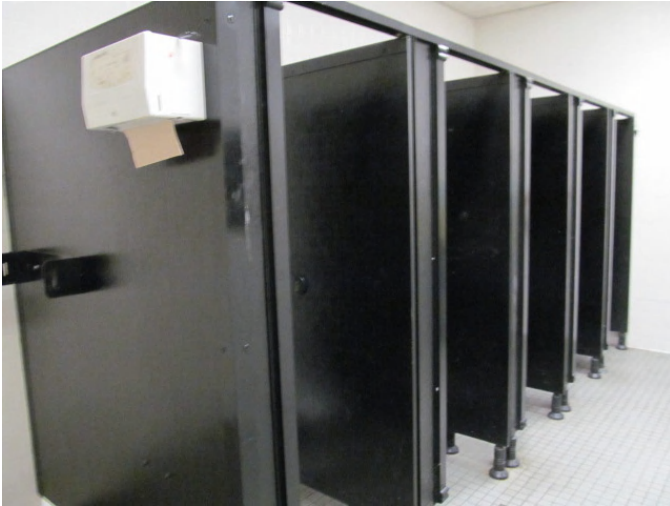
**System: C1030 - Fittings**

**Location:** Throughout Building

**Distress:** Beyond Service Life

**Notes:** Fittings, such as toilet partitions, handrails, lockers and signage, are beyond their expected service life, damaged, not fully ADA compliant and should be replaced. SPLOST project 421-305 to reconfigure / remodel existing girls' and boys' gym shower and gym restrooms, and existing teachers' gym office restrooms for ADA accessibility.

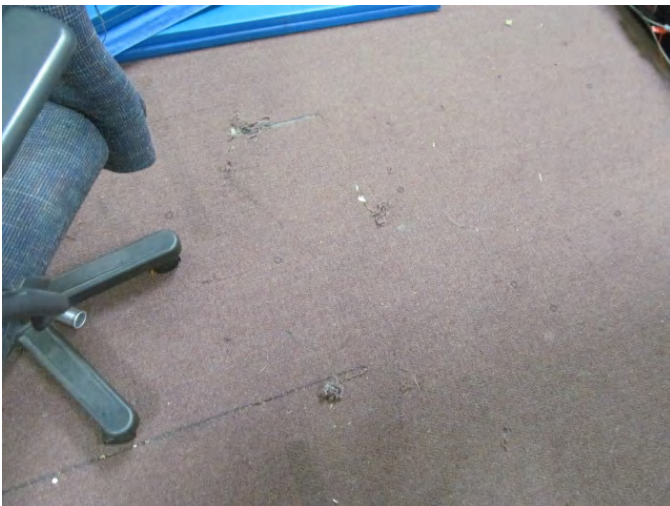
**System: C3020 - Floor Finishes - Carpet**

**Location:** Offices and Media Center

**Distress:** Beyond Service Life

**Notes:** The carpet is beyond its expected service life, damaged with tripping hazards, and should be replaced.

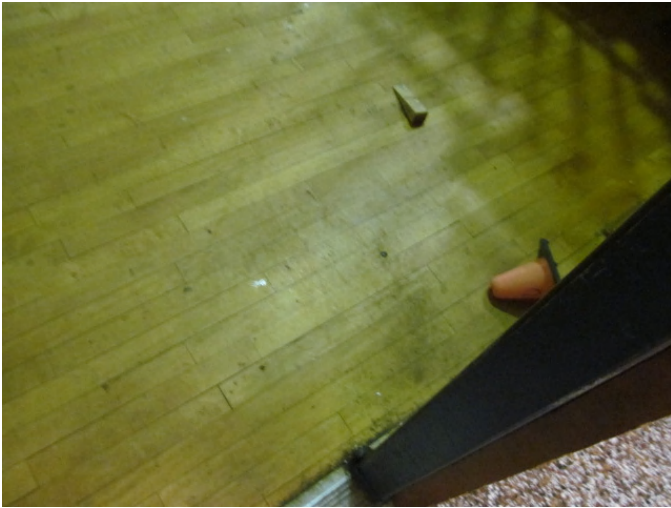
**System: C3020 - Floor Finishes - Wood**

**Location:** Gym

**Distress:** Damaged

**Notes:** The wood floor finish is damaged, is rotting from water damage, has loose boards and tripping hazards, and should be replaced.

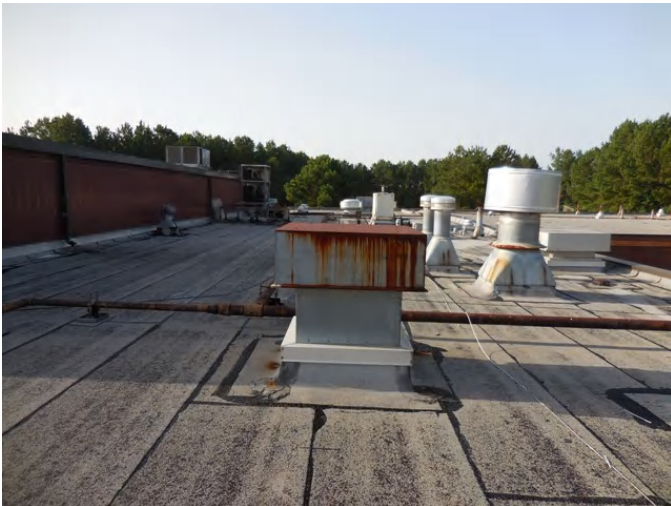
**System: D3040 - Distribution Systems & Exhaust Systems**

**Location:** Throughout Building and Roof

**Distress:** Damaged

**Notes:** Roof exhaust systems are showing heavy signs of wear and rust. Interior fans in the restrooms are missing covers, creating safety hazard. School staff reports odors in restrooms and cafeteria.

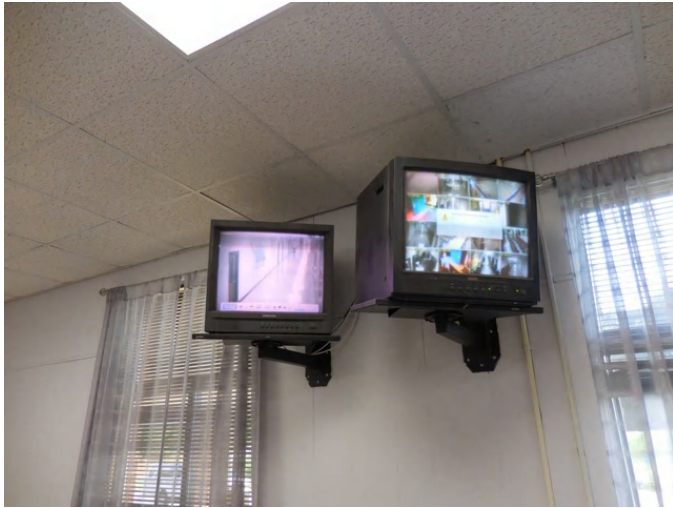
**System: D5030 - Communications and Security - Security & CCTV**

**Location:** Throughout Building

**Distress:** Beyond Service Life

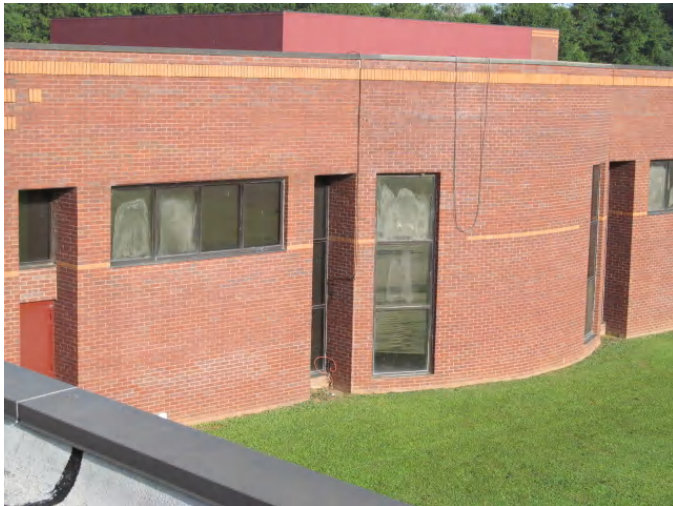
**System: B2020 - Exterior Windows**

**Location:** Throughout Building

**Distress:** Damaged

**Notes:** The exterior windows are failing early, reported to leak, and should be replaced.

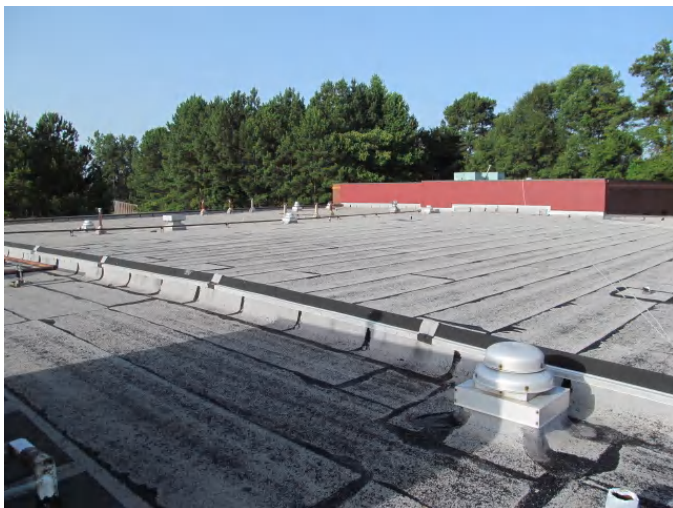
**System: B3010 - Roof Coverings - BUR**

**Location:** Roof

**Distress:** Beyond Service Life

**Notes:** The roof is reported to leak, has multiple bubbles and cracks, and should be replaced. SPLOST project 324-422 to replace the roof and install a roof hatch and ladder by June 2016.

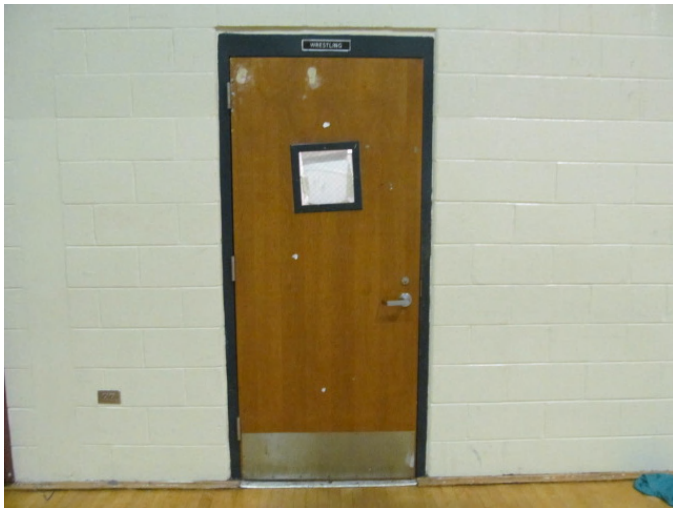
**System: C1020 - Interior Doors**

**Location:** Throughout Building

**Distress:** Damaged

**Notes:** The interior doors are failing early, stick and are hard to open and close, hardware is not ADA compliant, and should be replaced.

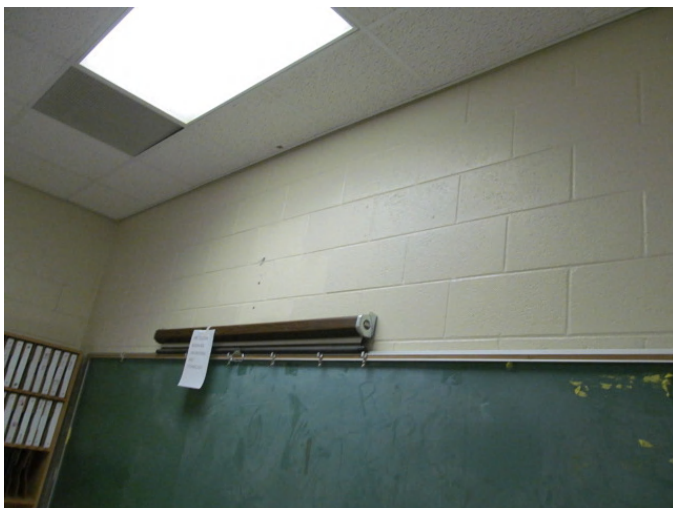
**System: C3010 - Wall Finishes - Paint**

**Location:** Throughout Building

**Distress:** Beyond Service Life

**Notes:** The painted wall finish is beyond its expected service life, damaged with holes in areas, and should be replaced.

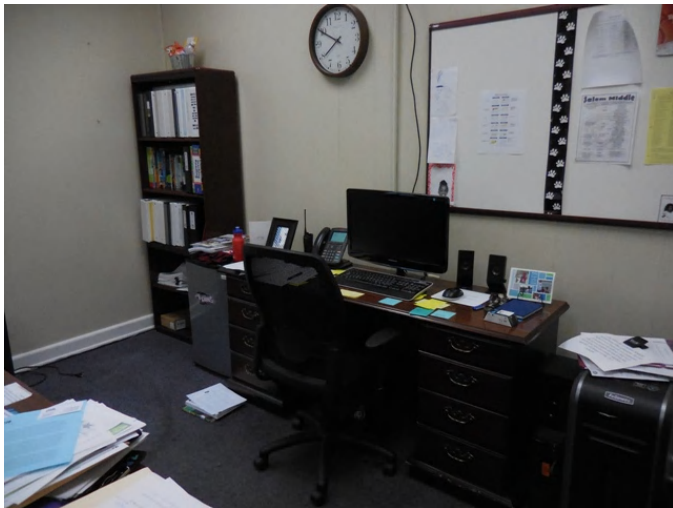
**System: C3010 - Wall Finishes - Wood Paneling**

**Location:** Offices

**Distress:** Beyond Service Life

**Notes:** The wood paneling is beyond its expected service life and should be replaced.

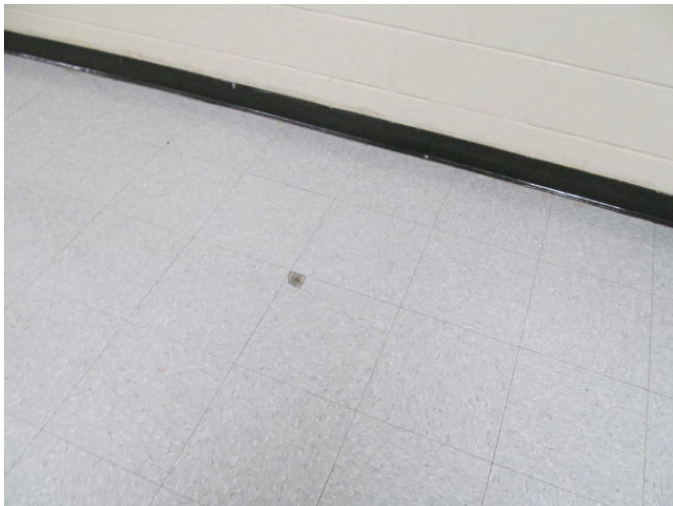
**System: C3020 - Floor Finishes - VCT**

**Location:** Throughout Building

**Distress:** Beyond Service Life

**Notes:** The VCT flooring is beyond its expected service life and should be replaced.

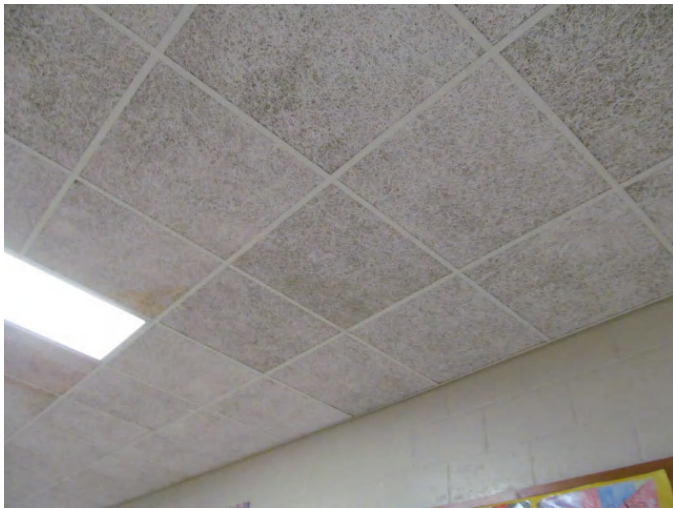
**System: C3030 - Ceiling Finishes**

**Location:** Throughout Building

**Distress:** Beyond Service Life

**Notes:** The original ceilings are beyond their expected service life, stained and damaged, and should be replaced.

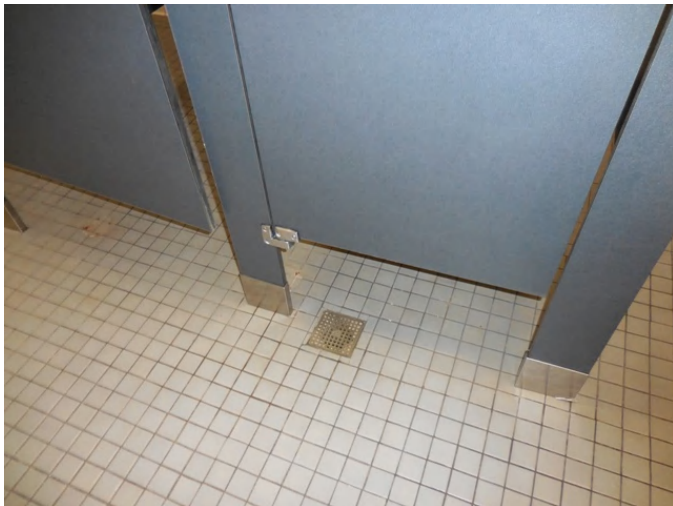
**System: D2030 - Sanitary Waste**

**Location:** Restrooms

**Distress:** Damaged

**Notes:** The sanitary waste system is damaged and failing, possibly the source of odors, and should be scheduled for replacement.

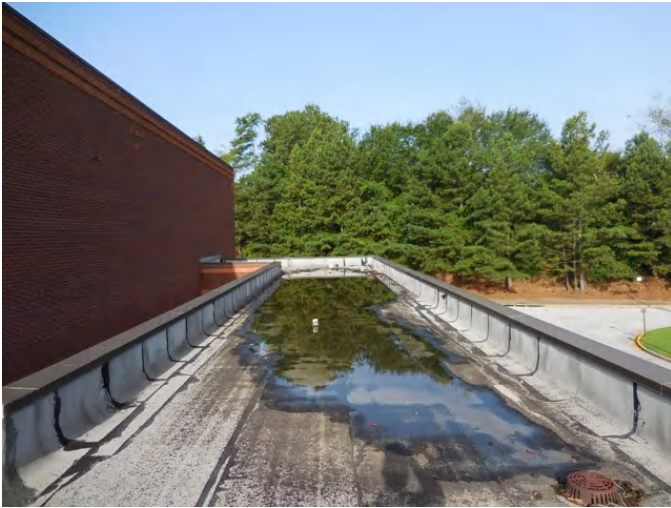
**System: D2040 - Rain Water Drainage**

**Location:** Roof

**Distress:** Inadequate

**Notes:** Rain water drainage is nearing the end of its expected service life, inadequate, with ponding water around roof drain areas, and should be replaced in conjunction with the roof.

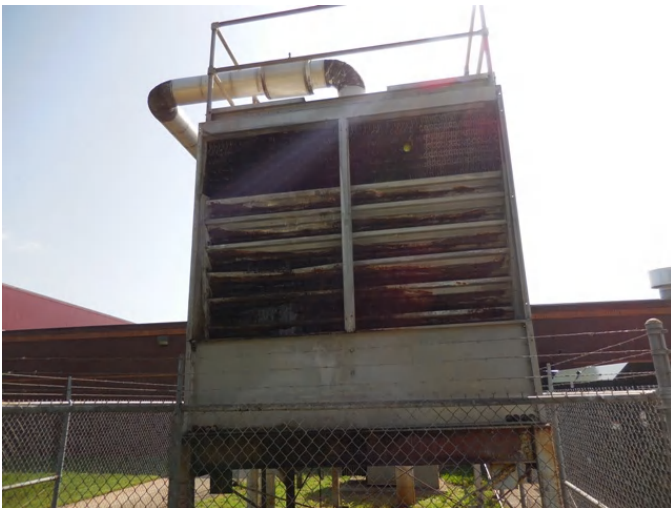
**System: D3030 - Cooling Generating Systems**

**Location:** Roof and Outside Mechanical Room

**Distress:** Damaged

**Notes:** Cooling system is showing heavy signs of wear and tear. The cooling tower coils are corroded and the evaporative unit on the roof is severely rusted.

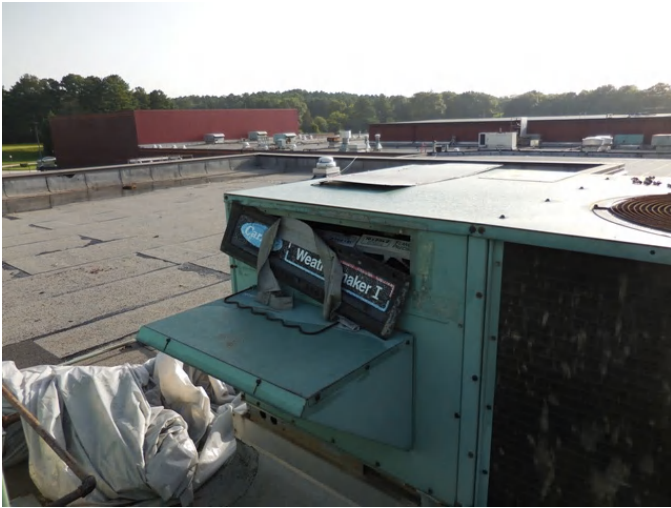
**System: D3050 - Terminal & Package Units**

**Location:** Roof

**Distress:** Beyond Service Life

**Notes:** Original package units are corroded, rusted, and constantly down for repairs, and should be scheduled for replacement.

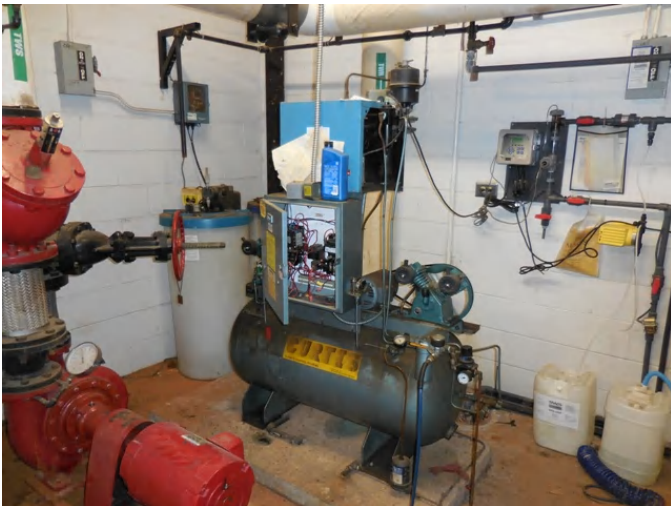
**System: D3060 - Controls & Instrumentation**

**Location:** Mechanical Room/Building

**Distress:** Beyond Service Life

**Notes:** Controls and instrumentation are beyond their expected service life, inadequate, and should be scheduled for replacement.

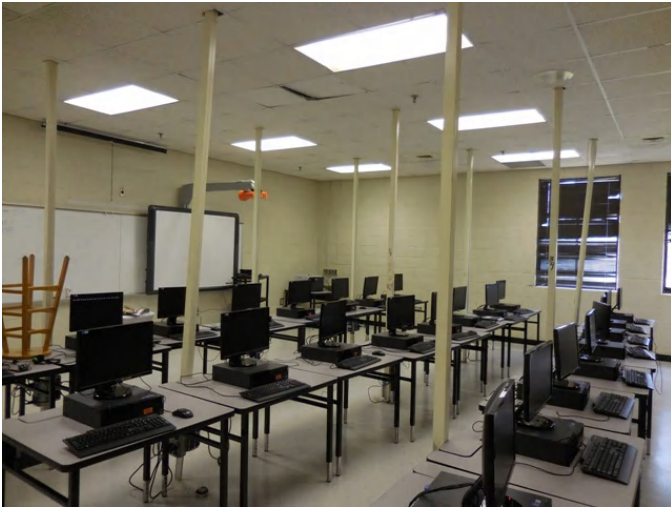
**System: D5020 - Branch Wiring**

**Location:** Throughout Building

**Distress:** Inadequate

**Notes:** Branch wiring system is nearing the end of its expected service life and should be scheduled for replacement. Staff reports that the pole outlets in the classrooms are loose and constantly trip circuit breakers.

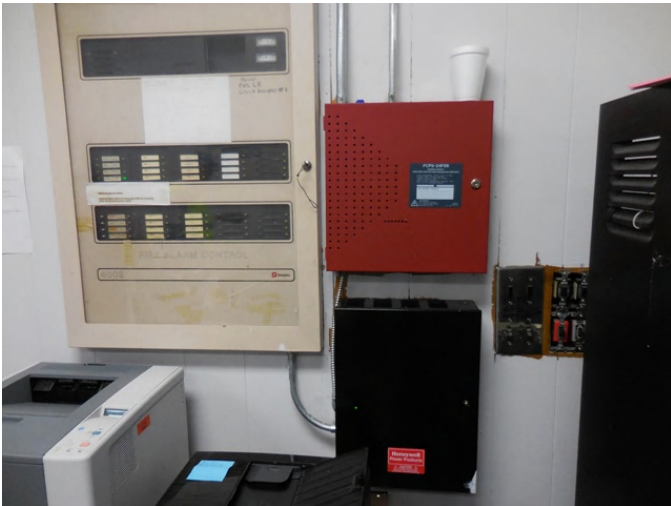
**System: D5030 - Communications and Security - Fire Alarm**

**Location:** Throughout Building

**Distress:** Beyond Service Life

**Notes:** Fire alarm system is beyond its expected service life and should be scheduled for replacement.

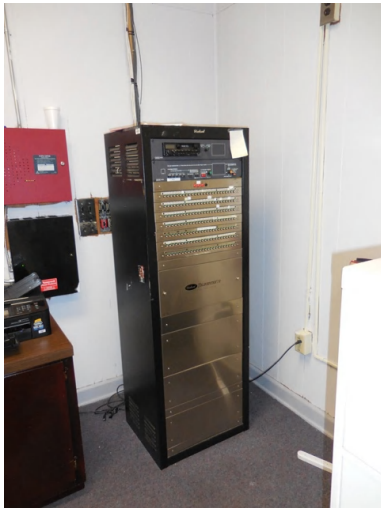
**System: D5030 - Communications and Security - PA & Clock Systems**

**Location:** Office/Throughout Building  
**Distress:** Beyond Service Life  
**Category:** Deferred Maintenance  
**Priority:** 3 Priority  
**Correction:** Renew System  
**Qty:** 117,062.00  
**Unit of Measure:** S.F.  
**Estimate:** \$428,798.00  
**Assessor Name:** Ben Nixon  
**Date Created:** 04/11/2015

**Notes:** PA and clock systems are beyond their expected service life and should be scheduled for replacement.

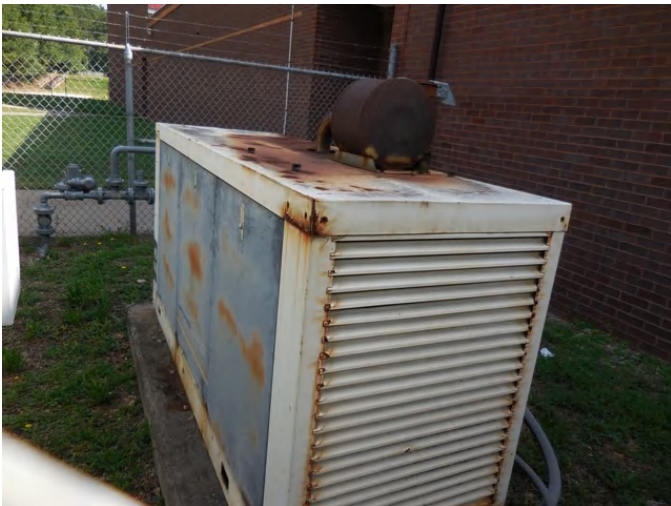
**System: D5090 - Other Electrical Systems - Emergency Generator**

**Location:** Outside of Mechanical Room  
**Distress:** Beyond Service Life  
**Category:** Deferred Maintenance  
**Priority:** 3 Priority  
**Correction:** Renew System  
**Qty:** 117,062.00  
**Unit of Measure:** S.F.  
**Estimate:** \$108,165.00  
**Assessor Name:** Ben Nixon  
**Date Created:** 04/11/2015

**Notes:** Emergency generator is beyond its expected service life and should be scheduled for replacement.

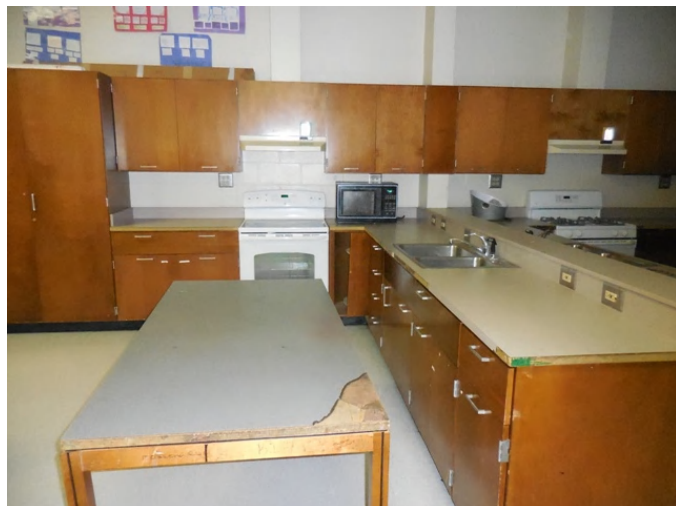
**System: E2010 - Fixed Furnishings**

**Location:** Throughout Building

**Notes:** The fixed furnishings are beyond their expected service life and should be replaced.

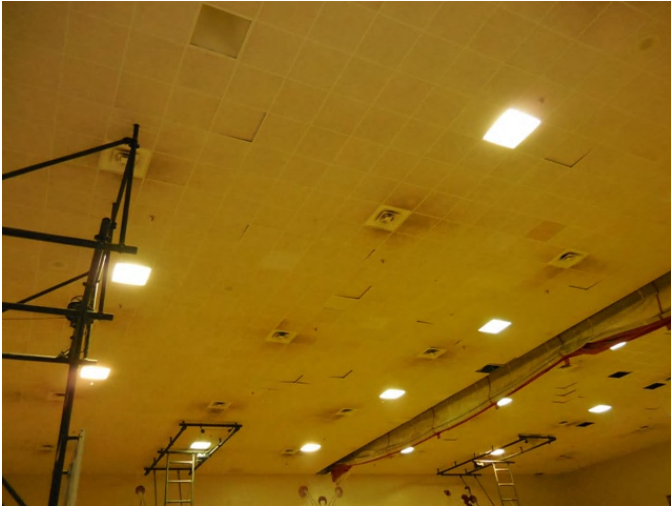
**System: D5020 - Lighting**

**Location:** Throughout Building

**Notes:** Lighting is nearing the end of its expected service life, inadequate in the hallways and gym, and should be scheduled for replacement. The majority of the lights are T-12 and should be upgraded to T-5.

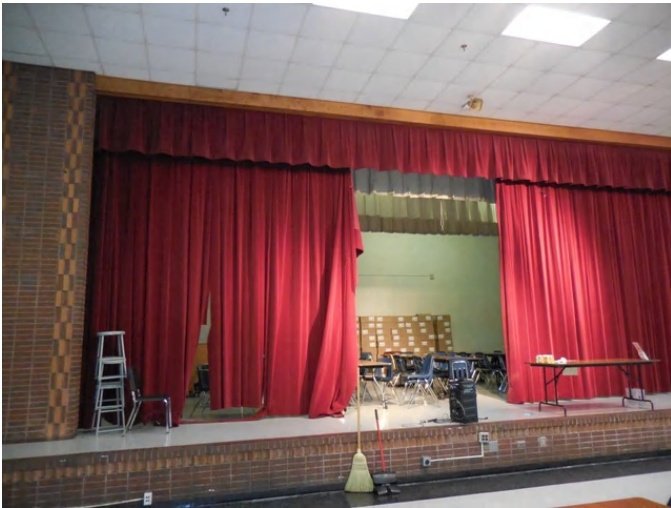
**System: E1020 - Institutional Equipment**

**Location:** Stage

**Notes:** Institutional equipment, such as theater and stage equipment and audio-visual equipment, is beyond its expected service life and should be scheduled for replacement.

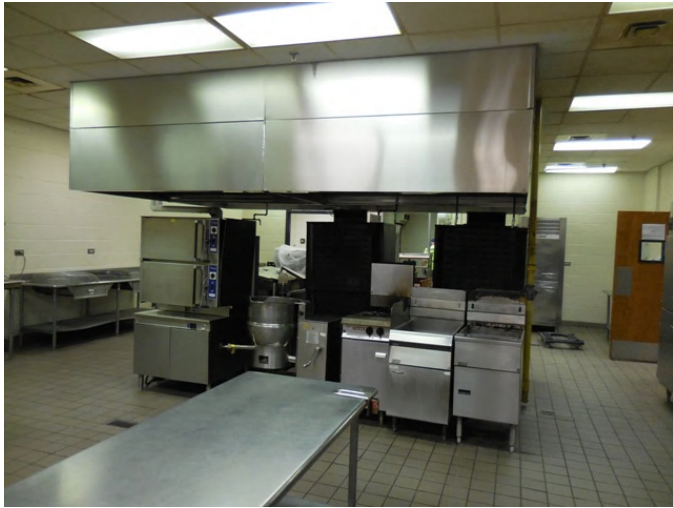
**System: E1090 - Other Equipment - Kitchen Equipment**

**Location:** Kitchen

**Notes:** Kitchen equipment, such as stoves and ovens, is beyond its expected service life and should be scheduled for replacement. Equipment is still functional but recommend replacement.

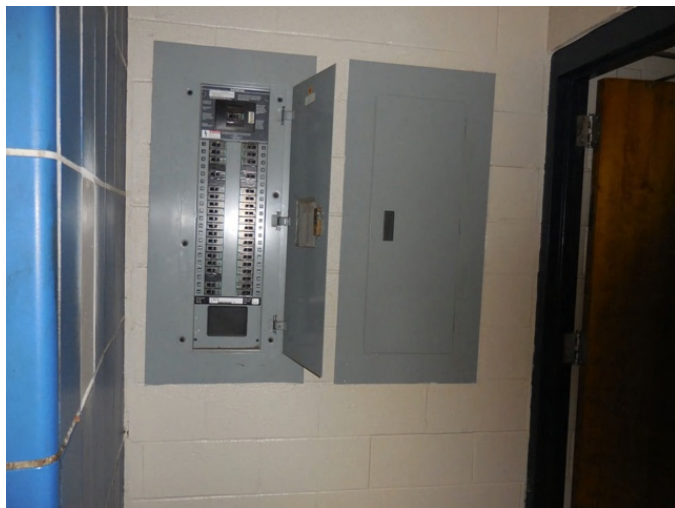
#### **System: D5010 - Electrical Service/Distribution**

**Location:** Panel Boards

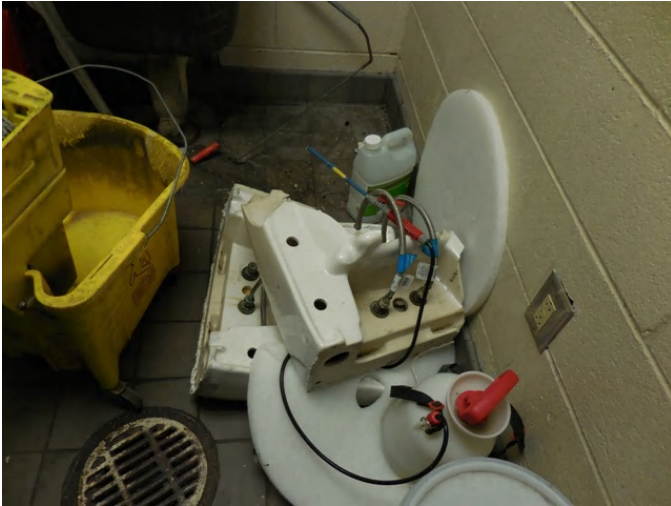
**System: D2030 - Sanitary Waste**

**Location:** Restrooms

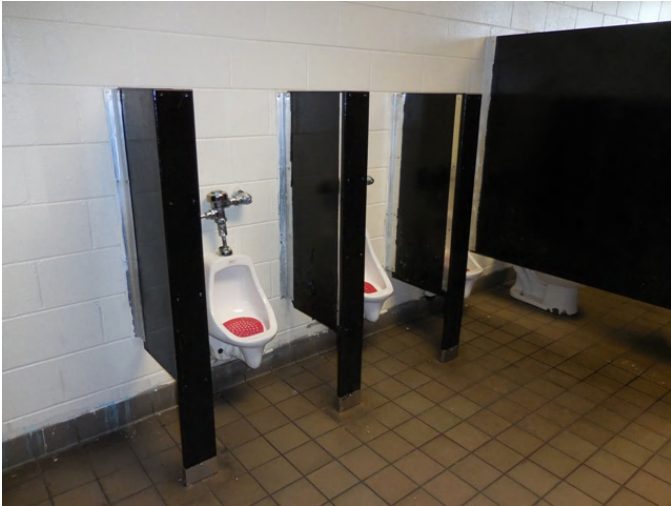
**System: C1030 - Fittings**

**Location:** Throughout Building

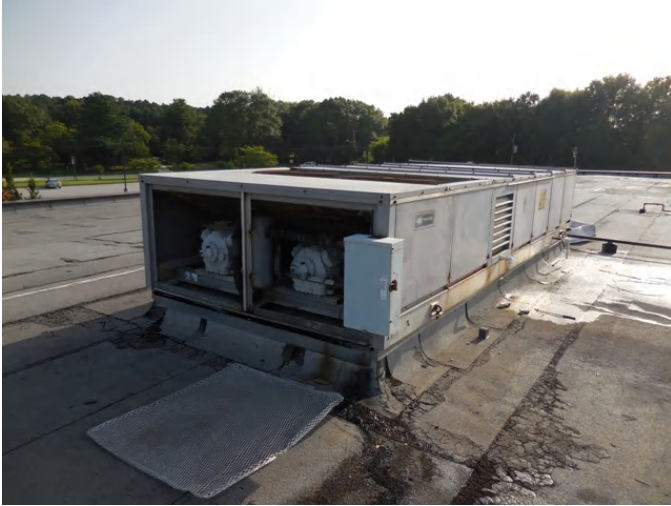
**System: D3050 - Terminal & Package Units**

**Location:** Throughout Building  
**Distress:** Beyond Service Life  
**Category:** Deferred Maintenance  
**Priority:** 3 Priority  
**Correction:** Renew System  
**Qty:** 21,047.00  
**Unit of Measure:** S.F.  
**Estimate:** \$63,667.00  
**Assessor Name:** Ben Nixon  
**Date Created:** 09/18/2015

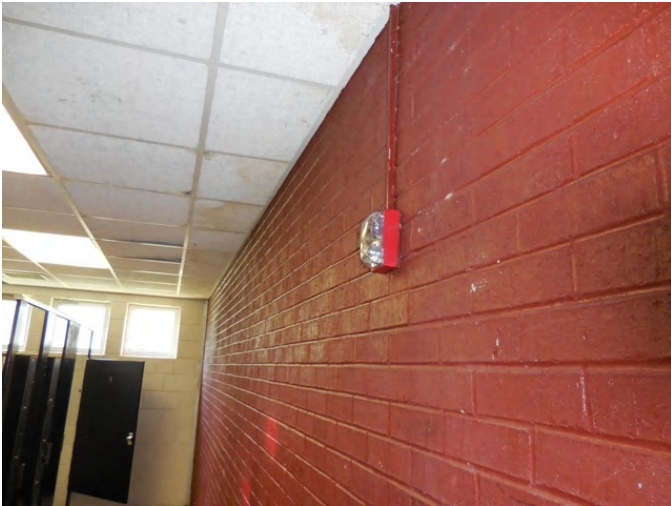
**System: D5030 - Communications and Security - Fire Alarm**

**Location:** Throughout Building  
**Distress:** Beyond Service Life  
**Category:** Deferred Maintenance  
**Priority:** 3 Priority  
**Correction:** Renew System  
**Qty:** 21,407.00  
**Unit of Measure:** S.F.  
**Estimate:** \$33,909.00  
**Assessor Name:** Ben Nixon  
**Date Created:** 04/11/2015

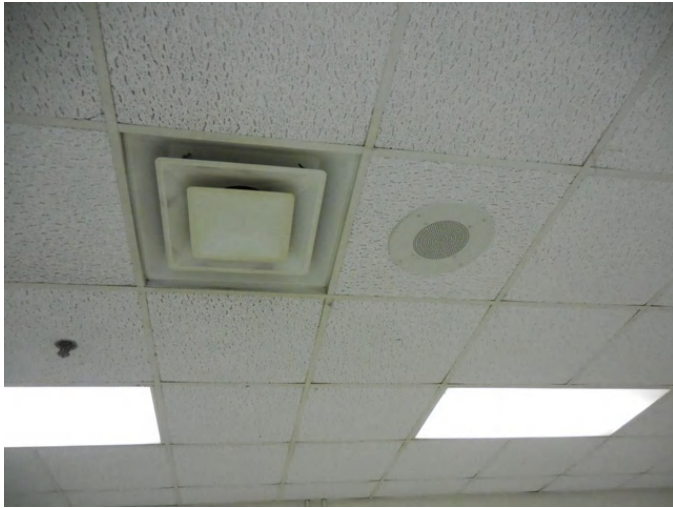
**System: D5030 - Communications and Security - PA & Clock Systems**

**Location:** Throughout Building

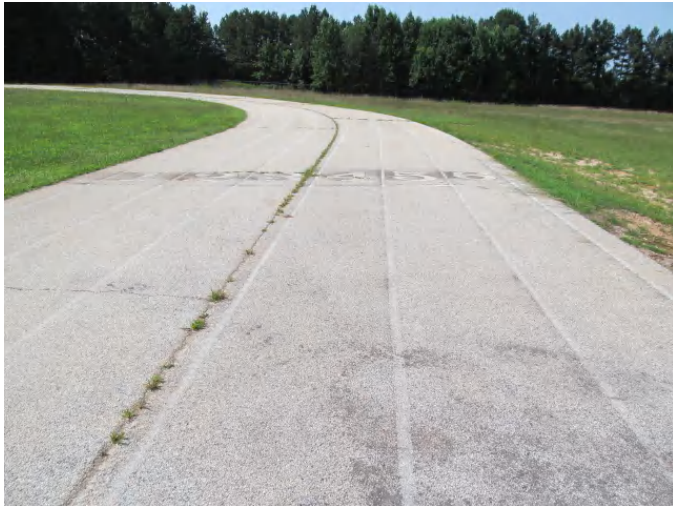
#### **System: G2040 - Track**

**Location:** Site

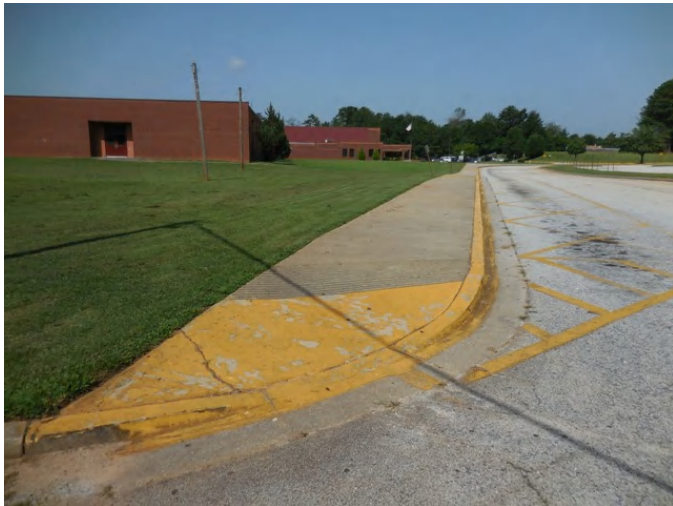
**System: G2010 - Roadways**

**Location:** Site

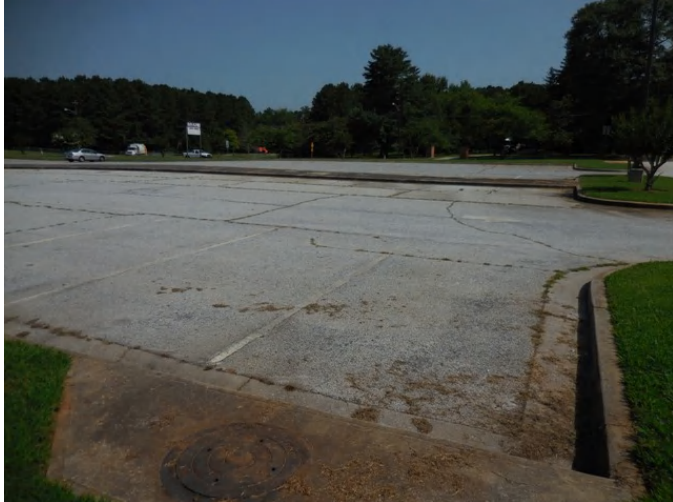
**System: G2020 - Parking Lots**

**Location:** Site

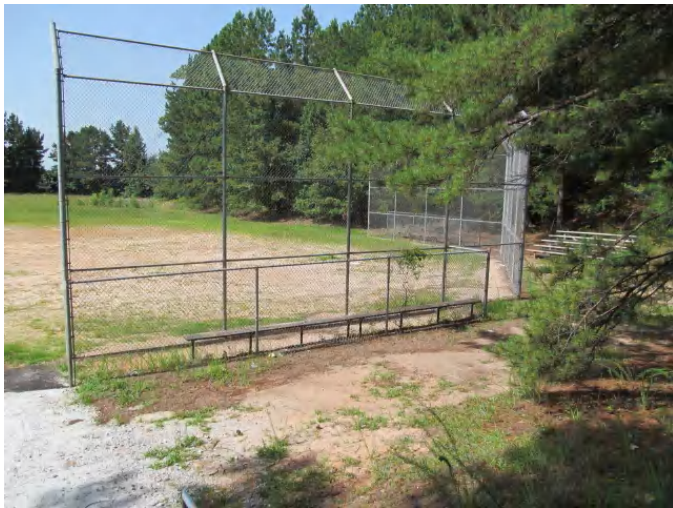
**System: G2040 - Softball Field**

**Location:** Site

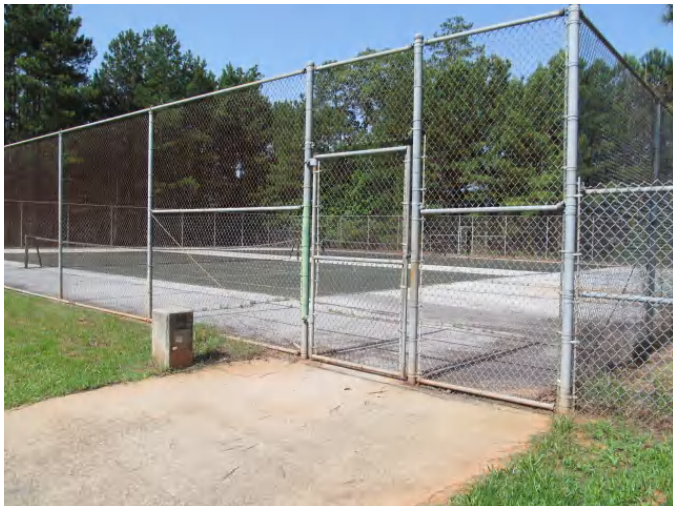
**System: G2040 - Tennis Courts**

**Location:** Site

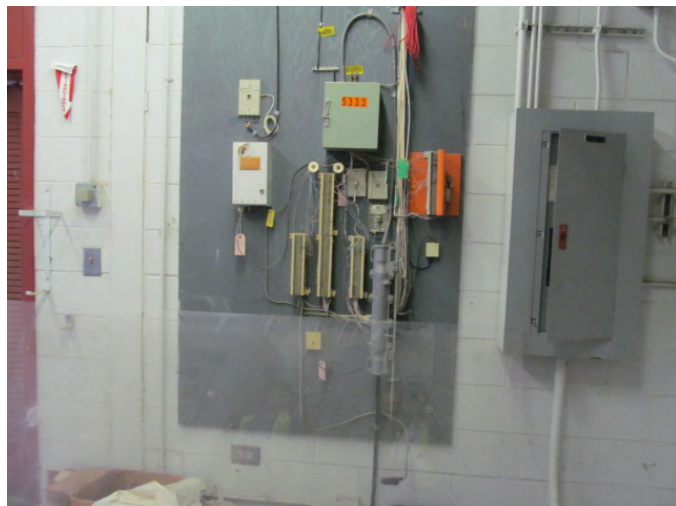
**System: G4030 - Site Communications & Security**

**Location:** Mechanical Room
