DeKalb County School District/Middle Schools

Sequoyah Middle

School Assessment Report

May 20, 2016

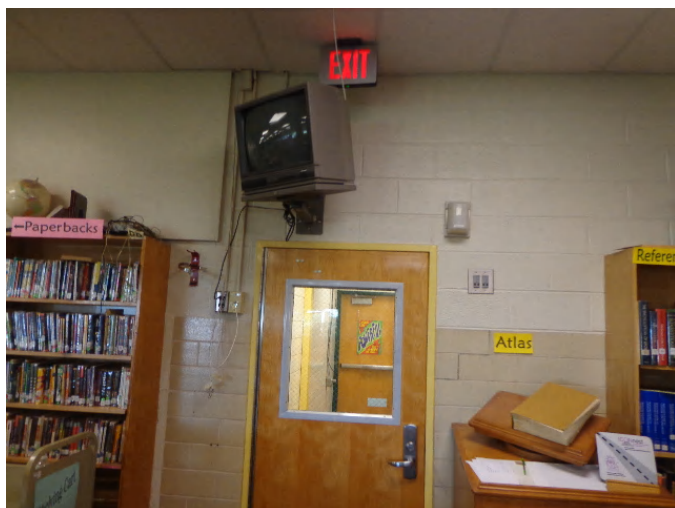
System: C1020 - Interior Doors

Location: Throughout Building

Distress: Needs Remediation

Notes: In rooms 305 Art and 300 and 301 Science, the emergency exit doors open in the opposite direction of egress and do not have panic hardware installed. In the Media Center 99, the single-door emergency exits door opens in the opposite direction and the panic hardware is installed in the opposite side as well. In the main office areas, Office 98.16 is at the end of the corridor creating a dead end space; it is recommended to remove this office/door and invert both end doors from the corridor to allow flow in the direction of emergency exits.

Correction: Remove/replace emergency exit door to include panic hardware.

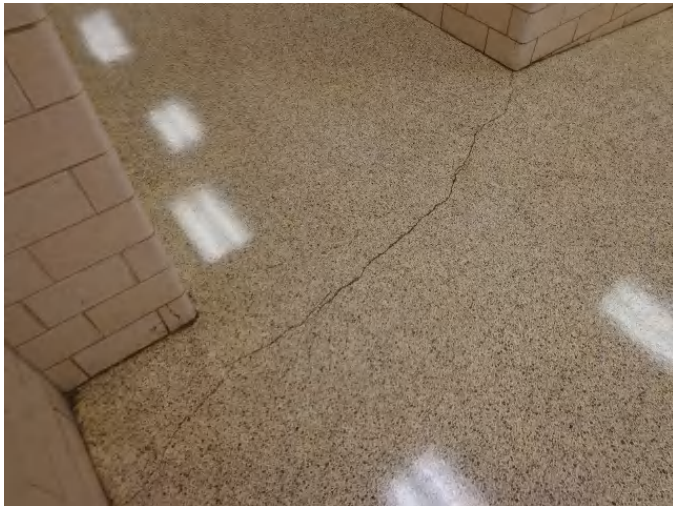
System: A1010 - Standard Foundations

Location: Throughout Building

Distress: Damaged

Notes: Significant cracks were observed on the floors throughout the building. An engineering study is recommended to determine the cause. Pricing does not include remediation measures.

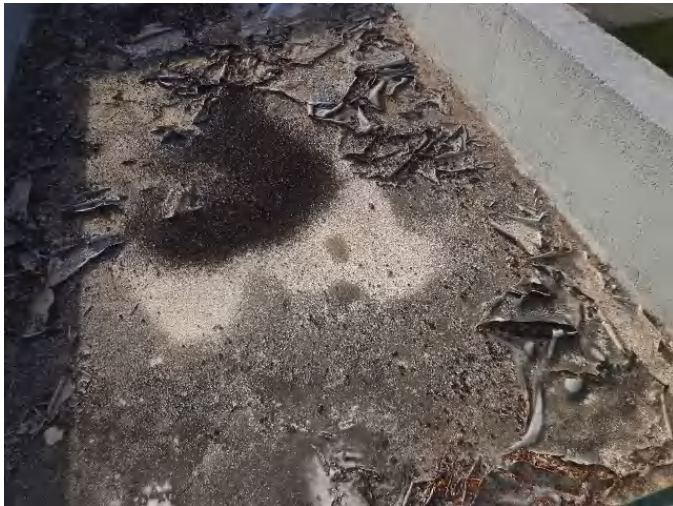
System: B3010 - Roof Coverings - EPDM

Location: Both Ends of Front Canopy

Distress: Damaged

Notes: The roof covering was replaced except for two areas above the canopy, which are in deteriorating condition, with reported water leaks and damaged ceilings in the same area. It is recommended to be replaced.

Correction: Membrane replacement-(25% of roof area),modified bitum/thermoplastic

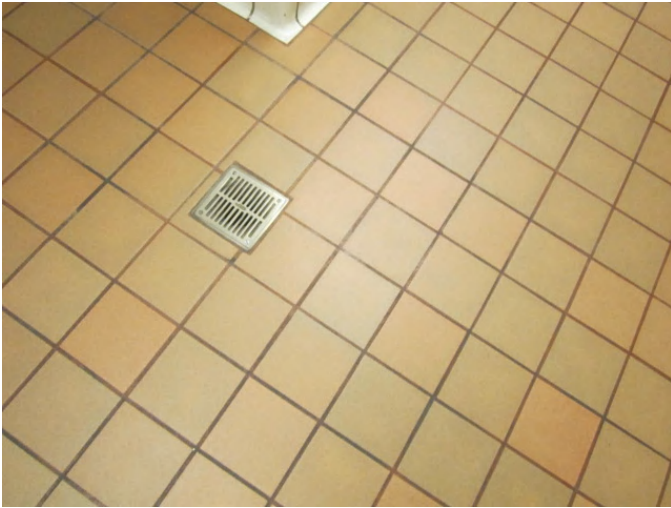
System: D2030 - Sanitary Waste

Location: Throughout Building

Distress: Beyond Service Life

Notes: Sanitary waste system is beyond its expected service life and should be scheduled for replacement.

Correction: Clean Out, Repair

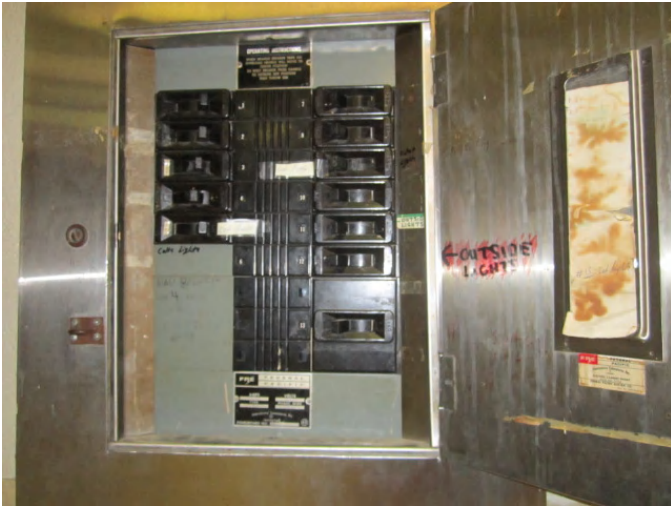
System: D5020 - Branch Wiring

Location: Throughout Building

Distress: Beyond Service Life

Notes: Branch wiring is beyond its expected service life and should be scheduled for replacement. Older, original panel boards have missing parts, such as cover plates, which is a safety issue. GFI outlets are also missing from some wet areas.

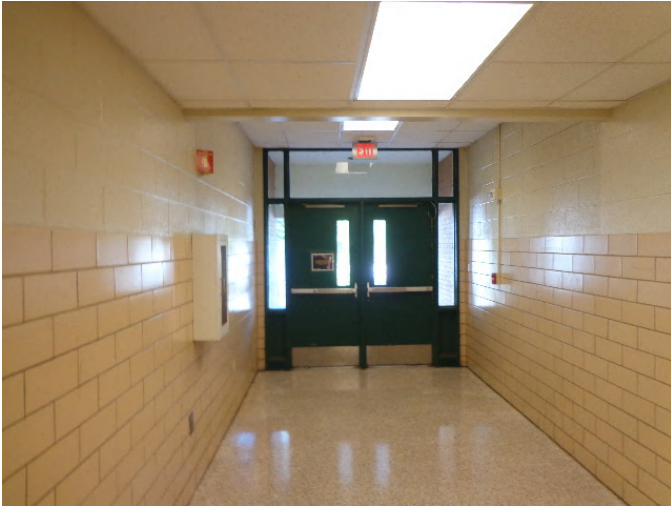
System: B2030 - Exterior Doors

Location: Throughout Building

Distress: Beyond Service Life

Notes: The original exterior doors are aged, rusted, not energy efficient, and should be replaced. The exterior door in the electrical room swings in wrong direction and does not have exit hardware.

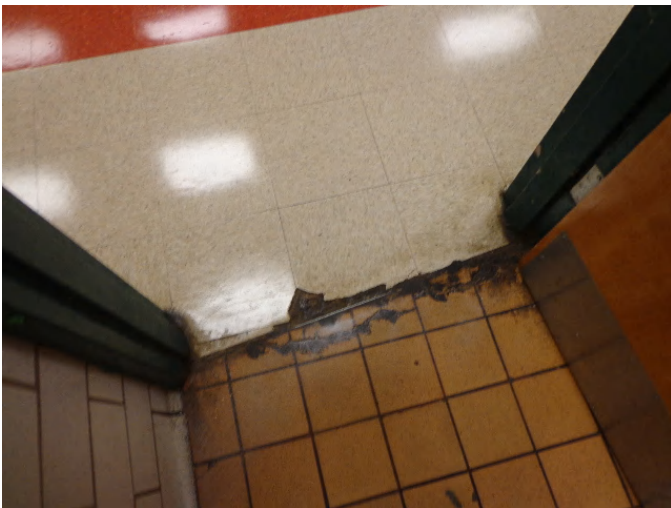
System: C3020 - Floor Finishes - Ceramic & Quarry Tile

Location: Kitchen and Restrooms

Distress: Beyond Service Life

Notes: The original tile flooring is aged, chipped, cracked, patched and worn, and should be replaced.

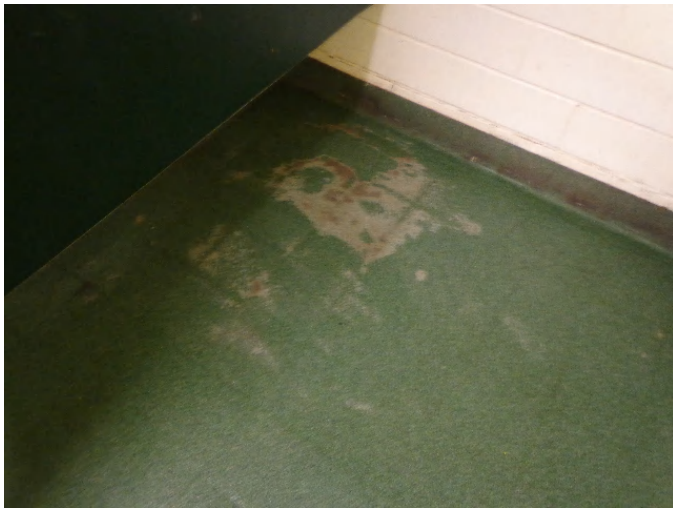
System: C3020 - Floor Finishes - Epoxy

Location: Restrooms

Distress: Inadequate

Notes: The original quarry tile in restrooms was painted with an epoxy coat finish, which is an unsuitable material. The epoxy finish is wearing off rapidly, there have been complaints of not being able to wash or clean this surface, and It is recommended to be removed and replaced with a more suitable coating material for wet areas.

Correction: Replace epoxy flooring

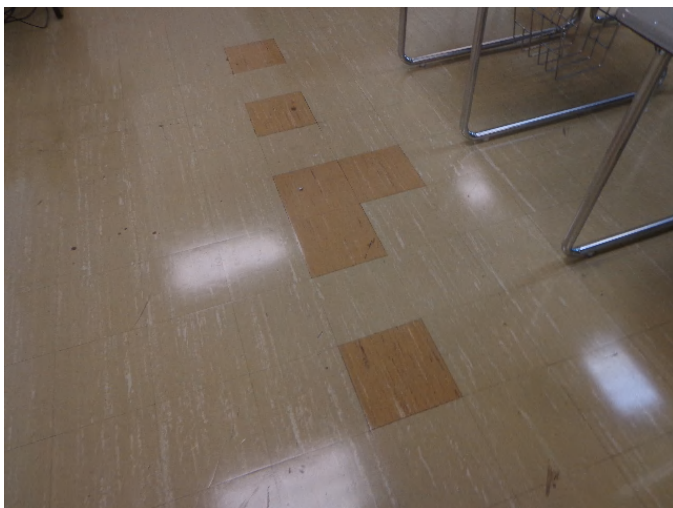
System: C3020 - Floor Finishes - VCT

Location: Throughout Building

Distress: Beyond Service Life

Notes: The VCT was replaced in some classrooms, offices and common areas. However, there are areas with the original VAT flooring that is in poor condition and should be replaced.

Correction: Replace VCT flooring

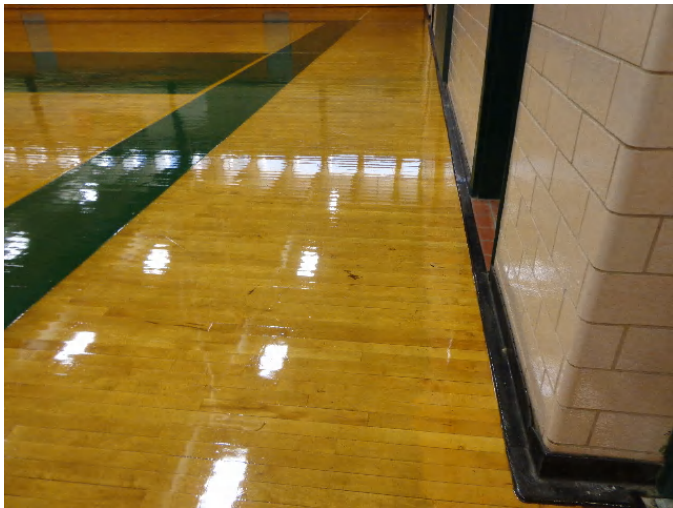
System: C3020 - Floor Finishes - Wood

Location: Gymnasium and Stage

Distress: Beyond Service Life

Notes: The original wood flooring was recently varnished; however, the surface is noticeable uneven and becoming a trip hazard. The wood flooring is beyond its expected service life and should be replaced.

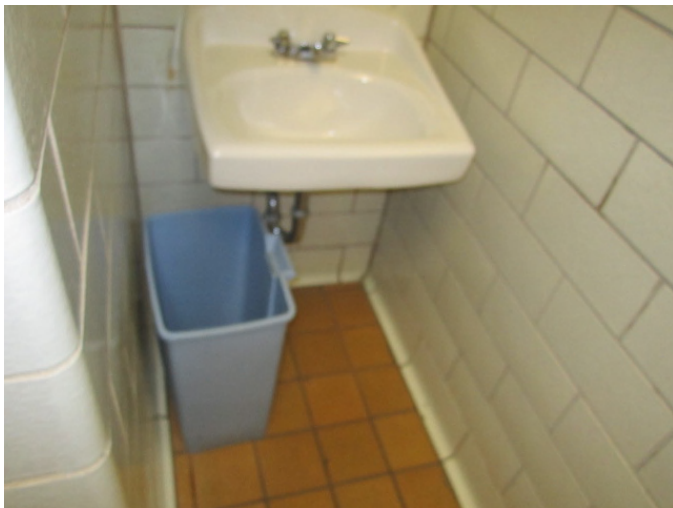
System: D2020 - Domestic Water Distribution

Location: Throughout Building

Distress: Beyond Service Life

Notes: Domestic water distribution is beyond its expected service life and should be scheduled for replacement.

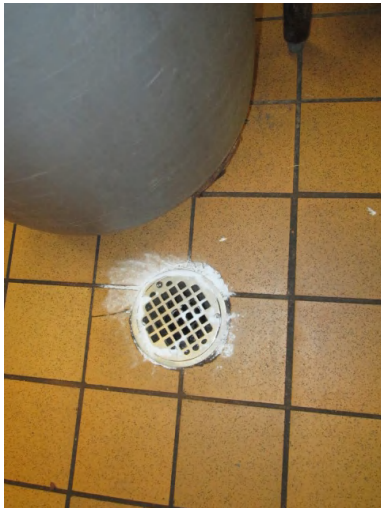
System: D2030 - Sanitary Waste

Location: Throughout Building

Distress: Beyond Service Life

Notes: The sanitary waste system is beyond its expected service life and should be scheduled for replacement.

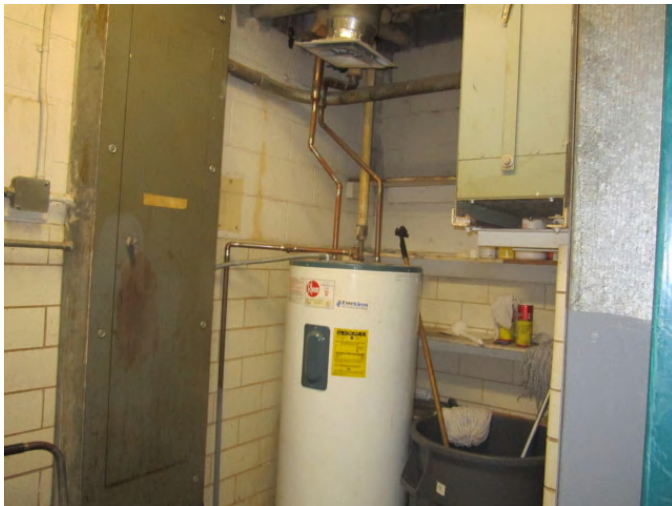
System: D2090 - Other Plumbing Systems - Natural Gas

Location: Throughout Building

Distress: Beyond Service Life

Notes: The natural gas distribution system is beyond its expected service life and should be scheduled for replacement to include shut-off valves in science labs. SPLOST project 129-422 to replace grease trap and backflow preventer.

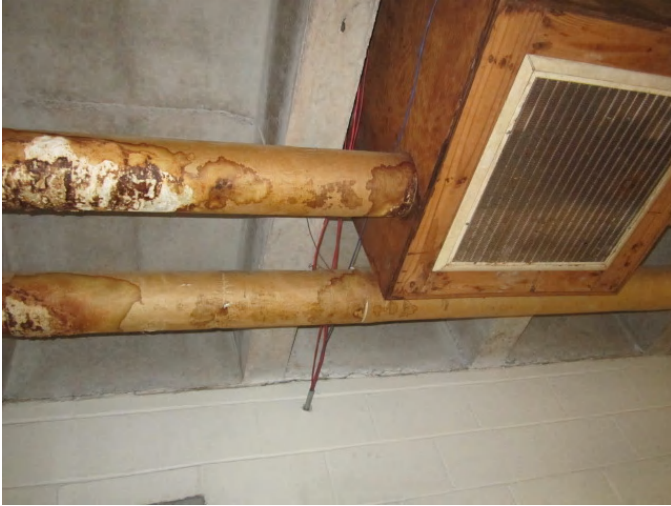
System: D3040 - Distribution Systems & Exhaust Systems

Location: Throughout Building

Distress: Beyond Service Life

Notes: Distribution and exhaust systems are beyond their expected service life and should be scheduled for replacement. Lower level locker rooms have inadequate ventilation.

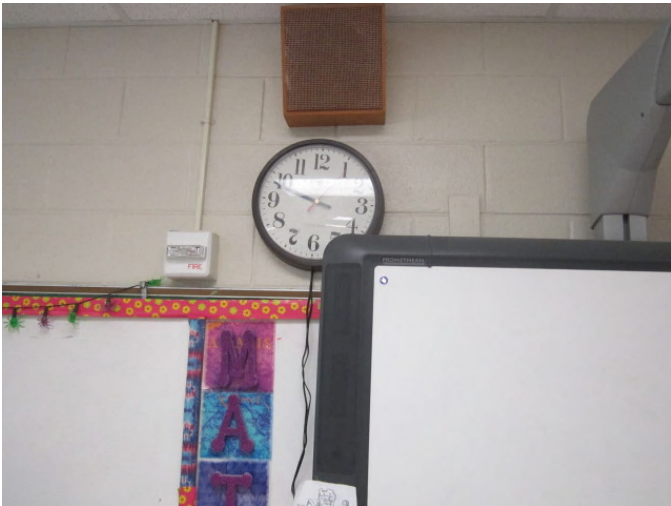
System: D5030 - Communications and Security - PA & Clock Systems

Location: Throughout Building

Distress: Beyond Service Life

Notes: The PA and clock systems are beyond their expected service life and should be scheduled for replacement.

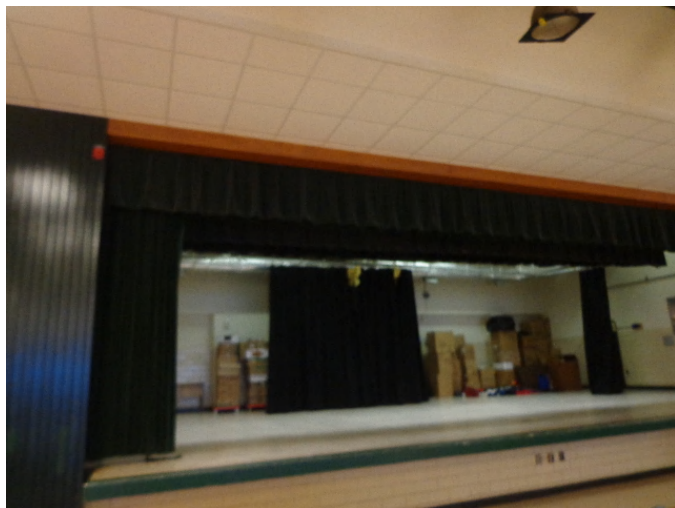
System: E1020 - Institutional Equipment

Location: Throughout Building

Distress: Beyond Service Life

Notes: Institutional equipment, such as theater and stage and audio-visual equipment, is beyond its expected life and should be schedule for replacement.

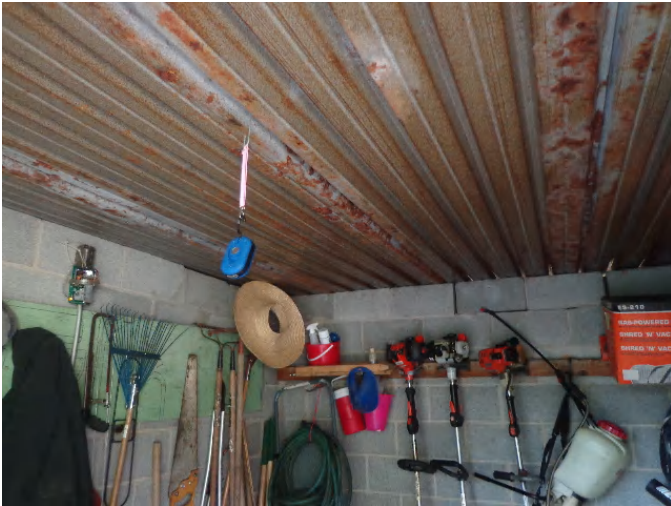
System: B1020 - Roof Construction

Location: Roof

Distress: Beyond Service Life

Notes: The built-up roof covering is aged, showing signs of failure, and should be replaced.

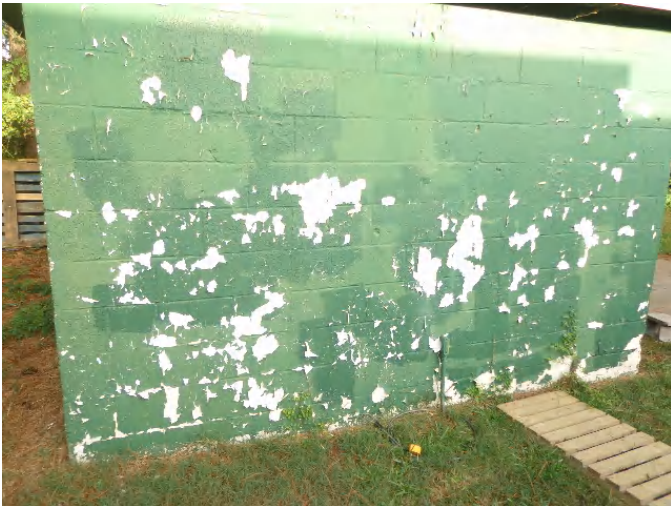
System: B2010 - Exterior Walls

Location: Exterior Walls

Distress: Inadequate

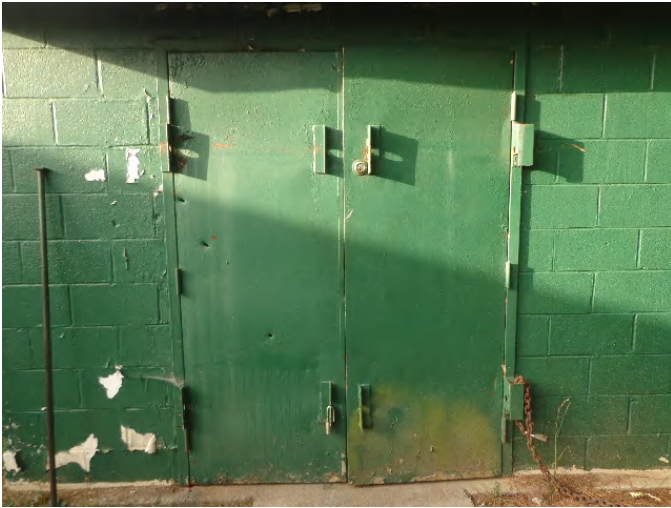
System: B2030 - Exterior Doors

Location: Exterior Wall
Distress: Beyond Service Life
Category: Deferred Maintenance
Priority: 3 Priority
Correction: Renew System
Qty: 144.00
Unit of Measure: S.F.
Estimate: \$824.00
Assessor Name: Eduardo Lopez
Date Created: 07/09/2015

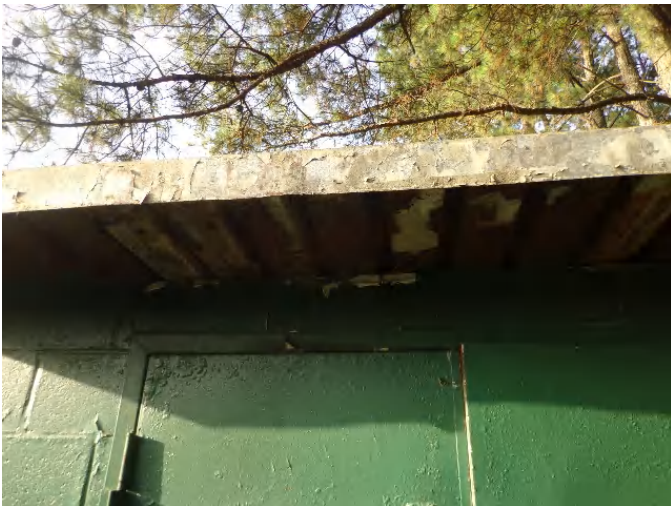
System: B3010 - Roof Coverings

Location: Roof
Distress: Beyond Service Life
Category: Deferred Maintenance
Priority: 3 Priority
Correction: Renew System
Qty: 144.00
Unit of Measure: S.F.
Estimate: \$2,618.00
Assessor Name: Eduardo Lopez
Date Created: 04/11/2015

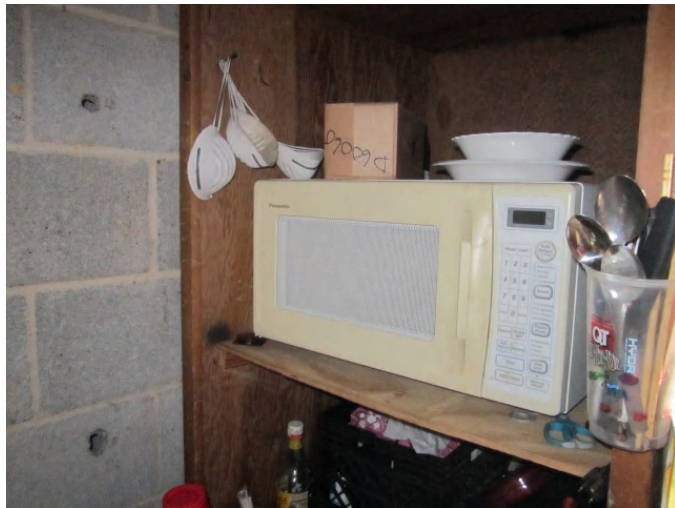
System: D5010 - Electrical Service/Distribution

Location: Throughout Building

Distress: Beyond Service Life

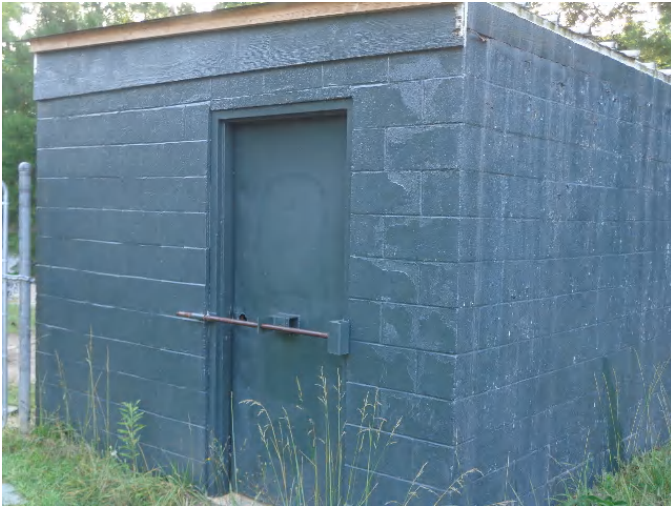
System: B2030 - Exterior Doors

Location: Exterior Wall

Distress: Beyond Service Life

Notes: The original exterior door is aged, rusted, and should be replaced.

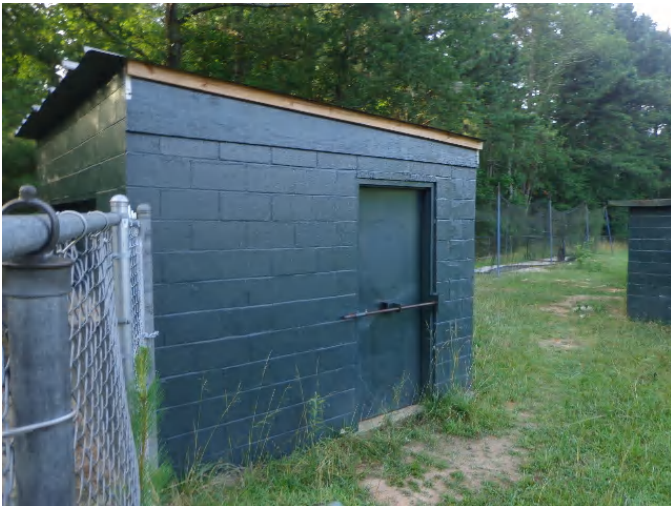
System: D2010 - Plumbing Fixtures

Location: Throughout Building

Distress: Beyond Service Life

Notes: Plumbing fixtures are beyond their expected service life and should be scheduled for replacement.

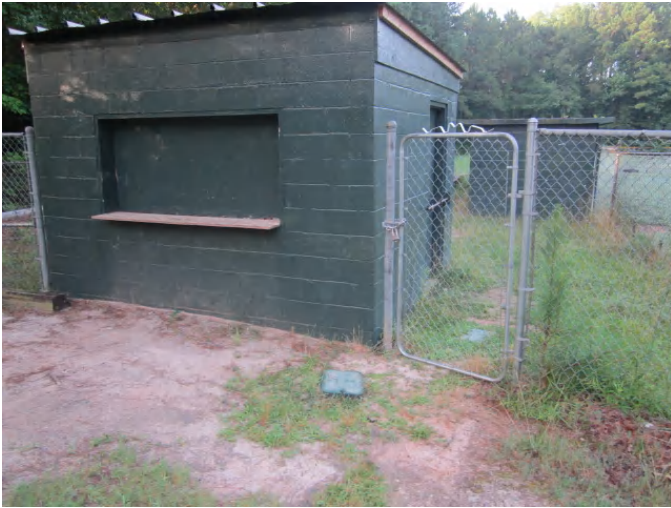
System: D2020 - Domestic Water Distribution

Location: Throughout building

Distress: Beyond Service Life

Notes: The system is beyond its expected service life, and should be scheduled for replacement. Domestic water distribution is aged, and should be replaced.

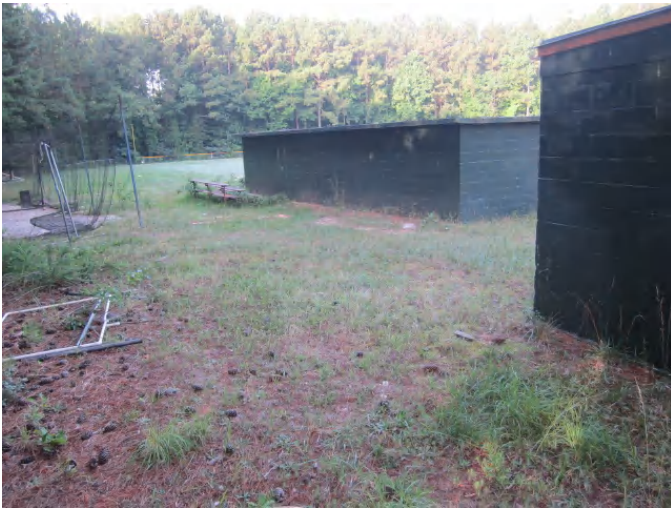
System: D2030 - Sanitary Waste

Location: Throughout Building

Distress: Beyond Service Life

Notes: The sanitary waste system is beyond its expected service life and should be scheduled for replacement.

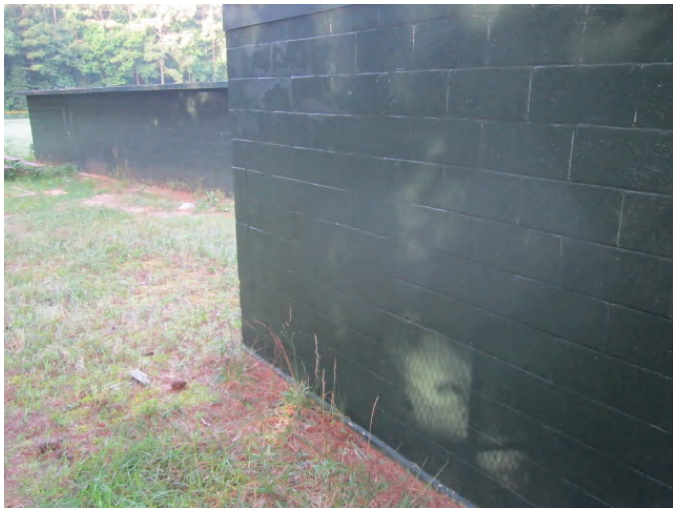
System: D5010 - Electrical Service/Distribution

Location: Throughout Building

Distress: Beyond Service Life

Notes: The electrical service/distribution system is beyond its expected service life and should be scheduled for replacement.

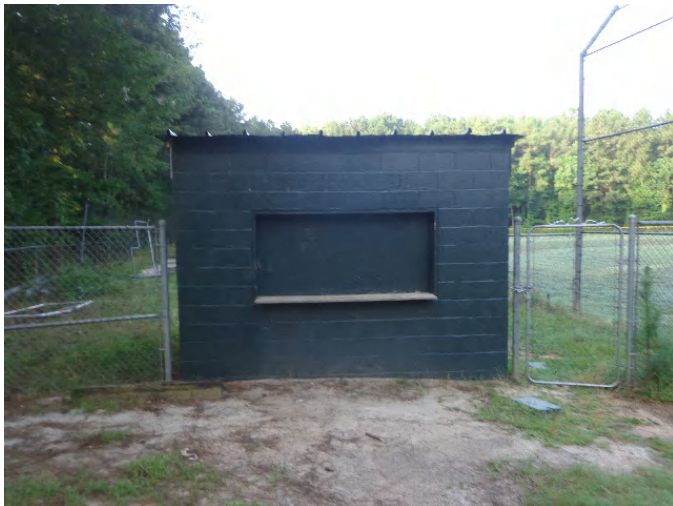
System: D5020 - Lighting and Branch Wiring

Location: Throughout Building

Distress: Beyond Service Life

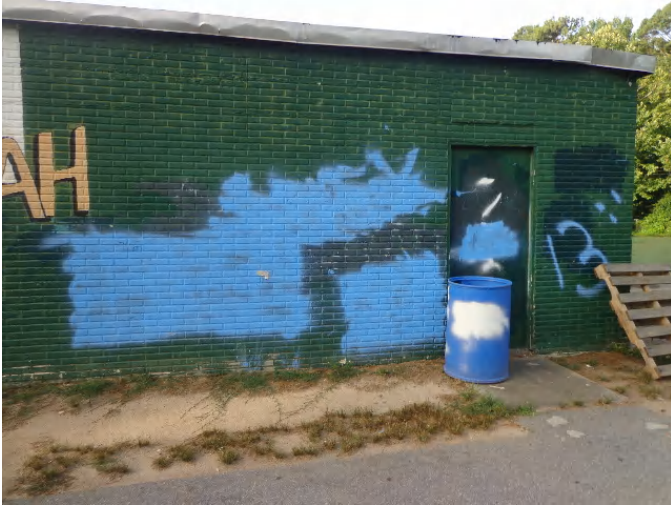
System: B2010 - Exterior Walls

Location: Exterior Walls

Distress: Beyond Service Life

Notes: The painted exterior wall finishes are aged and damaged, and should be replaced.

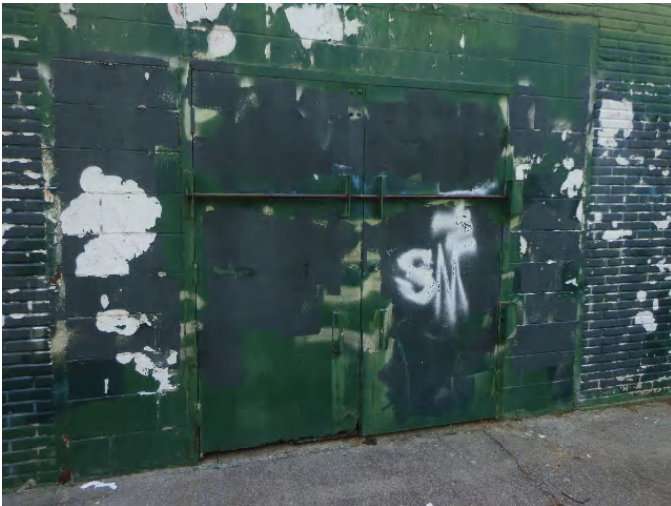
System: B2030 - Exterior Doors

Location: Exterior Wall

Distress: Beyond Service Life

Notes: The original exterior doors are aged, rusted, and should be replaced.

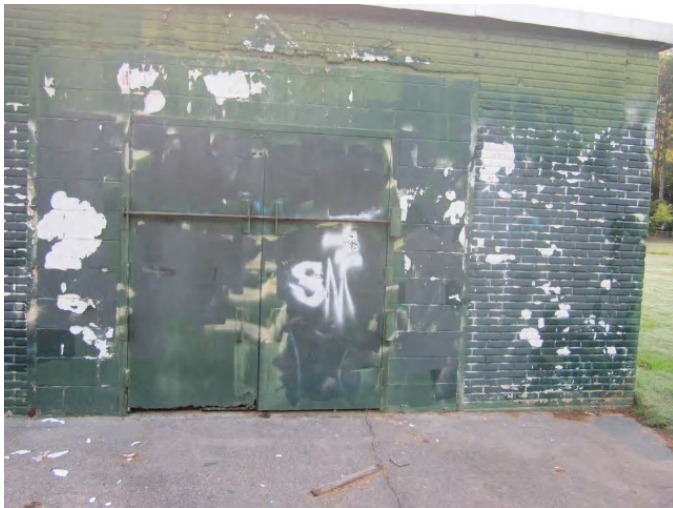
System: D5010 - Electrical Service/Distribution

Location: Throughout Building

Distress: Beyond Service Life

Notes: The electrical service/distribution system is beyond its expected service life and should be scheduled for replacement.

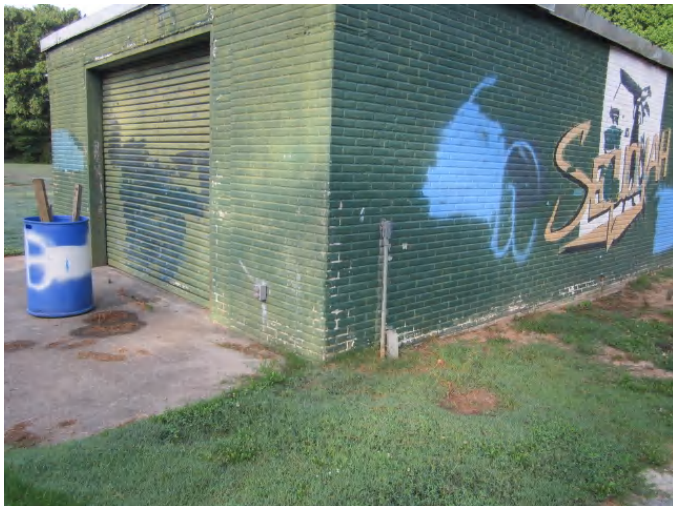
System: D5020 - Lighting and Branch Wiring

Location: Throughout Building

Distress: Beyond Service Life

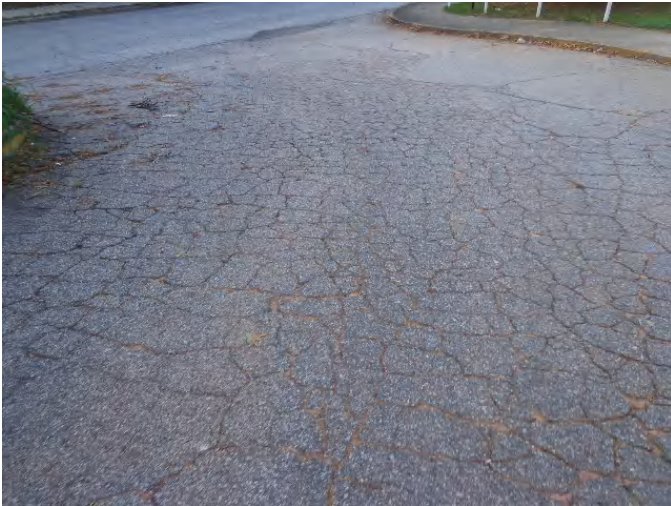
System: G2010 - Roadways

Distress: Beyond Service Life

Notes: The roadway is aged, has many cracks, and should be repaved.

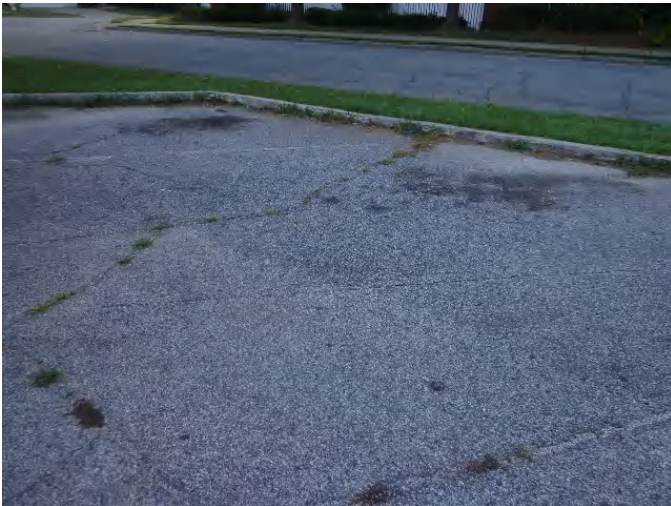
System: G2020 - Parking Lots

Distress: Beyond Service Life

Notes: The parking lot is aged, has many cracks, and should be resurfaced and re-striped. The front parking area does not have a designated ADA parking space and the available accessible space on the north side entrance does not meet ADA standards; it is missing a van accessible space, loading aisle, stripping from parking to sidewalk, and signage. SPLOST project 129-422 to provide ADA access from the parking lot to the front of the school building.

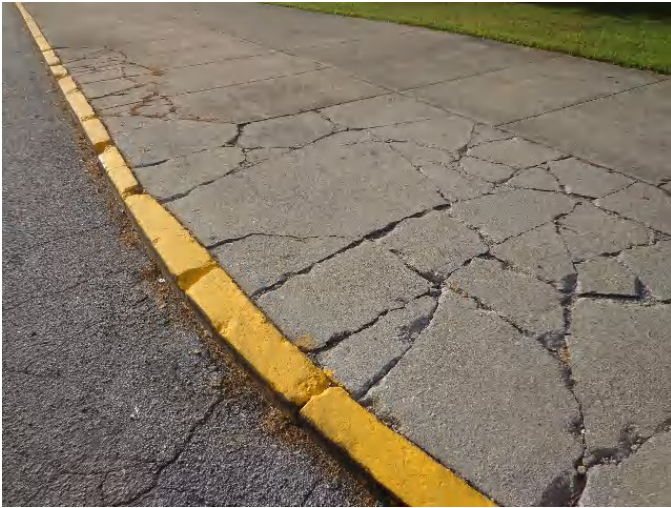
System: G2030 - Pedestrian Paving

Distress: Beyond Service Life

Notes: Pedestrian paving is aged and damaged, and should be replaced to include missing ramps per ADA standards. SPLOST project 129-422 to provide ADA access from the parking lot to the front of the school building by August 2016.

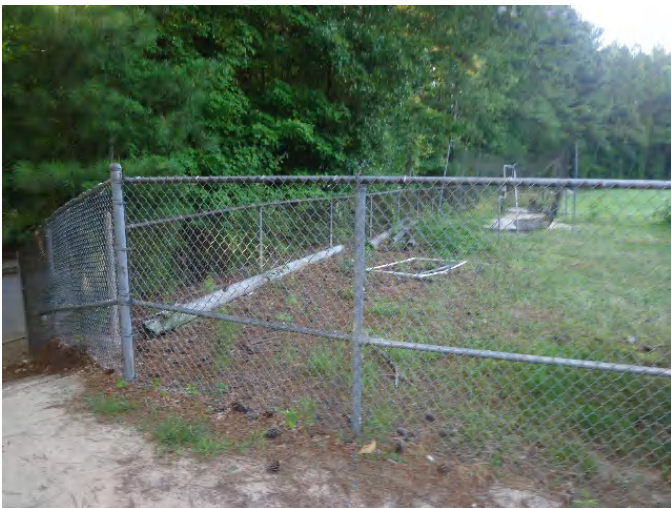
System: G2040 - Fencing & Guardrails

Distress: Beyond Service Life

Notes: The fence and gates are beyond their expected service life, rusted and failing, and should be scheduled for replacement.

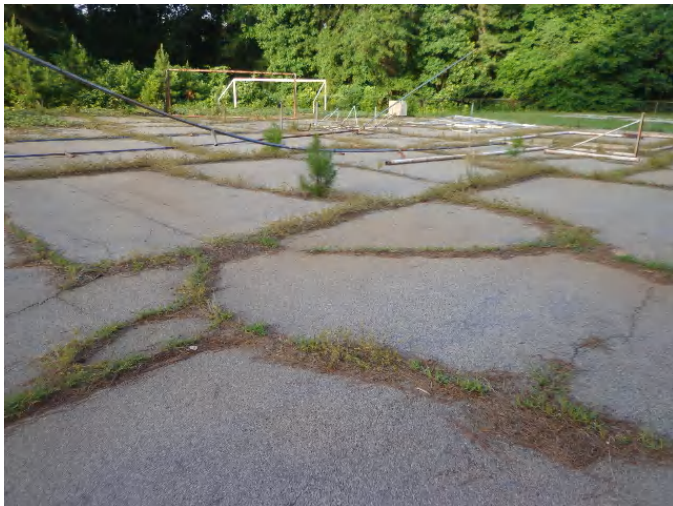
System: G2040 - Hard Surface Play Area

Distress: Beyond Service Life

Notes: The hard surface play area is beyond its expected service life, damaged, and should be replaced or demolished.

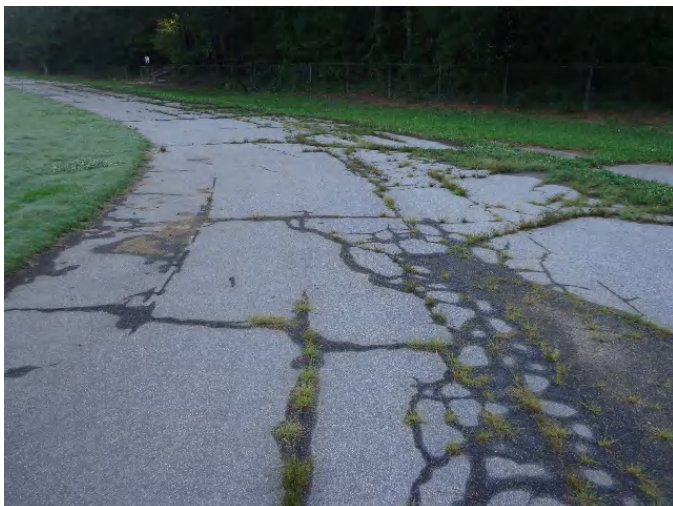
System: G2040 - Track

Distress: Beyond Service Life

Notes: Track is in deteriorating condition, with cracks and should be schedule for replacement.

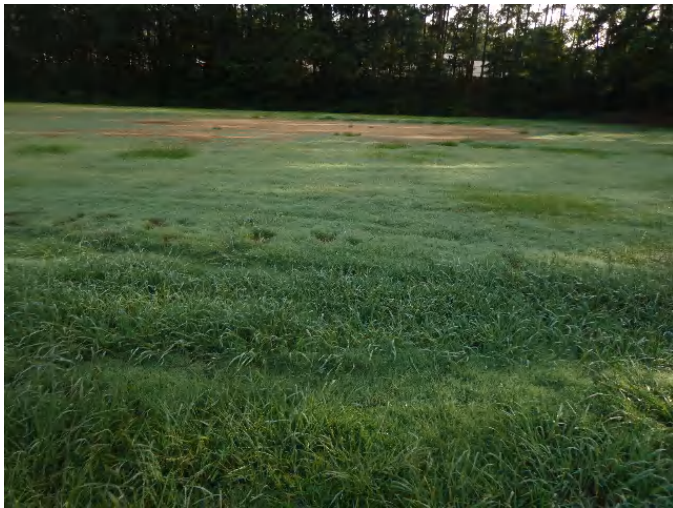
System: G2050 - Landscaping

Distress: Beyond Service Life

Notes: The landscaping is bare and worn, overgrown with weeds and eroded in areas, and should be replaced. Irrigation water supply not protected by reduced pressure backflow prevention device.

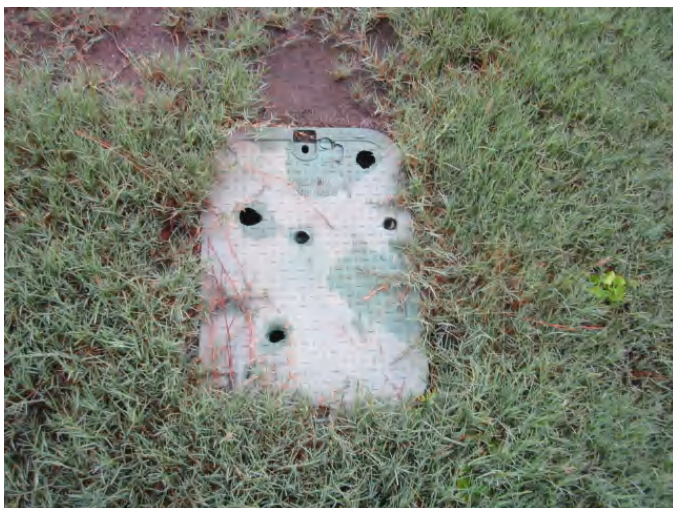
System: G3010 - Water Supply

Distress: Beyond Service Life

Notes: The water supply system is beyond its expected service life and should be scheduled for replacement. SPLOST project 129-422 to install a back flow preventer.

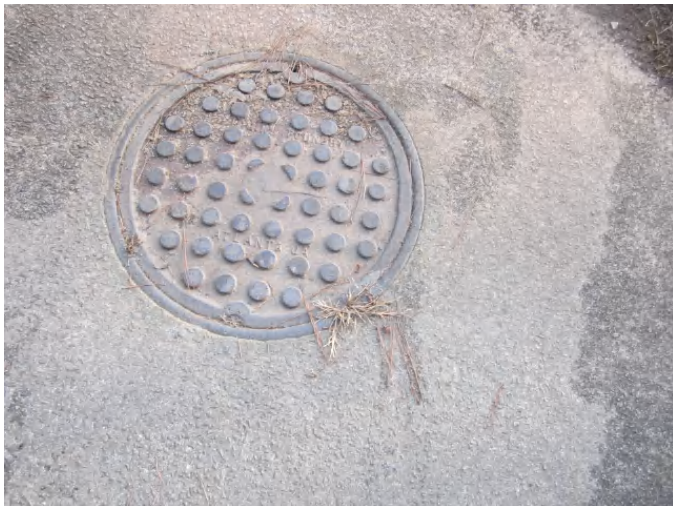
System: G3020 - Sanitary Sewer

Distress: Beyond Service Life

Notes: The sanitary sewer system is beyond its expected service life and should be scheduled for replacement. SPLOST project 129-422 to install a 3,000-gallon grease trap.

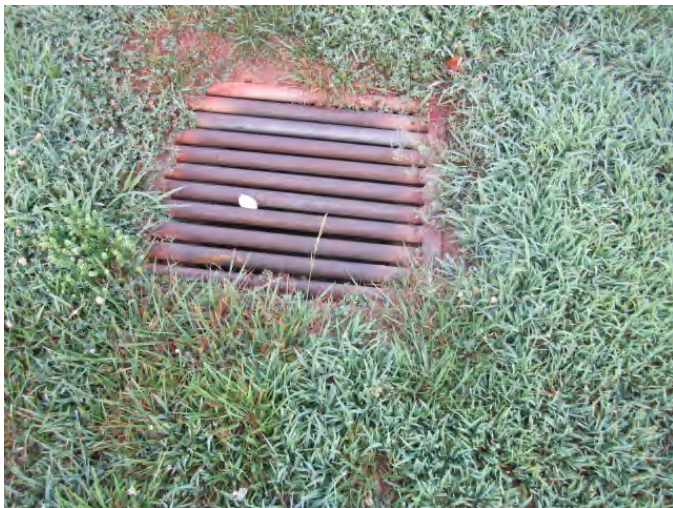
System: G3030 - Storm Sewer

Distress: Beyond Service Life

Notes: The storm sewer system is beyond its expected service life and should be scheduled for replacement.

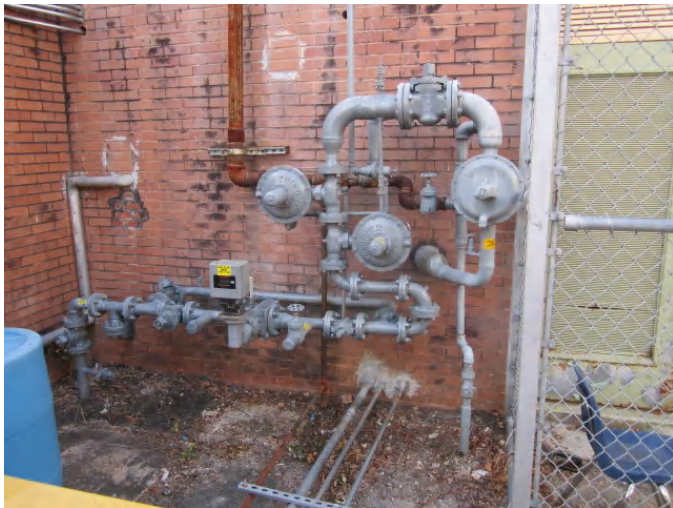
System: G3060 - Fuel Distribution

Distress: Beyond Service Life

Notes: Natural gas service is beyond its expected service life and should be scheduled for replacement.

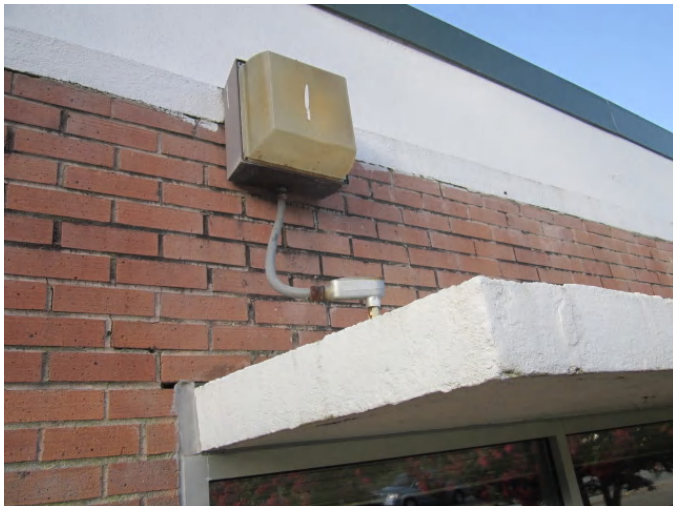
System: G4020 - Site Lighting

Distress: Beyond Service Life

Notes: Site lighting is beyond its expected service life, inadequate across the entire site, and should be replaced.

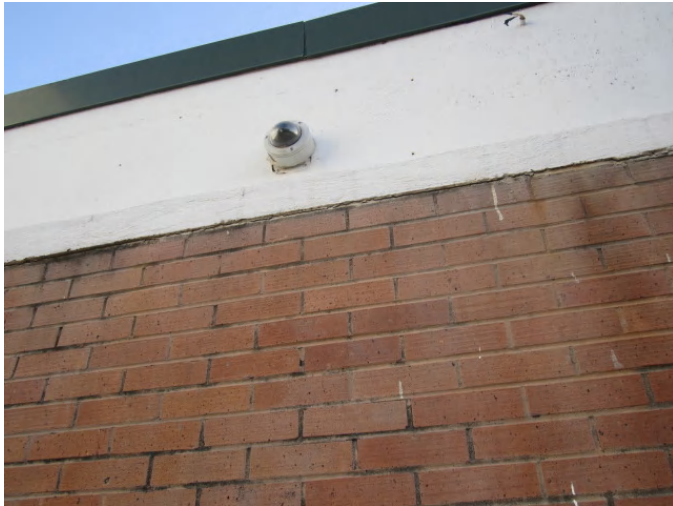
System: G4030 - Site Communications & Security

Distress: Beyond Service Life

Notes: Site communications and security systems are beyond their expected service life and should be scheduled for replacement.
