DeKalb County School District/High Schools

Stephenson High

School Assessment Report

May 20, 2016

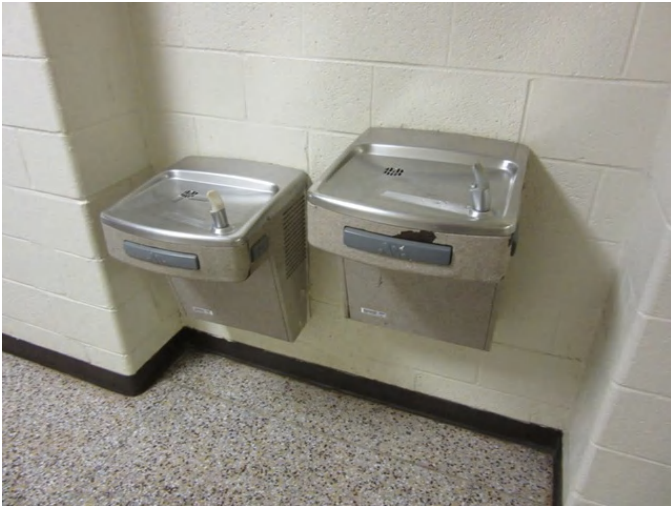
System: D2010 - Plumbing Fixtures

Location: Throughout Building

Distress: Beyond Service Life

Notes: The plumbing fixtures are severely worn and damaged, and should be scheduled for replacement.

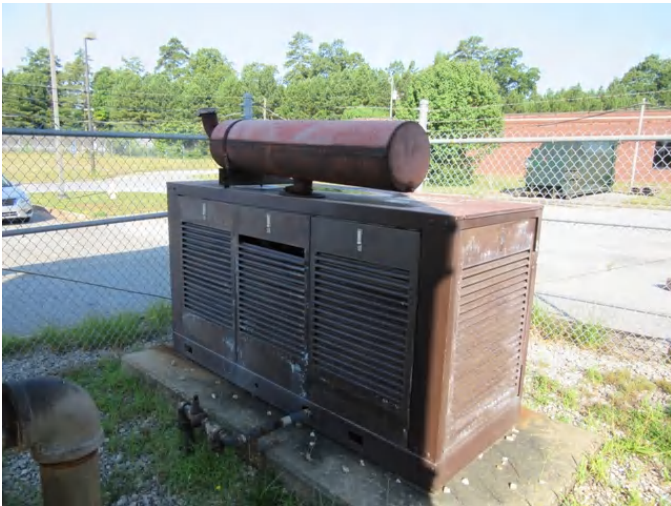
System: D5090 - Other Electrical Systems - Emergency Generator

Location: South Side of Building

Distress: Beyond Service Life

Notes: The emergency generator is beyond its expected service life, worn, rusted, and should be scheduled for replacement.

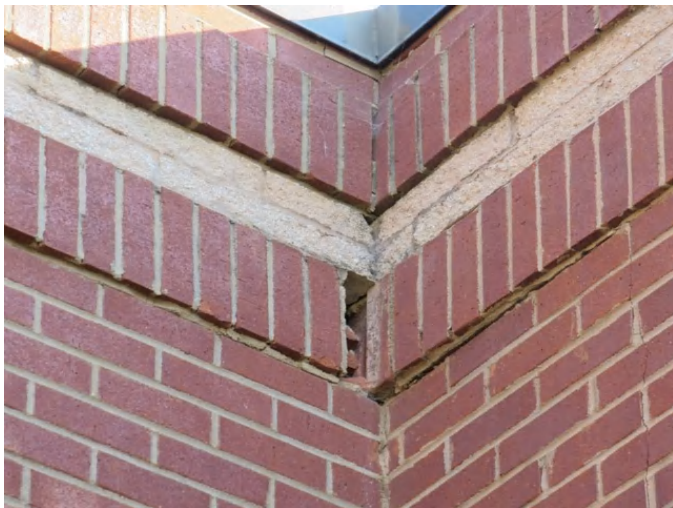
System: B2010 - Exterior Walls

Location: Exterior Walls

Distress: Damaged

Notes: Exterior walls are damaged and need to be repaired.

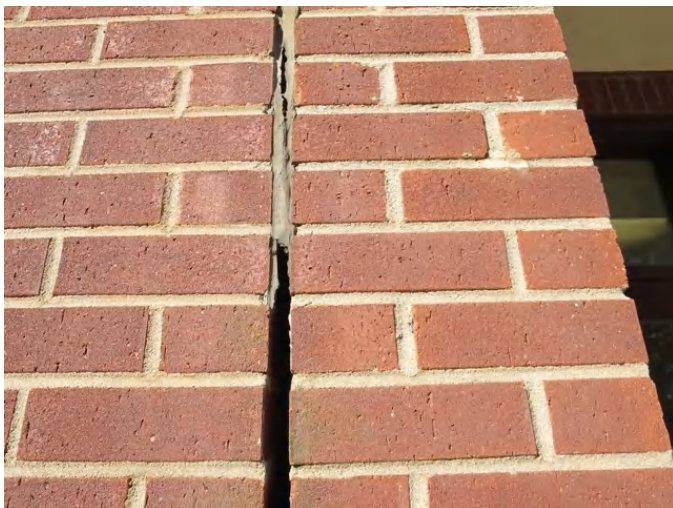
System: B2010 - Exterior Walls

Location: Exterior Walls

Distress: Damaged

Notes: Expansion joints are deteriorated and need to be replaced.

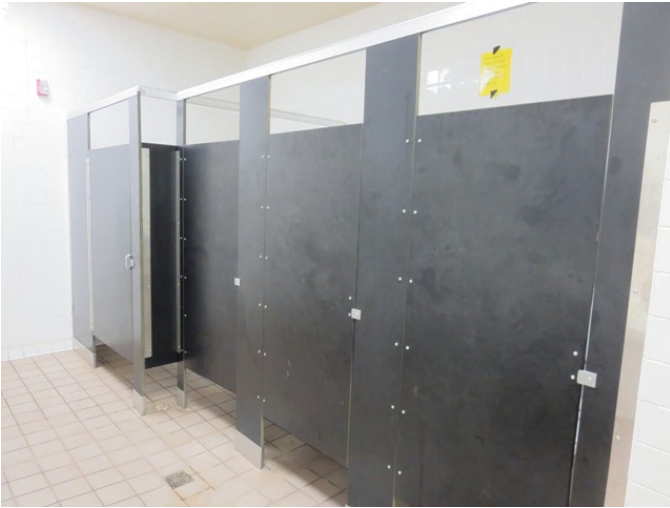
System: C1030 - Fittings

Location: Throughout Building

Distress: Beyond Service Life

Notes: Fittings, such as toilet partitions, handrails and signage, are beyond their expected service life, worn and damaged, and should be replaced.

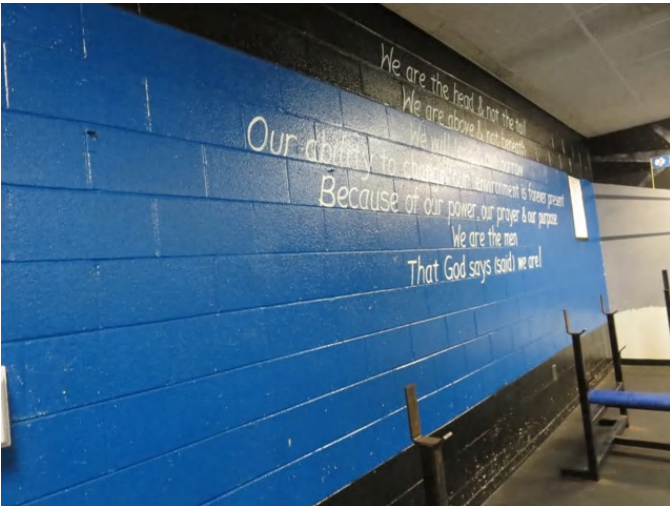
System: C3010 - Wall Finishes - Paint

Location: Throughout Building

Distress: Beyond Service Life

Notes: The painted wall finishes are beyond their expected service life, damaged and stained, and should be replaced.

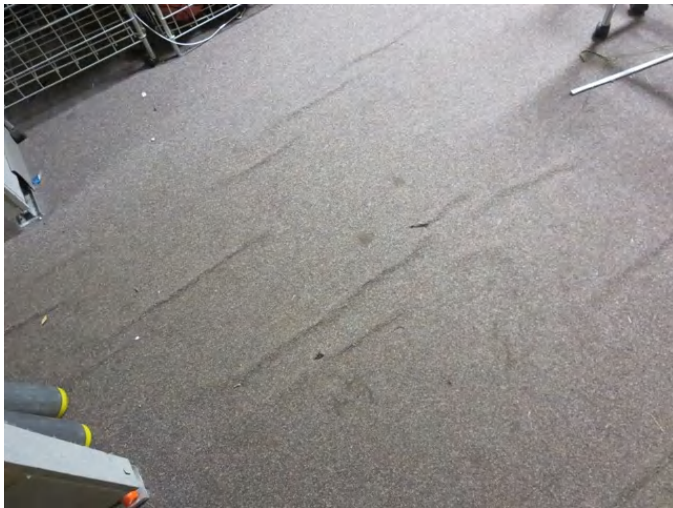
System: C3020 - Floor Finishes - Carpet

Location: Media Center, Gym

Distress: Beyond Service Life

Notes: The carpet is stained, showing signs of failure, and should be replaced.

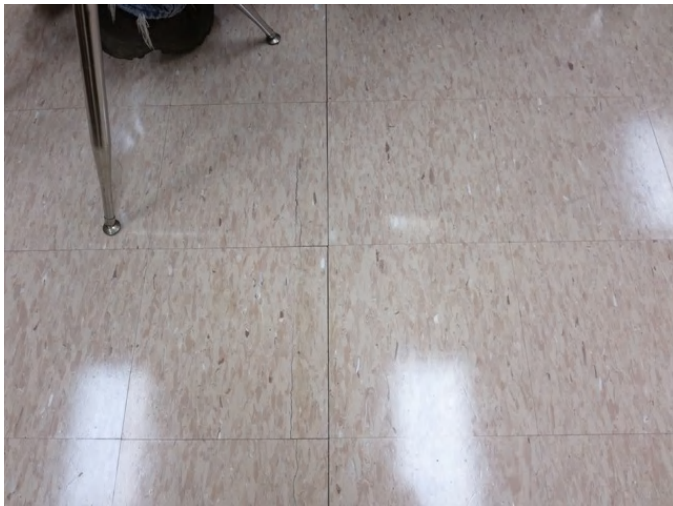
System: C3020 - Floor Finishes - VCT

Location: Throughout Building

Distress: Beyond Service Life

Notes: The VCT flooring is aged, cracked and worn, and should be replaced.

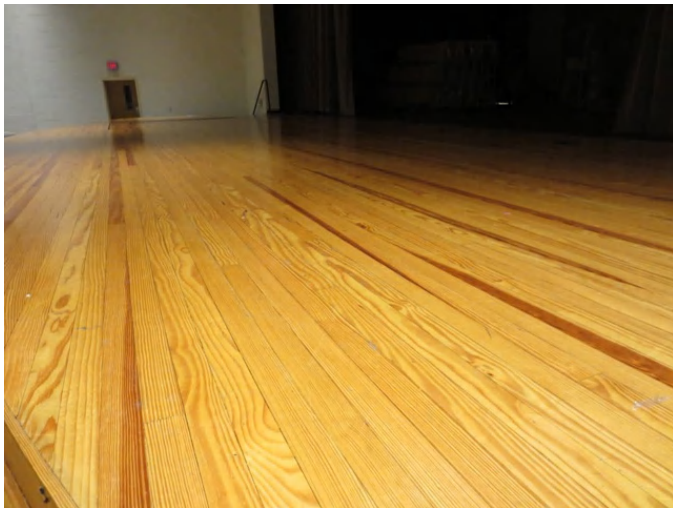
System: C3020 - Floor Finishes - Wood

Location: Gym and Stage

Distress: Beyond Service Life

Notes: The wood flooring is aged, worn, and should be renovated.

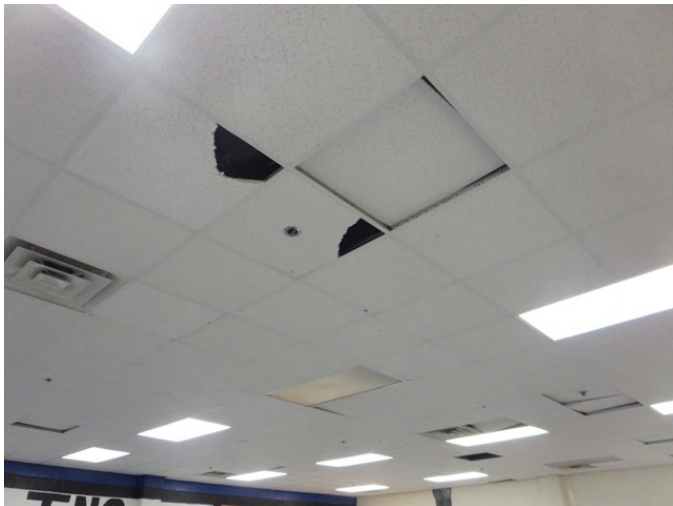
System: C3030 - Ceiling Finishes

Location: Throughout Building

Distress: Beyond Service Life

Notes: The acoustical ceiling system is deteriorating due to age and the environment, and should be replaced.

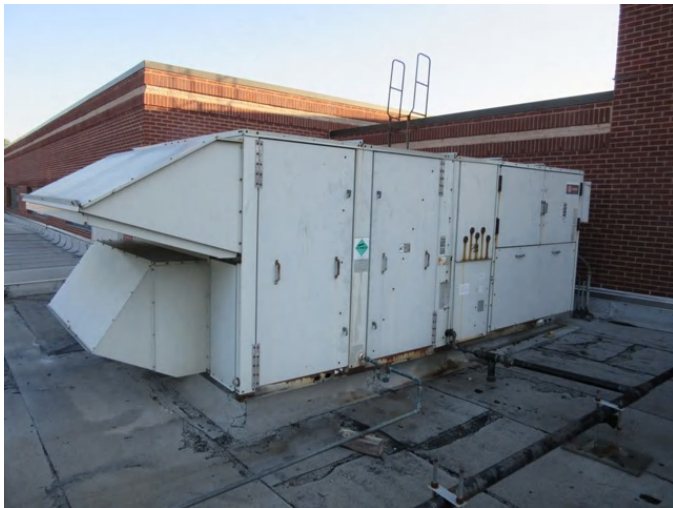
System: D3050 - Terminal & Package Units

Location: Roof

Distress: Beyond Service Life

Notes: The terminal and package units are beyond their expected service life and should be scheduled for replacement.

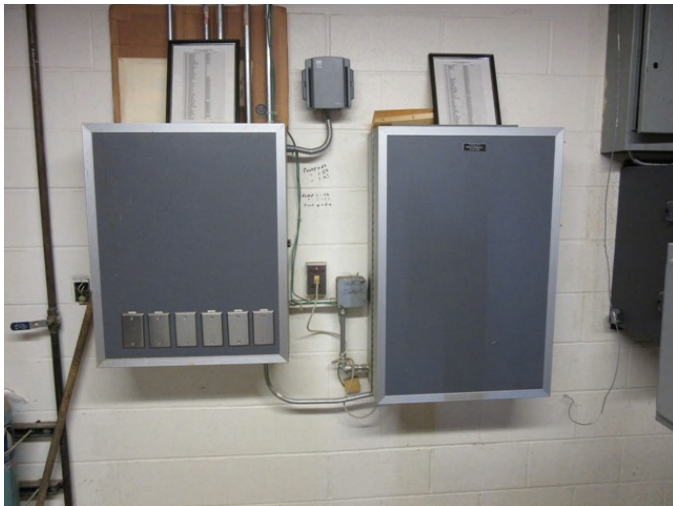
System: D3060 - Controls & Instrumentation

Location: Throughout Building

Distress: Beyond Service Life

Notes: The controls and instrumentation system is beyond its expected service life and should be scheduled for replacement.

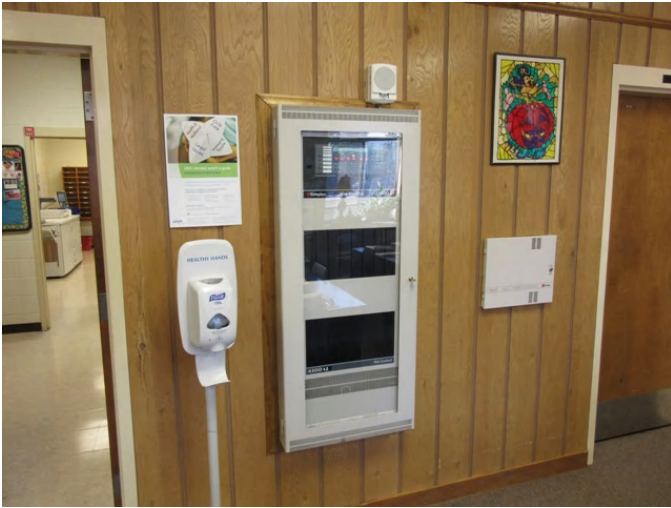
System: D5030 - Communications and Security - Fire Alarm

Location: Throughout Building

Distress: Beyond Service Life

Notes: The fire alarm system is beyond its expected service life and should be scheduled for replacement. Restrooms throughout the facility are in need of audible and visual (strobe) alarms.

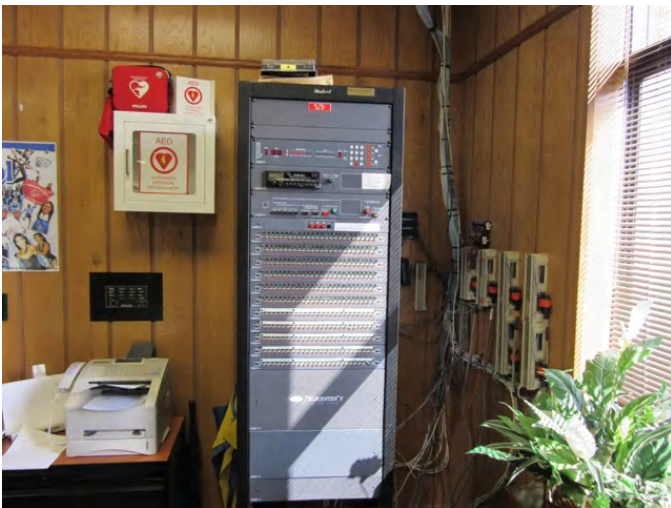
System: D5030 - Communications and Security - PA & Clock Systems

Location: Throughout Building

Distress: Beyond Service Life

Notes: PA and clock systems are beyond their expected service life and should be scheduled for replacement.

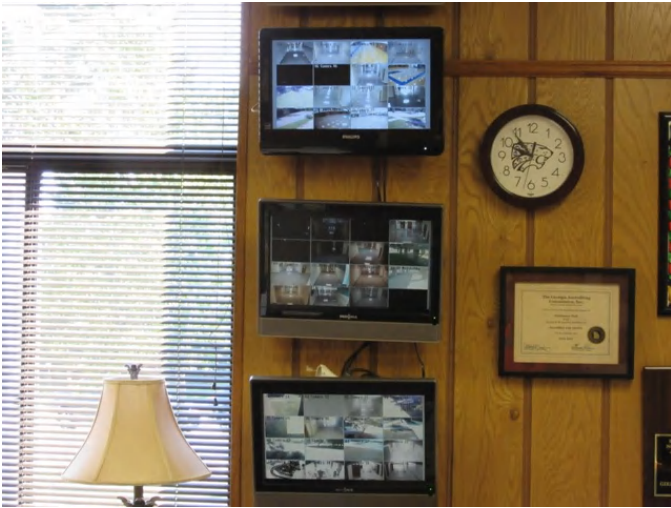
System: D5030 - Communications and Security - Security & CCTV

Location: Throughout Building

Distress: Beyond Service Life

Notes: The security and CCTV systems are beyond their expected service life and should be scheduled for replacement.

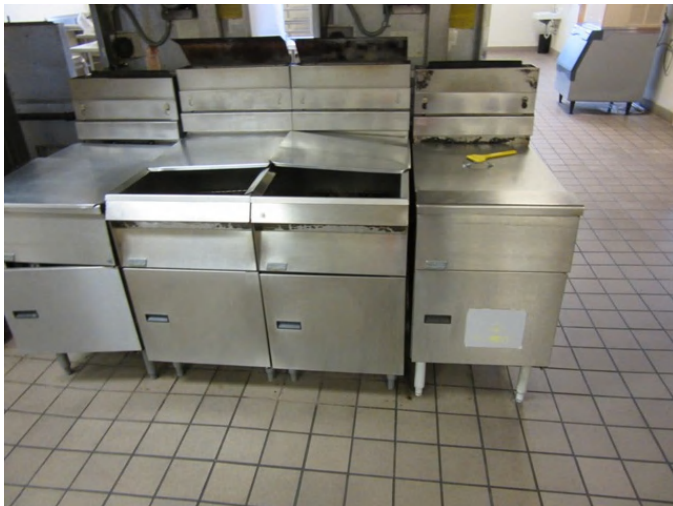
System: E1090 - Other Equipment - Kitchen Equipment

Location: Kitchen
Distress: Beyond Service Life
Category: Deferred Maintenance
Priority: 3 Priority
Correction: Renew System
Qty: 196,181.00
Unit of Measure: S.F.
Estimate: \$483,390.00
Assessor Name: Ben Nixon
Date Created: 04/11/2015

Notes: Kitchen equipment is beyond its expected service life and should be scheduled for replacement.

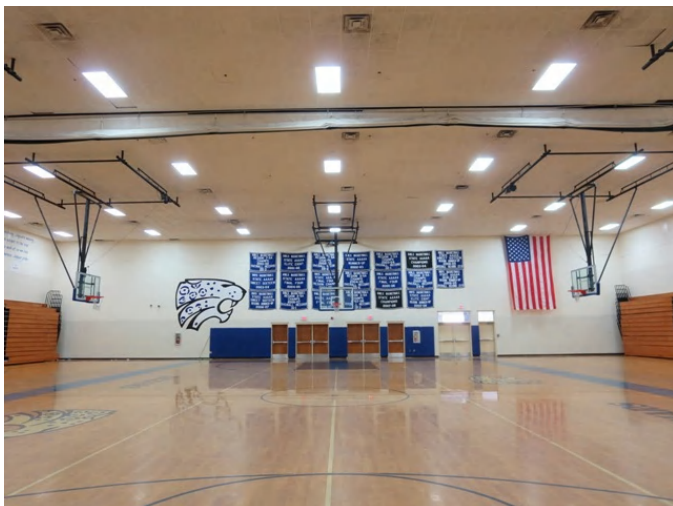
System: E1090 - Other Equipment - Sports Equipment

Location: Gym
Distress: Beyond Service Life
Category: Deferred Maintenance
Priority: 3 Priority
Correction: Renew System
Qty: 196,181.00
Unit of Measure: S.F.
Estimate: \$336,647.00
Assessor Name: Ben Nixon
Date Created: 12/11/2015

Notes: Sports equipment is beyond its expected service life and should be scheduled for replacement.

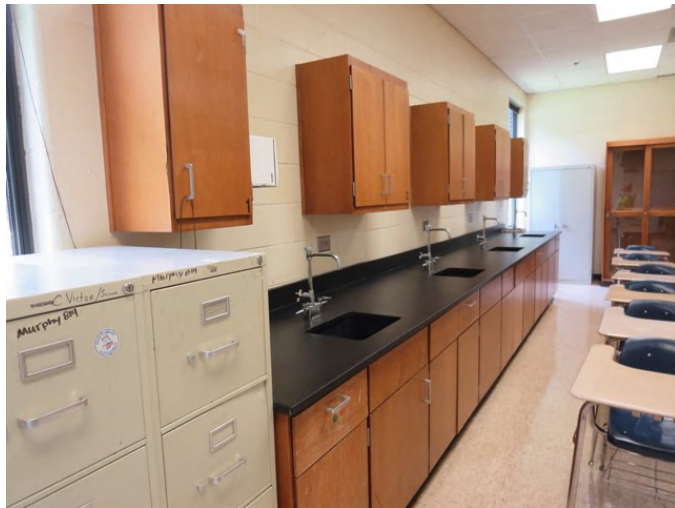
System: E2010 - Fixed Furnishings

Location: Throughout Building

Notes: Fixed furnishings, such as built-in cabinets, are beyond their expected service life and worn, and should be replaced.

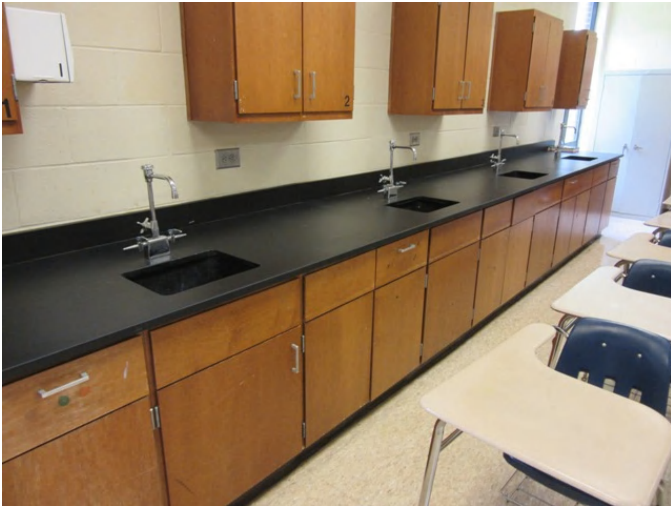
System: D5020 - Branch Wiring

Location: Science Labs

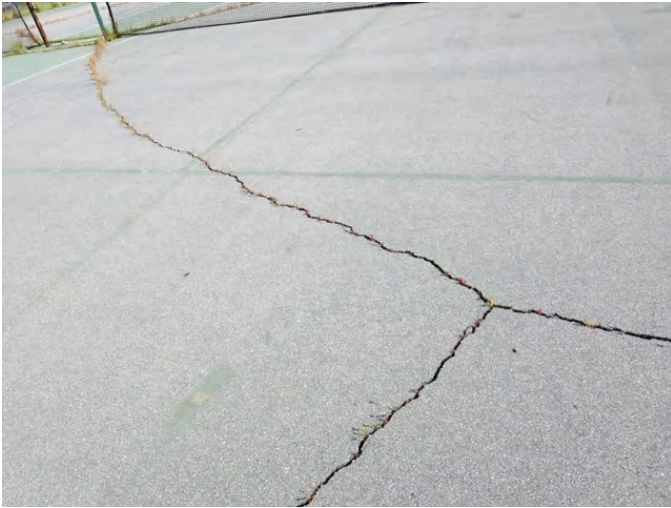
System: G2040 - Tennis Courts

Location: Site

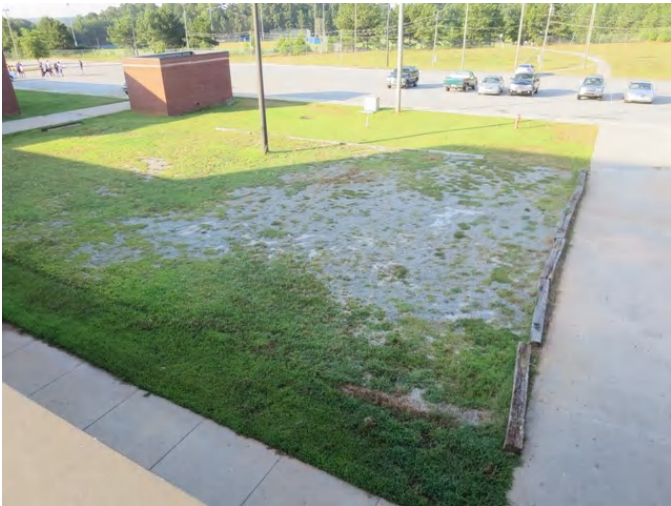
System: G2050 - Landscaping

Location: Site

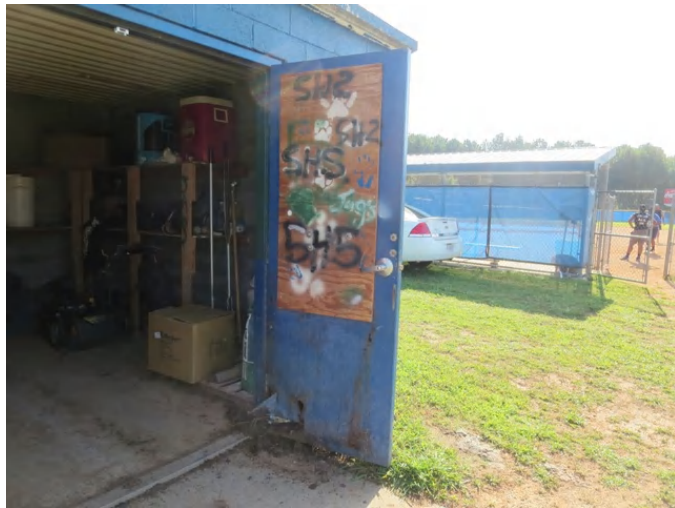
System: B2030 - Exterior Doors

Location: South Elevation
